Investigation Report

Block Island Transmission Cable Outage on November 18, 2022

EC-2022-39

STATE OF RHODE ISLAND DIVISION OF PUBLIC UTILITIES & CARRIERS

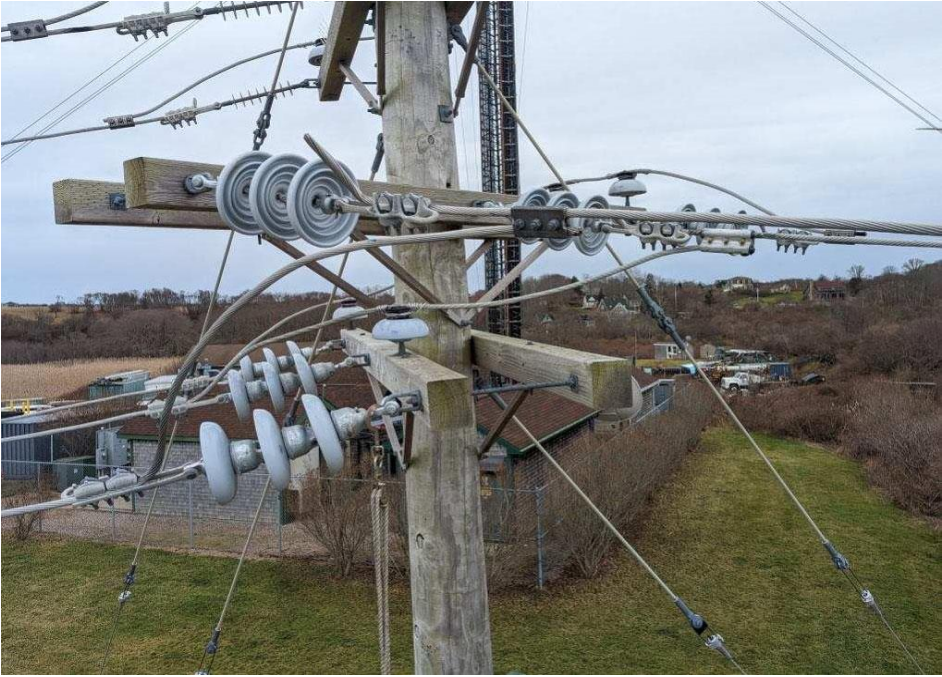
Below: Figure 1 pole 5 Beach Avenue Access Road

Per RIE, *“The following pictures are of the new porcelain suspension insulators installed at Pole 5 and Pole 6 Beach Avenue Access Road, Block Island, Rhode Island.”*

Although not the cause of this event, due to the location and exposure to coastal conditions, the Company replaced 18 35kV polymer insulators with porcelain type devices, which have smoother surfaces and allow rain to wash off accumulated salt and other contaminants more readily. Rhode Island Energy is further investigating

the use of higher voltage class insulators, which have more surface area and increase the distance from the energized conductor to ground, thus making them less prone to animal contact, tracking and flash over due to accumulated salt and other contaminants. Additionally, the Company is planning to install Smart Navigator LM HV DFCI directional faulted circuit indicators with smart controllers on the 160T1 and 165T1 overhead sections on Block Island. The Smart Navigator LM HV DFCI will communicate fault data to Rhode Island Energy's Energy Management System ("EMS") and fault information can then be used to help improve fault locating, response times, and restoration efforts. Finally, the Company is investigating the installation of Schweitzer SEL-T401L relays on the Block Island Transmission System ("BITS"). These relays utilize travelling wave technology to provide fault location accuracy within 200 feet.

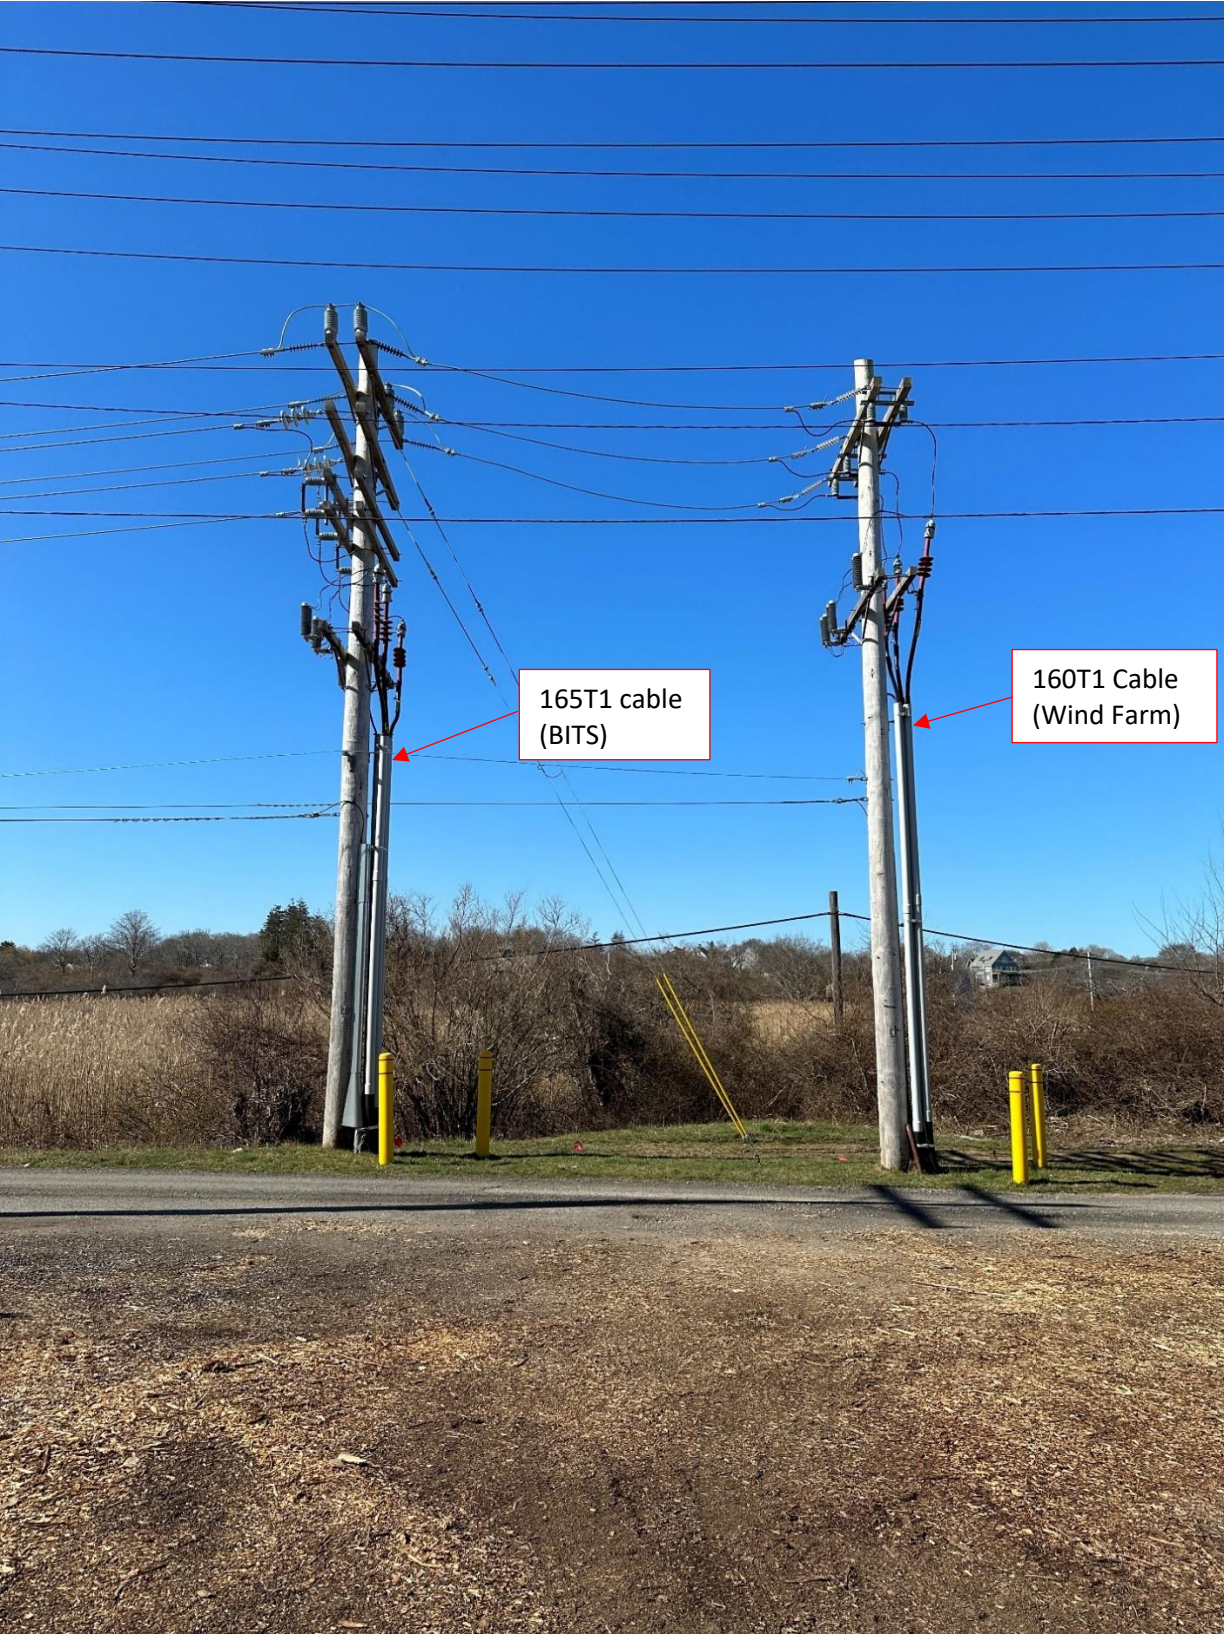
The location of the cause of the outage appears to have been along a 760-foot span of the aerial section of the BITS that is owned and maintained by RIE but is situated on the property of BIPCo.

Below: Figure 5 shows where the BITS transitions from underground to overhead

2. Installation of a recloser on Block Island where the BITS transitions from underground to the exposed bare wire overhead section. This recloser should have a reclosing feature that quickly restores power in response to a momentary fault condition (animal, tree branch, etc.). RIE could allow BIPCo the ability to operate this recloser to allow for de-energization for expedited and safer repairs potentially by BIPCo.

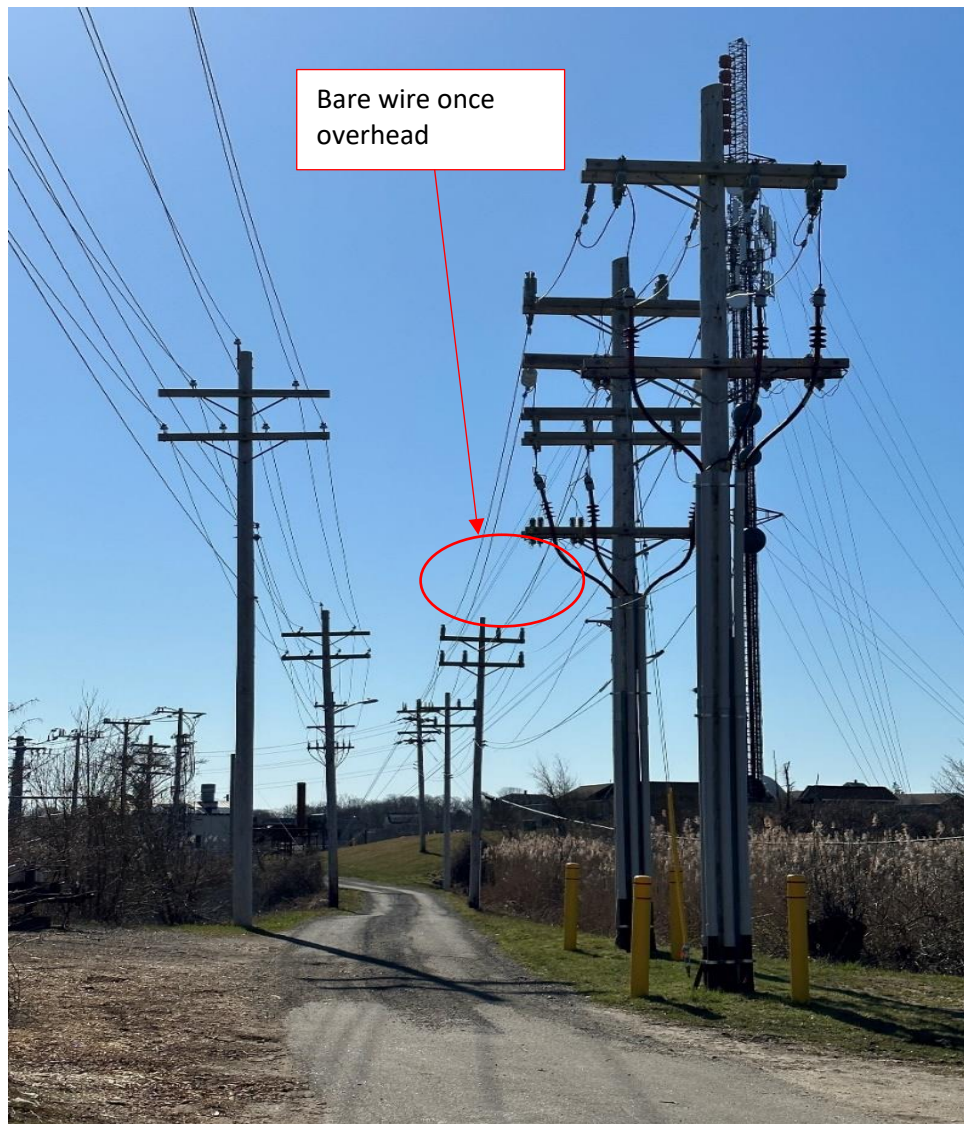
Below: Figure 6, is similar to Figure 5, showing the transition from underground to overhead (poles on the right side), but also shows the overhead going down Beach Access Road to the substations.¹⁰

¹⁰ **Onsite Visit:** On March 20, 2023, Robert Bailey, P.E., the Division’s Associate Public Utilities Administrator for Engineering and Pipeline Safety, and Joseph Shilling, E.I.T., a Division Public Utilities Engineering Specialist II, traveled to Block Island and met with Jeffery M. Wright, President of BIPCo, to look at the power grid. It was verified that the aerial section of the BITS is bare wire and vulnerable to outages.

The Division recommends that the exposed bare wire aerial section of the BITS facilities on Block Island be monitored for future outages. While moving these wires underground was discussed in the reports from both utility companies, doing so would require crossing the existing wetlands

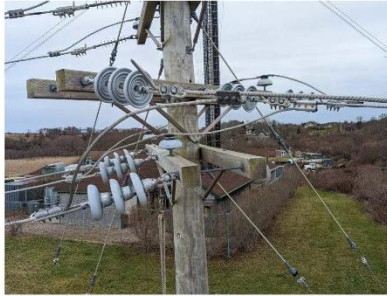
Figure 1 Pole 5 Beach Avenue Access Road

The following pictures are of the new porcelain suspension insulators installed at Pole 5 and Pole 6 Beach Avenue Access Road, Block Island, Rhode Island.

Although not the cause of this event, due to the location and exposure to coastal conditions, the Company replaced 18 35kV polymer insulators with porcelain type devices, which have smoother surfaces and allow rain to wash off accumulated salt and other contaminants more readily. Rhode Island Energy is further investigating the use of higher voltage class insulators, which have more surface area and increase the distance from the energized conductor to ground, thus making them less prone to animal contact, tracking and flash over due to accumulated salt and other contaminants.
