# Investigation Report

## Block Island Transmission Cable Outage on January 18, 2023

EC-2023-02

**DIVISION OF PUBLIC UTILITIES & CARRIERS**

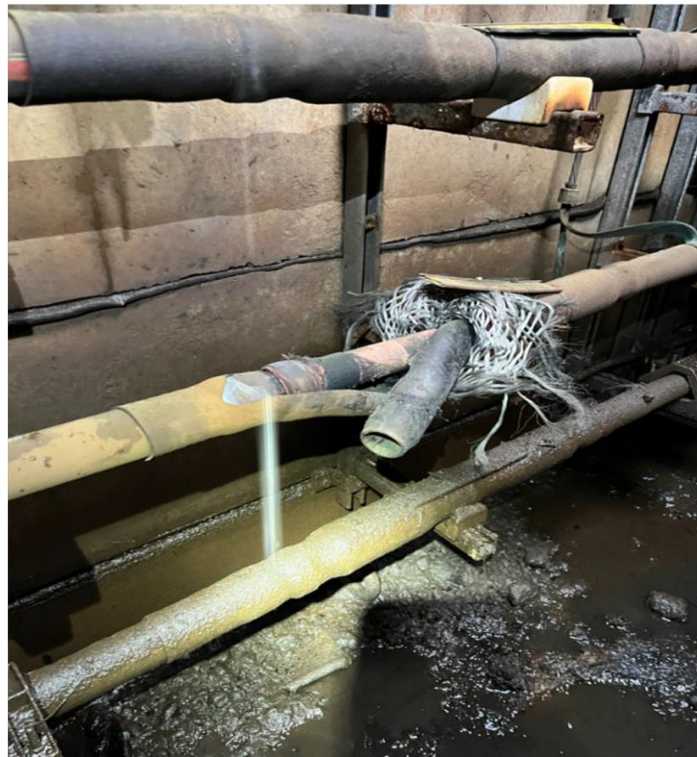
The cause of the outage was a failed electrical splice connection in manhole 9024 on Point Judith Road in Narragansett, Rhode Island. GPS coordinates are 41° 25' 53.40" N (Latitude), 71° 28' 53.68" W (Longitude).<sup>8</sup>

Below: Figure 1 shows the failed electrical splice in manhole 9024 on Point Judith Road

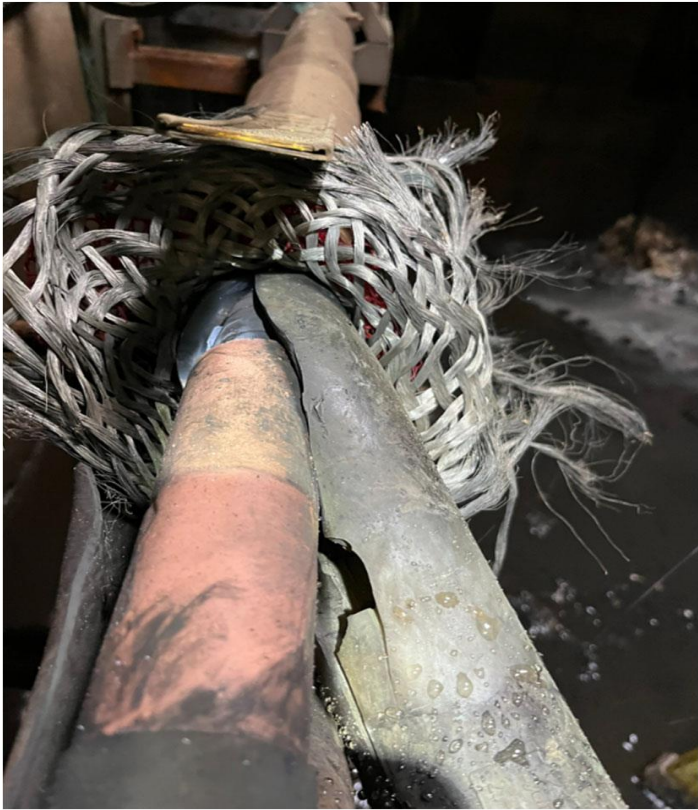
Below: Figure 2 shows additional pictures of the failed electrical splice in manhole 9024 on Point Judith Road

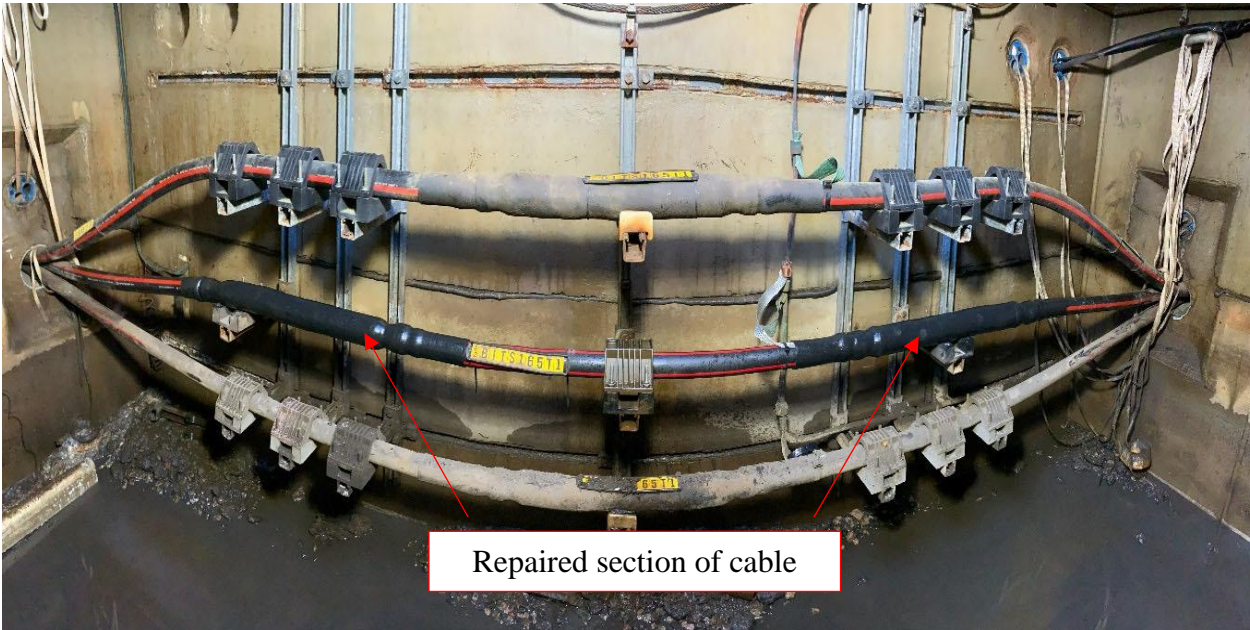
Below: Figure 3 shows a wide-angle photo of the failed electrical splice in manhole 9024 on Point Judith Road after repair.

<sup>16</sup> Figure 3 shows that the bottom and top cables have three (3) strain relieves/vertical supports on each side of the splices, however the middle cable (which was recently repaired) only has one strain relief in the middle with no strain relief on the outside of the splices and less vertical supports. Cable splice strain reliefs and supports are crucial to splice longevity and integrity.

2. Based on the NEETRAC analysis/evaluation of the existing cable support methods, the Division is requesting that RIE make all changes to add additional strain relief and vertical supports as necessary to all splices.<sup>16</sup>

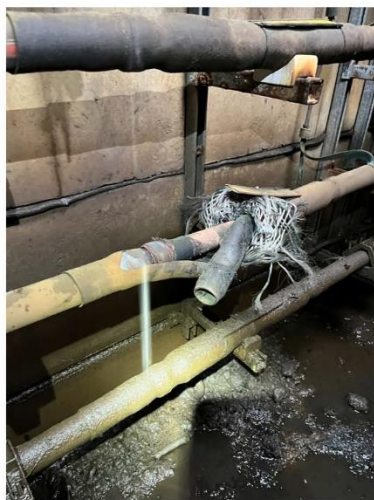
*Figure 1 MH 9024 Point Judith Road*

The following are pictures of the failed cable splice in MH 9024 Point Judith Road, Narragansett, Rhode Island.

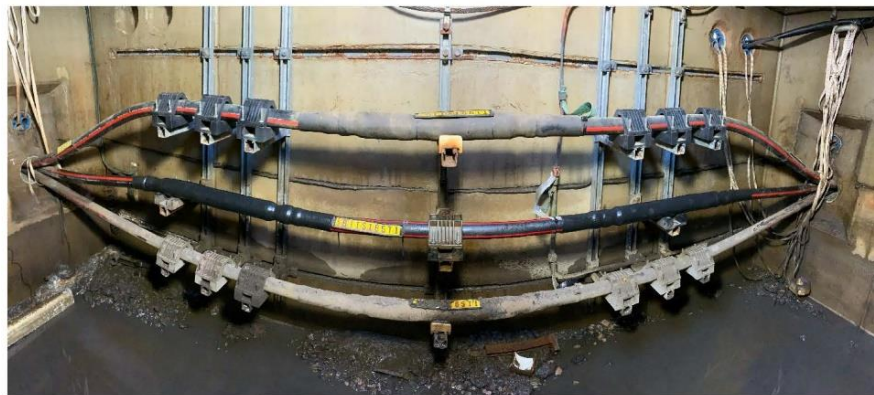
*Figure 3 MH 9024 Point Judith Road*

The following picture shows cable repairs in MH 9024 Point Judith Road, Narragansett, Rhode Island.
