**RE: Commission Investigation relating to Stray and Contact Voltage Occurring in
Narragansett Electric Company Territories
Responses to Commission Data Requests (Set 1)**

The Narragansett Electric Company
d/b/a National Grid
In Re: Commission Investigation Relating to Stray and Contact Voltage
Occurring in Narragansett Electric Company Territories
Responses to Commission Data Requests (Set 1)
Issued on March 1, 2011

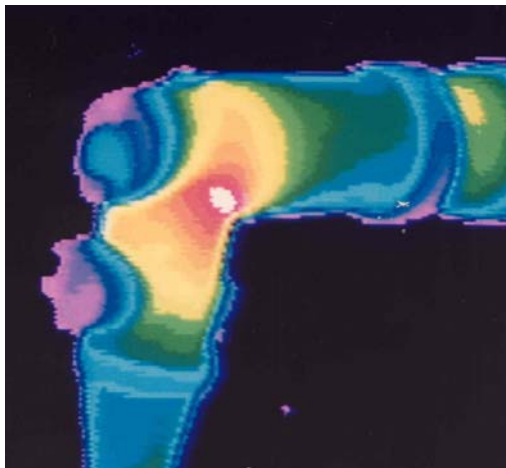
Defective 200A Elbow – Real Time IR Scan

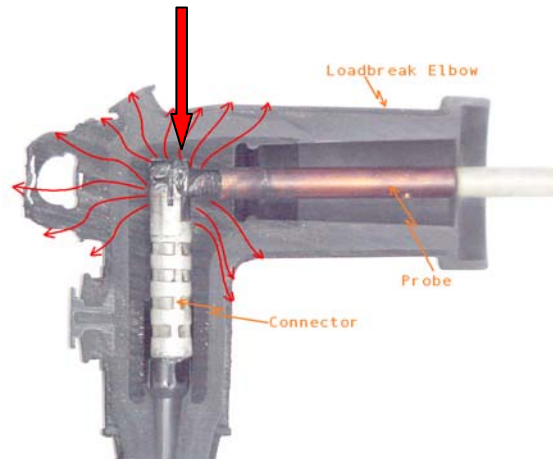
Cutaway showing connector defect and heat path

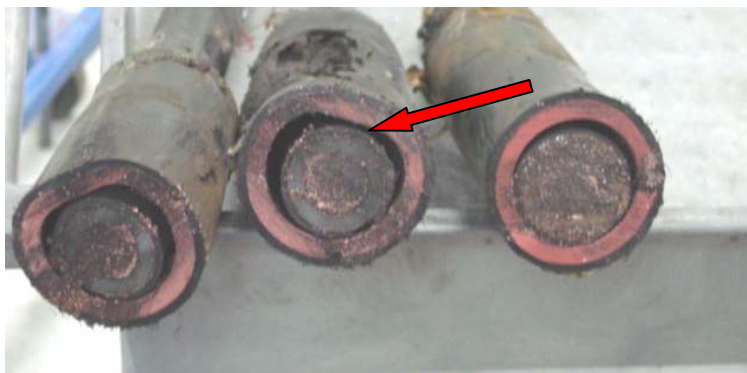
Figure 1: Voids between tubes

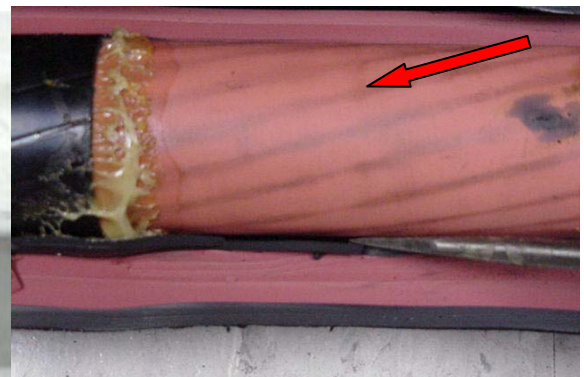
3. Cable end preparation: The semicon cutbacks must be smooth and the insulation surface thoroughly cleaned. A jagged semicon cutback is an electrical stress point which will eventually fail. When semicon material is not cleaned from the insulation, tracking will occur along the insulation surface causing the splice to fail (see Figure 2).

Figure 2: Semicon material
