RE: Docket 5209 - Proposed FY 2023 Electric Infrastructure, Safety, and Reliability Plan Responses to Data Requests - Division Set 4

Division 4-1

Regarding the 3763 Line Structure Replacements project (Section 2, page 48):

ANOMALY REPORT

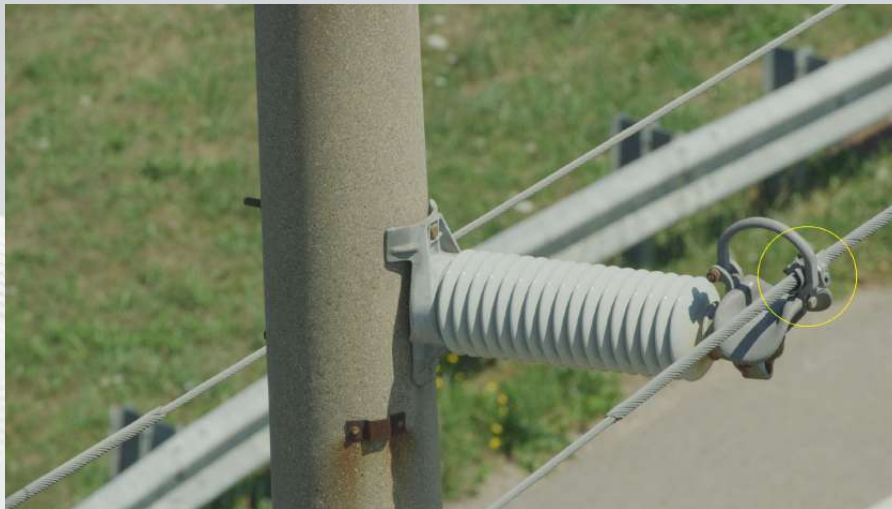
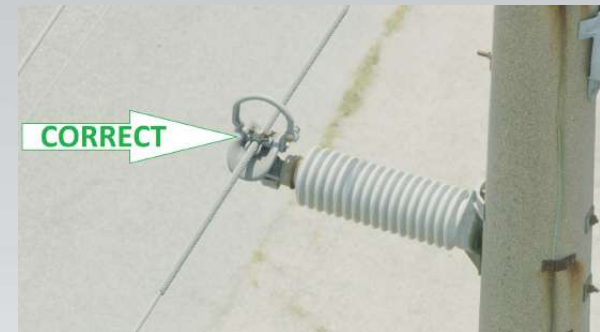
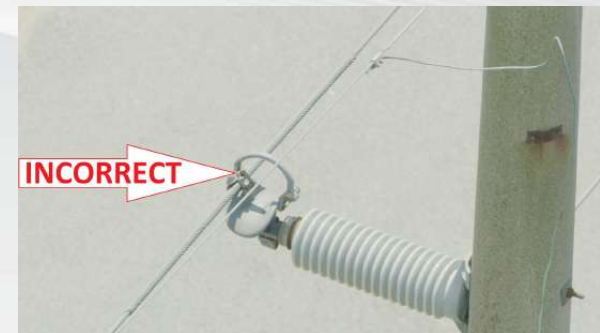
Anomaly: 28

Anomaly Rating		Anomaly Description				Anomaly Type	
2		The conductor clamp trunion saddle bolts have let go and the wire is loose but trapped inside a retainer ring on the top left phase.				Visual	
Circuit	3763	Location	3763_STR54_2030374	GPS	41.538015 -71.309654	Inspector Date	Darin McMaster Jul 26, 2020

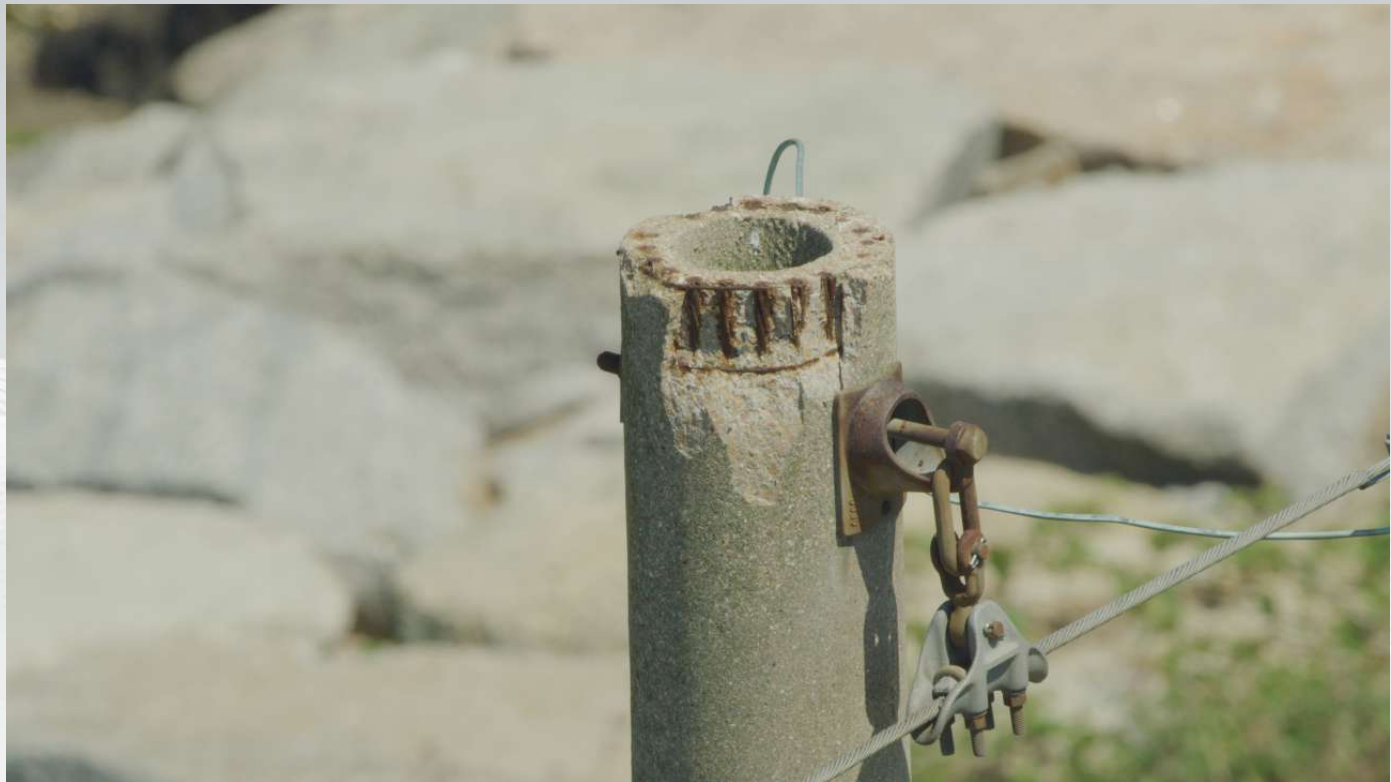
Anomaly: 30

Anomaly Rating		Anomaly Description				Anomaly Type	
3		The top of the concrete pole is damaged.				Visual	
Circuit	3763	Location	3763_STR55_2030378	GPS	41.537591 -71.310091	Inspector Date	Darin McMaster Jul 26, 2020

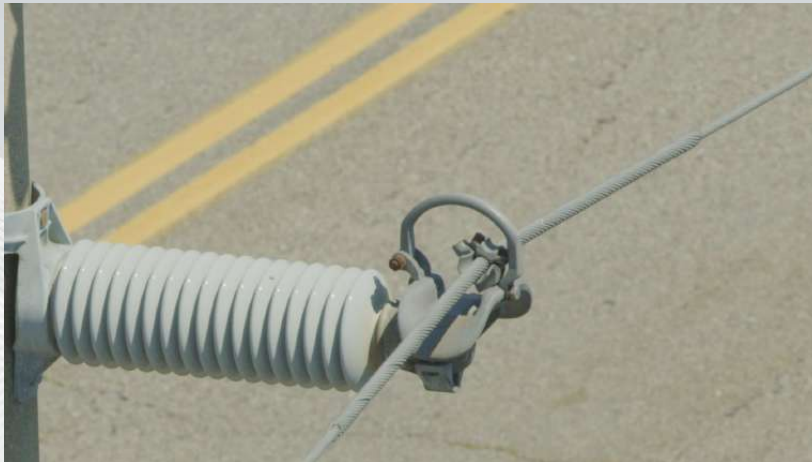
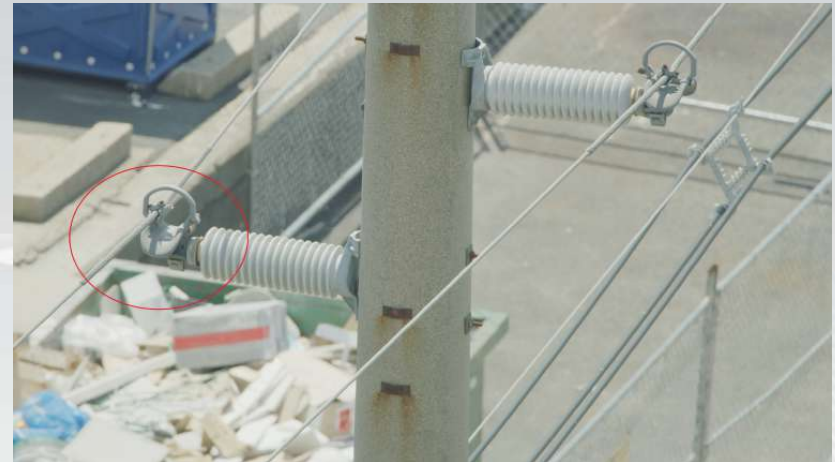
Anomaly: 31

Anomaly Rating		Anomaly Description				Anomaly Type	
2		The conductor clamp trunnion saddle bolts have let go and the wire is loose but trapped inside a retainer ring on the bottom left phase.				Visual	
Circuit	3763	Location	3763_STR57_2030386	GPS	41.536506 -71.311178	Inspector Date	Darin McMaster Jul 26, 2020

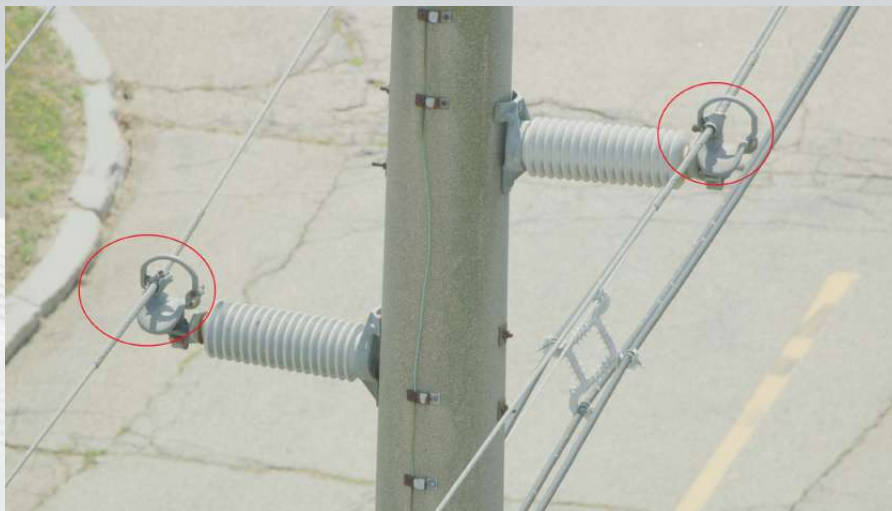
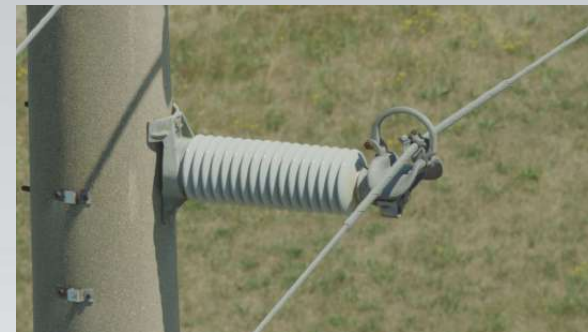
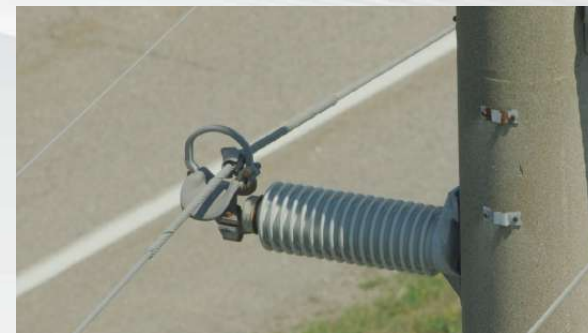
Anomaly: 32

Anomaly Rating		Anomaly Description				Anomaly Type	
2		The conductor clamp trunnion saddle bolts have let go and the wire is loose but trapped inside a retainer ring on the bottom left and right phases.				Visual	
Circuit	3763	Location	3763_STR58_2030390	GPS	41.535886 -71.311615	Inspector Date	Darin McMaster Jul 26, 2020

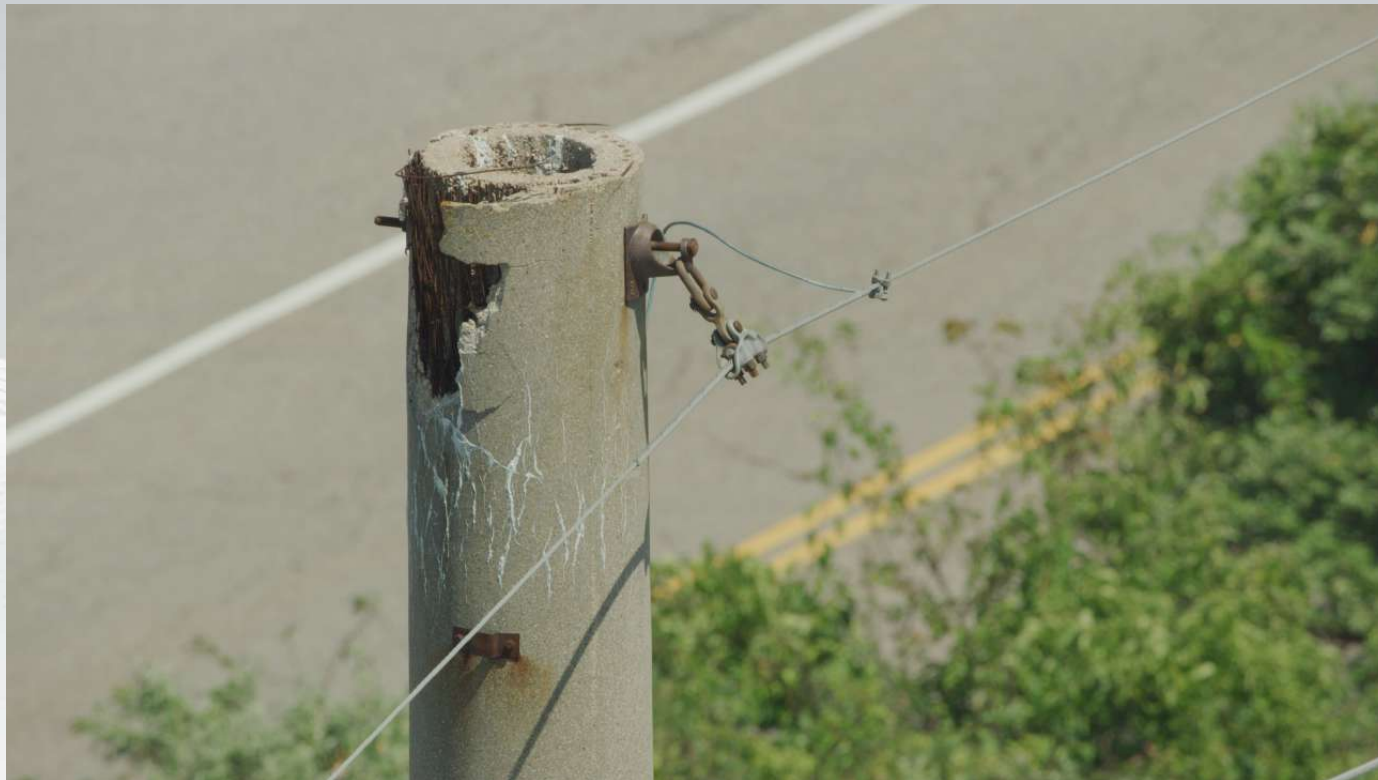
Anomaly: 33

Anomaly Rating		Anomaly Description				Anomaly Type	
3		The top of the concrete pole is damaged.				Visual	
Circuit	3763	Location	3763_STR59_2030394	GPS	41.535145 -71.312035	Inspector Date	Darin McMaster Jul 26, 2020

- f) Yes, the Company considered alternatives to concrete poles. Concrete poles are not a National Grid standard line structure. All 10 structures requiring replacement will be replaced with light duty steel structures. Structure 59 was already replaced in calendar year 2021 with a light duty steel direct embed structure. For the 10 remaining concrete structures requiring replacement, 8 will be directly embedded engineered steel. The material thickness and design will be specific to the needs of the structure. Two structures will have foundations due to the angle of the line and limitations of the right of way. These structures are in a coastal area with restricted access and critical need. The selection of the structures to be used for this project are specific to the project and designed to meet the project needs. No alternative cost estimates were prepared as the selected option is the one that meets current company standards. There is no alternative for replacing the structures as the 3763 line is essential to continue providing electric service to this area.

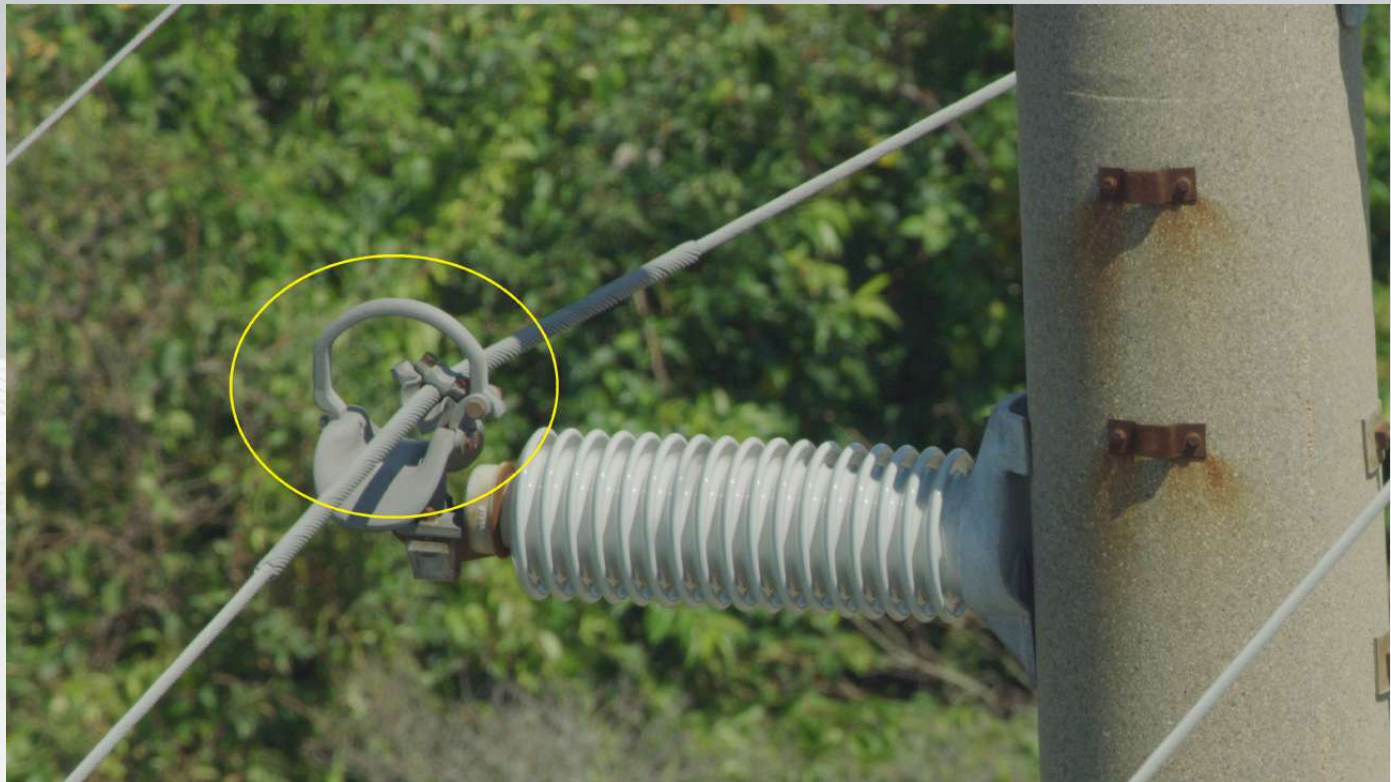
Anomaly: 34

Anomaly Rating		Anomaly Description				Anomaly Type	
2		The conductor clamp trunnion saddle bolts have let go and the wire is loose but trapped inside a retainer ring on the right phase.				Visual	
Circuit	3763	Location	3763_STR60_2030398	GPS	41.534378 -71.312373	Inspector Date	Darin McMaster Jul 26, 2020

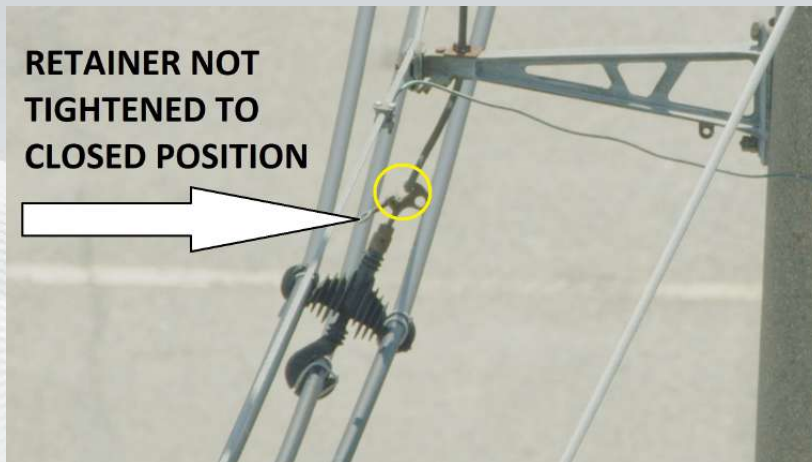
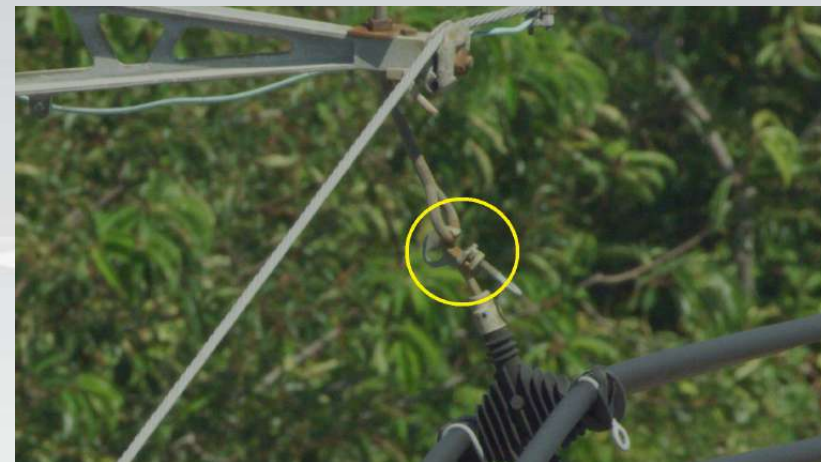
Anomaly: 35

Anomaly Rating		Anomaly Description				Anomaly Type	
2		The SPAC distribution suspension hardware has a hot line type fitting that is not screwed closed on the suspension eye bolt.				Visual	
Circuit	3763	Location	3763_STR61_2030402	GPS	41.533572 -71.312585	Inspector Date	Darin McMaster Jul 26, 2020

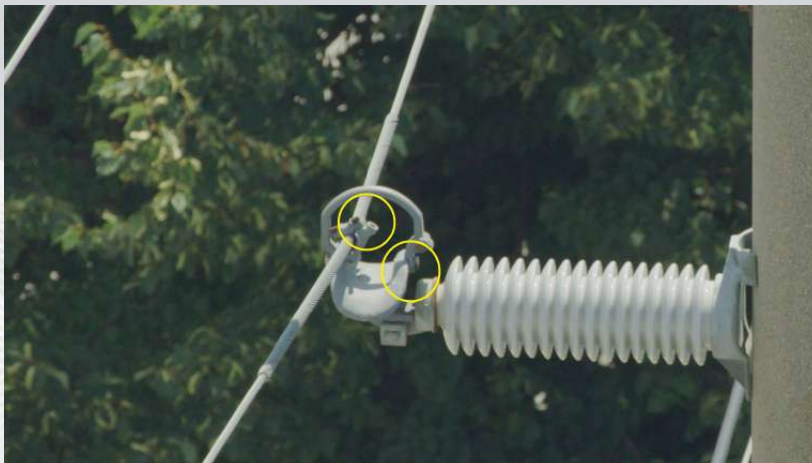
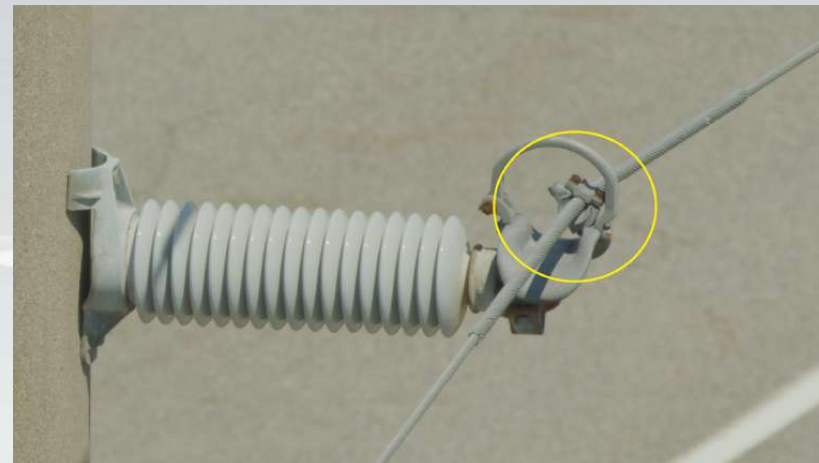
Anomaly: 36

Anomaly Rating		Anomaly Description				Anomaly Type	
2		The conductor clamp trunnion saddle bolts have let go and the wire is loose but trapped inside a retainer ring on the bottom left phase.				Visual	
Circuit	3763	Location	3763_STR62_2030406	GPS	41.532765 -71.312659	Inspector Date	Darin McMaster Jul 26, 2020

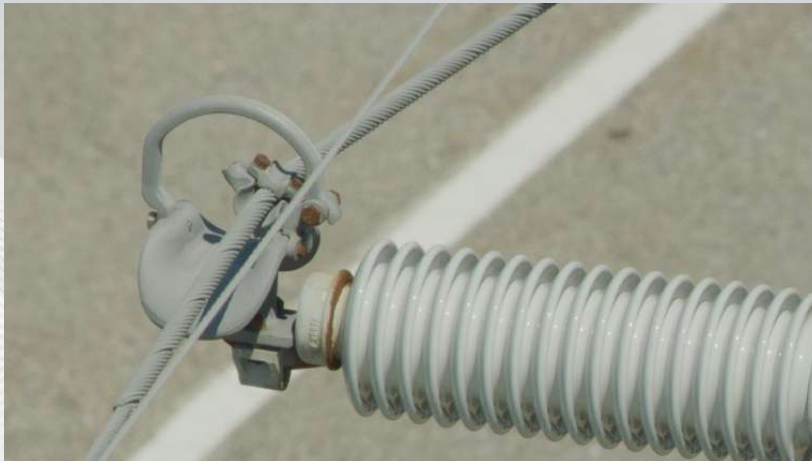
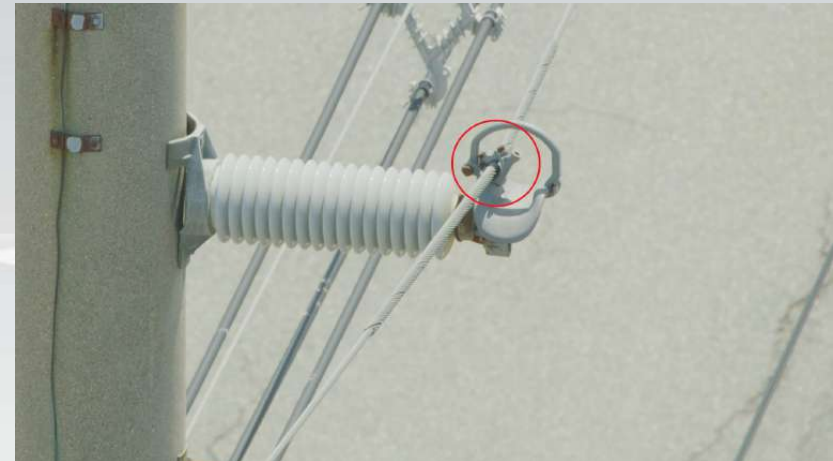
Anomaly: 37

Anomaly Rating		Anomaly Description				Anomaly Type	
2		The conductor clamp trunnion saddle bolts have let go and the wire is loose but trapped inside a retainer ring on the right phase.				Visual	
Circuit	3763	Location	3763_STR63_2030410	GPS	41.531947 -71.312603	Inspector Date	Darin McMaster Jul 26, 2020

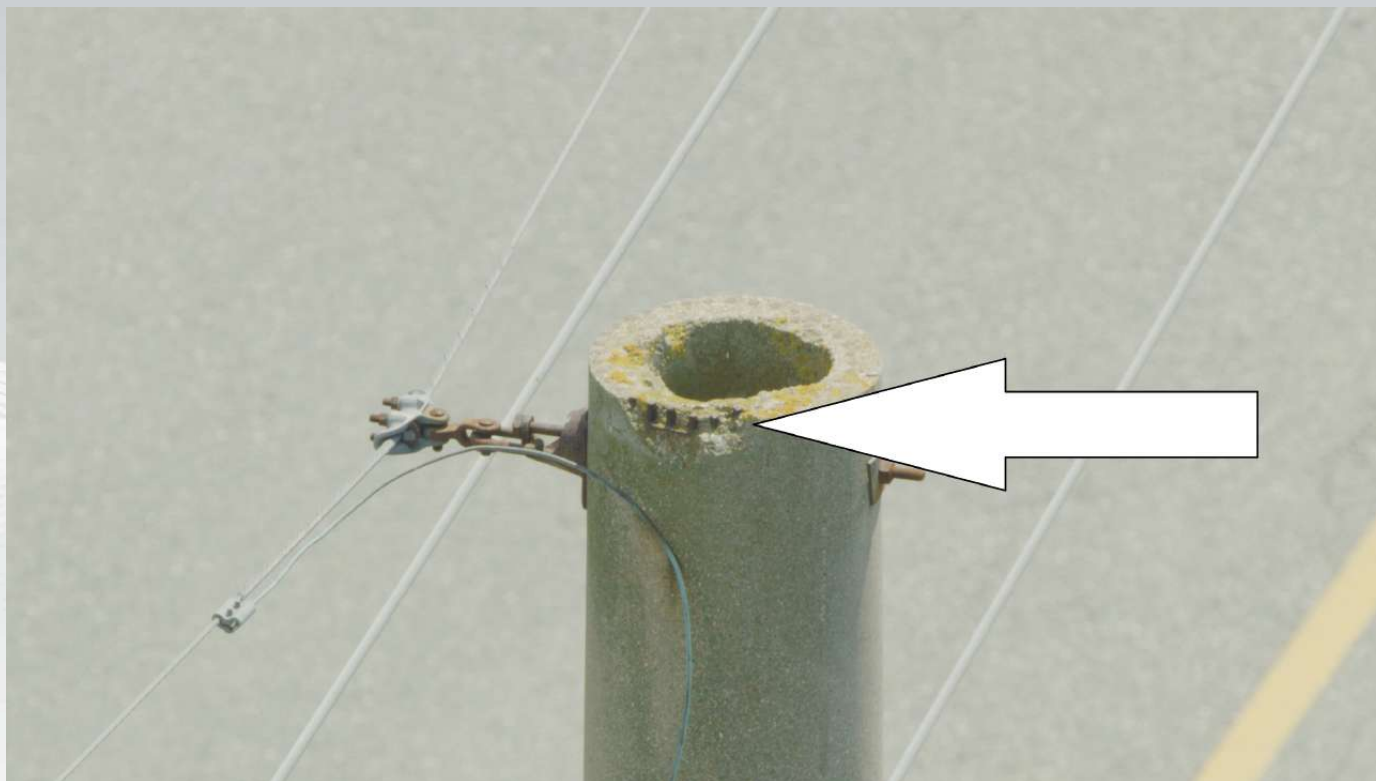
Anomaly: 38

Anomaly Rating		Anomaly Description				Anomaly Type	
3		The pole top concrete is damaged.				Visual	
Circuit	3763	Location	3763_STR63_2030410	GPS	41.531947 -71.312603	Inspector Date	Darin McMaster Jul 26, 2020

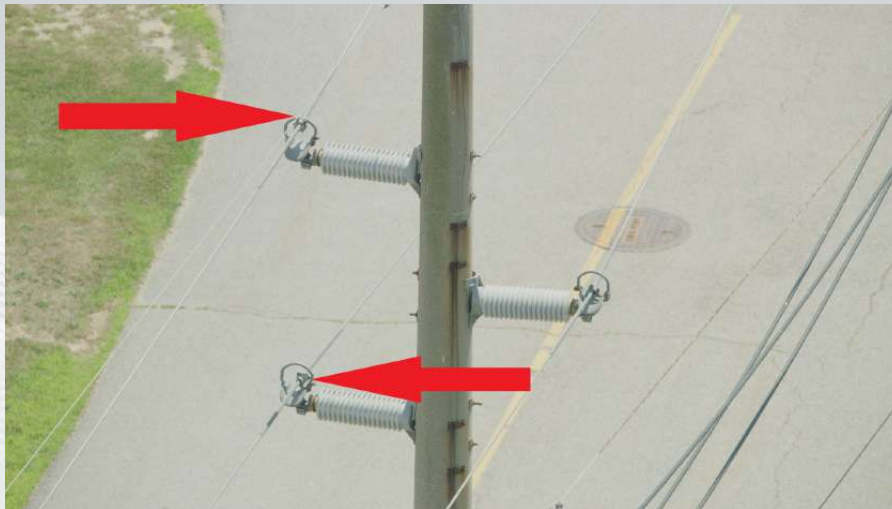
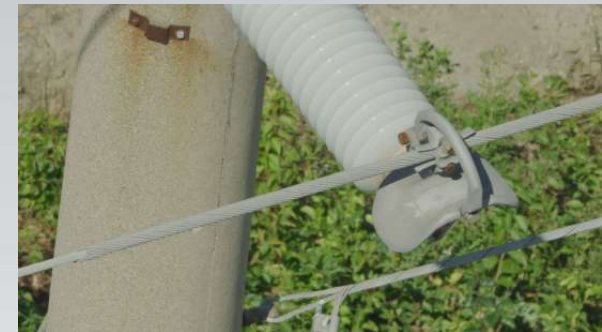
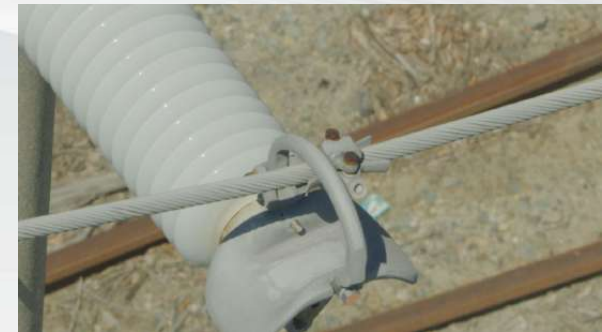
Anomaly: 39

Anomaly Rating		Anomaly Description				Anomaly Type	
2		The conductor clamp trunnion saddle bolts have let go and the wire is loose but trapped inside a retainer ring on the bottom left and top left phases.				Visual	
Circuit	3763	Location	3763_STR64_2030414	GPS	41.531164 -71.312385	Inspector Date	Darin McMaster Jul 26, 2020
