Andrew S. Marcaccio, Counsel
PPL Services Corporation
AMarcaccio@pplweb.com

280 Melrose Street
Providence, RI 02907
Phone 401-784-7263

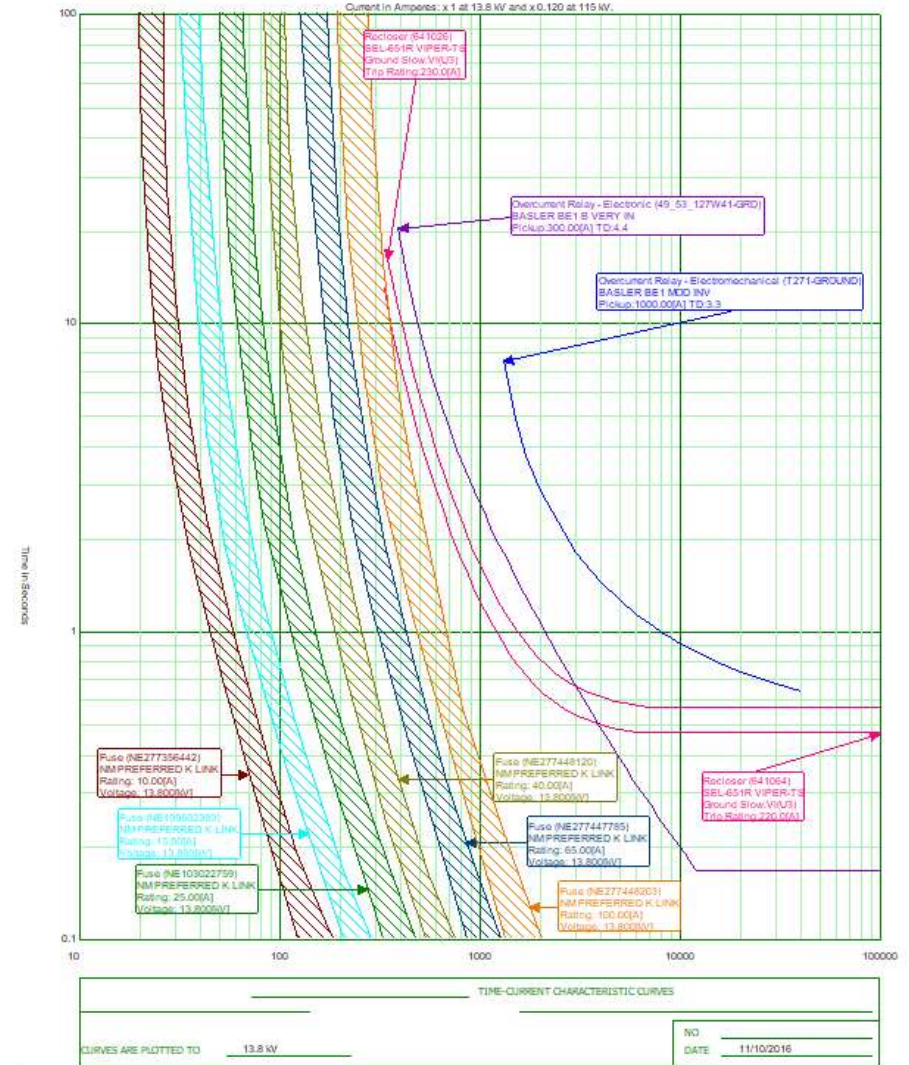
Attachment 4-5-3
Figure 1 - 26W1 Power Supply Deficiency

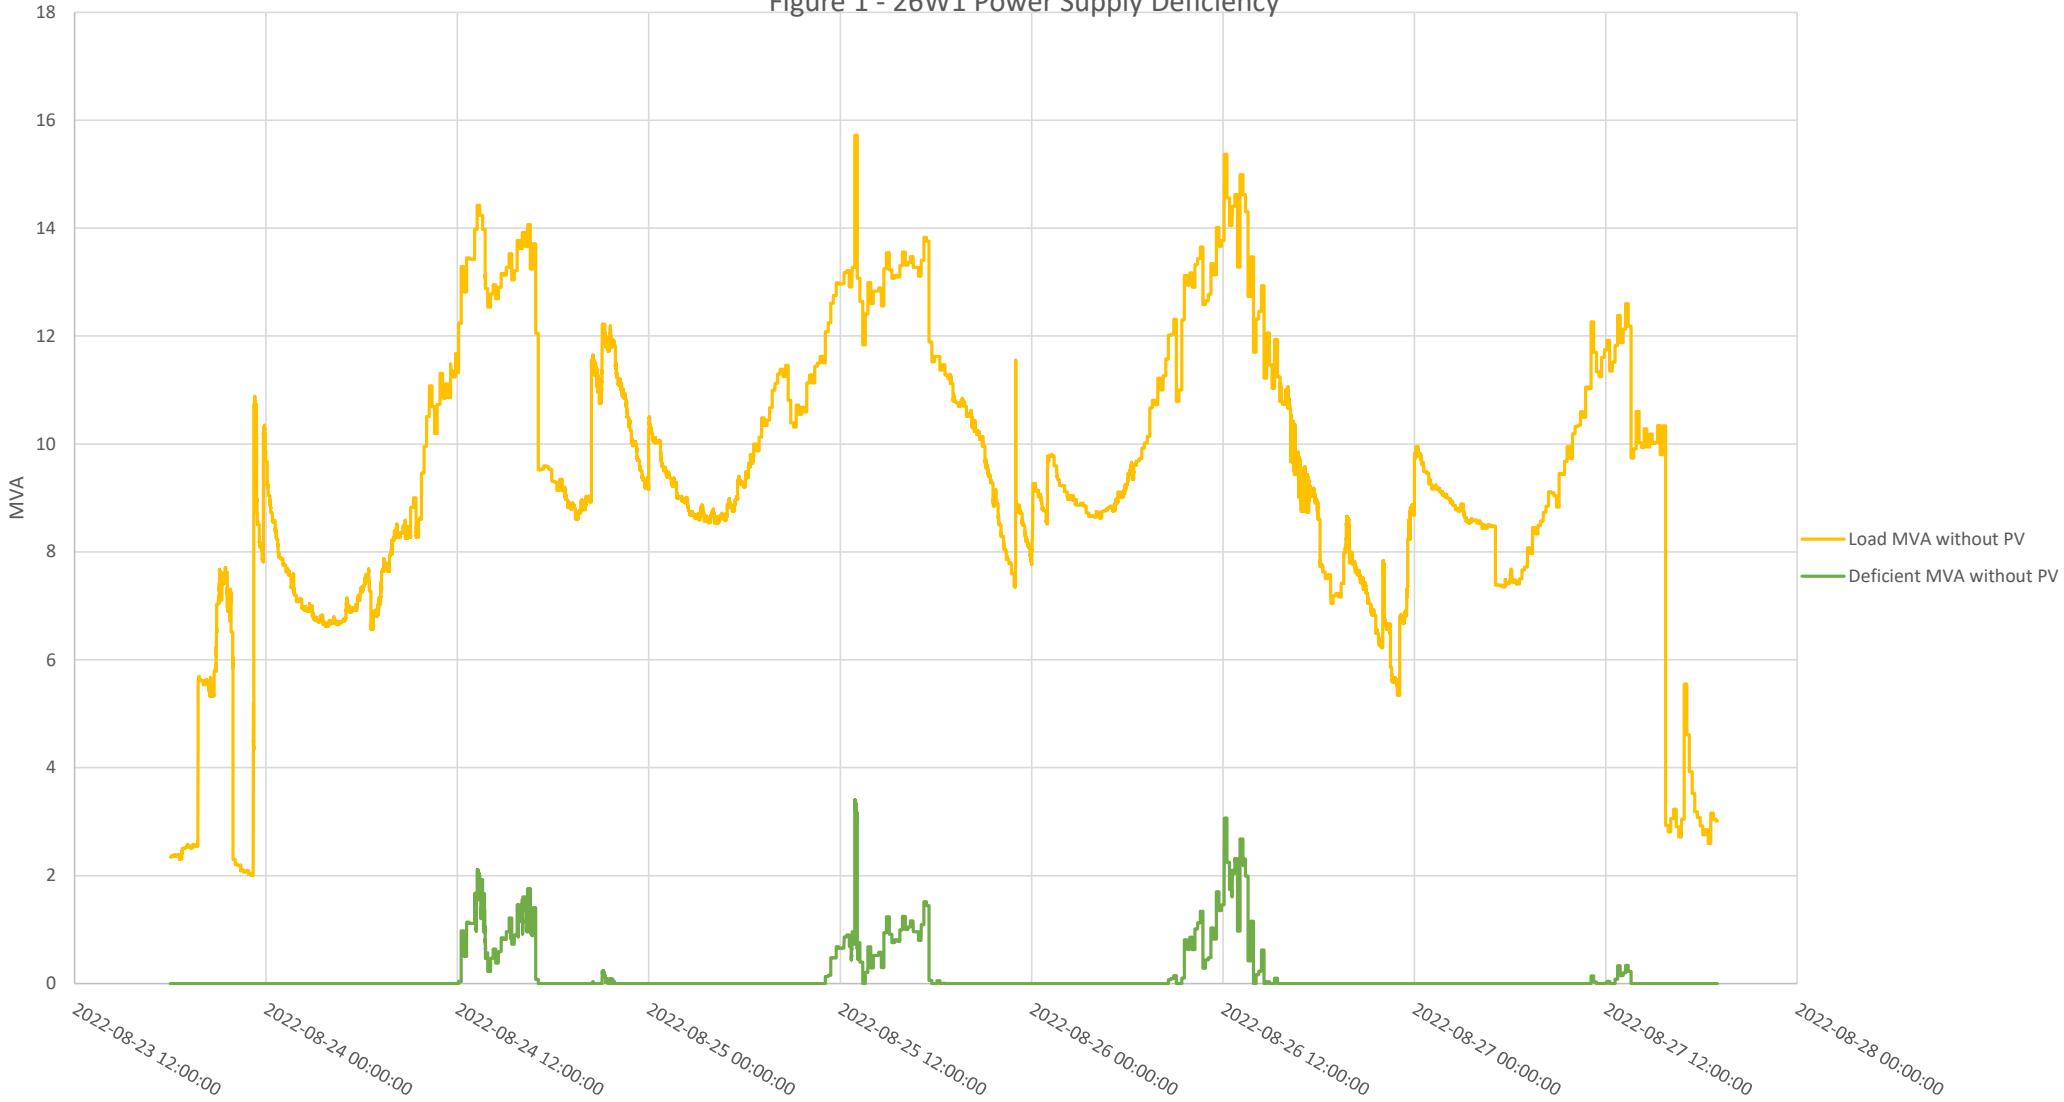
Attachment 4-5-3
Figure 2 - 26W5 Power Supply Deficiency
