# **Investigation Report**

## **Nasonville Substation Fire on August 23, 2022**

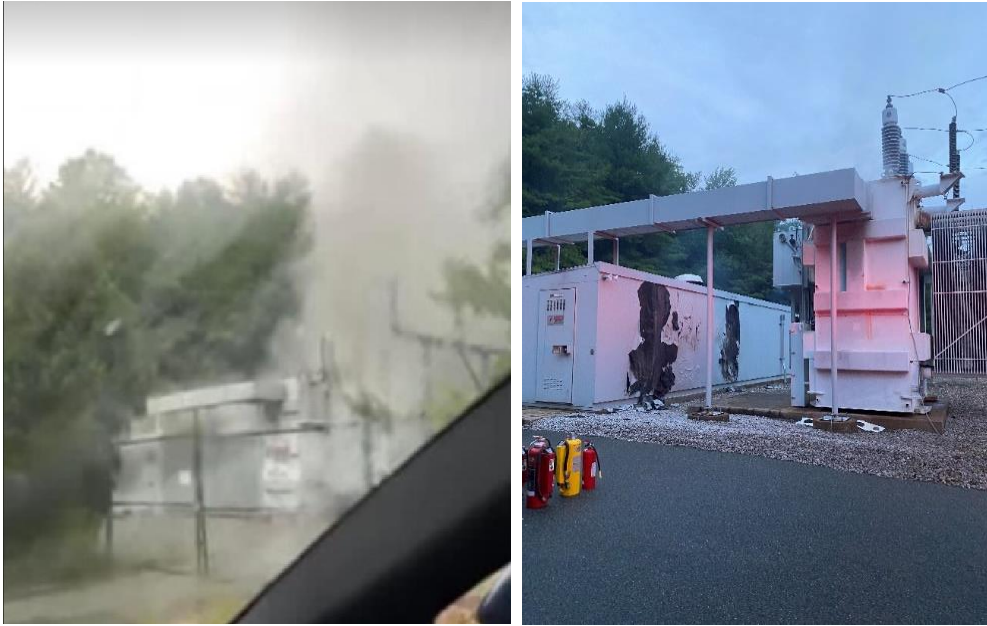
Below shows the fire damage to the station switchgear building dated August 24, 2022.

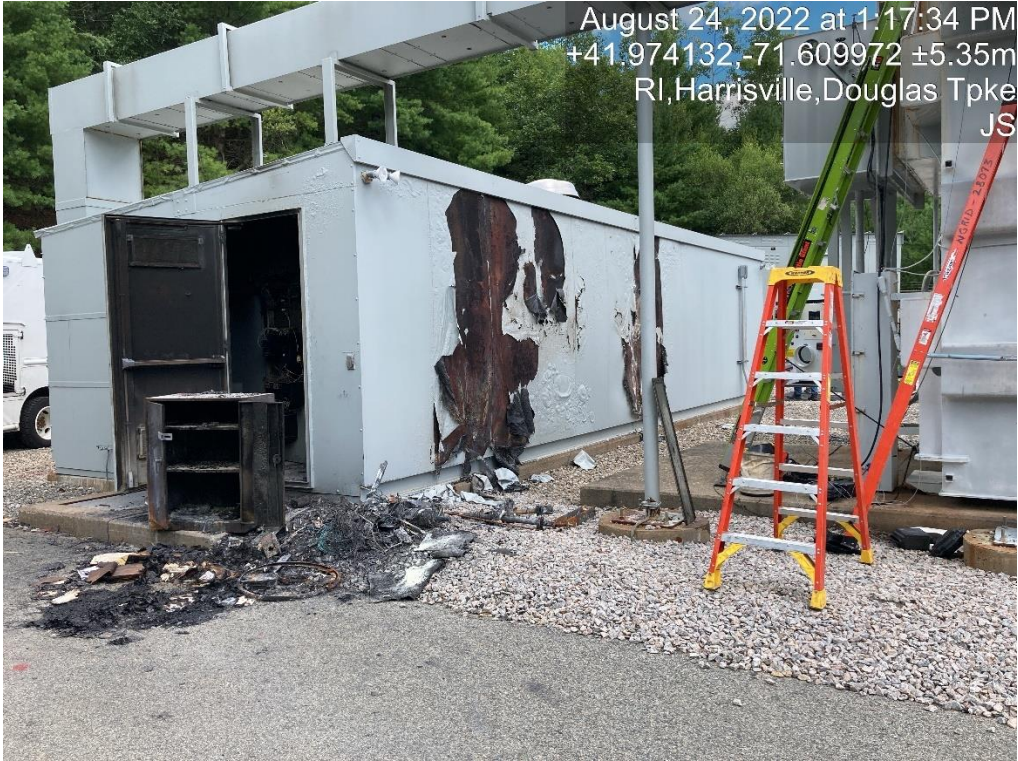
Below shows the fire damage to the inside of the station switchgear building, dated August 24, 2022.

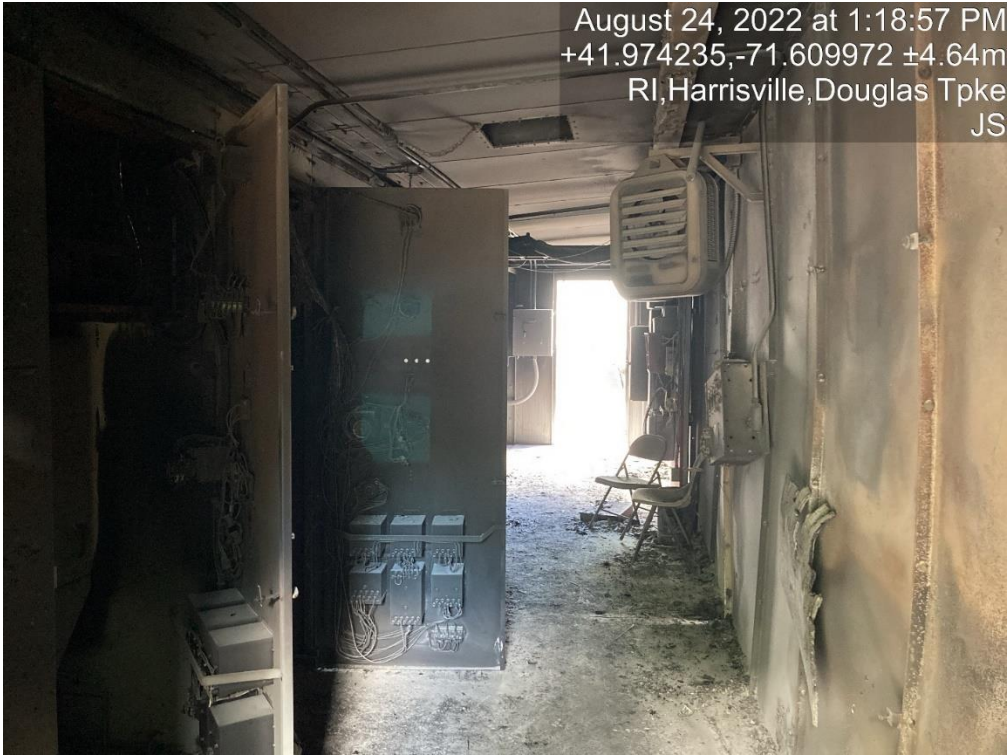
Below shows the fire damage to the inside of the station switchgear building, from the opposite end of the building than the picture above, dated August 24, 2022.

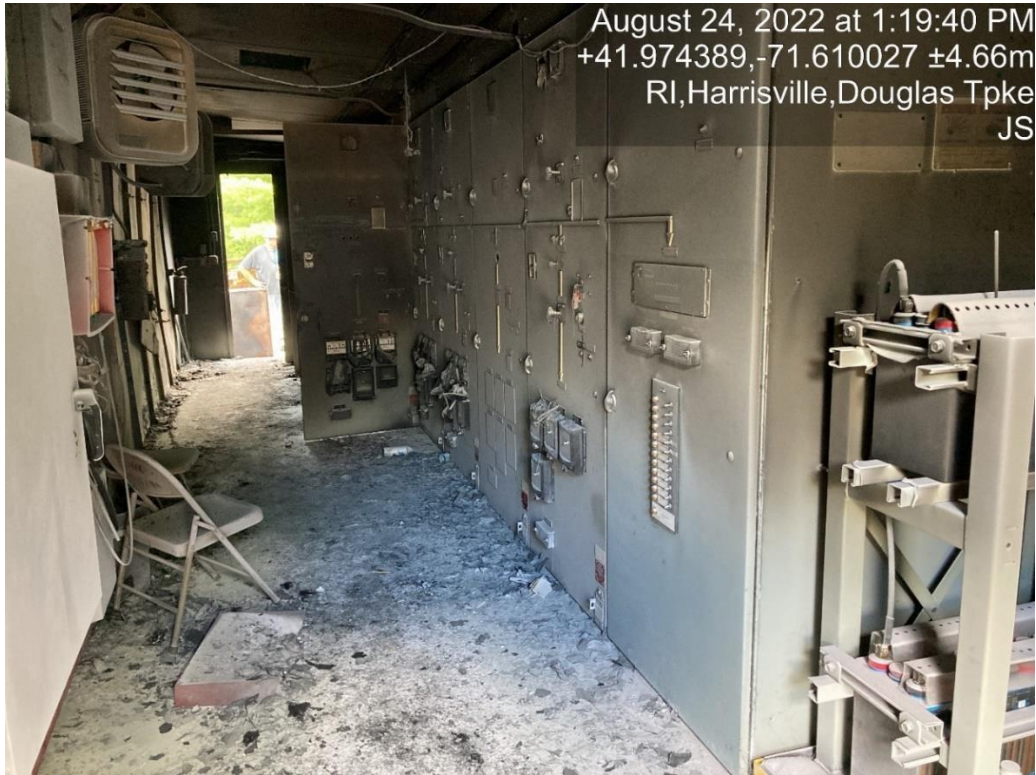
Below shows the fire damage to the inside of the station switchgear building, specifically the 41-breaker cell, dated August 24, 2022. The majority of the fire damaged occurred inside of this cell.

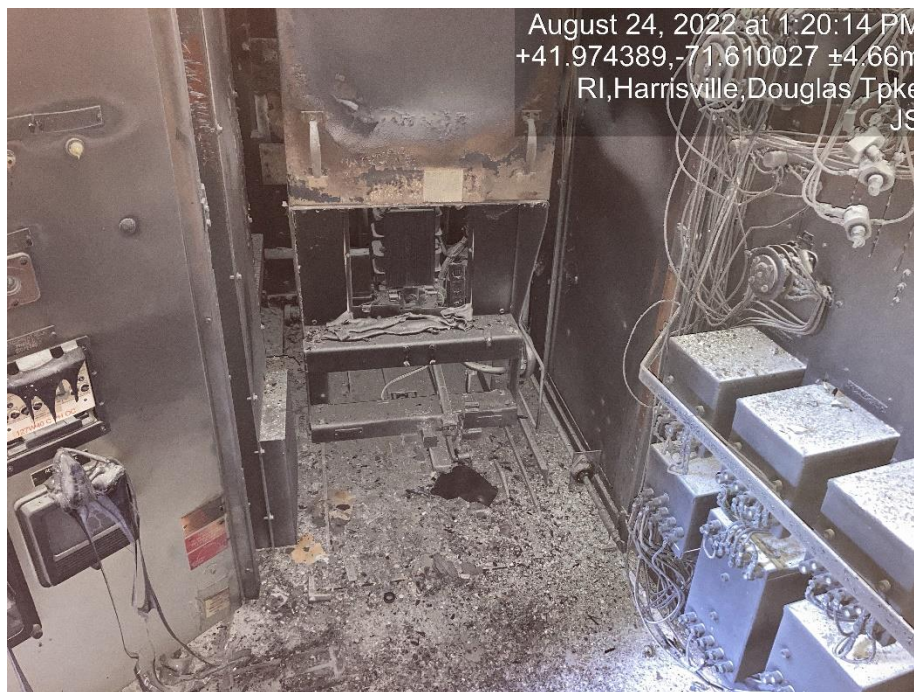
Below, the white circle, shows the outside access to the 41-feeder breaker cell which shows extensive fire damage.

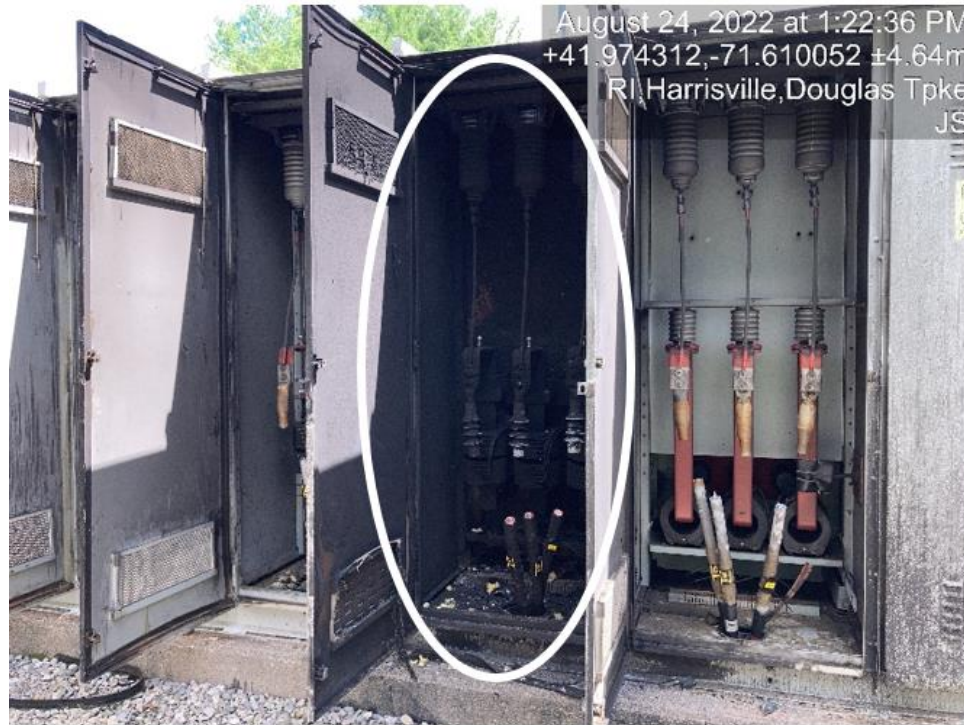
Below, shows the outside access to the 41-feeder breaker cell (left) which shows extensive fire damage and the far less damage to the neighboring breaker cell (right). Dated August 24, 2022.

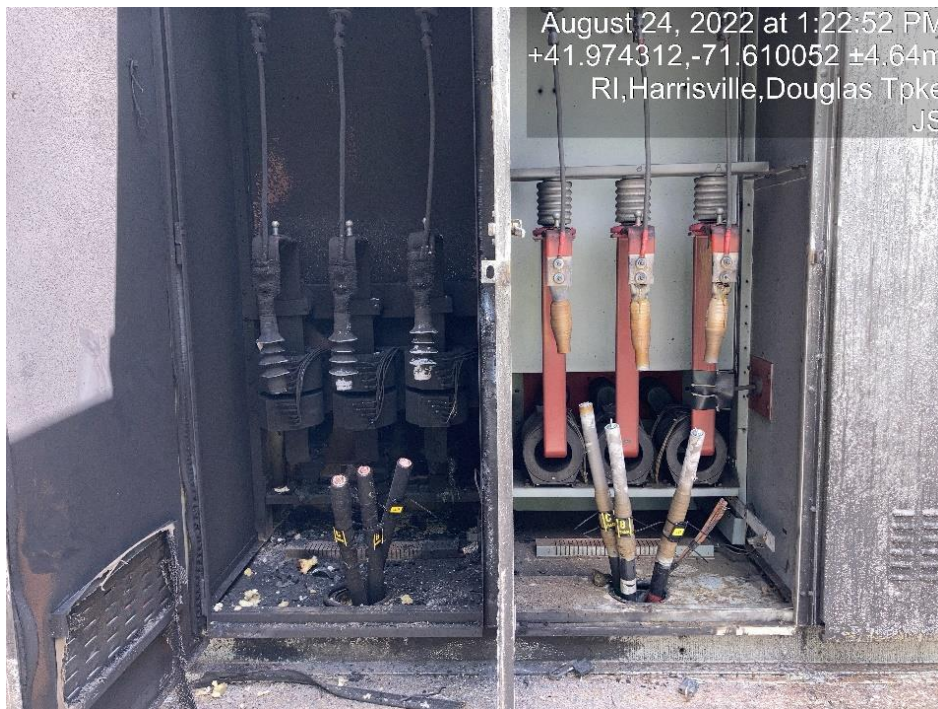
Below, shows the fire damage to the back of the station switchgear building, dated August 24, 2022.

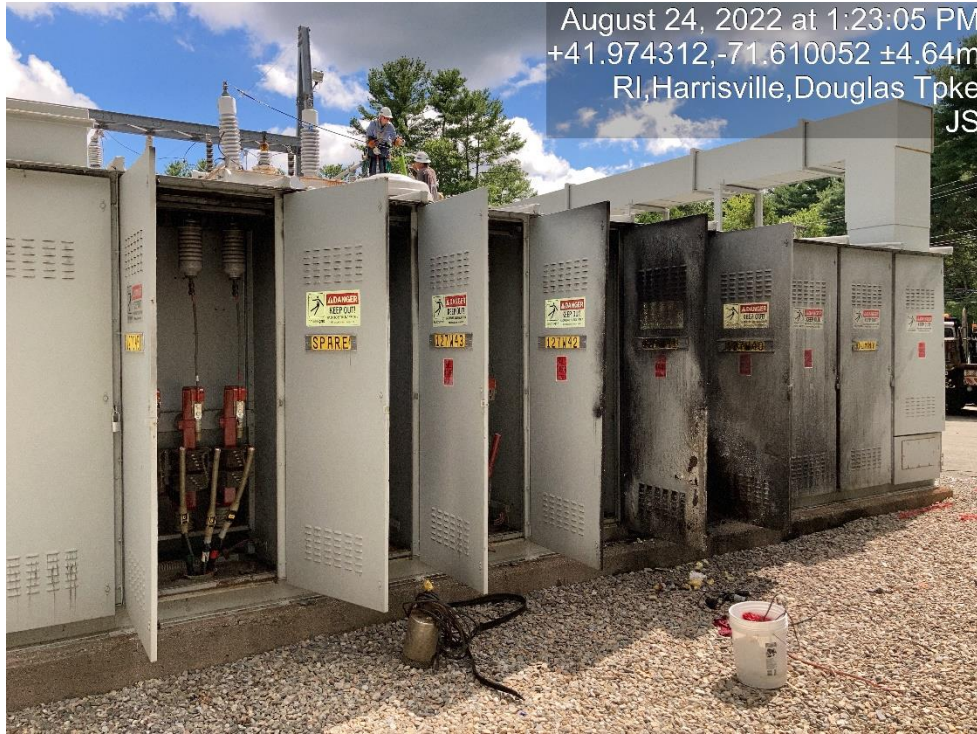
**Illustration of what failed (Source RIE report dated November 16, 2022, additional picture in Appendix B)**

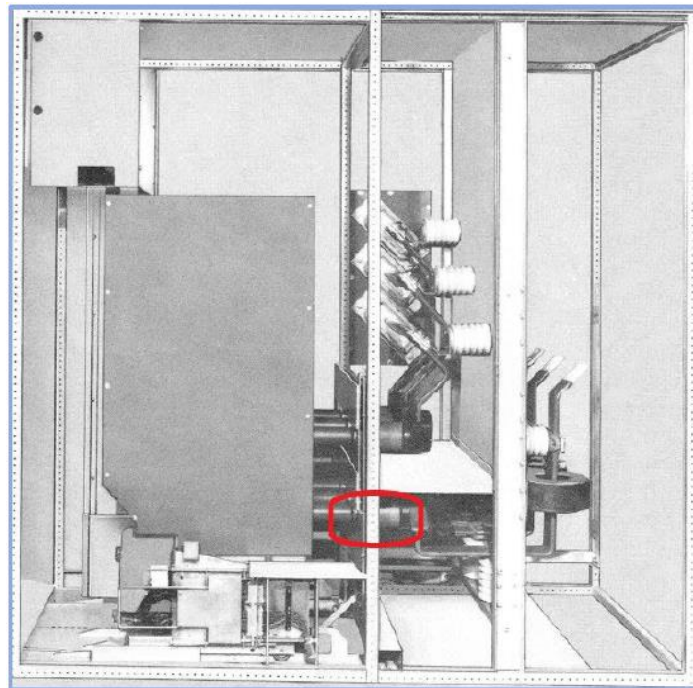
**New installation Picture (Source RIE report dated November 16, 2022, additional pictures in Appendix B)**

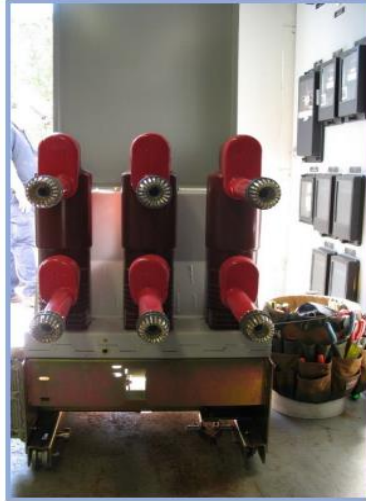
2011 Installation of Replacement

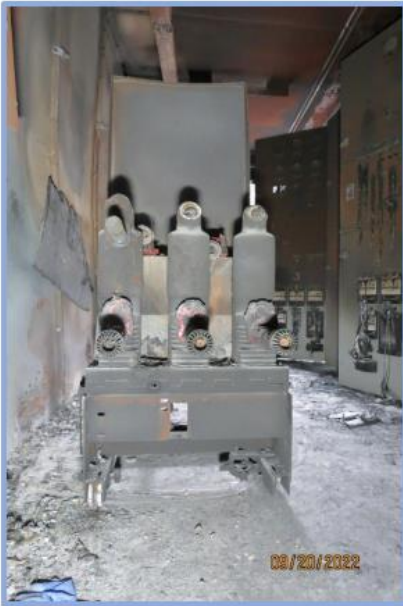
Failed 41 Feeder Breaker

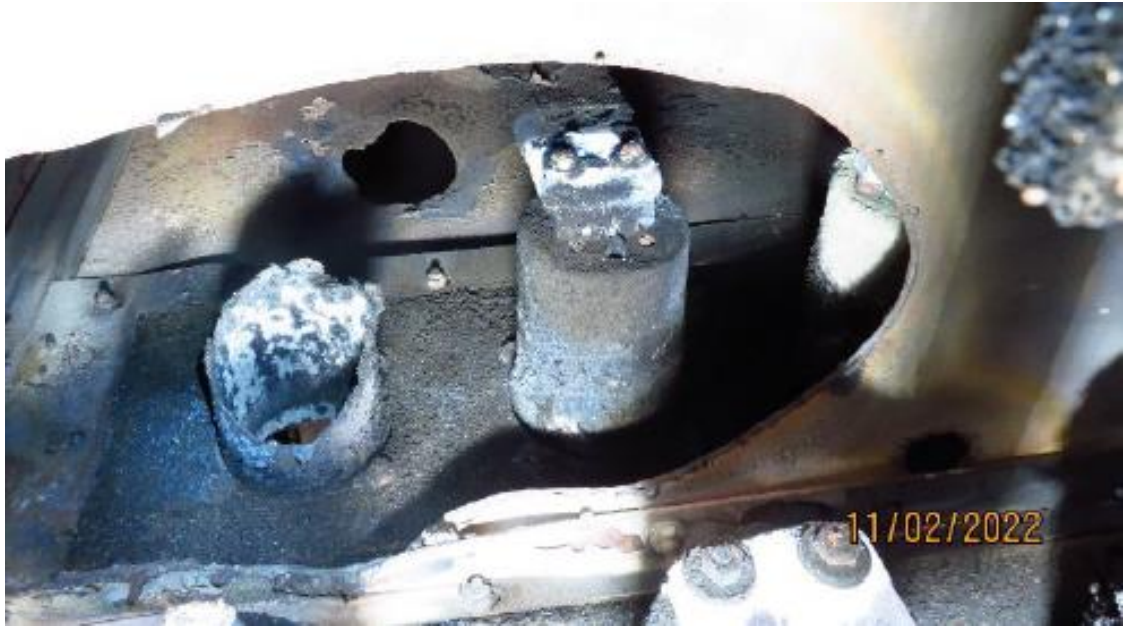
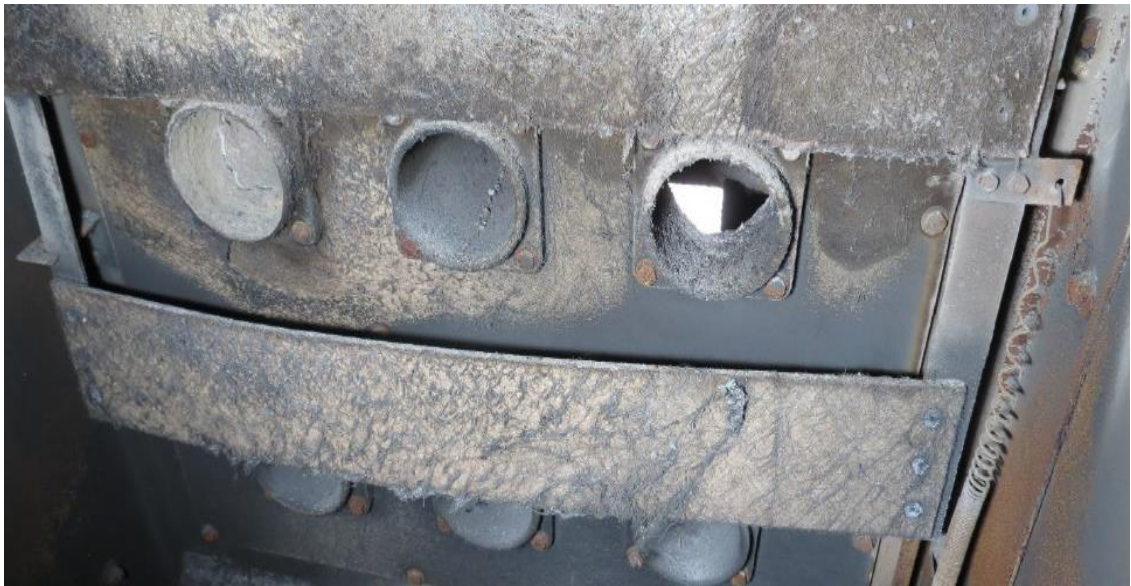
## Pictures of the Tree that Fell on the 41-Feeder

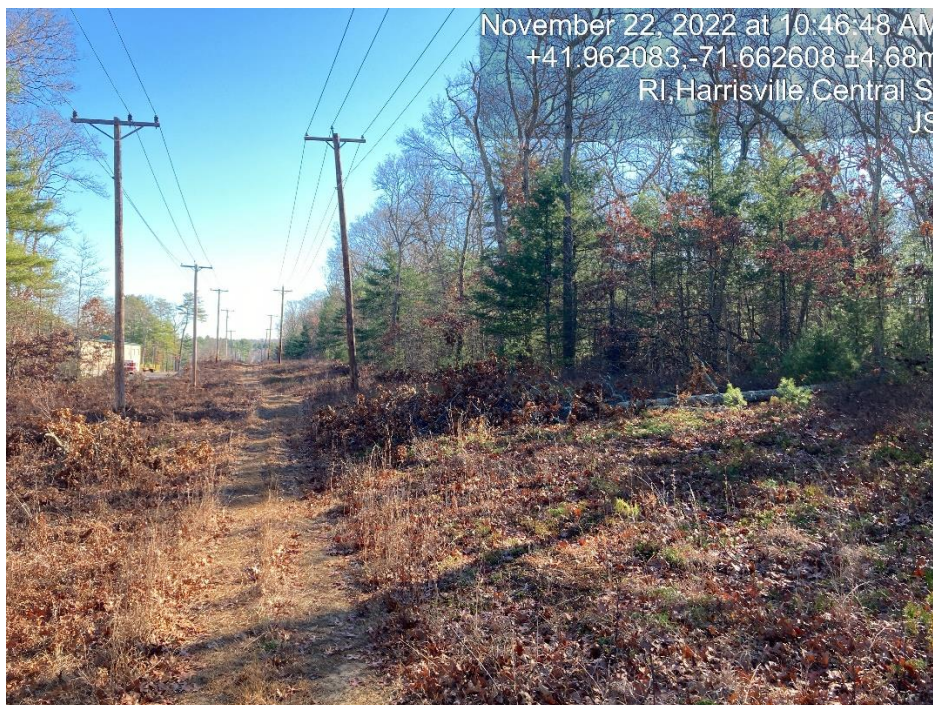
Below shows the base of the tree stump where it split in half from what appears to be insect damaged and rot. The tree section to the left fell towards the power lines. It is unknown why two 5-gallon buckets are inside of each other with a blue tarp inside of the inner bucket, it was found like this, however, the buckets do a good job providing scale to show how large this tree was.

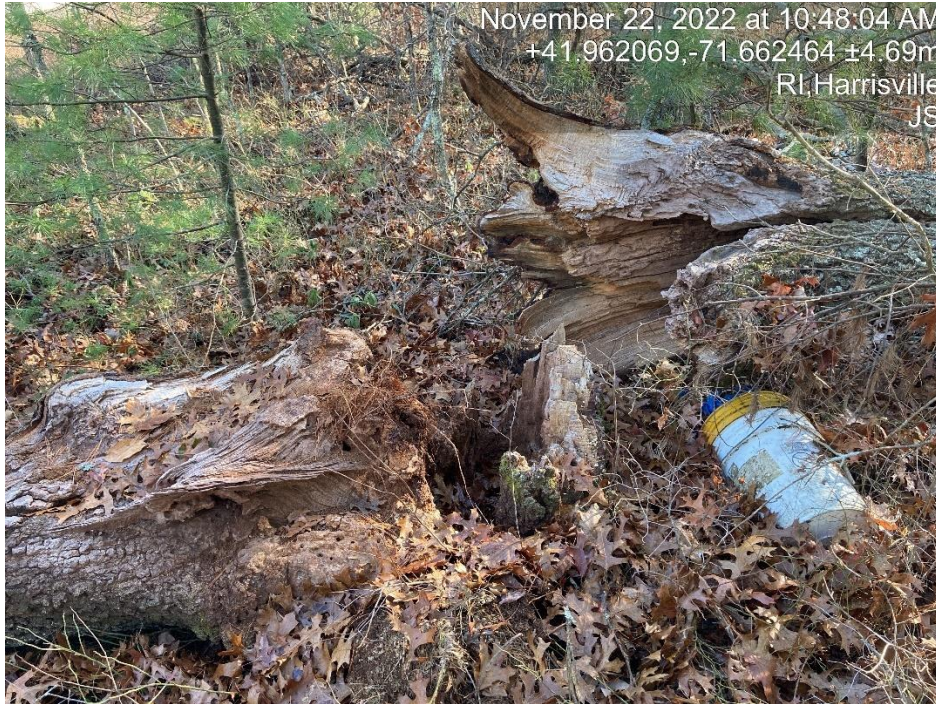
Below, picture of pole 253, shows marking indicating this is a class 3 pole that is 40 feet long.

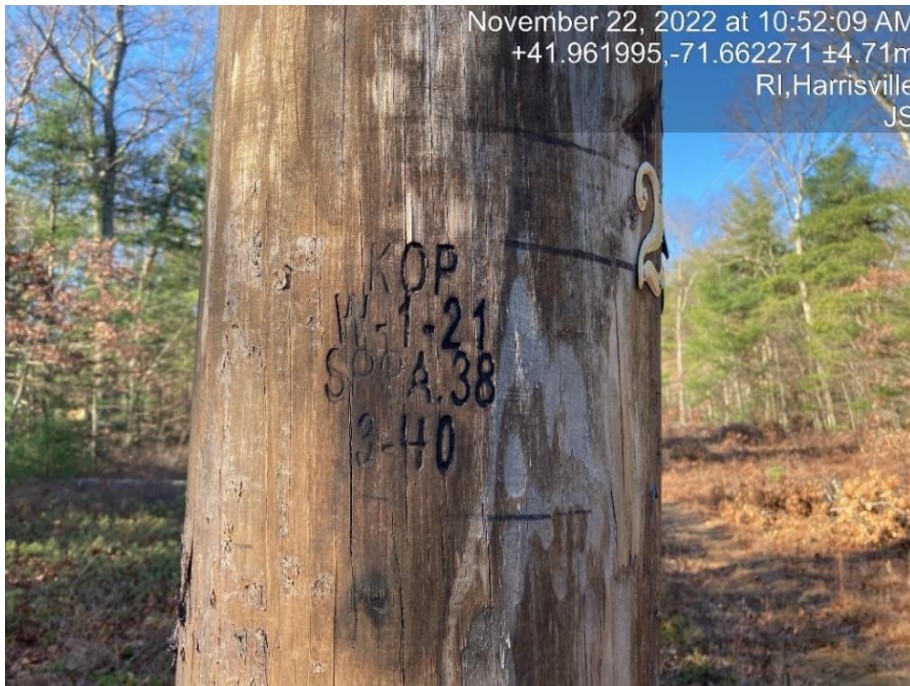
Below, the force of the falling tree appears to have moved the utility pole (pole 253); this was later repaired.

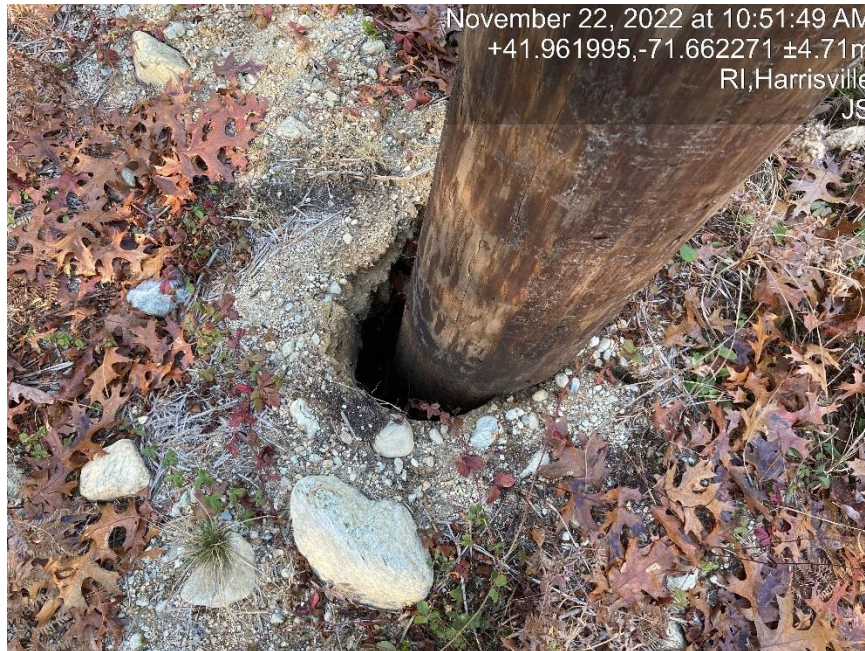
### **Pictures of the 41-Feeder Recloser**

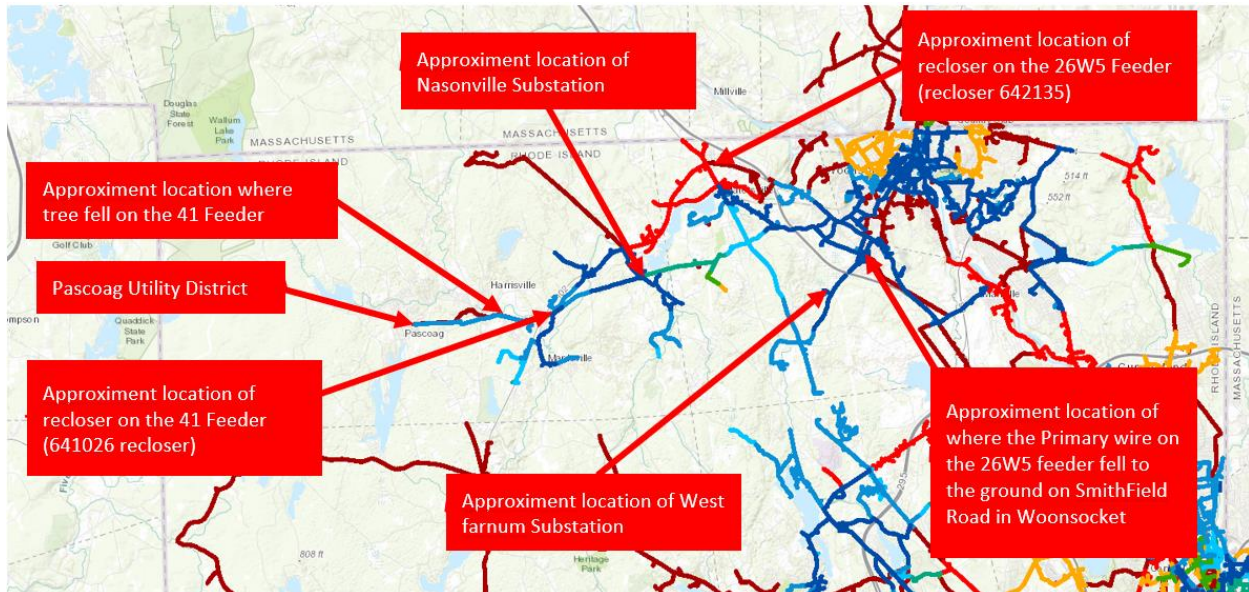
<sup>45</sup> Source: Rhode Island Energy's report dated March 3, 2023 (found in Appendix C).

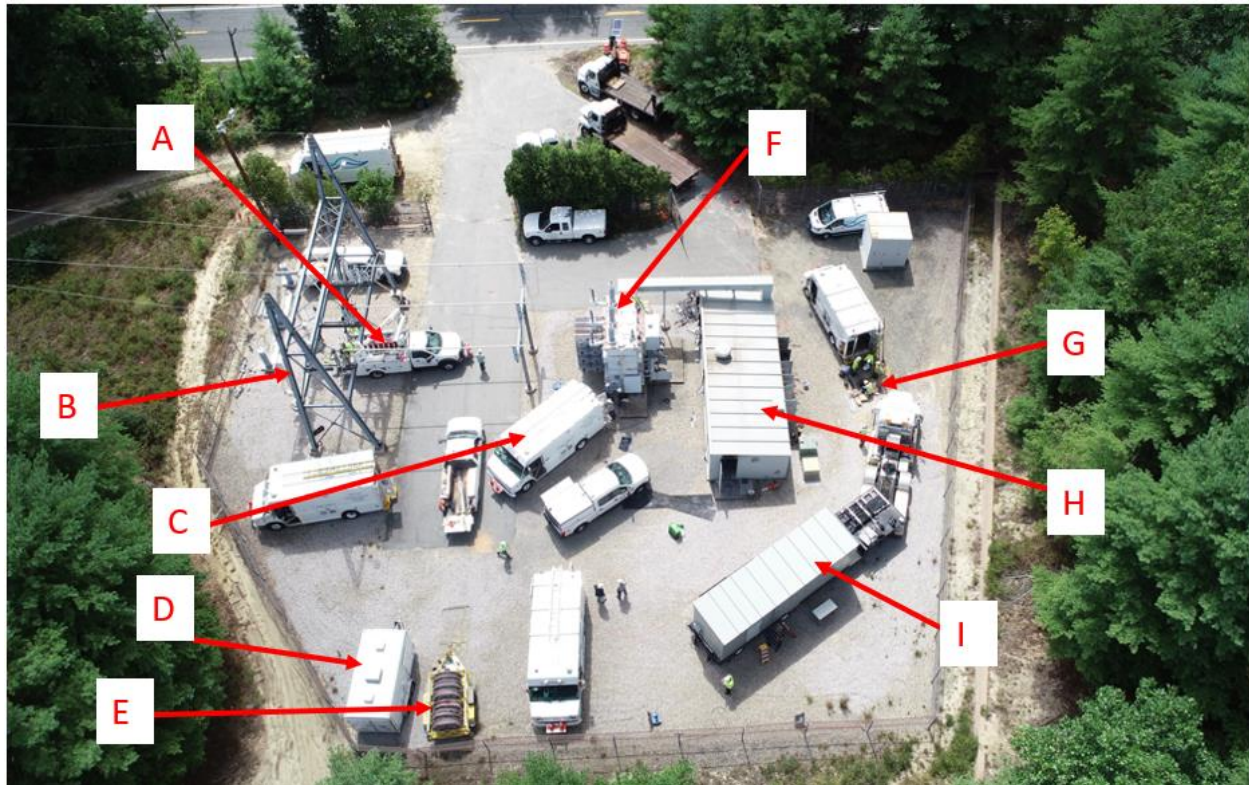
- A. RIE crews working on the MOS that was damaged by flashover.
- B. “A” frame structure that holds the MOS.
- C. RIE crews working on the transformer.
- D. Trailer where the batteries are stored that power the mobile switchgear building .
- E. Trailer that is holding the temporary insulated distribution wires on spools, later, these wires were taken off the spools and used to connect the transformer to the mobile switchgear building. Other pictures in this report show these wires on the ground in preparation to being energized.
- F. Substation transformer.
- G. A crew near a manhole. This manhole is used to access conduit that holds the wires that go out underground to the four nearby feeders.
- H. Fire damaged switchgear building.
- I. Mobile (trailed) switchgear building.

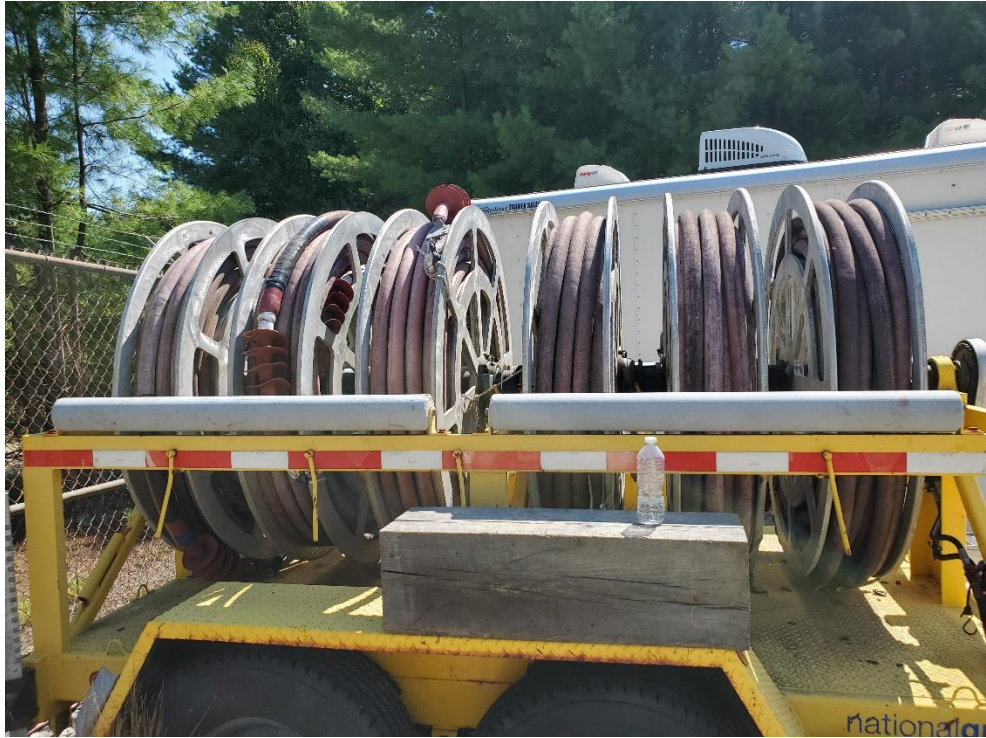
Below is the trailered mobile relay station (before the temporary distribution wires are connected to it, dated August 25, 2022)

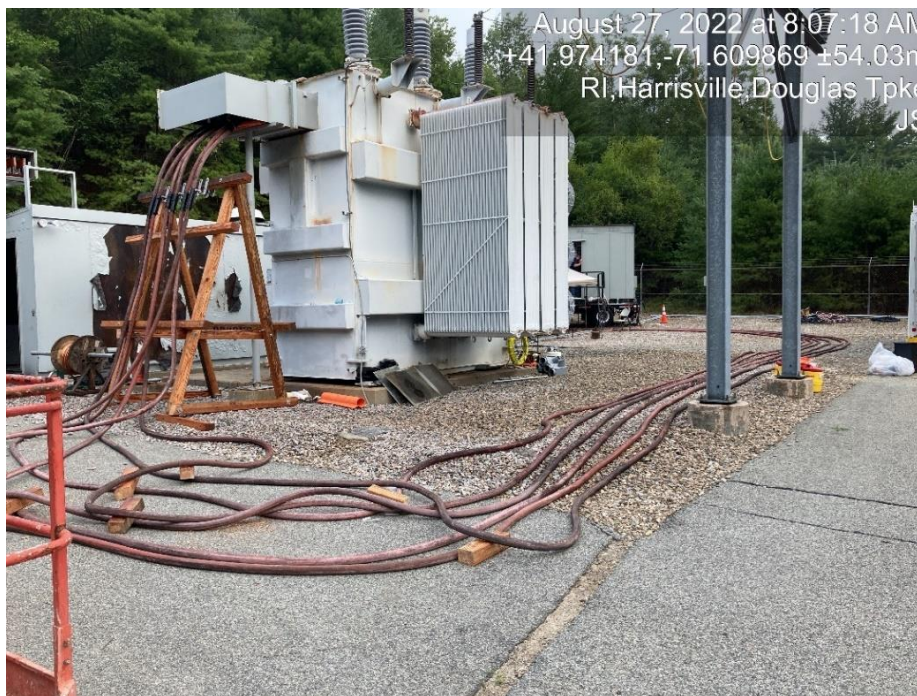
### **Pictures of the Motor Operated Switch (MOS) Damage and Temporary Repair**

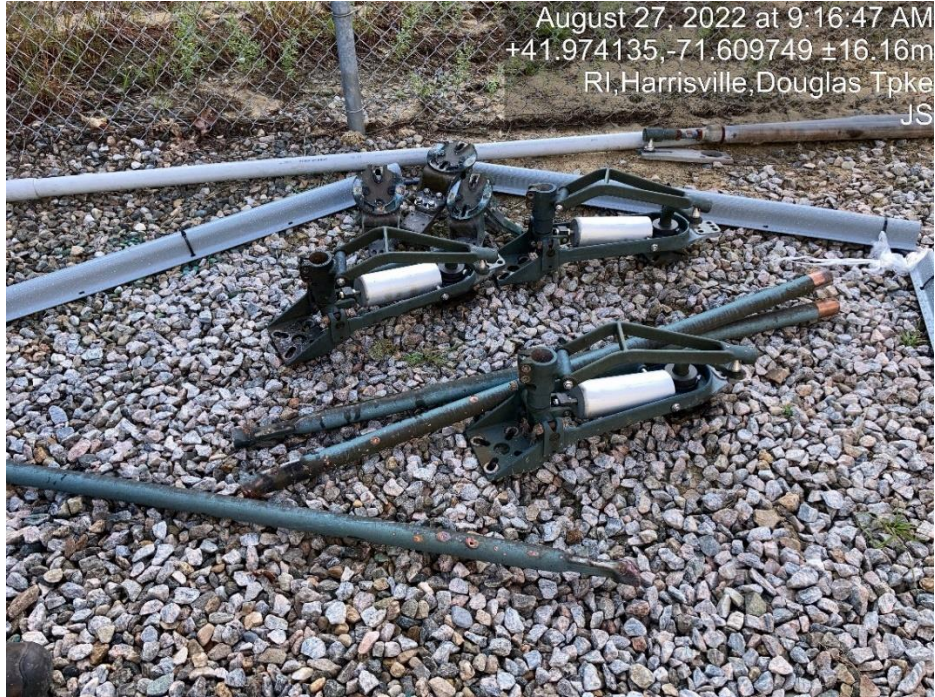
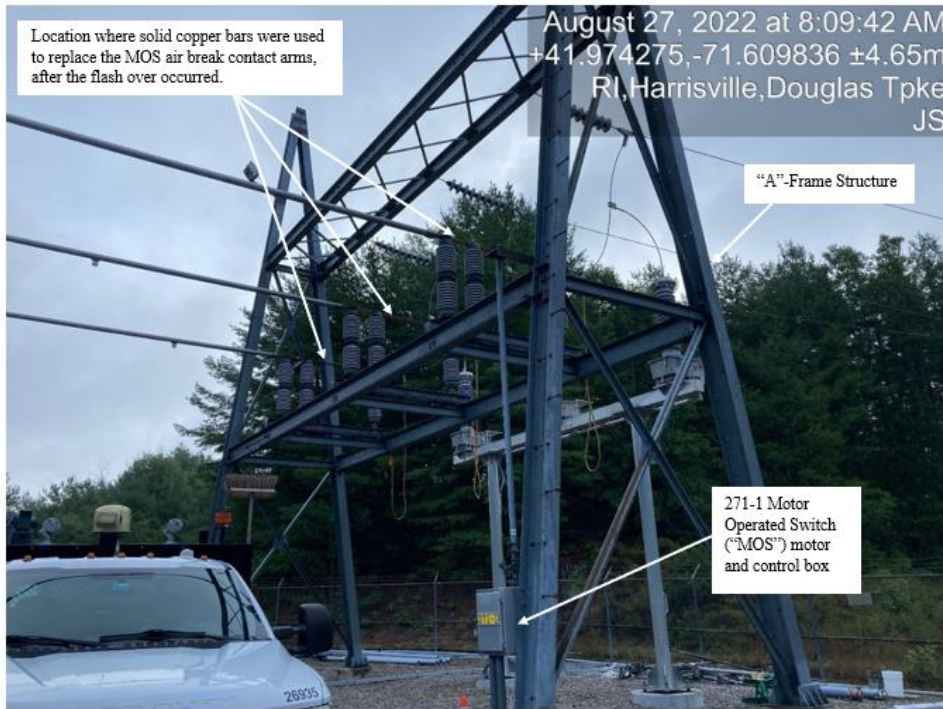
The picture below shows damaged/melted parts of the original MOS 3-phase gang switch (the damaged parts were removed, and temporarily replaced with solid copper bars).

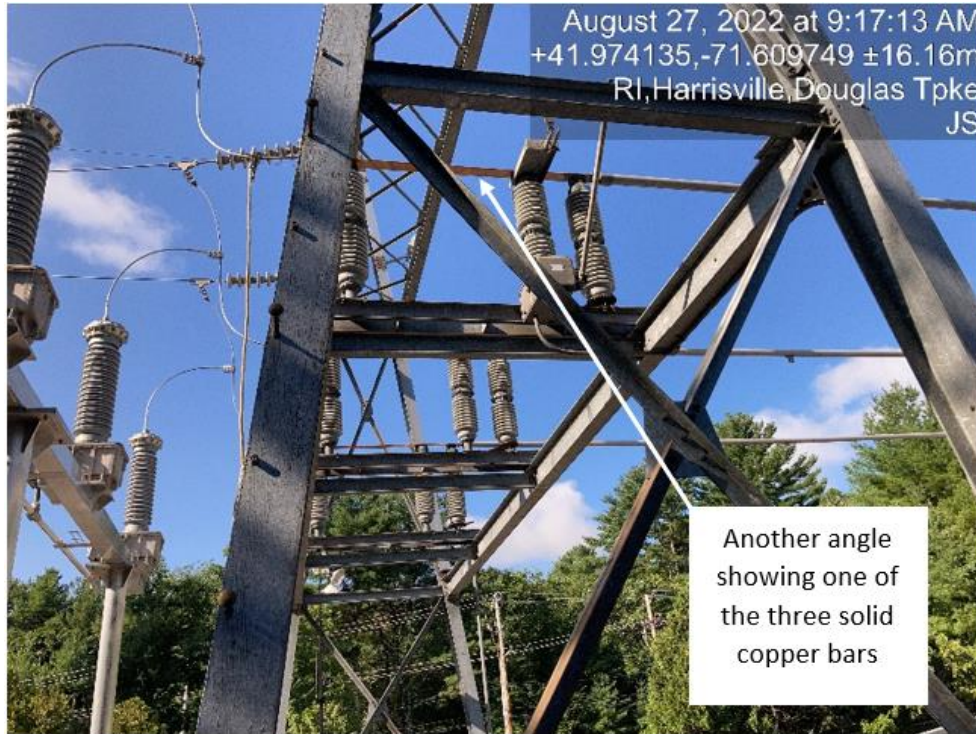
### **Pictures of the Recloser at 590 Victory Highway**

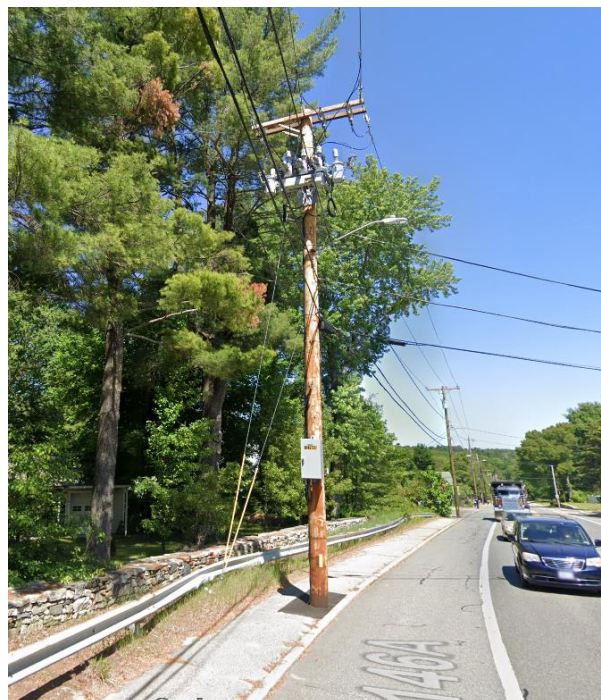
## **Pictures of the Wire Splice that Failed Resulting in a Primary Wire Falling to the Ground**

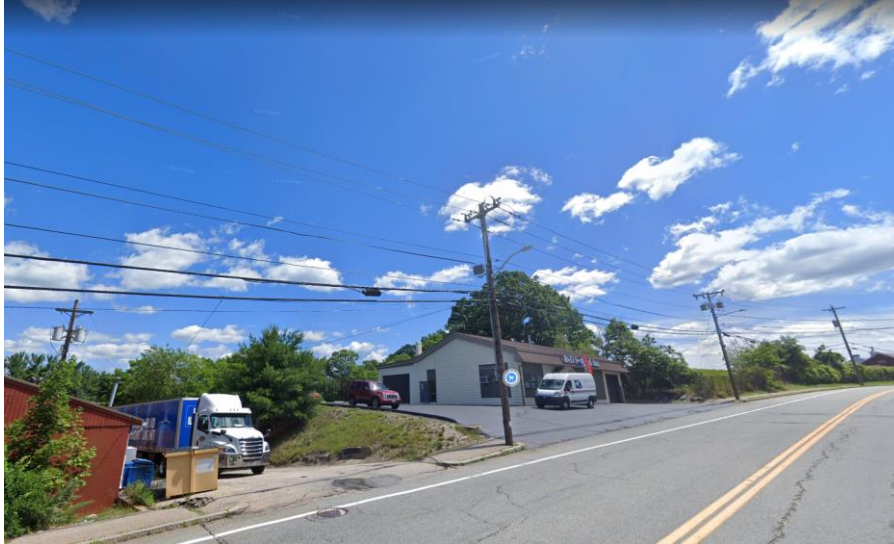
## **Pictures of Temporary Roll-on Generation<sup>47</sup>**

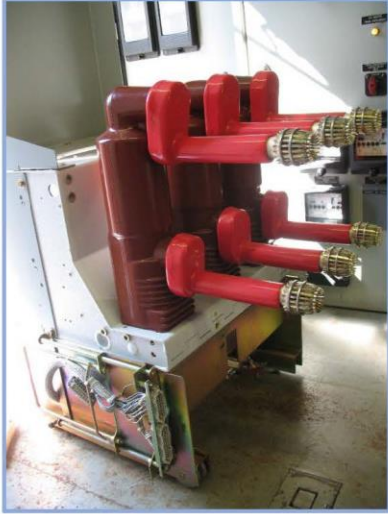
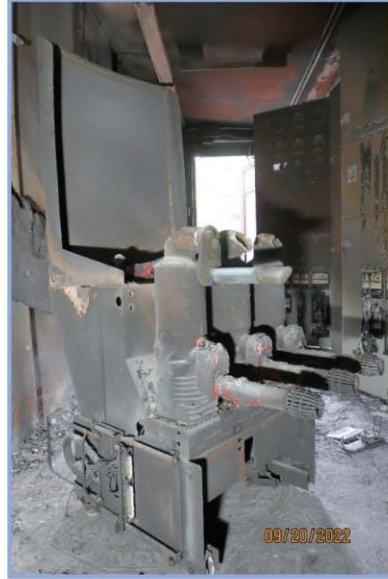
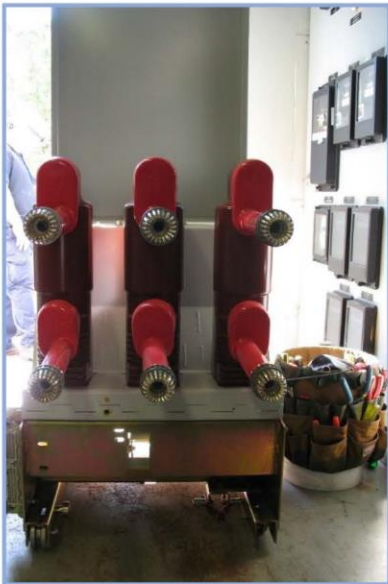
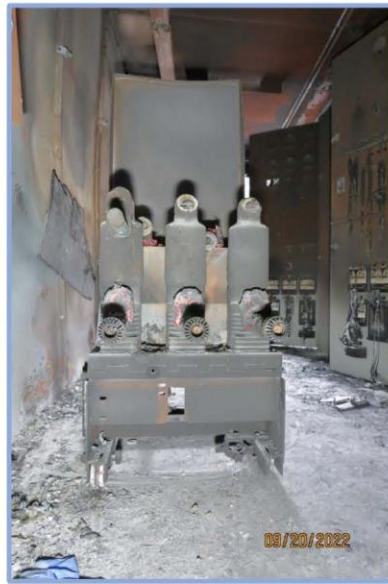
2011 Installation of Replacement

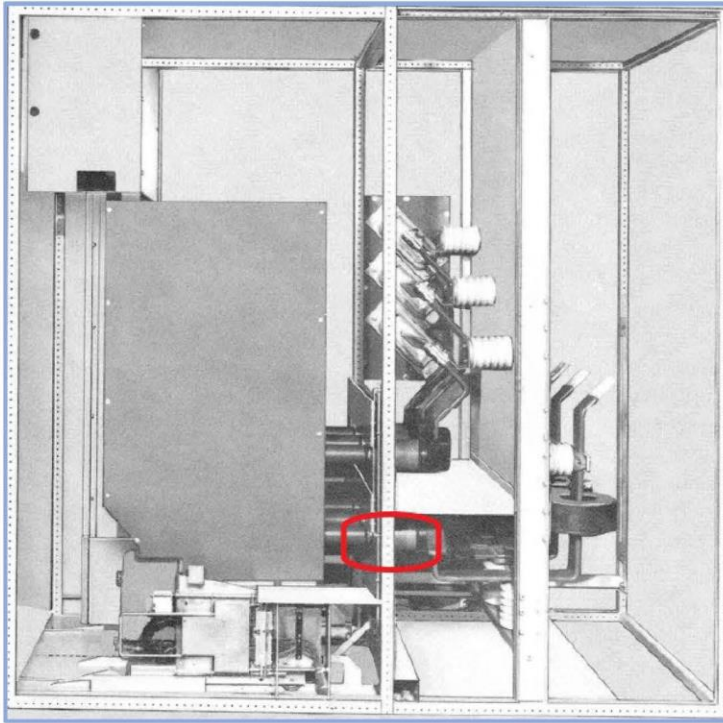
Illustration of Federal Pacific Electric metal-clad switchgear cell.  
Failure initiating area identified in red.

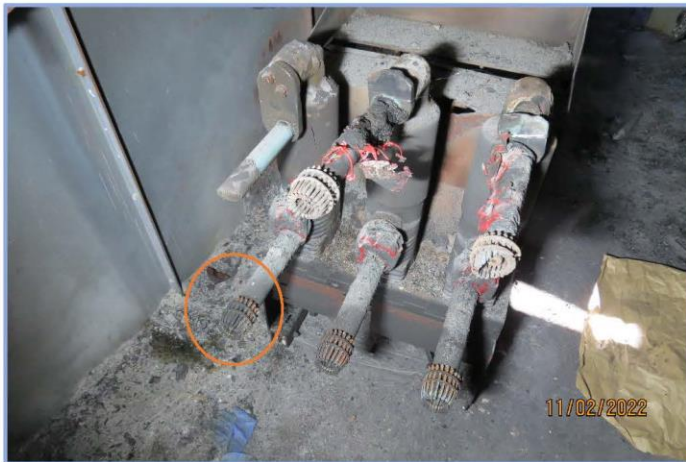
Failed 41 Feeder Breaker Showing Condition of the Rosettes  
Note: Top middle and right breaker conductor tubes have been reattached to show rosette positions.  
Note: Top left rosette completely burned from arcing.

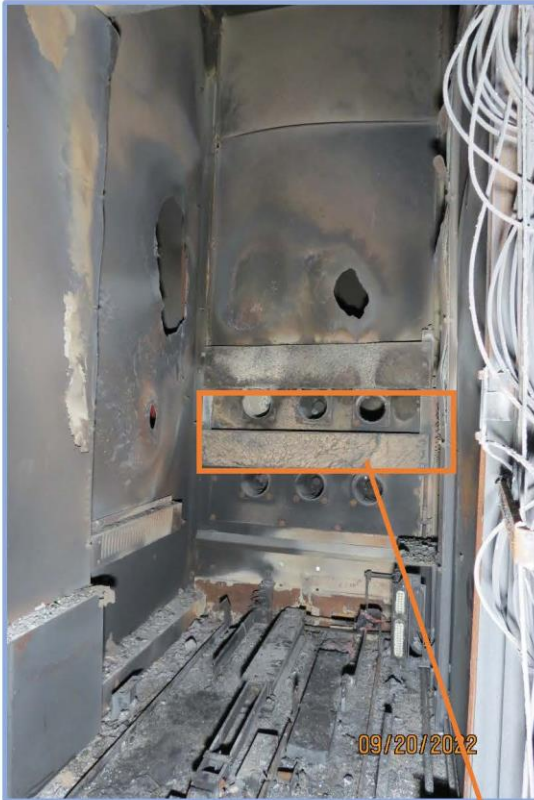
41 Feeder Switchgear Cell

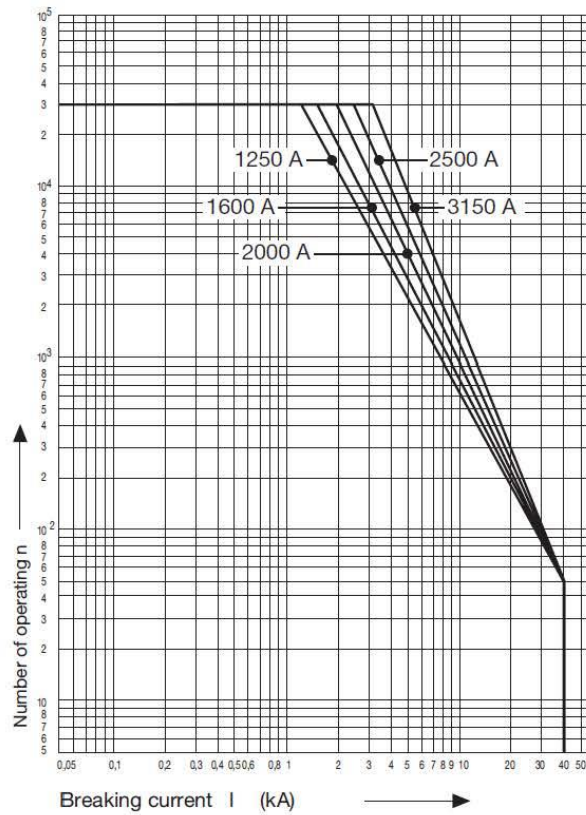
29. Please provide the maintenance records for the failed 41 feeder ABB breaker since it was new.  
Please refer to Attachment 4.

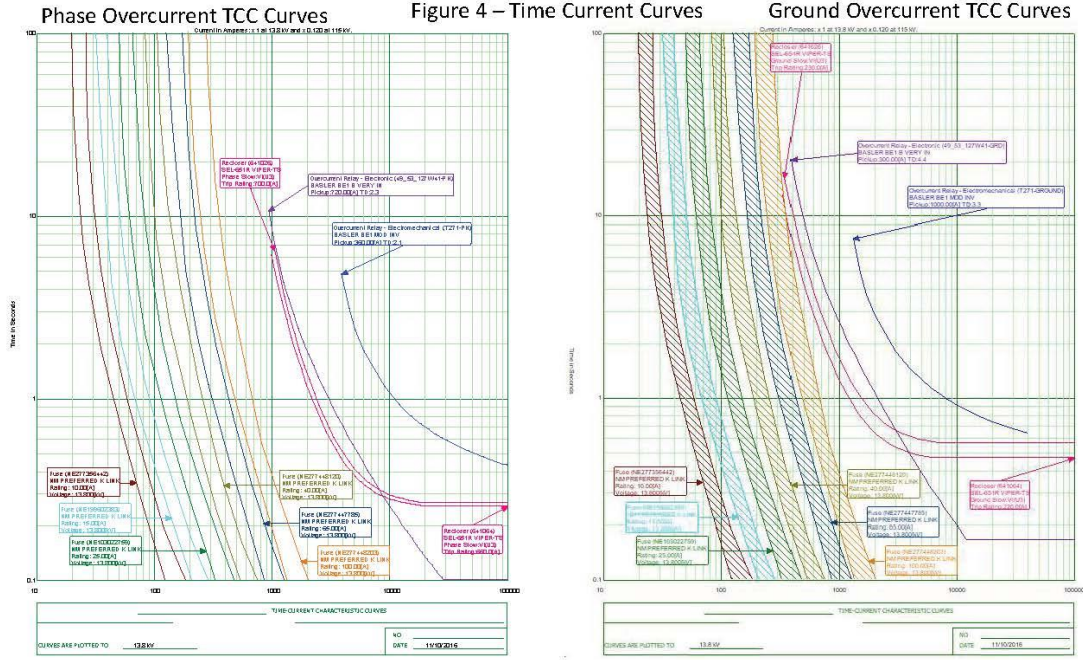
Attachment 4-5-3  
Figure 1 - 26W1 Power Supply Deficiency

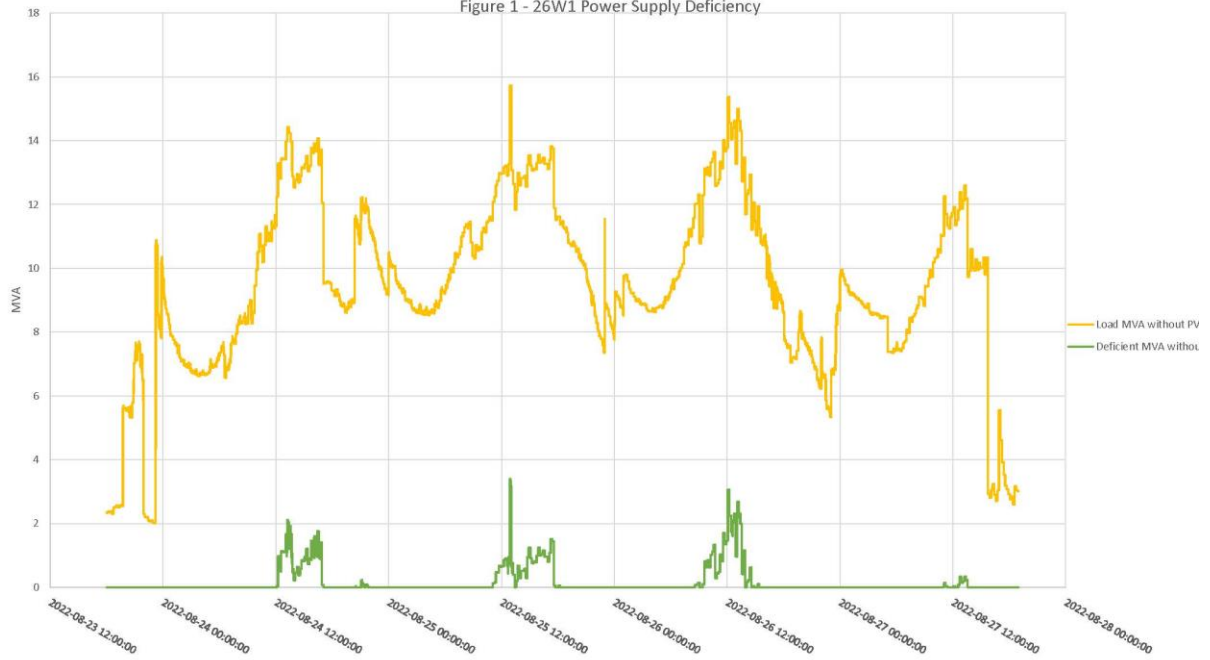
Attachment 4-5-3  
Figure 2 - 26W5 Power Supply Deficiency

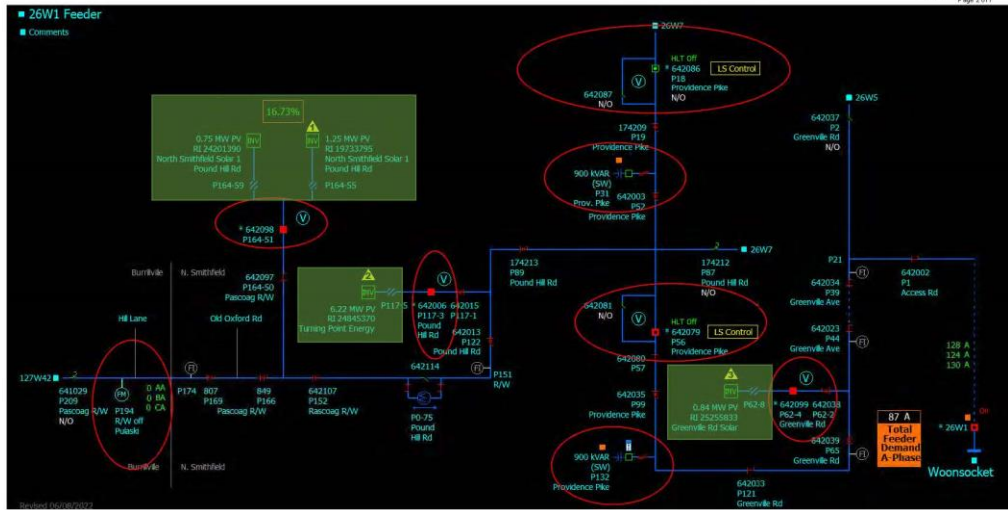
Prepared by or under the supervision of: Ryan Constable
