# INFRASTRUCTURE REPLACEMENT PLAN

## **PROVIDENCE WATER SUPPLY BOARD**

### **INFRASTRUCTURE REPLACEMENT PLAN For Fiscal Years 2006 Through 2025**

**MARCH 2006**

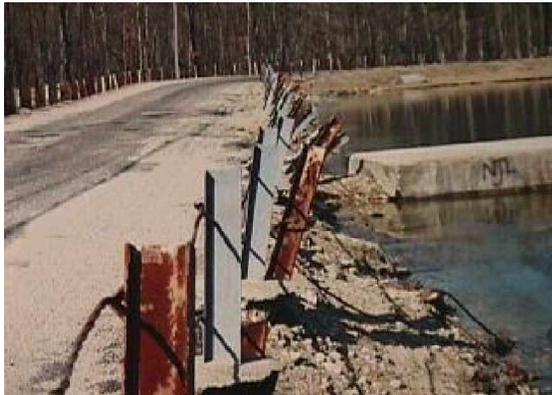
Construction is complete for the rehabilitation of Ponaganset Reservoir. Work included repair of dam erosion and placement of riprap, construction of a downstream buttress, restoration of the gate structure and outlet works, improvements to the discharge channel, and reconstruction of the road and drainage system over the dam

Ponaganset Reservoir before rehabilitation

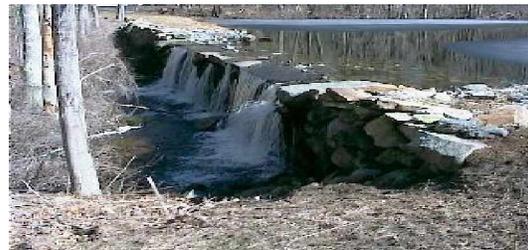
Burton Pond Dam

The project has been completed. The breached area of the earth/masonry dam has been reconditioned. Riprap was installed along the top upstream face of the dam to provide continued slope protection.

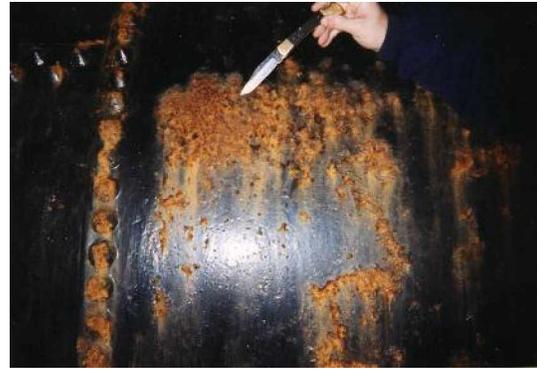
Construction was completed to rehabilitate and recoat the 900 feet long exposed portions of the twin 60 inch riveted steel transmission mains in the meter chamber. Rust was removed, the pipes sandblasted, and protective coatings applied. The exposed portion of twin 60 inch mains inside the junction chamber structure were sandblasted and protective coatings applied to protect against corrosion. In the process two lead joints that were found leaking were resealed. Construction has been completed to provide cathodic protection to 1000 feet of the underground portion of the twin mains. Four impressed current anode beds have been installed to complete the protection system.

Corrosion on 60 inch main prior to rehabilitation

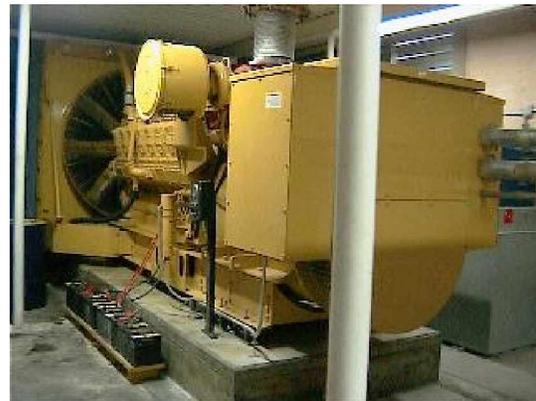
In March 1996, the engine of the old diesel generator failed and became inoperable. The unit was obsolete and the cost made it unfeasible to further repair the generator. In December 1996 a new 2000 kW generator was installed to replace the old 1750 kW generator. This generator has the capacity to power the entire treatment plant and raw water pumps in the event of an emergency power outage.

New Raw Water Booster Pump Station generator for backup power to treatment plant

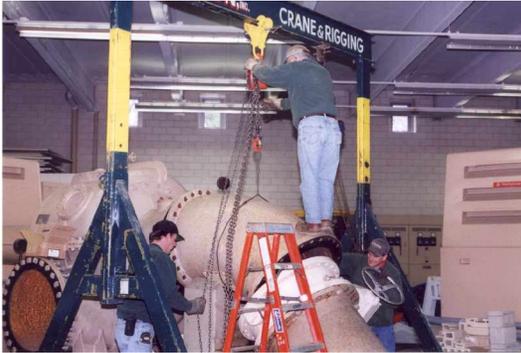
All eight (8) of the suction and discharge valves for the booster pumps in the pump station failed to provide a complete seal when closed. Construction has been completed in which all eight (8) valves and the four (4) actuators for the discharge valves were replaced.

Installation of spool piece after valve installation

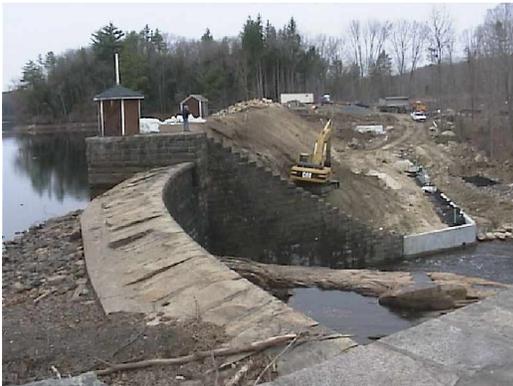
Construction is complete at Barden Reservoir. Work consisted of improvements to the inlet/outlet structures (including replacement of the gates at the inlet structure), the discharge channels, the spillway area, the crest of the dam to accommodate design flood flows, erosion protection along the upstream slope, and stabilizing the dam by flattening the downstream slope of the dam.

Repairs to the downstream slope of the dam

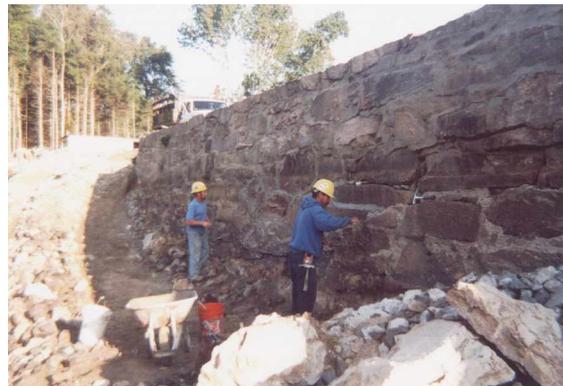
Repairs to upstream wall at Barden Dam

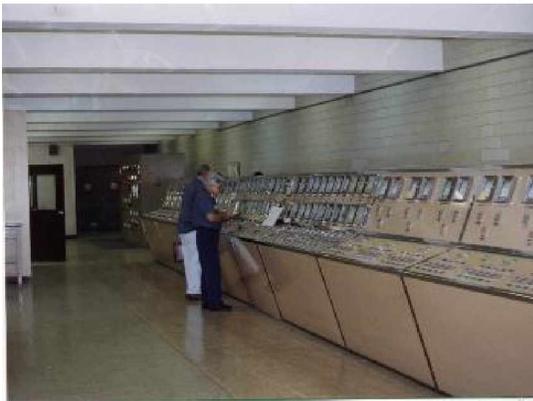
Installation of a new computerized control, instrumentation, and data acquisition system at the treatment plant is complete. The system monitors and controls the operation of the entire treatment plant and remote facilities. Construction of the new control room has been completed, process control equipment has been installed, all remote pump stations and reservoirs are on-line, and all of the in-plant points have been tied into the new control system. Wholesale facilities have been tied into the SCADA (Supervisory Control and Data Acquisition) system. Certification for Y2K compliance has been received from the prime contractor. Logs and reports are fully operational.

Old analog Central Control Board at treatment plant

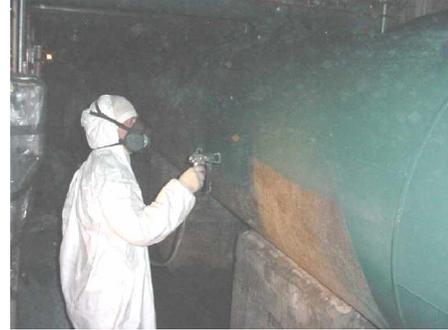
Recoating of the 48" dia. filter backwash washwater pipe and associated lateral piping, located in the Pipe Gallery of the treatment plant was completed. The old coating system was considerably deteriorated, threatening the integrity of the pipe. The coating was mechanically removed and a new moisture cured two-coat urethane paint system was applied.

Recoating of 48" dia pipe in progress

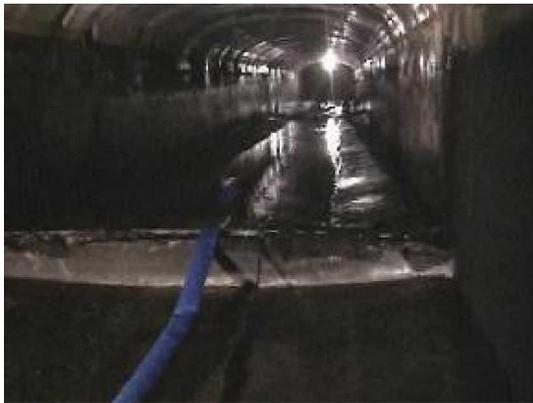
Construction is complete to rehabilitate the interior of the clearwell. Work consisted of rehabilitating eroded concrete surfaces and cracks, and leaking construction joints inside the interior of the structure. Also included in the scope of work was the structural rehabilitation of two cast-in place concrete 72" x 42" effluent venturi meters. The instrumentation has been fully restored with a new pressure sensing diaphragm type system replacing the annular rings. New process piping and signal wiring has been installed to carry the signal flow to the SCADA system.

Interior of the clearwell

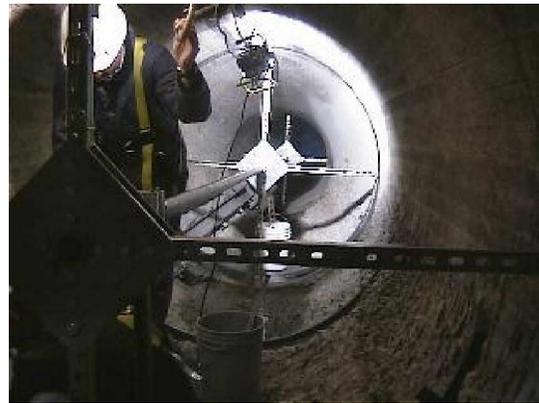
Concrete reconstruction and installation of new instrumentation in treatment plant's 72" x 42" effluent venturi meter

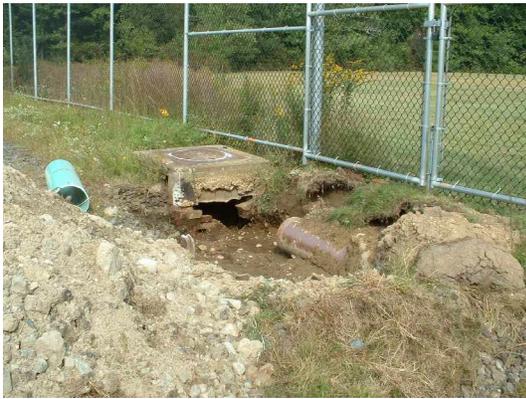
1,986 feet of 12" storm drain pipe was inspected with remotely operated closed circuit television equipment and cleaned through a water jetting process. The inspection identified several areas with blockages and cracks that required rehabilitation.

Section of vitrified clay pipe replaced with PVC

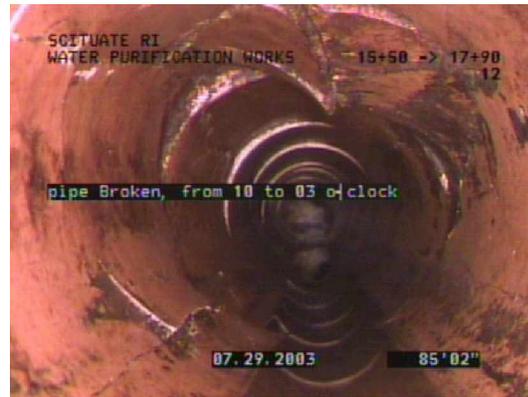
Screen shot of pipe inspection – Broken Pipe

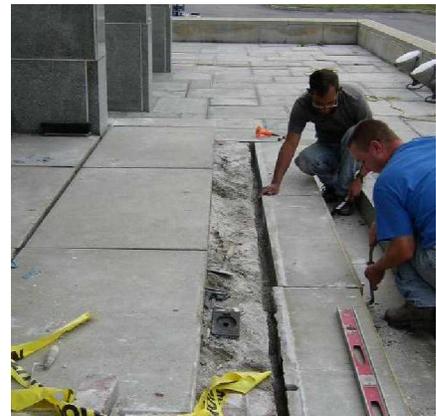
Construction is complete for the rehabilitation of the limestone and granite facade at the Treatment Plant. The Treatment Plant's limestone and granite facade was constructed during the 1960's and had deteriorated over time as a result of weathering and exposure from freeze-thaw cycles. The scope of work also included repair of mortar joints and spalled areas, cleaning of the limestone panels, parapet wall, and the brick chimney. The granite terrace and stairs were rehabilitated by removing and resetting sections of stone.

Resetting sections of stone on the stairs

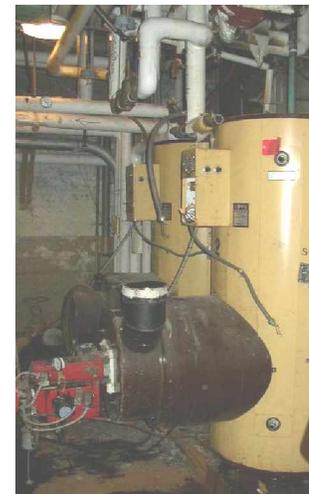
The construction contract to replace the two (2) water heaters at the treatment plant is substantially complete. Both units had failed and were out of service. The process water was being heated inefficiently by one of the two large heating boilers. A new system consisting of a new small boiler and an additional heat exchanger has been installed to correct this situation. The system will provide more efficient operation as well as redundancy to the entire hot water system that is used for domestic hot water and process water for water treatment. Only punchlist items remain.

Old Process Water Heaters

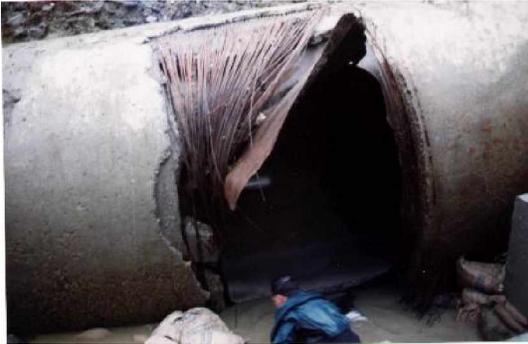
A portion of the 102" transmission aqueduct failed in November 1996. A failure analysis was conducted to determine the cause of the failure and corrective measures needed to prevent future failure. A risk assessment and internal inspection was performed between March 1998 and April 1998. The inspection and risk assessment resulted in recommendations to rehabilitate portions of the 102" main. In November 1998 work commenced on the 102" main consisting of exterior rehabilitation, internal reinforcing of sections of pipe with carbon fiber linings, installation of manholes for additional access points, and performing additional inspections of the main.

Rupture of the 102" Aqueduct – November 17, 1996

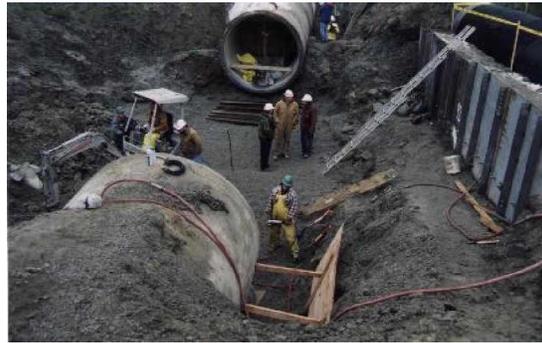
102" Aqueduct prepared for replacement sections

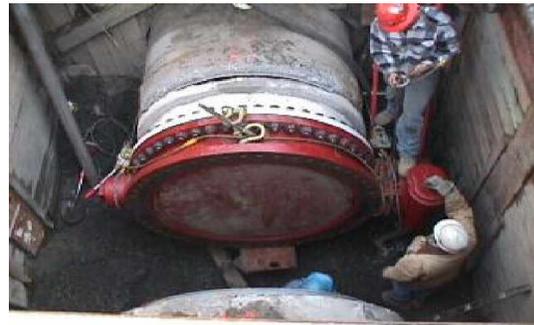
Installation of a new 60" butterfly valve to replace a defective valve at Budlong Road

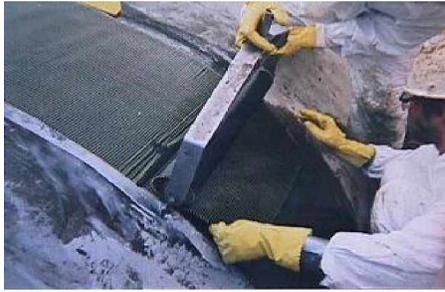
Application of carbon fiber to exterior of deteriorated section of 102" Aqueduct

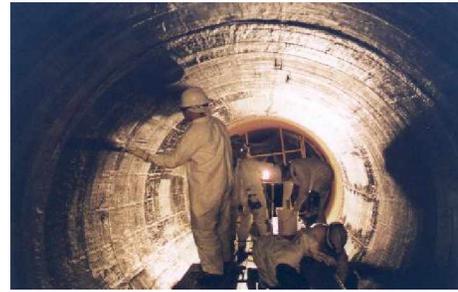
Crew applying carbon fiber lining to interior of deteriorated section of 102" Aqueduct

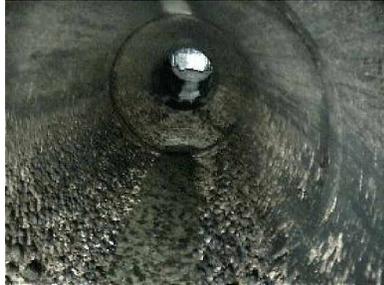
Extensive concrete corrosion damage was discovered in the treatment plant's 90-inch effluent conduit during the rehabilitation of the plant's effluent venturi meters. Subsequently, a video inspection in November 1999 revealed further extensive concrete corrosion damage continuing along the 90" aqueduct as it leaves the plant.

Concrete corrosion damage to the lower half of the effluent conduit

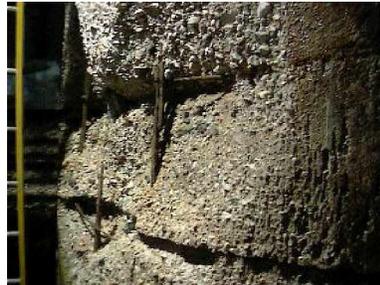
Extensive concrete corrosion damage in vicinity of south venturi meter

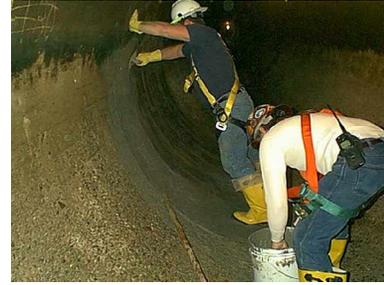
Concrete repairs to the interior of the 90" pipeline

Multiple methodologies and approaches for the rehabilitation of the 90" aqueduct were investigated and a work plan was developed that included the installation of a 90" butterfly valve in the aqueduct just downstream of the 78" aqueduct connection in order to enable the 78"/102" aqueduct to continue to function during an event in which the 90" is out of service. The installation of this valve made it possible to conduct the rehabilitative work on the 90". The interior of the 90" aqueduct was rehabilitated for a distance of 1000 feet from the Effluent Chamber to the West Portal using fast curing, potable water-safe, cementitious products.

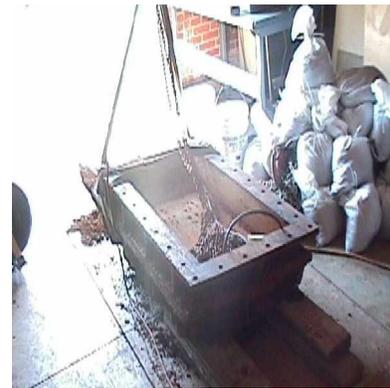
Construction is complete for the rehabilitation of the original section of Longview Reservoir. The rehabilitation work consisted of the application of a hot-applied reinforced rubber membrane sealant over the entire roof surface of the reservoir, sealing of all cracks and construction joints on the walls and floor of the interior of the reservoir, replacement of the sluice gate, and replacement of the stop shutters.

Old Longview Reservoir sluice gate being removed
