In re: City of Woonsocket Water Division - Application to Implement Multi-Year Rate Plan

Docket No. 4879

Dam Name (No):	Woonsocket Reservoir #3 Dam (068)
Location:	Smithfield/North Smithfield
Hazard Classification:	High
	-
Inspector:	David M. Matheson, P.E.
Inspection Date.	August 1, 2014

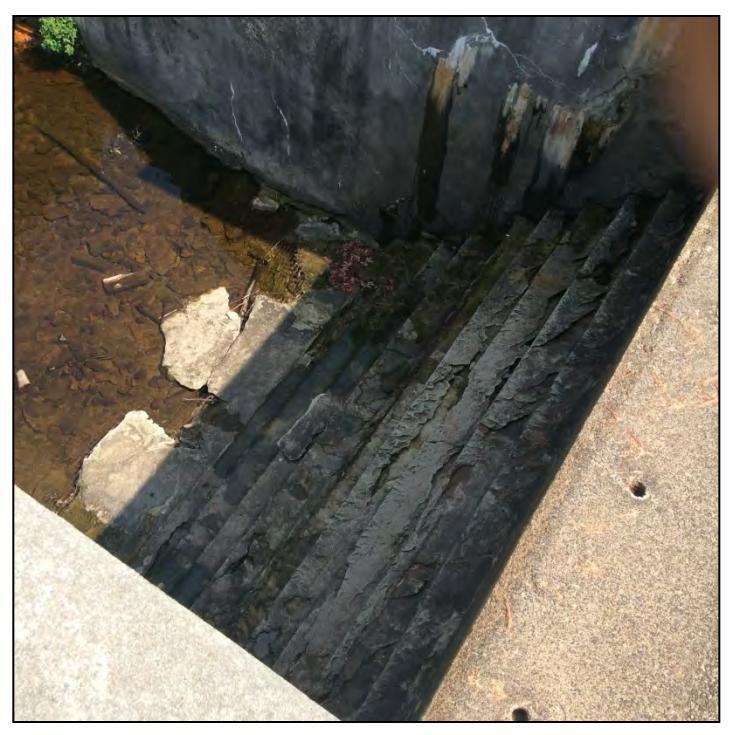
Photo No. 22: The primary spillway's stepped spill area as seen from the crest looking downstream. Note the heavily deteriorated shotcrete facing along the steps and adjacent training wall.

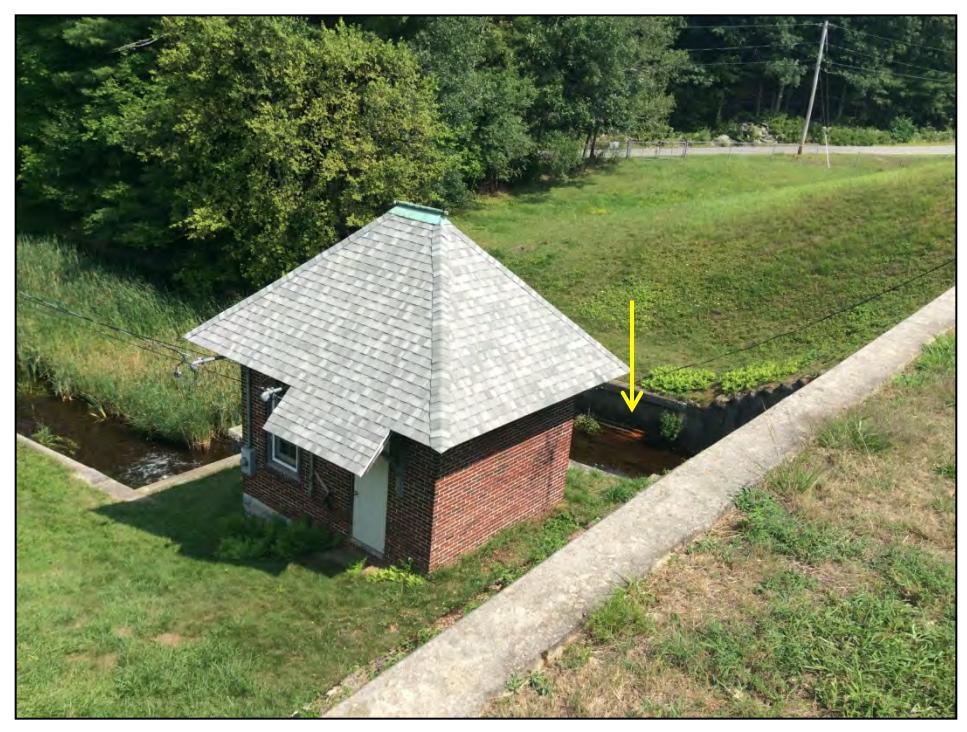
Photo No. 29: View of the gatehouse structure and spillway's discharge channel as seen from the crest looking slightly right and downstream. Note the drain outlet on the right side of the channel with the stained flow.

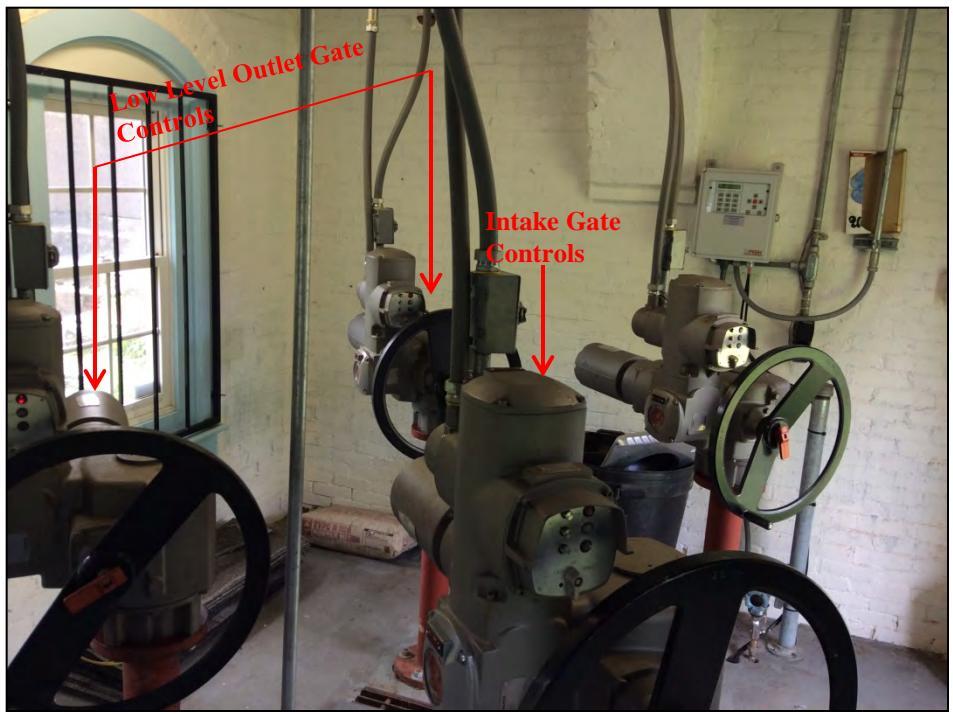
Photo No. 30: Photo from within the control structure looking upstream. The left two gates work in series to control the intake pipe that leads to the treatment plant located about 2 miles downstream. The right two gates work in series with the T-valve located outside and downstream of the gatehouse to operate the low level outlet. Presently the gates for the low level outlets are open to allow the required low flow downstream.

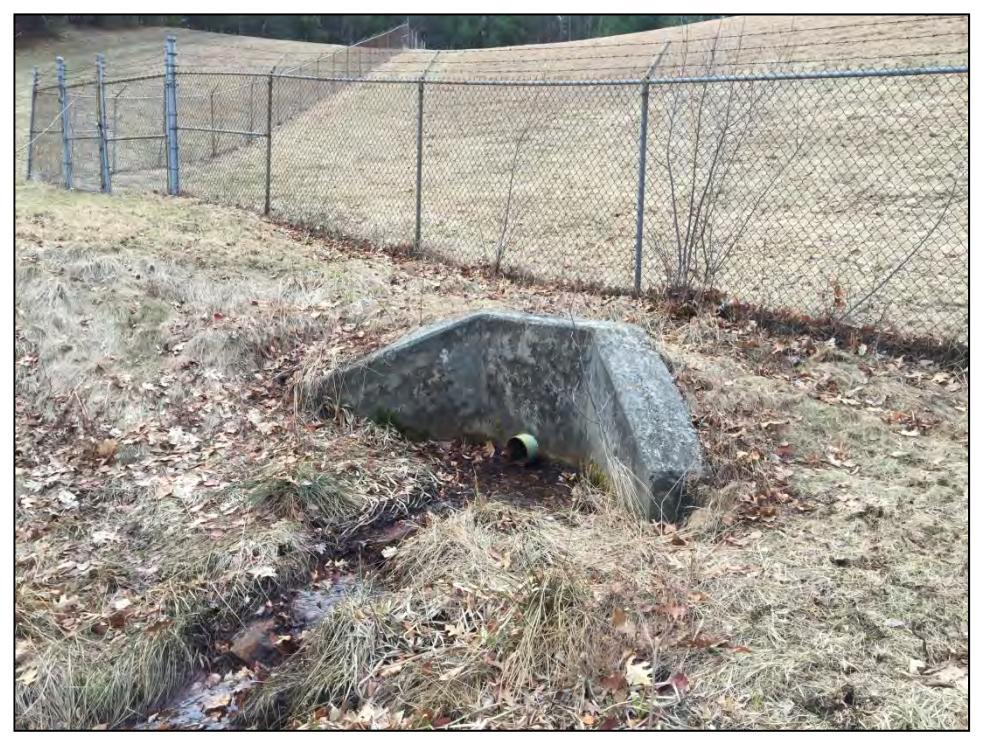
Photo No. 32: The discharge to the abandoned outlet at the toe of the dam near Station 8+00 (photo looking upstream and right). Note active leakage from discharge pipe (similar to that observed during the last inspection)

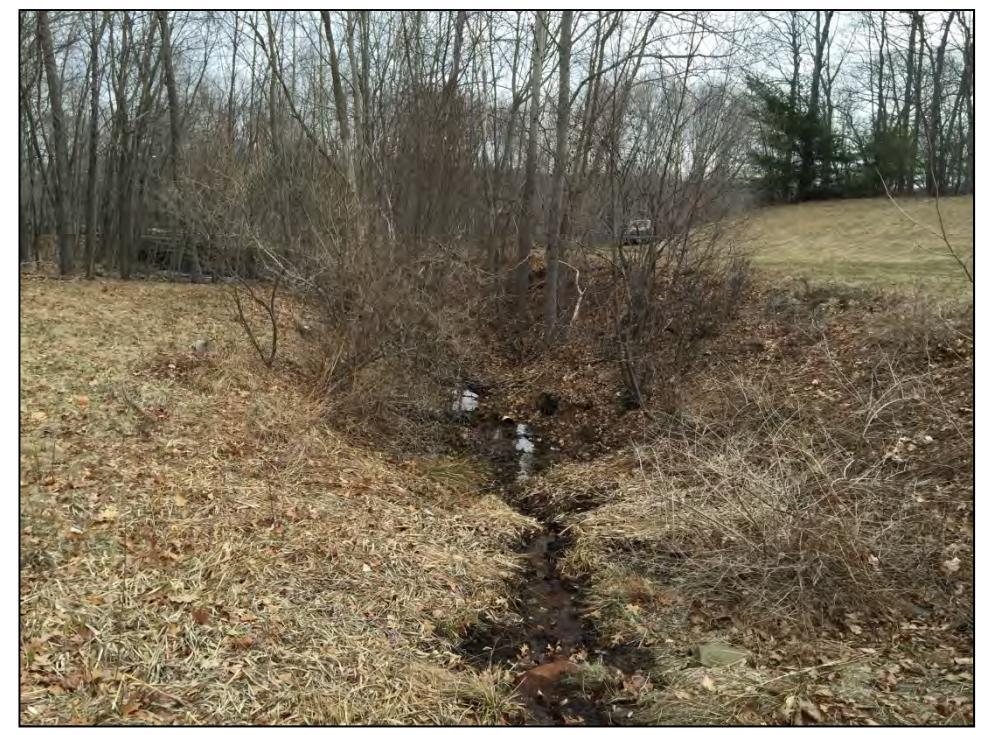
Photo No. 33: Discharge channel from abandoned outlet shown in previous photo. Note active flow from the leaking channel.

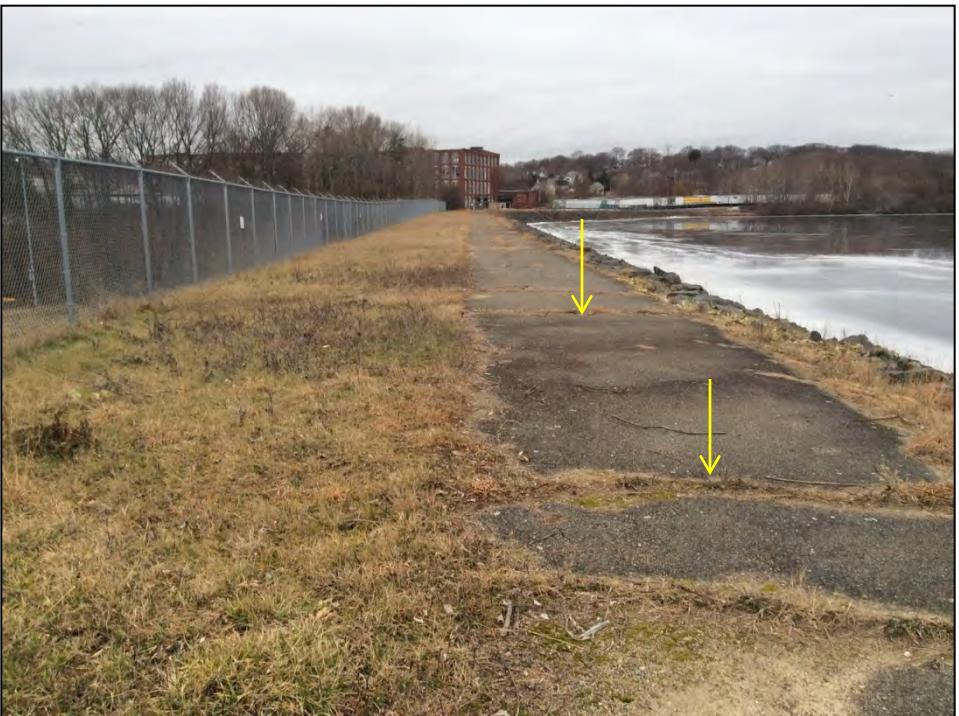
Photo No. 7: Crest as viewed from right of the primary spillway looking right. Note the cracked asphalt pavement.

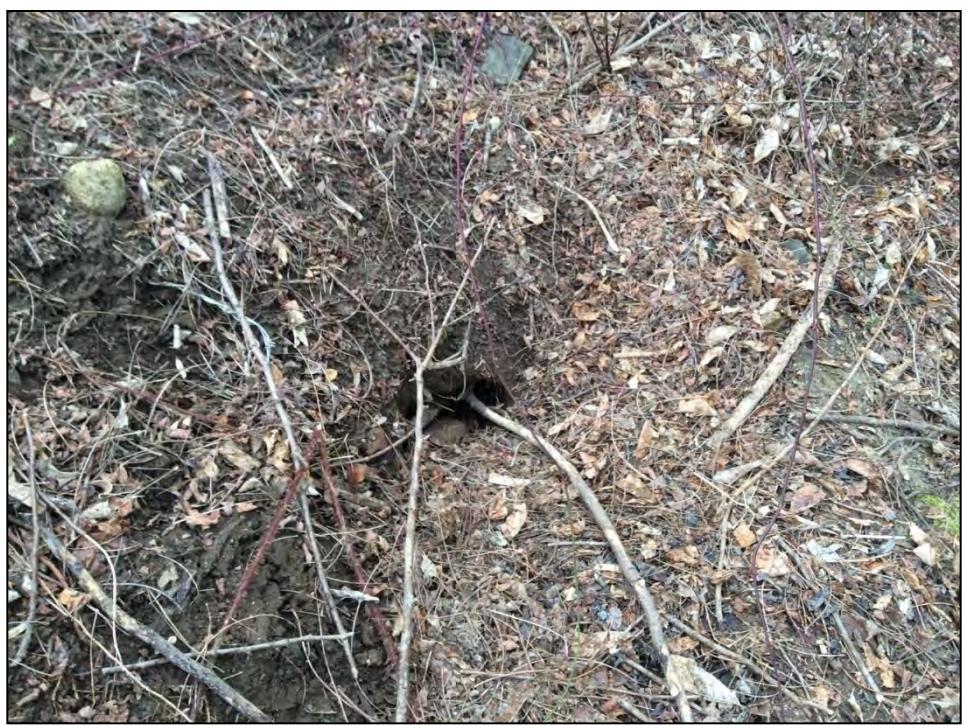
Photo No. 11: Animal Borrow behind the low level outlet discharge headwall.

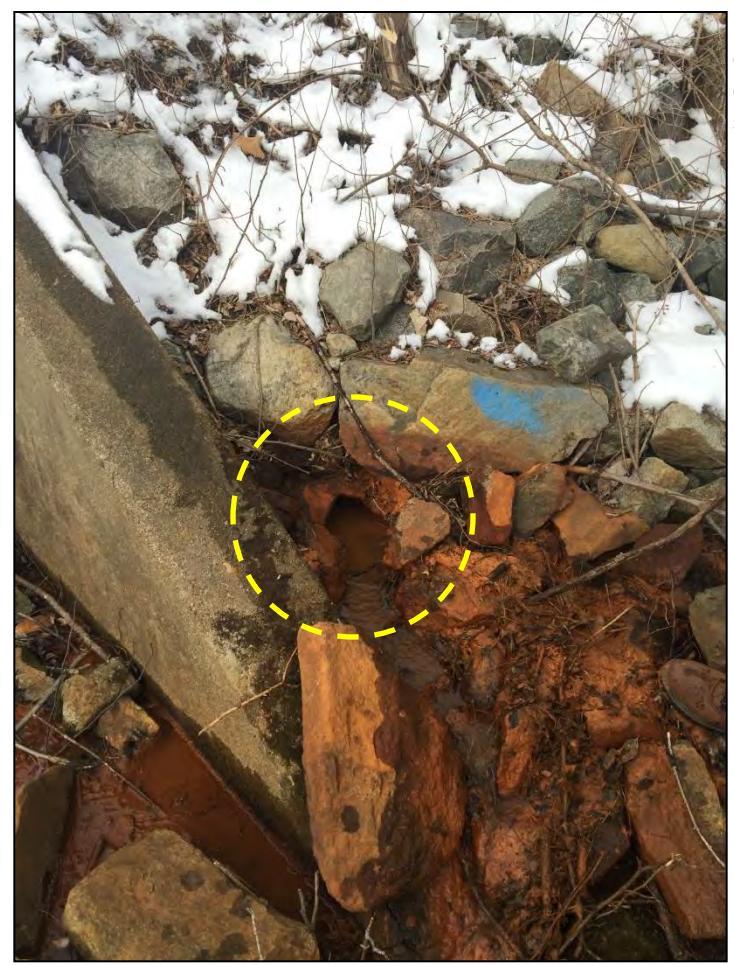
Photo No. 22: The recently uncovered toe drain outlet on the left side of the low level outlet headwall. Note the broken end and stained flow.

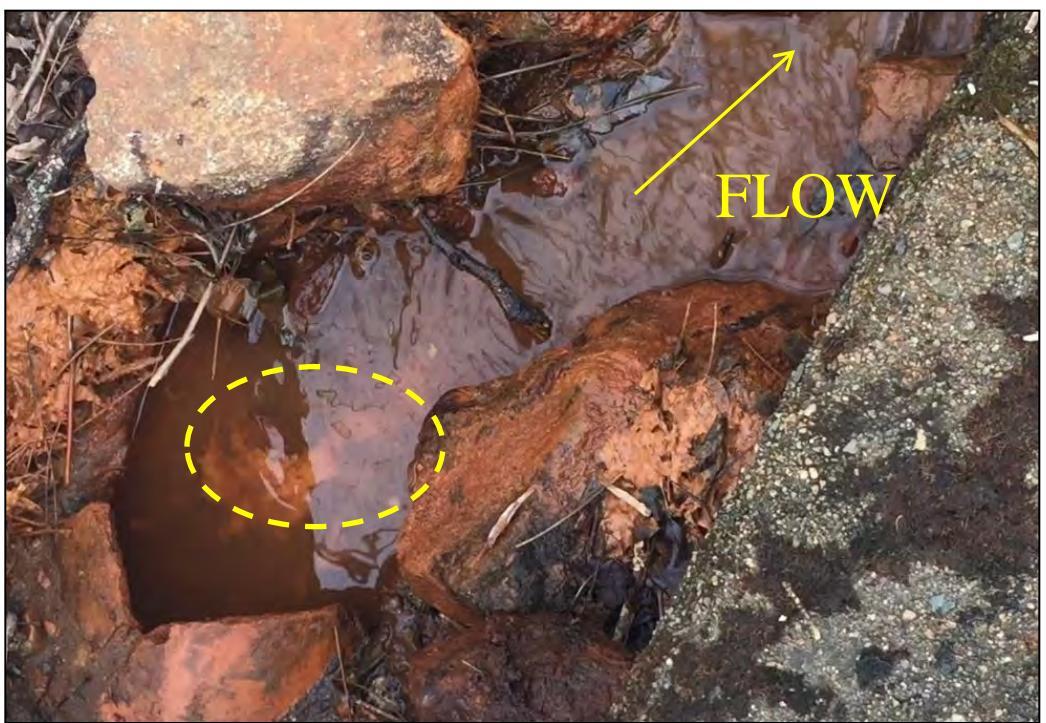
Photo No. 23: Close-up of Photo No. 22. Note the mass of iron flocculate within the discharge flows.

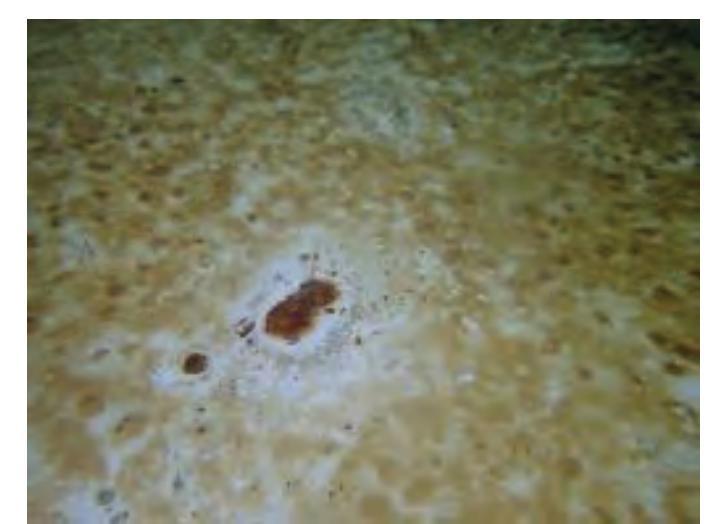
63 Floor With Ruptured Coating Blisters, Exposed Underlying Steel, Mild Surface Corrosion And Mild To Moderate Staining

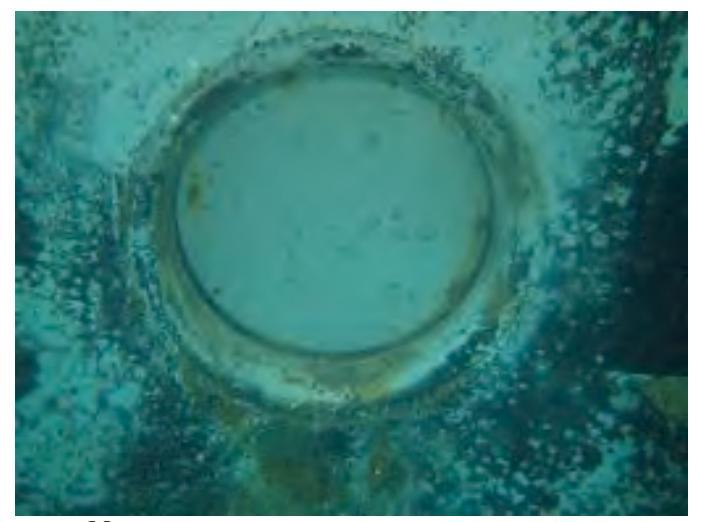
65 *Floor With Ruptured Coating Blisters, Exposed Underlying Steel, Mild Surface Corrosion And Mild To Moderate Staining*

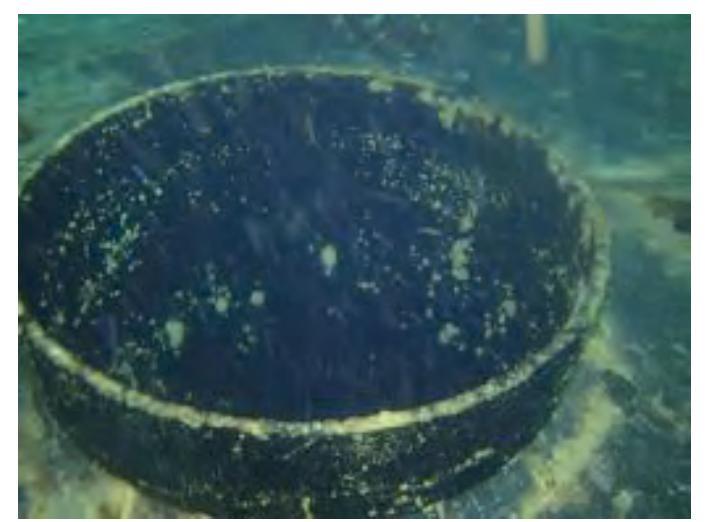
71 30" Inside Diameter Pipe - Flush Penetration Silt Stop With Coating Loss/Blistering, Exposed Underlying Steel And Mild To Moderate Corrosion

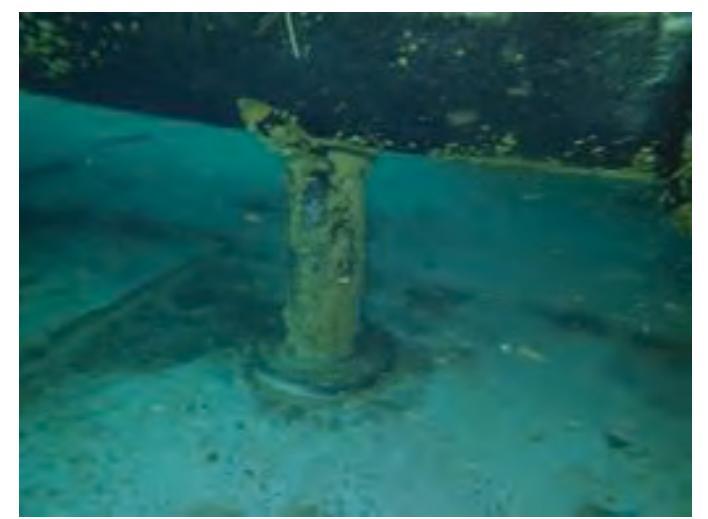
28" Inside Diameter Pipe With Ruptured Coating Blisters, Exposed Underlying Metal And Mild To Moderate Surface Corrosion

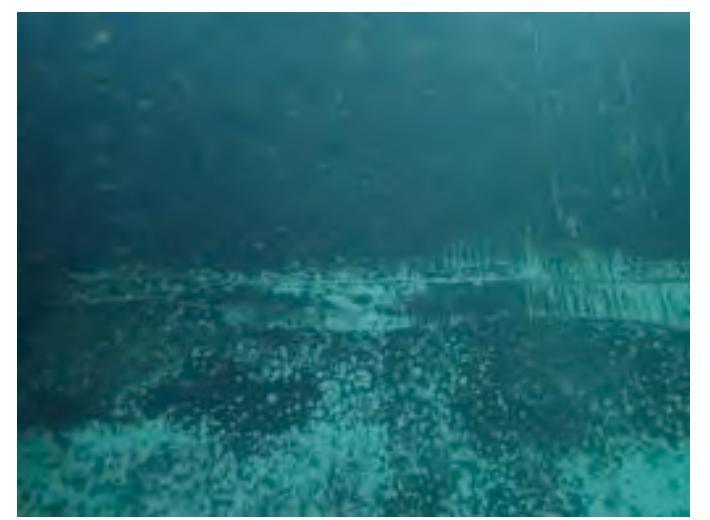
89 Interior Wall With Ruptured Coating Blisters, Exposed Underlying Steel, Fatigue (Pitting), Corrosion And Mild Staining

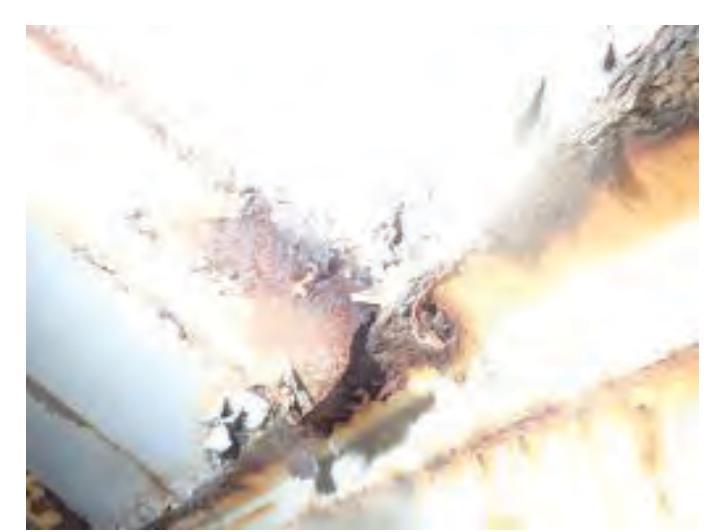
101 Overhead With Coating Loss, Exposed Steel And Surface Corrosion

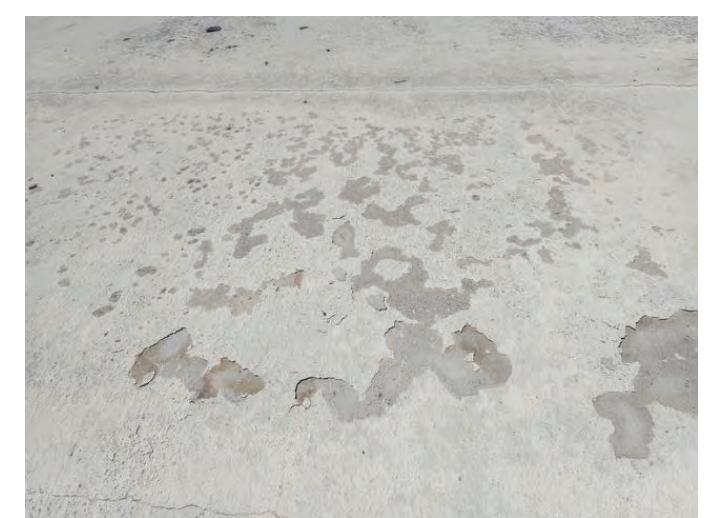
29 Roof Panels With Tight Cracks Within The Concrete-Filled Joints Due To Coating Loss Resulting In Exposed Underlying Concrete

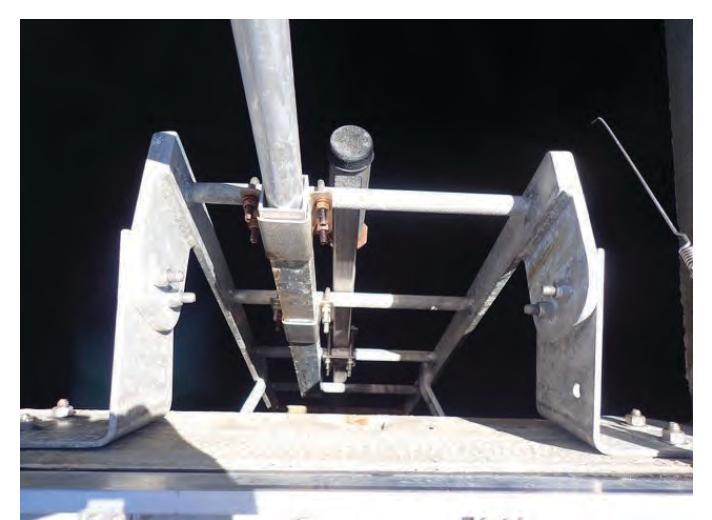
79 Interior Aluminum Ladder And Fall Prevention Device With Fatigue (Pitting) And Corrosion

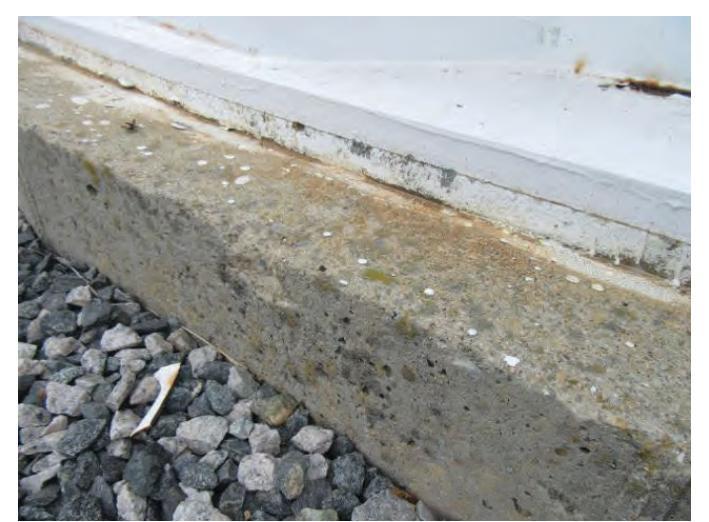
53 Concrete Foundation With Spall

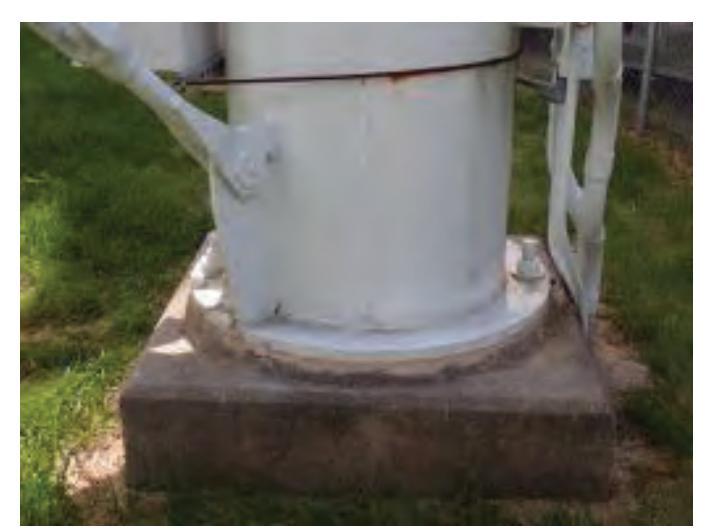
27 Tower Support Leg Having Coating Loss With The Concrete Support Pad Having Tight Surface Cracks And A Secure Anchor Bolt

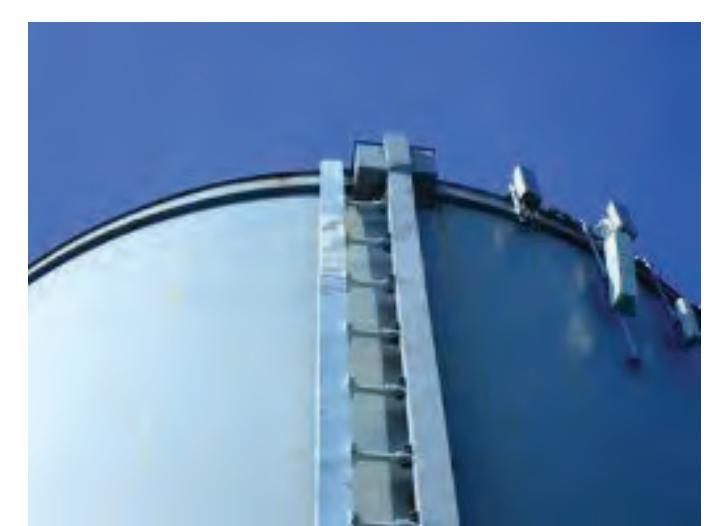
10 Exterior Wall With Coating Loss/Chalking, Exposed Underlying Steel, Mild Corrosion And Rust Staining

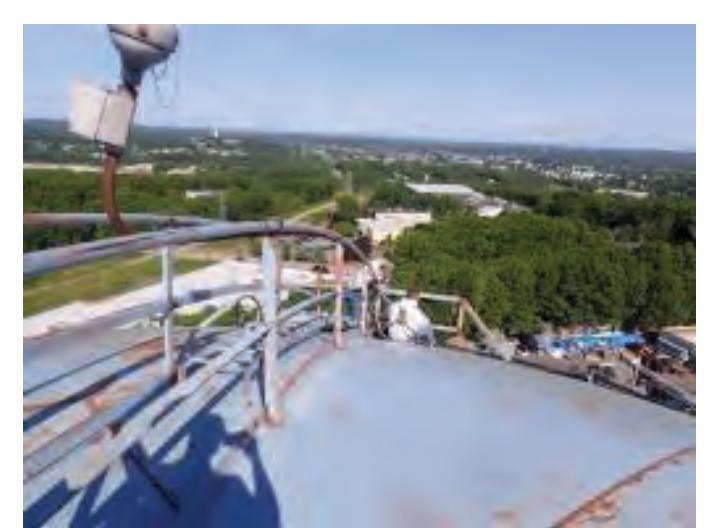
46 Secure Roof Safety Railings With Coating Loss (Nearing Expiration), Exposed Steel And Surface Corrosion

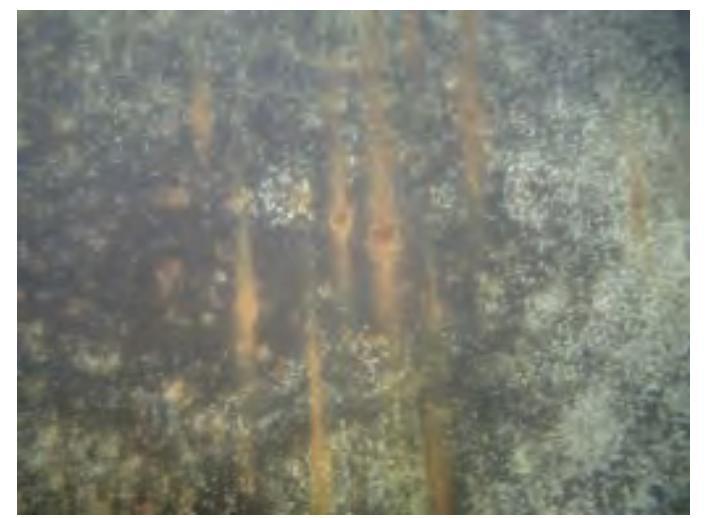
78 Interior Wall With Expired Coating, Exposed Underlying Steel, Fatigue (Pitting), Moderate Corrosion And Moderate To Heavy Staining

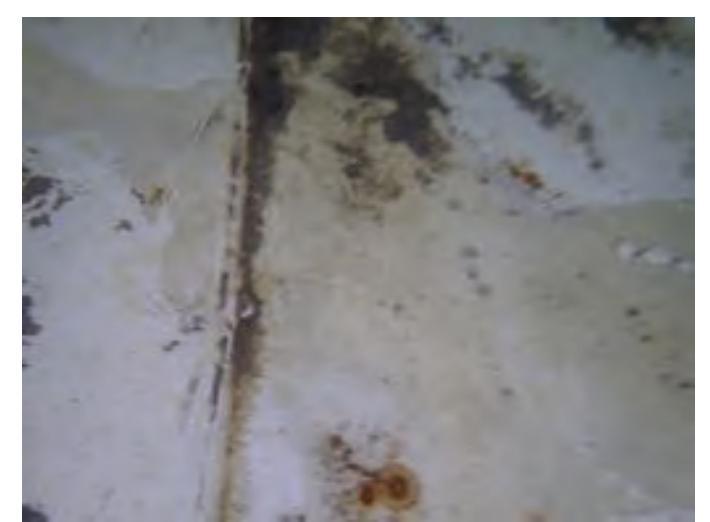
58 Floor With Coating Loss, Ruptured Coating Blisters, Exposed Underlying Steel And Mild To Moderate Staining

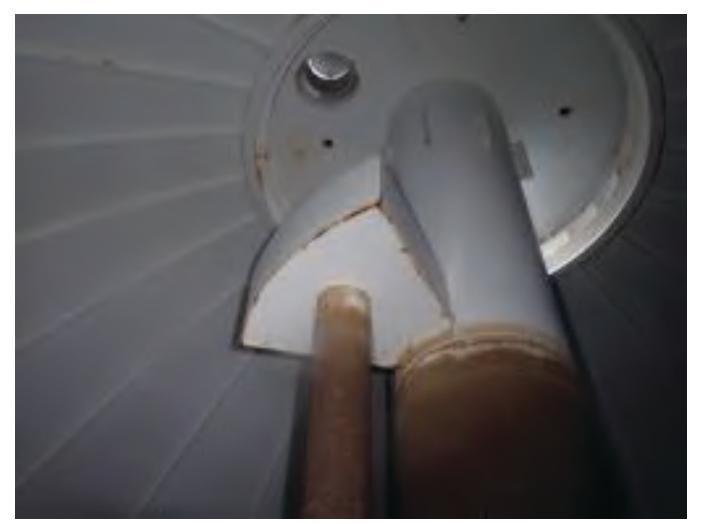
119 Overflow Pipe Weir Box With Secondary Coating Loss, Exposed Underlying Steel And Mild Corrosion
