Impact Evaluation of PY2018 Custom Gas Installations in Rhode Island

National Grid

Date: October 20, 2020

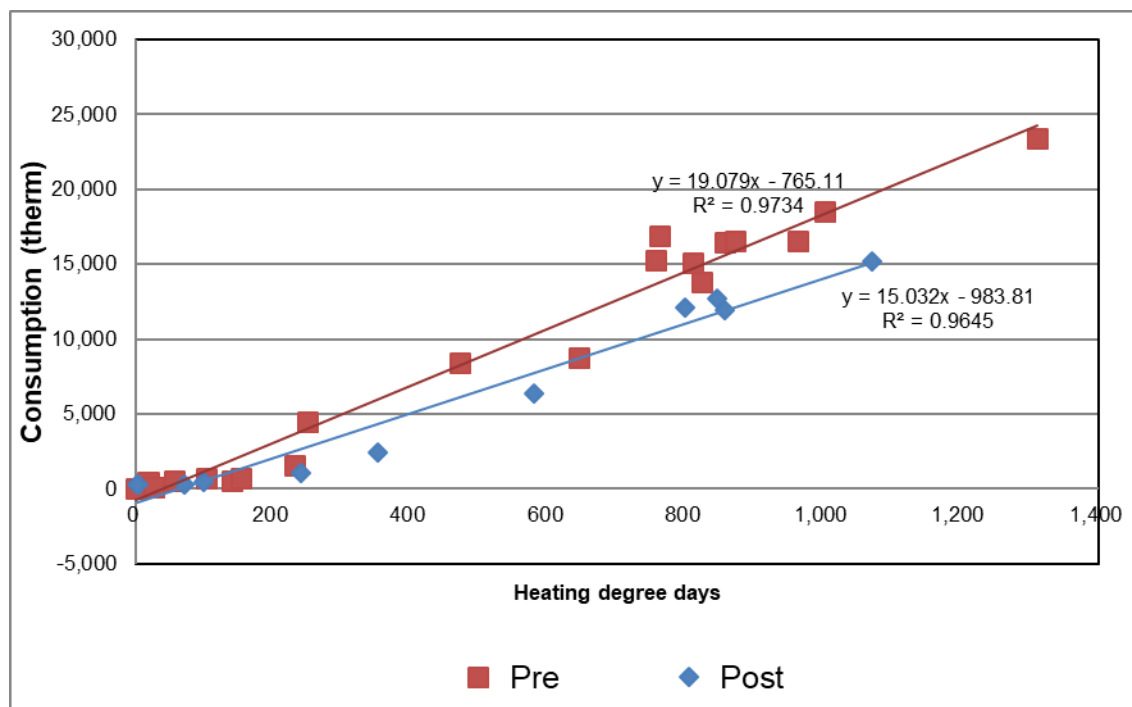
Figure 5-6. Pre- and post-installation correlation with degree days

Below in Figure 5-6, regression equations are shown for pre- and post-installation gas consumption when compared to HDD.

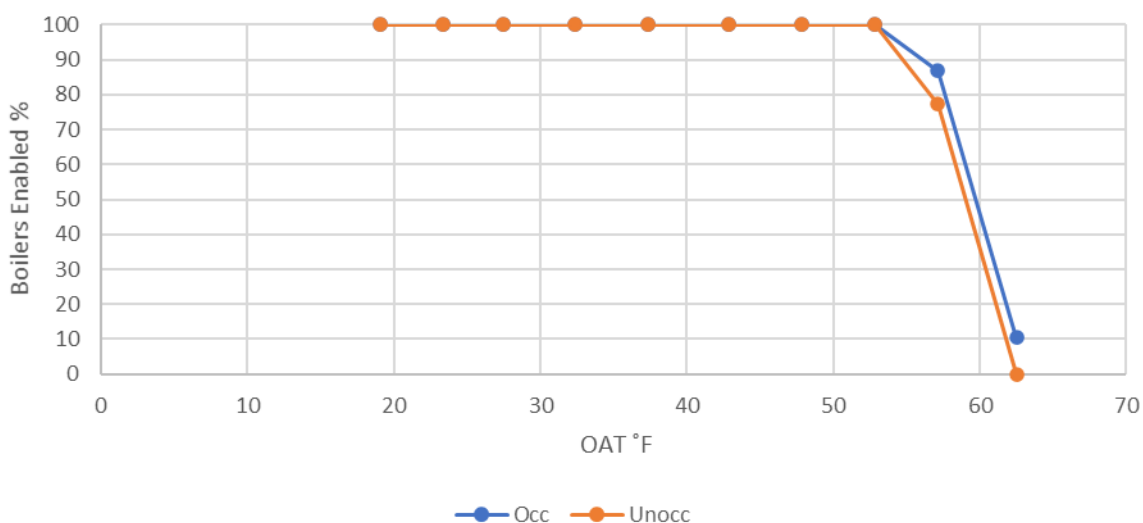
Figure 2-2. Boiler Plant Enabled vs OAT (Occupied/Unoccupied Comparison)

To demonstrate the impact of the 7-day schedule control sequence on boiler plant operation, the figure below shows the trended percentage of time that the boiler is enabled when the outside air temperature is less than 61°F as a function of time of day for each day of the week over the course of the trend period. Note that trends were not provided for actual boiler status.

The lack of correlation between boiler runtime and time of day/day of week shows that as implemented the 7-day schedule has little to no effect on the operation of the boiler plant. The only impact compared to the pre-existing case is that the system is automatically enabled at 60°F OAT rather than manually enabled/disabled.

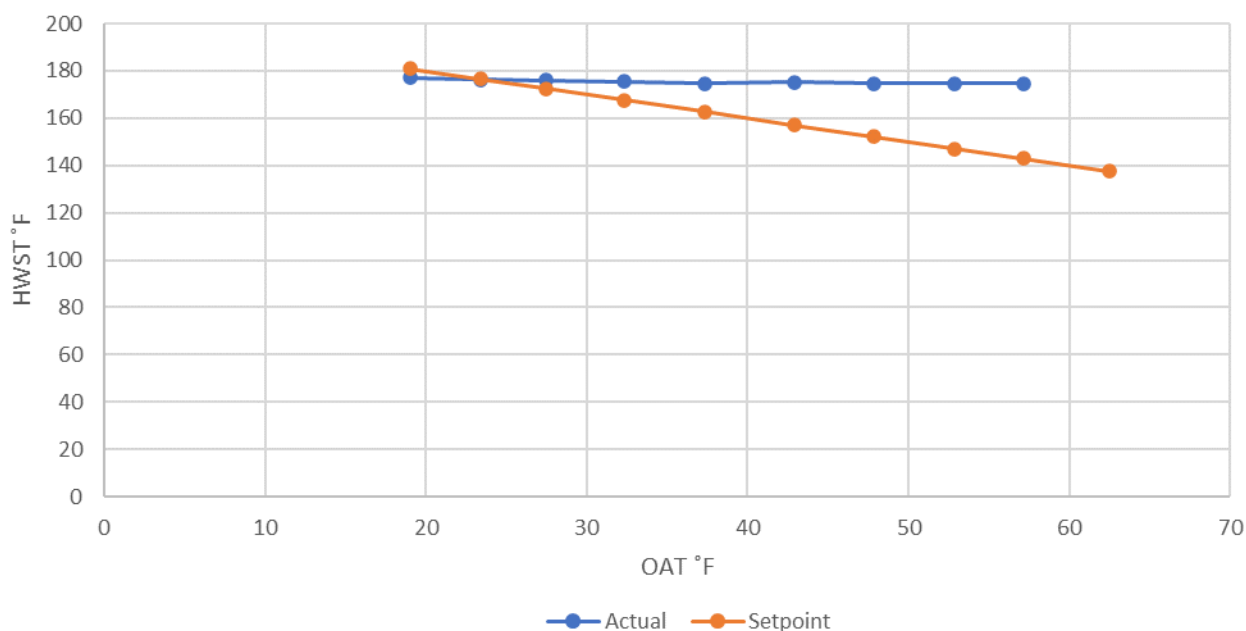
Figure 2-3. Average HWST°F vs OAT°F

below shows the average hot water supply temperature and hot water supply setpoint as a function of outside air temperature.

A screenshot of the EMS provided by the controls contractor demonstrated that the HWST setpoint is being reset based on outside air temperature. However, the faulty mixing valve described above is preventing the hot water reset schedule from being implemented as intended. The boiler provides ~180°F primary water which shows the faulty mixing valve is always leaking by into the circulation loop.

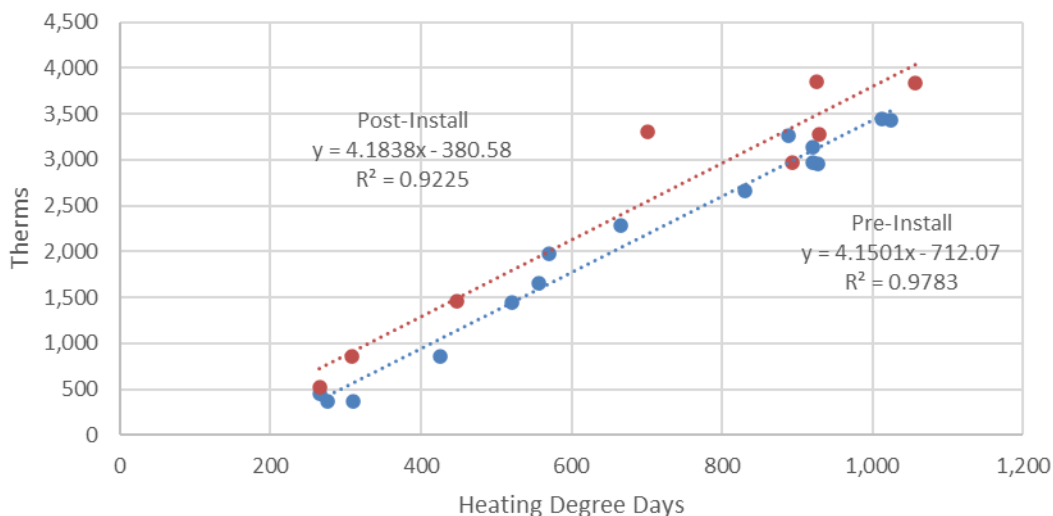
Figure 2-4. Actual Pre-Install vs Post-Install Gas Usage

Hourly weather station data from TF Green Airport in Providence was used to calculate the actual heating degree days (HDD) associated with each gas bill. Figure 2-4 below shows the pre-installation and post-installation relationship between monthly gas usage and heating degree days excluding months with less than 200 HDD.

The bill data shows that the boiler plant uses more gas per heating degree day with the new EMS.

The evaluated savings for this project are calculated using TMY3 weather data from TF Green Airport to calculate weather normalized gas savings. Months with less than 200 HDD are not considered in the evaluated savings. Note that the annual heating degree days calculated using TMY3 weather data (5,976 HDD) are greater than the heating degree days in the years of gas bill data used to calculate the relationship between heating degree days and gas usage (2016: 5,304 HDD, 2017: 5,296 HDD, 2018: 5,560 HDD, 2019: 5,678). Table 2-6 summarizes the weather normalized gas savings calculated for the project based on pre- and post-installation gas bill data.

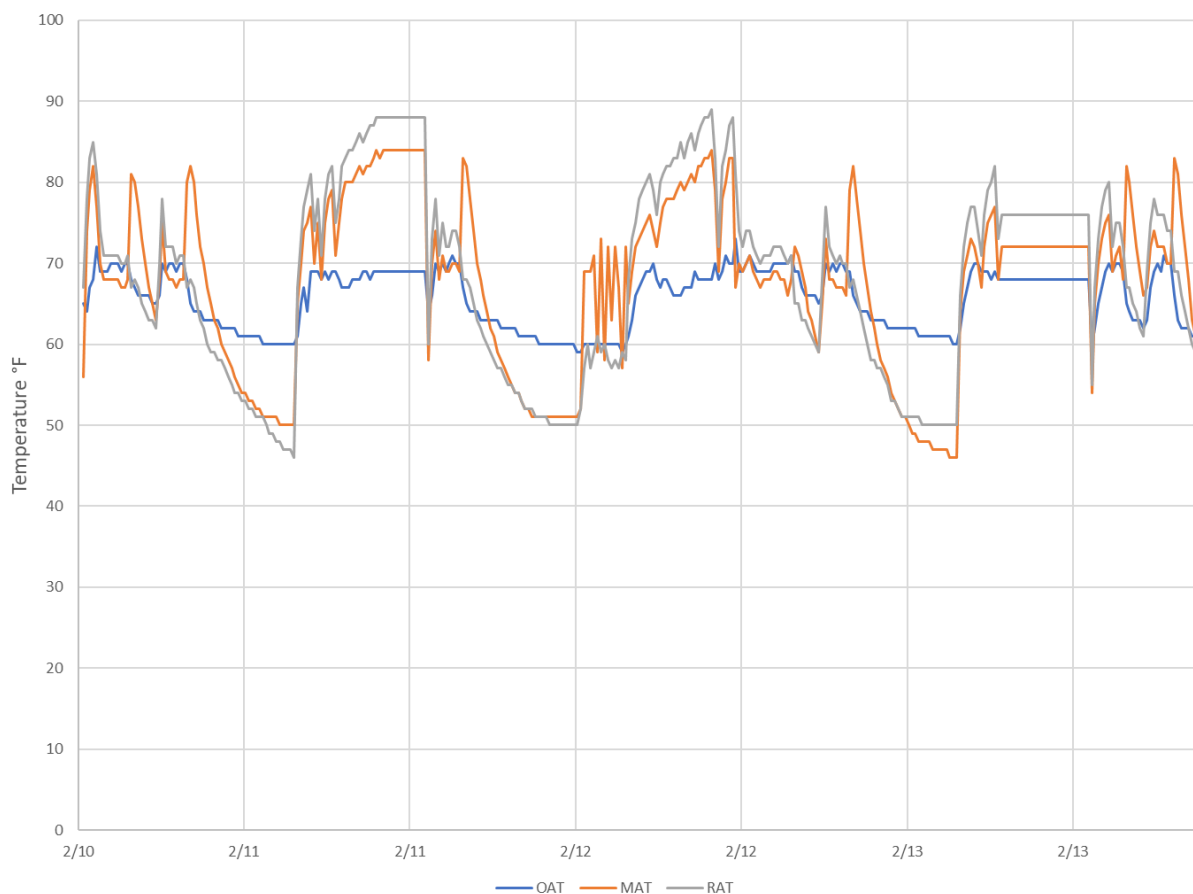
Figure 2-2. Raw Trend Data (RTU)

The figure below presents a representative portion of the raw trend data provided for the rooftop unit by the controls contractor that installed the new EMS. Note that there is a

significant gap in the RTU trend data provided. The data shows that the mixed air temperature roughly follows the return air temperature suggesting that the RTU operates at a fixed outside air percentage another indication besides no CO₂ sensor, that the demand control ventilation strategy is not working.

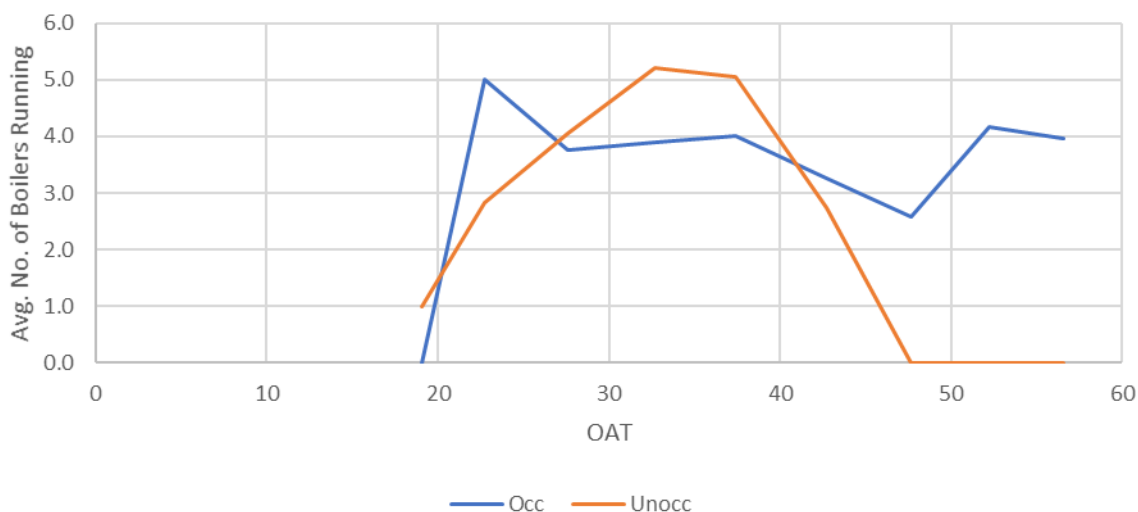
Figure 2-3. Number of Boilers Running vs OAT (Occupied/Unoccupied Comparison)

To demonstrate the impact of the 7-day schedule control sequence on boiler plant operation, the figure below shows the average number of boilers running as a function of outside air temperature during occupied and unoccupied hours.

The trends show that there is a different outside air enable temperature during occupied and unoccupied hours. It is unclear if the implementation of the 7-day schedule results in a reduction in hot water system run hours compared to the pre-existing control strategy of manually shutting down the hot water system with the emergency shutoff.

Figure 2-3 shows that more boilers run during unoccupied hours than occupied hours when OAT is between 30°F and 40°F. It is suspected that this is because there is less internal heat gain (occupant body heat, lighting heat, plug loads) during unoccupied hours than occupied hours.

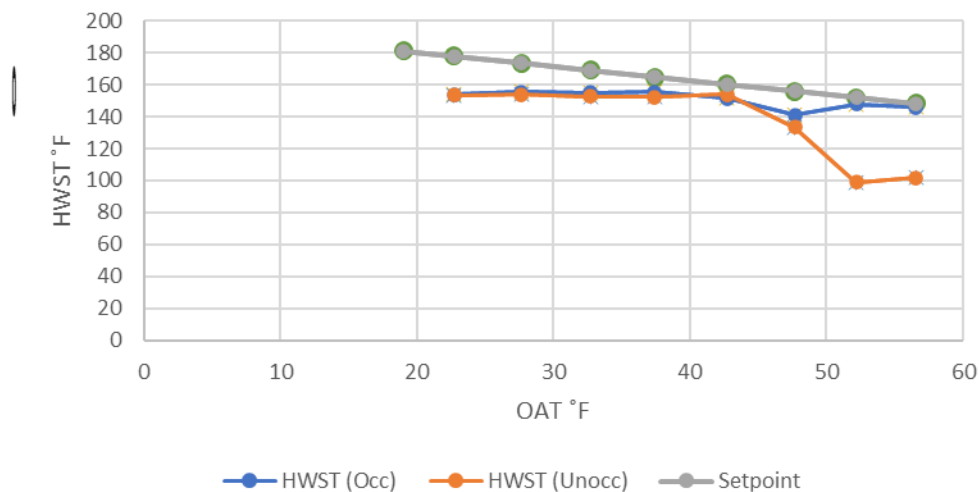
Figure 2-4. Average HWST°F vs OAT°F

Trends confirm that hot water supply temperature does vary slightly with outside air temperature. The figure below shows the average hot water supply temperature and hot water supply setpoint as a function of outside air temperature. The water temperature declines as outdoor air temperature increases during unoccupied hours because the hot water system is not enabled.

A screenshot of the EMS provided by the controls contractor demonstrated that the HWST setpoint is being reset based on outside air temperature. However, the boilers are unable to maintain the hot water setpoint.

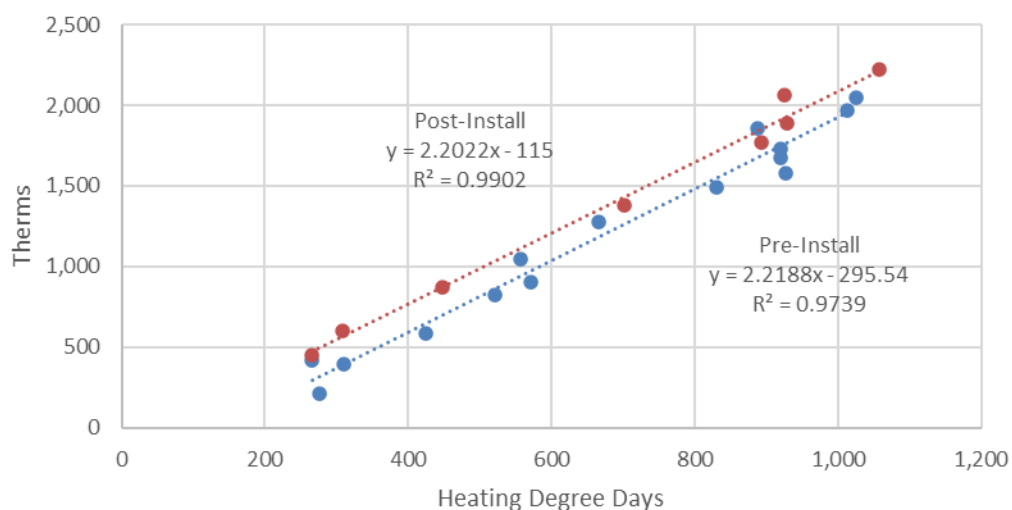
Figure 2-5. Pre-Install vs Post-Install Gas Usage

The bill data shows that the boiler plant uses more gas per heating degree day with the new EMS.

Billing analysis savings for this project are calculated using TMY3 weather data from TF Green Airport to calculate weather normalized gas savings. Months with less than 200 HDD are not considered in the evaluated savings. Note that the annual heating degree days calculated using TMY3 weather data (5,976 HDD) are greater than the heating degree days in the years of gas bill data used to calculate the relationship between heating degree days and gas usage (2016: 5,304 HDD, 2017: 5,296 HDD, 2018: 5,560 HDD, 2019: 5,678). Table 2-6 summarizes the weather normalized gas savings calculated for the project based on pre- and post-installation gas bill data.

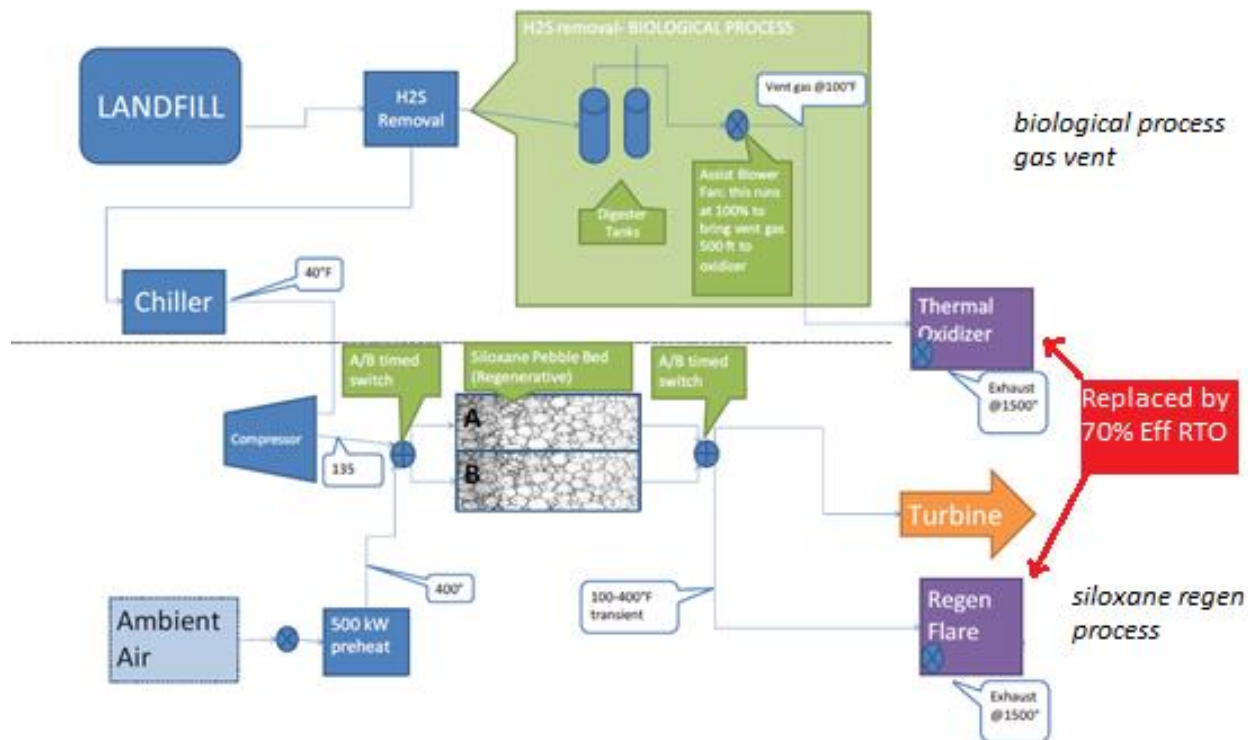
Figure 2-1: Pre-Retrofit System Diagram

Note: Natural gas consumed at thermal oxidizer and regen flare

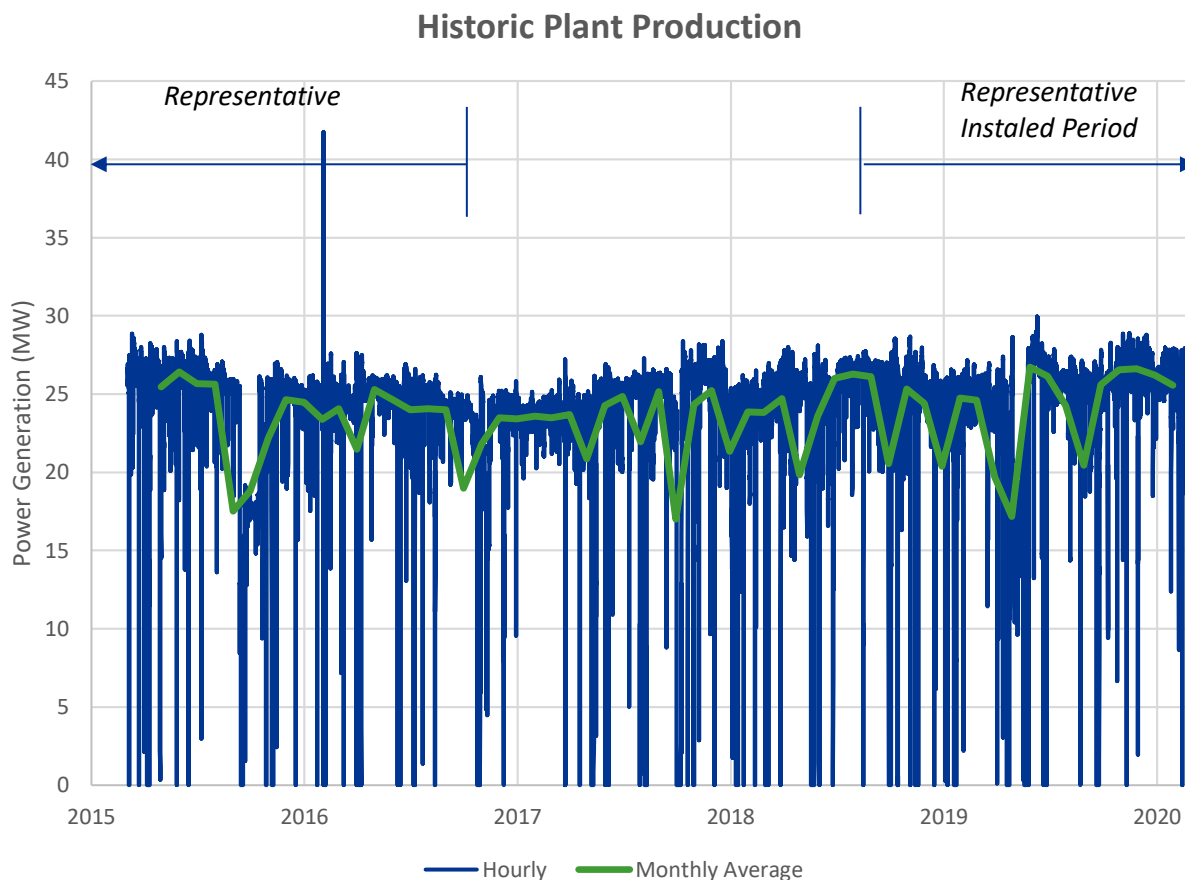
Figure 2-7 Plant Electrical Generation

SCADA trends included plant electrical generation for the previous 5 years, beginning in 2015. The generation data is shown below in Figure 2-7. Electrical generation is relatively constant over the 5 year period, which suggests that the oxidizer loads should be similar. The expectation is that more electrical generation would require more landfill gas, which would result in more bio-gas and siloxane removal. There should be some degree of relationship between the oxidizer/flare loads and electrical generation. Combustion fan speed and therefore airflow are relatively constant during the two operating modes, biogas vent only or bio gas vent with siloxane regen, which implies that the oxidizer loads are not sensitive to variations in electrical generation. The combustion fan speed is not being controlled such that it varies directly with electrical generation.

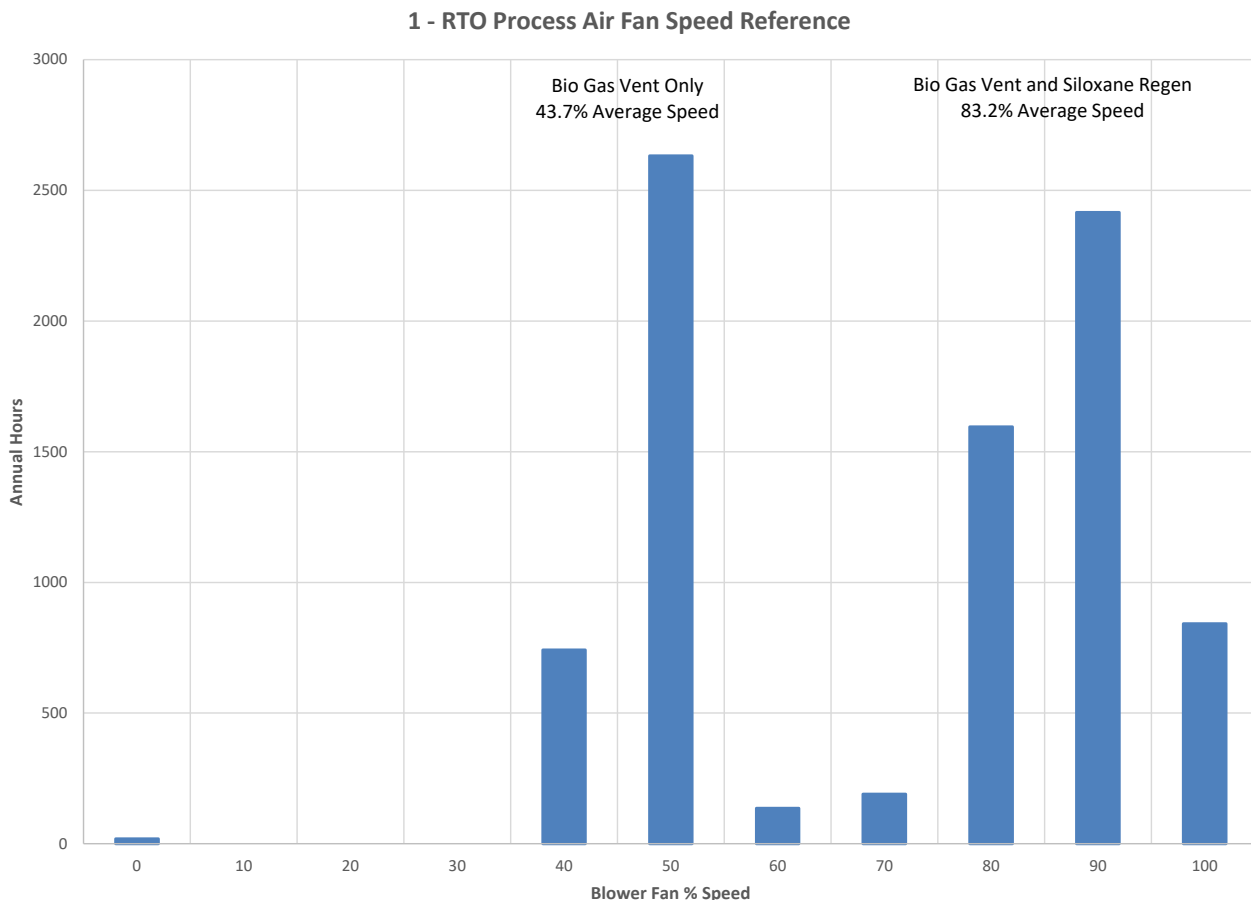
Figure 2-8 RTO Process Fan Speed Histogram

Temperatures at intermediate points of the thermal oxidizer vary similarly based on the fan speed. While the combustion temperature is the same during either operating condition (1,550°F), the intermediate temperatures vary somewhat because the inlet temperature coming off the siloxane beds is different than the bio gas vent. This difference affects the heat exchange effectiveness slightly. Figure 2-9 summarizes the average temperatures observed in the trend data. Figure 2-10 shows a system diagram with the locations of the corresponding RTO monitoring points.

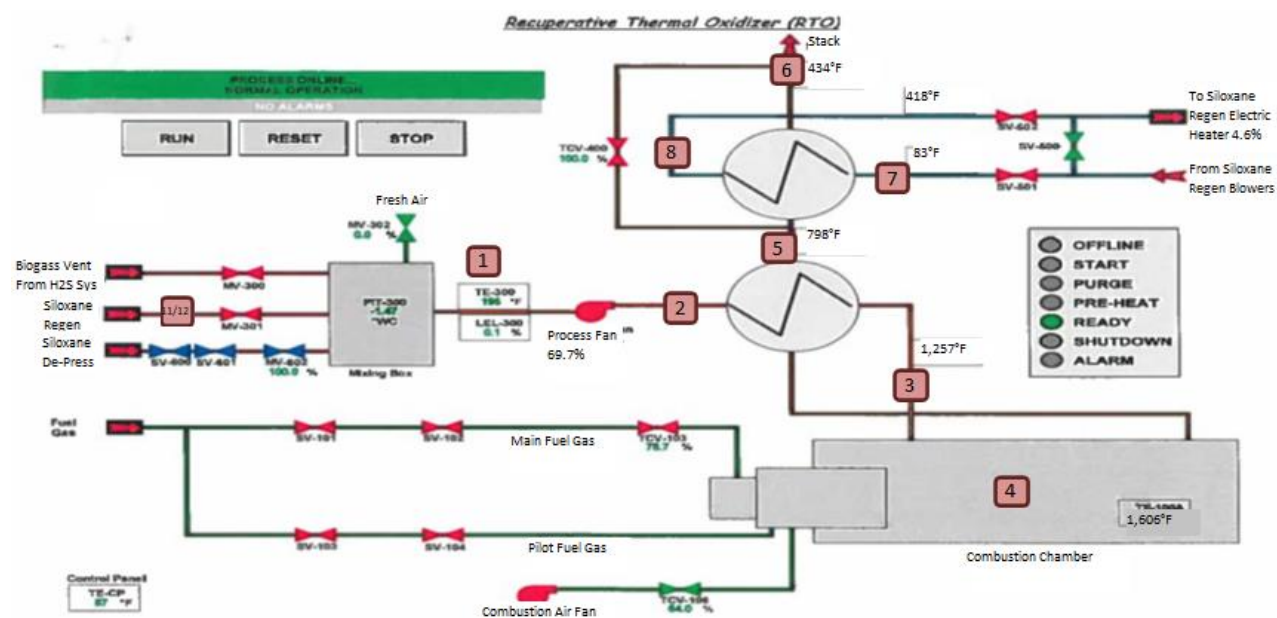
Figure 2-10 Installed System Diagram

Note: points 9 and 10 are part of the siloxane system and not shown on this schematic of the RTO

The recuperative thermal oxidizer effectiveness is calculated based on the entering and leaving temperatures of the heat exchanger. Based on the SCADA trend data, the evaluation calculates an average of 58% and 49% for bio gas vent and siloxane purge periods respectively, with an overall average of 53%. These values are calculated using the following expression for the mixture of biogas vent and siloxane regeneration streams:

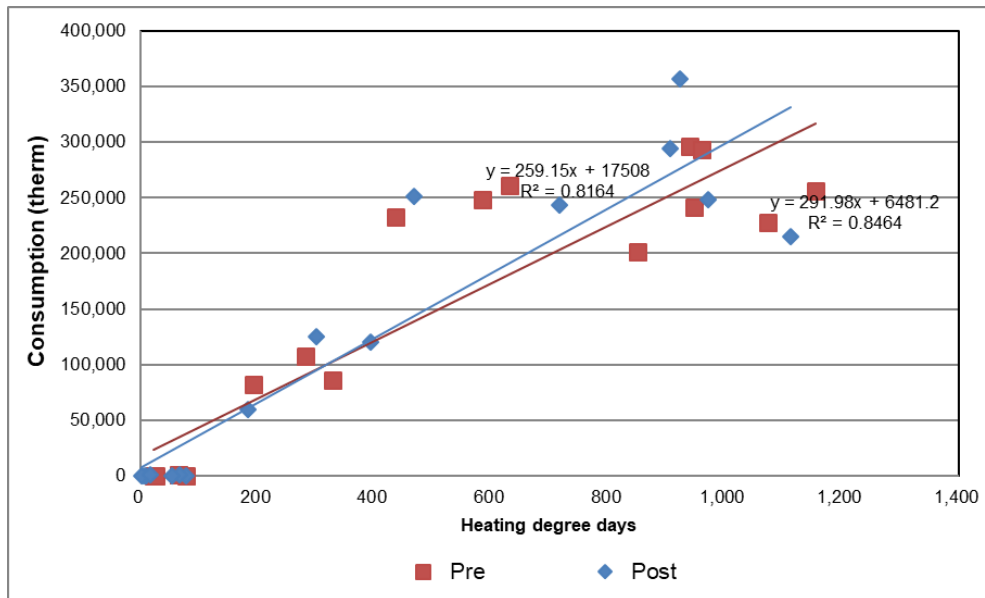
Figure 5-10. Pre- and post-installation correlation with degree days

The therms obtained from the billing data was normalized using actual and TMY3 weather data for both the pre and post case therms consumption data to ascertain if the billing data reflected the changes in the site’s gas consumption profile resulting from the implementation of the project, in this case, fixing the steam leaks by replacing faulty steam traps. As shown in Figure 5-10, the billing data does not reflect the reduced gas consumption in the post case following the implementation of the project. The billing analysis shows a large amount of additional gas usage estimated after normalizing to billing data. It is likely that 36 steam traps would not show considerable change in a facility as large as this research campus, but it is also possible there were additional loads placed on the facility as a new building was constructed. The savings percentage of the steam traps is approximately 1% of the total gas annual consumption at the facility.
