**STATE OF RHODE ISLAND  
DIVISION OF PUBLIC UTILITIES AND CARRIERS  
WARWICK, RHODE ISLAND**

**REVIEW OF  
NATIONAL GRID STORM PREPAREDNESS,  
RESPONSE, AND RESTORATION EFFORTS**

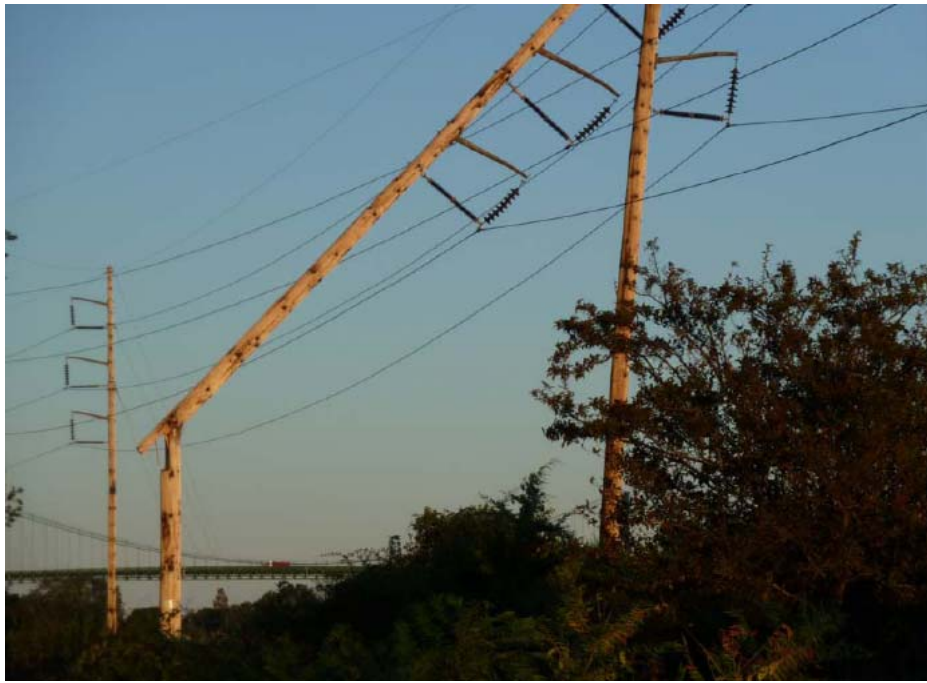
- a. National Grid's electric system experienced structural failures that are inconsistent with the typical performance of similar facilities designed using adequate engineering criteria under a comprehensive maintenance program. The visual review of the broken and downed transmission line poles indicate insufficient engineering design and maintenance.

In addition, since 2005, many utilities with transmission line facilities in proximity to coastal areas have implemented "System Hardening" improvements. With this in mind, it appears that the damaged facilities were not designed to appropriate reliability standards and this deficiency became a major weak link to the grid and consumers served. From the meteorological data provided, the winds presented throughout the system fall far below National Electrical Safety Code (NESC) worst-case conditions to impose stress on transmission facilities. For this geographical area of the state, all transmission and sub-transmission line facilities should be designed and maintained for worst case conditions beyond mere tropical storm wind forces. See *Figure 10* below.

*Figure 10: Damage Picture from National Grid's Irene Preparedness Report (Page 3 of 43).*

- b. National Grid should evaluate the structural loading for all transmission structures based upon the current NESC loading criteria. Analysis should consider the degradation of facilities from aging and additional storm hardening measures such as increased pole classes and storm guying for structures with coastal exposure. Since, National Grid does not utilize a specific hardening program for transmission or sub-transmission structures, all asset replacement and/or maintenance work is identified during periodic inspections based on condition-based assessments driven by the I & M Program <sup>2</sup>. PowerServices recommends these additional analyses and upgrades be integrated into National Grid's existing I & M Program.

- d. National Grid should follow the current National Electrical Safety Code (“NESC”) requirement stipulating that structures shall be replaced or rehabilitated when deterioration reduces the structure strength to 2/3 of that required when installed.
- e. National Grid’s response to Division 2-8 (Engineering and Design) outlines an appropriate Joint-Use Pole “Make Ready” process. Our observation, however, leads us to believe the process described is either not followed by all joint-use parties or the “shared responsibility” process lacks an ultimate responsible party and some deficiencies in strength arise. We recommend National Grid perform a post storm strength assessment on 30 miles of joint-use pole lines, randomly selected, that were involved in line outages, particularly lines in which poles failed or leaned over.

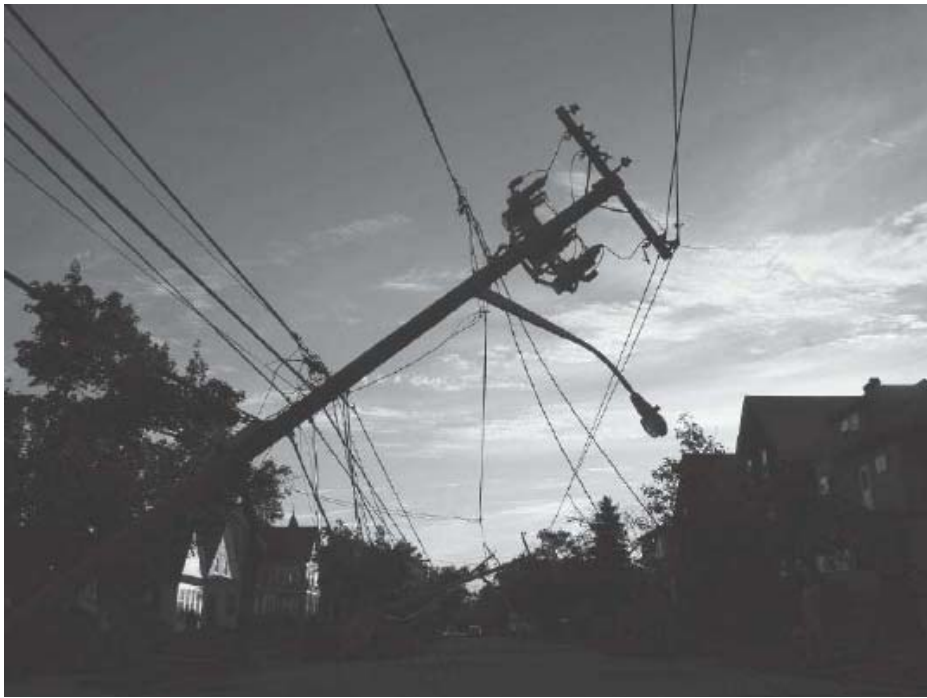
- b. National Grid's electric system experienced line failures that are consistent with issues stemming from insufficient engineering design standards, construction practices, or maintenance and system replacement or rehabilitation standards anticipated by the NESC and extend beyond the transmission system. From the meteorological data and our visual review of the leaning poles with downed conductors, there appears to be indications of inadequacies including: insufficient pole burial depths for soil conditions, lack of engineering consideration of the effect of additional pole attachments, and poorly attached conductors to electric structures. With this in mind, it is obvious the damaged facilities such as those shown in *Figure 11*, were not designed, constructed, and maintained to proper industry standards. Deficiencies in these areas became evident after the storm and ultimately affected the consumers served.

*Figure 11: Distribution Damage Grand Ave, Cranston RI, picture from the article: National Grid Learns Lessons from Irene (The Providence Journal; Date: Dec 18, 2011).*

- c. National Grid needs to review and supplement its distribution engineering practices and standards when designing, maintaining, and upgrading distribution pole structures with attachments. In general, distribution poles are not subject to the loading requirements of extreme wind (NESC Rule 250C) and extreme ice with concurrent wind (NESC Rule 250D) because most distribution lines don't have structures that exceed 60 feet aboveground. Due to this, the NESC district loading requirements of NESC Rule 250B will most always be the governing load case in determining strength parameters of distribution poles.
