**REPORT ON BEHALF OF MASSACHUSETTS ELECTRIC COMPANY and
NANTUCKET ELECTRIC COMPANY d/b/a NATIONAL GRID ON TROPICAL
STORM IRENE SERVICE RESTORATION EFFORTS**

I. EXECUTIVE SUMMARY

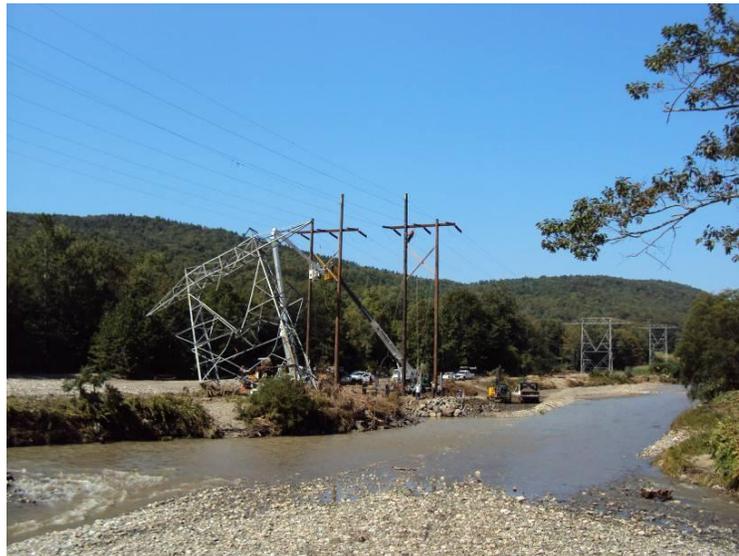
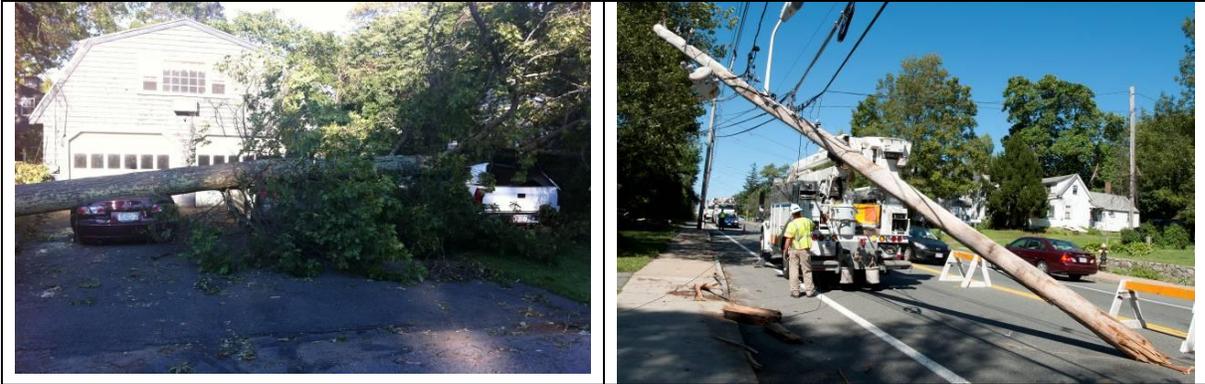
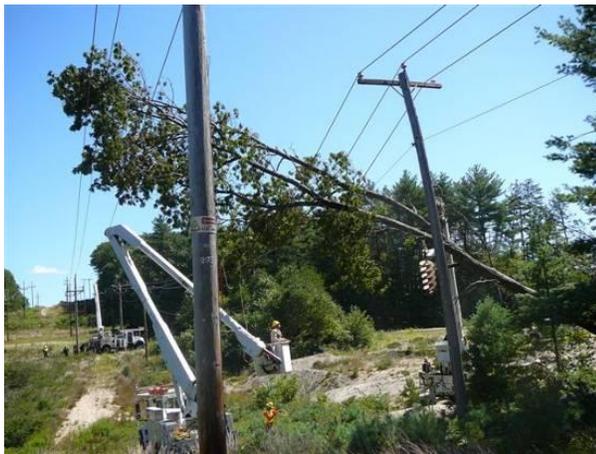
Irene hit Massachusetts on August 28. The photographs below from (clockwise) Colrain, Stoughton, Shirley, and Randolph illustrate the severity of the damage caused by the storm that was typical to the Company's transmission and distribution infrastructure.

As these photos indicate, once Irene passed through the service territory, the Company was left with a tremendous amount of damage. Damage appraisal itself was an extensive effort, performed by the Company’s complement of damage appraisers, working on foot, in vehicles, and in helicopters. The Company implemented its system of prioritization for restoration, because it was clear that the attention needed for public safety hazards caused by downed wires and restoration work needed across the Commonwealth was significant. As further described below, the Company’s Electric Emergency Plan (“EEP”), on file with the Department, provides a restoration priority focused first on securing public safety from the danger from inadvertent contact with live wires and extreme hazards. Then, under the Company’s priority system crews address problems with transmission lines and substations that serve large numbers of customers. Critical Facilities are given priority and consideration next, and the Company makes efforts to restore service to Life Support Customers as quickly as conditions warrant. Distribution lines that serve local neighborhoods are the next priority, starting with areas that involve the largest number of customers. Finally, distribution lines and transformers within neighborhoods and the wires that connect them to homes and businesses come next.

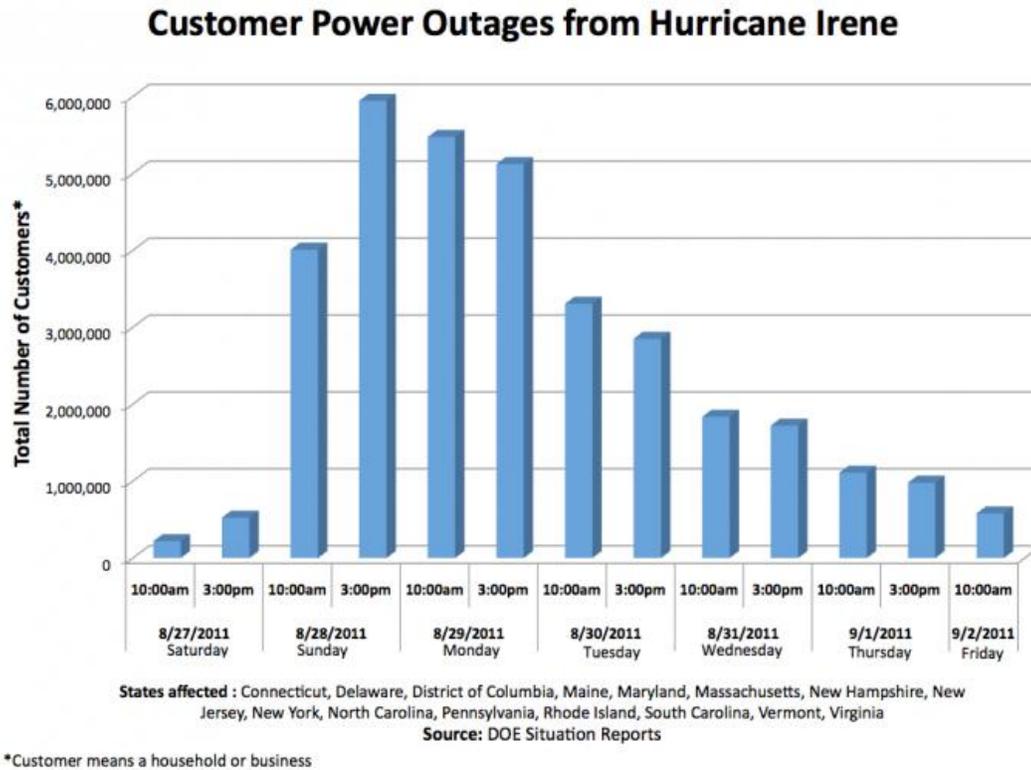
By the time the storm arrived in Massachusetts early on August 28, Hurricane Irene had been downgraded to a tropical storm, yet maintained the strength to cause significant physical damage and destruction to infrastructure. The U.S. Department of Energy gathered situational reports from utilities in the United States affected by the storm. According to the DOE, at its peak on Sunday August 28, Irene had caused nearly 6,000,000 customers on the east coast to lose electrical power, as Irene concluded its devastating trek up the Eastern Seaboard. The DOE reported the track of outages and service restoration from Irene on its website. Figure 1 below depicts the aggregate peak number of power outages from all affected utilities in the path of Irene to full restoration of service, from August 27 through to September 2.

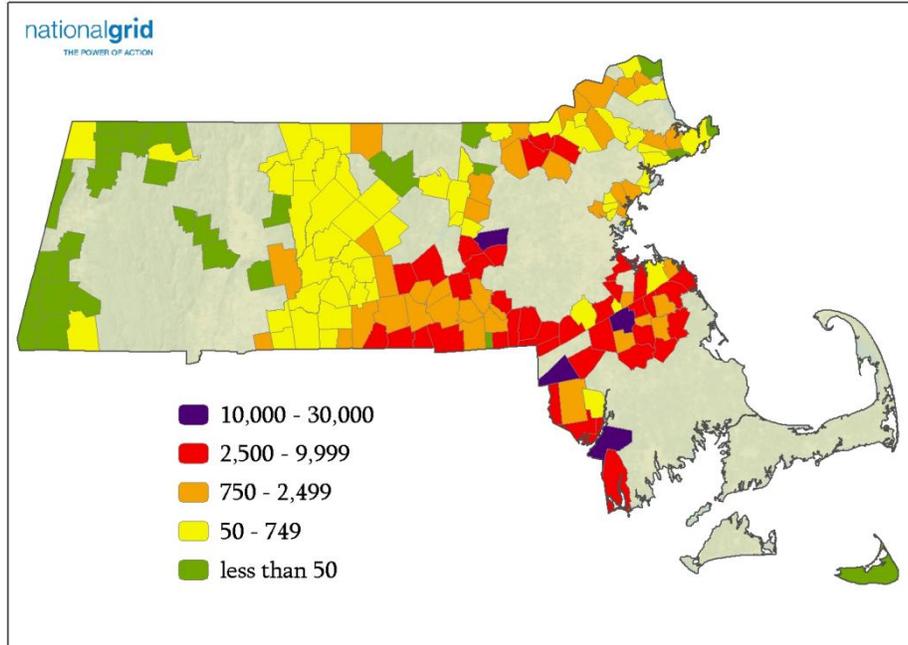
The storm impacted a total of 518,235 customers in Massachusetts Electric’s service territory¹; 326,586 customers at its peak. Figure 2 below shows a map of customers interrupted by town at the peak, which occurred on Sunday August 28 at 1:20 PM. Figure 3 below shows the percent of customers interrupted by town at the peak. While the impacts were wide ranging and outages were experienced as far west as the New York State border and north to the New Hampshire border, the heavier impacts in the Company’s service territory were on the south shore, south along the Rhode Island border and south central Massachusetts.

**Customers Interrupted by Town
at MA Peak**

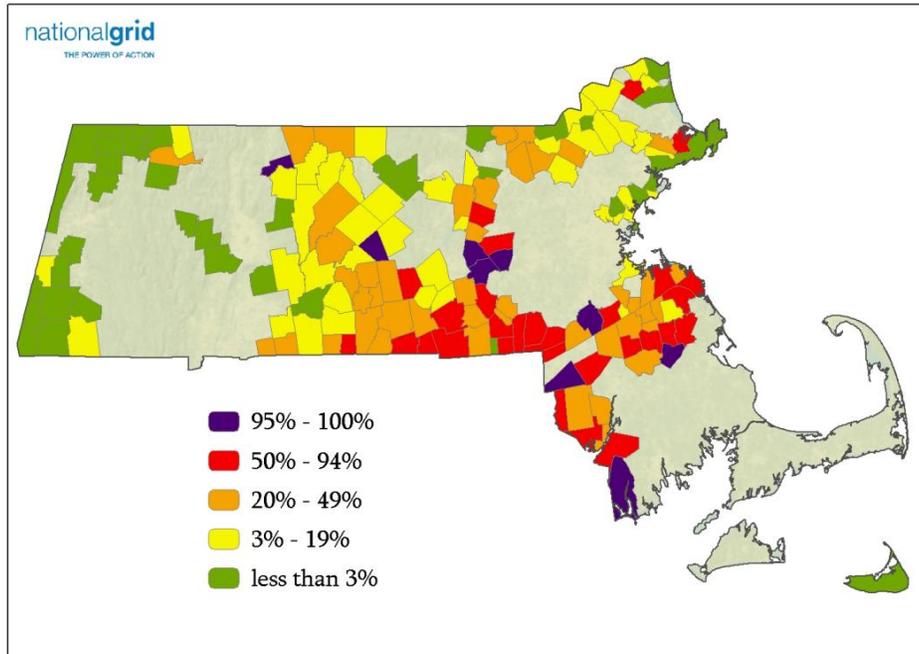
Figure 3

**Customers Interrupted by Town
at MA Peak**

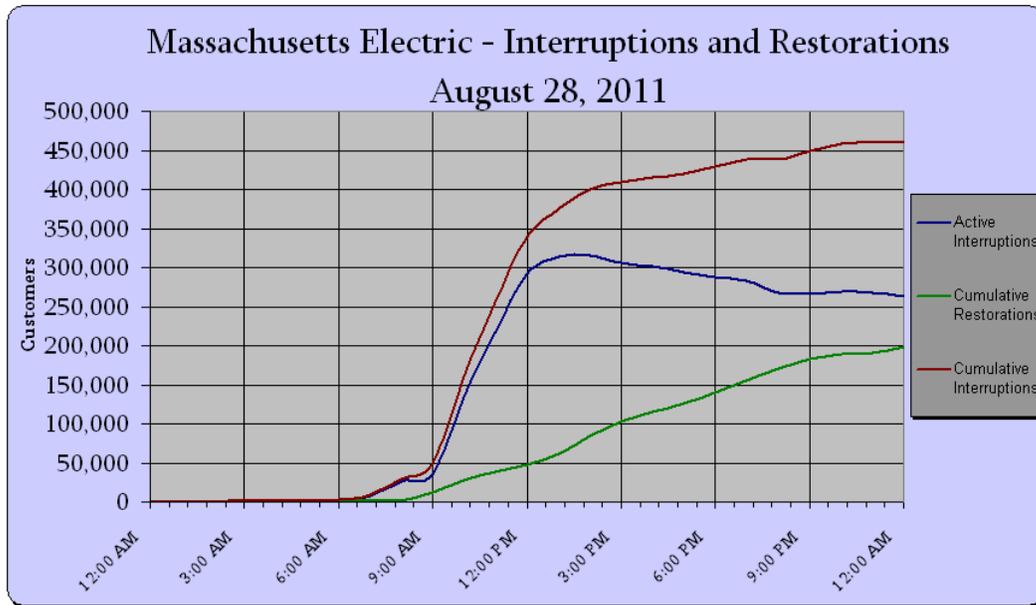
The storm started in the early morning hours of Sunday, August 28, with 9,000 customers interrupted in Massachusetts by 7:00 AM. This number of reported outages increased to 160,000 customers by 10:00 AM and peaked at approximately 327,000 customers at 1:20PM. The storm remained over New England throughout the day, with sustained winds of 44 mph and gusts up to 67 mph. Figure 4 below shows the customers interrupted and restored, by hour, from midnight on Saturday August 27, to midnight on Sunday August 28.

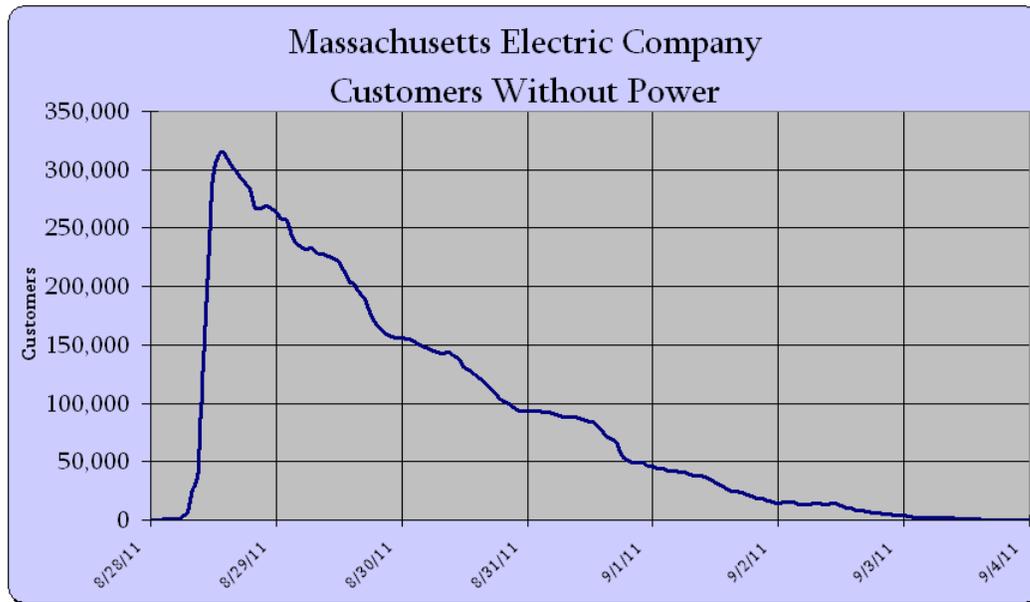
Figure 6 below shows a timeline of the number of customers without power from Sunday, August 28 through Saturday Sept 3.
