Investigation Report

Block Island Transmission Cable Outage on November 18, 2022

EC-2022-39

STATE OF RHODE ISLAND DIVISION OF PUBLIC UTILITIES & CARRIERS

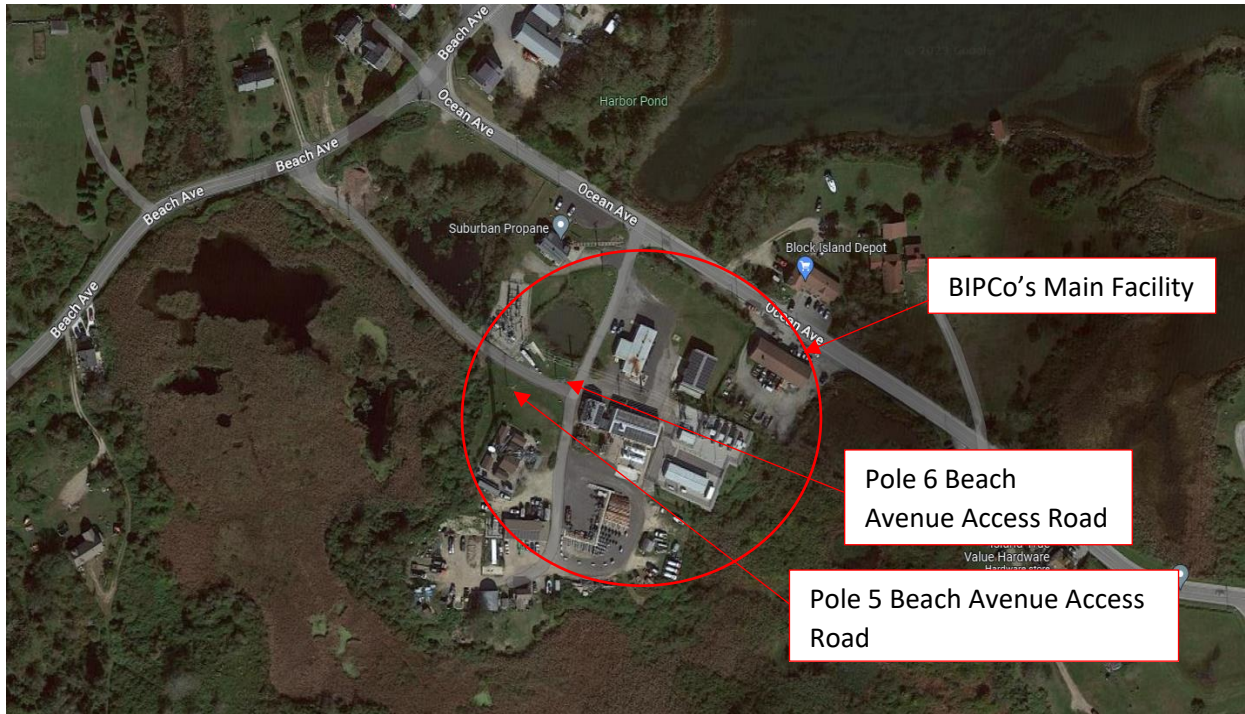
The location of the cause of the outage appears to have been along a 760-foot span of the aerial section of the BITS that is owned and maintained by RIE but is situated on the property of BIPCo.

Below: Figure 3 shows where pole 5 and pole 6 are located adjacent to Beach Avenue Access Road, within the BIPCo property located on Block Island. Map Source is Google Maps.
