# INFRASTRUCTURE REPLACEMENT PLAN

## **PROVIDENCE WATER SUPPLY BOARD**

### **INFRASTRUCTURE REPLACEMENT PLAN For Fiscal Years 2006 Through 2025**

**MARCH 2006**

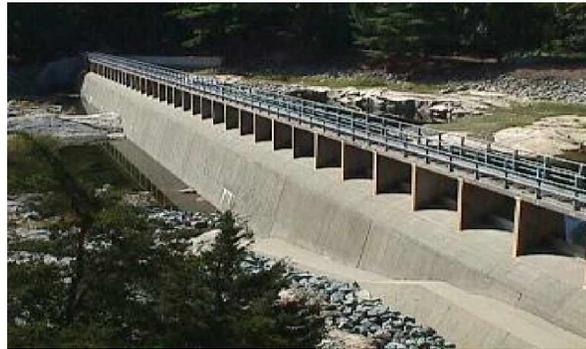
Construction has been completed to rehabilitate the 400 feet long Gainer Dam concrete spillway, the blowoff structure, and the meter chamber. Also completed was work to correct undermining of the Regulating Dam spillway structure footing.

400 foot Gainer Dam spillway showing new concrete facing

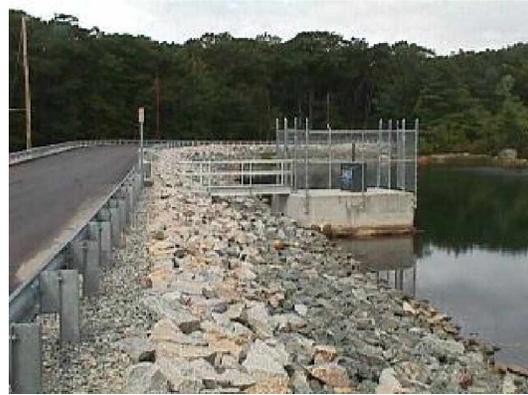
Ponaganset Reservoir after rehabilitation

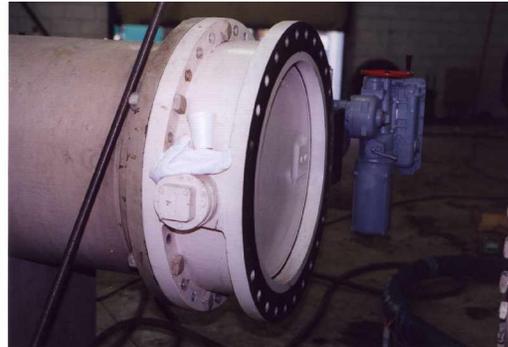
New 30" butterfly valve with actuator

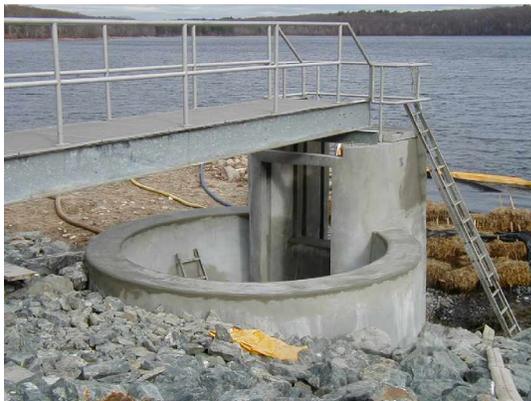
Concrete remediation at the outlet structure

Construction is complete consisting of regrading and armoring the upstream slope of the dam, miscellaneous concrete repairs to the outlet structure, regrading the crest of the dam, clearing and grubbing both the outlet and emergency spillway discharge channels, and regrading the access road to the dam.

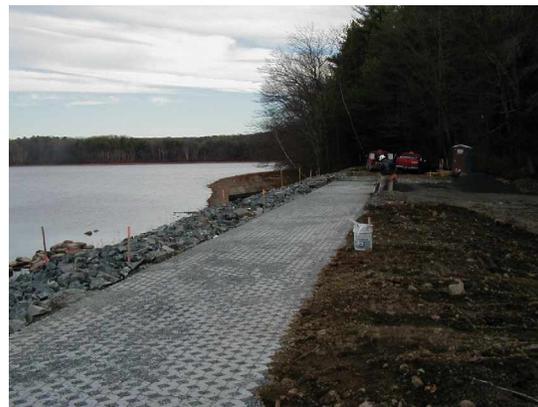
Regrading the access road on the crest of the dam

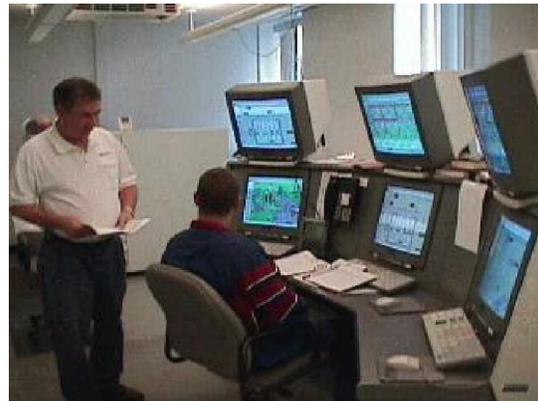
New state-of-the-art computerized Central Control System

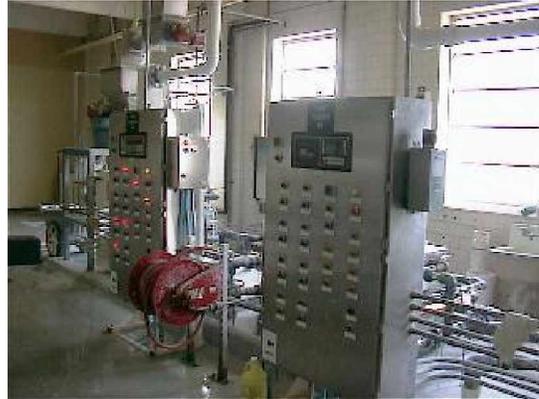
The old lime feeders at the plant have been replaced with 4 new feeders. New injection piping has been installed to provide for an additional lime injection point prior to raw water aeration for corrosion control optimization purposes. The corrosion control optimization measures are necessary as a result of the lead and copper rule.

Two of four new lime feeders installed at treatment plant

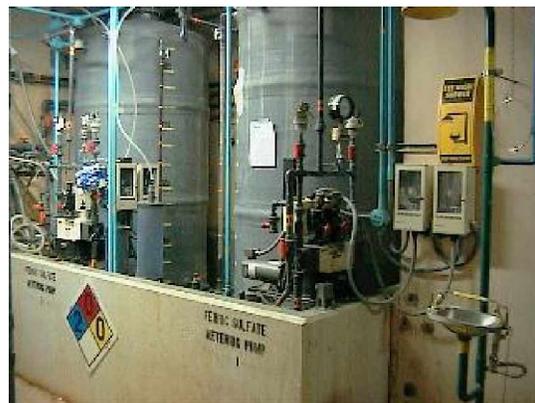
Installation of a new liquid feed system consisting of new chemical storage tanks, new feeder pumps, controls and piping has been completed. The system replaces the old problem-ridden dry feed system.

New sulfate feeder equipment and day tanks for liquid ferric sulfate coagulant injection

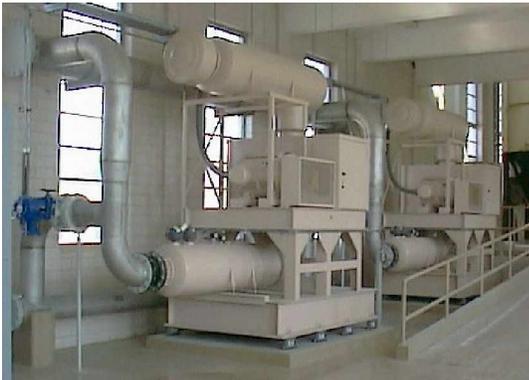
Installation of the new air blowers and piping for providing the capacity to air backwash the filters has been completed.

New air blower system at treatment plant for air scour backwashing of filters

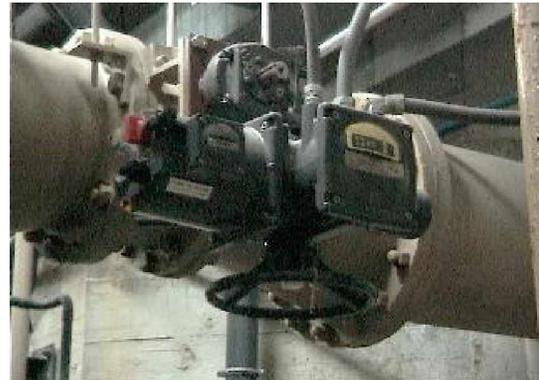
Typical new effluent valve actuator at treatment plant providing precise plant effluent control

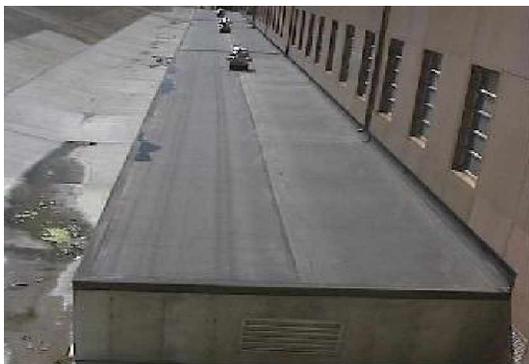
Construction is complete for the rehabilitation of the area of the effluent yard located directly over the clearwell. The scope of work for the project consisted of installation of a new protective structure directly above the clearwell to eliminate the possibility of rainwater or contaminants from entering. Also included were rehabilitation of the existing drainage system and replacement of deteriorated concrete slabs.

Completed clearwell protective structure

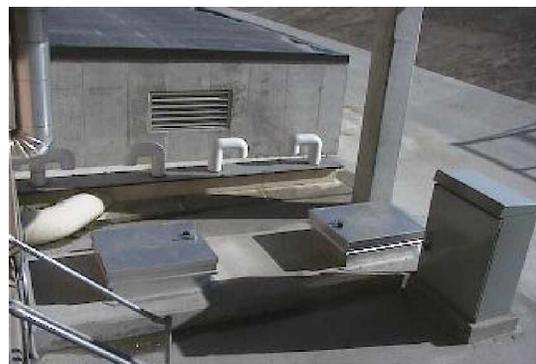
New access hatches and instrumentation panel installed over the opening of the venturi meters

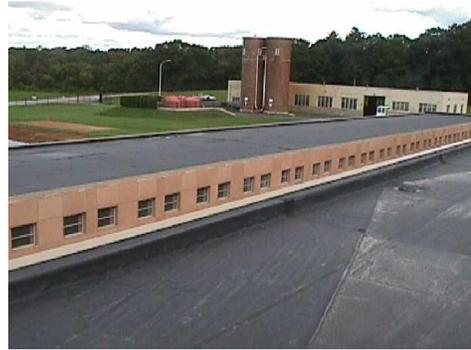
The replacement of the entire roof at the treatment plant has been completed. Construction consisted of the removal of the existing roof to the concrete deck and installation of new roof insulation and a new rubber membrane roof.

New treatment plant replacement roof

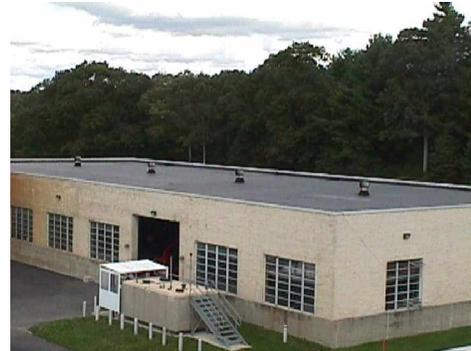
Included as part of the roof replacement for the treatment plant, the roof at the forestry garage building was replaced and completed during May 1997. The decision was made to move the project up in schedule because the roof was leaking in a number of locations. The construction consisted of removal of the existing roof to the concrete deck and replacement with rubber membrane roofing.

Forestry Garage replacement roof

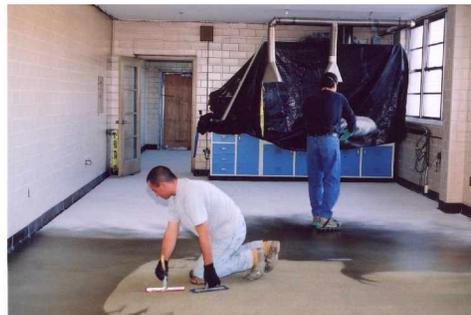
Construction has been completed to upgrade the testing laboratory at the treatment plant. A new epoxy floor, electrical feeder lines, lighting and laboratory benches have been installed. Also installed were three rooftop HVAC units and a new chemical fume hood.

Installation of a new epoxy floor in the lab

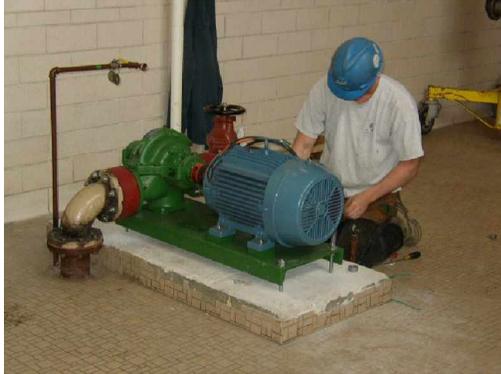
Wiring new service water pump

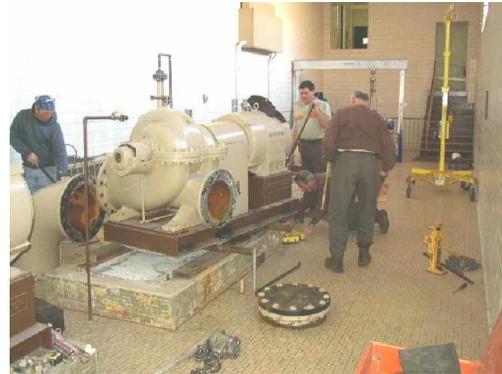
The two (2) 5600 GPM pumps which supply the backwash water for the treatment plant's filters were almost forty years old and had outlived their useful life.

Removal of existing Wash Water pump

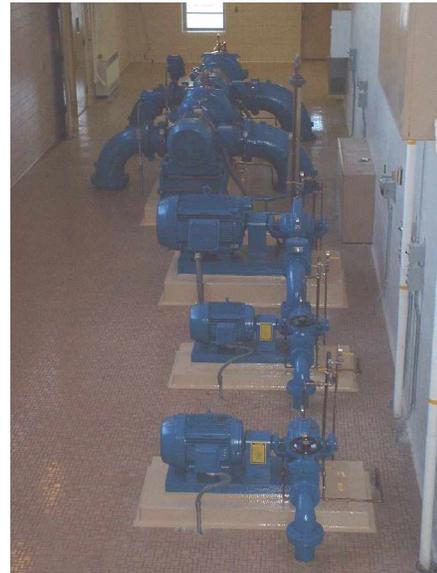
The two (2) 1750 GPM pumps for the service water system which provides process water at the treatment plant and the 1200 GPM hydrant pump which provides water to the hydrants surrounding the sedimentation basins were almost forty years old and had outlived their useful life. Construction for the replacement of the two service water pumps and the hydrant pump is complete.

New Pumps following replacement

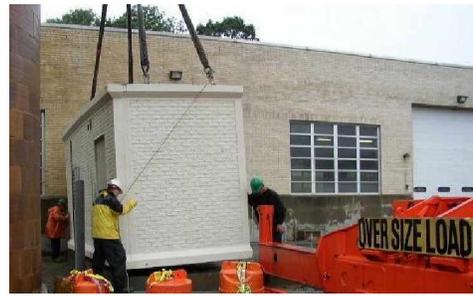
The existing pneumatic lime transfer system at the treatment plant installed in the 1940's had outlived its useful life and was generally in poor condition and in need of replacement. The project consisted of replacing the mechanical equipment located in the lime silo, the steel transfer piping, and the mechanical pneumatic transfer equipment in the lime handling area inside the treatment plant. Work included construction of a new exterior building to house the new transfer equipment. The new transfer equipment consists of a pressure conveyance system that replaced the antiquated vacuum system. The silo once used for ferric storage was also rehabilitated and converted to a lime silo to allow for a redundant storage silo. The new lime transfer system was placed in operation in January 2005 and the project is currently in the final stage of construction as only minor punch list items remain.

Lowering section of new blower building into place

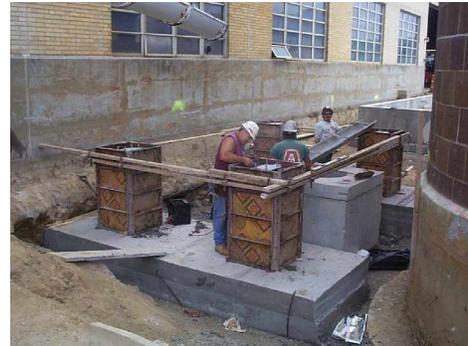
Footings for new access stairs to silos

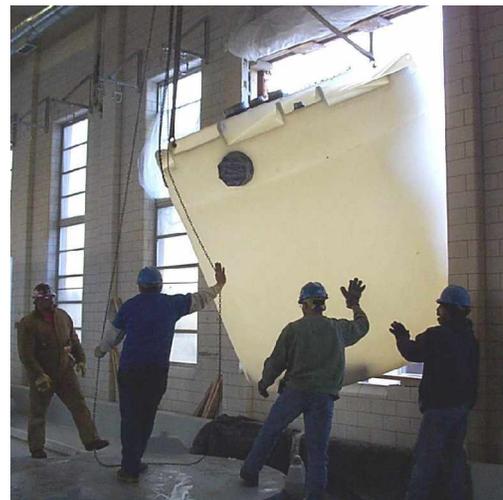
The existing pneumatic fluoride transfer system dated back to its original installation in the 1960's and needed to be upgraded. Needed improvements to the ventilation system in the fluoride room combined with an increase in chemical costs associated with the former delivery mode of fluoride in 400 pound cylinders necessitated moving this project up in priority and schedule. Providence Water investigated modifications to the fluoride handling process as part of the overall project and it was determined that the best long-term solution was to convert to a liquid based, fluorosilic acid system. The new liquid fluoride system is in service and construction is complete.

Bringing new Fluoride Storage Tank into the Treatment Plant

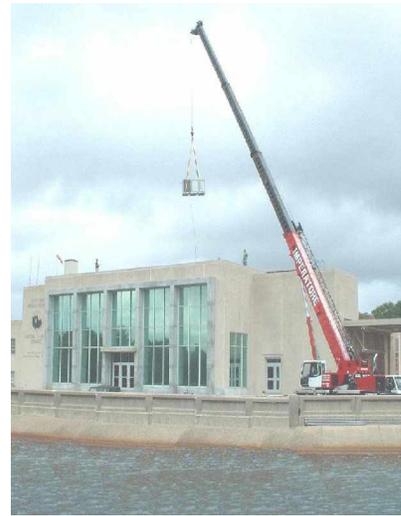
Placing A/C unit on top of the Auditorium

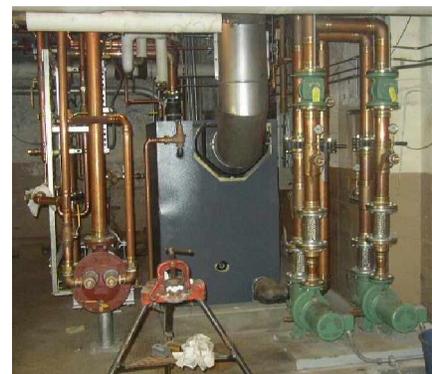
New Process Water Boiler

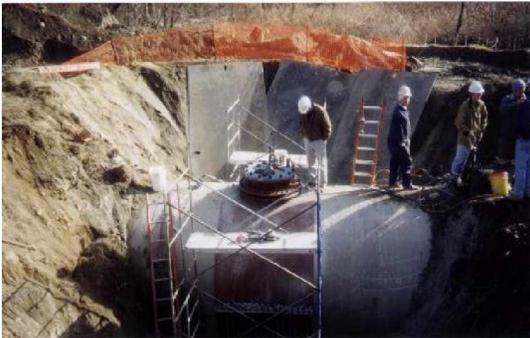
Installation of new access manhole into 102" Aqueduct

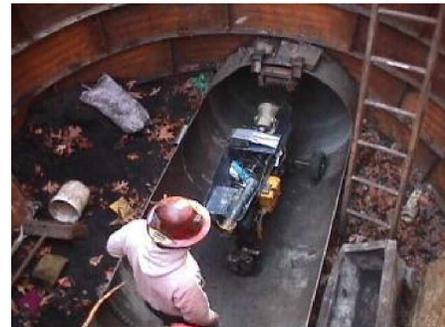
In 1990, a preliminary corrosion evaluation was conducted on a section of 48" steel transmission main that recommended corrosion protection of the structure to arrest any further deterioration. In order to accomplish this, the main needed to be electrically isolated. Construction has been completed for the installation of four isolation couplings and the installation of an impressed current cathodic protection system. A final inspection was conducted and a report was prepared which indicated that the system is operating to protect the main.

Interior cement mortar lining machine in 48" steel transmission main

In addition to cathodic protection, approximately 1400 feet of the 48" steel water main was cleaned and relined with cement mortar to eliminate the leaks that were found on the main.

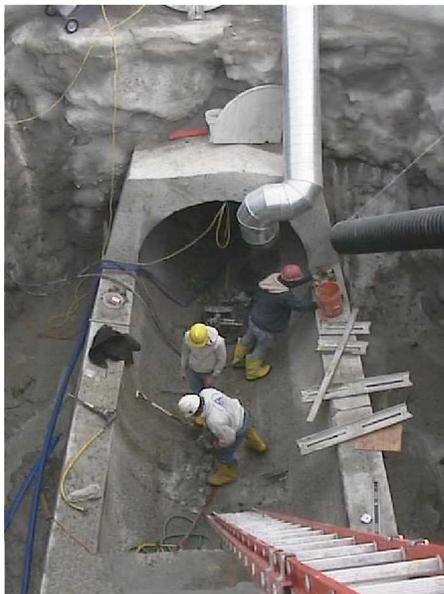
Access into 90" aqueduct at new valve location

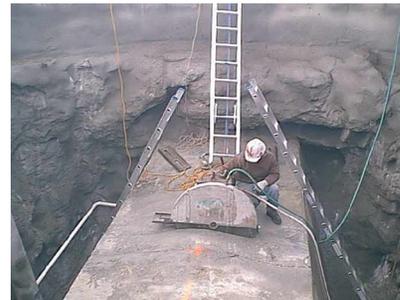
Sawcutting top of 90" pipeline to gain access for repairs and valve installation

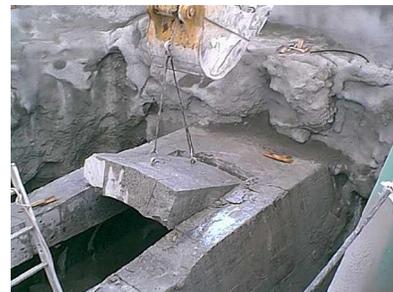
Removal of top of 90" pipeline

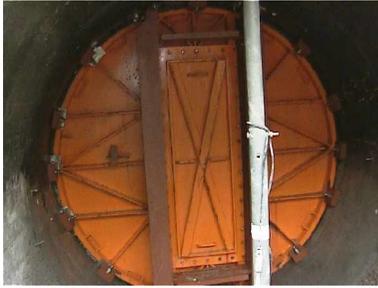
90” disc plug in place prior to rehabilitation and valve installation

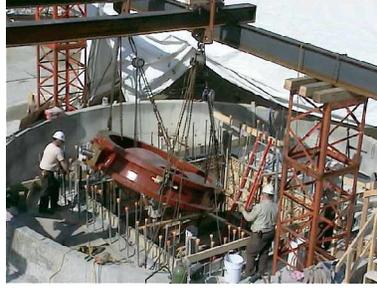
Lowering the 90” valve into place

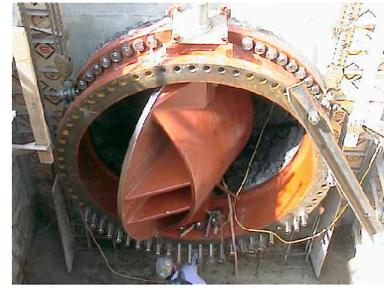
90” valve in place

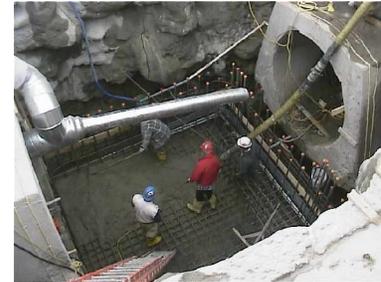
Pouring base slab of new valve enclosure

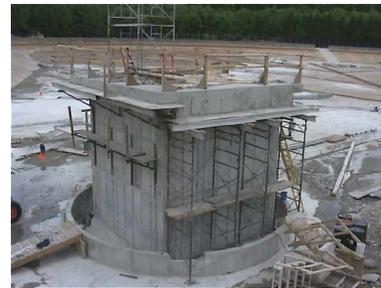
New 90” Valve Structure

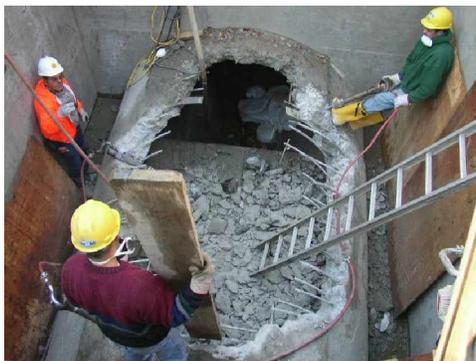
Opening into Aqueduct at New Access Structure

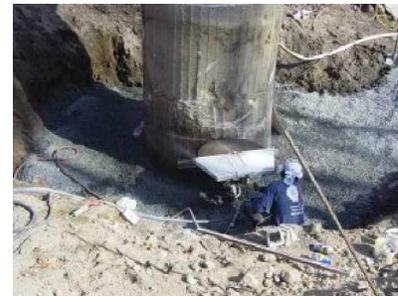
A new access point was constructed adjacent to the old East Portal. The old east portal was placed out of service because it had become antiquated and was in need of repairs. A new concrete block building was constructed with a new venting mechanism, a security system, and a hoisting system.

Removal of old East Portal Structure

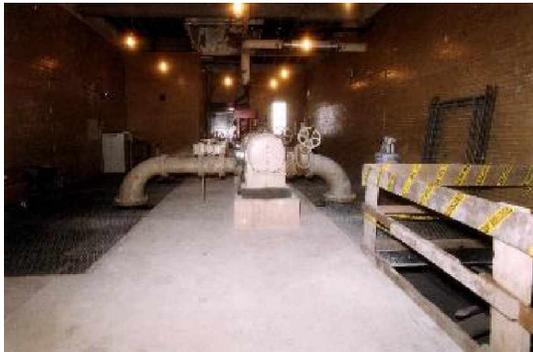
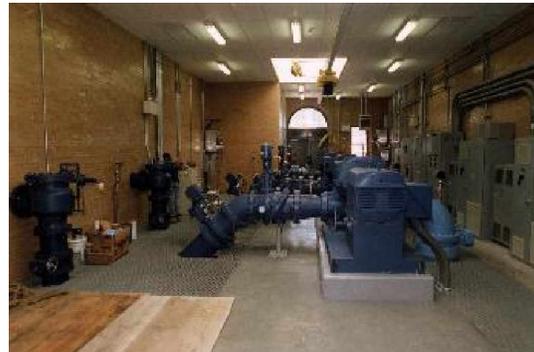
Bath Street Pump Station before upgrade

Bath Street Pump Station after upgrade

Construction is complete. Rehabilitation of the facility included replacing pumps, replacing suction and discharge piping, instrumentation and electrical system upgrades, architectural and structural improvements, and installation of an emergency power generator. Final pump control programming has been completed.

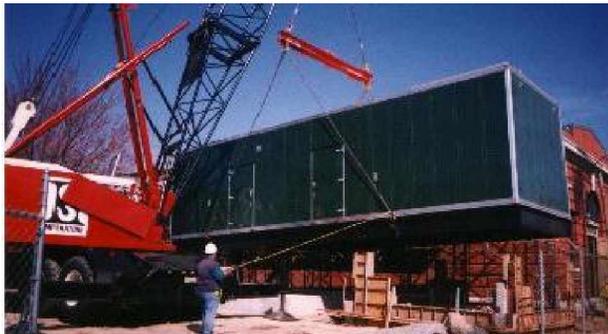
Delivery of new generator enclosure

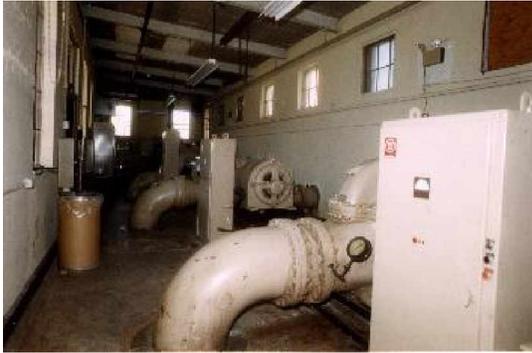
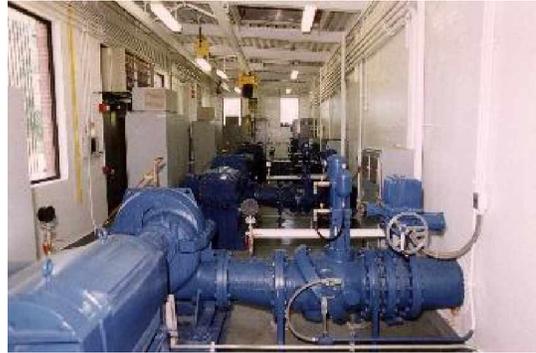
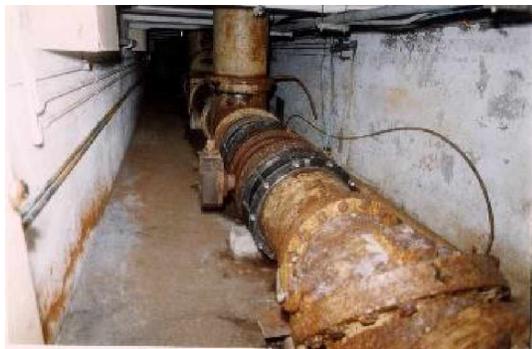
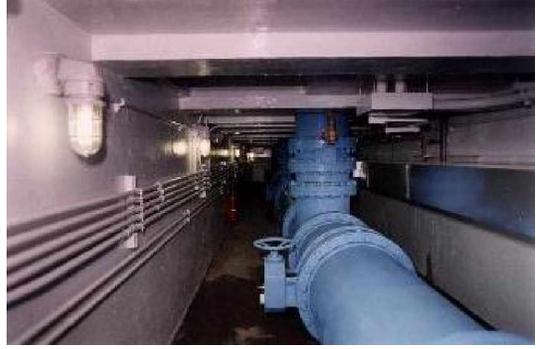
Interior of Neutaconkanut Pump Station before rehabilitation

Interior of Neutaconkanut Pump Station after rehabilitation

Neutaconkanut Pump Station piping before rehabilitation

Neutaconkanut Pump Station piping after rehabilitation

Construction is complete. Rehabilitation of the facility included replacing pumps, replacing suction and discharge piping, instrumentation and electrical system upgrades, and architectural and structural improvements. Final pump control programming has been completed.

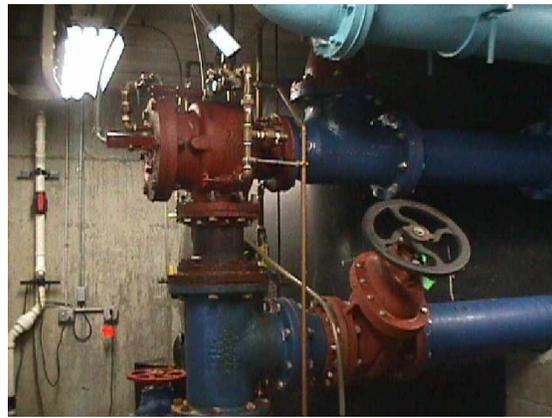
New surge control valve at Greenville Avenue Pump Station

A project has been completed in which a pump control valve was replaced inside the station that eliminates surges generated by the startup and shutdown of the booster pumps.

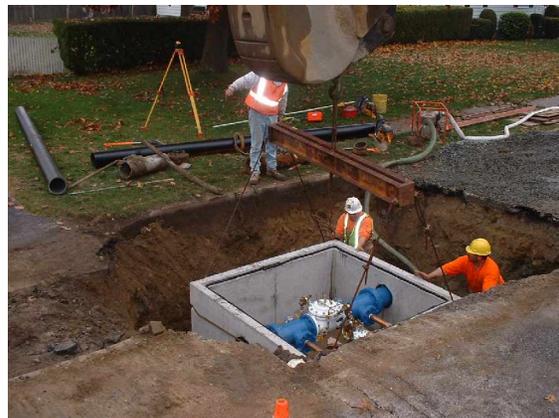
Installation of Pressure Reducing Valve Station

In the western Cranston section of the system two pressure reducing valves have been rehabilitated, and two others have been replaced. The valves are now fully functional and regulate the static pressure to that area of the system.

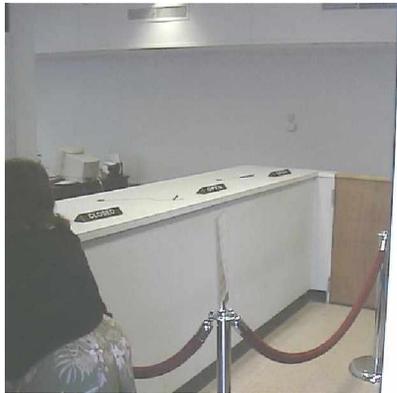
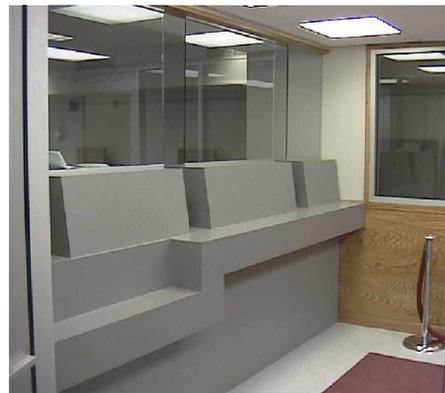
Old customer service counter

New customer service counter

Rehabilitation of the customer service entrance at the administration building has been completed. Construction consisted of replacing the old customer service counter area with a more secure enclosed customer waiting area, a new service counter with glass partitions for security, and improved lighting.

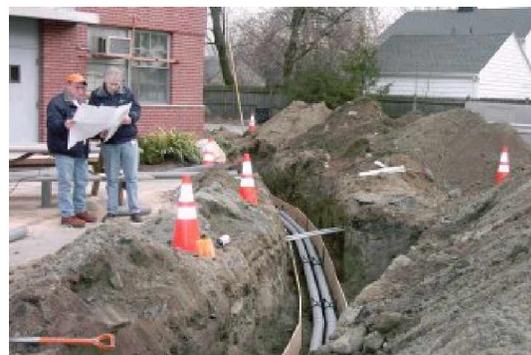
Excavation for Electrical Service to Academy Avenue

A project was completed to increase the capacity of the electrical system at Academy Avenue because the old 400-amp electrical service could not meet the additional power demands for the new security system. A new 800-amp electrical service consisting of a new overhead primary feed line and a new transformer was installed to replace the old service. In addition, a new electrical room inside the administration building was constructed which includes a new main circuit breaker, a distribution panel, and appurtenant lighting, receptacles, wiring, and ventilation.

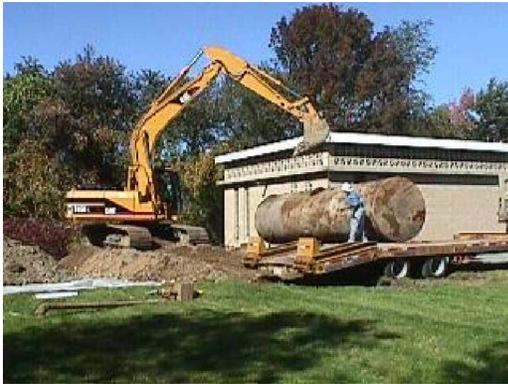
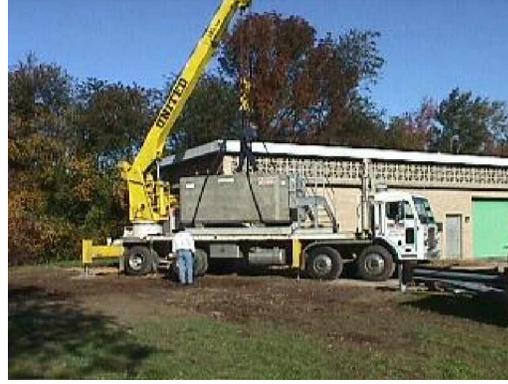
Removal of old underground fuel storage tank at the Aqueduct Pumping Station

Delivery of new above ground fuel storage tank at the Aqueduct Pumping Station

Underground fuel storage tanks (UST) have been removed and replaced with new above ground tanks at both the Raw Water Booster pump station at the base of Gainer Dam, and the Aqueduct pump station at Aqueduct Reservoir in Cranston. Leak monitoring equipment was installed on the Transformer Building fuel tank at the treatment plant, and modifications were made to the suction and return piping to comply with DEM regulations.

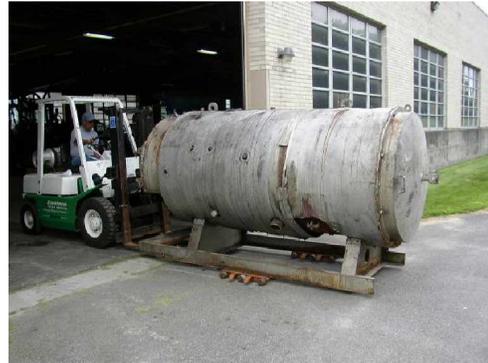
The original boiler for the forestry garage dated back to the 1960's and was in need of replacement. The boiler had pneumatic controls and drew power off of the 600V electrical service for the building.

Removal of Original Forestry Boiler

Replacement parts were difficult and expensive to maintain. The construction contract for the replacement of the heating system and a complete electrical upgrade of the service to a new 480V supply at the forestry building is substantially complete with only punchlist items remaining.

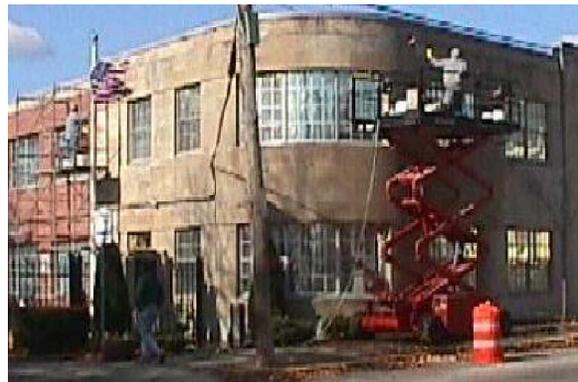
Restoration of the masonry and brickwork at Academy Avenue in progress

Construction has been completed for the restoration of the masonry and brickwork for the administration building at Academy Ave. Areas of the building surface had cracked and deteriorated because of age and exposure to the external elements.

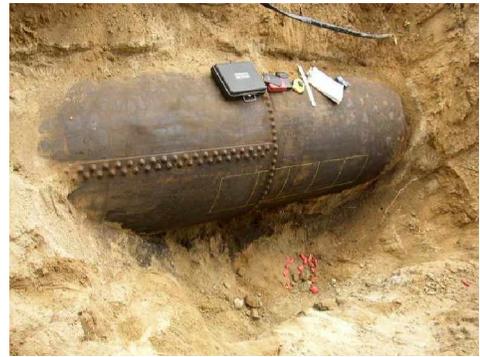
**External section of 48" Washwater pipe**

Concrete rehabilitation inside the tank and concrete rehabilitation of the valve chamber located adjacent to the tank has been completed.

Construction is in progress for the replacement of the three access hatches for the tank and for the replacement of the main 36" washwater valve.

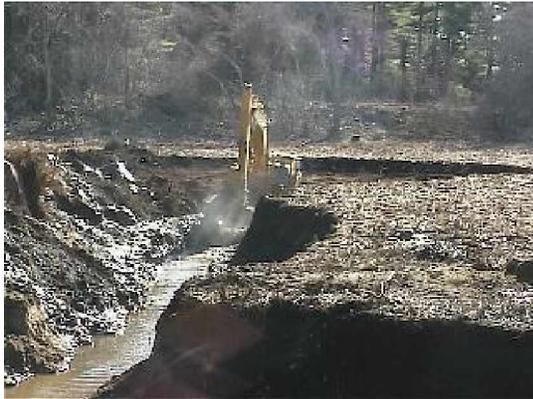
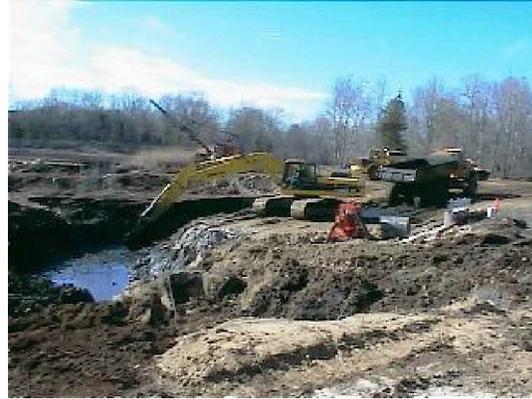
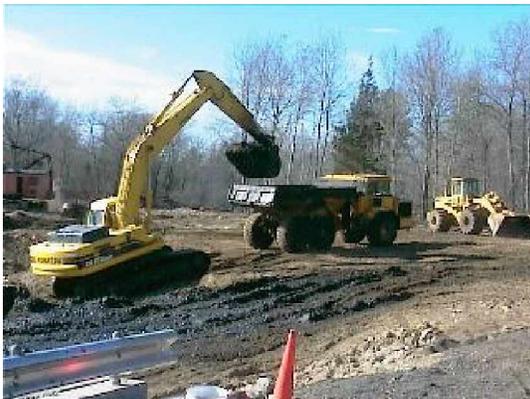
Sludge lagoon at the beginning of dredging operations

Sludge lagoon dredging operations in progress

This project was divided into two phases. The first phase consisted of the removal, dewatering, and disposal of accumulated sludge from all of Lagoon #1 (1A and 1B) to replace lost storage capacity. Removal of sludge from Lagoon #1A began in June 1998 and was completed in July 1999. Approximately 23,000 dry tons of ferric sludge were dredged and disposed of. Under the continuing contract, all accumulated sludge in Lagoon #1B was removed and disposed of during the summer of 2000. Additional sludge which had accumulated in Lagoon #1A was also subsequently removed in 2001.

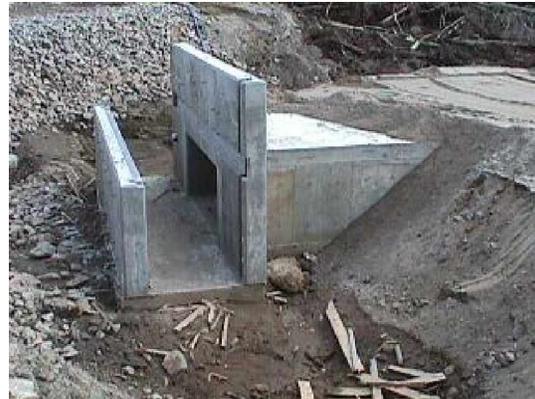
New culvert and stop-log structure prior to final backfill

A new culvert and stop-log structure was installed under the division road between both sections of the lagoon to replace the existing damaged culvert and to provide better control of residual deposits. Construction has been completed on a new improved residual management system. New flow channels and control structures have been installed which will route the flow between alternate lagoons to allow for future alternate drying and removal operations.

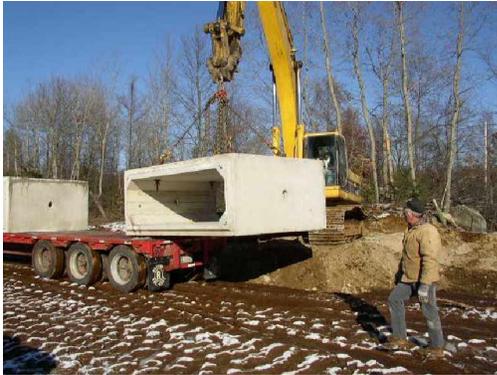
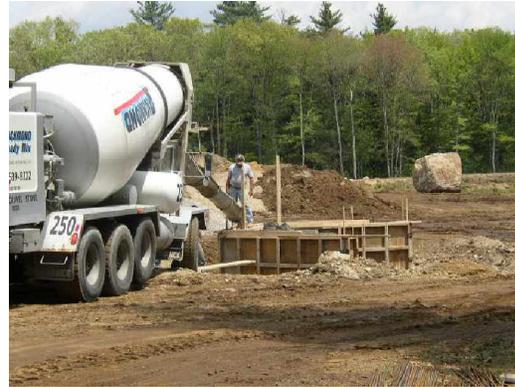
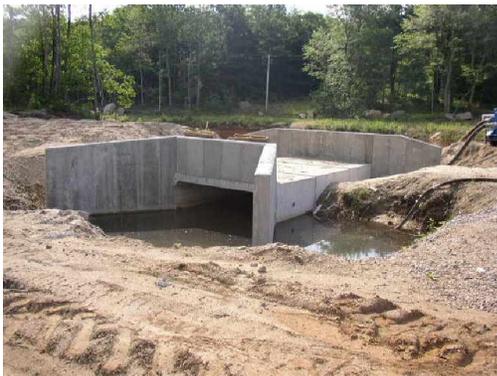
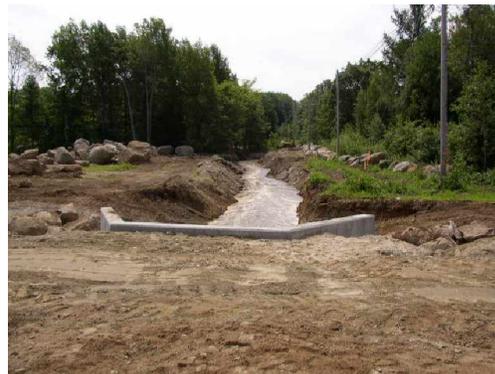
Unloading of culvert sections for residual management system

Concrete pour of wing wall on culvert sections for residual management system

Culvert sections prior to backfill

Flow through new residual management system

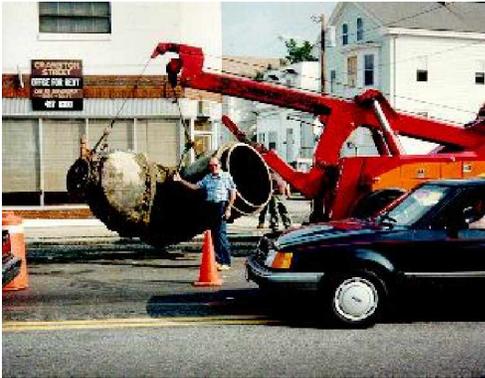
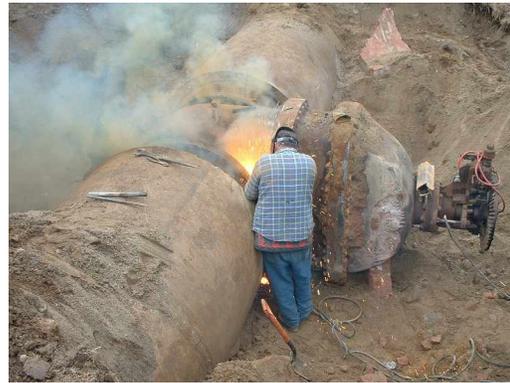
Removal of old 42 inch transmission gate valve

Removal of old 48 inch transmission gate valve

Five separate contracts were completed for replacing 193 old and outmoded transmission valves in the system. The old gate style valves were replaced with new butterfly valves. The valves were comprised of the following sizes: one hundred eighteen (118) 16" valves, seven (7) 20" valves, forty-one (41) 24" valves, twenty-two (22) 30" valves, four (4) 42" valves and one (1) 48" valve.

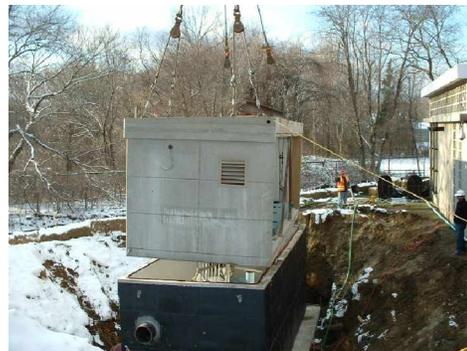
Installation of new addition

The station upgrade is currently under construction. The station was constructed in 1972 by the City of Cranston and was acquired in 1998 by Providence Water as part of the acquisition of the Western Cranston Water District. Rehabilitation of the facility includes a modular addition to the existing building that will house new vertical turbine pumps, instrumentation and electrical system

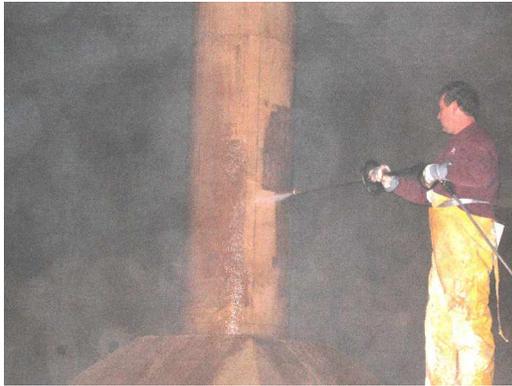
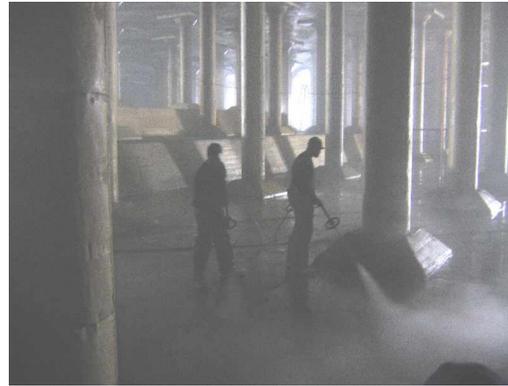
Cleaning of Reservoir Column

Cleaning of Floor Inside Reservoir

Neutaconkanut Reservoir, constructed in 1928, has a storage capacity of 42.1 MG. The facility feeds the gravity fed low service system and the Neutaconkanut Pump Station. Concrete rehabilitation of the interior of the tank is in progress. The project also consists of the installation of a new electric hoist in the gatehouse, rehabilitation of the existing stop shutters, installation of a 60" butterfly valve to functionally replace a 75-year-old gate valve, and installation of a 48" feed line adjacent to the tank to promote better water circulation within the tank.

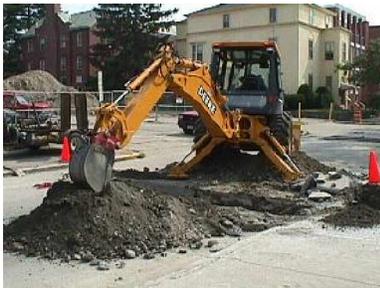
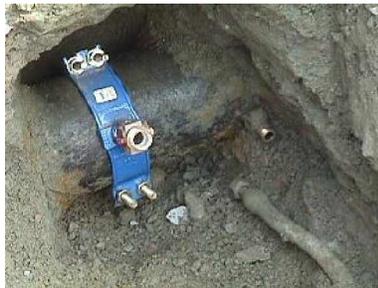
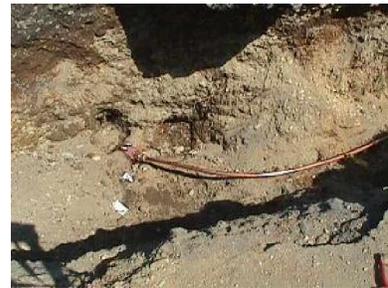
Typical lead service being replaced with a new copper service

Since 1996, 4085 lead services have been replaced. Replacement of lead services was significantly accelerated during the 1998 construction season to take advantage of the massive street repaving program conducted by the City of Providence. Please note, in previous reports the number of lead services were incorrectly reported, and that Providence Water has made that correction in this report.

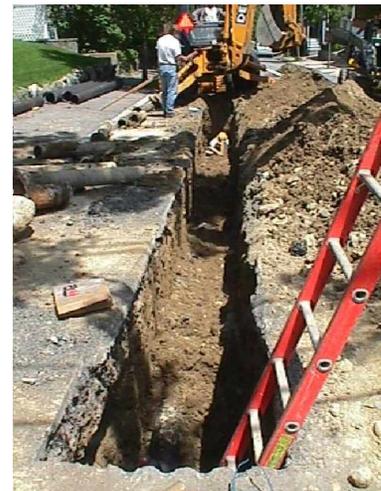
Main Installation

Since 1996, 32,924 feet of main were replaced at 78 locations. All of the mains replaced were bleeder-mains and dead-ended mains for which water quality complaints had been received. Bleeder-mains are dead-ended mains in which past rusty water problems had necessitated the installation of a continuously discharging small diameter pipe at the end of the main. Out of the 78 locations, 53 were bleeder main replacements. These have since been eliminated, resulting in a substantial reduction in the wasting of water.

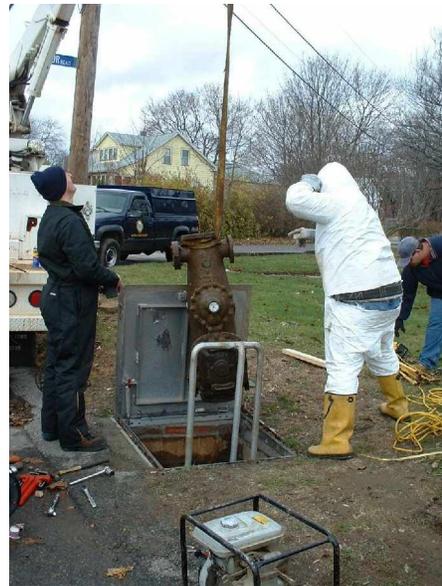
Removal of old meter from meter pit

Plans are to essentially replace all older non-encoded customer water meters that have outlived their standard useful life with new meters. Meters are currently being replaced by in-house forces. Since the beginning of 1996, 68,565 meters have been replaced. This will result in more accurate readings and better water accountability.

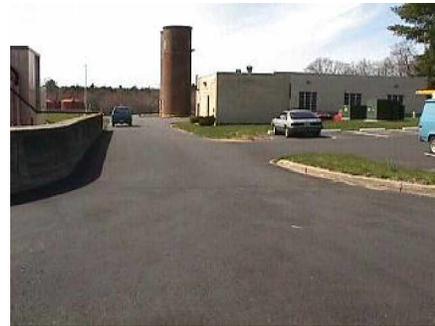
North Access Road After Repaving

Construction is complete for the restoration of the north and south access roads leading into the treatment plant. The projects consisted of removal of the deteriorated pavement and installation of a new bituminous concrete surface. Construction is complete for the restoration of the access road surrounding the storage tank at the Ridge Road site.
