The Narragansett Electric Company
d/b/a Rhode Island Energy

**Proposed FY 2025 Electric
Infrastructure, Safety, and
Reliability Plan**

**Responses to Division Data
Requests Sets 2 through 6**

Docket No. 23-48-EL

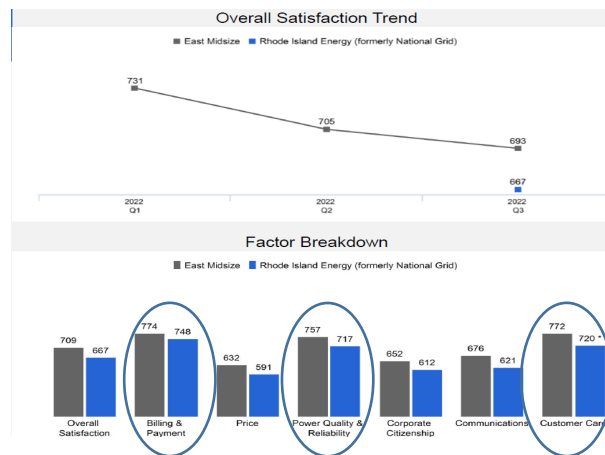
The Q3 2022 results are shown below. Updated results will be forwarded when available. Please note that the dark gray bars represent the category mean with 1/2 of all respondents performing above that target.

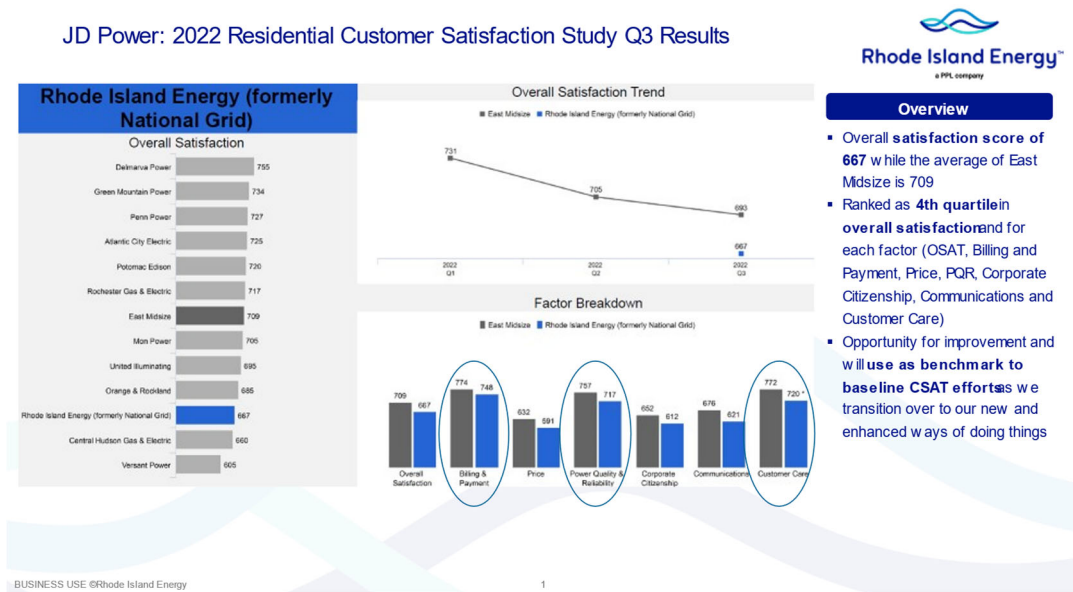
The information used to create the foot note came from the JD Power 2022 Residential Customer Satisfaction Study Q3 results, summarized in the slide below. The Overall Satisfaction Trend (Center -top of slide) indicates a Q1 score of 731, followed by a Q2 score of 705. Lastly, the third quarter score drops to 693 for a third consecutive quarter.

Q3 2022 was used because it was the first quarter in which survey results are specific to RI Energy. Before then, the Narragansett Electric results were rolled up into National Grid.

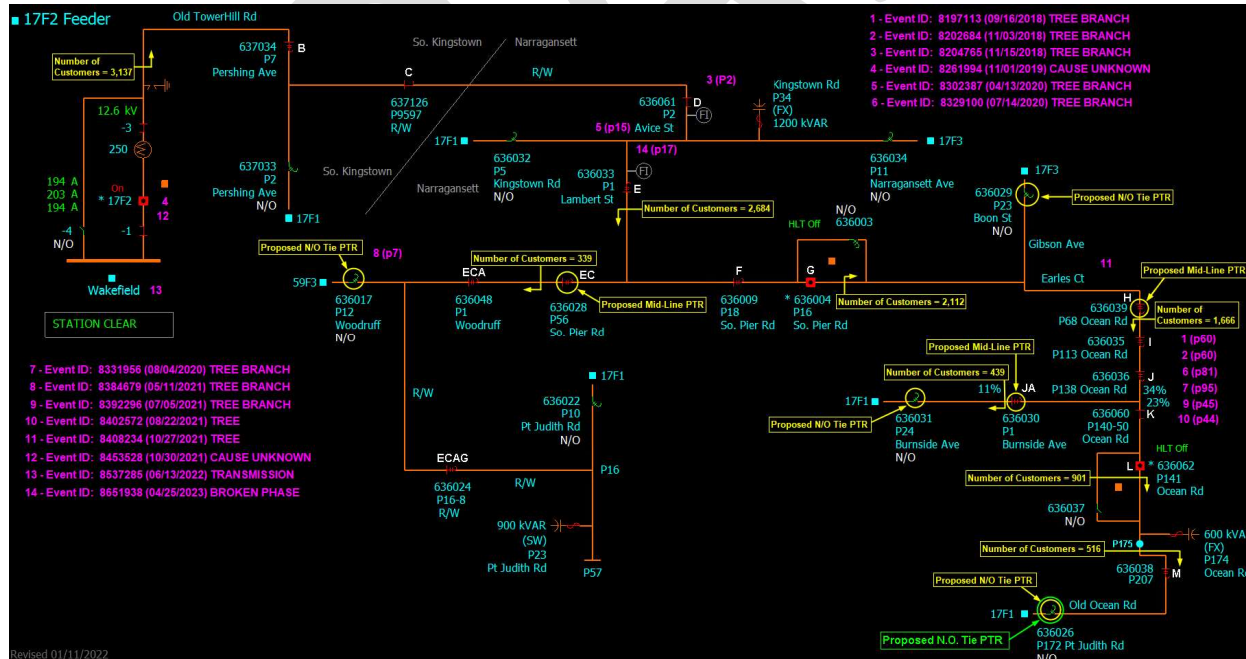
This memo documents the recommendations to improve CKAIDI and CKAIFI on the 2022 Poor Performing **17F2** feeder.

PRESENT CONFIGURATION OF 17F2

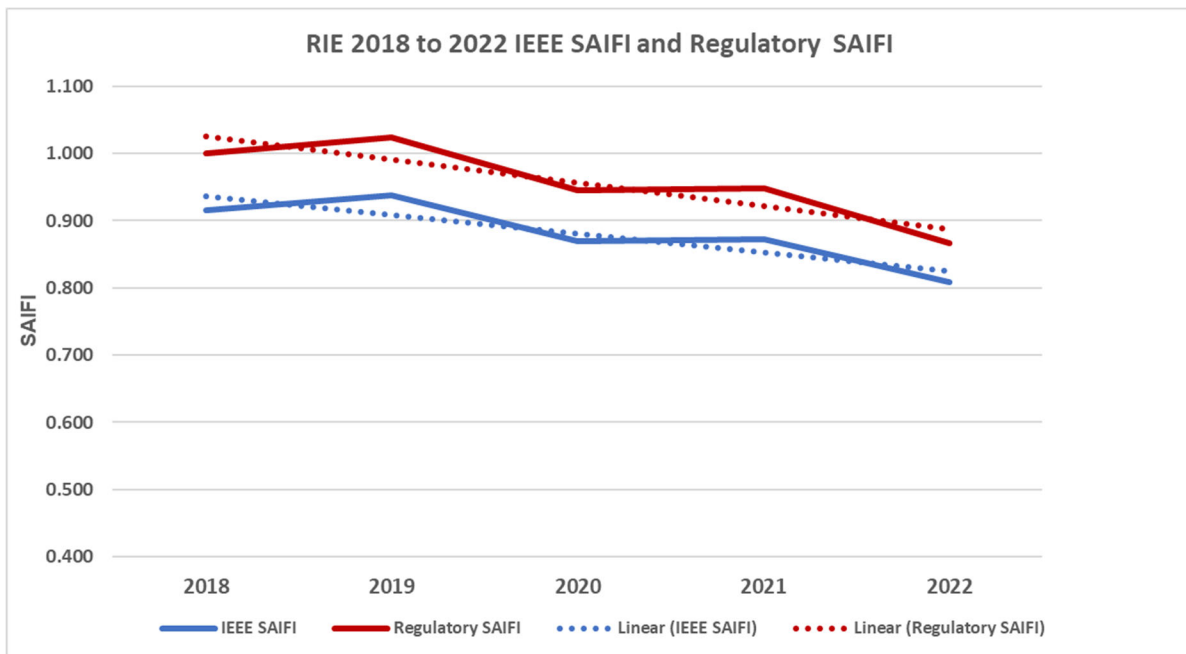
Figure 1. RIE historic SAIFI performance

Figure 1 and Figure 2 are RIE historic SAIFI and SAIDI performance in the past five years. Both SAIFI and SAIDI are showing improvement over this period.
