> Re: Commission Investigation Relating to Stray and Contact Voltage Occurring in Narragansett Electric Company Territories Docket 4237

Electric Field Detection Primer

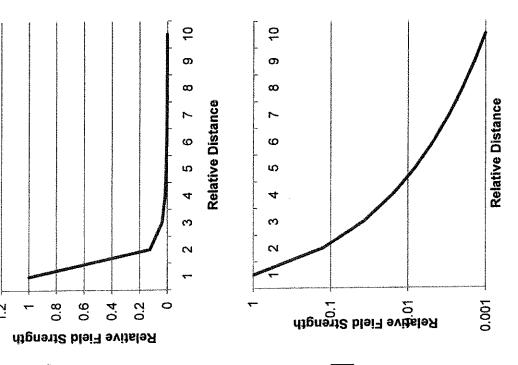
is reduced by more than 99% At 5 times the distance signal

Half the voltage and the signal strength is reduced by 50%

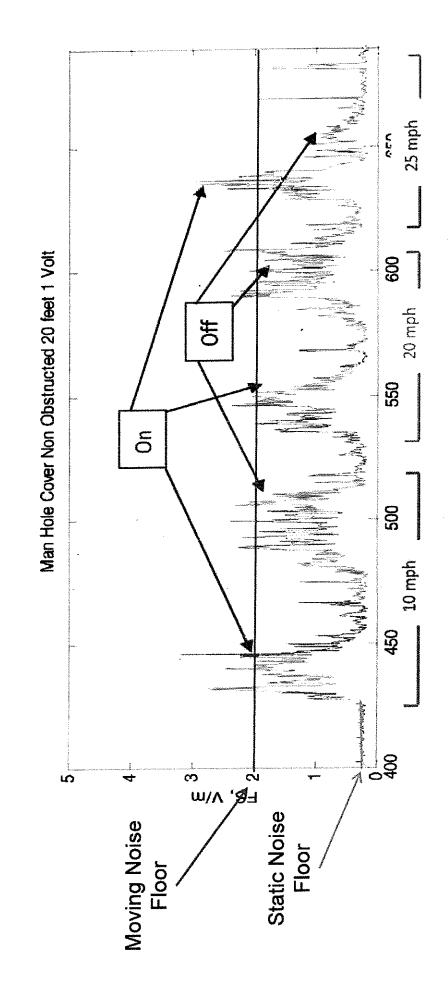
Estimating the NARDA Noise Floor

Found by averaging noise level when the "target" was off

- Signals that are below the noise floor cannot be differentiated from noise
- SVD-2000 has unpublished noise floor but from data appears to be less than 0.070 V/m
- NARDA EFA-300 sensor has a published noise floor of 0.140 V/m when the sensor is static
- NARDA 8950 System has noise floor, when moving, of approximately 2 V/m based on charts from NARDA

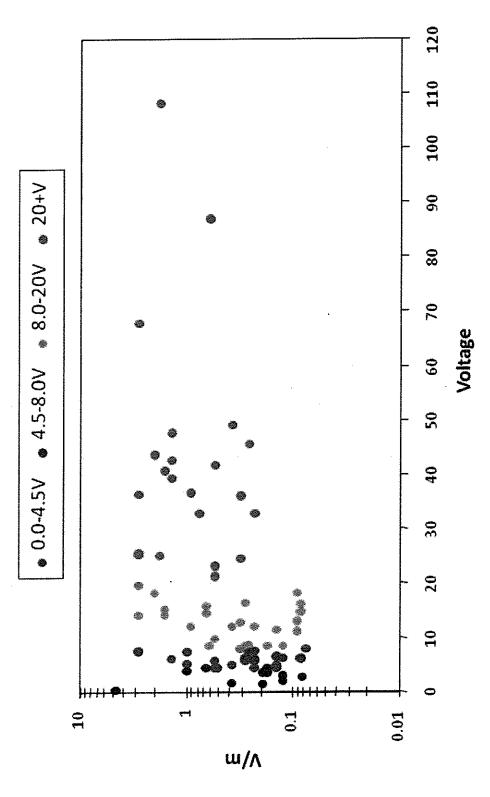
Data from Power Survey

Data collect by Power Survey indicates that many objects are below 2 V/m at all voltage levels

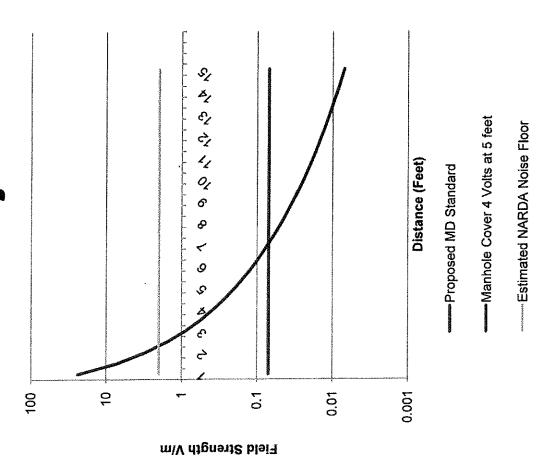
Manhole Cover Example

Effect of distance on real world objects

- Originally detected at 4 volts from 5 feet away
- At approximately 2.25 feet the e-field would be <u>below</u> the estimated 2.0 V/m NARDA noise floor
- Under MD Standard the efield from this object would be below the noise floor at approximately 7 feet

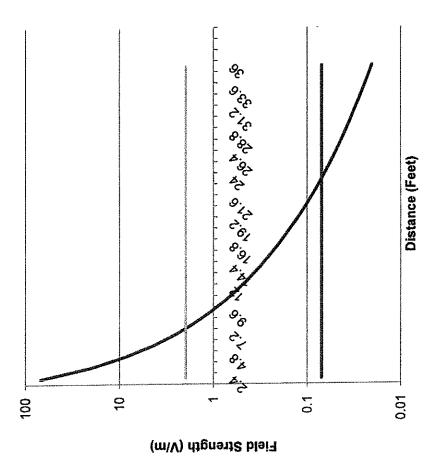
Scaffold Example

- Originally detected at 10 volts from 12 feet away
- At approximately 8 feet the efield would be <u>below</u> the estimated 2.0 V/m NARDA noise floor
- Under MD Standard the efield from this object would be below the noise floor at approximately 24 feet

Scaffold 10 Volts at 12 feet ——Proposed MD Standard ——Estimated NARDA Noise Floor

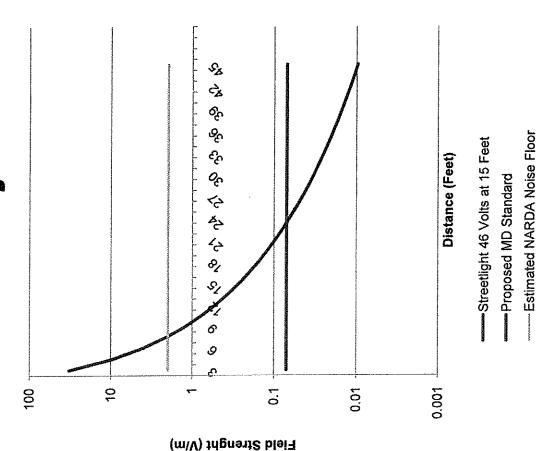
Streetlight Example

- Originally detected at 46 volts from 15 feet away
- At approximately 7.5 feet the estimated 2.0 V/m NARDA e-field would be **below** the noise floor
- field from this object would be Under MD Standard the e**below** the noise floor at approximately 23 feet

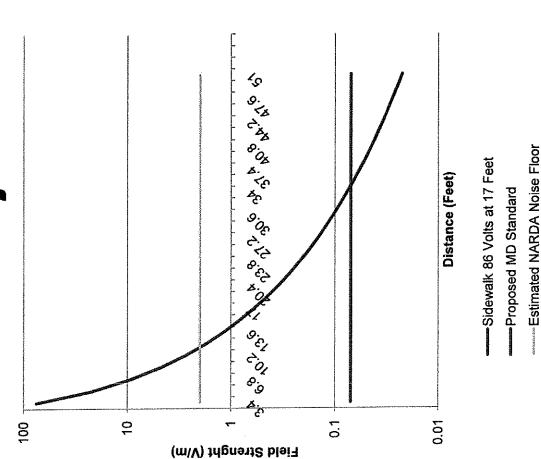
Sidewalk Example

- Originally detected at 86 volts from 17 feet away
- At approximately 12 feet the e-field would be <u>below</u> the estimated 2.0 V/m NARDA noise floor
- Under MD Standard the efield from this object would be below the noise floor at approximately 35 feet

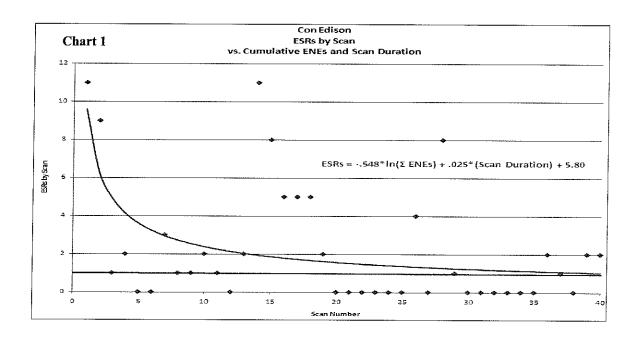
The reduction of ESRs associated with Con Edison's equipment appears on Chart 1. The duration of scans is 30-35 days per scan. If we continue a comparable ENE repair rate and scan duration in 2011, we can expect ESRs at this scan duration level to fall to approximately 1 per scan. This prediction is consistent with the 2010 actual results of 15 shocks due to Con Edison responsibility.

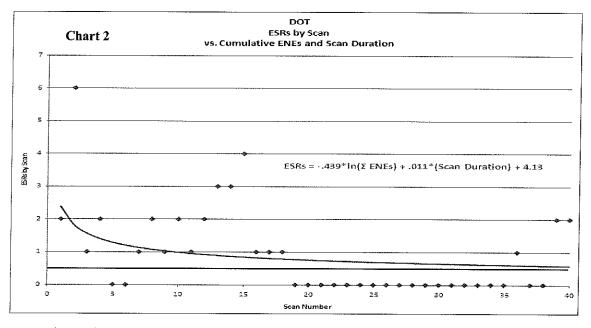
The reduction of ESRs associated with the DOT appears on Chart 2. The duration of scans is 30-35 days per scan. If we continue a comparable ENE repair rate and scan duration in 2011, we can expect ESRs at this scan duration level to be approximately 1 every two scans. This demonstrates marginal improvement over current scan durations. In 2010 there was 1 shock associated with DOT equipment failures. This result is better than predicted, and is likely the result of various programs implemented by both DOT and Con Edison to mitigate shocks.

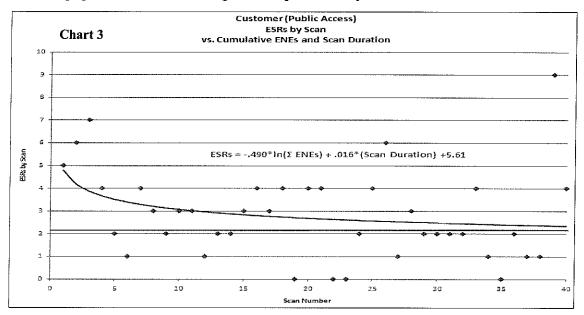
The reduction of ESRs associated with Customer Equipment (Public Access) appears on Chart 3. The duration of scans is 30-35 days per scan. If we continue

a comparable ENE repair rate and scan duration in 2011, we can expect ESRs to remain at 2 per scan with no significant reduction anticipated below that level in the near future. These ESRs appear essentially insensitive to changes in scan duration at this point in time. The actual performance indicates that these shock events are less sensitive to our mitigation efforts then we initially projected. In 2010, we responded to 43 validated shock reports on publicly accessible customer equipment, this is 32 % higher than predicted by the model.

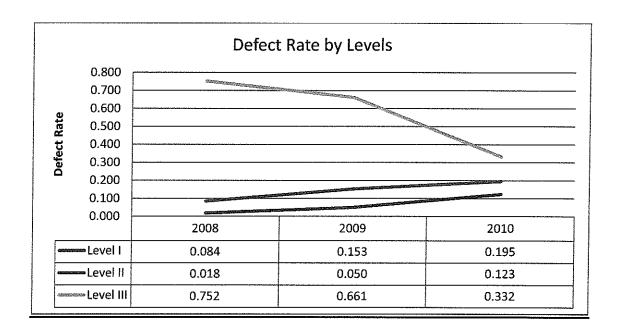
The chart below shows the number of defects found per inspection:

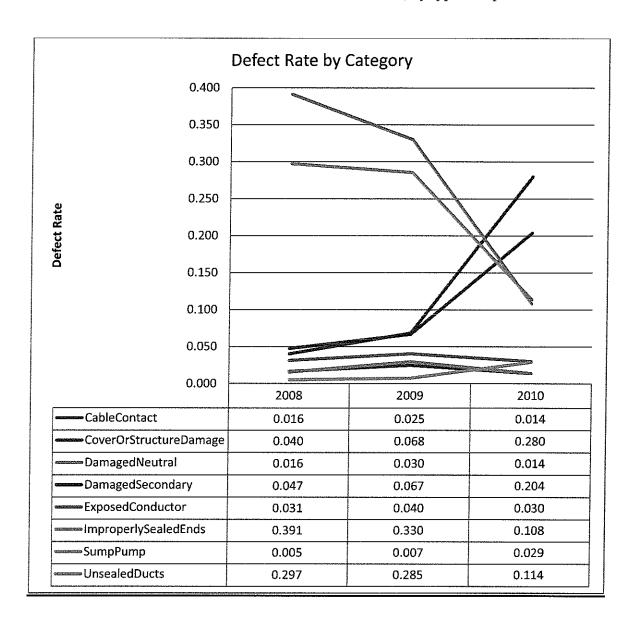
The defect found ratio can be broken down further, by type of repair:

Since 2008, we have made changes to our inspection program, the major change being moving from a tiered structure (prior to 2009) for categorizing repairs to a level based system. In doing so, when comparing 2008 to 2009 and 2010, repair categories do not directly translate to a specific level, which slightly skews our defect ratios. We have grouped these shared repairs (prior to 2009 Tier 2, and after 2009 Level 2 and 3) using our knowledge of and the intent of our specification changes.

For most categories, we see a minor decrease in defect rate from 2009 to 2010. Two categories that we see a major decrease in defect rate are unsealed ducts and improperly sealed ends. In 2009, we included the sealing of ducts and improperly sealed ends as a Level 1 repair. This resulted in a significant reduction of these types of defects being found in 2010 (as shown in the graph above). We also saw an upward spike in a few categories.

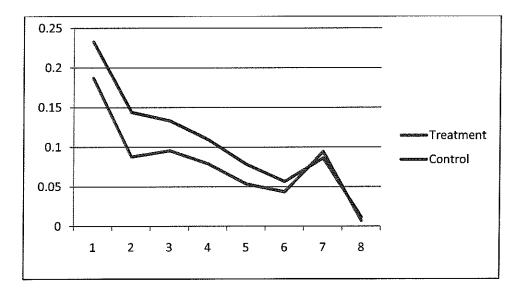
The conclusion of the study was that, as a result of the inspection program approximately 1,300 events across all 8 categories were avoided over a 5 year period. Of the 1,300 events approximately 200 were smoking manholes. The remaining 1,100 events were other secondary conditions such as flickering lights, energized objects, etc. The study did not detect a reduction in manhole fires and explosions as a result of the inspection program.

The benefit derived from the inspection of the 52,000 structures studied was a reduction in probability between the treatment group (blue) and the control group (red) of about 5% for categories 1, 2 and 3 with less of an impact on categories 4,5, and 6. Categories 7 and 8 showed no significant impact. This translates to a reduction of approximately 1300 secondary events from the inspection of 52,000 structures.

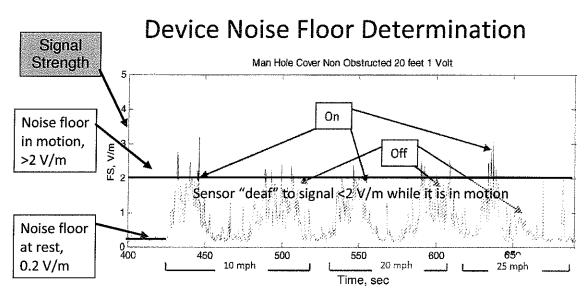
Narda's first test run shows that with no energized structure present, the device returns about 2 V/m. Figure 1, taken from p8 of the test report, illustrates this. The Narda sensor is unable to detect signals smaller than 2V/m while operating at any speed.

Figure 1 Narda signal strength with substitute structures "Off" is the level of noise produced by the system, vehicle, road vibrations, etc. and is the minimum detectable signal strength, or Noise Floor.

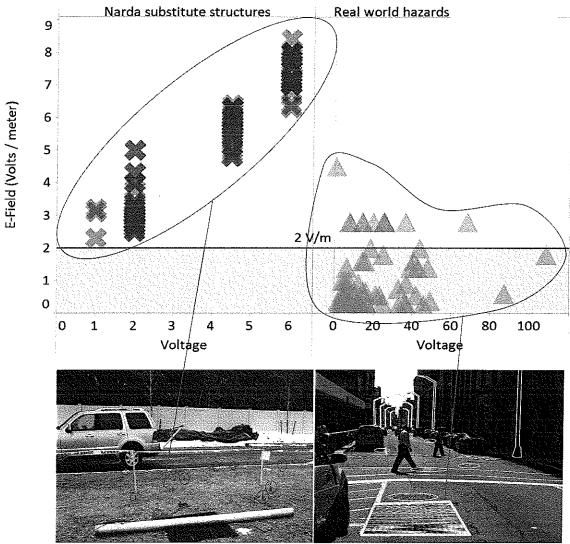
Figure 2 (on page 4) compares the Narda device noise floor with two important data groups. The blue data group at the left represents the signals generated by Narda's substitute structures. The orange data group at the right represents a random sample of 86 real energized structures detected in New York using similarly calibrated test equipment and actual manhole covers and streetlights encountered in the public landscape. The substitute structures emit much stronger electric field sources than all but a handful of real energized objects. Also, a majority of the real energized objects emit signals well below the Narda device noise floor and would thus be invisible to the Narda device. To be more precise, 88% of the real world samples emitted below 2 V/m, giving us a rough idea of just how many real hazards the Narda device would miss in a real-world field test. This estimate is validated by the experience of RGE in Rochester, NY, where 84% of the energized structures were undetected.

Figure 2 Comparison of E-field levels emitted by Narda substitute structures and real world energized structures. Narda recorded 105 passes, avg field of 5.1V/m, median 5.5V/m. Real sample of 86 energized objects had avg field of 0.85 V/m, median 0.38 V/m.

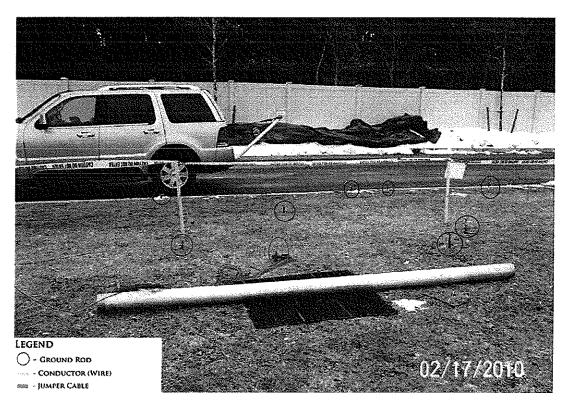
A careful review of the photograph on page 16 of the report (and displayed in Figure 3 below) shows why the signals generated by the substitute structures are far larger than those generated by real world energized structures. The substitute structure in this photo (long pipe), and in fact all substitute structures used during testing, is directly connected (via yellow wire highlighted in blue) to a ground rod driven into the earth. This effectively energizes the earth around it, and boosts the electric field level produced. What's more, Narda installed additional conductors (highlighted in green) and ground rods (circled in red) around the test area and along the curb of the test range in close proximity to the Narda 8950. These are either directly or indirectly energized by the voltage applied to the substitute structure.

Figure 3 Photo from p 16 of L3 [Narda] test report, showing an array of added electrodes and ground rods added which boost the E-field signal from the substitute structure (Legend added)

The effect of this additional hardware is a large increase in the signal picked up by the sensor for two primary reasons. First, the additional hardware effectively increases the size of the substitute structure. It now includes the group of ground rods and the earth around them. Secondly, the additional hardware reduces the distance between the device and the substitute structure. While the pipe in the photograph may be 30 feet away from the sensor, the additional ground rods and wires are clearly much closer. The effects of these objects were clearly known by Narda's technicians performing the test, as they demonstrated repeatedly that
