The Narragansett Electric Company
d/b/a National Grid

**Electric Infrastructure,
Safety, and Reliability Plan
FY 2021 Proposal**

**Responses to Division's Data
Requests**

Docket No. 4995

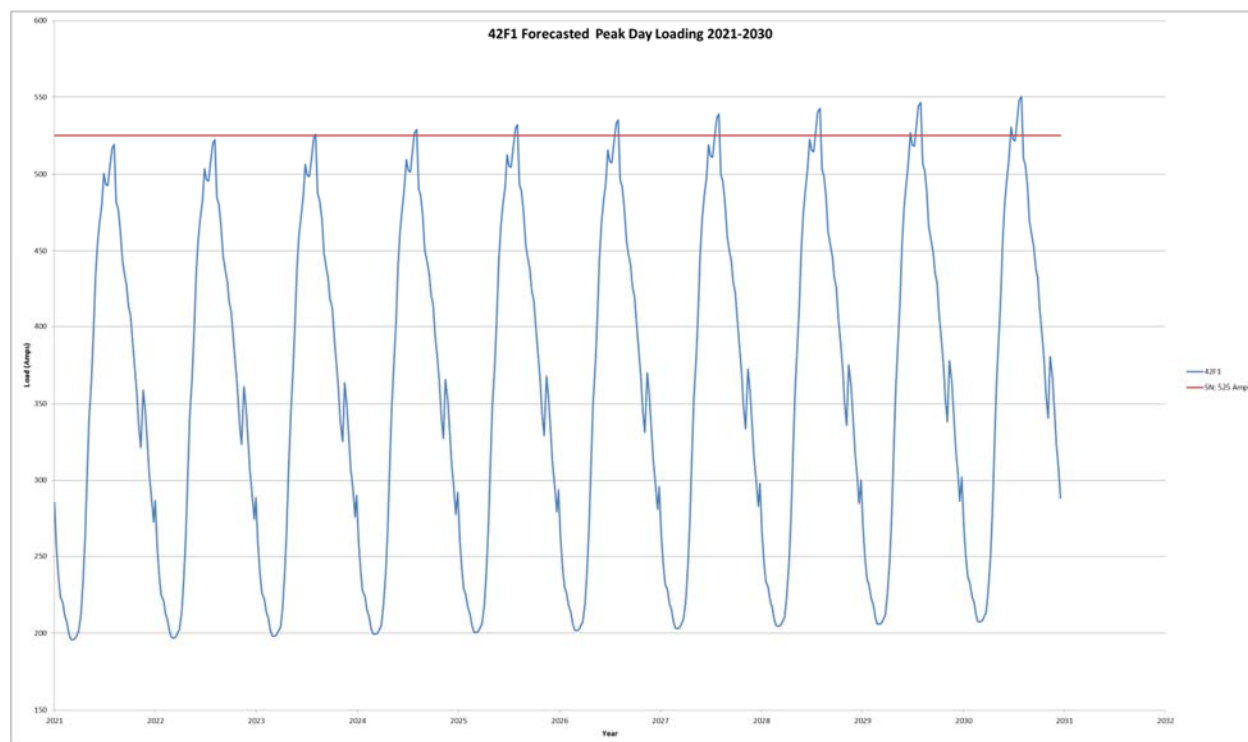
Loading on the 42F1 and 17F2 feeders is predicted to be over 100% of their summer normal ratings and will be overloaded over the next ten years. All other facilities' loadings are within their normal equipment ratings. The rating of feeders is determined by the equipment with the most limiting element (that with the lowest normal summer rating). The load forecast utilizes a technique called weather normalization, a process that assumes future year peaks will occur given high loading condition (e.g., a June peak will occur on hot day, where the temperature in the 95th percentile of hottest years). The charts below show the projected load on the feeders using the peak day at the time of study and the loads are grown according to the forecasted analysis.

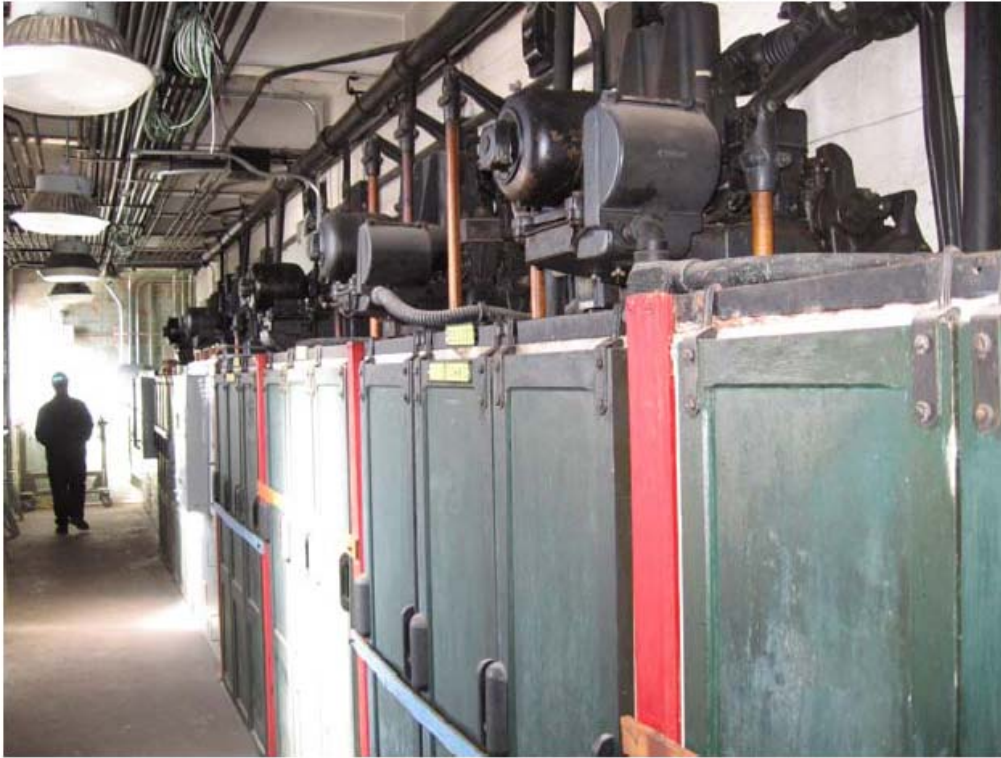
One of 7 Breaker Rooms with H-Type Breakers

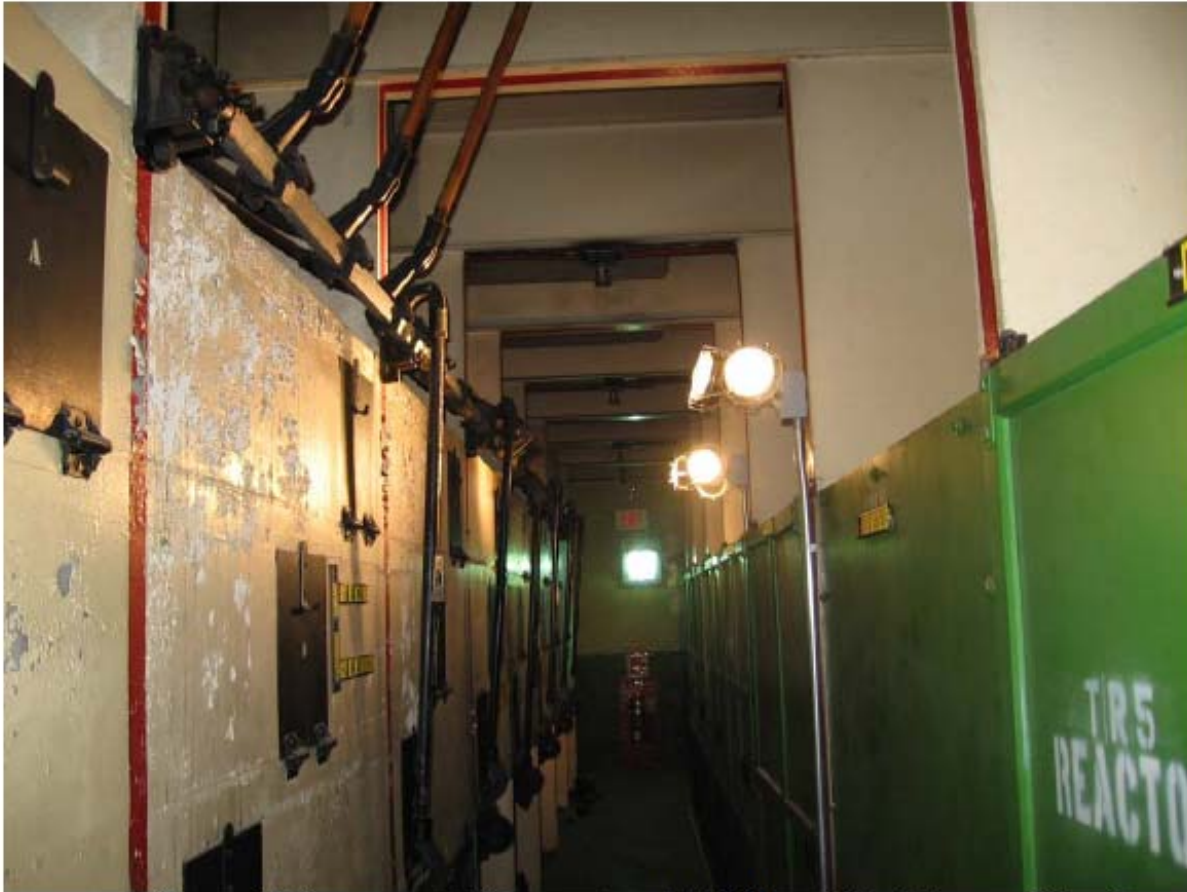
Dyer St Indoor Substation 1st row of switches off the 4 kV

Room with Gang operated disconnects and 4.16kV bus – Black doors on left wall provide access to each phase energized bus. 1 of 2 such rooms

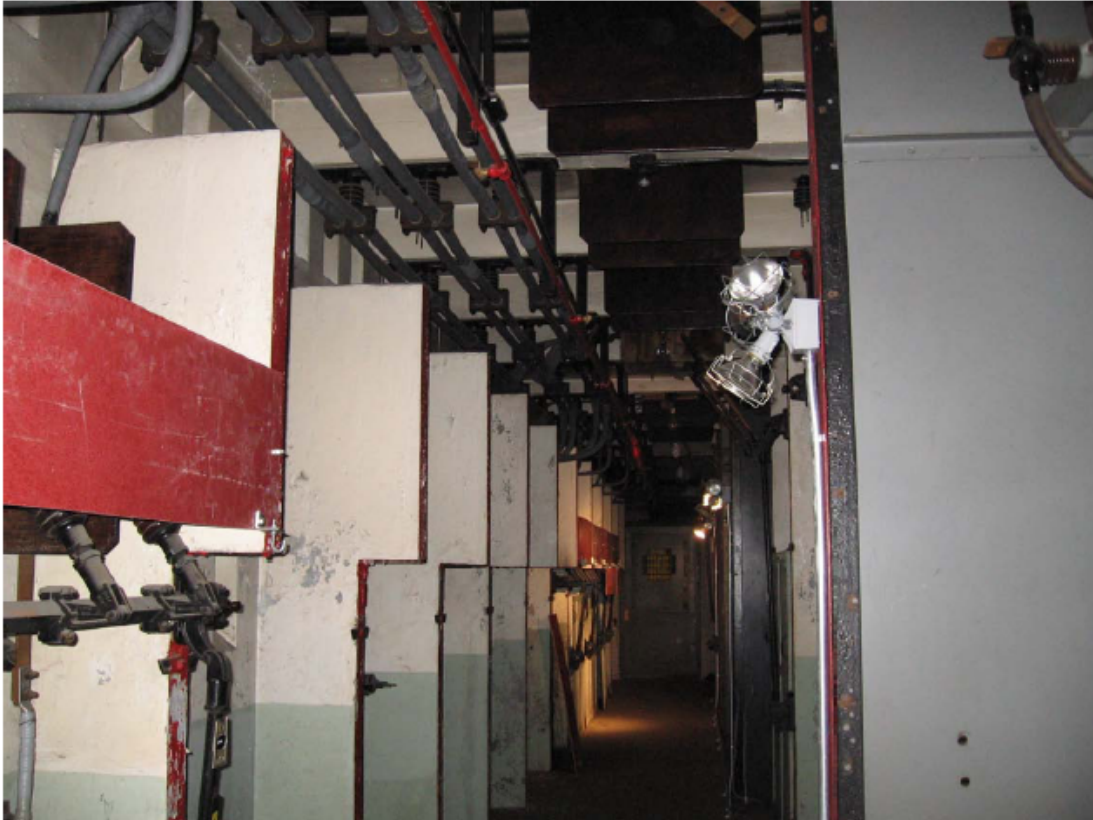
Dyer St Indoor Substation 2nd row of switches off the 4 kV bus

Room with 4.16kV -4 switches (left), -3 disconnects (ceiling)

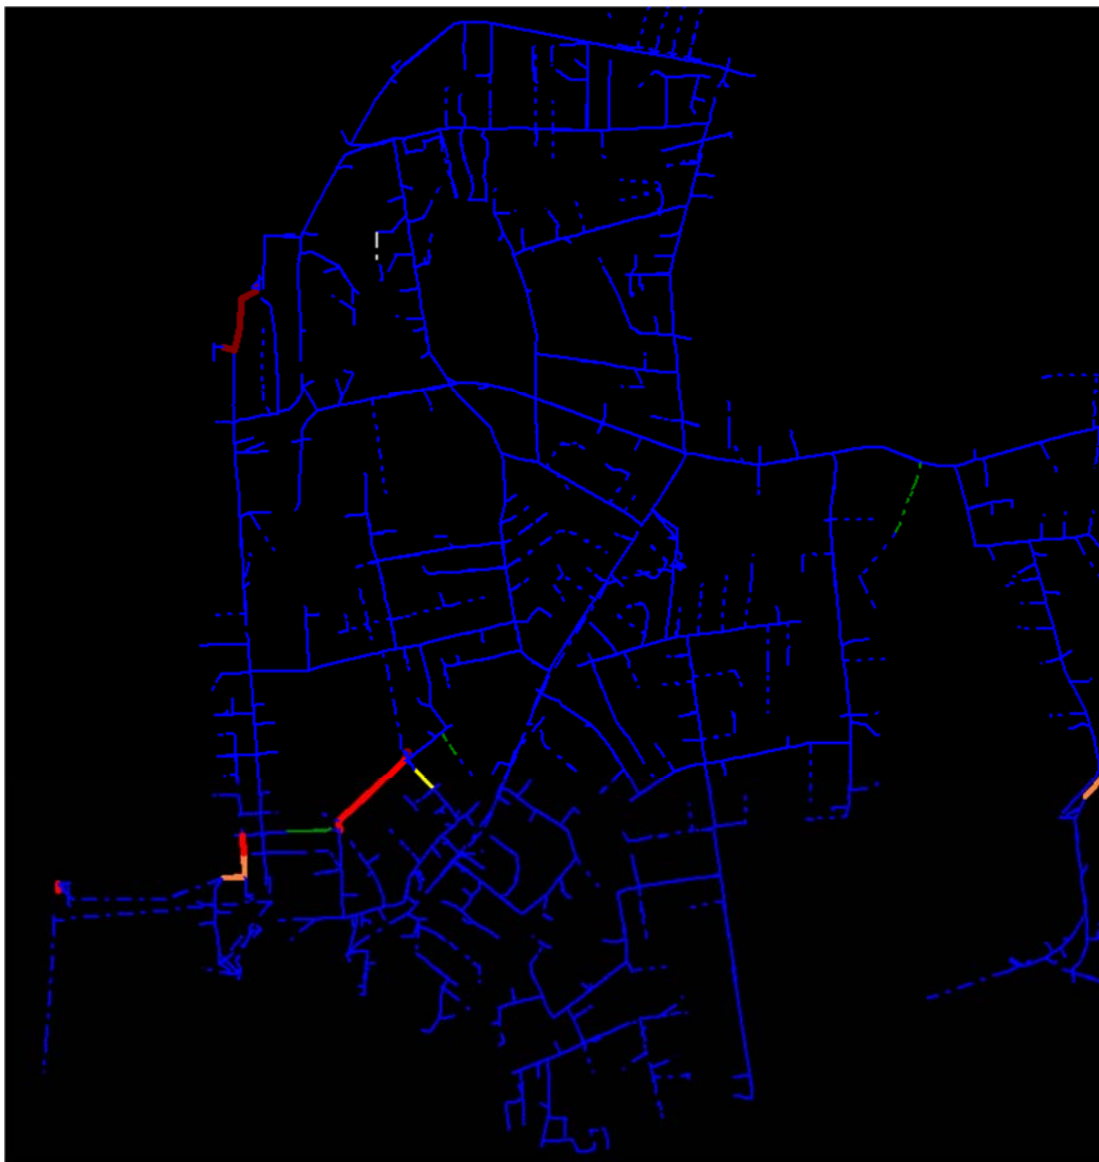
Figure 3: Newport Substation Thermal Loading: Pre- Project Implementation

The following figures outline the Newport Substation's associated feeders' thermal levels, pre- and post- project implementation:

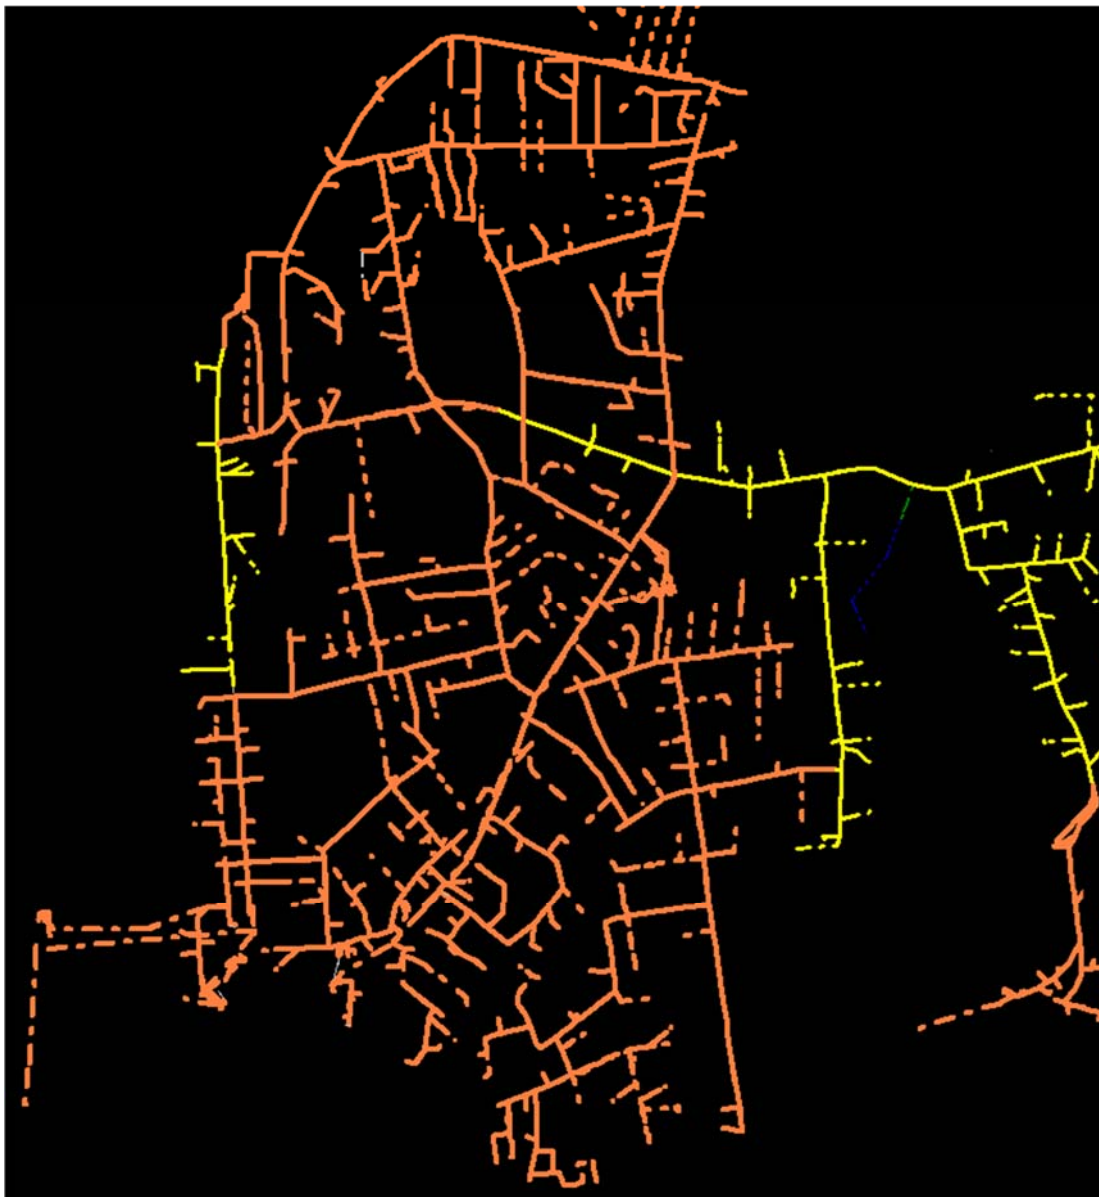
Figure 5: Newport Substation Voltage Levels: Pre-Project Implementation

The following figures outline the Newport Substation's associated feeders' voltage levels, pre- and post-project implementation:

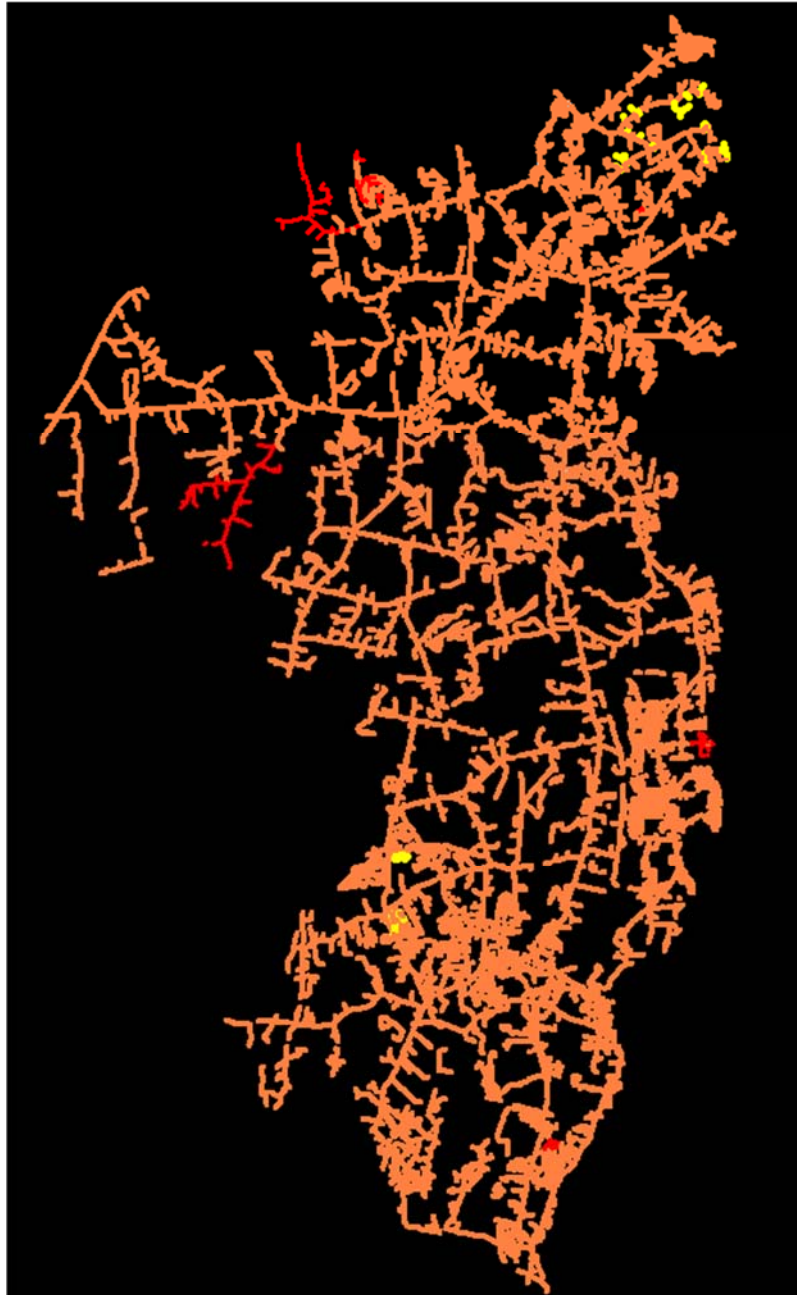
Figure 9: SCE Voltage Levels: Pre-Project Implementation

The following figures outline the South County East Area Study's associated feeders' voltage levels, pre- and post-project implementation:

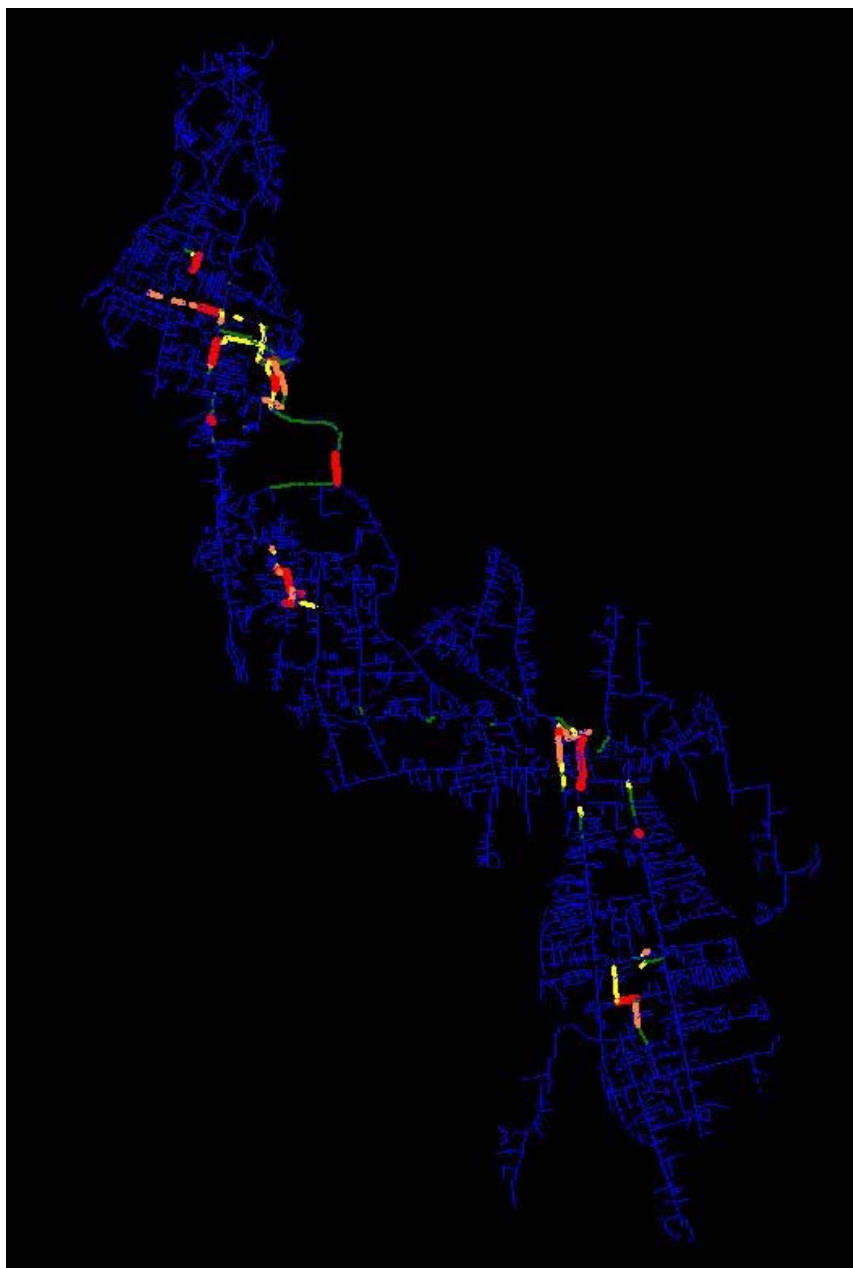
Figure 11: East Bay Thermal Loading: Pre- Project Implementation

The following figures outline the East Bay Study's associated feeders' thermal levels, pre- and post-project implementation:
