The Narragansett Electric Company d/b/a National Grid

Electric Infrastructure, Safety, and Reliability Plan FY 2024 Proposal

Responses to Division's Data Requests

RE: National Grid's Proposed FY 2022 Electric Infrastructure, Safety, and Reliability Plan Docket No. 5098

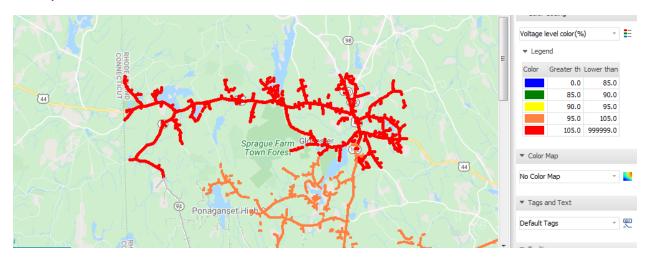
<u>CASE 1:</u> Low load day (Winter) during expected high solar DER production hours. 34F2 feeder in current configuration with currently connected and proposed DER (large and small scale).

The voltage profile above depicts the 34F2 feeder in its current state, including existing and proposed large and small scale DER facilities. The voltage stability worsens the further away from the substation due to the increased levels of DER interconnected to the Chopmist Substation.

The substation was also modeled using only existing connected DER (large and small scale), and analysis showed voltage issues are already emerging today.

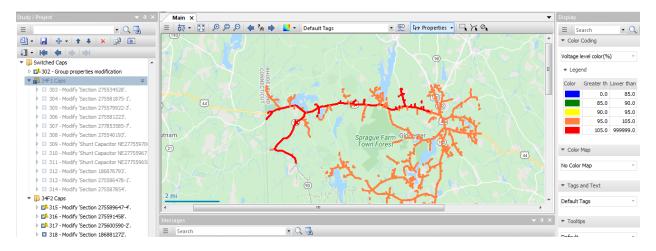
<u>CASE 2</u>: Low load day (Winter) during expected high solar DER production. 34F2 feeder in current configuration with currently connected and proposed DER (large and small scale) with only installing advanced capacitor controls on the 34F2 Feeder.

Replacing existing capacitors with advanced switched capacitors on the 34F2 slightly improves the voltage profile but does not solve all issues.

The recommendation is to install advanced devices on all the Chopmist feeders. As can be seen in Case 2, installing advanced devices on only one feeder at the substation would not solve all the issues. Case 3 shows upgrading all devices at a substation solves all voltage issues. This demonstrates how DER can impact voltage across multiple feeders at a substation and a more comprehensive solution is necessary.

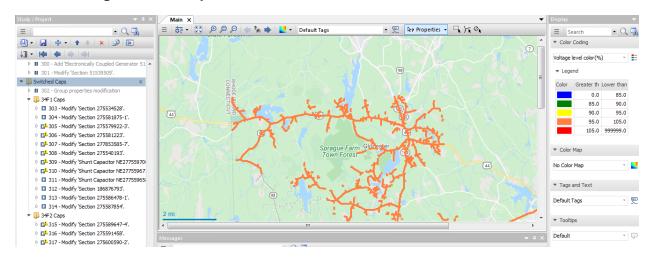
<u>CASE 3</u>: Low load day (Winter) during expected high solar DER production. 34F2 feeder in current configuration with currently connected and proposed DER (large and small scale) with installing advanced capacitor controls on both the 34F1 and 34F2 Feeder.

Replacing all existing capacitors with advanced switched capacitors on both the 34F1 and 34F2 improves the voltage profile and brings voltages within an acceptable range.

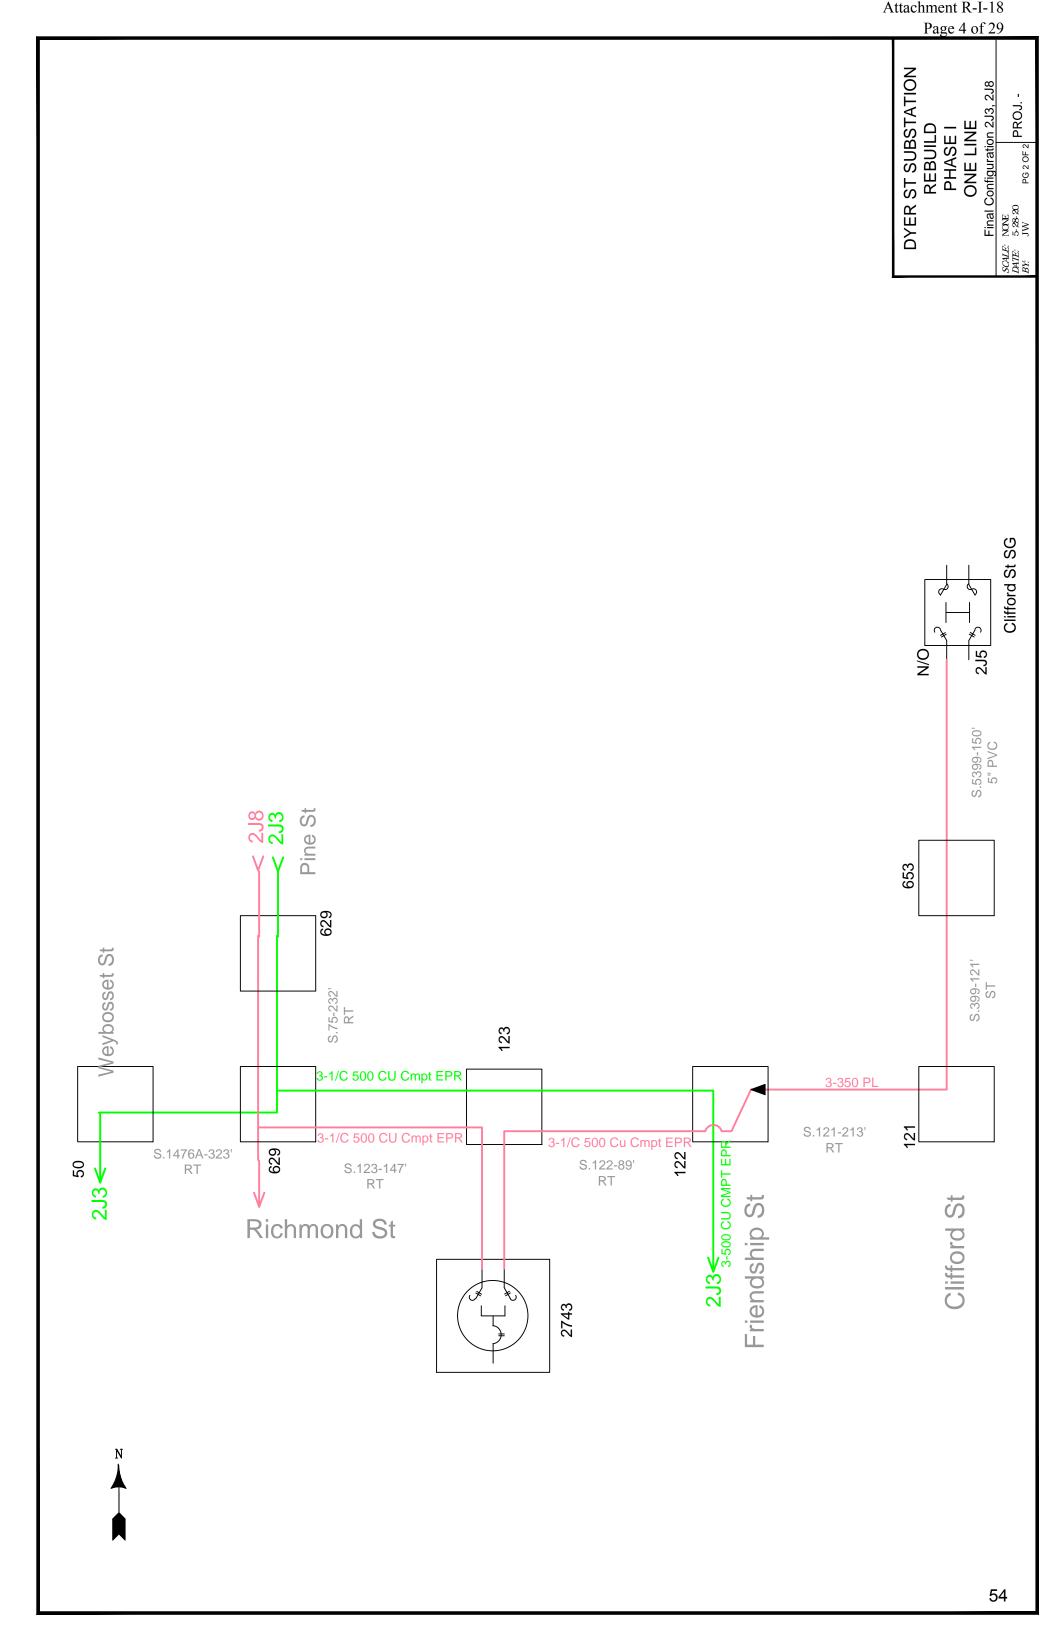
- One Line- Phase I, Feeders 2J2, 2J3, 2J8
- One Line- Phase I, Final Configuration 2J3, 2J8

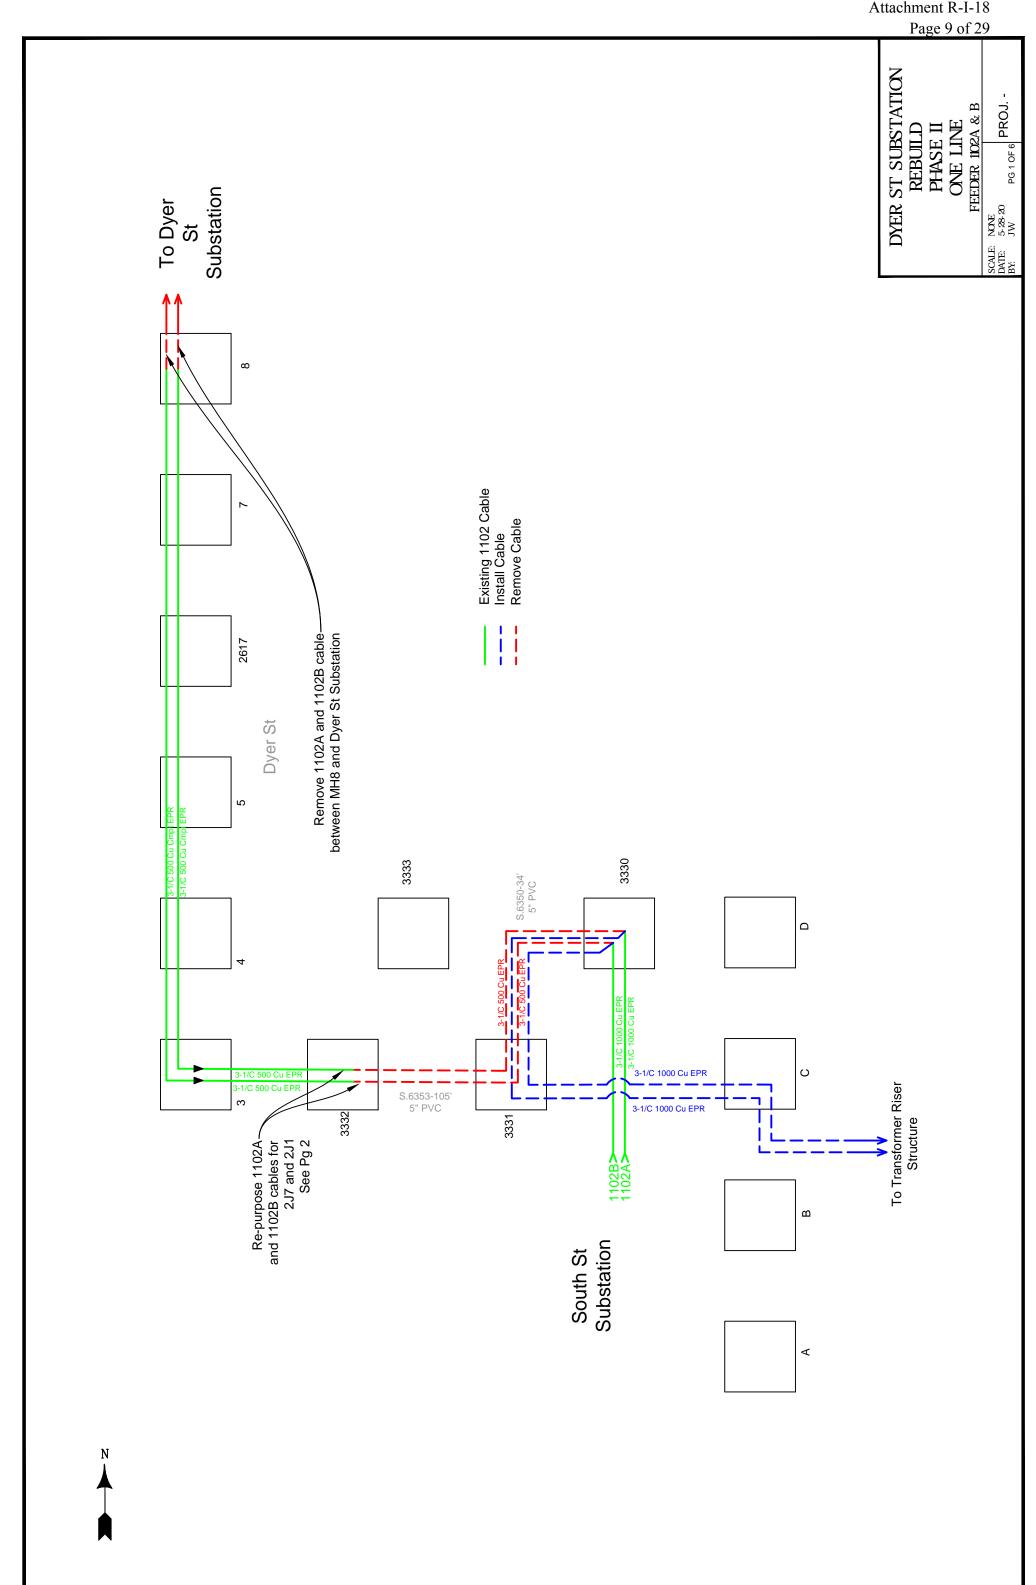
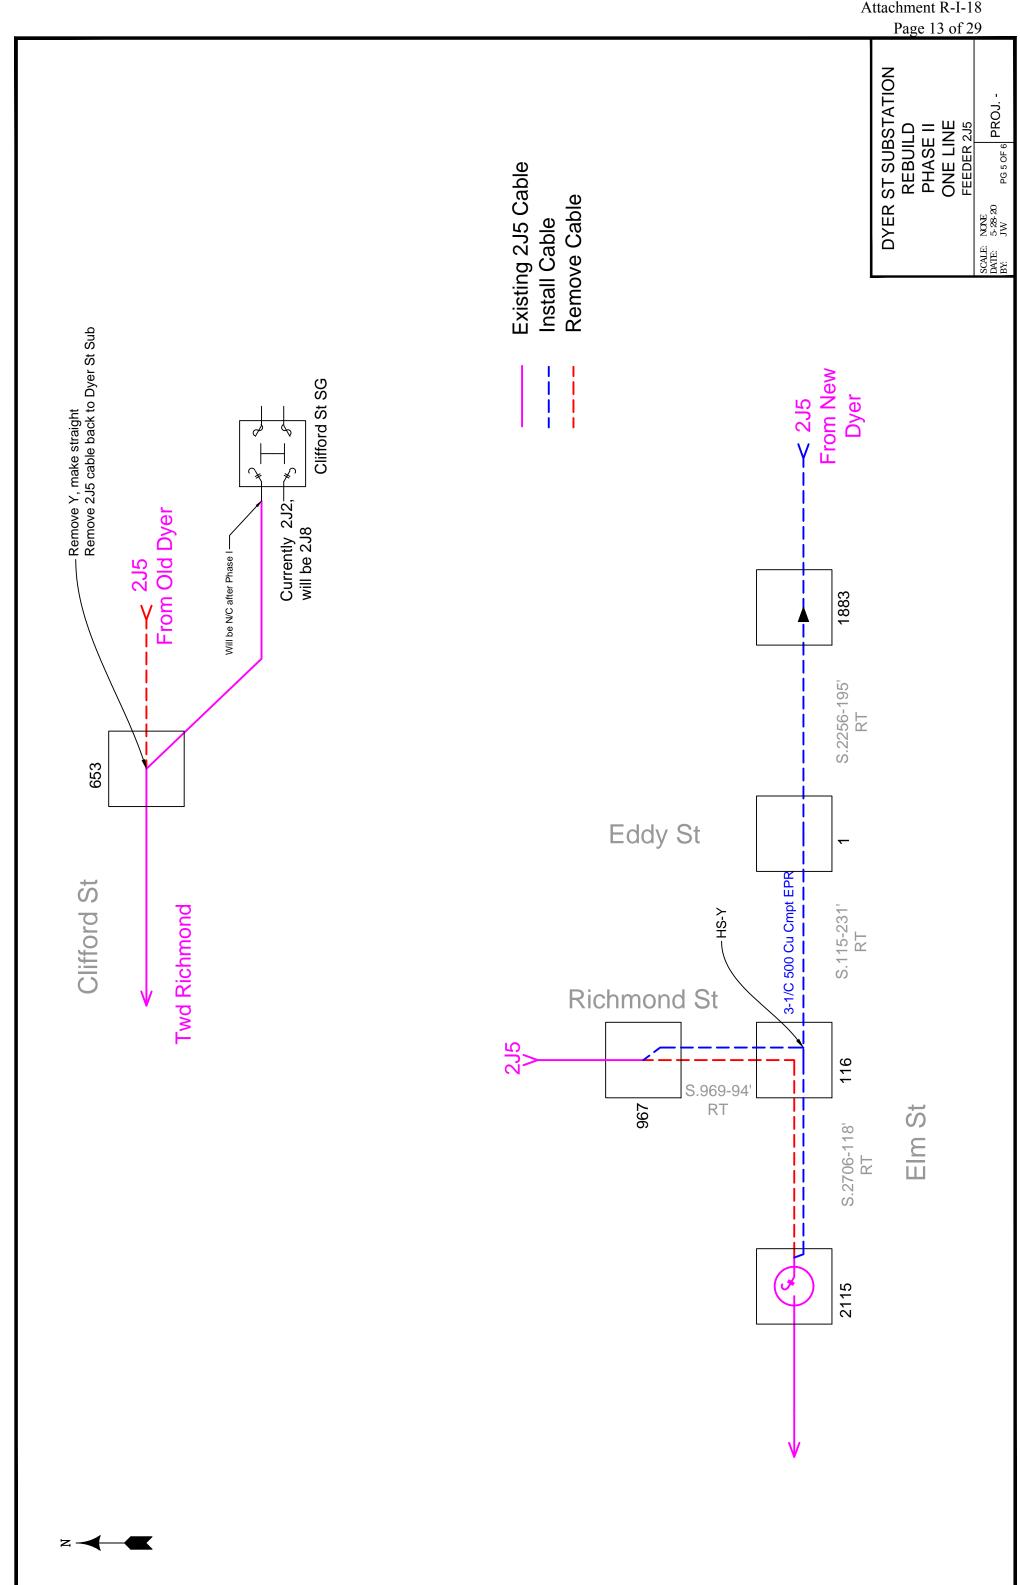
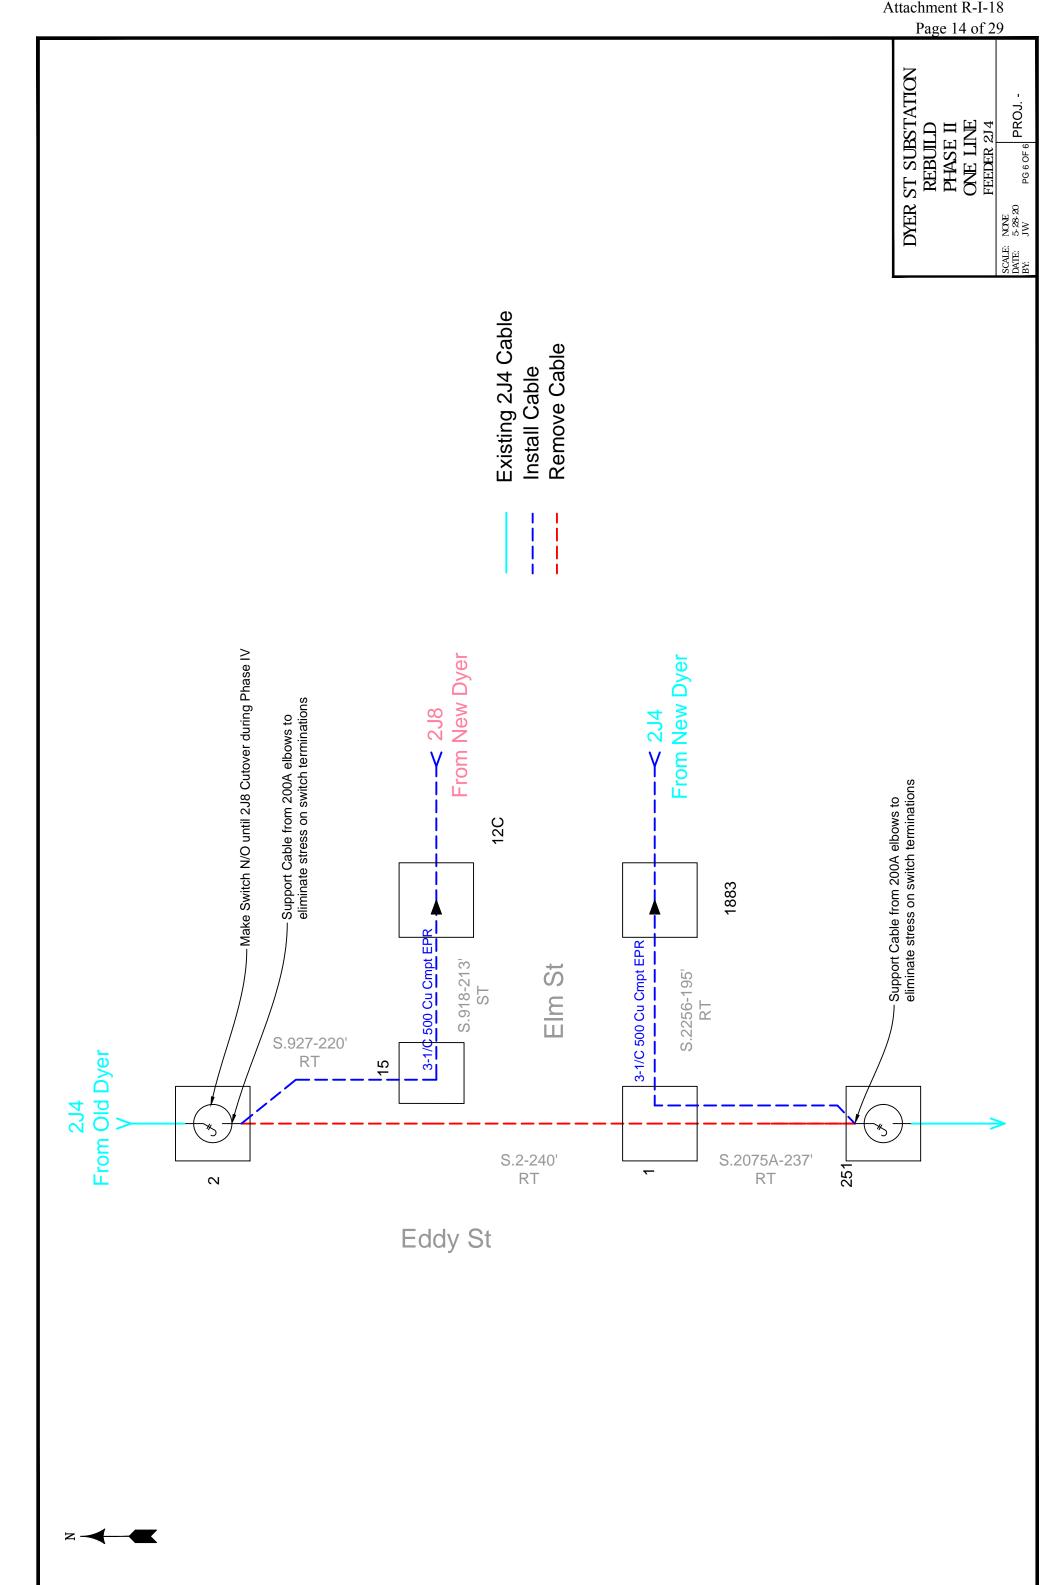
- One Line- Phase II, Feeders 1102A &B
- One Line- Phase II, Feeders 2J1, 2J4, 2J5, 2J7, 2J8
- One Line- Phase II, Feeder 2J1
- One Line- Phase II, Feeder 2J7
- One Line- Phase II, Feeder 2J5
- One Line- Phase II, Feeders 2J4, 2J8

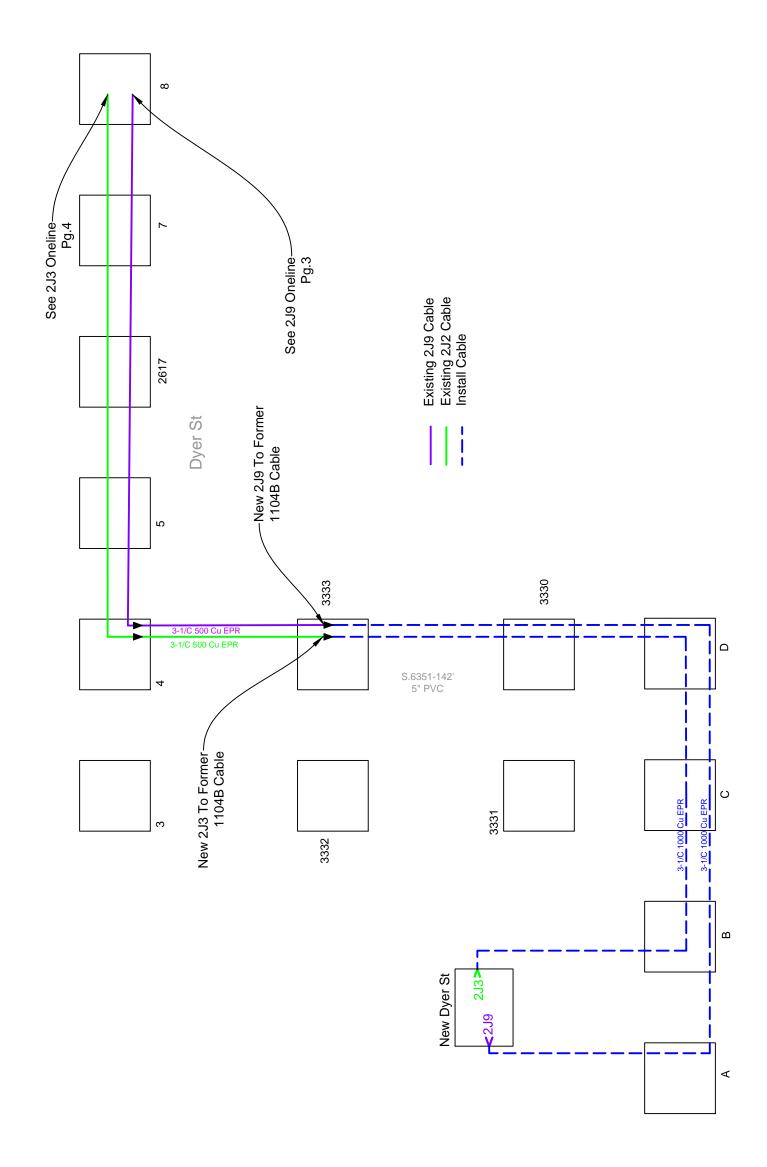
DYER ST SUBSTATION
REBUILD
PHASE III
ONE LINE
FEEDER 2J3 & 2J9
SCALE: NONE
DATE: 5.28.20
BY: JW PG 2 OF 4
BY: JW PG 2 OF 4

- One Line- Phase III, Feeders 1104A &B
- One Line- Phase III, Feeders 2J3, 2J9
- One Line- Phase II, Feeder 2J9
- One Line- Phase II, Feeder 2J3

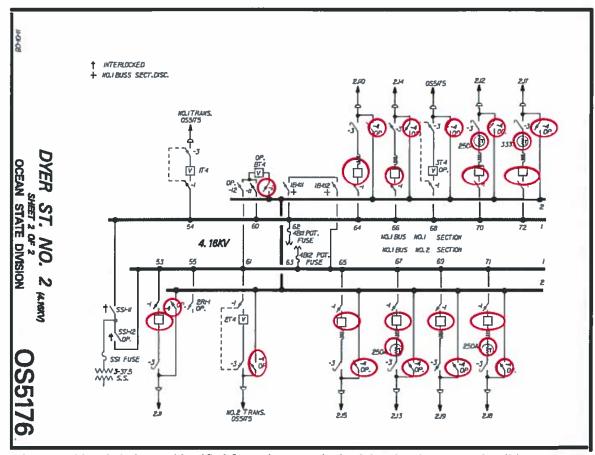
Equipment with red circle was identified for replacement in the O&M Services Asset Condition Report

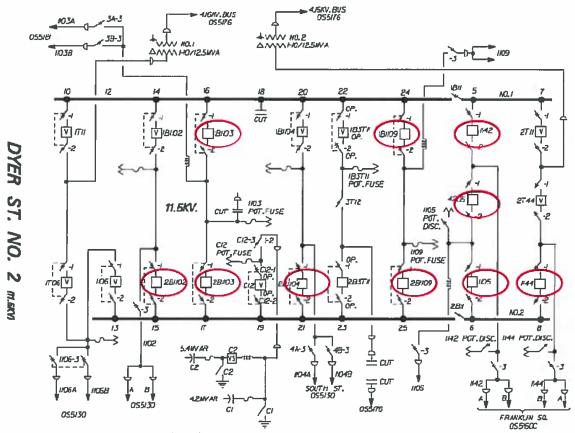
Equipment with red circle was identified for replacement in the O&M Services Asset Condition Report

Close up of H- Breakers that were recommend for replacement in the Asset Condition Report.

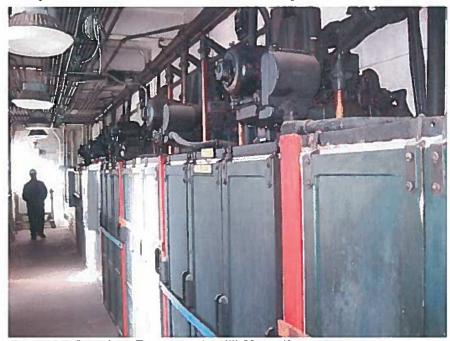
One of 7 Breaker Rooms with H-Type Breakers

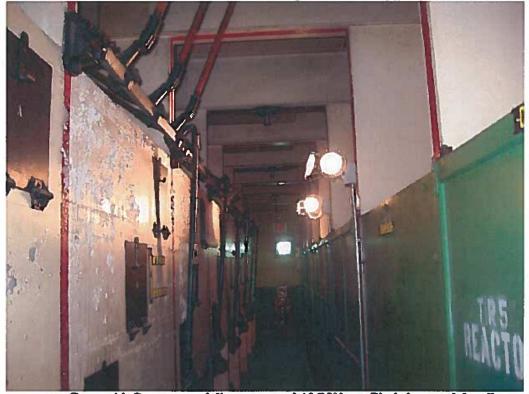
Dyer St Indoor Substation 1st row of switches off the 4 kV

Room with Gang operated disconnects and 4.16kV bus – Black doors on left wall provide access to each phase energized bus. 1 of 2 such rooms

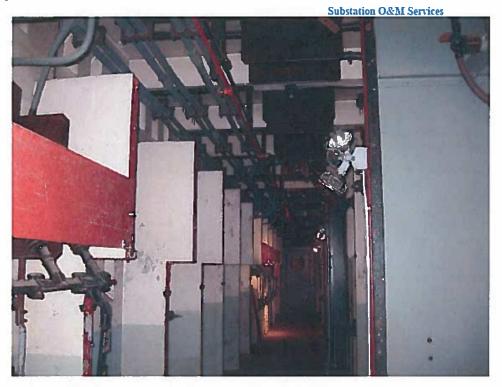
Dyer St Indoor Substation 2nd row of switches off the 4 kV bus

Room with 4.16kV -4 switches (left), -3 disconnects (ceiling)

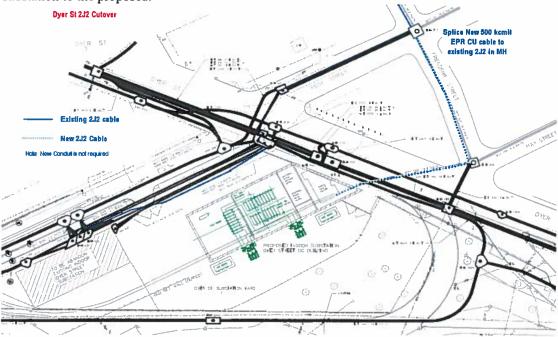
C051211 Distribution line work. Sample of 4 kV distribution circuit cutover from existing indoor substation to the proposed.

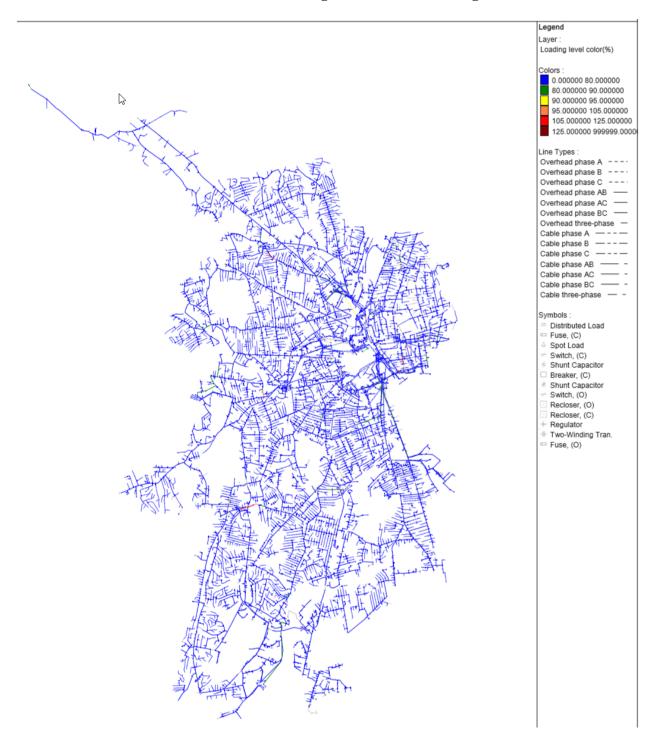
R-III-4, page 5

CYME Base (Existing) Case – 2030 Loading

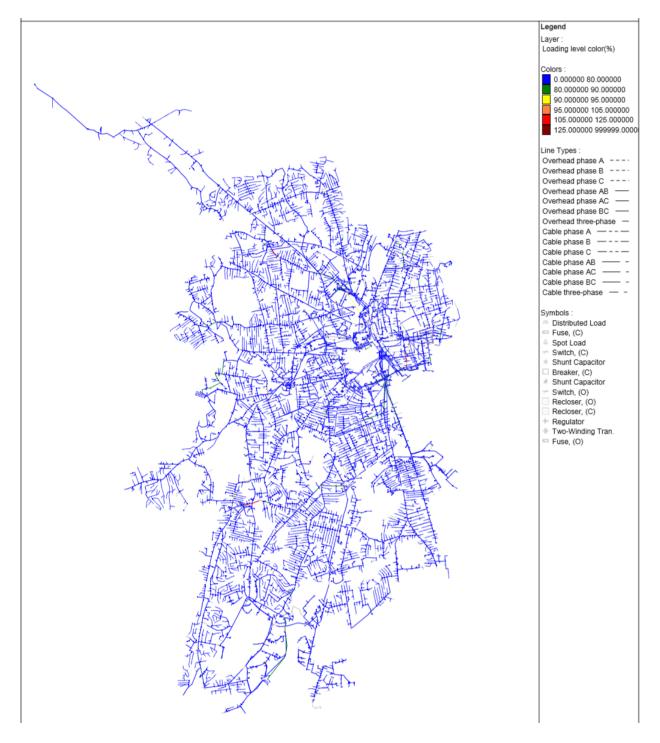
R-III-4, page 6

CYME Base (Existing) Case – 2034 Loading
