In re: City of Woonsocket Water Division - Application to Implement Multi-Year Rate Plan

Docket No. 4879

Dam Name (No):	Woonsocket Reservoir #3 Dam (068)
Location:	Smithfield/North Smithfield
Hazard Classification:	High
	-
Inspector:	David M. Matheson, P.E.
Inspection Date.	August 1, 2014

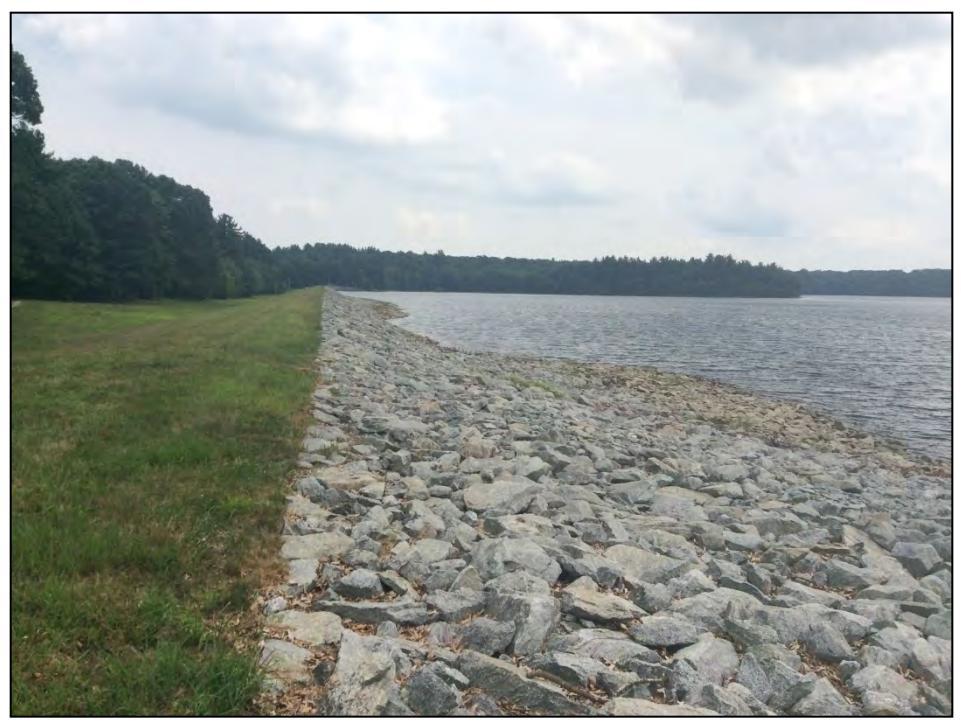
Photo No. 1: Upstream slope as seen from the left abutment.

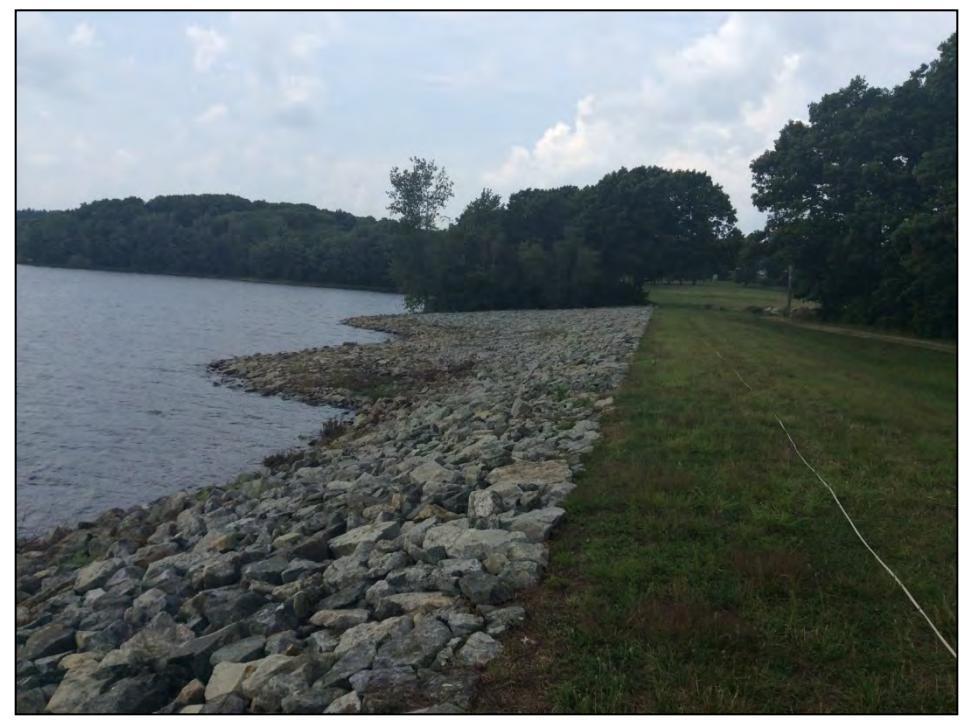
Photo No. 2: Upstream slope as seen from near station 3+00 looking towards the left abutment.

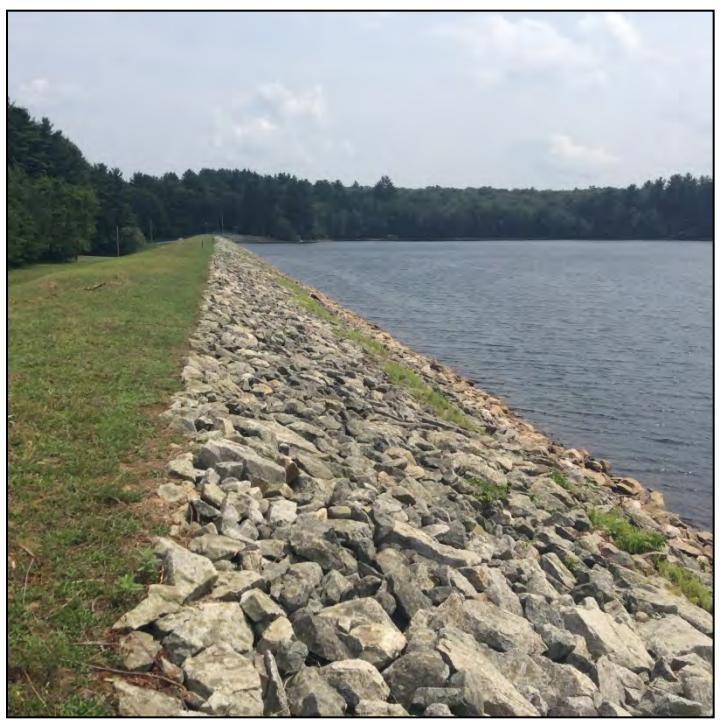
Photo No. 3: Upstream slope as viewed from near station 9+00 looking right.

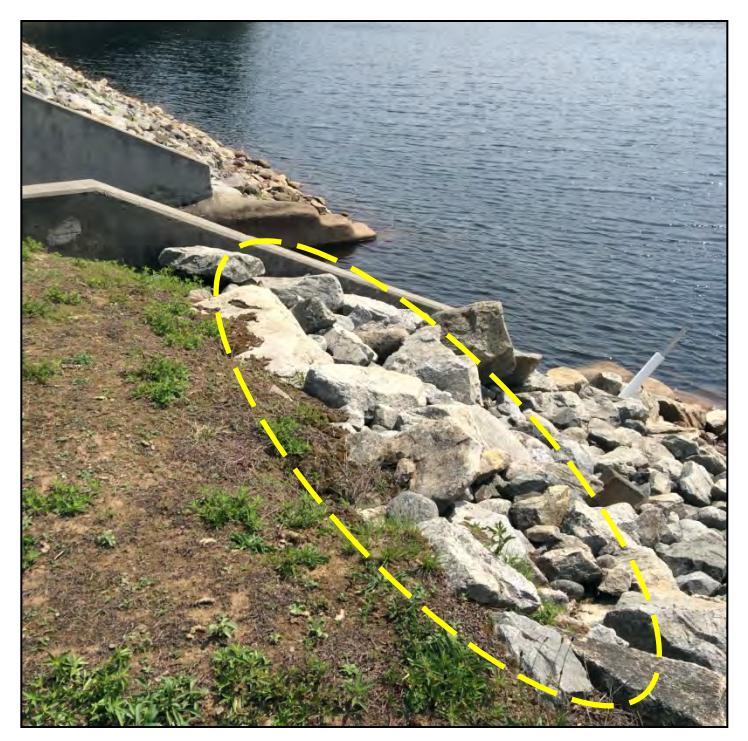
Photo No. 4: Upstream slope near its contact with the auxiliary spillway. Note the potential downward shifting of the rip rap.

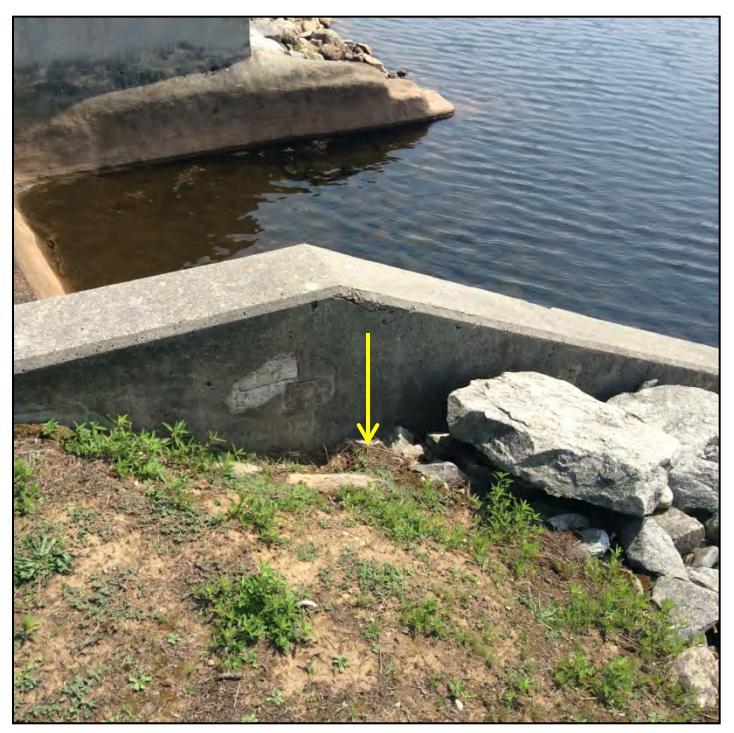
Photo No. 5: Eroded area left of the spillway at the transition between the upstream slope and the crest.

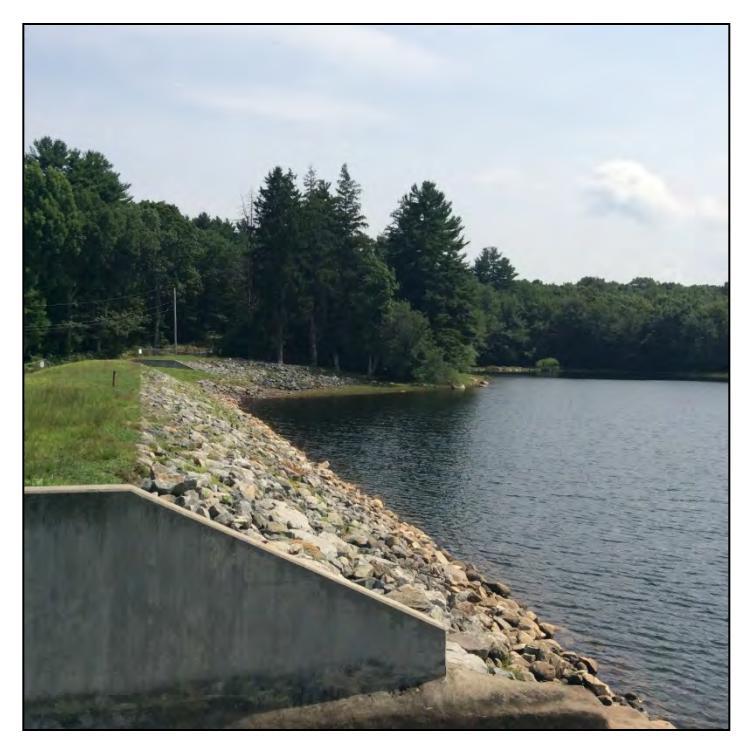
Photo No. 6: View of the upstream slope as seen from the primary spillway looking right.

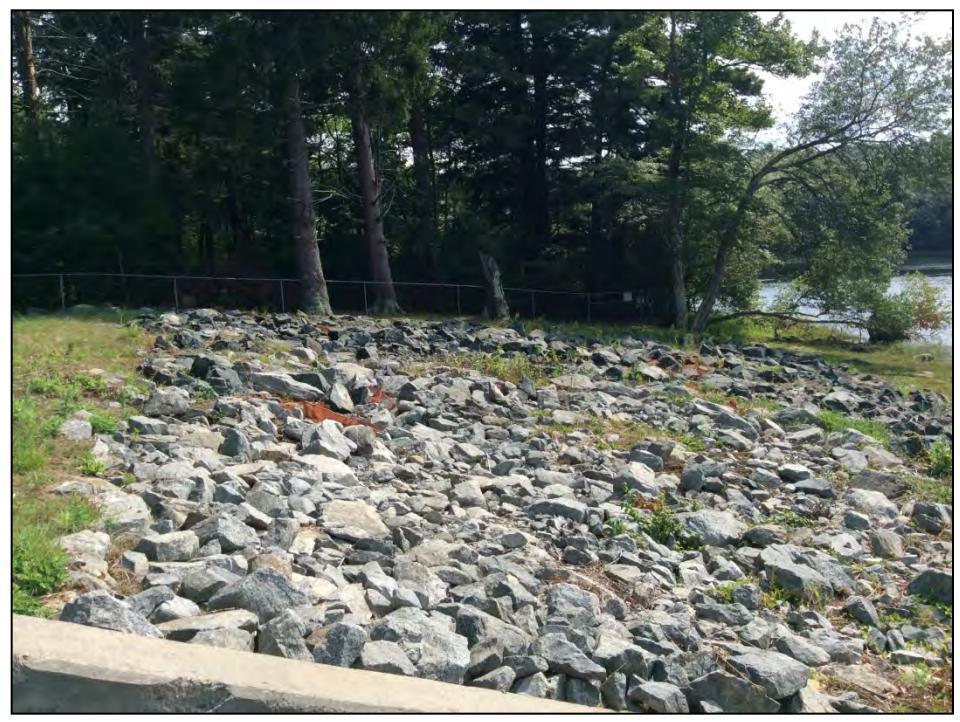
Photo No. 7: The upstream slope right of the auxiliary spillway. Note the depressions and irregularities in this area.

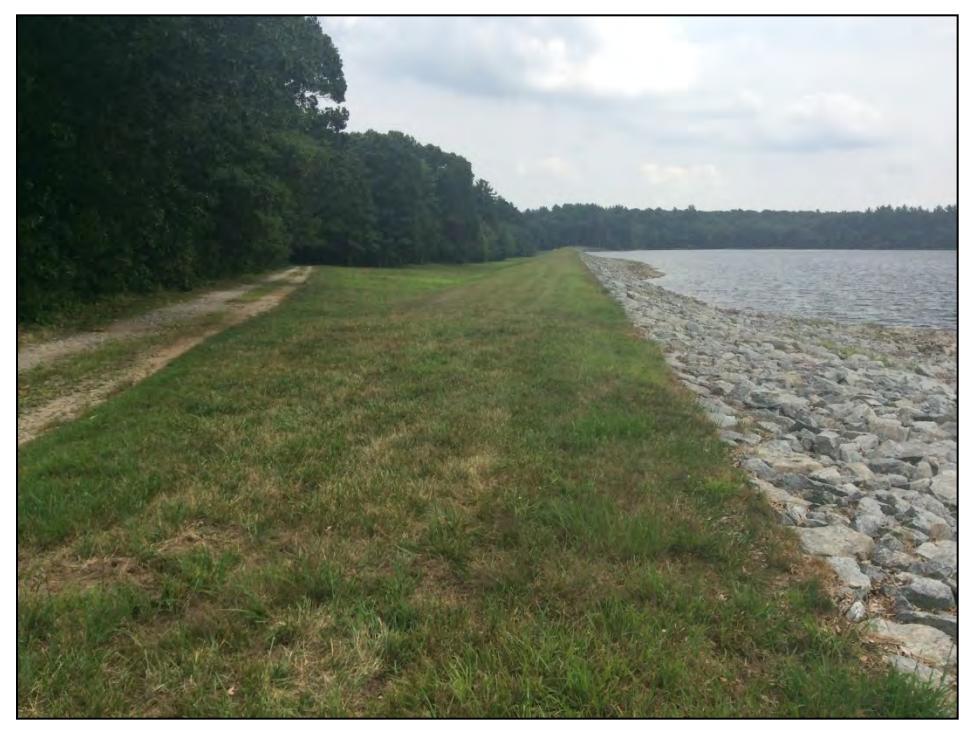
Photo No. 8: Crest as seen from the left abutment.

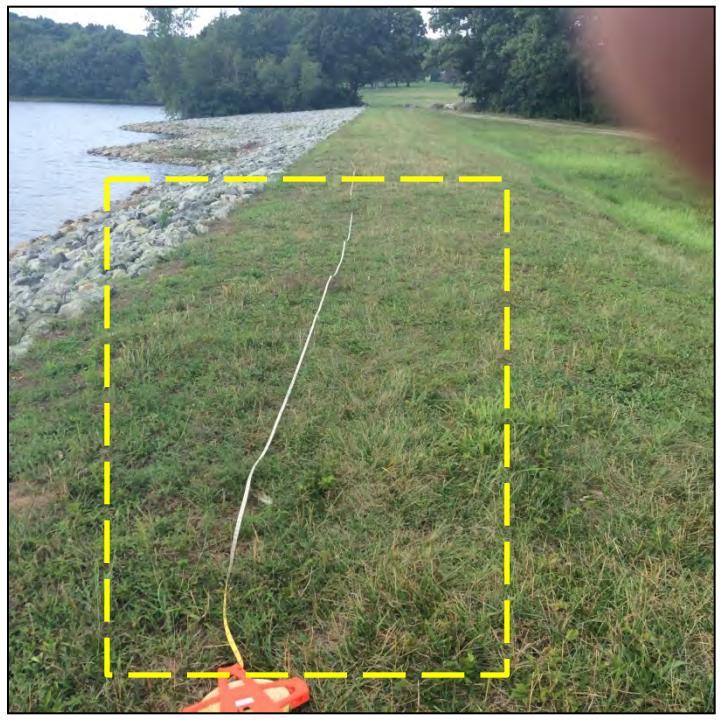
Photo No. 9: Overview of crest as seen from near station 4+00 looking right. Note the thatched areas of grass.

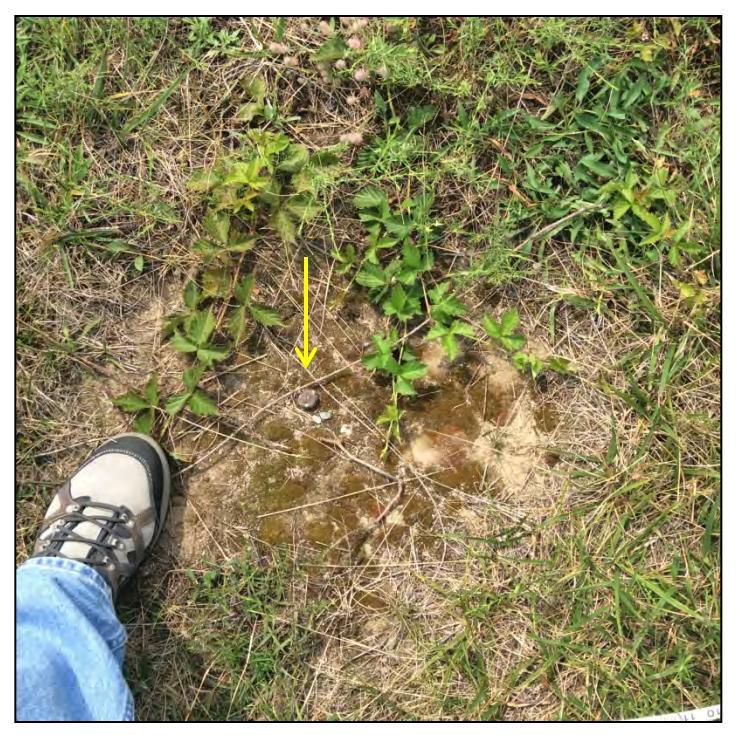
Photo No. 10: Historic monitoring point along the middle of the crest near station 10+40.

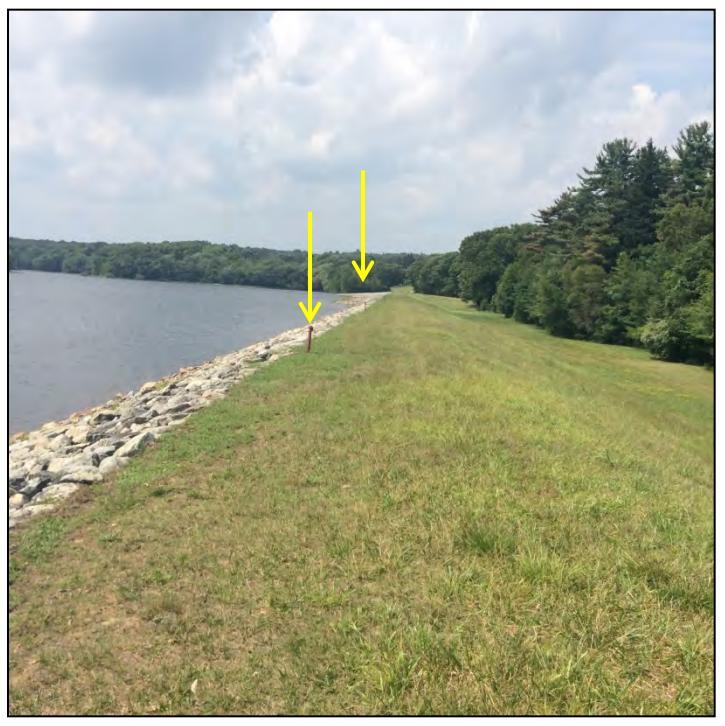
Photo No. 11: The crest as seen from near station 15+00 looking left. Note the series of monitoring wells along the upstream side of the crest.

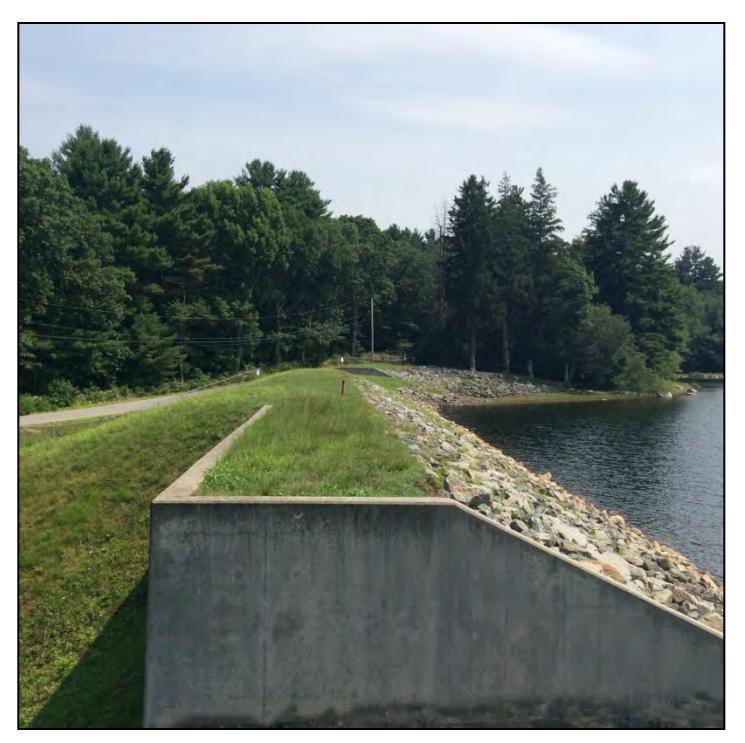
Photo No. 12: View of the crest as seen from the primary spillway looking right.

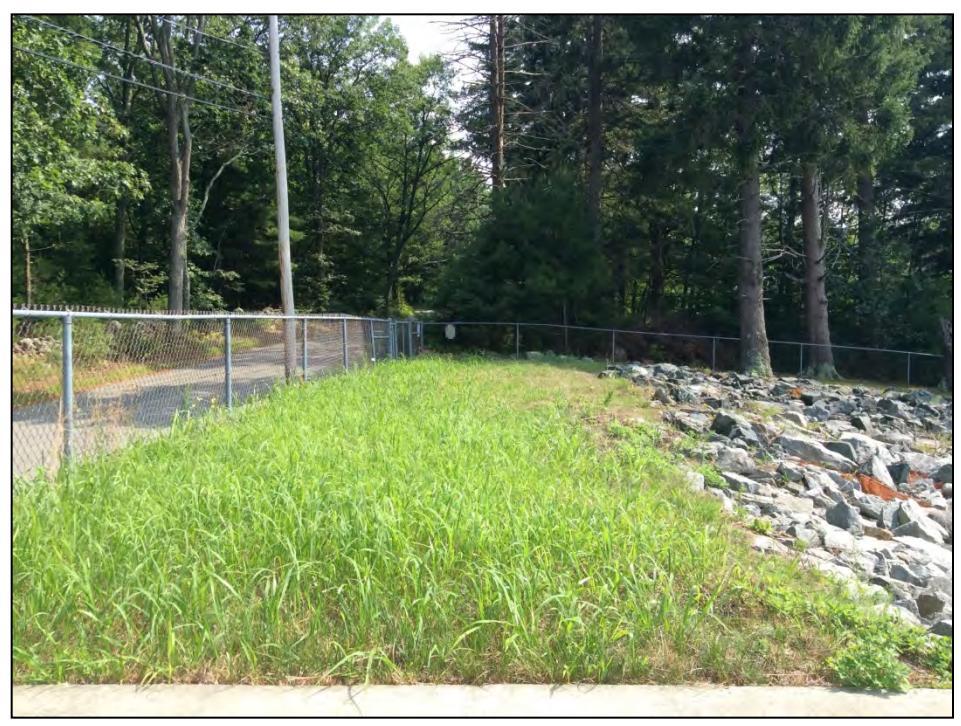
Photo No. 13: The crest of the embankment right of the auxiliary spillway.

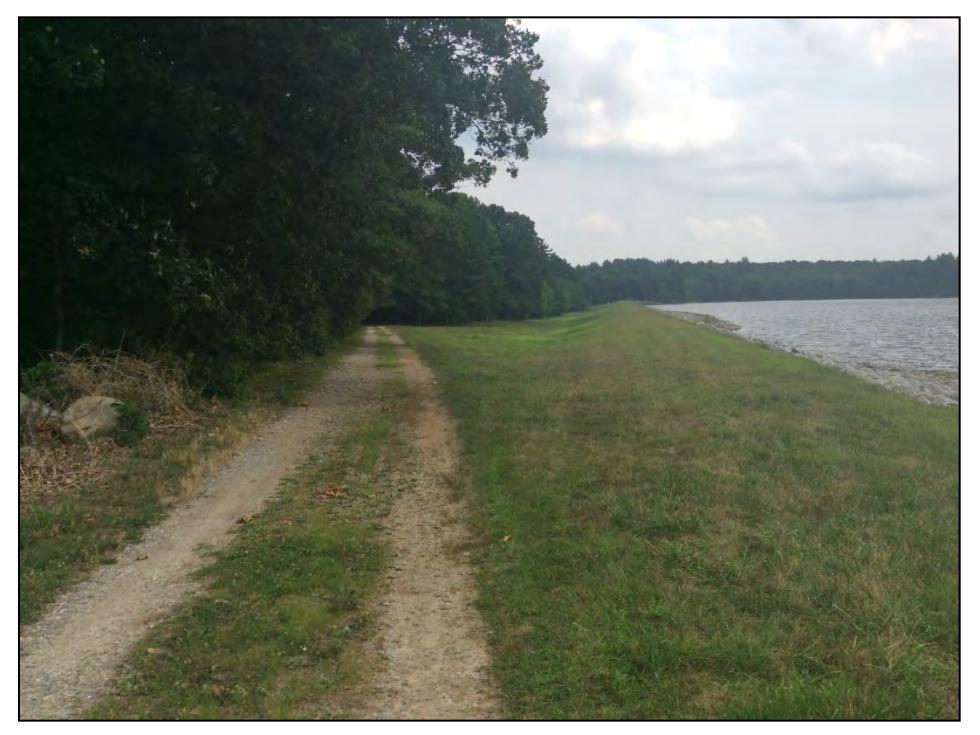
Photo No. 14: Downstream slope as seen from the left abutment.

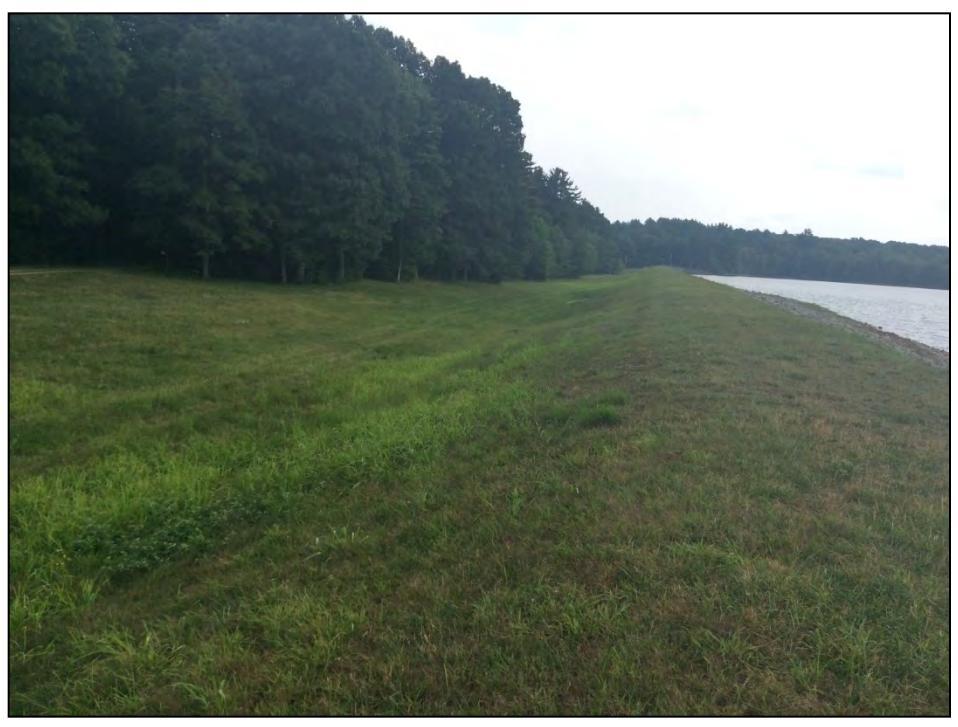
Photo No. 15: Downstream slope as seen from near station 3+00 looking right.

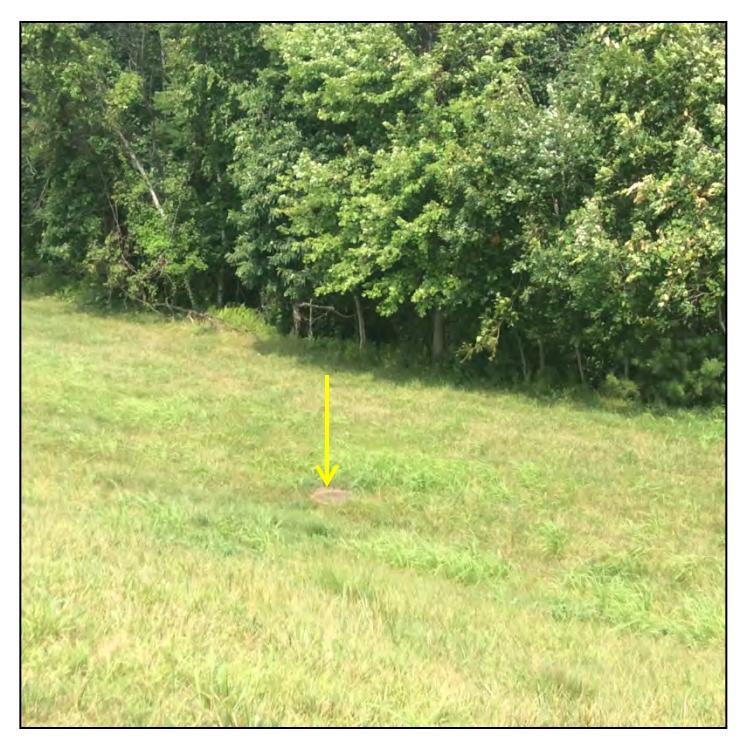
Photo No. 16: Clean-out manhole for the toe drain as viewed from the crest near station 9+00 looking downstream and slightly left.

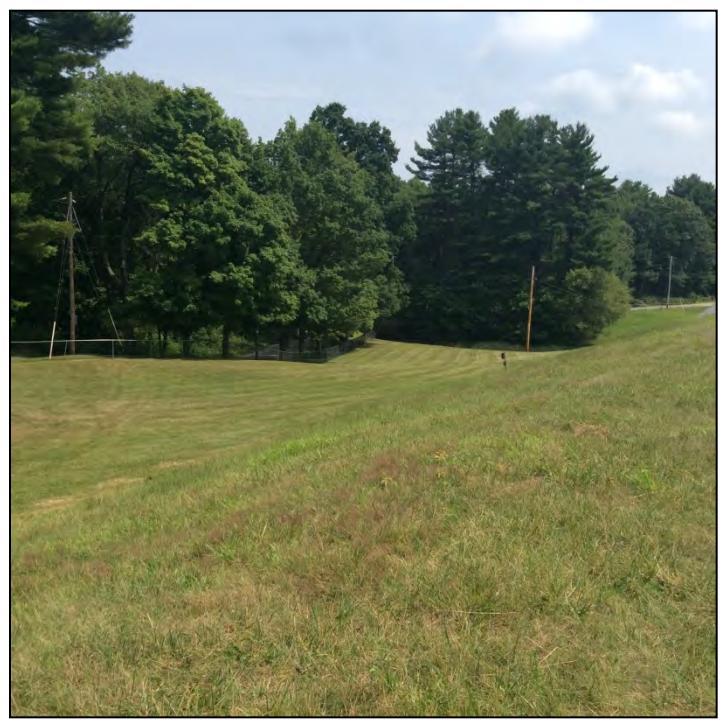
Photo No. 17: View of the downstream area from the crest near station 15+00 looking downstream and slightly right.

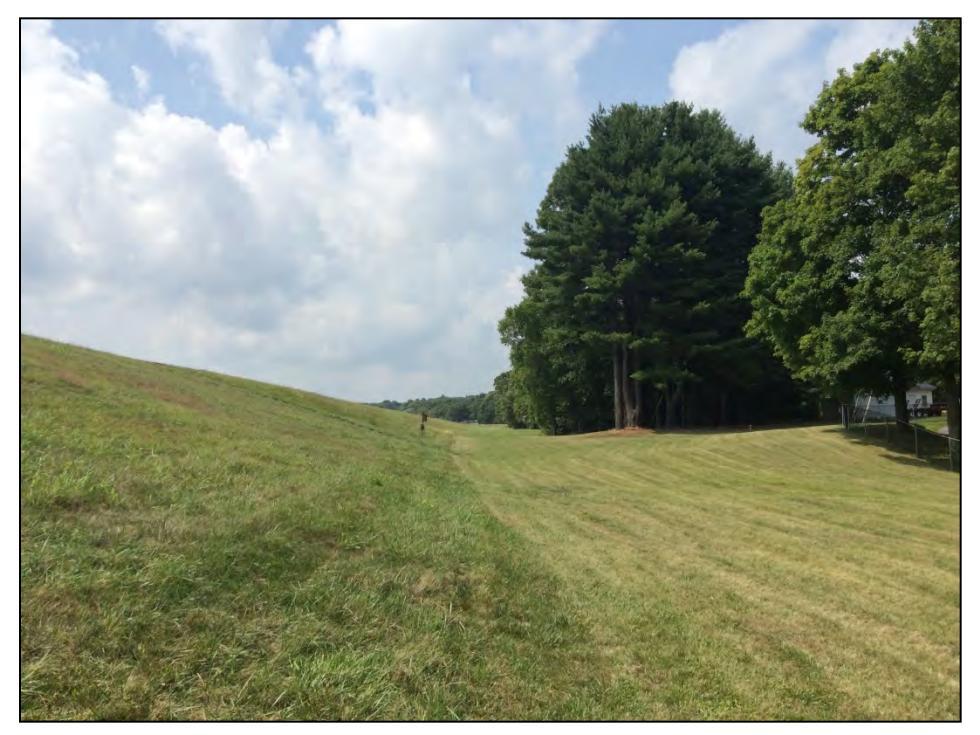
Photo No. 18: The downstream toe as viewed from the spillway channel looking left.

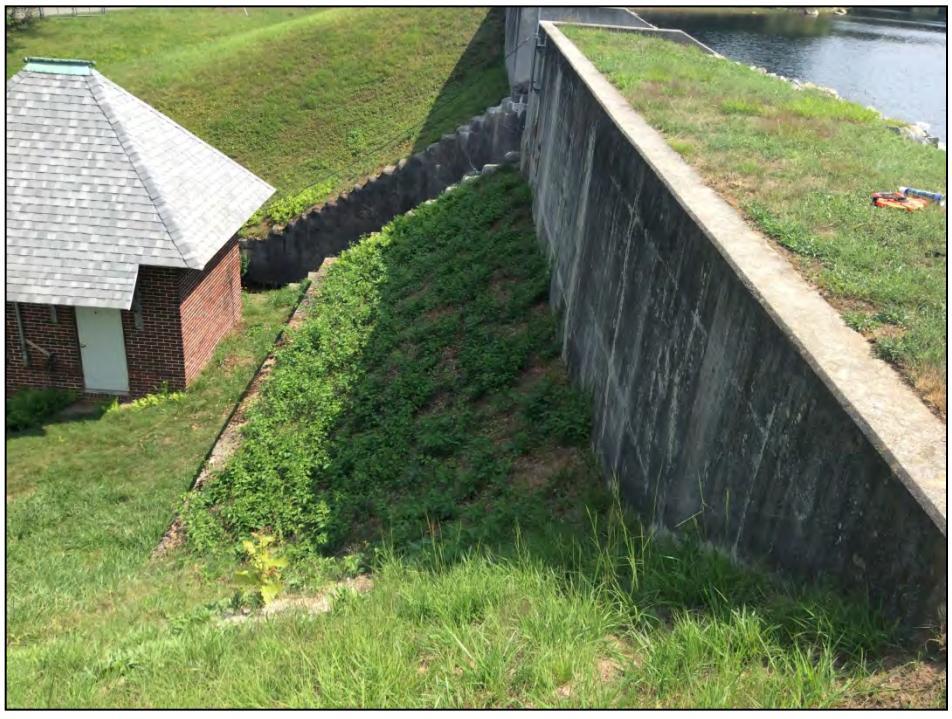
Photo No. 19: A view behind the spillway's left downstream return wall.

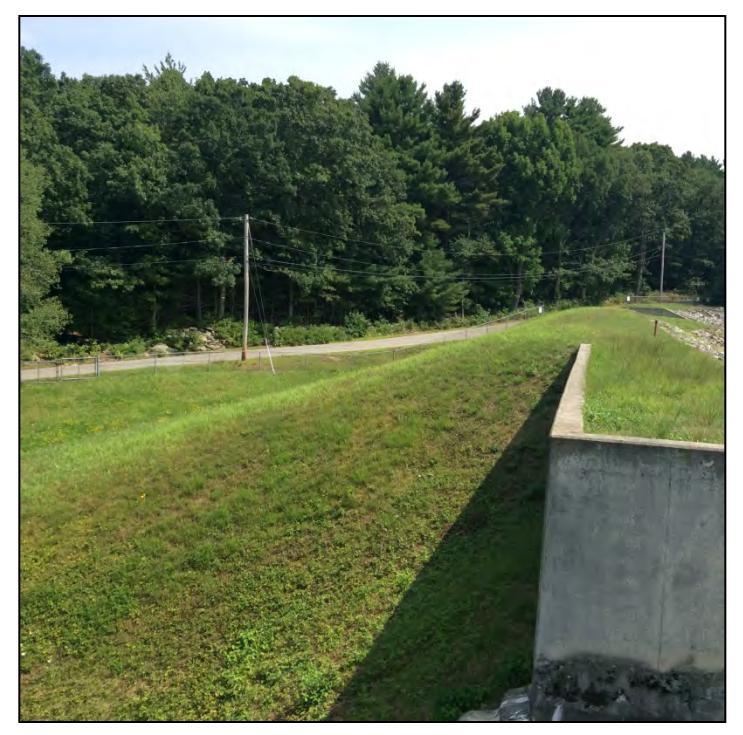
Photo No. 20: View of the downstream slope as seen from the spillway looking right.

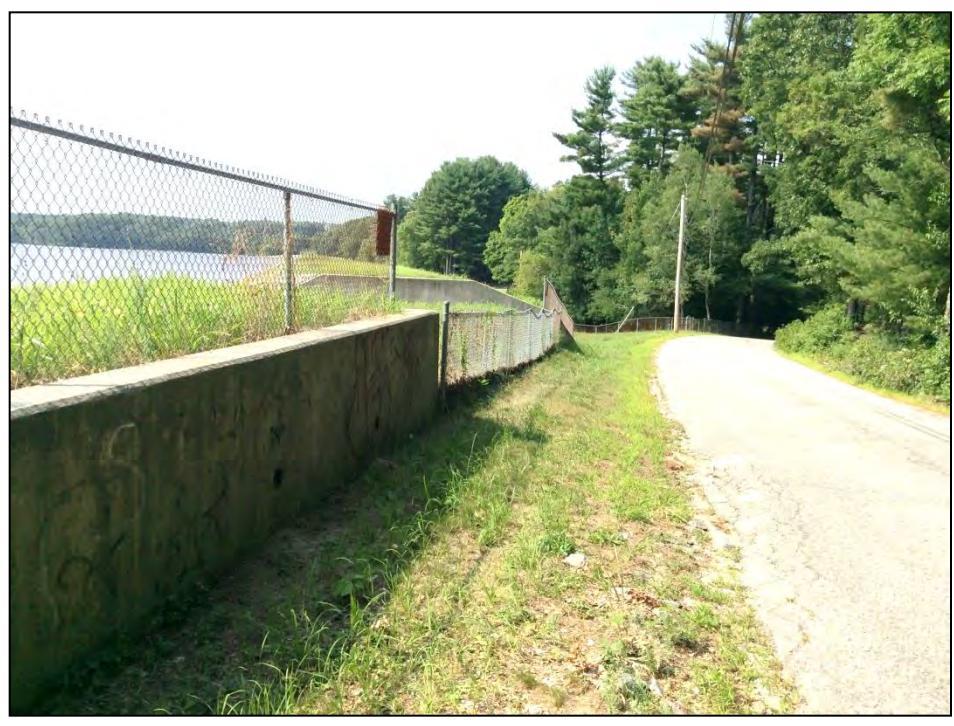
Photo No. 21: Overview of the auxiliary spillway's downstream return wall as viewed from the right abutment.

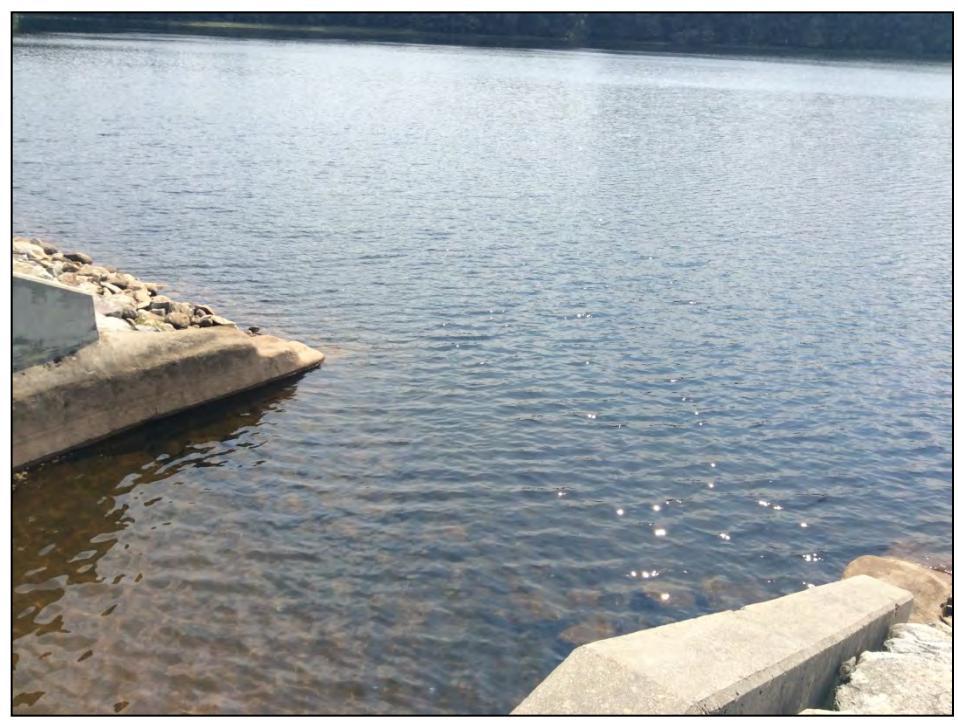
Photo No. 23: The spillway's approach as viewed from the left looking slightly upstream.

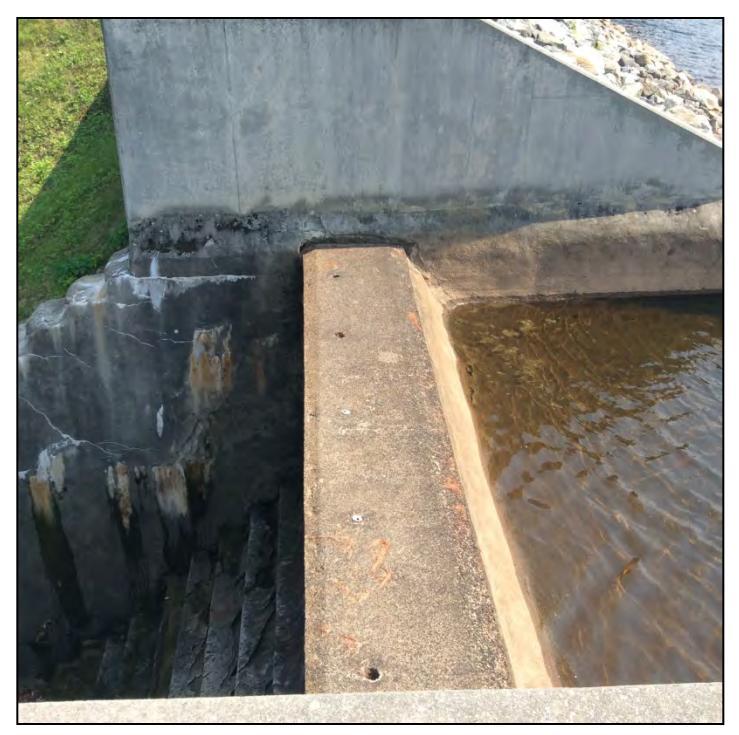
Photo No. 24: Photo of the primary spillway's control weir as seen from the left.

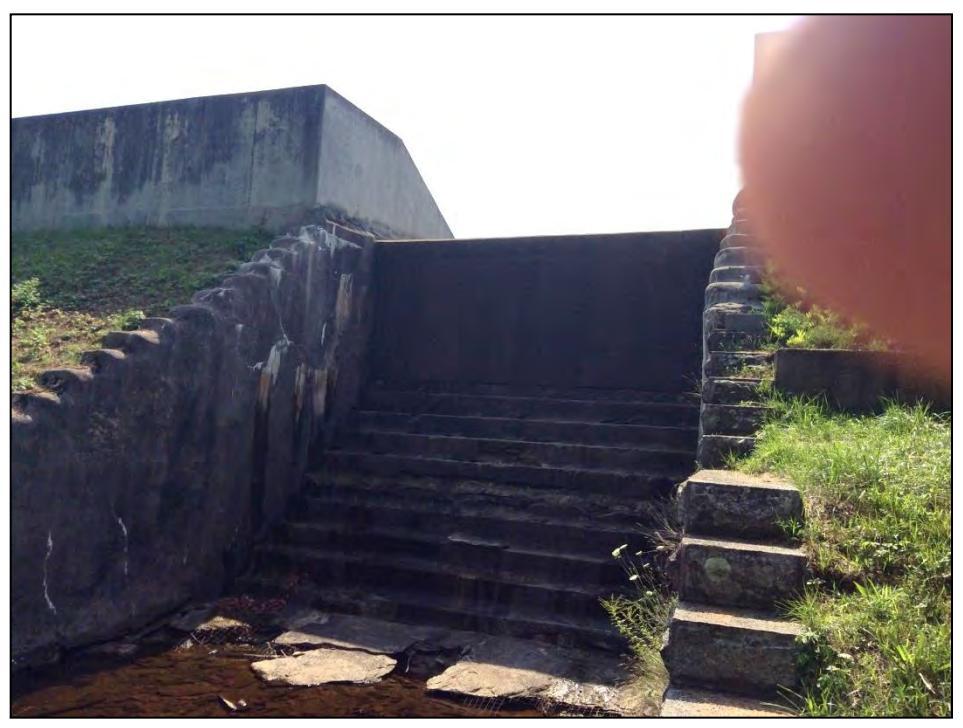
Photo No. 25: The downstream side of the spillway as viewed from the downstream toe right of the gatehouse structure.

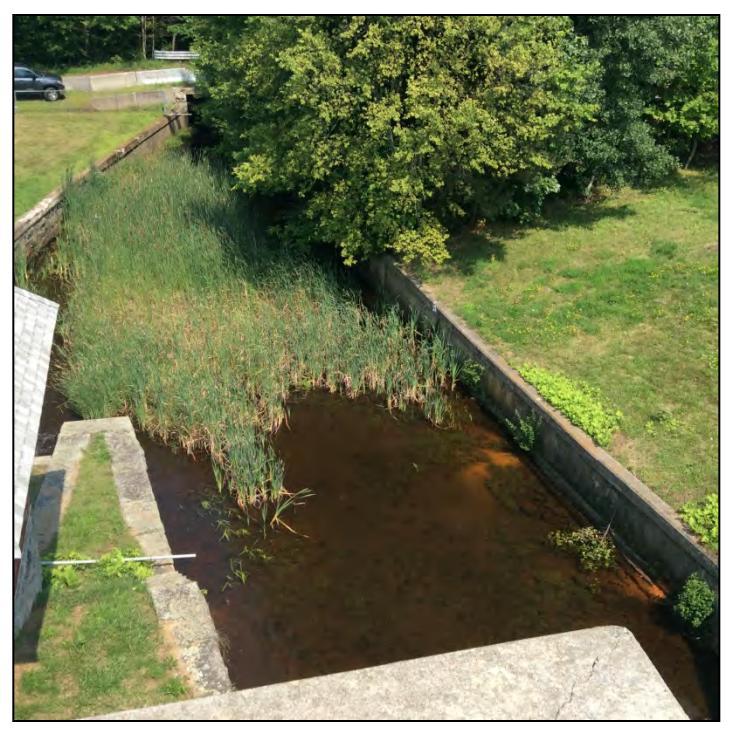
Photo No. 26: Discharge channel as seen from the primary spillway.

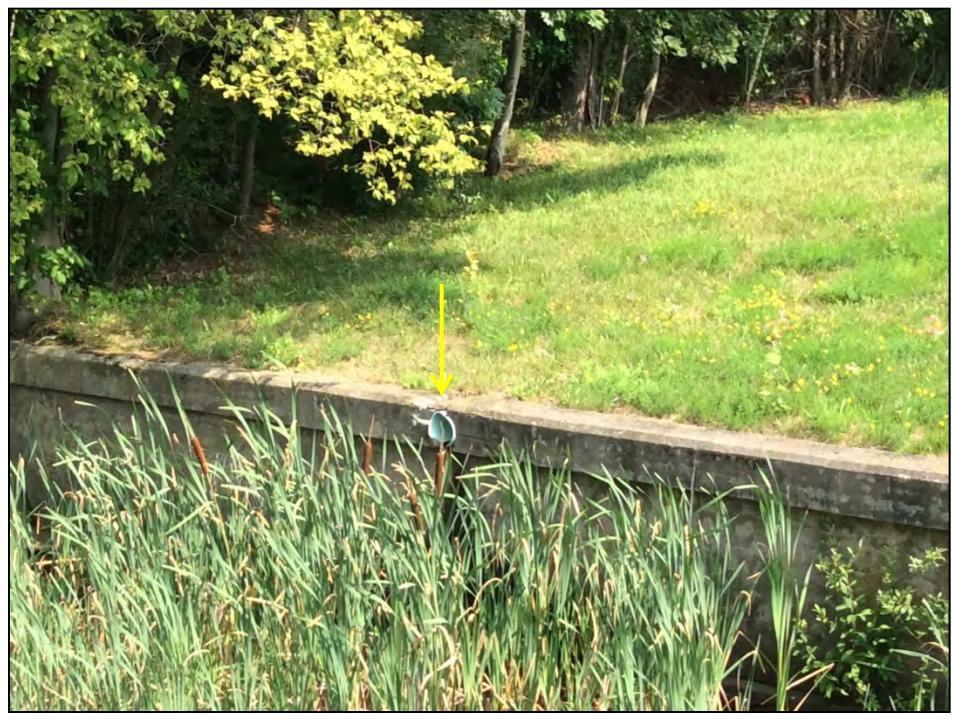
Photo No. 27: The toe drain discharge along the right side of the spillway channel is flowing at approximately 2 gallons per minute.

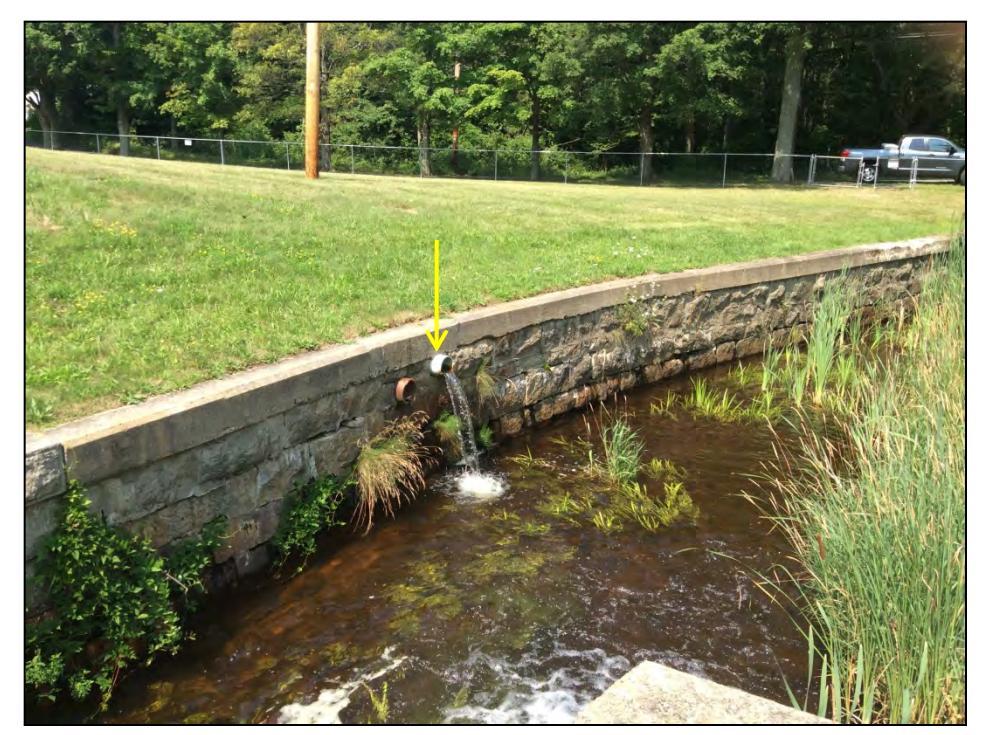
Photo No. 28: The toe drain discharge along the left side of the spillway channel is flowing at approximately 5 gallons per minute.

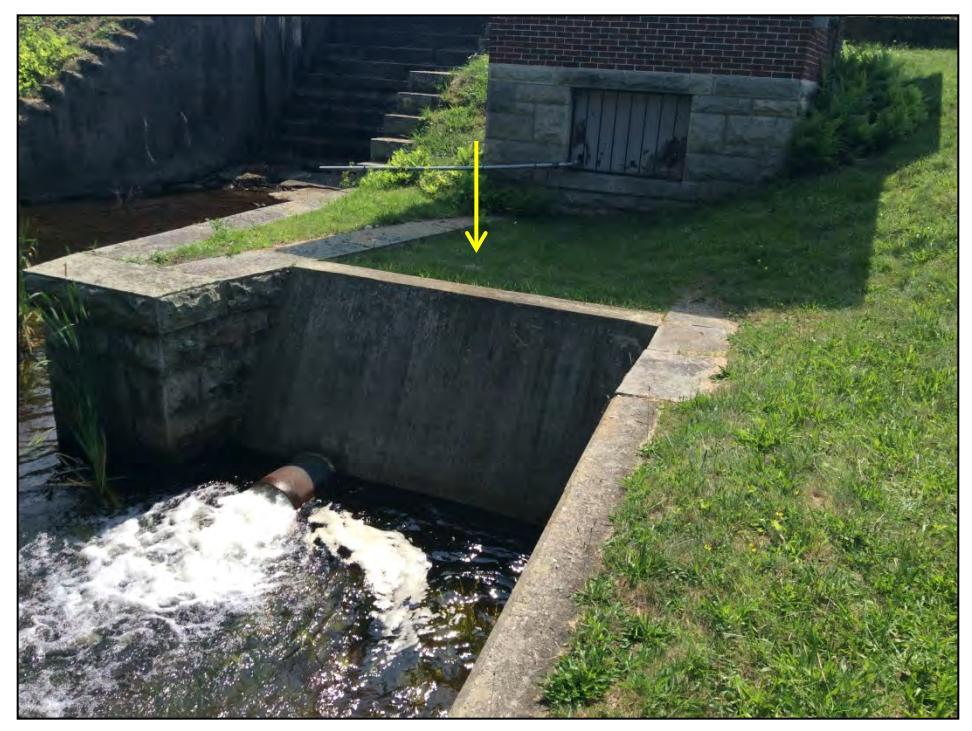
Photo No. 30: Photo from within the control structure looking upstream. The left two gates work in series to control the intake pipe that leads to the treatment plant located about 2 miles downstream. The right two gates work in series with the T-valve located outside and downstream of the gatehouse to operate the low level outlet. Presently the gates for the low level outlets are open to allow the required low flow downstream.

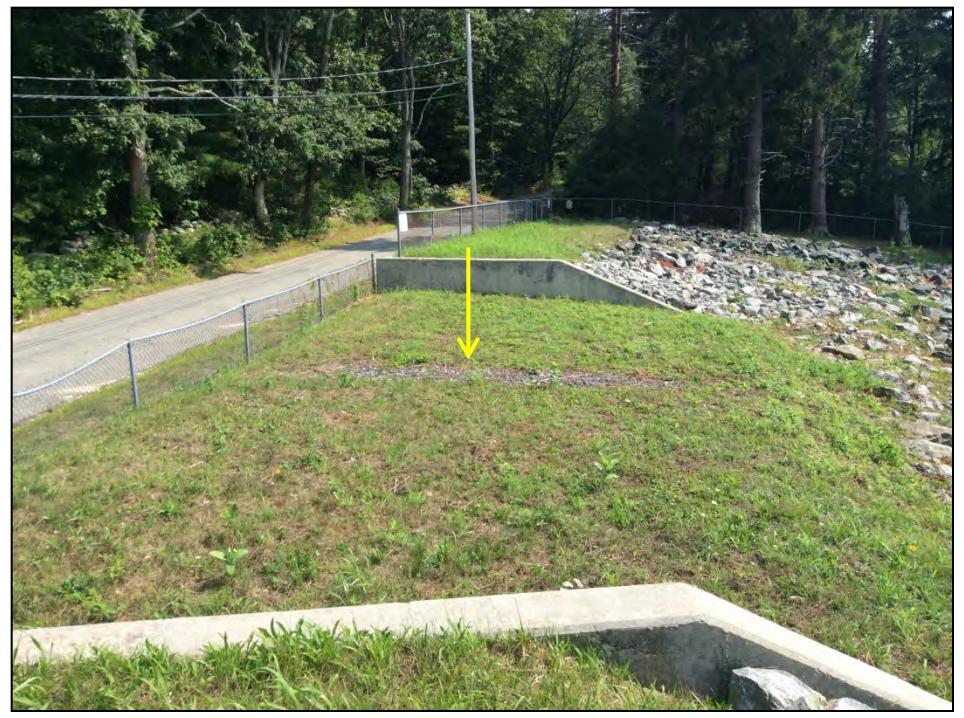
Photo No. 31: The low level outlet's discharge opening looking upstream towards the primary spillway. Note the location of the access to the T-valve.

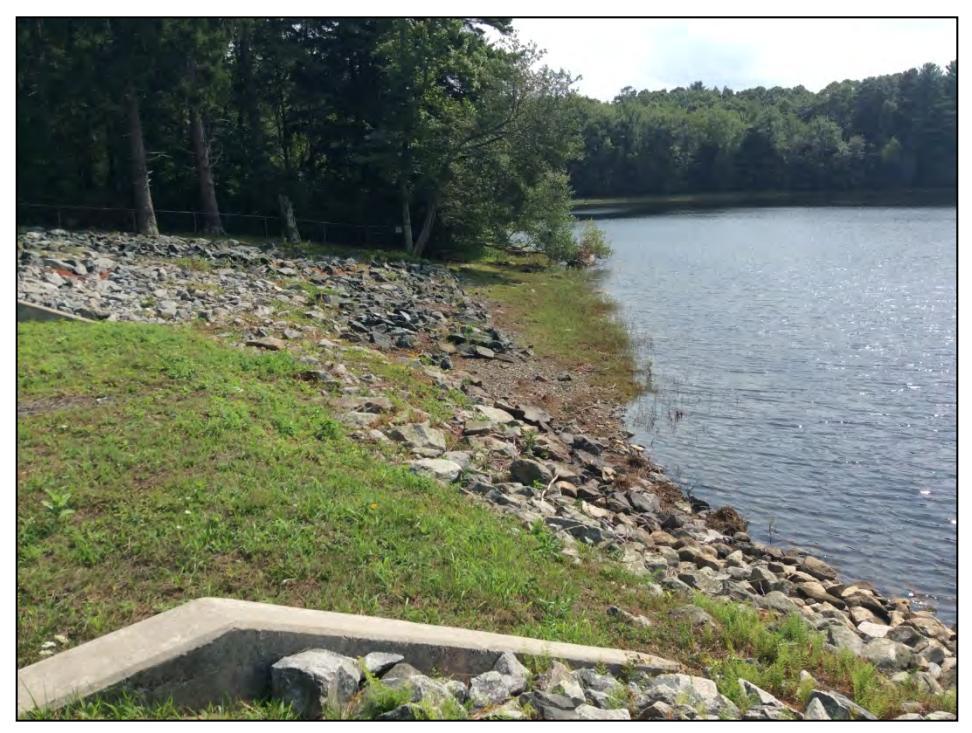
Photo No. 32: Overview of the auxiliary spillway from the left. Note the crushed stone area.

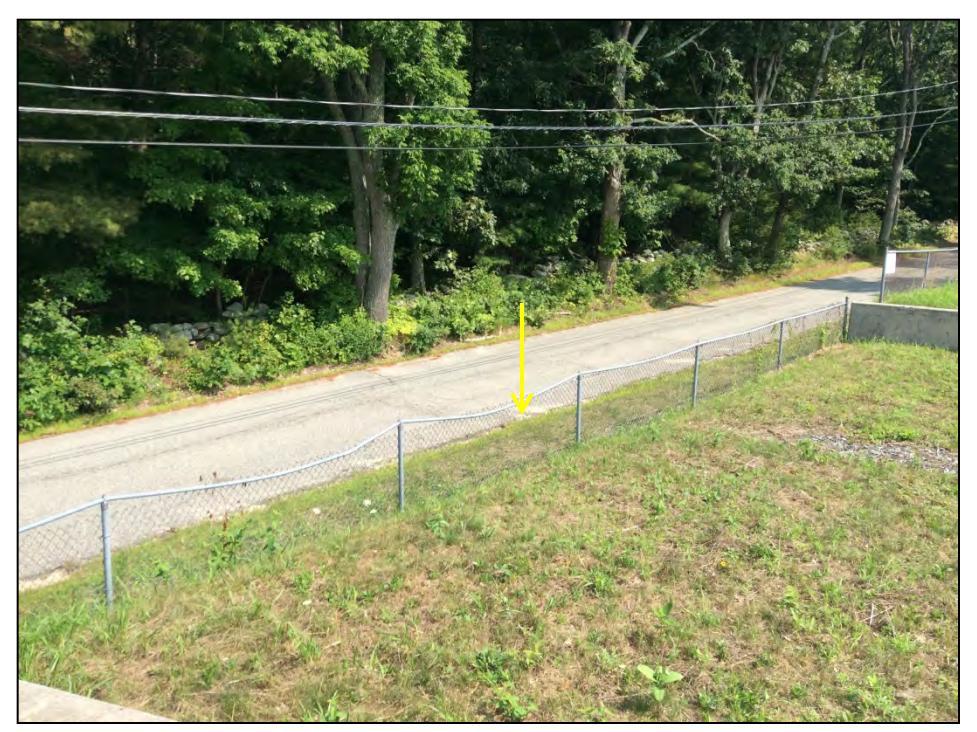
Photo No. 33: The approach to the auxiliary spillway as viewed from the left.

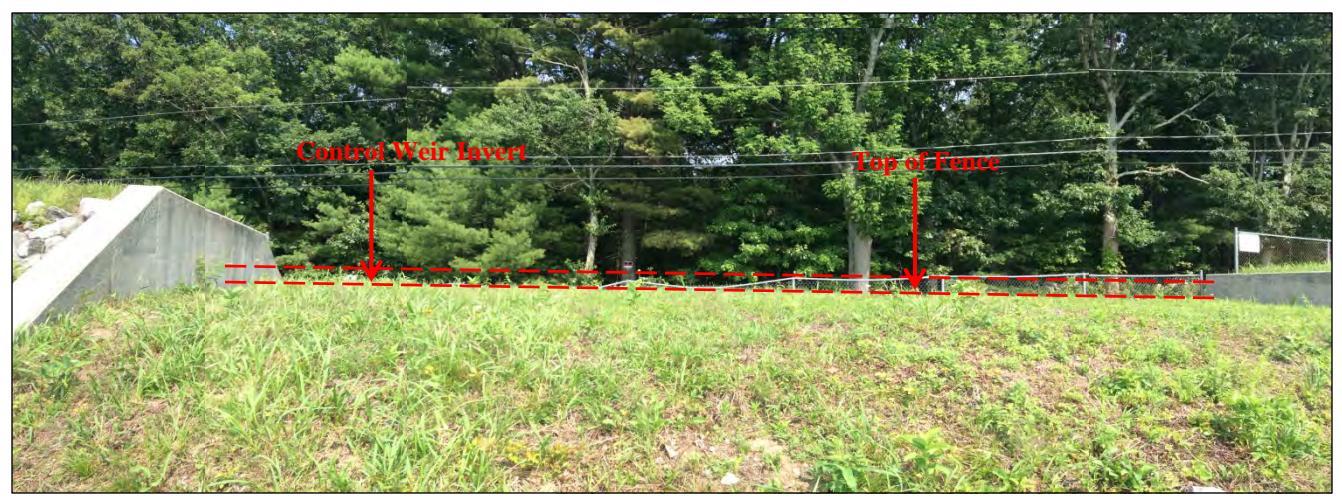
Photo No. 34: The downstream side of the auxiliary spillway as viewed from the left looking right and slightly downstream. Note the security fencing along its downstream side.

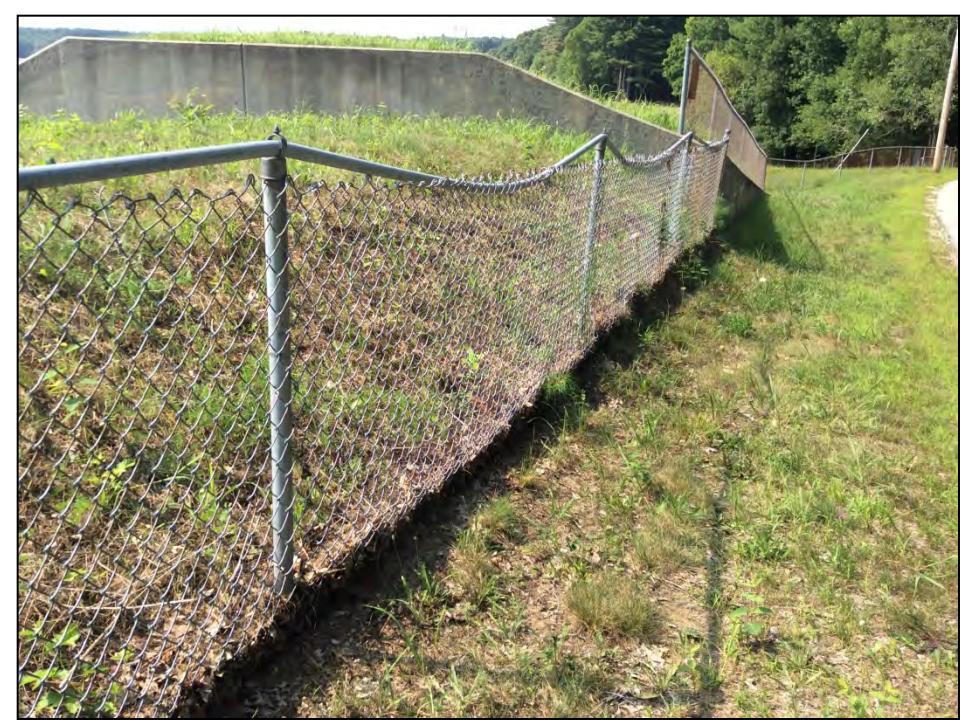
Photo No. 35: As seen from the upstream side of the auxiliary spillway looking downstream, the top elevation of the security fence increases linearly from left to right where the left side appears to match the elevation of the control section and the right side appears to match top of training wall elevation.

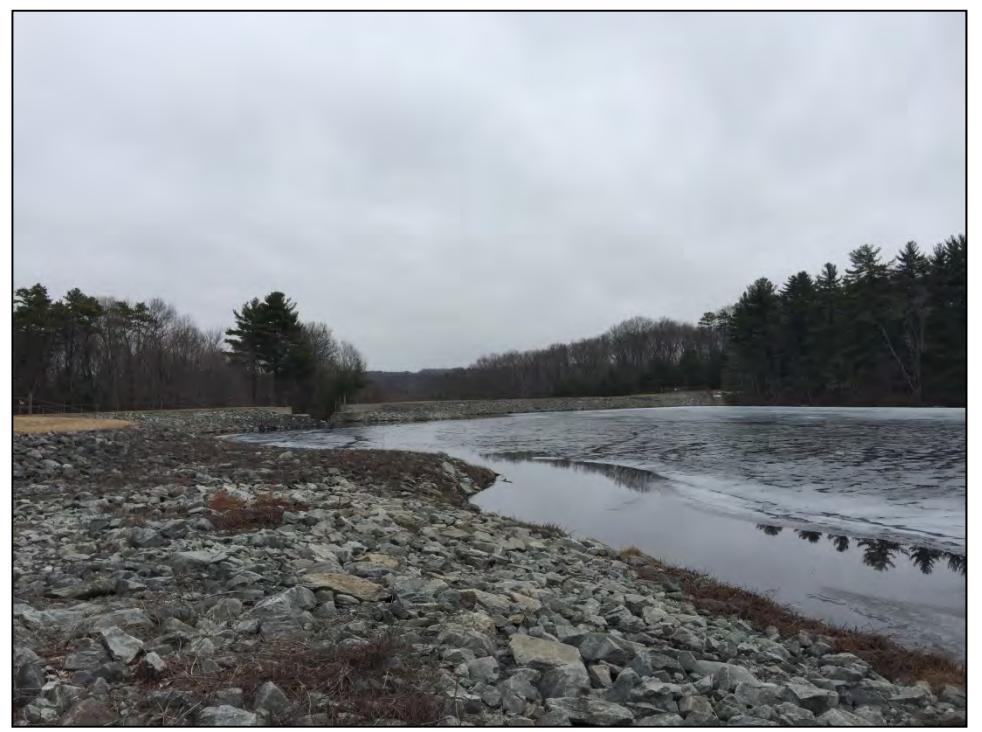
Photo No. 1: An overview of the dam from the left abutment.
