In re: City of Woonsocket Water Division - Application to Implement Multi-Year Rate Plan

Docket No. 4879

Dam Name (No):	Woonsocket Reservoir #3 Dam (068)
Location:	Smithfield/North Smithfield
Hazard Classification:	High
	-
Inspector:	David M. Matheson, P.E.
Inspection Date.	August 1, 2014

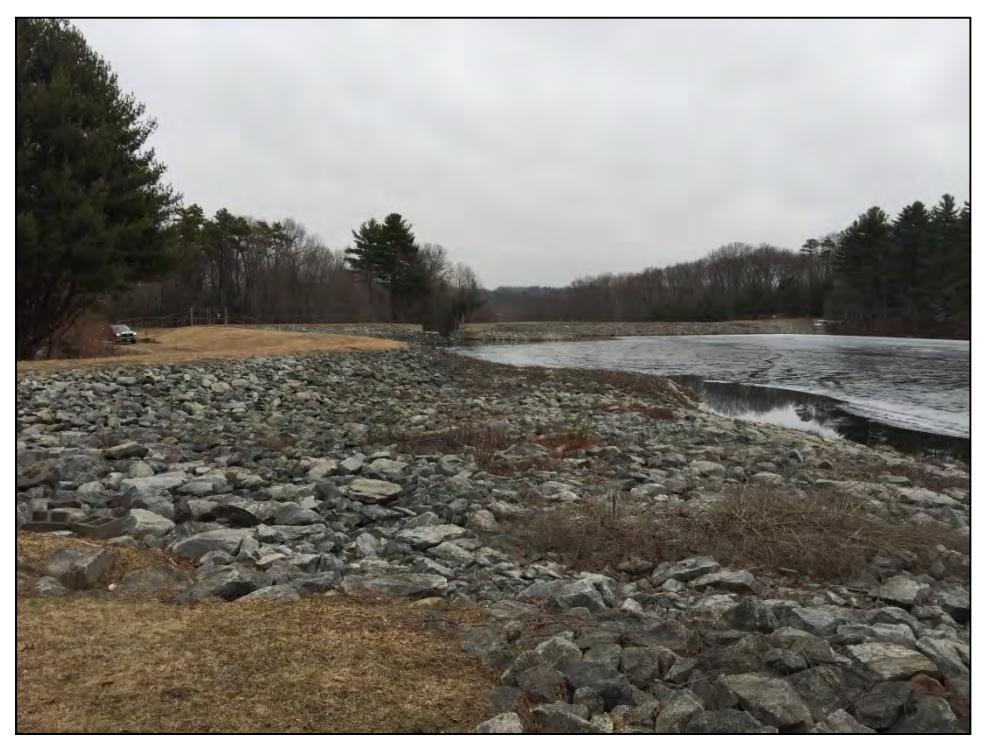
Photo No. 2: A view of the upstream slope as viewed from near the left abutment.

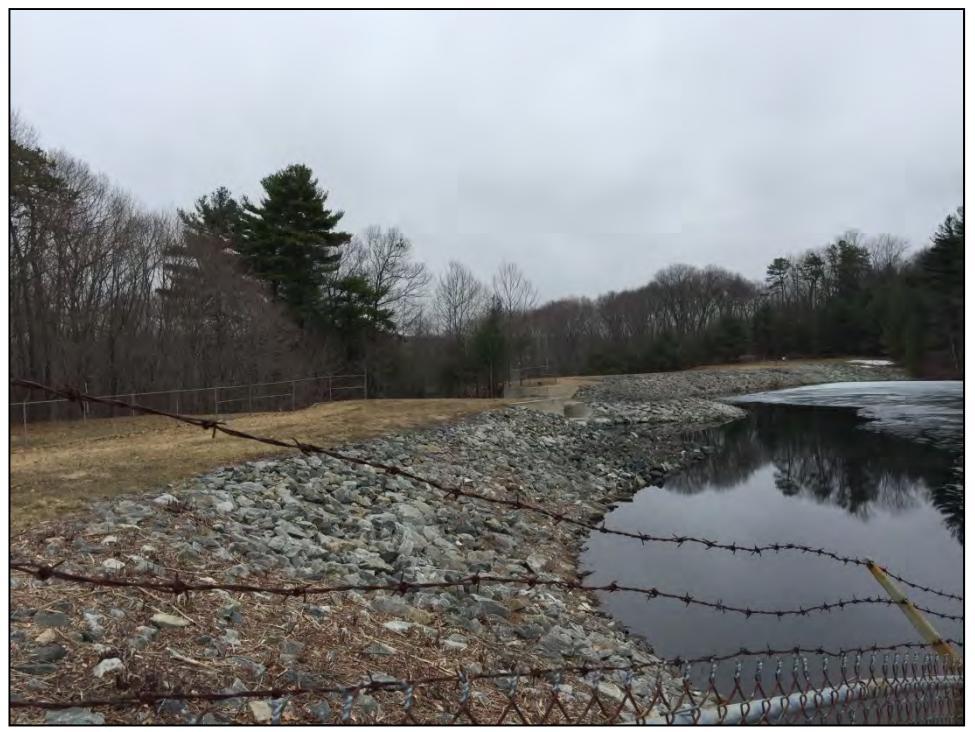
Photo No. 3: The upstream slope as viewed from near Station 3+50 looking right.

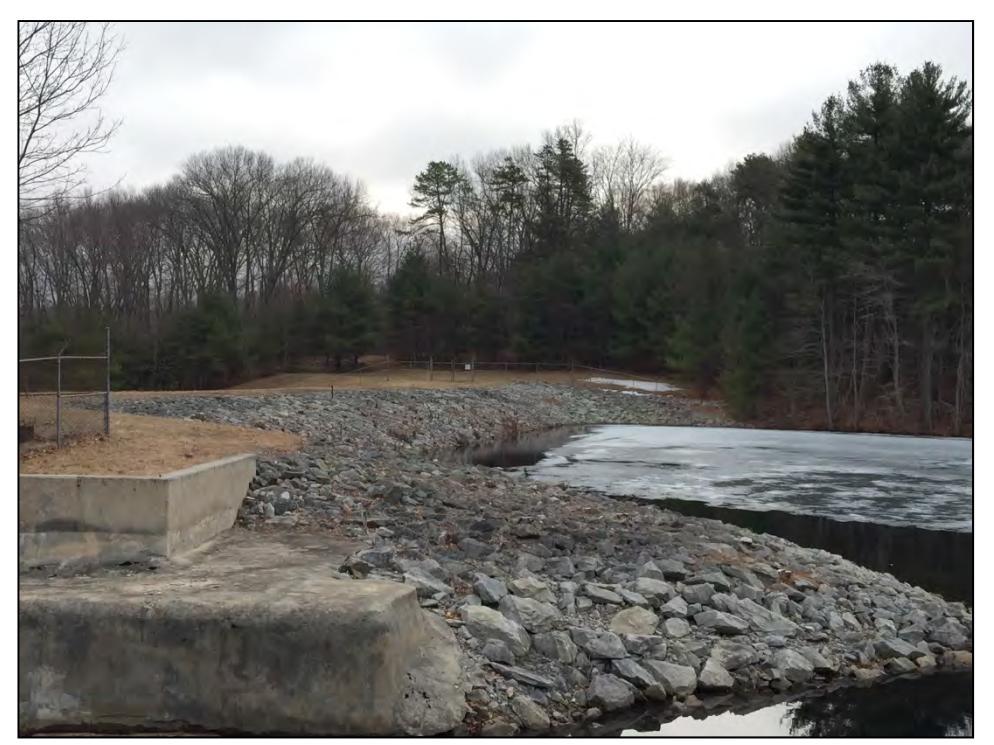
Photo No. 4: The upstream side of the dam as viewed from left of the spillway looking right and upstream.

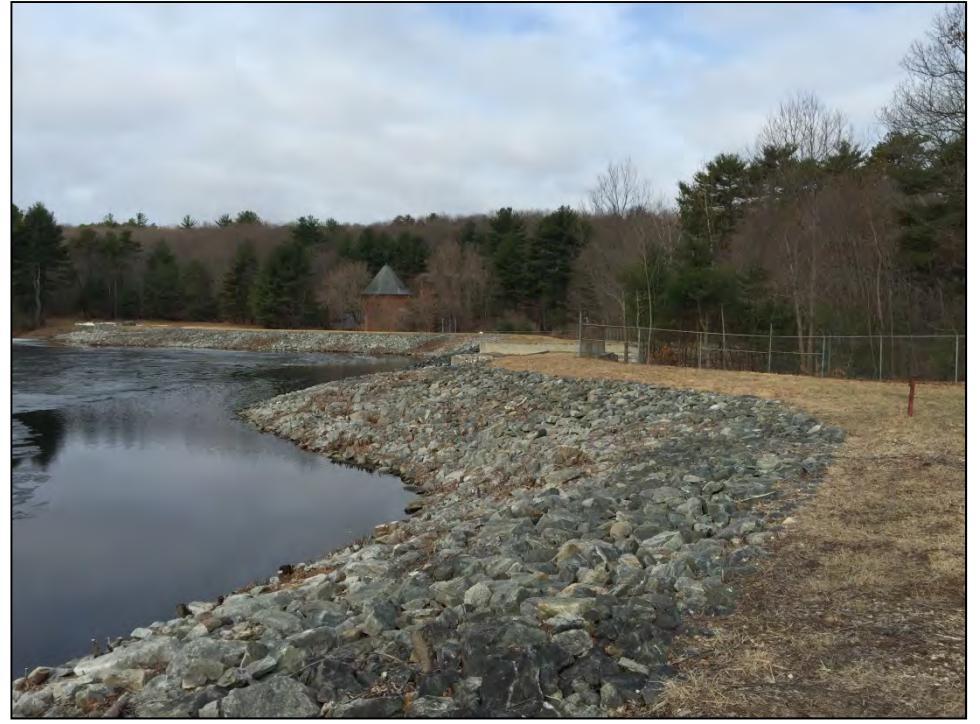
Photo No. 5: The upstream side of the dam as viewed from near Station 7+00 looking left.

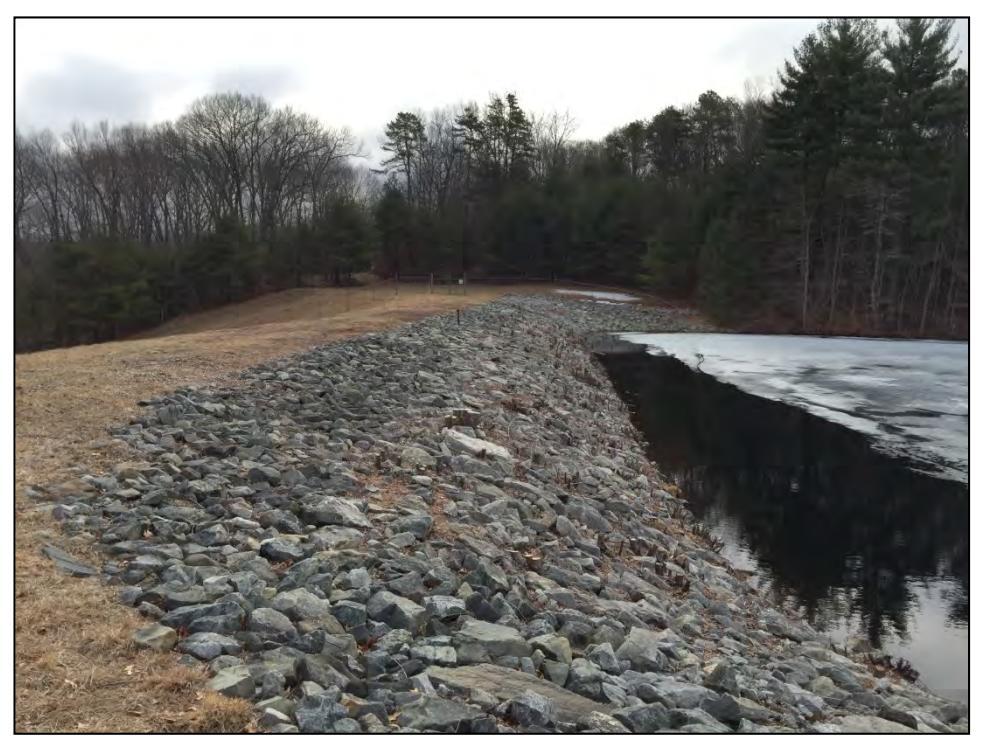
Photo No. 6: The upstream side of the dam as viewed from near Station 7+00 looking right. Note the areas of cut vegetation.

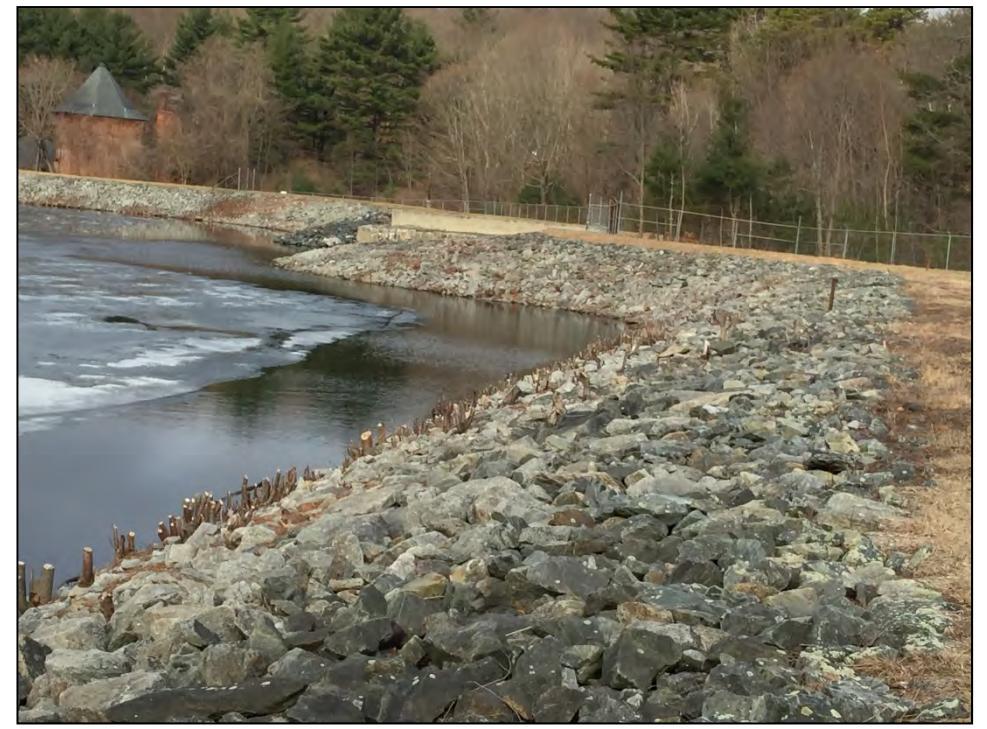
Photo No. 7: The upstream side of the dam as viewed from the right abutment looking left.

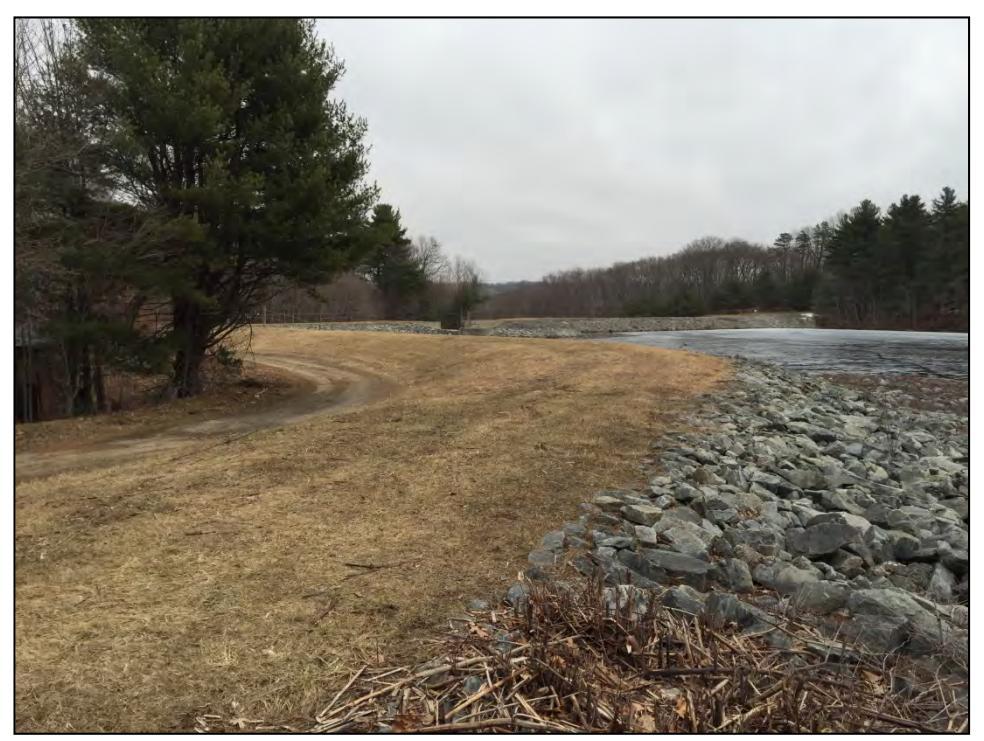
Photo No. 8: The crest of the dam as viewed from near the left abutment looking right.

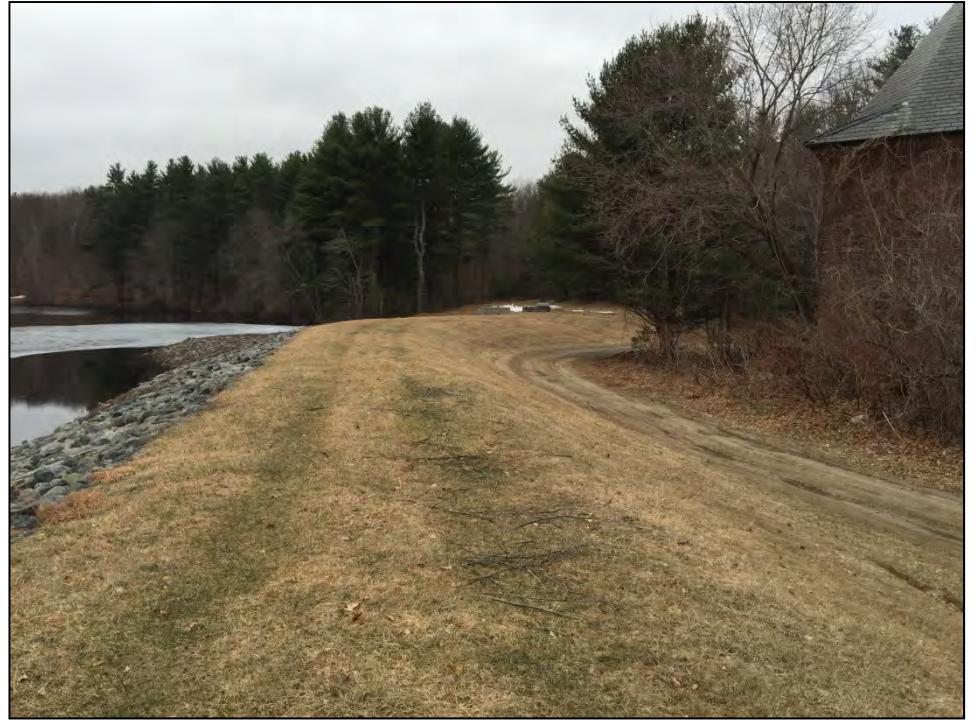
Photo No. 9: The crest of the dam as viewed from near Station 3+50 looking left.

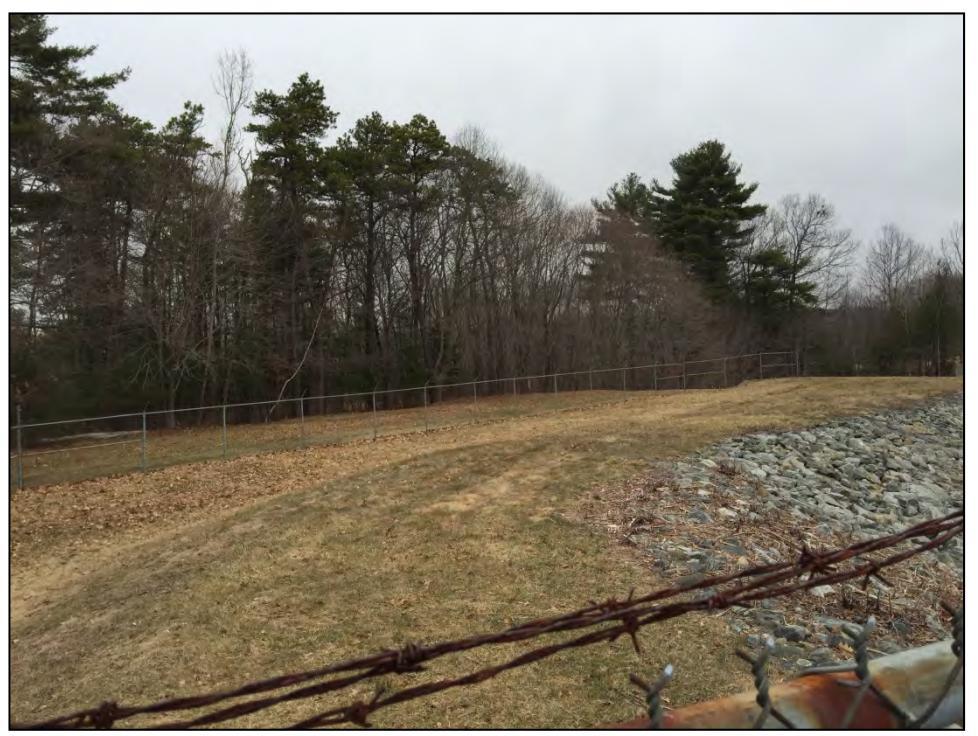
Photo No. 10: The crest of the dam as viewed from near Station 3+50 looking right.

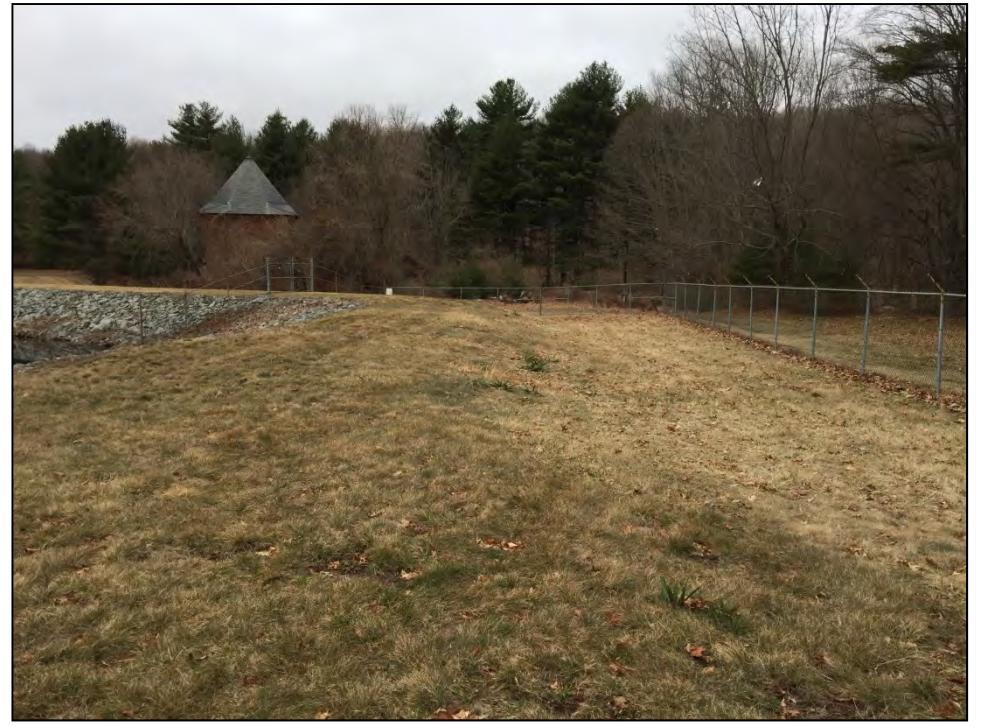
Photo No. 11: The crest of the dam as viewed from left of the primary spillway looking left.

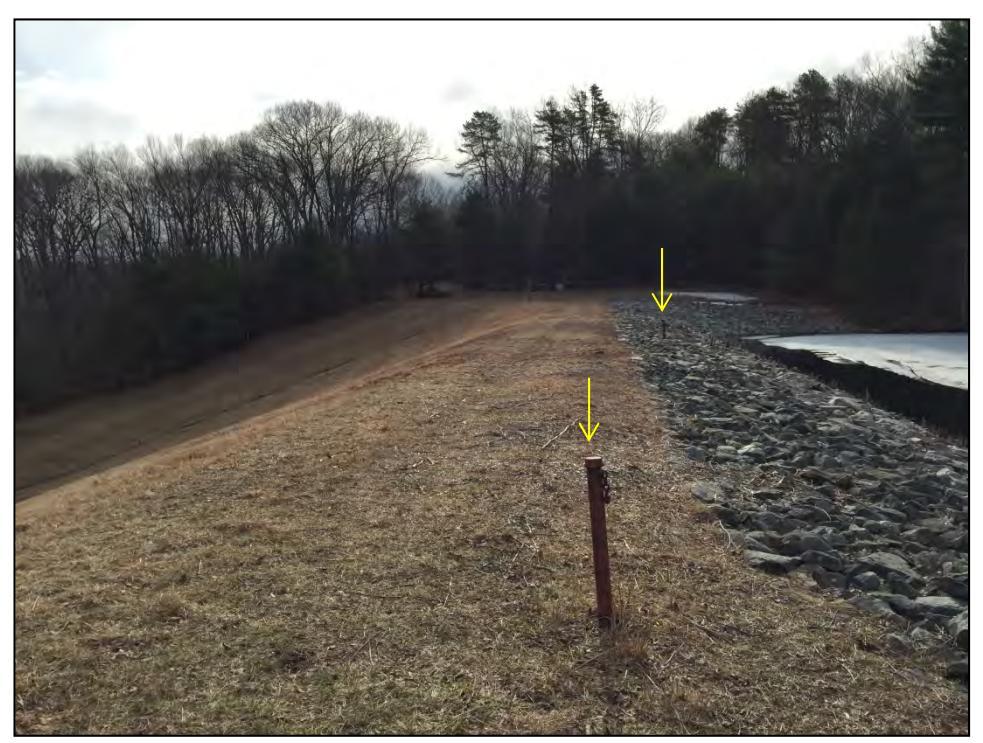
Photo No. 12: The crest of the dam as viewed form near Station 7+00 looking right. Note the stand pipes for the monitoring wells.

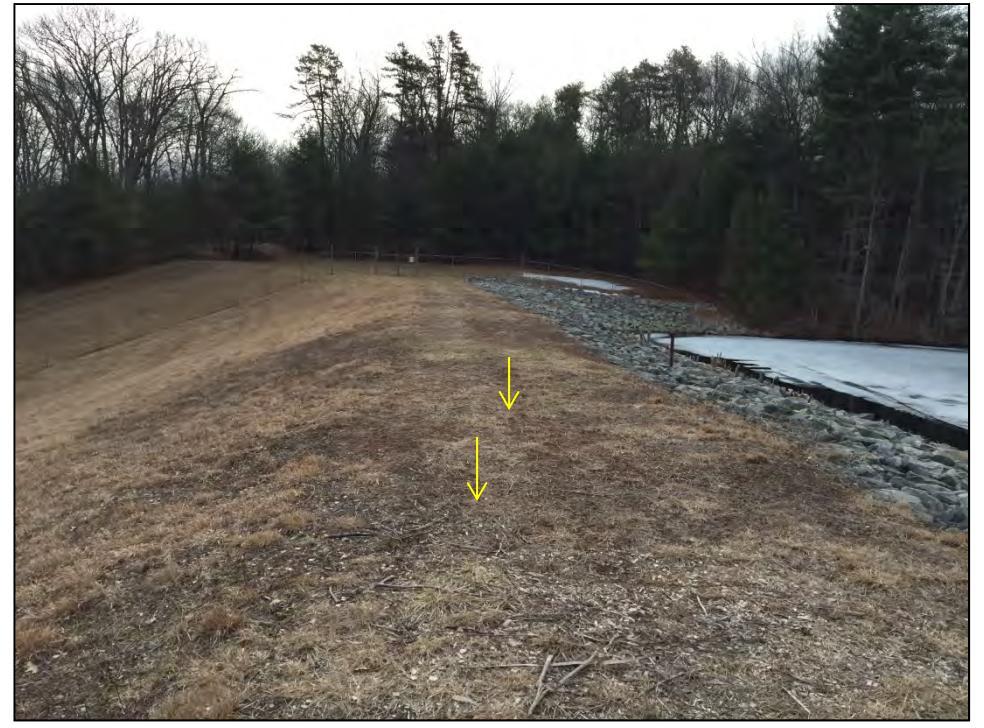
Photo No. 13: Crest of the dam as viewed from near Station 7+00 looking right. Note the areas of thinning grass.

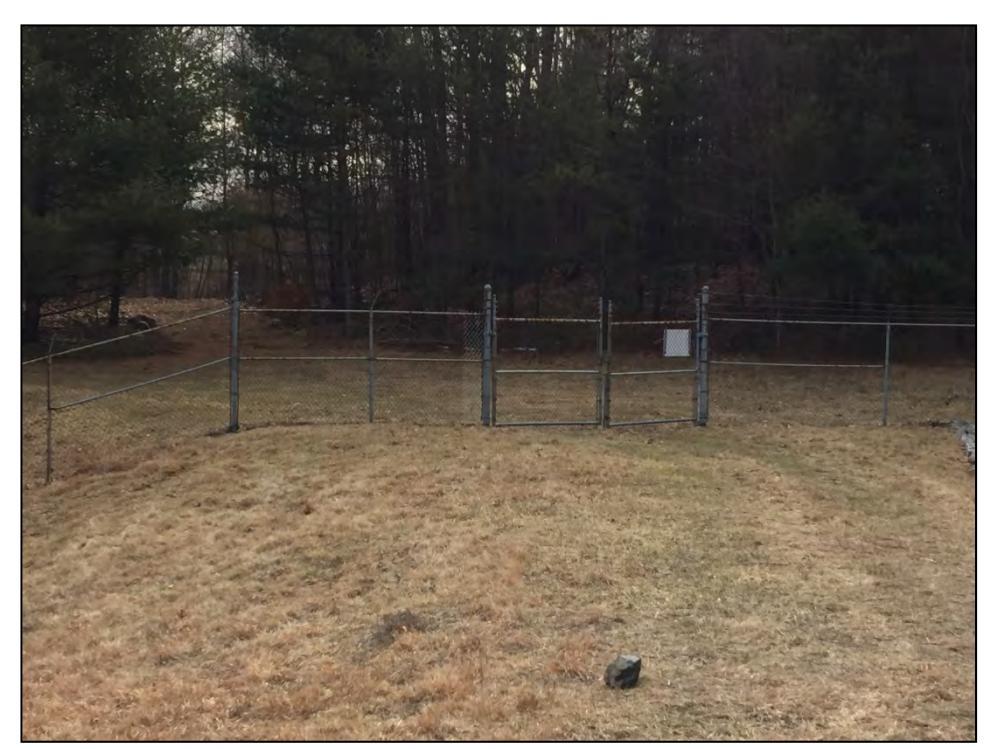
Photo No. 14: The right abutment along the crest (Looking right).

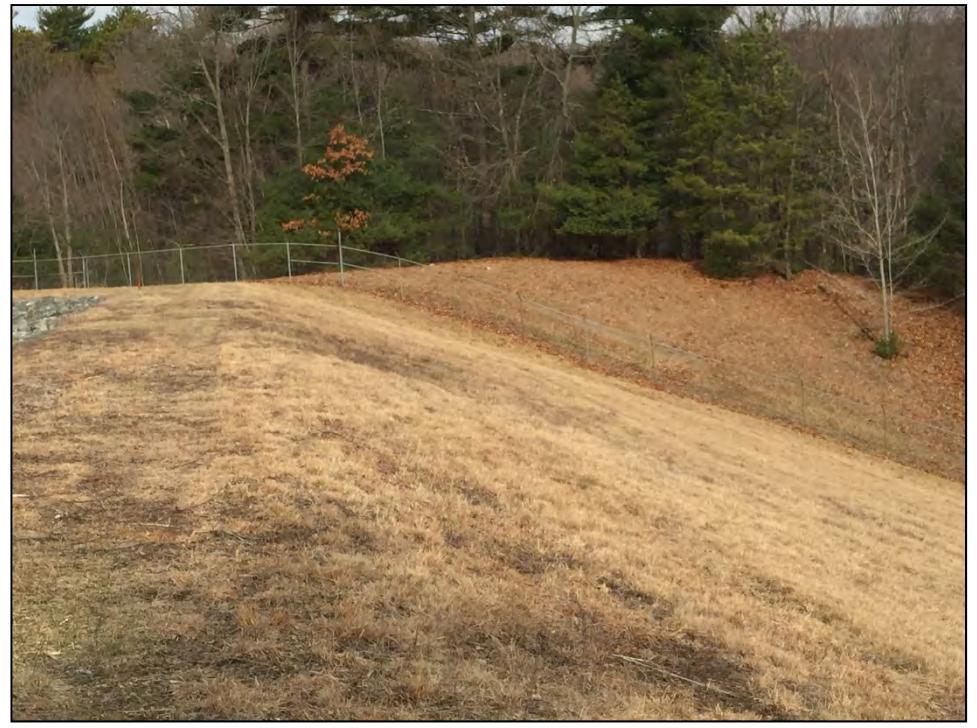
Photo No. 15: The crest of the dam as viewed from near the right abutment looking left.

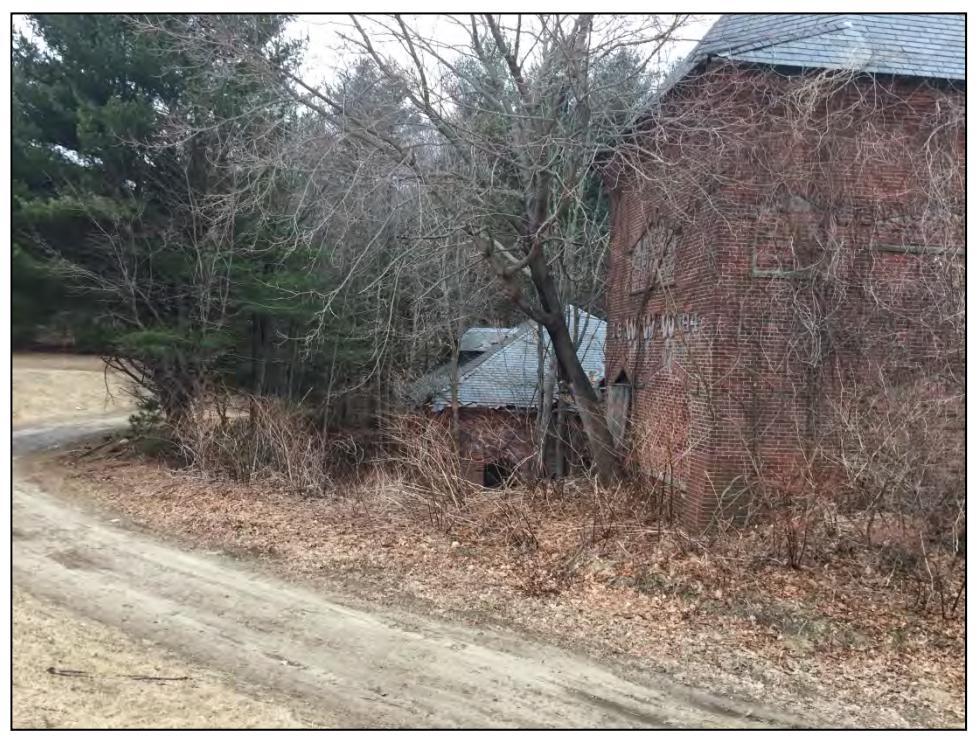
Photo No. 16: The former water treatment plant located downstream of the left side of the dam (between Stations 1+00 and 3+00).

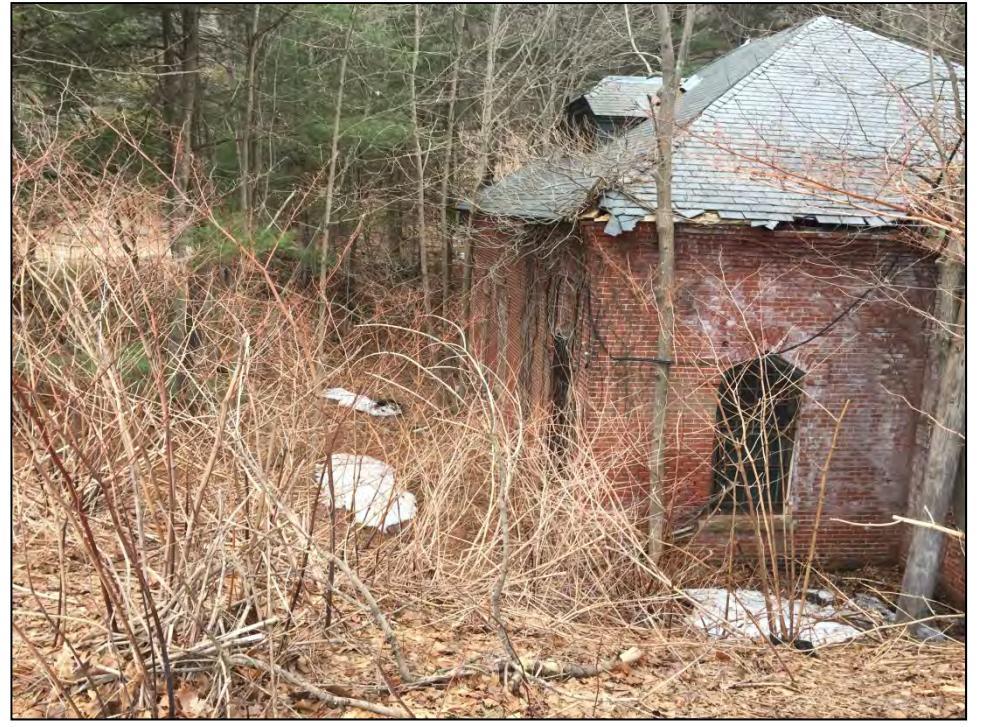
Photo No. 17: The downstream slope in the area of the former water treatment plant looking left from the access road/bench near the dam.

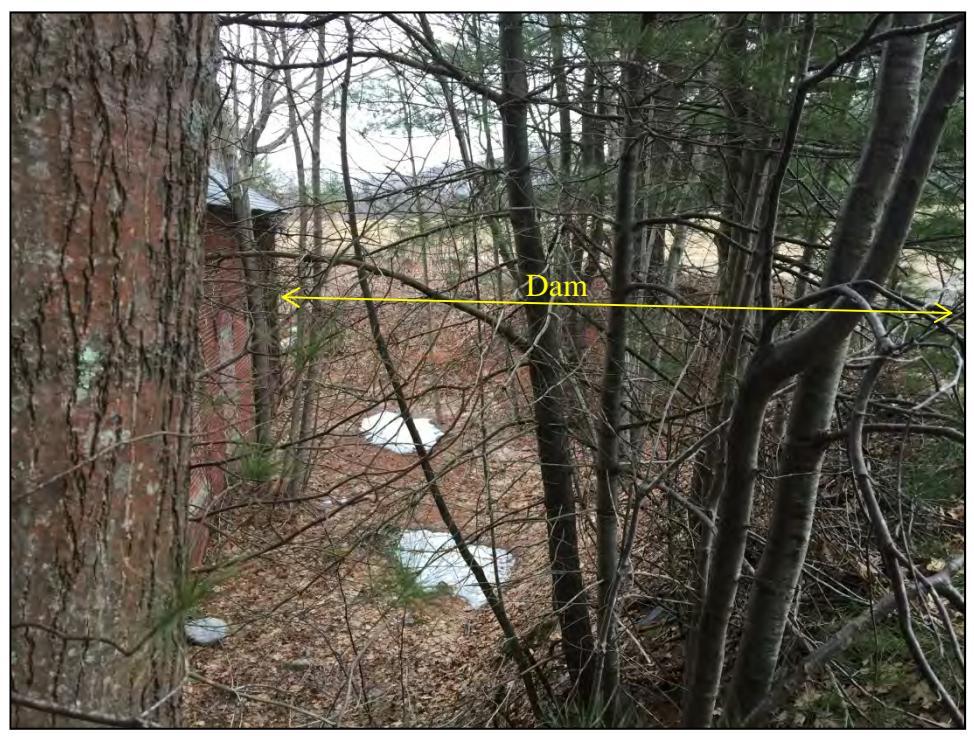
Photo No. 18: The downstream slope in the area of the former water treatment plant looking left from the access road/bench away from the dam.

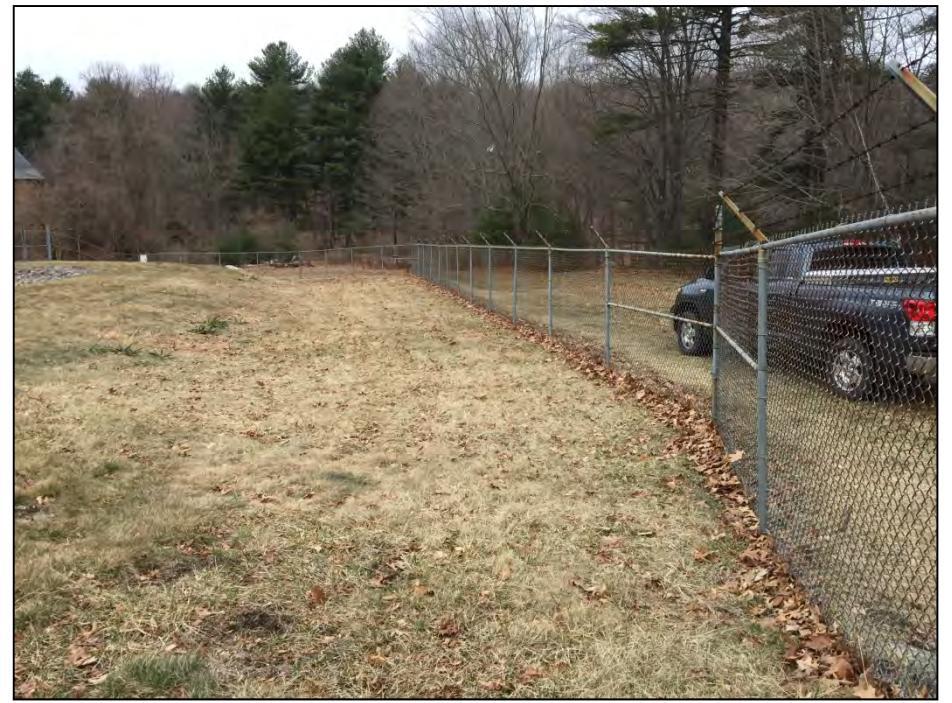
Photo No. 19: The downstream side of the dam as viewed from right of the primary spillway looking left.

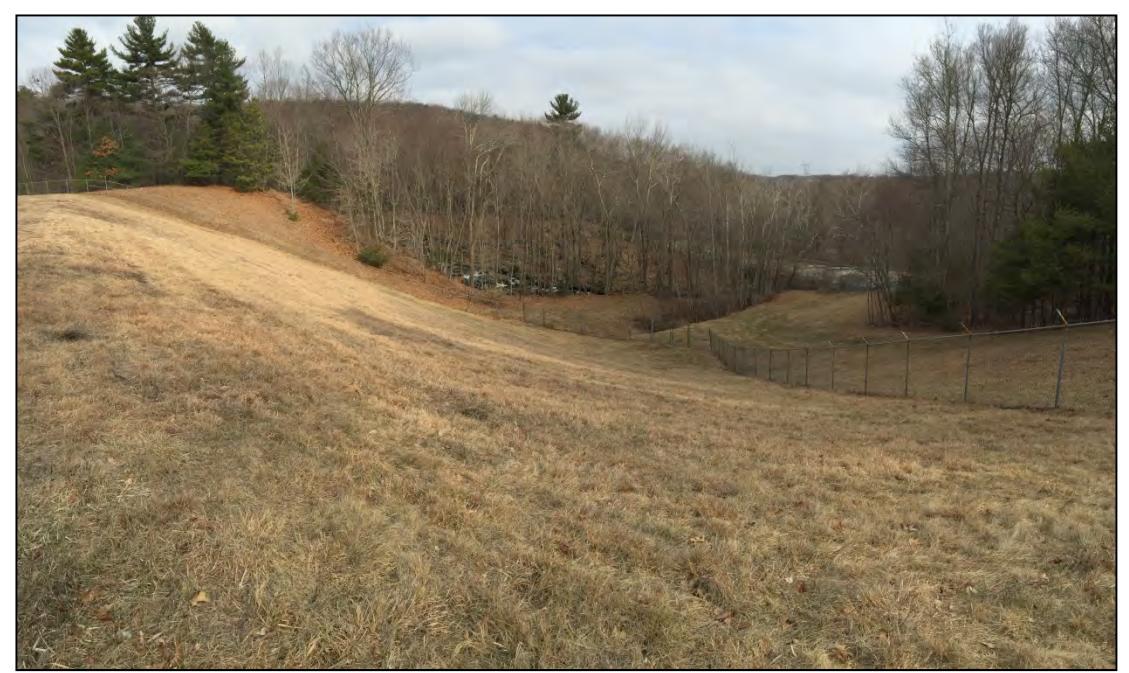
Photo No. 20: The downstream side of the dam as viewed from the left abutment along the crest looking left and dwonstream.

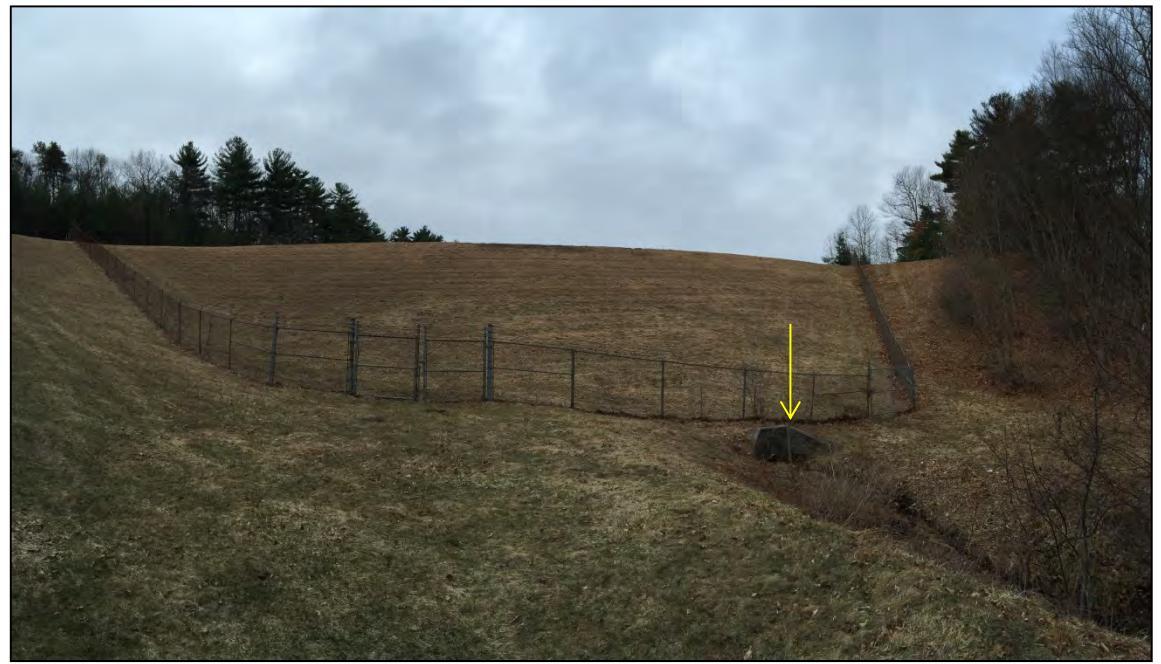
Photo No. 21: A panoramic of the dam as viewed from the toe near Station 8+00. Note the location of the abandoned outlet.

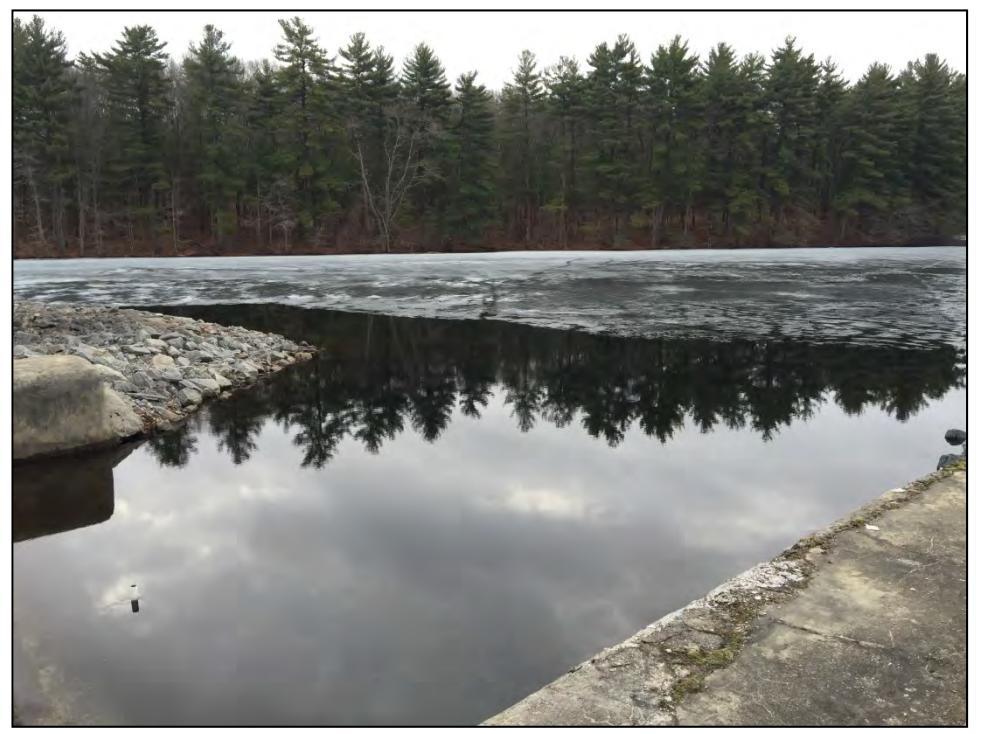
Photo No. 22: The primary spillway approach channel as viewed from right of the spillway.

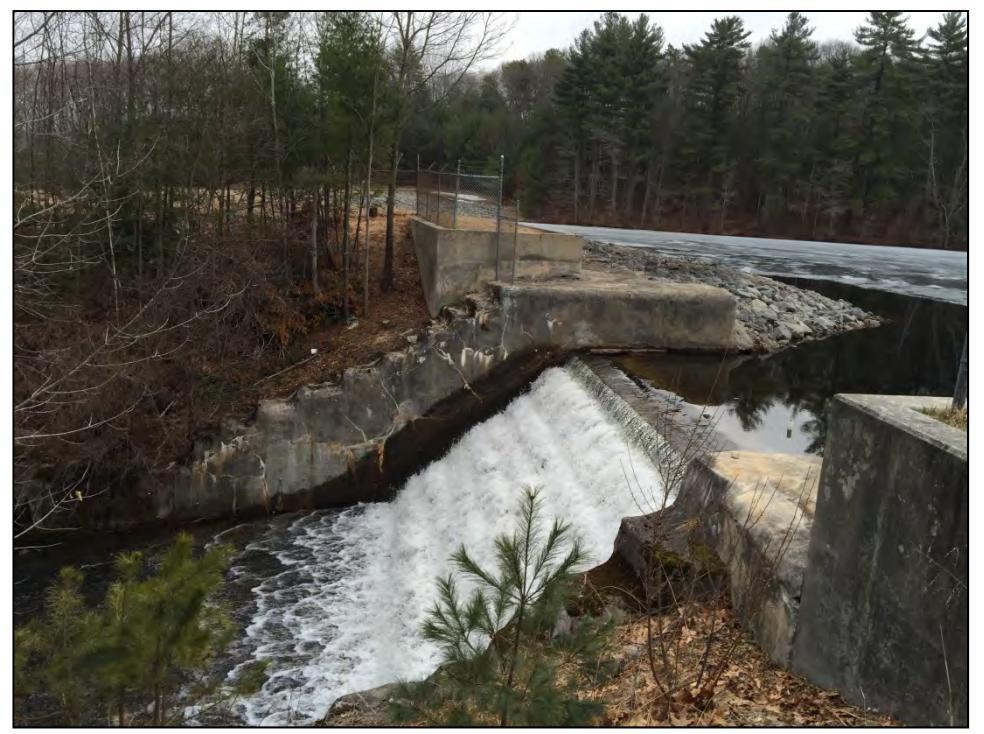
Photo No. 23: The stepped section of the primary spillway as viewed from the left. Note the small trees growing behind the right return wall.

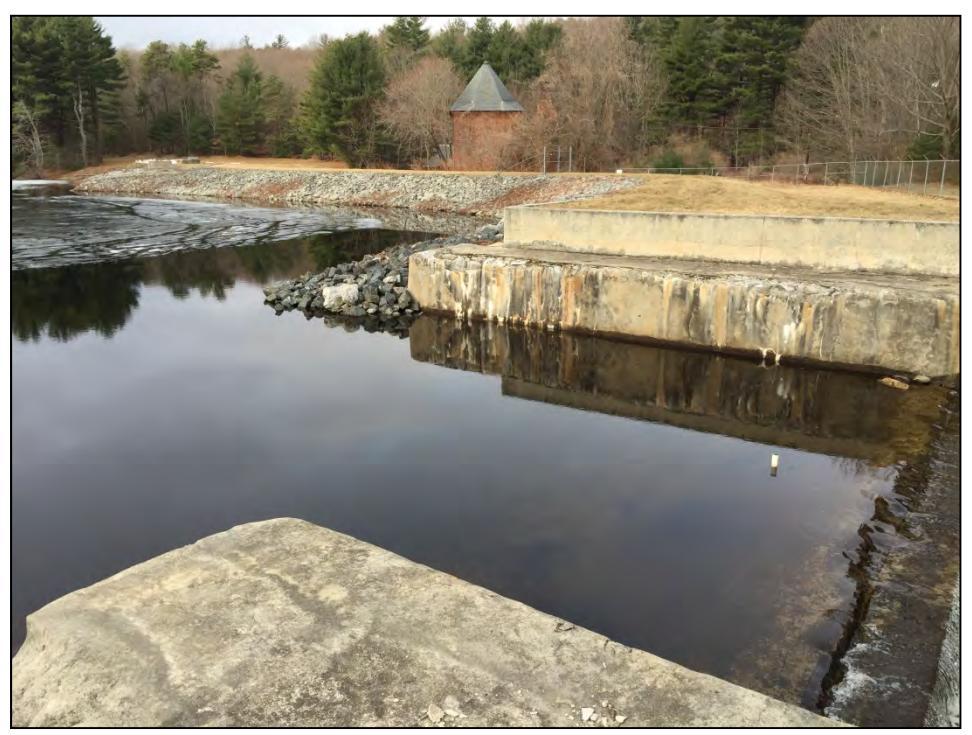
Photo No. 24: The primary spillway approach channel as viewed from left of the spillway.

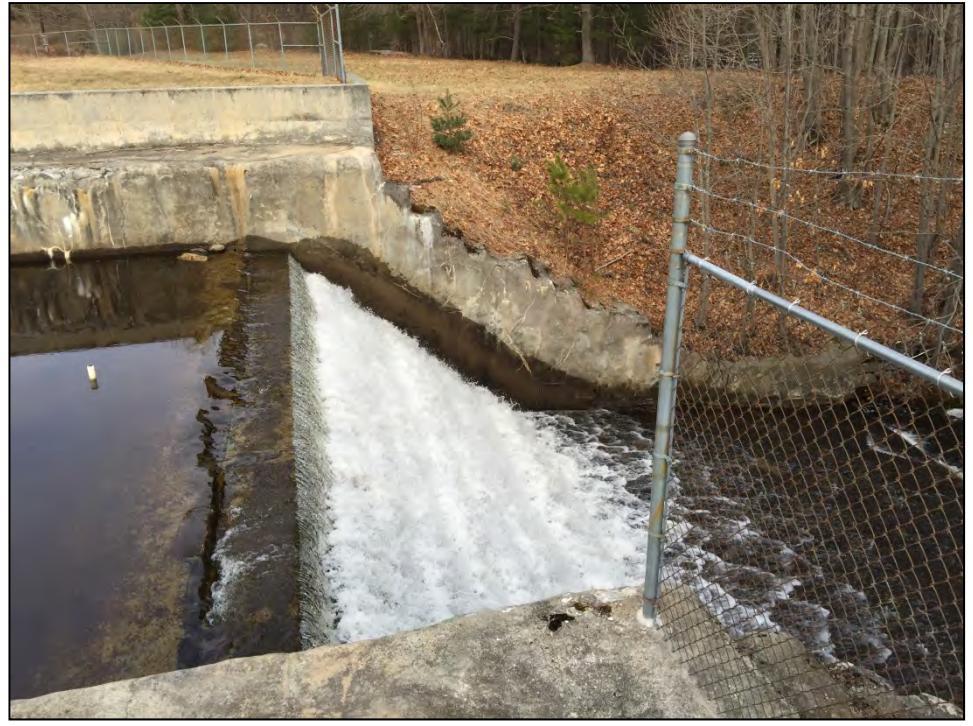
Photo No. 25: The primary spillway weir as viewed from right of the spillway looking left and downstream.

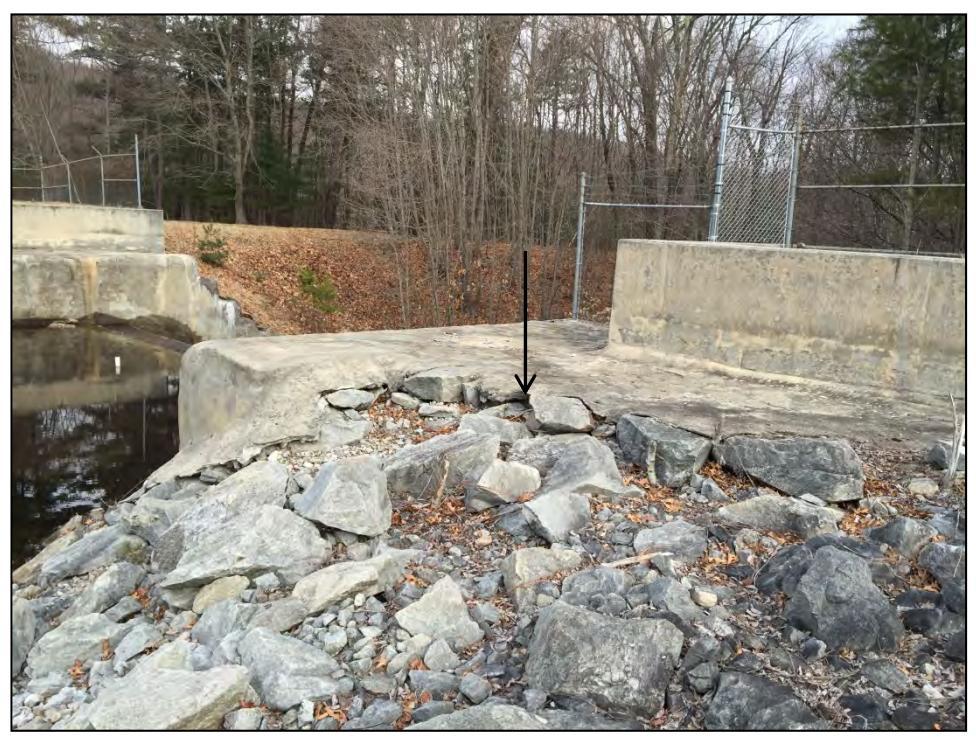
Photo No. 26: The connection of the upstream riprapped slope with the primary spillway. Note the erosion and undermining.

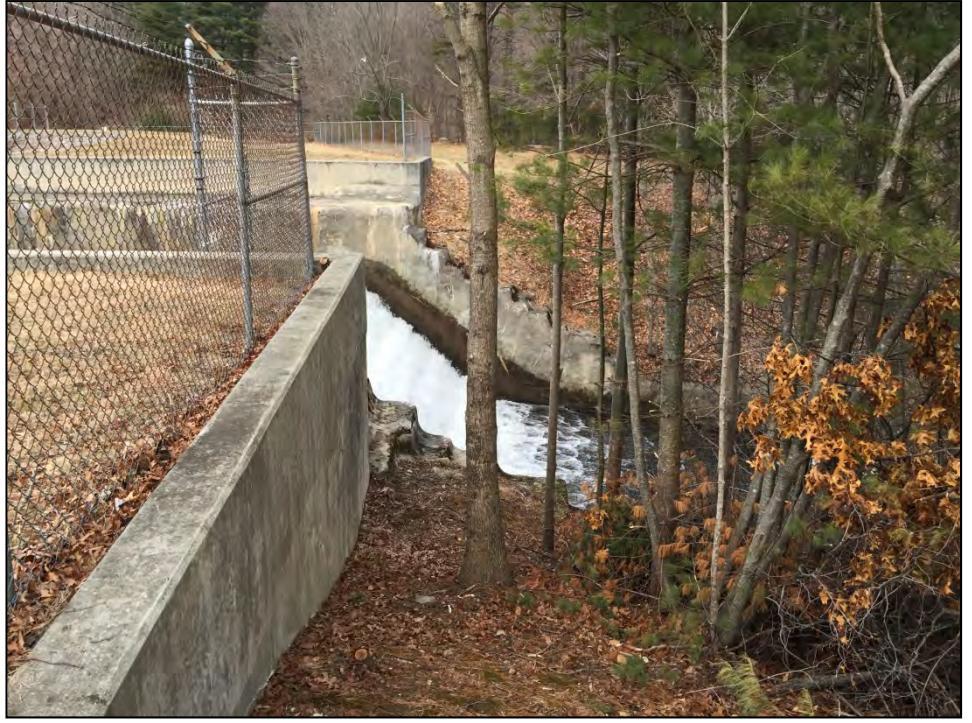
Photo No. 27: The downstream side of the primary spillway right return wall is overgrown with small trees.

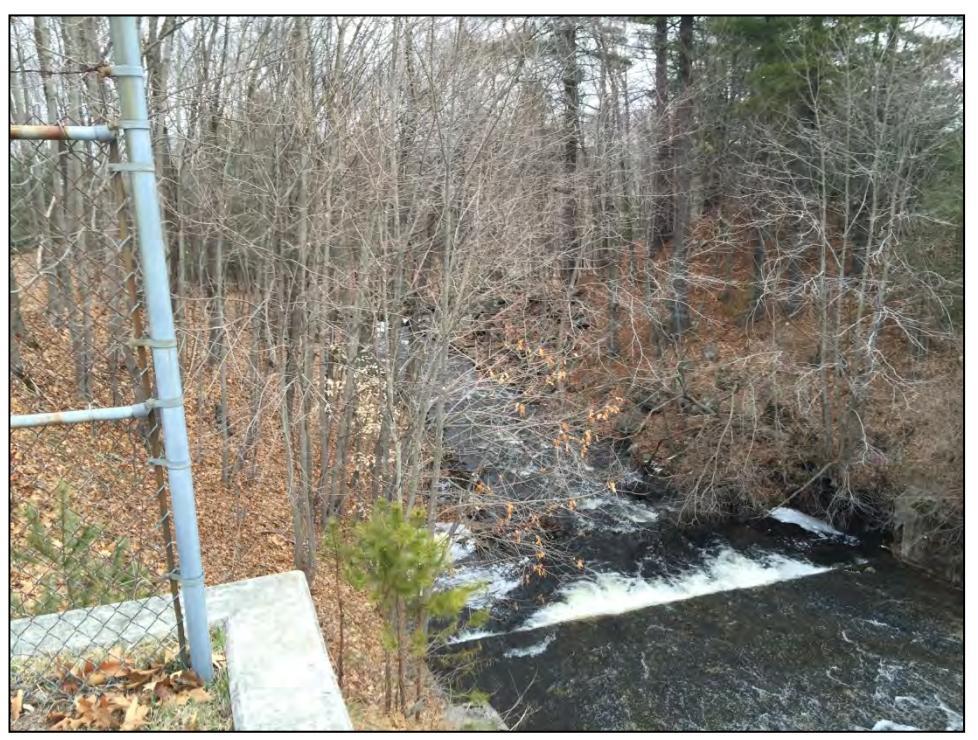
Photo No. 28: Primary spillway discharge channel as viewed from the crest of the dam left of the spillway.

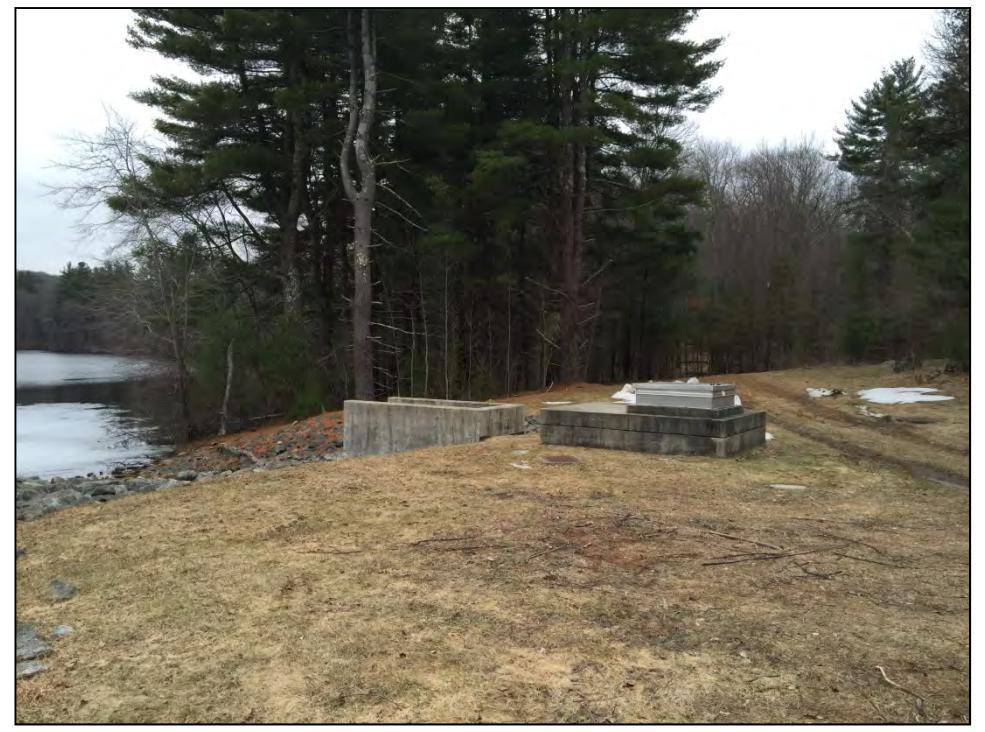
Photo No. 29: Concrete pressure relief blowoff structure at the dam's left abutment (photo looking left).

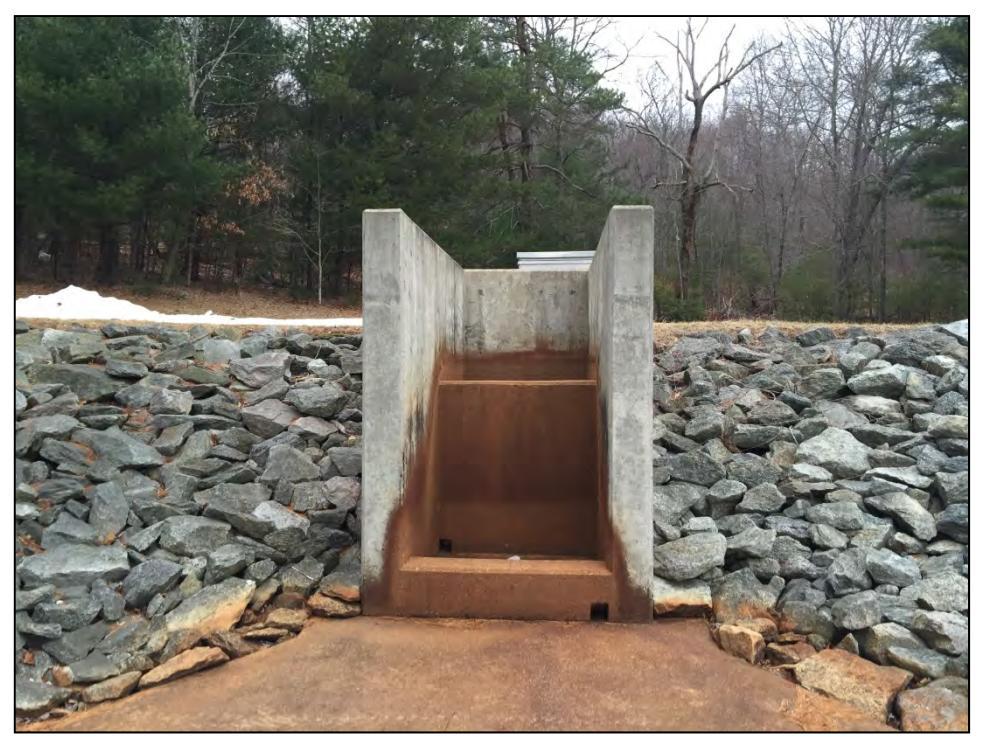
Photo No. 30: Concrete pressure relief blowoff structure from Photo 29 looking downstream.

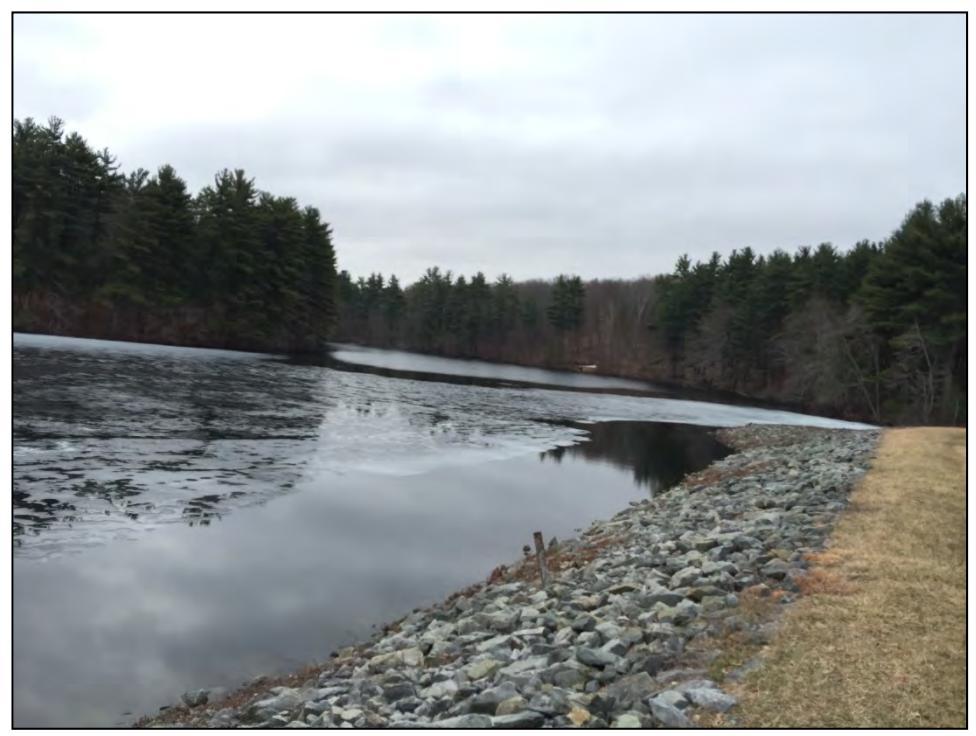
Photo No. 34: Overview of the impoundment as viewed from near Station 3+40. the pipe protruding from the ground is a marker for the intake alignment.

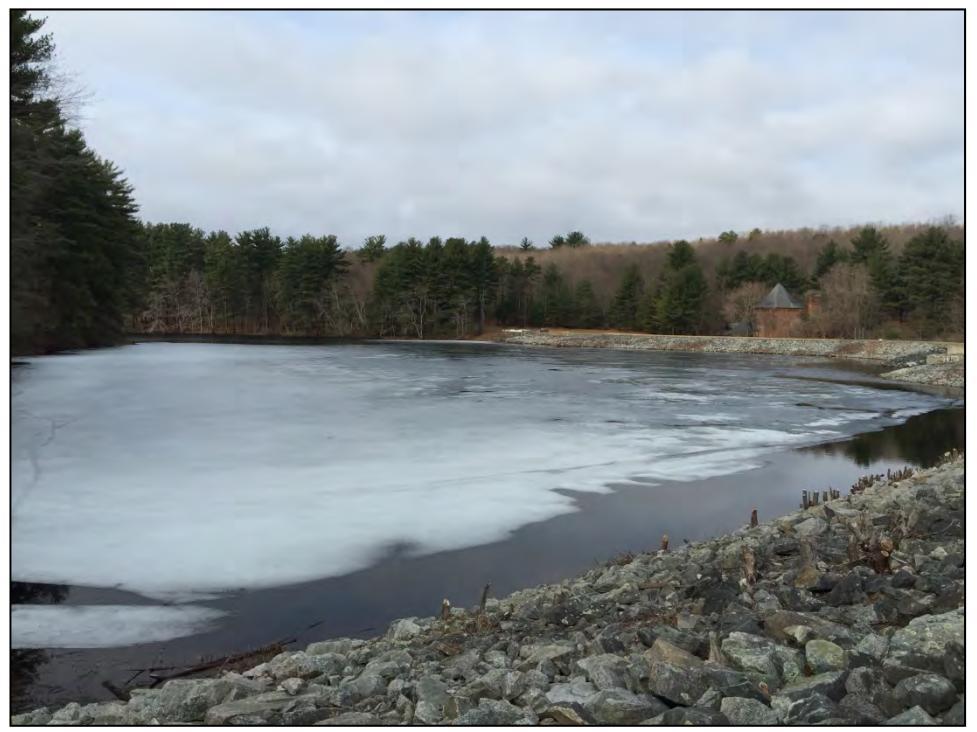
Photo No. 35: Overview of the impoundment as viewed from near the right abutment.
