In re: City of Woonsocket Water Division - Application to Implement Multi-Year Rate Plan

Docket No. 4879

Dam Name (No):	Woonsocket Reservoir #3 Dam (068)
Location:	Smithfield/North Smithfield
Hazard Classification:	High
	-
Inspector:	David M. Matheson, P.E.
Inspection Date.	August 1, 2014

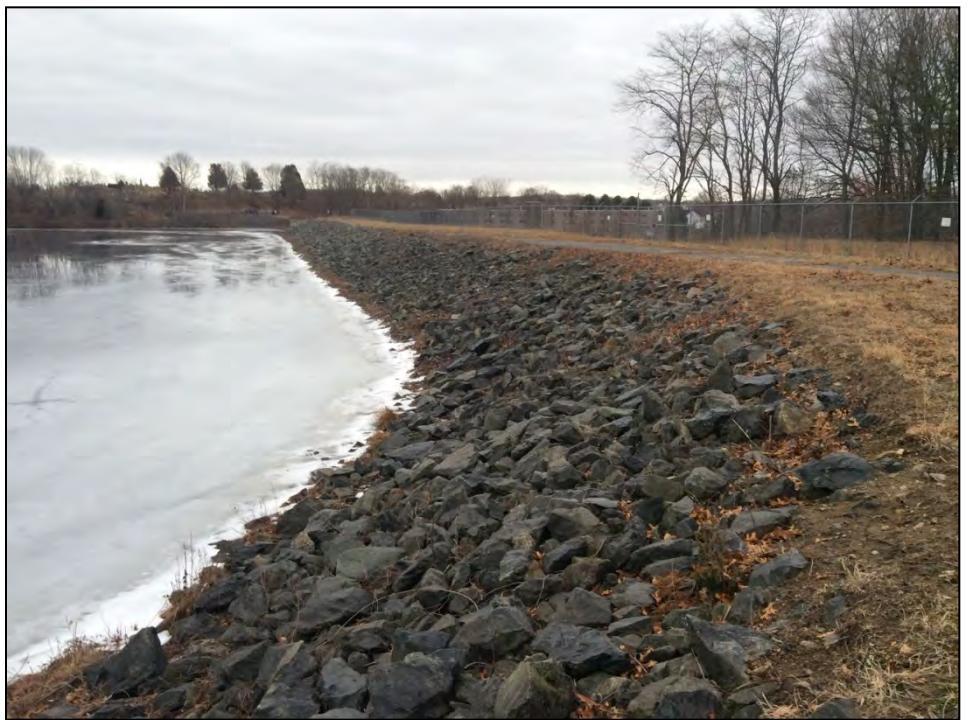
Photo No. 1: Panoramic overview of the dam from the right abutment. The clearing of vegetation from the upstream slope has been completed.

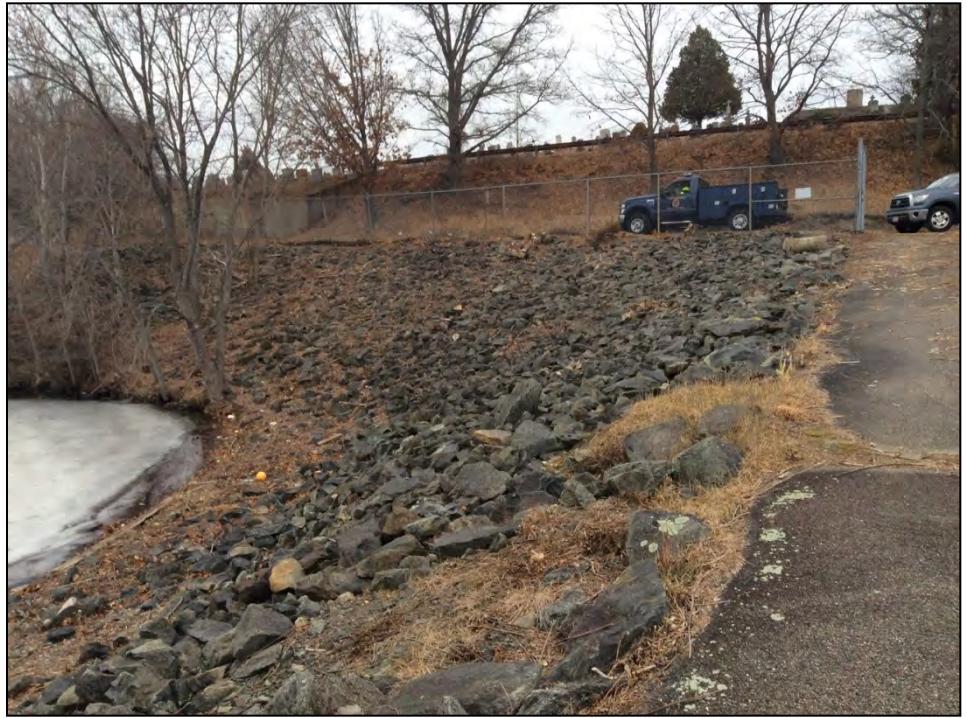
Photo No. 2: The upstream side of the left abutment contact area as viewed from near Station 1+00.

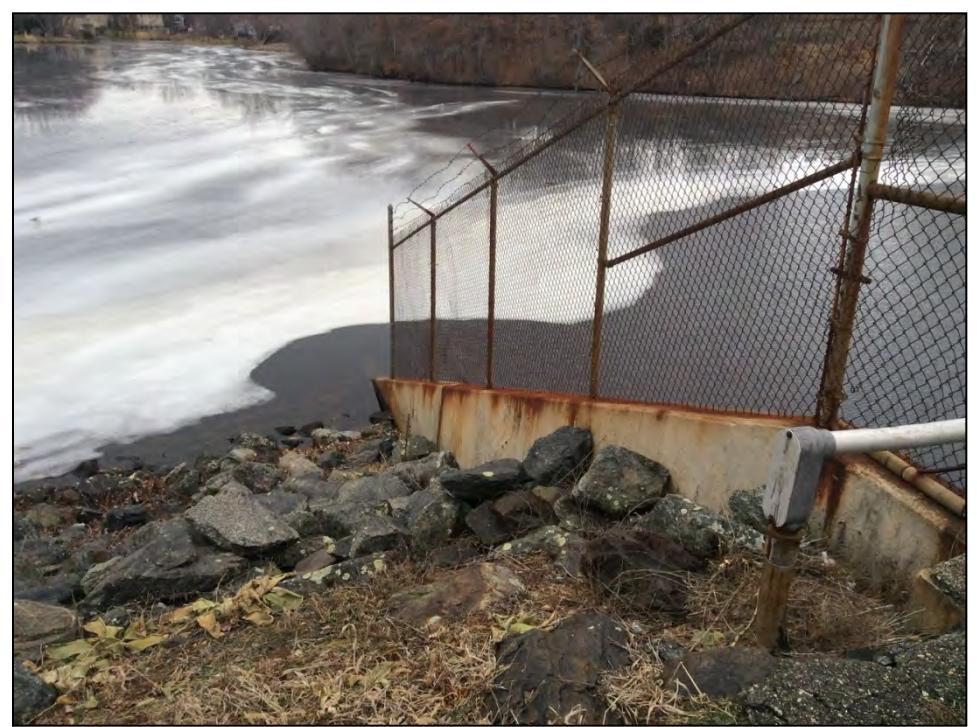
Photo No. 3: Thinning areas of rip rap right of the primary spillway approach looking upstream from the crest. This is typical of the opposite side.

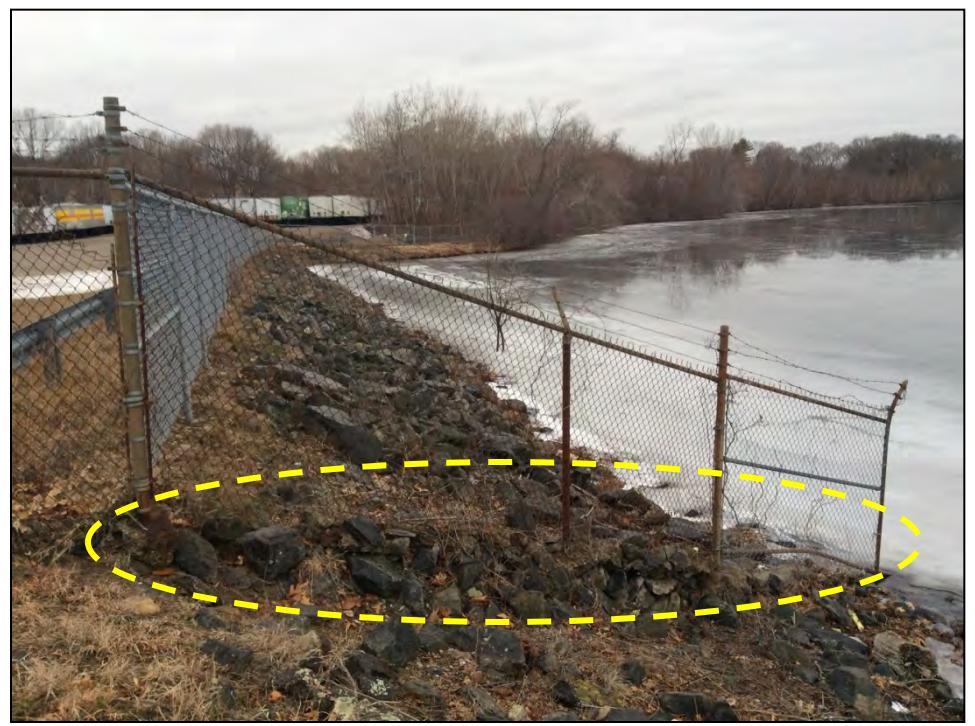
Photo No. 4: The right abutment contact at the upstream slope. Note erosion around fence line. .

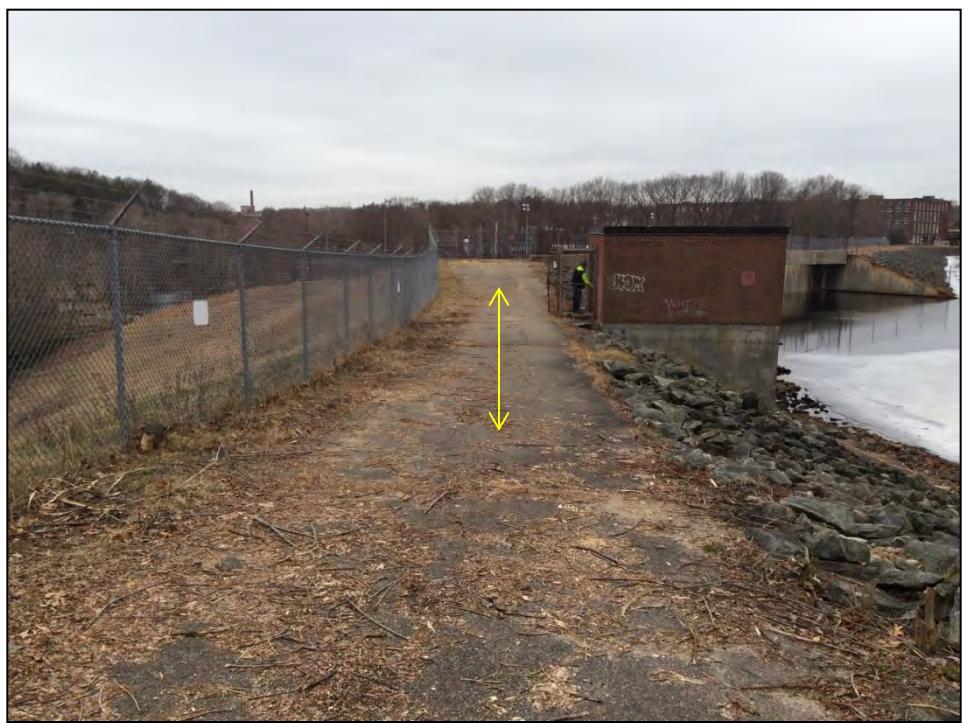
Photo No. 5: Crest as viewed from the left abutment. Note the low area between the gatehouse and the primary spillway.

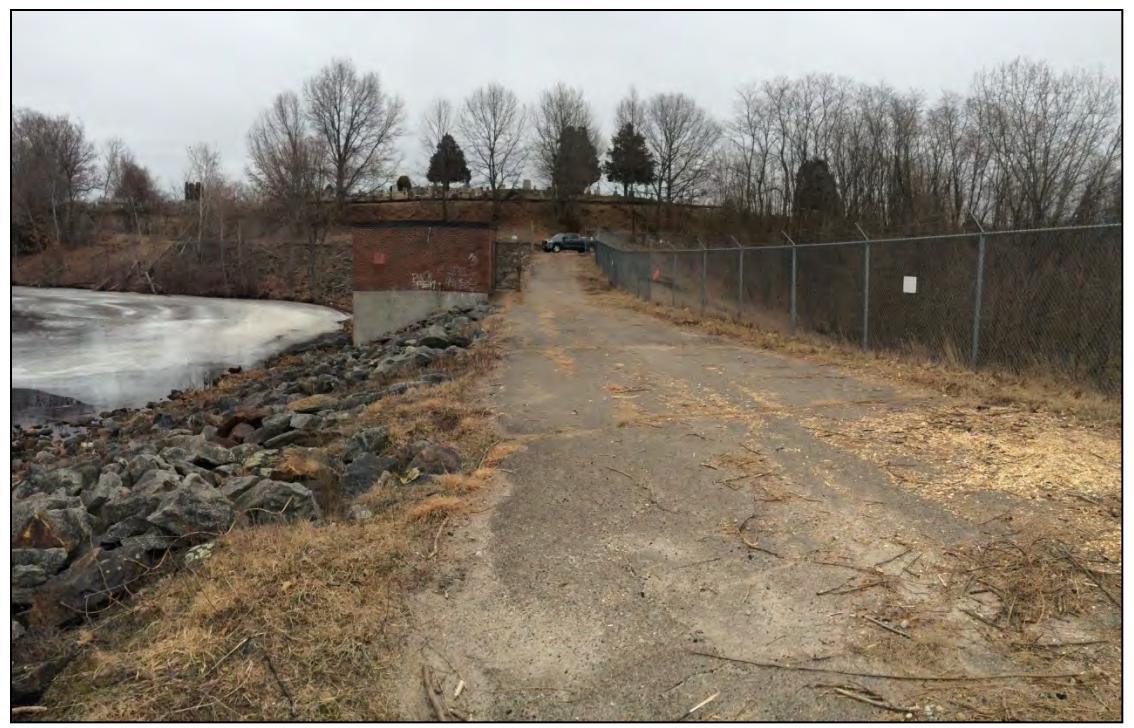
Photo No. 6: The crest as viewed from left of the primary spillway looking left.

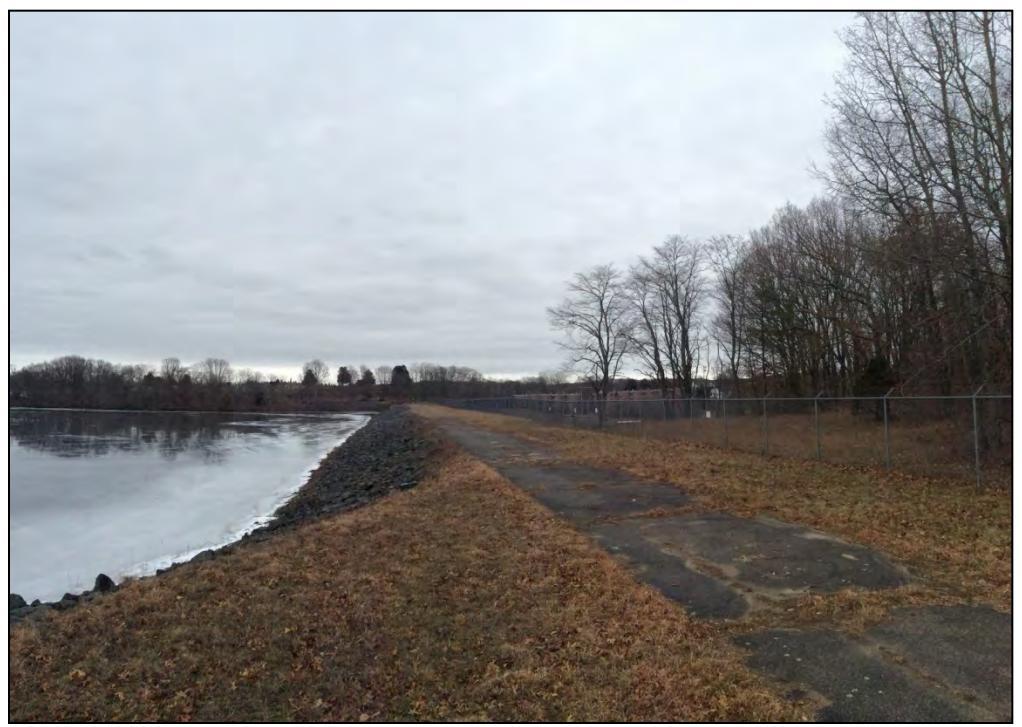
Photo No. 8: Crest as viewed from near Station 20+00 looking left.

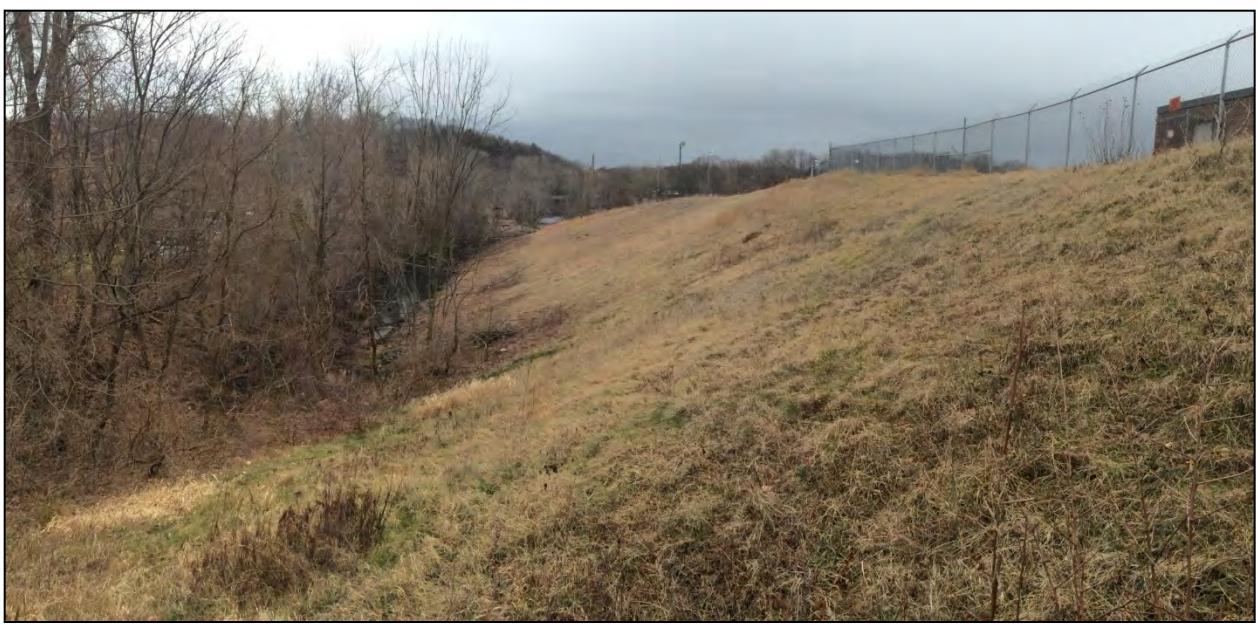
Photo No. 9: Downstream slope and outlet discharge channel as viewed from the left abutment looking right.

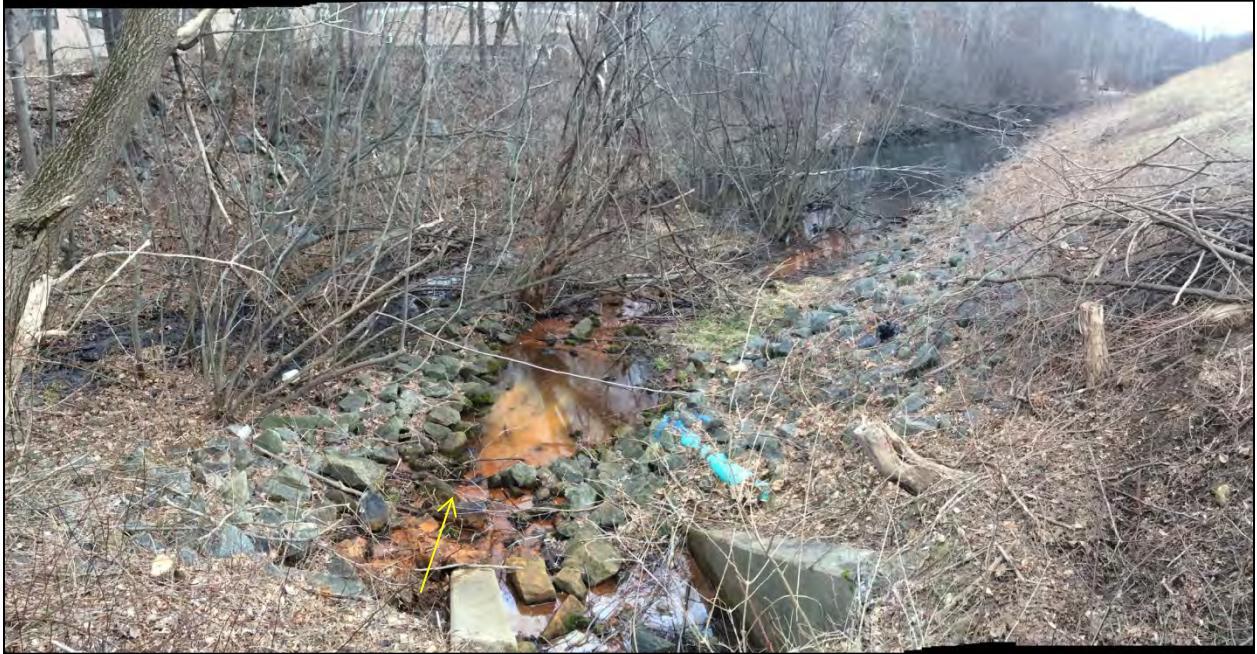
Photo No. 10: Downstream toe and low level outlet discharge channel looking right from the outlet headwall. The stained water is sourced from the cleared toe drain located left of the headwall (arrow shows flow direction).

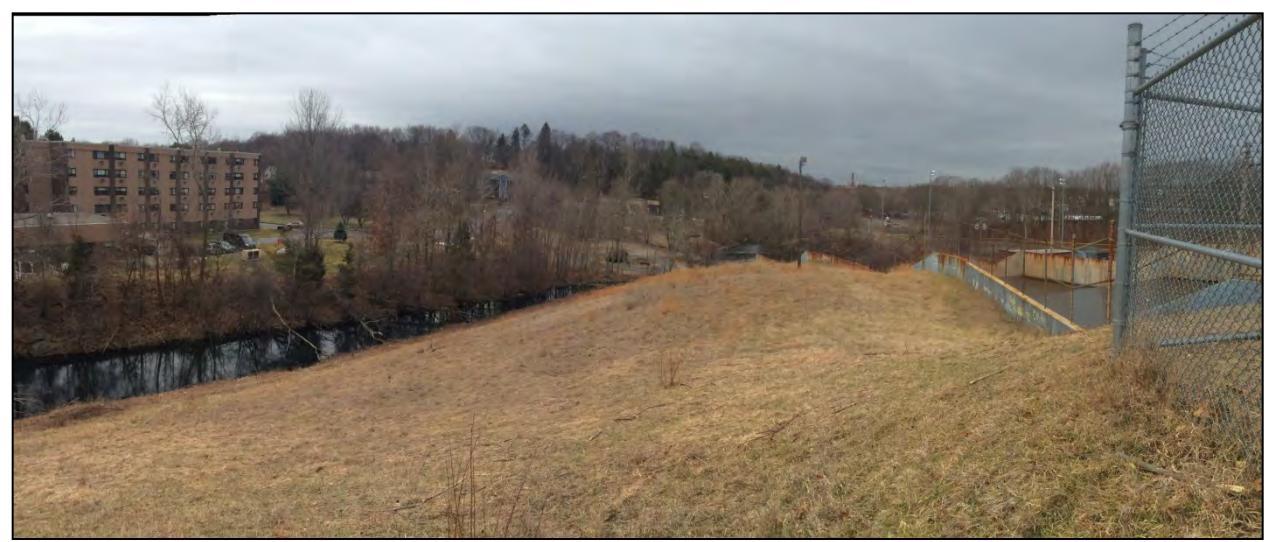
Photo No. 12: The downstream slope left of the spillway as viewed from left of the primary spillway looking downstream. Note the irregular surfaces.

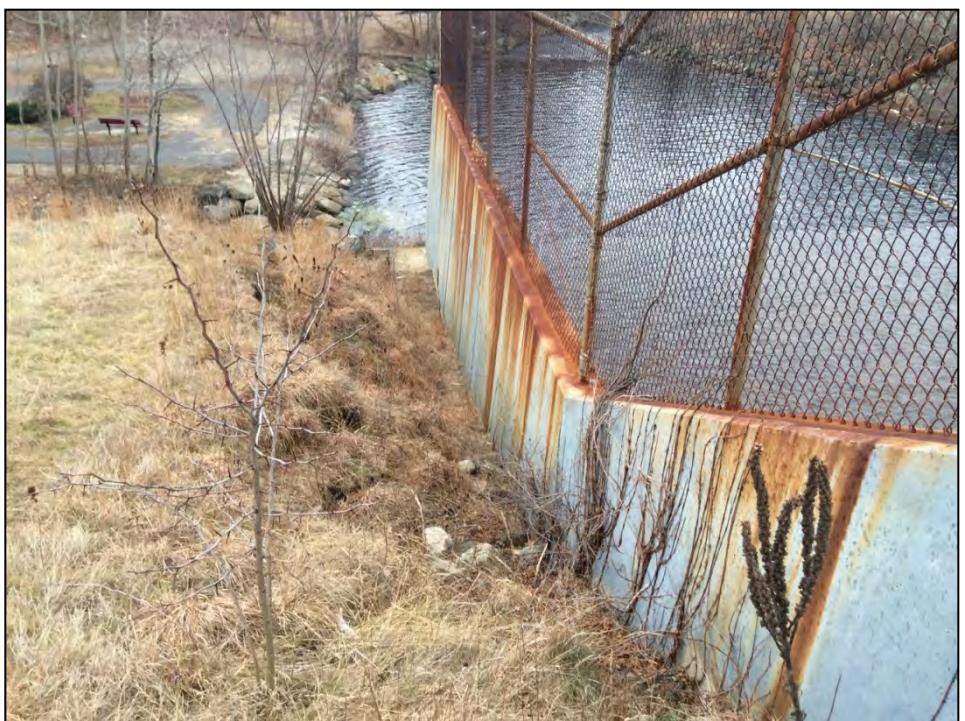
Photo No. 13: Deep erosion behind the spillway's left training wall looking downstream from mid-slope.

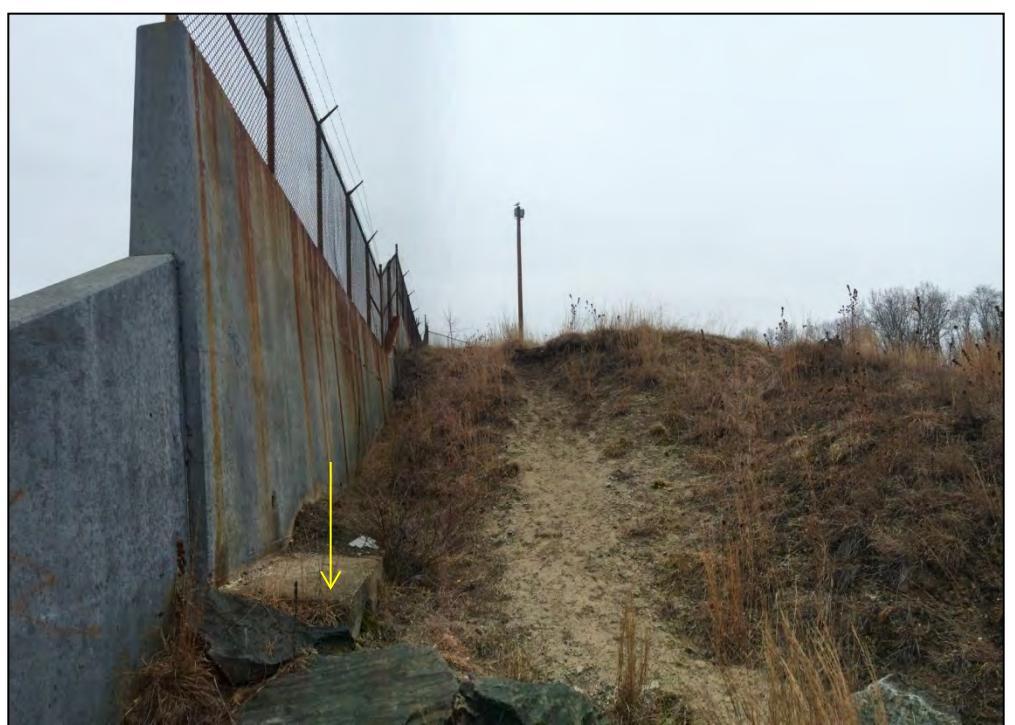
- The previously observed irregular slopes left of the spillway remain unchanged including the eroded channel that has formed behind the training wall near the base of the slope. Part of the wall footing is exposed as a result of the erosion (See Photo No. 14).

Photo No. 14: Erosion behind the spillway's left training wall looking upstream from the toe. Note the exposed wall footing.

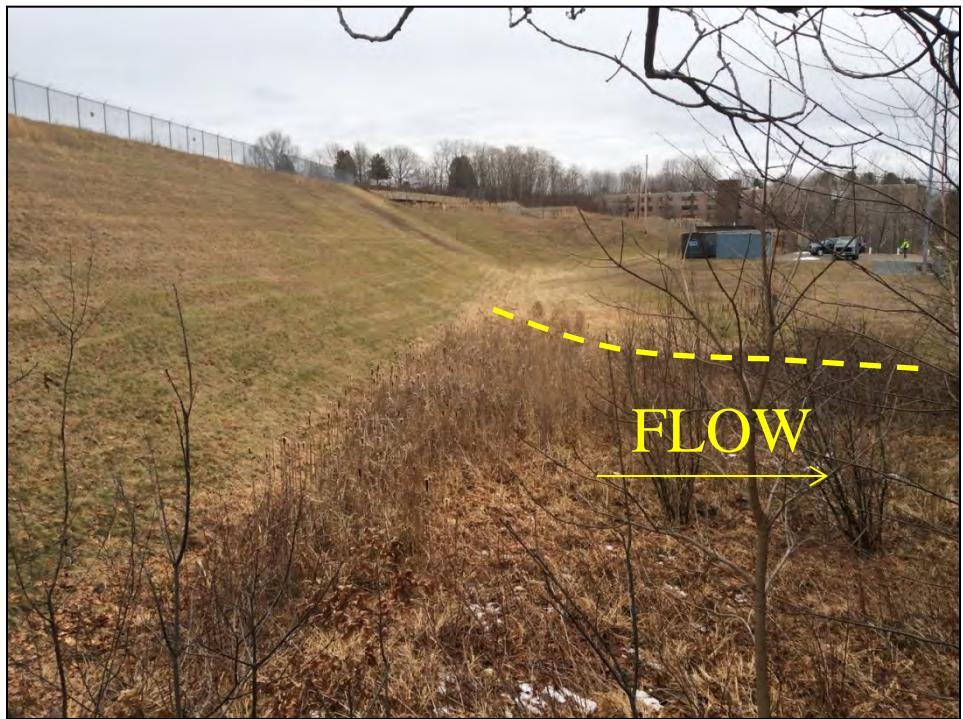
Photo No. 15: Downstream slope as viewed from the right abutment looking left. Note the wide flow channel from the assumed toe drain outlet.

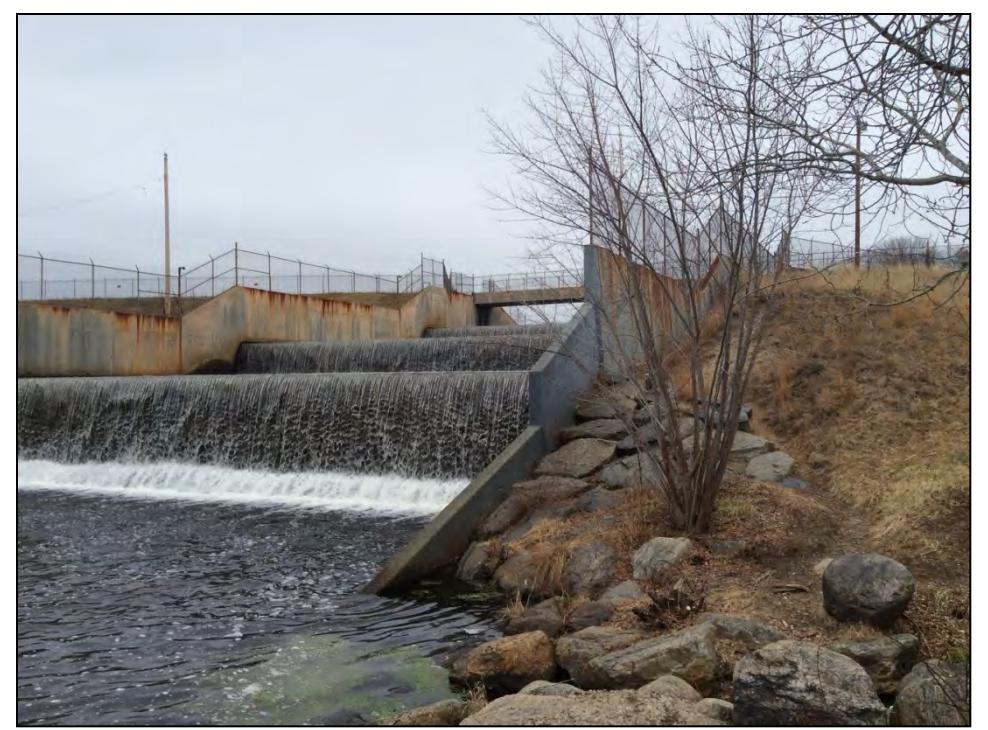
Photo No. 16: Primary spillway as viewed from the left side of the main channel looking upstream.

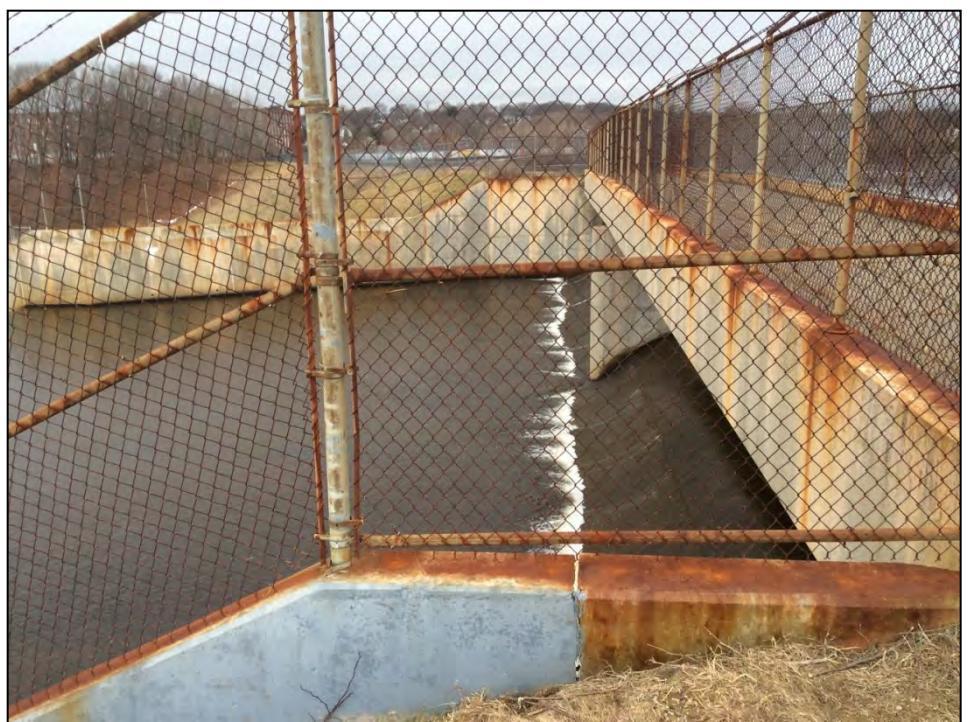
Photo No. 17: The primary spillway upstream weir looking right.

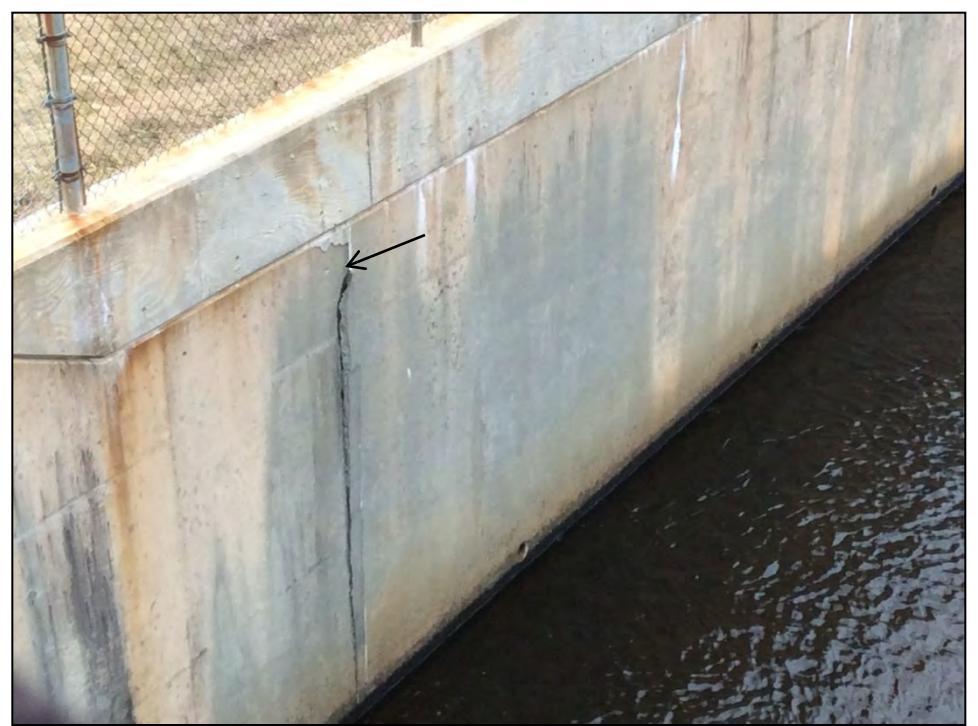
Photo No. 18: Open joint at the spillway's left training wall as viewed from the spillway bridge looking downstream.

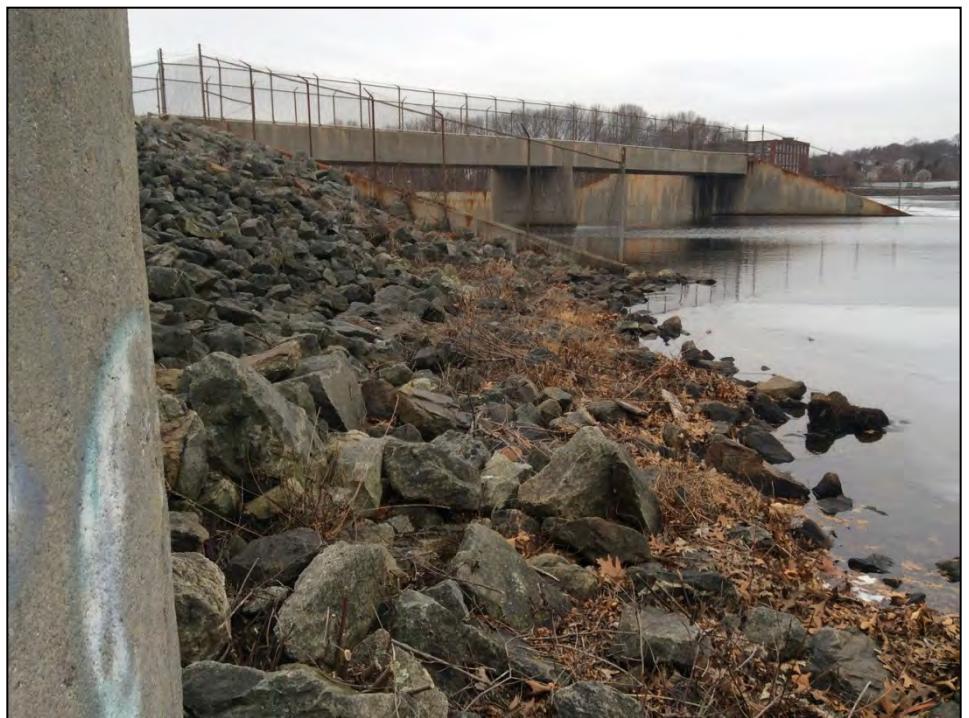
Photo No. 19: The primary spillway approach as viewed from near the gatehouse looking right.

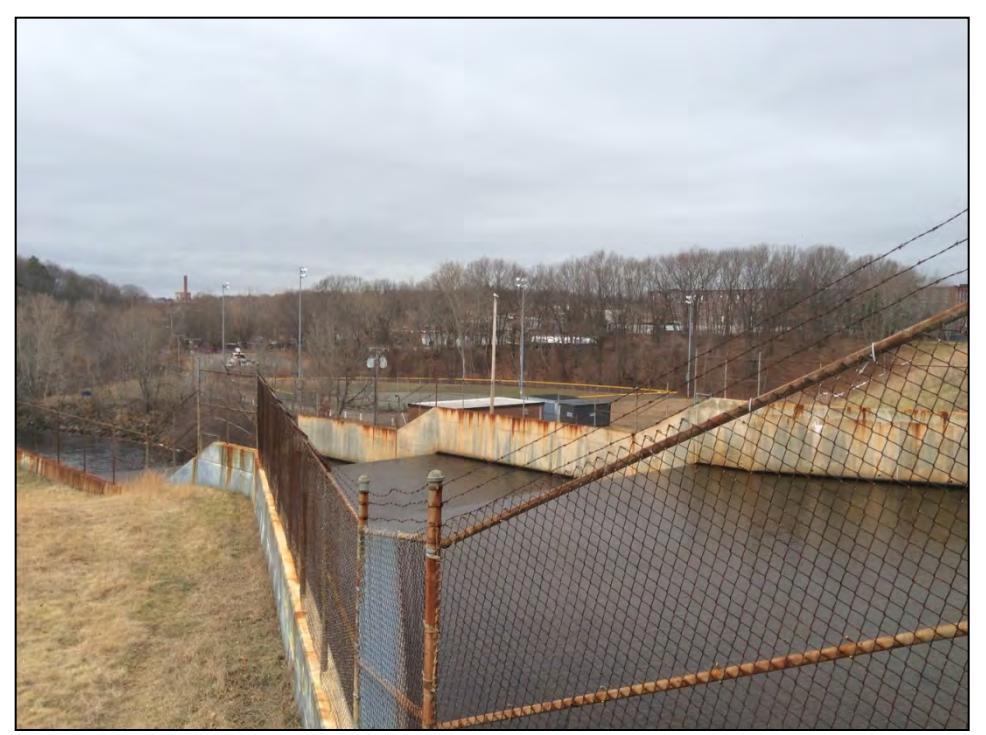
Photo No. 20: Overview of the primary spillway stepped section and downstream channel beyond.

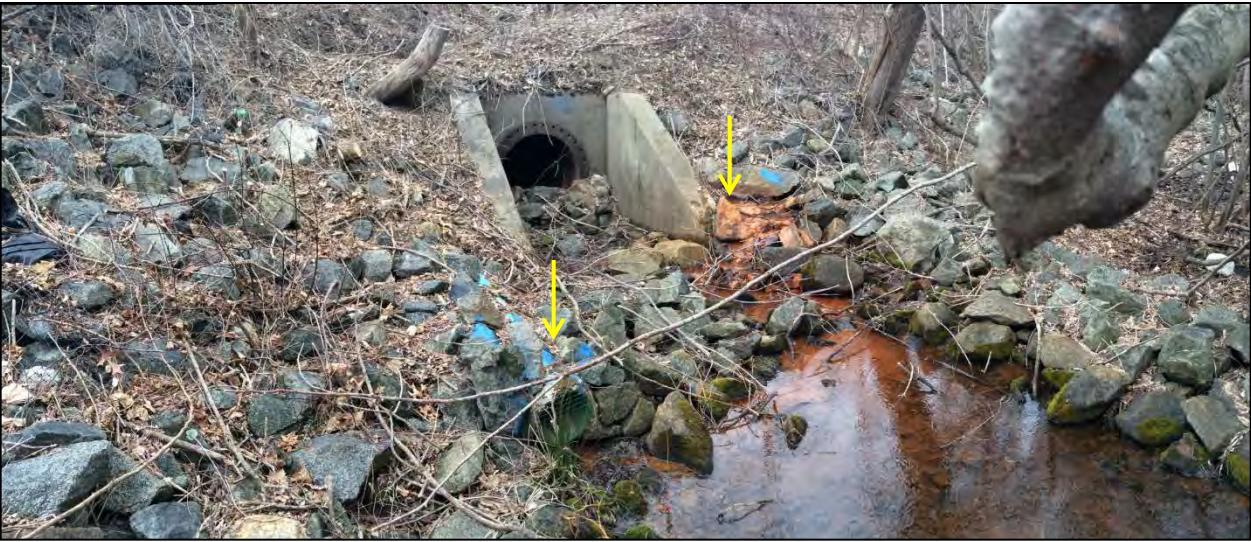
Photo No. 21: The low level outlet discharge structure looking upstream and to the right from the discharge channel. Note the locations of the 2 toe drains.

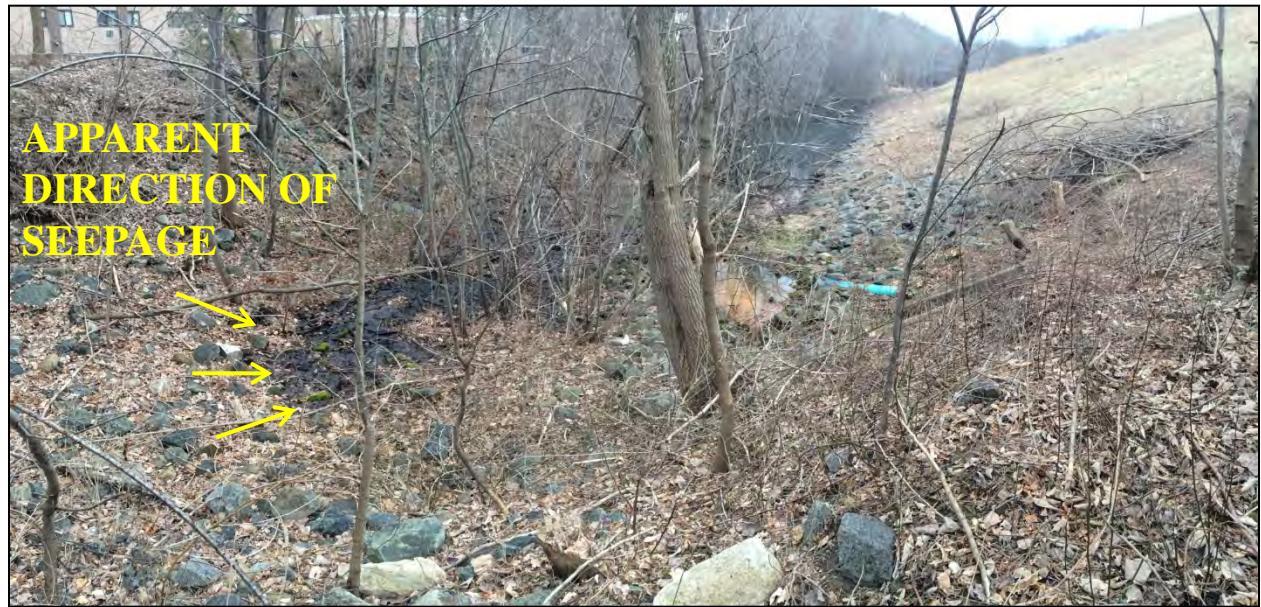
Photo No. 24: Low Level outlet discharge channel and wet area beyond the toe looking left. The wet area beyond the toe appears to be sourced from outside the dam limits.

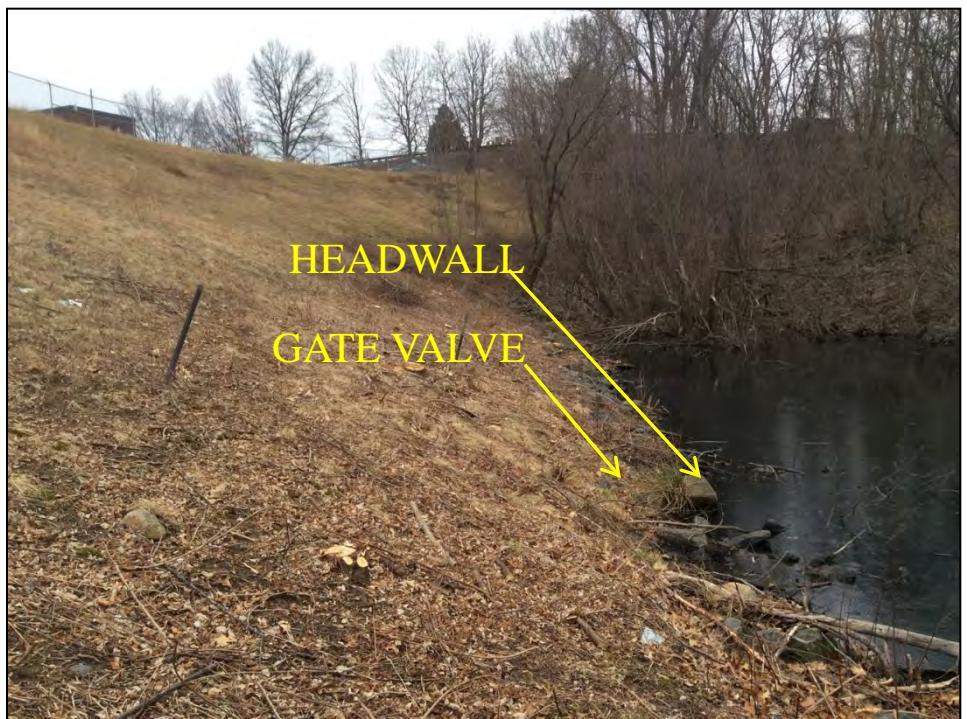
Photo No. 25: Concrete headwall at the suction pipe blow-off. Note the gate valve location.

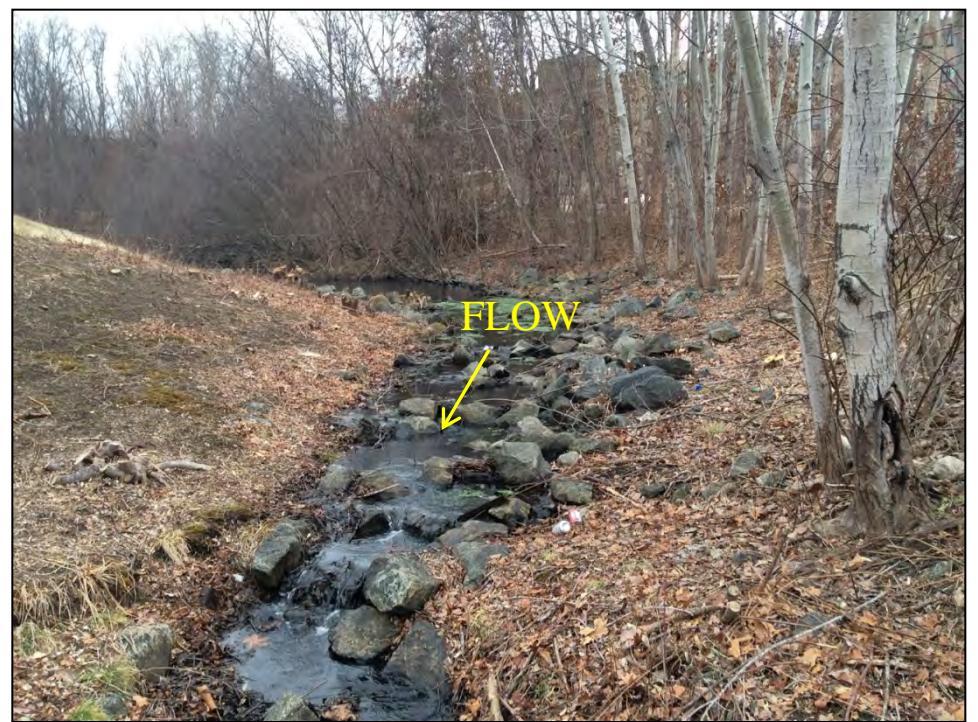
Photo No. 26: Low level outlet discharge channel as viewed from the main channel looking right. Accumulated flows were estimated at 20 gallons per minute.

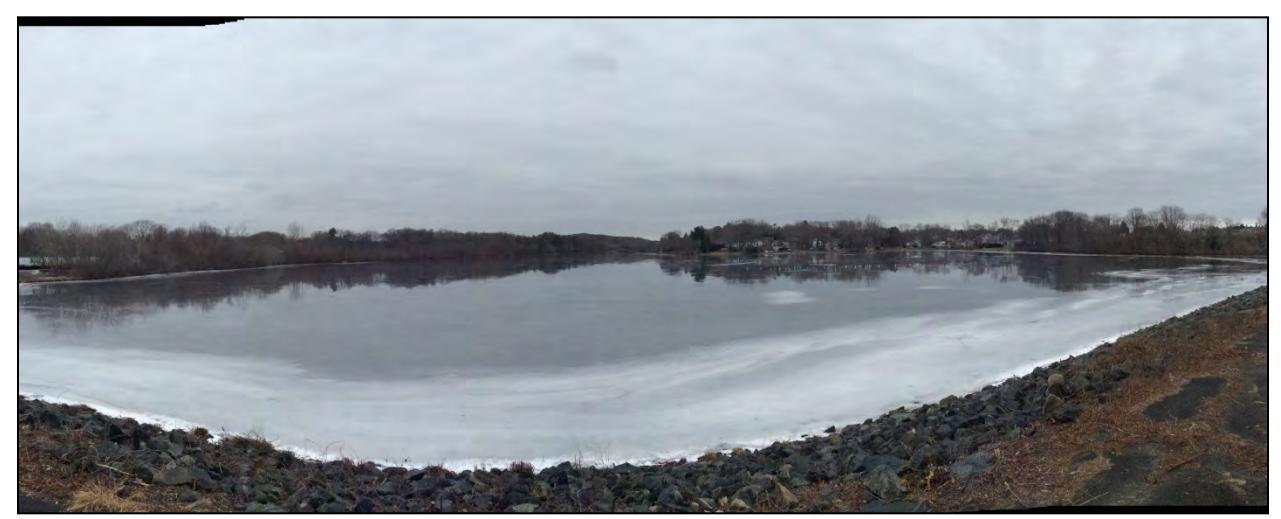
Photo No. 27: Panoramic view of the impoundment as viewed from the right abutment.

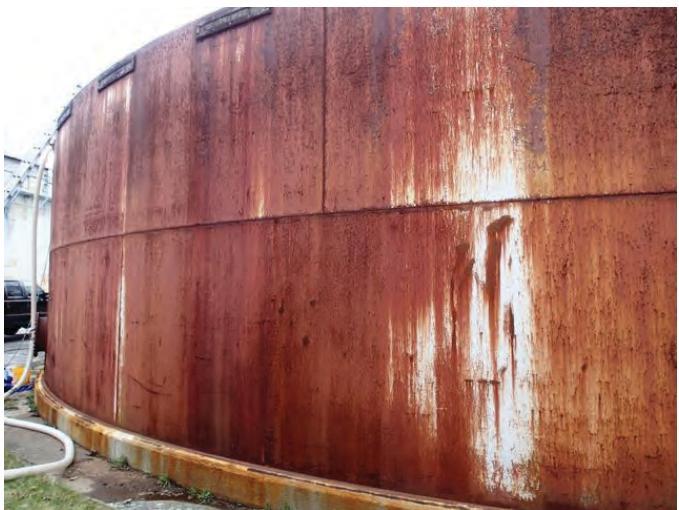
1 Exterior Wall With Expired Coating/Cracking/Lifting, 1 Exposed Primary Coating, Exposed Underlying Steel, Mildew And Steel Corrosion

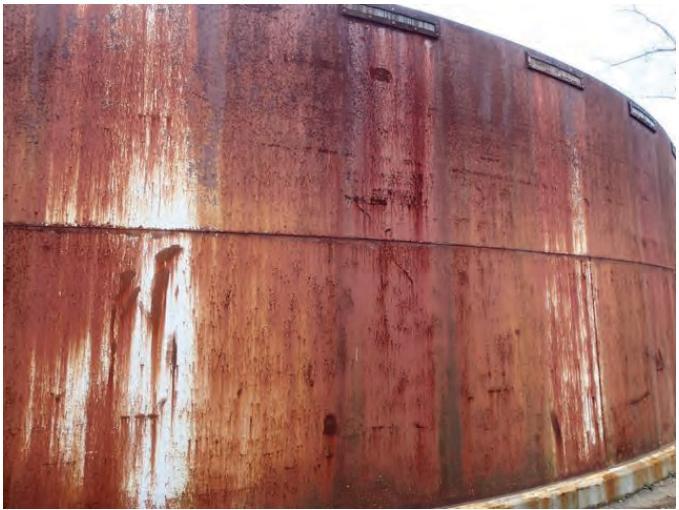
Exterior Wall With Expired Coating/Cracking/Lifting,
Exposed Primary Coating, Exposed Underlying Steel,
Mildew And Steel Corrosion

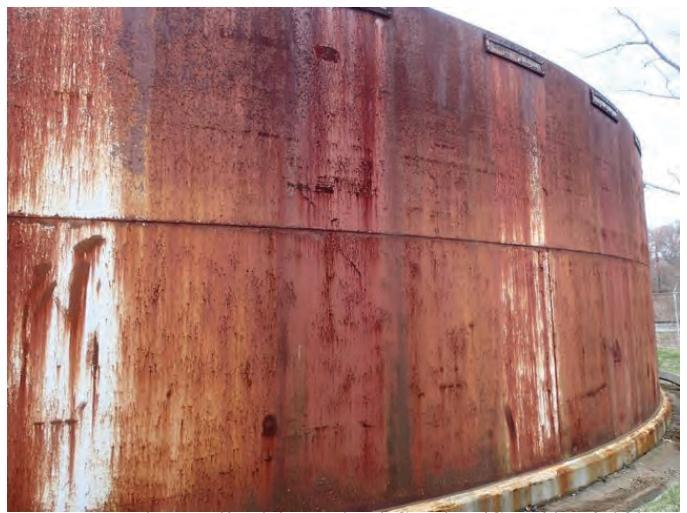
3 Exterior Wall With Expired Coating/Cracking/Lifting, 3 Exposed Primary Coating, Exposed Underlying Steel, Mildew And Steel Corrosion

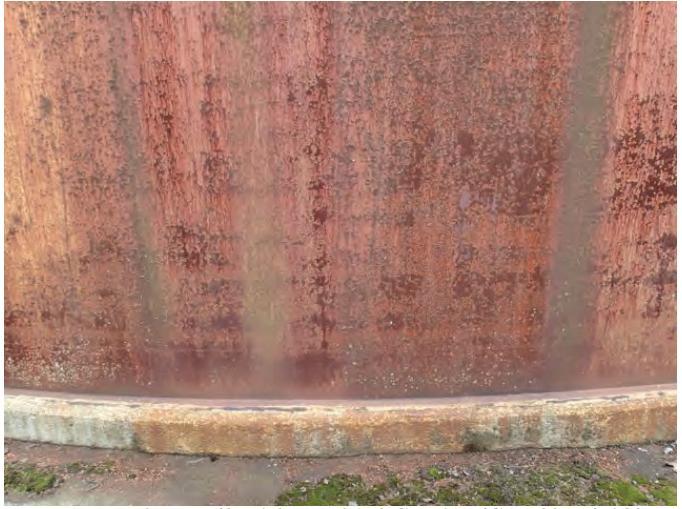
4 Exterior Wall With Expired Coating/Cracking/Lifting, 4 Exposed Primary Coating, Exposed Underlying Steel, Mildew And Steel Corrosion

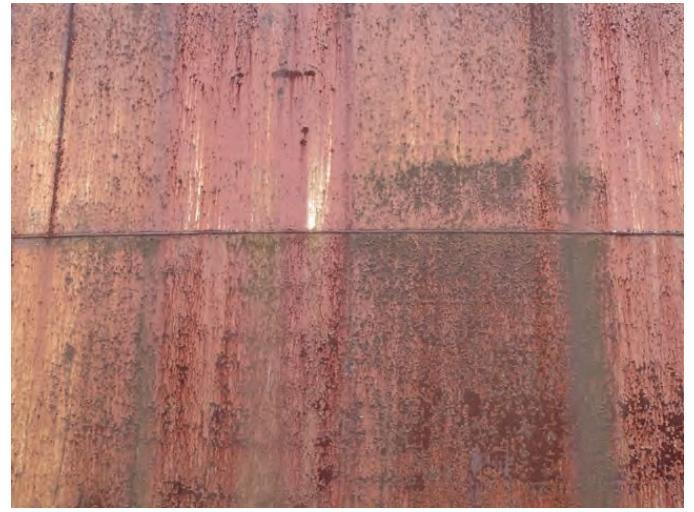
5 Exterior Wall With Expired Coating/Cracking/Lifting, Exposed Primary Coating, Exposed Underlying Steel, Mildew And Steel Corrosion

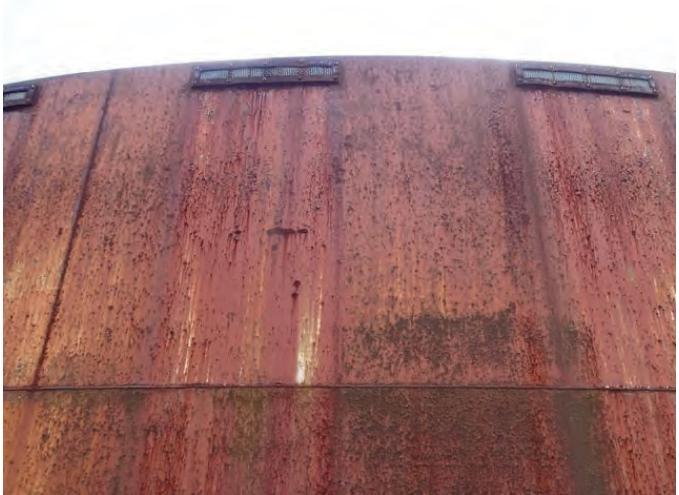
6 Exterior Wall With Expired Coating/Cracking/Lifting, Exposed Primary Coating, Exposed Underlying Steel, Mildew And Steel Corrosion

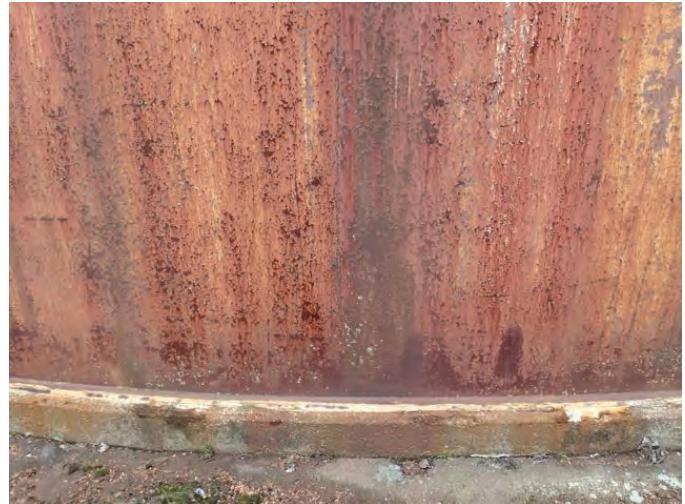
Exterior Wall With Expired Coating/Cracking/Lifting,
Exposed Primary Coating, Exposed Underlying Steel,
Mildew And Steel Corrosion

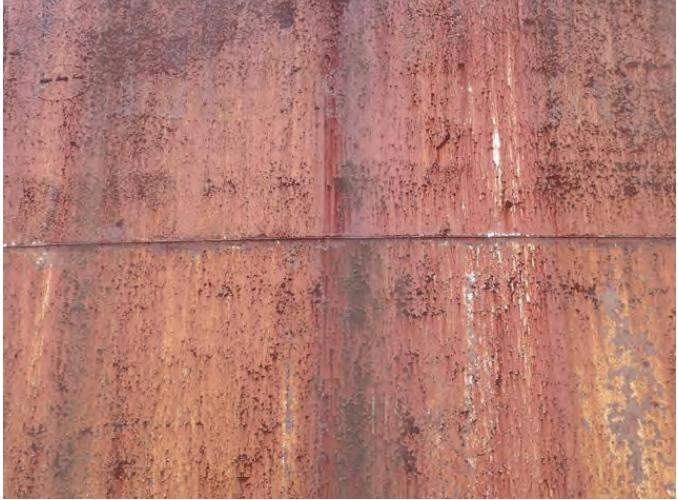
8 Exterior Wall With Expired Coating/Cracking/Lifting, 8 Exposed Primary Coating, Exposed Underlying Steel, Mildew And Steel Corrosion

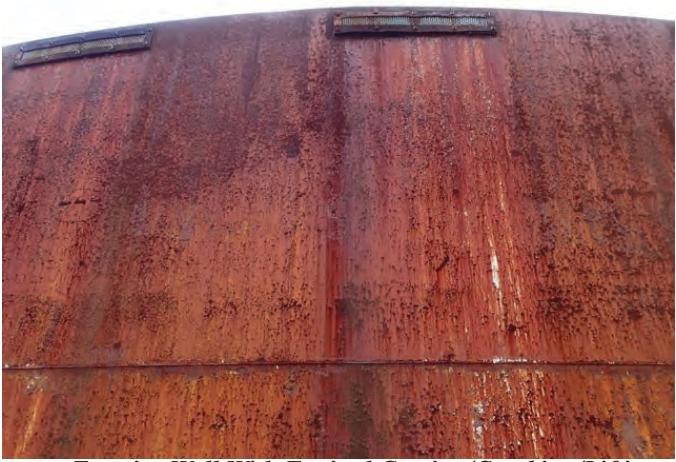
9 Exterior Wall With Expired Coating/Cracking/Lifting, Exposed Primary Coating, Exposed Underlying Steel, Mildew And Steel Corrosion

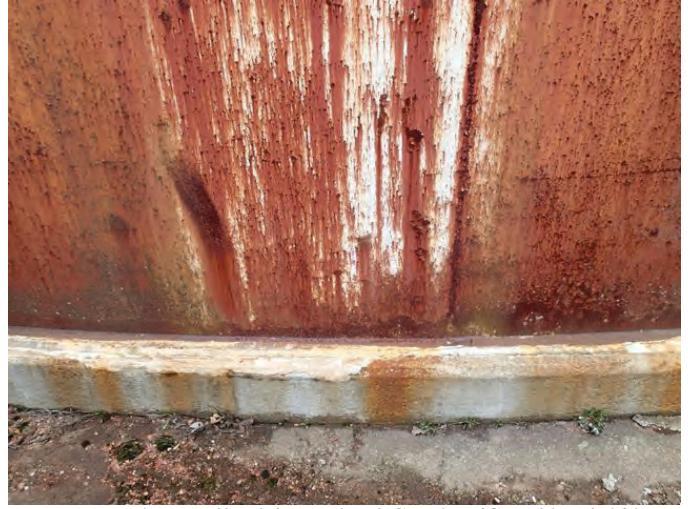
Exterior Wall With Expired Coating/Cracking/Lifting,
Exposed Primary Coating, Exposed Underlying Steel,
Mildew And Steel Corrosion

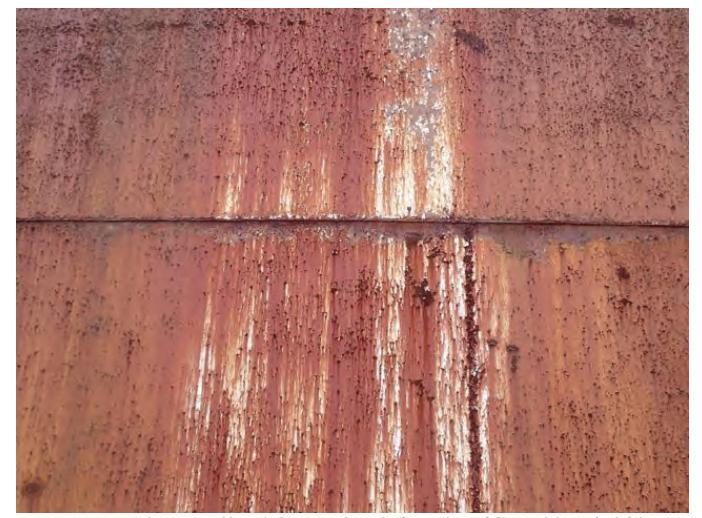
11 Exterior Wall With Expired Coating/Cracking/Lifting, Exposed Primary Coating, Exposed Underlying Steel, Mildew And Steel Corrosion

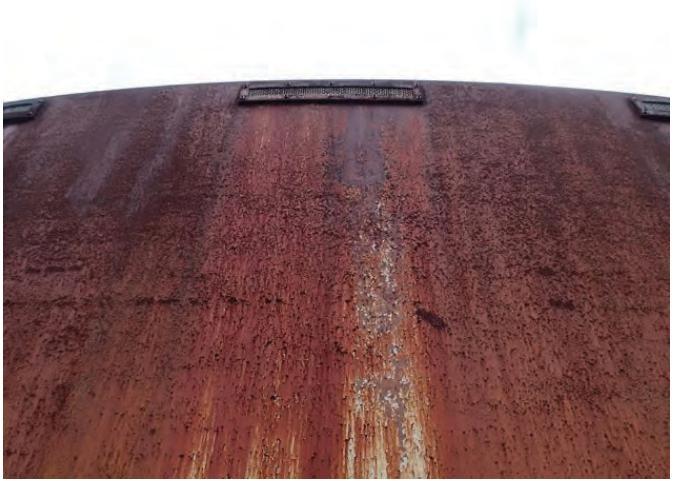
12 Exterior Wall With Expired Coating/Cracking/Lifting, Exposed Primary Coating, Exposed Underlying Steel, Mildew And Steel Corrosion

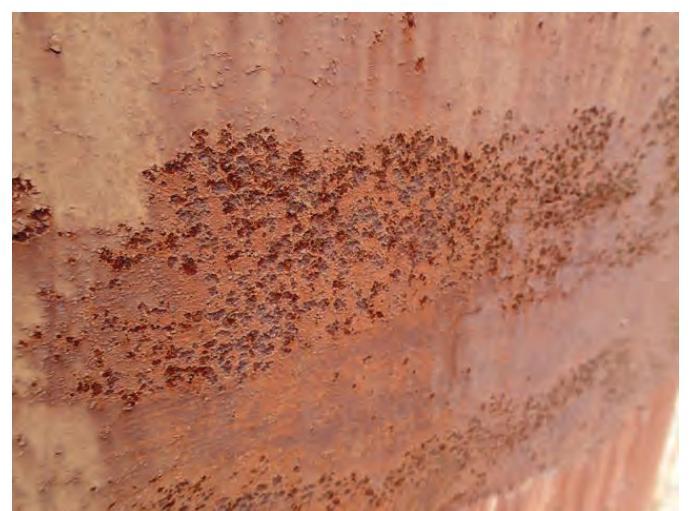
13 Exterior Wall With Expired Coating/Cracking/Lifting, 13 Exposed Primary Coating, Exposed Underlying Steel, Mildew And Steel Corrosion

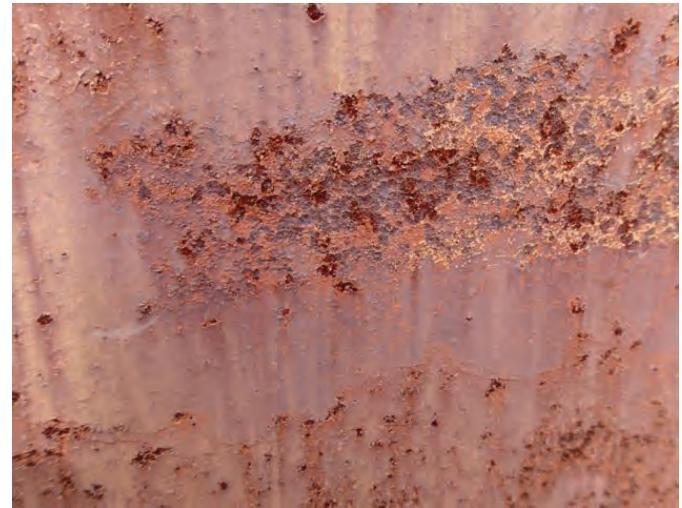
Exterior Wall With Surface Corrosion And Minimal 14 Steel Fatigue (Pitting)

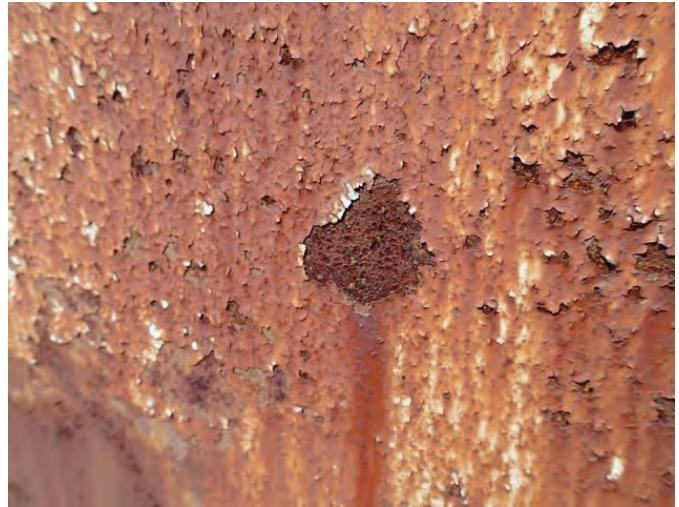
Exterior Wall With Surface Corrosion And Minimal
Steel Fatigue (Pitting)
