In re: City of Woonsocket Water Division - Application to Implement Multi-Year Rate Plan

Docket No. 4879

Dam Name (No):	Woonsocket Reservoir #3 Dam (068)
Location:	Smithfield/North Smithfield
Hazard Classification:	High
	-
Inspector:	David M. Matheson, P.E.
Inspection Date.	August 1, 2014

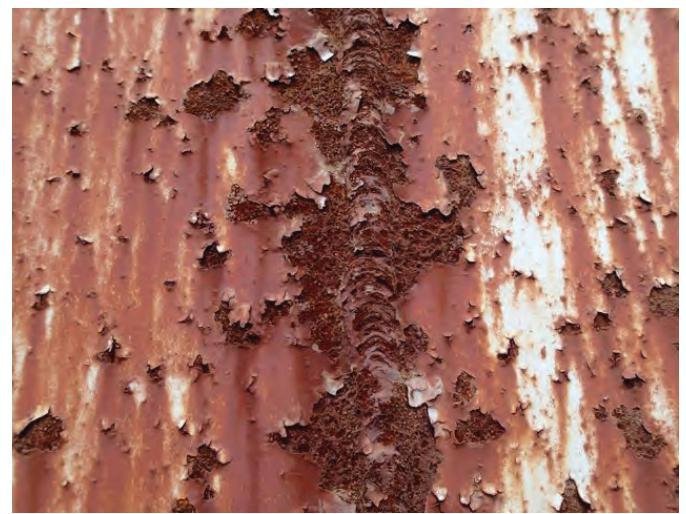
16 *Exterior Wall With Surface Corrosion And Minimal Steel Fatigue (Pitting)*

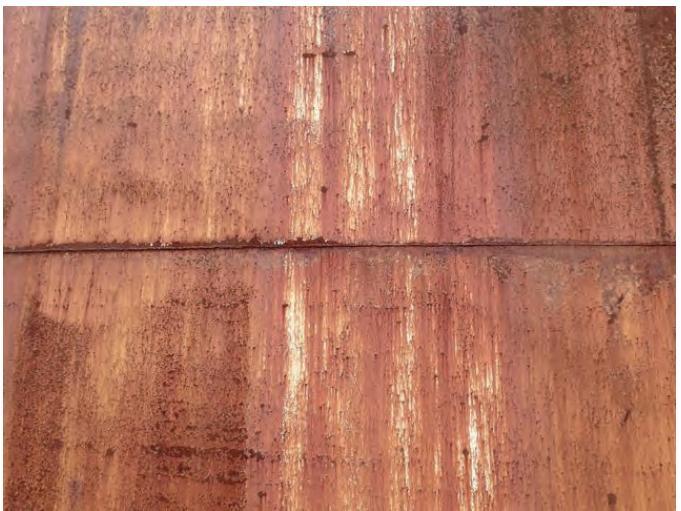
18 *Exterior Weld Between Wall Panels With Surface Corrosion*

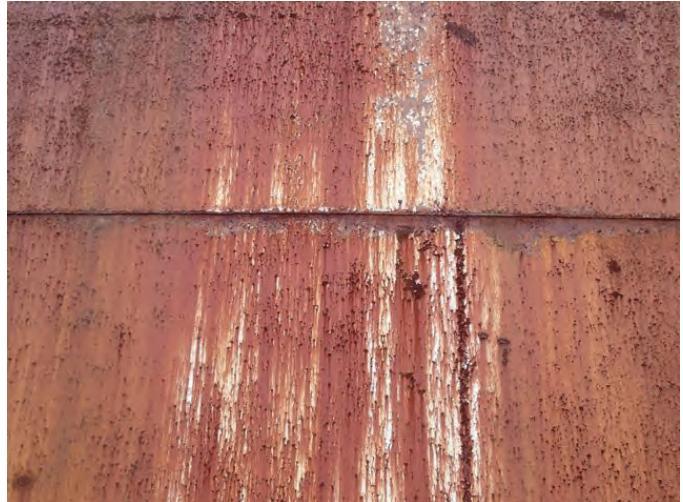
Exterior Weld Between Wall Panels With Surface 19 Corrosion

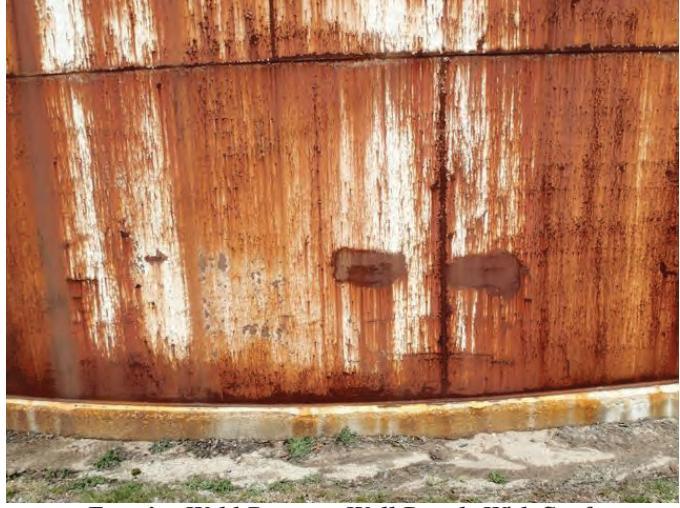
Exterior Weld Between Wall Panels With Surface 20 *Corrosion*

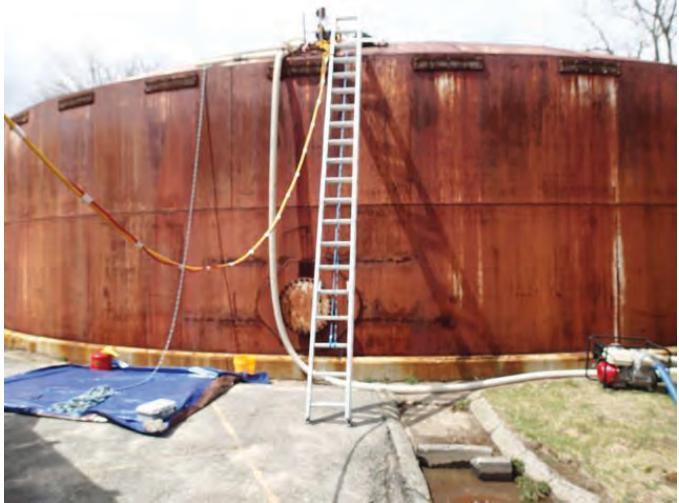
22 Secure Manway With Secondary Coating Loss, 22 Exposed Primary Coating, Exposed Underlying Steel And Mild Surface Corrosion

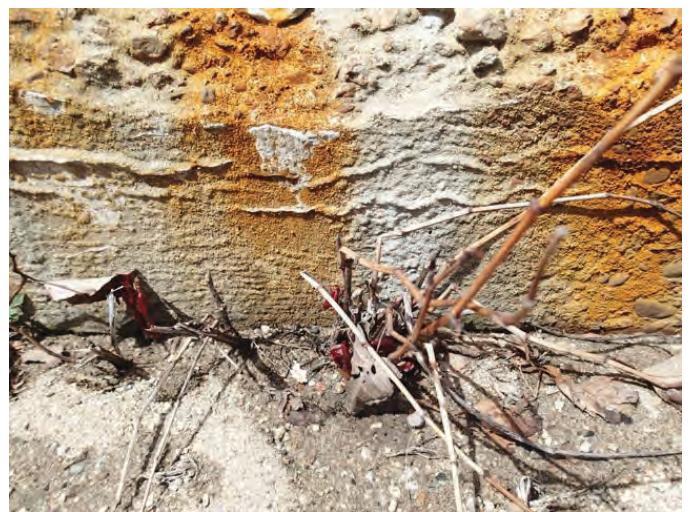
24 Concrete Foundation With Tight Surface Cracks And Spall

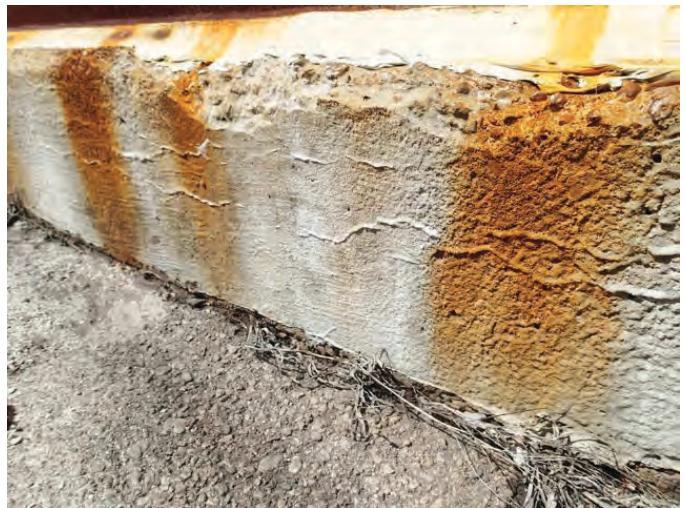
25 Concrete Foundation With Tight Surface Cracks And Spall

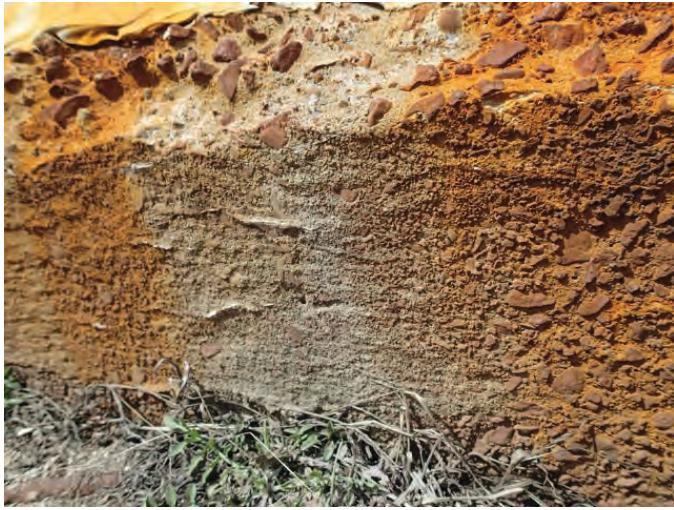
Concrete Foundation With Tight Surface Cracks And 26 Spall

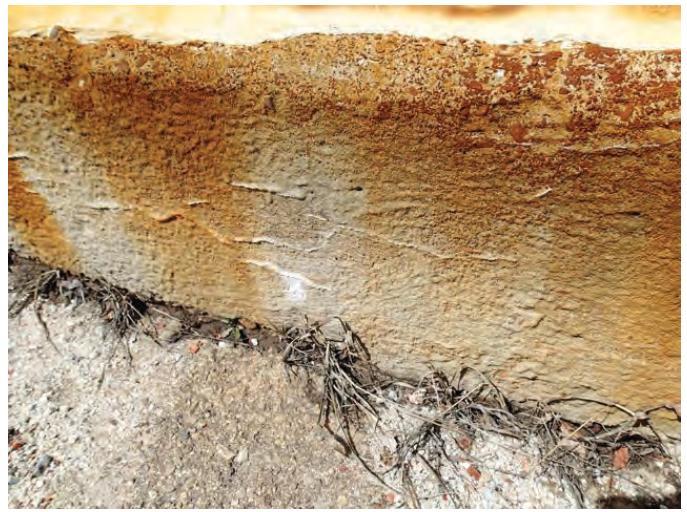
27 Concrete Foundation With Tight Surface Cracks And Spall

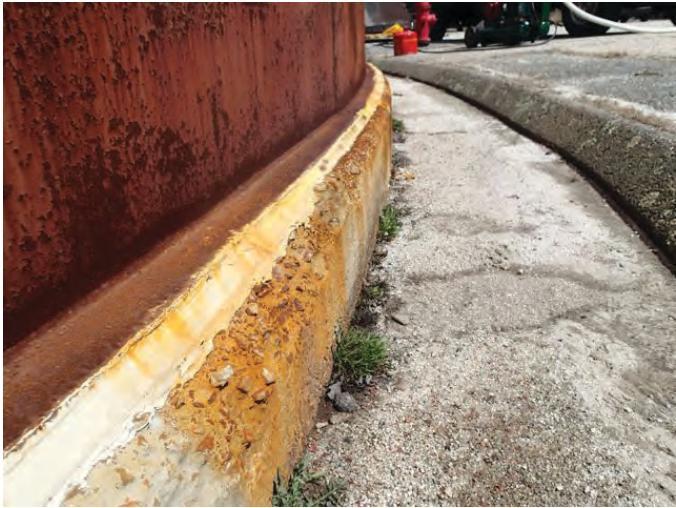
28 *Concrete Foundation With Tight Surface Cracks*

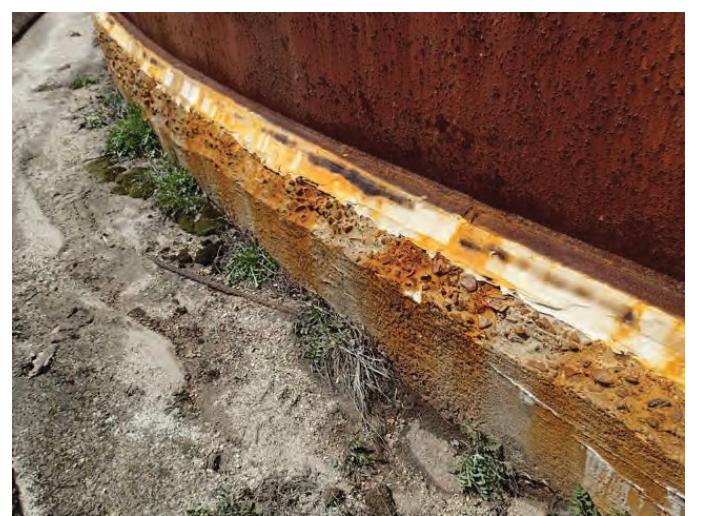
29 Concrete Foundation With Spall

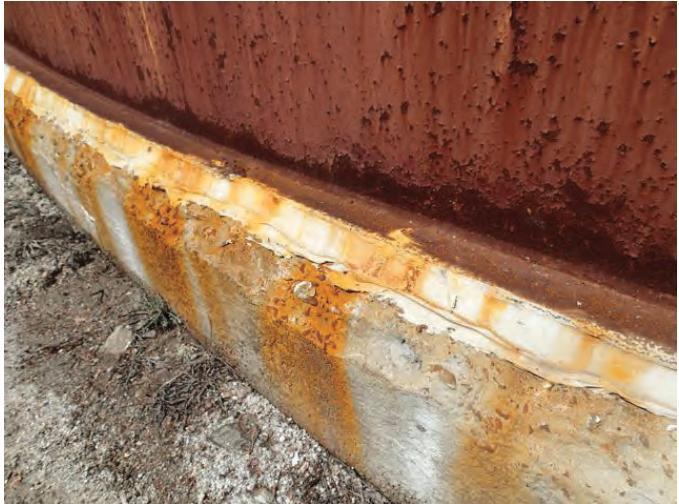
30 Concrete Foundation With Spall

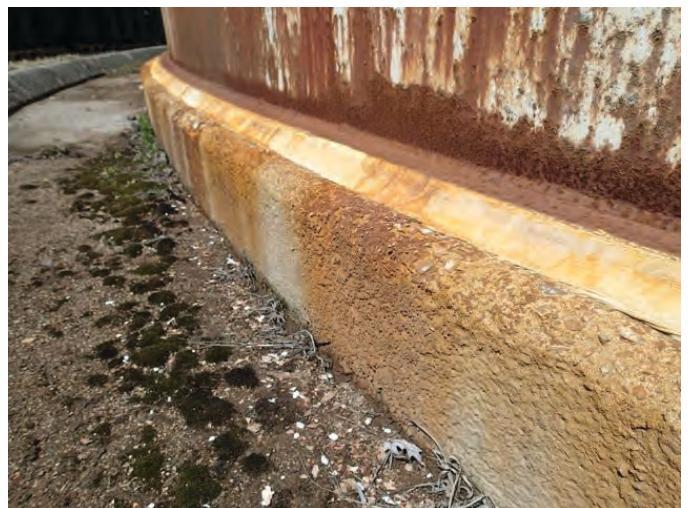
Concrete Foundation With Spall

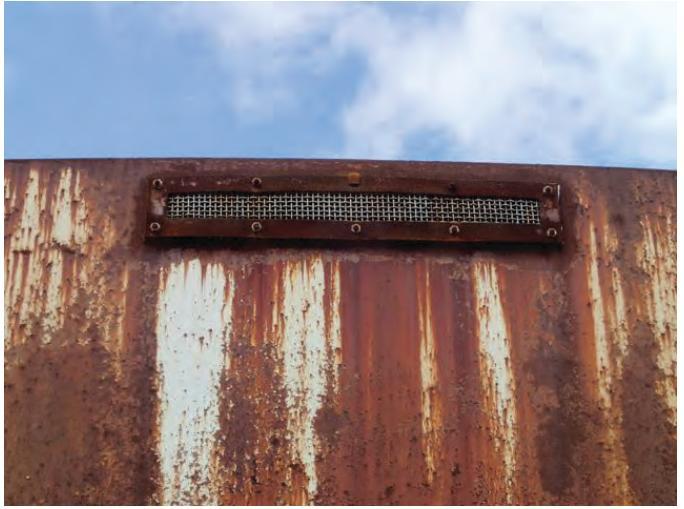
42 Secure Overflow Screen Cutout

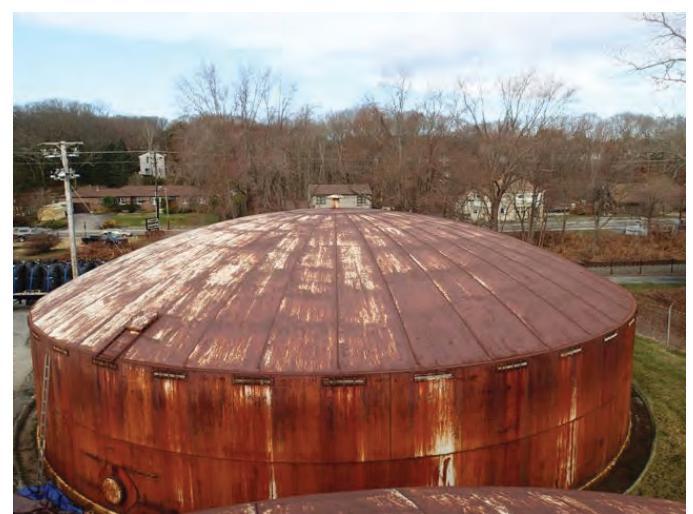
43 Secure Overflow Screen Cutout

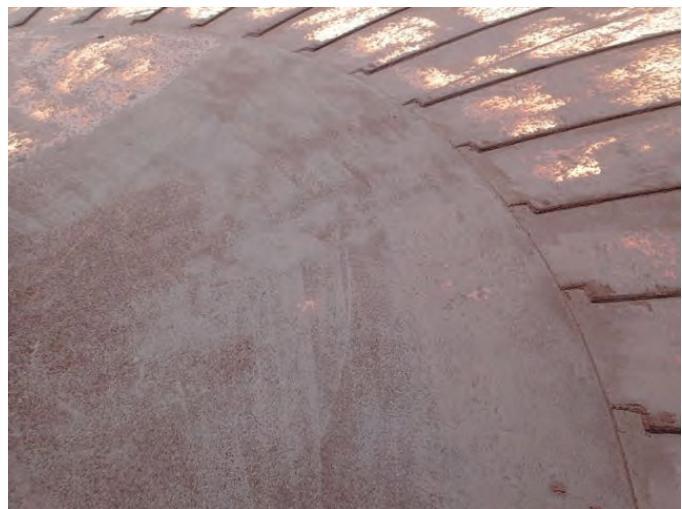
Roof Panels With Coating Loss, Exposed Secondary/
Primary Coating, Exposed Underlying Steel, Mild Surface Corrosion And Steel Corrosion

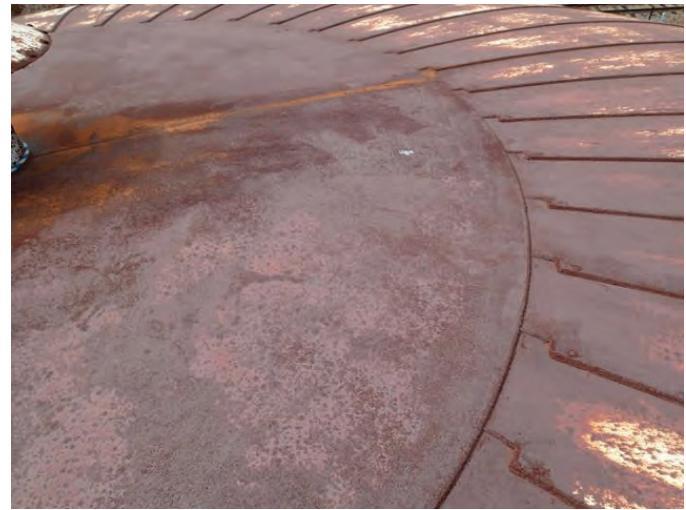
45 Roof Panels With Coating Loss, Exposed Secondary/ Primary Coating, Exposed Underlying Steel, Mild Surface Corrosion And Steel Corrosion

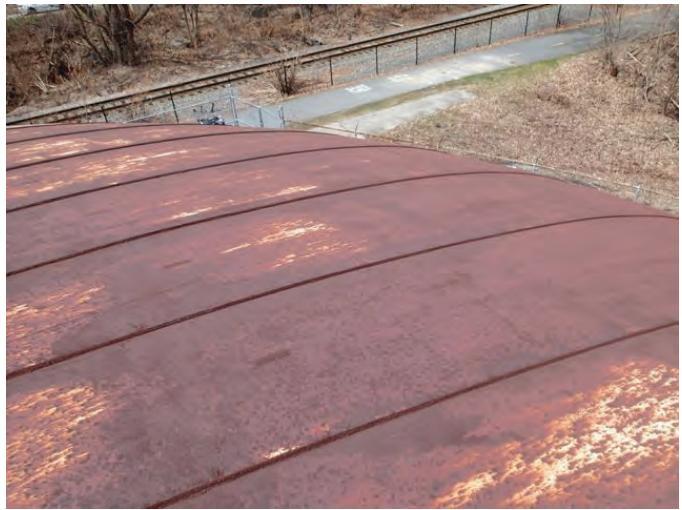
46 Roof Panels With Coating Loss, Exposed Secondary/ Primary Coating, Exposed Underlying Steel, Mild Surface Corrosion And Steel Corrosion

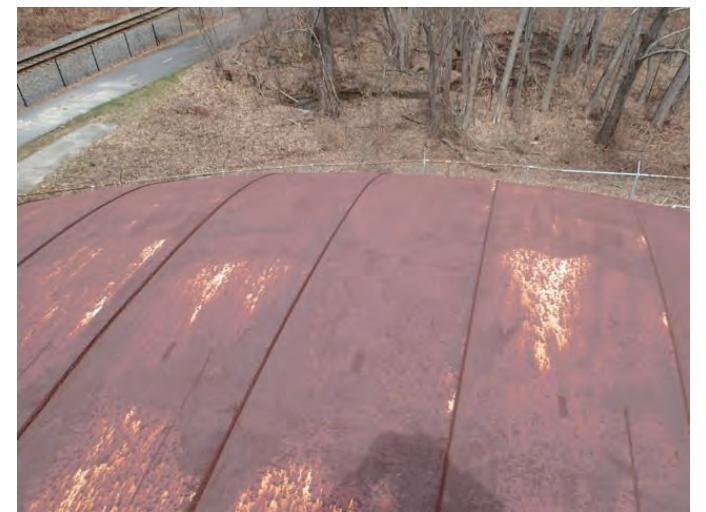
47 Roof Panels With Coating Loss, Exposed Secondary/ Primary Coating, Exposed Underlying Steel, Mild Surface Corrosion And Steel Corrosion

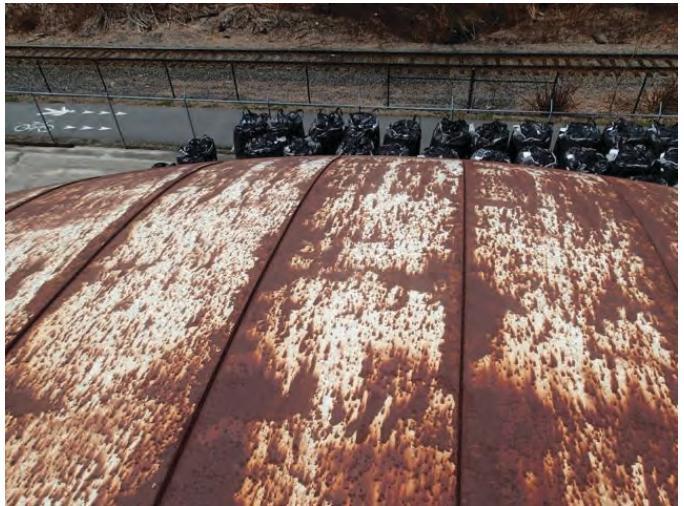
48 Roof Panels With Coating Loss, Exposed Secondary/ Primary Coating, Exposed Underlying Steel, Mild Surface Corrosion And Steel Corrosion

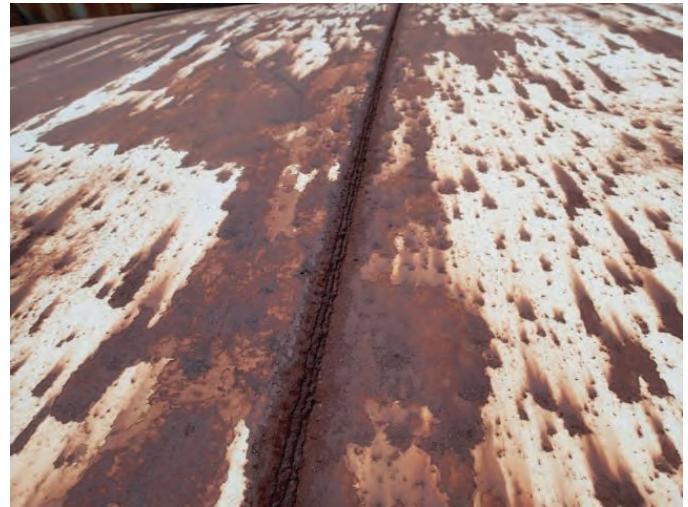
49 Roof Panels With Coating Loss, Exposed Secondary/ Primary Coating, Exposed Underlying Steel, Mild Surface Corrosion And Steel Corrosion

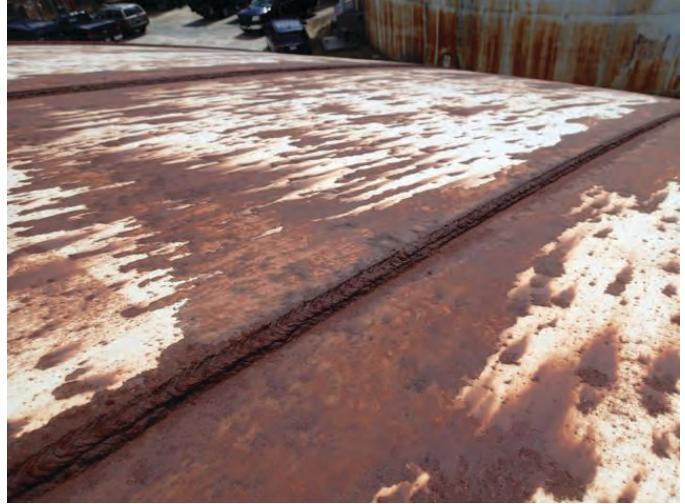
Roof Panels With Coating Loss, Exposed Secondary/
Primary Coating, Exposed Underlying Steel, Mild
Surface Corrosion And Steel Corrosion

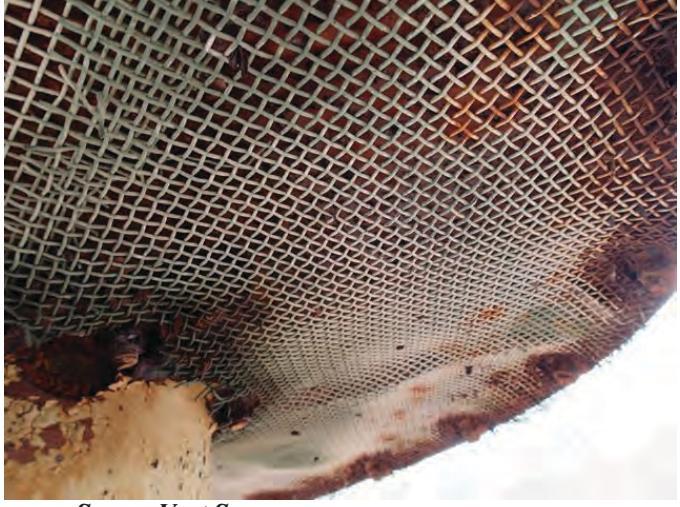
52 Secure Vent Cap With Expired Coating, Exposed 52 Steel And Corrosion

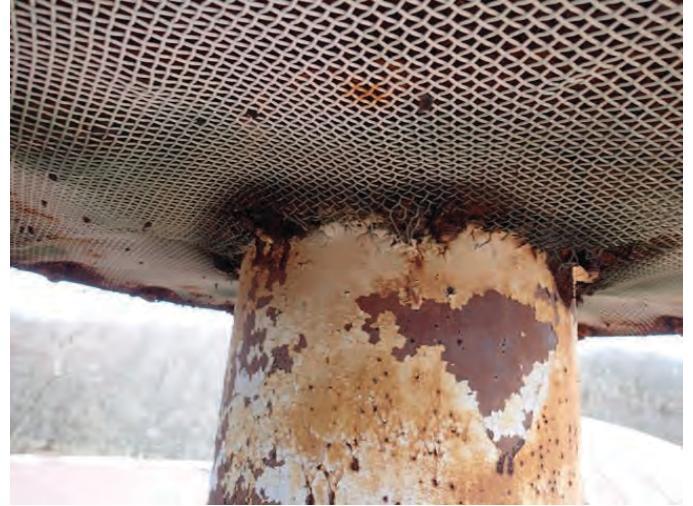
53 Secure Vent Screen

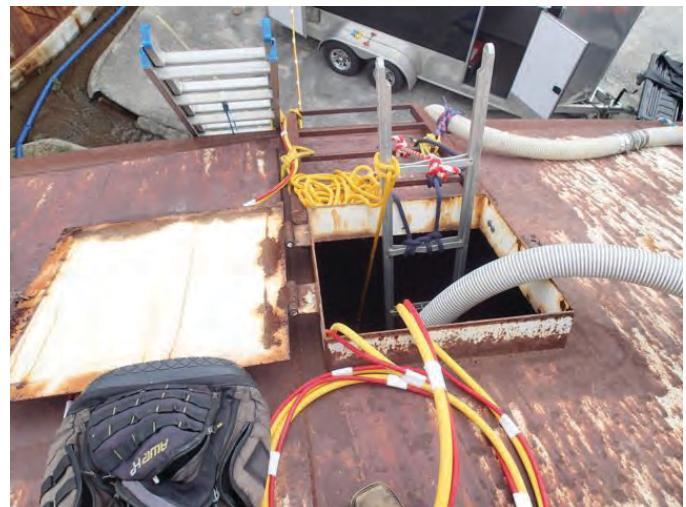
54 Secure Vent Screen

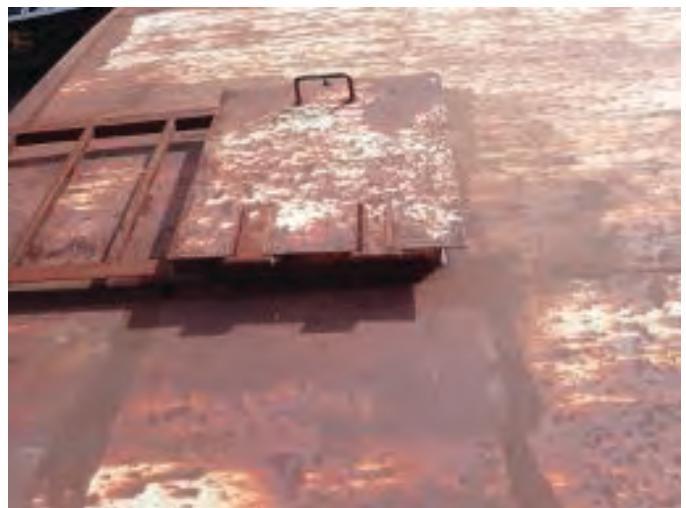
Open Access Hatch With Expired Coating, Exposed55Steel And Corrosion

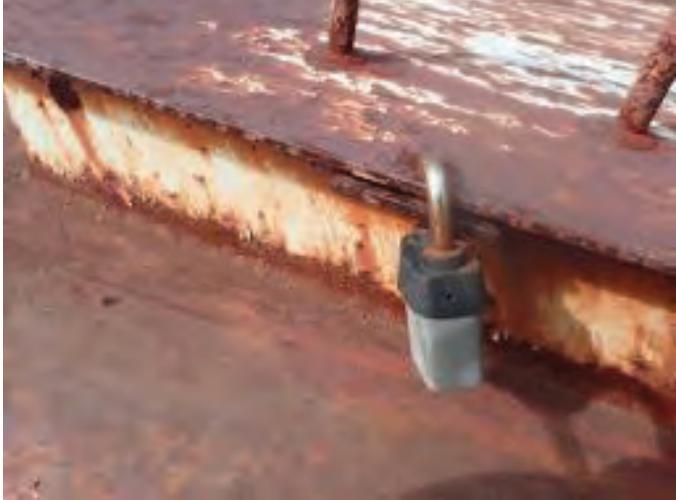
Closed Access Hatch With Expired Coating, Exposed56Steel And Corrosion

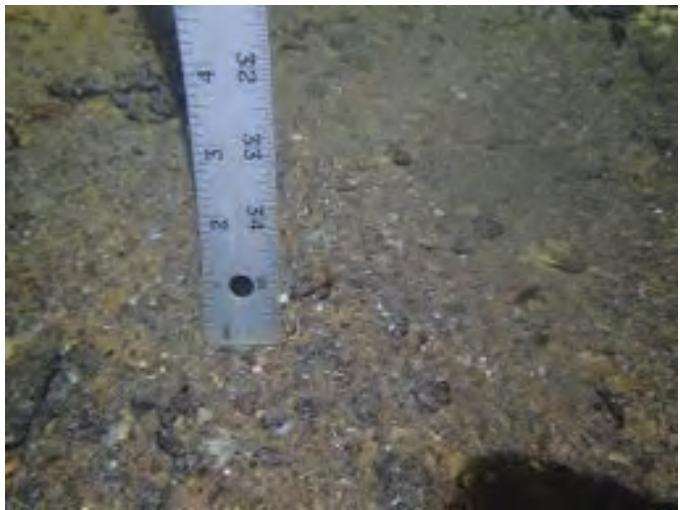
57 Secure Access Hatch

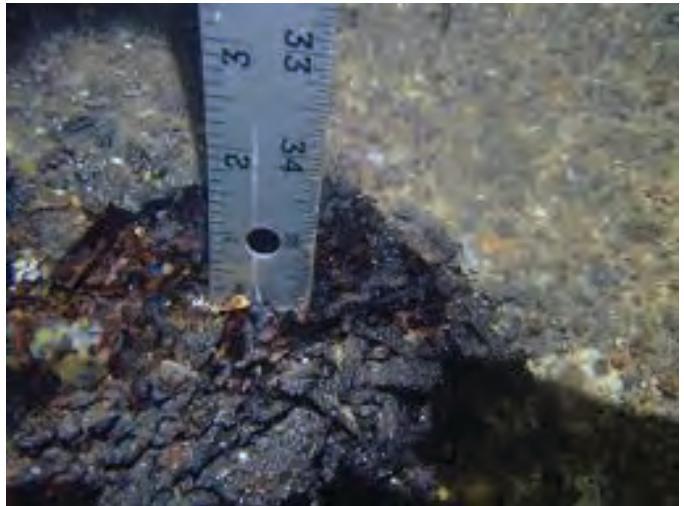
Layer Of Precipitate 58

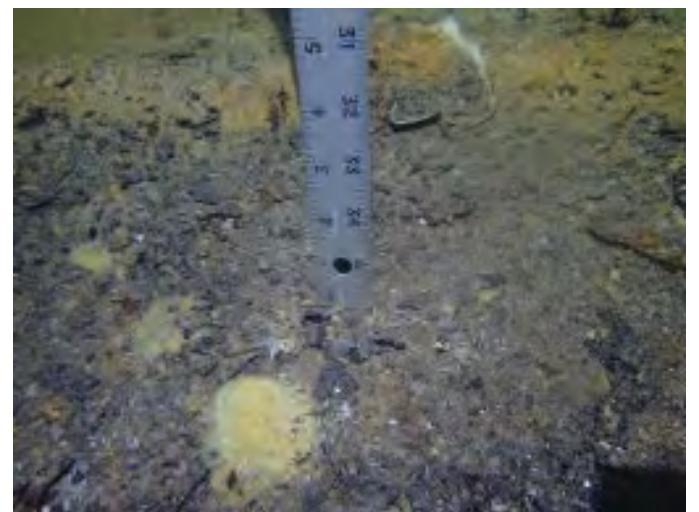
59 *Layer Of Precipitate*

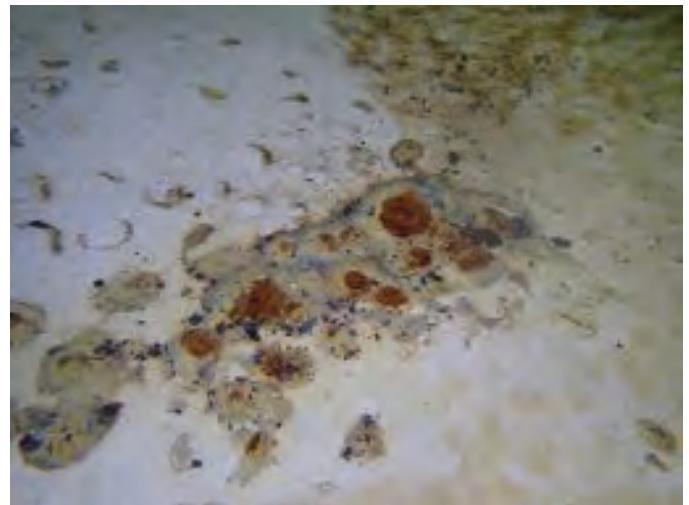
60 *Layer Of Precipitate*

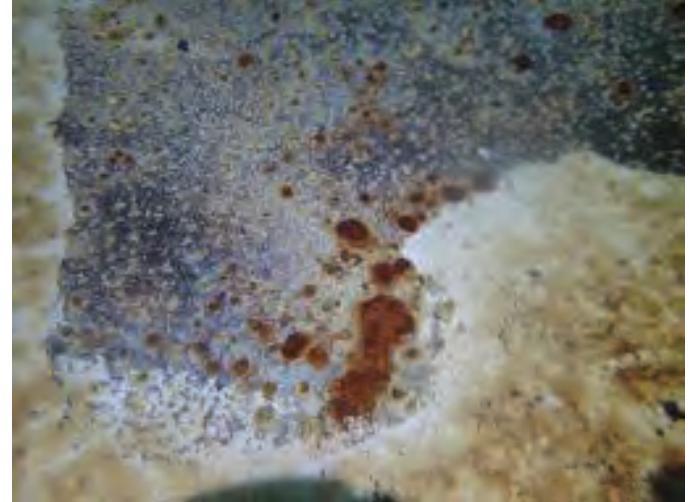
61 Floor With Ruptured Coating Blisters, Exposed Underlying Steel, Mild Surface Corrosion And Mild To Moderate Staining

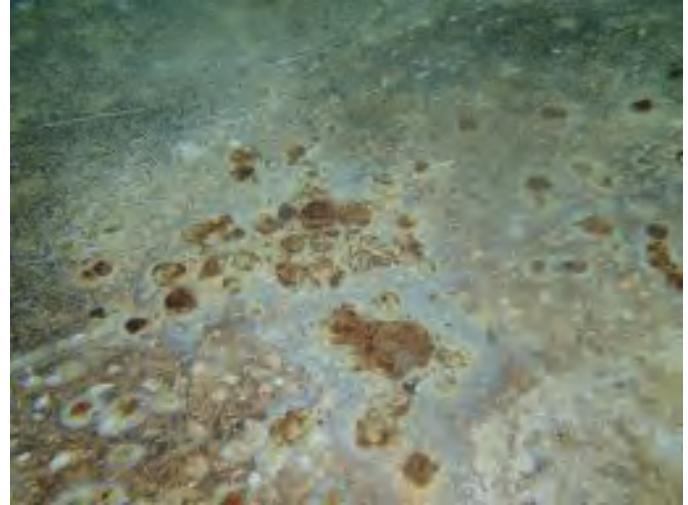
62 Floor With Ruptured Coating Blisters, Exposed Ounderlying Steel, Mild Surface Corrosion And Mild To Moderate Staining

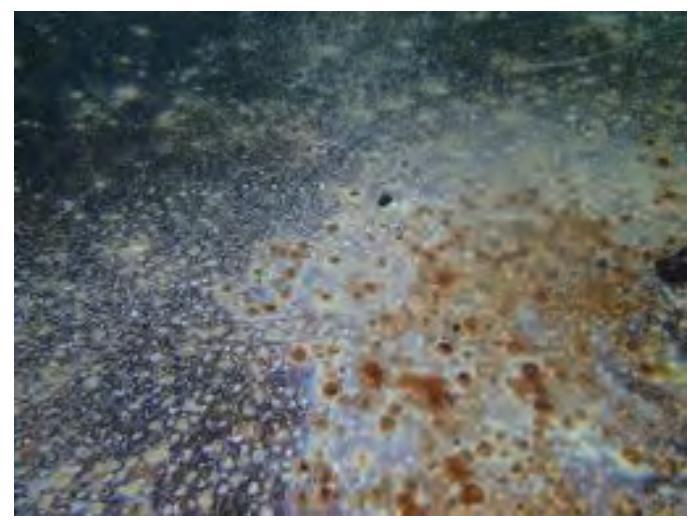
64 Floor With Ruptured Coating Blisters, Exposed Underlying Steel, Mild Surface Corrosion And Mild To Moderate Staining

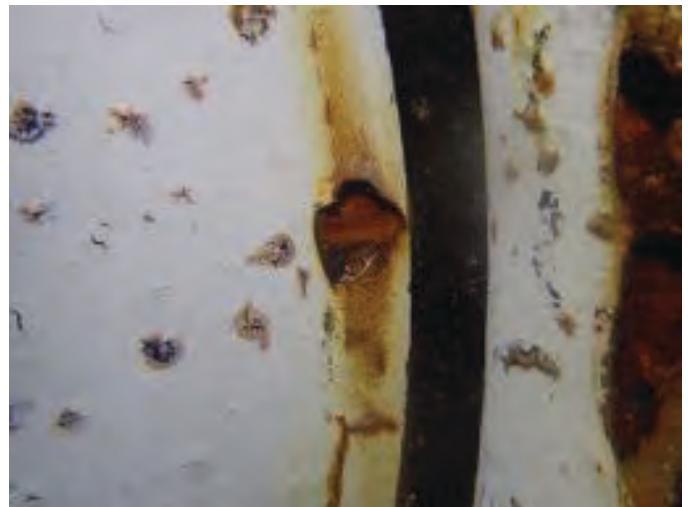
66 Manway

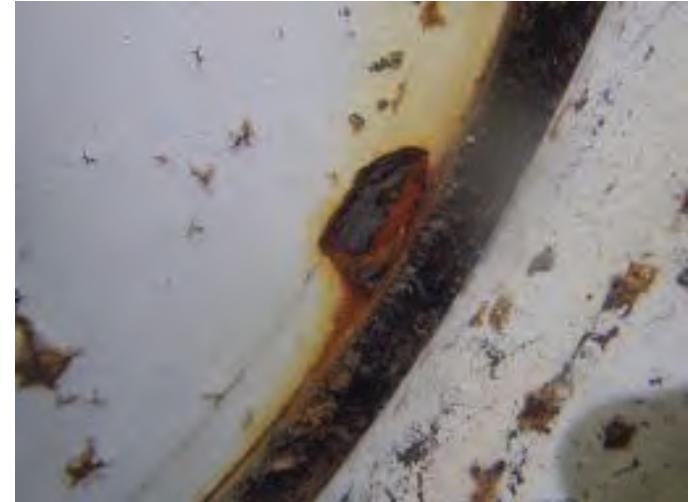
Manway Lid With Coating Loss/Blistering/Cracking,
Exposed Underlying Steel, Corrosion And Fatigue (Pitting)

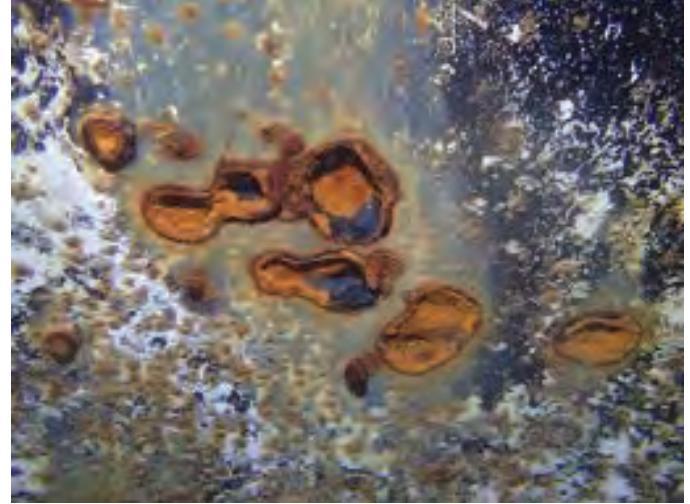
Manway Lid With Coating Loss/Blistering/Cracking,
Exposed Underlying Steel, Corrosion And Fatigue (Pitting)

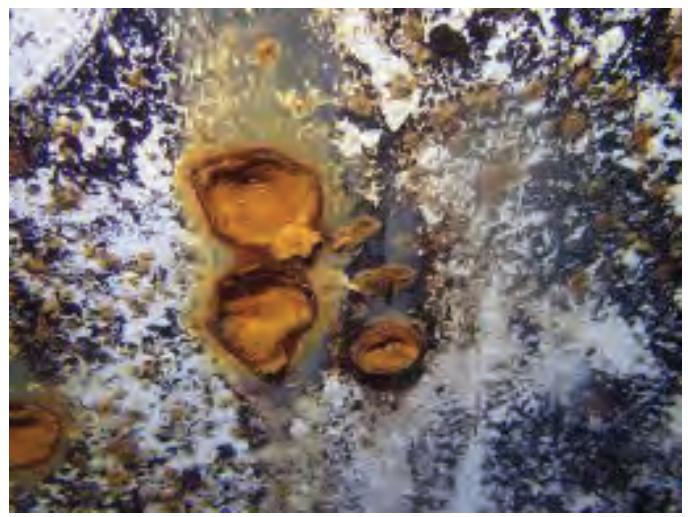
Manway Trunk With Coating Loss/Blistering/ Cracking, Exposed Underlying Steel, Corrosion And Fatigue (Pitting)

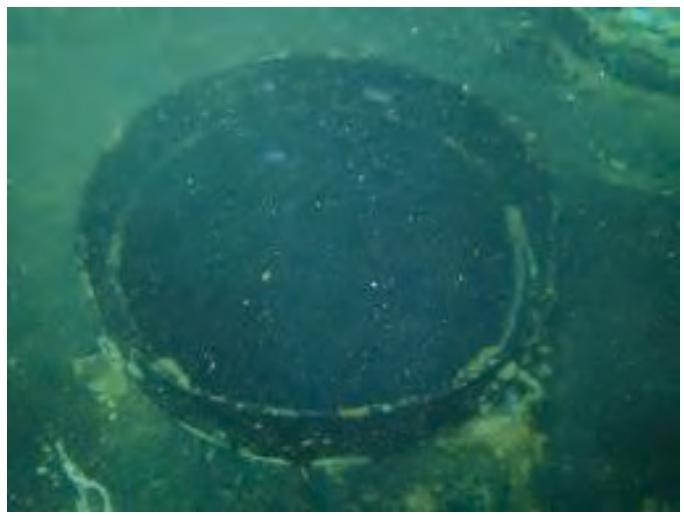
70 Manway Trunk With Coating Loss/Blistering/ Cracking, Exposed Underlying Steel, Corrosion And Fatigue (Pitting)

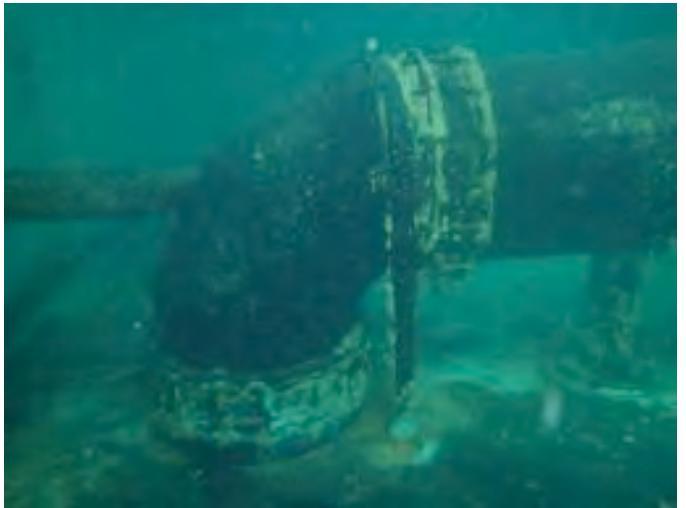
72 23" Inside Diameter Pipe Penetrating The Tank Floor With Coating Loss/Blistering, Exposed Underlying Steel And Mild To Moderate Corrosion

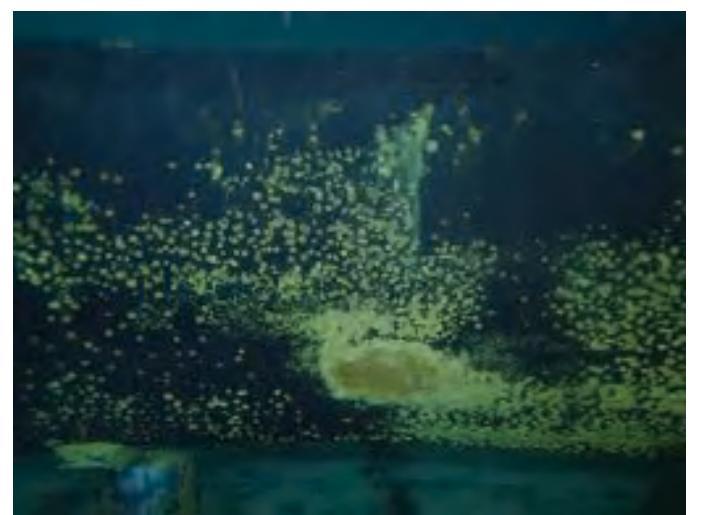
28" Inside Diameter Pipe Penetrating The Tank Floor
With Ruptured Coating Blisters, Exposed Underlying Metal And Mild To Moderate Surface Corrosion

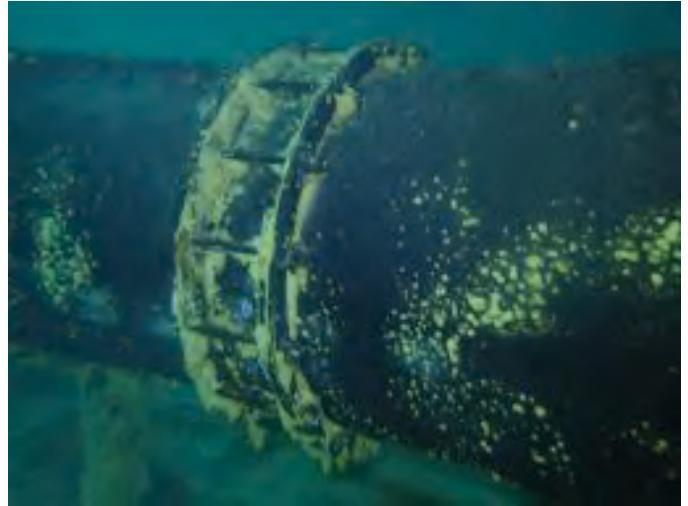
28" Inside Diameter Pipe With Ruptured Coating
74 Blisters, Exposed Underlying Metal And Mild To
Moderate Surface Corrosion

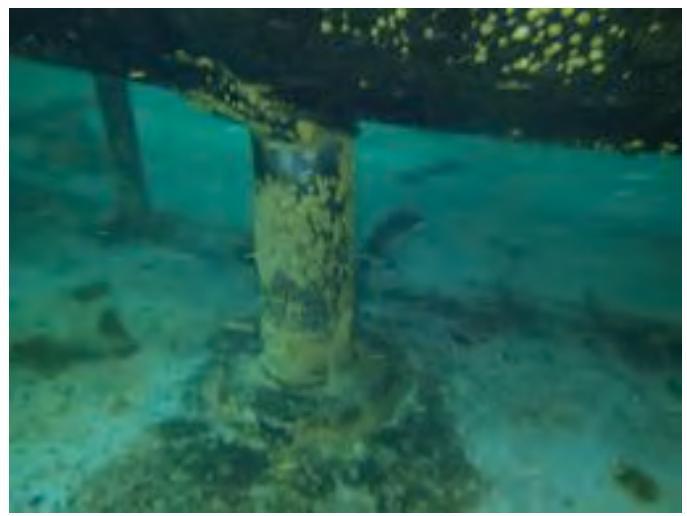
28" Inside Diameter Pipe Standoff With Ruptured
Coating Blisters, Exposed Underlying Metal And
Mild To Moderate Surface Corrosion

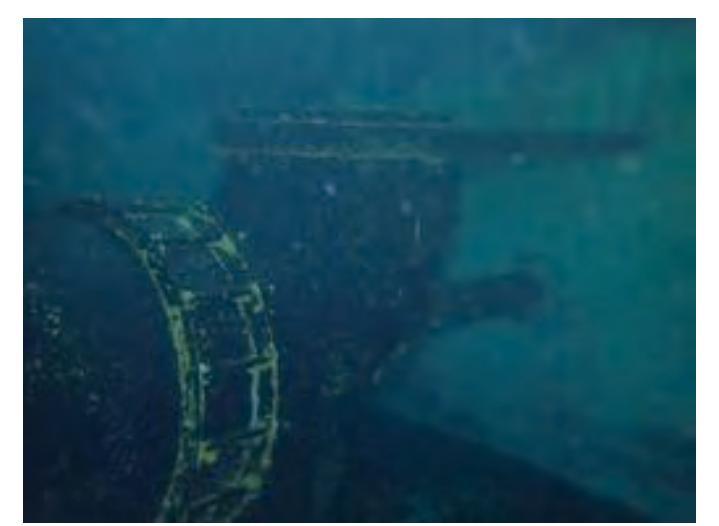
77 28" Inside Diameter Pipe Standoff With Ruptured Coating Blisters, Exposed Underlying Metal And Mild To Moderate Surface Corrosion

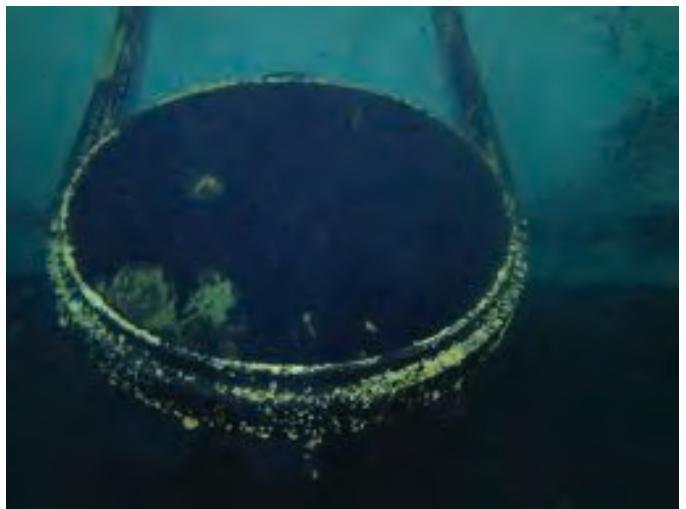
78 28" Inside Diameter Pipe Turning 90° Up

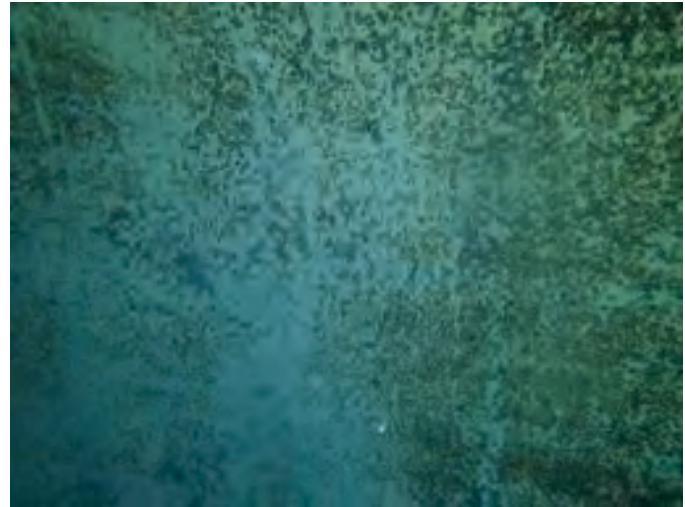
28" Inside Diameter Pipe With Ruptured Coating
Blisters, Exposed Underlying Metal And
Mild To Moderate Surface Corrosion

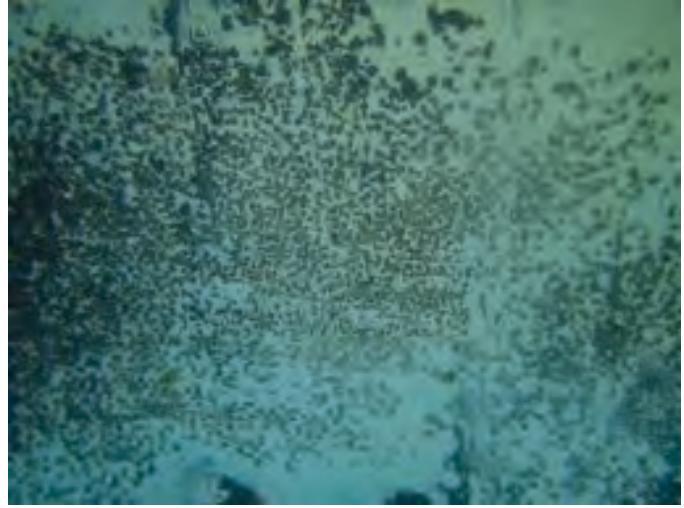
Interior Wall With Ruptured Coating Blisters, 80 Exposed Underlying Steel, Fatigue (Pitting), Corrosion And Mild Staining

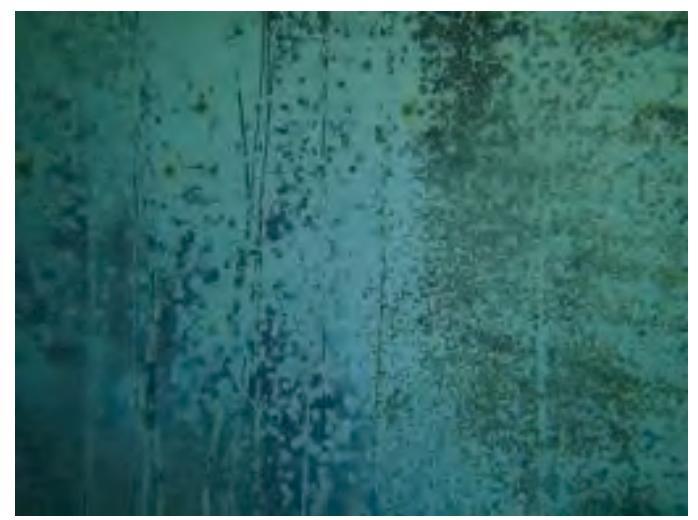
81 Interior Wall With Ruptured Coating Blisters, Exposed Underlying Steel, Fatigue (Pitting), Corrosion And Mild Staining

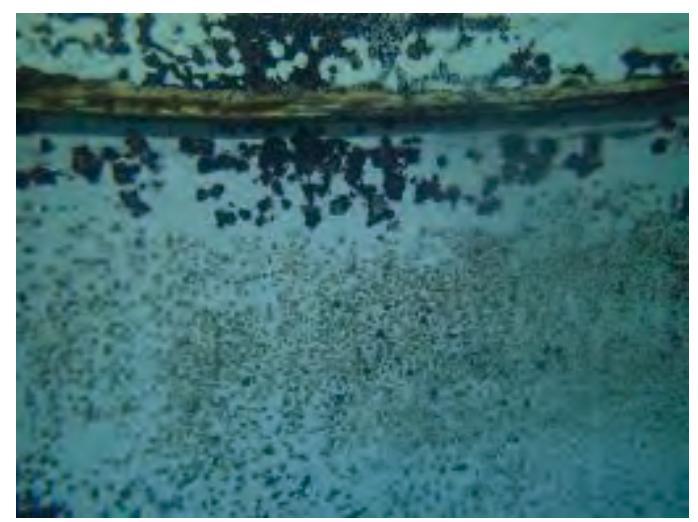
82 Interior Wall With Ruptured Coating Blisters, Exposed Underlying Steel, Fatigue (Pitting), Corrosion And Mild Staining

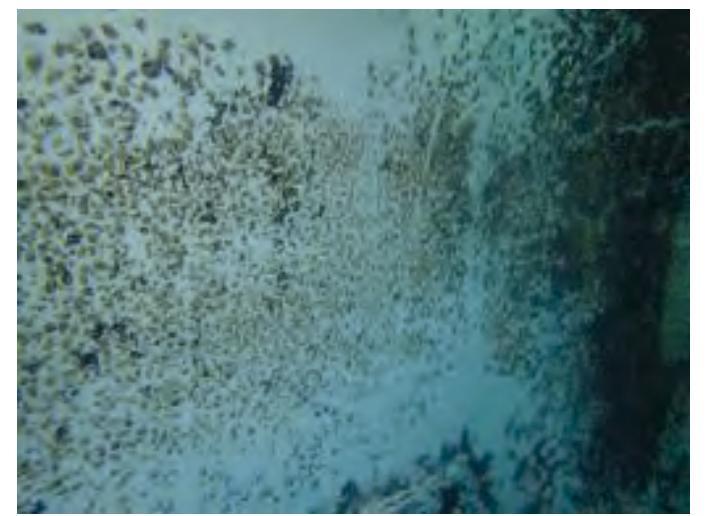
83 Interior Wall With Ruptured Coating Blisters, Exposed Underlying Steel, Fatigue (Pitting), Corrosion And Mild Staining

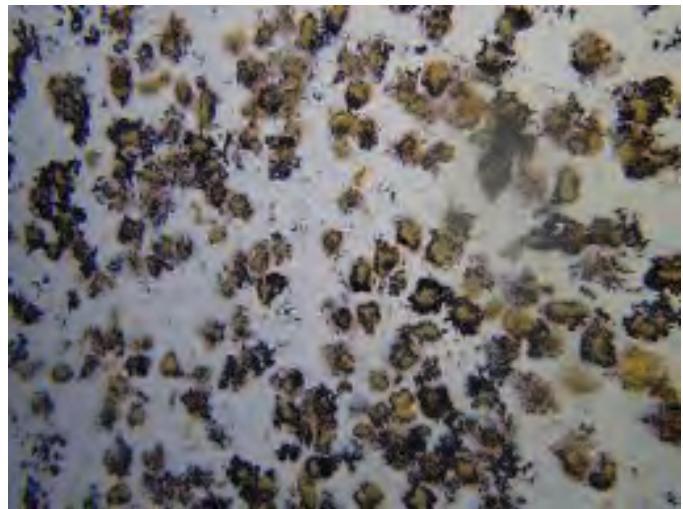
84 Interior Wall With Ruptured Coating Blisters, Exposed Underlying Steel, Fatigue (Pitting), Corrosion And Mild Staining

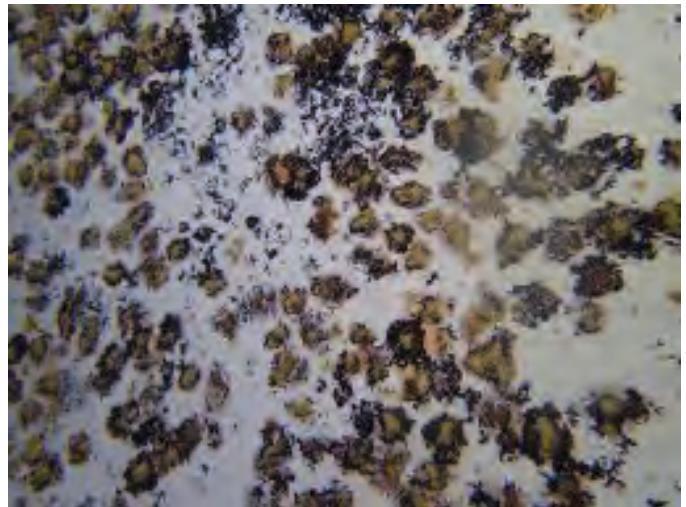
Interior Wall With Ruptured Coating Blisters,
Exposed Underlying Steel, Fatigue (Pitting),
Corrosion And Mild Staining

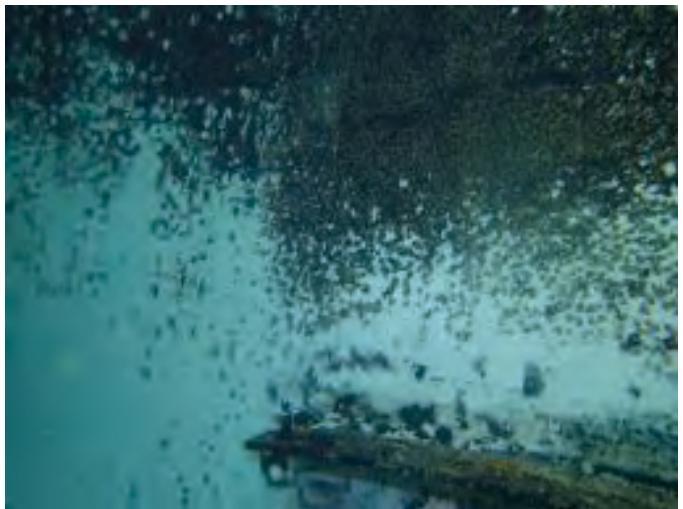
91 Interior Wall With Ruptured Coating Blisters, 91 Exposed Underlying Steel, Fatigue (Pitting), Corrosion And Mild Staining

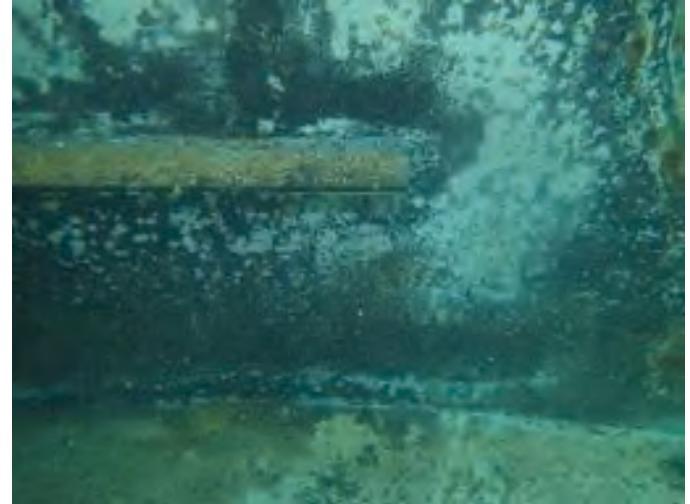
92 Interior Wall With Ruptured Coating Blisters, Exposed Underlying Steel, Fatigue (Pitting), Corrosion And Mild Staining

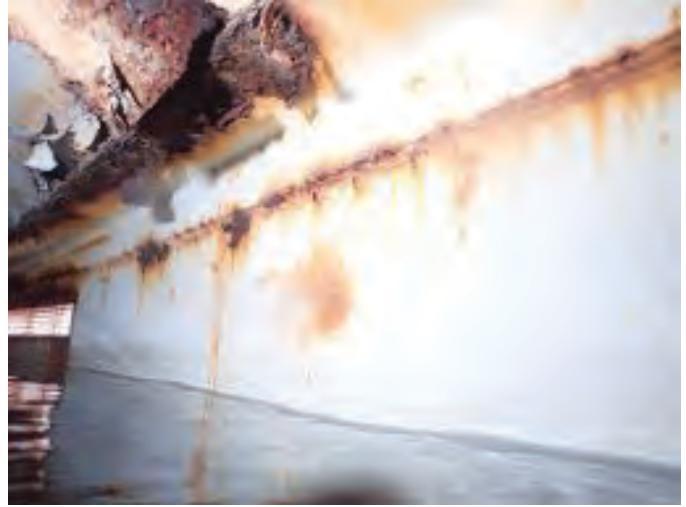
93 Interior Wall With Ruptured Coating Blisters, Exposed Underlying Steel, Fatigue (Pitting), Corrosion And Mild Staining

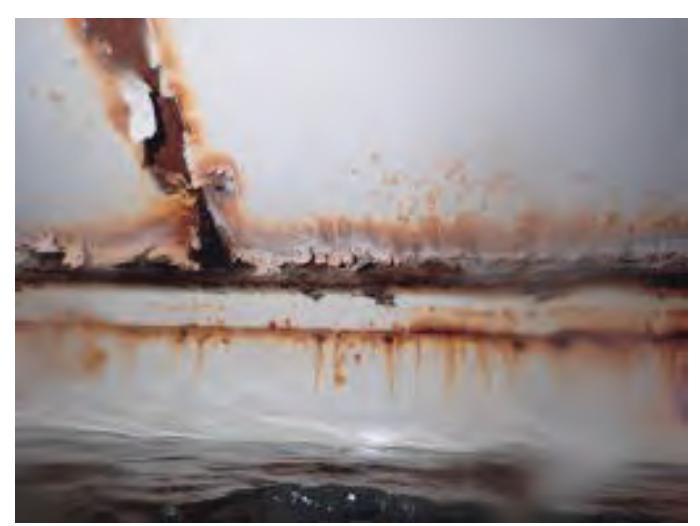
94 Interior Wall With Ruptured Coating Blisters, Exposed Underlying Steel, Fatigue (Pitting), Corrosion And Mild Staining

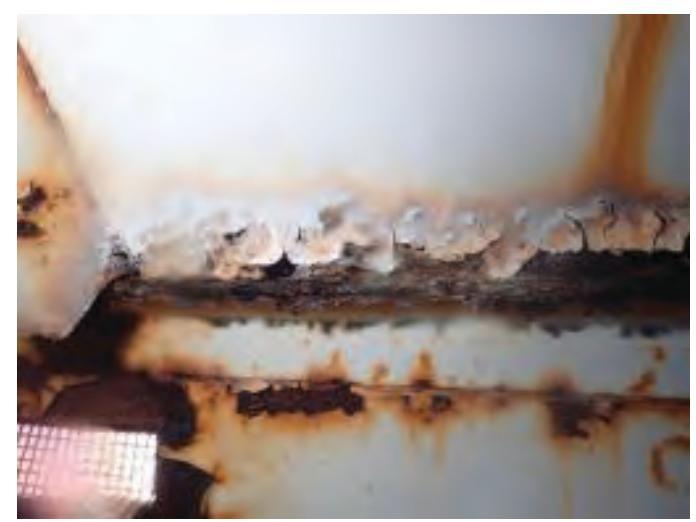
95 Interior Wall With Ruptured Coating Blisters, Exposed Underlying Steel, Fatigue (Pitting), Corrosion And Mild Staining

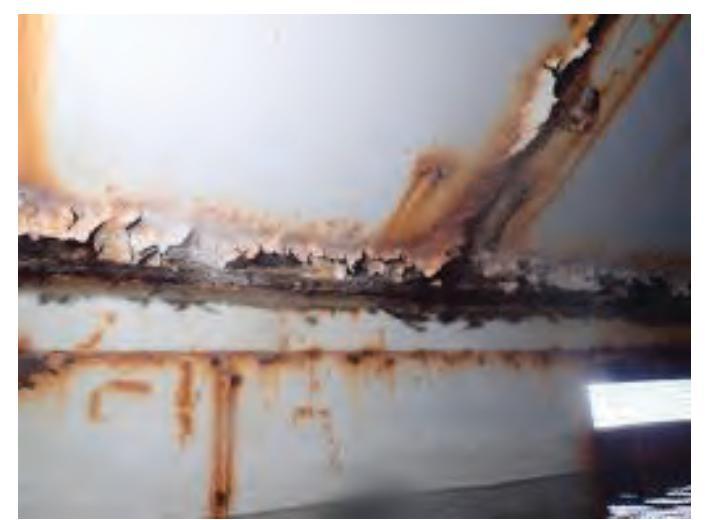
96 Interior Wall With Ruptured Coating Blisters, Exposed Underlying Steel, Fatigue (Pitting), Corrosion And Mild Staining

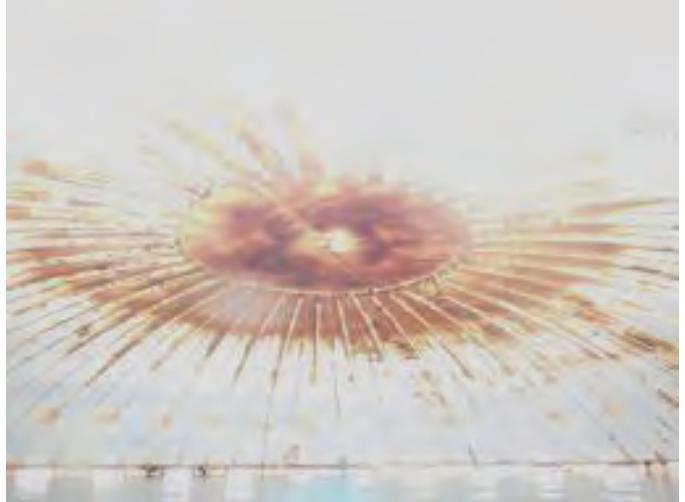
97 Overhead With Coating Thinning, Exposed Underlying Steel And Mild To Moderate Surface Corrosion

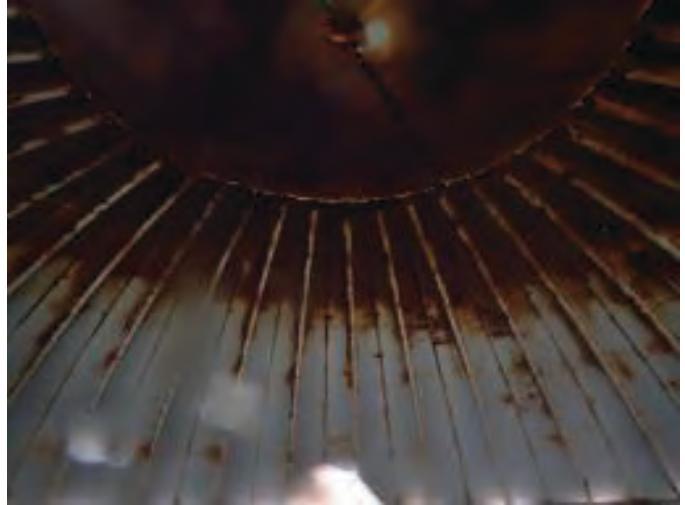
98 Overhead With Coating Thinning, Exposed Underlying Steel And Mild To Moderate Surface Corrosion

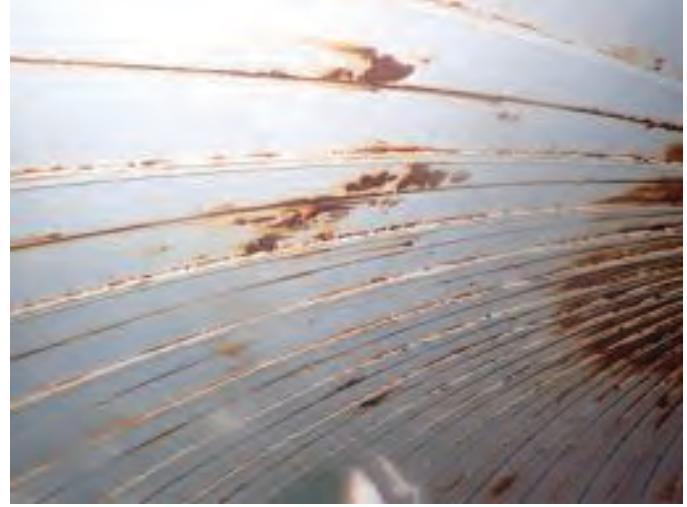
99 Overhead With Coating Loss, Exposed Steel And Surface Corrosion
