In re: City of Woonsocket Water Division - Application to Implement Multi-Year Rate Plan

Docket No. 4879

Dam Name (No):	Woonsocket Reservoir #3 Dam (068)
Location:	Smithfield/North Smithfield
Hazard Classification:	High
	-
Inspector:	David M. Matheson, P.E.
Inspection Date.	August 1, 2014

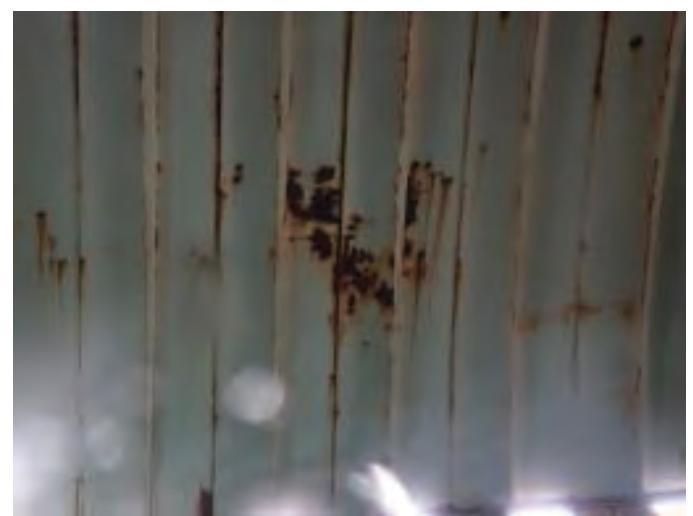
Overhead With Coating Loss, Exposed Steel And100Surface Corrosion

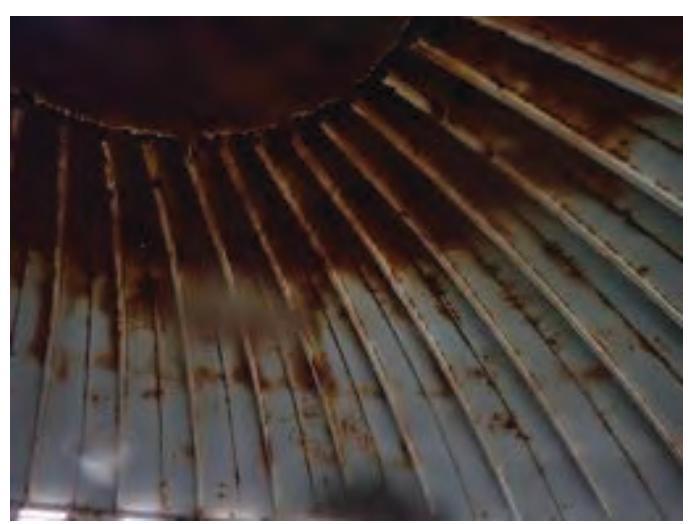
101 Overhead With Coating Loss, Exposed Steel And Surface Corrosion

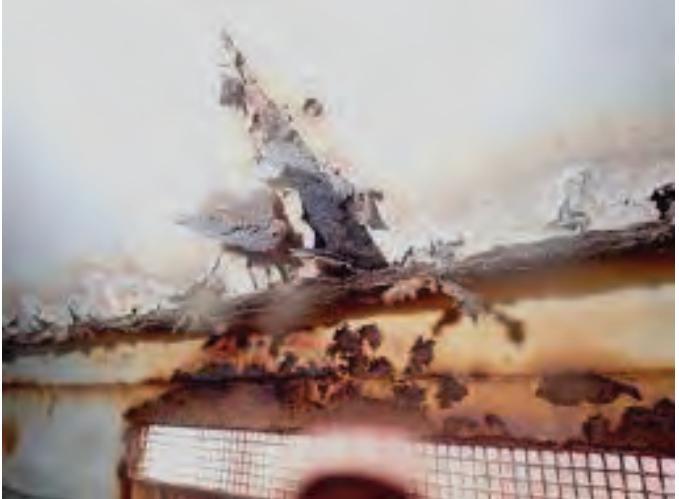
Overhead Angle Iron Supports With Coating Loss,103Exposed Steel, Corrosion And Fatigue
(Deterioration)

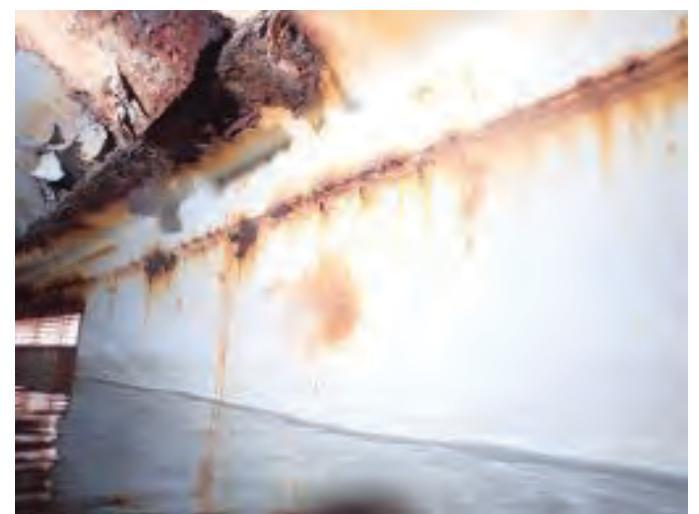
Overhead Angle Iron Supports With Coating Loss, 104 Exposed Steel, Corrosion And Fatigue (Deterioration)

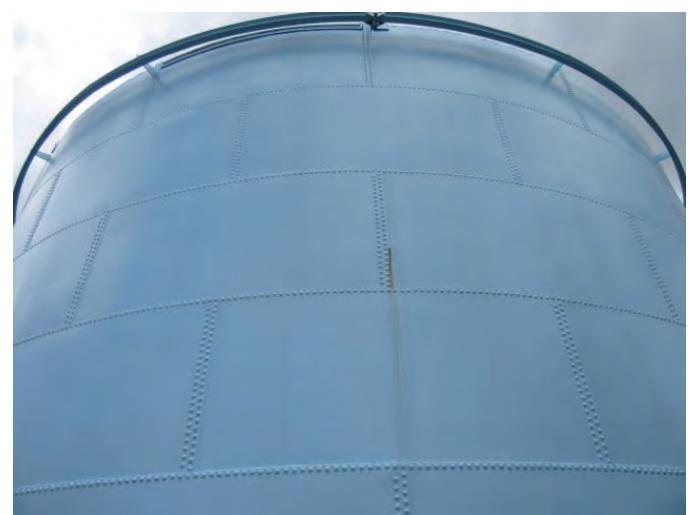
The protective coating applied to the exterior walls appears to have been applied uniformly, meets the AWWA's recommendations and was found having mostly good adhesion value. However, one area of coating loss and exposed steel was observed on the northernmost side of the tank, located within one of the vertical lap joints within the fourth row of wall panels above the tank base. Corrosion of the exposed steel exists within this 1/4" diameter area of coating loss, yet no obvious fatigue (pitting) of the steel was evident at this time.

Northernmost Side Of The Exterior Wall Vertical LapJoint Within The Fourth Row Having Coating Loss,Exposed Steel And Corrosion

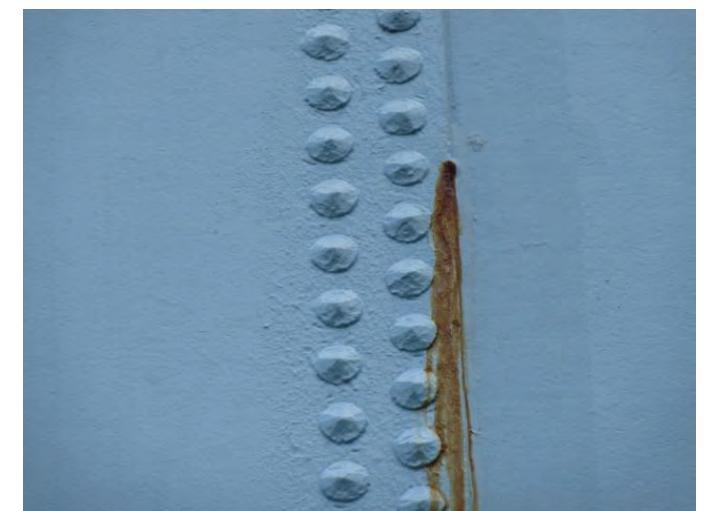
2 Northernmost Side Of The Exterior Wall Vertical Lap 2 Joint Within The Fourth Row Having Coating Loss, Exposed Steel And Corrosion

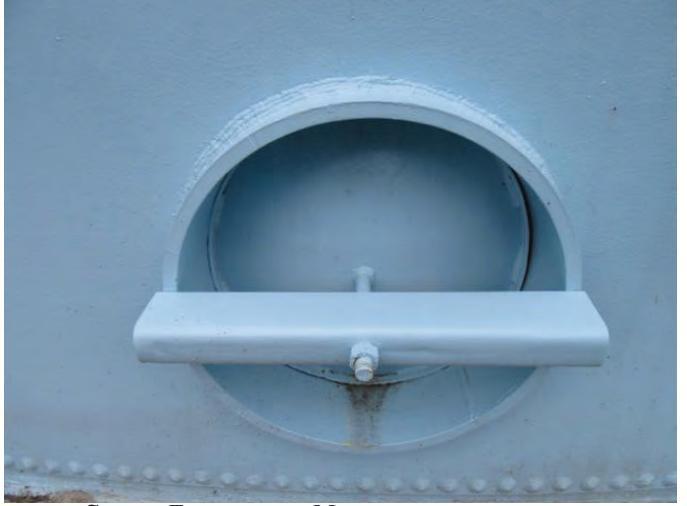
The protective coating applied to the easternmost manway has an average dry film thickness of 23.4 mils and was found having good adhesion value at this time.

15 Secure Easternmost Manway

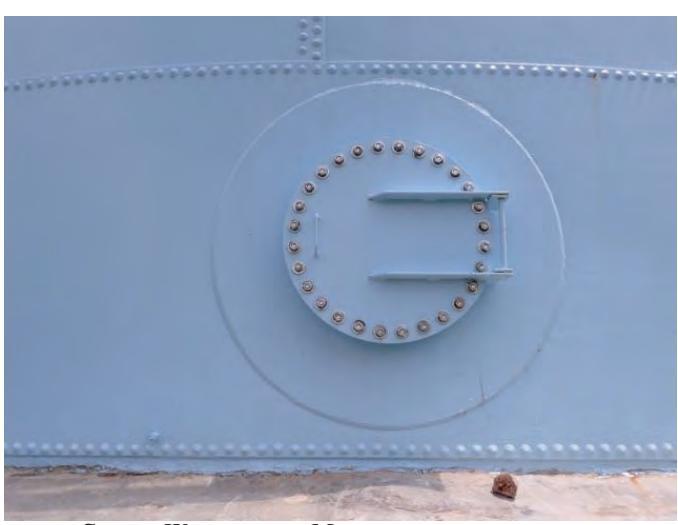
The protective coating applied to the westernmost manway has an average dry film thickness of 16.3 mils and was found having good adhesion value at this time.

16 Secure Westernmost Manway

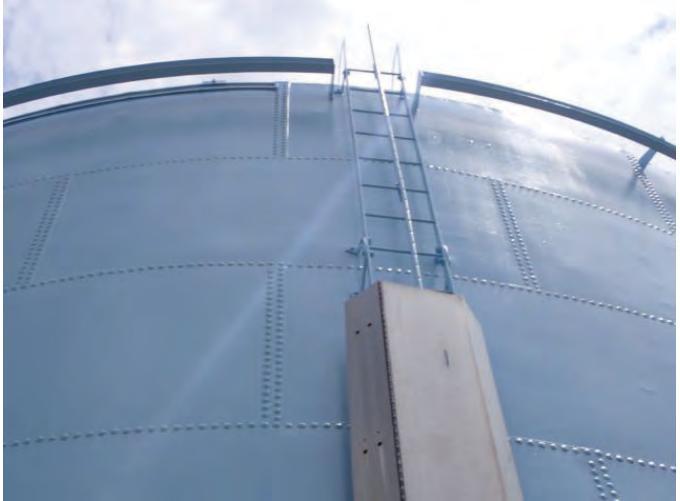
A steel ladder extends from approximately 14' above the ground up to the roof, supported to the tank wall with four sets of riveted standoffs. This ladder has a fall prevention device installed throughout its length, providing safe access to the roof. The protective coating applied to the steel ladder and steel fall prevention device was found having good adhesion value at this time.

17 *Ladder With Fall Prevention Device*

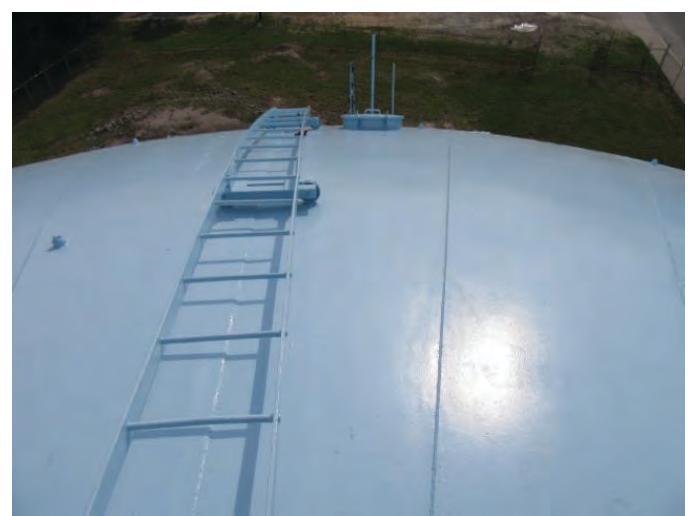
Ladder Extending From Roof Edge To The Vent

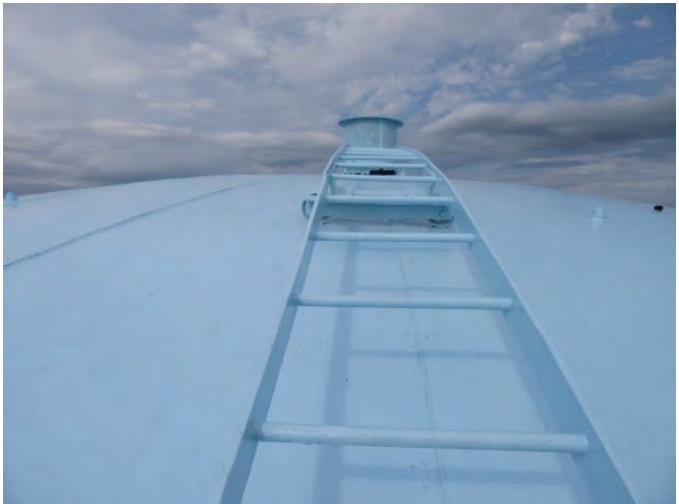
Ladder Extending From Roof Edge To The Vent

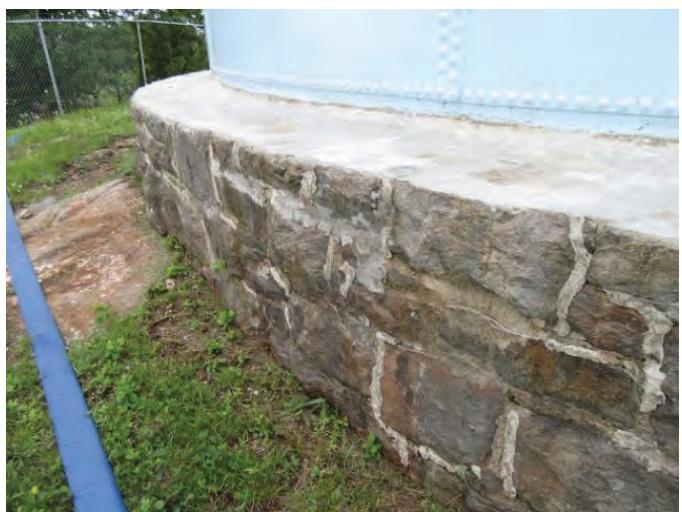
21 Granite Block And Mortar Joint Foundation With Tight Cracks

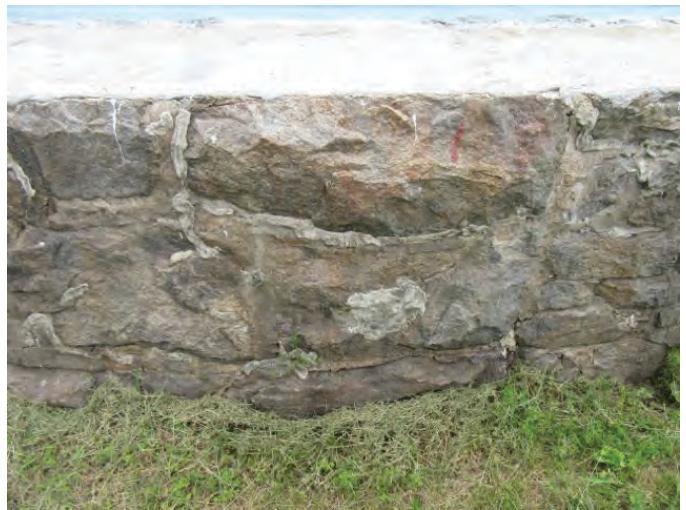
Granite Block And Mortar Joint Foundation With Tight Cracks

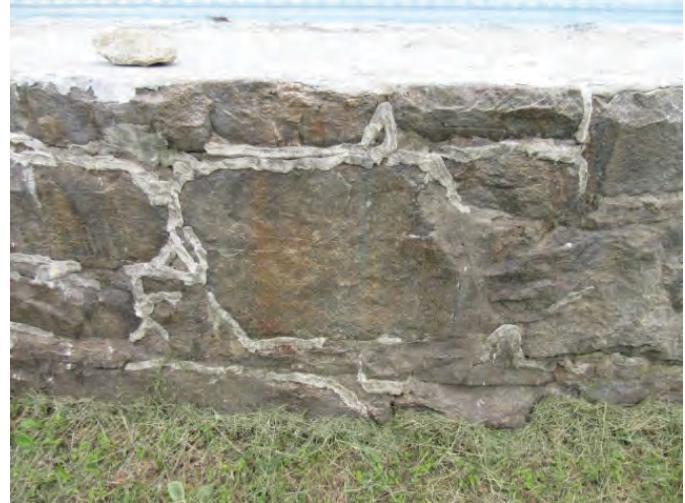
23 Granite Block And Mortar Joint Foundation With Tight Cracks

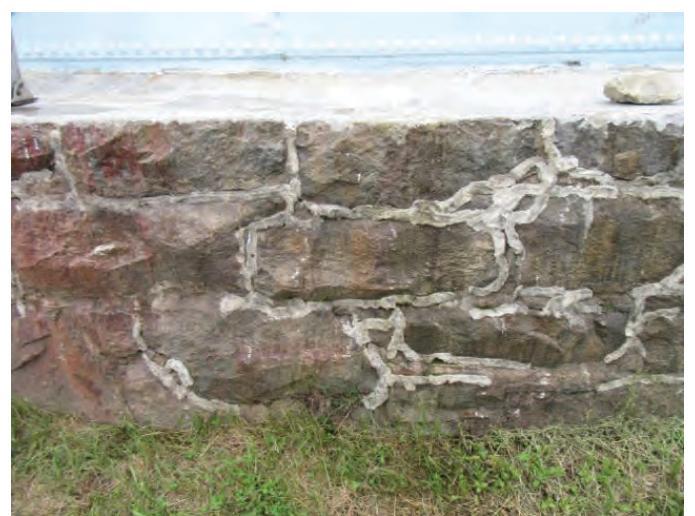
24 Granite Block And Mortar Joint Foundation With Tight Cracks

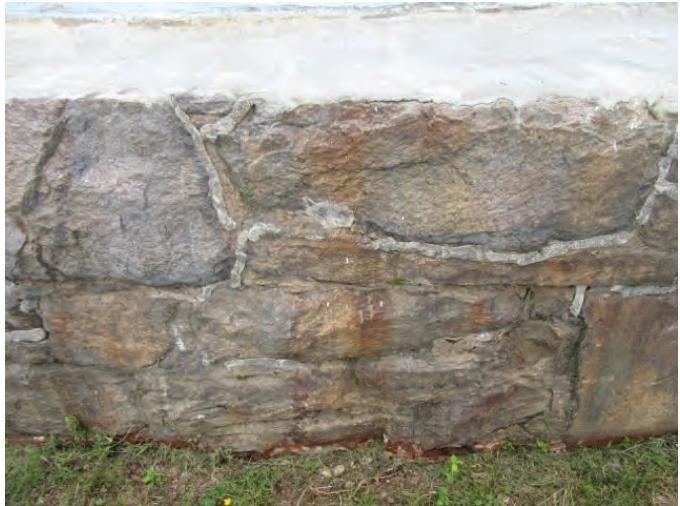
25 Granite Block And Mortar Joint Foundation With Tight Cracks

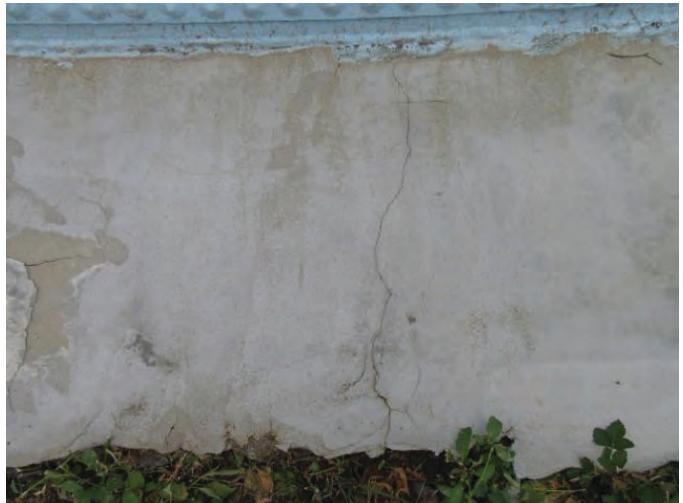
Concrete Foundation Cap With Tight Cracks 26

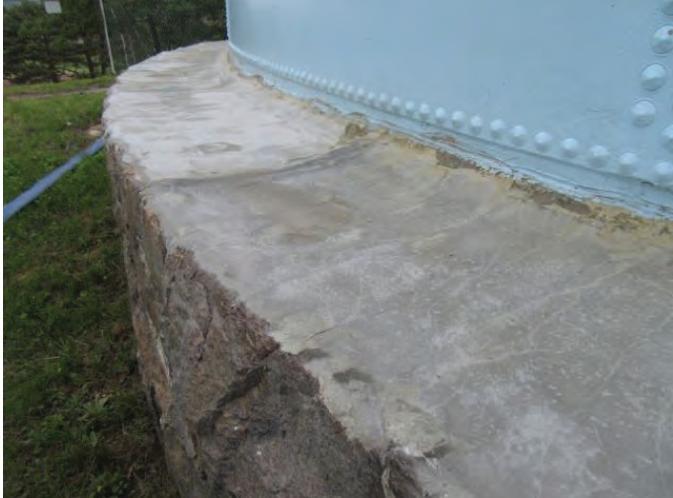
27 *Concrete Foundation Cap With Tight Cracks*

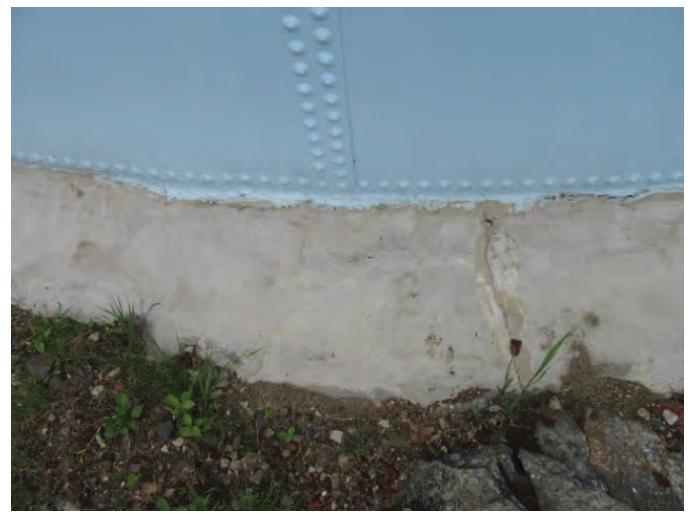
28 Concrete Foundation Cap With Tight Cracks

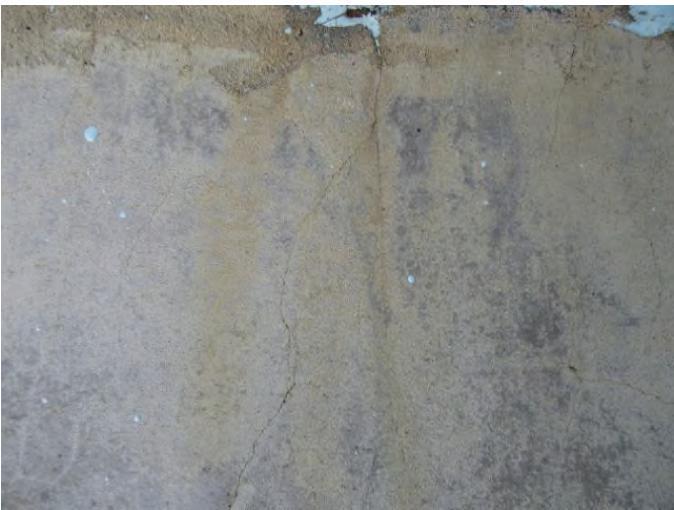
29 Concrete Foundation Cap With Tight Cracks

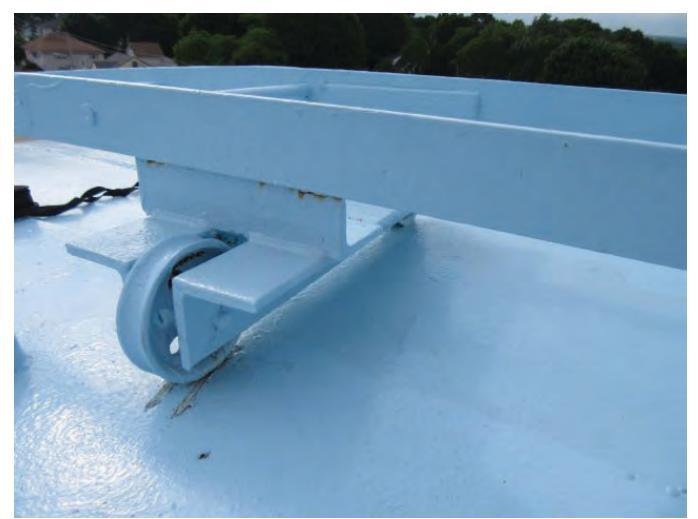
34Vent Access Ladder Wheel Causing Secondary
Coating Loss And Exposed Primary Coating

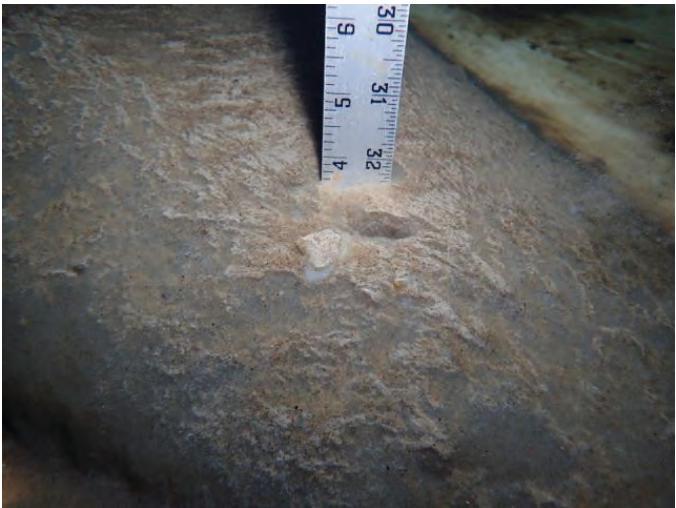
47 Layer Of Precipitate

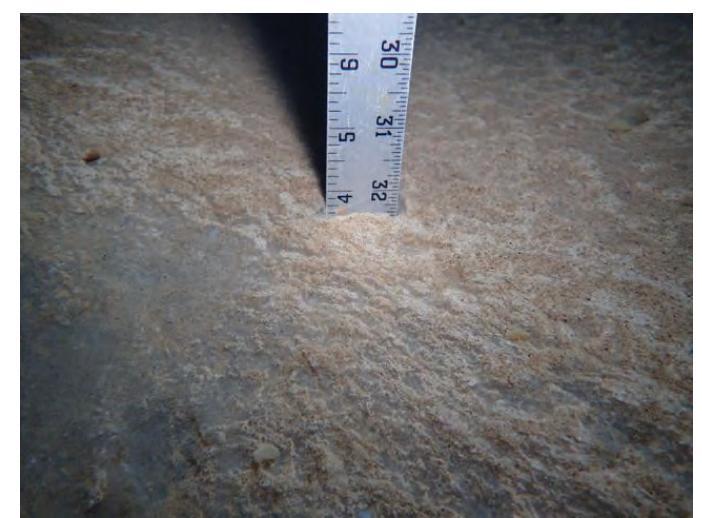
48 *Layer Of Precipitate*

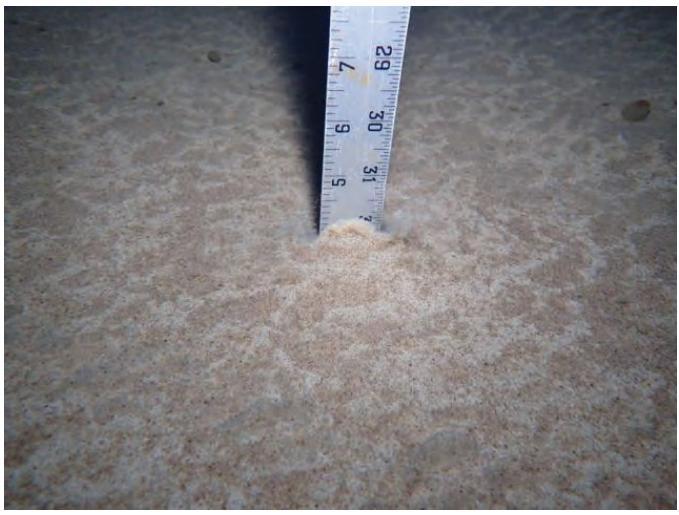
49 *Layer Of Precipitate*

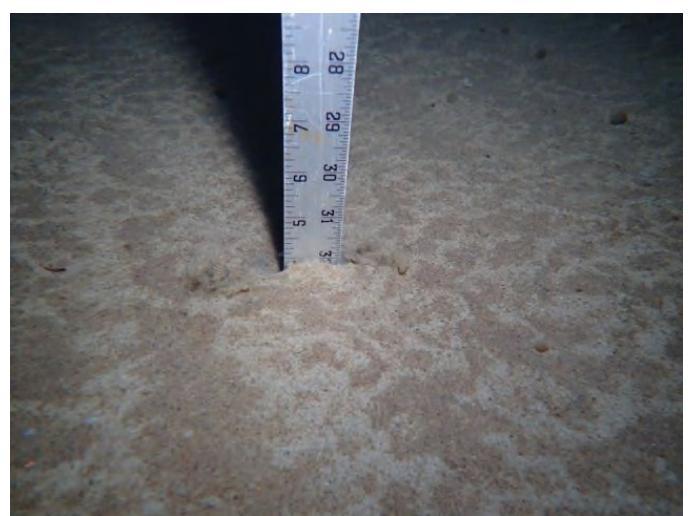
Layer Of Precipitate 50

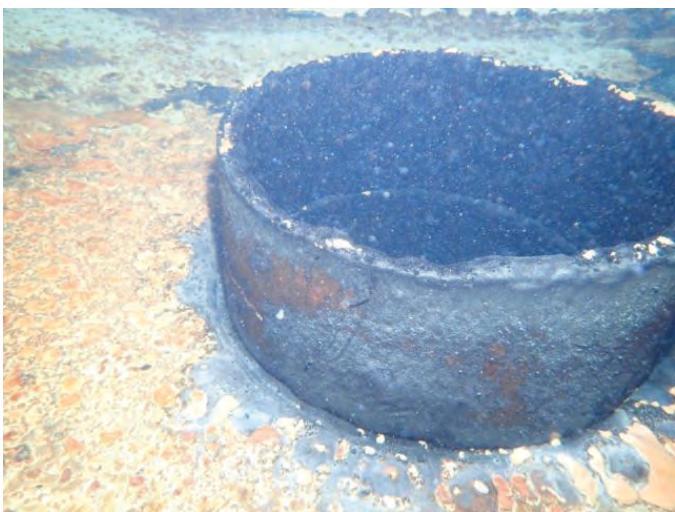
51 Floor With Metal Scale Hardened Around The Influent/Effluent Pipe

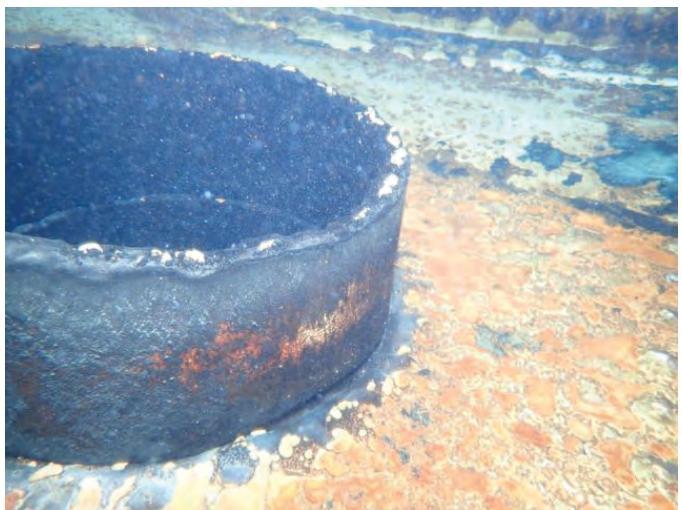
52 Floor With Metal Scale Hardened Around The Influent/Effluent Pipe

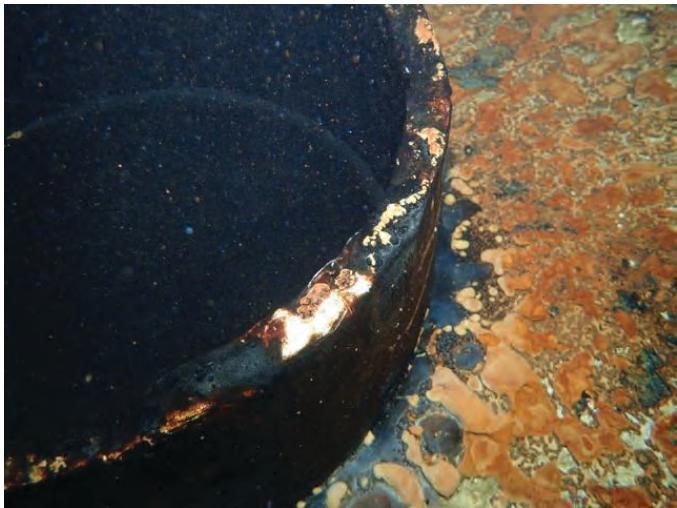
53 Floor With Metal Scale Hardened Around The Influent/Effluent Pipe

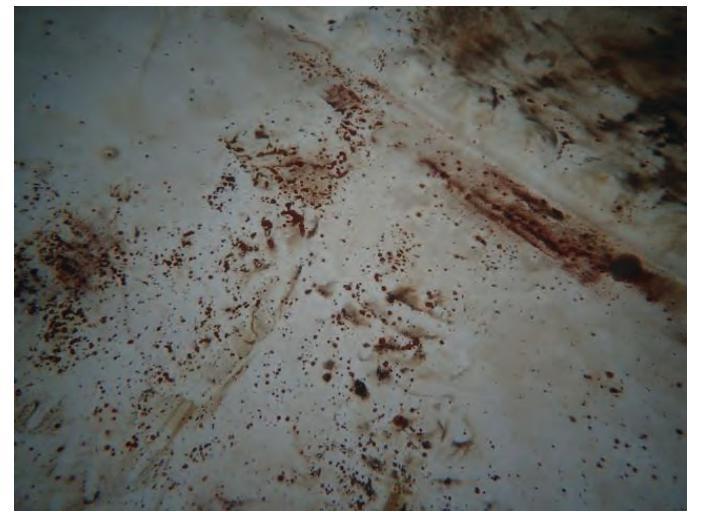
54 Floor With Coating Blisters, Exposed Underlying Steel, Mild Surface Corrosion And Mild To Moderate Staining

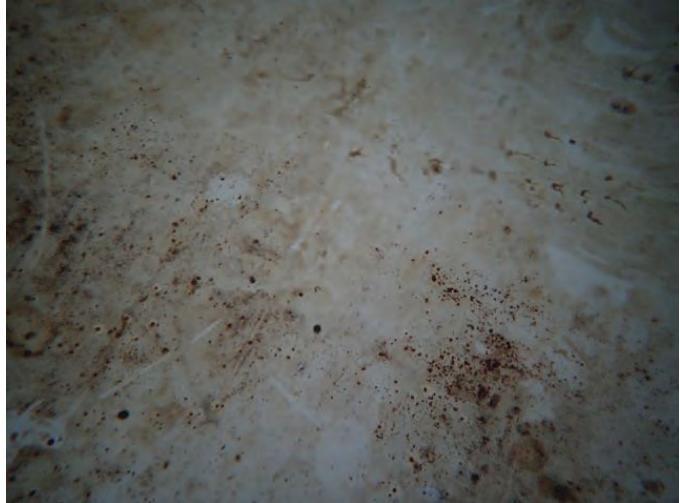
55 Floor With Coating Blisters, Exposed Underlying 55 Steel, Mild Surface Corrosion And Mild To Moderate Staining

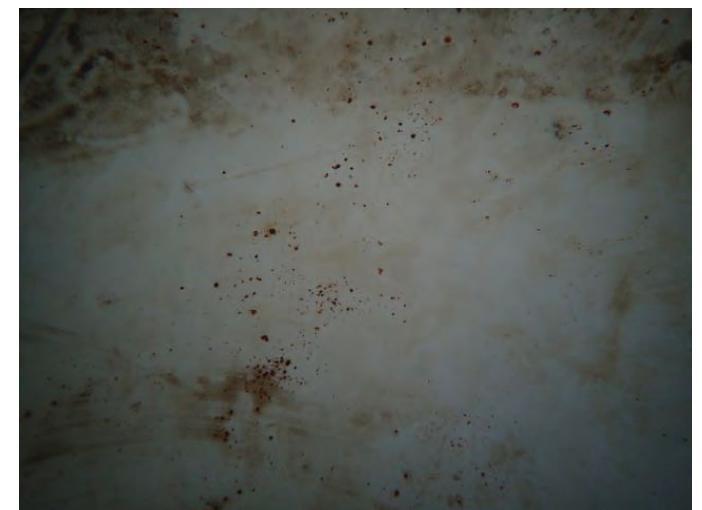
56 Floor With Coating Blisters, Exposed Underlying 56 Steel, Mild Surface Corrosion And Mild To Moderate Staining

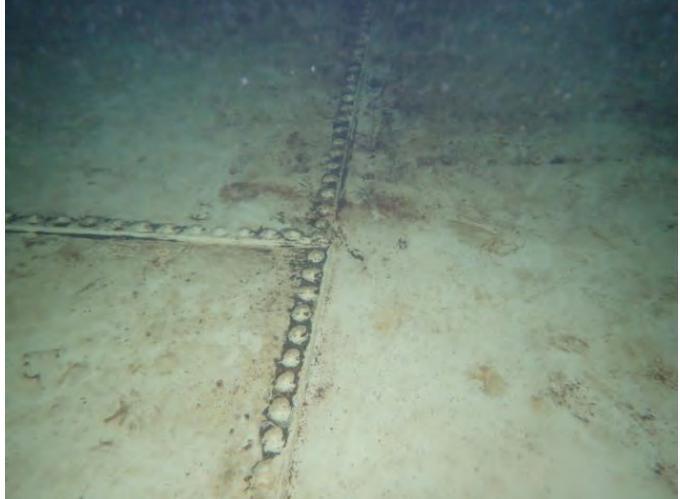
57 Floor With Mild To Moderate Staining

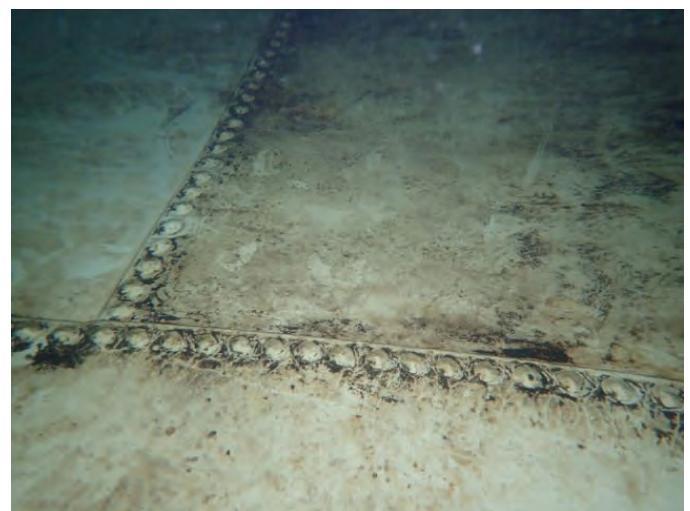
Floor With Mild To Moderate Staining

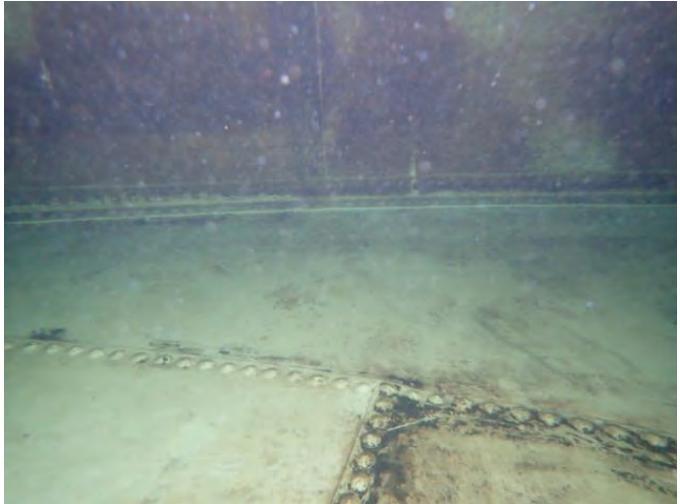
59 Floor With Mild To Moderate Staining

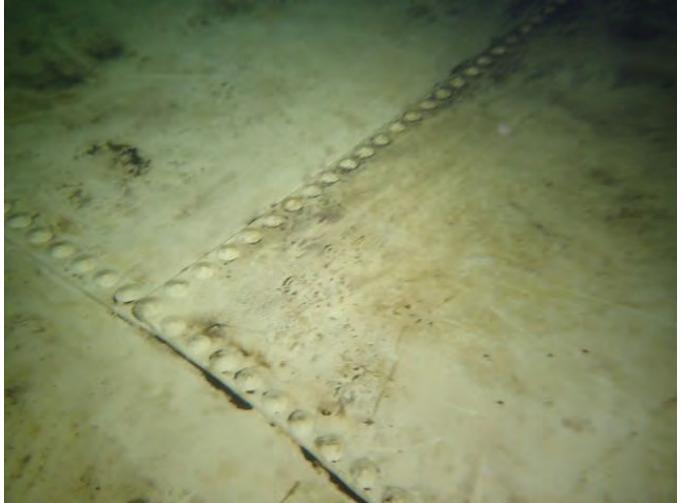
60 Floor With Mild To Moderate Staining

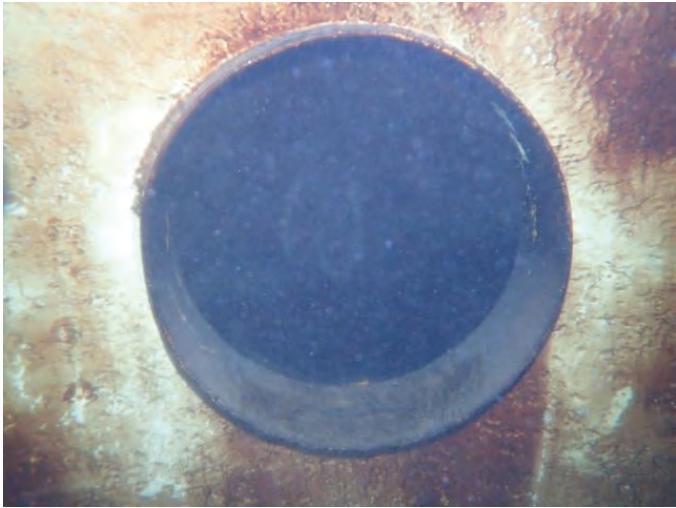
Easternmost Manway With Moderate Staining 62

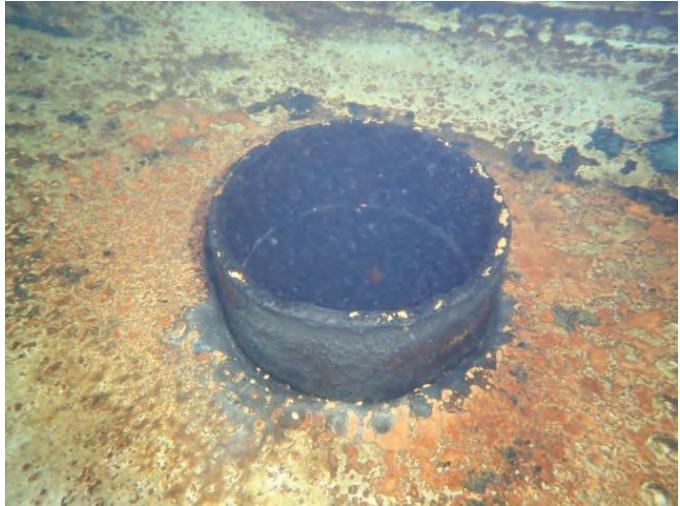
63 Westernmost Manway With Moderate Staining

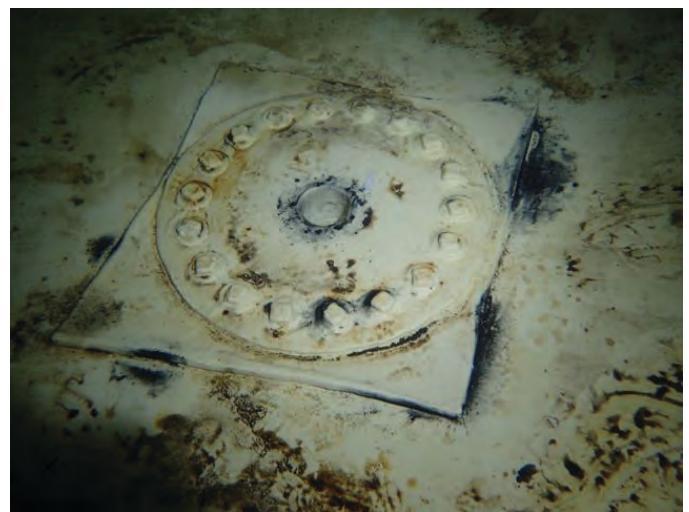
64 *14" Inside Diameter Pipe With Coating Blisters,* 64 *Exposed Steel And Corrosion*

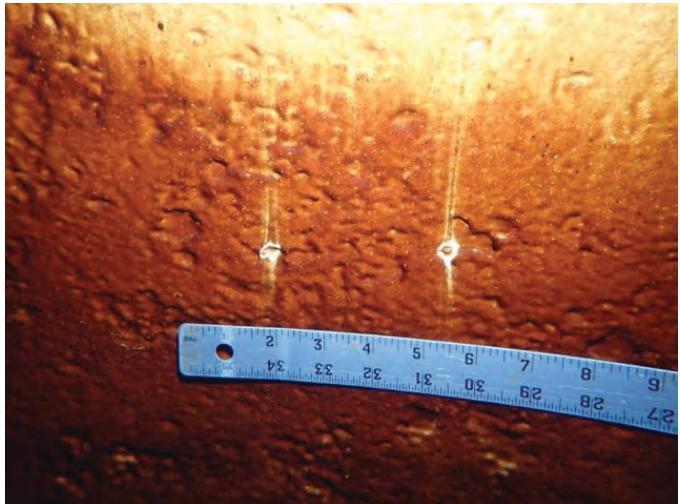
66 Interior Wall With Coating Blisters, Exposed Underlying Steel, Mild Corrosion And Moderate To Heavy Staining

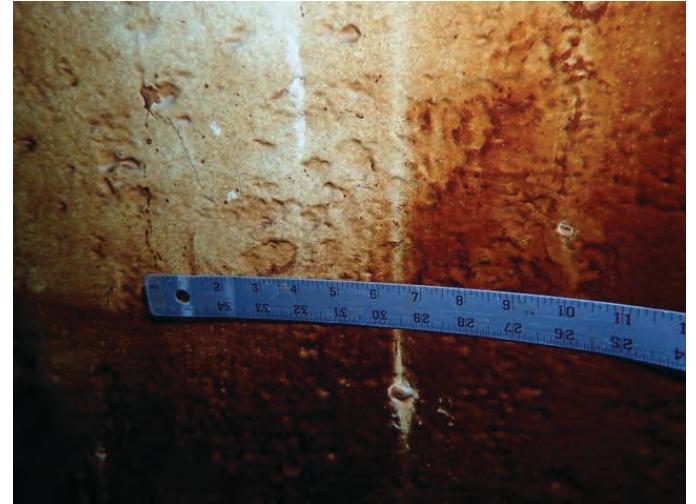
Interior Wall With Coating Blisters, Exposed
Underlying Steel, Mild Corrosion And Moderate To Heavy Staining

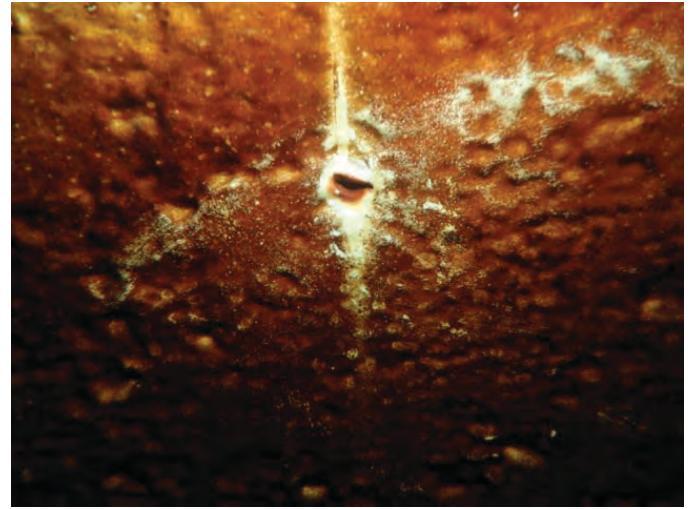
Interior Wall With Coating Blisters, Exposed
Underlying Steel, Mild Corrosion And Moderate To Heavy Staining

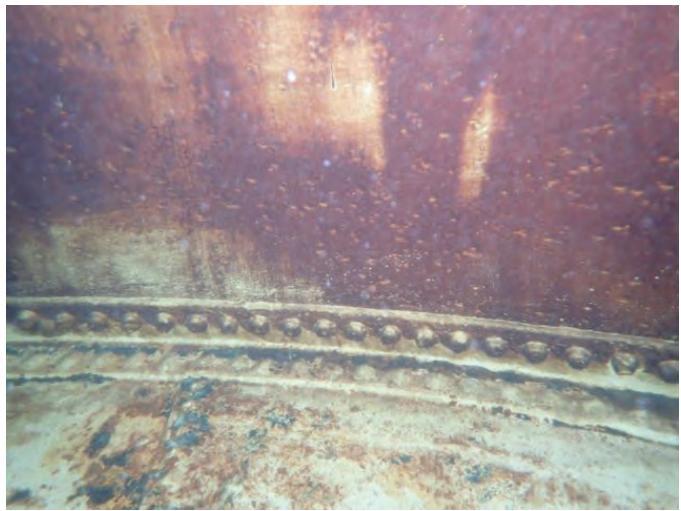
69 Interior Wall With Coating Blisters, Exposed Underlying Steel, Mild Corrosion And Moderate To Heavy Staining

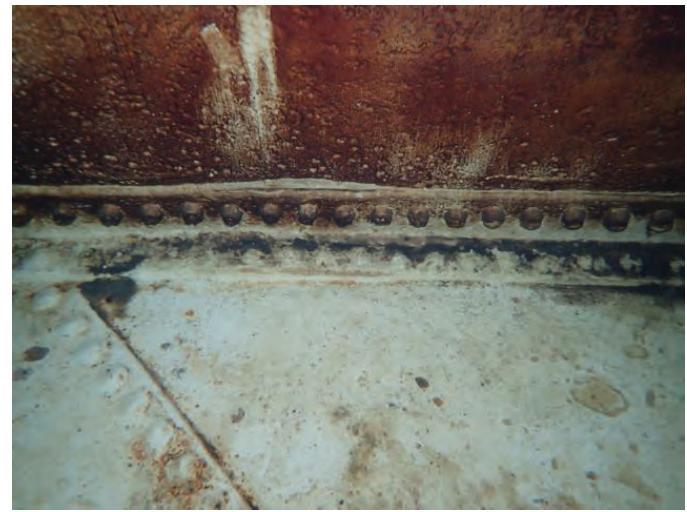
Interior Wall With And Moderate To Heavy Staining 70

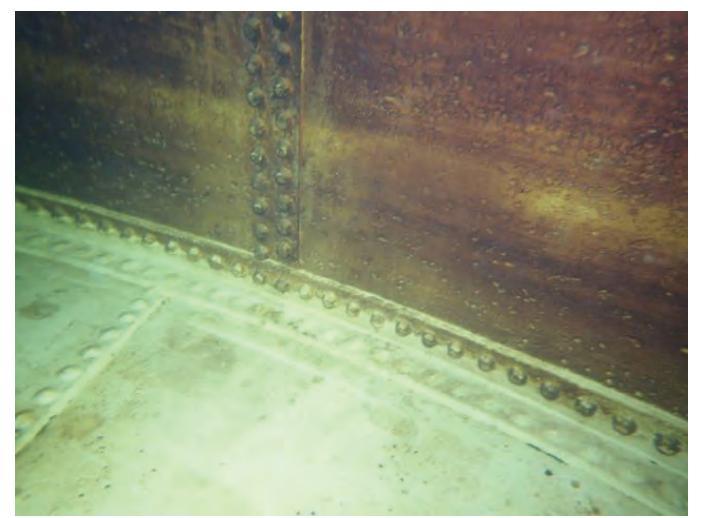
71 Interior Wall With And Moderate To Heavy Staining

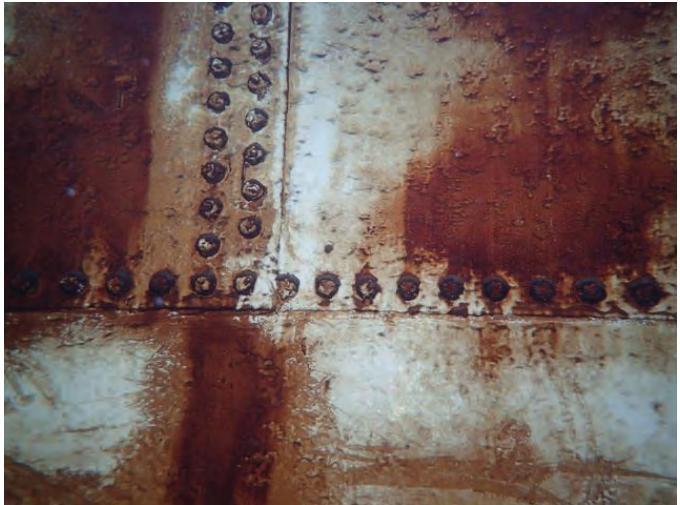
72 Interior Wall With Moderate To Heavy Staining

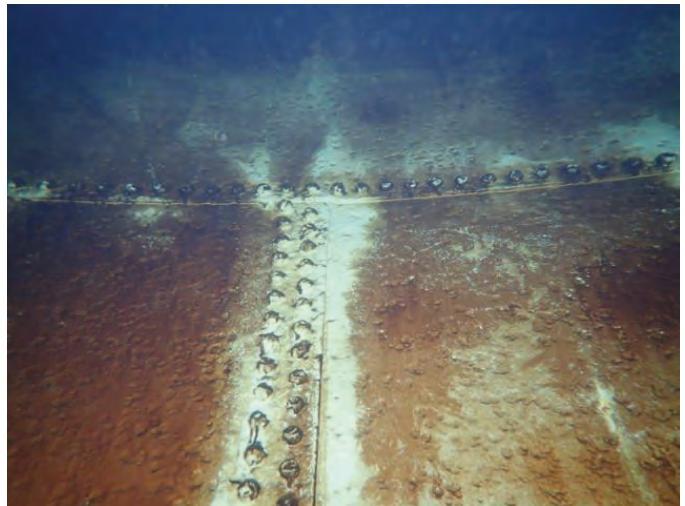
73 Interior Wall With Moderate To Heavy Staining

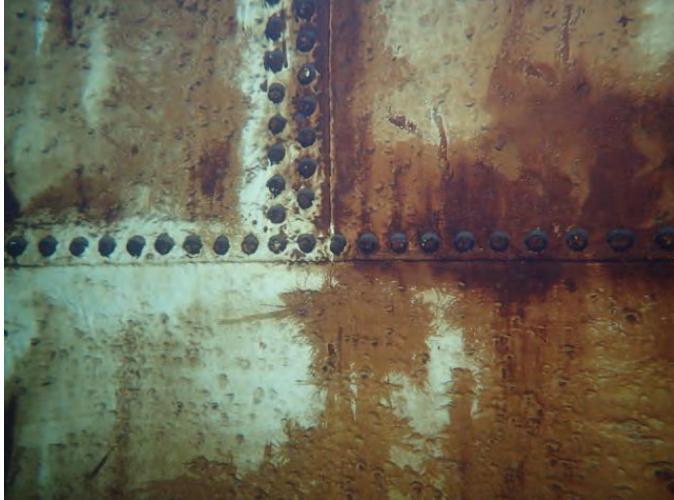
Interior Wall With Moderate To Heavy Staining

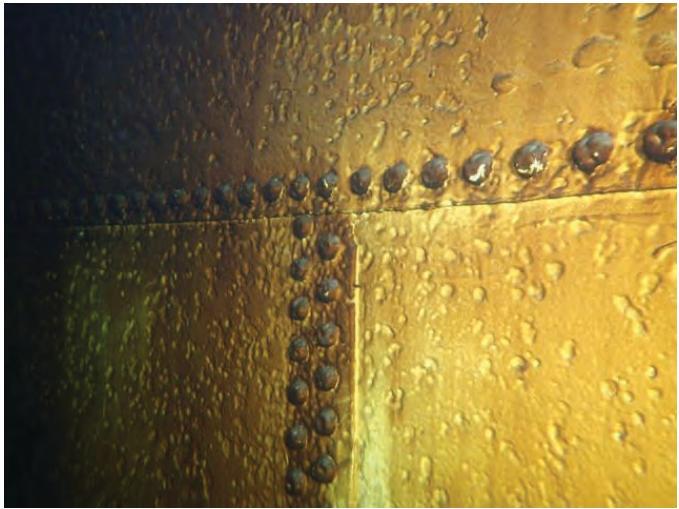
75Interior Wall With Moderate To Heavy Staining

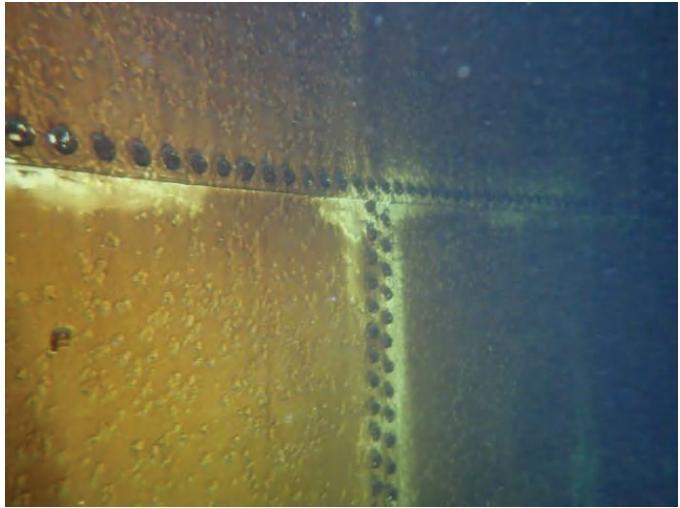
76 Interior Wall With Moderate To Heavy Staining

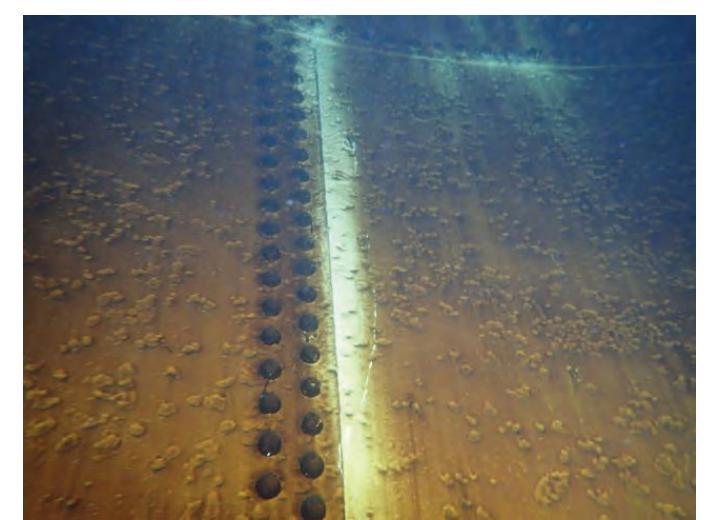
77 Interior Wall With Moderate To Heavy Staining

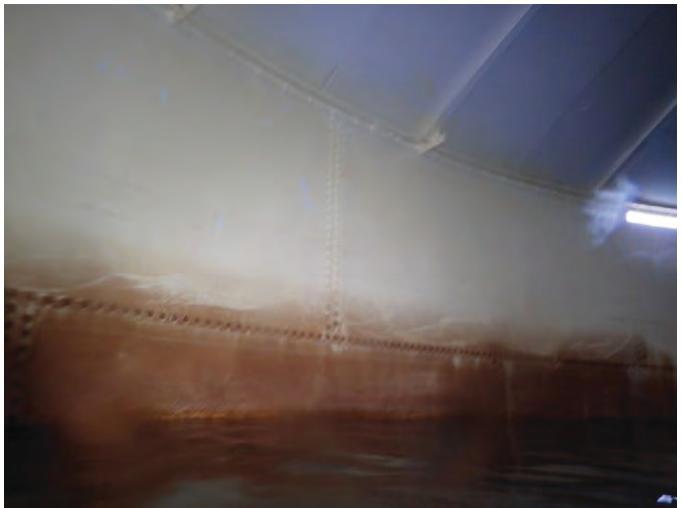
78 Interior Wall With Moderate To Heavy Staining

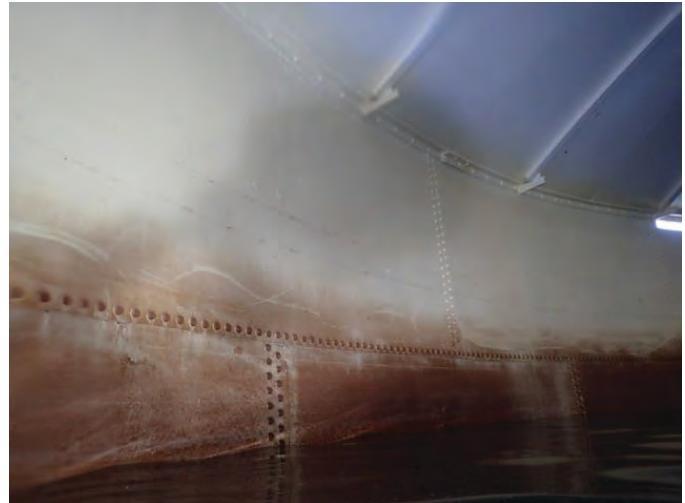
79 Interior Wall With Moderate To Heavy Staining

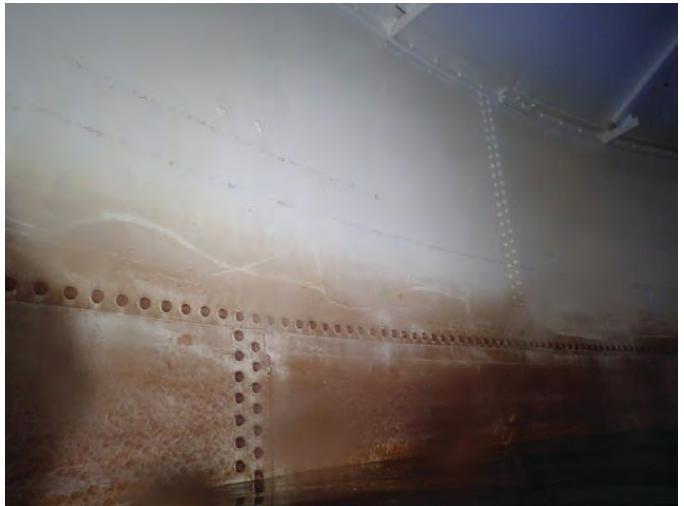
Interior Wall With Moderate To Heavy Staining 80

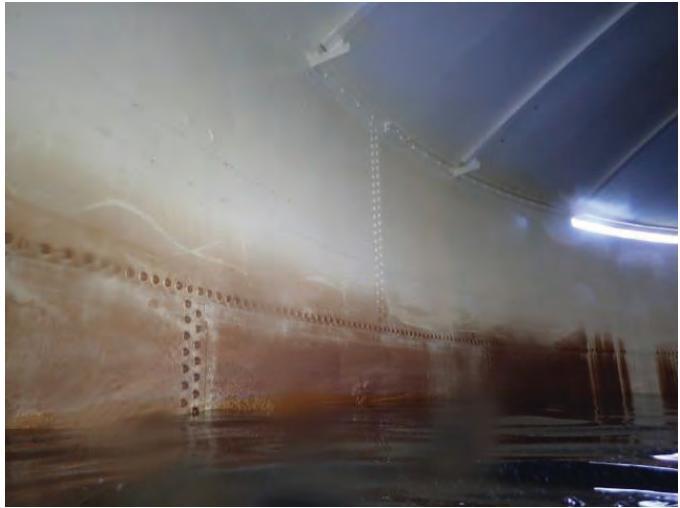
81 Interior Wall With Moderate To Heavy Staining

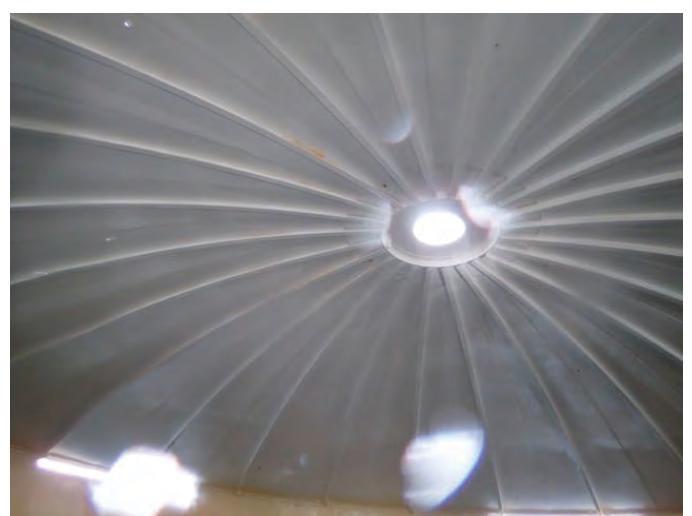
83 *Overhead With Minimal Coating Loss, Exposed Underlying Steel And Mild Surface Corrosion*

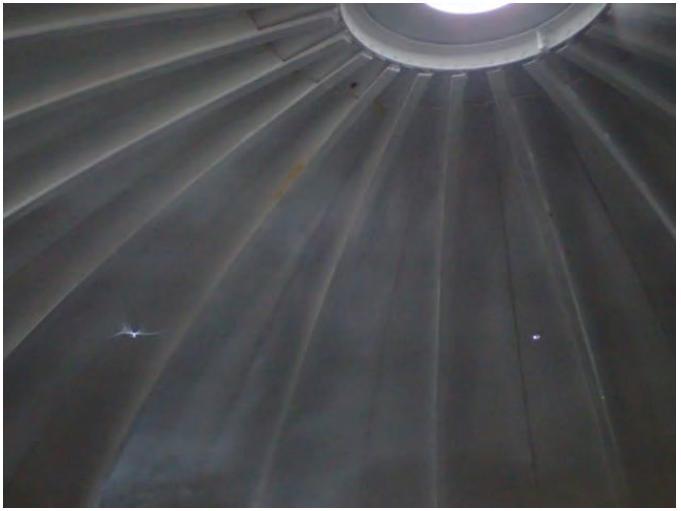
84 *Overhead With Minimal Coating Loss, Exposed Underlying Steel And Mild Surface Corrosion*

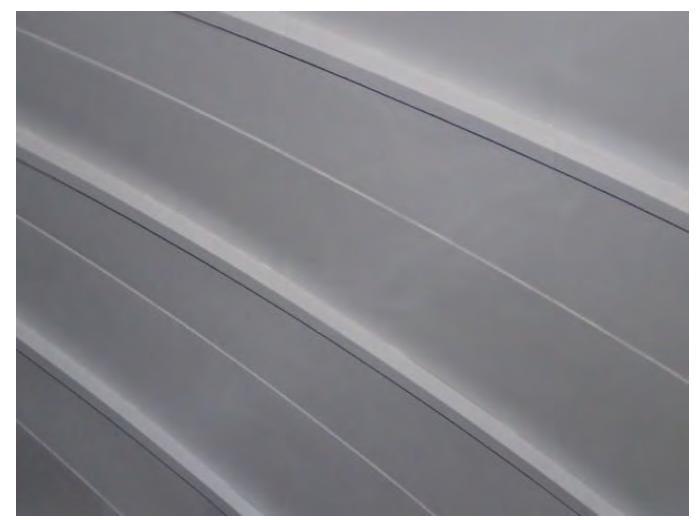
85 Overhead With Minimal Coating Loss, Exposed Underlying Steel And Mild Surface Corrosion

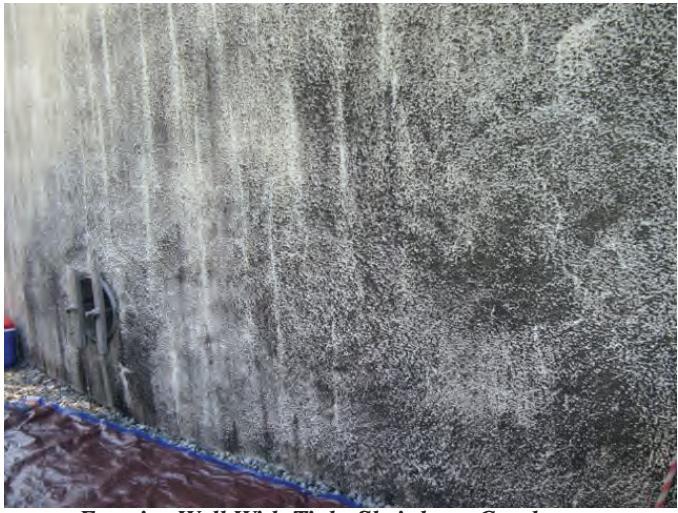
1 Exterior Wall With Tight Shrinkage Cracks, Efflorescence And Mild To Moderate Mildew

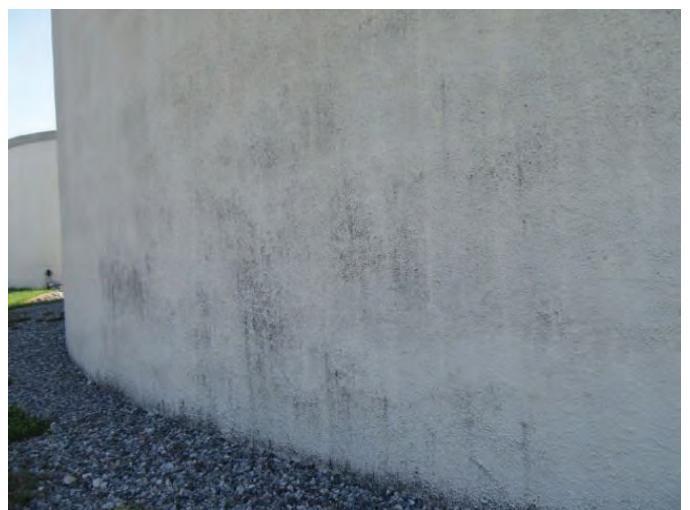
Exterior Wall With Tight Shrinkage Cracks, 2 Efflorescence And Mild To Moderate Mildew

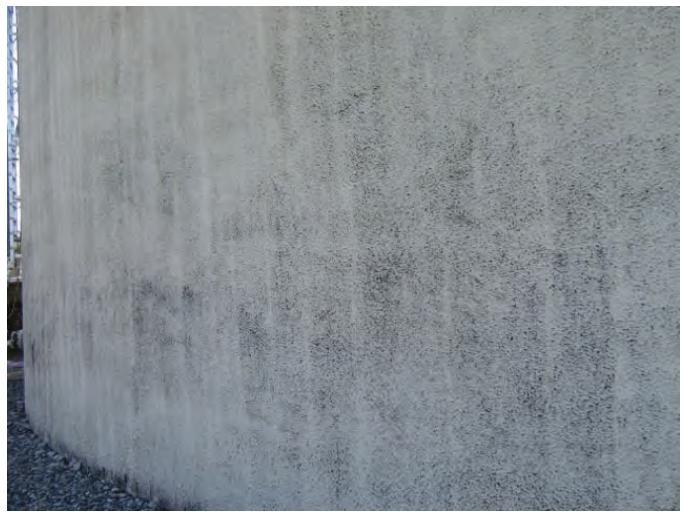
3 Exterior Wall With Tight Shrinkage Cracks, Efflorescence And Mild To Moderate Mildew

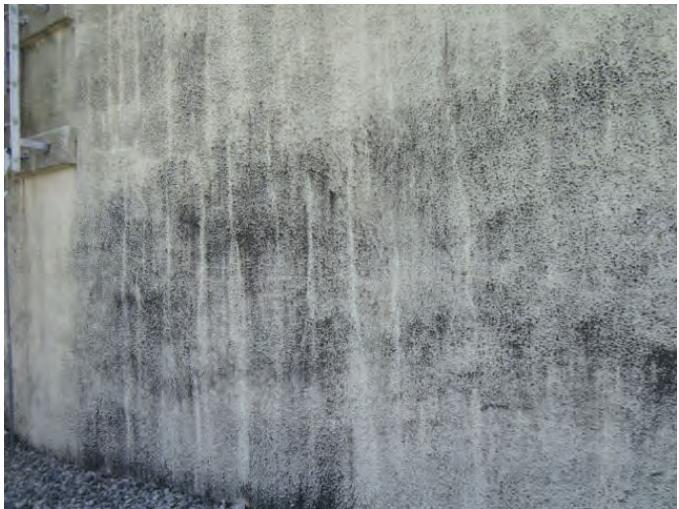
4 Exterior Wall With Tight Shrinkage Cracks, Efflorescence And Mild To Moderate Mildew

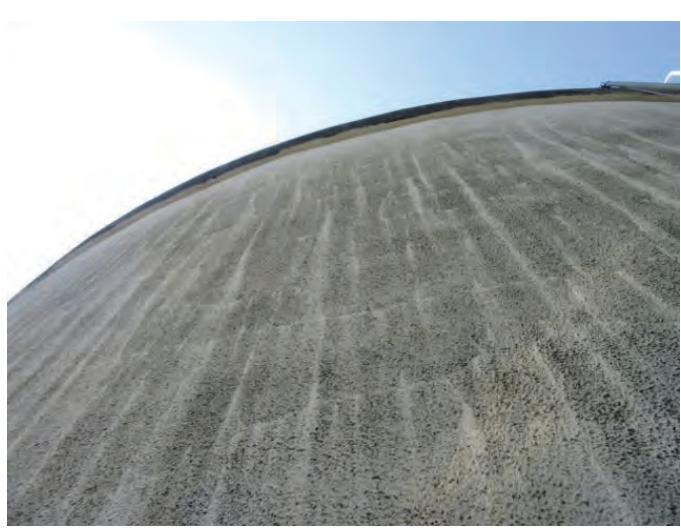
5 Exterior Wall With Tight Shrinkage Cracks, Efflorescence And Mild To Moderate Mildew
