In re: City of Woonsocket Water Division - Application to Implement Multi-Year Rate Plan

Docket No. 4879

Dam Name (No):	Woonsocket Reservoir #3 Dam (068)
Location:	Smithfield/North Smithfield
Hazard Classification:	High
	-
Inspector:	David M. Matheson, P.E.
Inspection Date.	August 1, 2014

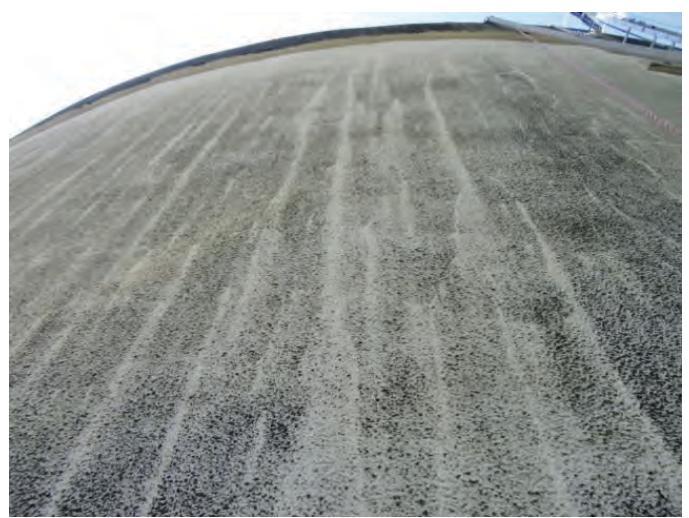
6 Exterior Wall With Tight Shrinkage Cracks, Efflorescence And Mild To Moderate Mildew

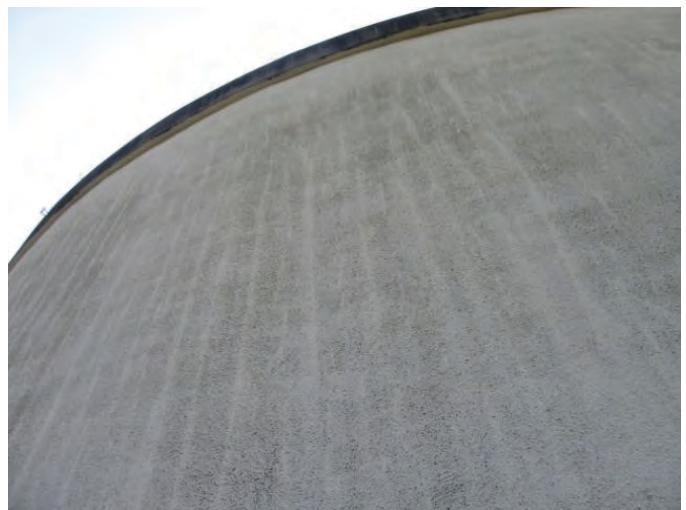
7 Exterior Wall With Tight Shrinkage Cracks, Efflorescence And Mild To Moderate Mildew

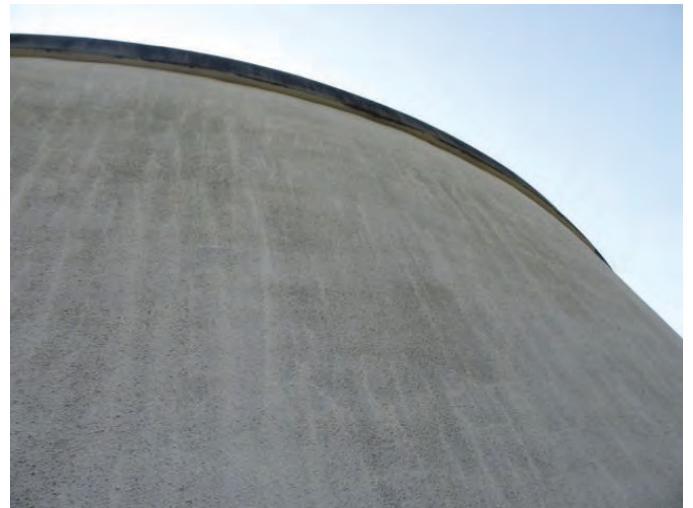
8 Exterior Wall With Tight Shrinkage Cracks, 8 Efflorescence And Mild To Moderate Mildew

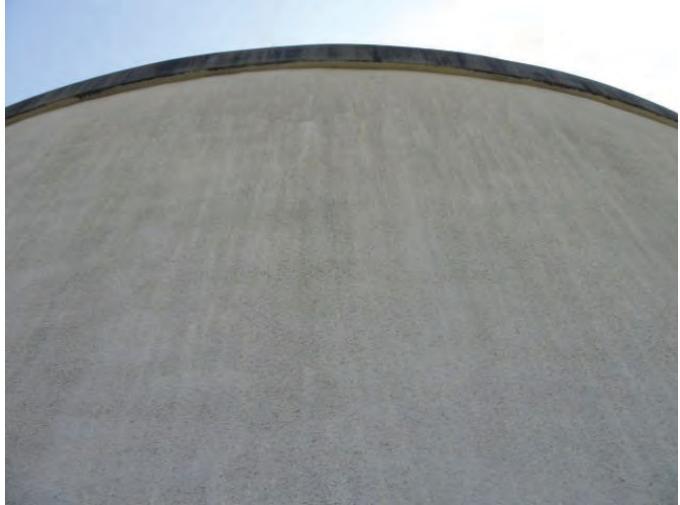
9 Exterior Wall With Mild To Moderate Mildew

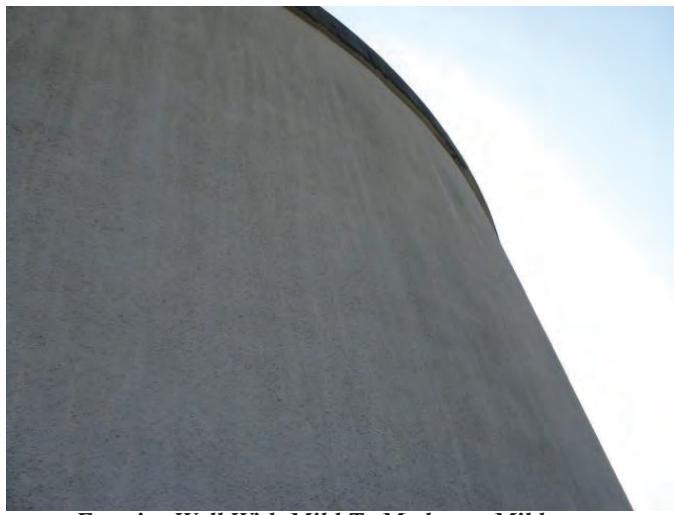
Exterior Wall With Mild To Moderate Mildew

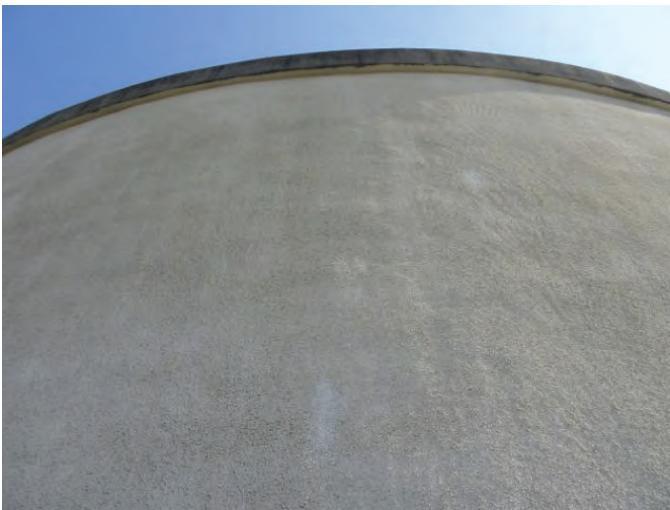
11 Exterior Wall With Mild To Moderate Mildew

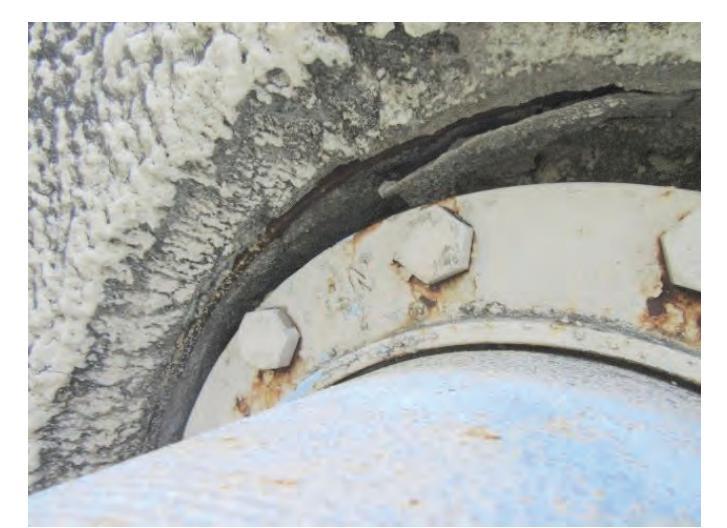
12 Exterior Wall With Adhesion Loss Resulting In Exposure Steel Sleeve That Forms The Overflow Pipe Penetration In The Tank Wall

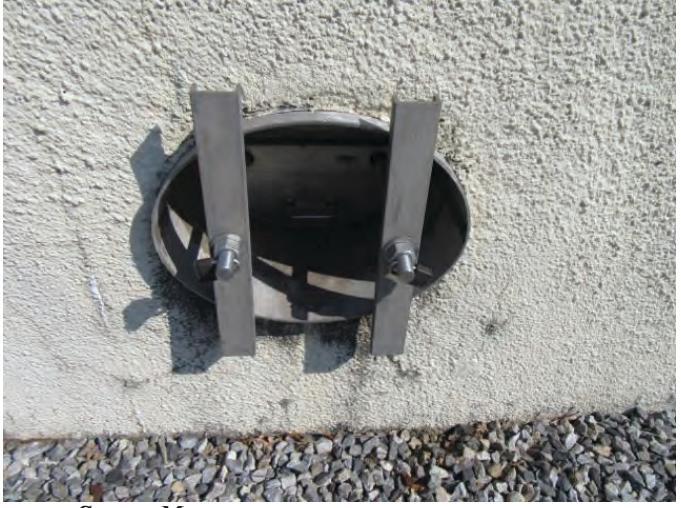
Secure Manway

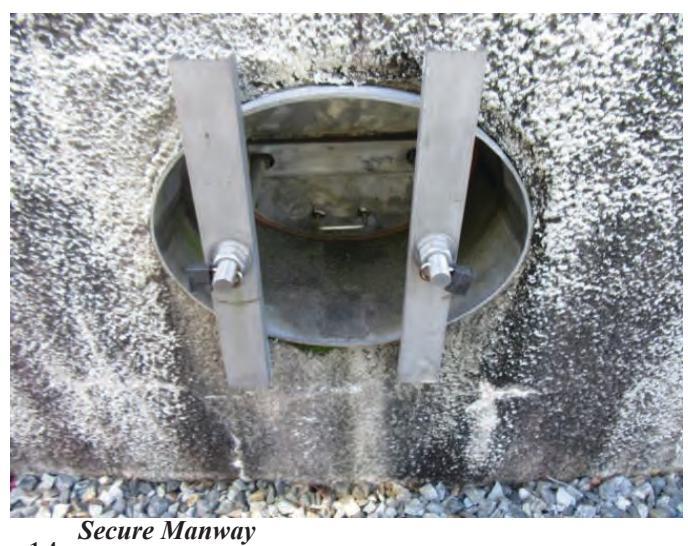
14 Secure

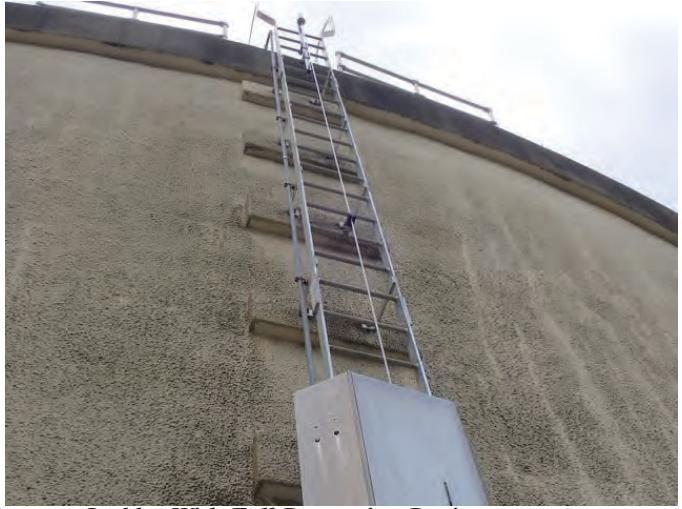
15 Ladder With Fall Prevention Device

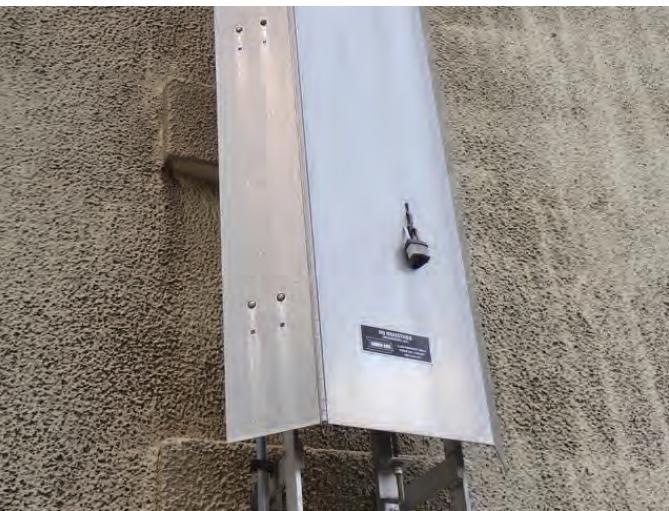
Ladder Guard Secured With A Lock

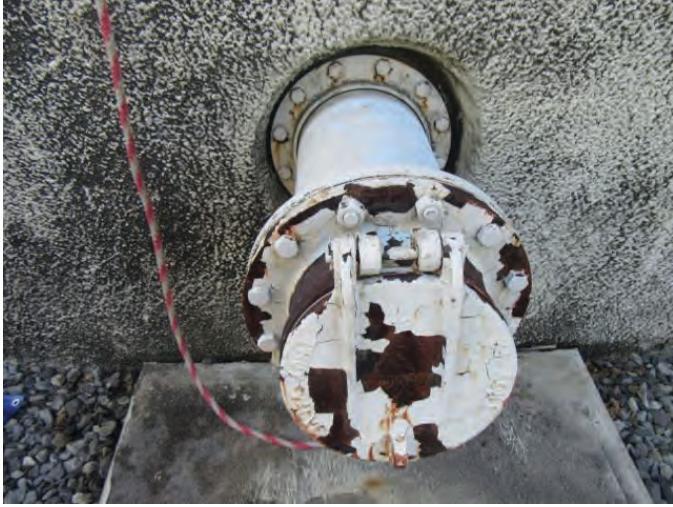
17Overflow Pipe And Flap-Valve With Coating Peeling,
Exposed Metal And Mild Corrosion

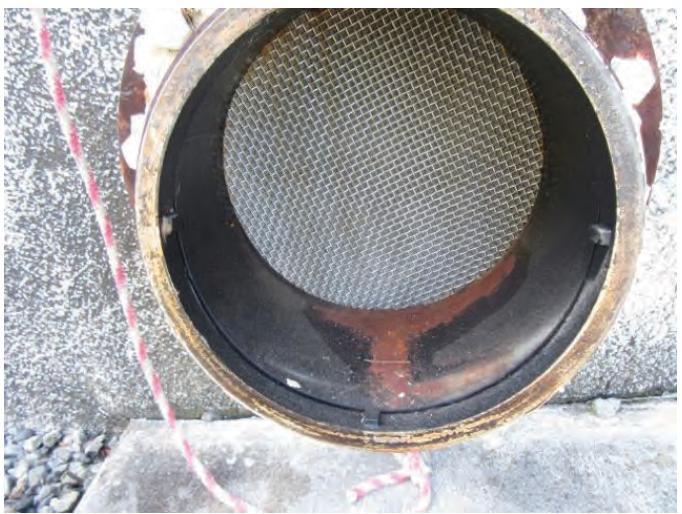
18 Secure Overflow Pipe Screen

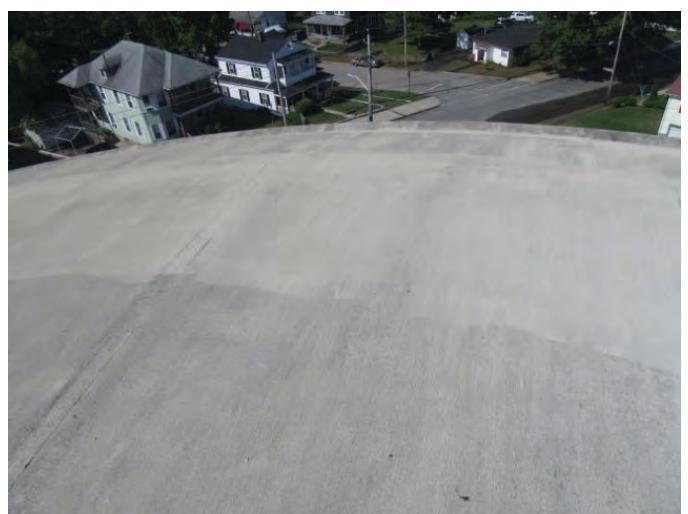
Roof Panel With Tight Cracks Within The Filled19Panel Joints And Mildew

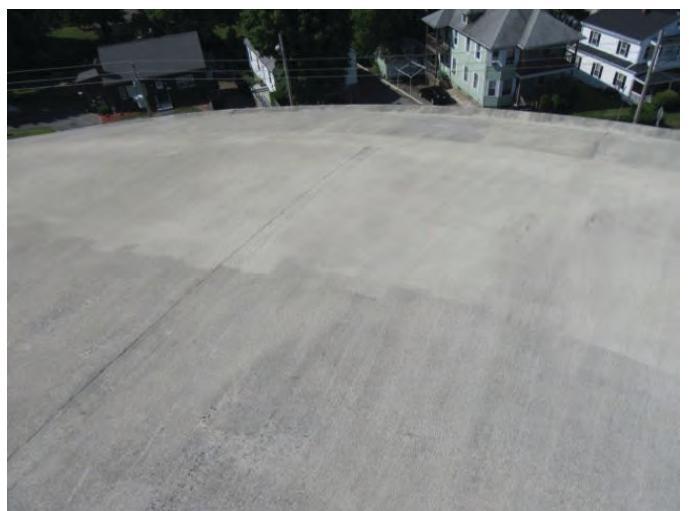
Roof Panel With Tight Cracks Within The Filled 20 Panel Joints And Mildew

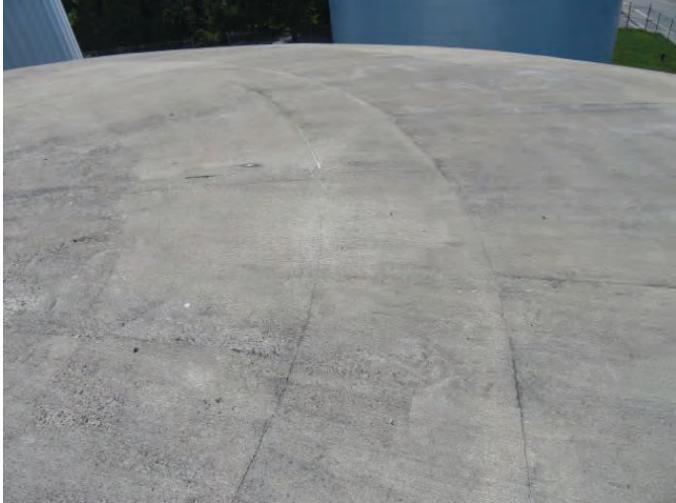
21 *Roof Panel With Tight Cracks Within The Filled Panel Joints And Mildew*

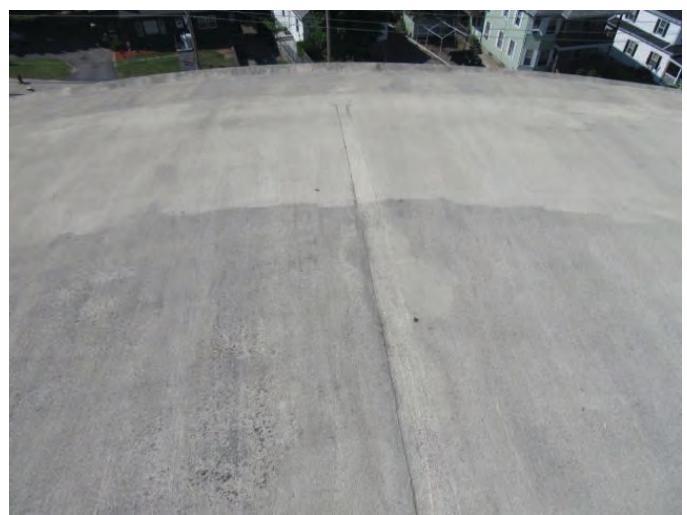
22 Roof Panel With Tight Cracks Within The Filled Panel Joints And Mildew

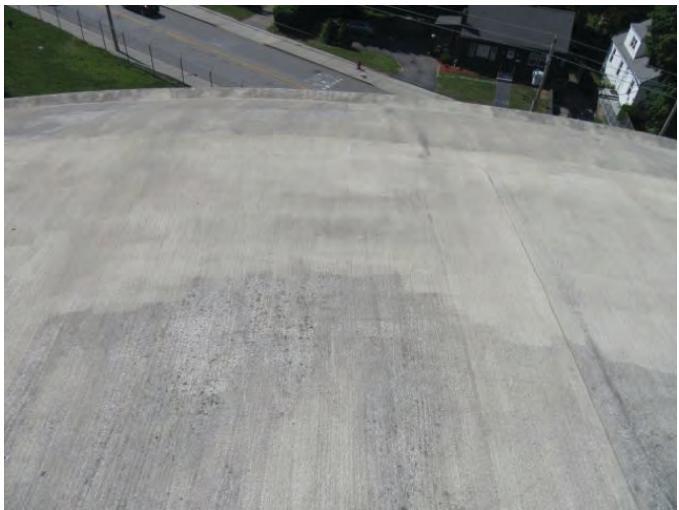
23 Roof Panel With Tight Cracks Within The Filled Panel Joints And Mildew

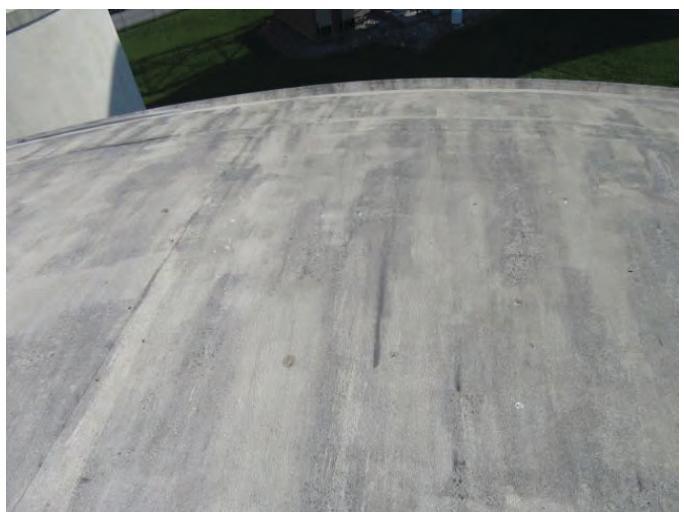
24 Roof Panel With Tight Cracks Within The Filled Panel Joints And Mildew

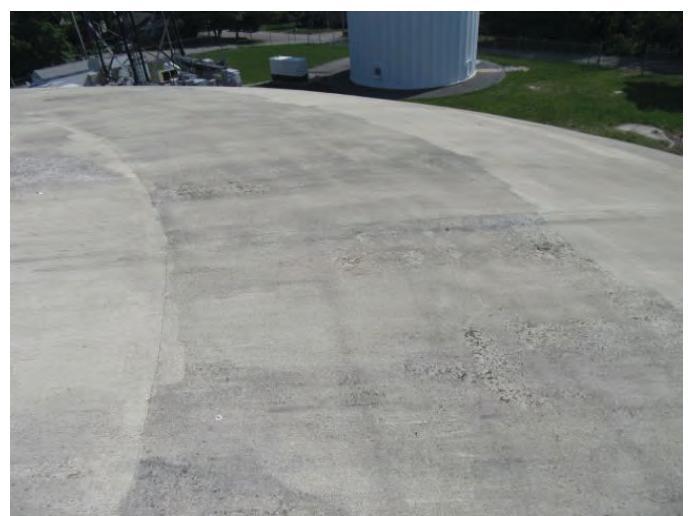
25 Roof Panel With Coating Loss, Exposed Underlying Concrete And Mildew

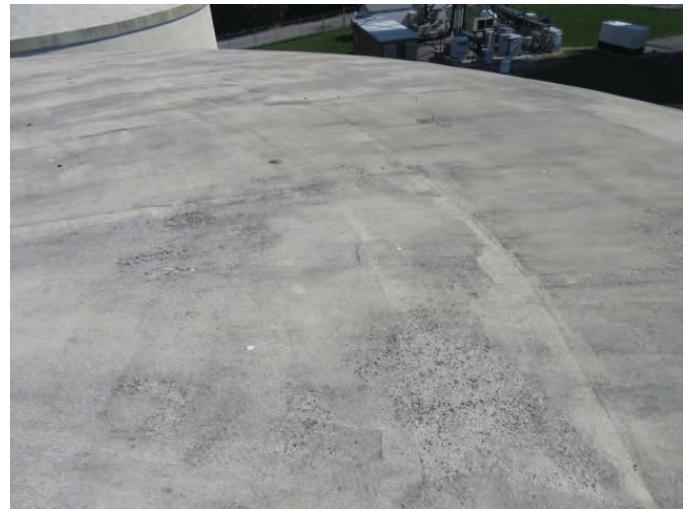
Roof Panel With Coating Loss, Exposed Underlying26Concrete And Mildew

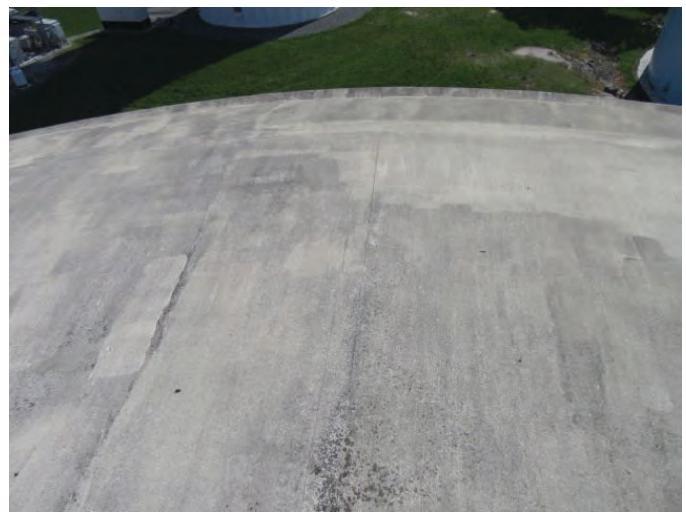
27 Roof Panel With Coating Loss, Exposed Underlying Concrete And Mildew

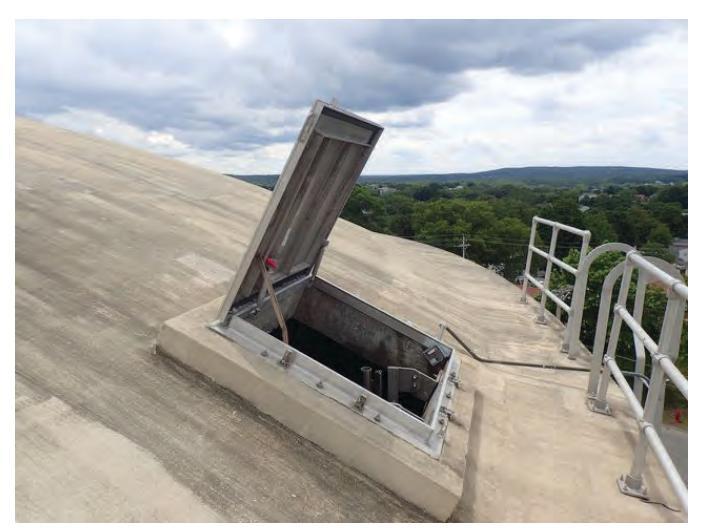
28 Secure Roof Safety Railings

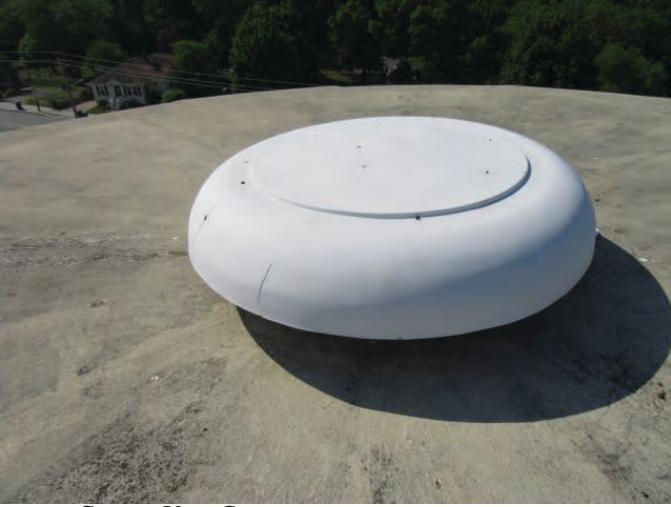
29 Secure Vent Cap

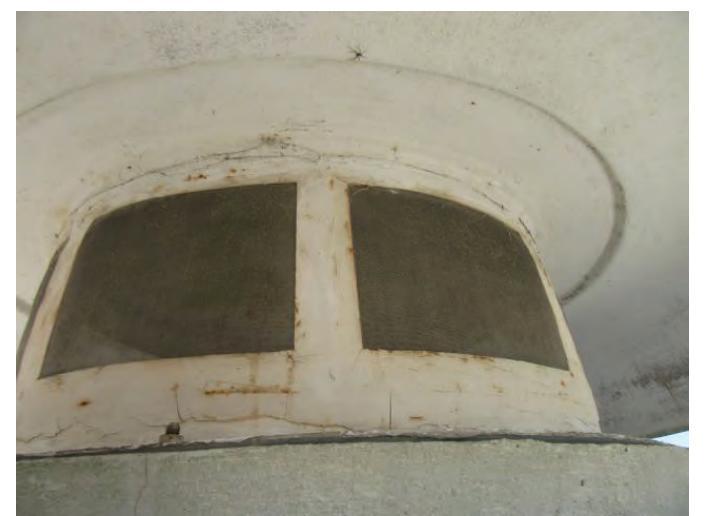
30 Secure Vent Screen

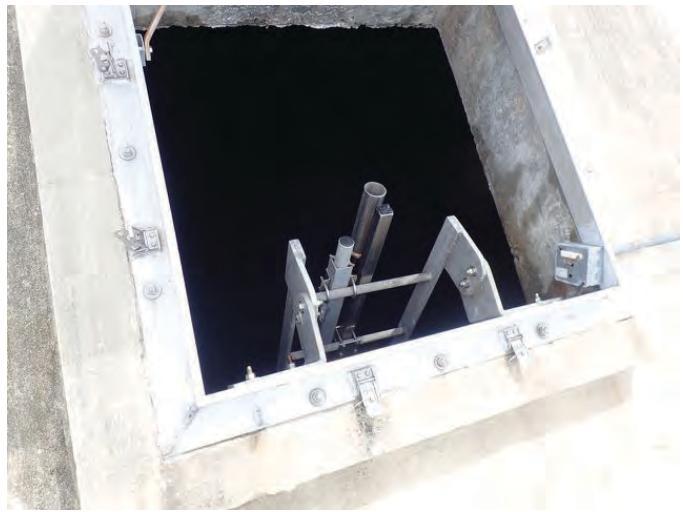
Open Access Hatch

It is our recommendation to install a lock on this hatch to prevent unwanted access to the interior of the tank.

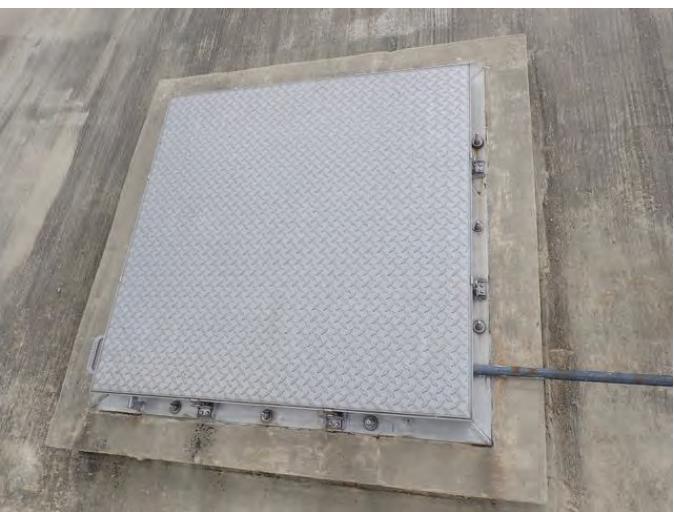
Closed Access Hatch

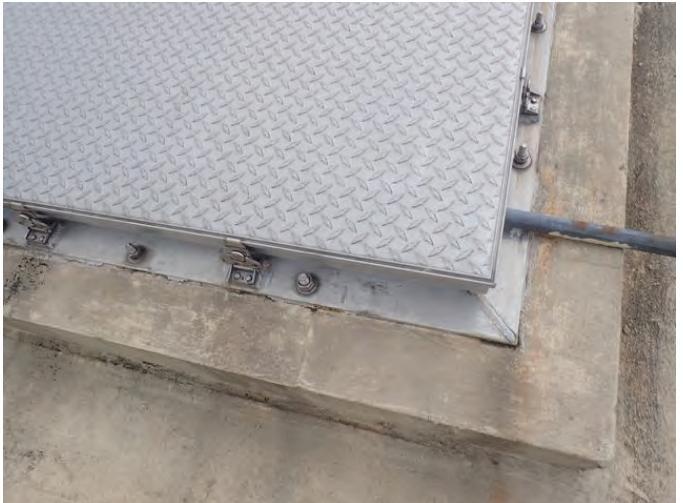
33 Secure Stainless-Steel Pressure Lock

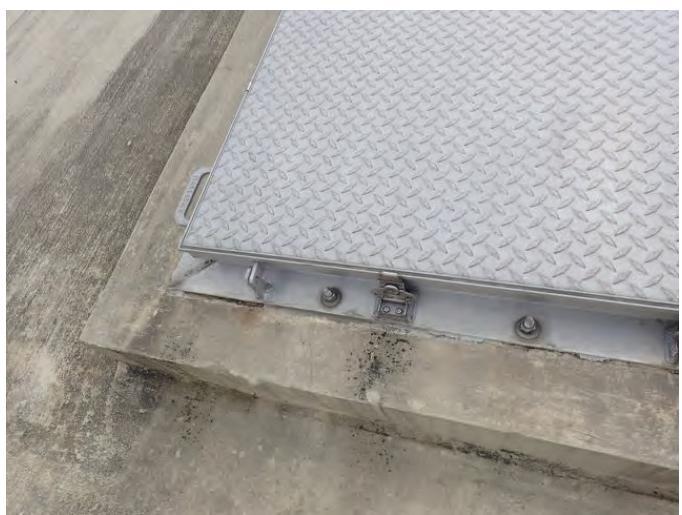
34 Secure Stainless-Steel Pressure Lock

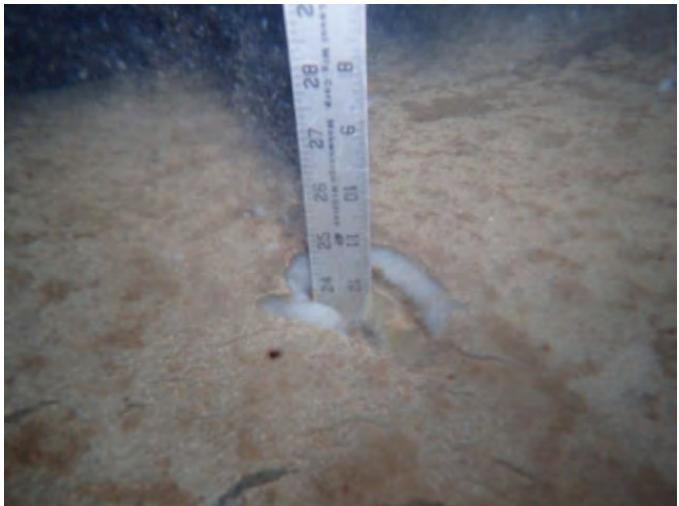
35 *Layer Of Precipitate*

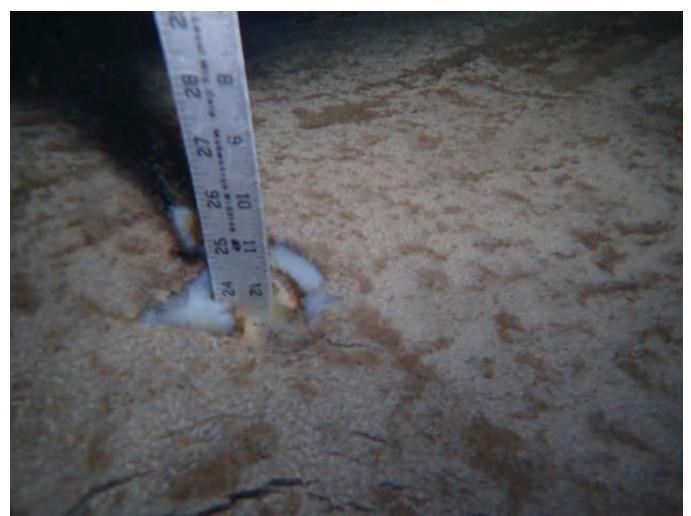
36 *Layer Of Precipitate*

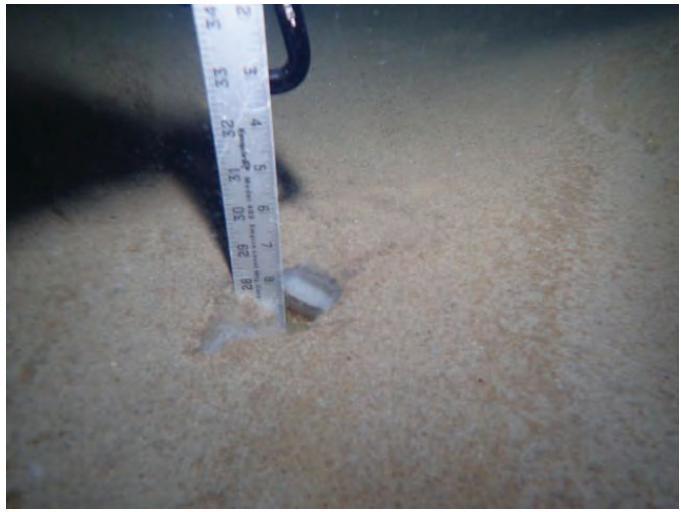
37 Layer Of Precipitate

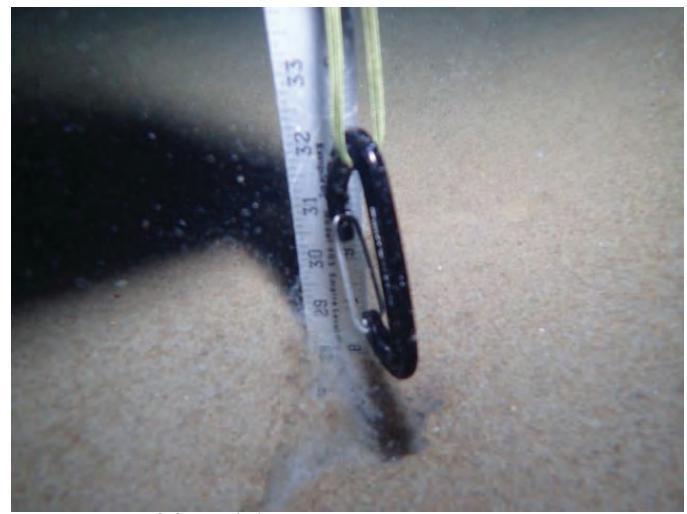
Layer Of Precipitate 38

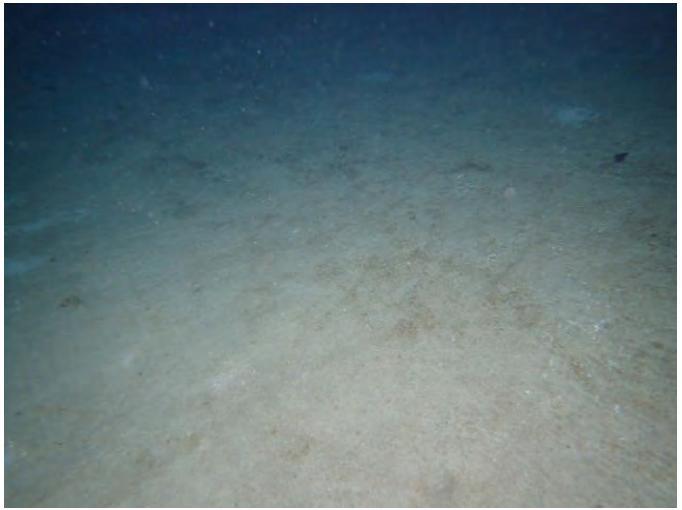
39 Floor With Mild Staining

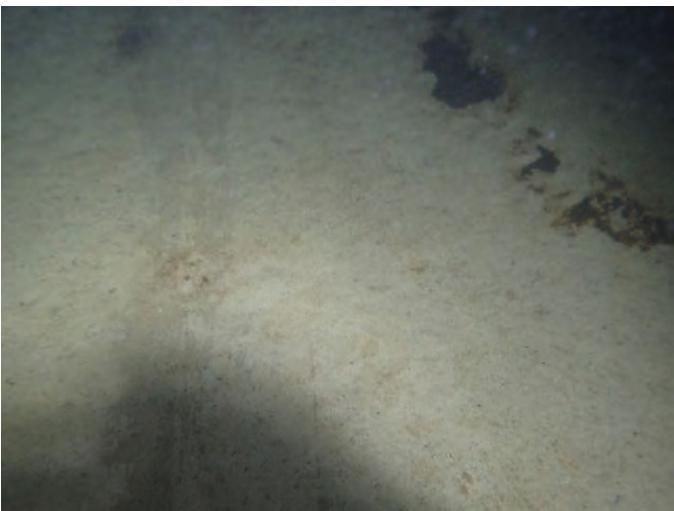
40 Floor With Mild Staining

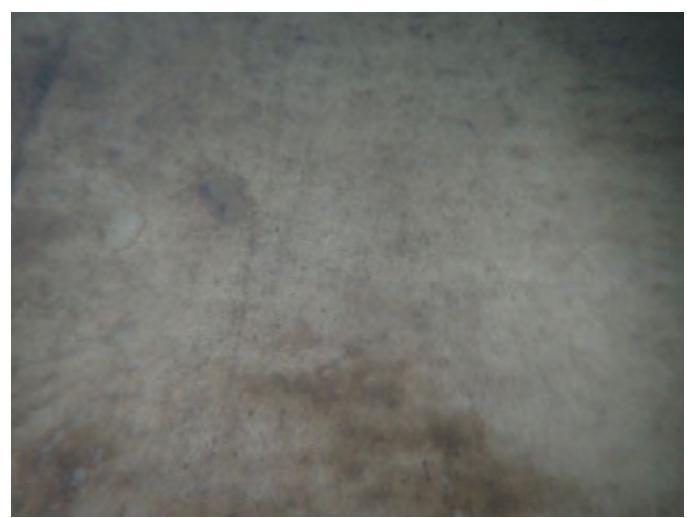
41 Floor With Mild Staining

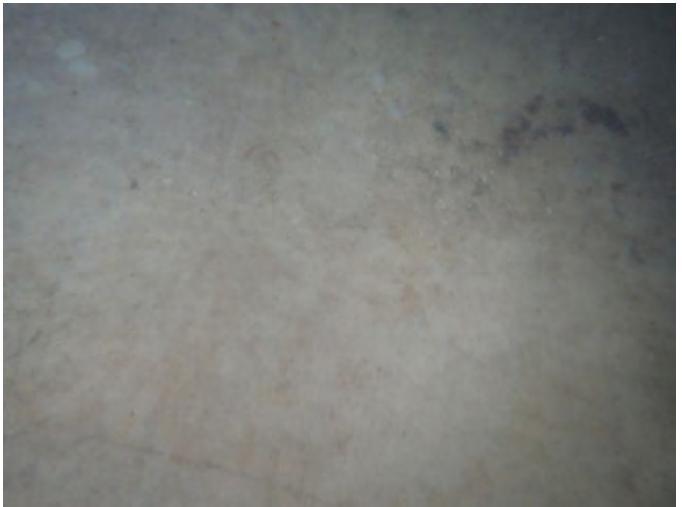
42 Floor With Mild Staining

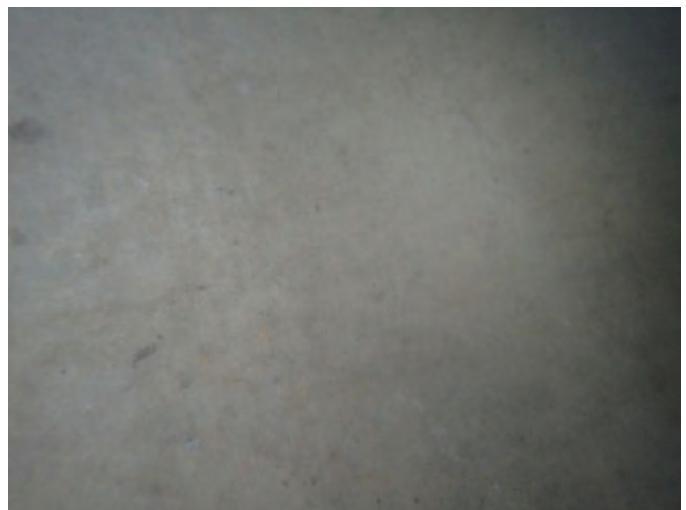
43 Floor With Mild Staining

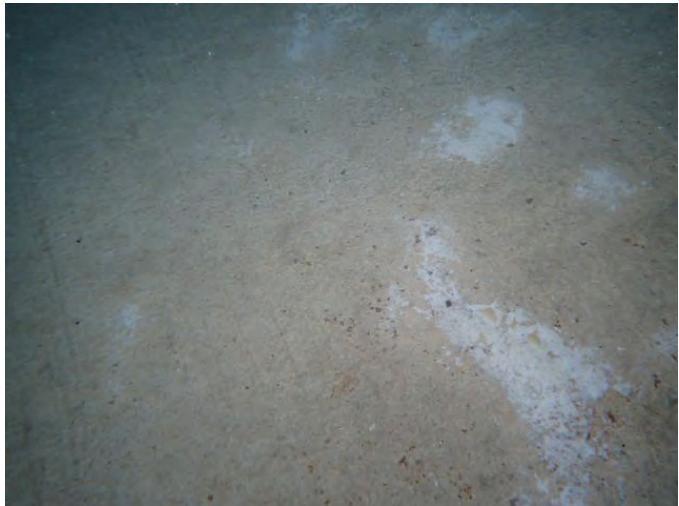
44 Floor With Mild Staining

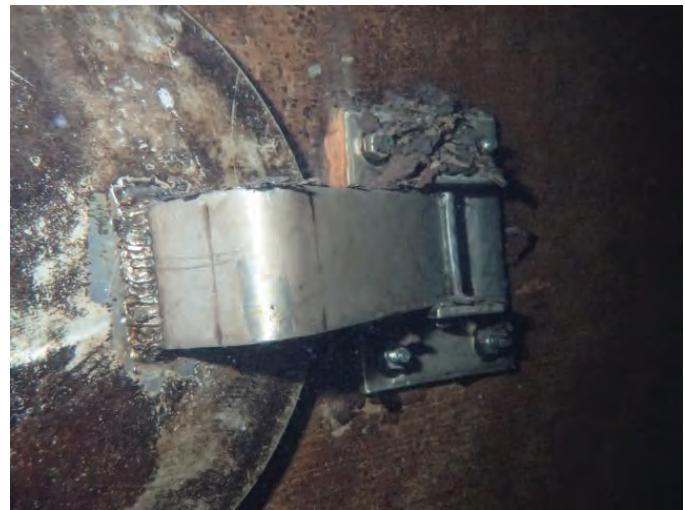
46 *Northernmost Manway*

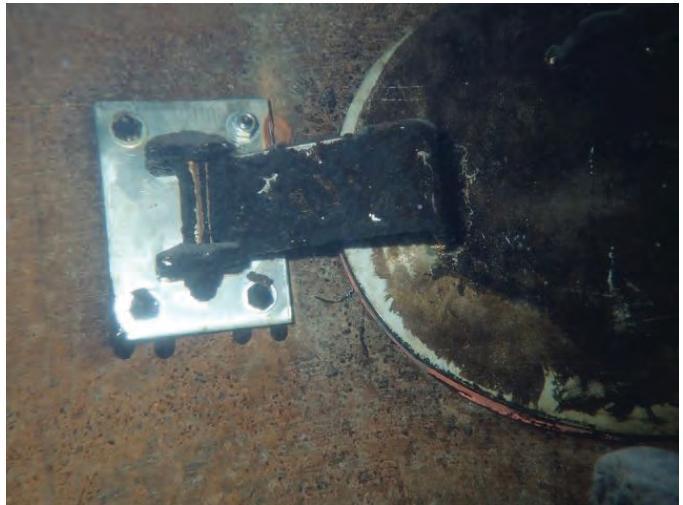
49 Southernmost Manway

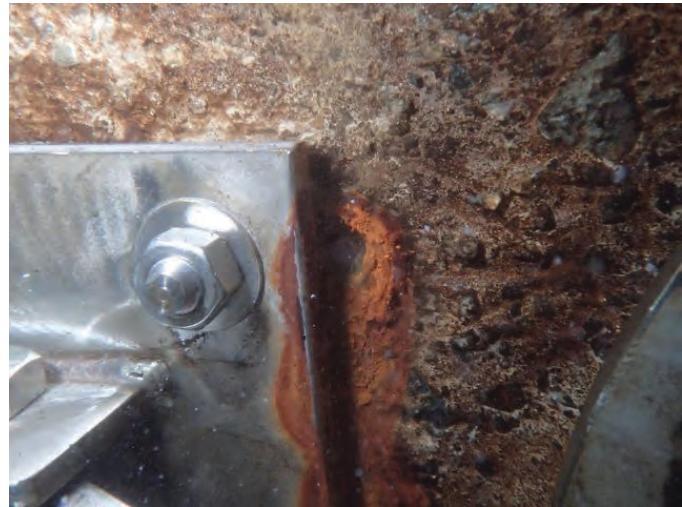
Southernmost Manway With In-Place Davit Hinge 50

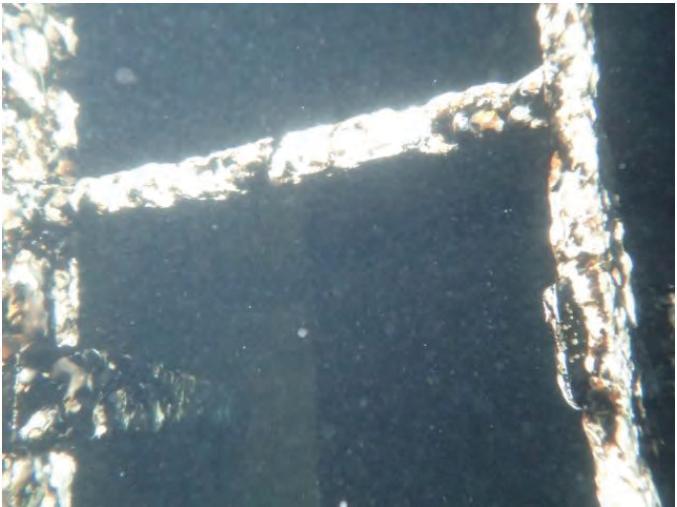
51 Southernmost Manway Davit Hinge With Free Spinning Bolt And Miss-Drilled/ Unused Bolt-hole

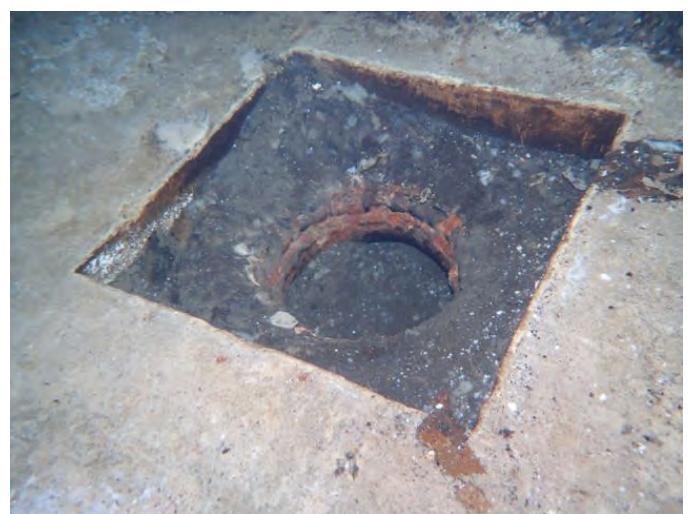
52 Southernmost Manway Access Aluminum Ladder With Corrosion

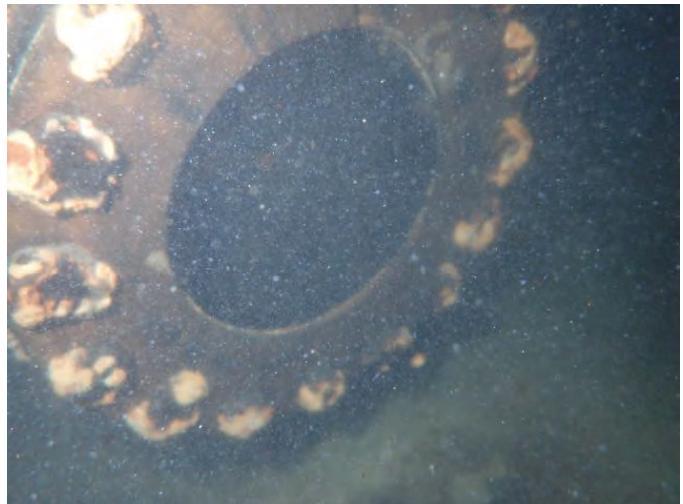
54 *16" Inside Diameter Pipe Penetrating The Tank Floor*

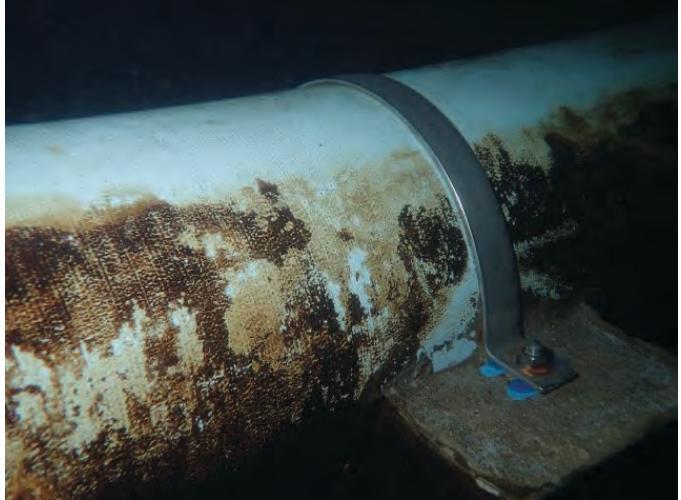
16" Inside Diameter Pipe Effluent Opening 56

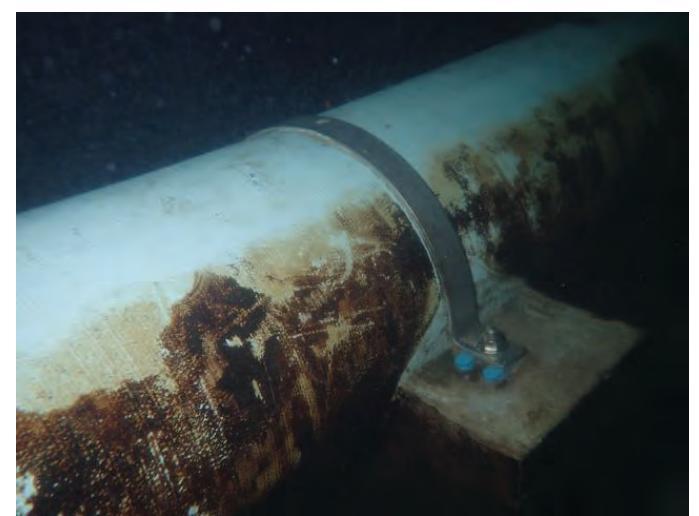
57 16" Inside Diameter Pipe Having Coating Blisters, Exposed Metal and Corrosion With Secure Hardware

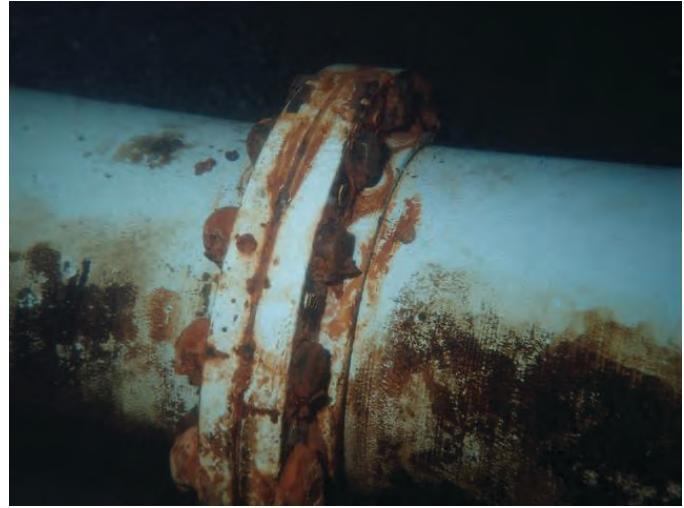
16" Inside Diameter Pipe Having Coating Blisters,
58 Exposed Metal and Corrosion With Secure Hardware

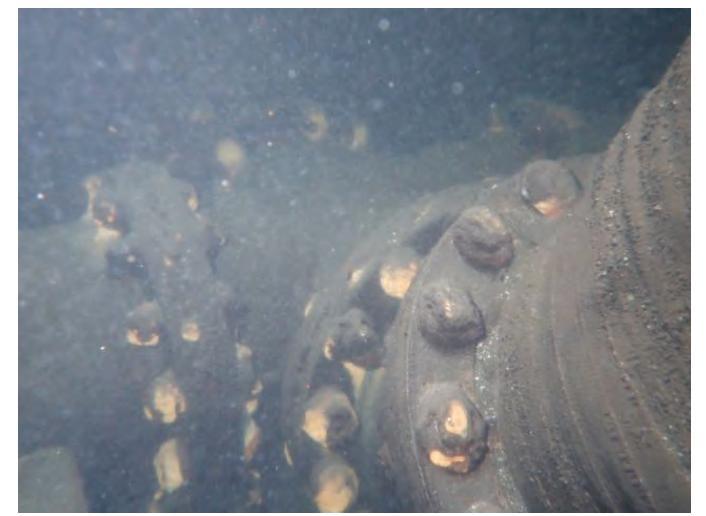
59 16" Inside Diameter Pipe Having Coating Blisters, Exposed Metal and Corrosion With Secure Hardware

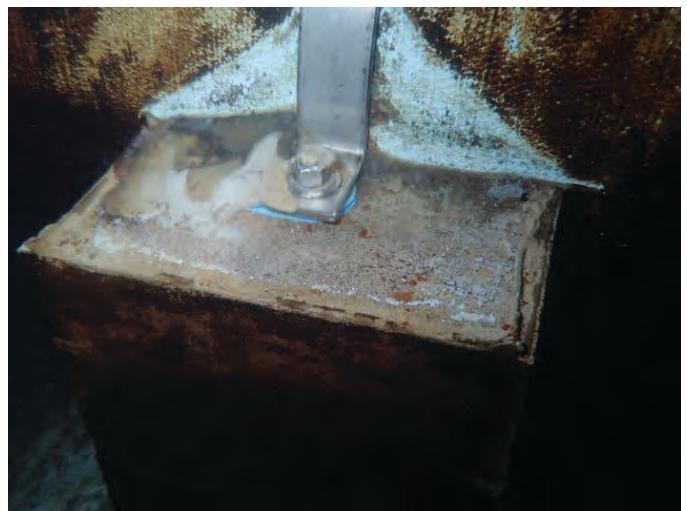
60 16" Inside Diameter Pipe Having Coating Blisters, Exposed Metal and Corrosion With Secure Hardware

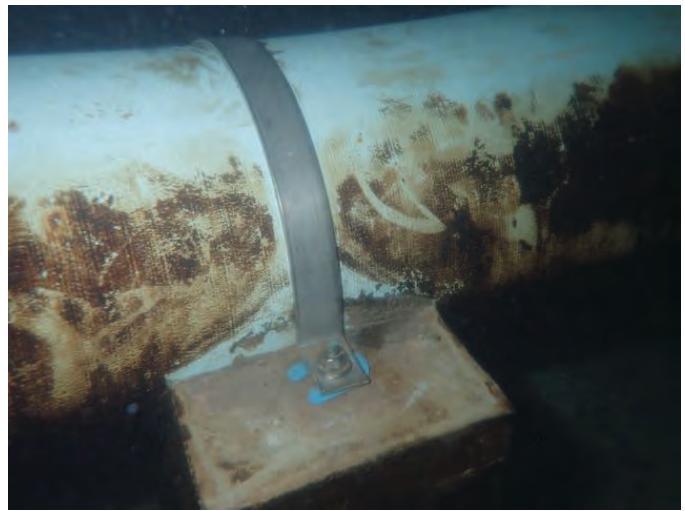
Concrete Pipe Support 61

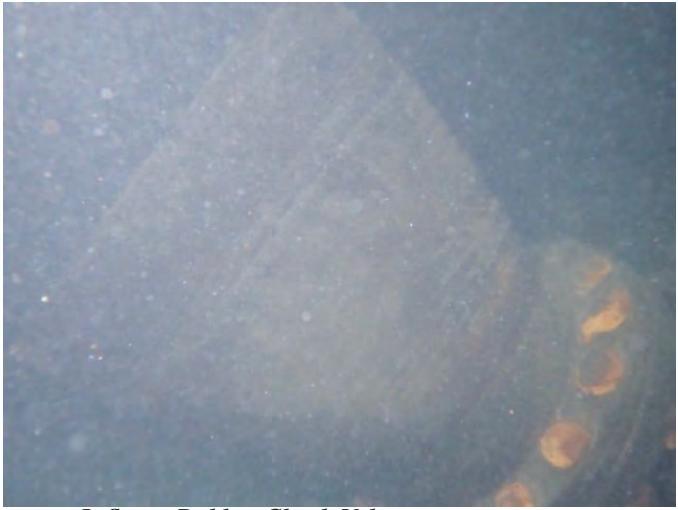
62 *Concrete Pipe Support*

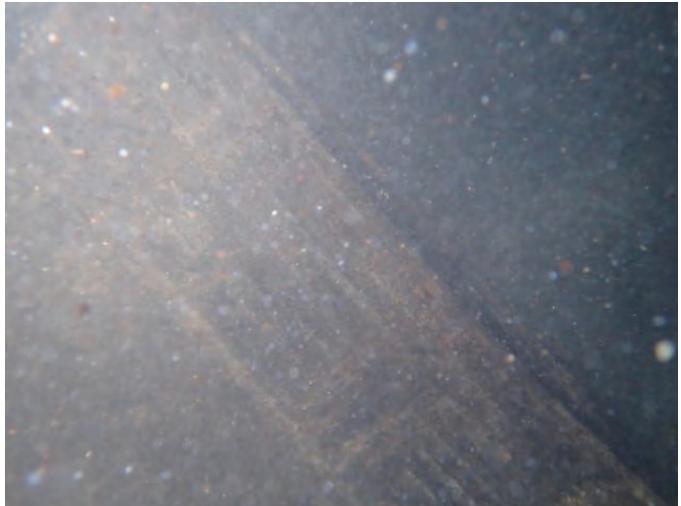
63 Influent Rubber Check Valve

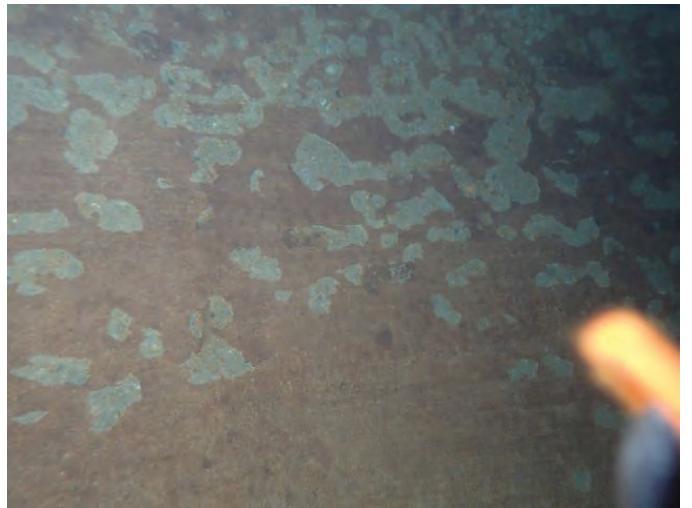
65 Interior Wall With Concrete Scour And Moderate To Heavy Staining

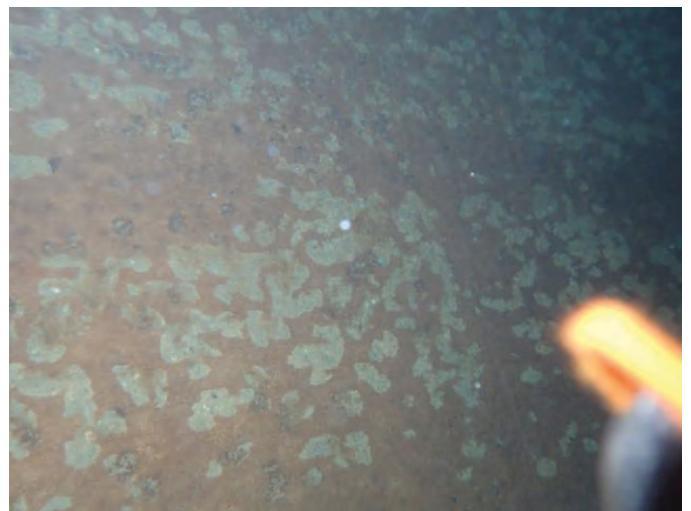
66 Interior Wall With Concrete Scour And Moderate To Heavy Staining

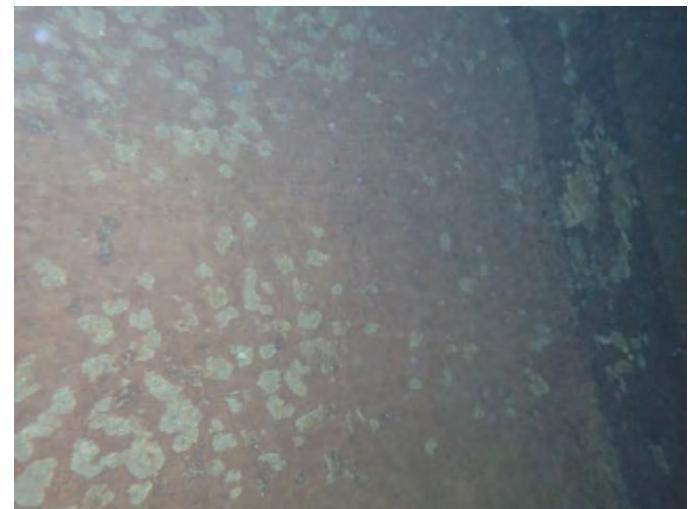
67 Interior Wall With Concrete Scour And Moderate To Heavy Staining

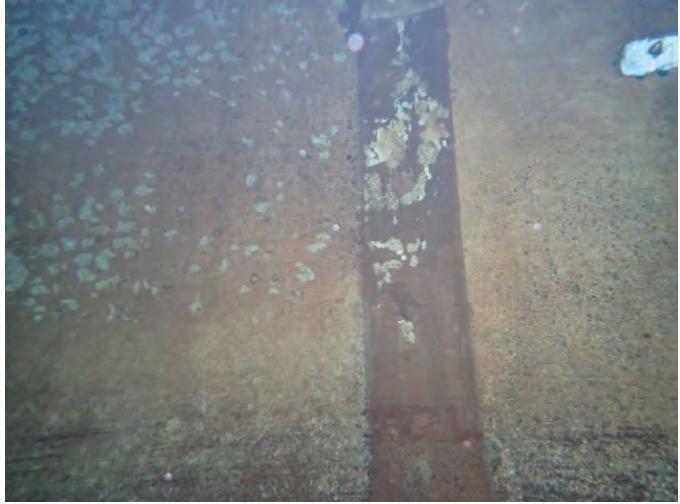
Interior Wall With Concrete Scour And Moderate To 68 Heavy Staining

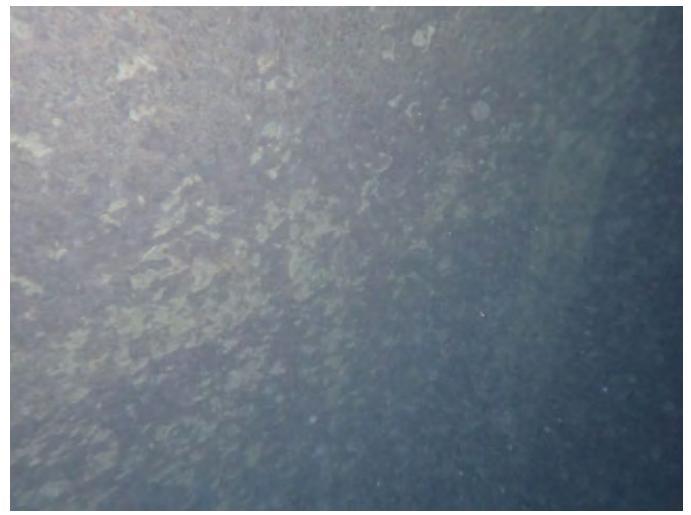
69 Interior Wall With Concrete Scour And Moderate To Heavy Staining

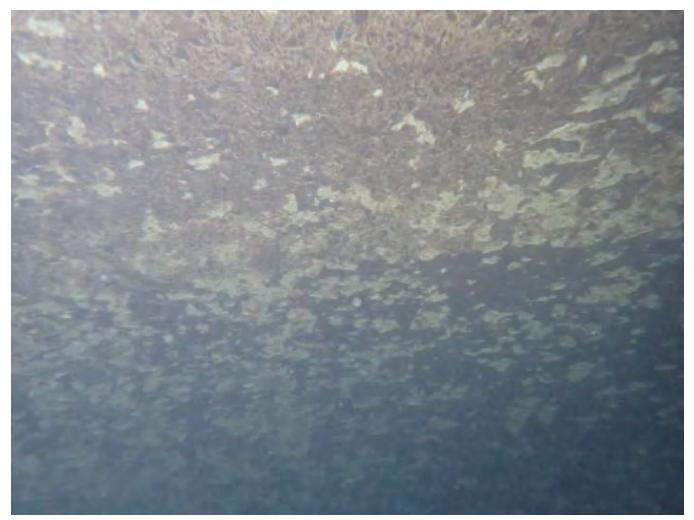
70Interior Wall With Concrete Scour And Moderate To
Heavy Staining

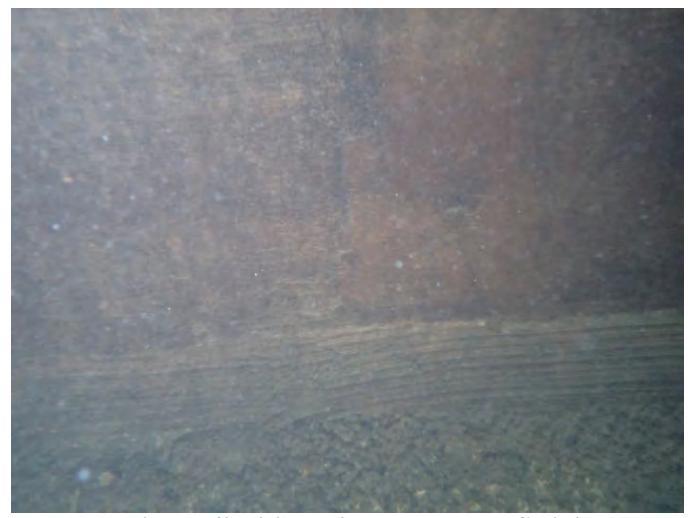
71 Interior Wall With Concrete Scour And Moderate To Heavy Staining

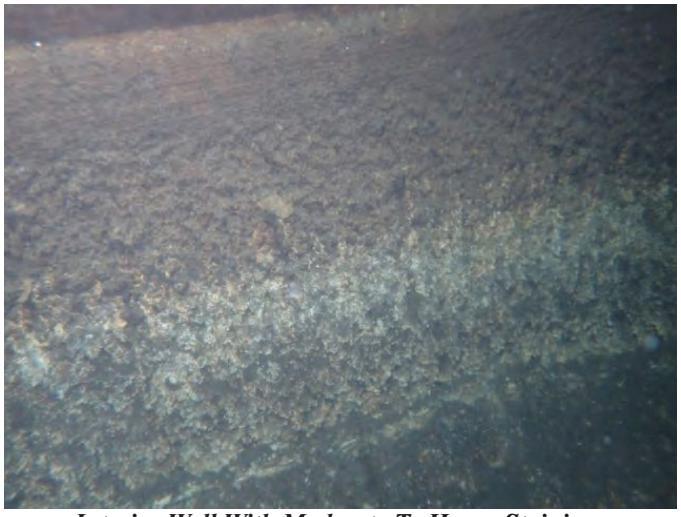
72 Interior Wall With Moderate To Heavy Staining

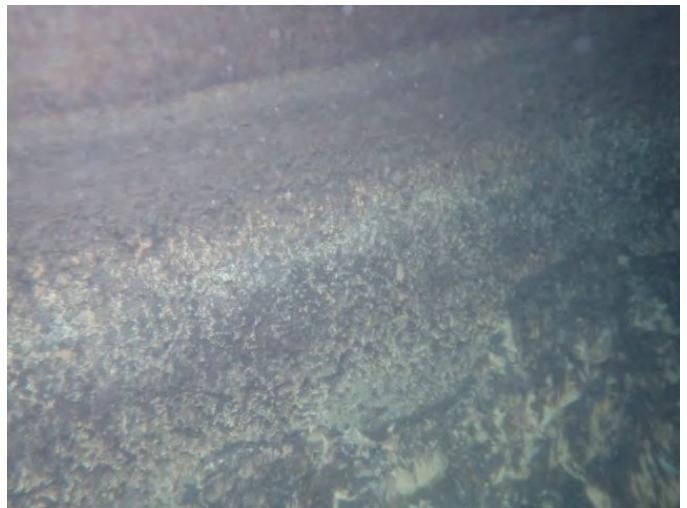
73 Interior Wall With Moderate To Heavy Staining

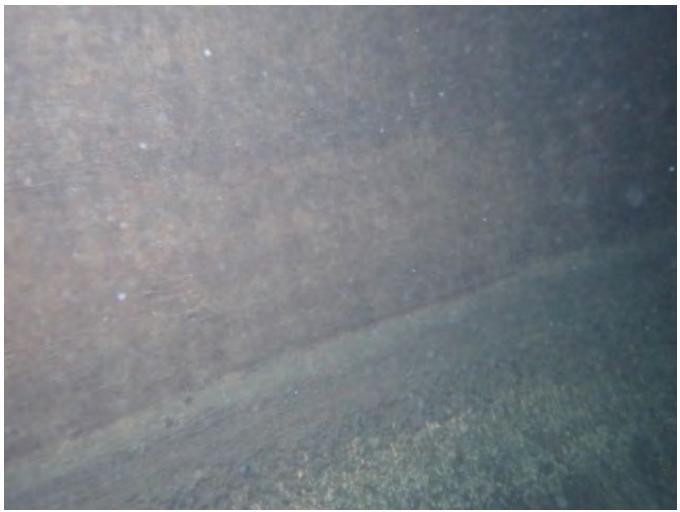
Interior Wall With Moderate To Heavy Staining
