In re: City of Woonsocket Water Division - Application to Implement Multi-Year Rate Plan

Docket No. 4879

Dam Name (No):	Woonsocket Reservoir #3 Dam (068)
Location:	Smithfield/North Smithfield
Hazard Classification:	High
	-
Inspector:	David M. Matheson, P.E.
Inspection Date.	August 1, 2014

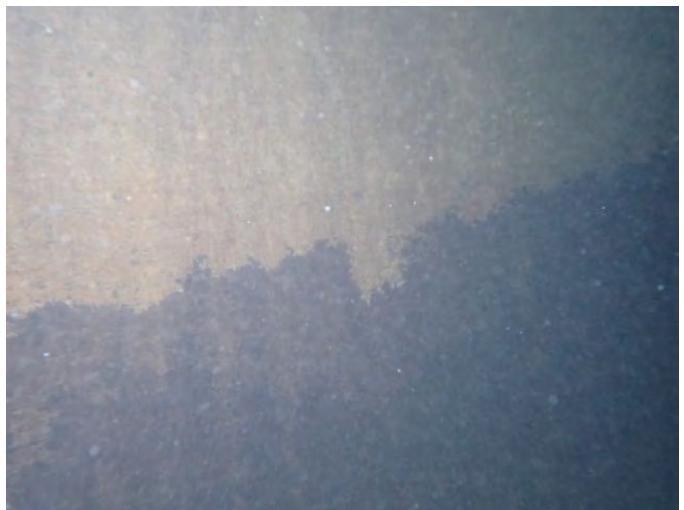
Interior Wall With Moderate To Heavy Staining75

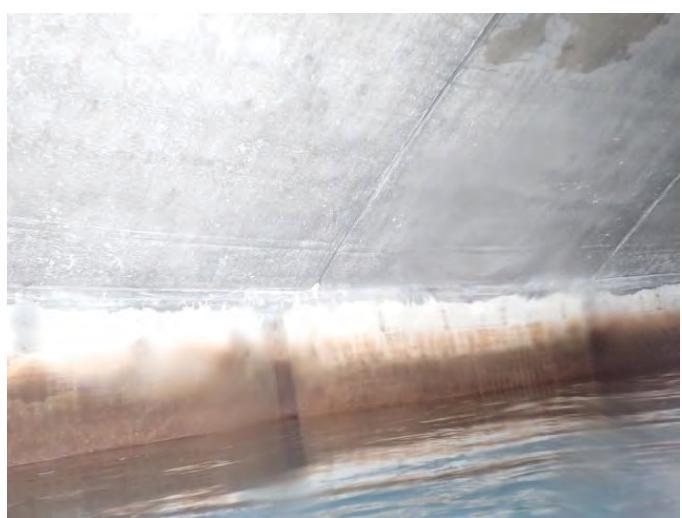
Interior Wall With Moderate To Heavy Staining76

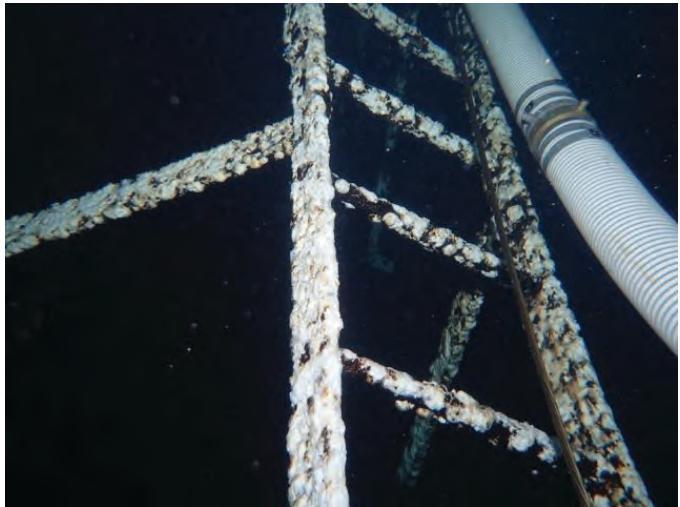
78 Interior Aluminum Ladder And Fall Prevention Device With Fatigue (Pitting) And Corrosion

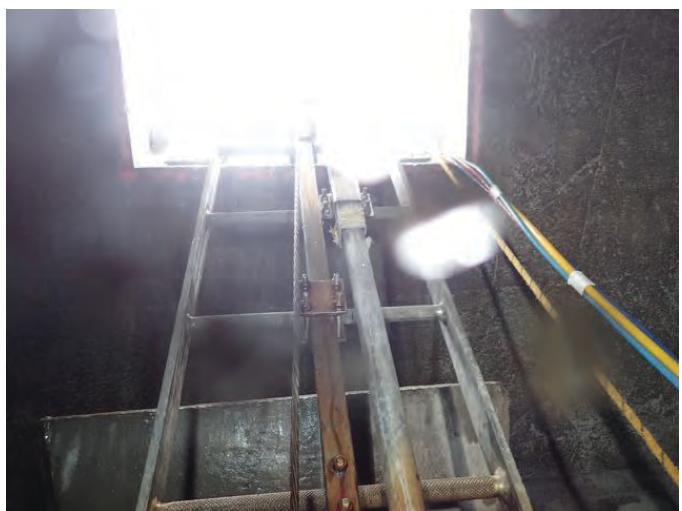
79 *Interior Aluminum Ladder And Fall Prevention Device With Fatigue (Pitting) And Corrosion*

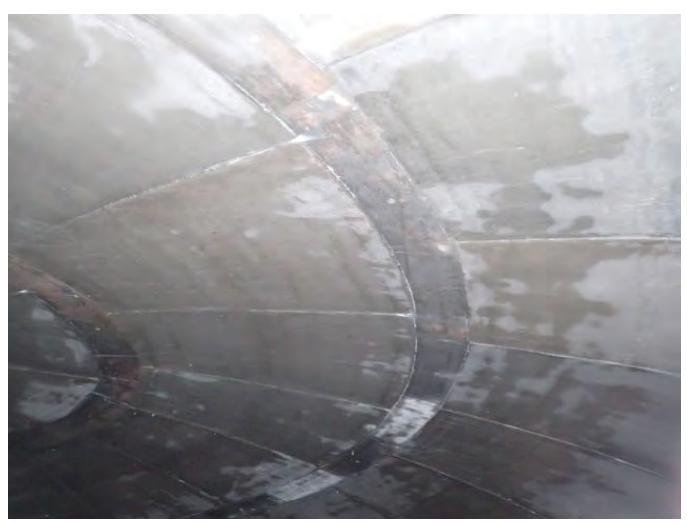
81 *Overhead With Efflorescence*

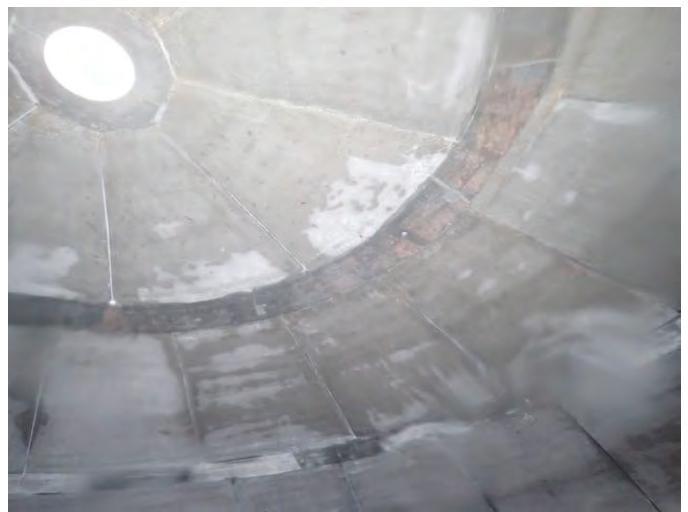
82 *Overhead With Efflorescence*

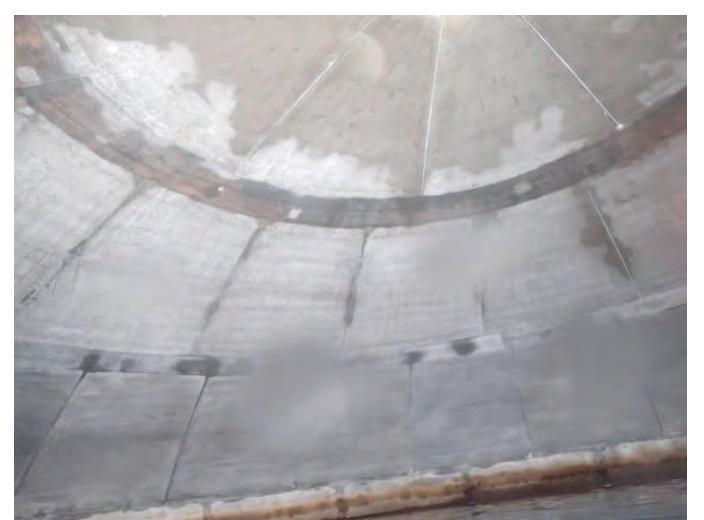
83 Overhead With Efflorescence

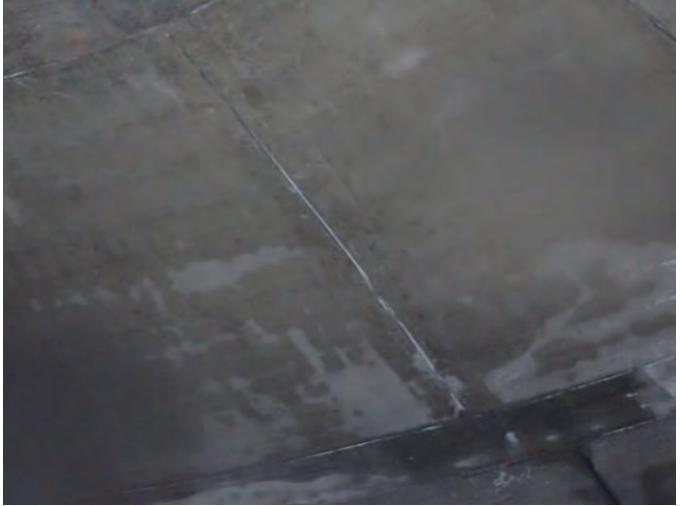
84 Overhead With Efflorescence

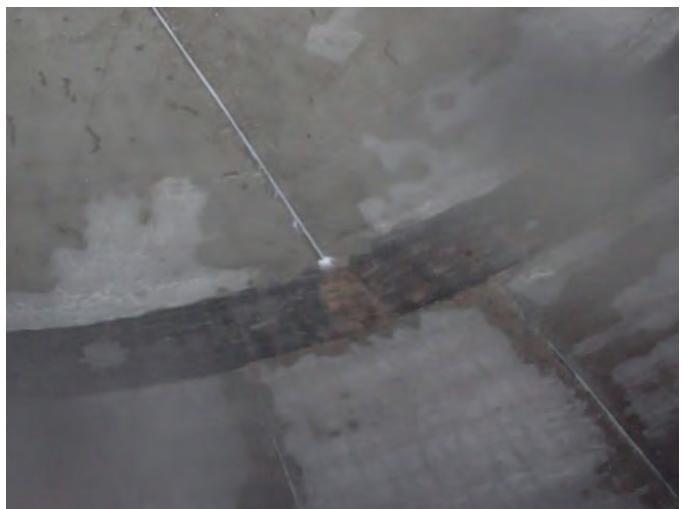
Overhead With Efflorescence

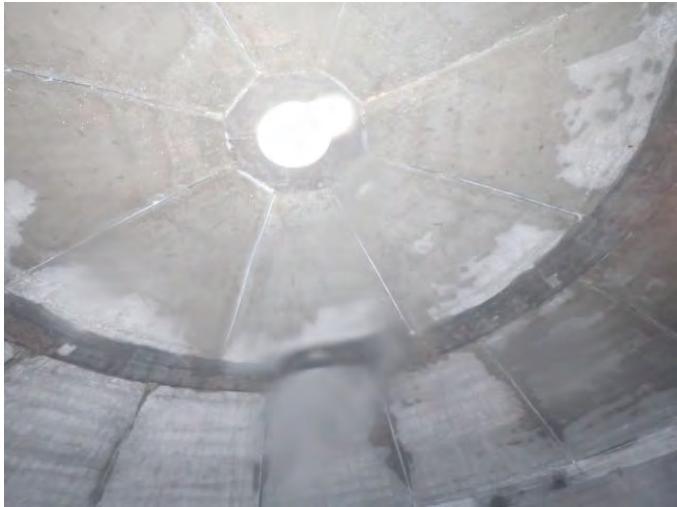
Overhead With Efflorescence

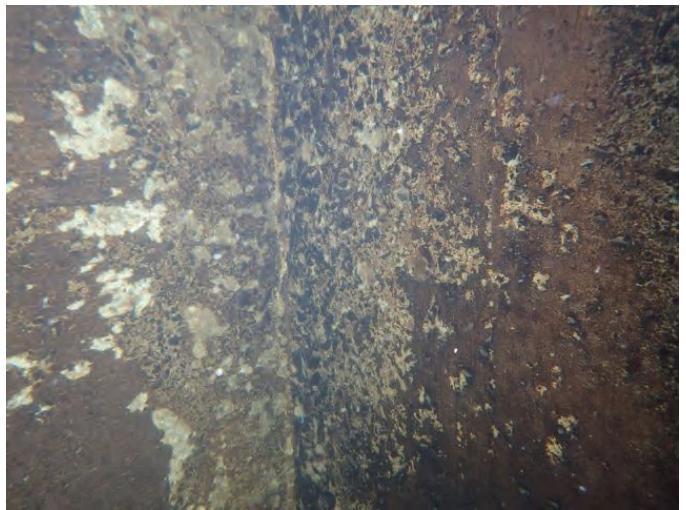
90 Concrete Overflow Box With Concrete Scour

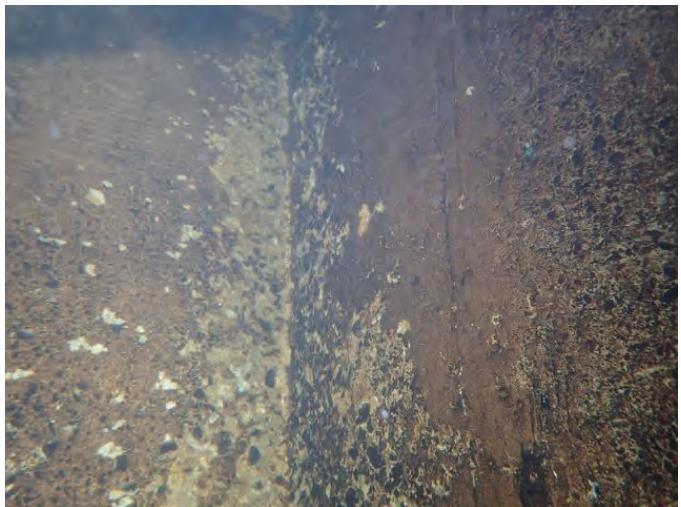
91 *Concrete Overflow Box With Concrete Scour*

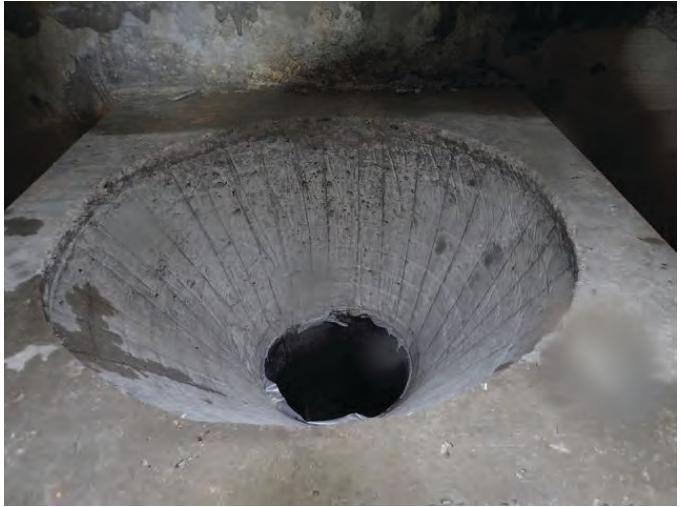
92 *Concrete Overflow Box With Concrete Scour*

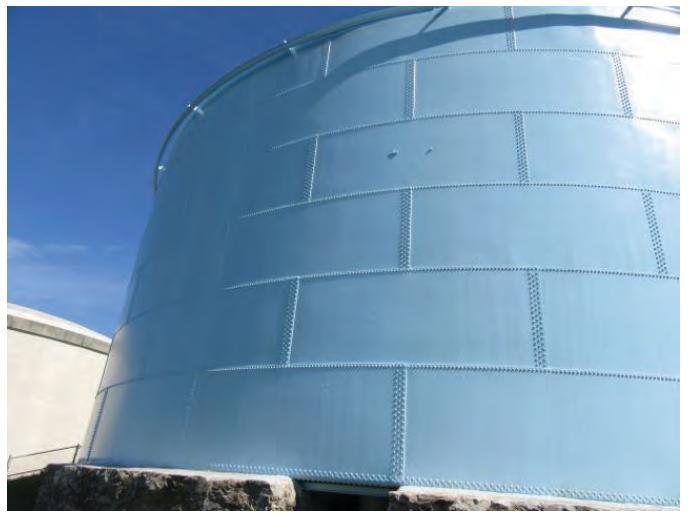
A mild, non-uniform accumulation of mildew throughout the exterior walls causes declined aesthetics.

Exterior Wall With Mildew

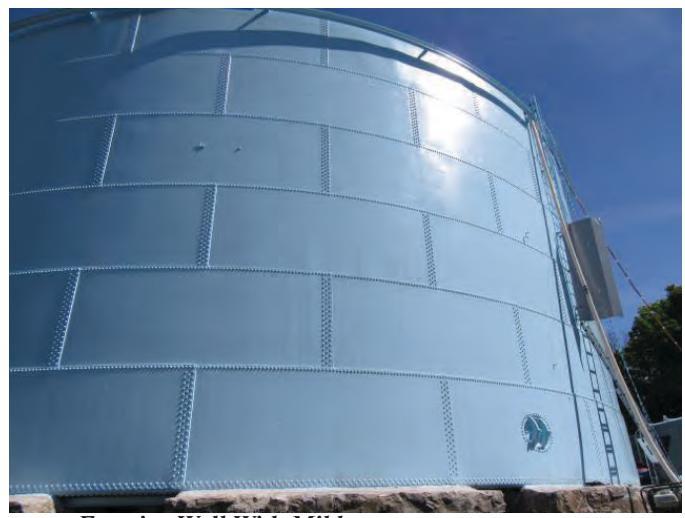
Exterior Wall With Mildew 2

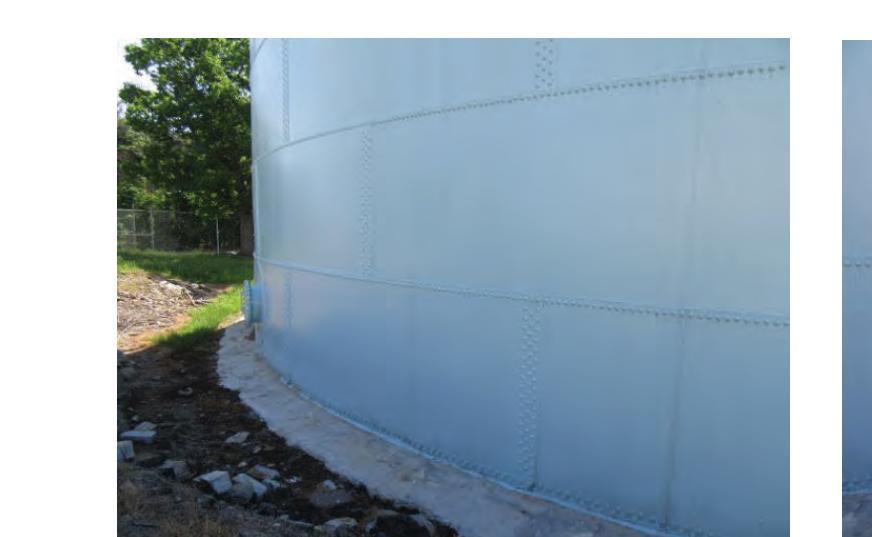
3 *Exterior Wall With Mildew*

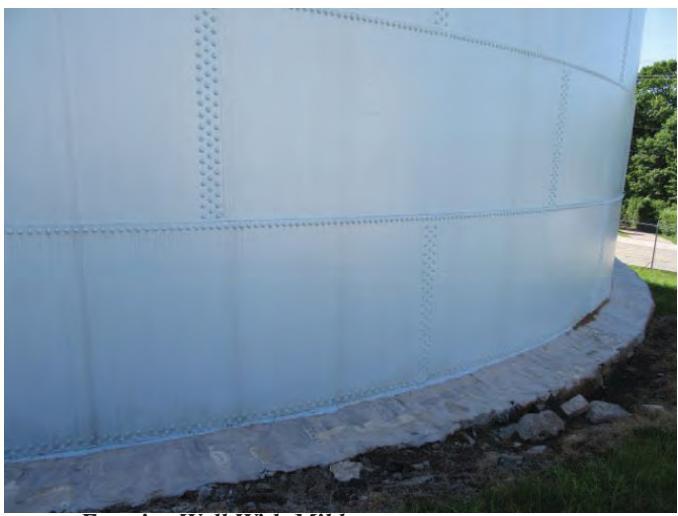
Exterior Wall With Mildew

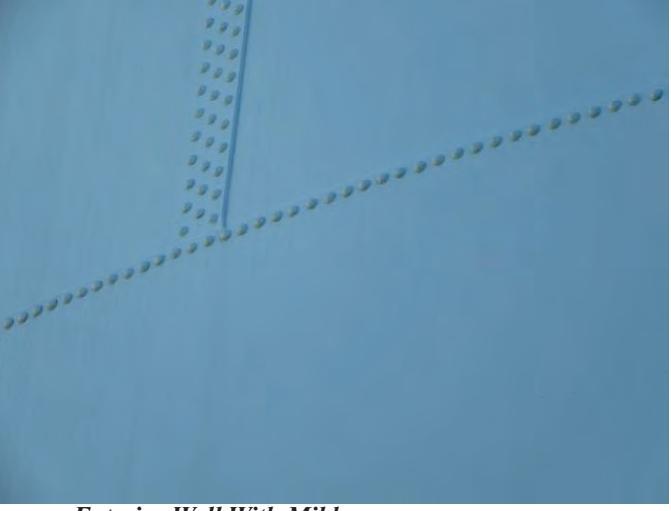
5 *Exterior Wall With Mildew*

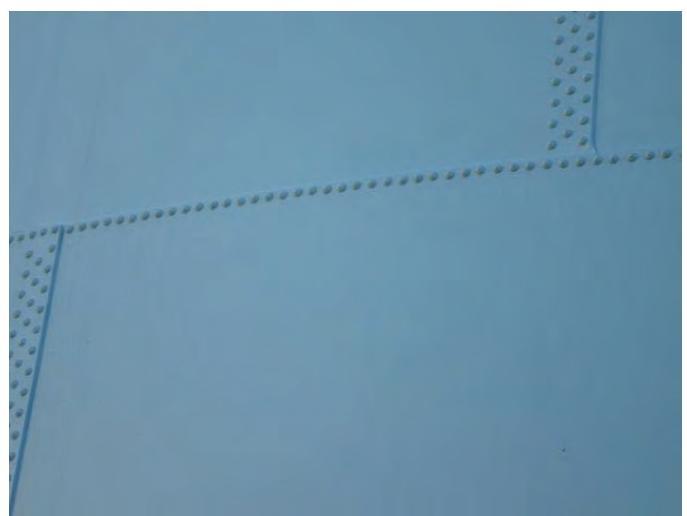
6 Exterior Wall With Mildew

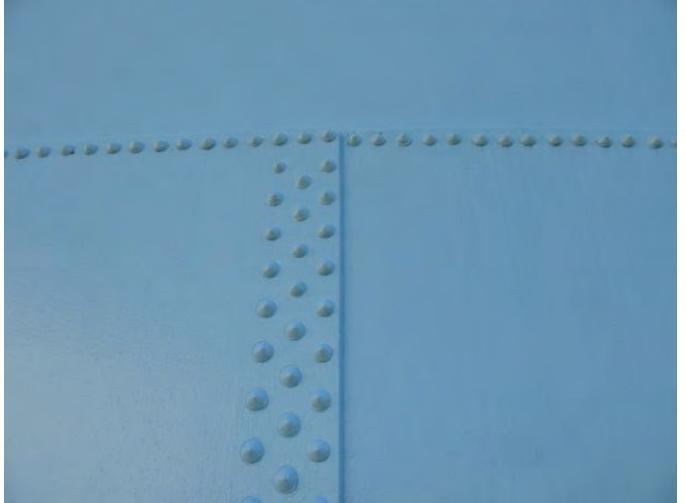
Exterior Wall With Mildew 7

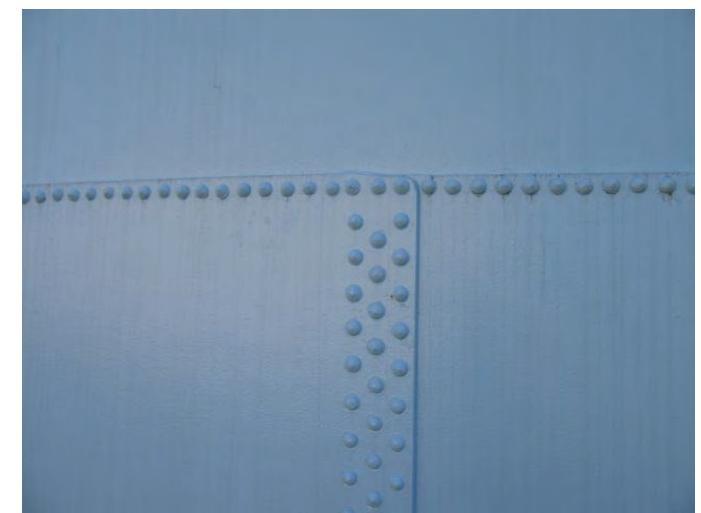
Exterior Wall With Mildew 8

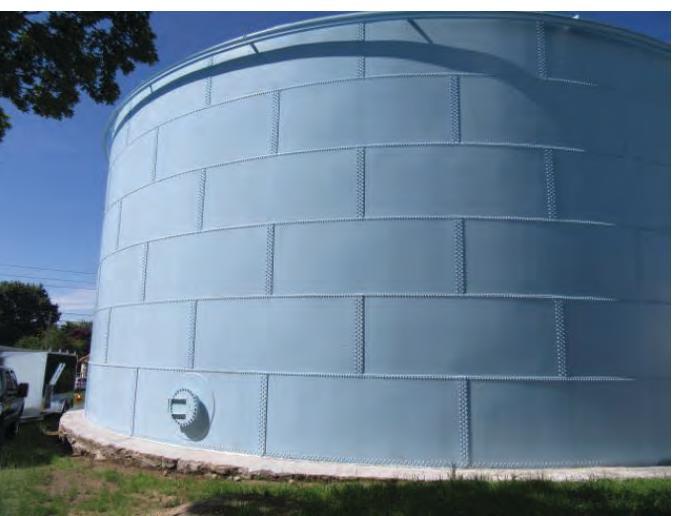
9 *Exterior Wall With Mildew*

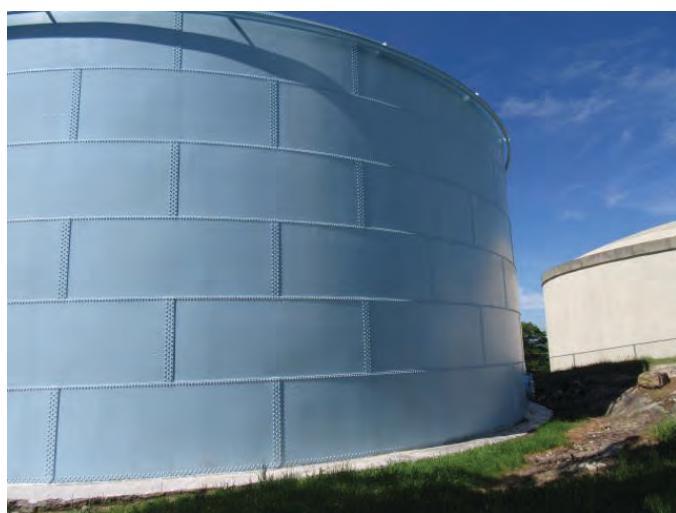
Exterior Wall With Mildew 10

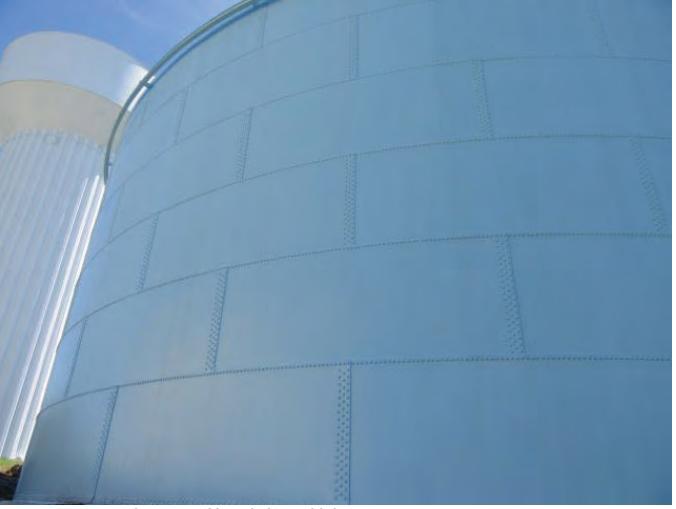
11 *Exterior Wall With Mildew*

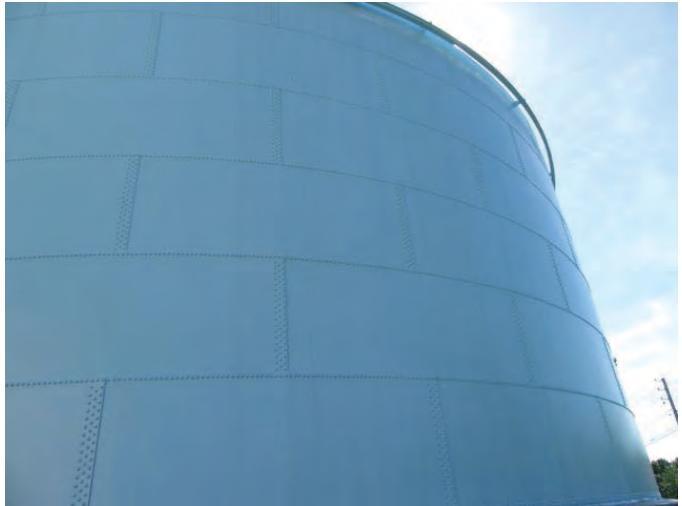
12 Exterior Wall With Mildew

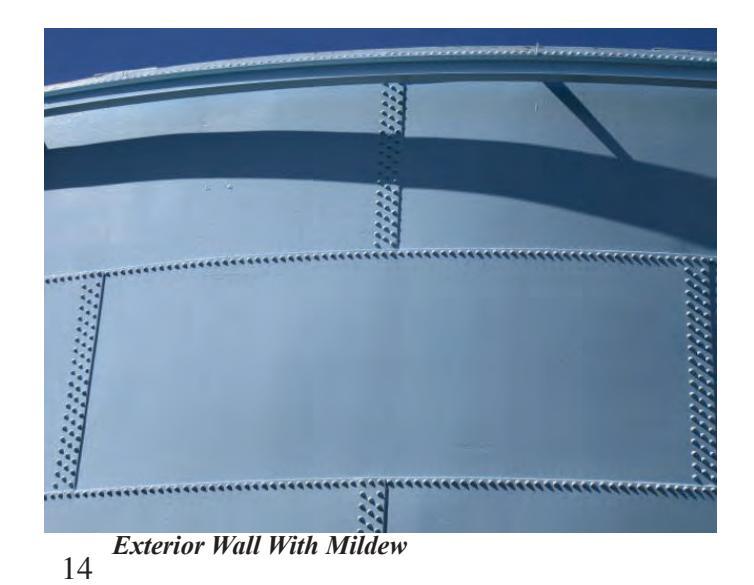
15

A STATE OF THE STA Exterior Wall With Mildew

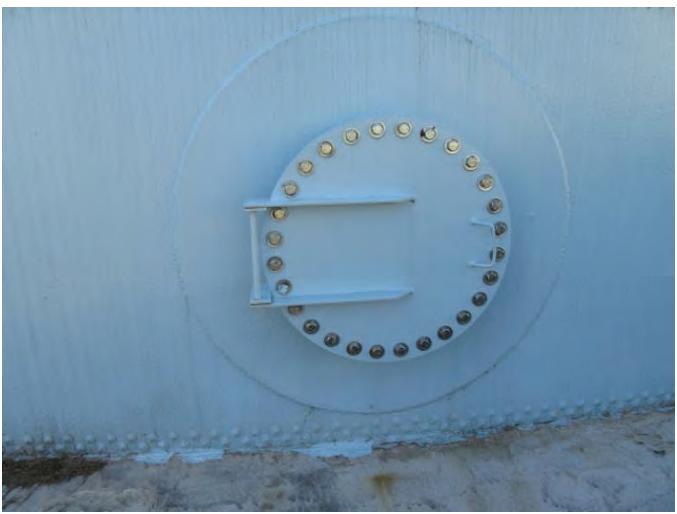
Two, 24" inside diameter manways penetrate the lowest row of wall panels on the northernmost and north-easternmost sides of the tank, located 22" above the tank base, and are securely installed and free of leakage.

The protective coating applied to the northernmost manway has an average dry film thickness of 12.9 mils, meets the AWWA's recommendations and was found having good adhesion value at this time.

Secure Northernmost Manway 16

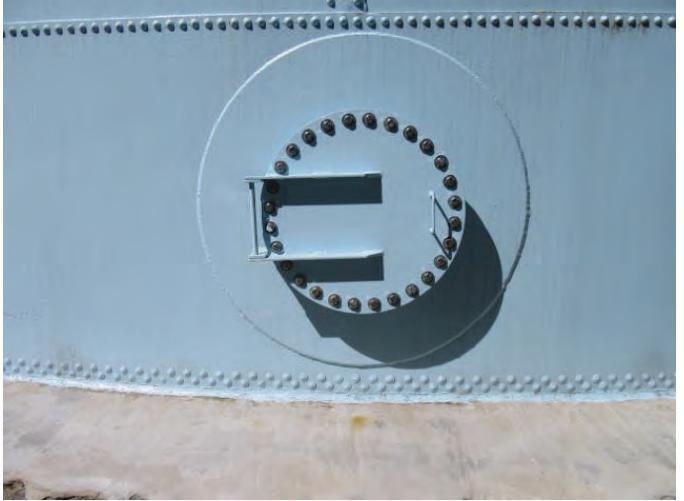
The protective coating applied to the north-easternmost manway has an average dry film thickness of 21.9 mils, meets the AWWA's recommendations and was found having good adhesion value at this time.

Secure North-Easternmost Manway 17

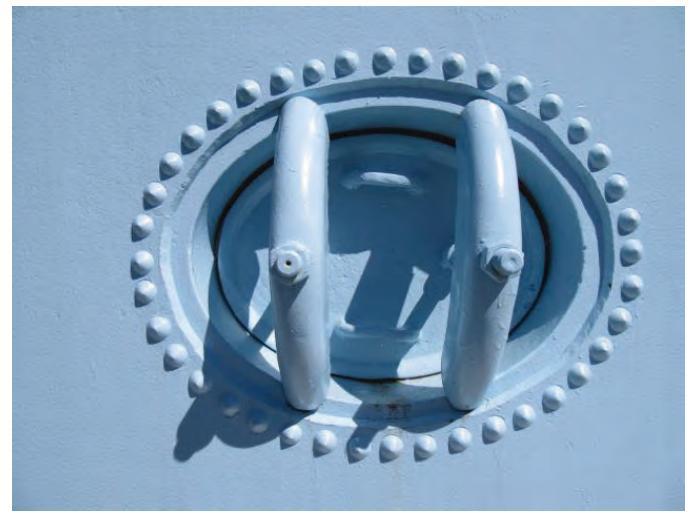
One, 24" by 18" inside diameter manway penetrates the lowest wall panel on the southernmost side of the tank, located 24" above the tank base, and is securely installed and free of leakage.

The protective coating applied to this manway has an average dry film thickness of 18.5 mils, meets the AWWA's recommendations and was found having good adhesion value at this time.

Secure Southernmost Manway 18

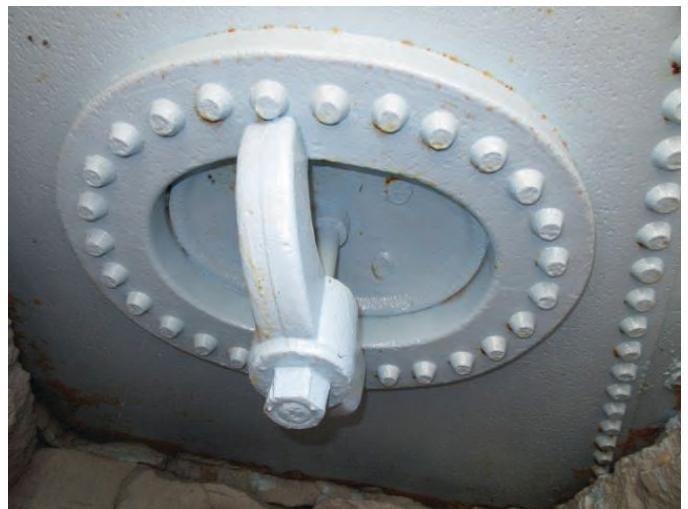
One, 15" by 10-1/2" inside diameter manway penetrates the floor on the southernmost side of the tank, located 26" in from the wall, and is securely installed and free of leakage.

The protective coating applied to this manway has an average dry film thickness of 12.8 mils, meets the AWWA's recommendations and was found having good adhesion value at this time.

Manway Penetrating The Tank Floor On The South 19 Side Of The Tank

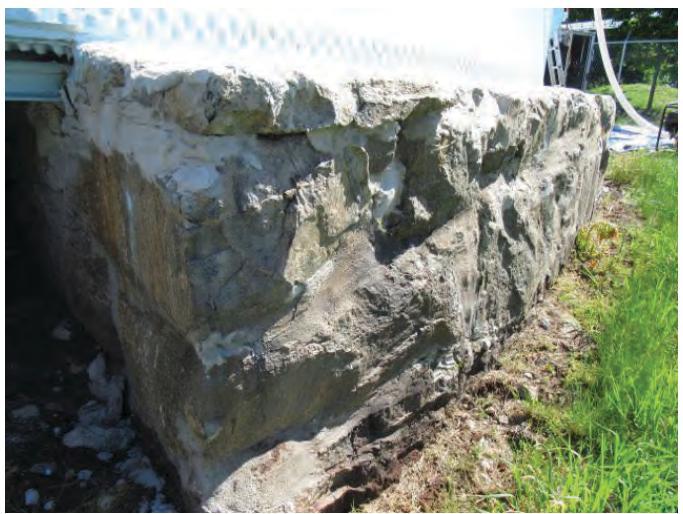
The exposed portion of the 24" wide granite block and mortar joint foundation ranges in height from 1" to 52" in height and was found appearing mostly sound, however tight cracks were observed throughout approximately 30% of the surfaces of the mortar placed between the granite blocks.

These tight cracks were sounded and no obvious voids were evident, while minimal spall of the mortar was observed throughout approximately 10% of these surfaces. However, all granite blocks remain in-place and are sound at this time.

23 Granite Block Foundation With Tight Cracks And Minimal Mortar Spall

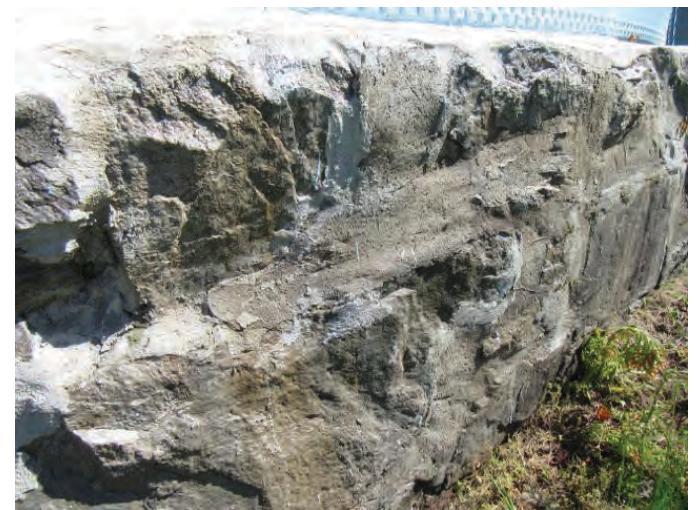
24 Granite Block Foundation With Tight Cracks And Minimal Mortar Spall

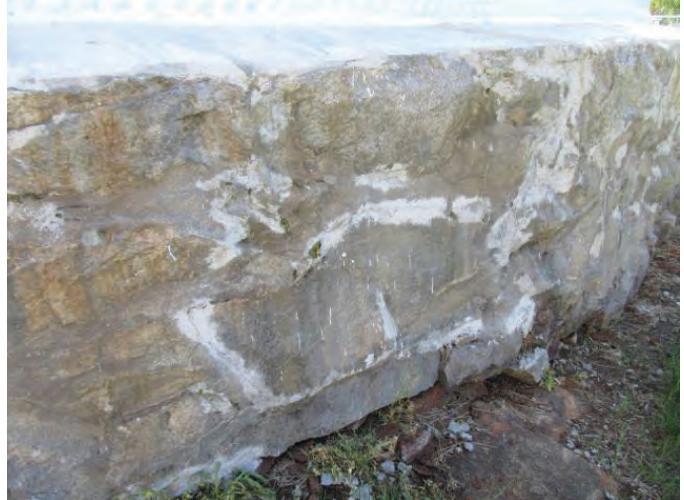
Granite Block Foundation With Tight Cracks And 25 Minimal Mortar Spall

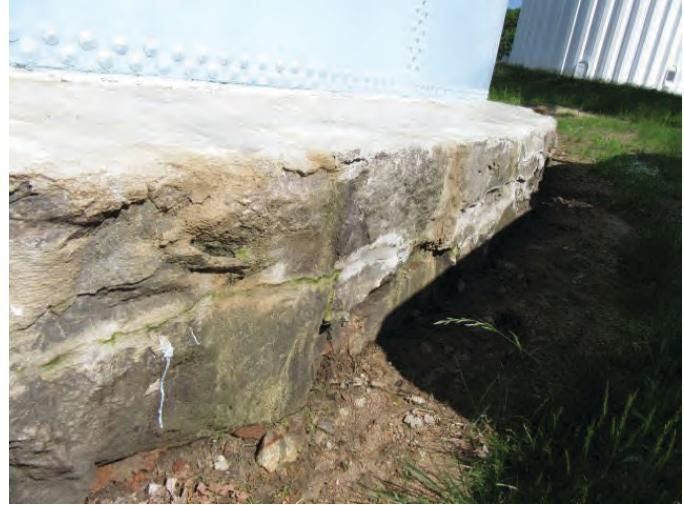
Granite Block Foundation With Tight Cracks And Minimal Mortar Spall

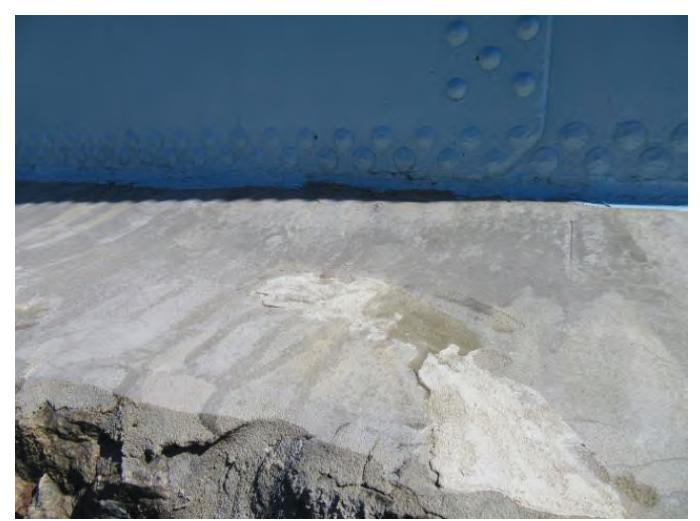
27 Granite Block Foundation With Tight Cracks And Minimal Mortar Spall

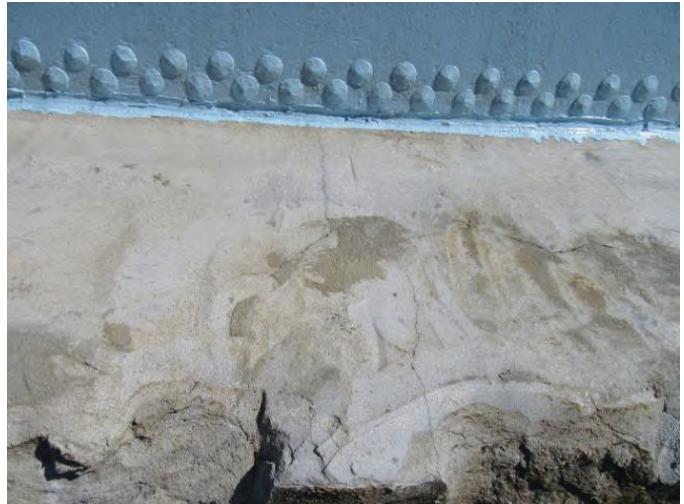
28 Concrete Foundation Cap With Tight Cracks

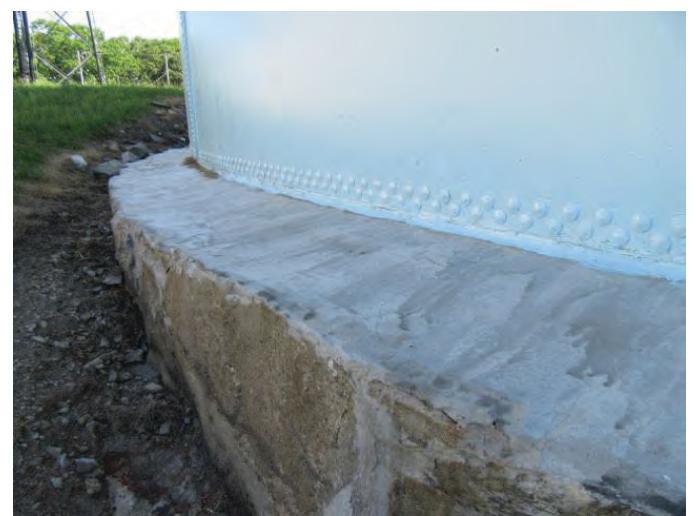
29 Concrete Foundation Cap With Tight Cracks

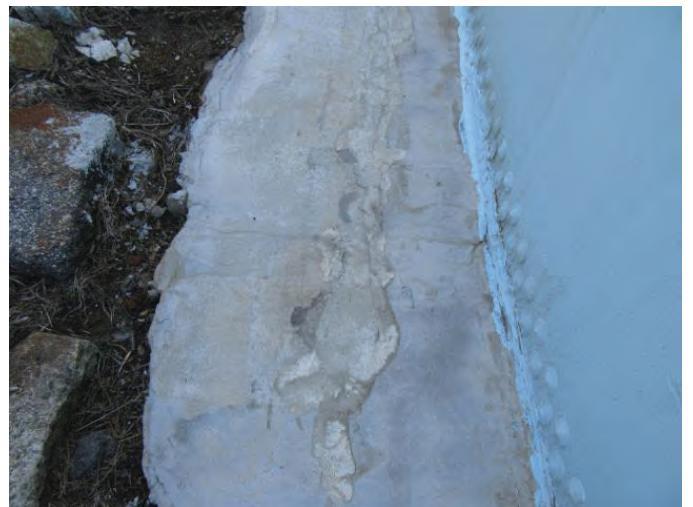
30 Concrete Foundation Cap With Tight Cracks

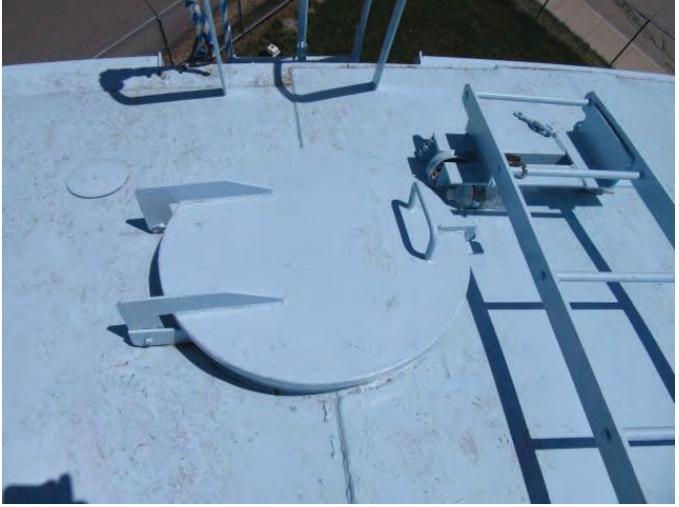
46 *Open Access Hatch*

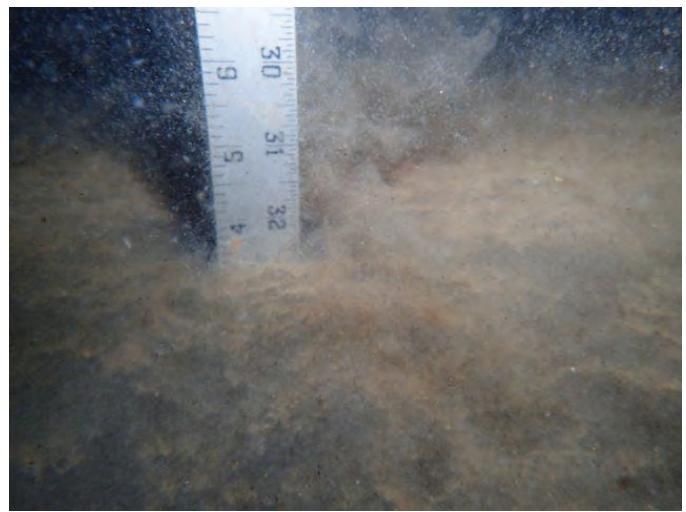
49 *Layer of Precipitate*

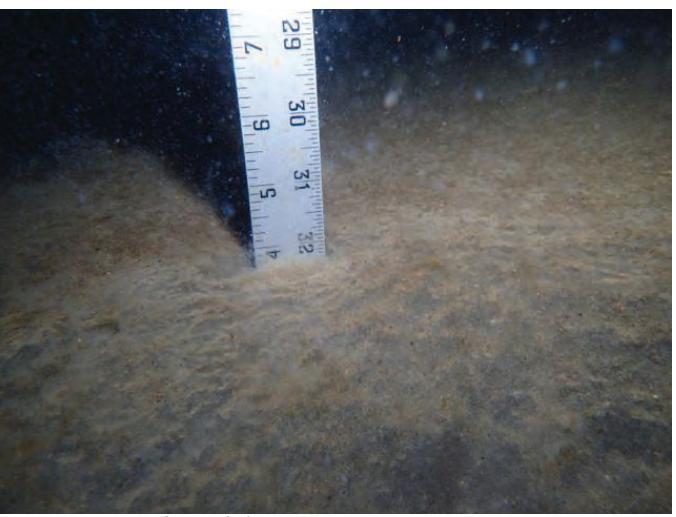
Layer of Precipitate 50

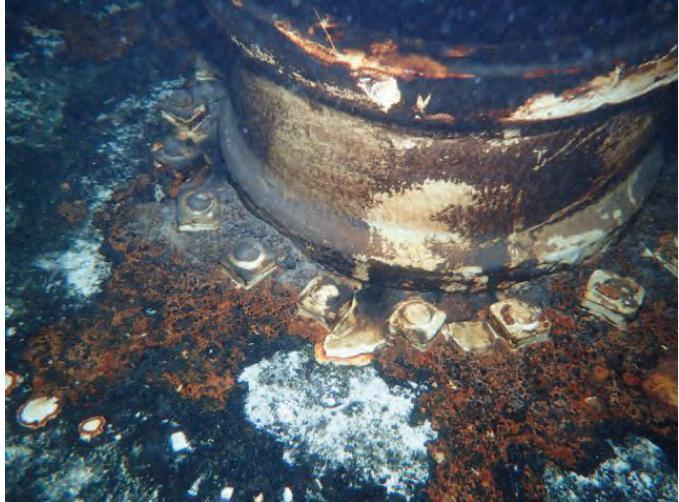
The protective coating applied to the floor appears to have been applied uniformly and was found having good adhesion value, however metal scale that appears to have entered the tank throughout the influent/effluent pipe was observed throughout a 6' radius around the influent/effluent pipe.

52 Floor With Metal Scale Hardened Around The Influent/Effluent Pipe

It is our recommendation that the next time this tank is removed from service and de-watered that this hardened metal scale be removed, and if the removal of this hardened scale causes coating damage/steel exposure, it would be our recommendation to power-tool clean these affected areas to prepare the substrate. We then recommend re-coating these affected areas using an A.N.S.I./N.S.F.61 approved coating for use in structures containing potable water to provide good protection for the steel.

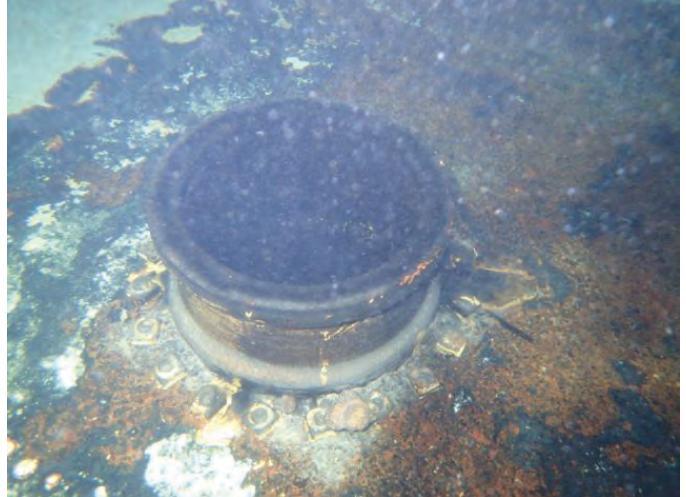
53 Floor With Metal Scale Hardened Around The Influent/Effluent Pipe

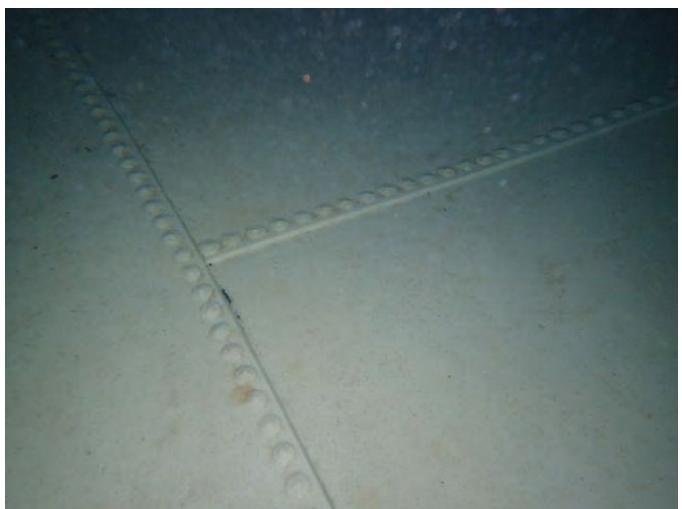
55 Floor With Mild Staining

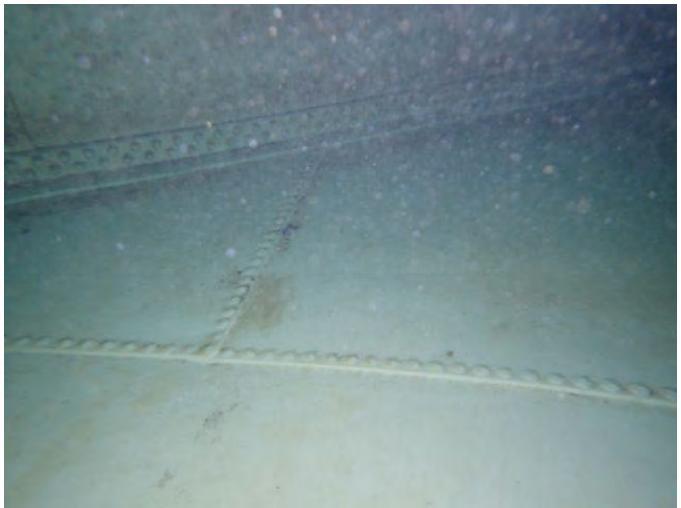
Floor With Mild Staining 56

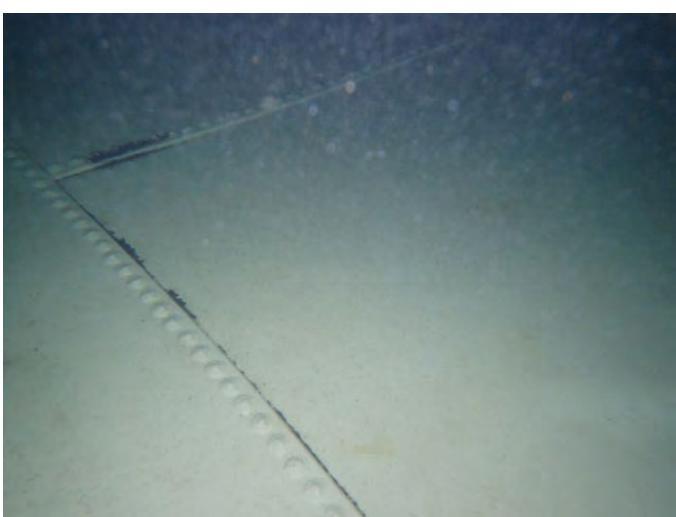
57 Floor With Mild Staining

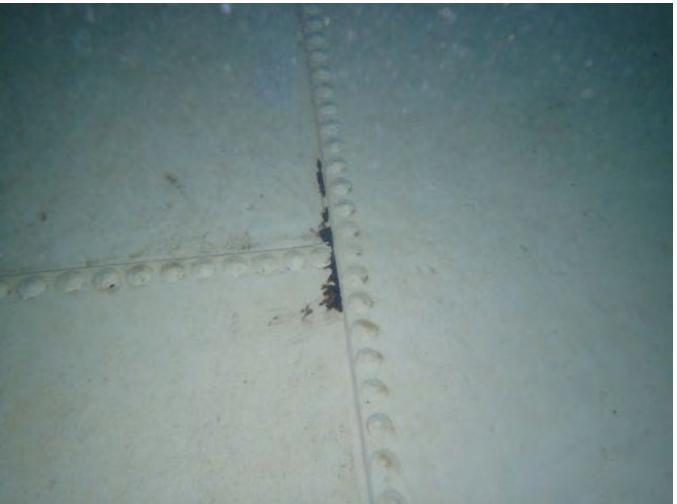
58 Floor With Mild Staining

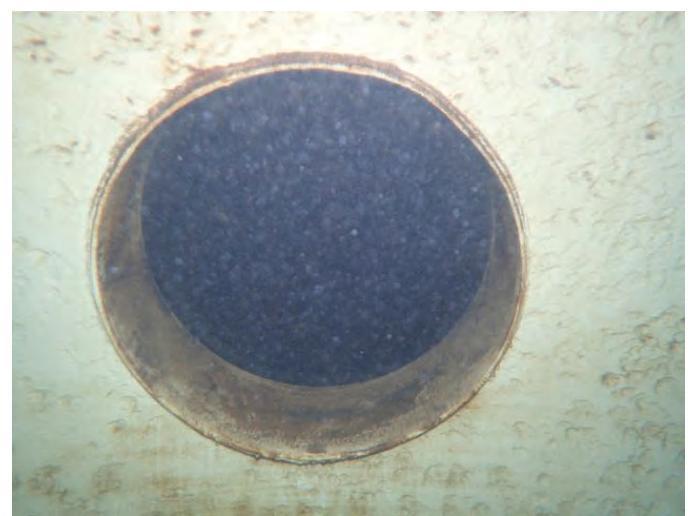
59 Floor With Mild Staining

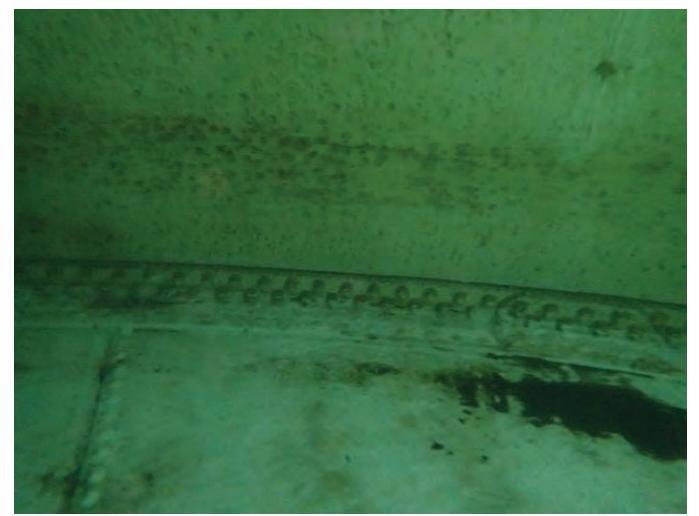
65 Interior Wall With Moderate To Heavy Staining

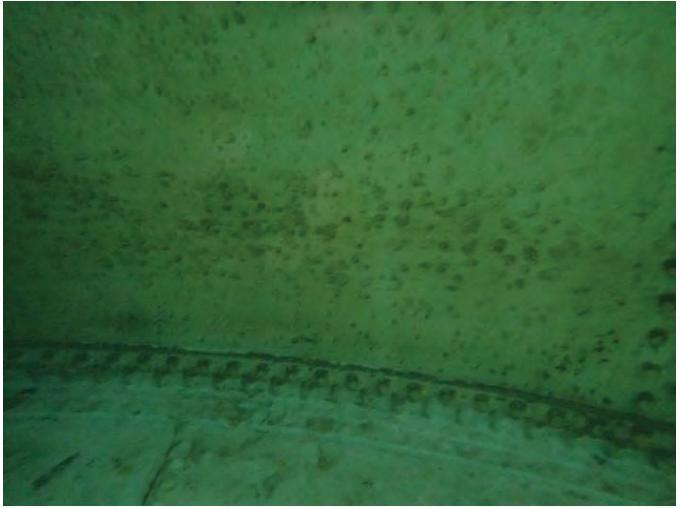
66 Interior Wall With Moderate To Heavy Staining

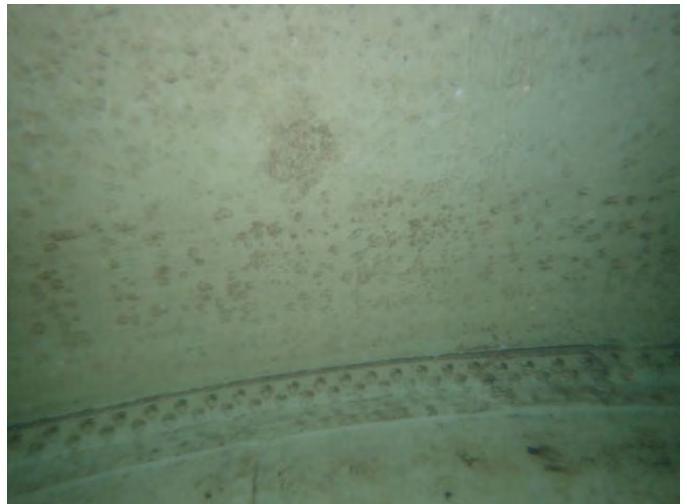
Interior Wall With Moderate To Heavy Staining

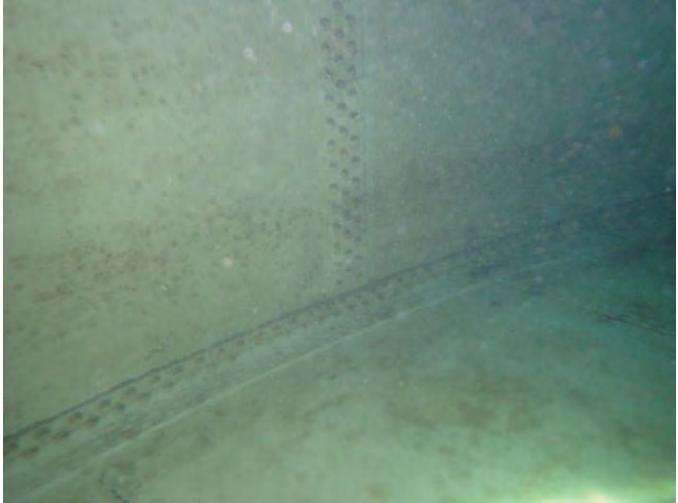
Interior Wall With Moderate To Heavy Staining

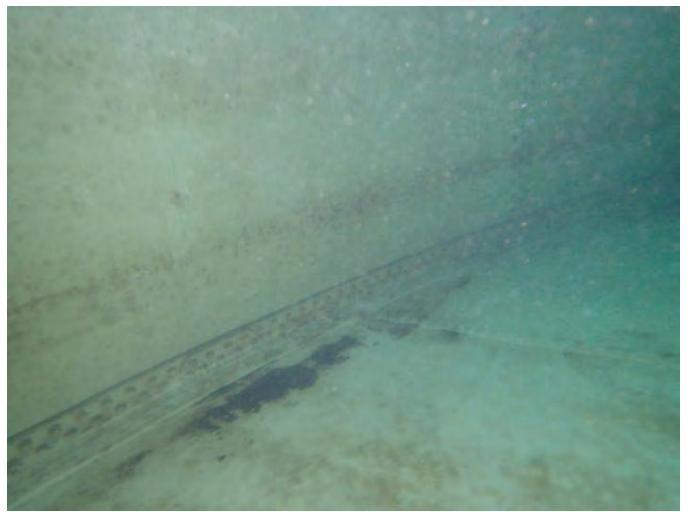
69 Interior Wall With Moderate To Heavy Staining

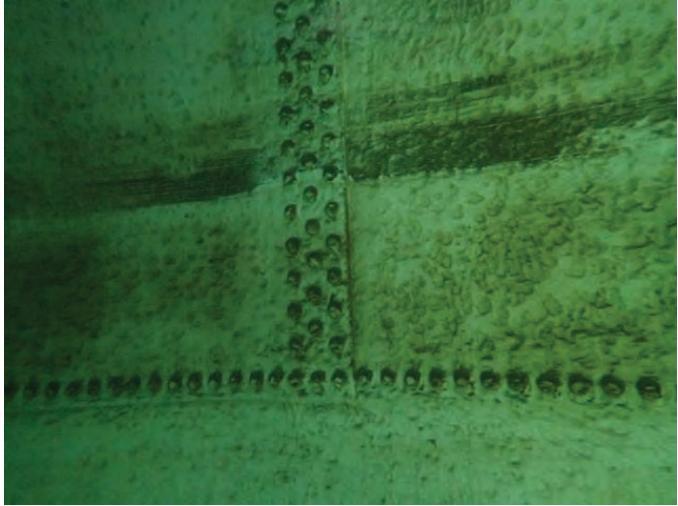
70 Interior Wall With Moderate To Heavy Staining

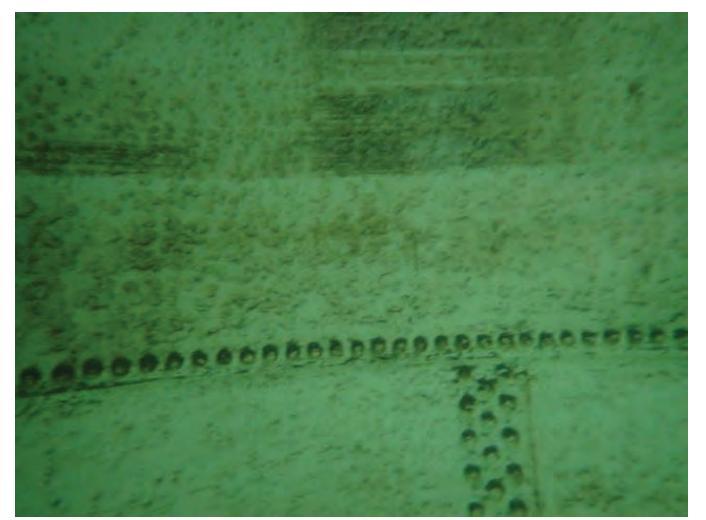
71 Interior Wall With Moderate To Heavy Staining

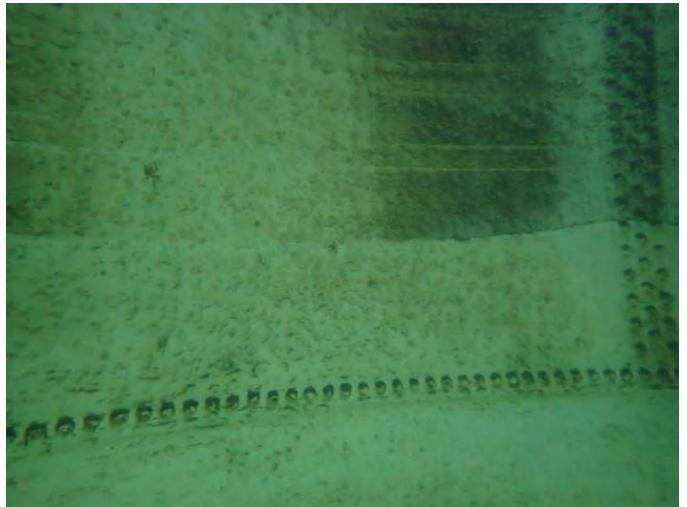
72 Interior Wall With Moderate To Heavy Staining

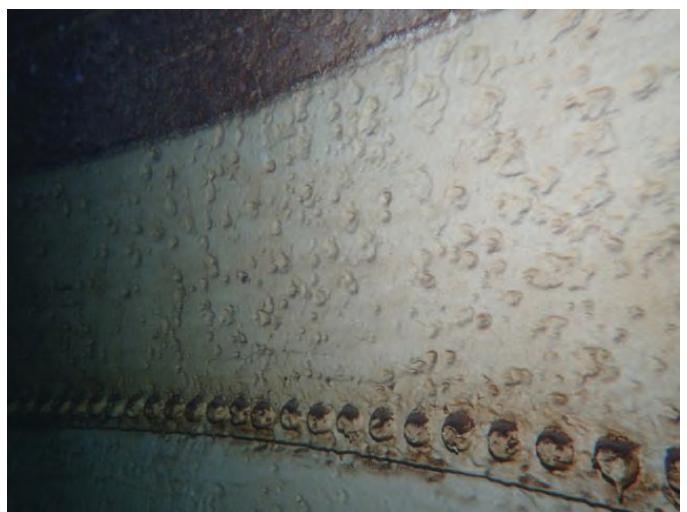
73 Interior Wall With Moderate To Heavy Staining

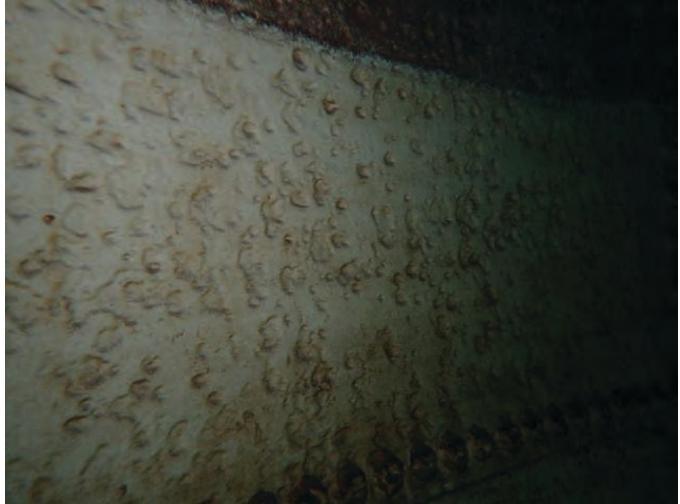
Interior Wall With Moderate To Heavy Staining

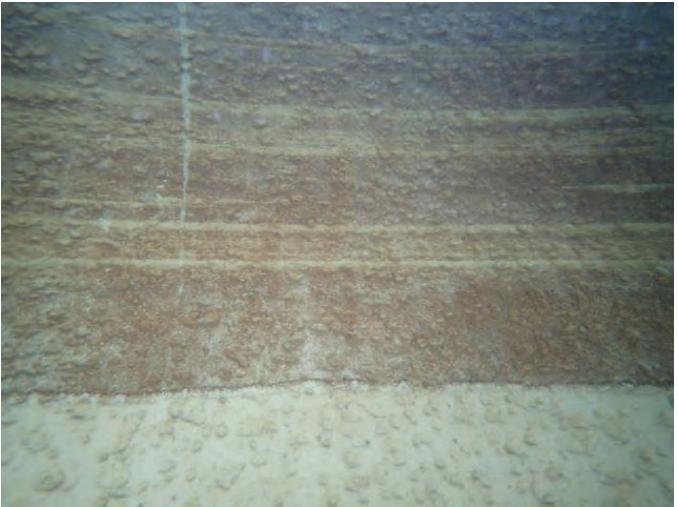
75 Interior Wall With Moderate To Heavy Staining

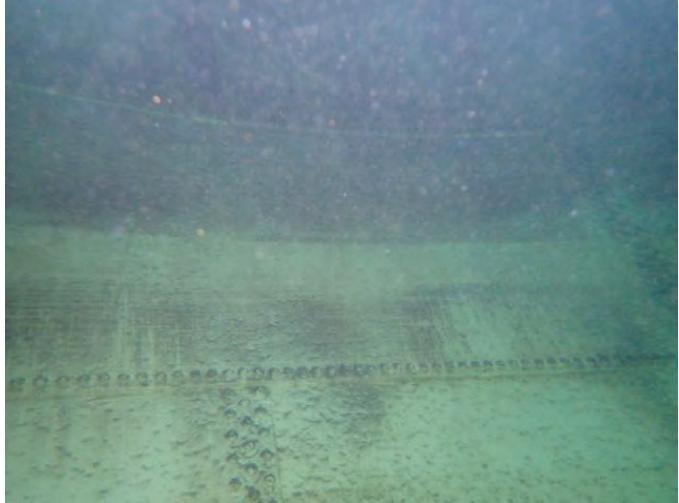
Interior Wall With Moderate To Heavy Staining76

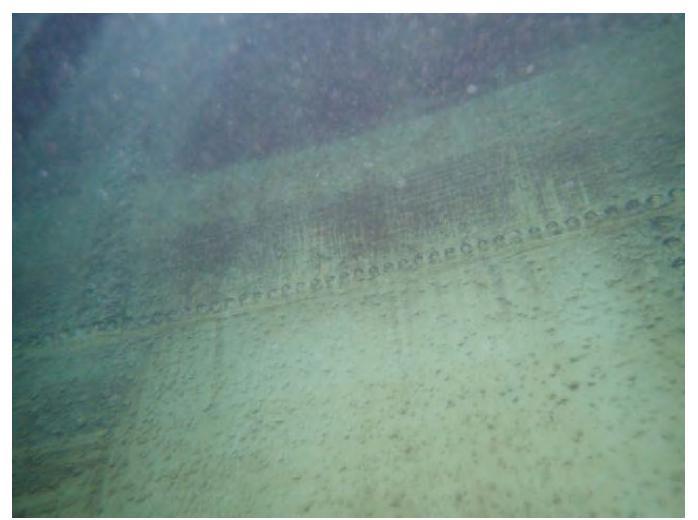
77 Interior Wall With Moderate To Heavy Staining
