In re: City of Woonsocket Water Division - Application to Implement Multi-Year Rate Plan

Docket No. 4879

Dam Name (No):	Woonsocket Reservoir #3 Dam (068)
Location:	Smithfield/North Smithfield
Hazard Classification:	High
	-
Inspector:	David M. Matheson, P.E.
Inspection Date.	August 1, 2014

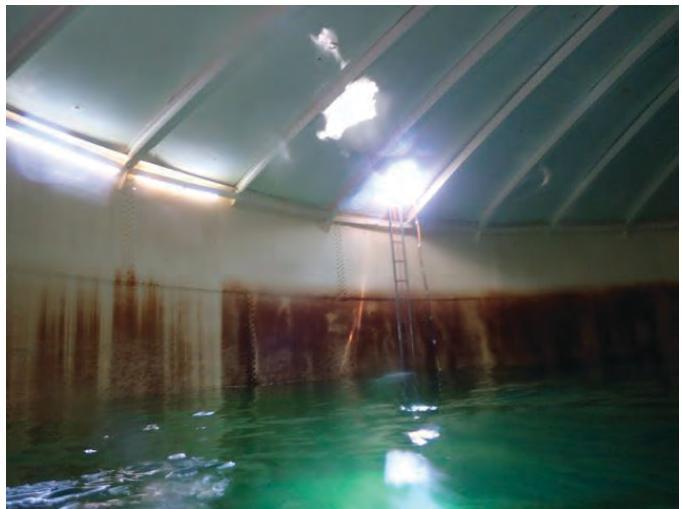
78 Interior Wall With Moderate To Heavy Staining

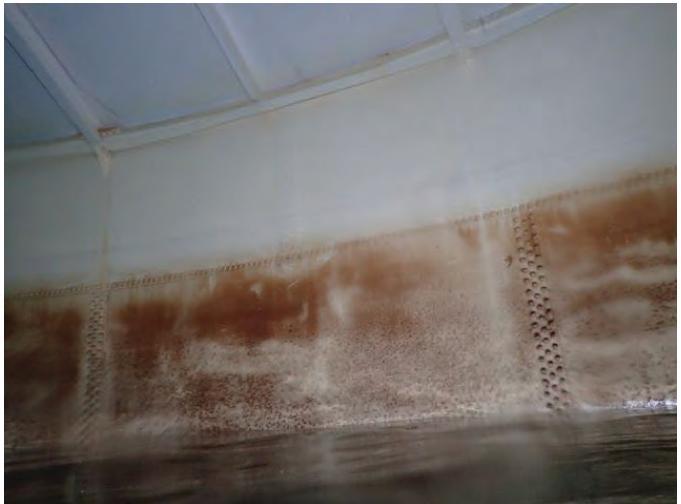
79 Interior Wall With Moderate To Heavy Staining

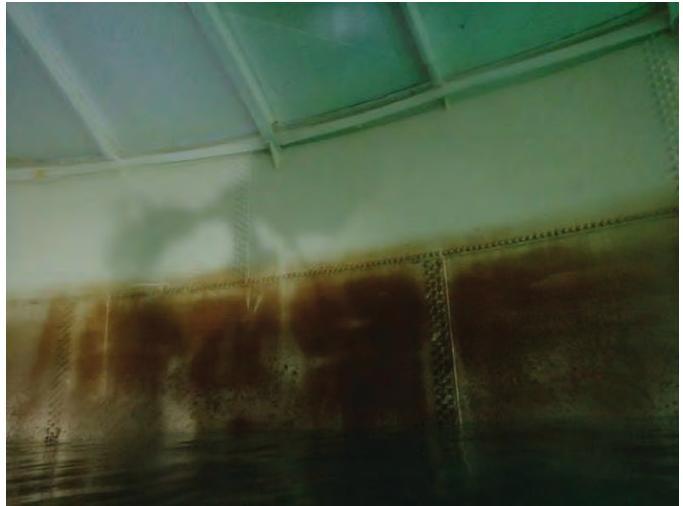
Interior Wall With Moderate To Heavy Staining 80

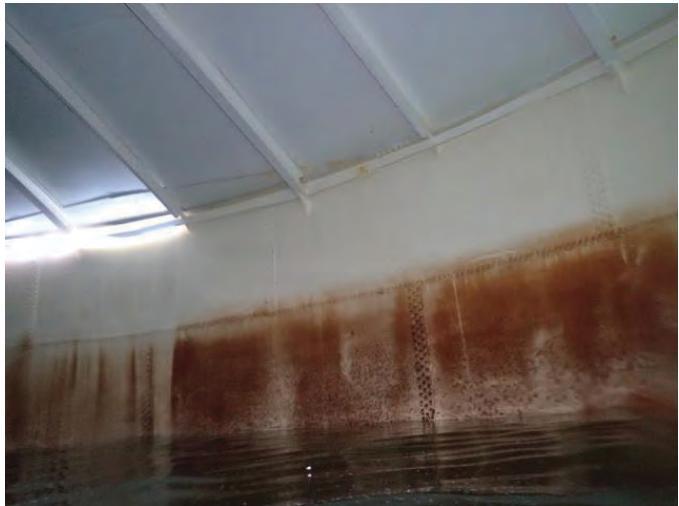
81 Interior Wall With Moderate To Heavy Staining

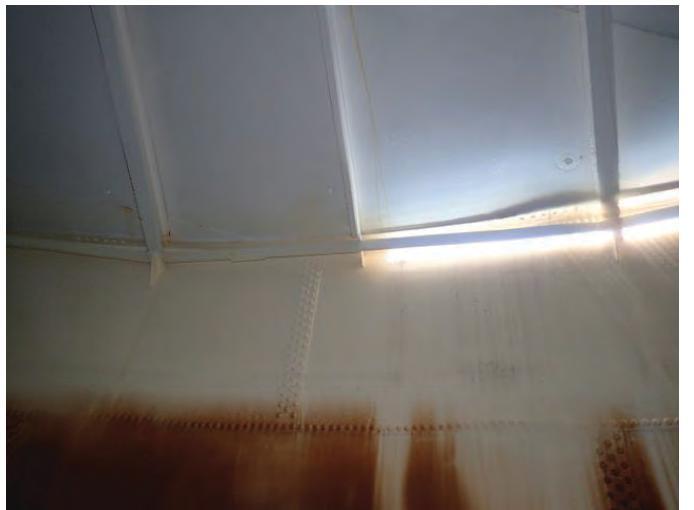
Overhead With Mild Rust Staining 89

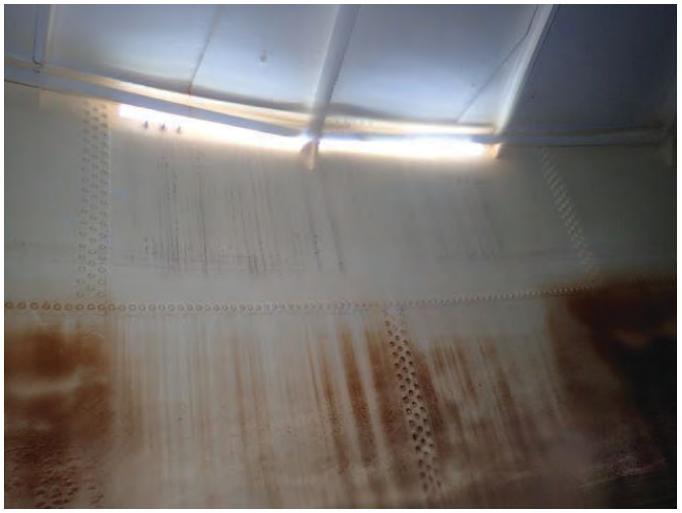
Overhead With Mild Rust Staining 90

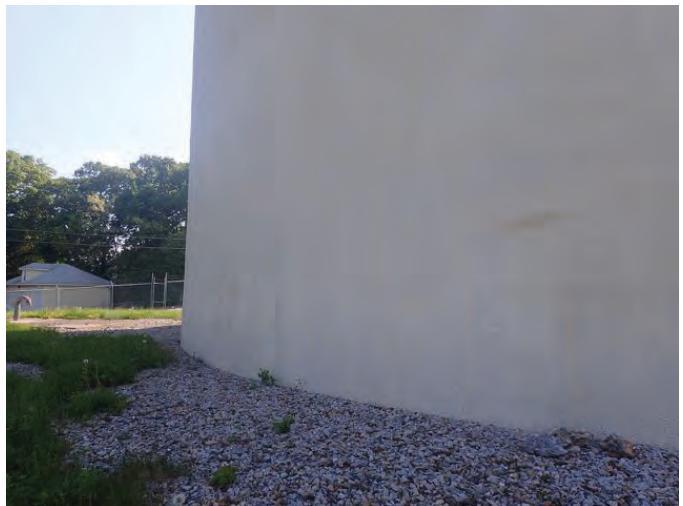
The exterior shotcrete coated concrete walls were inspected and found appearing mostly sound, however numerous tight shrinkage cracks were found throughout approximately 25% of these surfaces and were observed throughout all elevations of the exterior walls.

Approximately 60-75% of these surface (shrinkage) cracks have accumulated efflorescence due to moisture penetration, yet when these cracks were sounded, no obvious voids or spalls were evident.

The protective coating applied to the exterior walls appears to have been applied uniformly and remains having mostly good adhesion value, however this coating no longer seals the shrinkage cracks found throughout these surfaces.

1 Exterior Wall With Coating Loss, Tight Shrinkage Cracks And Efflorescence

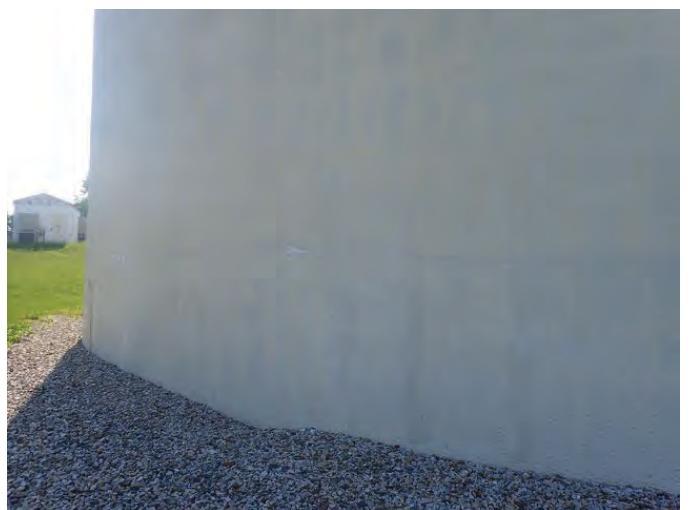
Exterior Wall With Coating Loss, Tight Shrinkage 2 Cracks And Efflorescence

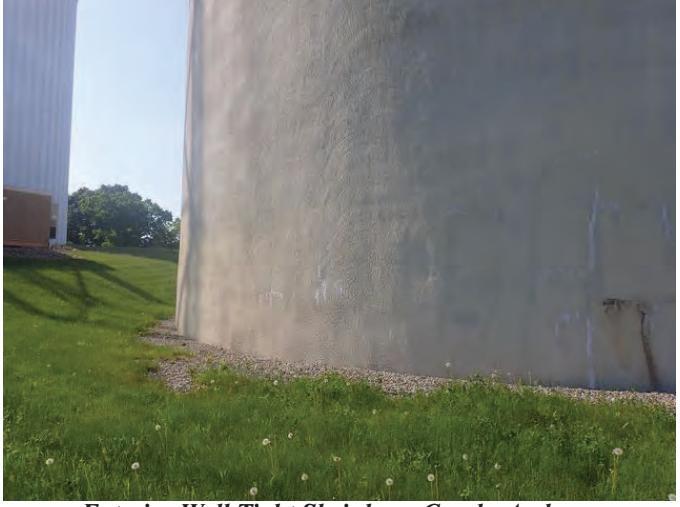
3 Exterior Wall Tight Shrinkage Cracks And Efflorescence

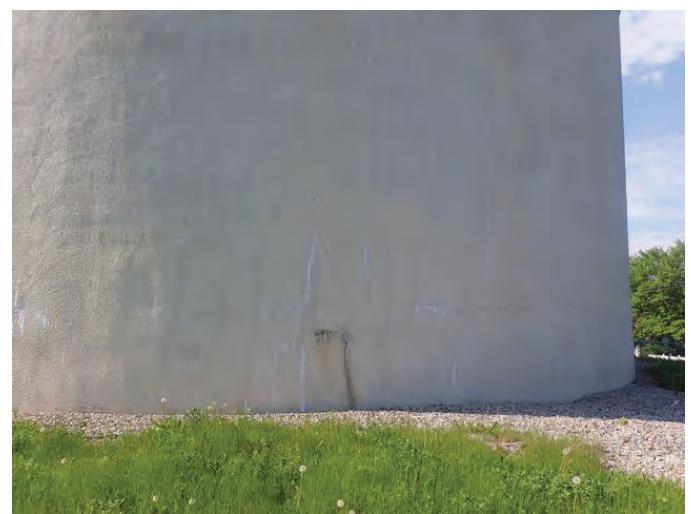
4 Exterior Wall Tight Shrinkage Cracks And Efflorescence

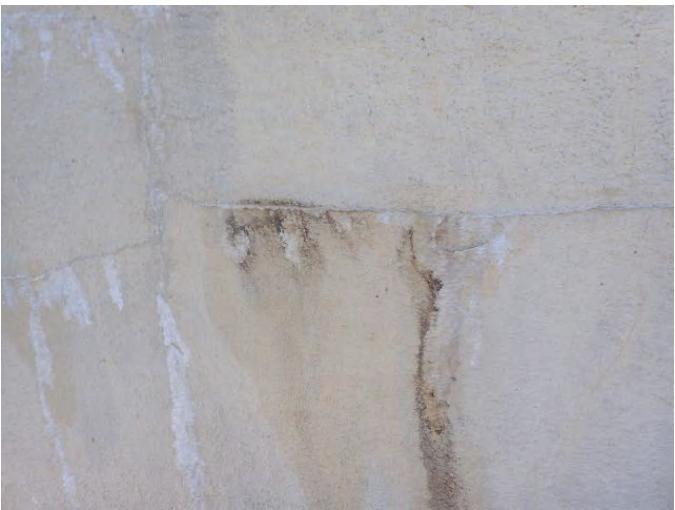
5 Exterior Wall With Coating Loss, Tight Shrinkage Cracks And Efflorescence

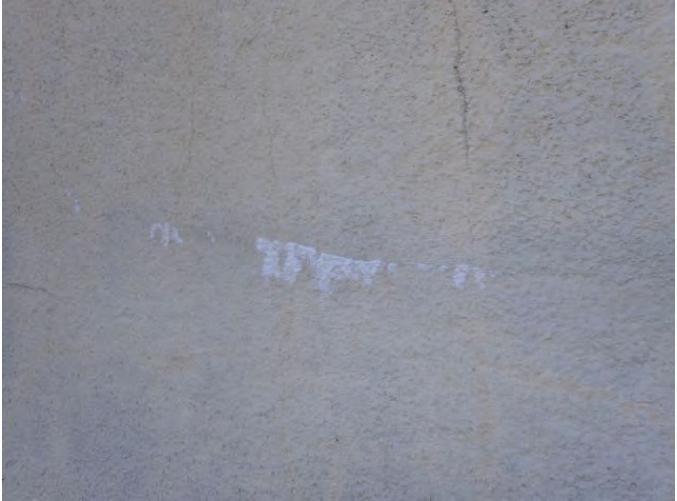
6 Exterior Wall With Coating Loss, Tight Shrinkage Cracks And Efflorescence

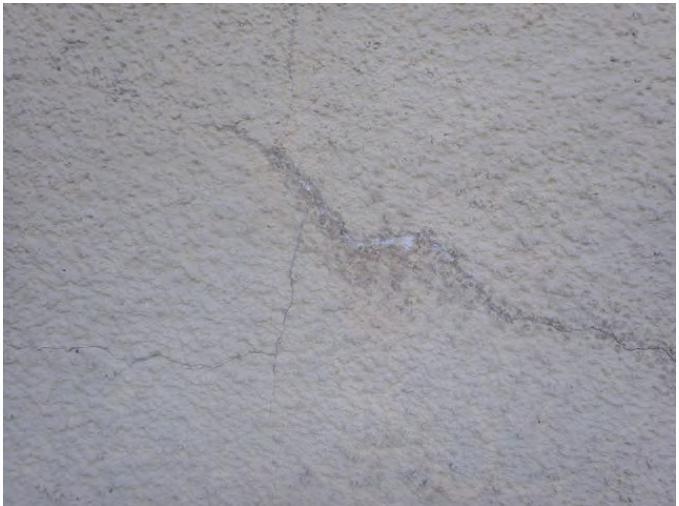
7 Exterior Wall With Coating Loss, Tight Shrinkage 7 Cracks And Efflorescence

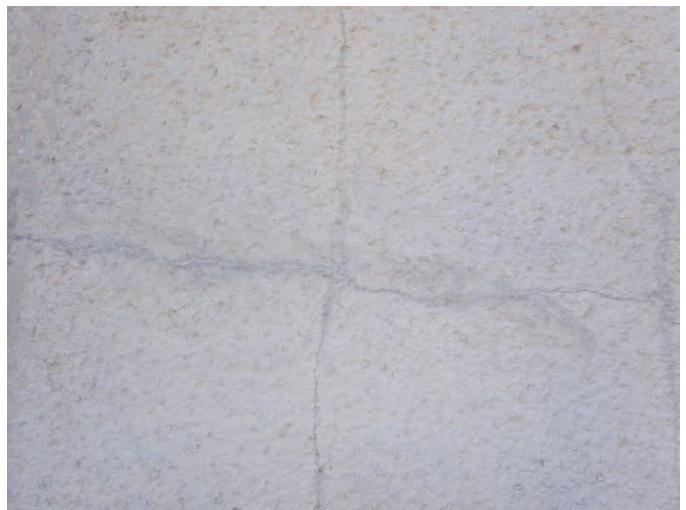
8 Exterior Wall With Coating Loss, Tight Shrinkage 8 Cracks And Efflorescence

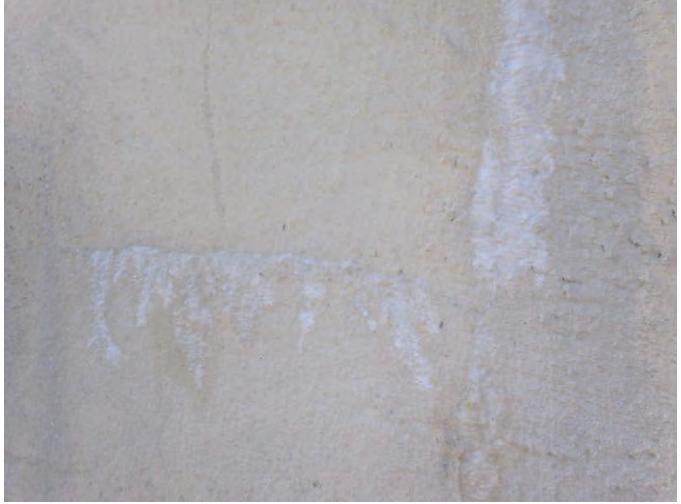
9 Exterior Wall With Coating Loss, Tight Shrinkage Cracks And Efflorescence

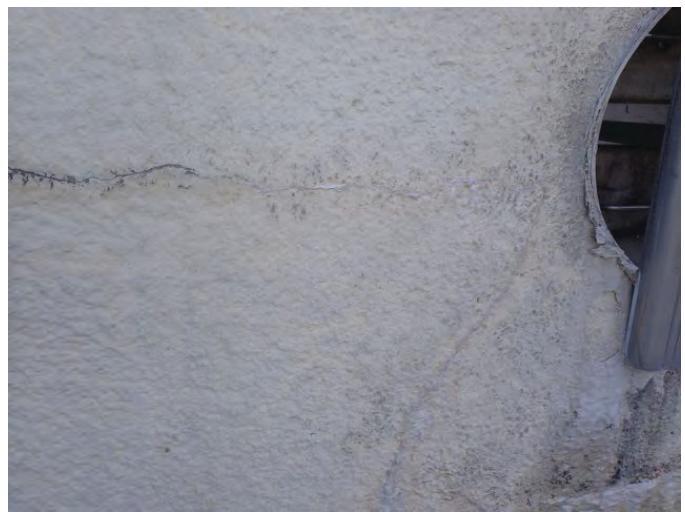
Exterior Wall With Coating Loss, Tight Shrinkage10Cracks And Efflorescence

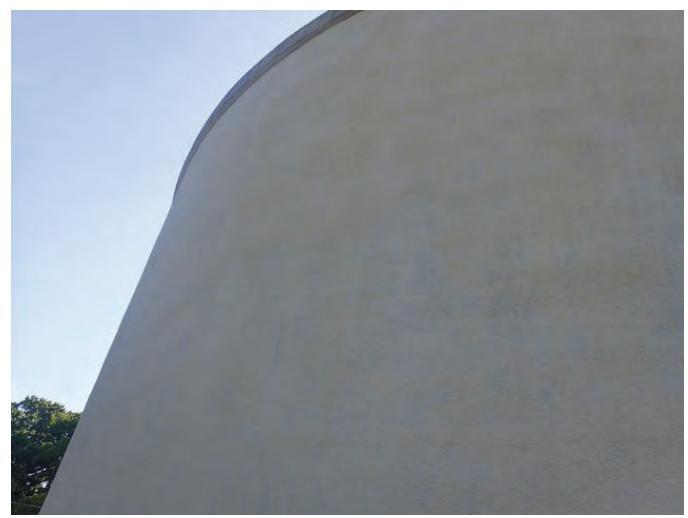
11 Exterior Wall With Coating Loss, Tight Shrinkage Cracks And Efflorescence

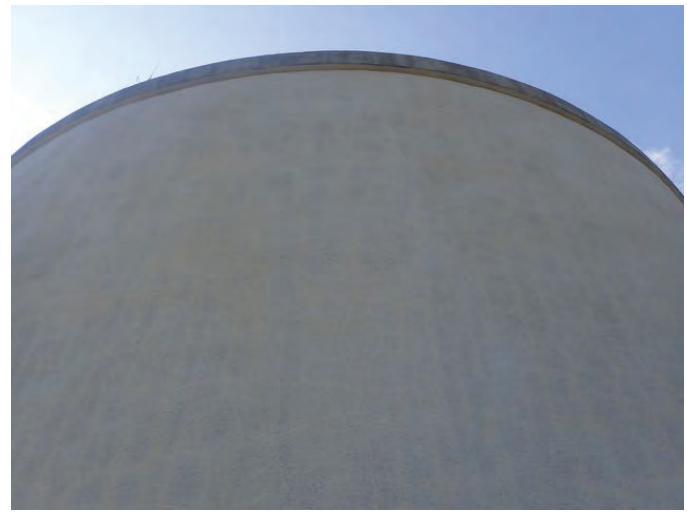
12 Exterior Wall With Coating Loss, Tight Shrinkage Cracks And Efflorescence

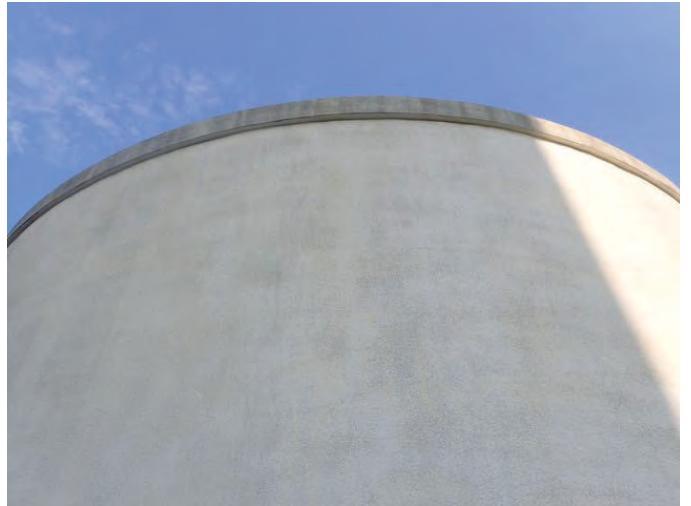
Exterior Wall With Coating Loss, Tight Shrinkage13Cracks And Efflorescence

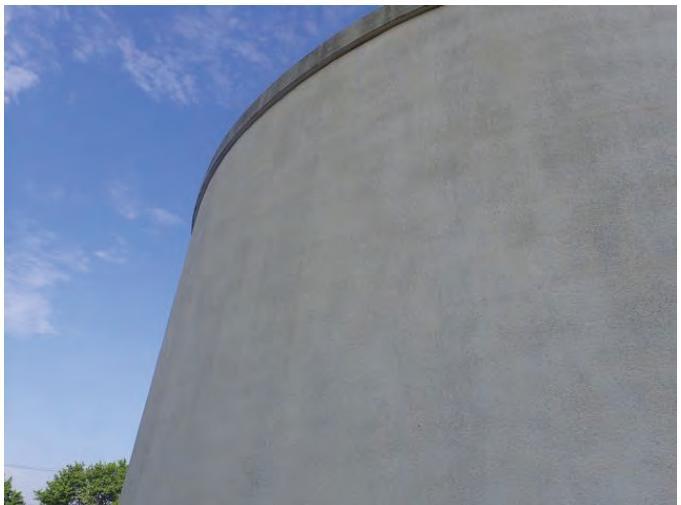
Exterior Wall With Coating Loss, Tight Shrinkage 14 *Cracks And Efflorescence*

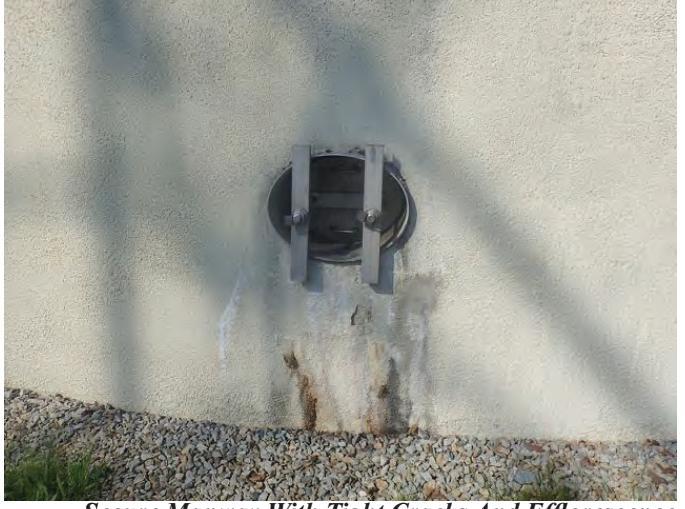
Secure Manway With Tight Cracks And Efflorescence

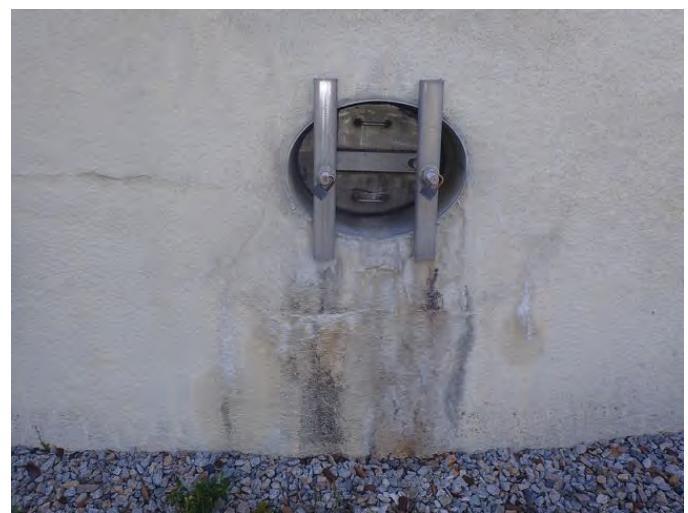
Secure Manway With Tight Cracks And Efflorescence

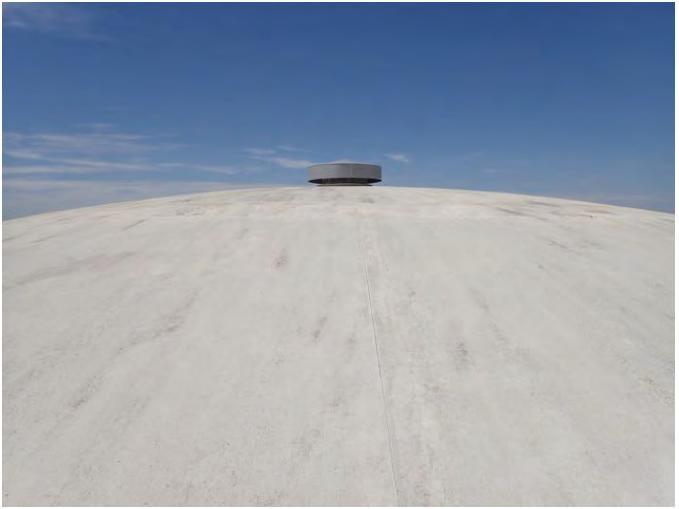
21 Roof Panels With Coating Loss

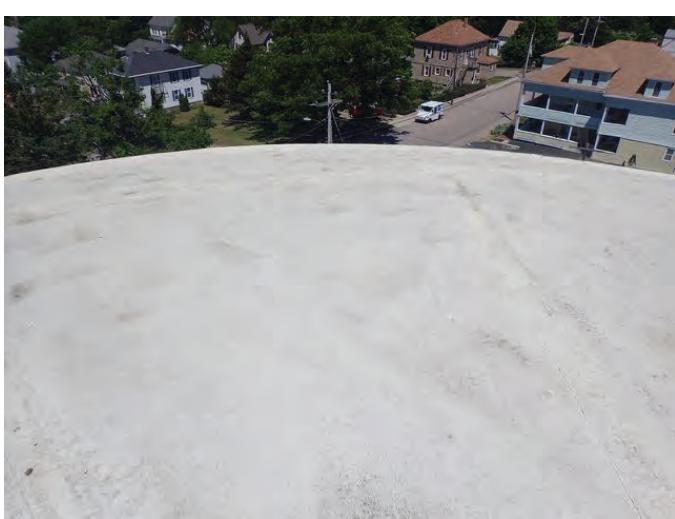
22 *Roof Panels With Coating Loss*

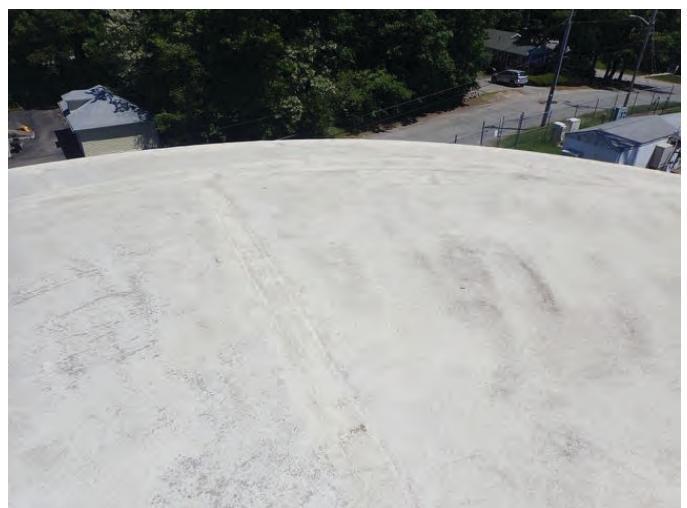
23 Roof Panels With Coating Loss

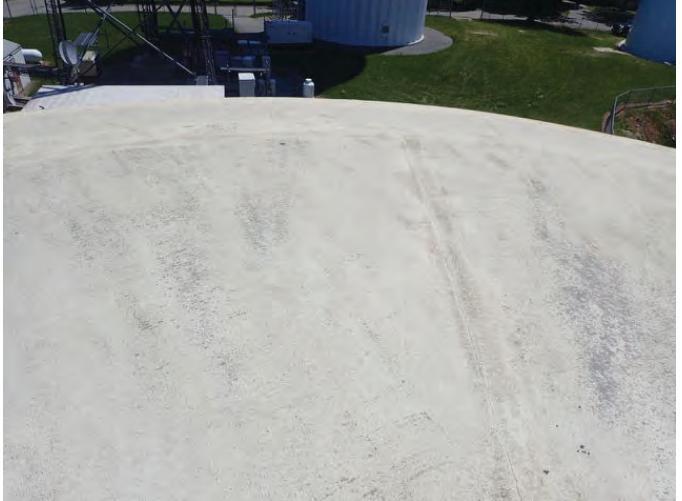
24 Roof Panels With Coating Loss

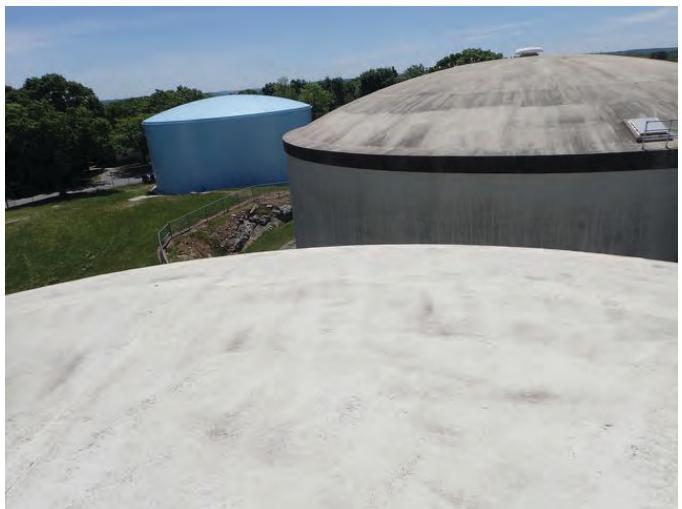
Roof Panels With Coating Loss

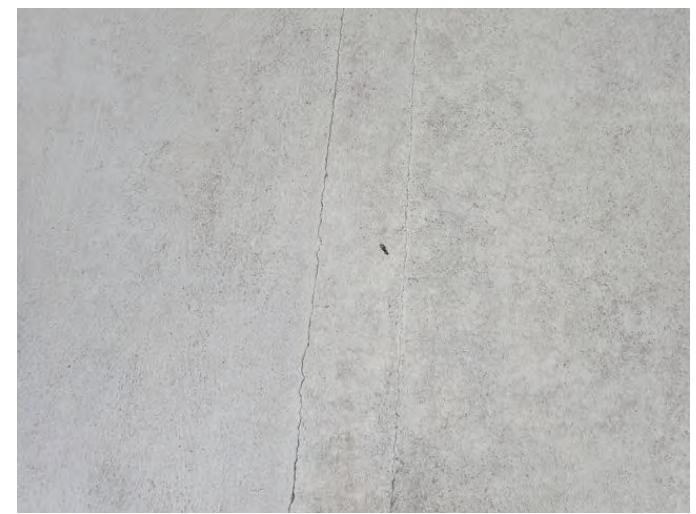
26 Roof Panels With Tight Cracks Within The Concrete-Filled Joints Due To Coating Loss Resulting In Exposed Underlying Concrete

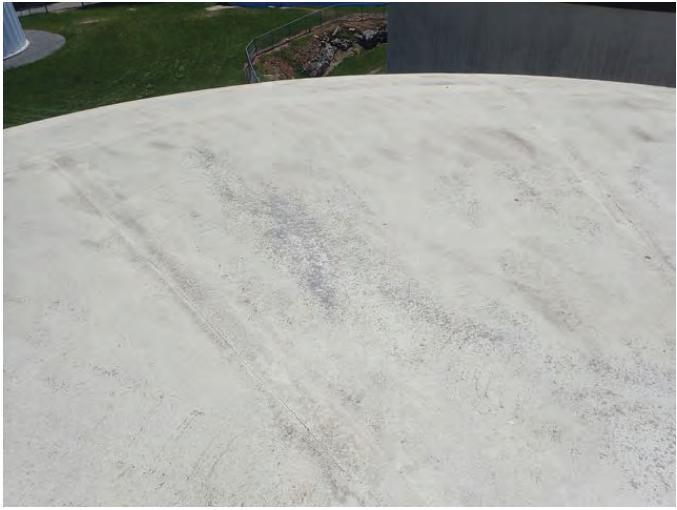
27 Roof Panels With Tight Cracks Within The Concrete-Filled Joints Due To Coating Loss Resulting In Exposed Underlying Concrete

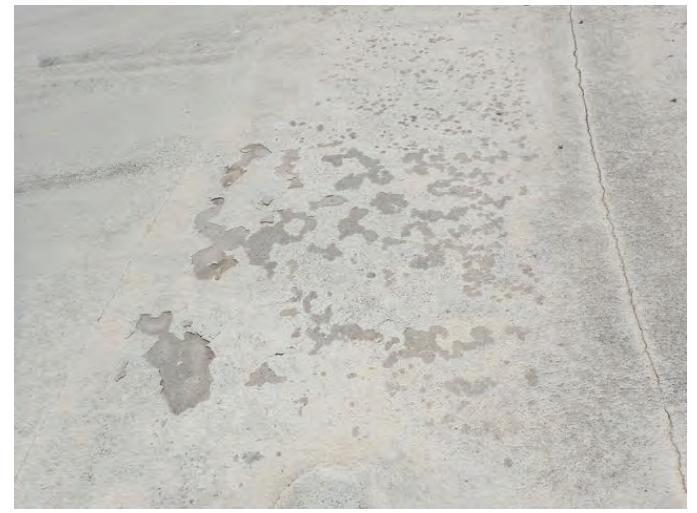
28 Roof Panels With Tight Cracks Within The Concrete-Filled Joints Due To Coating Loss Resulting In Exposed Underlying Concrete

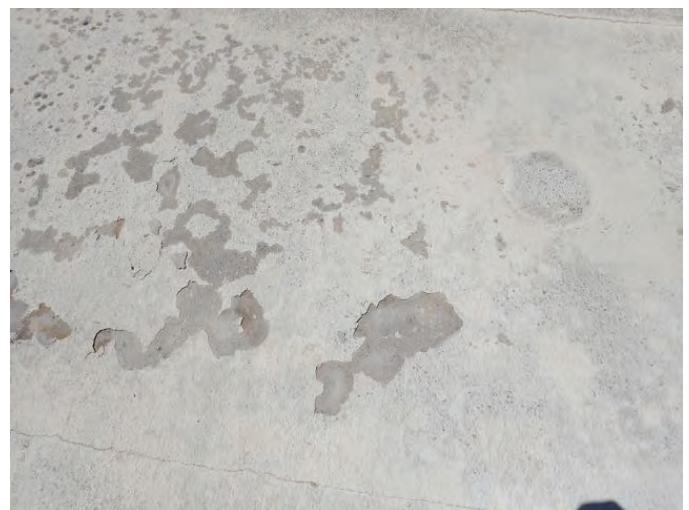
29 Roof Panels With Tight Cracks Within The Concrete-Filled Joints Due To Coating Loss Resulting In Exposed Underlying Concrete

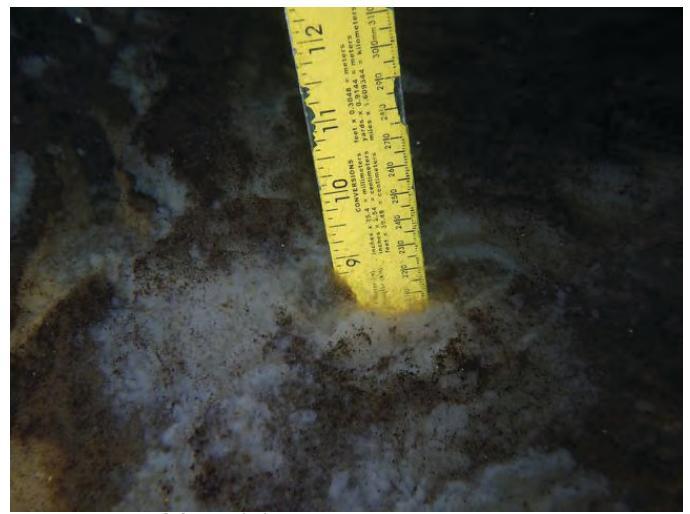
39 *Layer Of Precipitate*

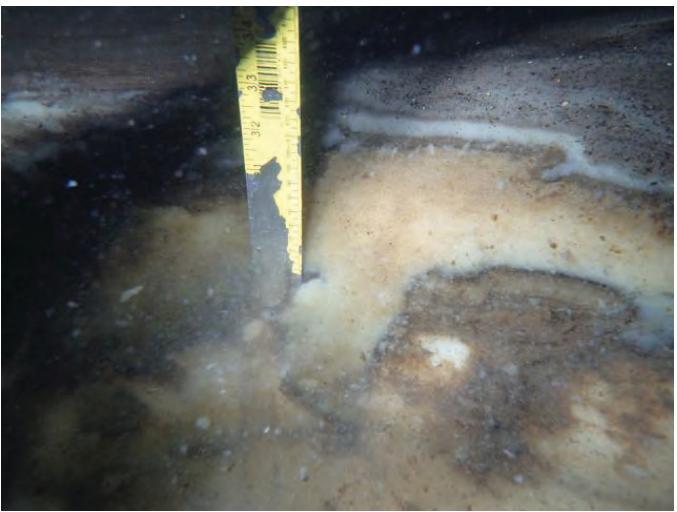
40 Floor With Mild Staining

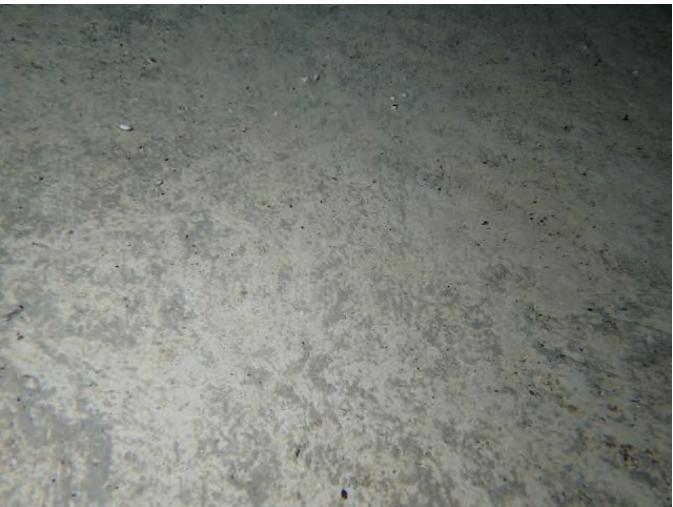
41 Floor With Mild Staining

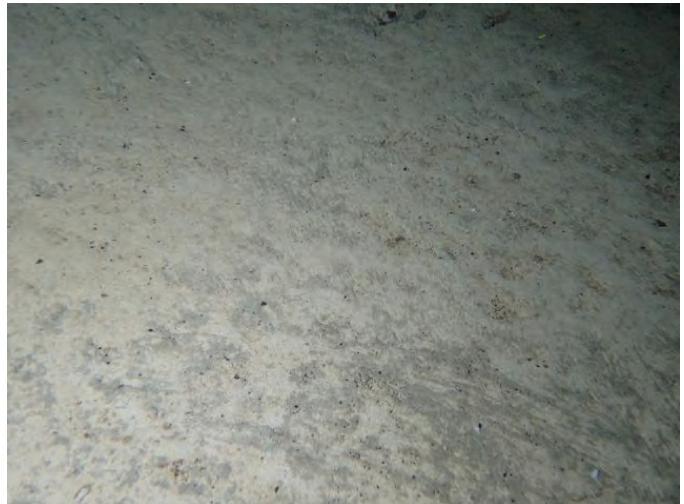
42 Floor With Mild Staining

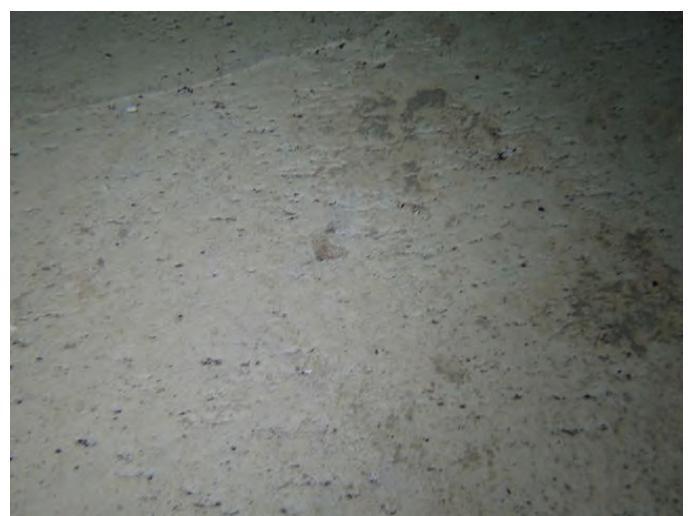
43 Floor With Mild Staining

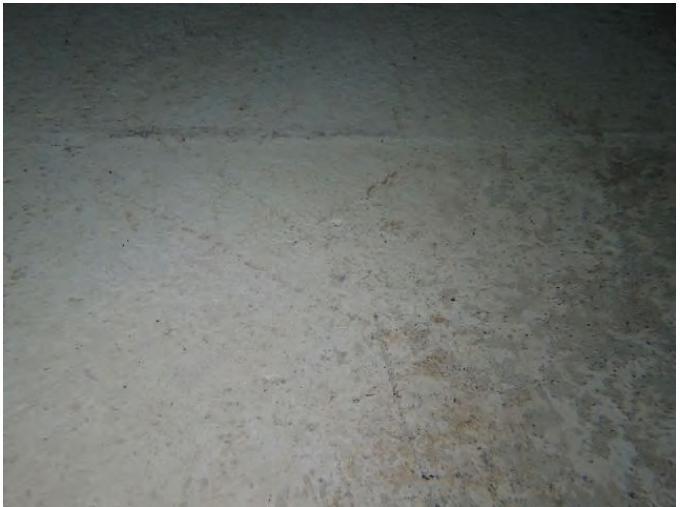
Floor With Mild Staining 44

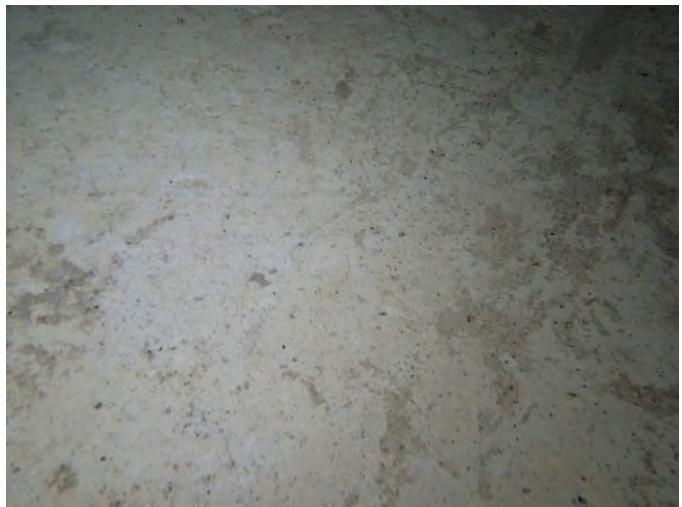
45 Floor With Mild Staining

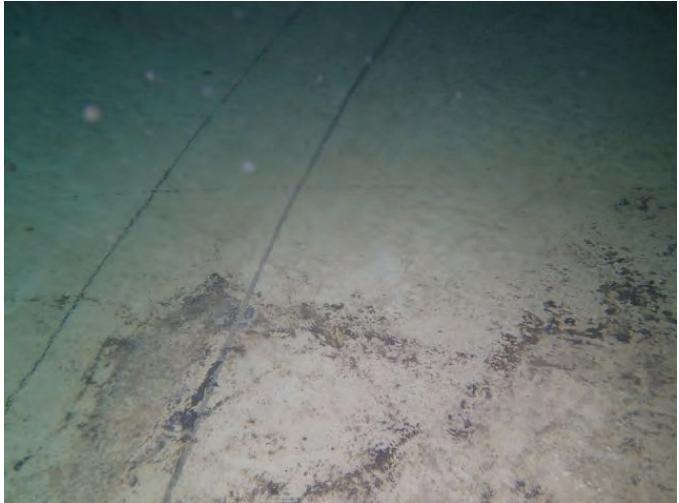
46 *Floor With Mild Staining*

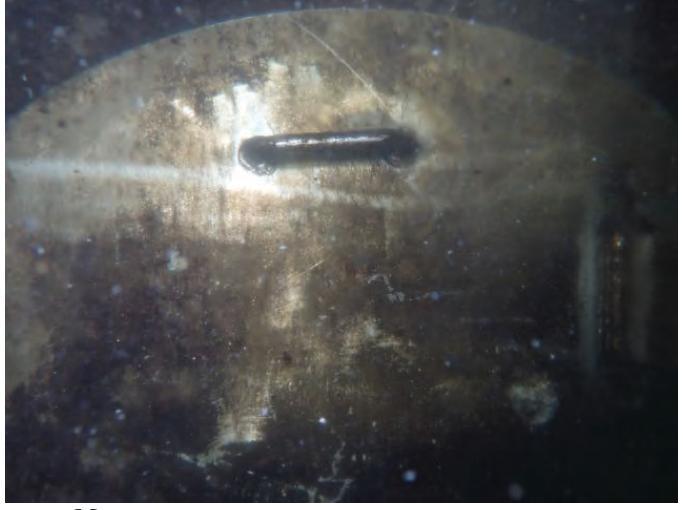
48 Manway With Secure Davit Hinge

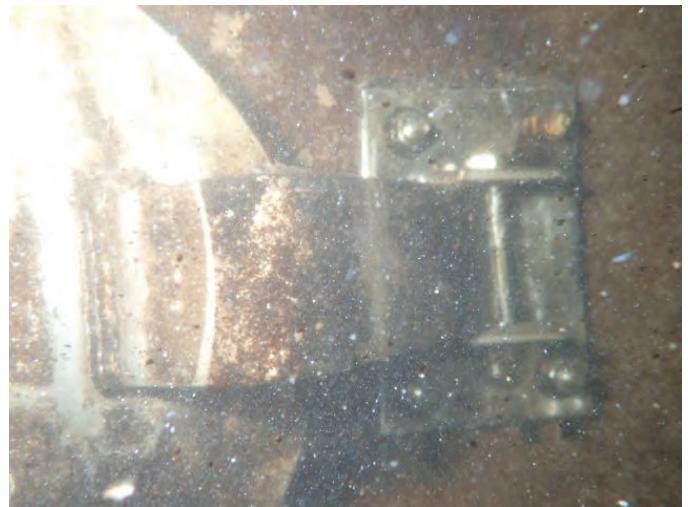
Manway

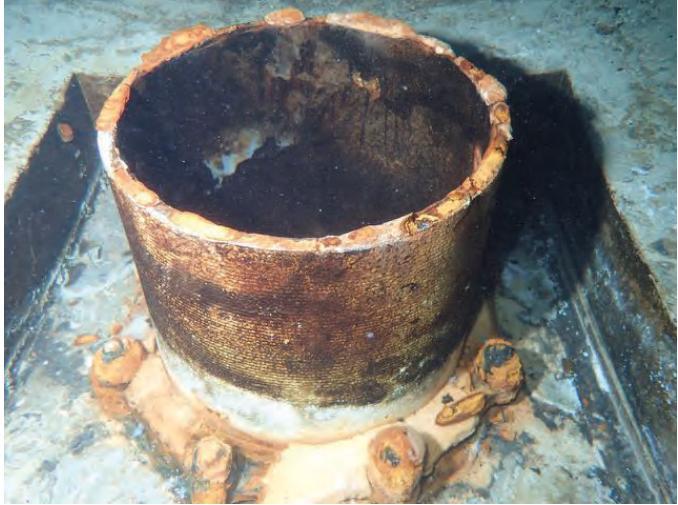
Manway With Secure Davit Hinge 50

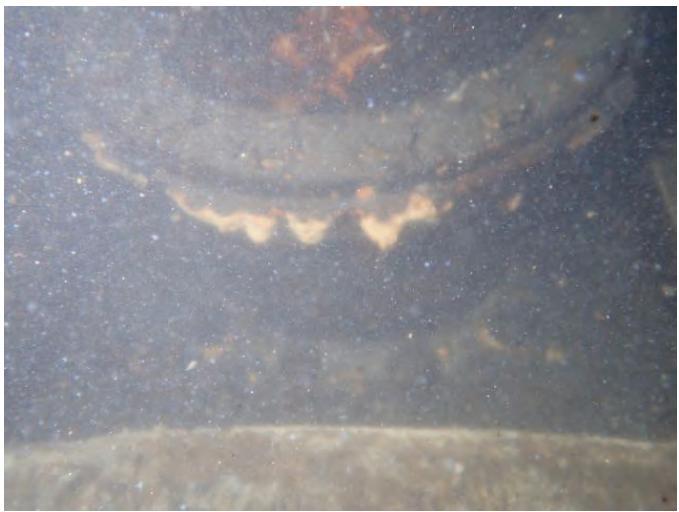
12" Inside Diameter Pipe

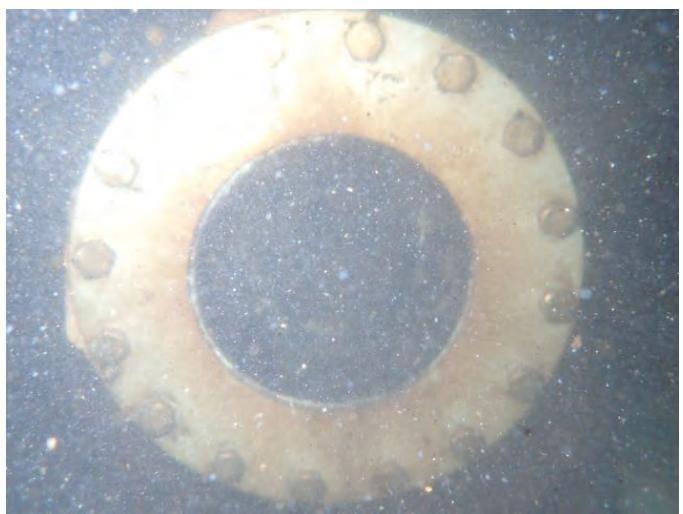
16" Inside Diameter Flush Penetration Within The52Sump

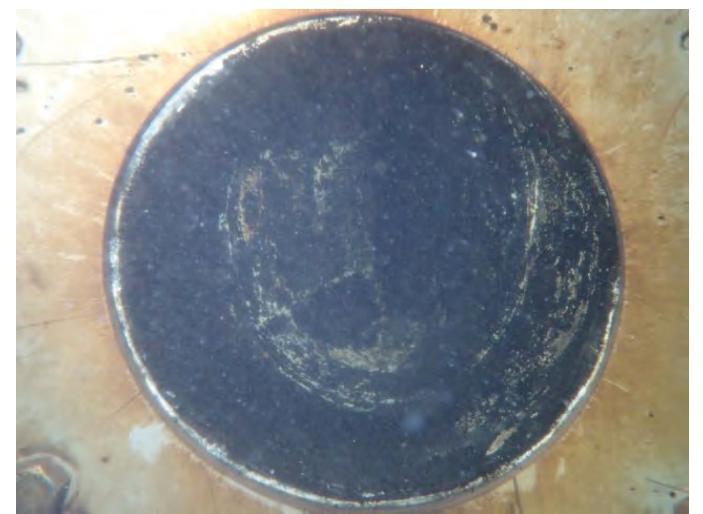
16" Inside Diameter Effluent Opening

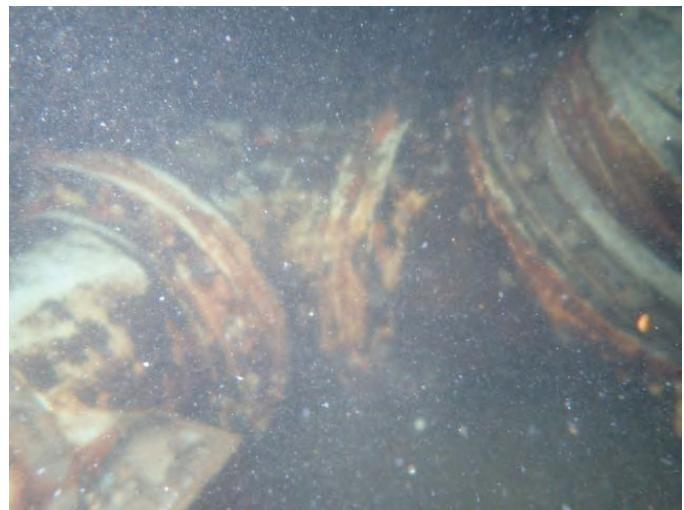
16" Inside Diameter Effluent Opening

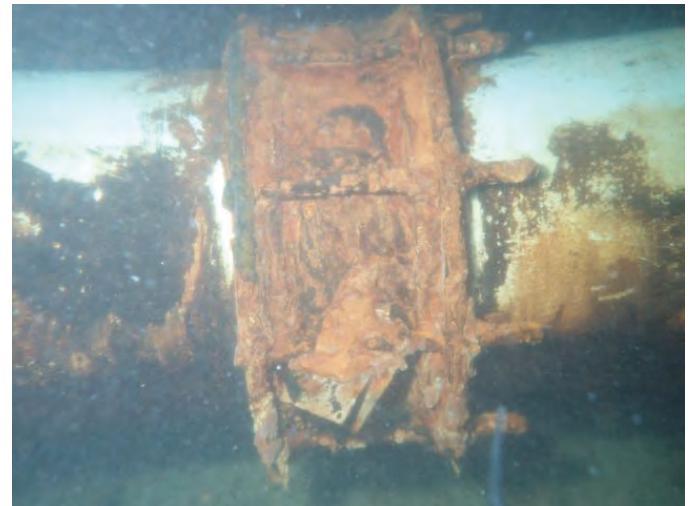
55 Four-Way Cross Pipe With Coating Failure, Exposed 55 Metal And Corrosion

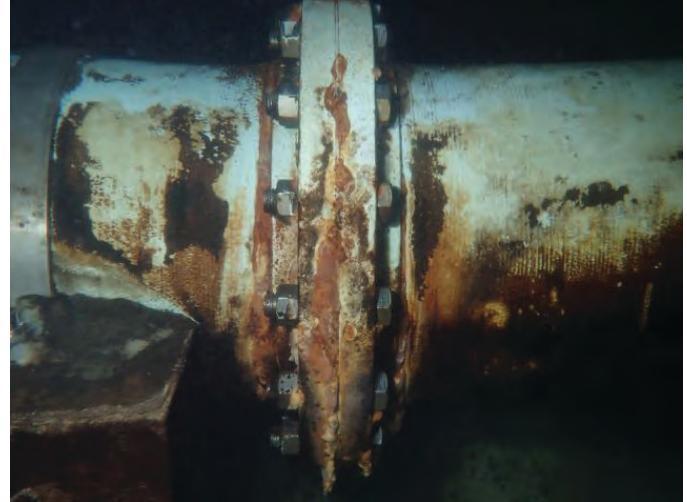
Four-Way Cross Pipe With Coating Failure, Exposed 56 Metal And Corrosion

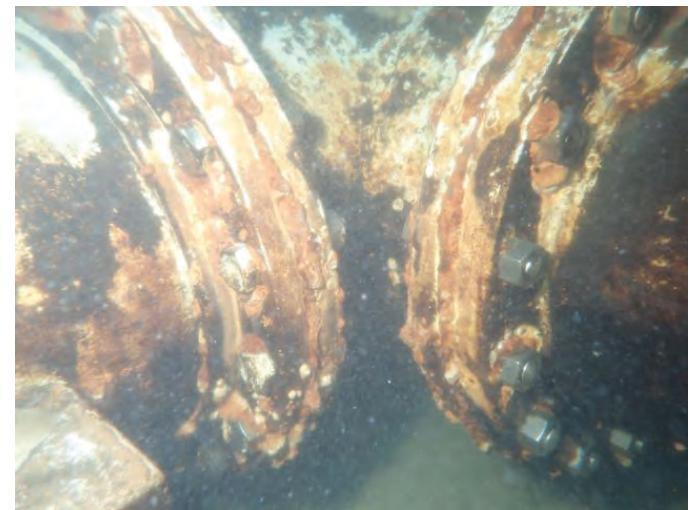
57 Four-Way Cross Pipe With Coating Failure, Exposed Metal And Corrosion

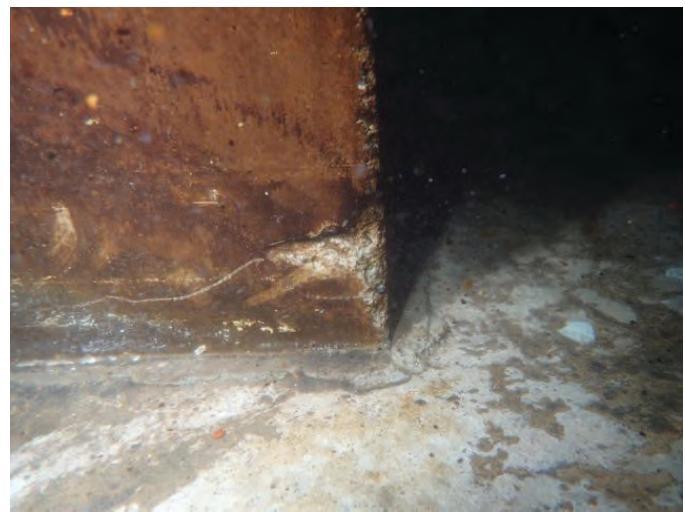
58 Four-Way Cross Pipe With Coating Failure, Exposed Metal And Corrosion

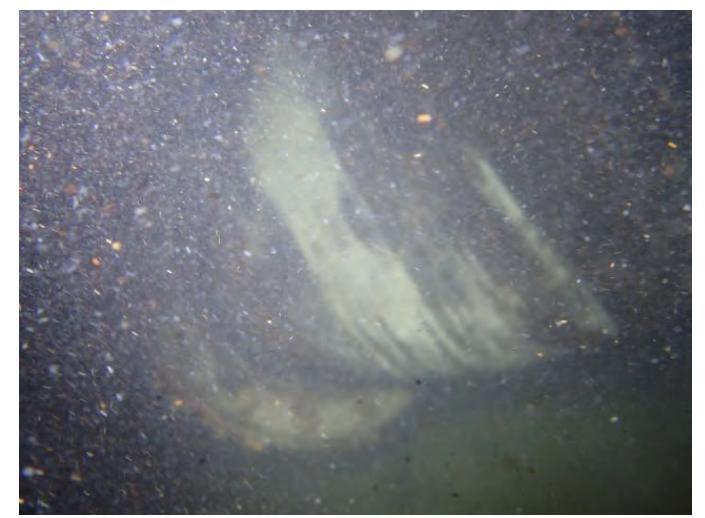
59 Northernmost Concrete Support With Spall

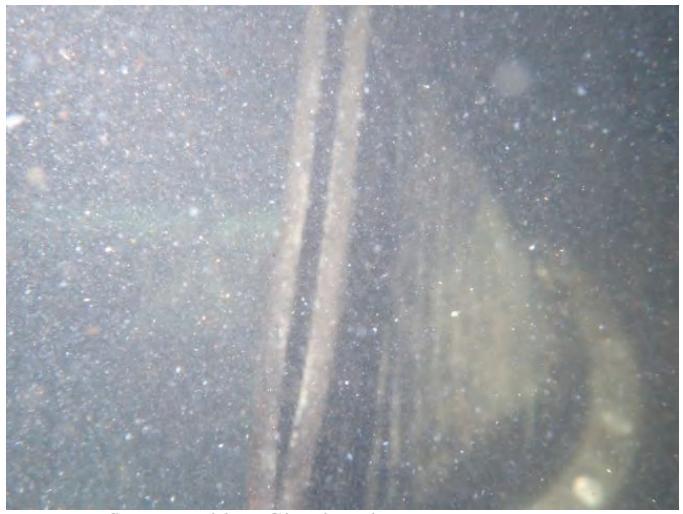
60 Influent Rubber Check Valve

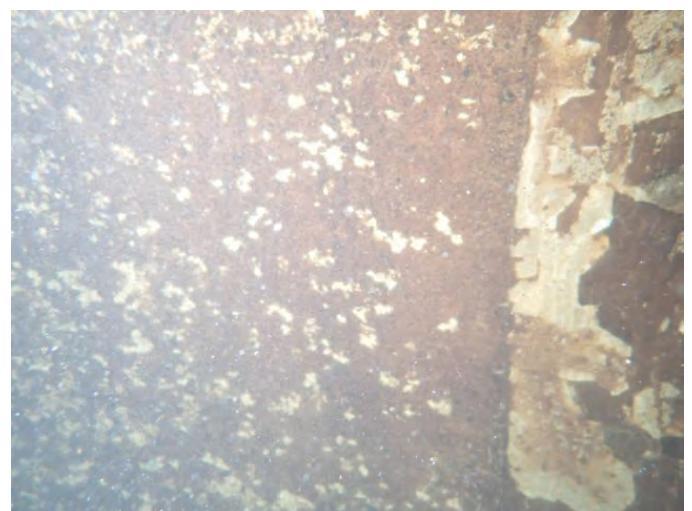
61 *Influent Rubber Check Valve*

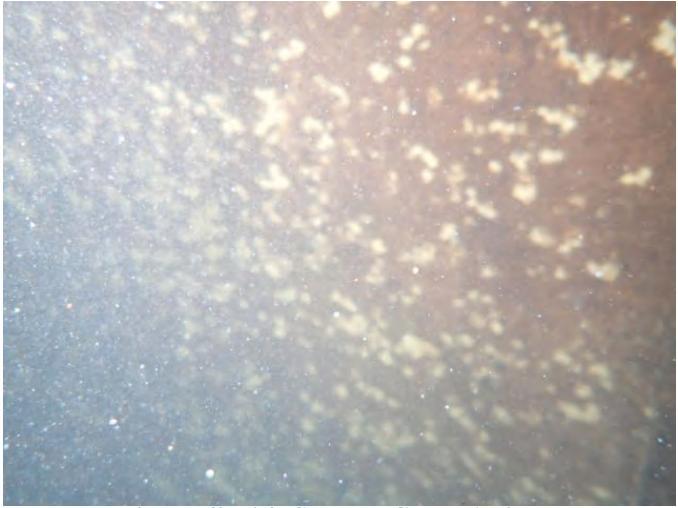
Interior Wall With Concrete Scour And Heavy62Staining

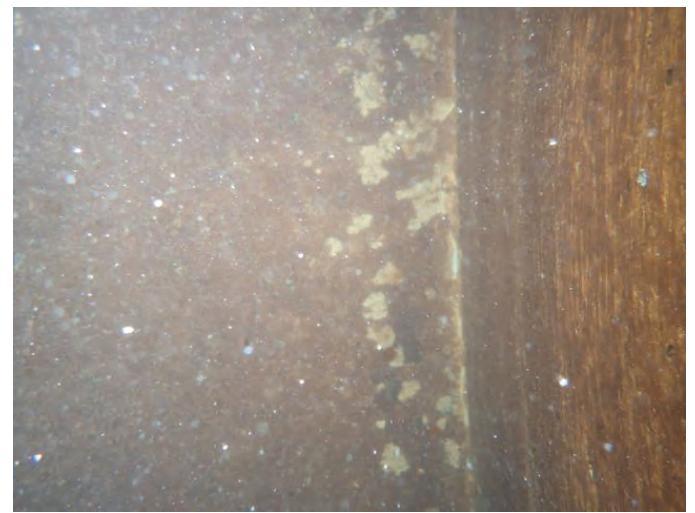
63 Interior Wall With Concrete Scour And Heavy Staining

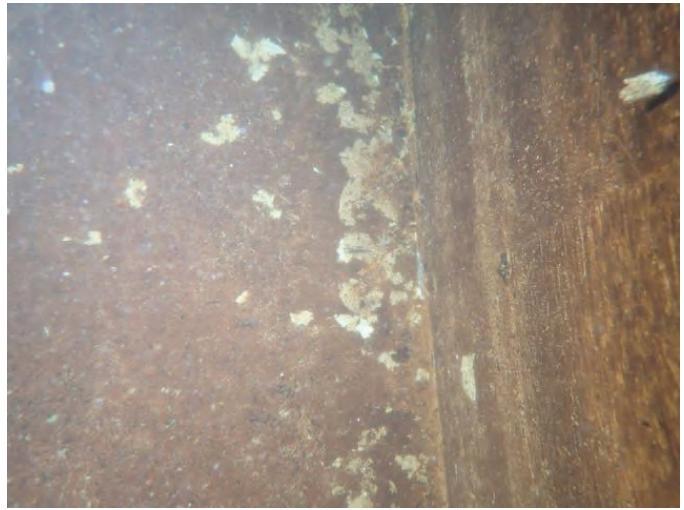
64 Interior Wall With Concrete Scour And Heavy Staining

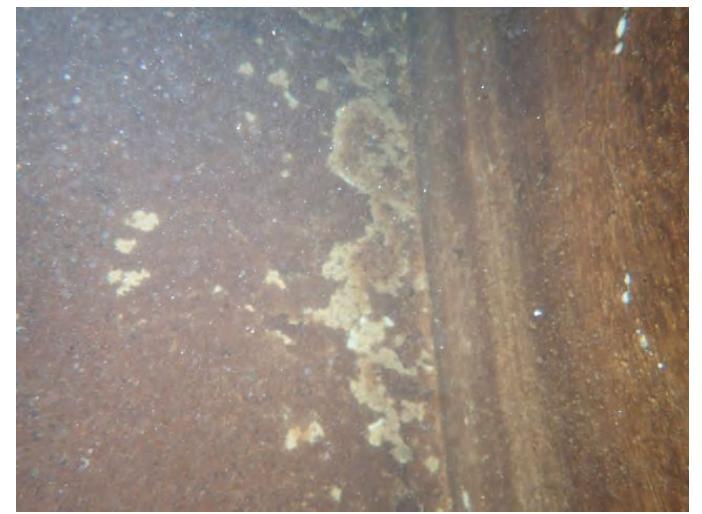
65 Interior Wall With Concrete Scour And Heavy Staining

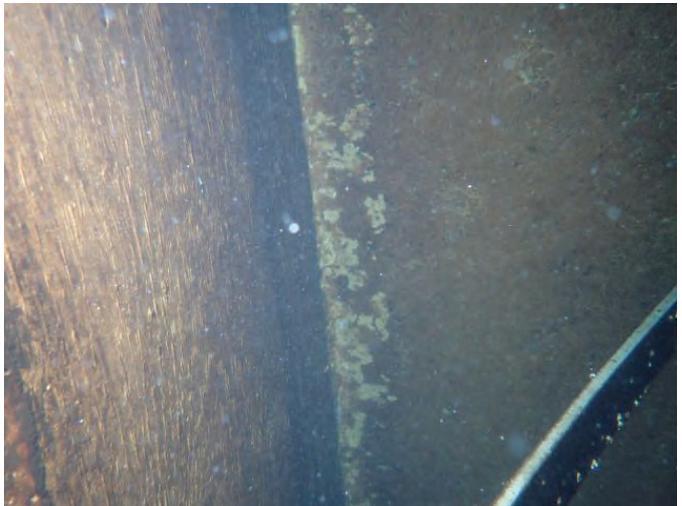
66 Interior Wall With Concrete Scour And Heavy Staining

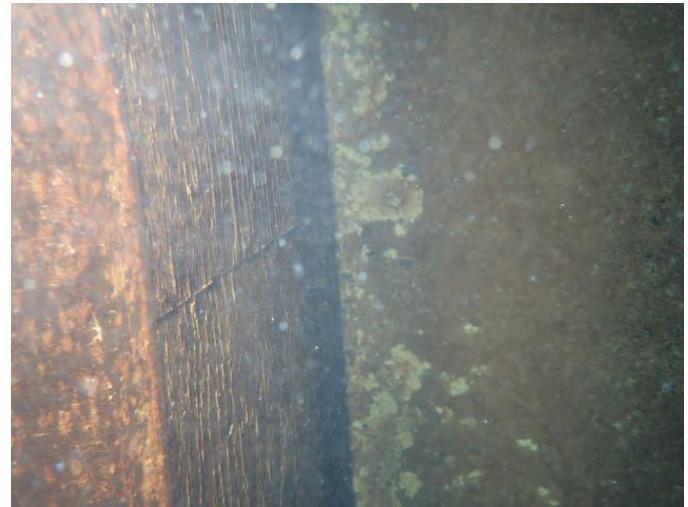
67 Interior Wall With Concrete Scour And Heavy Staining

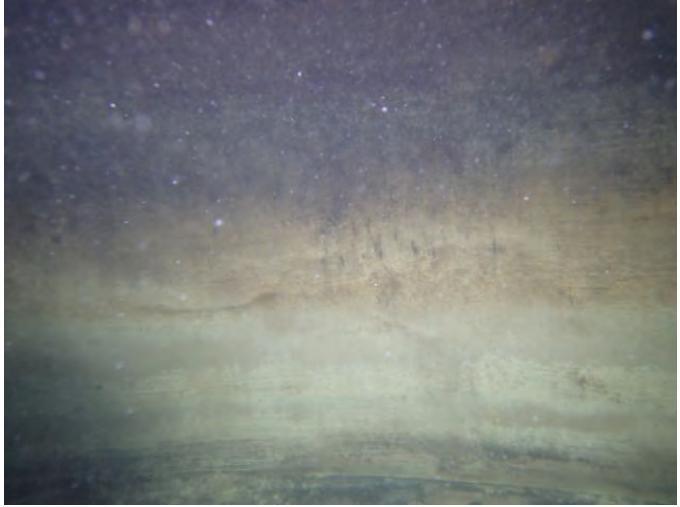
68 Interior Wall With Concrete Scour And Heavy 59 Staining

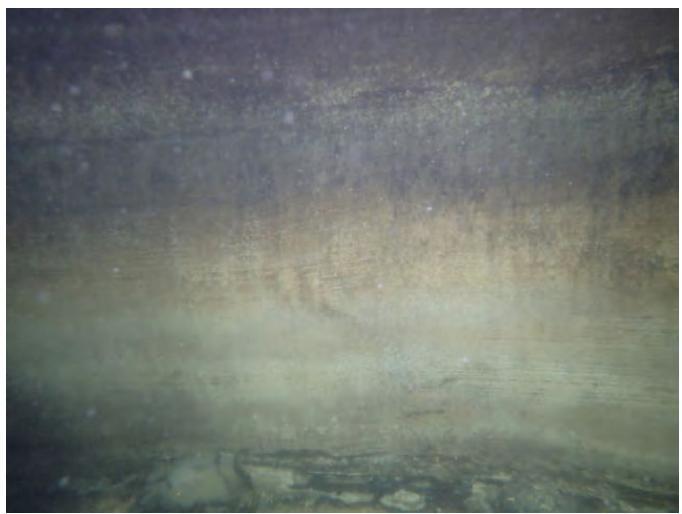
69 *Interior Wall With Heavy Staining*

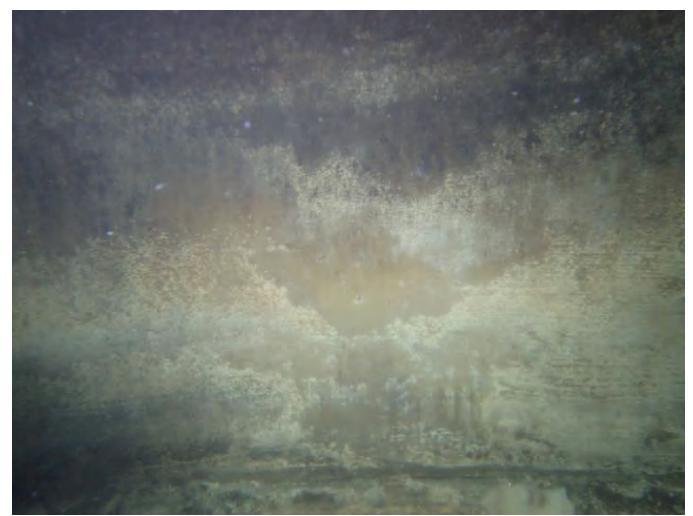
Interior Wall With Heavy Staining

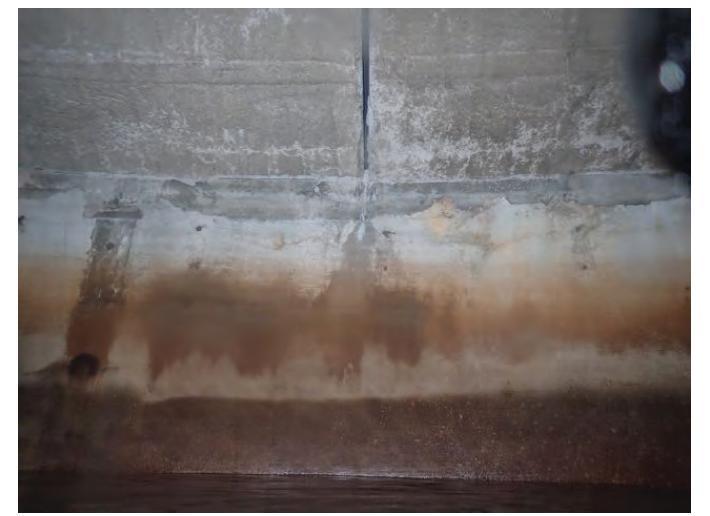
71 *Interior Wall With Heavy Staining*
