In re: City of Woonsocket Water Division - Application to Implement Multi-Year Rate Plan

Docket No. 4879

Dam Name (No):	Woonsocket Reservoir #3 Dam (068)
Location:	Smithfield/North Smithfield
Hazard Classification:	High
	-
Inspector:	David M. Matheson, P.E.
Inspection Date.	August 1, 2014

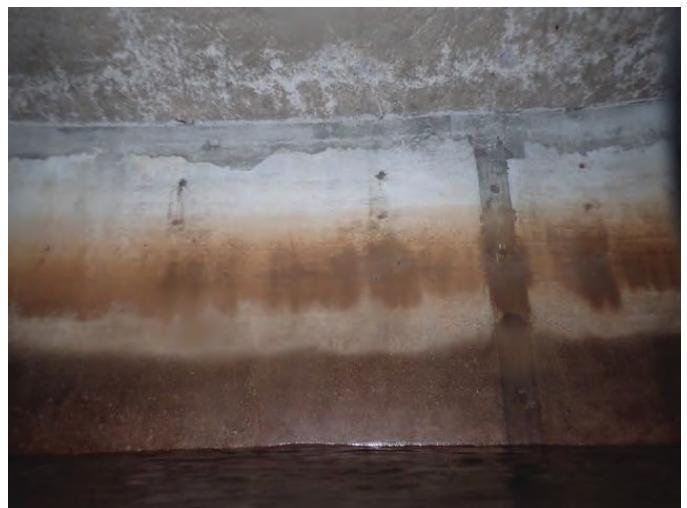
72 Interior Wall With Heavy Staining

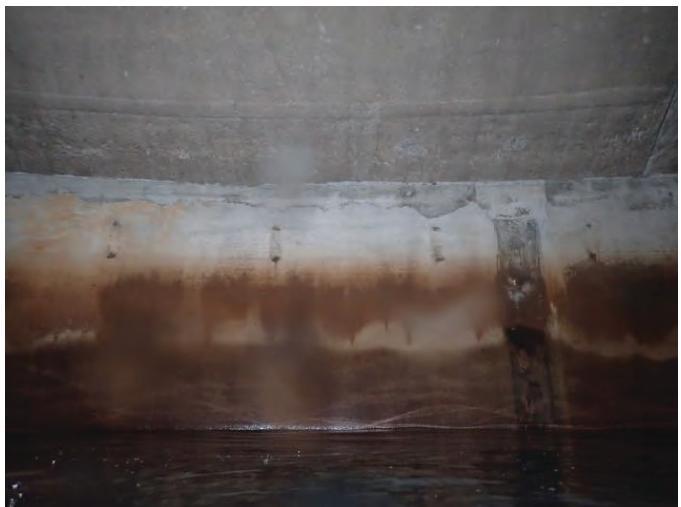
Interior Wall With Heavy Staining73

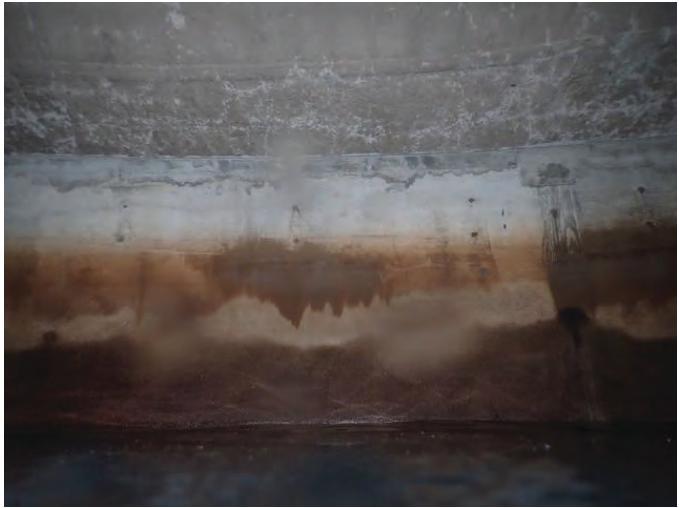
Interior Wall With Heavy Staining

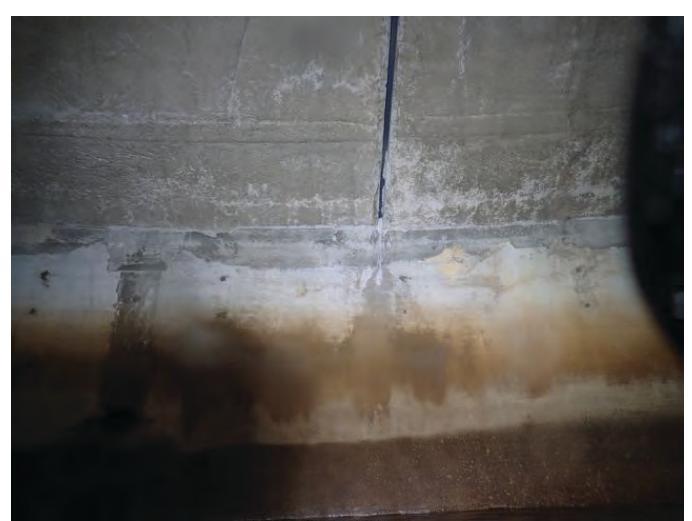
75 Interior Wall With Heavy Staining

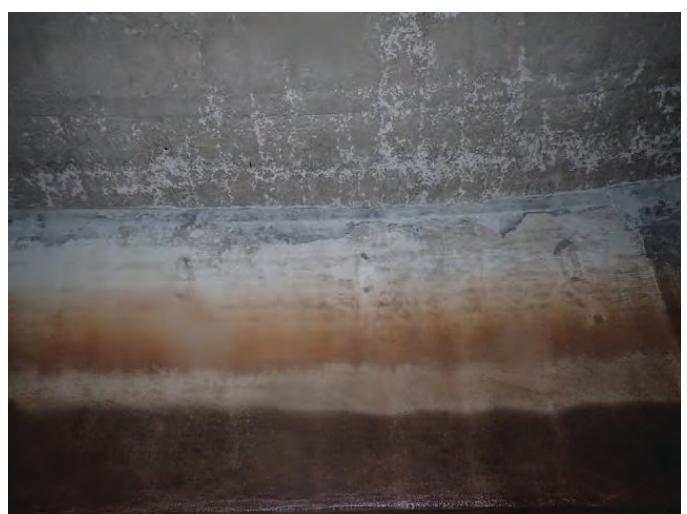
76 *Interior Wall With Heavy Staining*

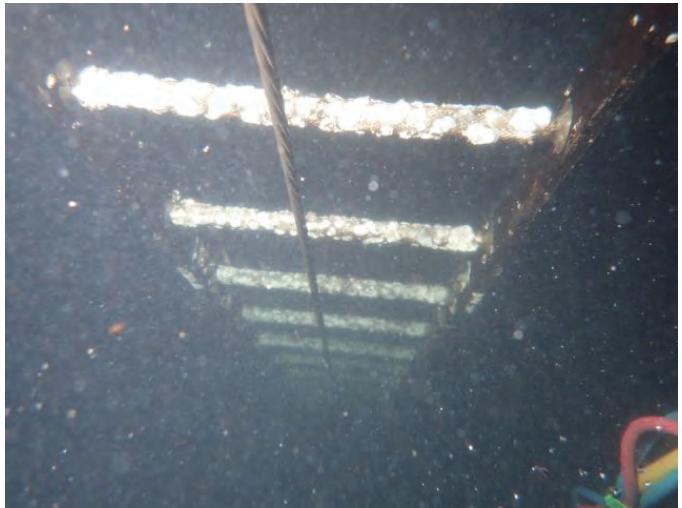
78 Interior Aluminum Ladder And Fall Prevention Device With Fatigue (Pitting) And Corrosion

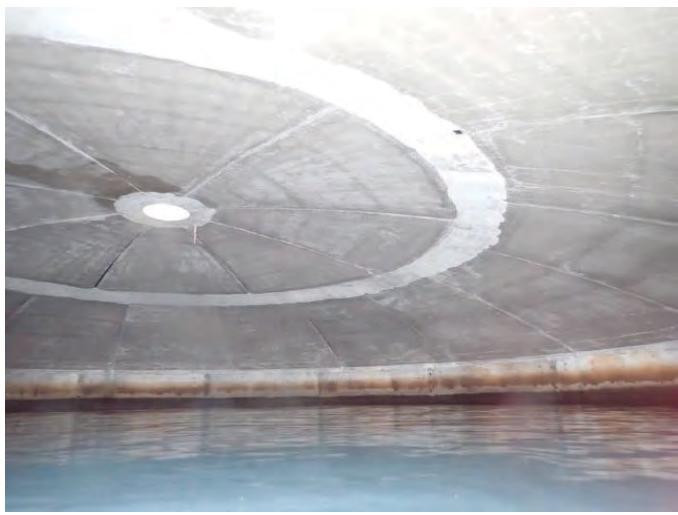
81 *Overhead With Efflorescence*

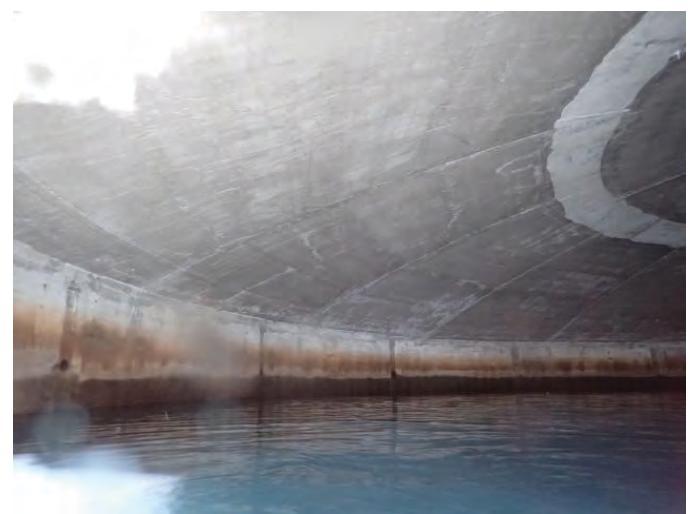
82 Overhead With Efflorescence

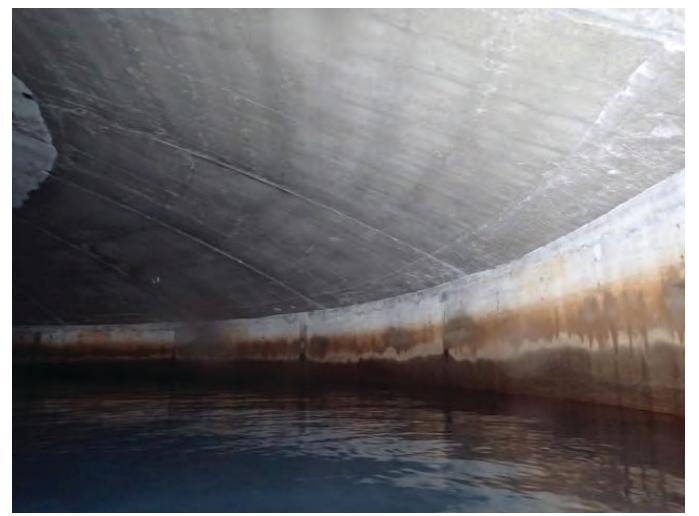
83 Overhead With Efflorescence

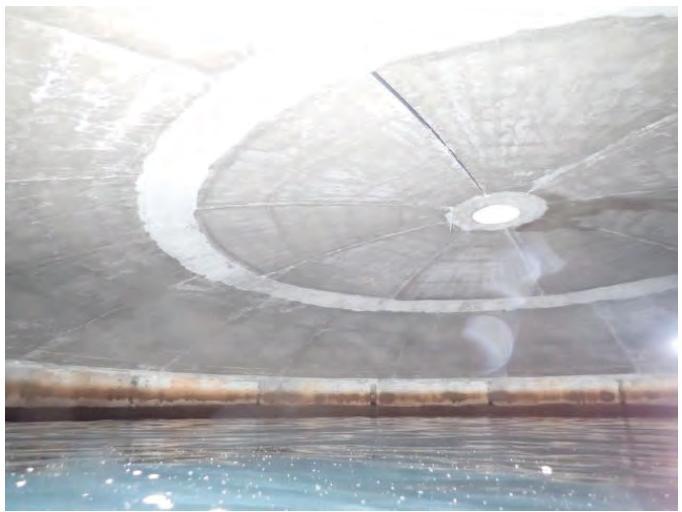
84 Overhead With Efflorescence

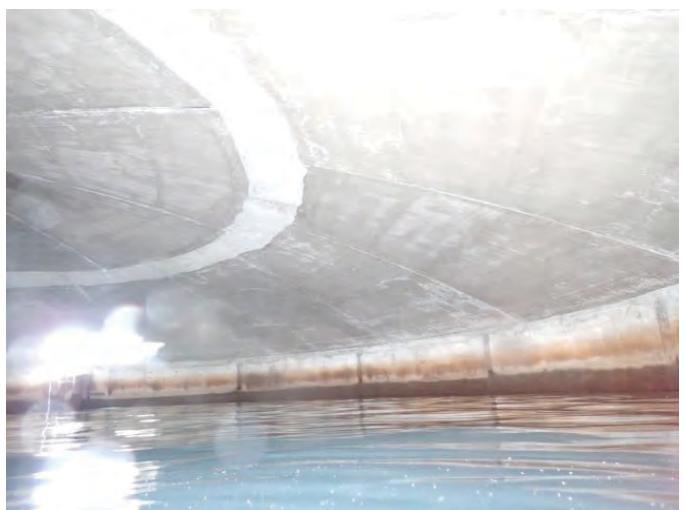
85 *Overhead With Efflorescence*

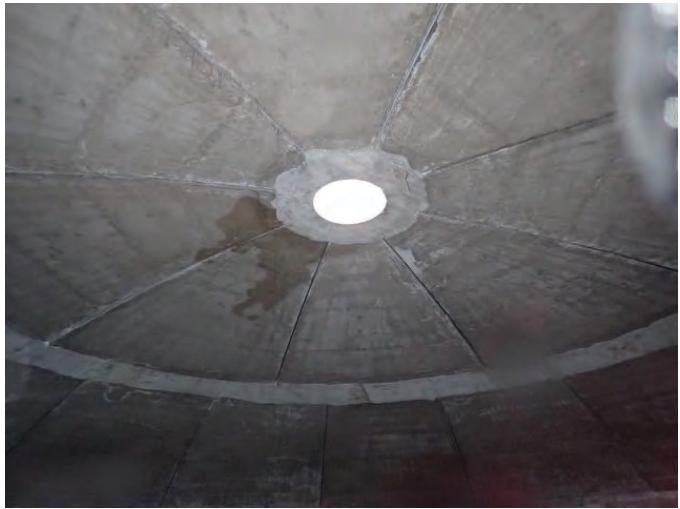
Overhead With Efflorescence 86

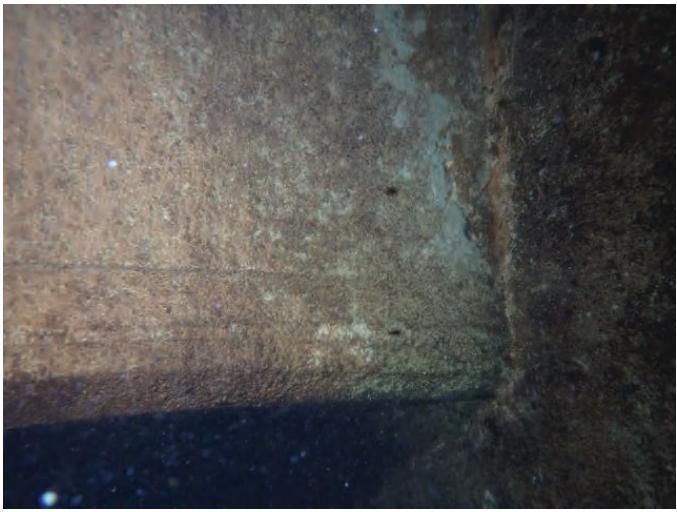
88 *Concrete Overflow Box With Heavy Staining*

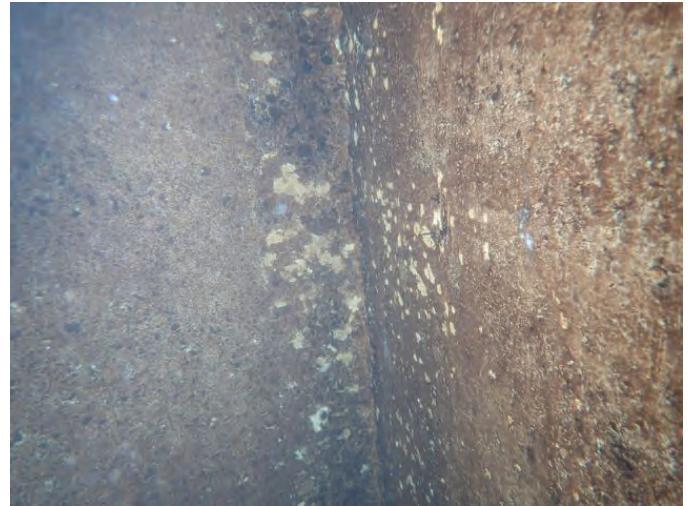
89 Concrete Overflow Box With Heavy Staining

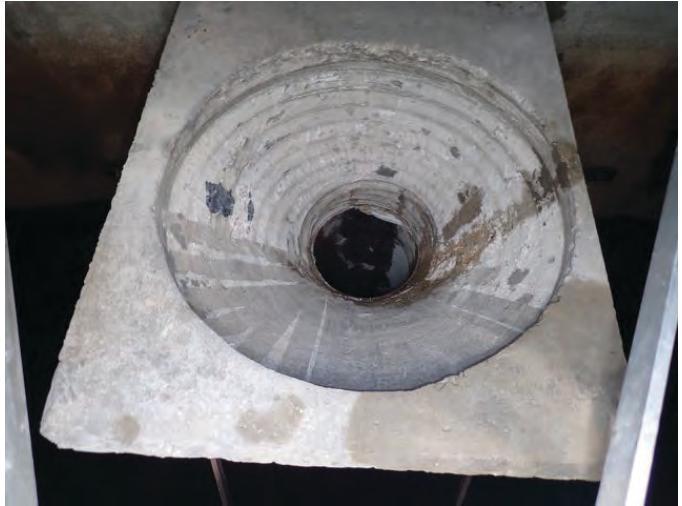
90 Concrete Overflow Box With Concrete Scour And Heavy Staining

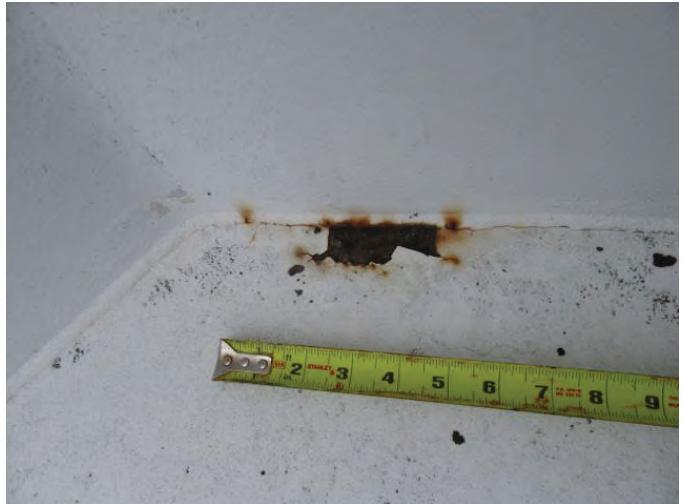
The protective coating applied to the exterior steel surfaces of the support pedestal has an average dry film thickness of 11.0 mils, appears to have been applied uniformly, meets the AWWA's recommendations and remains having mostly good adhesion value, but has become chalky due to weathering. Adhesion loss of the protective coating was observed throughout approximately 10% of the steel floor extension, located and welded to the base of the support pedestal, resulting in exposure of the underlying steel. No obvious fatigue/deterioration of the steel was evident within these areas of exposure, rather mild corrosion exists at this time.

13 Support Pedestal Exterior With Adhesion Loss Exposed Underlying Steel, Mild Corrosion And Mild Mildew

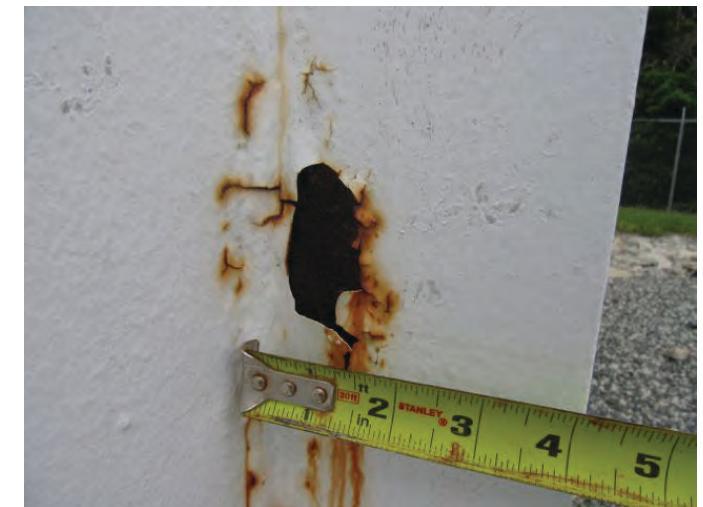
14Support Pedestal Exterior With Adhesion Loss14Exposed Underlying Steel, Mild Corrosion And
Mild Mildew

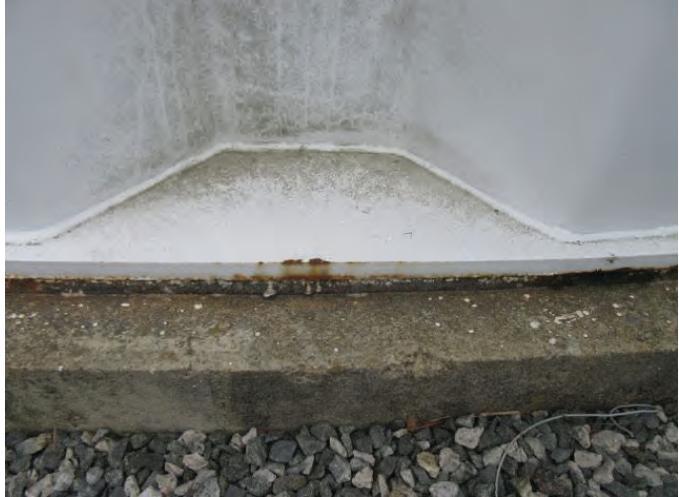
15 Support Pedestal Exterior With Coating Loss/ Chalking Exposed Underlying Steel, Mild Corrosion And Mild Mildew

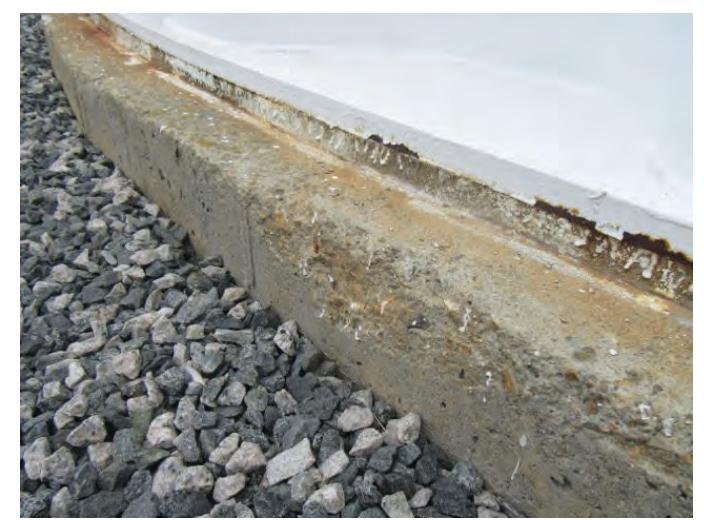
16 Support Pedestal Exterior With Coating Loss/ Chalking Exposed Underlying Steel, Mild Corrosion And Mild Mildew

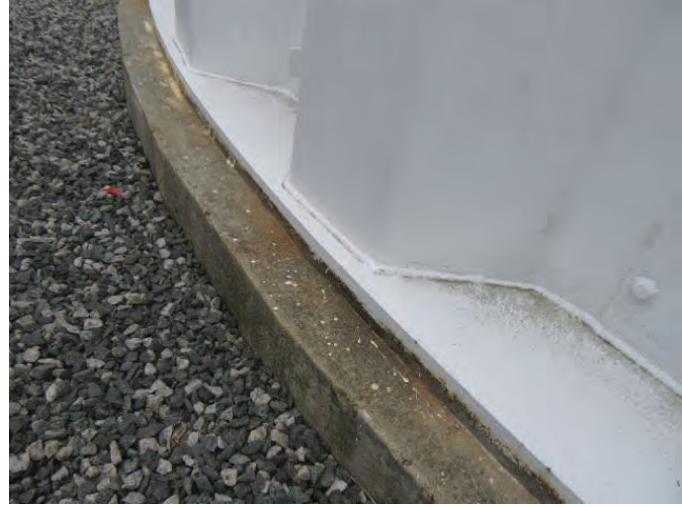
17 Support Pedestal Exterior With Coating Loss/ Chalking Exposed Underlying Steel, Mild Corrosion And Mild Mildew

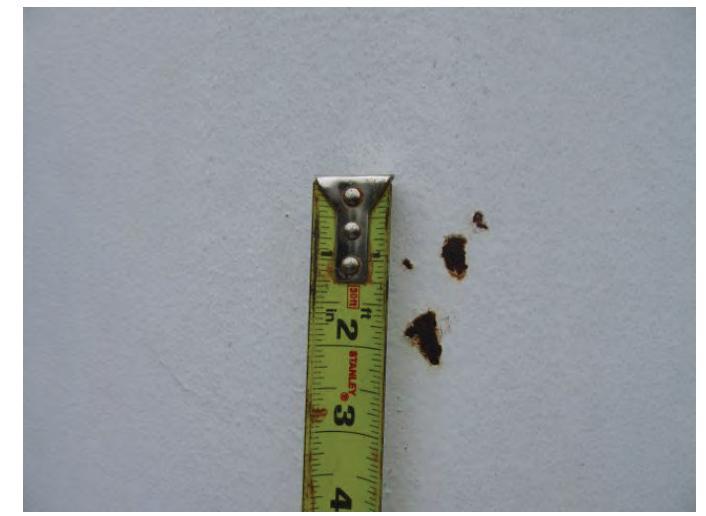
Several areas of coating damage were observed throughout approximately 5% of the lowest 10' of the exterior of the support pedestal, appearing to be the result of objects striking these surfaces and resulting in exposure of the underlying steel. No obvious fatigue/deterioration of the steel was evident within these 1/8" to 3" diameter areas of steel exposure, rather mild corrosion exists at this time.

18 Support Pedestal Exterior With Coating Damage, Exposed Underlying Steel, Mild Corrosion And Mild Mildew

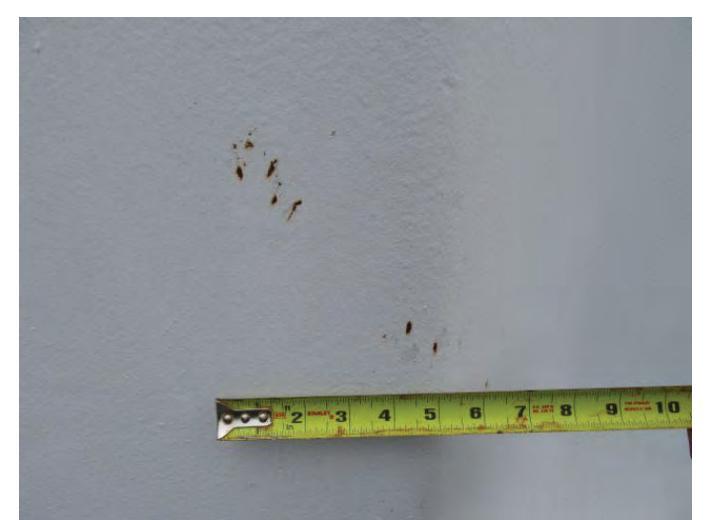
Support Pedestal Exterior With Coating Damage,
Exposed Underlying Steel, Mild Corrosion And Mild Mildew

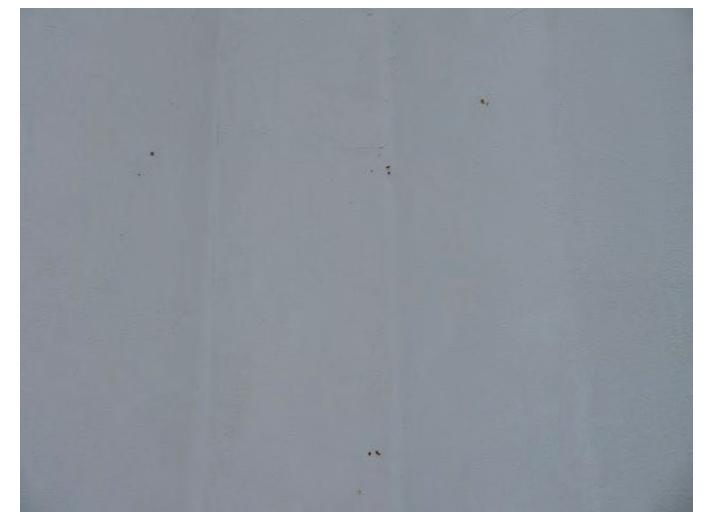
20 Support Pedestal Exterior With Coating Damage, 20 Exposed Underlying Steel, Mild Corrosion And Mild Mildew

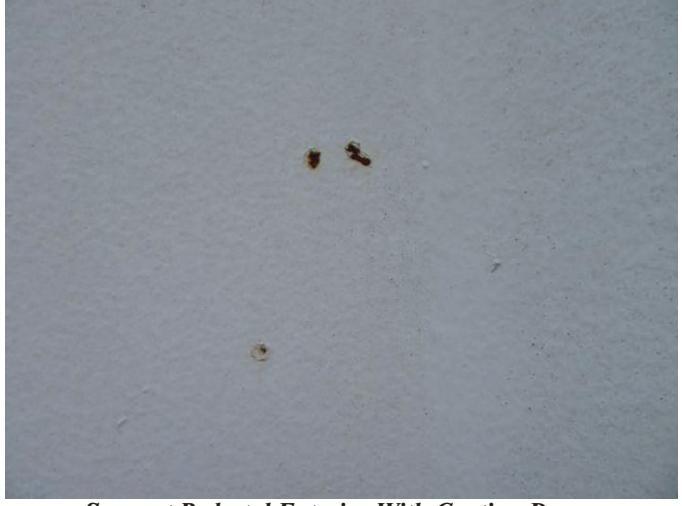
21 Support Pedestal Exterior With Coating Damage, Exposed Underlying Steel, Mild Corrosion And Mild Mildew

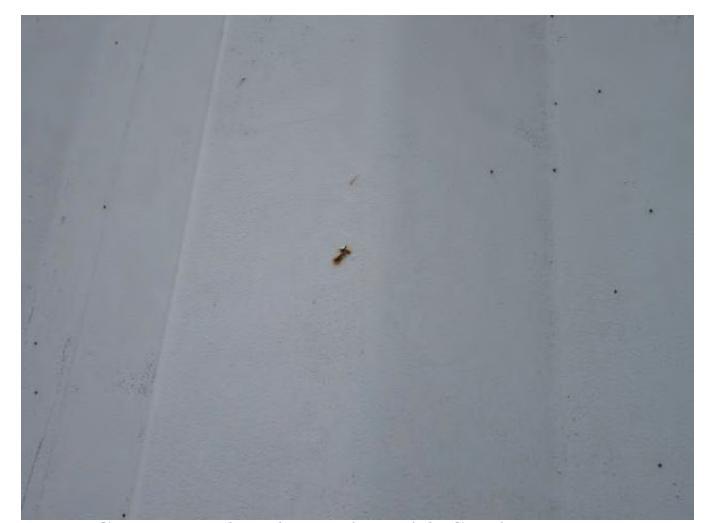
Support Pedestal Exterior With Coating Damage,
Exposed Underlying Steel, Mild Corrosion And Mild Mildew

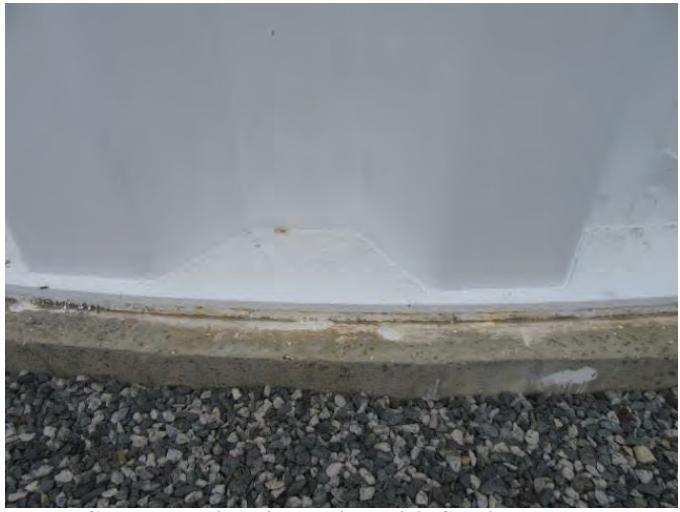
23 Support Pedestal Exterior With Coating Damage, Exposed Underlying Steel, Mild Corrosion And Mild Mildew

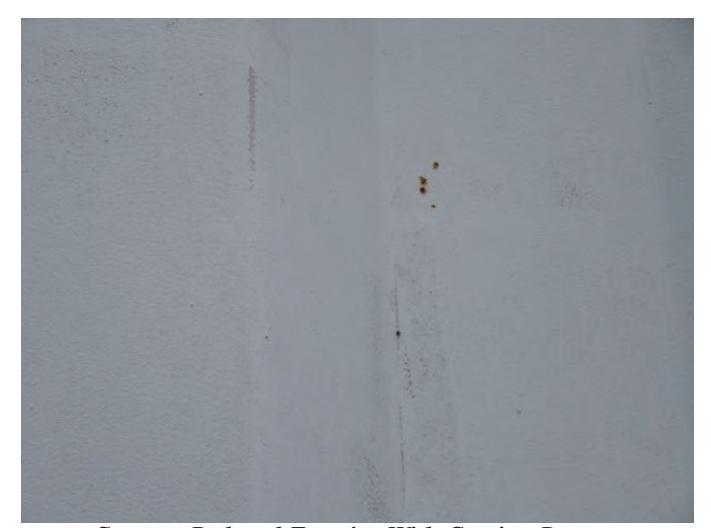
24 Support Pedestal Exterior With Coating Damage, Exposed Underlying Steel, Mild Corrosion And Mild Mildew

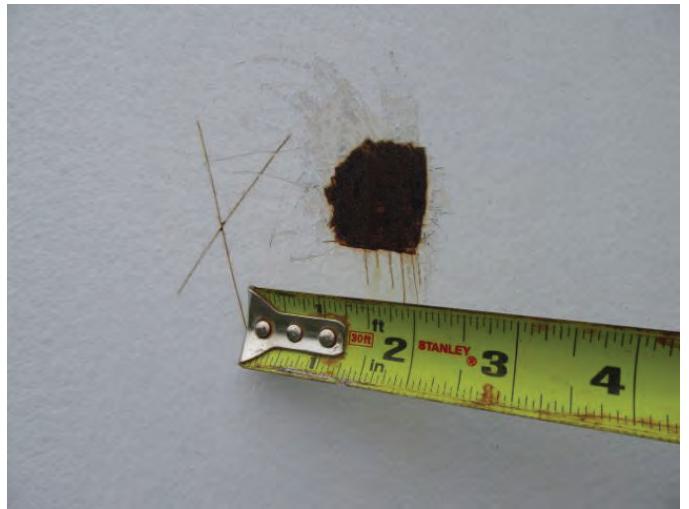
25 Support Pedestal Exterior With Coating Damage, 25 Exposed Underlying Steel, Mild Corrosion And Mild Mildew

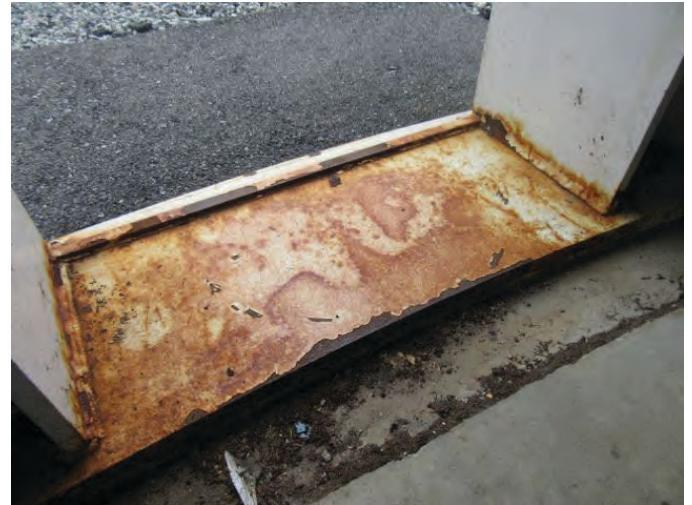
26 Support Pedestal Access Door With Coating Damage, 27 Exposed Underlying Steel And Mild Corrosion

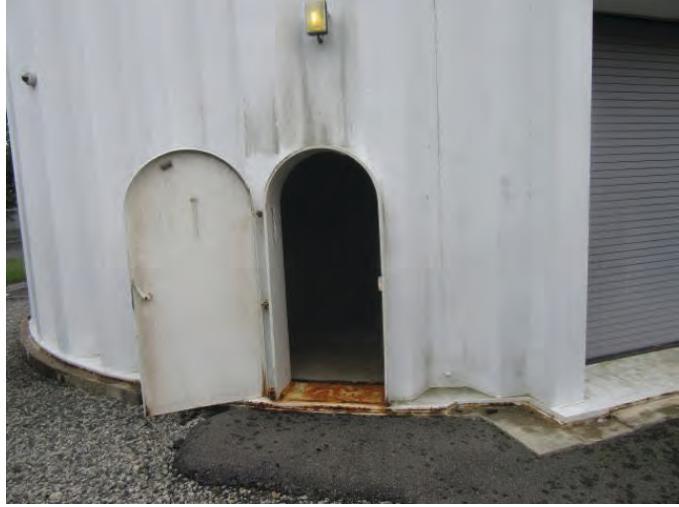
A mild, non-uniform accumulation of mildew throughout the exterior surfaces of the support pedestal causes declined aesthetics.

27 Support Pedestal Exterior With Coating Loss/ Chalking With Mild Mildew

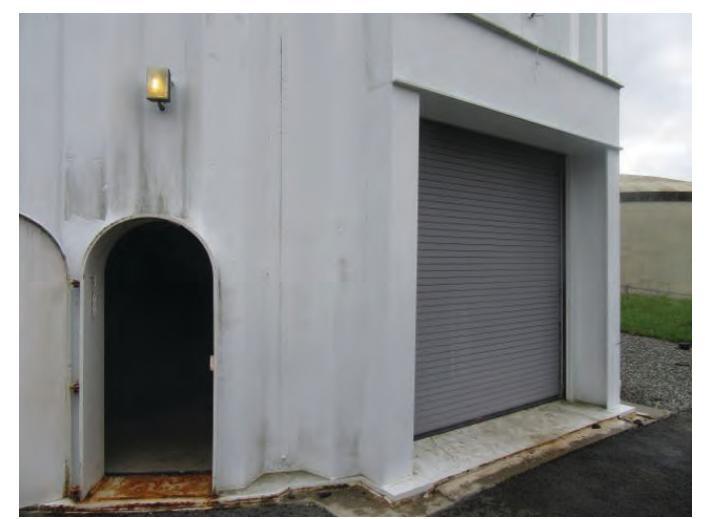
28 Support Pedestal Exterior With Coating Loss/ 28 Chalking With Mild Mildew

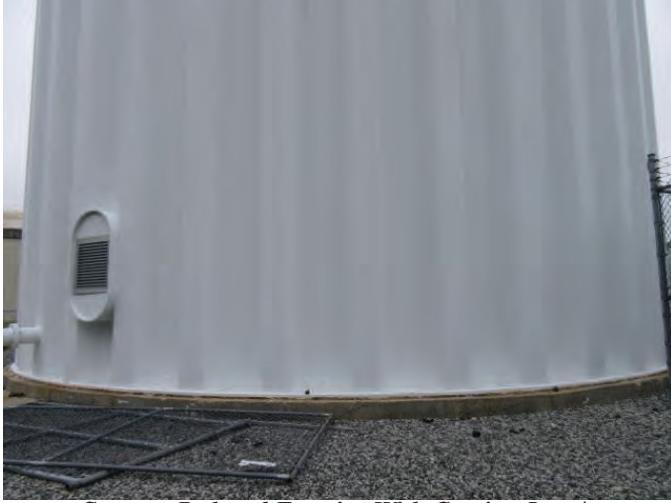
29 Support Pedestal Exterior With Coating Loss/ Chalking With Mild Mildew

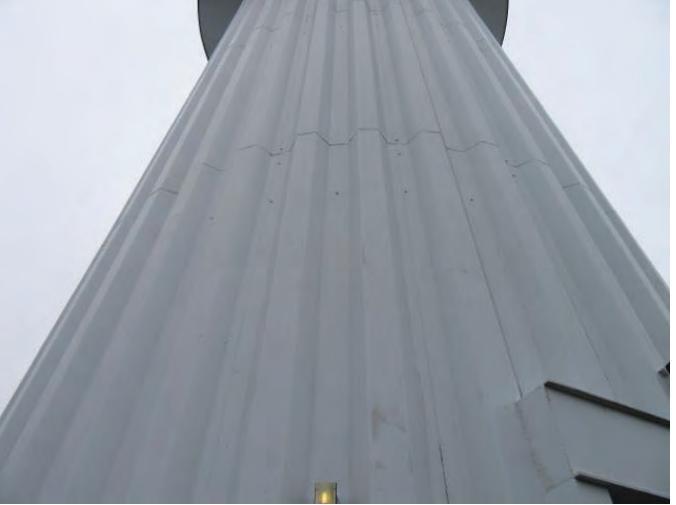
30 Support Pedestal Exterior With Coating Loss/ Chalking With Mild Mildew

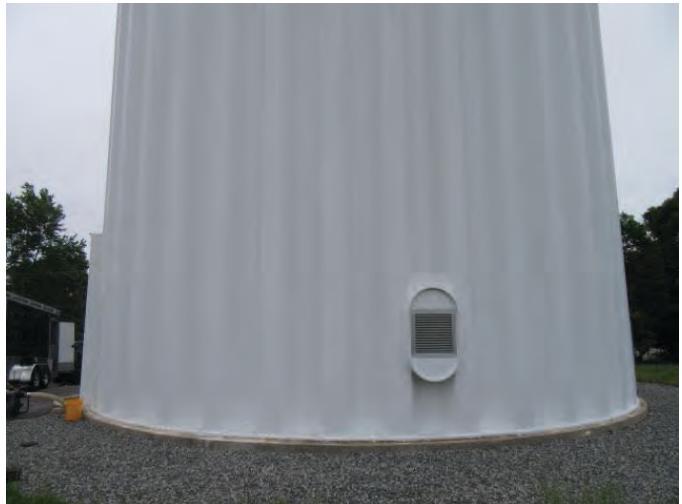
31 Support Pedestal Exterior With Coating Loss/ Chalking With Mild Mildew

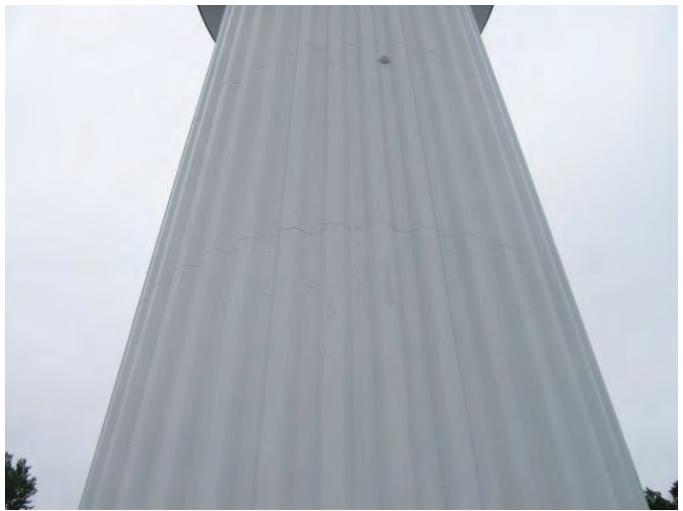
Support Pedestal Exterior With Coating Loss/ 32 Chalking With Mild Mildew

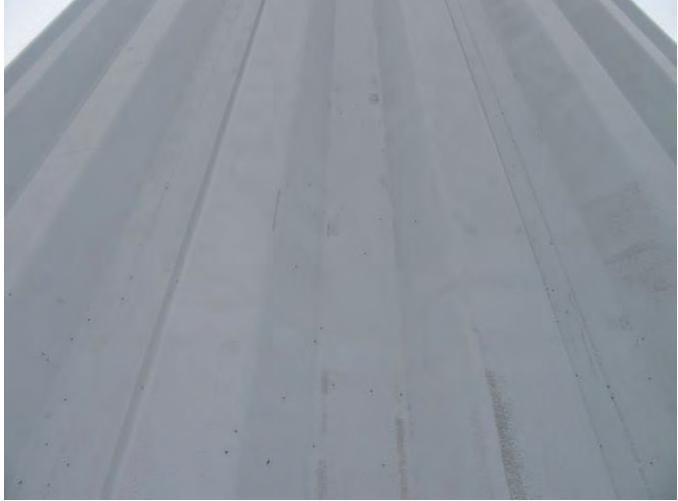
33 Support Pedestal Exterior With Coating Loss/ Chalking With Mild Mildew

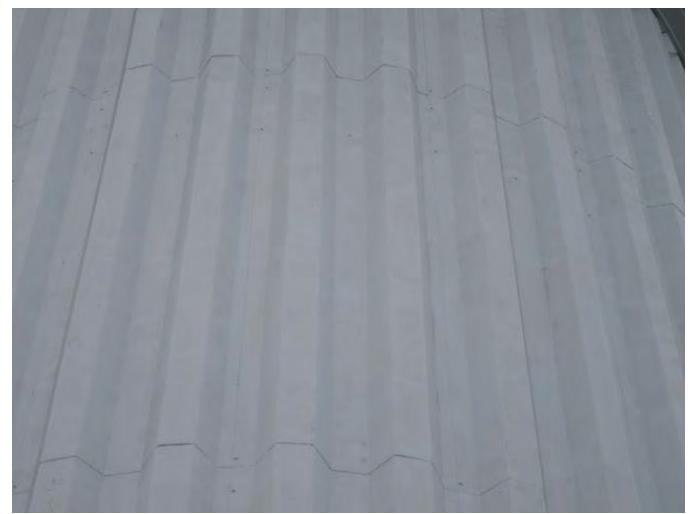
34 Support Pedestal Exterior With Coating Loss/ Chalking With Mild Mildew

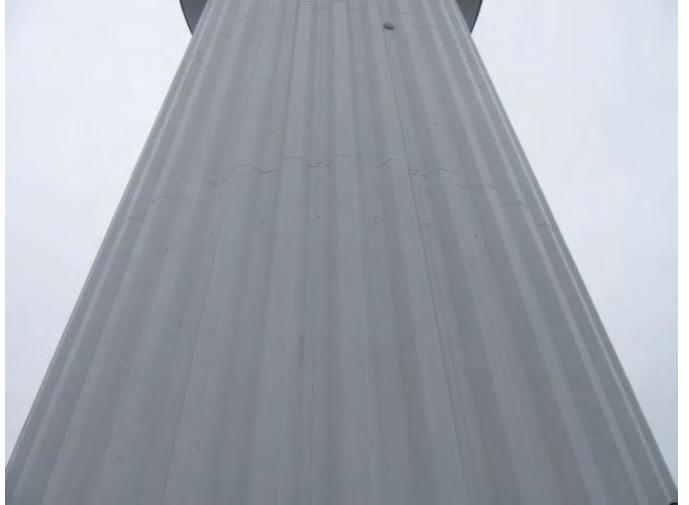
35 Support Pedestal Exterior With Coating Loss/ Chalking With Mild Mildew

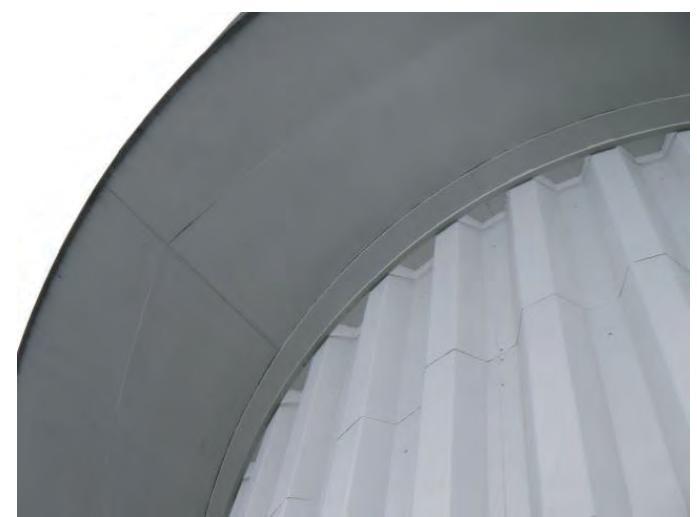
36 Support Pedestal Exterior With Coating Loss/ Chalking With Mild Mildew

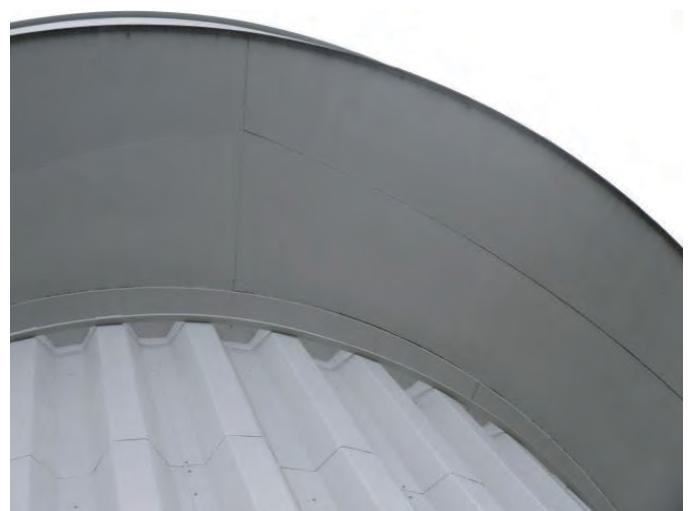
37 *Exterior Support Pedestal And Tank Base With Mild Mildew*

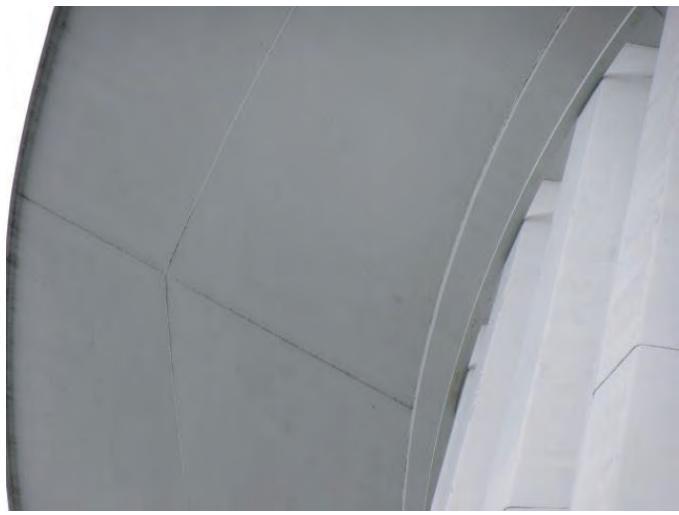
Exterior Support Pedestal And Tank Base With Mild 38 Mildew

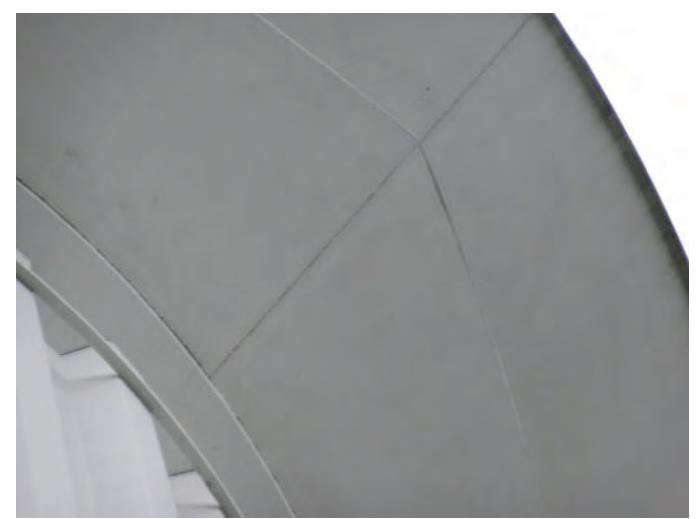
39 *Exterior Support Pedestal And Tank Base With Mild Mildew*

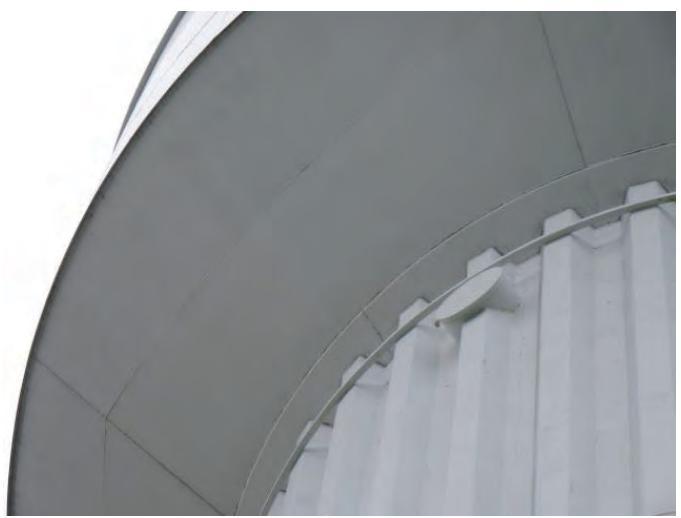
40 *Exterior Support Pedestal And Tank Base With Mild Mildew*

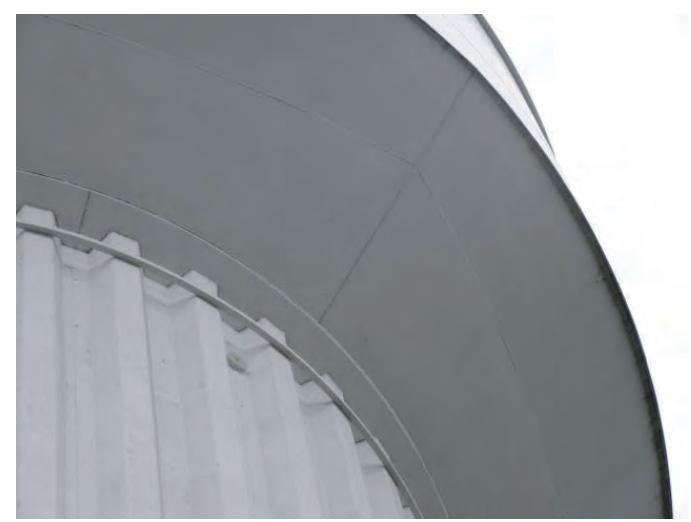
41 *Exterior Support Pedestal And Tank Base With Mild Mildew*

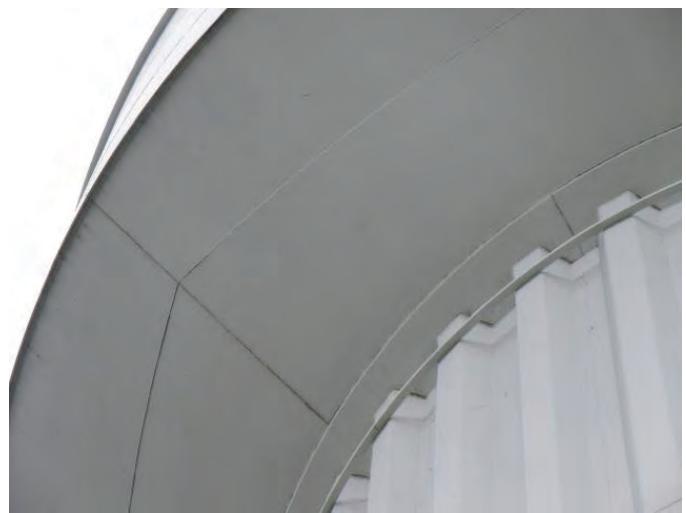
42 Exterior Support Pedestal And Tank Base With Mild Mildew

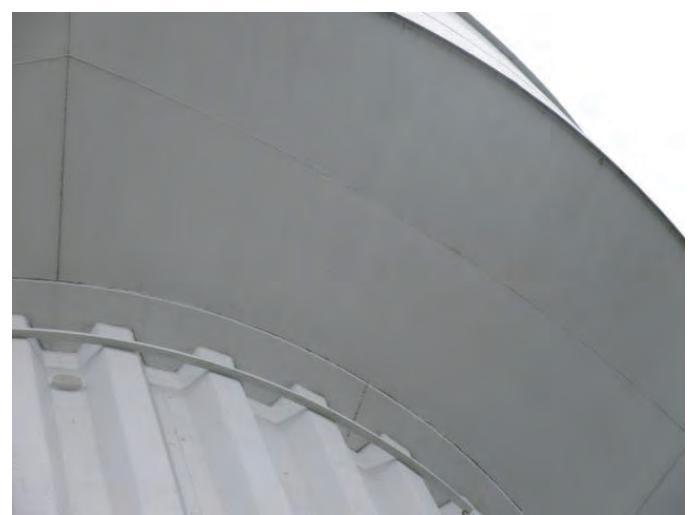
43 *Exterior Support Pedestal And Tank Base With Mild Mildew*

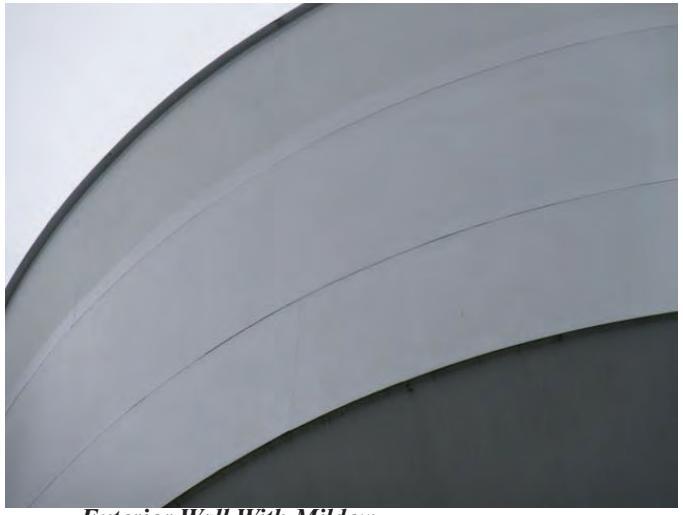
Exterior Support Pedestal And Tank Base With Mild 44 *Mildew*

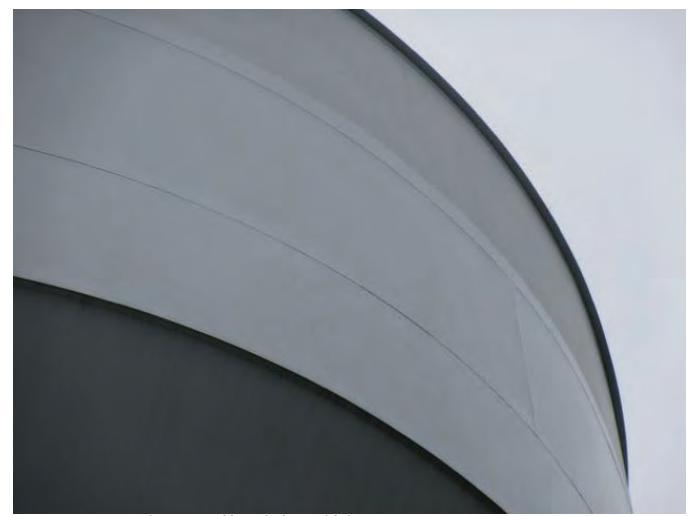
45 *Exterior Wall With Mildew*

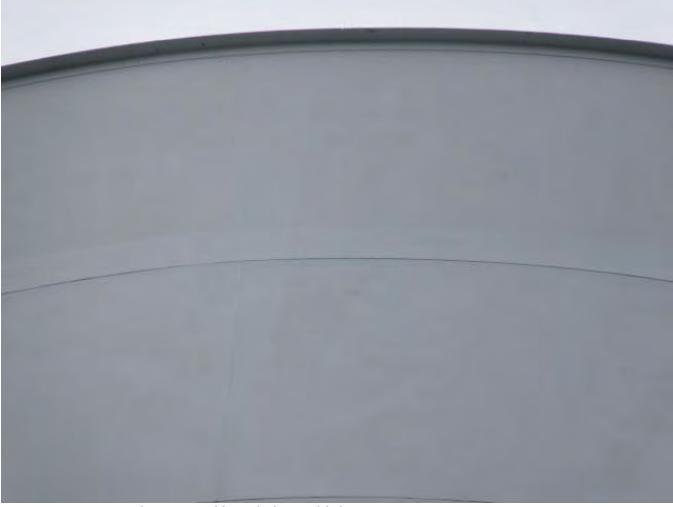
46 *Exterior Wall With Mildew*

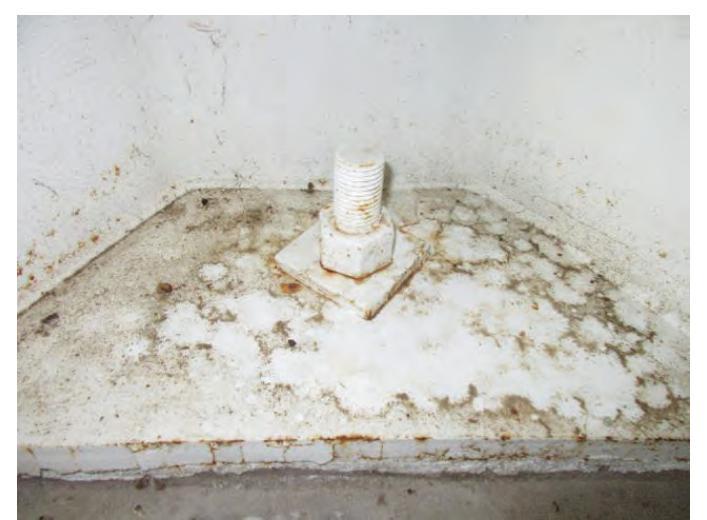
47 Exterior Wall With Mildew

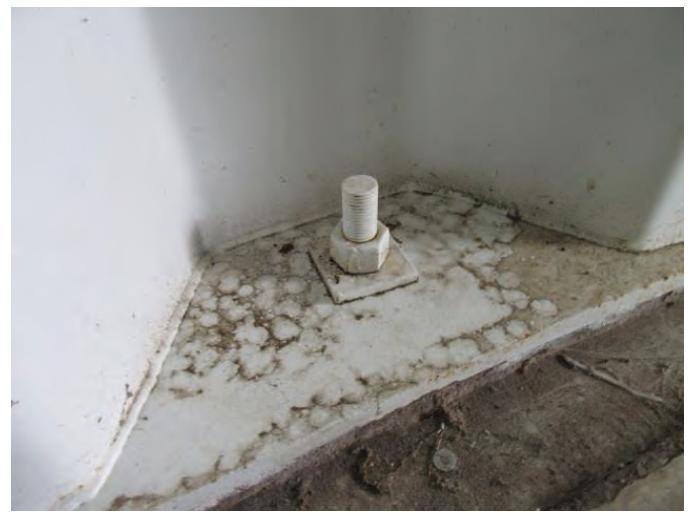
48 Anchor Bolt And Hardware With Mild Rust Staining

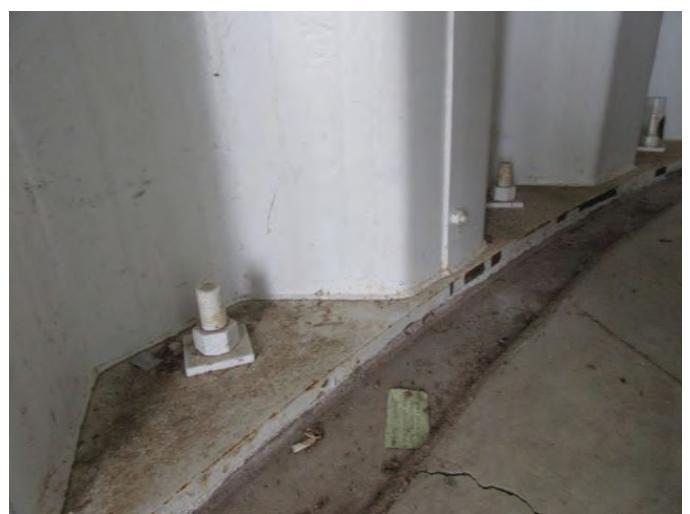
Anchor Bolt And Hardware With Mild Rust Staining

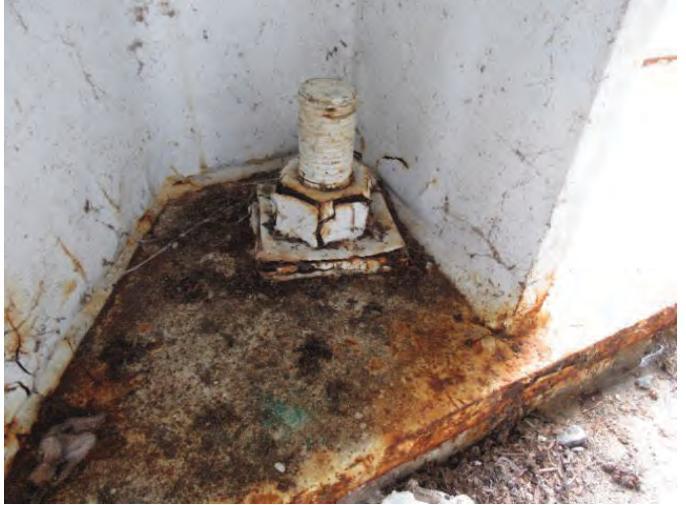
Anchor Bolt And Hardware With Mild Rust Staining 50

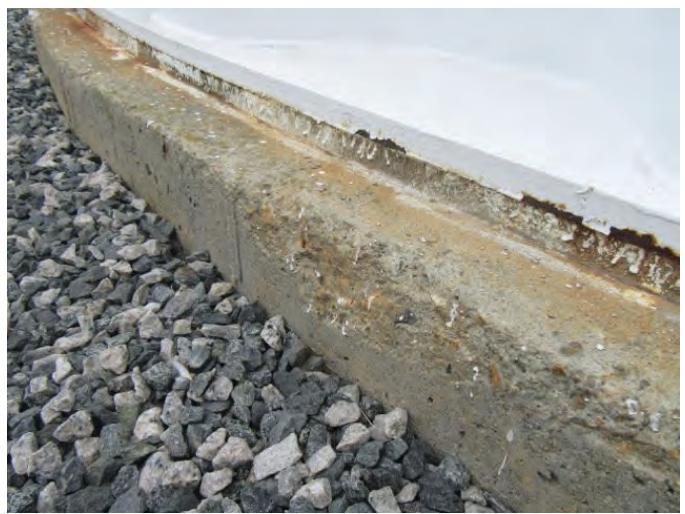
51 Anchor Bolt And Hardware With Coating Loss, Exposed Steel And Corrosion

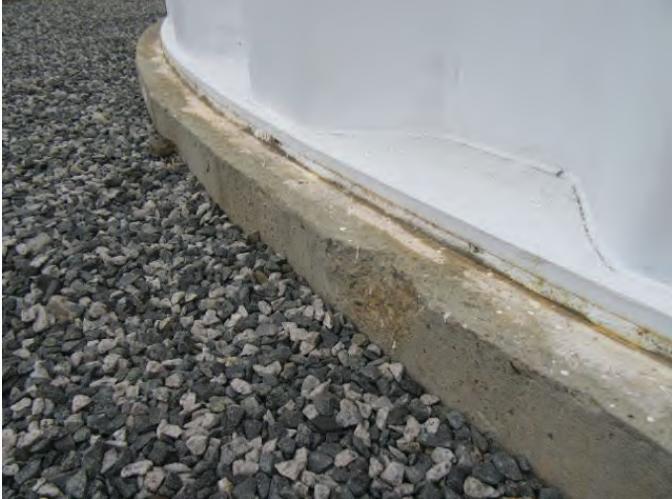
52 *Concrete Foundation With Spall*

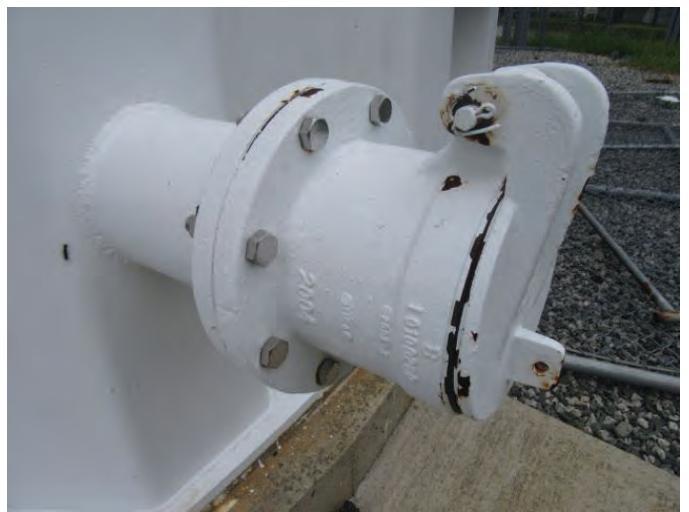
Overflow Pipe And Flap-Valve With Coating Loss, Exposed Steel And Corrosion 65

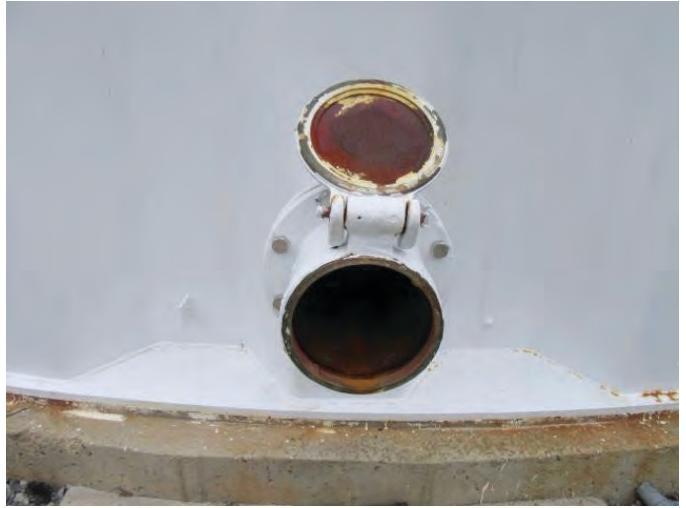
Overflow Pipe And Flap-Valve With Coating Loss, Exposed Steel And Corrosion 66

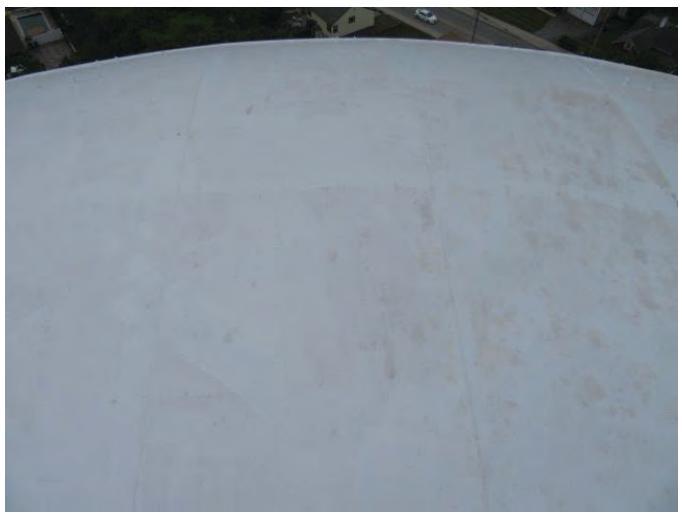
Roof Panels With Secondary Coating Loss And
Exposed Underlying Primary Coating

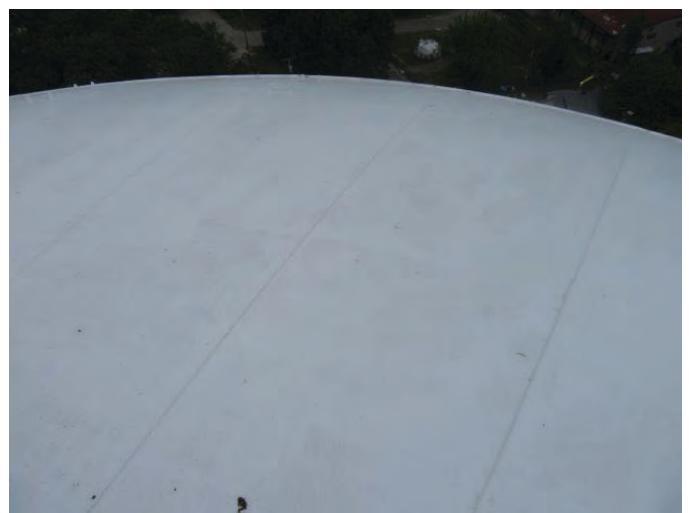
69 *Roof Panels With Secondary Coating Loss And Exposed Underlying Primary Coating*

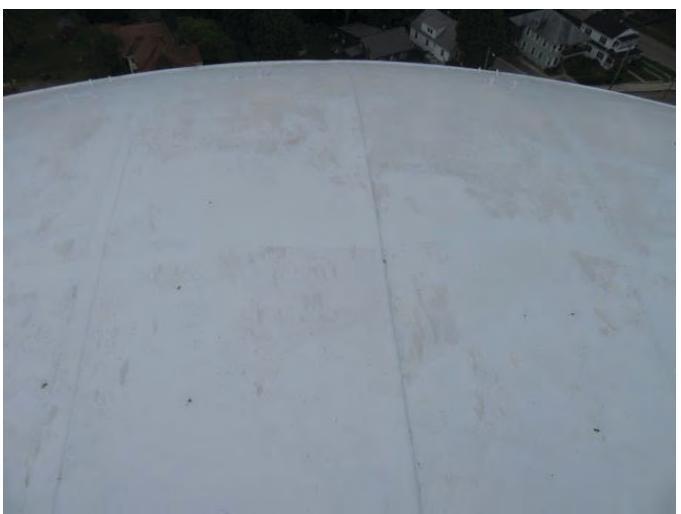
Roof Panels With Secondary Coating Loss And70Exposed Underlying Primary Coating

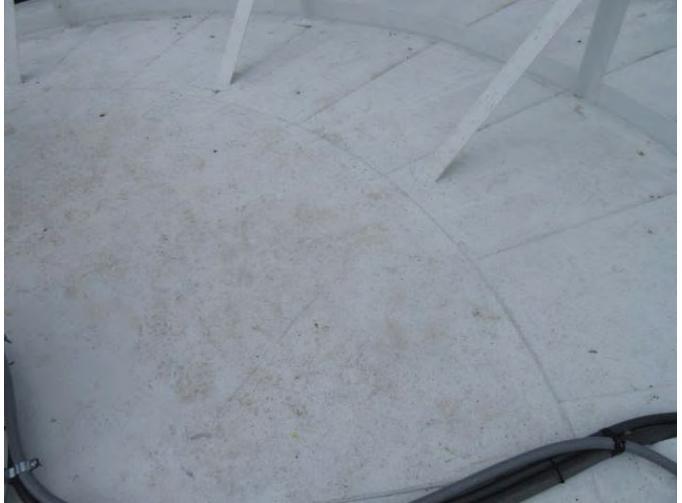
71 Roof Panels With Secondary Coating Loss And Exposed Underlying Primary Coating
