In re: City of Woonsocket Water Division - Application to Implement Multi-Year Rate Plan

Docket No. 4879

Dam Name (No):	Woonsocket Reservoir #3 Dam (068)
Location:	Smithfield/North Smithfield
Hazard Classification:	High
	-
Inspector:	David M. Matheson, P.E.
Inspection Date.	August 1, 2014

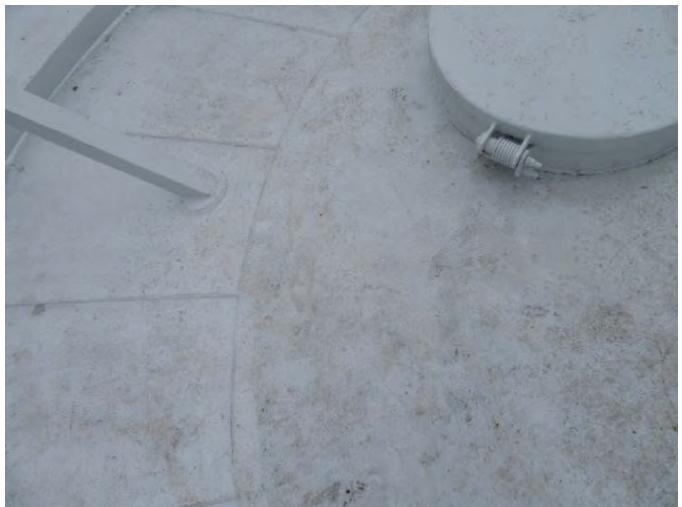
72 Roof Panels With Secondary Coating Loss And Exposed Underlying Primary Coating

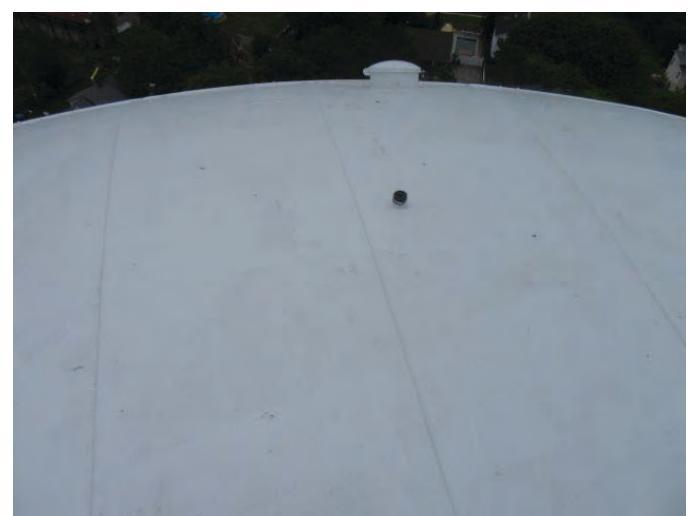
73Roof Panels With Secondary Coating Loss And
Exposed Underlying Primary Coating

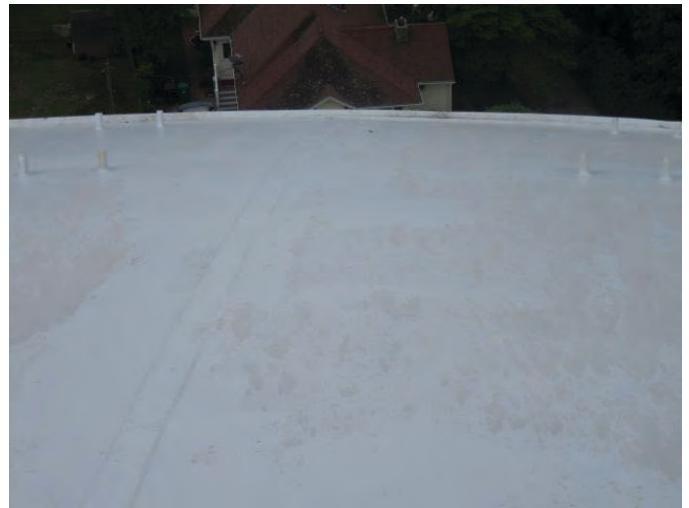
Roof Panels With Secondary Coating Loss And74Exposed Underlying Primary Coating

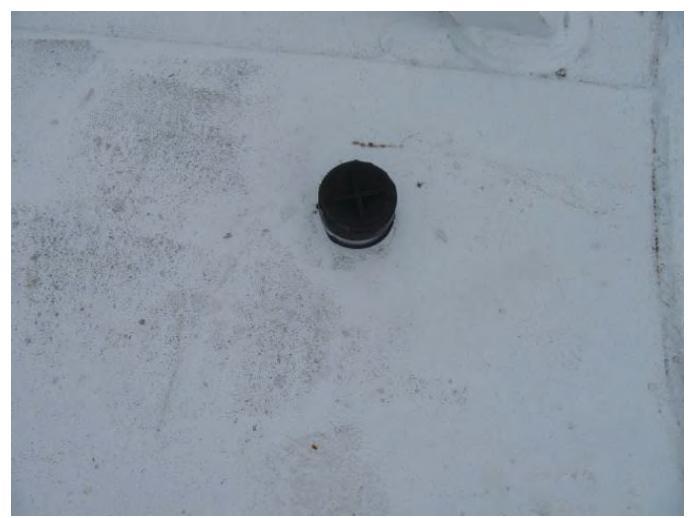
Secure / Sealed Roof Rigging Hole Penetrations

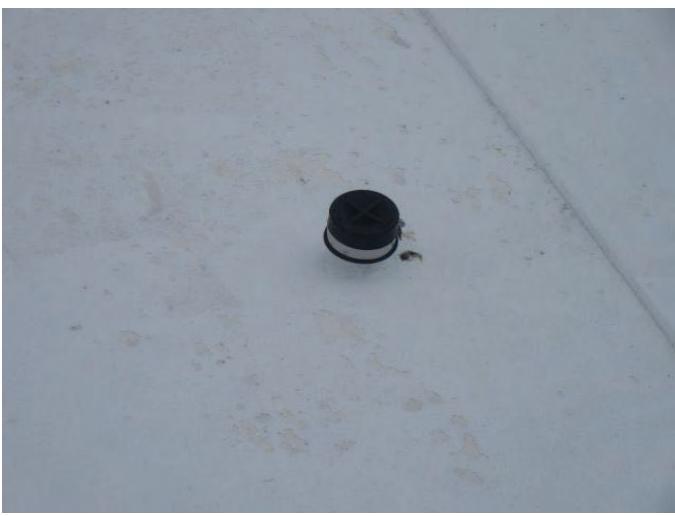
77 Secure / Sealed Roof Rigging Hole Penetrations

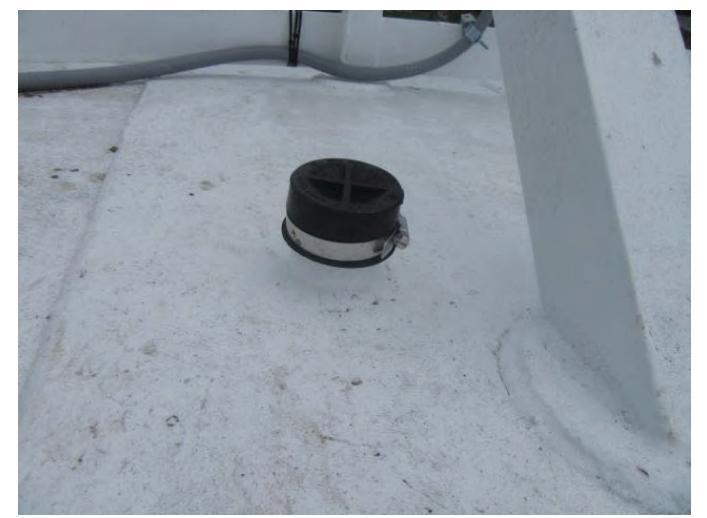
78 Secure / Sealed Roof Rigging Hole Penetrations

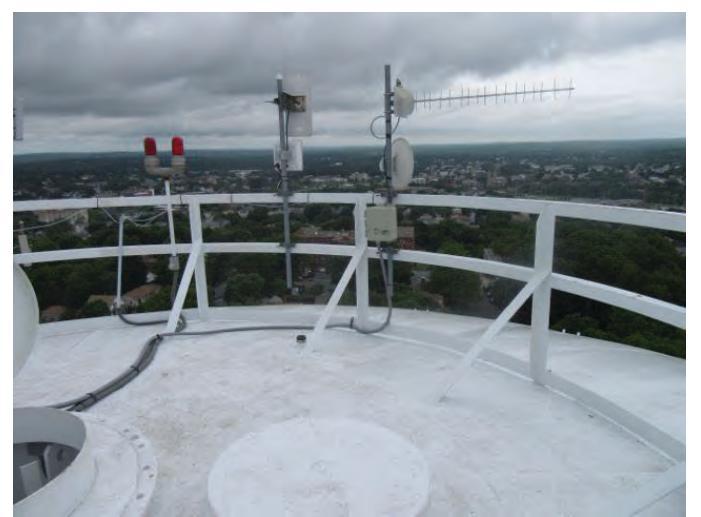
79 Secure Roof Safety Railings With Secondary Coating Loss And Exposed Primary Coating

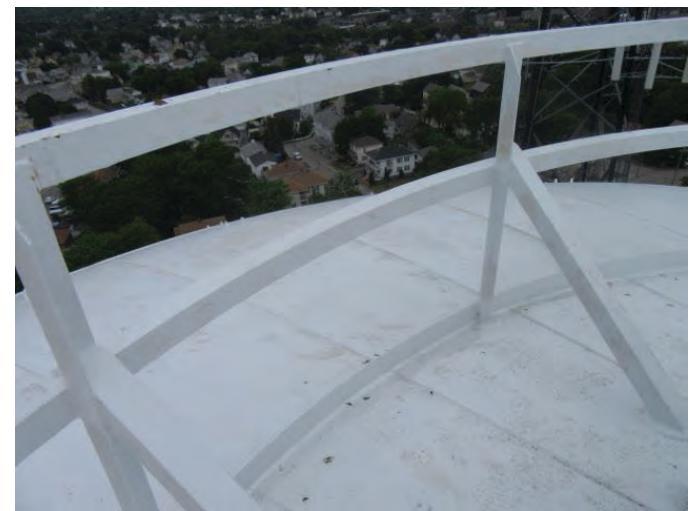
80 Secure Roof Safety Railings With Secondary Coating 81 Loss And Exposed Primary Coating

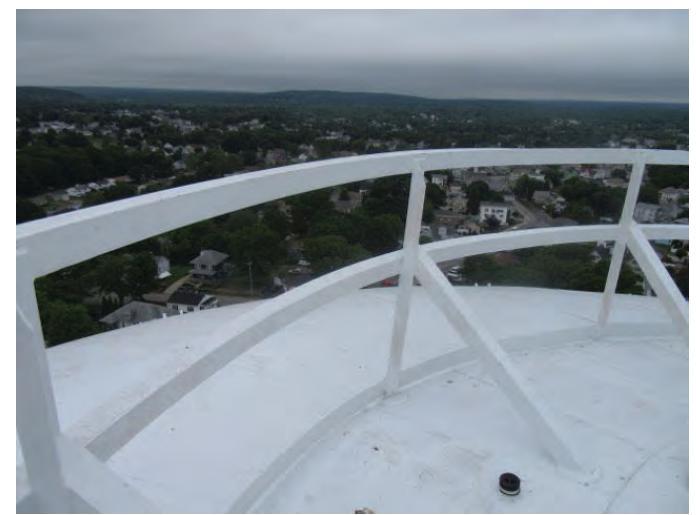
81 Secure Roof Safety Railings With Secondary Coating Loss And Exposed Primary Coating

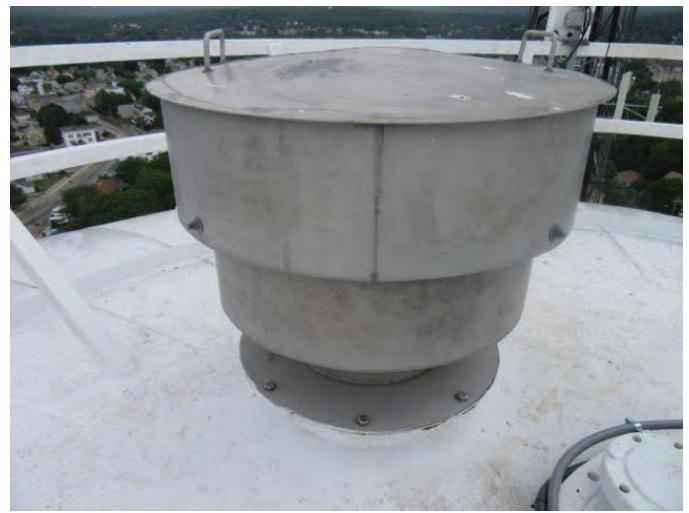
82 Secure Fail Safe (Frost Proof) Vent

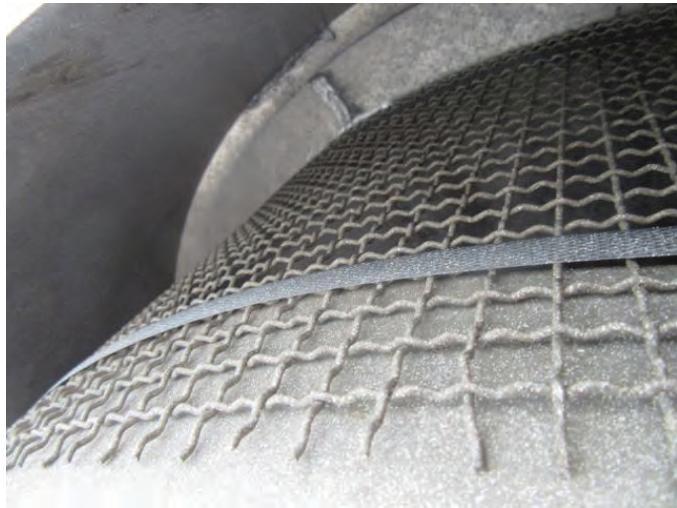
83 Secure Vent Screen

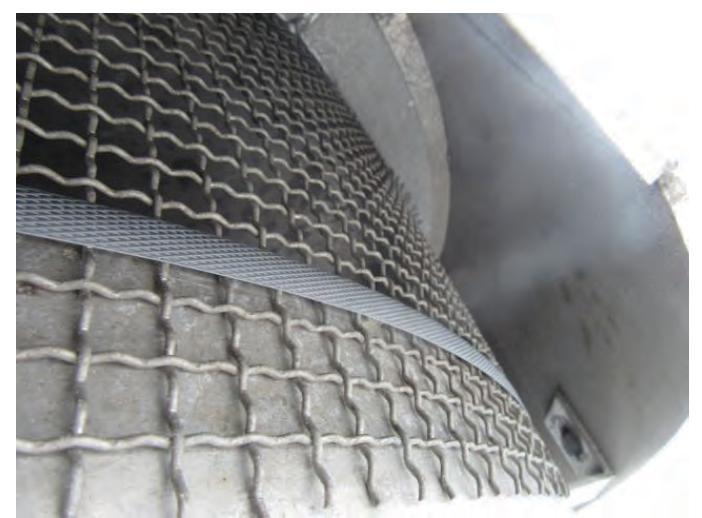
84 Secure Vent Screen

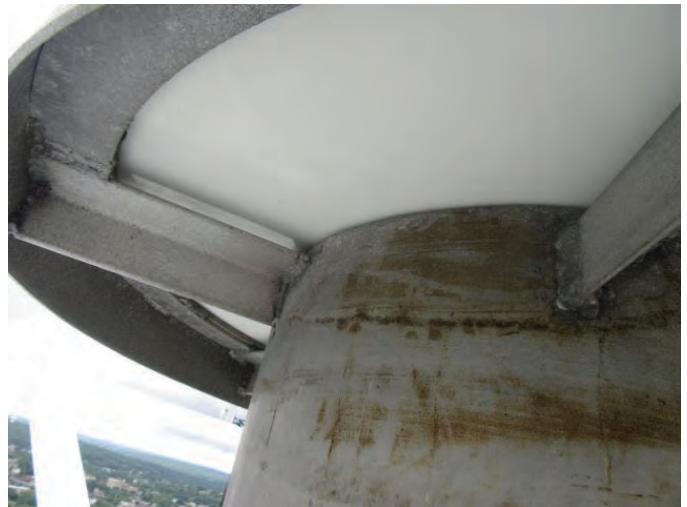
85 Free Moving Vacuum Release Plate

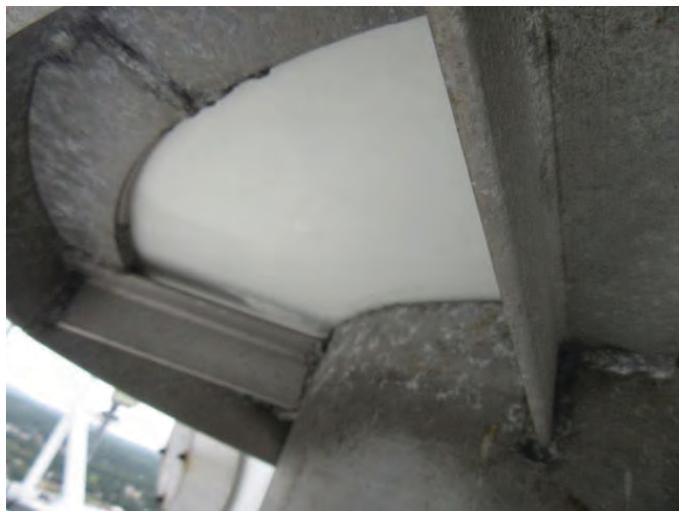
Free Moving Vacuum Release Plate

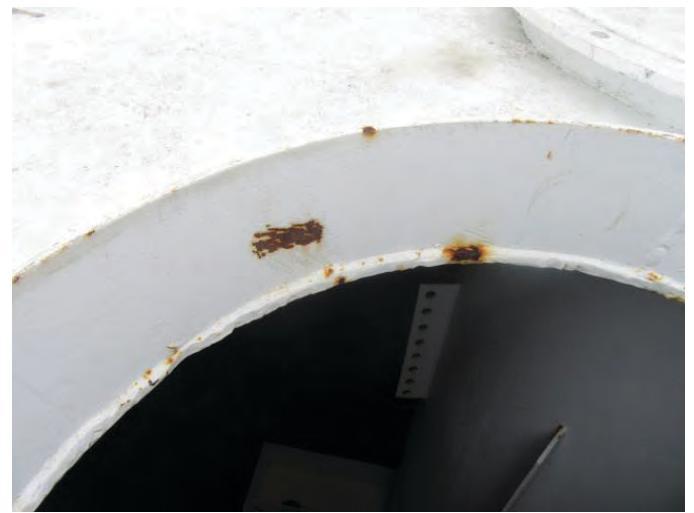
Hatch Trunk With Coating Loss, Exposed Underlying
Steel And Mild Corrosion

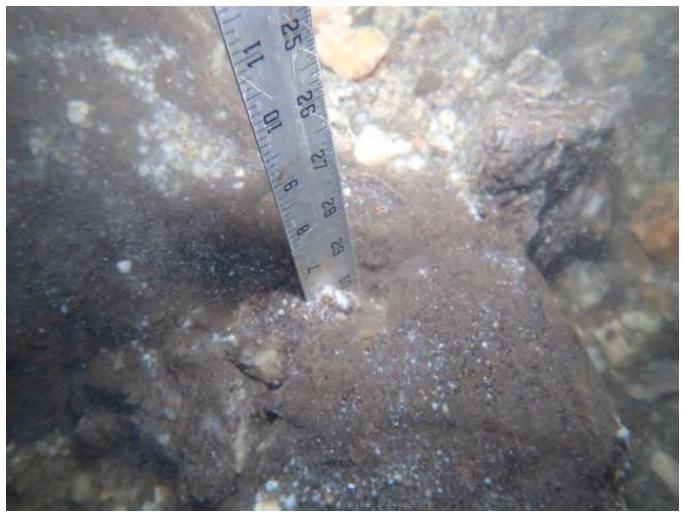
95 Layer Of Precipitate

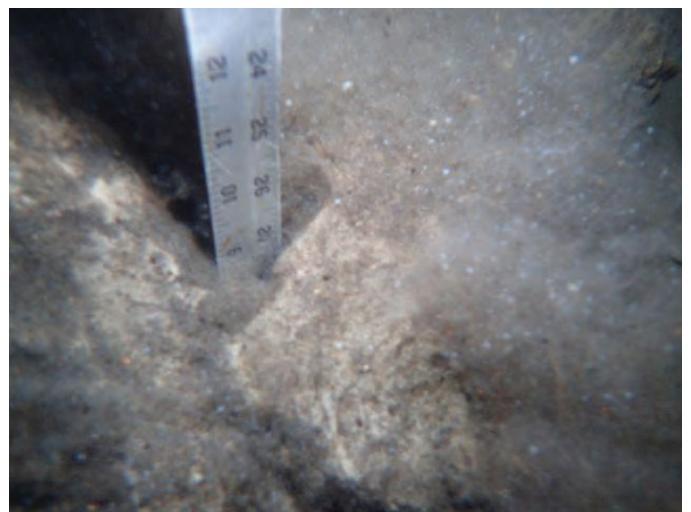
96 *Layer Of Precipitate*

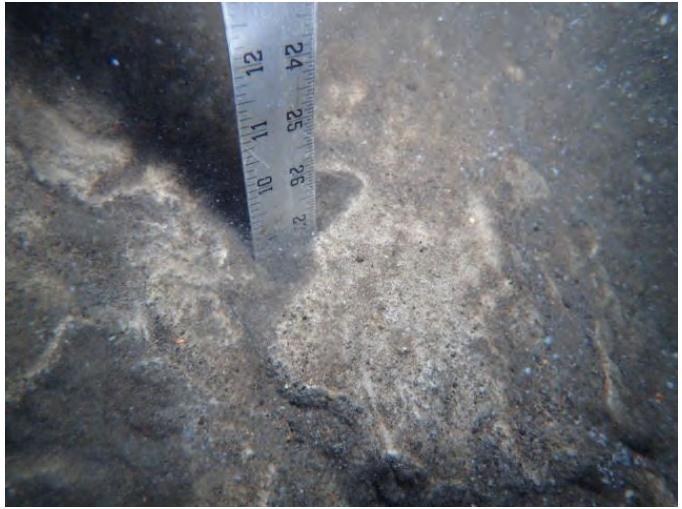
97 *Layer Of Precipitate*

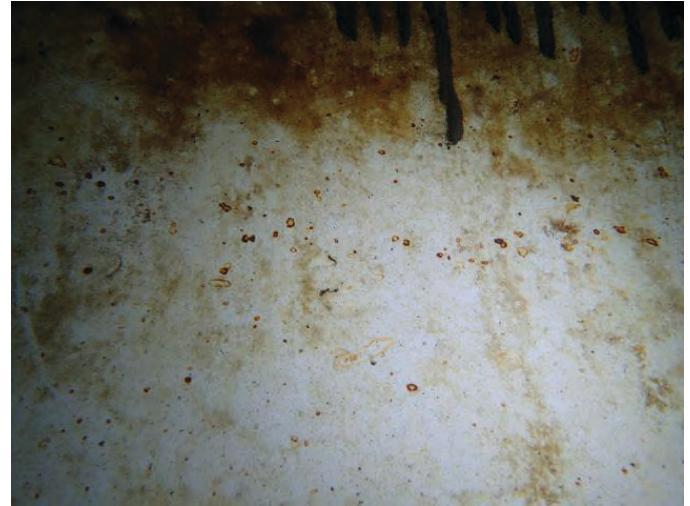
98 Floor With Coating Loss/Blisters, Exposed 98 Underlying Steel, Mild Corrosion And Mild To Moderate Staining

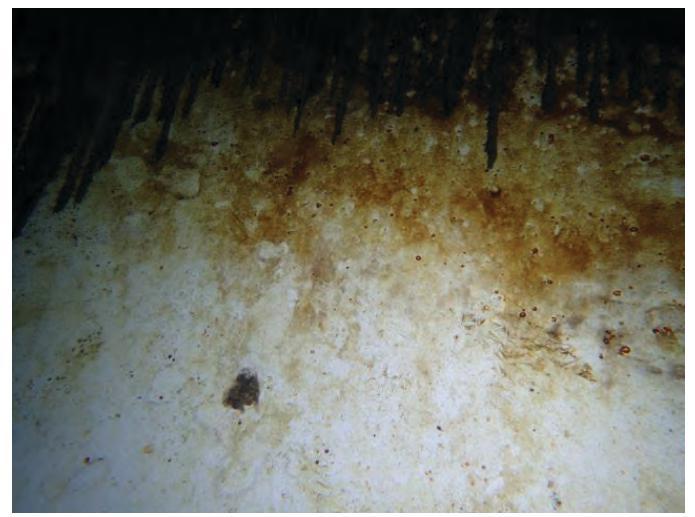
99 Floor With Coating Loss/Blisters, Exposed Underlying Steel, Mild Corrosion And Mild To Moderate Staining

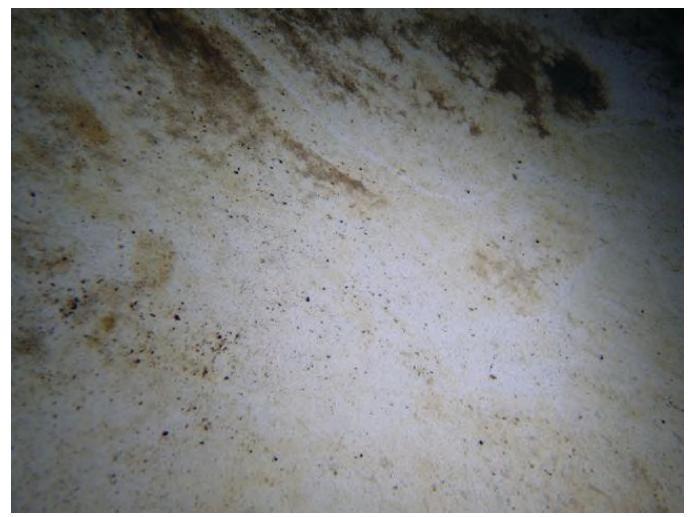
100 Floor With Coating Loss/Blisters, Exposed Underlying Steel, Mild Corrosion And Mild To Moderate Staining

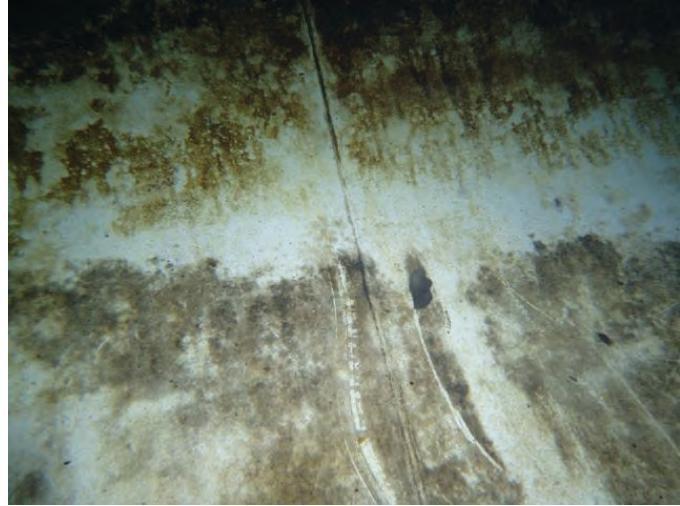
101 Floor With Mild To Moderate Staining

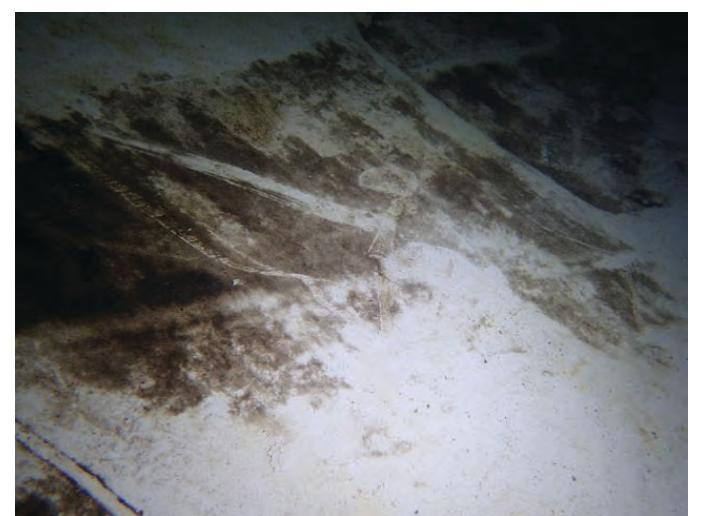
102 Floor With Mild To Moderate Staining

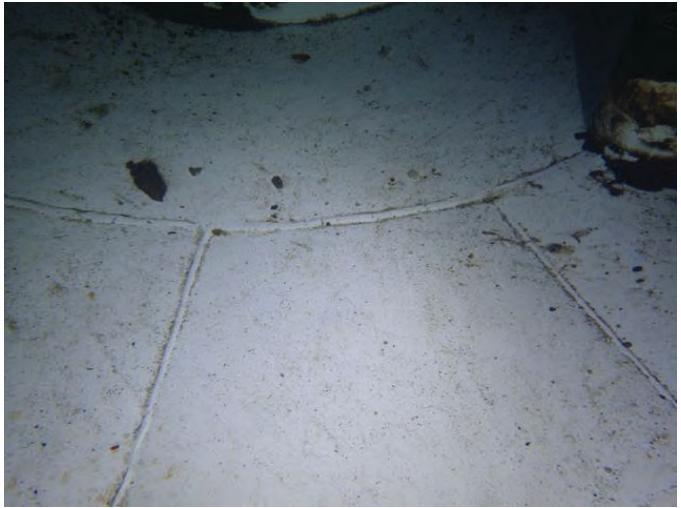
103 Floor With Mild To Moderate Staining

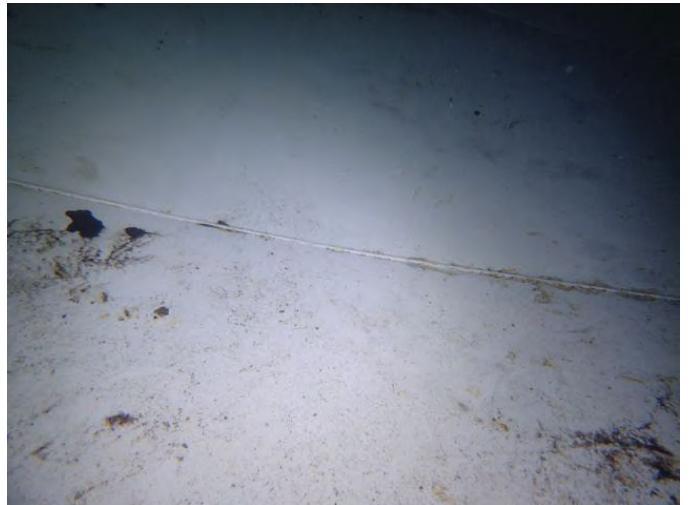
Floor With Mild To Moderate Staining

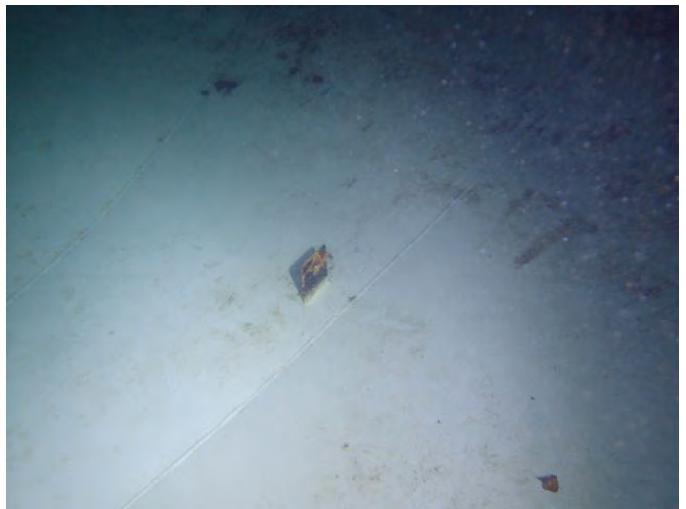
105 Floor With Mild To Moderate Staining

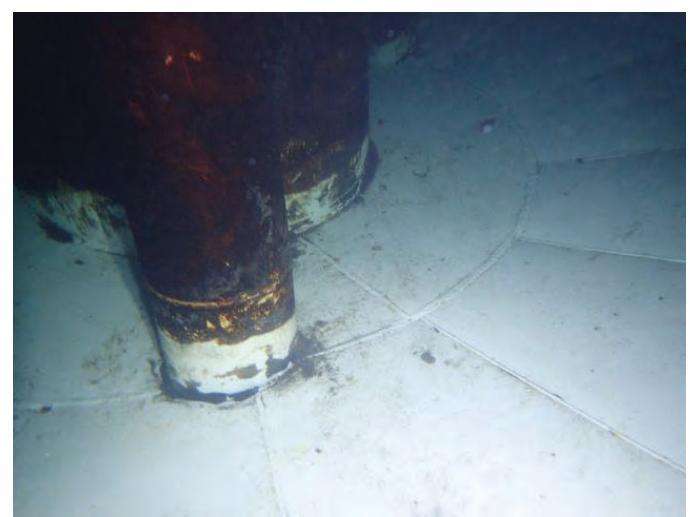
106 Floor With Mild To Moderate Staining

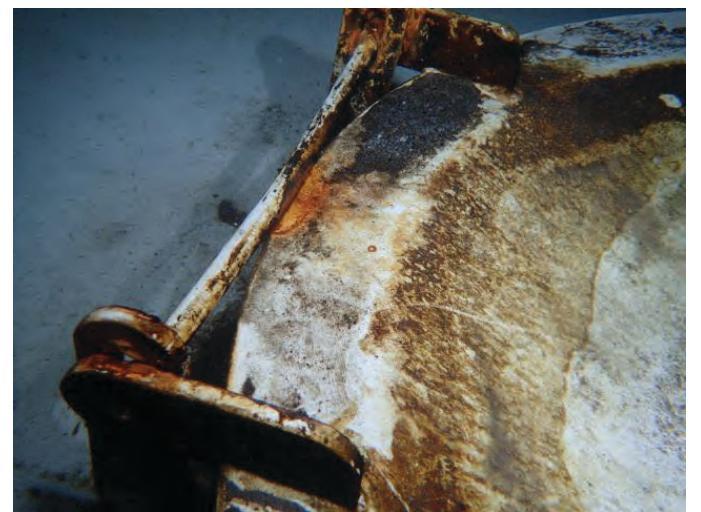
108 Manway With Coating Loss/Blisters, Exposed Underlying Steel And Mild Corrosion

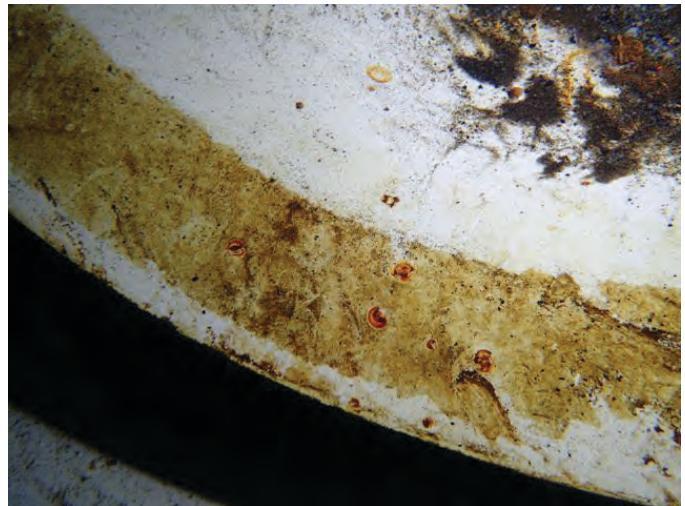
Manway With Coating Loss/Blisters, Exposed 109 Underlying Steel And Mild Corrosion

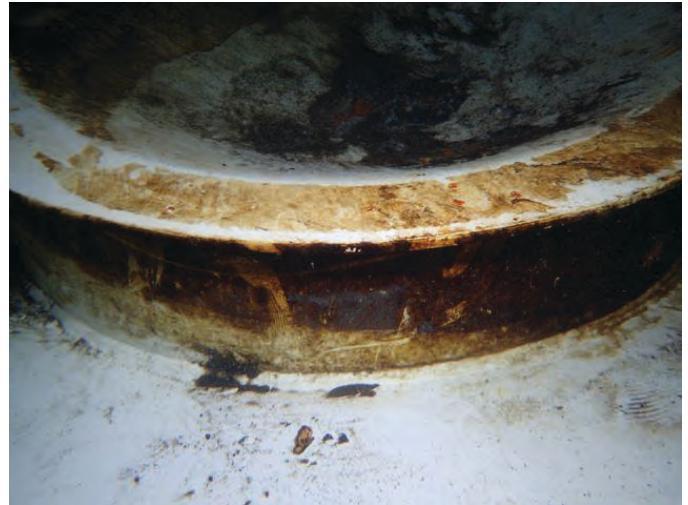
Manway With Coating Loss/Blisters, Exposed 110 Underlying Steel And Mild Corrosion

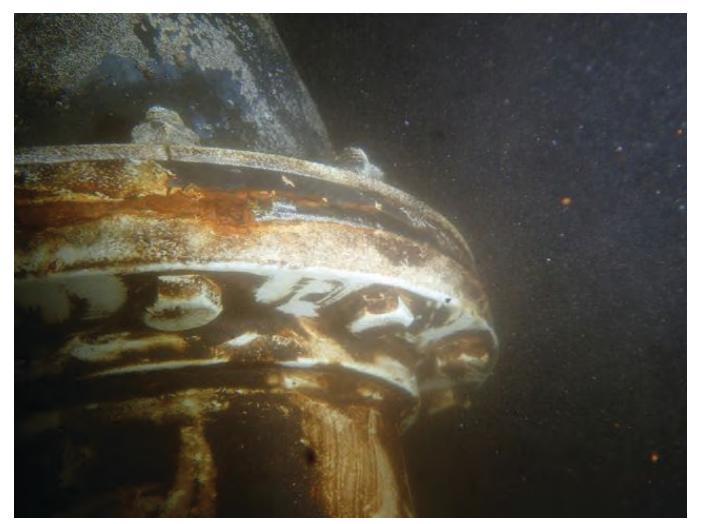
113 *10" Inside Diameter Pipe Flange With Coating Loss, Exposed Underlying Metal And Mild To Moderate Corrosion*

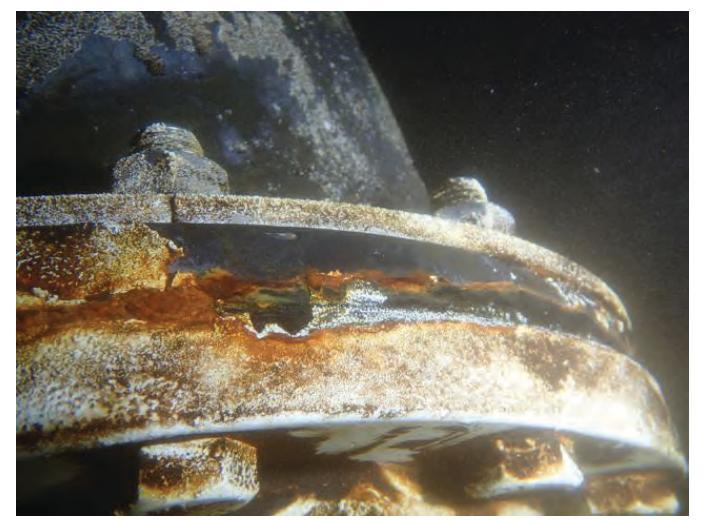
114 *10" Inside Diameter Pipe Flange With Coating Loss, Exposed Underlying Metal And Mild To Moderate Corrosion*

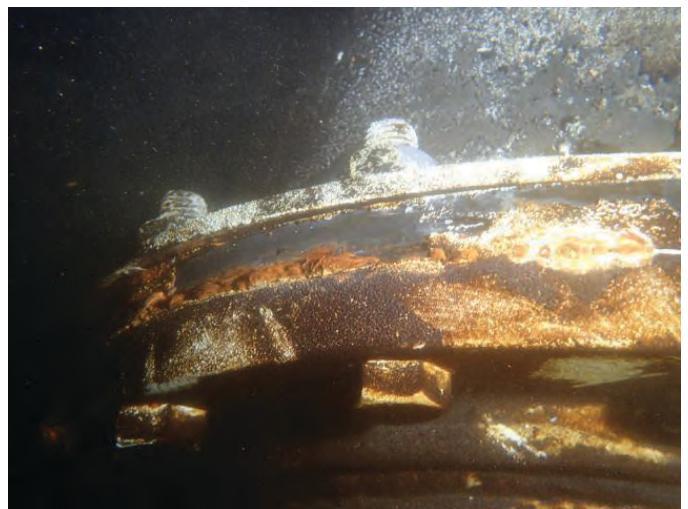
10" Inside Diameter Pipe Flange With Coating Loss,
115 Exposed Underlying Metal And Mild To Moderate Corrosion

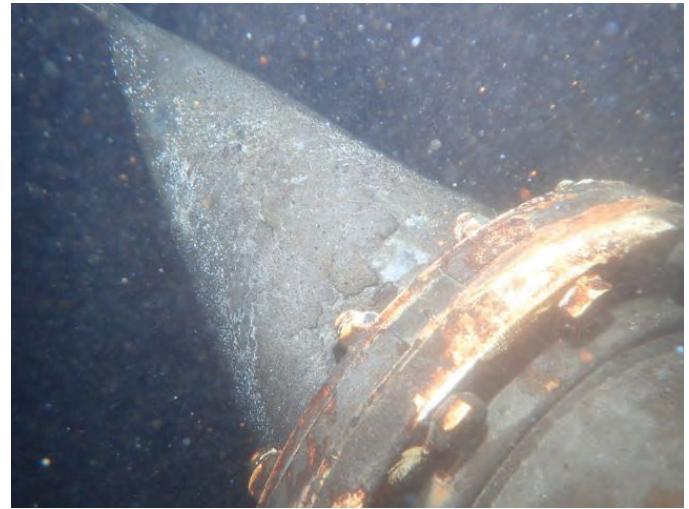
Rubber Check Valve

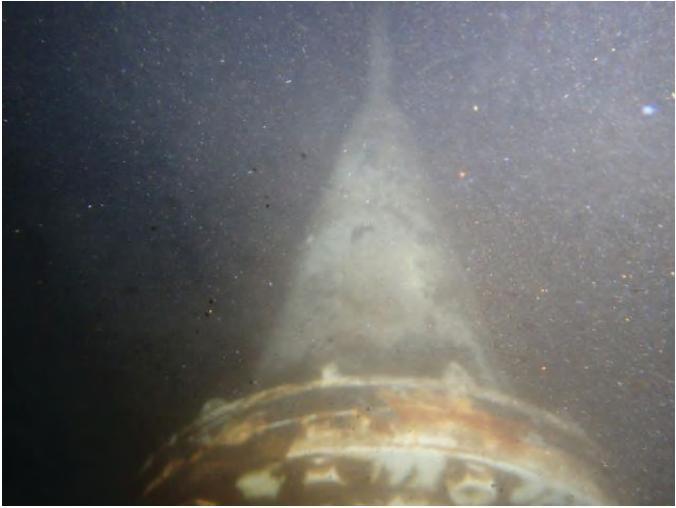
Rubber Check Valve

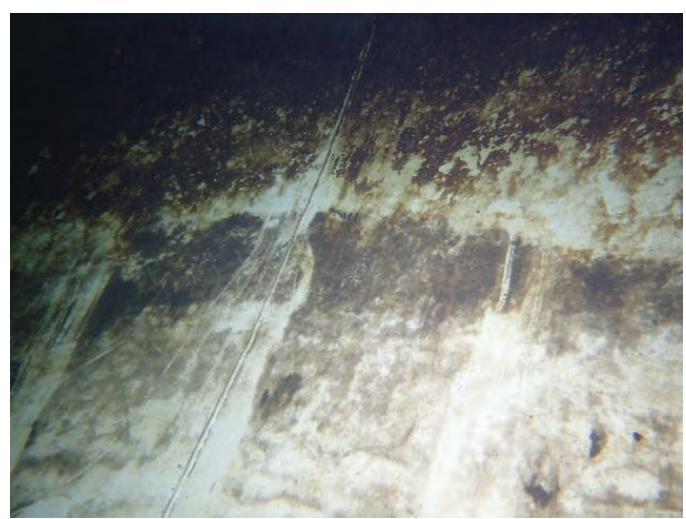
Interior Wall With Heavy Staining118

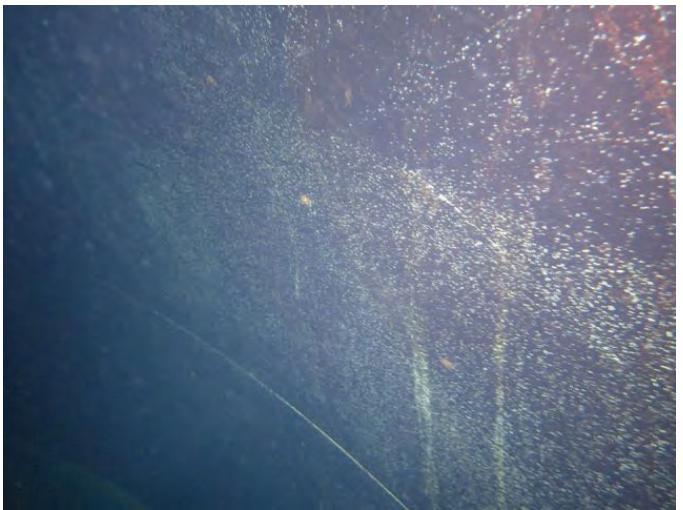
119 Interior Wall With Heavy Staining

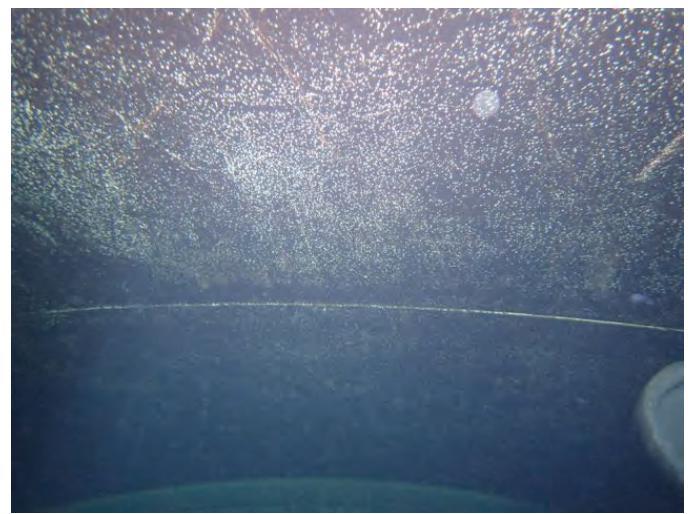
120 Interior Wall With Heavy Staining

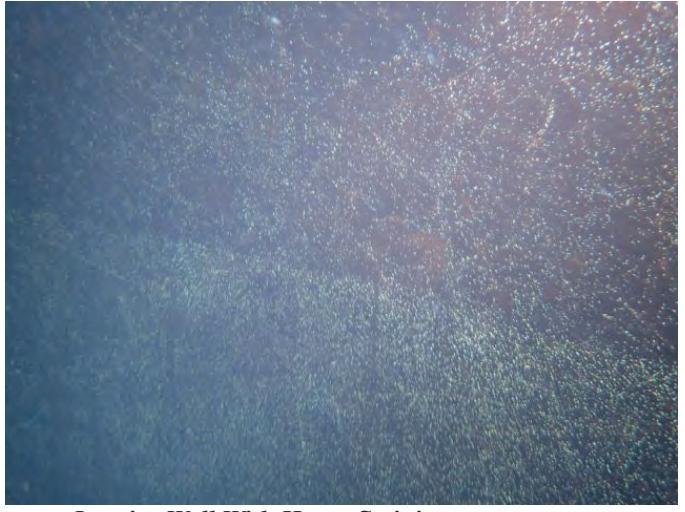
121 *Interior Wall With Heavy Staining*

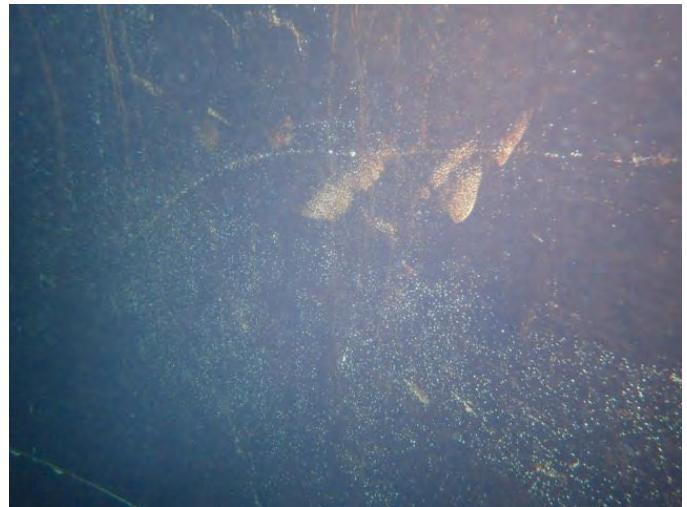
Interior Wall With Heavy Staining

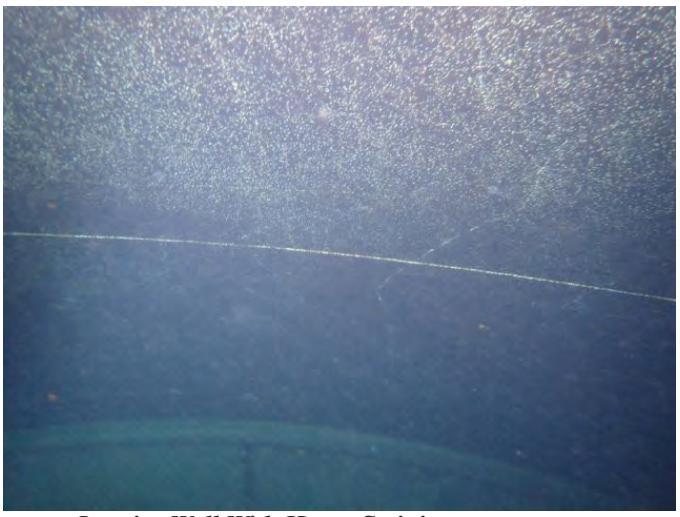
123 Interior Wall With Heavy Staining

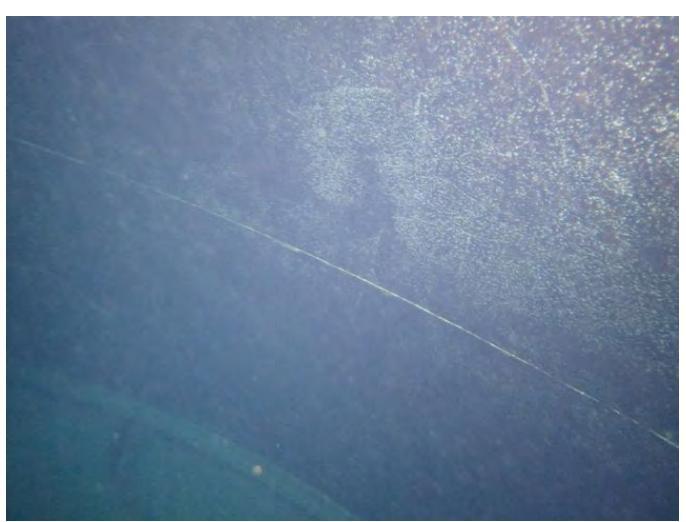
Interior Wall With Heavy Staining124

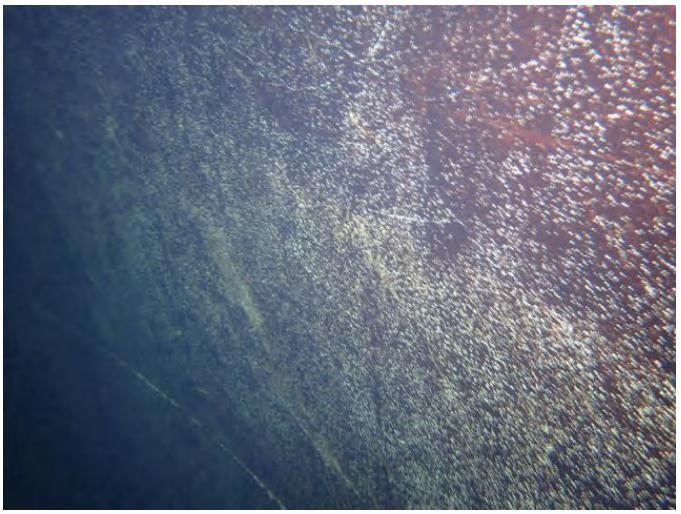
125 Interior Wall With Heavy Staining

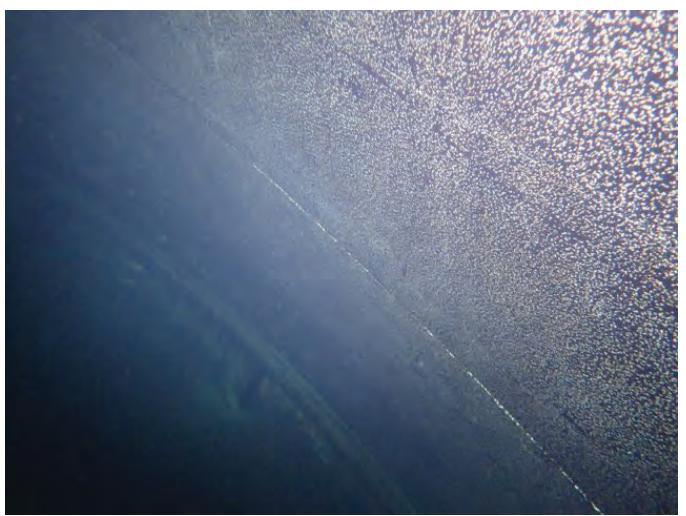
126 Interior Wall With Heavy Staining

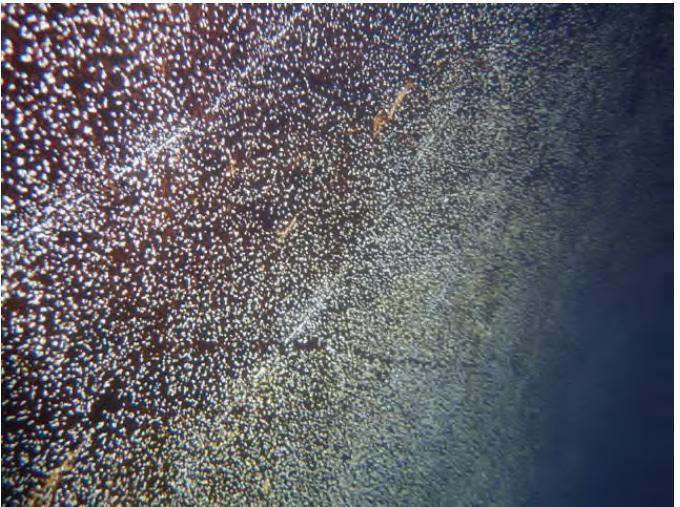
127 *Interior Wall With Heavy Staining*

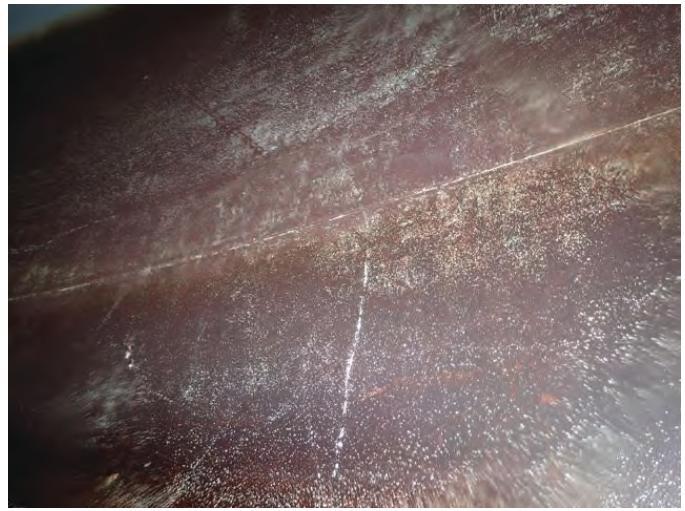
Interior Wall With Heavy Staining128

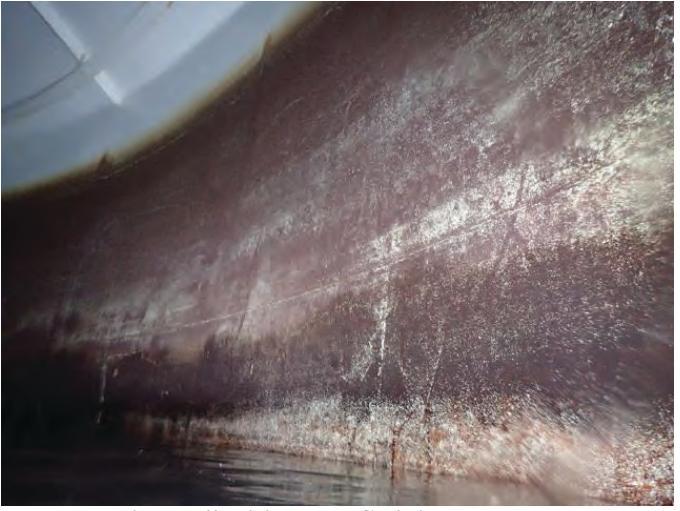
129 *Interior Wall With Heavy Staining*

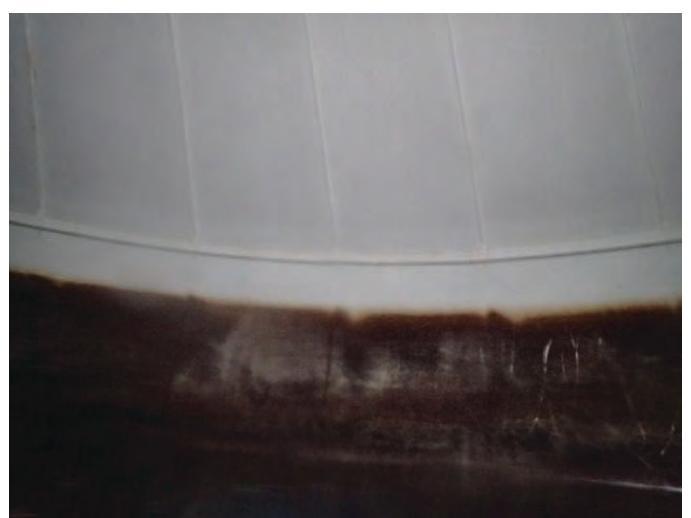
Interior Wall With Heavy Staining130

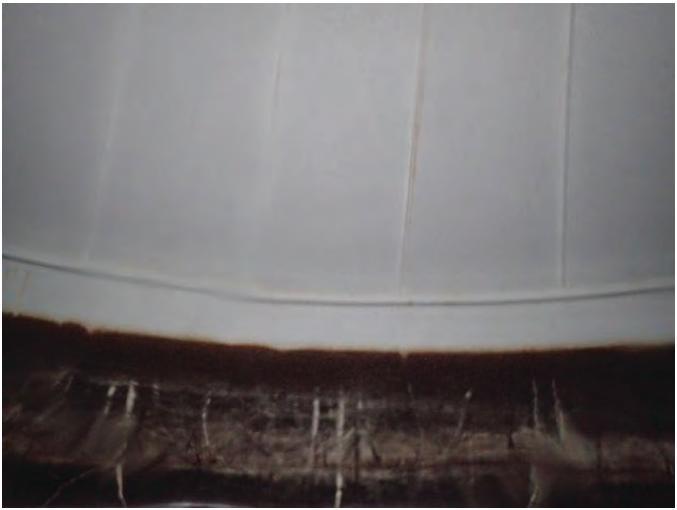
131 Interior Wall With Heavy Staining

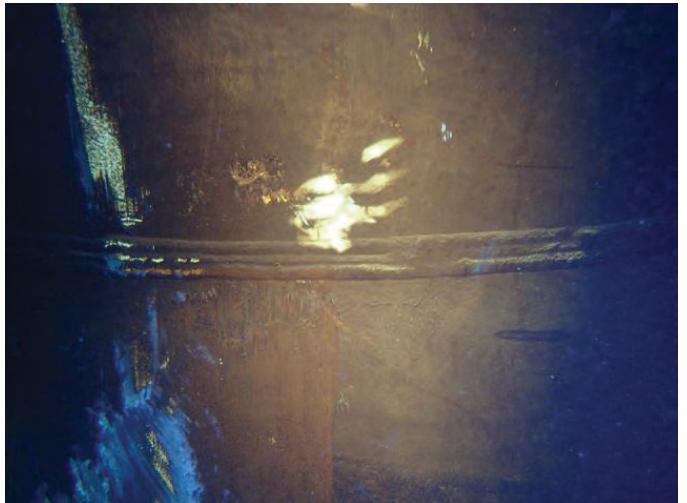
Center Riser Column With Heavy Staining

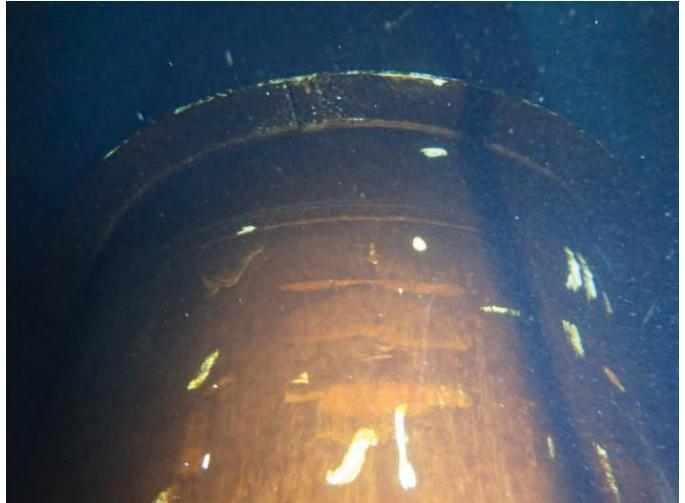
Center Riser Column With Heavy Staining

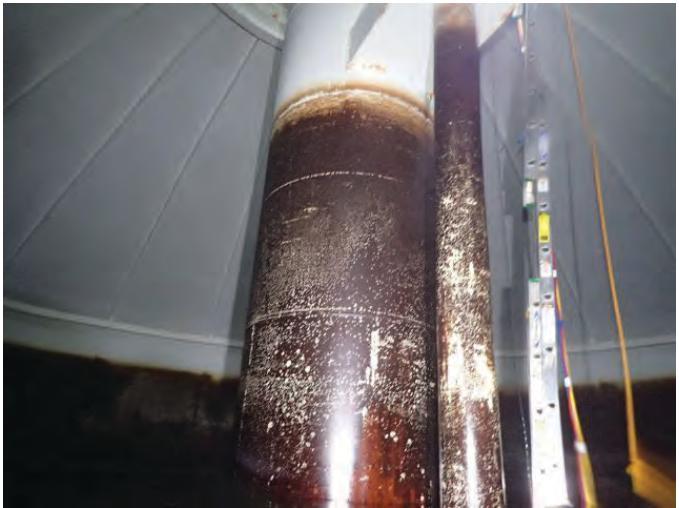
135 *Center Riser Column With Heavy Staining*

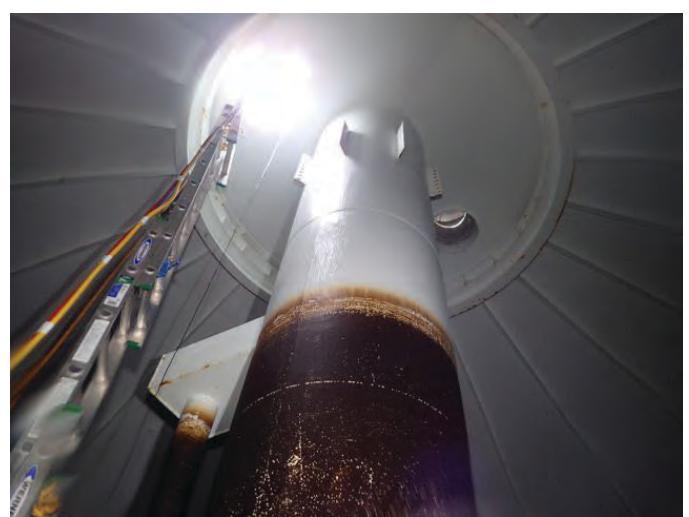
Center Riser Column With Heavy Staining

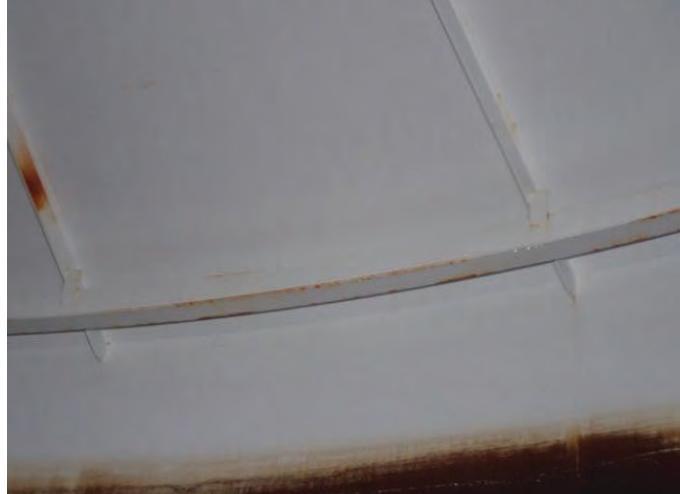
Overhead With Steel Supports Having Mild Surface 140 Corrosion (Blotch Rusting)

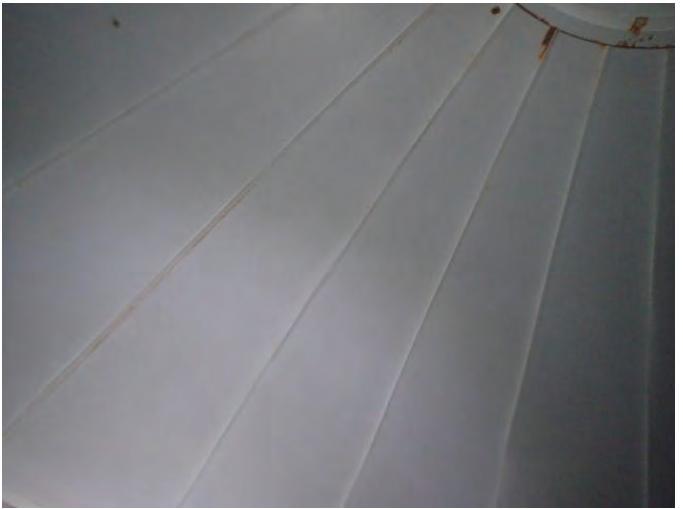
Overhead With Steel Supports Having Mild Surface141Corrosion (Blotch Rusting)

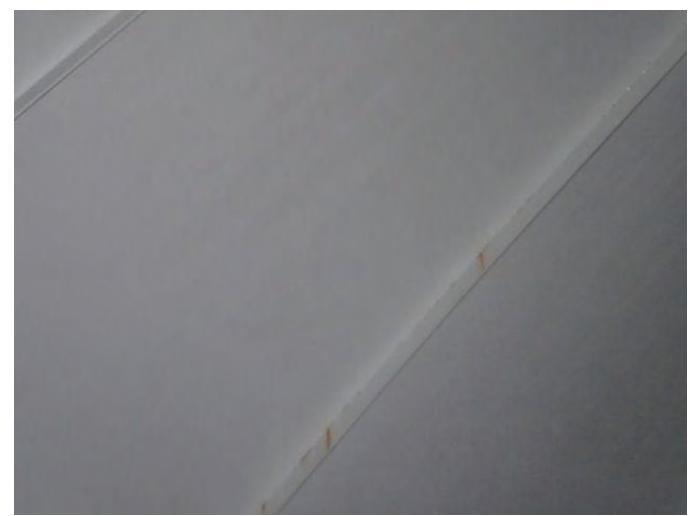
Overhead With Steel Supports Having Mild Surface142Corrosion (Blotch Rusting)

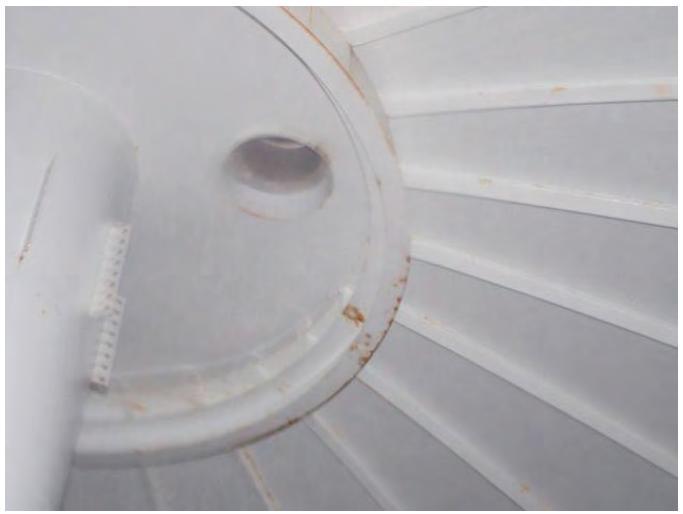
143 Overhead With Steel Supports Having Mild Surface Corrosion (Blotch Rusting)

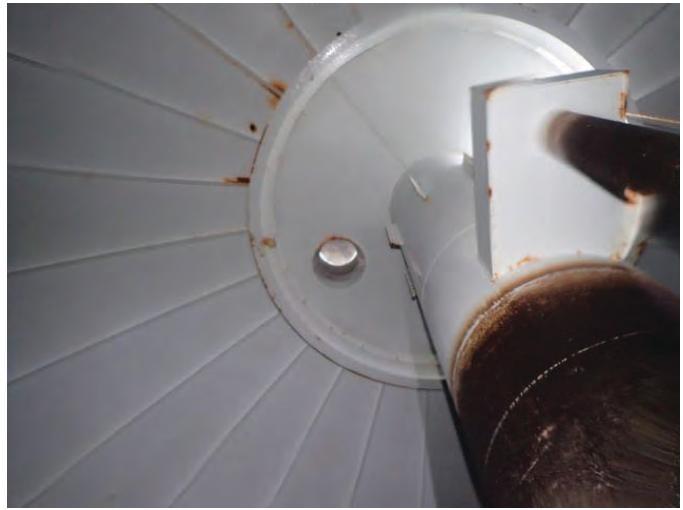
144Overhead With Steel Supports Having Mild Surface
Corrosion (Blotch Rusting)

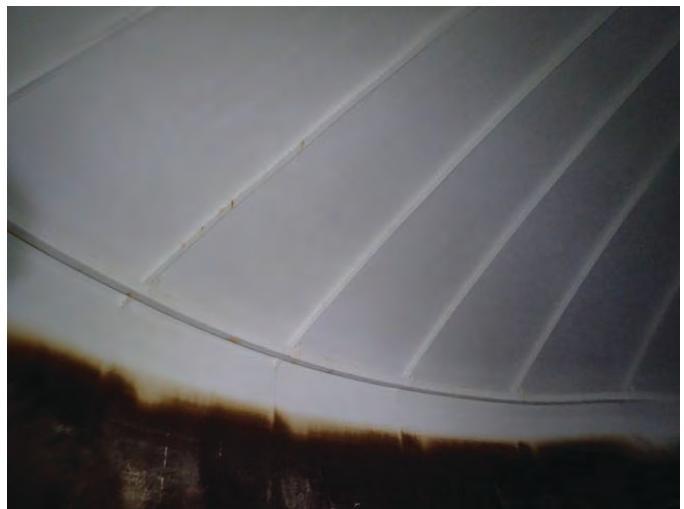
Overhead With Steel Supports Having Mild Surface 145 Corrosion (Blotch Rusting)

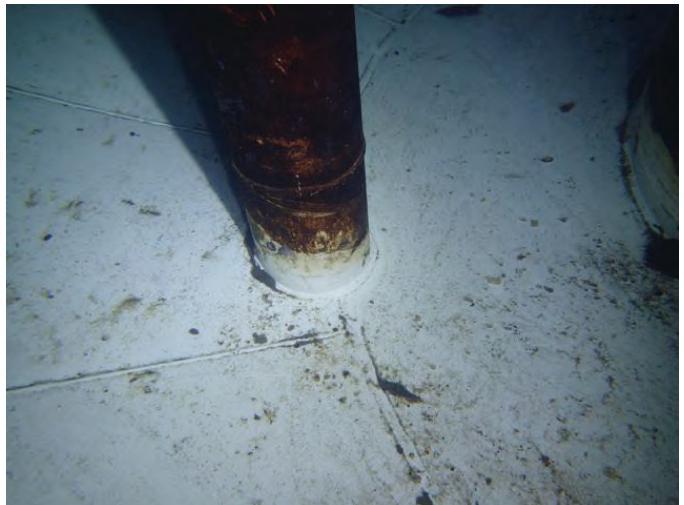
Overflow Pipe Penetrating The Tank Floor 146

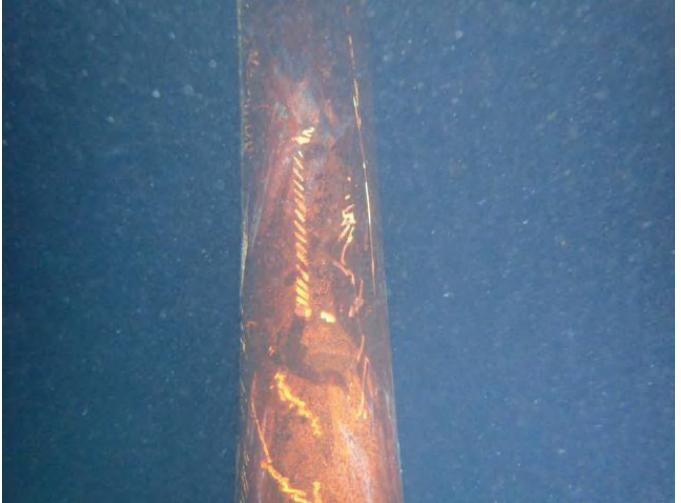
147 Overflow Pipe With Heavy Staining

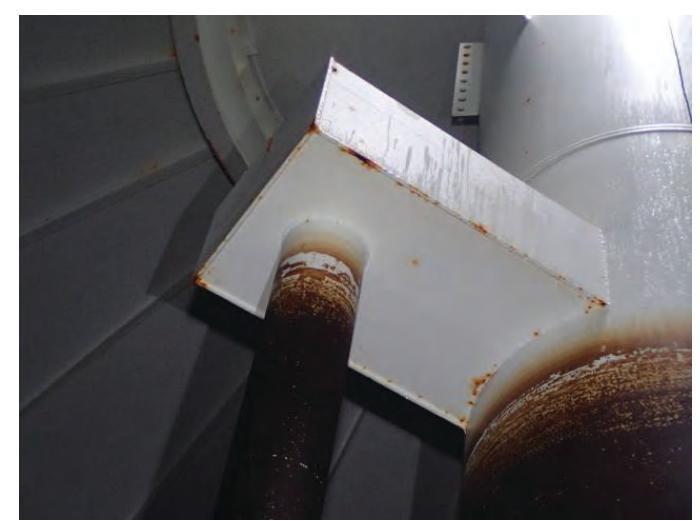
Overflow Pipe Weir Box With Coating Blisters,148Exposed Underlying Steel And Mild Corrosion

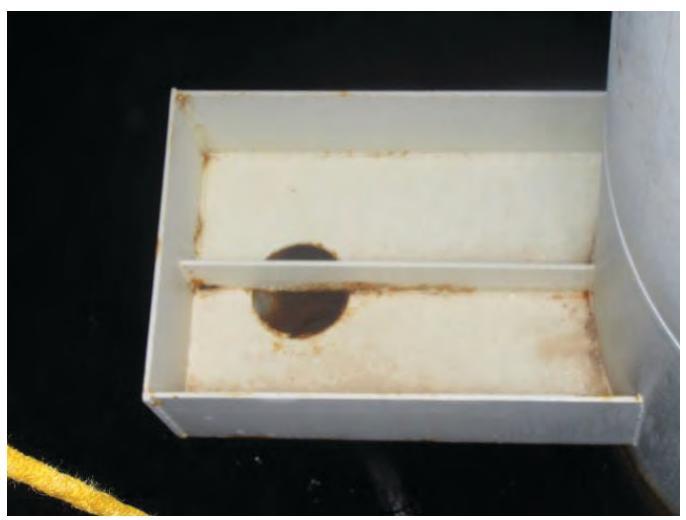
149 *Overflow Pipe Weir Box With Coating Blisters, Exposed Underlying Steel And Mild Corrosion*
