In re: City of Woonsocket Water Division - Application to Implement Multi-Year Rate Plan

Docket No. 4879

Dam Name (No):	Woonsocket Reservoir #3 Dam (068)
Location:	Smithfield/North Smithfield
Hazard Classification:	High
	-
Inspector:	David M. Matheson, P.E.
Inspection Date.	August 1, 2014

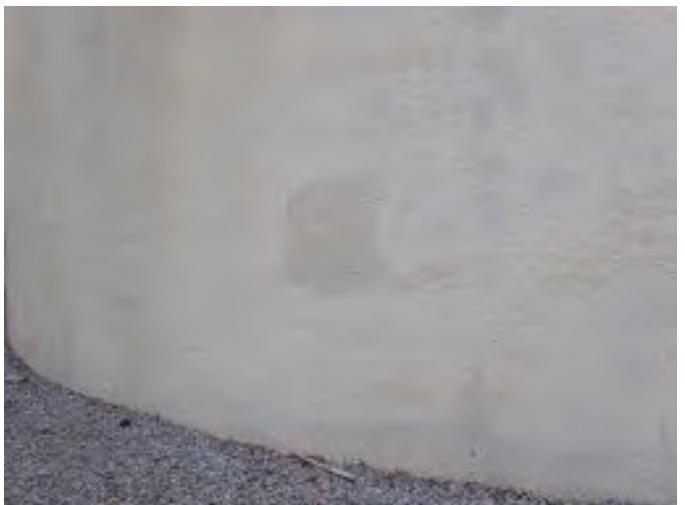
The exterior shotcrete coated concrete walls were inspected and found appearing mostly sound, however tight shrinkage cracks were found throughout approximately 5-10% of these surfaces and were observed throughout all elevations of the exterior walls.

Efflorescence has accumulated within less than 25% of these cracks due to moisture penetration.

Exterior Wall With Tight Shrinkage Cracks,1Efflorescence And Mild Mildew

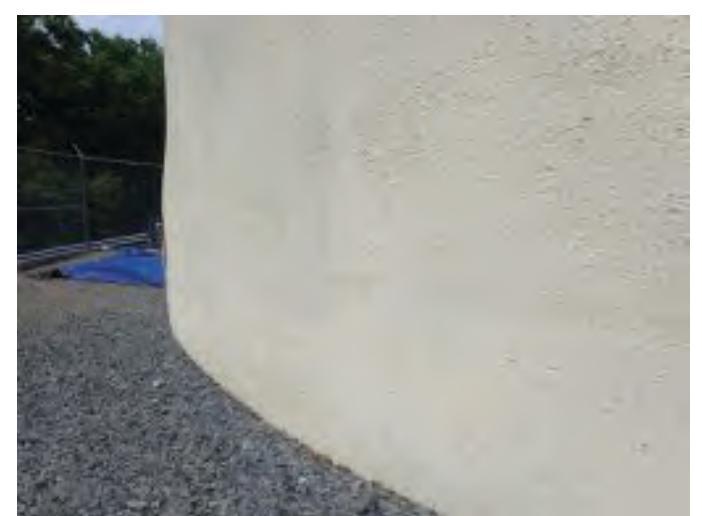
3 Exterior Wall With Tight Shrinkage Cracks, Efflorescence And Mild Mildew

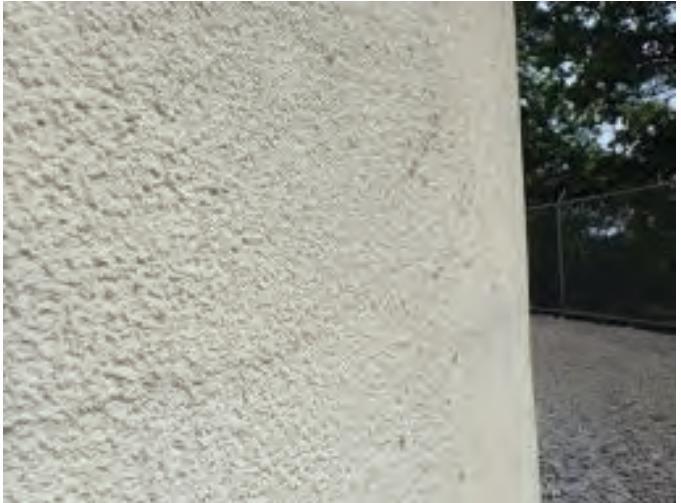
4 Exterior Wall With Tight Shrinkage Cracks, Efflorescence And Mild Mildew

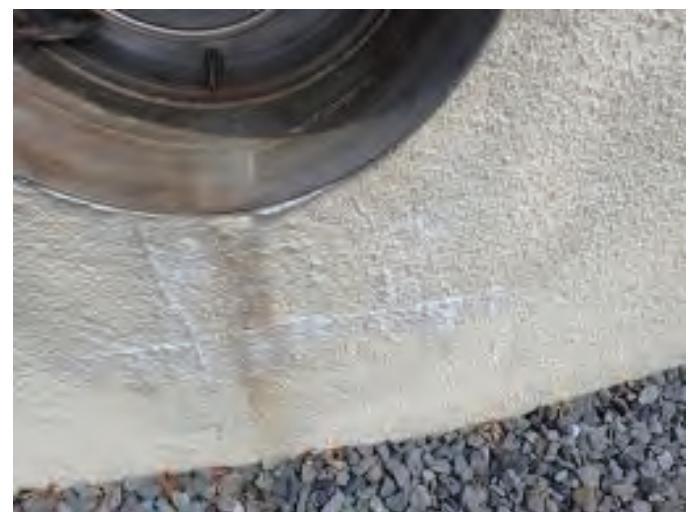
5 Exterior Wall With Tight Shrinkage Cracks, Efflorescence And Mild Mildew

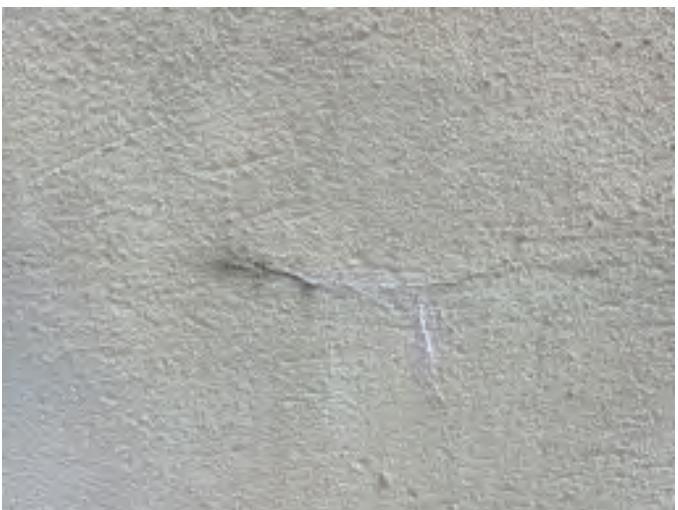
6 Exterior Wall With Tight Shrinkage Cracks, Efflorescence And Mild Mildew

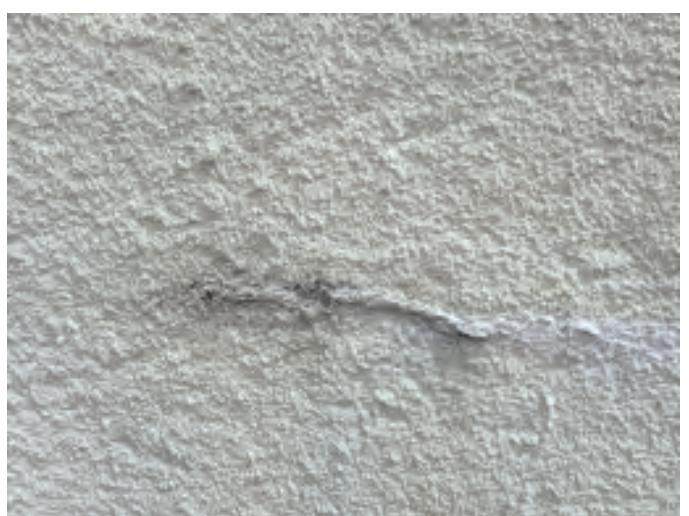
7 Exterior Wall With Tight Shrinkage Cracks, 7 Efflorescence And Mild Mildew

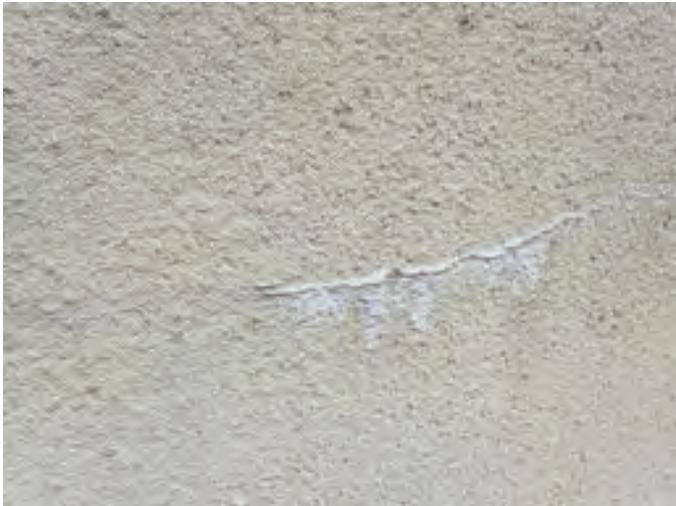
Exterior Wall With Tight Shrinkage Cracks, 8 Efflorescence And Mild Mildew

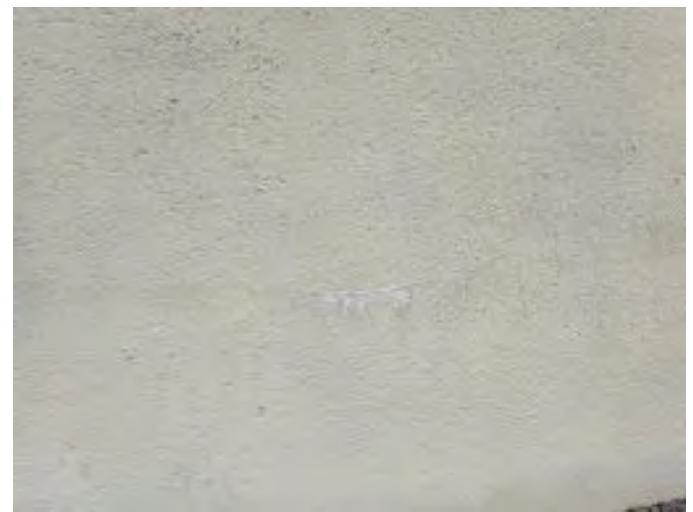
9 Exterior Wall With Tight Shrinkage Cracks, Efflorescence And Mild Mildew

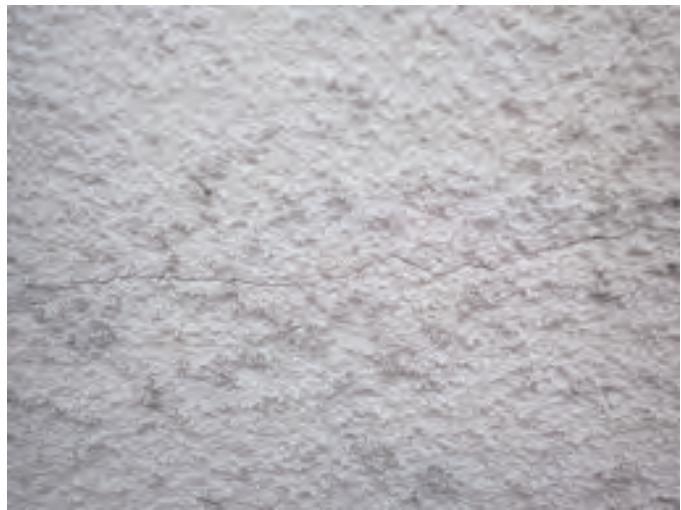
10 *Exterior Wall With Tight Shrinkage Cracks, Efflorescence And Mild Mildew*

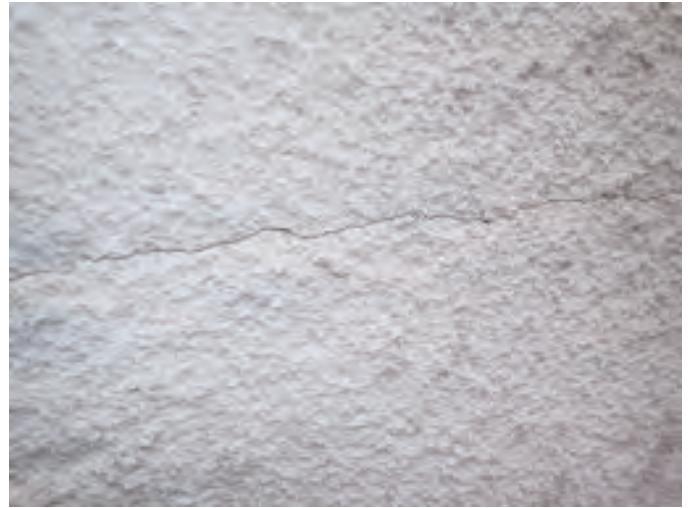
11 *Exterior Wall With Tight Shrinkage Cracks, Efflorescence And Mild Mildew*

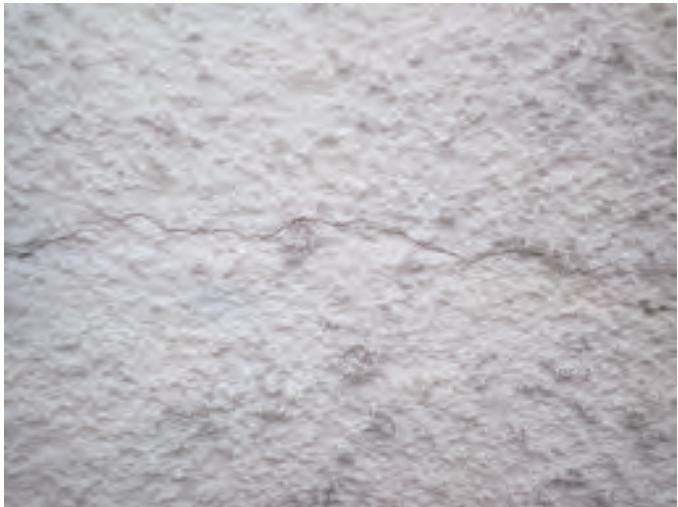
12 Exterior Wall With Tight Shrinkage Cracks, Efflorescence And Mild Mildew

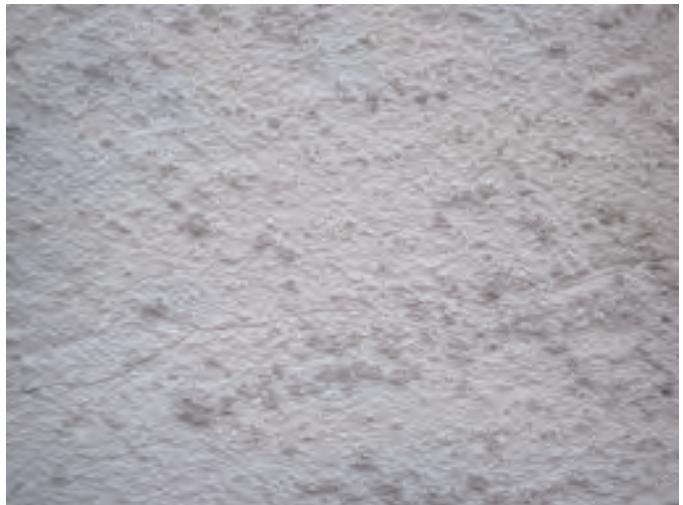
13 *Exterior Wall With Tight Shrinkage Cracks, Efflorescence And Mild Mildew*

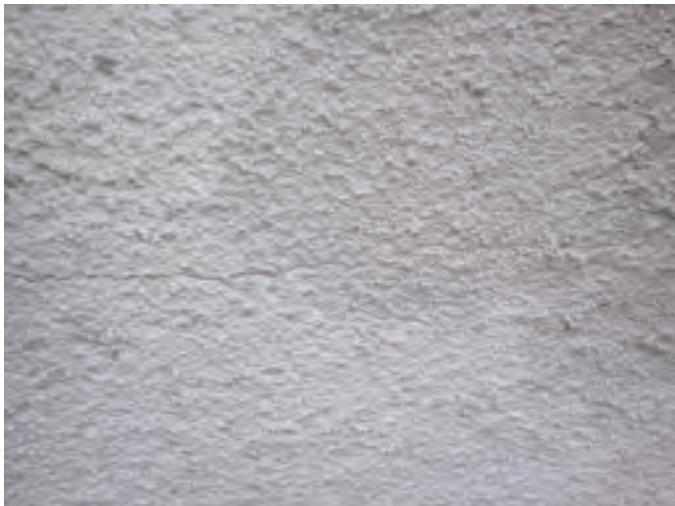
Exterior Wall With Tight Shrinkage Cracks, 14 Efflorescence And Mild Mildew

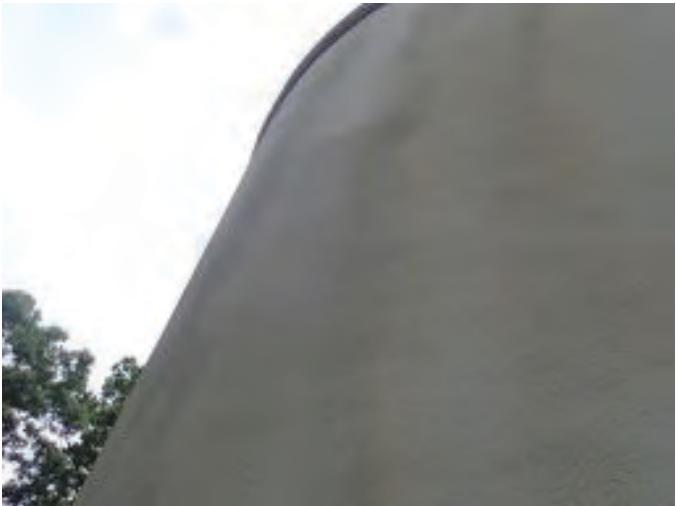
15 *Exterior Wall With Tight Shrinkage Cracks, Efflorescence And Mild Mildew*

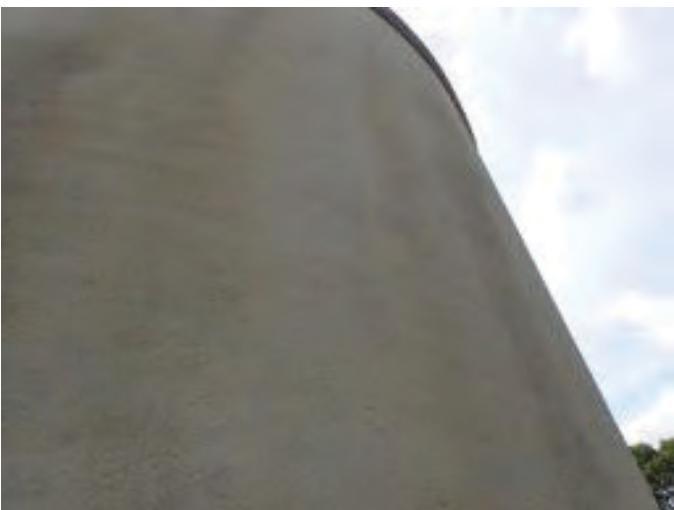
Exterior Wall With Mild Mildew 16

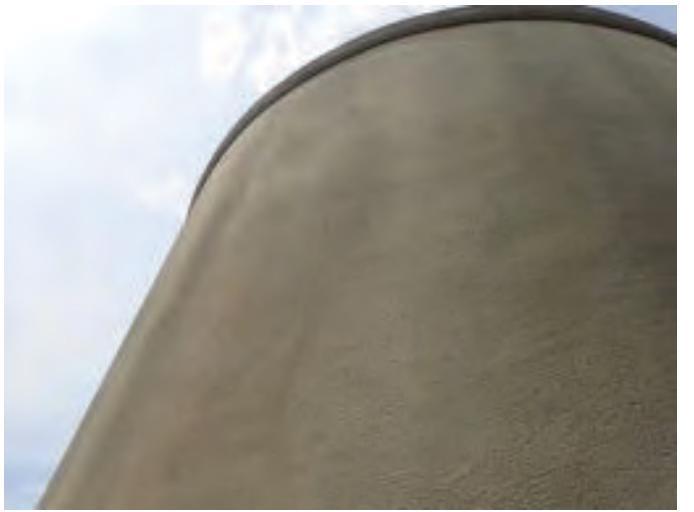
17 Exterior Wall With Mild Mildew

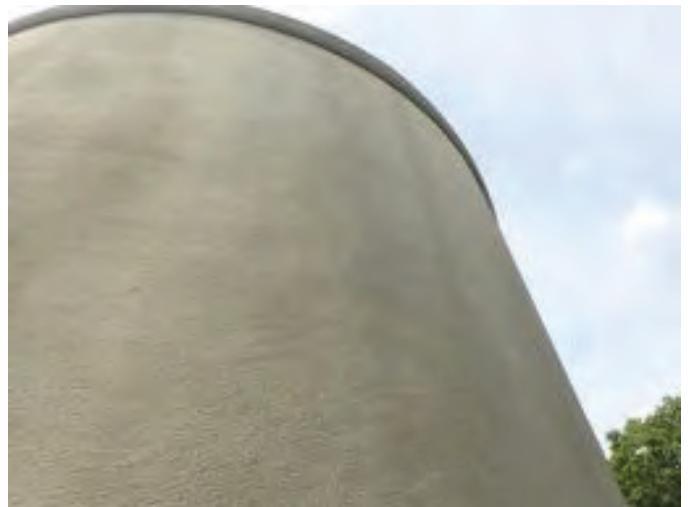
18 Exterior Wall With Mild Mildew

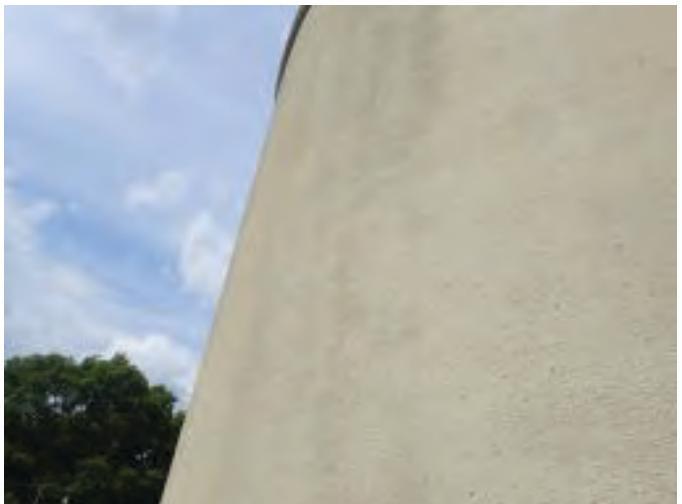
Exterior Wall With Mild Mildew

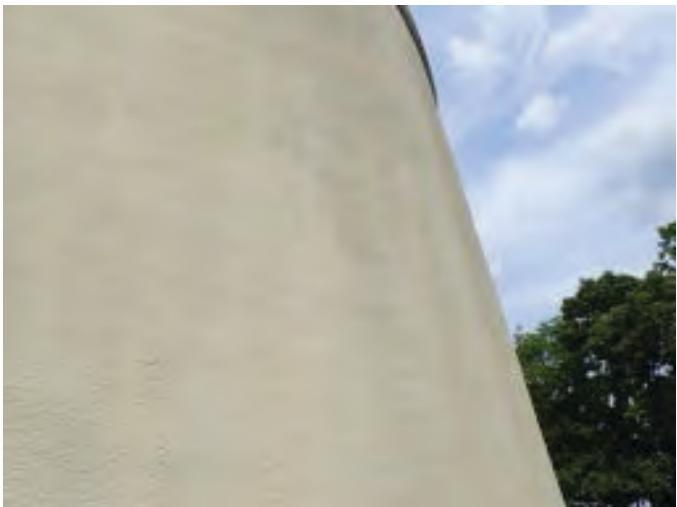
20 *Exterior Wall With Mild Mildew*

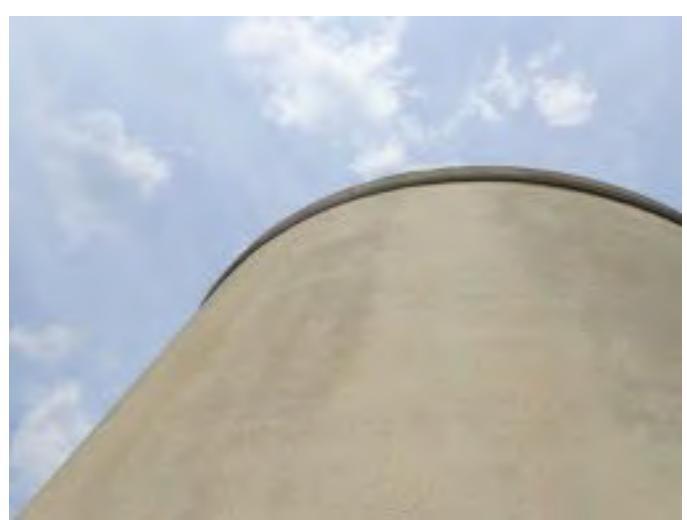
21 *Exterior Wall With Mild Mildew*

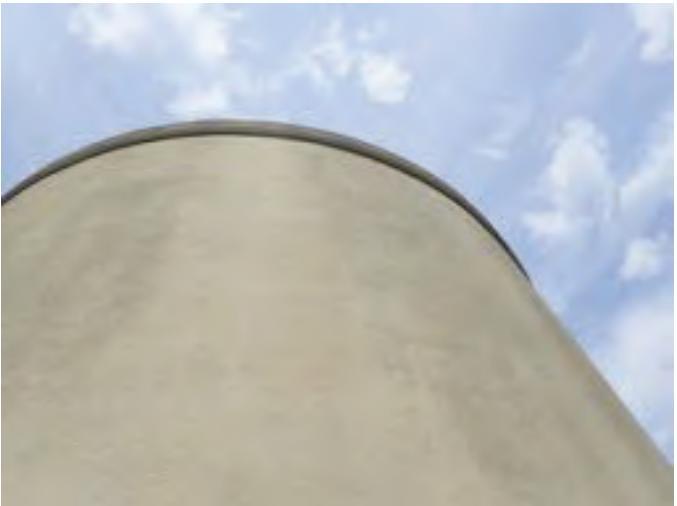
22 *Exterior Wall With Mild Mildew*

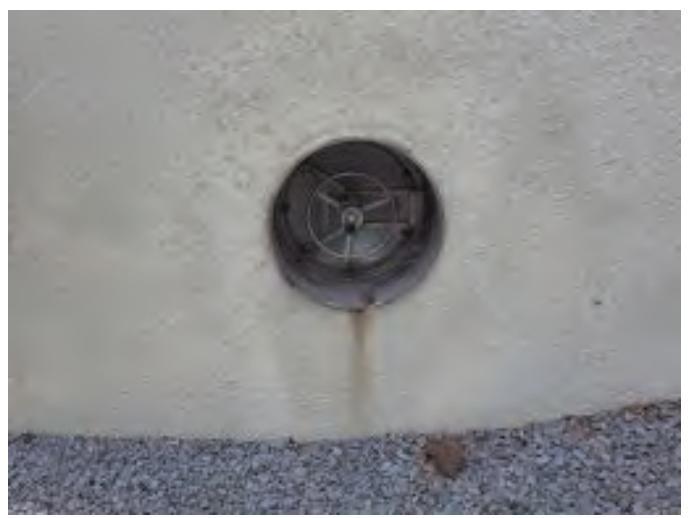
23 Exterior Wall With Mild Mildew

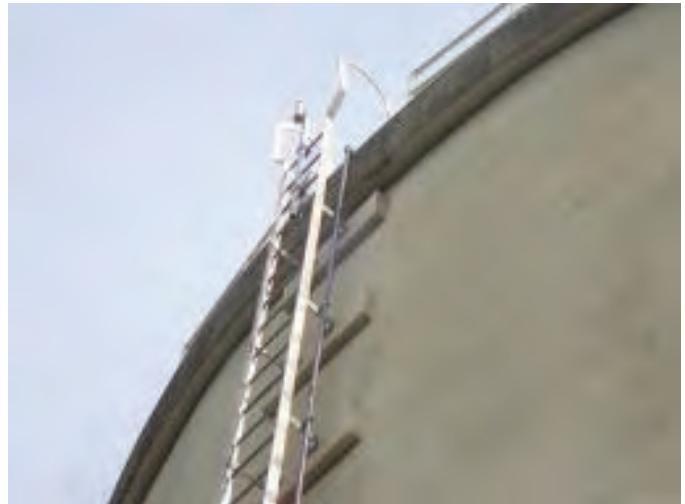
25 Secure Manway

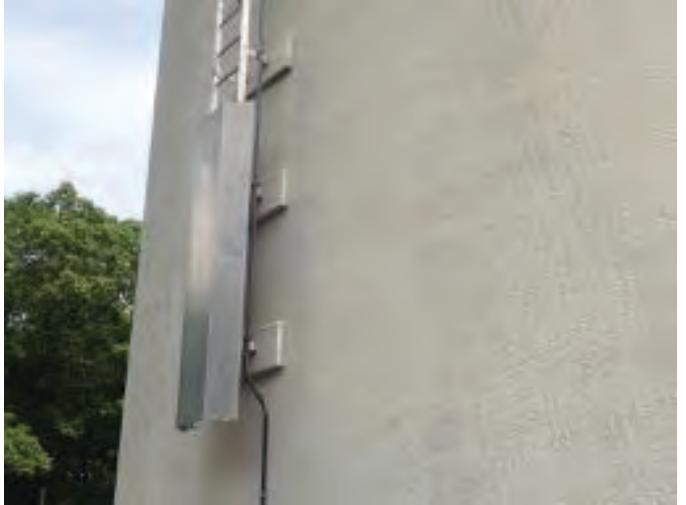
Ladder With A Fall Prevention Device

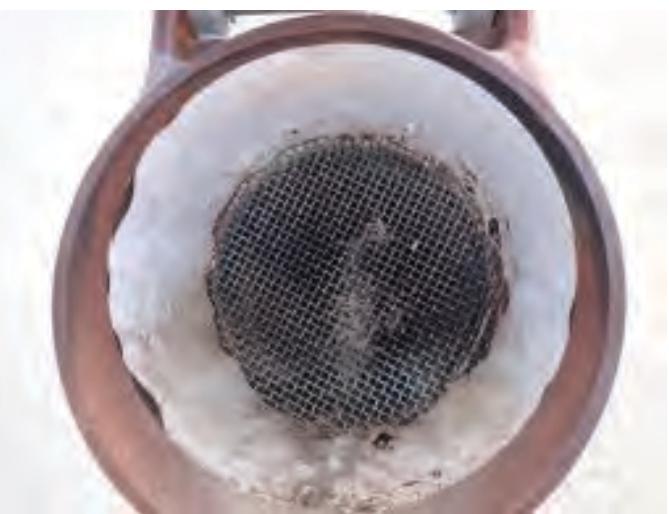
28 Overflow Pipe Having Coating Peeling, Exposed Primary Coating, Underlying Metal And Mild Corrosion With A Flap-Valve

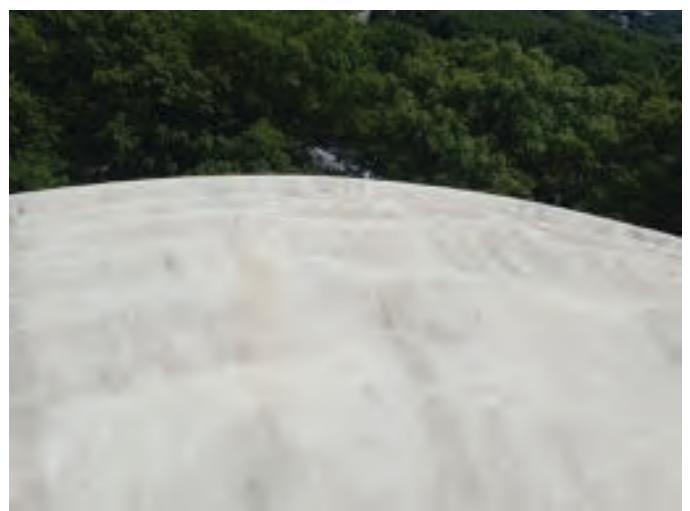
30 *Roof Panels With Tight Cracks Within The Concrete-Filled Joints And Mildew*

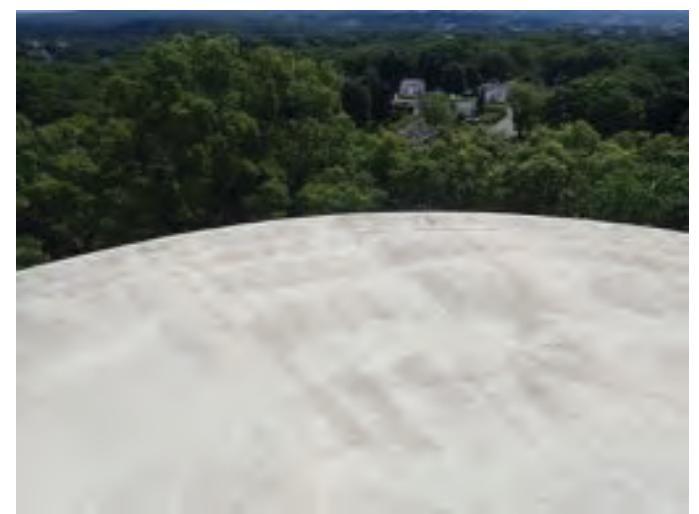
Roof Panels With Tight Cracks Within The31Concrete-Filled Joints And Mildew

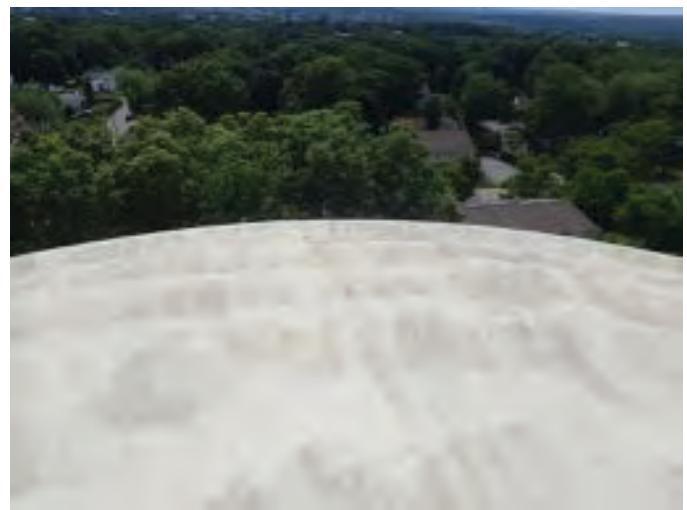
Roof Panels With Tight Cracks Within The32Concrete-Filled Joints And Mildew

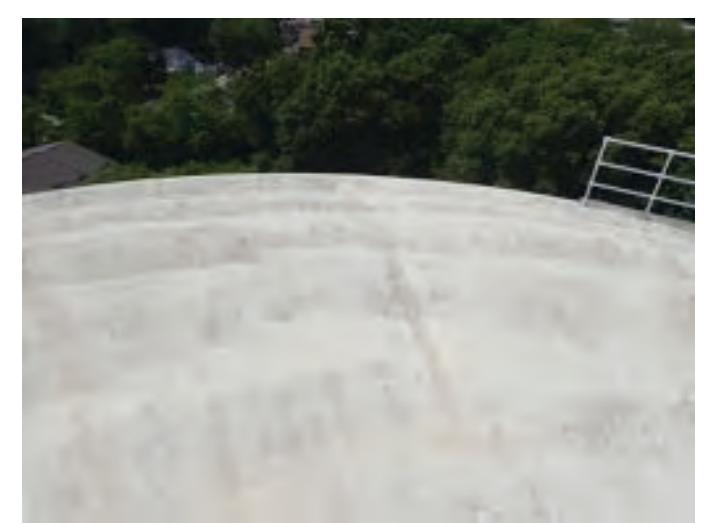
Roof Panels With Tight Cracks Within The
 Concrete-Filled Joints And Mildew

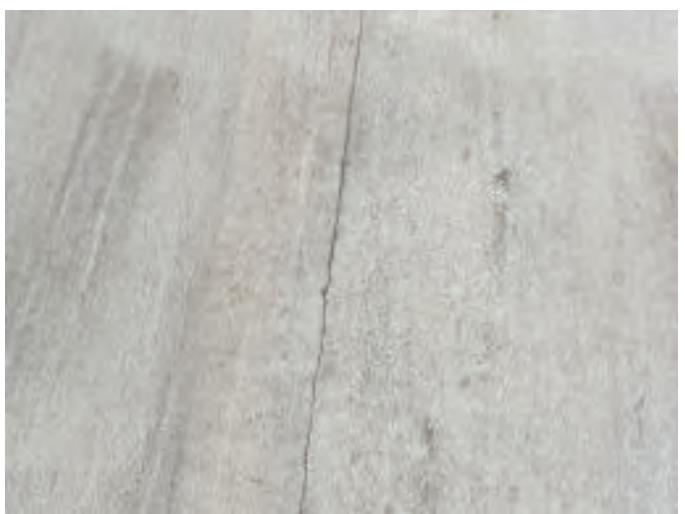
Roof Panels With Tight Cracks Within The34Concrete-Filled Joints And Mildew

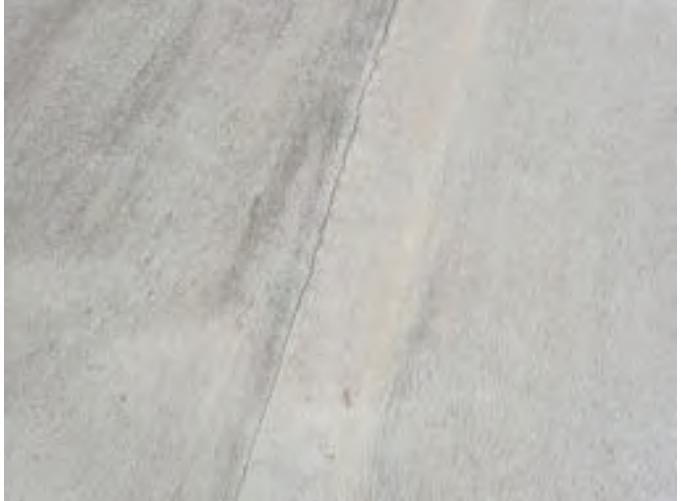
35 Roof Panels With Tight Cracks Within The Concrete-Filled Joints And Mildew

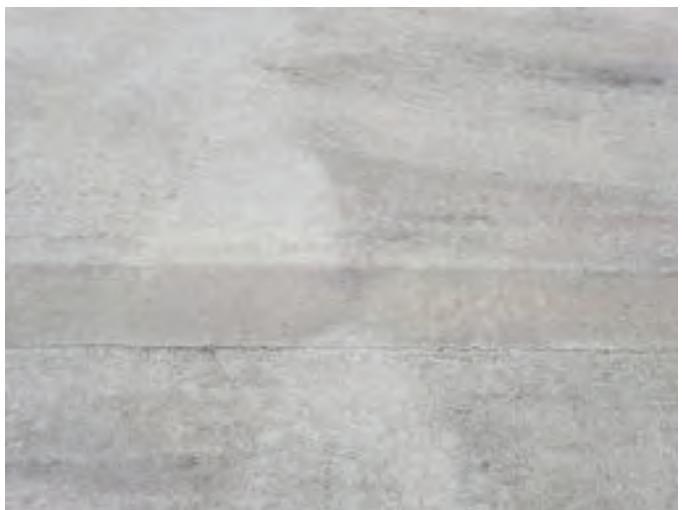
36 Roof Panels With Tight Cracks Within The Concrete-Filled Joints And Mildew

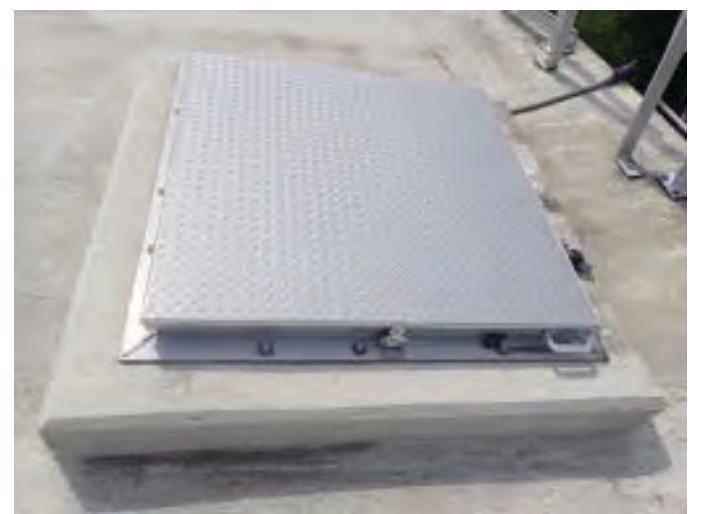
41 Open Access Hatch

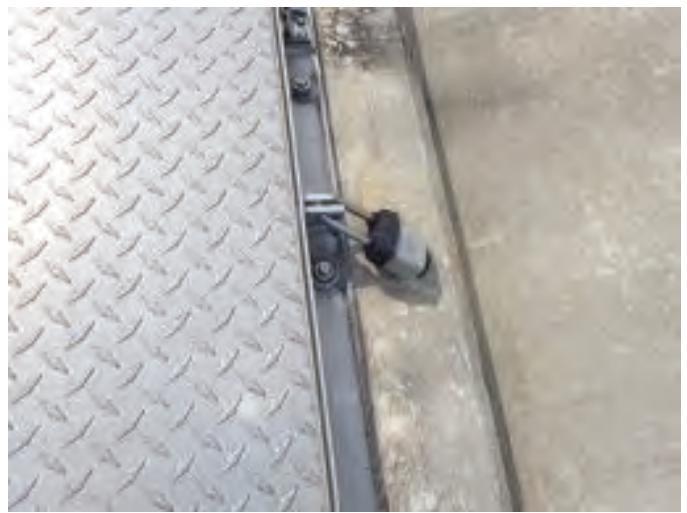
42 Closed Access Hatch

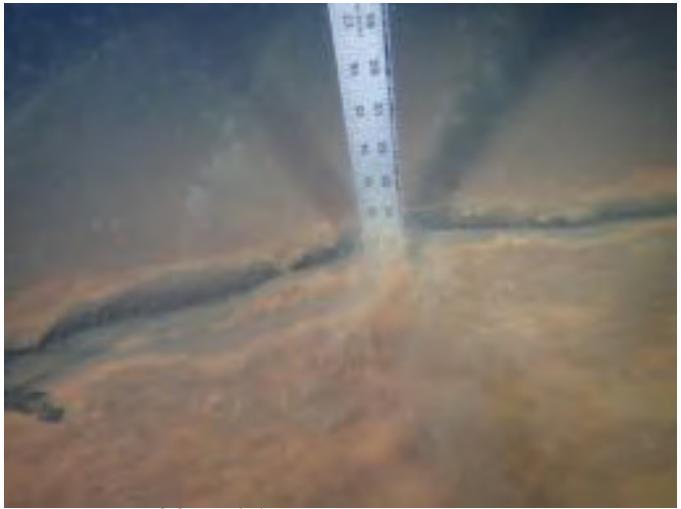
Layer Of Precipitate

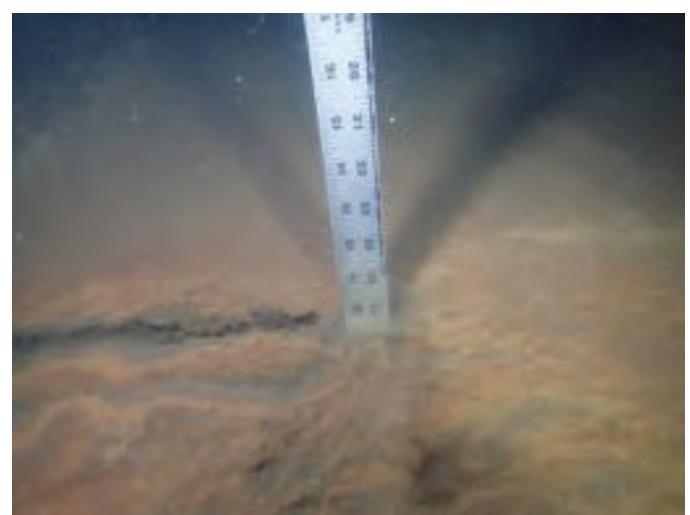
Layer Of Precipitate

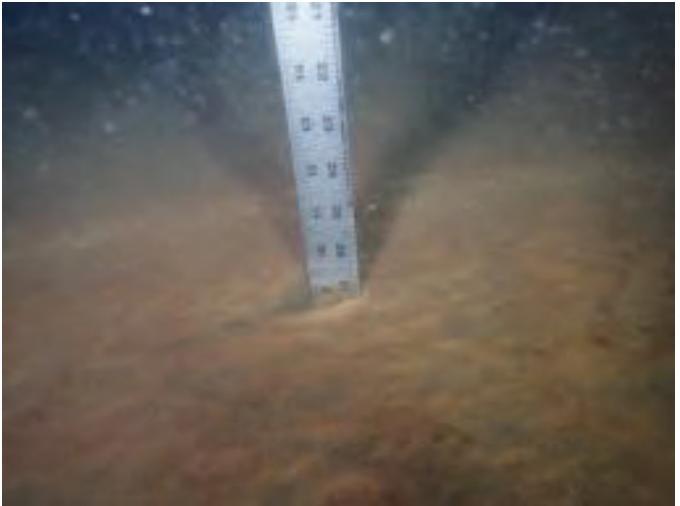
Layer Of Precipitate

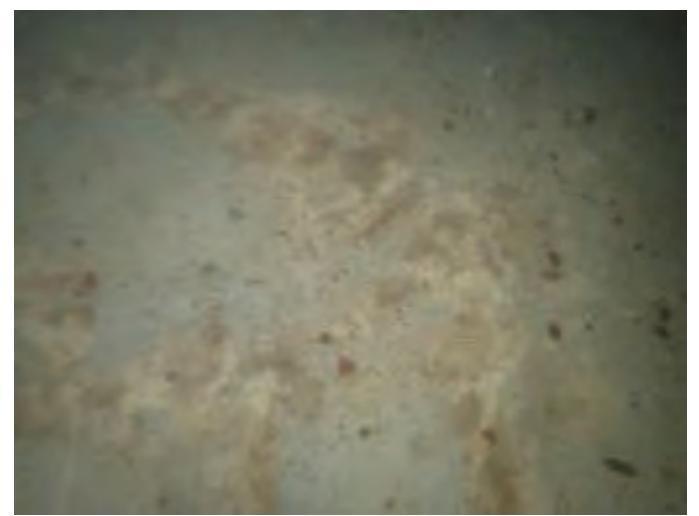
Layer Of Precipitate

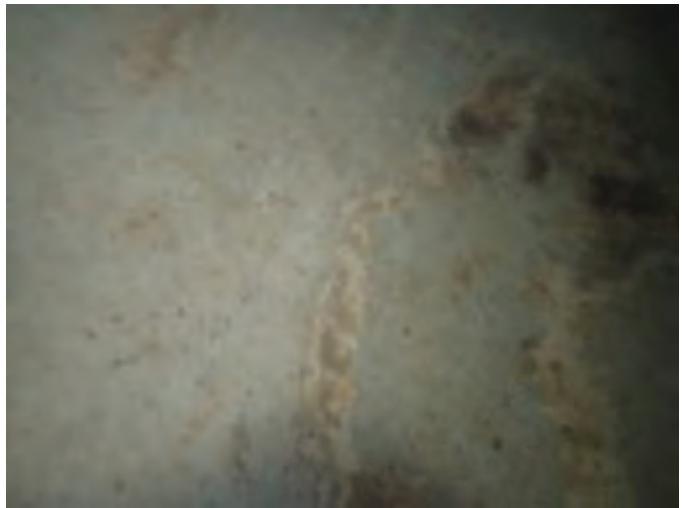
48 Floor With Mild Staining

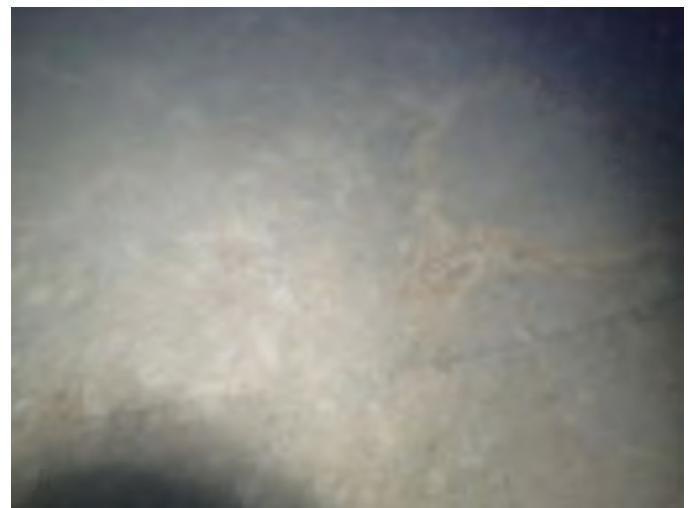
49 Floor With Mild Staining

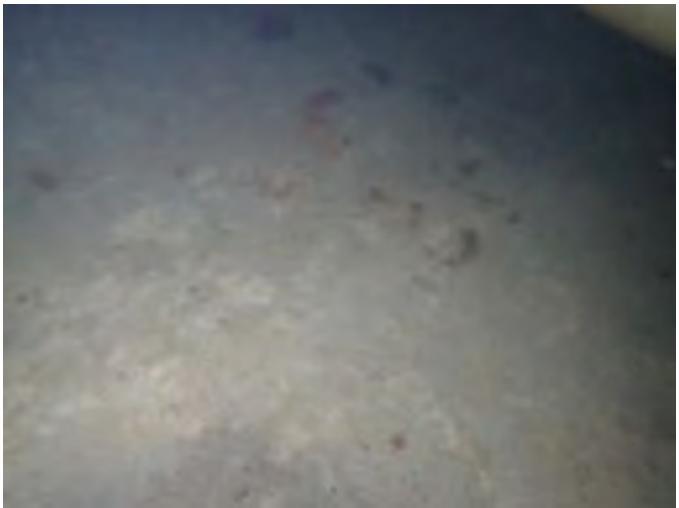
50 Floor With Mild Staining

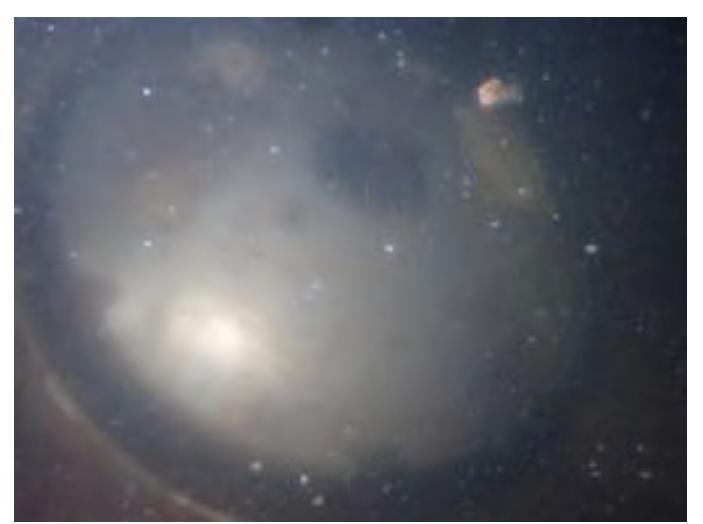
53 Floor With Mild Staining

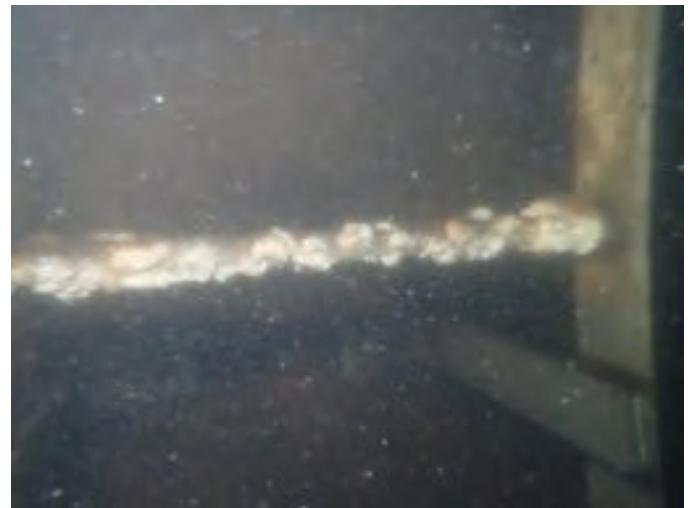
55Northernmost Manway Aluminum Access Ladder55With Fatigue (Pitting) And Mild Corrosion

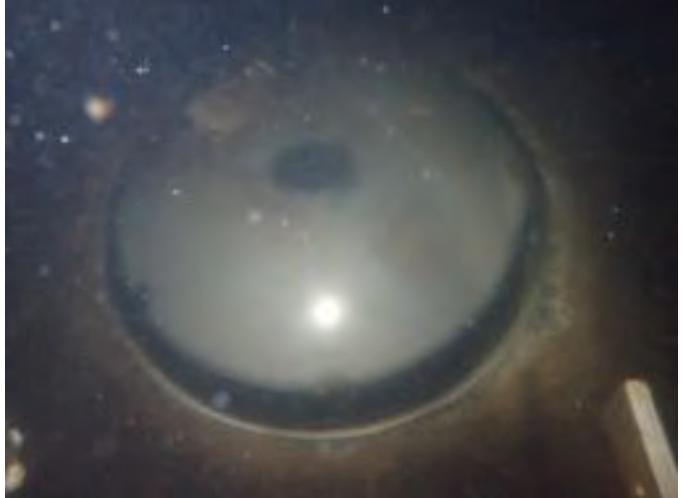
Northernmost Manway Aluminum Access Ladder 56 With Fatigue (Pitting) And Mild Corrosion

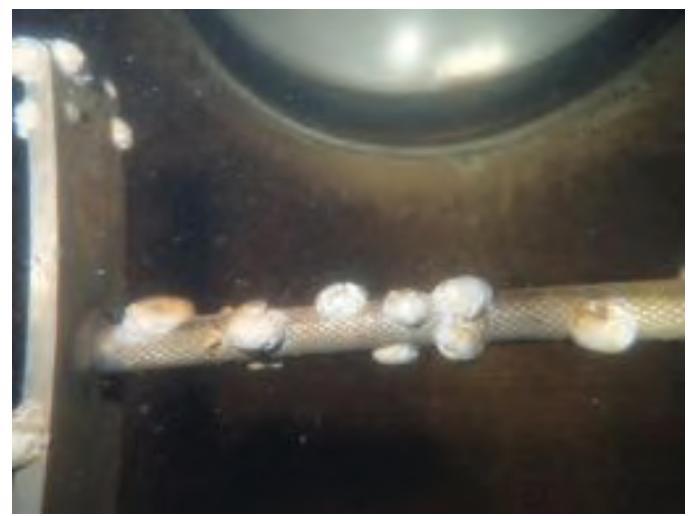
58 Southernmost Manway Aluminum Access Ladder With Fatigue (Pitting) And Mild Corrosion

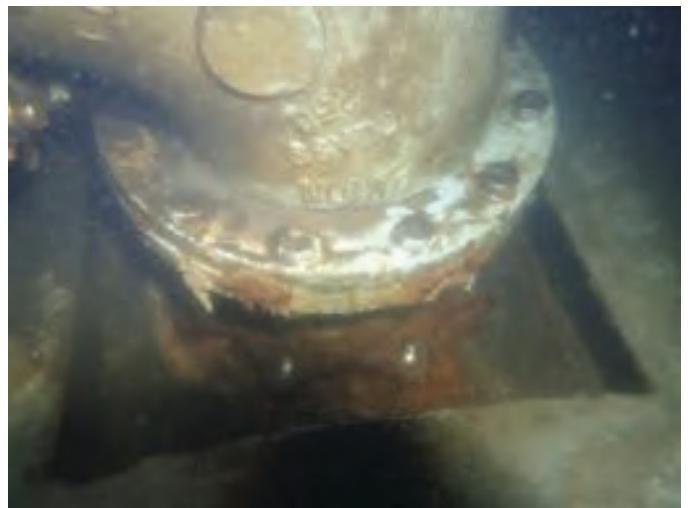
60 *10" Inside Diameter Pipe With Coating Loss, Exposed Metal, Fatigue (Pitting) And Corrosion*

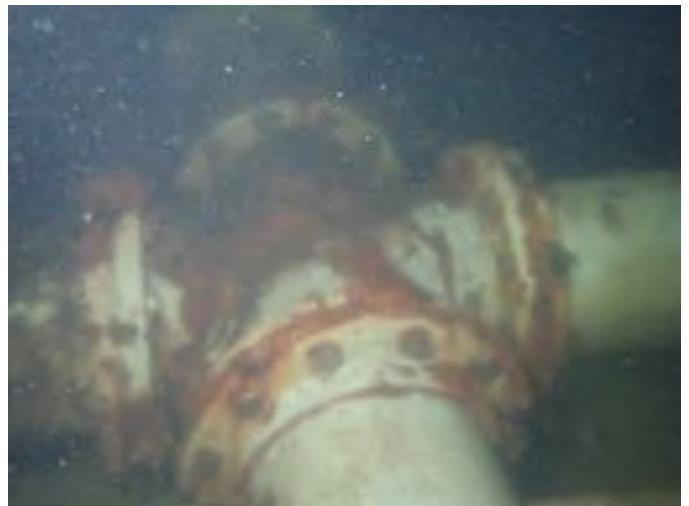
14" Inside Diameter Flush Penetration Within A61 Sump Floor

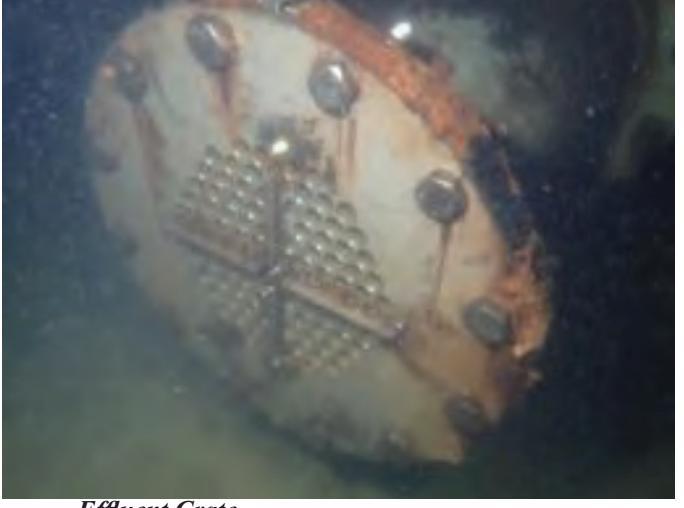
14" Inside Diameter Pipe With Coating Blisters,
62 Exposed Metal And Corrosion

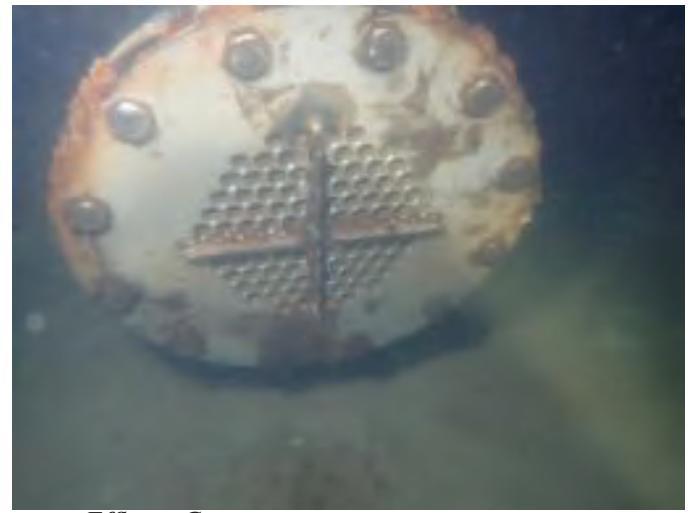
63 *Effluent Grate*

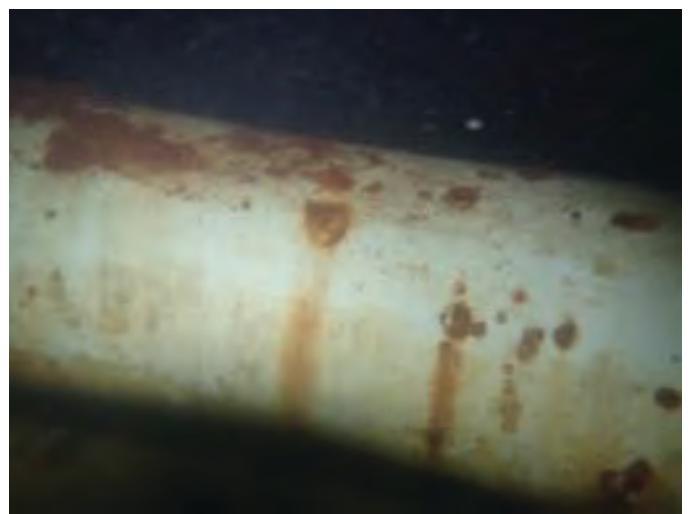
64 *Effluent Grate*

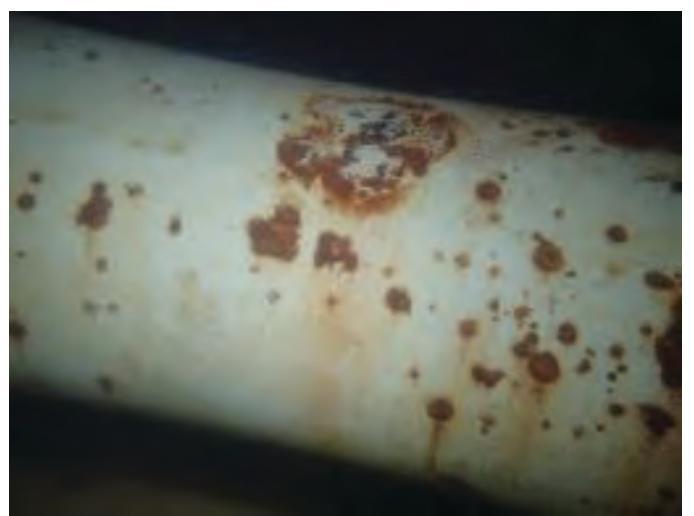
65 *14" Inside Diameter Pipe With Coating Blisters, Exposed Metal And Corrosion*

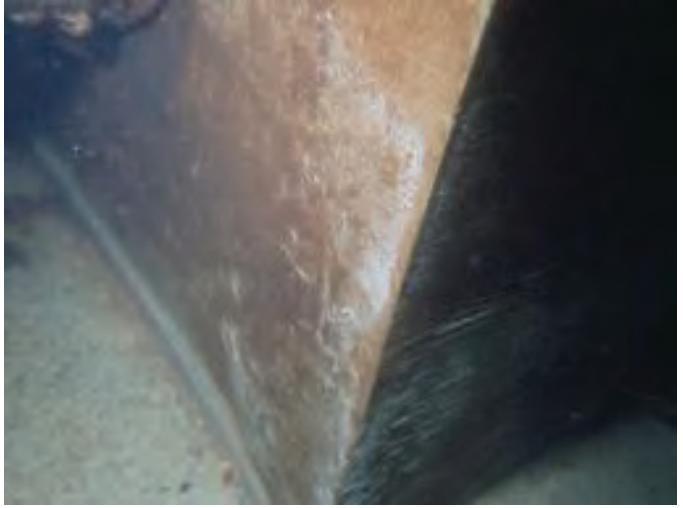
66 *14" Inside Diameter Pipe With Coating Blisters, Exposed Metal And Corrosion*

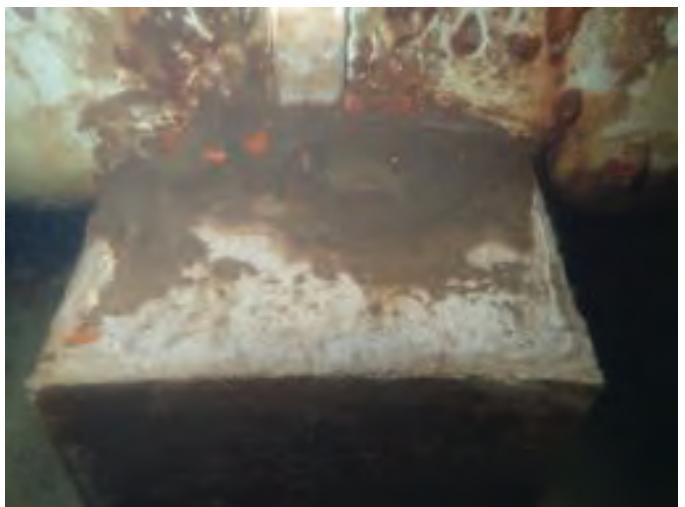
Concrete Pipe Support

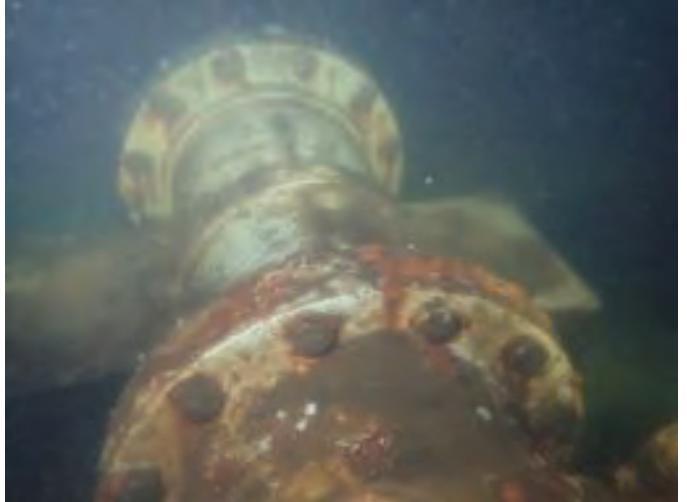
Concrete Pipe Support

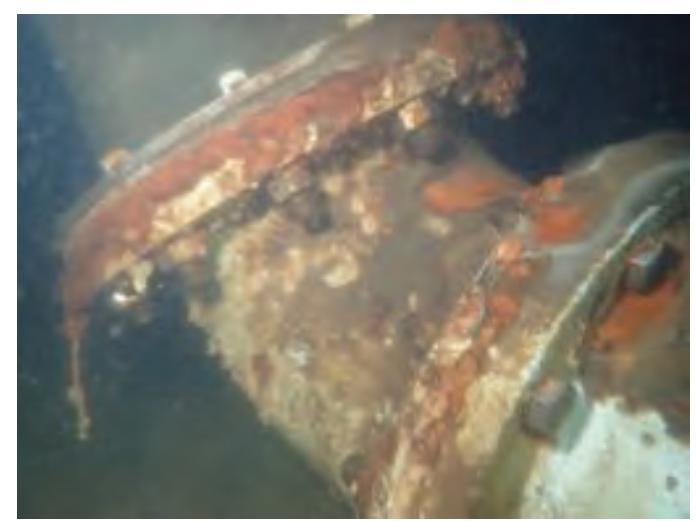
Concrete Pipe Support

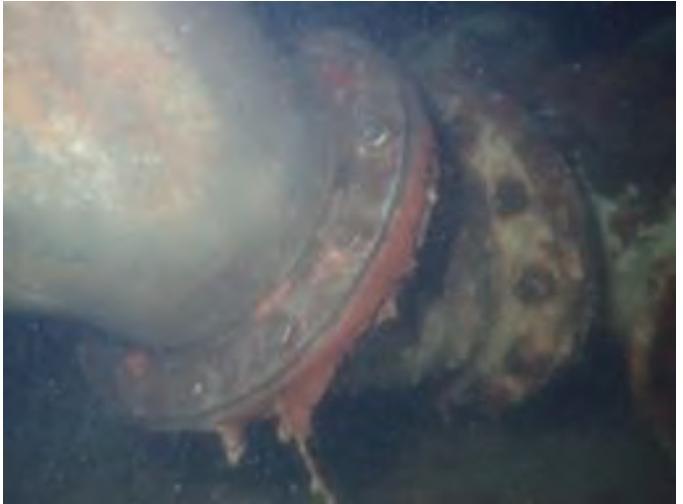
Concrete Pipe Support

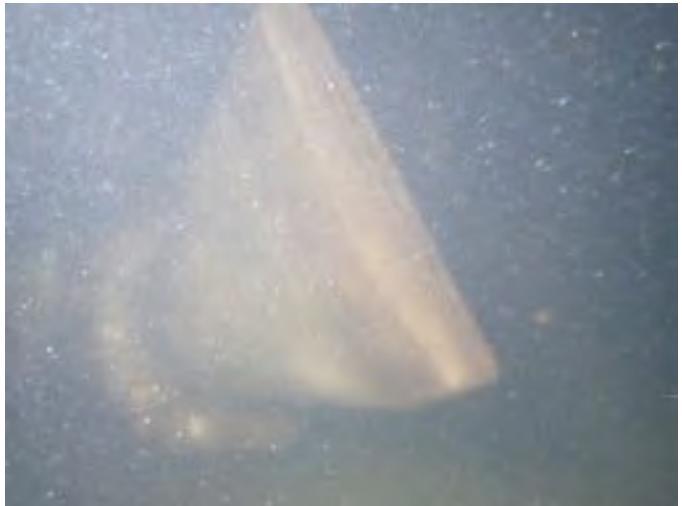
72 Influent Rubber Check Valve

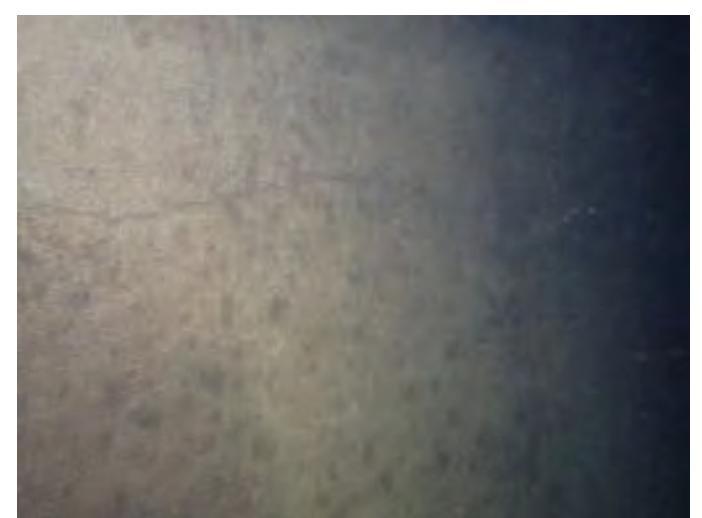
73 *Influent Rubber Check Valve*

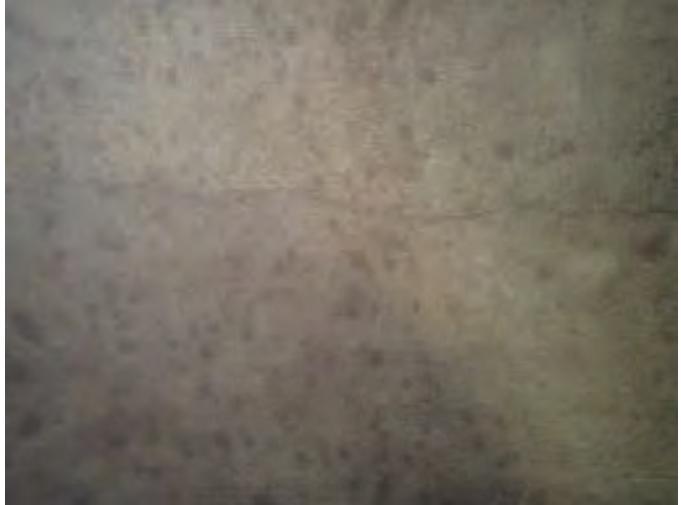
Interior Wall With Tight Surface Cracks And Heavy74Staining

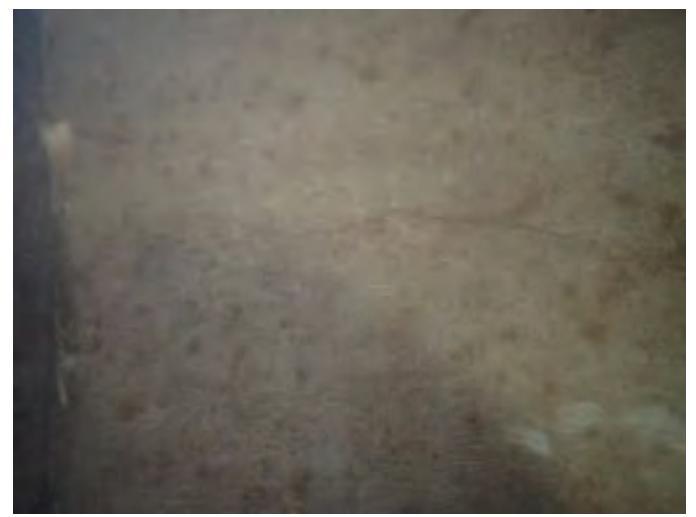
75 Interior Wall With Tight Surface Cracks And Heavy Staining

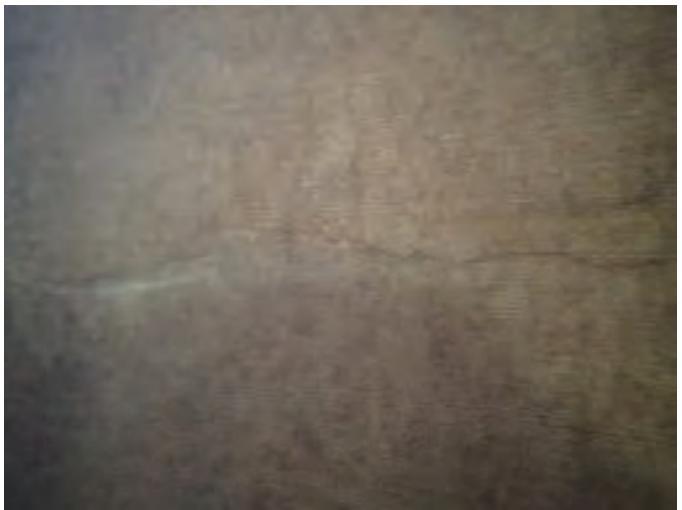
78 Interior Wall With Tight Surface Cracks And Heavy Staining

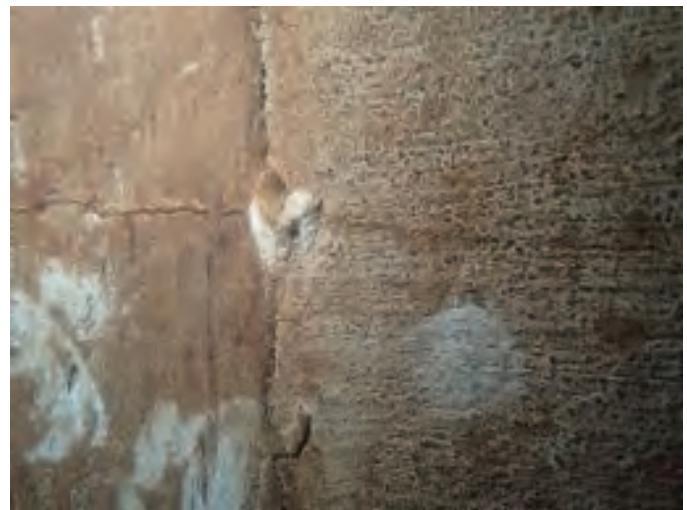
79 Interior Wall With Tight Surface Cracks And Heavy Staining

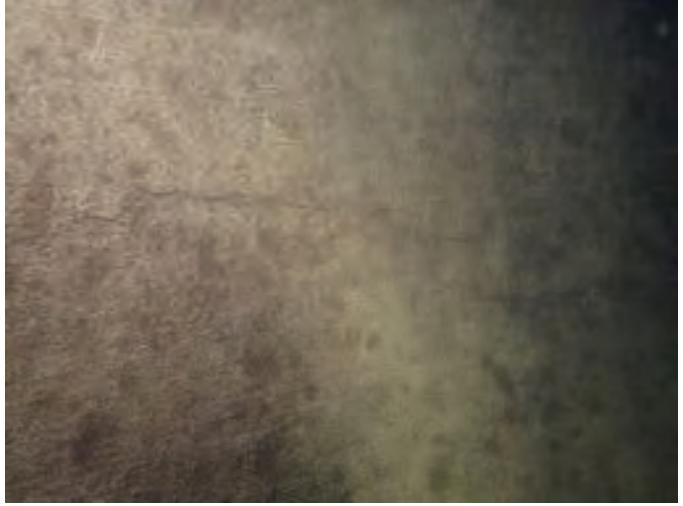
Interior Wall With Tight Surface Cracks And Heavy 80 Staining
