In re: City of Woonsocket Water Division - Application to Implement Multi-Year Rate Plan

Docket No. 4879

Dam Name (No):	Woonsocket Reservoir #3 Dam (068)
Location:	Smithfield/North Smithfield
Hazard Classification:	High
	-
Inspector:	David M. Matheson, P.E.
Inspection Date.	August 1, 2014

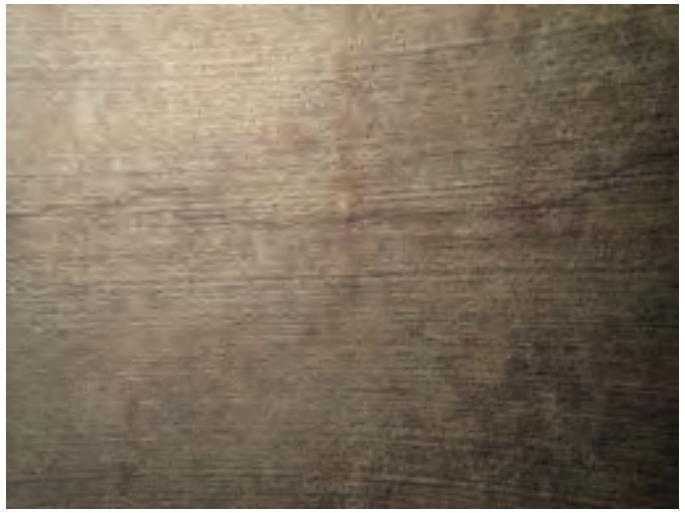
81 Interior Wall With Tight Surface Cracks And Heavy Staining

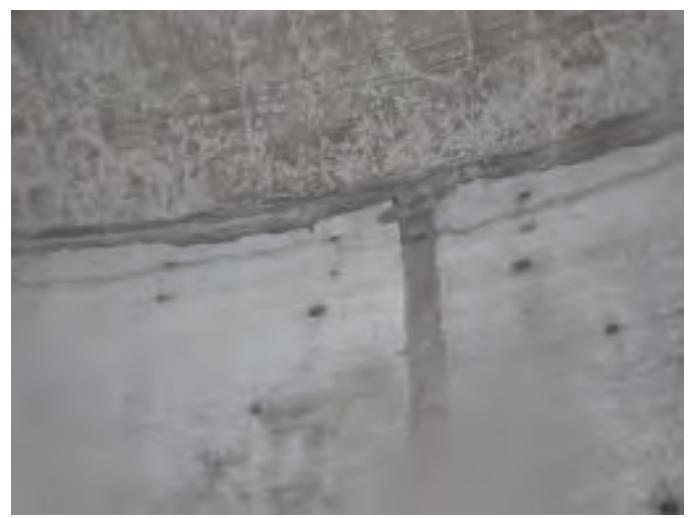
83 Interior Wall With Tight Cracks And Heavy Staining

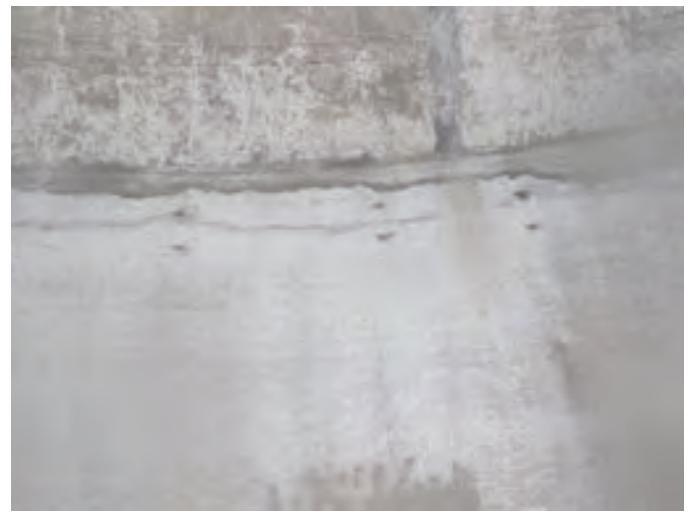
84 Interior Wall With Tight Cracks And Heavy Staining

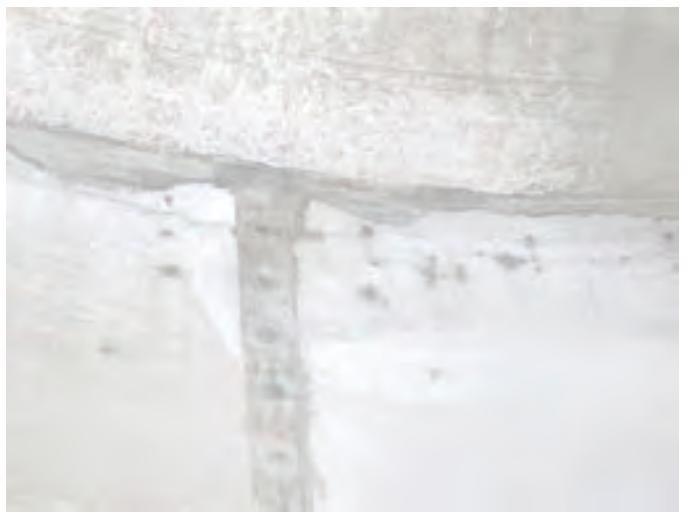
85 Interior Wall With Tight Cracks And Heavy Staining

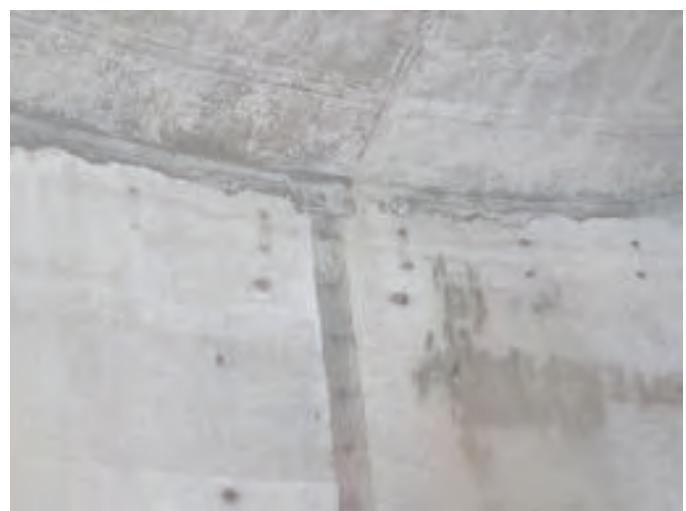
86 *Interior Wall With Tight Cracks And Heavy Staining*

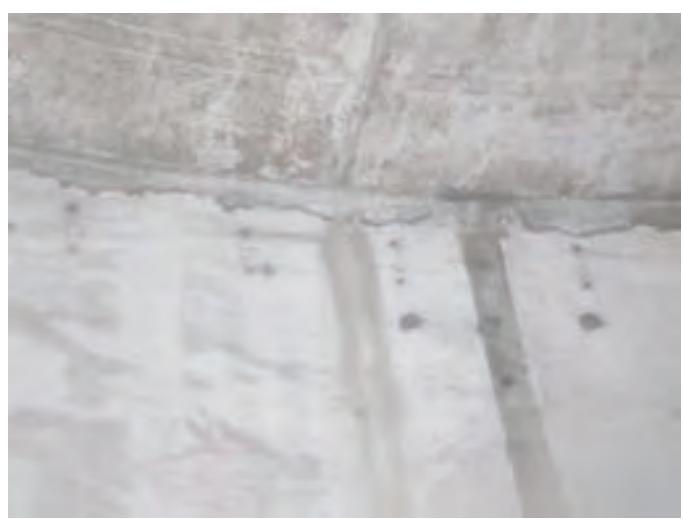
87 Interior Wall With Tight Cracks And Heavy Staining

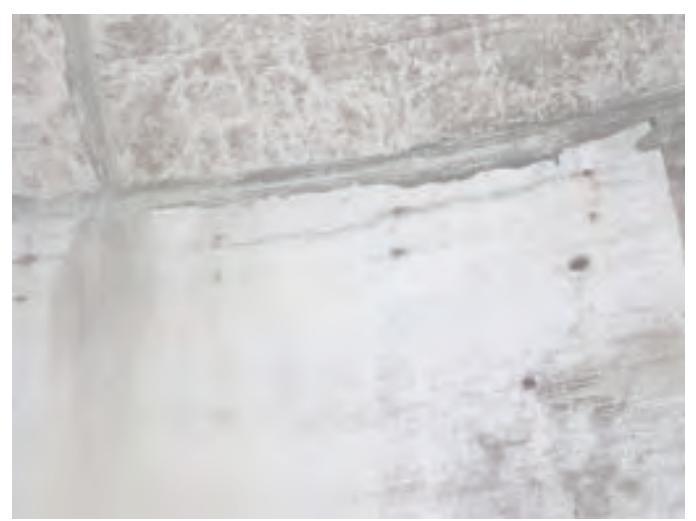
88 Interior Wall With Tight Cracks And Heavy Staining

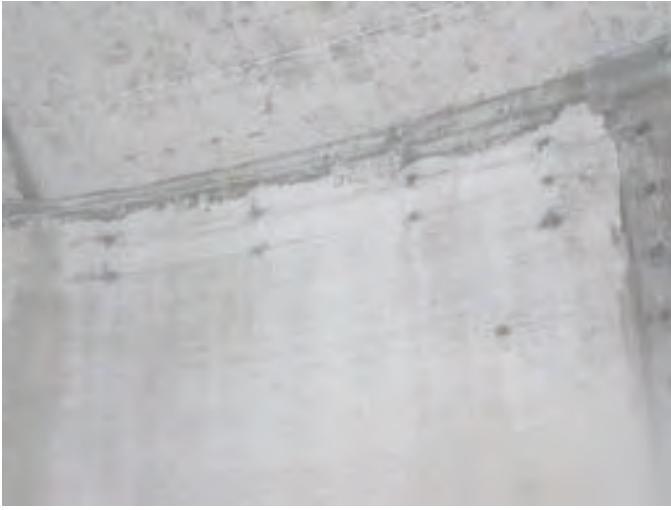
89 Interior Wall With Tight Cracks And Heavy Staining

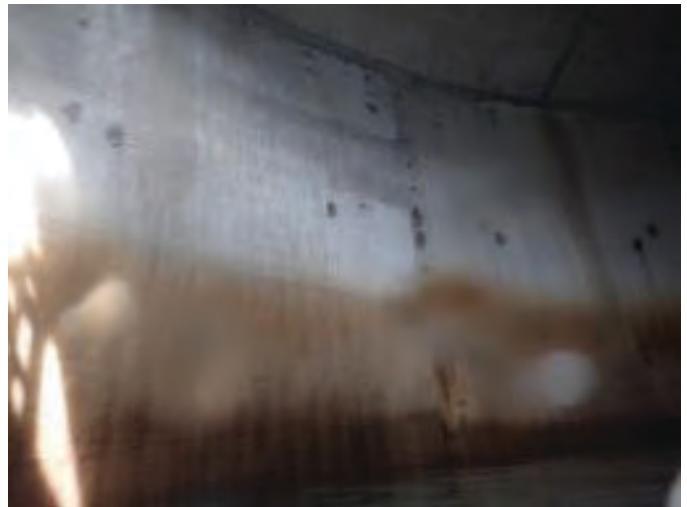
93 Interior Wall With Heavy Staining

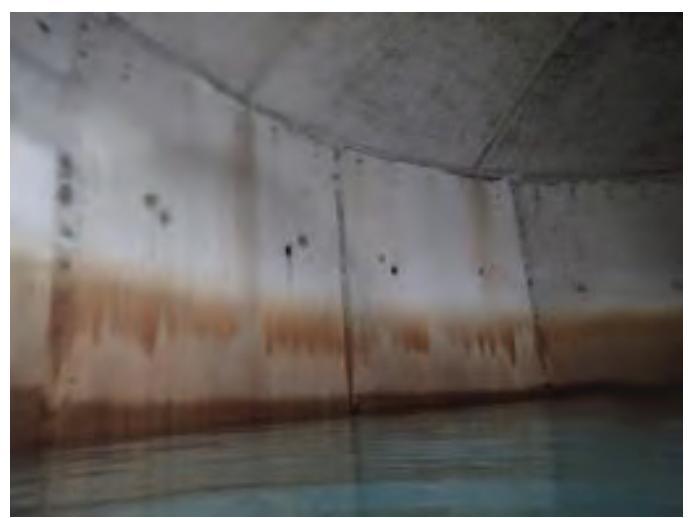
94 *Interior Wall With Heavy Staining*

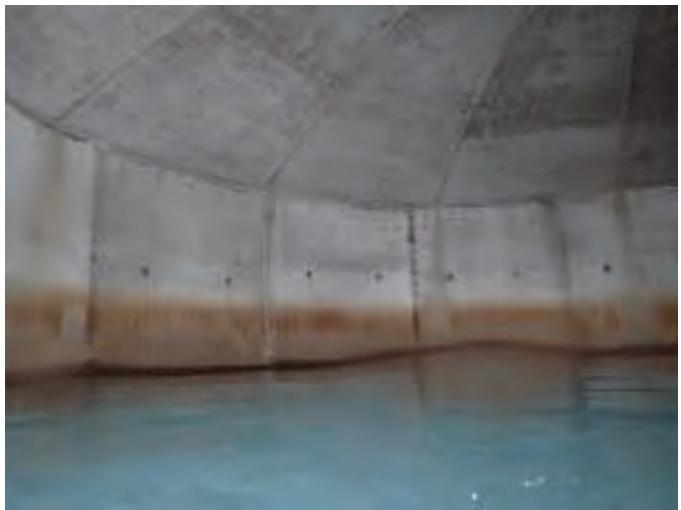
95 Interior Wall With Heavy Staining

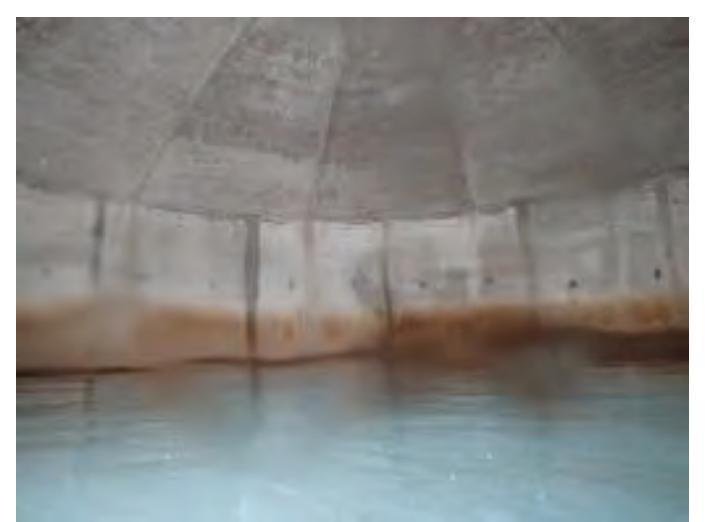
96 Interior Wall With Heavy Staining

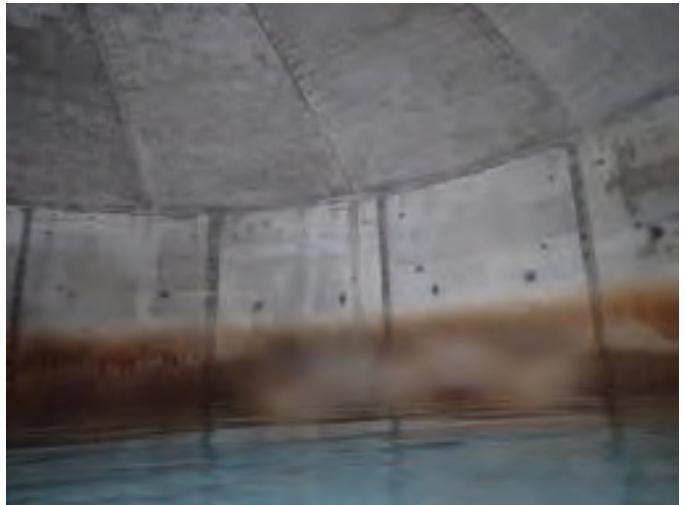
97 Interior Wall With Heavy Staining

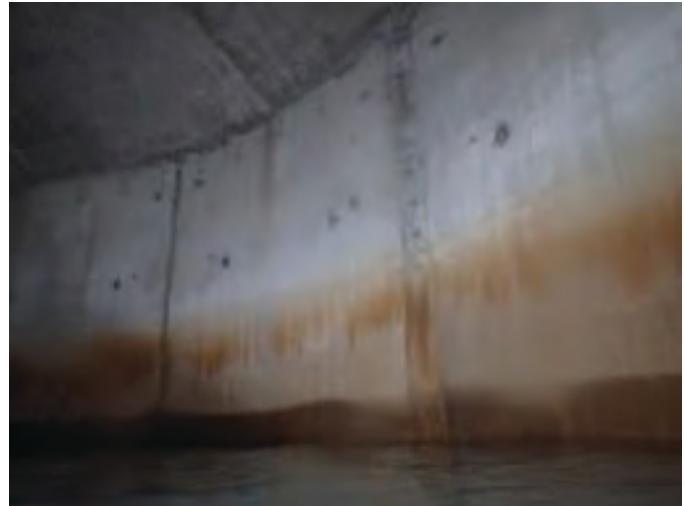
98 Interior Wall With Heavy Staining

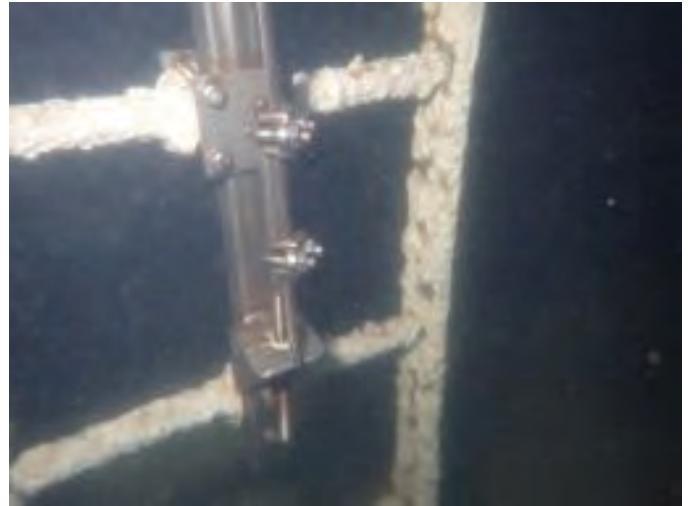
99 Interior Aluminum Ladder And Fall Prevention Device With Fatigue (Pitting) And Corrosion

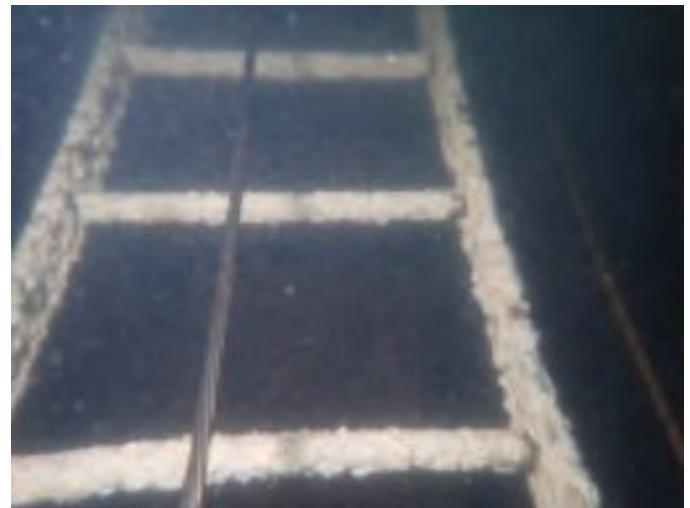
Interior Aluminum Ladder And Fall Prevention100Device With Fatigue (Pitting) And Corrosion

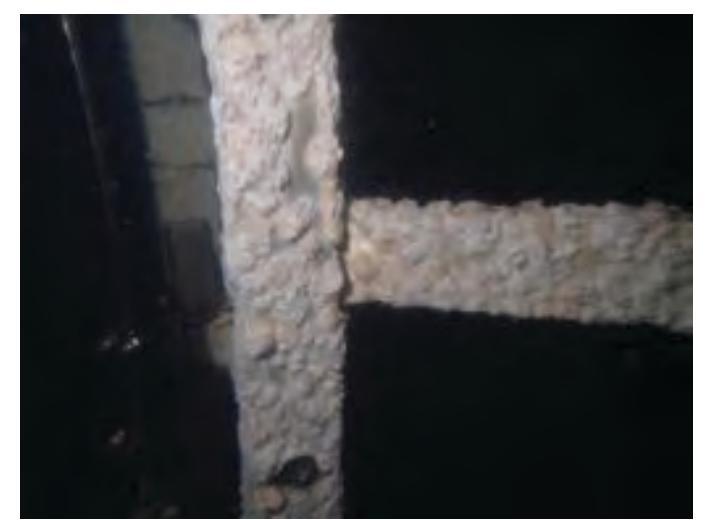
102 Interior Aluminum Ladder And Fall Prevention Device With Fatigue (Pitting) And Corrosion

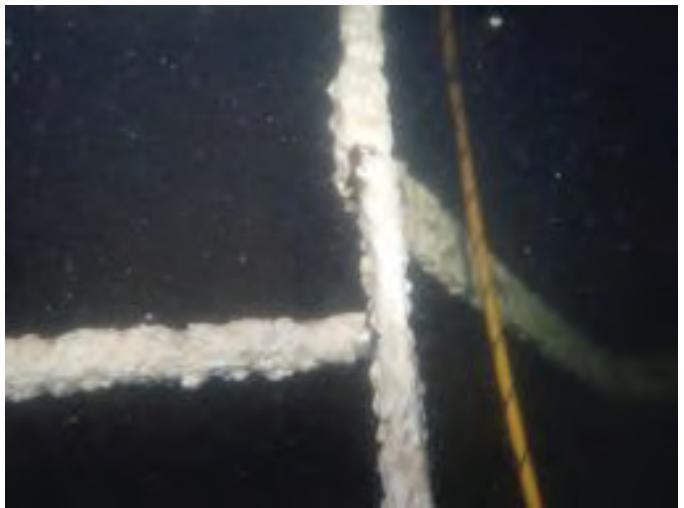
Interior Aluminum Ladder And Fall Prevention103Device With Fatigue (Pitting) And Corrosion

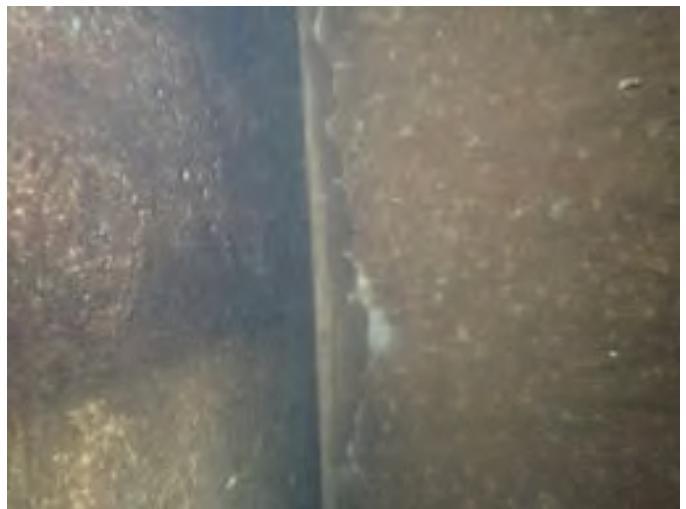
Concrete Overflow Box With Tight Cracks And Efflorescence

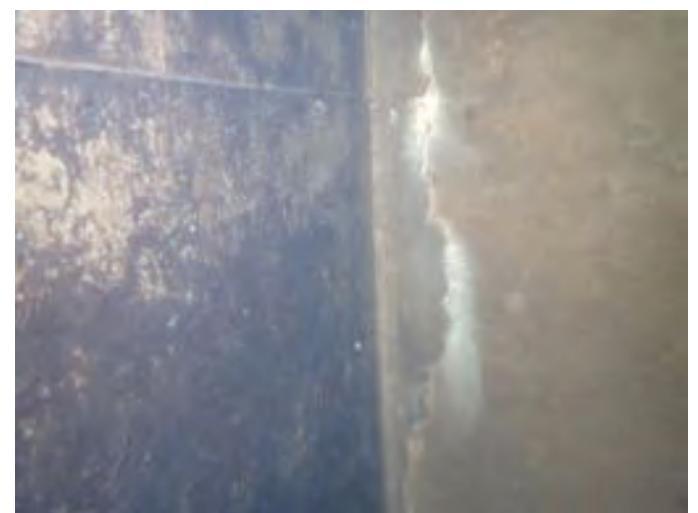
Concrete Overflow Box With Tight Cracks And 110 Efflorescence

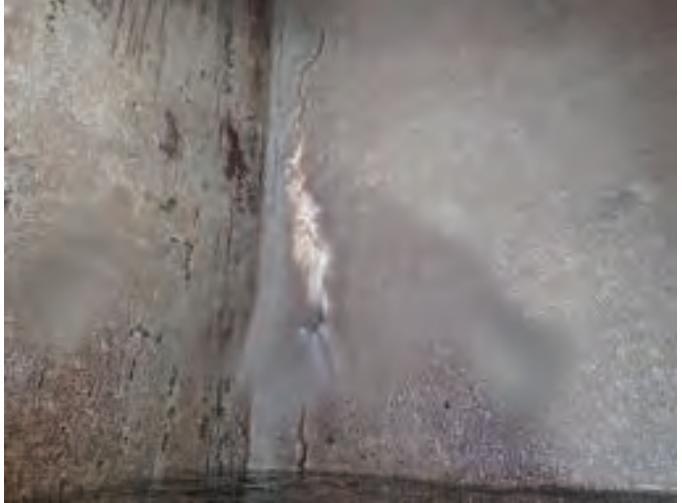
Concrete Overflow Box With Tight Cracks And111Efflorescence

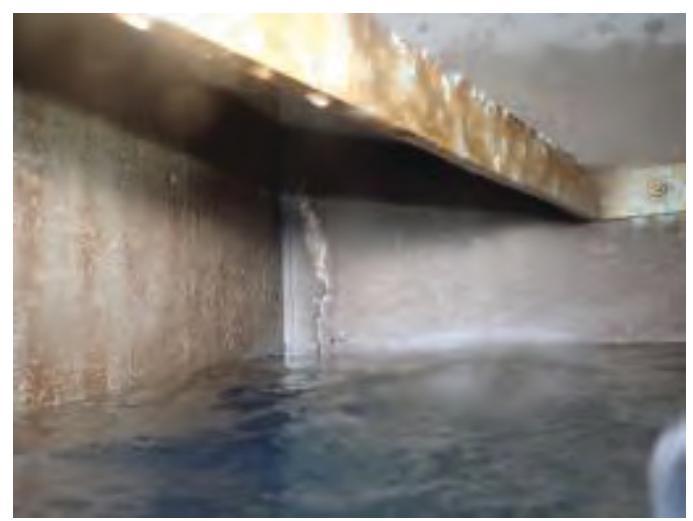
Concrete Overflow Box With Tight Cracks And Efflorescence

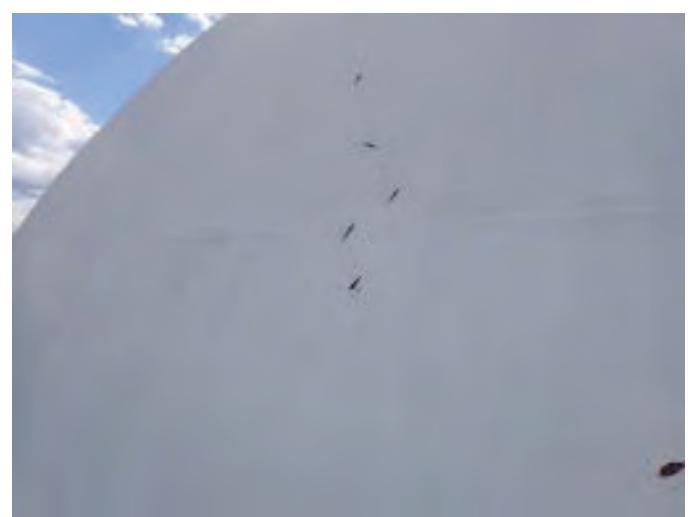
The protective coating applied to the exterior walls and tank base has an average dry film thickness of 13.4 mils, appears to have been applied uniformly, meets the AWWA's recommendations and was found having good adhesion value. However, damage to the protective coating was observed throughout approximately 5% of all elevations of the exterior walls, appearing to be the result of objects striking the tank, and cause exposure of the underlying steel. No obvious fatigue/deterioration of the steel was evident within these 2"-7" long areas of steel exposure, rather mild corrosion exists at this time.

1 Exterior Tank Wall With Coating Damage, Exposed Underlying Steel And Mild Corrosion

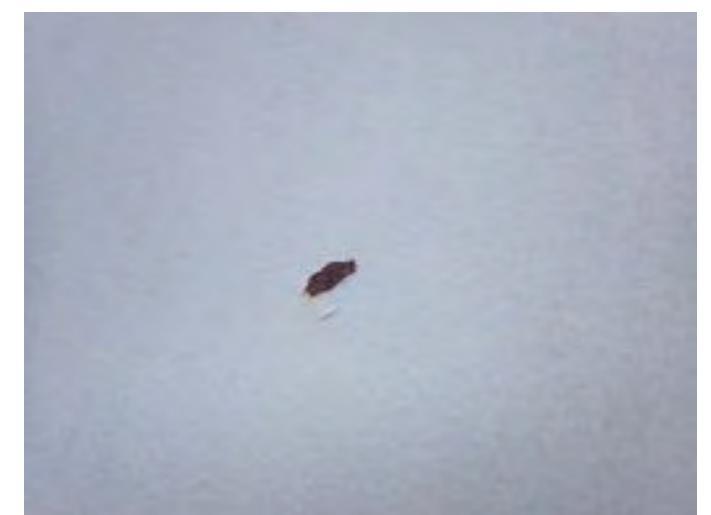
Exterior Tank Wall With Coating Damage, Exposed 2 Underlying Steel And Mild Corrosion

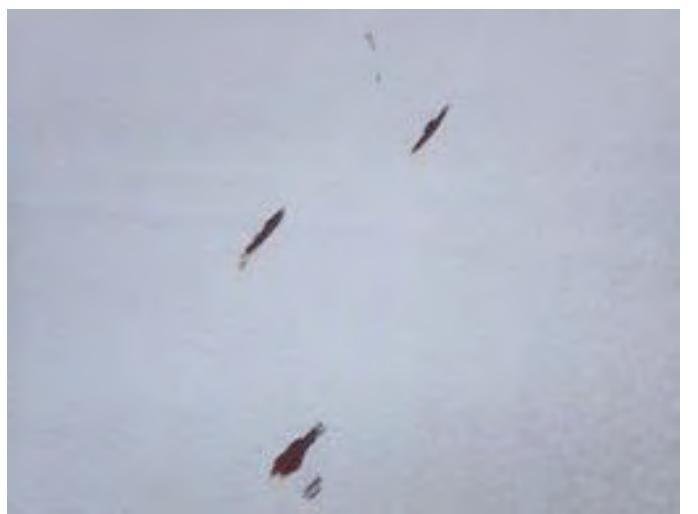
3 Exterior Tank Wall With Coating Damage, Exposed 3 Underlying Steel And Mild Corrosion

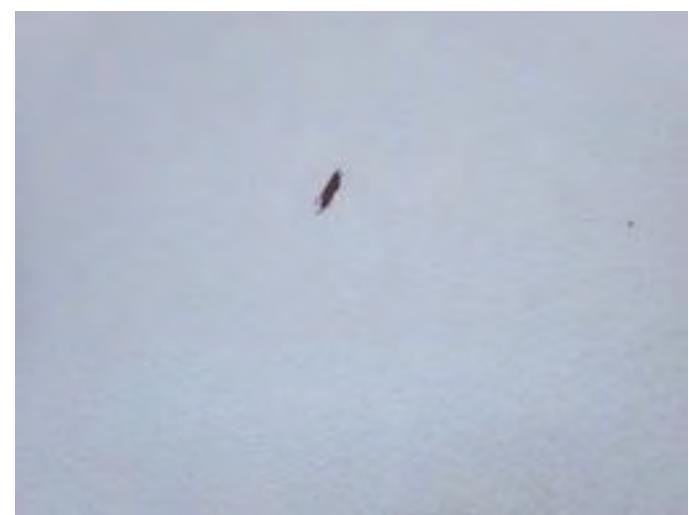
4 Exterior Tank Wall With Coating Damage, Exposed Underlying Steel And Mild Corrosion

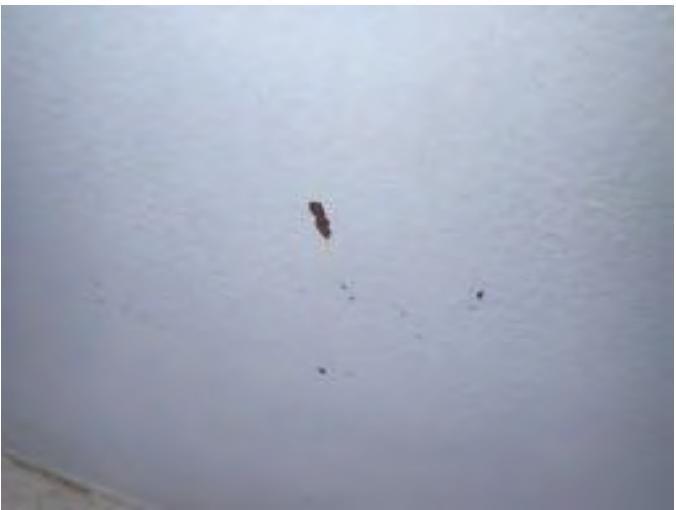
5 *Exterior Tank Wall With Coating Damage, Exposed Underlying Steel And Mild Corrosion*

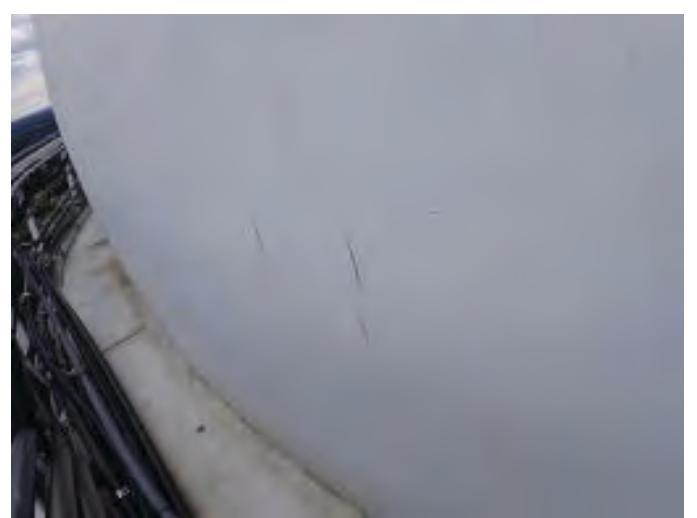
The protective coating applied to the exterior walls and tank base has an average dry film thickness of 13.4 mils, appears to have been applied uniformly, meets the AWWA's recommendations and was found having good adhesion value. However, damage to the protective coating was observed throughout approximately 5% of all elevations of the exterior walls, appearing to be the result of objects striking the tank, and cause exposure of the underlying steel. No obvious fatigue/deterioration of the steel was evident within these 2"-7" long areas of steel exposure, rather mild corrosion exists at this time.

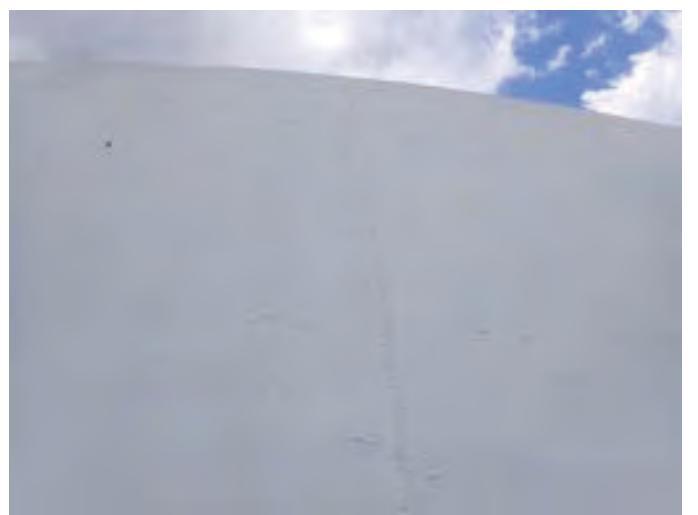
6 Exterior Tank Wall With Coating Damage, Exposed Underlying Steel And Mild Corrosion

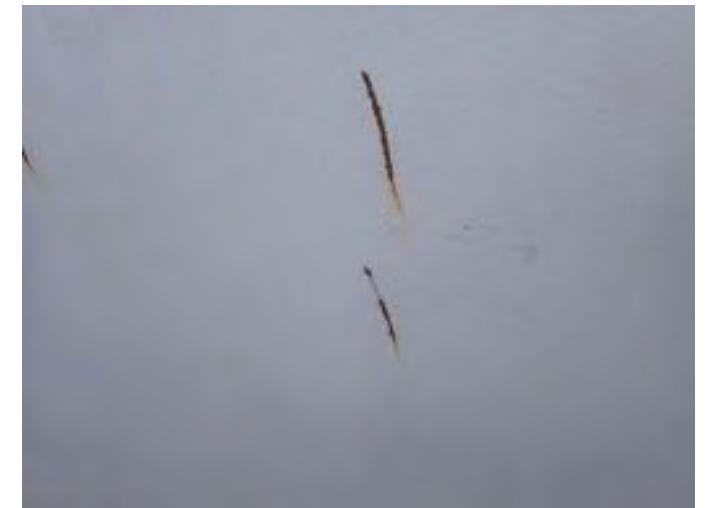
7 Exterior Tank Wall With Coating Damage, Exposed 7 Underlying Steel And Mild Corrosion

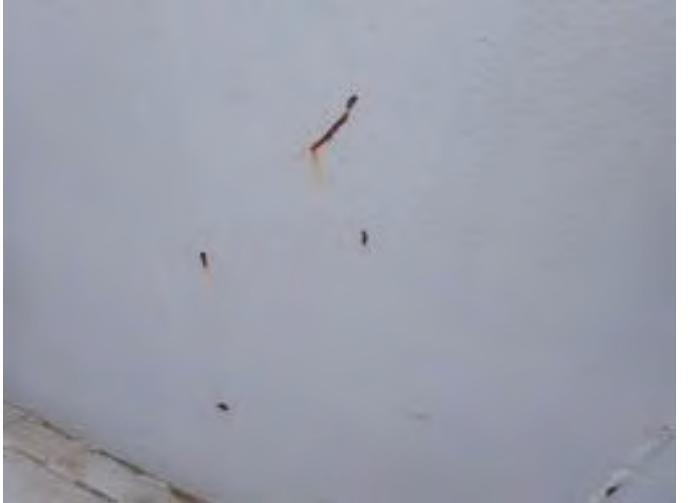
8 Exterior Tank Wall With Coating Damage, Exposed 8 Underlying Steel And Mild Corrosion

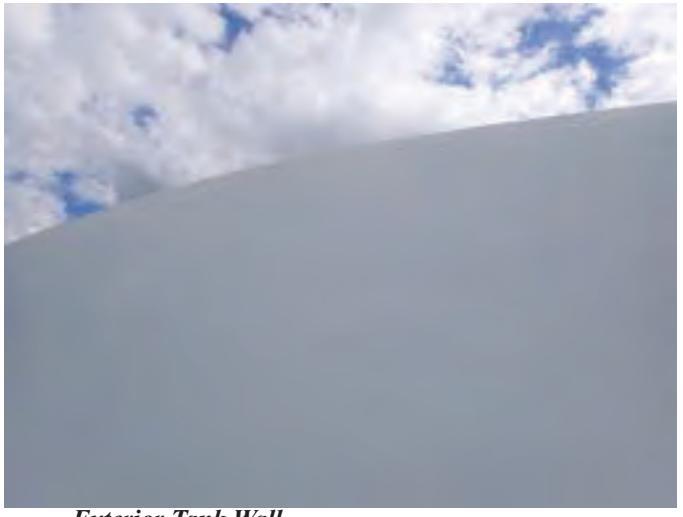
9 *Exterior Tank Wall With Coating Damage, Exposed Underlying Steel And Mild Corrosion*

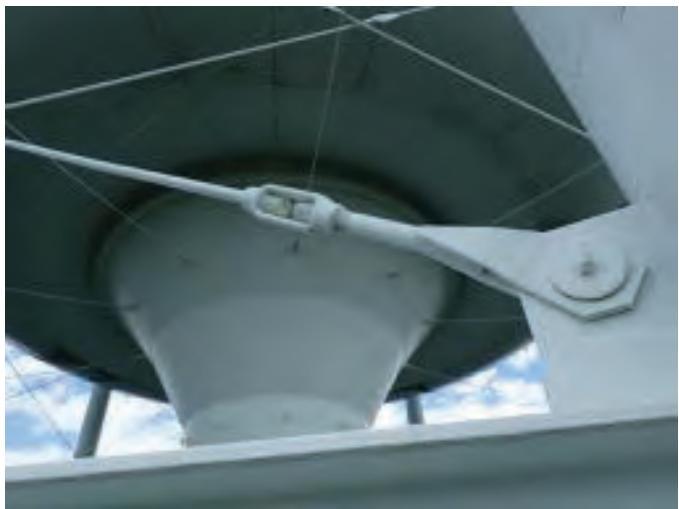
21 Tank Base With Mild Mildew

A mild, non-uniform accumulation of mildew throughout the tank base causes declined aesthetics.

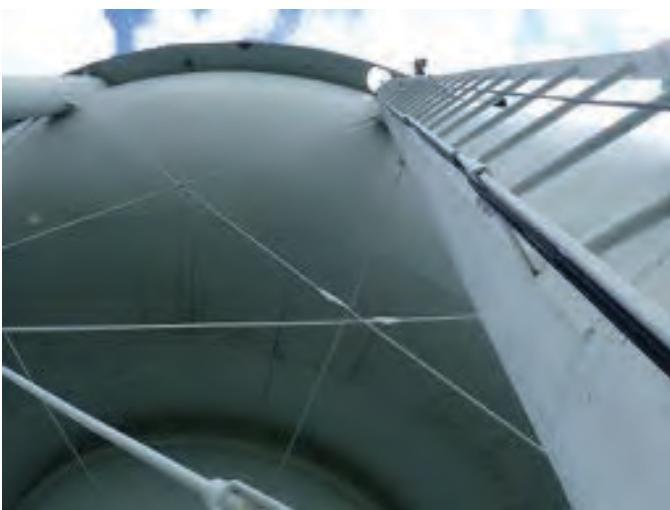
22Tank Base With Mild Mildew

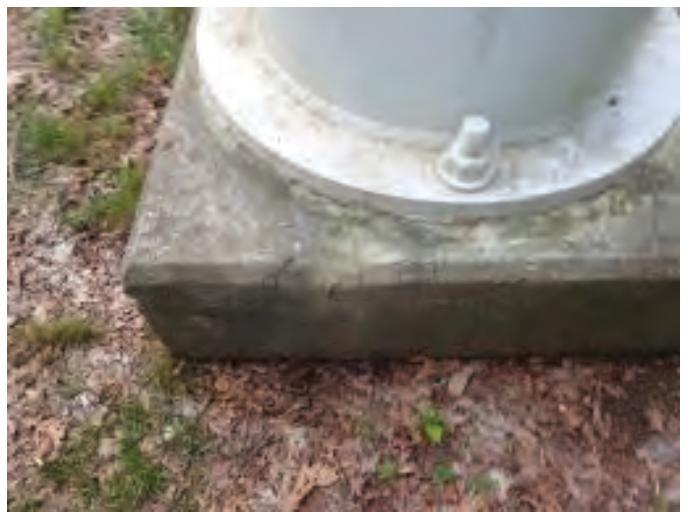
23 Tank Base With Mild Mildew

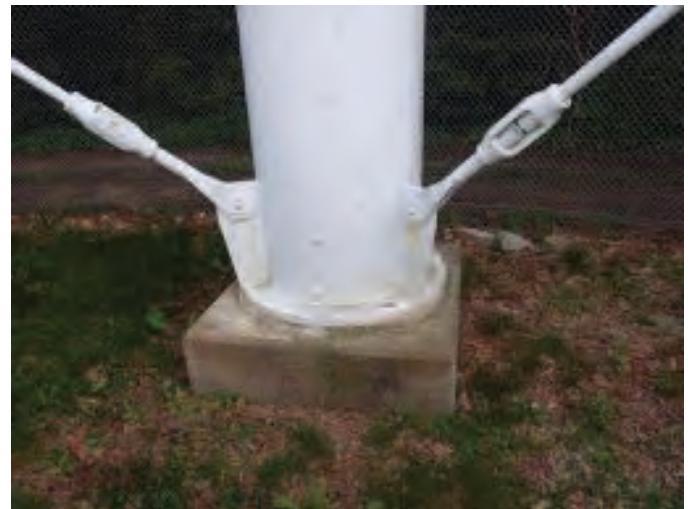
The concrete support pads located below each tower support leg are not coated and were found appearing mostly sound, however tight cracks were observed throughout approximately 5-10% of the surfaces of each concrete support pad. These cracks were sounded and appeared to be limited to the surface of the concrete and free of obvious voids or spalls at this time.

25 Tower Support Leg Having Coating Loss With The 25 Concrete Support Pad Having Tight Surface Cracks 26 And A Secure Anchor Bolt

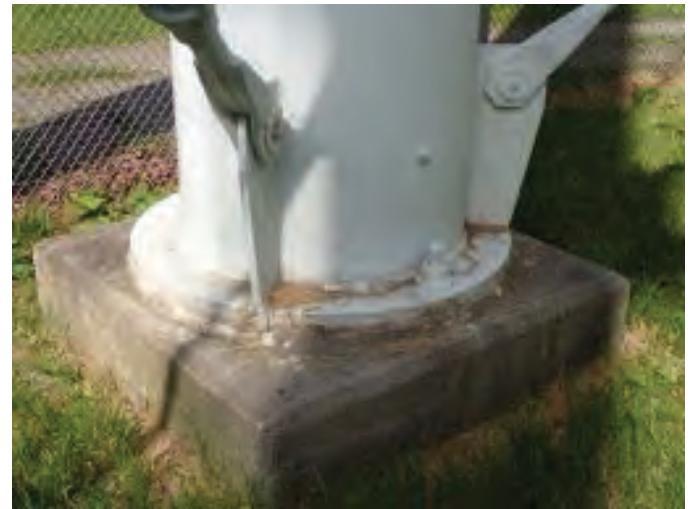
Tower Support Leg Having Coating Loss With The26Concrete Support Pad Having Tight Surface CracksAnd A Secure Anchor Bolt

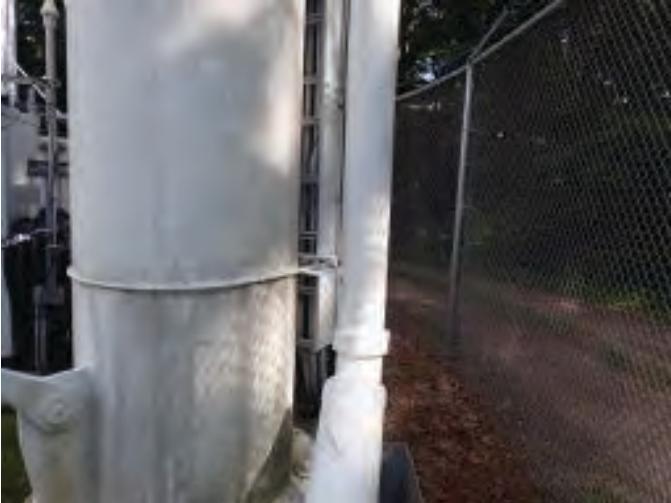
28 Tower Support Leg Having Coating Loss With The 28 Concrete Support Pad Having Tight Surface Cracks And A Secure Anchor Bolt

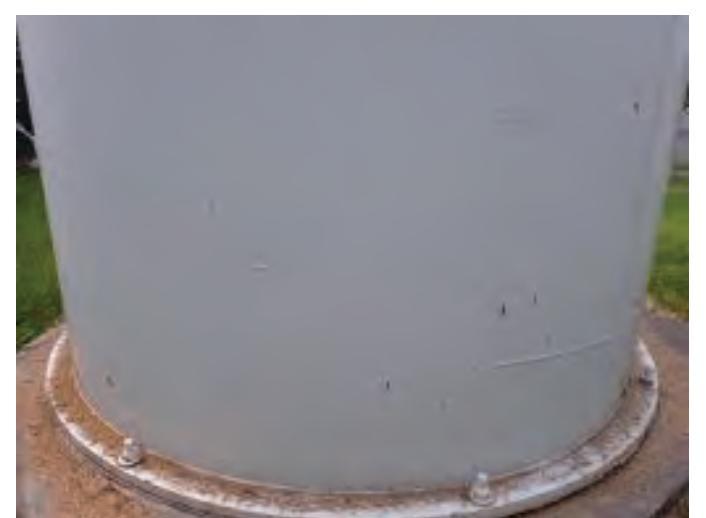
29 Tower Support Leg With Coating Loss

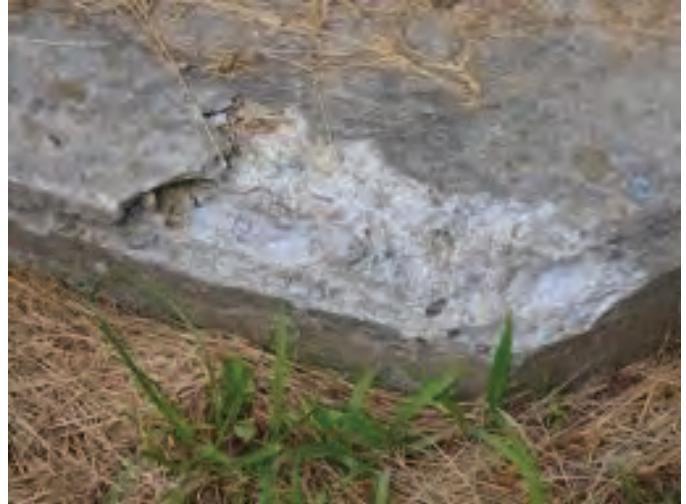
The concrete support pad located below the center riser columns is not coated and was found appearing mostly sound, however three areas of concrete spall were found throughout these surfaces at this time. The first area of concrete spall measures 30" in length by 4" in width and has an average maximum depth of 1/2" deep. The second area of concrete spall measures 7" in length by 6" in width and has an average maximum depth of 1" deep. The third area of concrete spall measures 6" in length by 4" in width and has an average maximum depth of 1/2" deep.

The surrounding and underlying concrete within each spall remains sound and with no obvious exposure of the underlying reinforcement steel at this time.

32 Center Riser Column Concrete Support Pad With 32 Concrete Spall, Expose Underlying Concrete And Exposed Underlying Reinforcement Steel

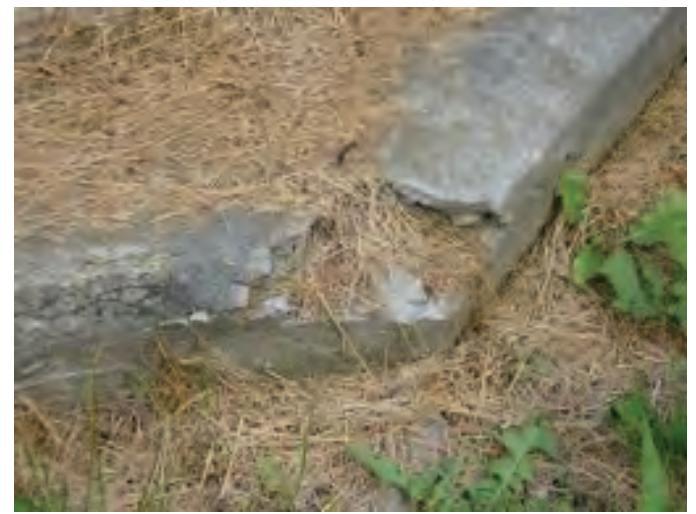
33 Center Riser Column Concrete Support Pad With Concrete Spall, Expose Underlying Concrete And Exposed Underlying Reinforcement Steel

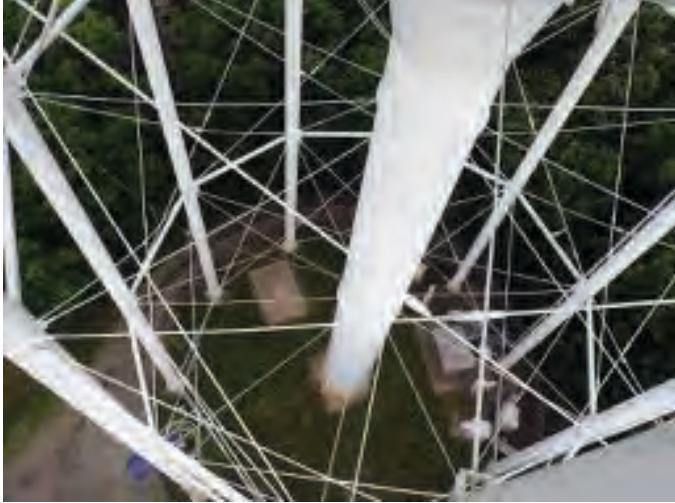
34 Center Riser Column Concrete Support Pad With Concrete Spall, Expose Underlying Concrete And Exposed Underlying Reinforcement Steel

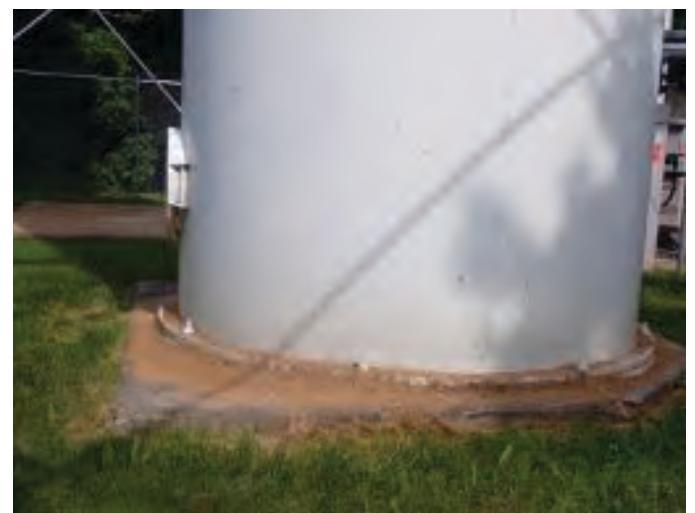
The protective coating applied to the support components appears to have been applied uniformly and was found having good adhesion value. A mild rust stain was observed extending from the connecting plates and support component securing hardware, however no obvious coating fatigue or steel exposure was evident within these areas of rust staining.

42 Secure Support Components With Mild Rust Staining

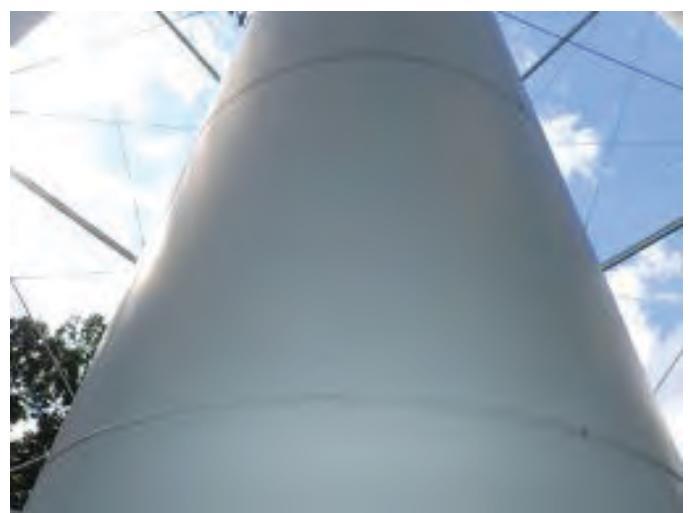
A mild, non-uniform accumulation of mildew throughout the outer center riser column and each support leg also causes declined aesthetics.

43 *Outer Center Riser Column With Mild Mildew*

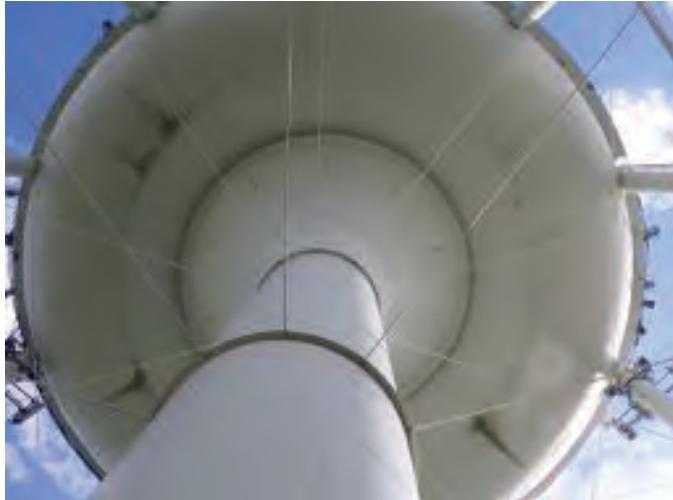
Outer Center Riser Column With Mild Mildew

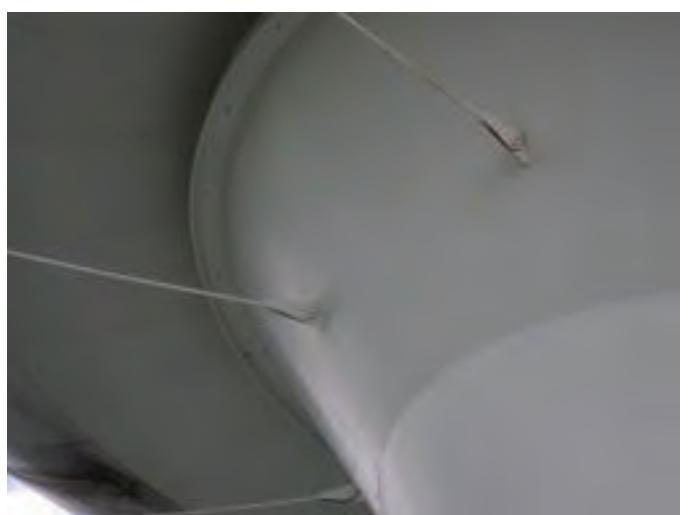
45 Outer Center Riser Column With Mild Mildew

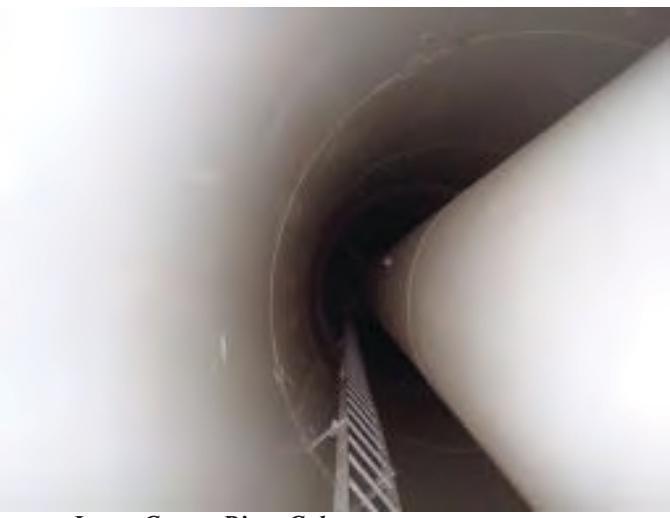
46 Outer Center Riser Column With Mild Mildew

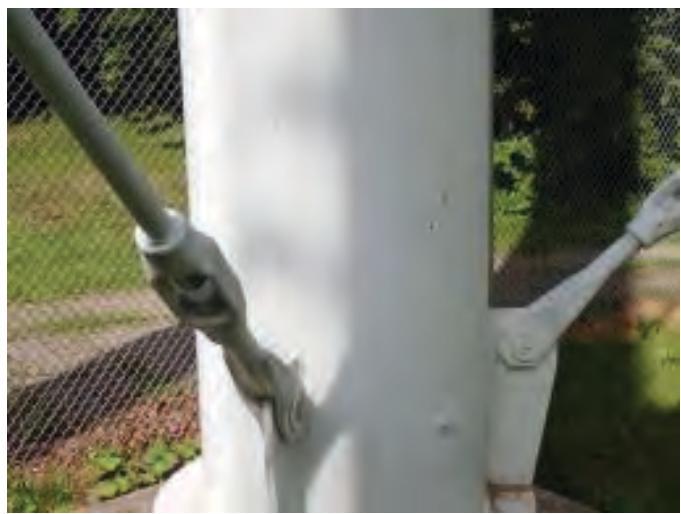
Tower Support Legs With Mild Mildew51

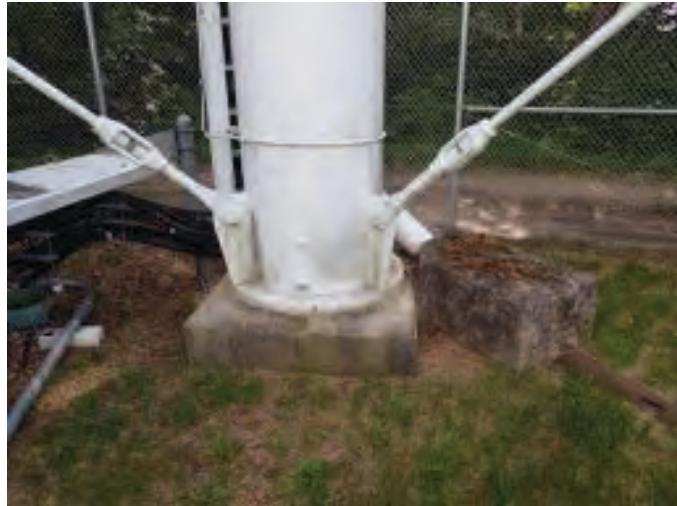
52 *Tower Support Legs With Mild Mildew*

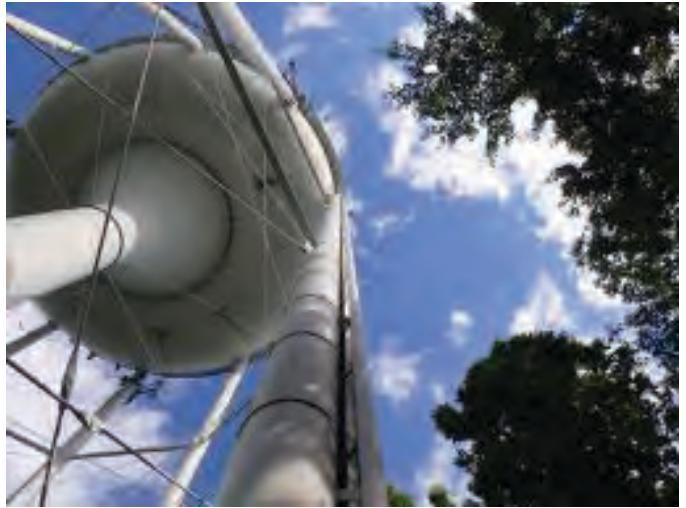
53 Tower Support Legs With Mild Mildew

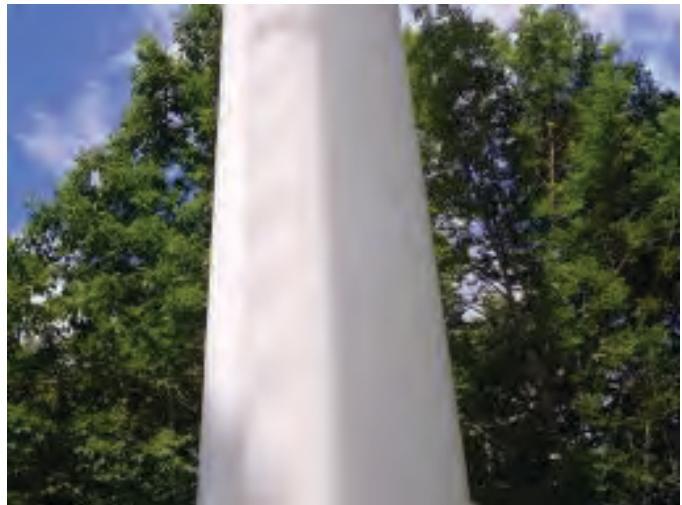
54 Tower Support Legs With Mild Mildew

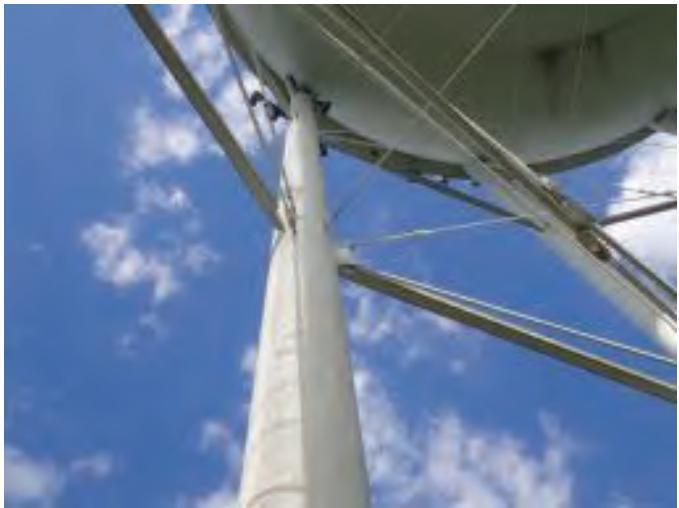
Tower Support Legs With Mild Mildew55

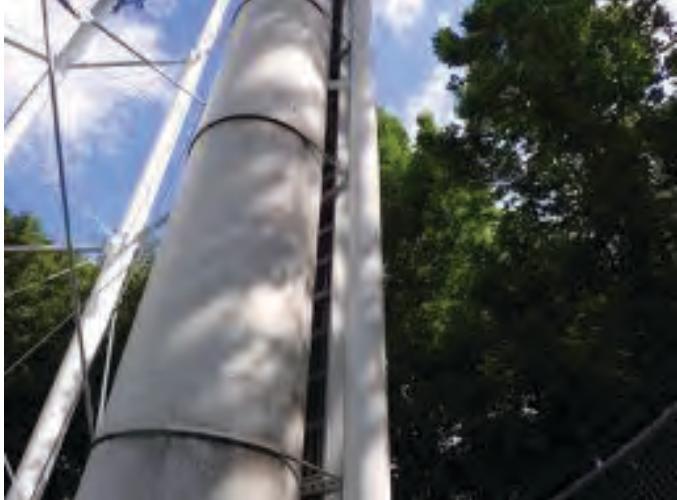
Tower Support Legs With Mild Mildew 56

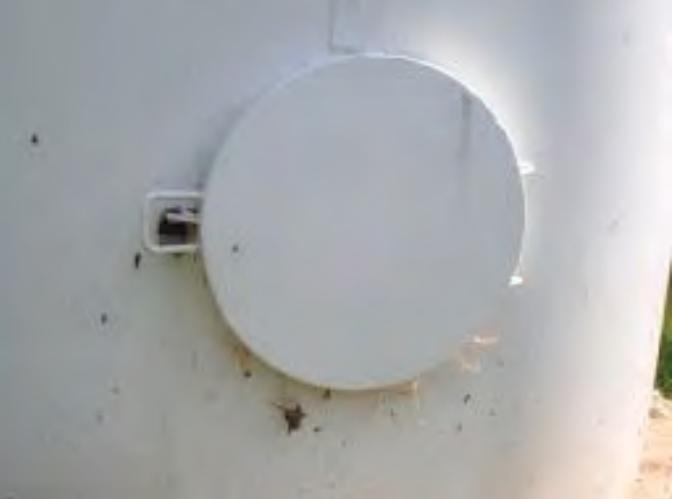
Open Outer Riser Column Manway58

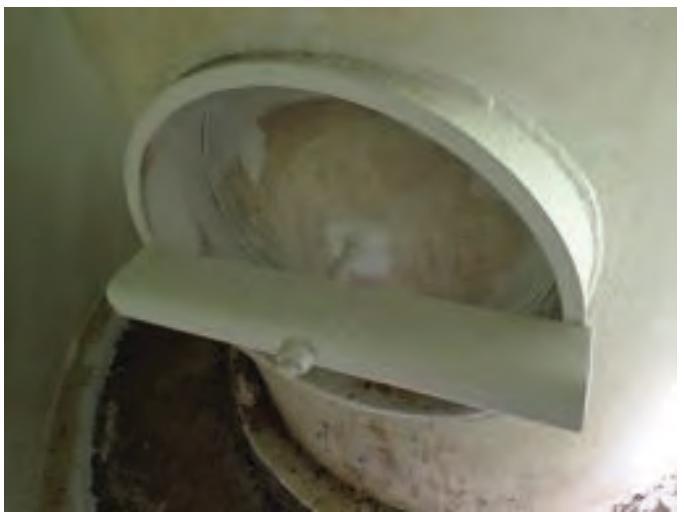
59 Closed Outer Riser Column Manway

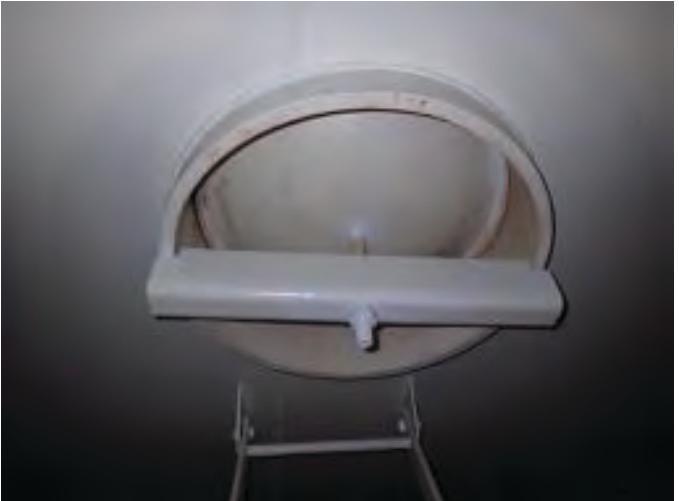
60 Secure Inner Riser Column Manway

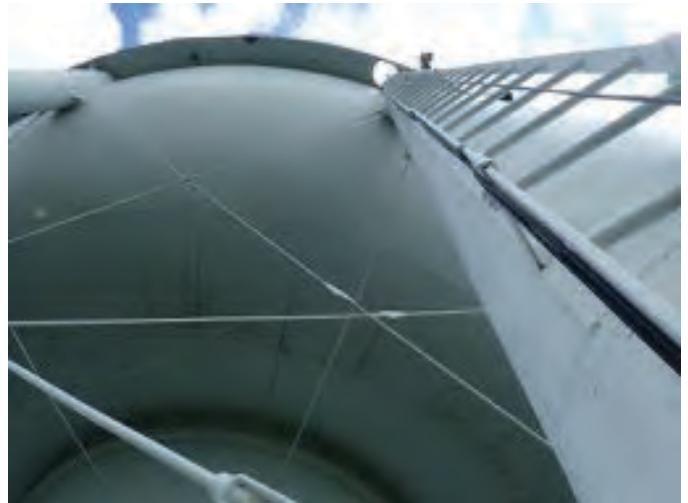
Secure Manway Penetrating Tank Base 61

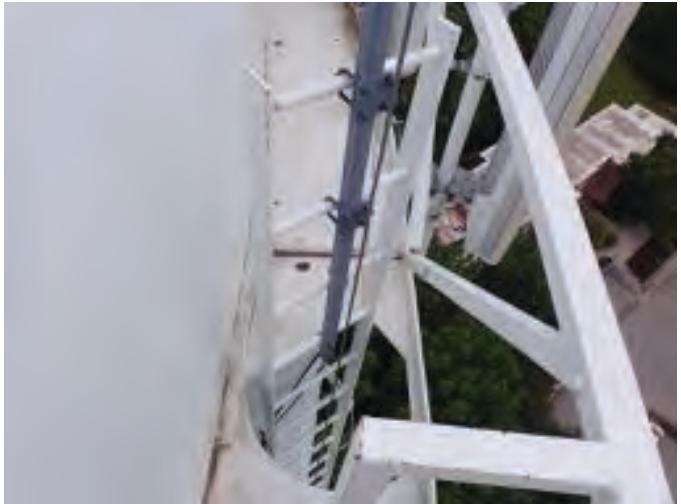
62Ladder With Isolated Coating Loss, Exposed Steel,
Mild Surface Corrosion And Fall Prevention Device

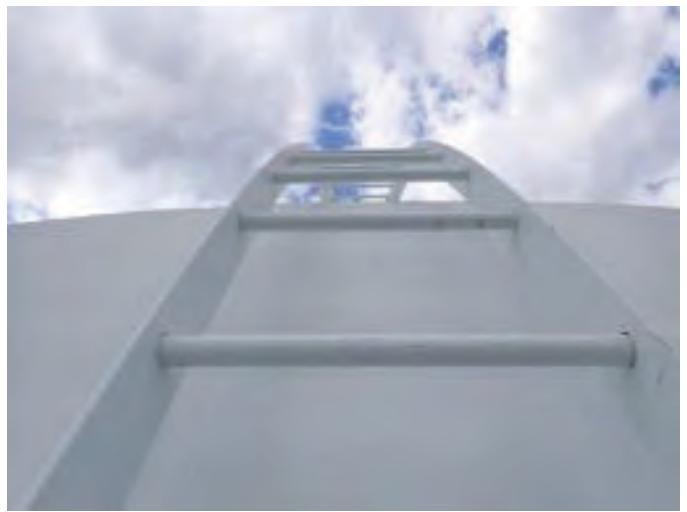
64 Vent Access Ladder With Isolated Coating Loss, Exposed Steel And Mild Surface Corrosion

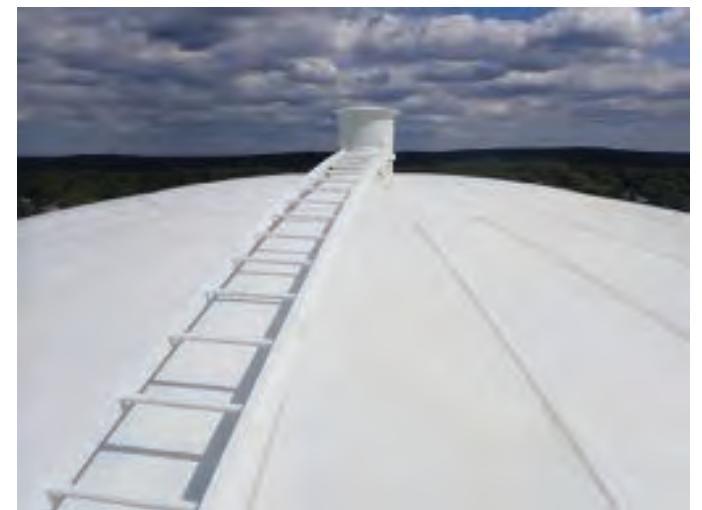
65 Vent Access Ladder With Isolated Coating Loss, Exposed Steel And Mild Surface Corrosion
