In re: City of Woonsocket Water Division - Application to Implement Multi-Year Rate Plan

Docket No. 4879

Dam Name (No):	Woonsocket Reservoir #3 Dam (068)
Location:	Smithfield/North Smithfield
Hazard Classification:	High
	-
Inspector:	David M. Matheson, P.E.
Inspection Date.	August 1, 2014

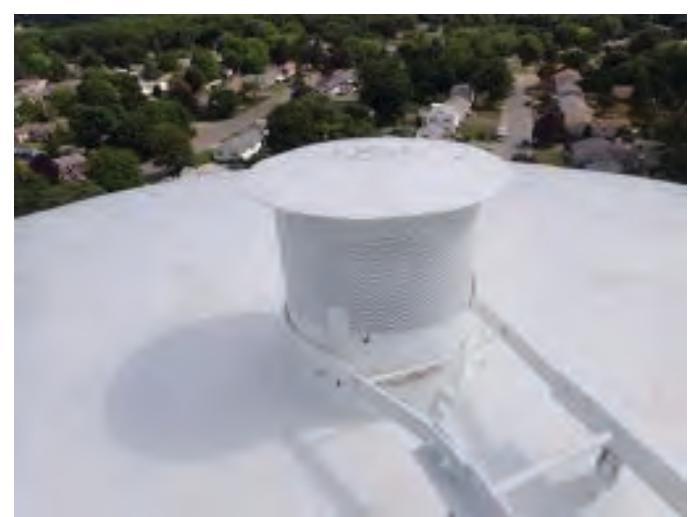
66 *Vent Access Ladder With Isolated Coating Loss, Exposed Steel And Mild Surface Corrosion*

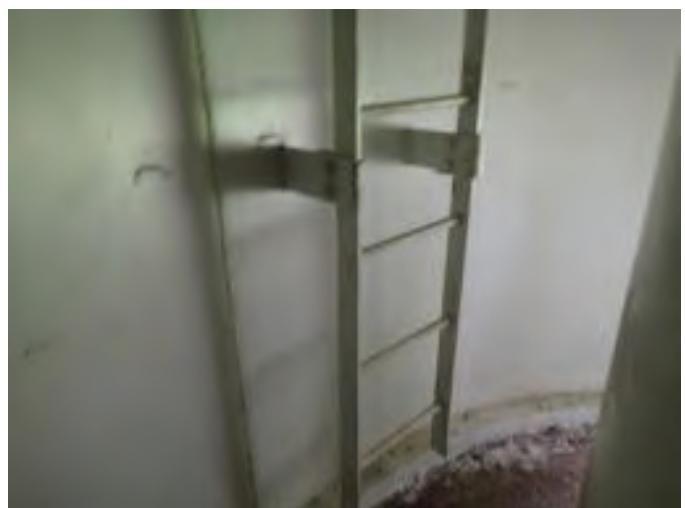
67 Vent Access Ladder With Isolated Coating Loss, Exposed Steel And Mild Surface Corrosion

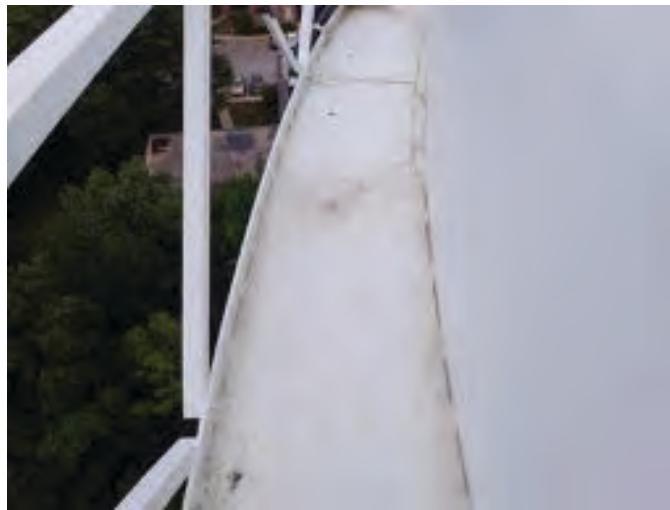
Catwalk And Secure Safety Railings

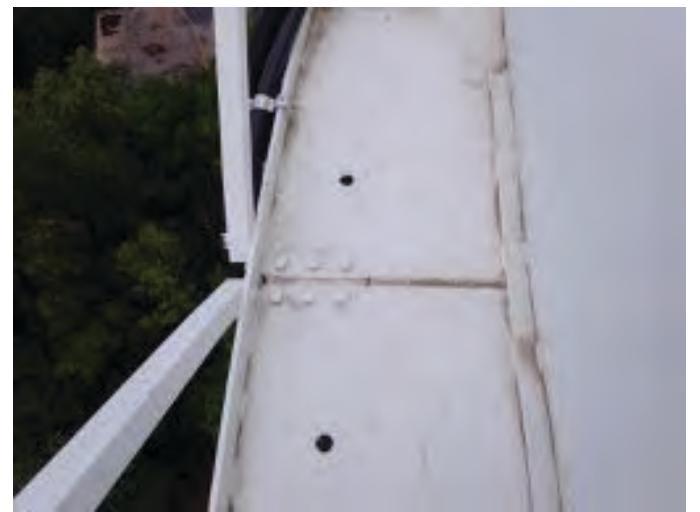
71 Catwalk And Secure Safety Railings

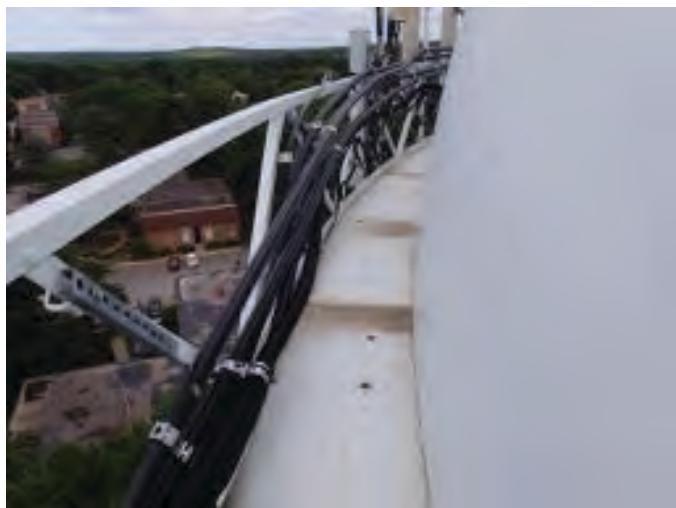
72 Catwalk And Secure Safety Railings

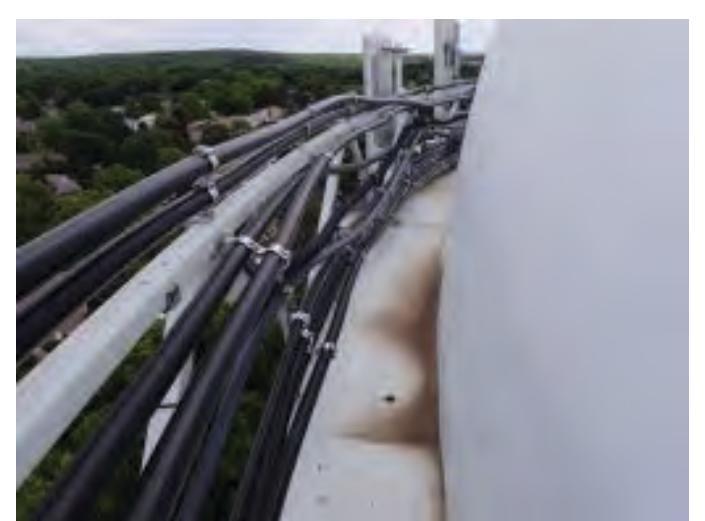
Catwalk And Secure Safety Railings

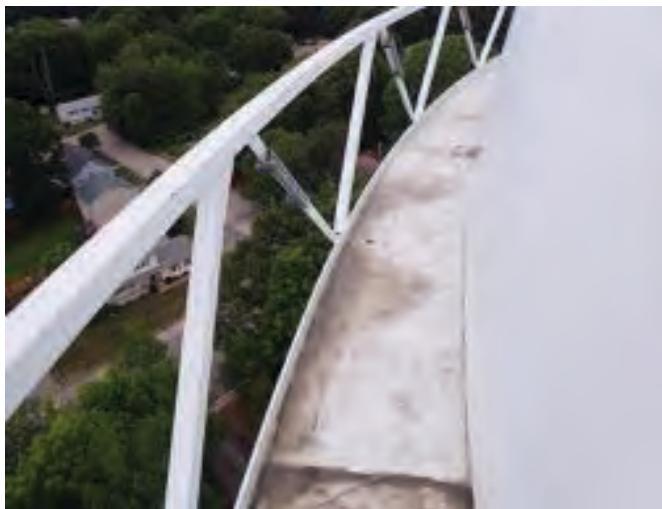
Catwalk And Secure Safety Railings

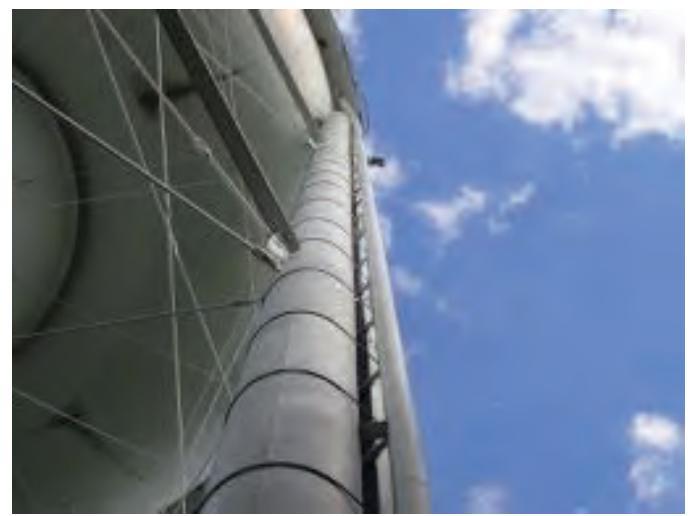
77 Overflow Weir Box With Coating Loss, Exposed Steel And Surface Corrosion

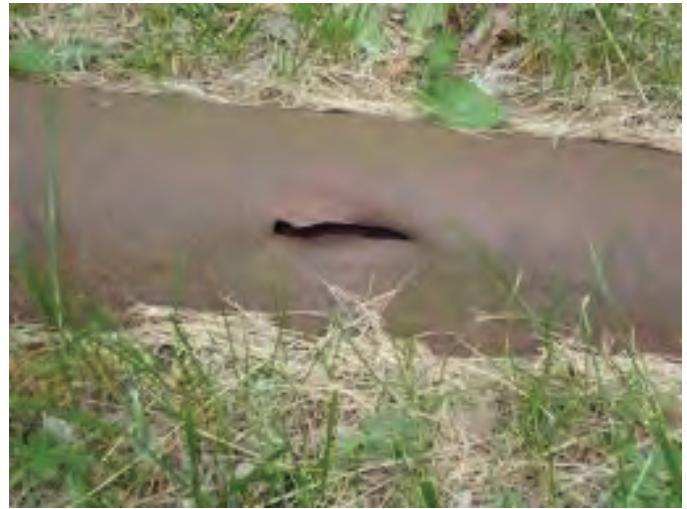
Exposed Overflow Pipe With Penetration And 80 Corrosion

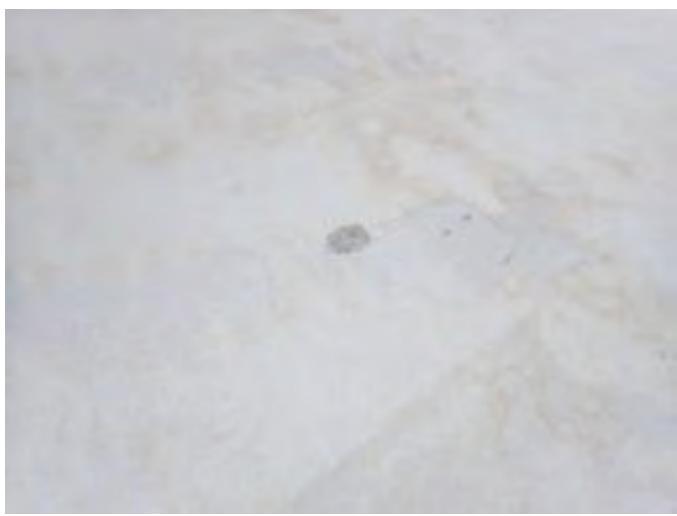
82 Roof Panels With Secondary Coating Loss And Exposed Primary Coating

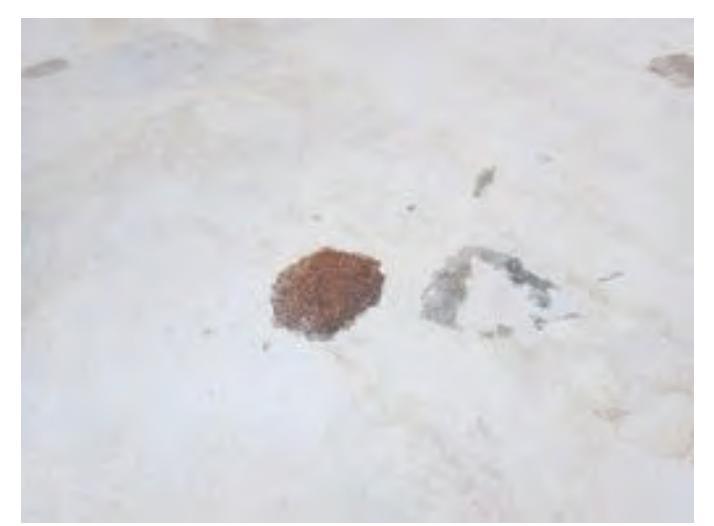
83 *Roof Panels With Secondary Coating Loss And Exposed Primary Coating*

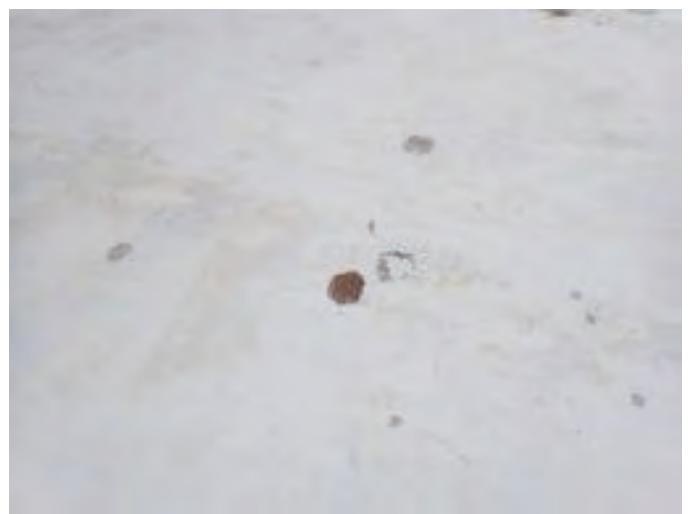
84 Roof Panels With Secondary Coating Loss, Exposed Primary Coating, Exposed Underlying Steel, Mild Corrosion And Mild Mildew

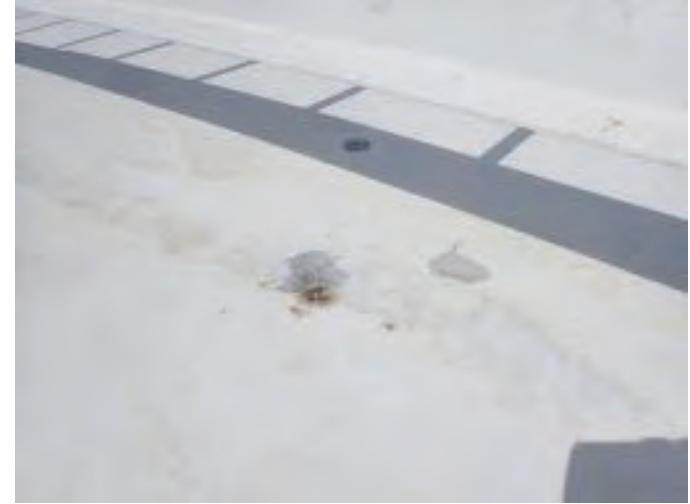
Roof Panels With Secondary Coating Loss, Exposed
Primary Coating, Exposed Underlying Steel, Mild
Corrosion And Mild Mildew

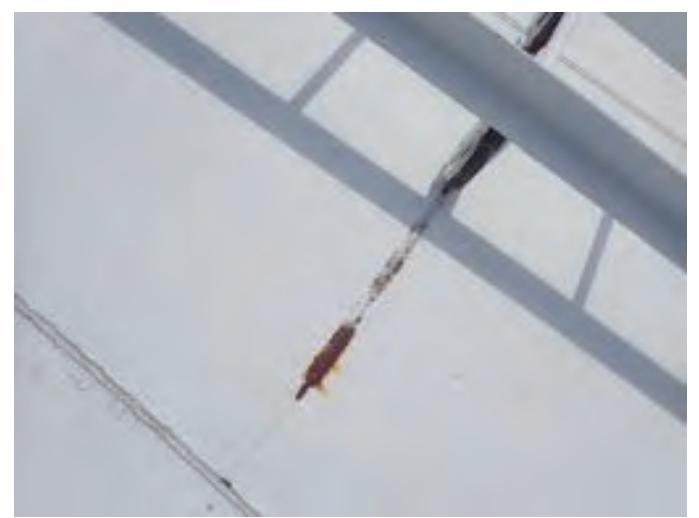
Roof Panels With Secondary Coating Loss, Exposed
Primary Coating, Exposed Underlying Steel, Mild
Corrosion And Mild Mildew

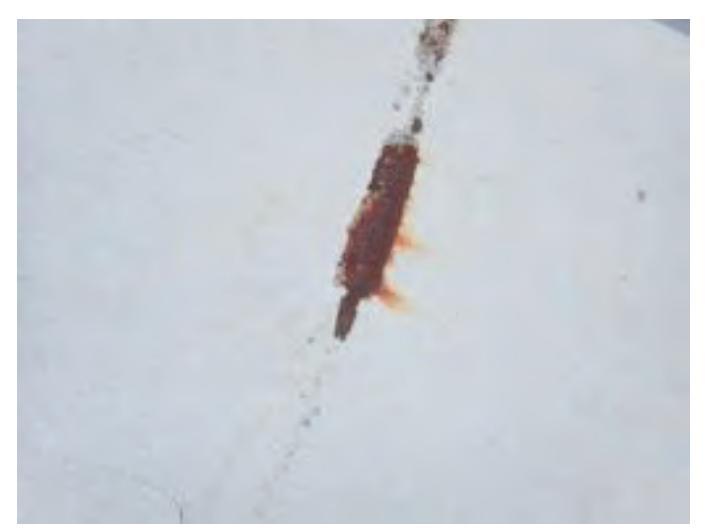
87 *Roof Panels With Coating Loss, Exposed Underlying Steel, Mild Corrosion And Mild Mildew*

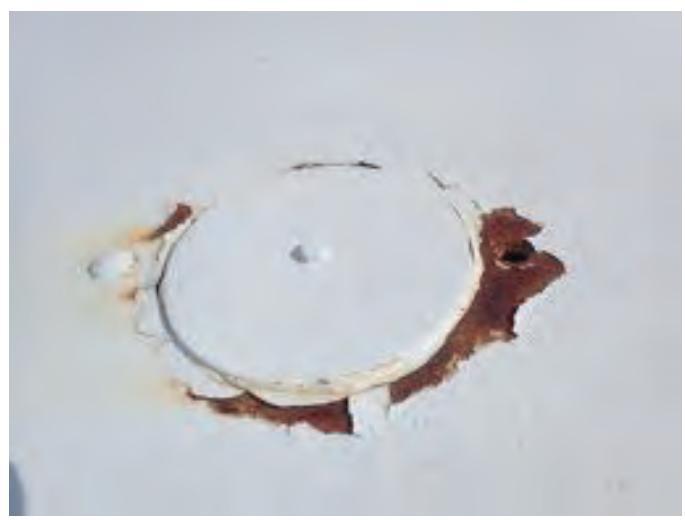
Roof Panels With Coating Loss, Exposed Underlying
Steel, Mild Corrosion And Mild Mildew

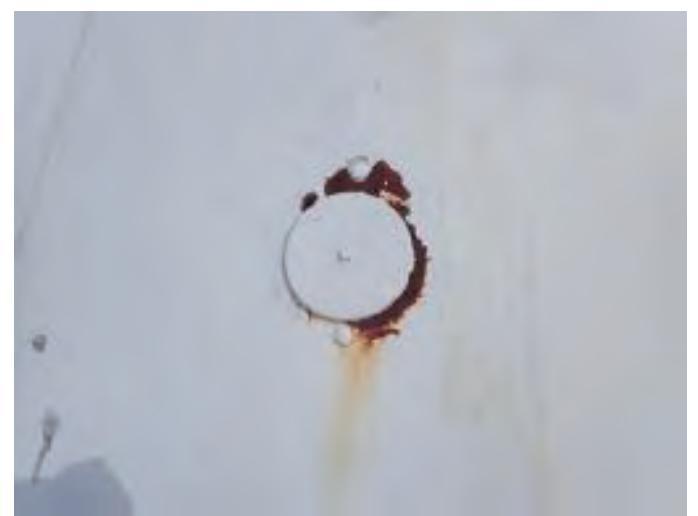
89 Roof Panels With Coating Loss, Exposed Underlying Steel, Mild Corrosion And Mild Mildew

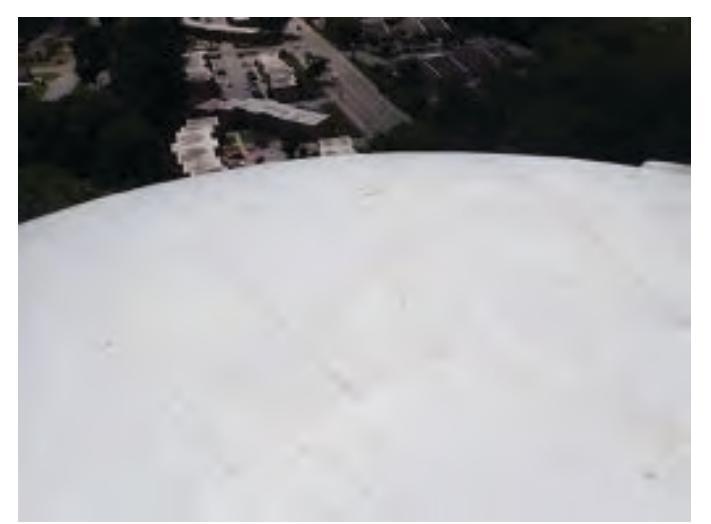
90 *Roof Panels With Coating Loss, Exposed Underlying Steel, Mild Corrosion And Mild Mildew*

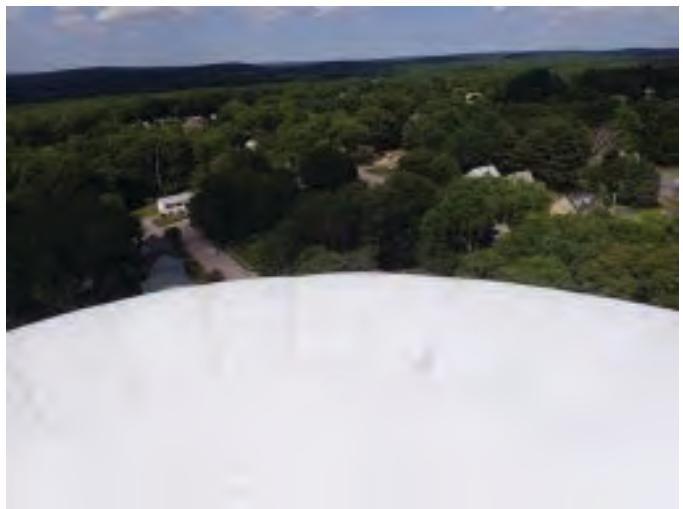
Roof Panels With Mild Mildew

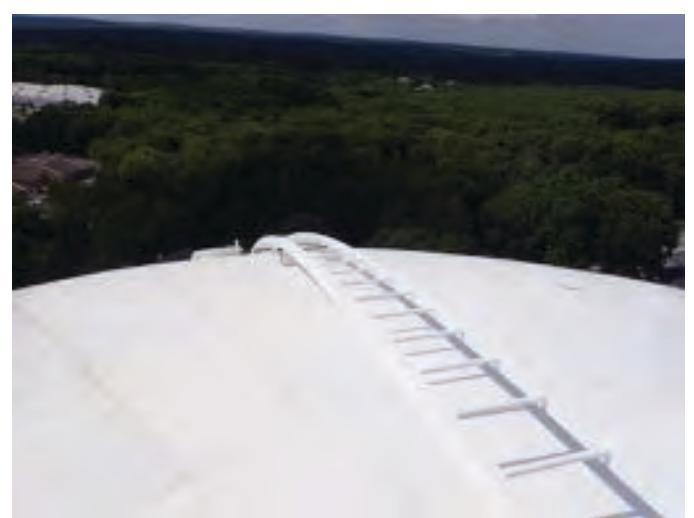
Roof Panels With Mild Mildew

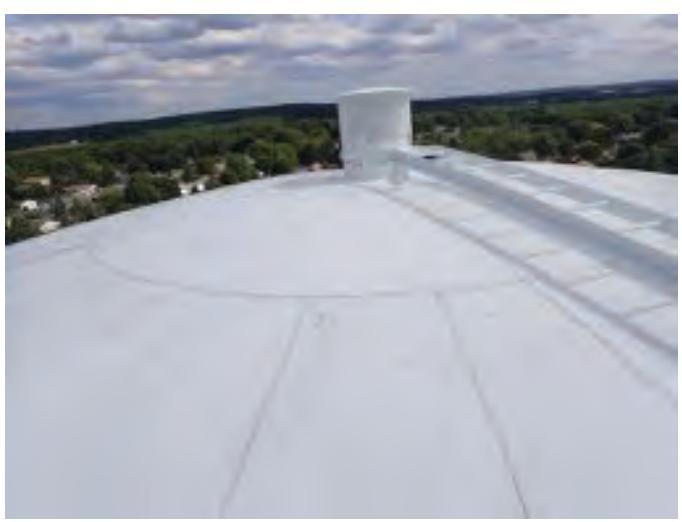
Roof Panels With Mild Mildew

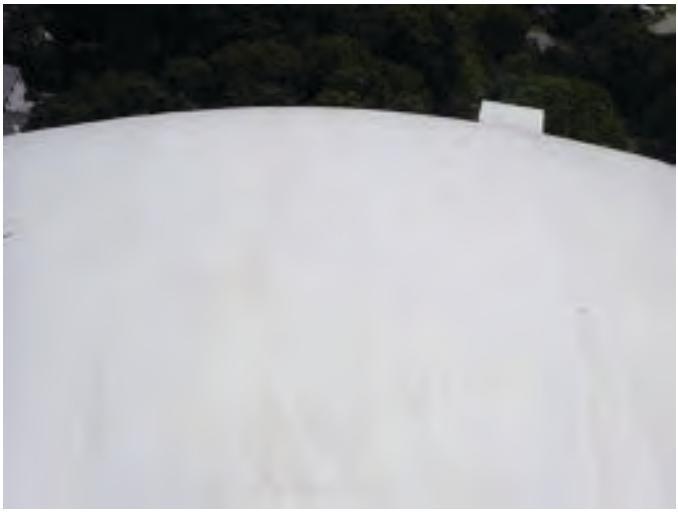
Roof Panels With Mild Mildew

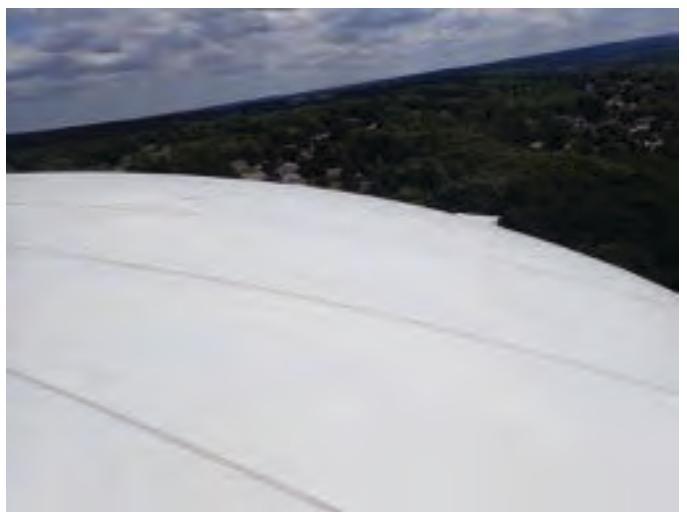
Roof Panels With Mild Mildew

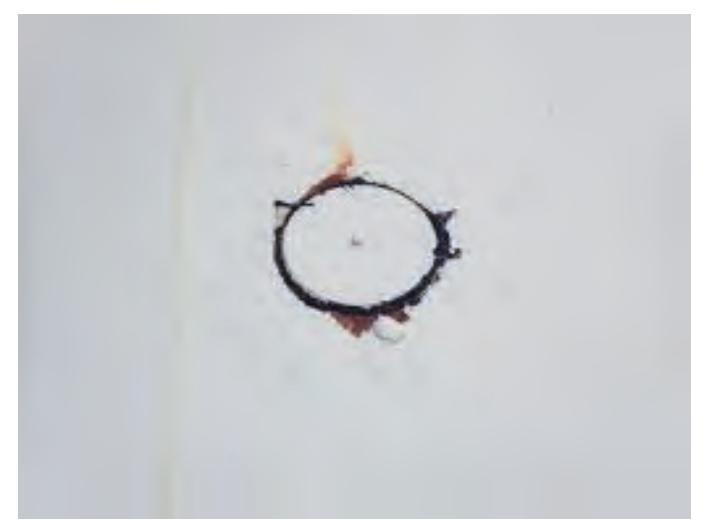
Roof Panels With Mild Mildew

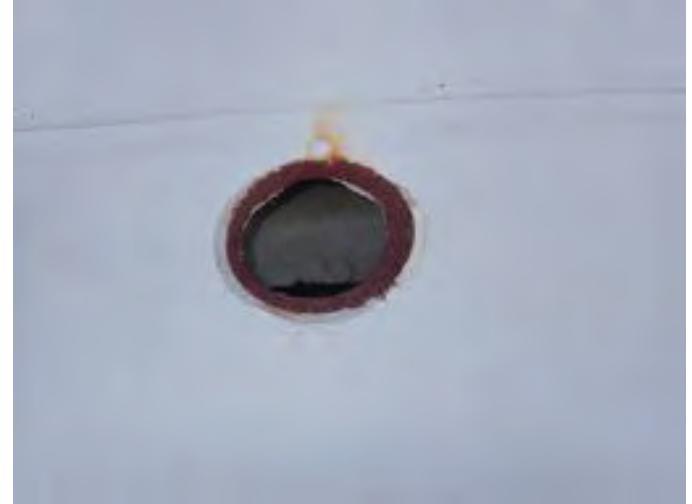
Roof Rigging Hole Penetration Sealed With A Cover Plate

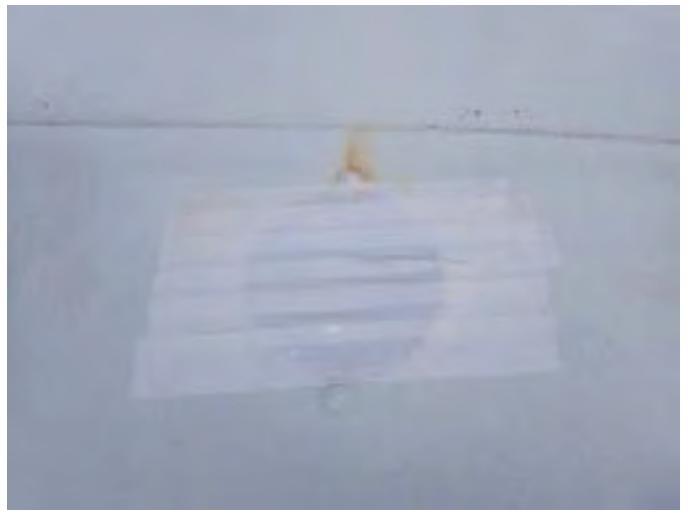
Open Roof Rigging Hole Penetration 98

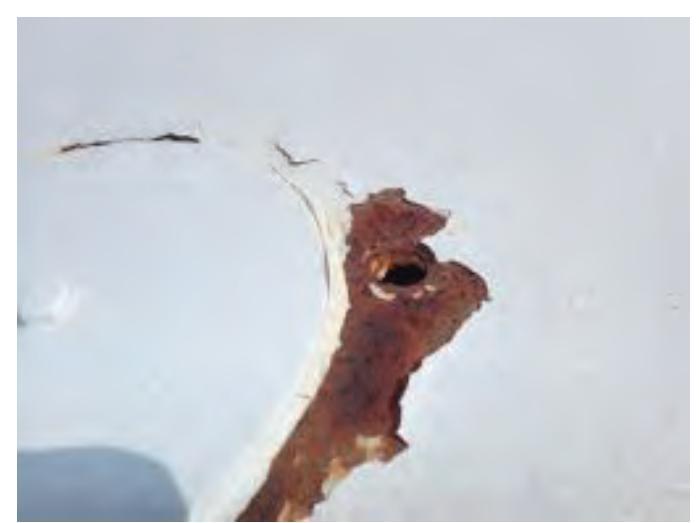
99 *Temporary Adhesive Tape Sealing The Open Roof Rigging Hole Penetration*

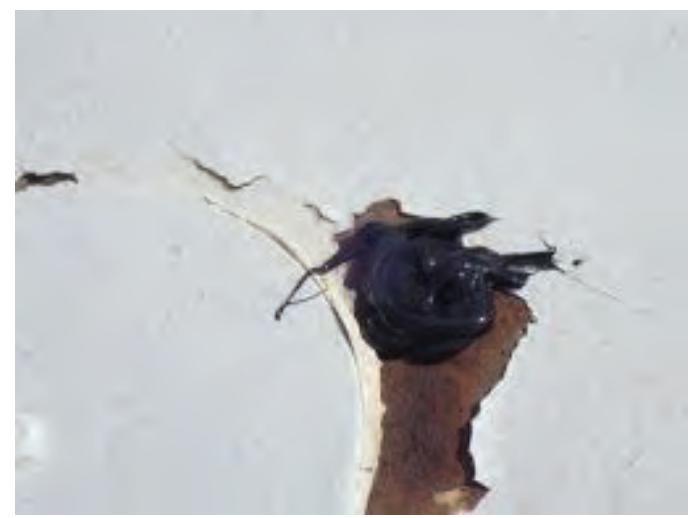
1/4" Diameter Penetration Wihin The Roof

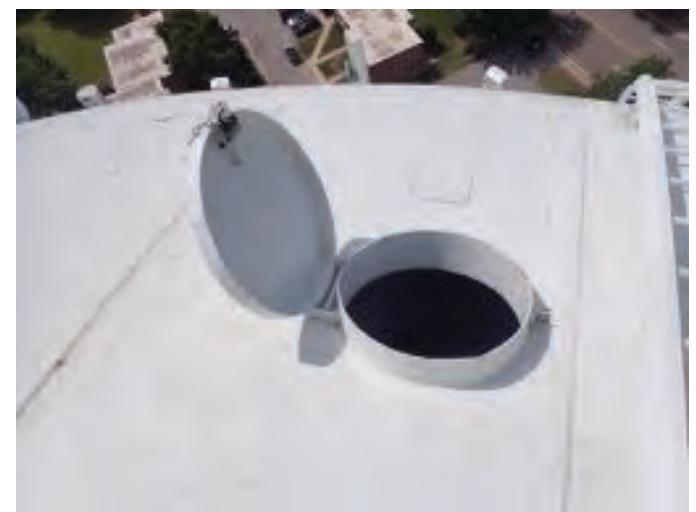
103 Secure Vent Screen With The Vent Assembly Having Isolated Coating Loss, Exposed Underlying Steel And Mild Corrosion

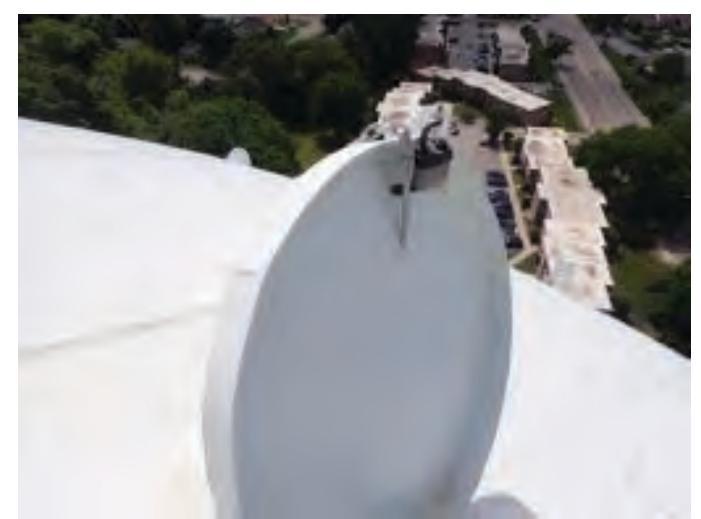
105 Interior Surfaces Of The Access Hatch Trunk With Minimal Coating Loss, Exposed Steel And Mild Surface Corrosion

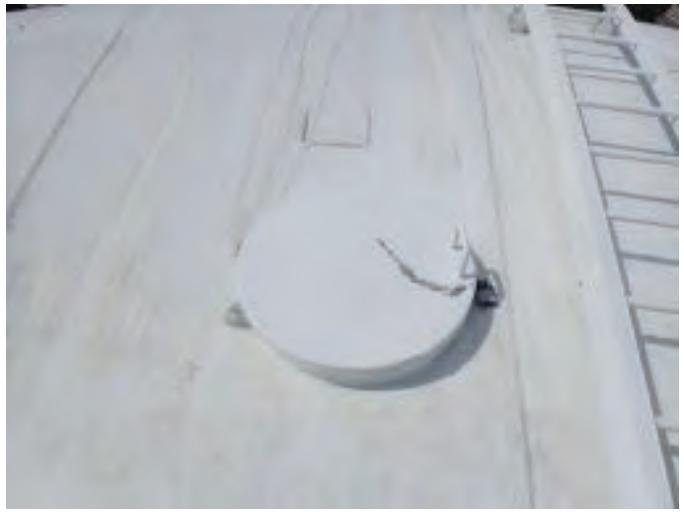
Access Hatch Inner Lid With Minimal Coating Loss, 106 Exposed Steel And Mild Surface Corrosion

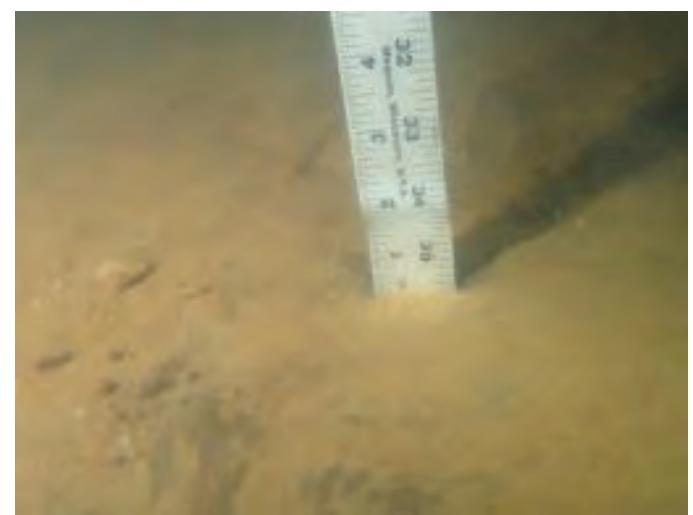
109 *Layer Of Precipitate*

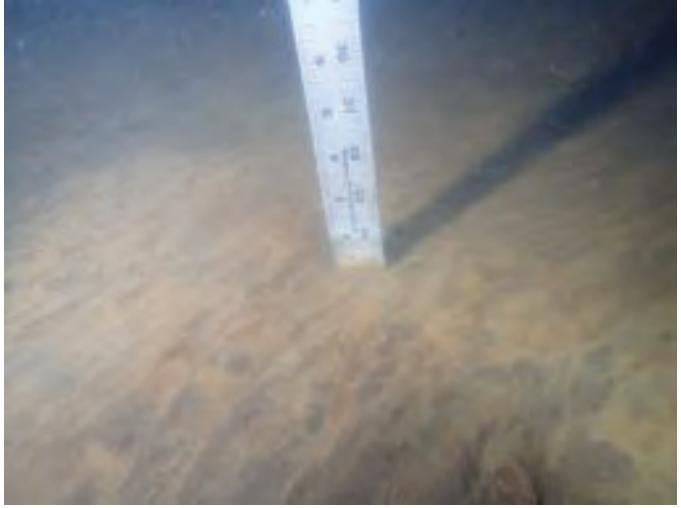
Layer Of Precipitate

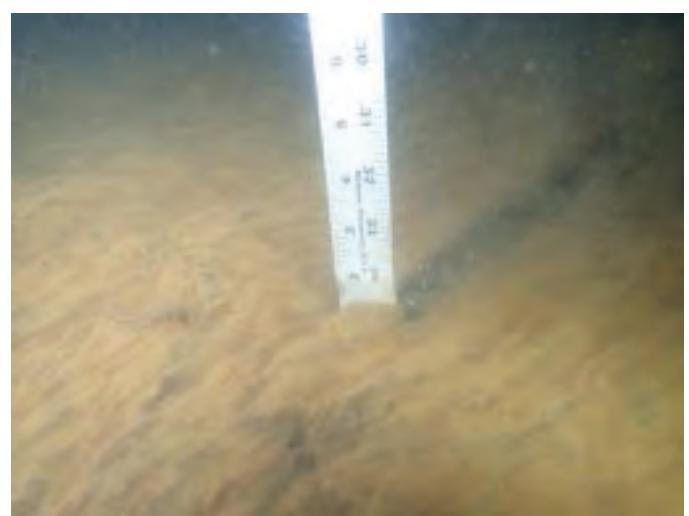
Layer Of Precipitate111

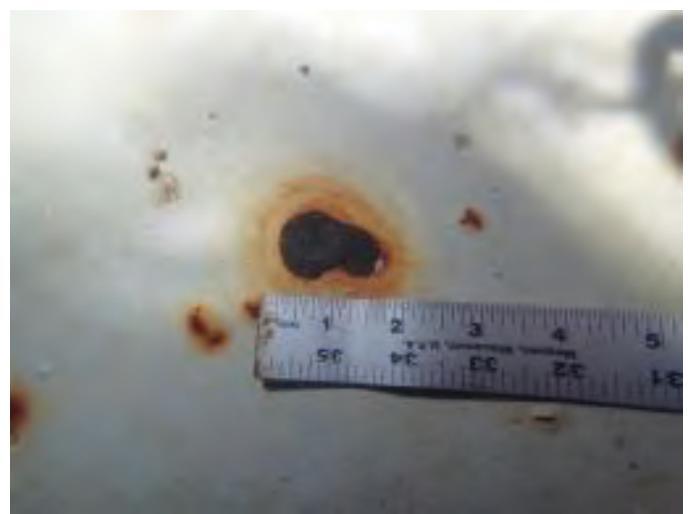
113 Floor With Coating Loss, Exposed Underlying Steel, Fatigue (Pitting), Corrosion And Mild Staining

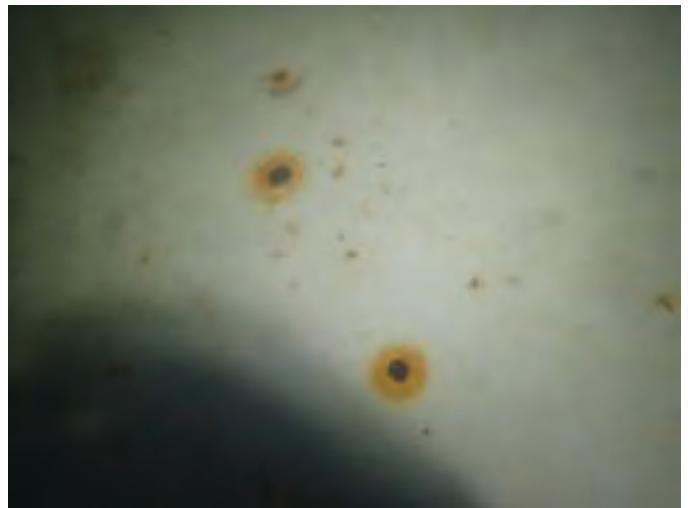
114 Floor With Coating Loss, Exposed Underlying Steel, Fatigue (Pitting), Corrosion And Mild Staining

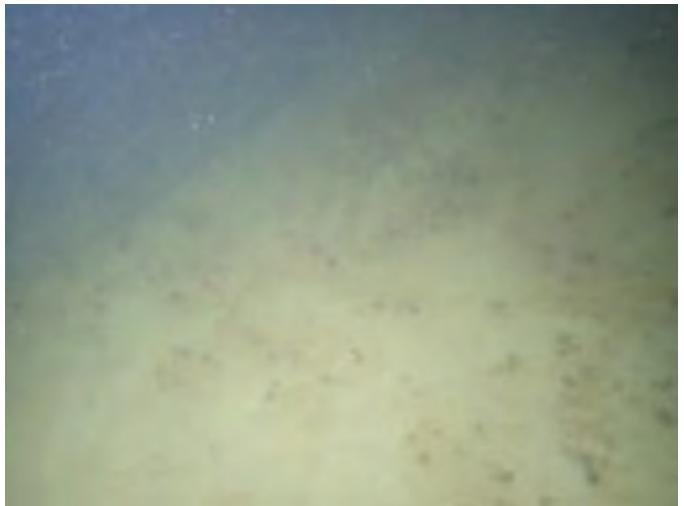
Floor With Coating Loss, Exposed Underlying Steel, 115 Fatigue (Pitting), Corrosion And Mild Staining

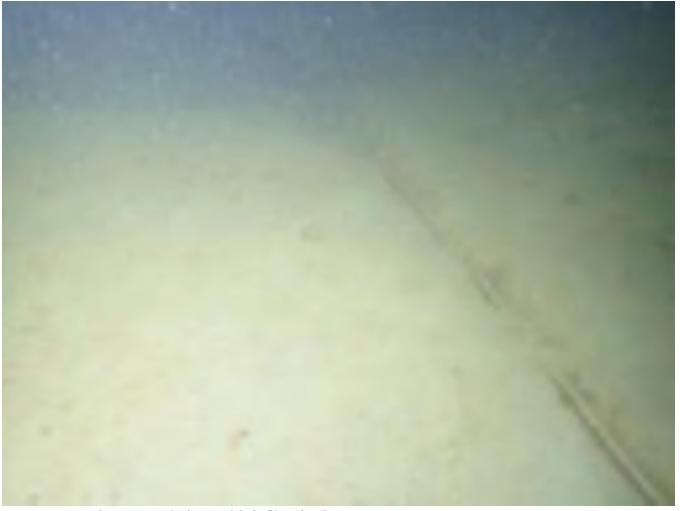
Floor With Mild Staining 116

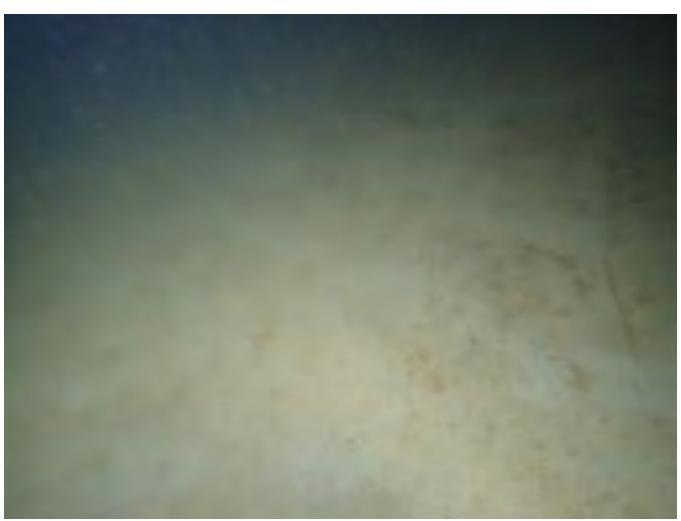
Floor With Mild Staining

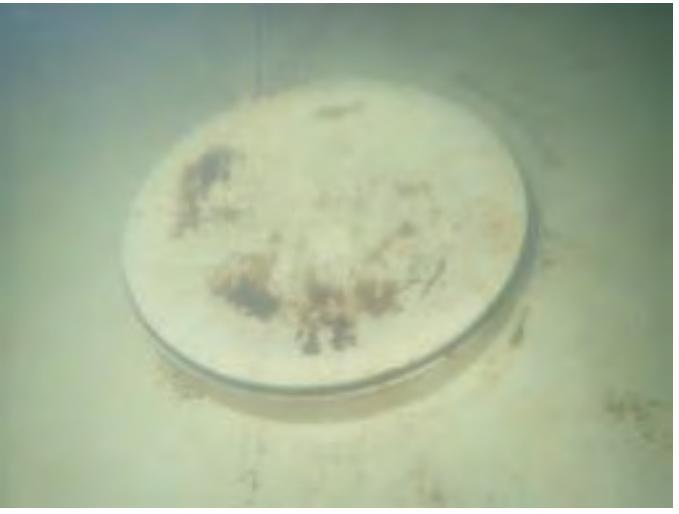
Floor With Mild Staining118

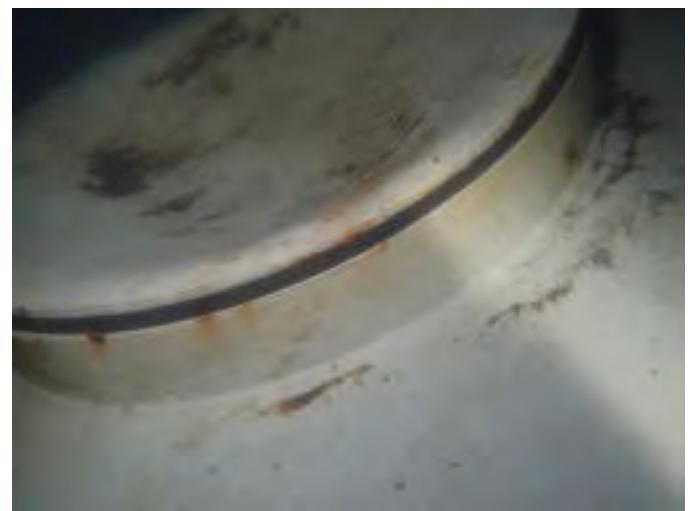
120 Manway With Coating Loss, Exposed Underlying Steel And Mild Corrosion

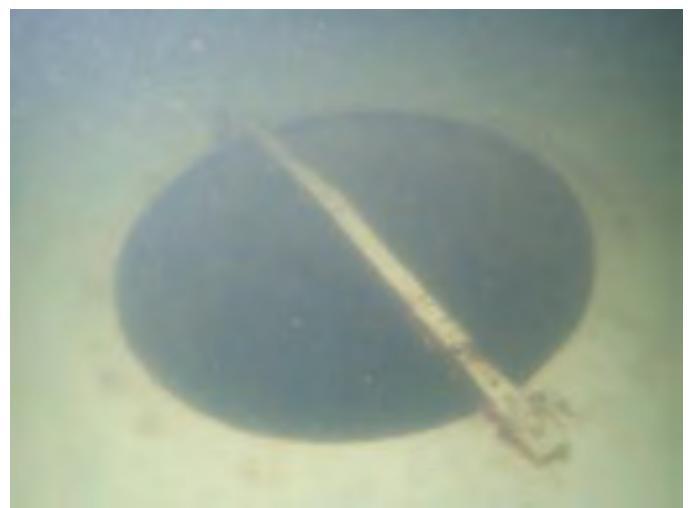
Manway With Coating Loss, Exposed Underlying 121 Steel And Mild Corrosion

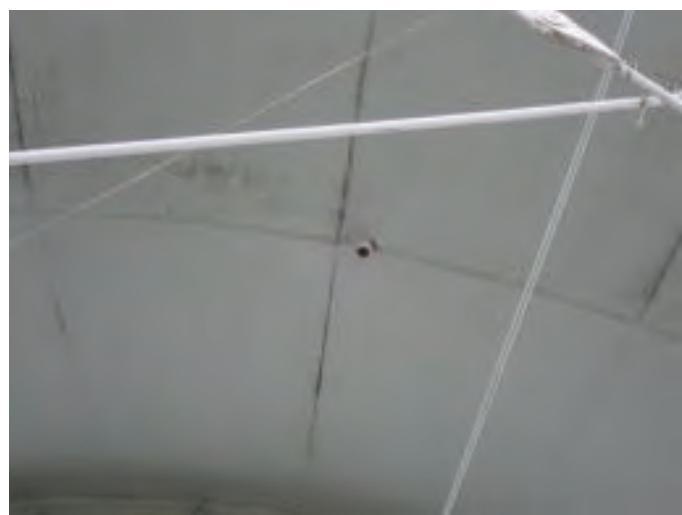
123 *3" Inside Diameter Penetration With A Plug Installed Having Coating Blisters, Exposed Metal And Corrosion*

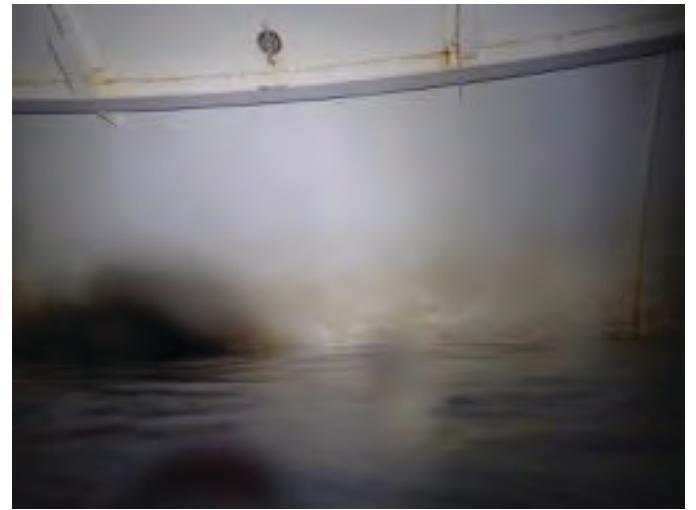
125 Interior Wall With Mild Staining

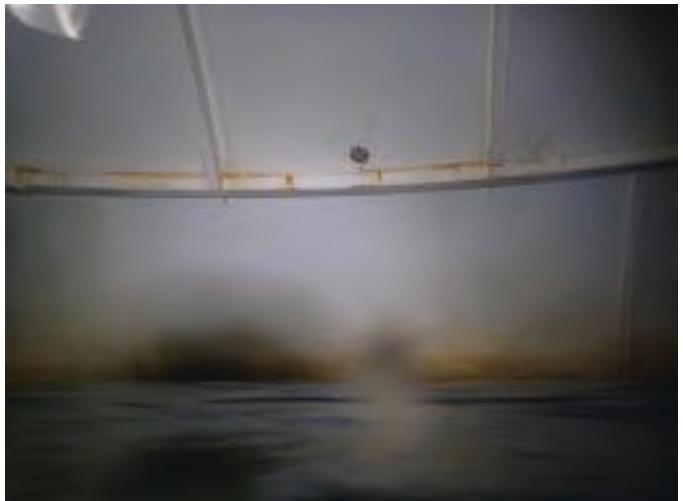
126 Interior Wall With Mild Staining

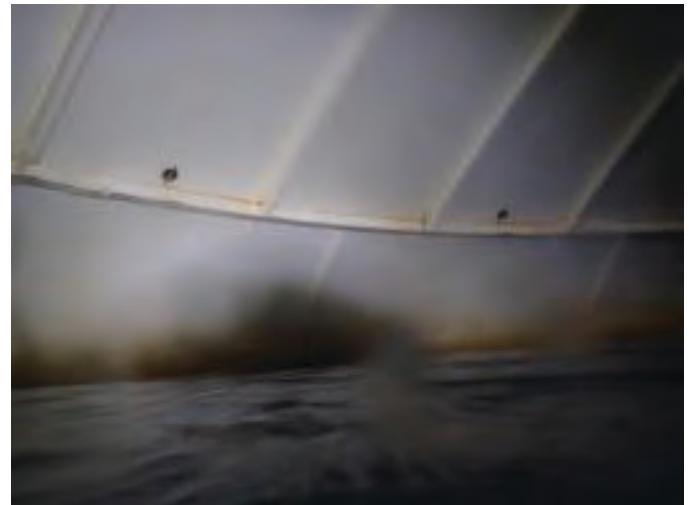
127 *Interior Wall With Mild Staining*

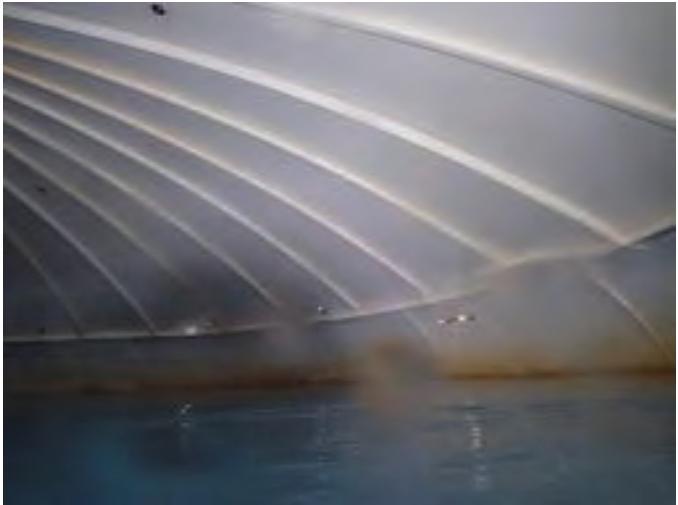
Interior Wall With Mild Staining128

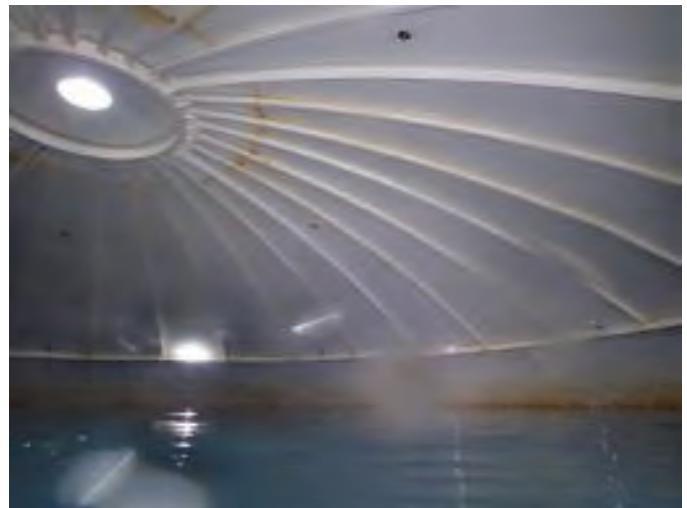
Overhead With Rust Staining

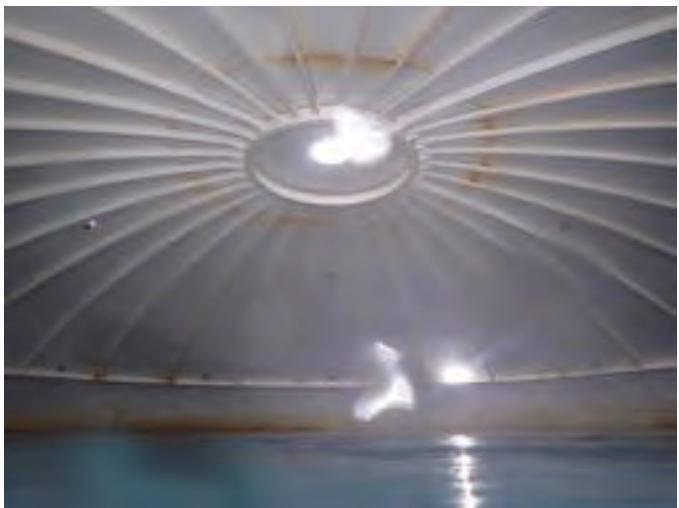
Overhead With Rust Staining

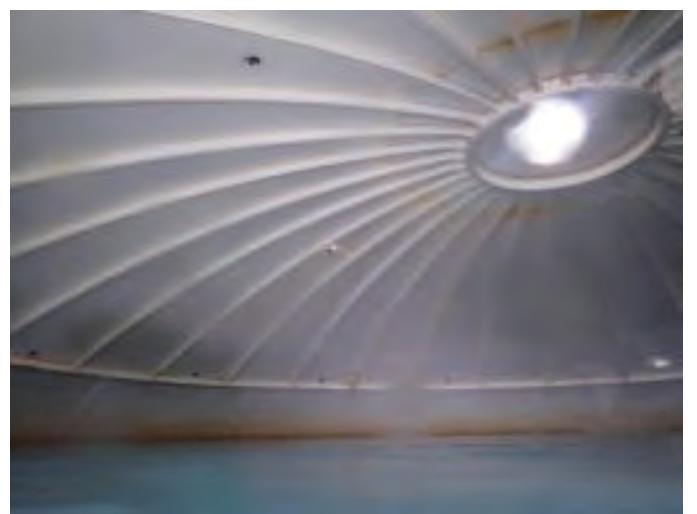
131 Overhead With Rust Staining

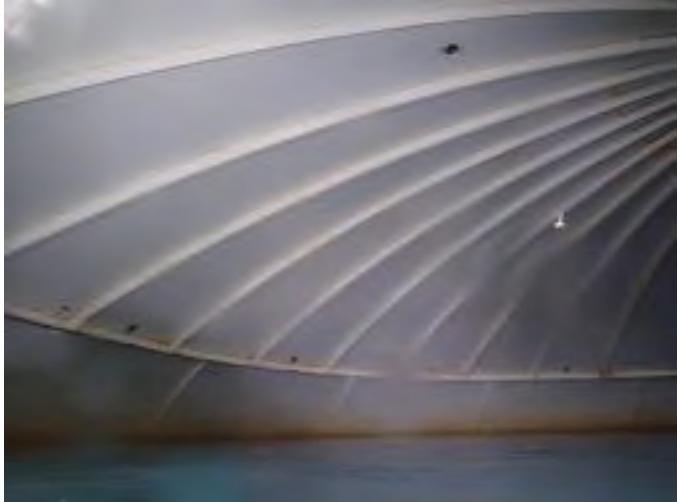
132 Overhead With Rust Staining

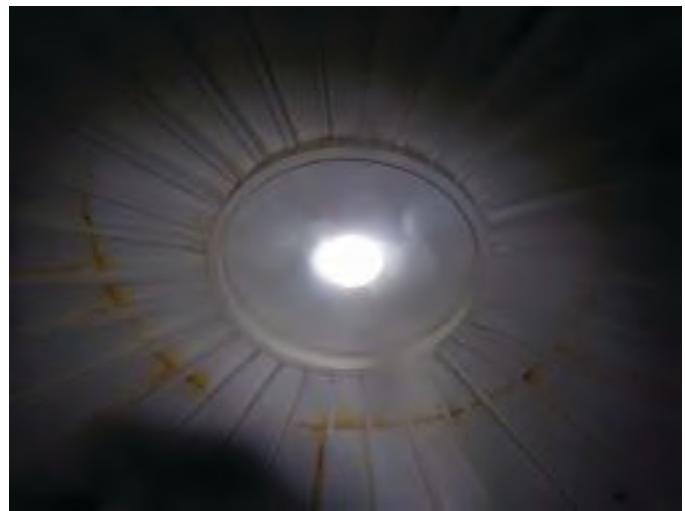
Overhead With Rust Staining

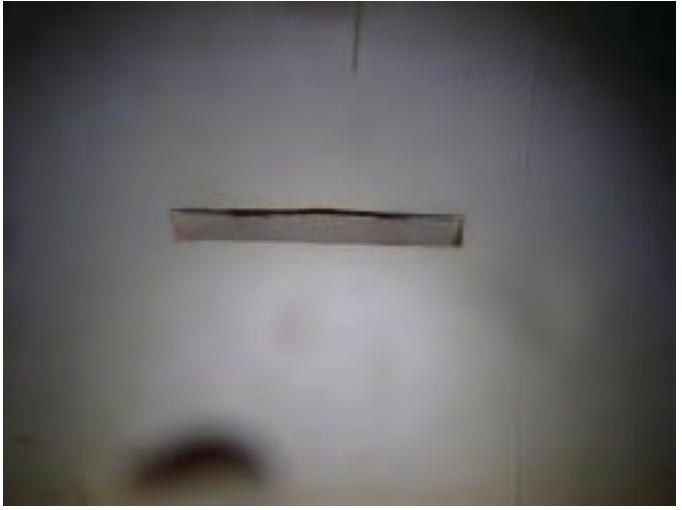
Overhead With Vent Penetration 134
