In re: City of Woonsocket Water Division - Application to Implement Multi-Year Rate Plan

Docket No. 4879

Dam Name (No):	Woonsocket Reservoir #3 Dam (068)
Location:	Smithfield/North Smithfield
Hazard Classification:	High
	-
Inspector:	David M. Matheson, P.E.
Inspection Date.	August 1, 2014

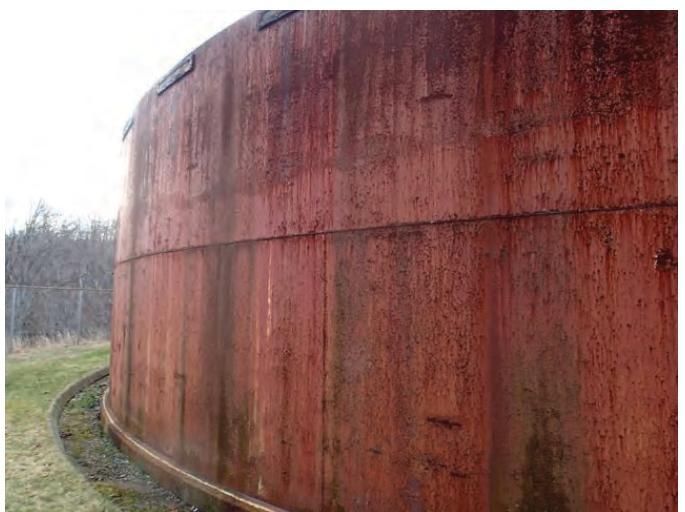
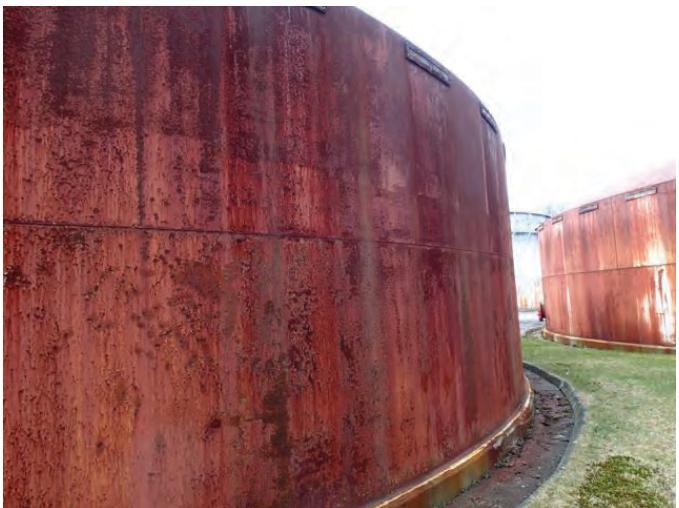
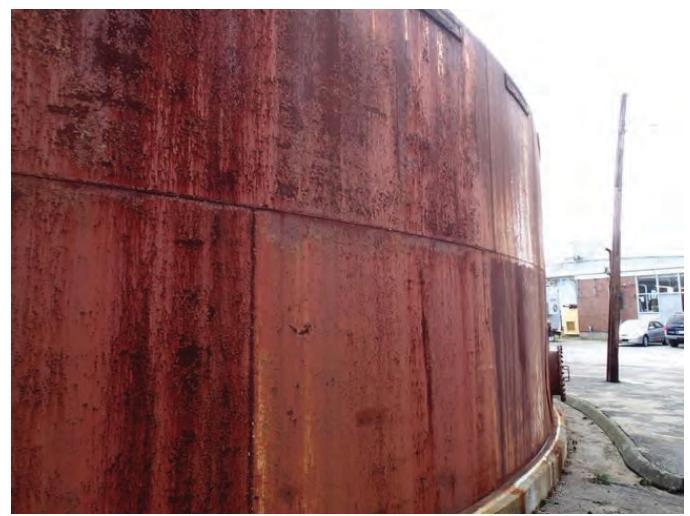
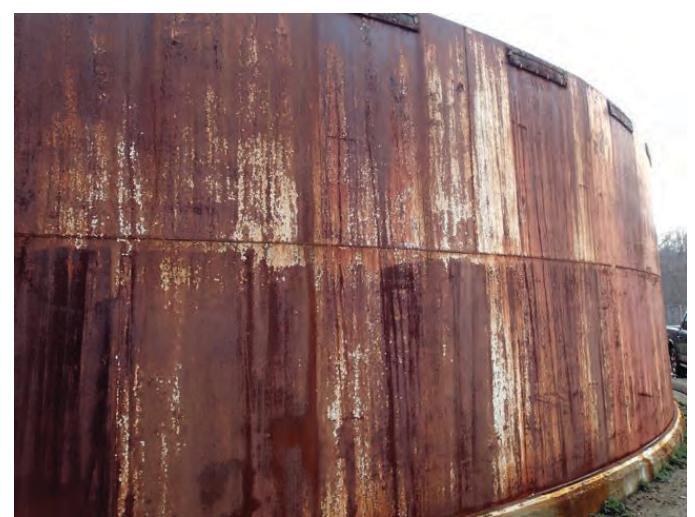
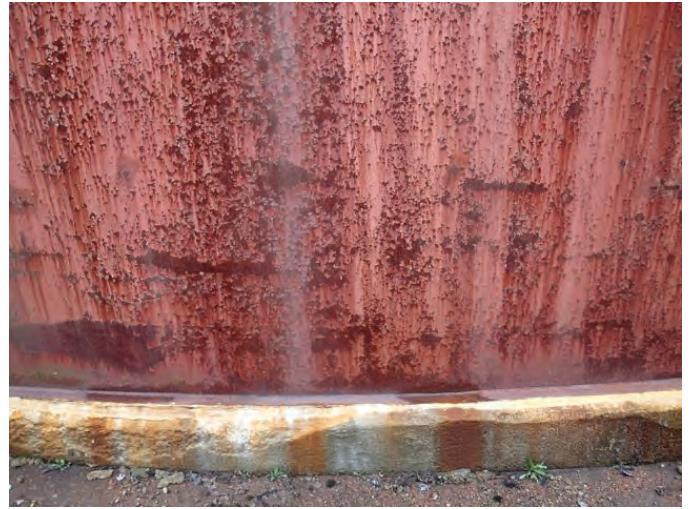
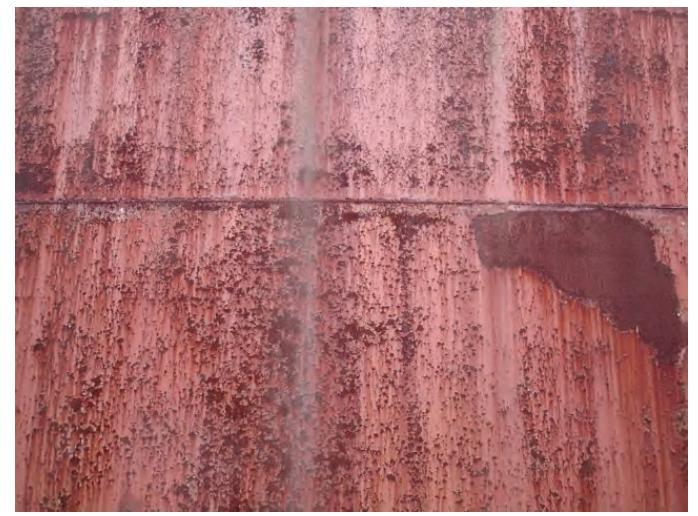
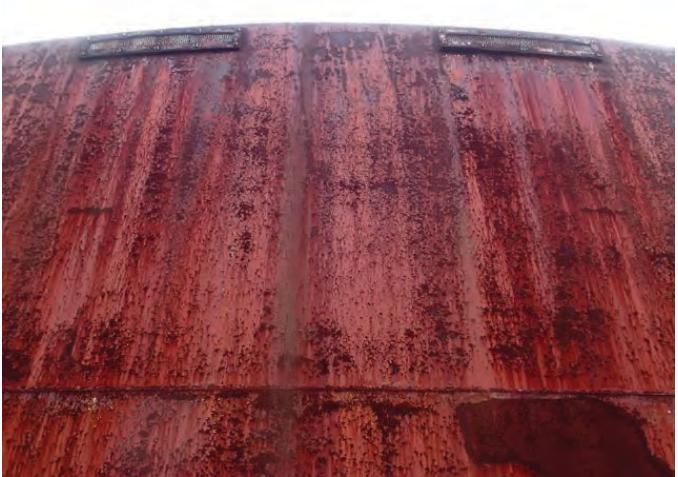
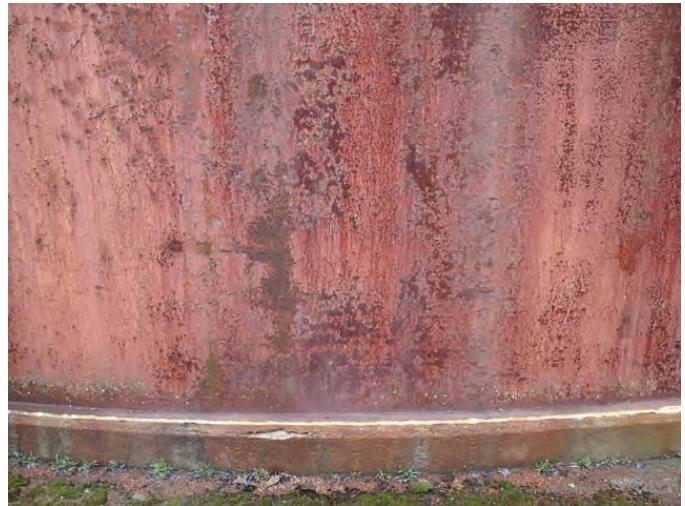
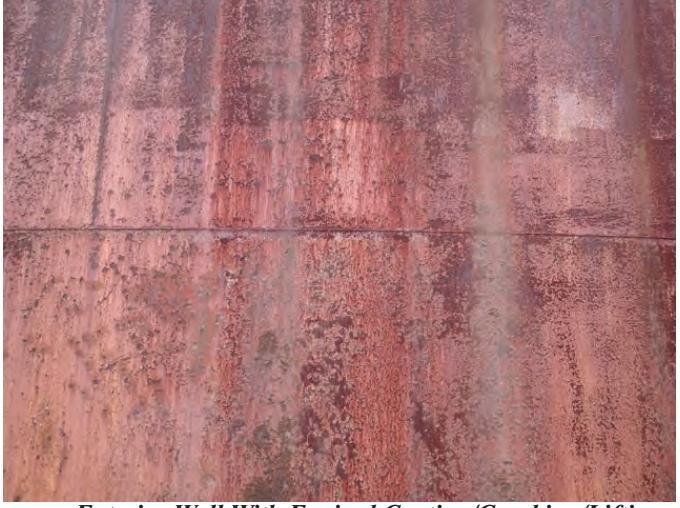
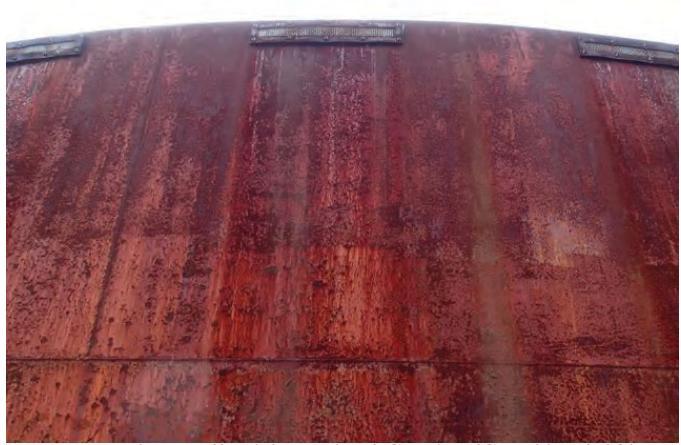
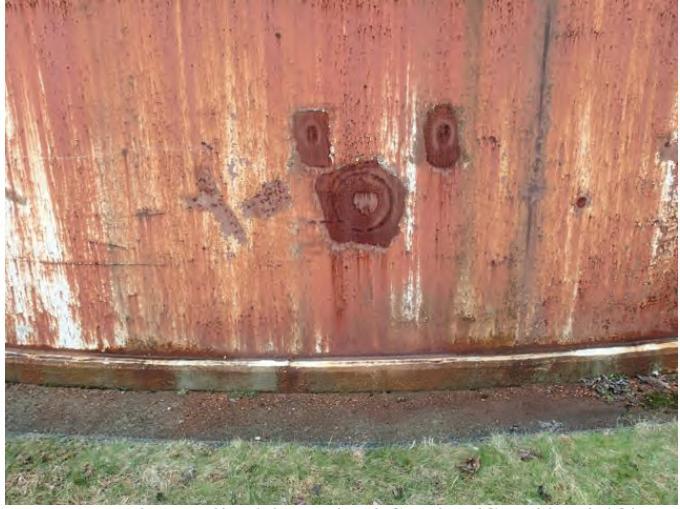
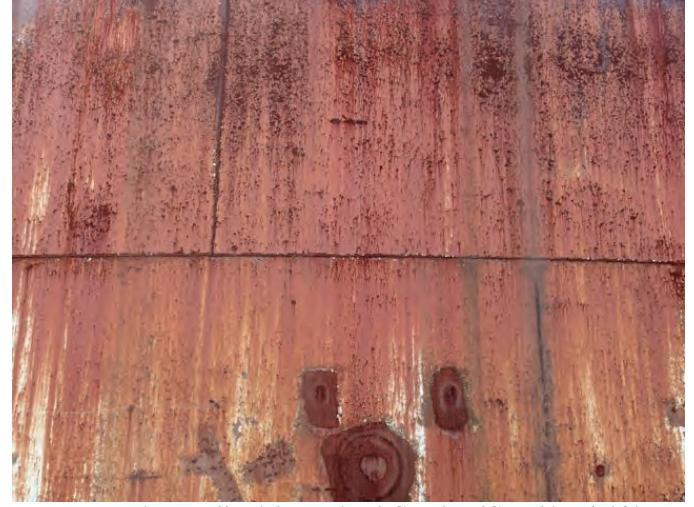
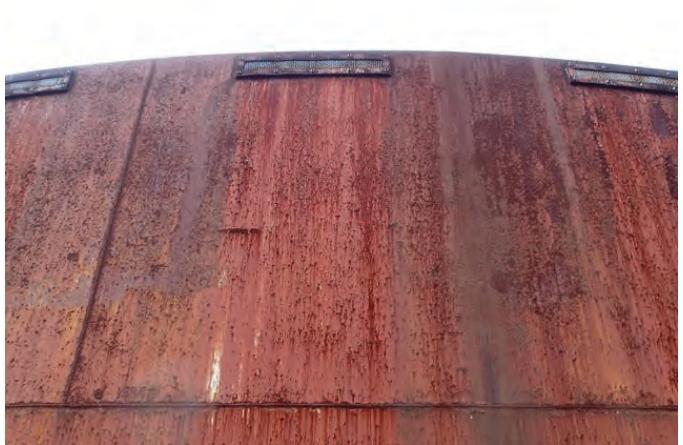
The protective coating applied to these welded steel surfaces has an average dry film thickness that is below the AWWA's recommendations and has expired and no longer provides protection for the steel wall panels or welds.

Cracking and lifting of the protective coating was found throughout approximately 85% of these surfaces and was observed throughout all elevations of the exterior walls, causing mild surface corrosion (blotch rusting) to show through the coating. Secondary coating adhesion loss has resulted in exposure of the primary coating throughout approximately 10% of these surfaces, while complete coating loss has resulted in exposure of the underlying steel throughout approximately 60% of these surfaces at this time.

1 Exterior Wall With Expired Coating/Cracking/Lifting, 1 Exposed Primary Coating, Exposed Underlying Steel, Mildew And Steel Corrosion

Exterior Wall With Expired Coating/Cracking/Lifting,
Exposed Primary Coating, Exposed Underlying Steel,
Mildew And Steel Corrosion

3 Exterior Wall With Expired Coating/Cracking/Lifting, 3 Exposed Primary Coating, Exposed Underlying Steel, Mildew And Steel Corrosion

4 Exterior Wall With Expired Coating/Cracking/Lifting, Exposed Primary Coating, Exposed Underlying Steel, Mildew And Steel Corrosion

5 Exterior Wall With Expired Coating/Cracking/Lifting, Exposed Primary Coating, Exposed Underlying Steel, Mildew And Steel Corrosion

6 Exterior Wall With Expired Coating/Cracking/Lifting, Exposed Primary Coating, Exposed Underlying Steel, Mildew And Steel Corrosion

8 Exterior Wall With Expired Coating/Cracking/Lifting, 8 Exposed Primary Coating, Exposed Underlying Steel, Mildew And Steel Corrosion

9 Exterior Wall With Expired Coating/Cracking/Lifting, Exposed Primary Coating, Exposed Underlying Steel, Mildew And Steel Corrosion

10 Exterior Wall With Expired Coating/Cracking/Lifting, Exposed Primary Coating, Exposed Underlying Steel, Mildew And Steel Corrosion

11 Exterior Wall With Expired Coating/Cracking/Lifting, Exposed Primary Coating, Exposed Underlying Steel, Mildew And Steel Corrosion

12 Exterior Wall With Expired Coating/Cracking/Lifting, Exposed Primary Coating, Exposed Underlying Steel, Mildew And Steel Corrosion

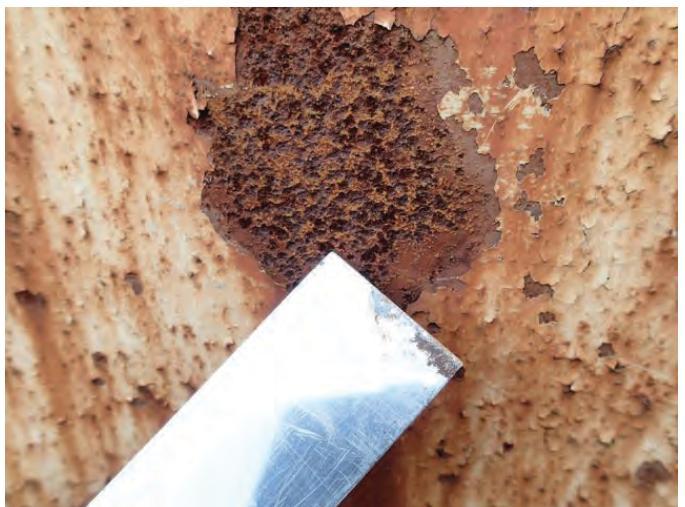
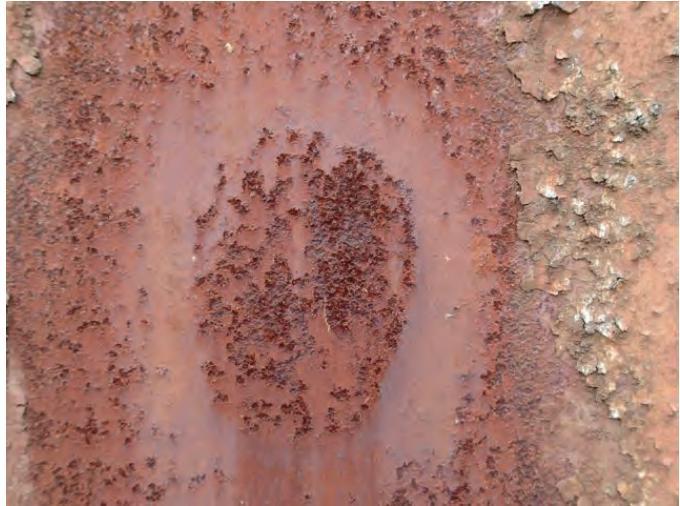
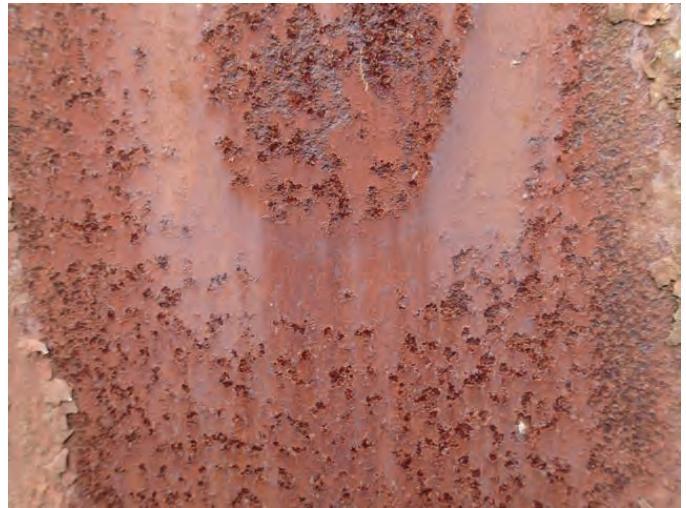
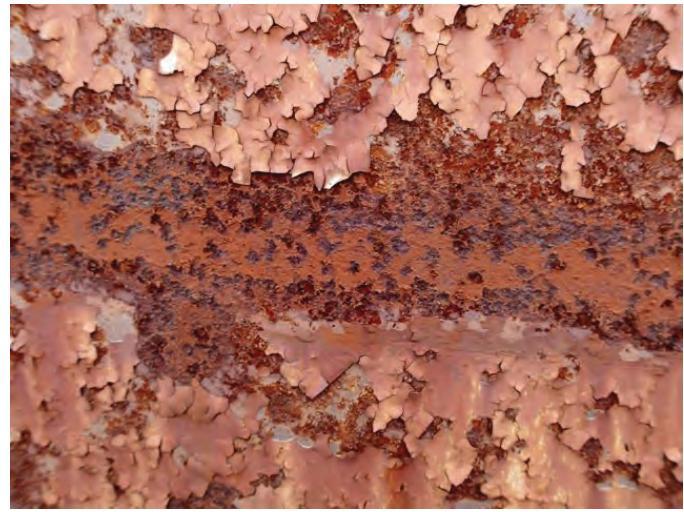
Corrosion of the exposed steel was evident within all areas of coating adhesion loss, while fatigue (pitting) of the steel having depths from barely detectable levels up to 1/32" was observed within approximately 5% of the areas of steel exposure at this time.

Exterior Wall With Surface Corrosion And Minimal 14 Steel Fatigue (Pitting)

Exterior Wall With Surface Corrosion And Minimal
Steel Fatigue (Pitting)

16 *Exterior Wall With Surface Corrosion And Minimal Steel Fatigue (Pitting)*

17 Exterior Wall With Surface Corrosion And Minimal Steel Fatigue (Pitting)

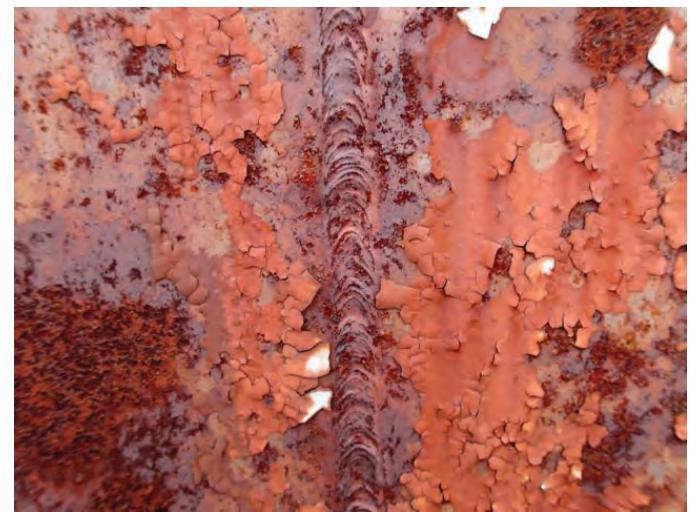
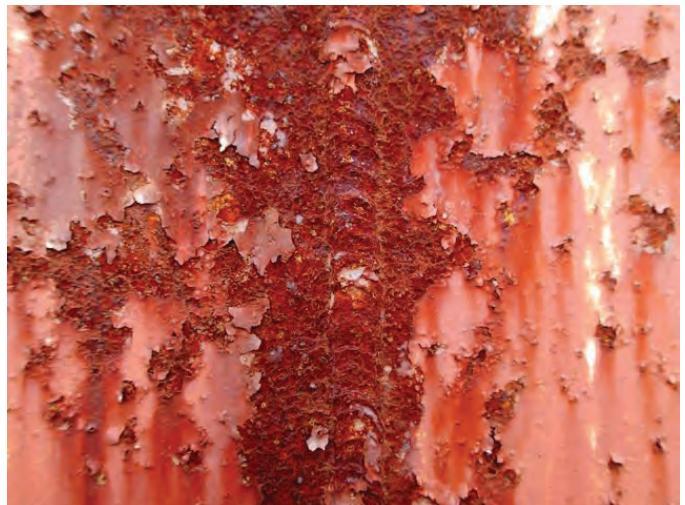
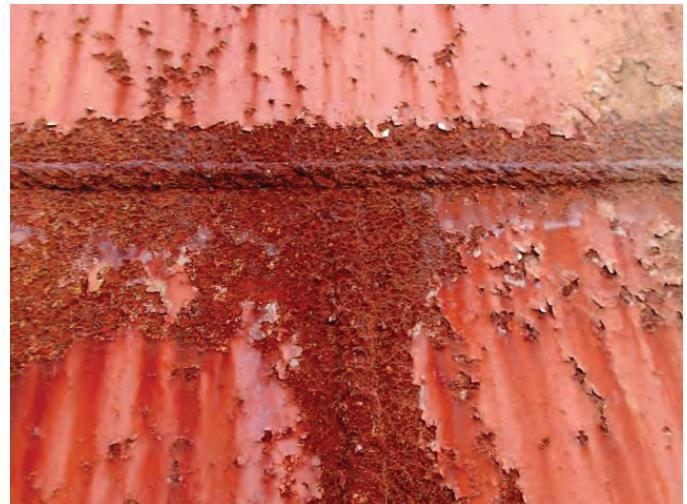
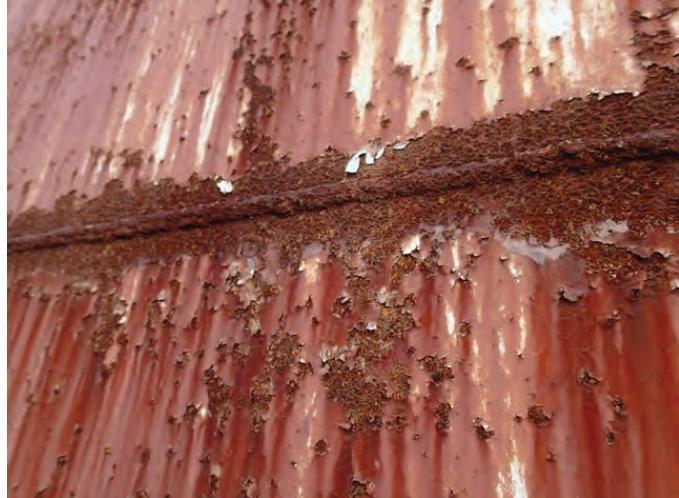
18Exterior Weld Between Wall Panels With Surface
Corrosion

19 Exterior Weld Between Wall Panels With Surface Corrosion

Exterior Weld Between Wall Panels With Surface 20 Corrosion

21 *Exterior Weld Between Wall Panels With Surface* Corrosion

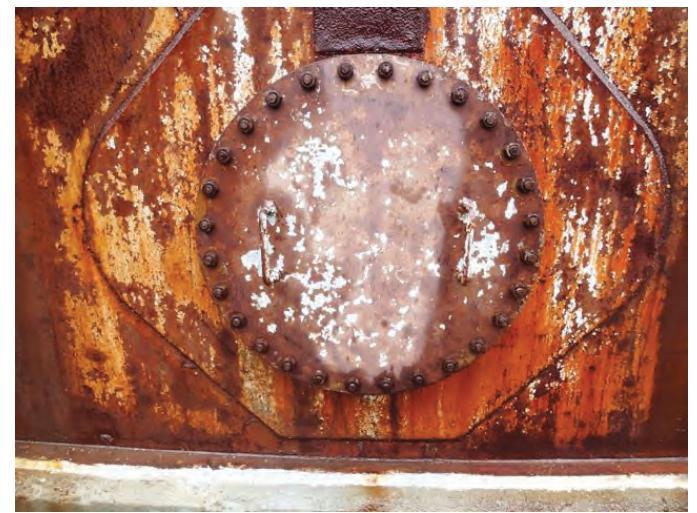
No obvious fatigue (pitting) of the steel manway lid or trunk was evident within these areas of steel exposure and no obvious deterioration of the securing hardware was evident within these areas of steel exposure, rather mild surface corrosion exists at this time.

22 Secure Manway With Expired Coating, Exposed Underlying Primary Coating, Exposed Underlying Steel And Mild Surface Corrosion

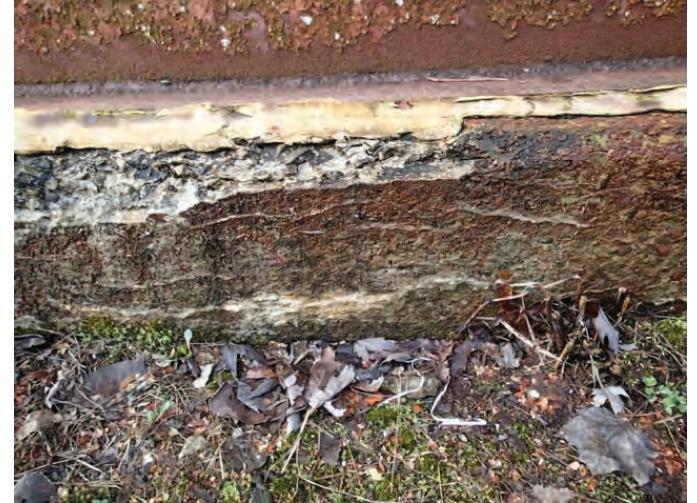
The exposed surfaces of the 3" wide by 12" tall concrete foundation is not coated and was found having tight surface cracks throughout approximately 5% of these exposed concrete surfaces.

These cracks were sounded, and no obvious voids were evident, however numerous areas of concrete spall exist throughout approximately 10% of the circumference of the foundation, ranging in size from 6" long by 2" wide to 19' long by 6" wide. The surrounding and underlying concrete within these areas of spall appeared sound. No obvious exposure of the underlying reinforcement steel was evident within these areas of concrete spall at this time.

24 Concrete Foundation With Tight Surface Cracks And Spall

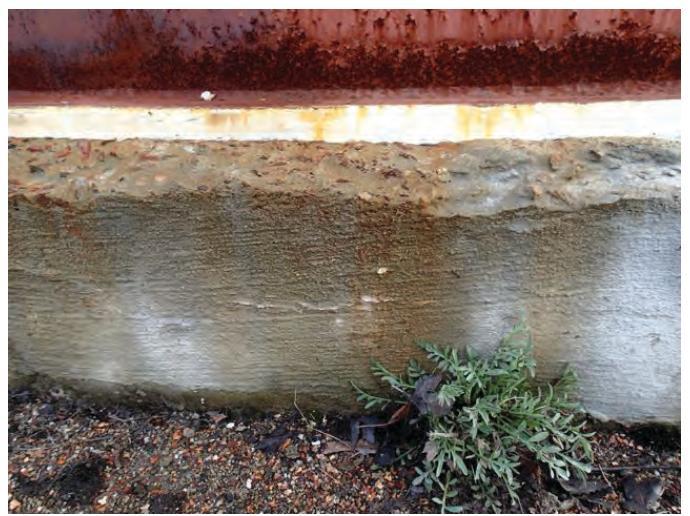
25 Concrete Foundation With Tight Surface Cracks

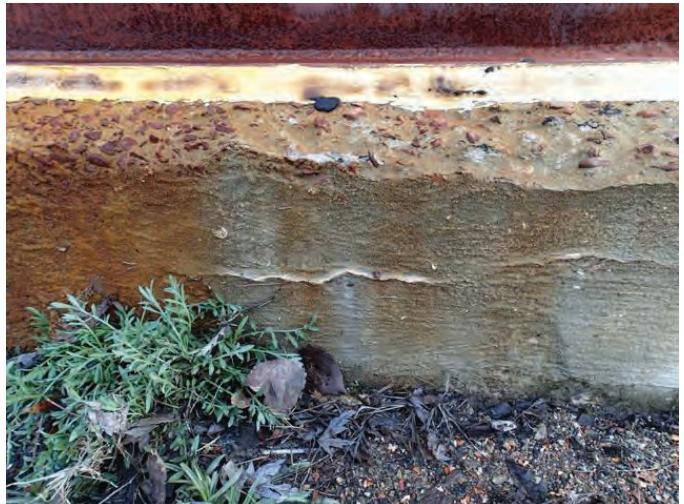
Concrete Foundation With Tight Surface Cracks 26

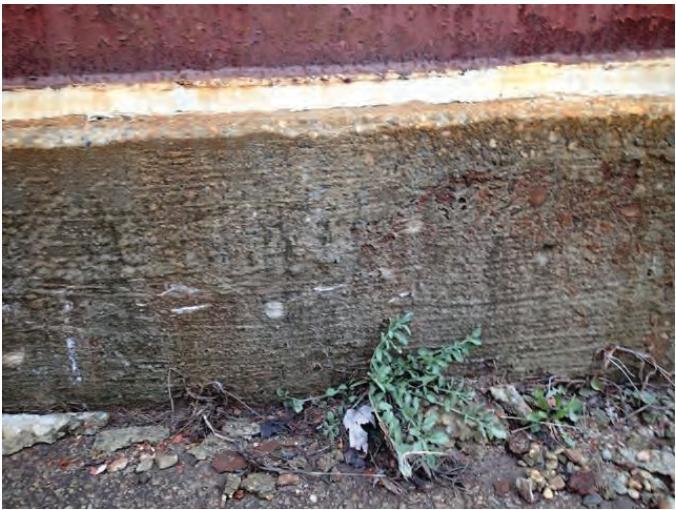
27 Concrete Foundation With Tight Surface Cracks

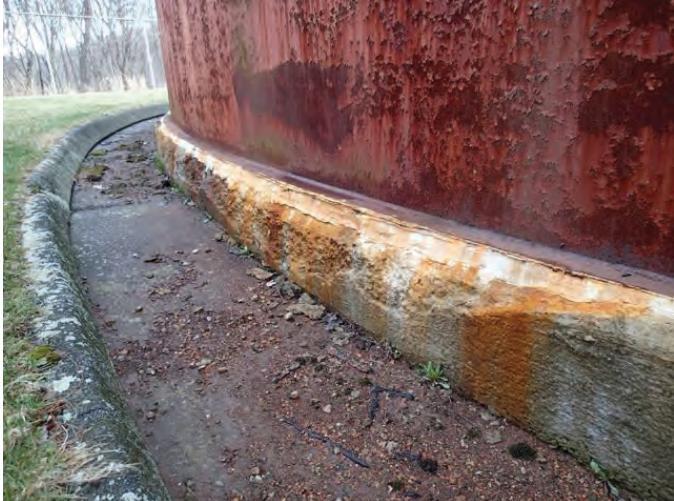
28 Concrete Foundation With Tight Surface Cracks

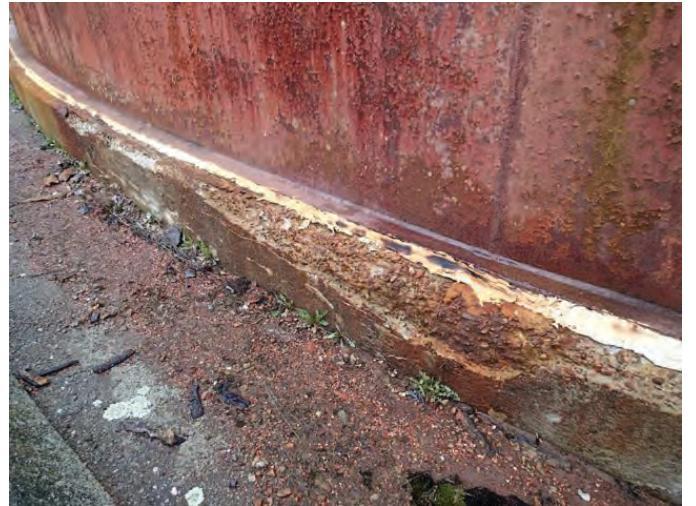
29 Concrete Foundation With Spall

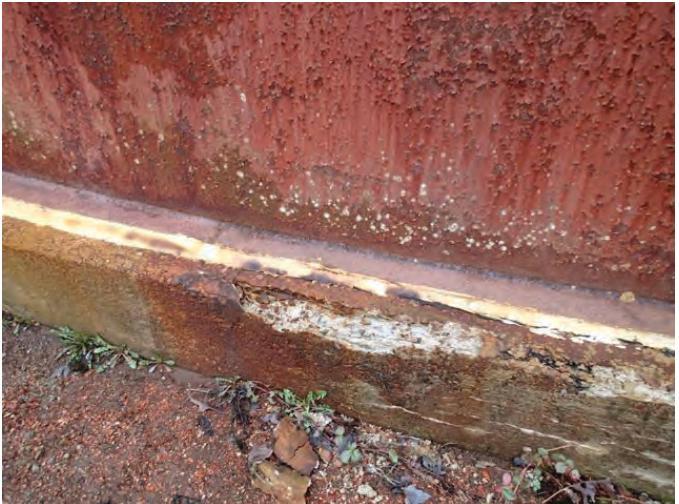
30 Concrete Foundation With Spall

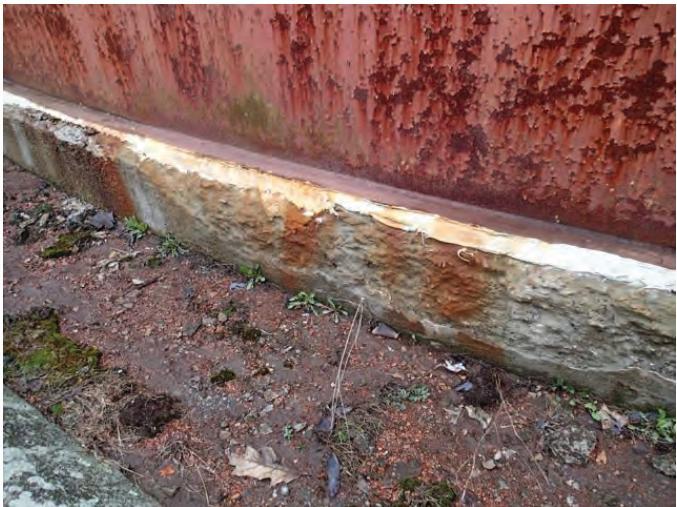
Concrete Foundation With Spall

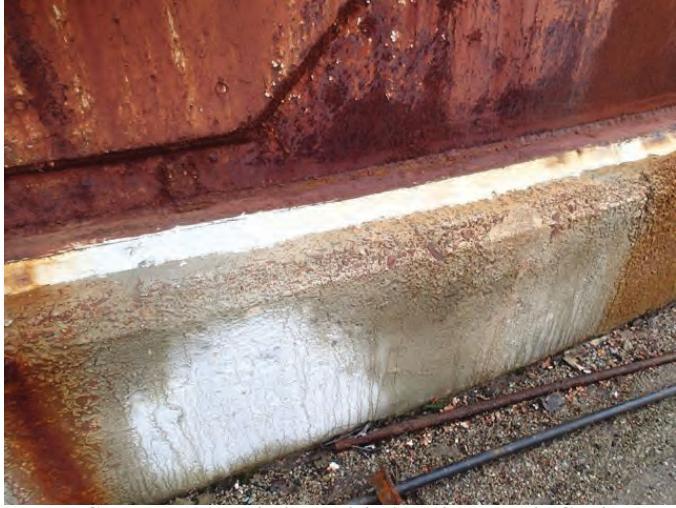
Concrete Foundation With Spall

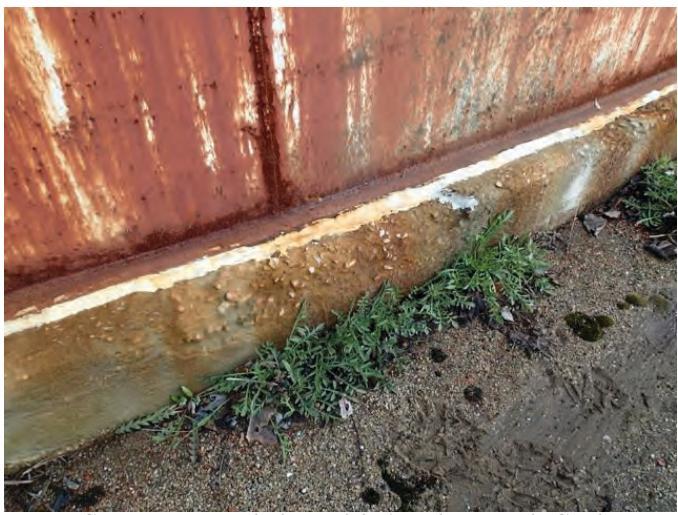
33 Concrete Foundation With An Elastemeric Sealant Applied

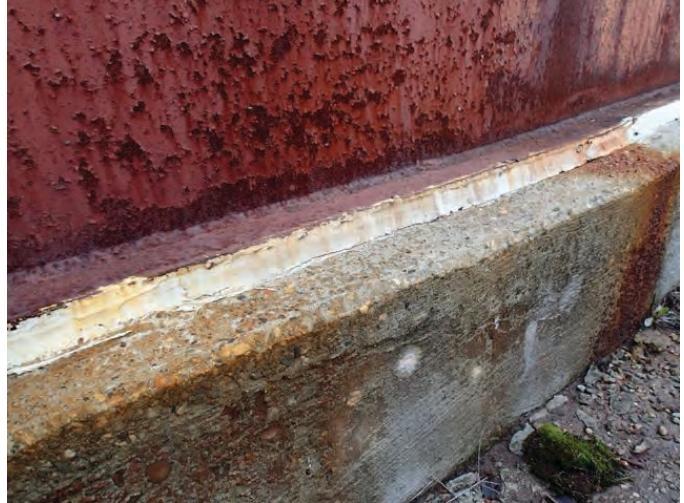
34 *Concrete Foundation With An Elastemeric Sealant Applied*

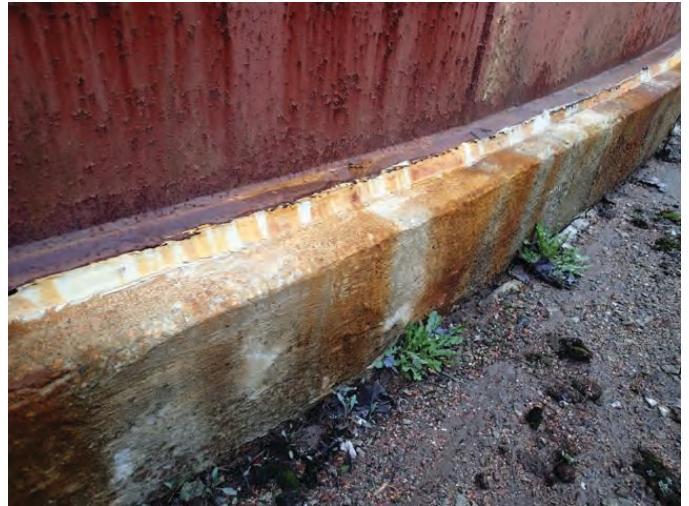
35 Concrete Foundation With An Elastemeric Sealant Applied At The Tank Base And Foundation

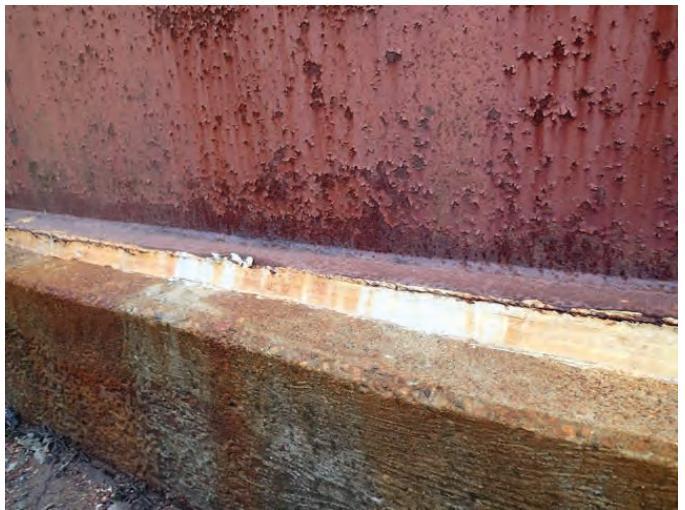
36 *Concrete Foundation With An Elastemeric Sealant Applied At The Tank Base And Foundation*

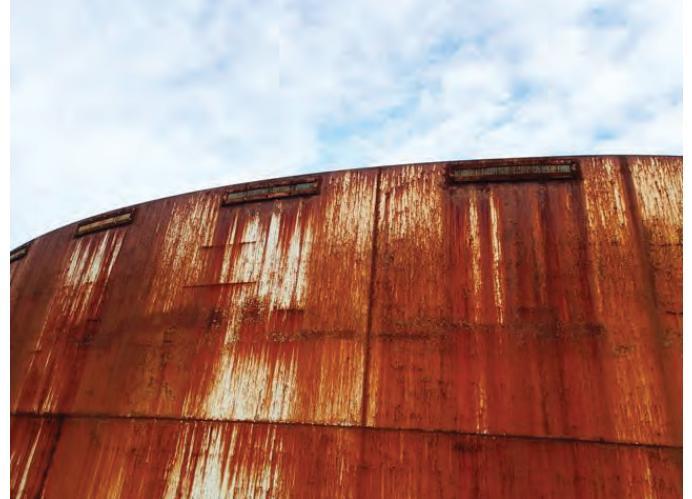
Secure Overflow Screen Cutouts

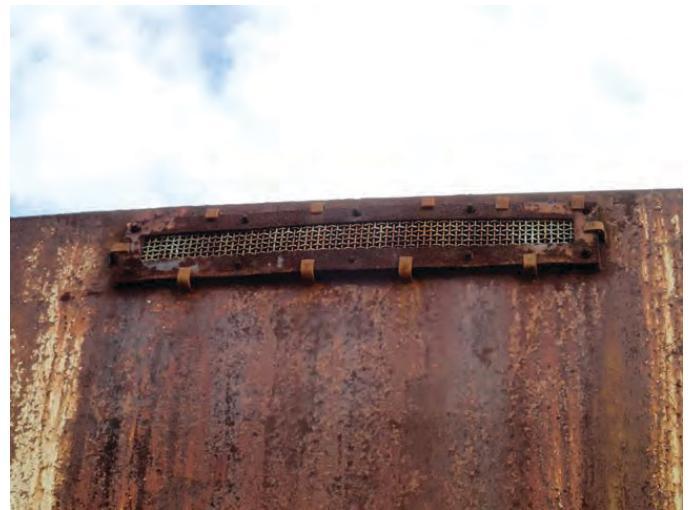
39 Secure Overflow Screen Cutouts

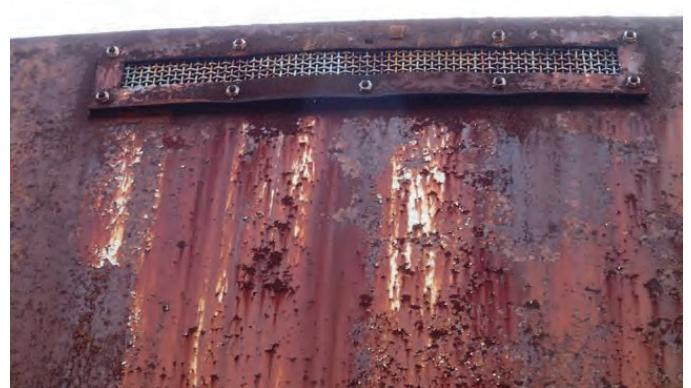
40 Secure Overflow Screen Cutout

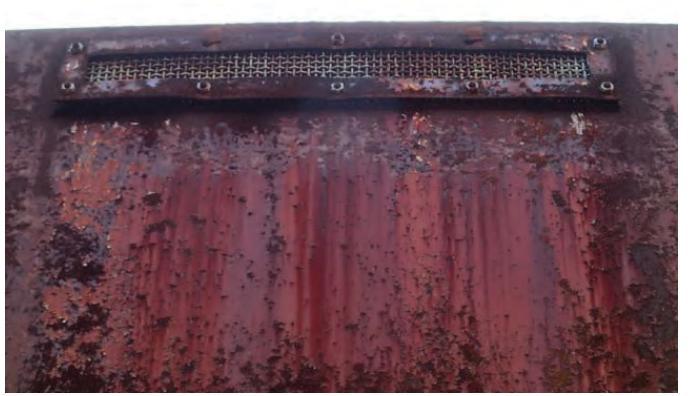
41 Secure Overflow Screen Cutout

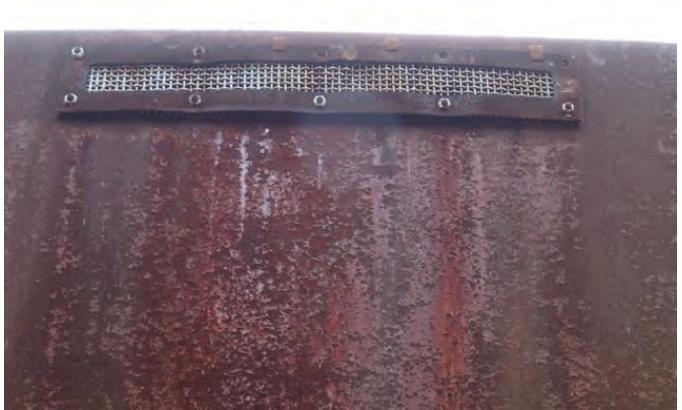
42 Secure Overflow Screen Cutout

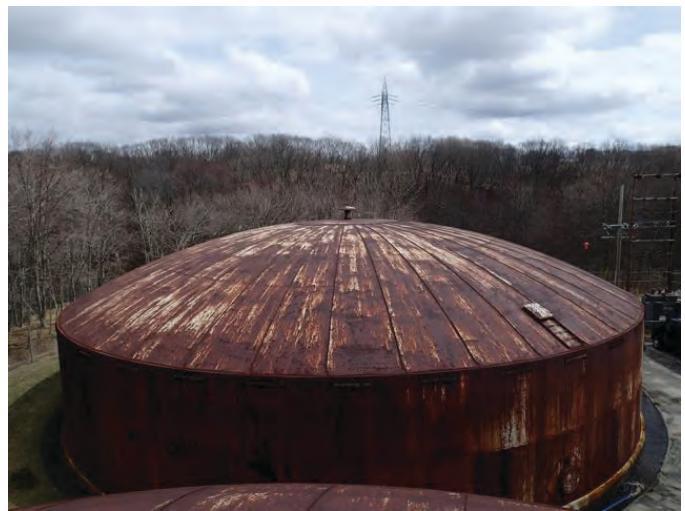
43 Secure Overflow Screen Cutout

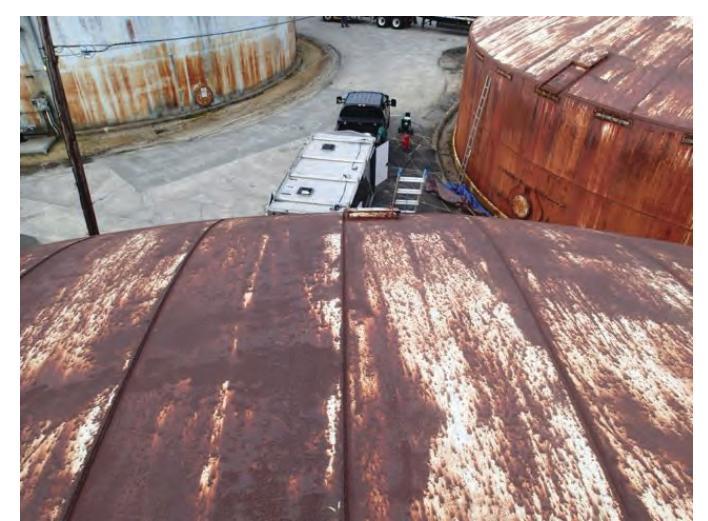
45 Roof Panels With Expired Coating, Exposed Primary/ Secondary Coating, Exposed Underlying Steel And Mild Surface Corrosion

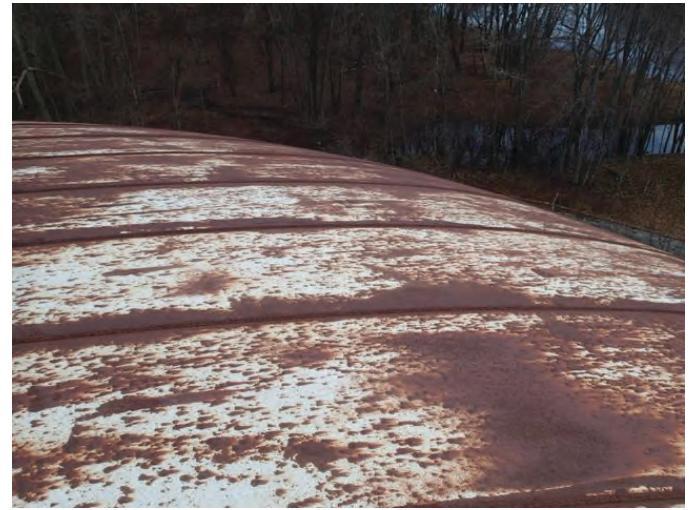
Roof Panels With Expired Coating, Exposed Primary/ Secondary Coating, Exposed Underlying Steel And Mild Surface Corrosion

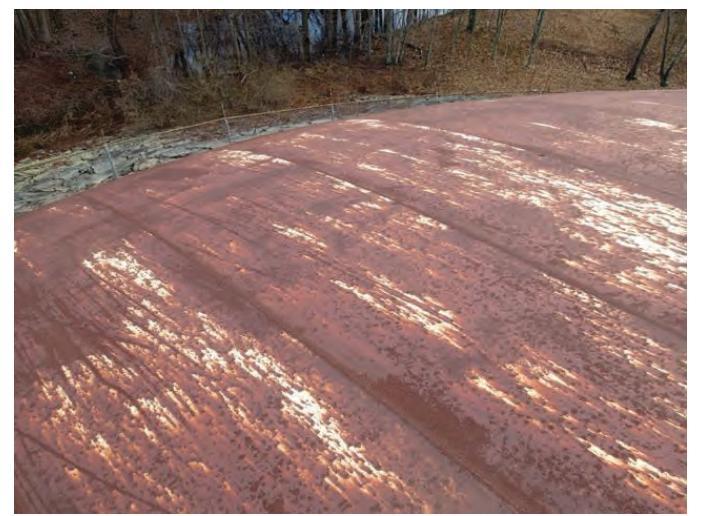
47 Roof Panels With Expired Coating, Exposed Primary/ Secondary Coating, Exposed Underlying Steel And Mild Surface Corrosion

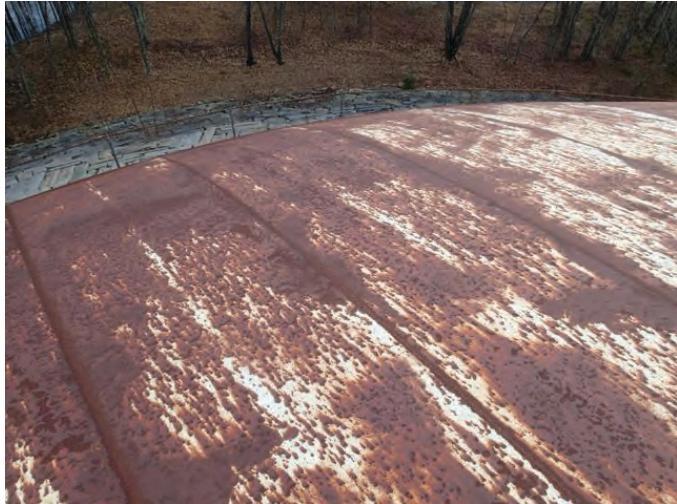
48 Roof Panels With Expired Coating, Exposed Primary/ Secondary Coating, Exposed Underlying Steel And Mild Surface Corrosion

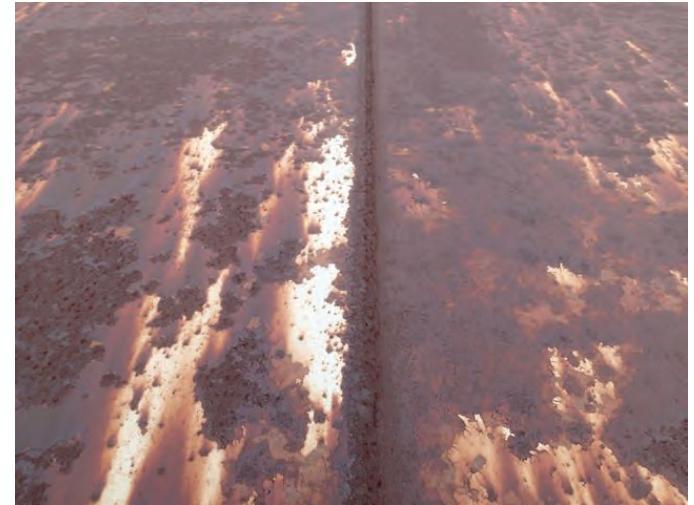
49 Roof Panels With Expired Coating, Exposed Primary/ Secondary Coating, Exposed Underlying Steel And Mild Surface Corrosion

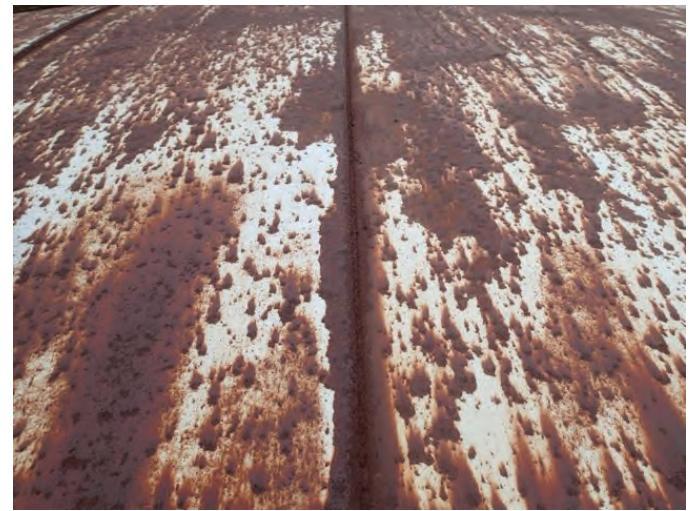
Roof Panels With Expired Coating, Exposed Primary/
Secondary Coating, Exposed Underlying Steel And Mild Surface Corrosion

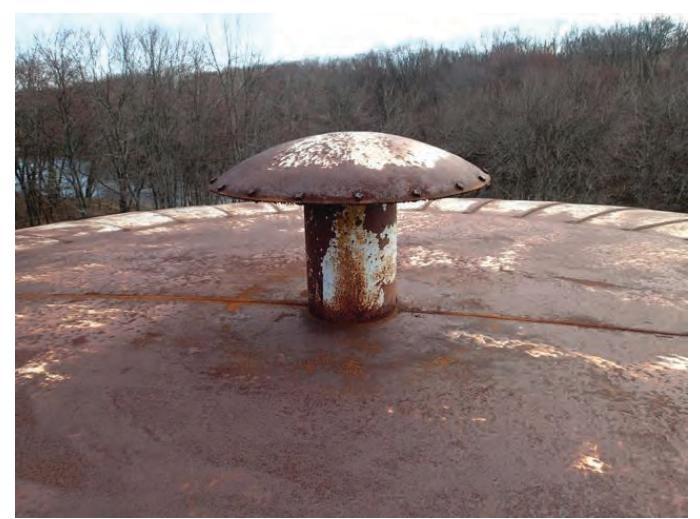
51 Roof Panels With Expired Coating, Exposed Primary/ Secondary Coating, Exposed Underlying Steel And Mild Surface Corrosion

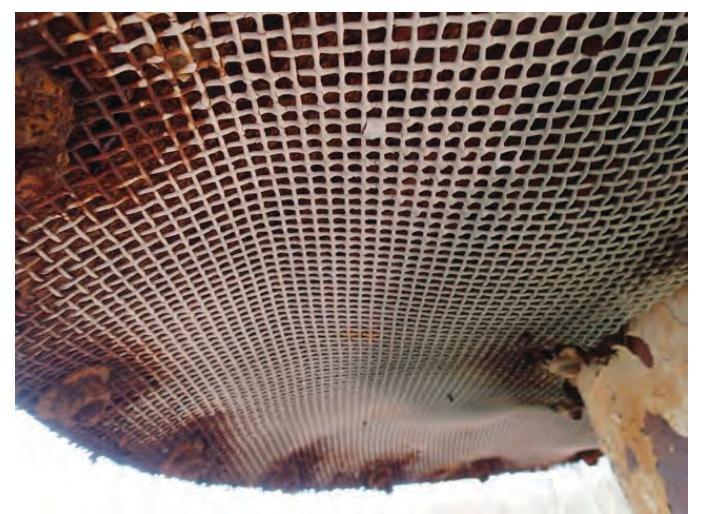
52 Secure Vent Cap With Expired Coating, Exposed 52 Steel And Corrosion

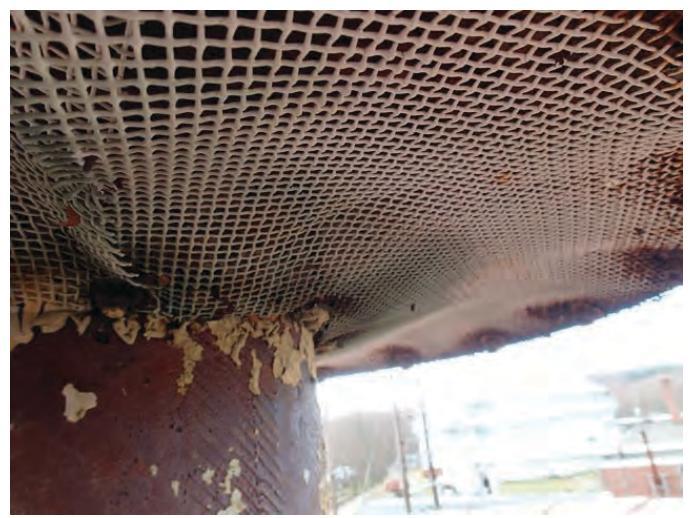
53 Secure Vent Screen

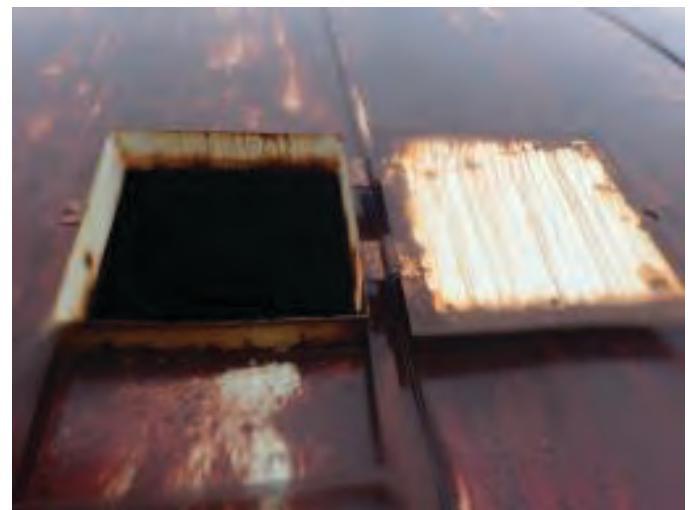
54 Secure Vent Screen

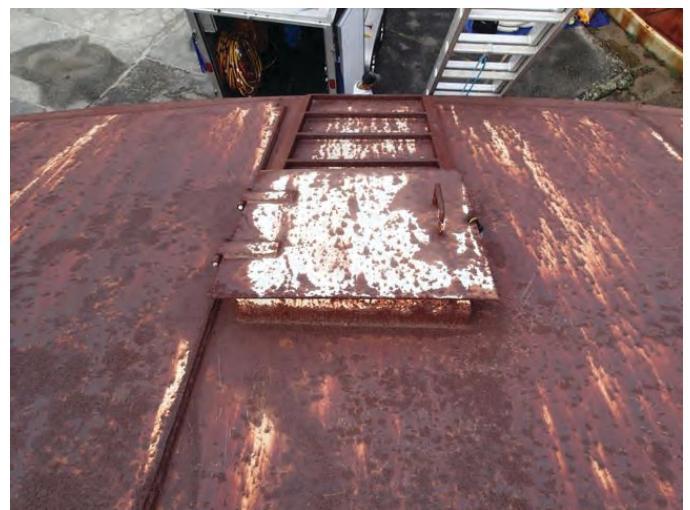
Open Access Hatch With Expired Coating, Exposed55Steel And Corrosion

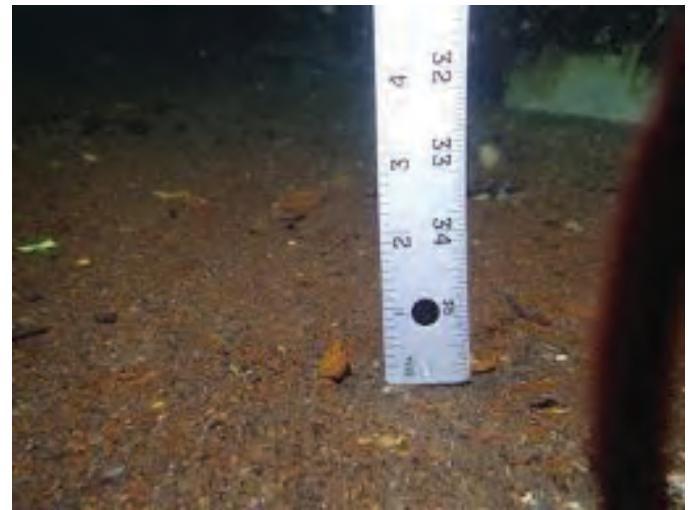
57 *Layer Of Precipitate*

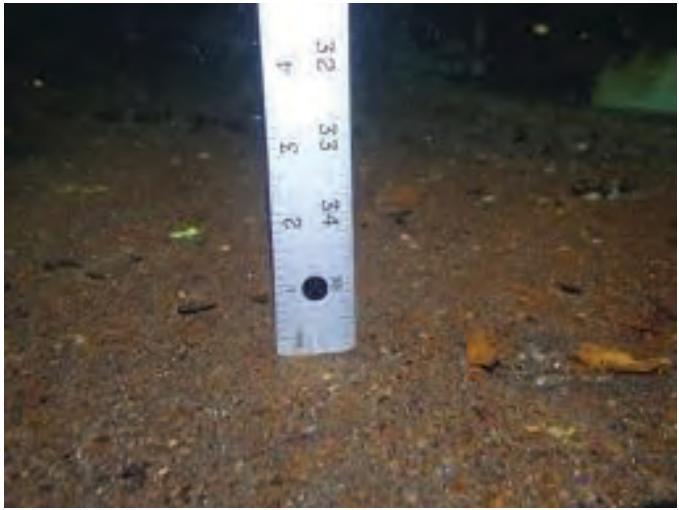
58 *Layer Of Precipitate*

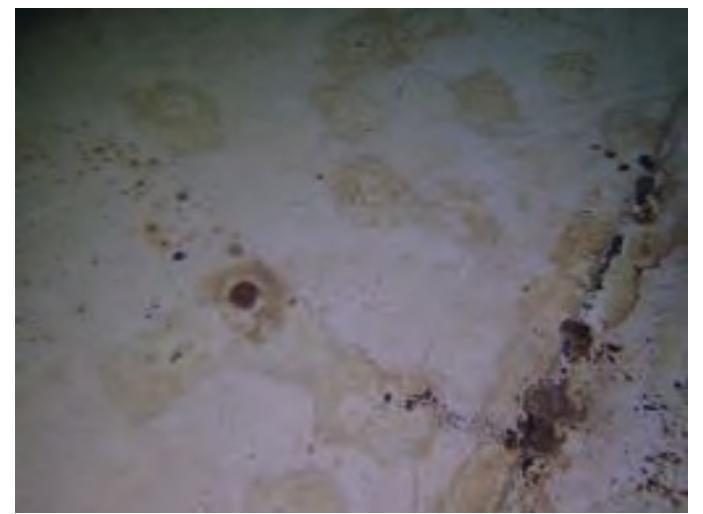
59 *Layer Of Precipitate*

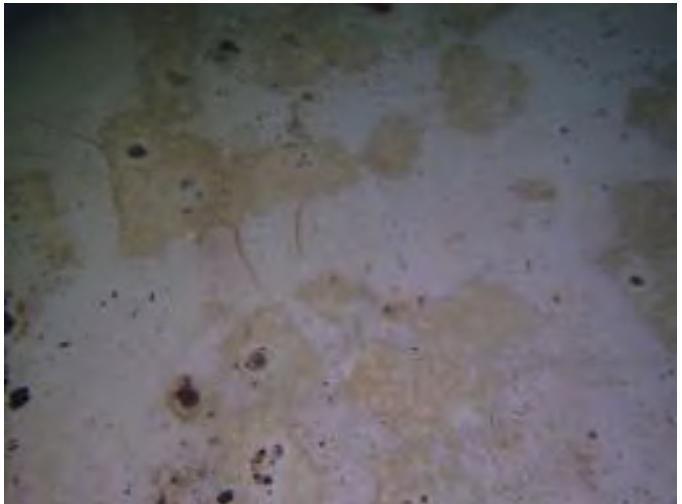
60 Floor With Ruptured Coating Blisters, Exposed Underlying Steel, Mild Surface Corrosion And Mild Staining

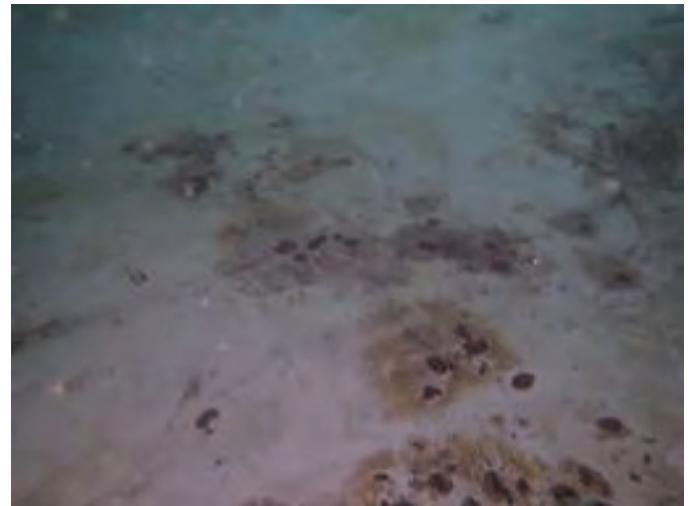
61 Floor With Ruptured Coating Blisters, Exposed Underlying Steel, Mild Surface Corrosion And Mild Staining

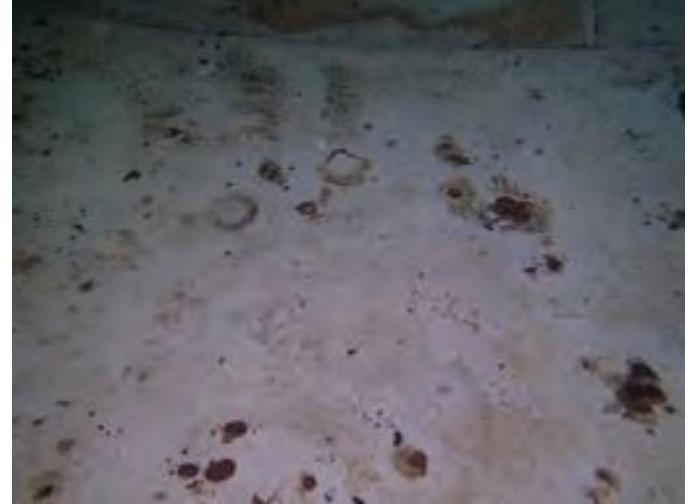
Floor With Ruptured Coating Blisters, Exposed
62 Underlying Steel, Mild Surface Corrosion And Mild Staining

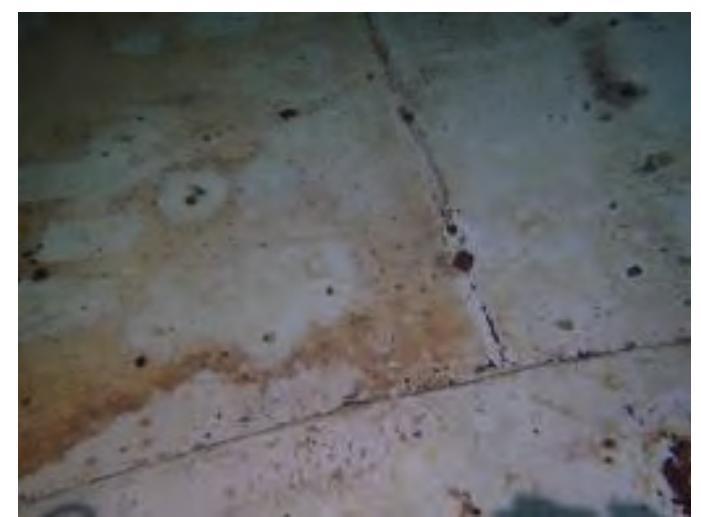
63 Floor With Ruptured Coating Blisters, Exposed Underlying Steel, Mild Surface Corrosion And Mild Staining

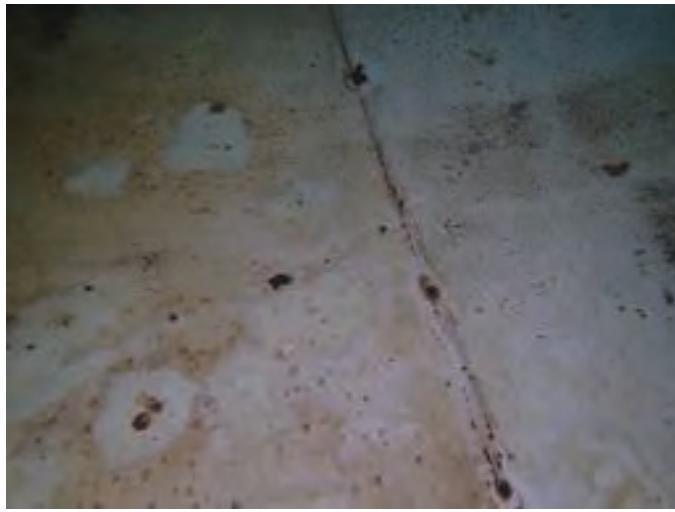
64 Floor With Ruptured Coating Blisters, Exposed 64 Underlying Steel, Mild Surface Corrosion And Mild Staining

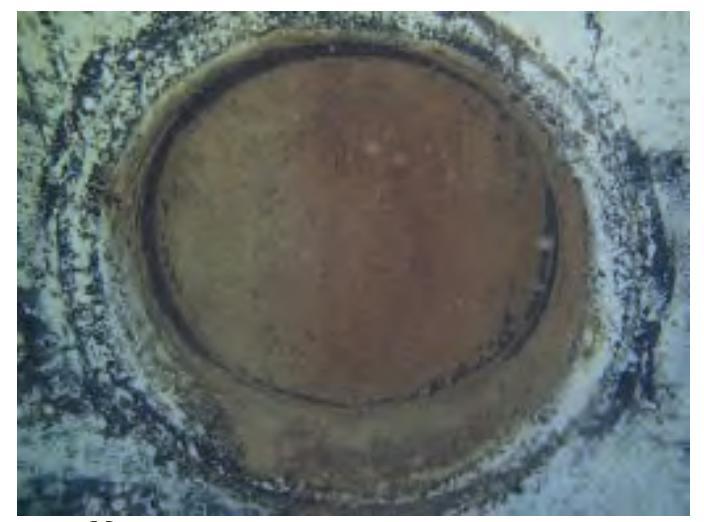
65 Floor With Ruptured Coating Blisters, Exposed Underlying Steel, Mild Surface Corrosion And Mild Staining
