In re: City of Woonsocket Water Division - Application to Implement Multi-Year Rate Plan

Docket No. 4879

Dam Name (No):	Woonsocket Reservoir #3 Dam (068)
Location:	Smithfield/North Smithfield
Hazard Classification:	High
	-
Inspector:	David M. Matheson, P.E.
Inspection Date.	August 1, 2014

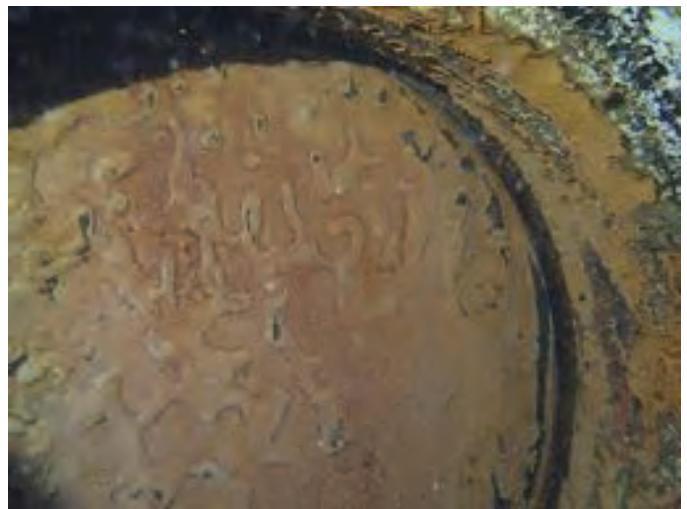
66 Manway

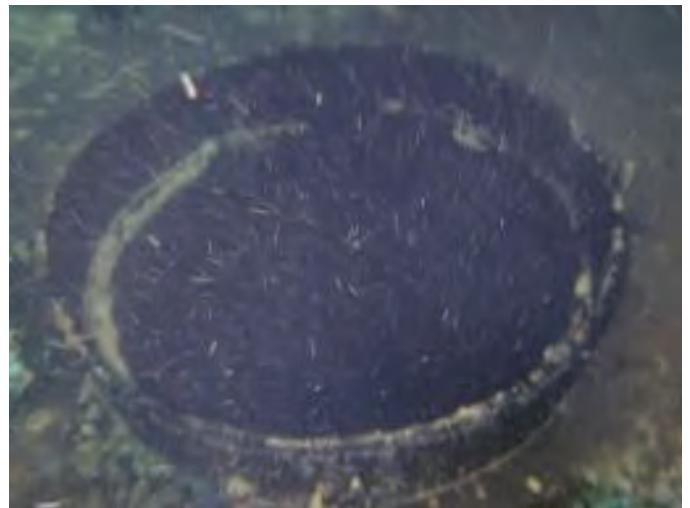
30" Inside Diameter Pipe - Flush Penetration Silt 68 Stop With Coating Loss/Blistering, Exposed Underlying Steel And Mild To Moderate Corrosion

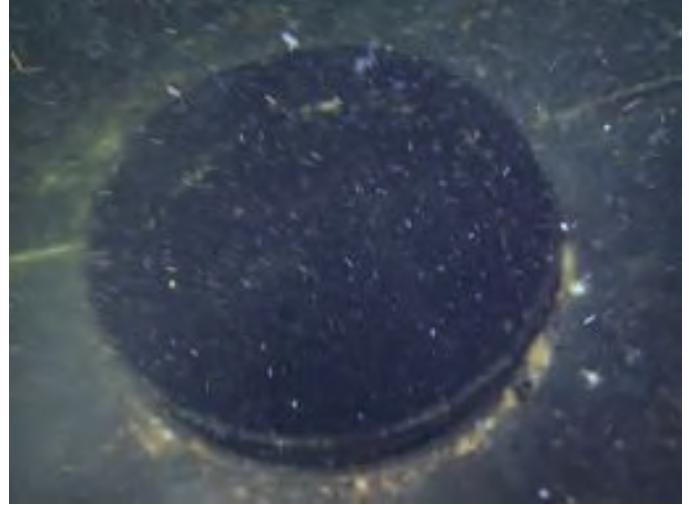
69 23" Inside Diameter Pipe Penetrating With Coating Loss/Blistering, Exposed Underlying Steel And Mild To Moderate Surface Corrosion

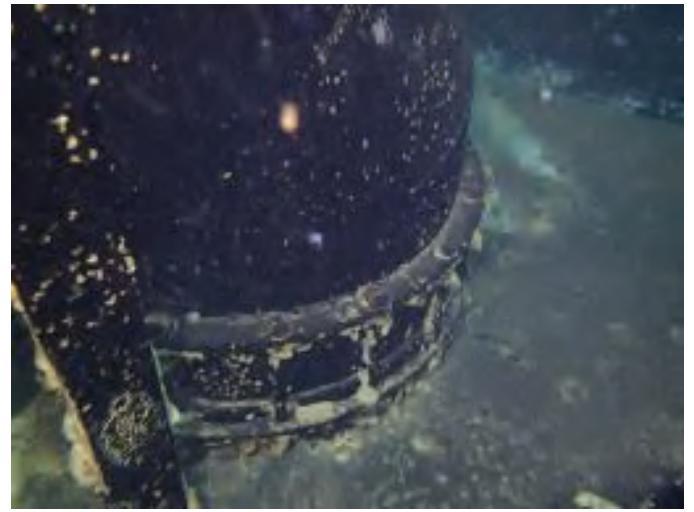
28" Inside Diameter Pipe Penetrating The Tank Floor
With Ruptured Coating Blisters, Exposed Underlying Metal And Mild To Moderate Surface Corrosion

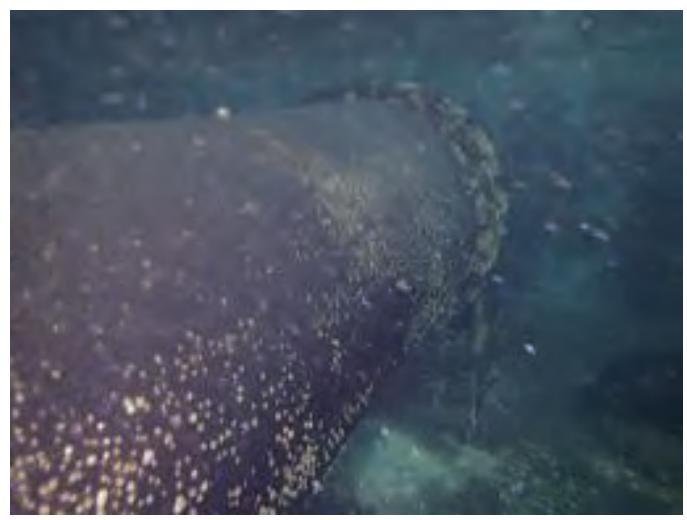
71 28" Inside Diameter Pipe With Ruptured Coating Blisters, Exposed Underlying Metal And Mild To Moderate Surface Corrosion

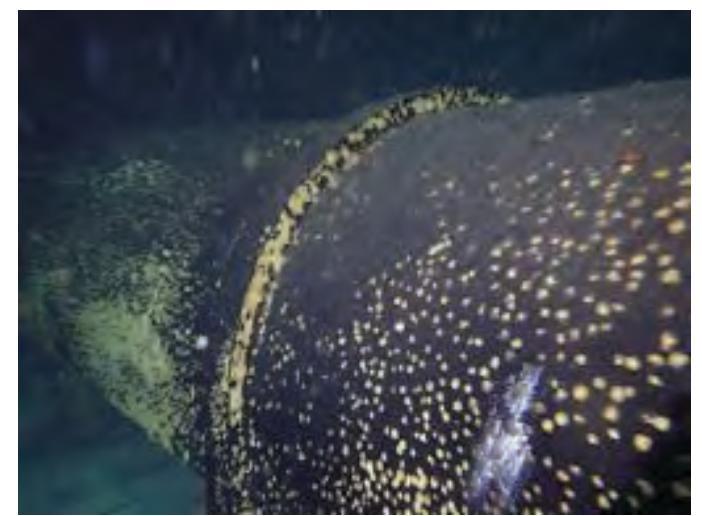
72 28" Inside Diameter Pipe With Ruptured Coating Blisters, Exposed Underlying Metal And Mild To Moderate Surface Corrosion

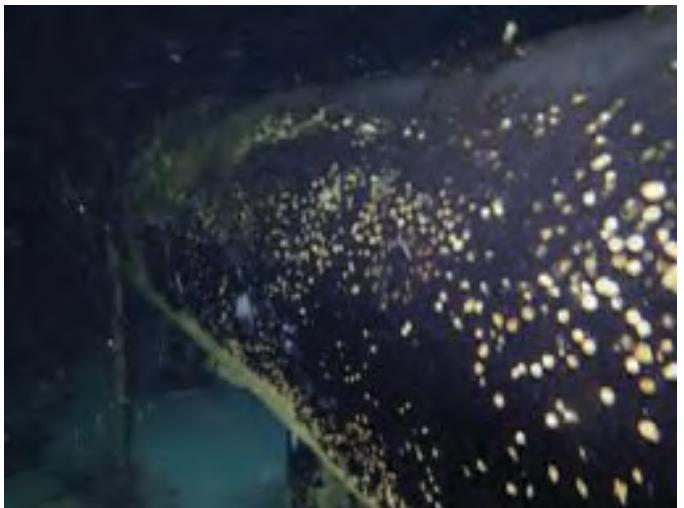
28" Inside Diameter Pipe With Ruptured Coating
Blisters, Exposed Underlying Metal And Mild To
Moderate Surface Corrosion

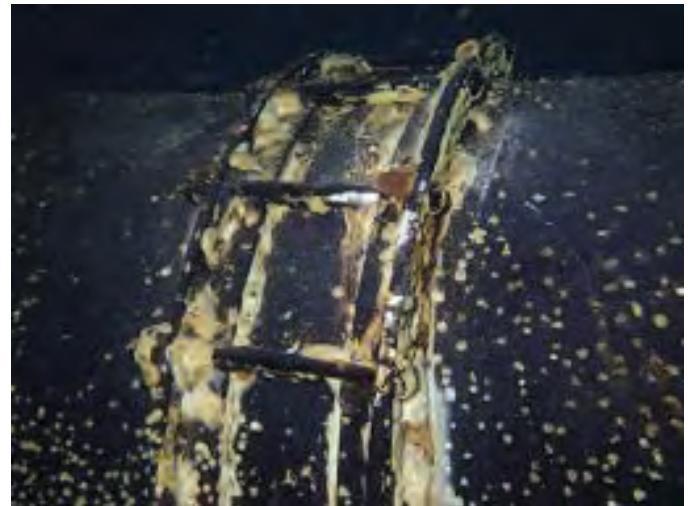
28" Inside Diameter Pipe With Ruptured Coating
74 Blisters, Exposed Underlying Metal And Mild To
Moderate Surface Corrosion

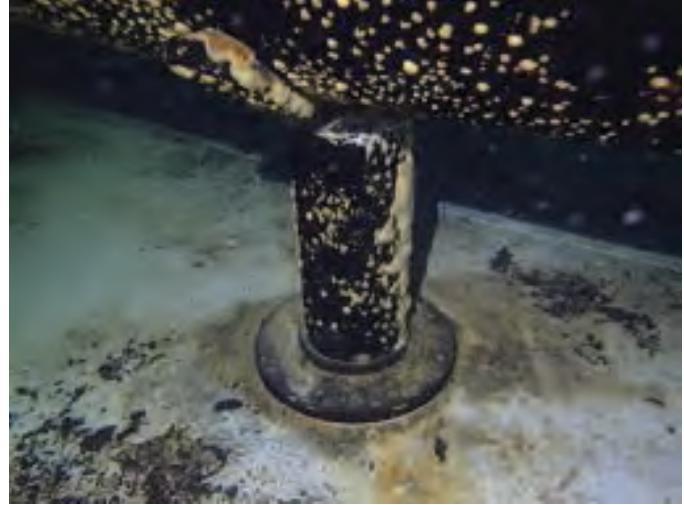
28" Inside Diameter Pipe Standoffs With Ruptured
Coating Blisters, Exposed Underlying Metal
And Mild To Moderate Surface Corrosion

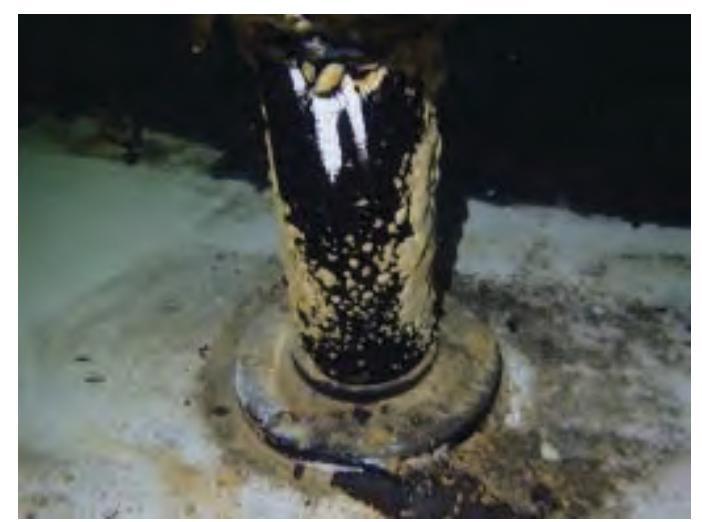
28" Inside Diameter Pipe Standoffs With Ruptured
Coating Blisters, Exposed Underlying Metal
And Mild To Moderate Surface Corrosion

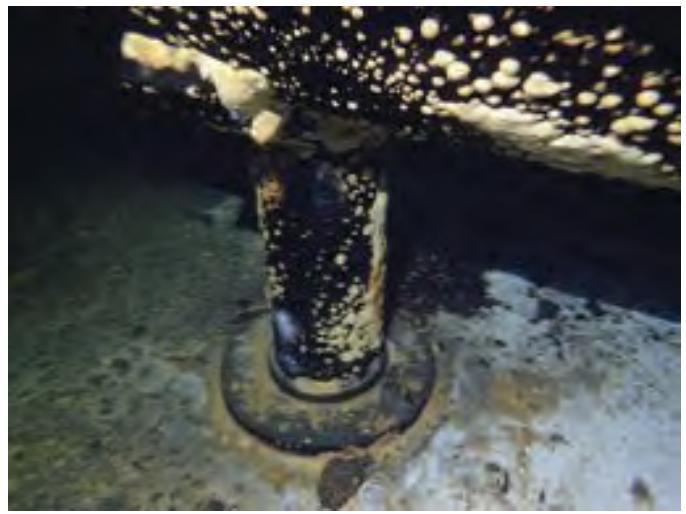
77 28" Inside Diameter Pipe Standoffs With Ruptured Coating Blisters, Exposed Underlying Metal And Mild To Moderate Surface Corrosion

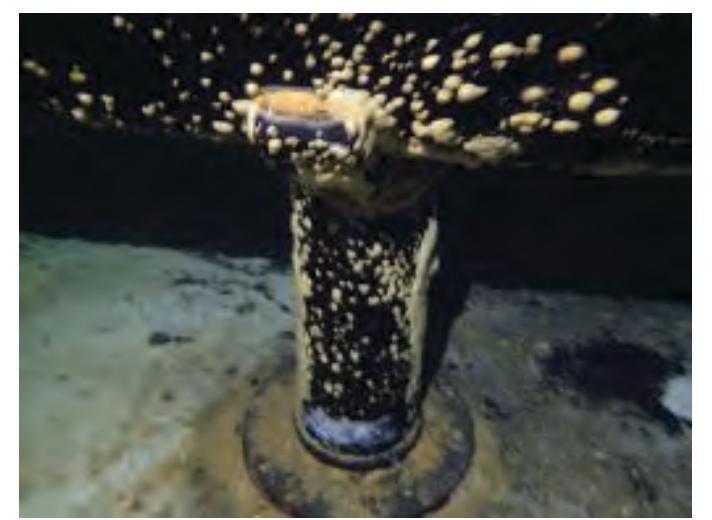
78 28" Inside Diameter Pipe Standoffs With Ruptured Coating Blisters, Exposed Underlying Metal And Mild To Moderate Surface Corrosion

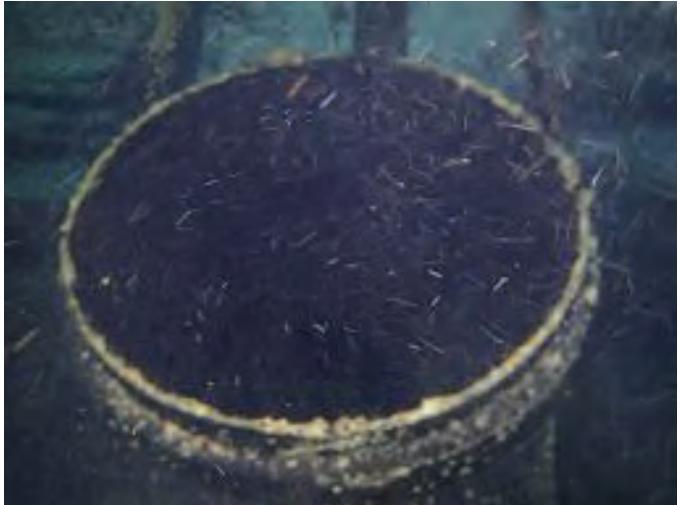
28" Inside Diameter Pipe With Ruptured Coating
Blisters, Exposed Underlying Metal And Mild To
Moderate Surface Corrosion

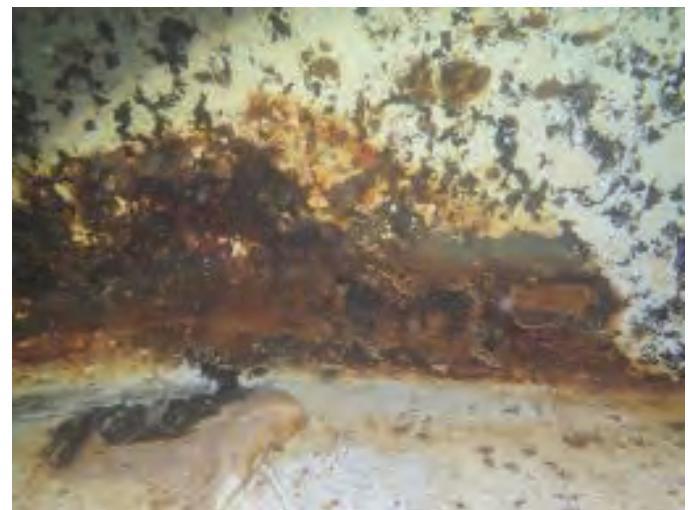
80 Interior Wall With Ruptured Coating Blisters, 80 Exposed Underlying Steel, Fatigue (Pitting), Corrosion And Mild Staining

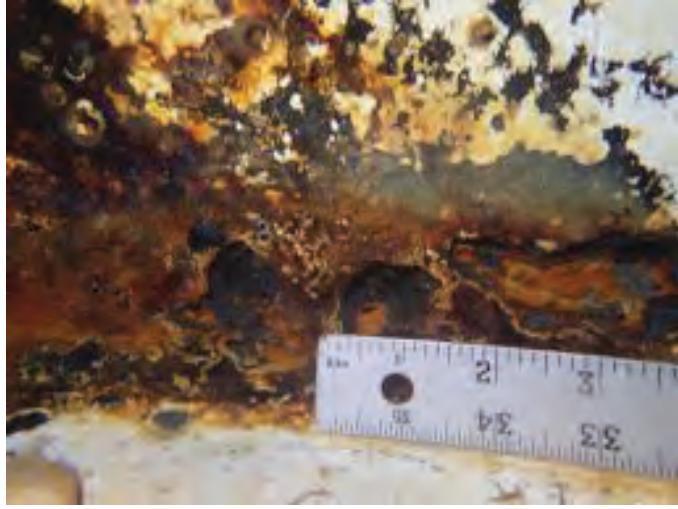
81 Interior Wall With Ruptured Coating Blisters, Exposed Underlying Steel, Fatigue (Pitting), Corrosion And Mild Staining

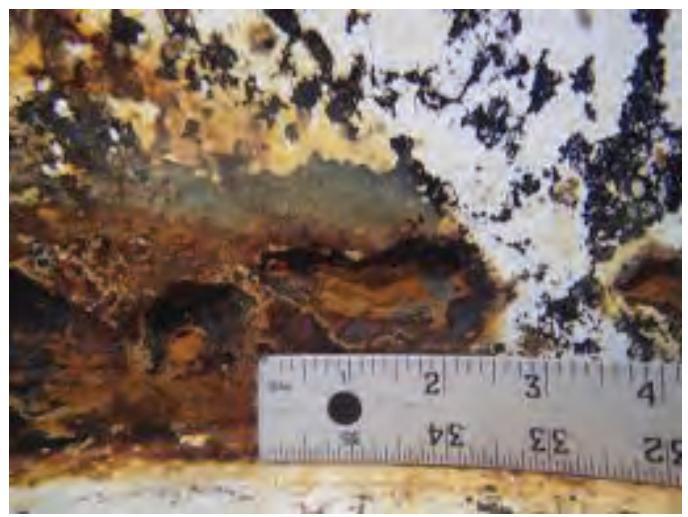
82 Interior Wall With Ruptured Coating Blisters, Exposed Underlying Steel, Fatigue (Pitting), Corrosion And Mild Staining

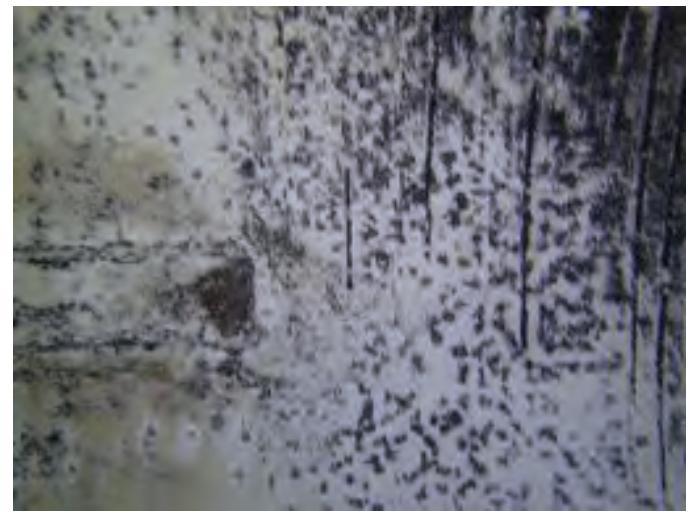
83 Interior Wall With Ruptured Coating Blisters, Exposed Underlying Steel, Corrosion And Mild Staining

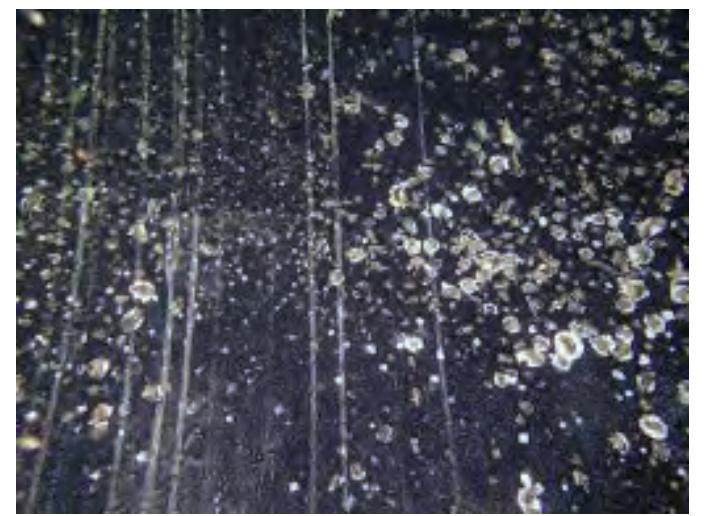
84 Interior Wall With Ruptured Coating Blisters, Exposed Underlying Steel, Corrosion And Mild Staining

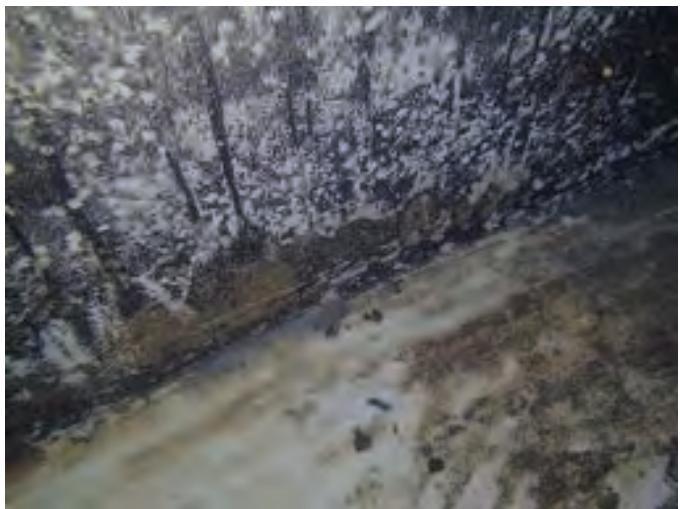
85 Interior Wall With Ruptured Coating Blisters,
85 Exposed Underlying Steel, Corrosion And Mild Staining

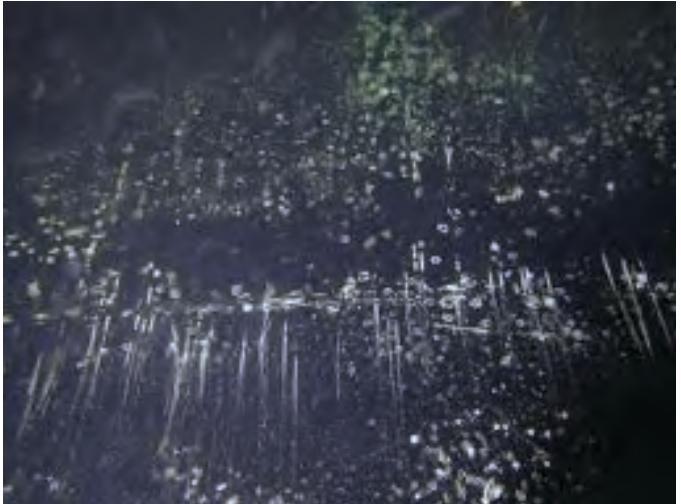
86 Interior Wall With Ruptured Coating Blisters, Exposed Underlying Steel, Corrosion And Mild Staining

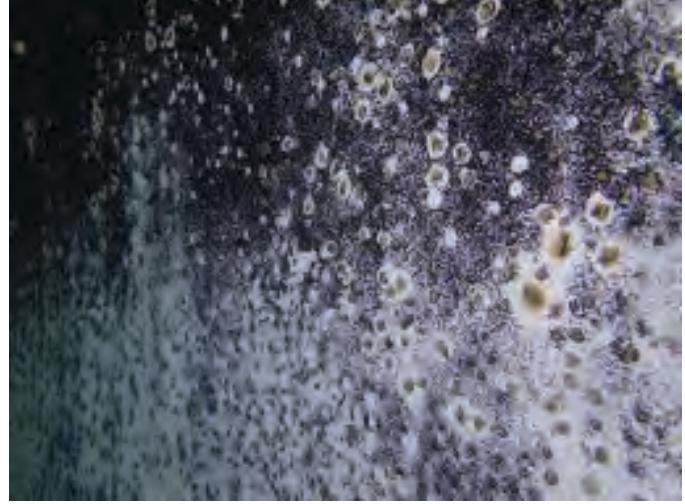
87 Interior Wall With Ruptured Coating Blisters, Exposed Underlying Steel, Corrosion And Mild Staining

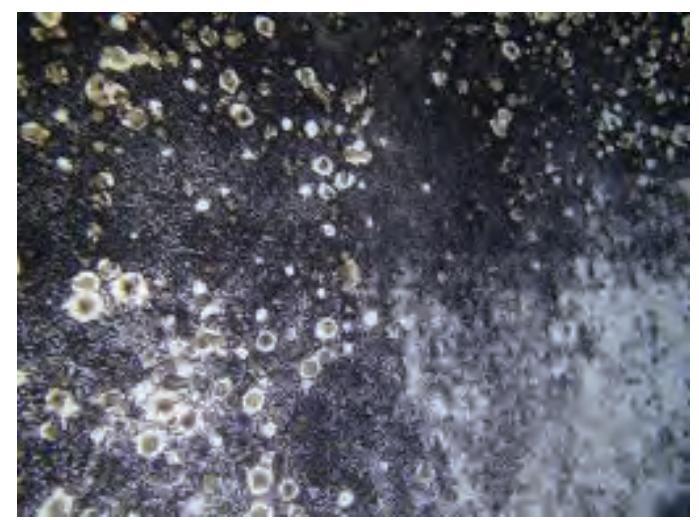
Interior Wall With Ruptured Coating Blisters,
Exposed Underlying Steel, Corrosion And
Mild Staining

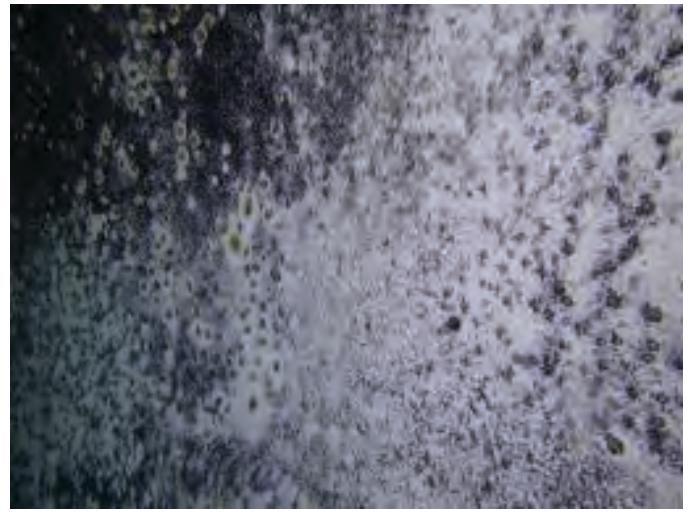
89 Interior Wall With Ruptured Coating Blisters, Exposed Underlying Steel, Corrosion And Mild Staining

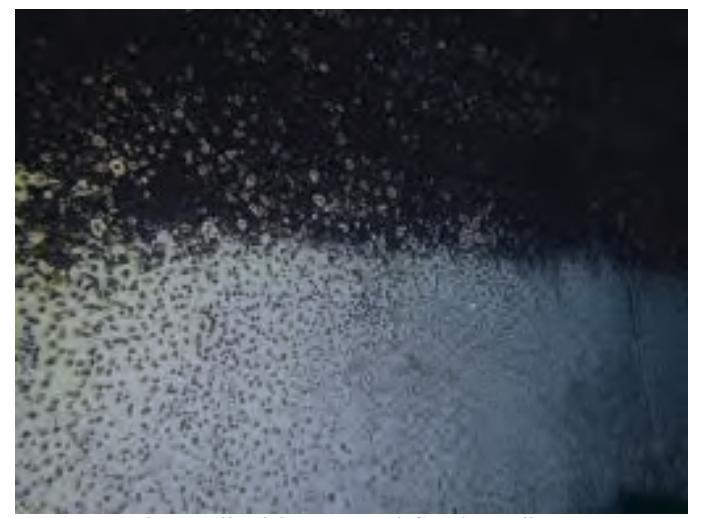
90 Interior Wall With Ruptured Coating Blisters, Exposed Underlying Steel, Corrosion And Mild Staining

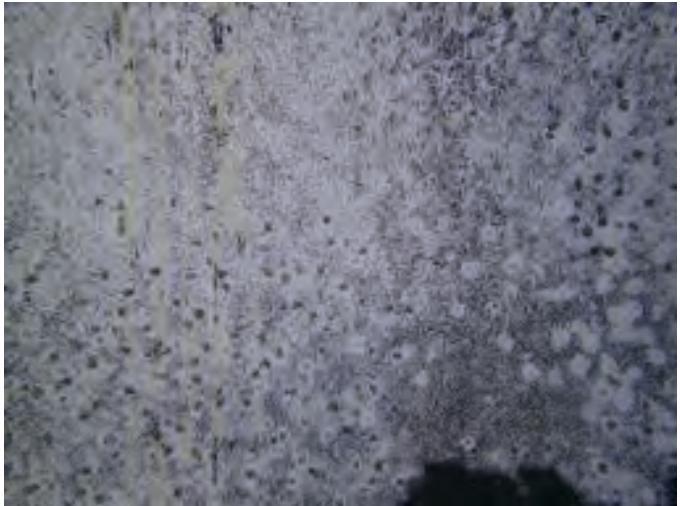
91 Interior Wall With Ruptured Coating Blisters, Exposed Underlying Steel, Corrosion And Mild Staining

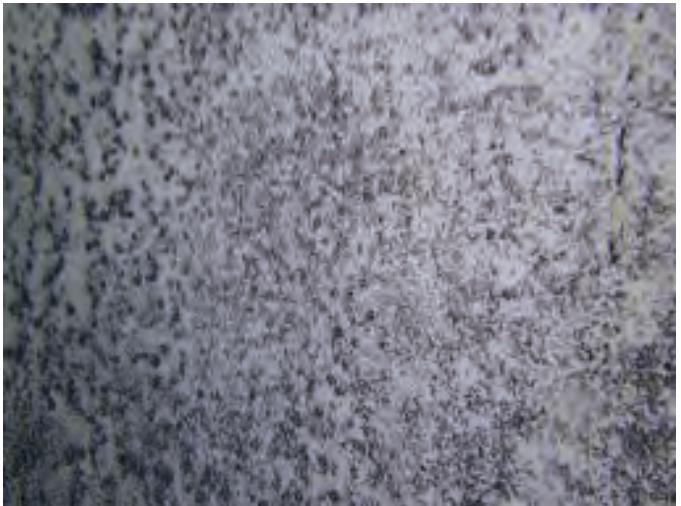
92 Interior Wall With Ruptured Coating Blisters, 92 Exposed Underlying Steel, Corrosion And Mild Staining

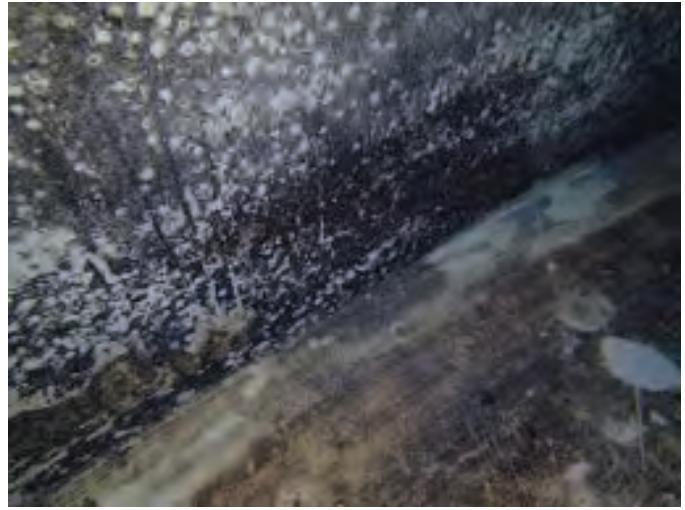
93 Interior Wall With Ruptured Coating Blisters, Exposed Underlying Steel, Corrosion And Mild Staining

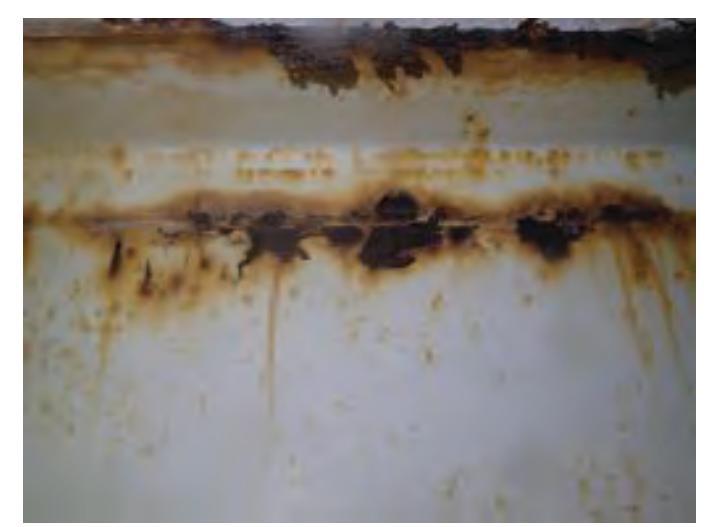
94 Interior Wall With Ruptured Coating Blisters, 94 Exposed Underlying Steel, Corrosion And Mild Staining

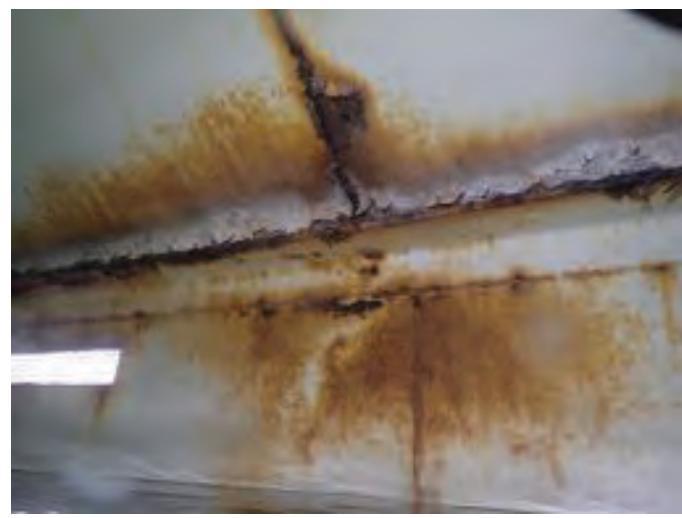
95 Interior Wall With Ruptured Coating Blisters, Exposed Underlying Steel, Corrosion And Mild Staining

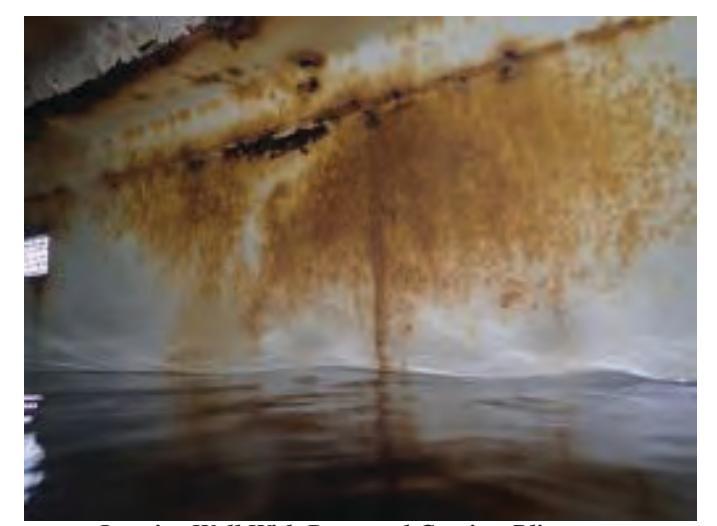
96 Interior Wall With Ruptured Coating Blisters, Exposed Underlying Steel, Corrosion And Mild Staining

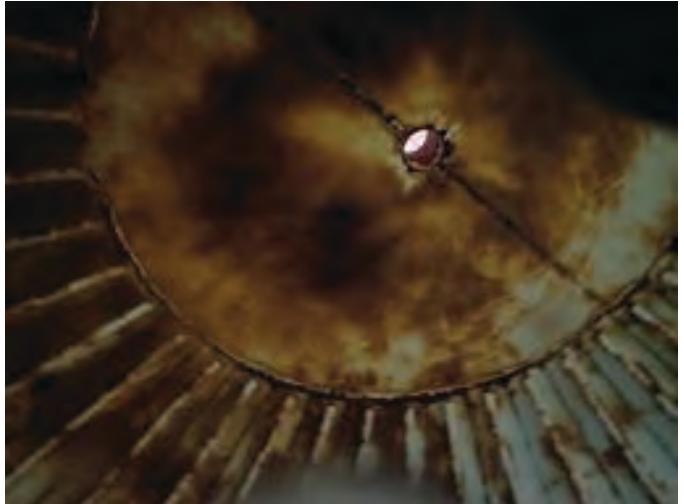
97 Overhead With Coating Thinning Exposed Underlying Steel And Mild To Moderate Corrosion

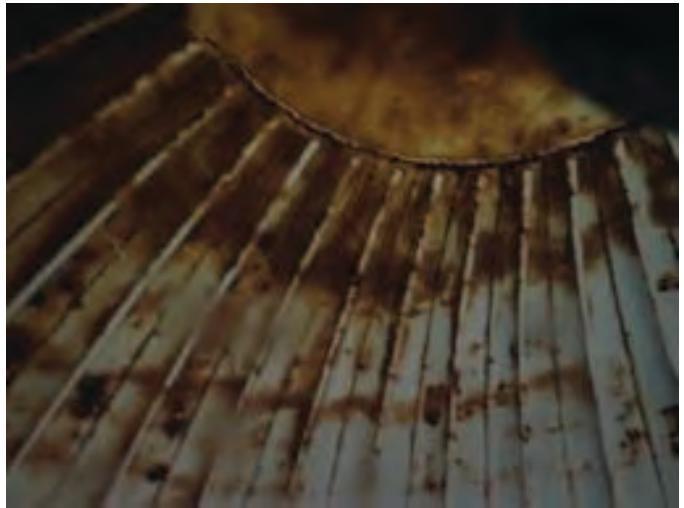
98 Overhead With Coating Thinning Exposed 98 Underlying Steel And Mild To Moderate Corrosion

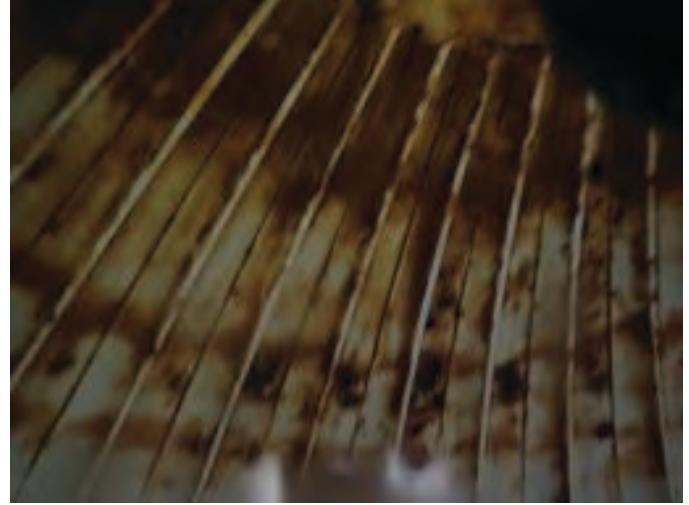
99 Overhead With Coating Thinning Exposed Underlying Steel And Mild To Moderate Corrosion

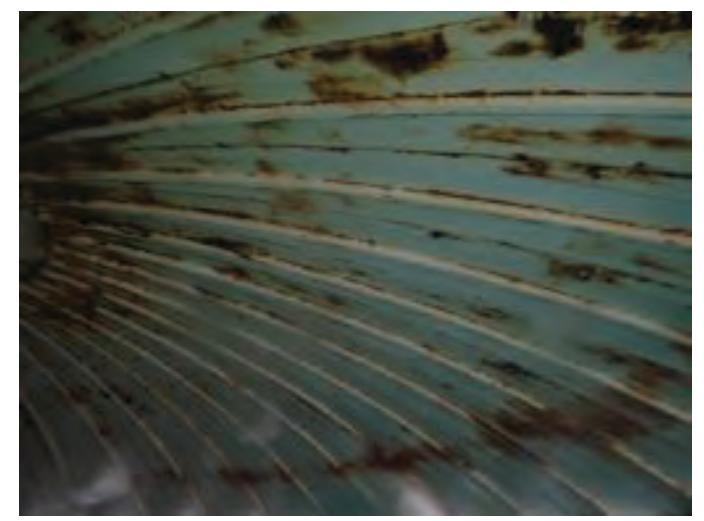
100 Overhead With Coating Loss/Peeling, Exposed Underlying Steel And Mild To Moderate Corrosion

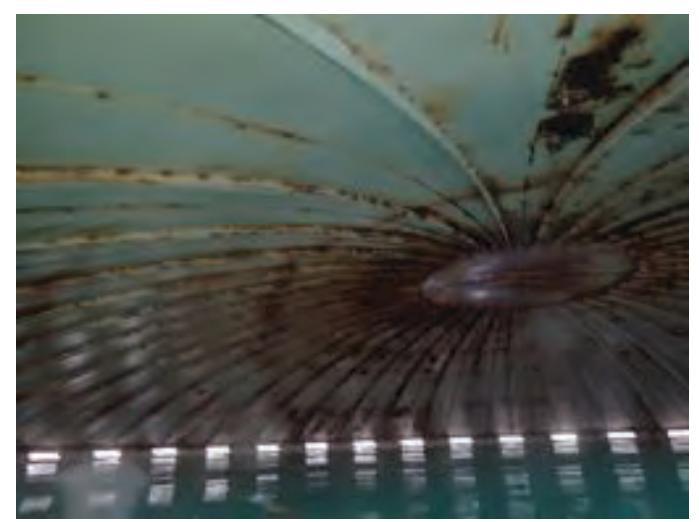
101 Overhead With Coating Loss/Peeling, Exposed Underlying Steel And Mild To Moderate Corrosion

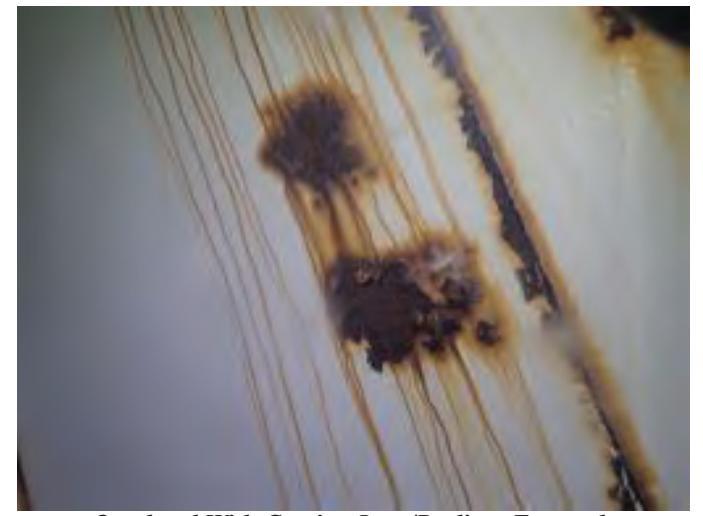
102 Overhead With Coating Loss/Peeling, Exposed Underlying Steel And Mild To Moderate Corrosion

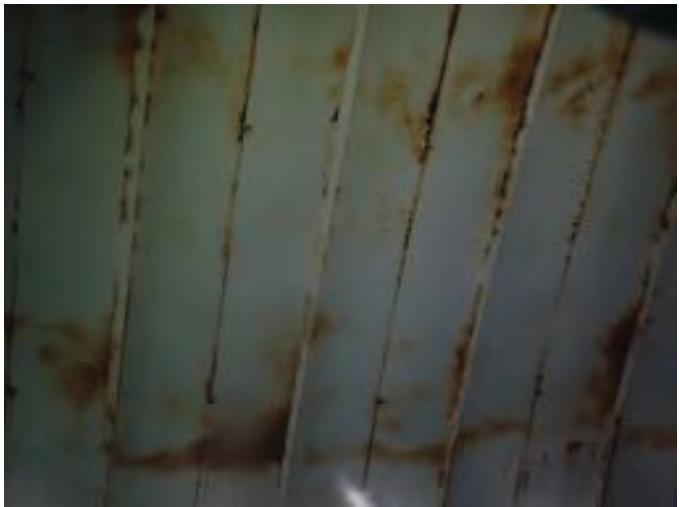
Overhead With Coating Loss/Peeling, Exposed103 Underlying Steel And Mild To ModerateCorrosion

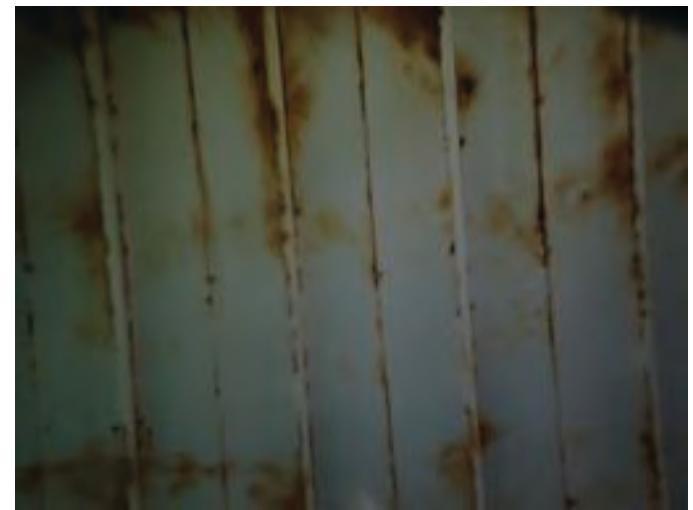
Overhead With Coating Loss/Peeling, Exposed 104 Underlying Steel And Mild To Moderate Corrosion

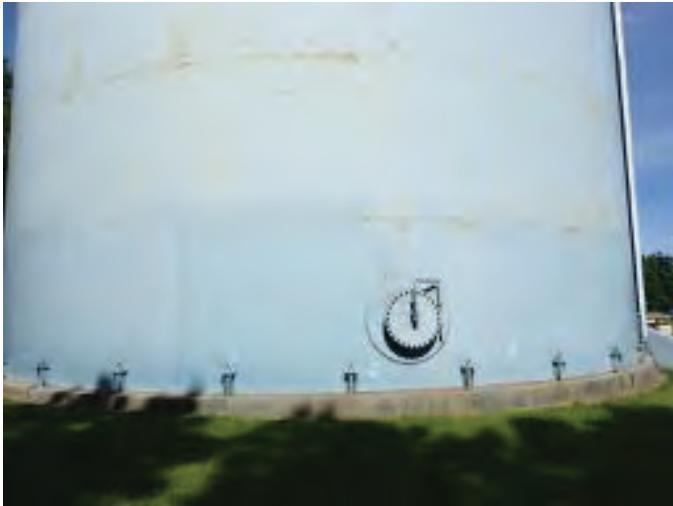
Adhesion loss of the protective coating was evident throughout approximately 15% of these surfaces and was observed throughout all elevations of the exterior walls, resulting in exposure of the underlying steel. No obvious fatigue (pitting) of the steel panels or deterioration of the welds was evident within these areas of exposure, rather mild surface corrosion exists at this time.

1 Exterior Wall With Coating Loss/Chalking, Exposed Underlying Steel, Mild Corrosion And Rust Staining

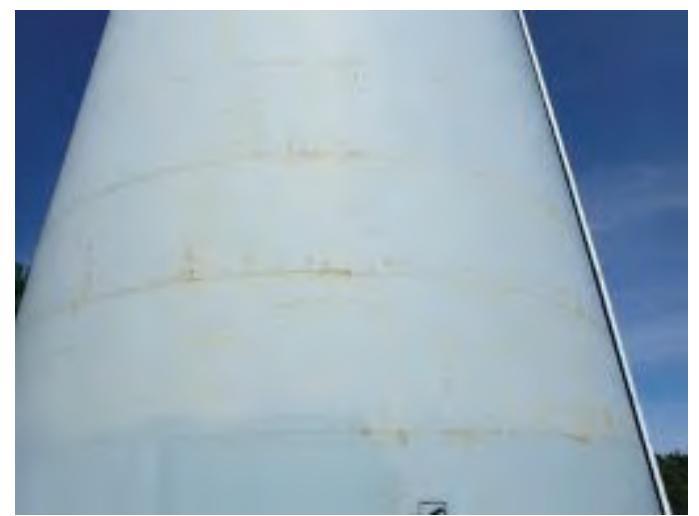
2 Exterior Wall With Coating Loss/Chalking, Exposed 2 Underlying Steel, Mild Corrosion And Rust Staining

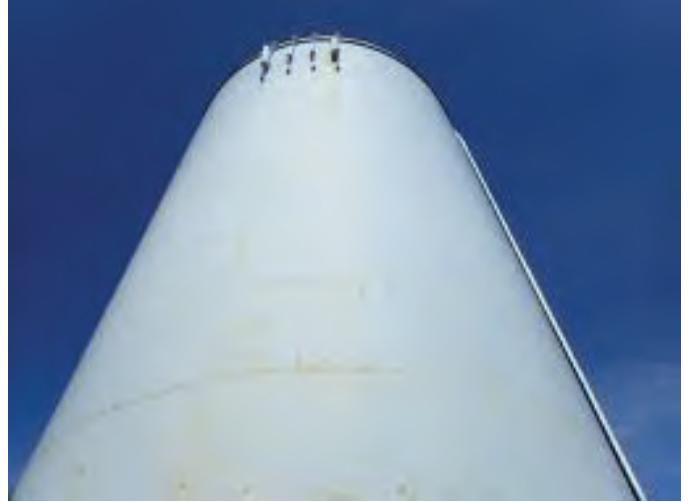
3 Exterior Wall With Coating Loss/Chalking, Exposed 3 Underlying Steel, Mild Corrosion And Rust Staining

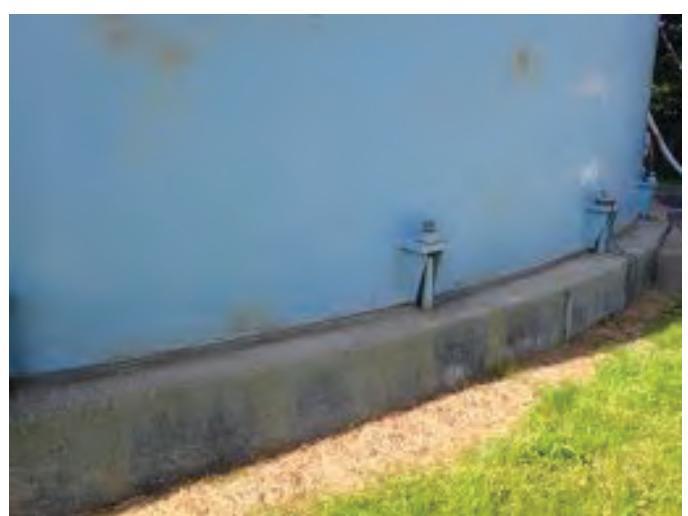
4 Exterior Wall With Coating Loss/Chalking, Exposed 4 Underlying Steel, Mild Corrosion And Rust Staining

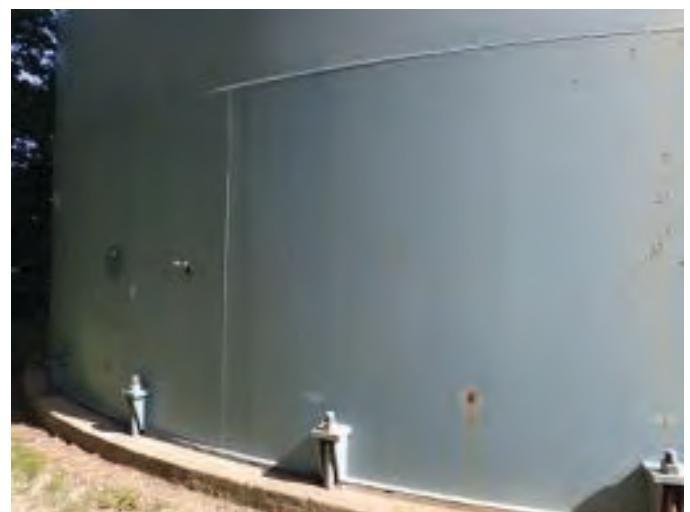
5 Exterior Wall With Coating Loss/Chalking, Exposed Underlying Steel, Mild Corrosion And Rust Staining

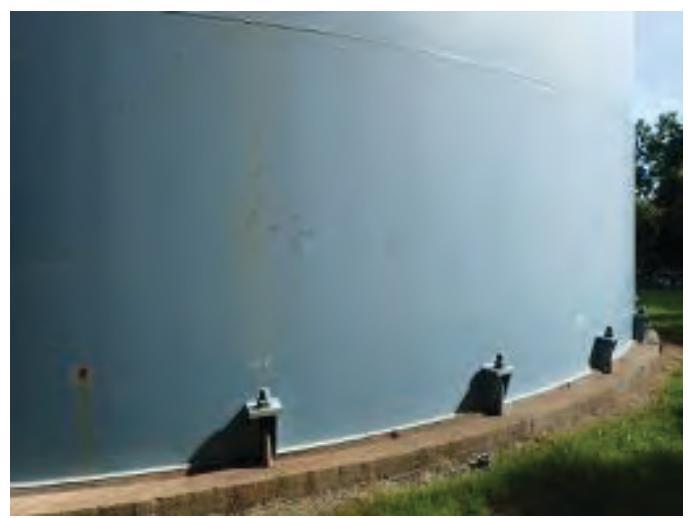
6 *Exterior Wall With Coating Loss/Chalking, Exposed Underlying Steel, Mild Corrosion And Rust Staining*

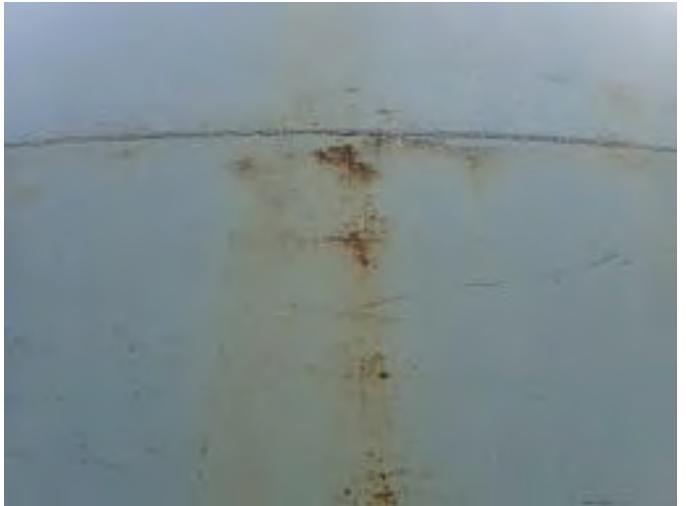
Numerous areas of coating damage (coating chips) were found throughout the lowest 40' of the exterior walls and appear to be the result of objects striking the tank. These areas of coating damage have caused exposure and corrosion of underlying steel. No obvious fatigue/deterioration of the steel was evident within these 1/8" to 3" diameter areas of exposure, rather mild to moderate corrosion exists at this time.

7 Exterior Wall With Coating Damage, Coating Loss/ 7 Chalking, Exposed Underlying Steel, Mild Corrosion And Rust Staining

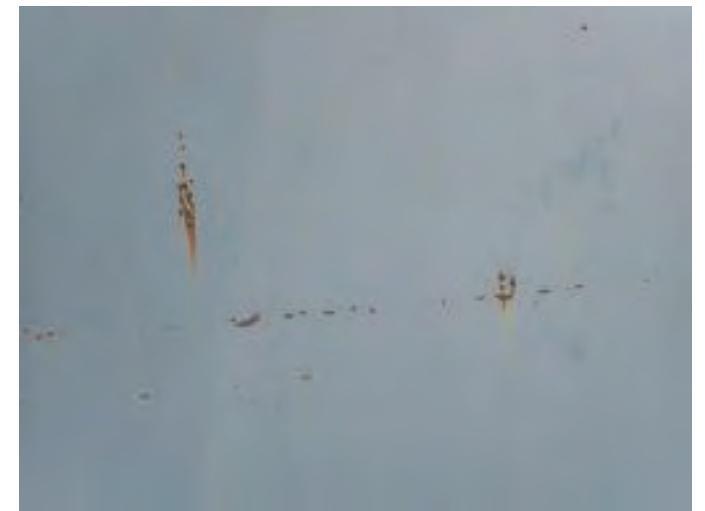
8 Exterior Wall With Coating Damage, Coating Loss/ 8 Chalking, Exposed Underlying Steel, Mild Corrosion And Rust Staining

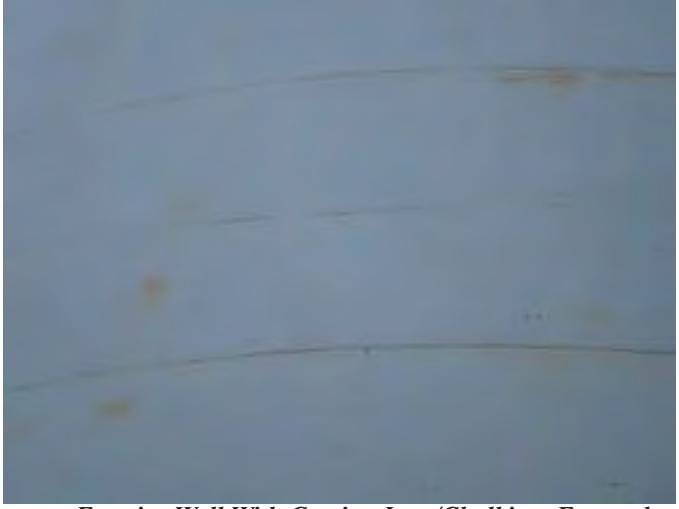
9 Exterior Wall With Coating Loss/Chalking, Exposed Underlying Steel, Mild Corrosion And Rust Staining

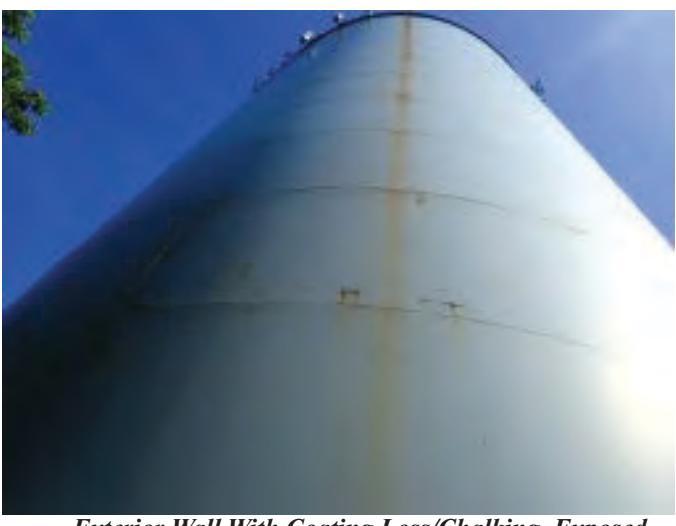
11 *Exterior Wall With Coating Loss/Chalking, Exposed* Underlying Steel, Mild Corrosion And Rust Staining

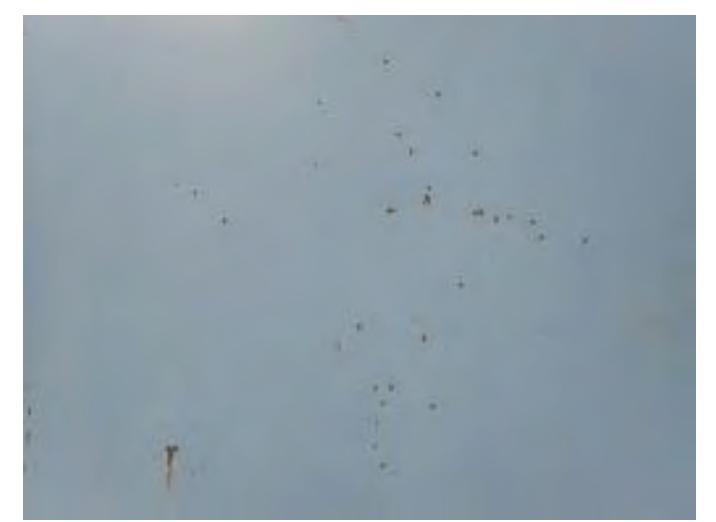
12 Exterior Wall With Coating Damage, Coating Loss/ Chalking, Exposed Underlying Steel, Mild Corrosion And Rust Staining

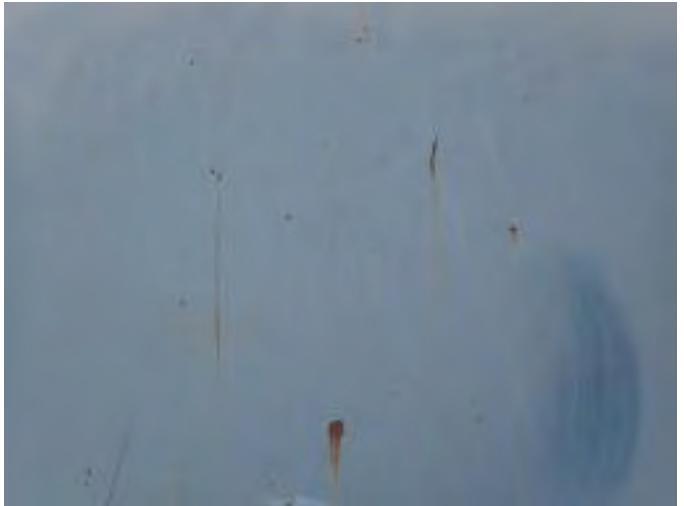
Exterior Wall With Coating Damage, Coating Loss/
Chalking, Exposed Underlying Steel, Mild Corrosion And Rust Staining

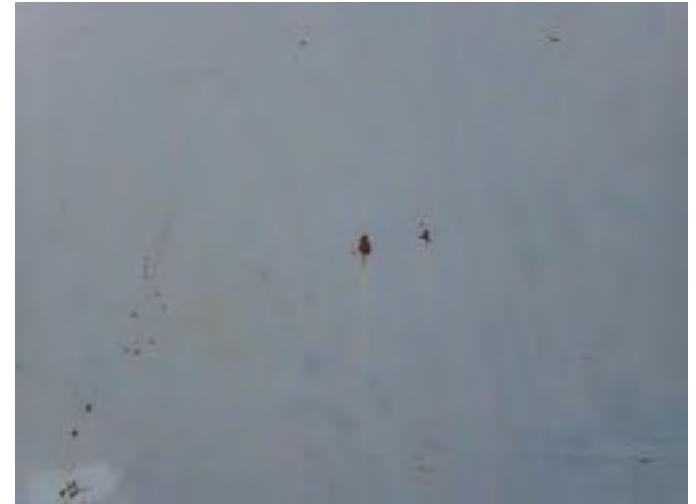
14Exterior Wall With Coating Damage, Coating Loss/
Chalking, Exposed Underlying Steel, Mild Corrosion
And Rust Staining

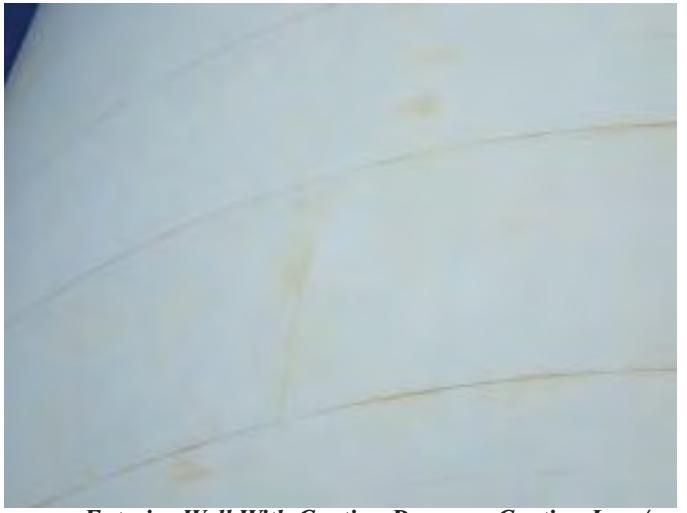
15 *Exterior Wall With Coating Damage, Coating Loss/ Chalking, Exposed Underlying Steel, Mild Corrosion And Rust Staining*

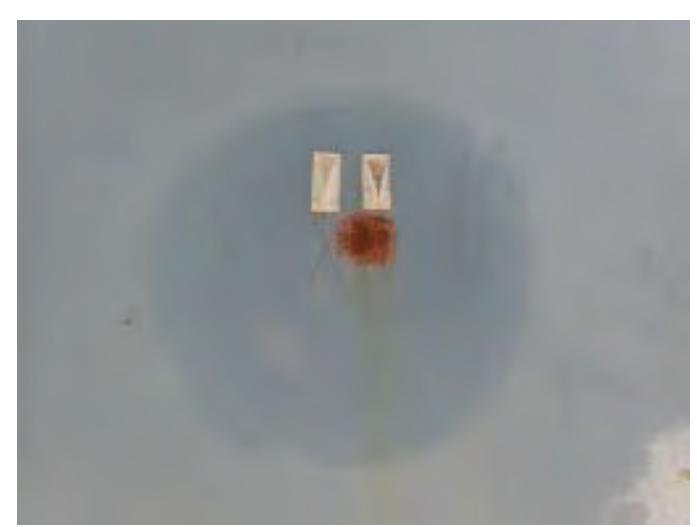
16 *Exterior Wall With Coating Damage, Coating Loss/ Chalking, Exposed Underlying Steel, Mild Corrosion And Rust Staining*

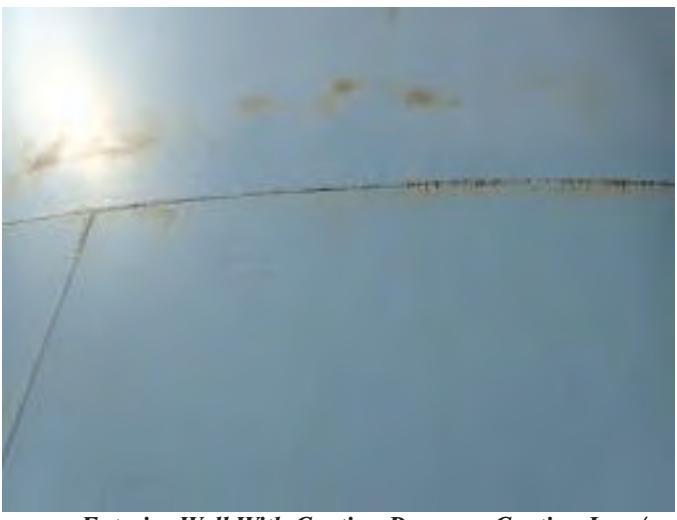
17 Exterior Wall With Coating Damage, Coating Loss/ Chalking, Exposed Underlying Steel, Mild Corrosion And Rust Staining

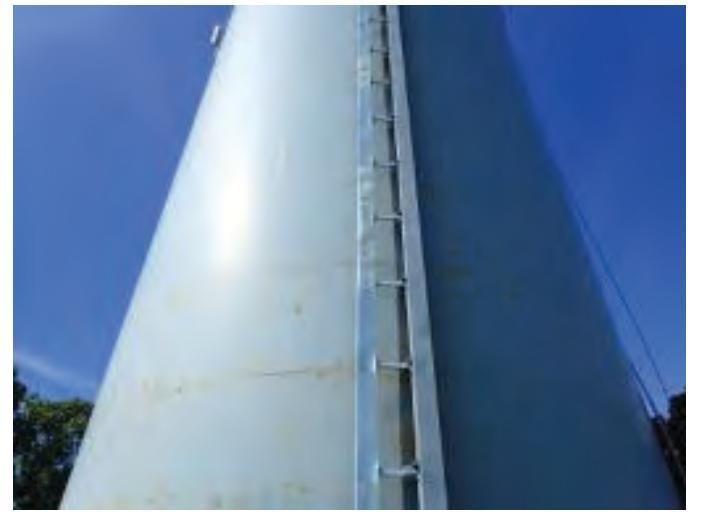
18 *Exterior Wall With Coating Loss/Chalking, Exposed Underlying Steel, Mild Corrosion And Rust Staining*

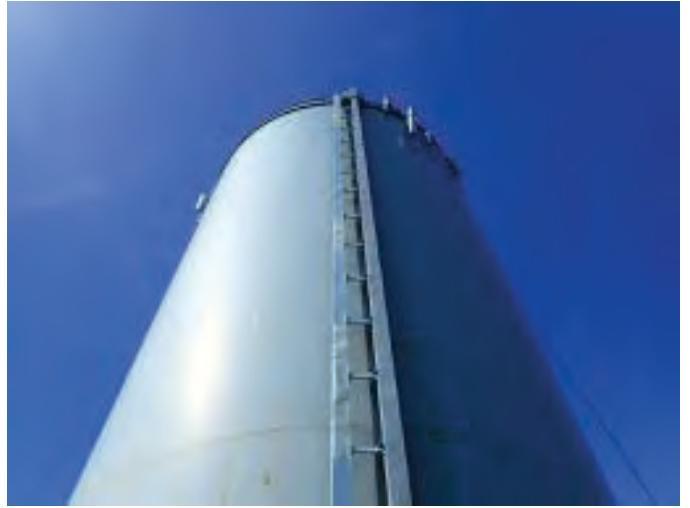
19 *Exterior Wall With Coating Loss/Chalking, Exposed Underlying Steel, Mild Corrosion And Rust Staining*

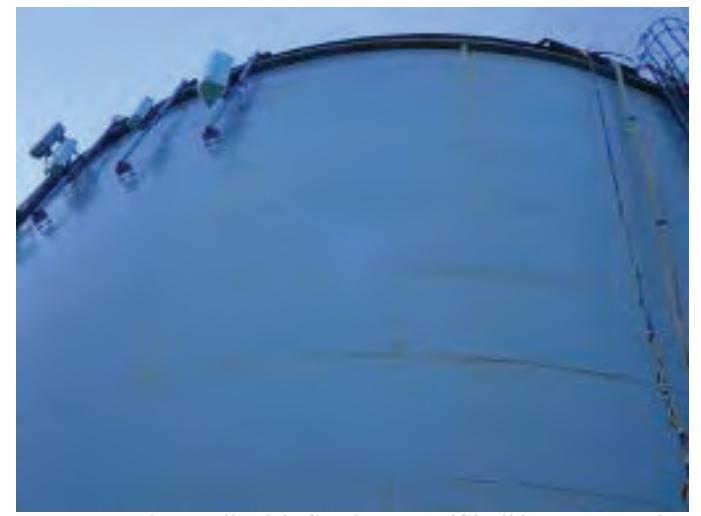
20 Exterior Wall With Coating Loss/Chalking, Exposed 20 Underlying Steel, Mild Corrosion And Rust Staining

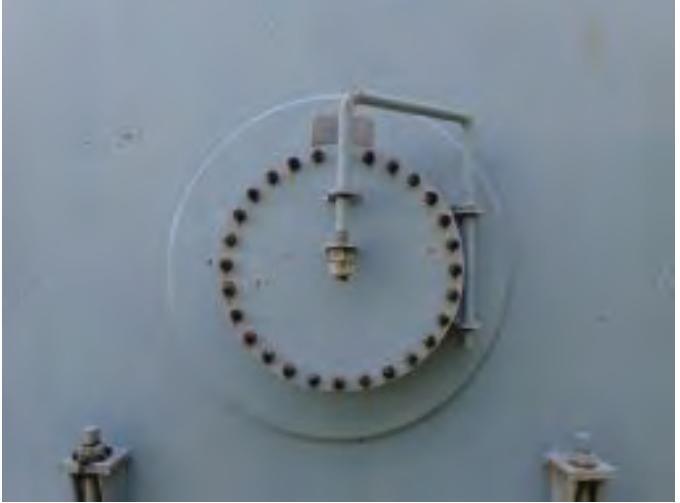
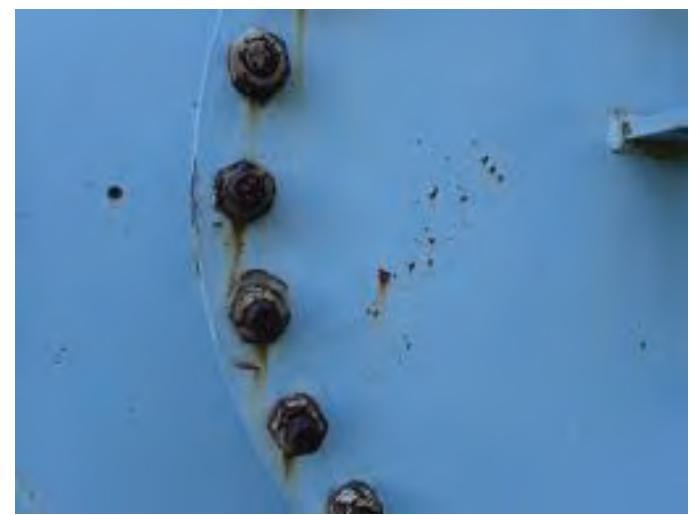
The protective coating applied to the easternmost manway has an average dry film thickness of 4.7 mils and is below the AWWA's recommendation. The protective coating was found having poor adhesion value and has lost adhesion throughout approximately 10% of the surfaces of the manway lid and throughout approximately 80% of the surfaces of the securing hardware, causing steel exposure and corrosion. However, the surfaces of the manway lid and trunk having steel exposure remain sound and free of obvious fatigue/deterioration, and the securing hardware remains sound and free of obvious fatigue/deterioration at this time.

21 Easternmost Manway With Securing Hardware Having Coating Loss, Exposed Steel And Corrosion

Easternmost Manway With Securing Hardware
Having Coating Loss, Exposed Steel And Corrosion
