In re: City of Woonsocket Water Division - Application to Implement Multi-Year Rate Plan

Docket No. 4879

Dam Name (No):	Woonsocket Reservoir #3 Dam (068)
Location:	Smithfield/North Smithfield
Hazard Classification:	High
	-
Inspector:	David M. Matheson, P.E.
Inspection Date.	August 1, 2014

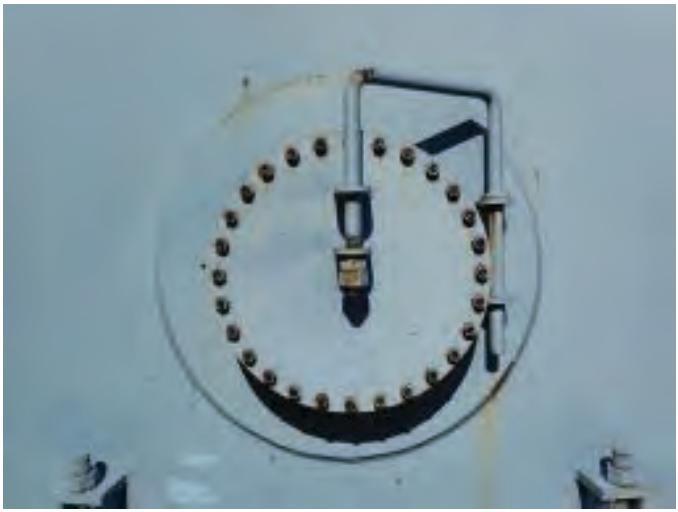
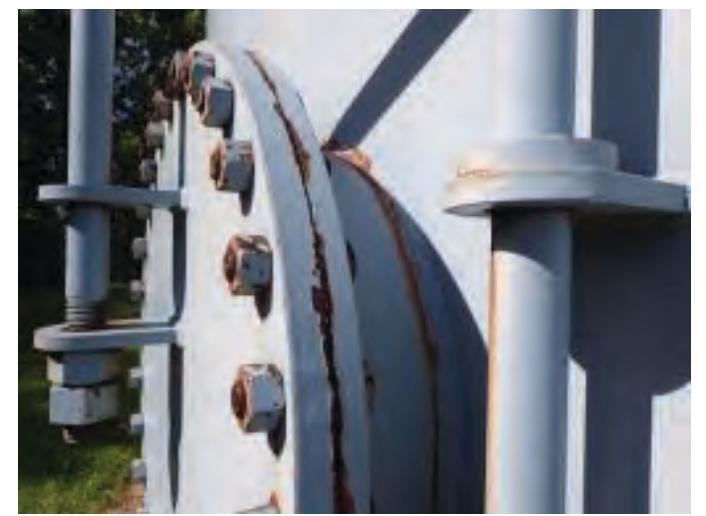
The protective coating applied to the westernmost manway has an average dry film thickness of 4.9 mils and is below the AWWA's recommendation. The protective coating was found having poor adhesion value and has lost adhesion throughout approximately 5% of the surfaces of the manway lid and throughout approximately 80% of the surfaces of the securing hardware, causing steel exposure and corrosion. However, the surfaces of the manway lid and trunk having steel exposure remain sound and free of obvious fatigue/deterioration and the securing hardware remains sound and free of obvious fatigue/deterioration at this time.

23 Westernmost Manway With Securing Hardware Having Coating Loss, Exposed Steel And Corrosion

24 Westernmost Manway With Securing Hardware Having Coating Loss, Exposed Steel And Corrosion

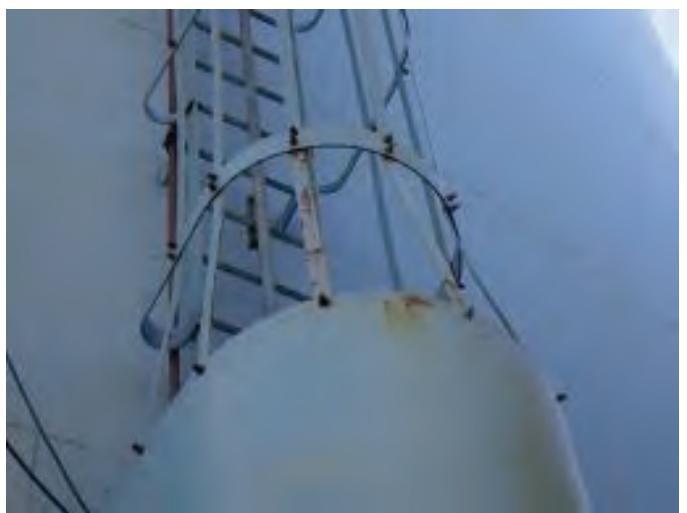
The protective coating applied to the steel ladder, safety cage and fall prevention device has lost adhesion throughout approximately 15% of these surfaces, resulting in exposure of the underlying steel. No obvious fatigue or deterioration of the steel was evident within these areas of exposure, rather mild surface corrosion exists at this time.

25 Ladder With Safety Cage And Fall Prevention Device Having Coating Loss, Underlying Steel And Mild Corrosion

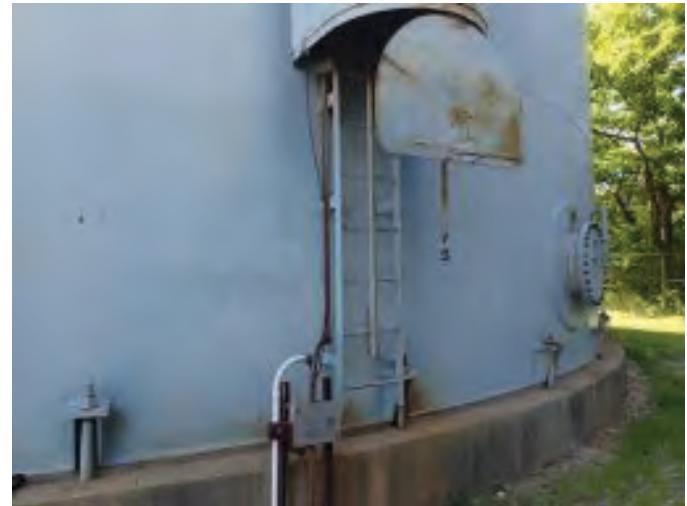
A ladder guard secured with a lock is installed at the base of this ladder, preventing unwanted access to the ladder/roof. The protective coating applied to the steel ladder guard has lost adhesion throughout approximately 5% of these surfaces, resulting in exposure of the underlying steel. No obvious fatigue or deterioration of the exposed steel was evident within these areas of coating adhesion loss, rather mild surface corrosion exists at this time.

Ladder Guard With Coating Loss, Exposed 26 Underlying Steel and Mild Surface Corrosion

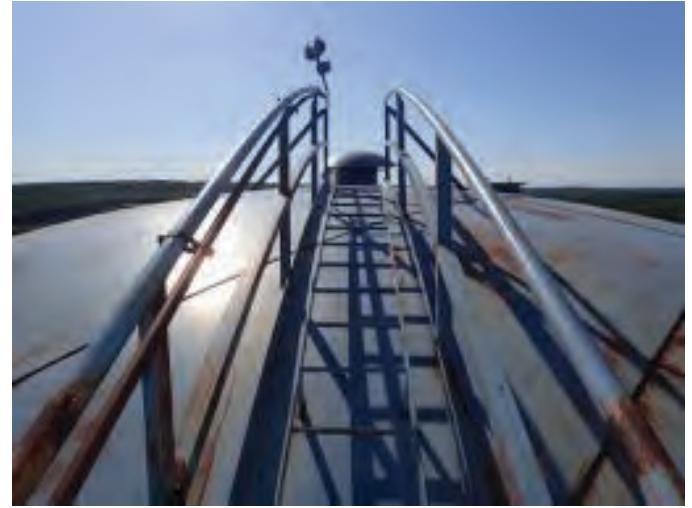
The protective coating applied to this ladder has lost adhesion throughout approximately 10% of these surfaces, causing steel exposure and surface corrosion. However, this ladder remains sound and free of obvious fatigue/deterioration at this time.

27 *Vent Access Ladder With Secure Roof Safety Railings Having Coating Loss (Nearing Expiration), Exposed Steel And Surface Corrosion*

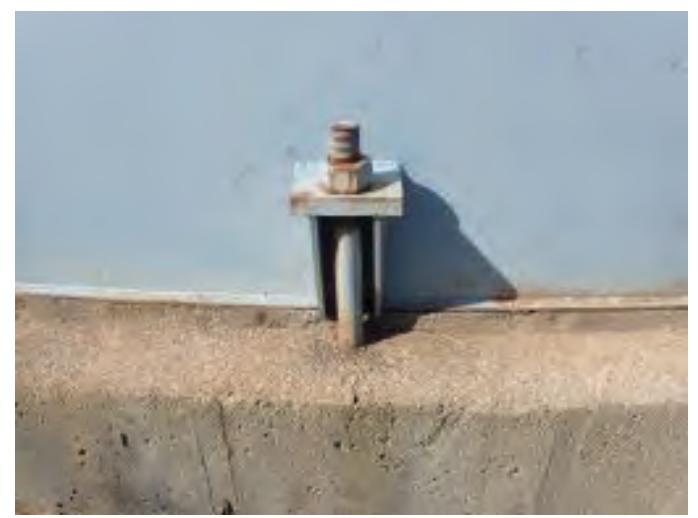
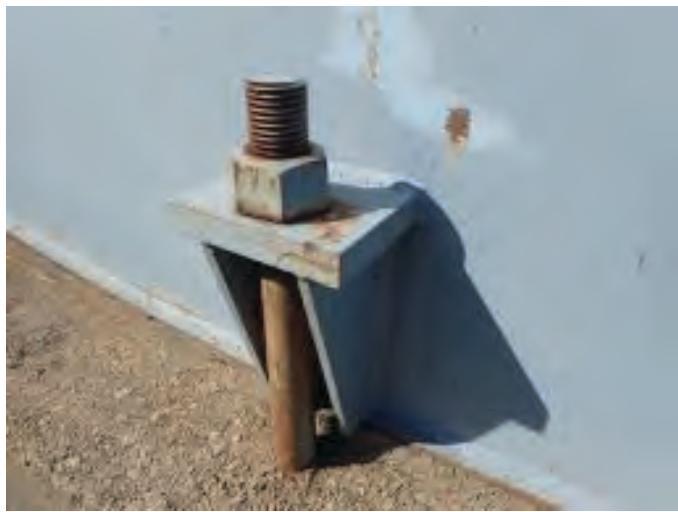
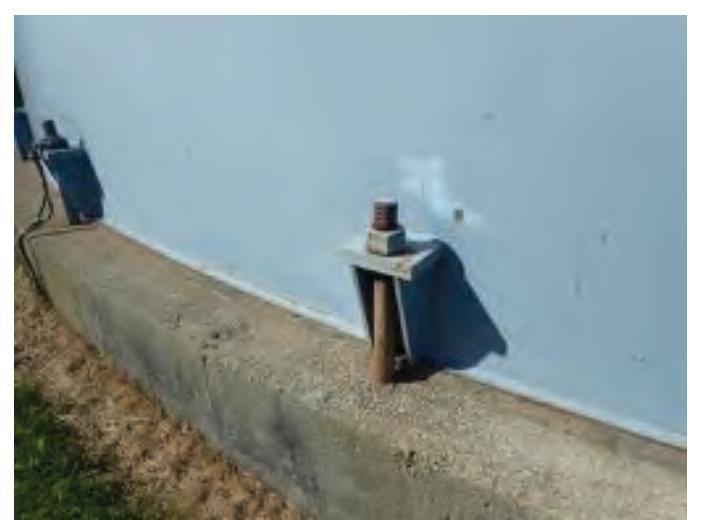
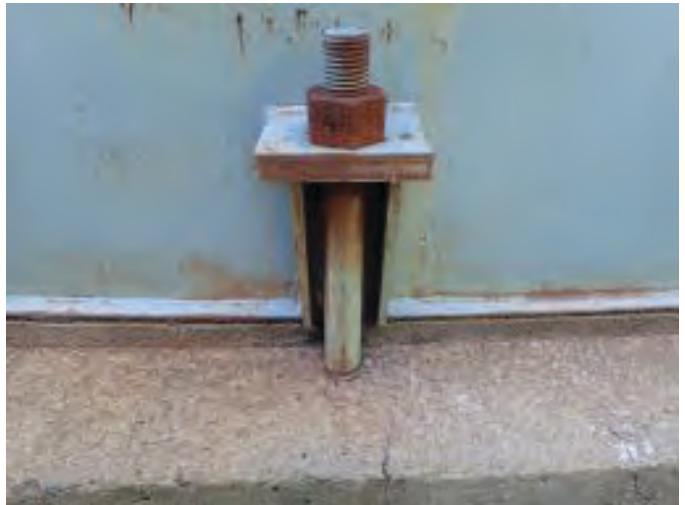
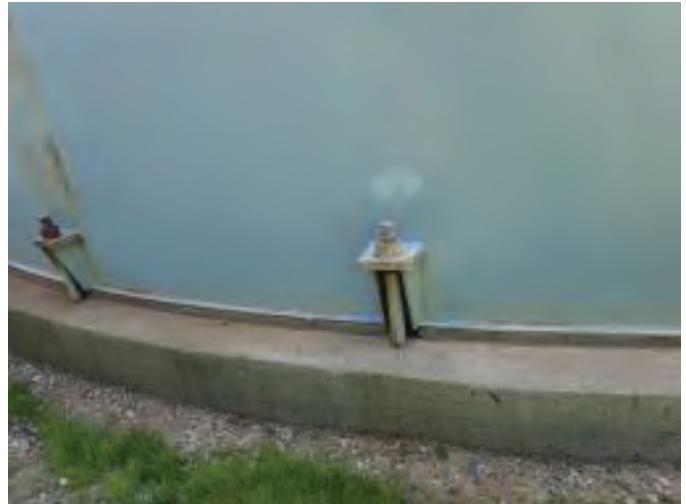
Each anchor bolt has one nut securely installed. The protective coating applied to this steel support hardware is nearing expiration and has become thin, causing steel exposure and surface corrosion throughout approximately 15%-20% of these surfaces. However, these steel support components remain free of obvious fatigue/deterioration of the steel at this time.

28 Secure Anchor Bolt With Support Hardware Having 28 Coating Loss (Nearing Expiration), Exposed Steel And Surface Corrosion

29 Secure Anchor Bolt With Support Hardware Having Coating Loss (Nearing Expiration), Exposed Steel And Surface Corrosion

30 Secure Anchor Bolt With Support Hardware Having Coating Loss (Nearing Expiration), Exposed Steel And Surface Corrosion

31 Secure Anchor Bolt With Support Hardware Having Coating Loss (Nearing Expiration), Exposed Steel And Surface Corrosion

32 Secure Anchor Bolt With Support Hardware Having 32 Coating Loss (Nearing Expiration), Exposed Steel And Surface Corrosion

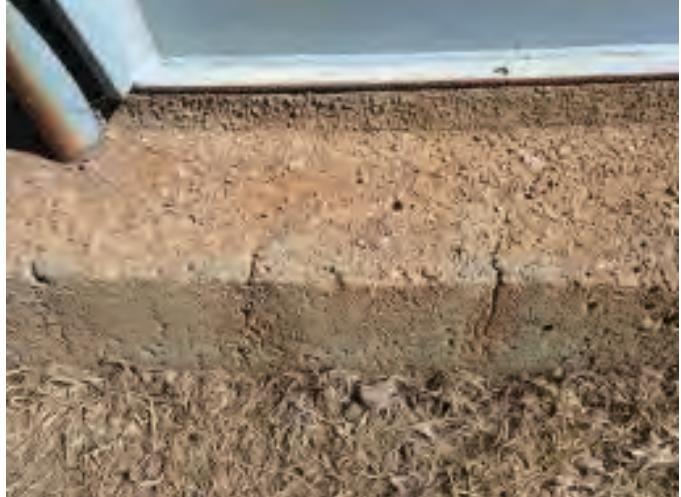
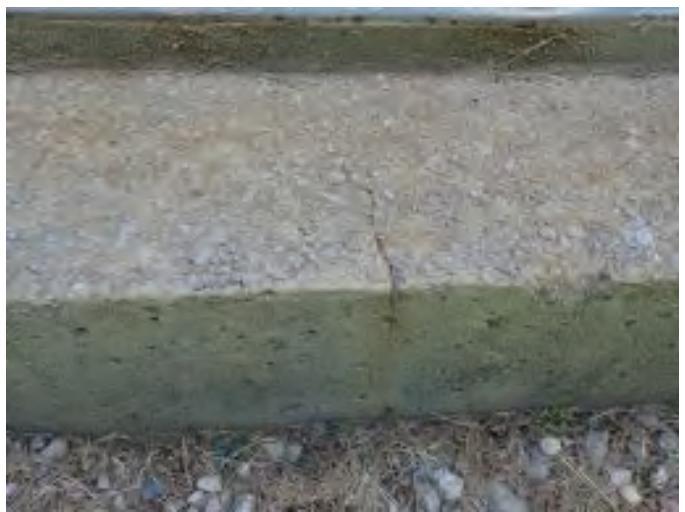
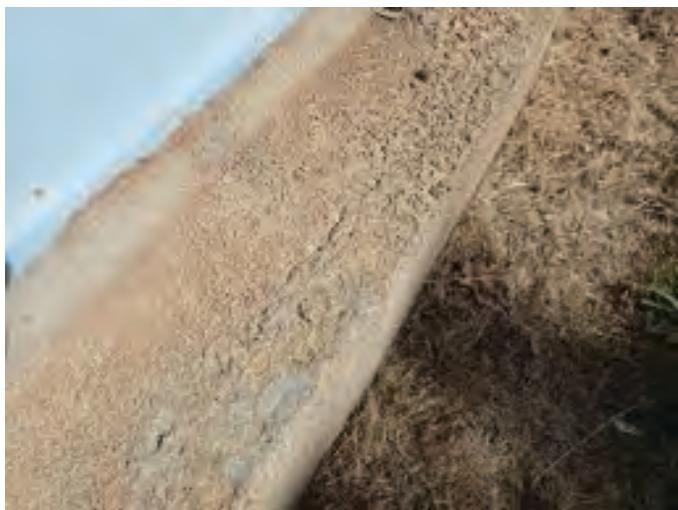
The exposed surfaces of the 10" wide concrete foundation range from 4" to 18" tall, are not coated and were found having tight cracks throughout approximately 10% of these exposed surfaces.

These cracks were sounded and appeared to be limited to the surface of the concrete and remain free of obvious voids or spalls at this time.

33 Concrete Foundation With Tight Cracks

Concrete Foundation With Tight Cracks

35 Concrete Foundation With Tight Cracks

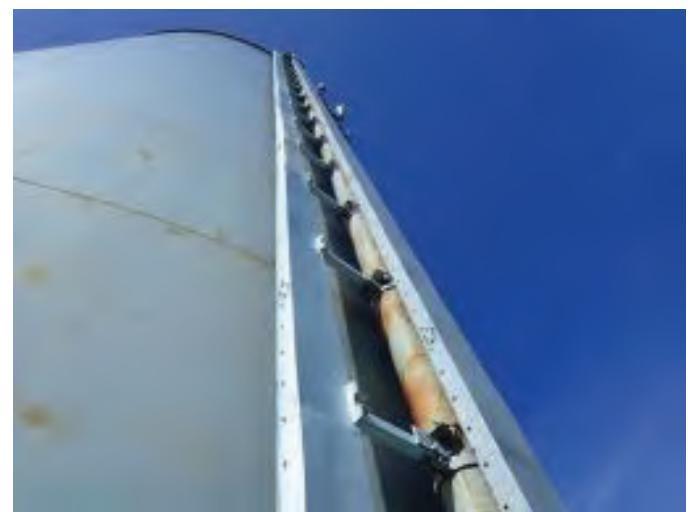
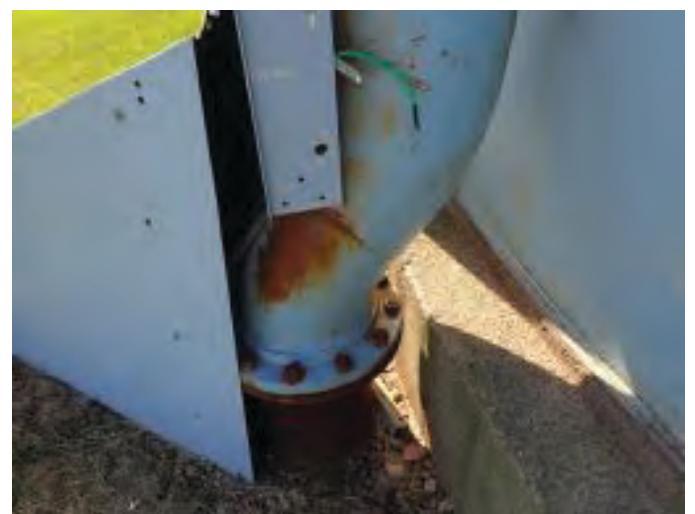
The protective coating applied to this steel pipe has lost adhesion and has become thin, causing steel exposure throughout approximately 25% of the surfaces of this pipe. No obvious fatigue/deterioration of the steel was evident within these areas of exposure, rather mild corrosion exists at this time.

36 Overflow Pipe With Coating Loss/Thinning, Exposed Steel And Mild Corrosion

Overflow Pipe With Coating Loss/Thinning, Exposed37Steel And Mild Corrosion

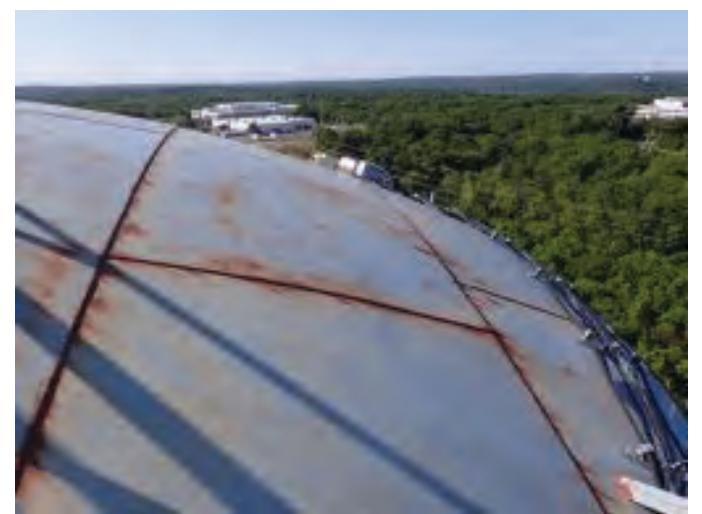
Roof Panels With Coating Loss/Thinning, Exposed
Primary Coating, Exposed Underlying Steel And Mild
Corrosion

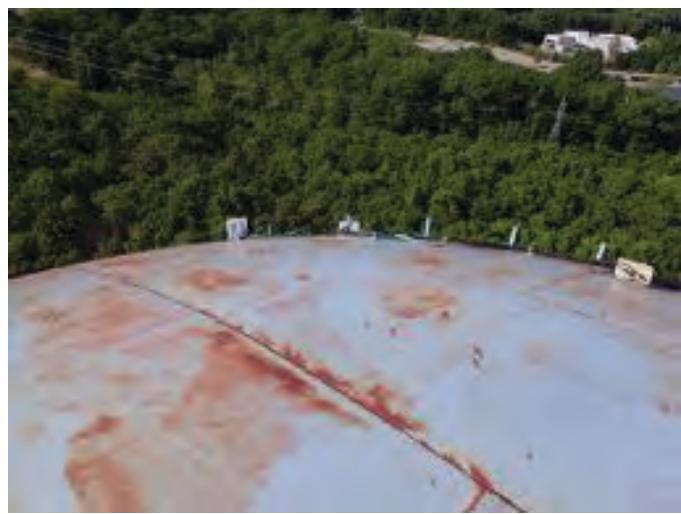
40 Roof Panels With Coating Loss/Thinning, Exposed Primary Coating, Exposed Underlying Steel And Mild Corrosion

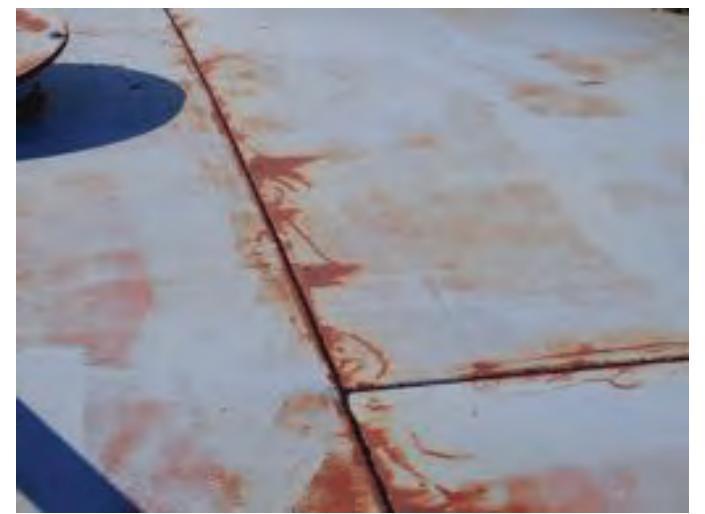
41 Roof Panels With Coating Loss/Thinning, Exposed Primary Coating, Exposed Underlying Steel And Mild Corrosion

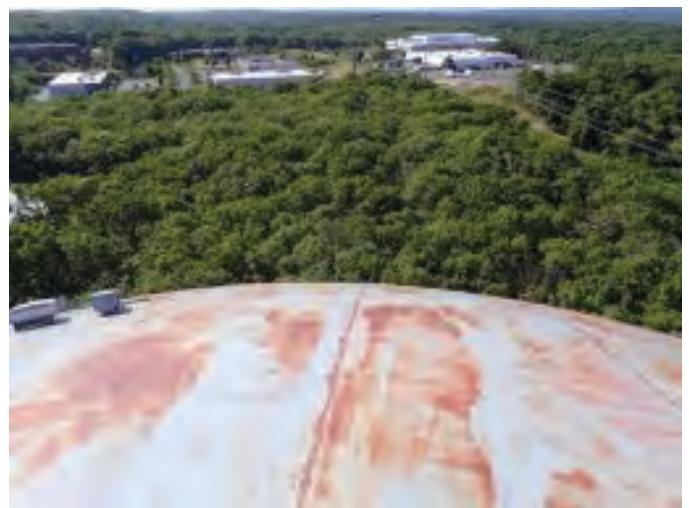
42 Roof Panels With Coating Loss/Thinning, Exposed Primary Coating, Exposed Underlying Steel And Mild Corrosion

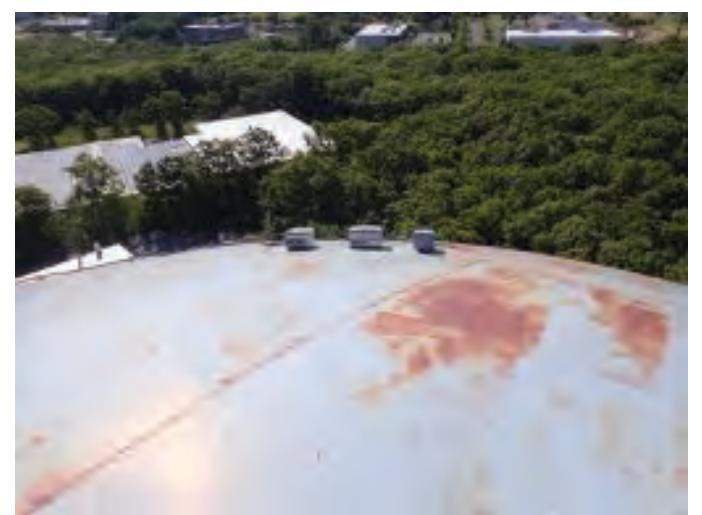
43 Roof Panels With Coating Loss/Thinning, Exposed Primary Coating, Exposed Underlying Steel And Mild Corrosion

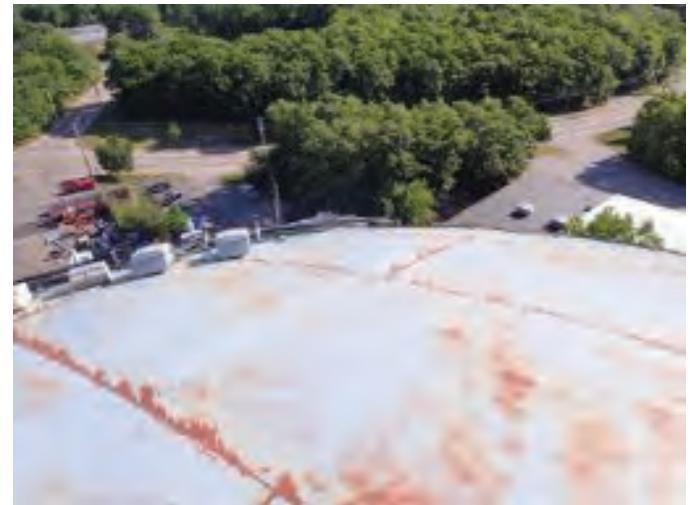
Roof Panels With Coating Loss/Thinning, Exposed
Primary Coating, Exposed Underlying Steel And
Mild Corrosion

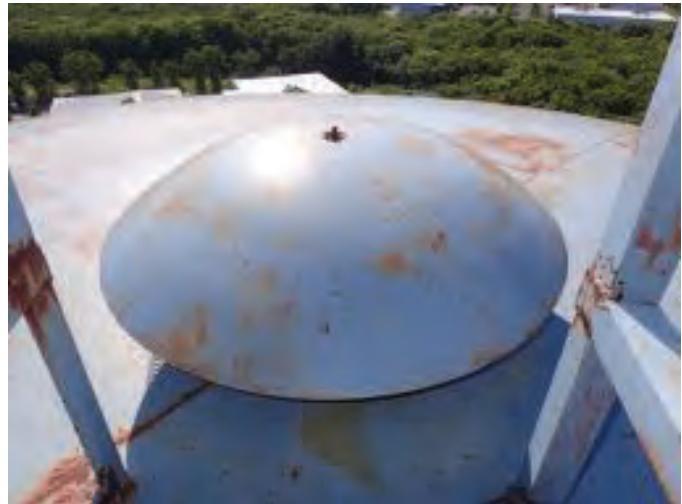
46 Secure Roof Safety Railings With Coating Loss (Nearing Expiration), Exposed Steel And Surface Corrosion

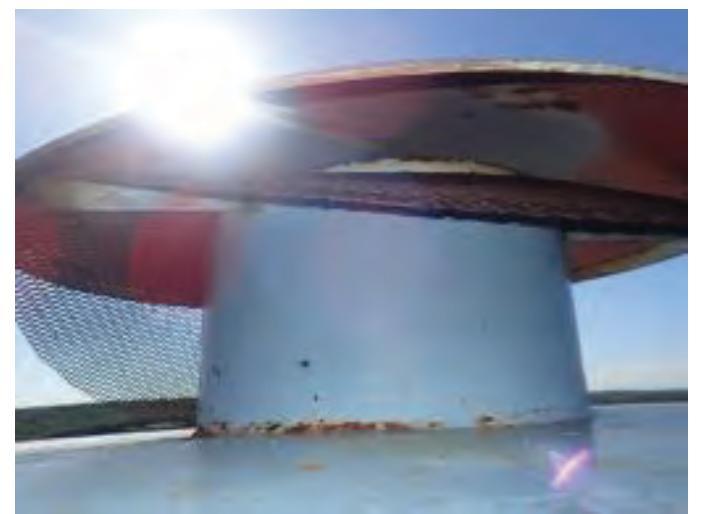
47 Secure Vent Cap With Coating Loss, Exposed Underlying Steel And Mild Corrosion

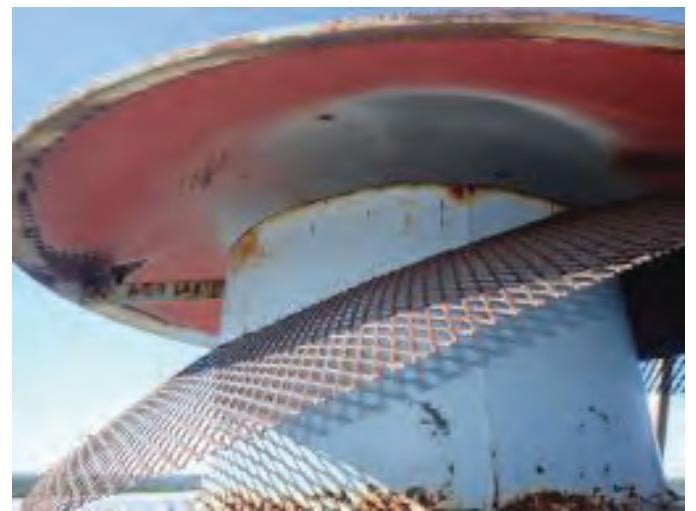
48 Failed Vent Screen Due To Corrosion

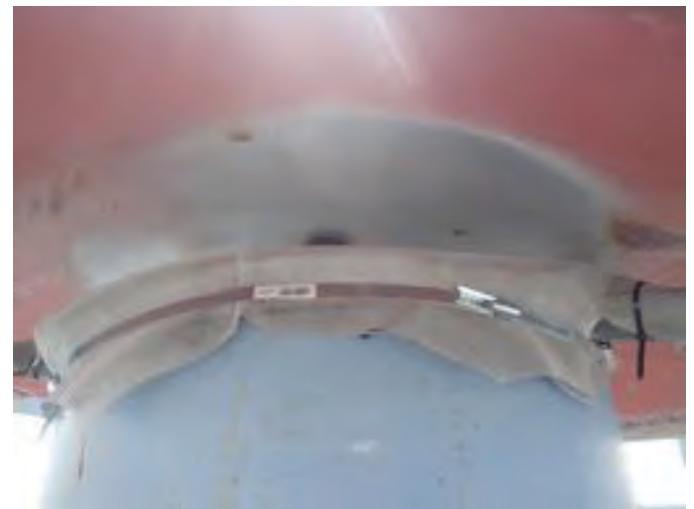
49 Failed Vent Screen Due To Corrosion

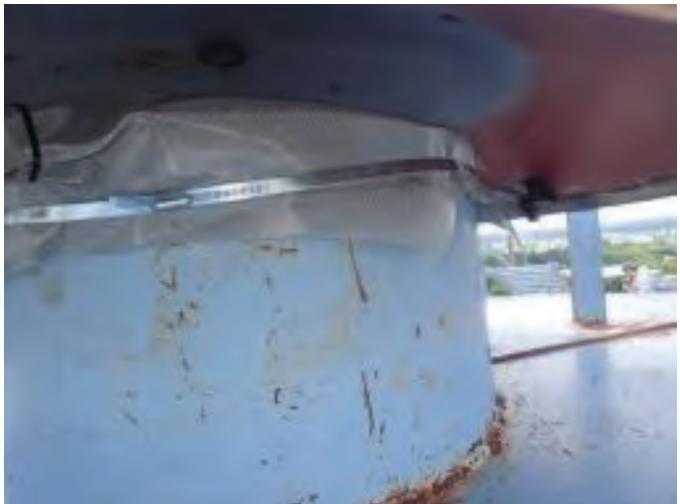
Temporary Installed Vent Screen 50

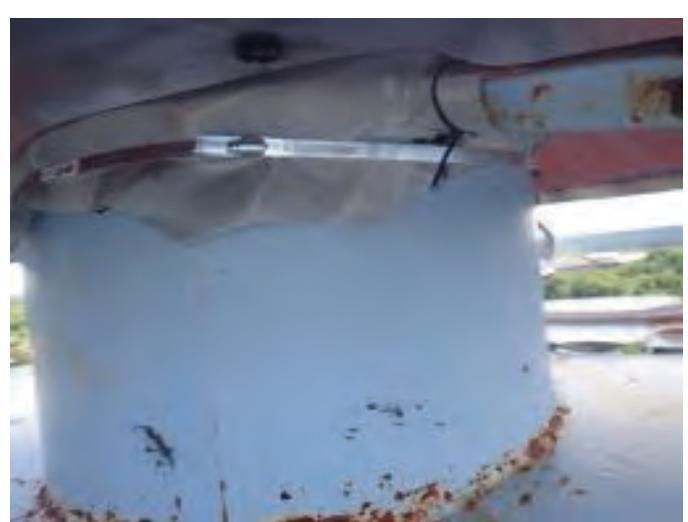
51 *Temporary Installed Vent Screen*

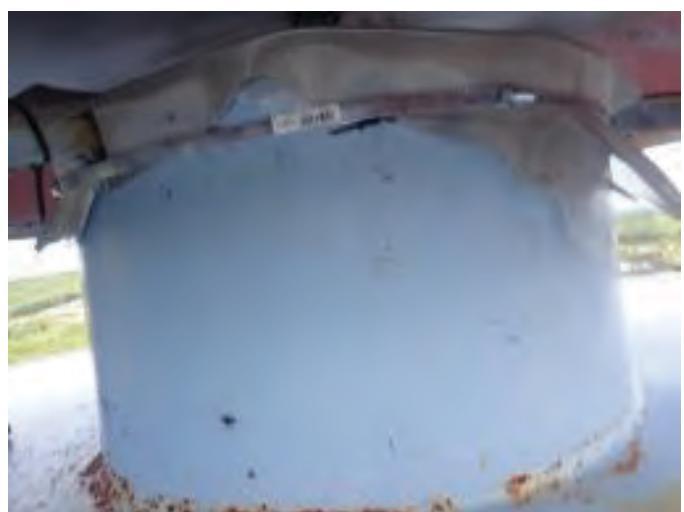
52 *Temporary Installed Vent Screen*

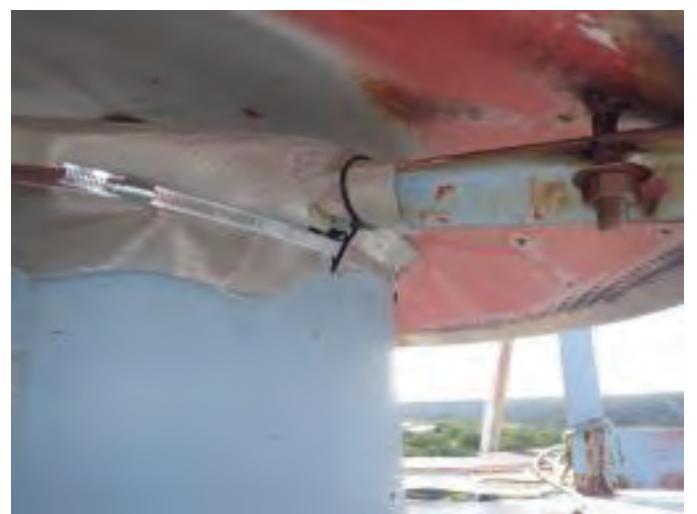
53 Temporary Installed Vent Screen

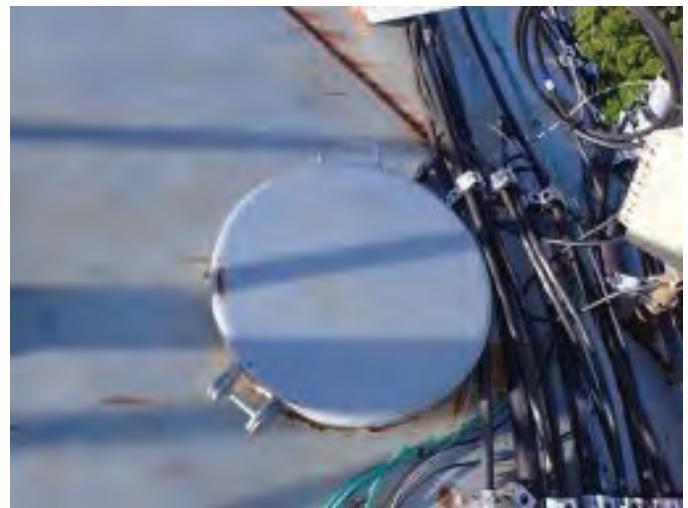
Open Westernmost Access Hatch

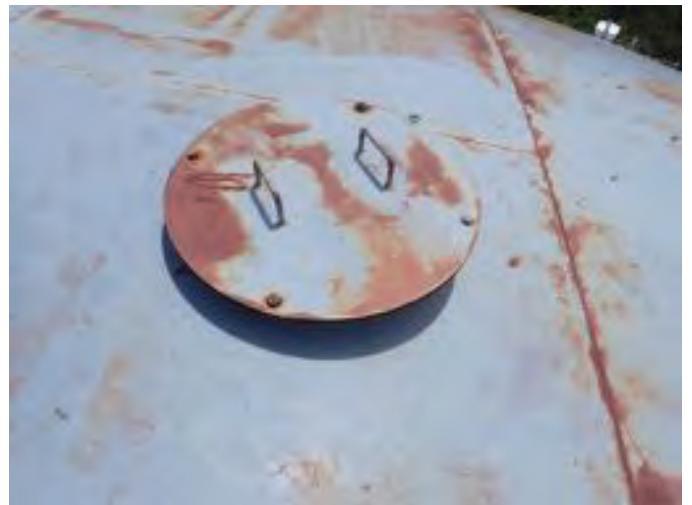
Closed Westernmost Access Hatch

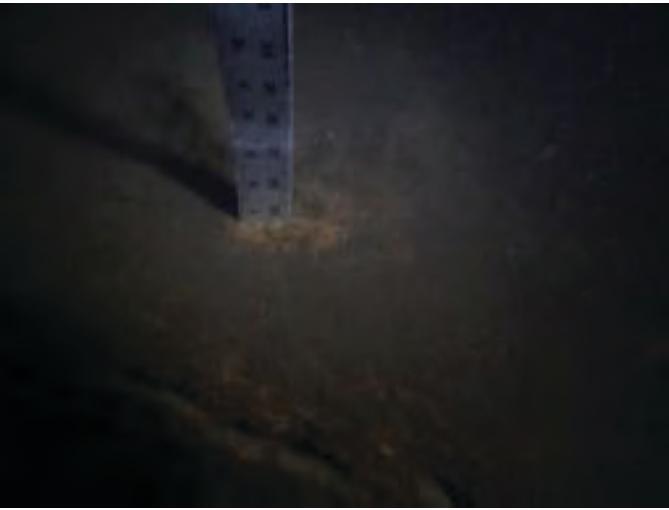
58 *Layer Of Precipitate*

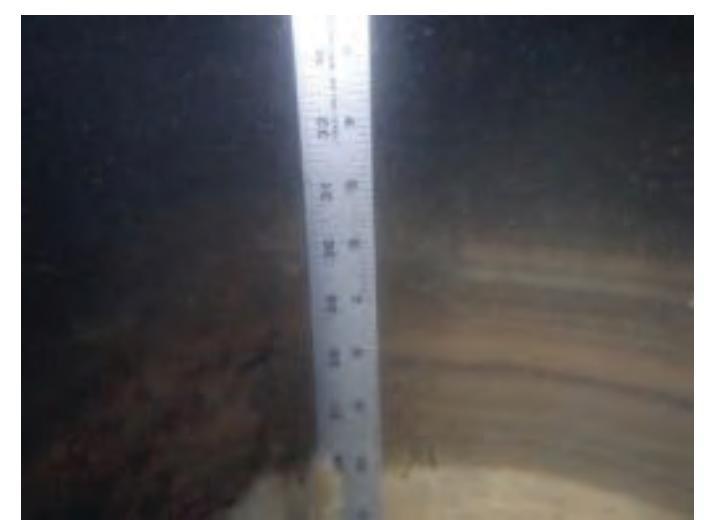
59 *Layer Of Precipitate*

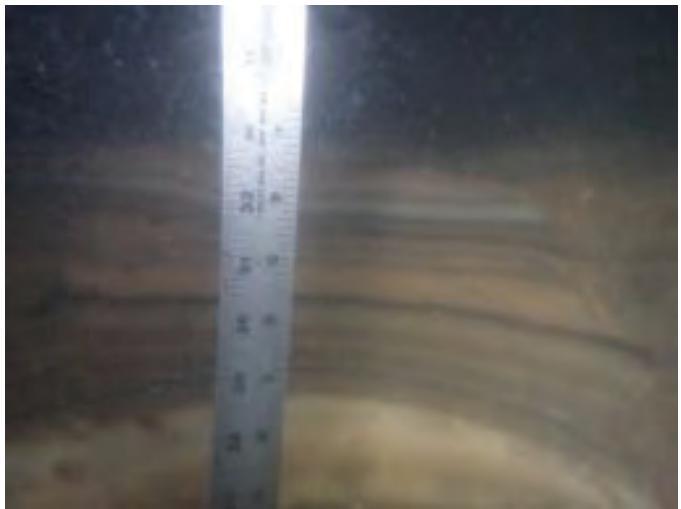
60 *Layer Of Precipitate*

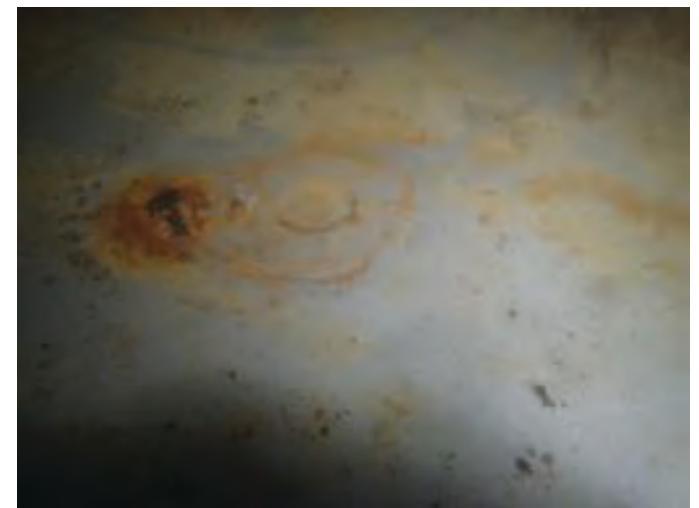
61 *Layer Of Precipitate*

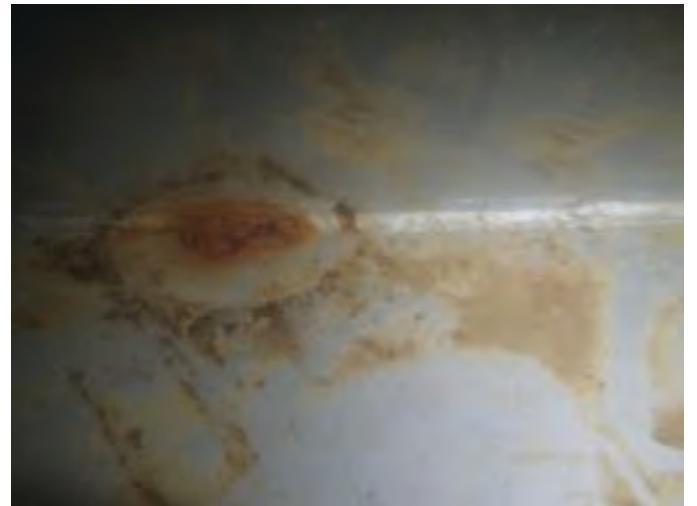
Floor With Coating Loss, Exposed Underlying Steel,
Mild To Moderate Corrosion And Moderate To Heavy Staining

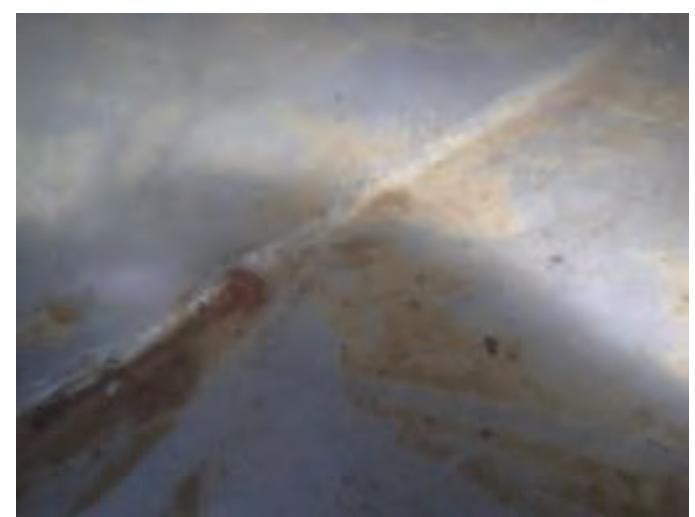
63 Floor With Coating Loss, Exposed Underlying Steel, Mild To Moderate Corrosion And Moderate To Heavy Staining

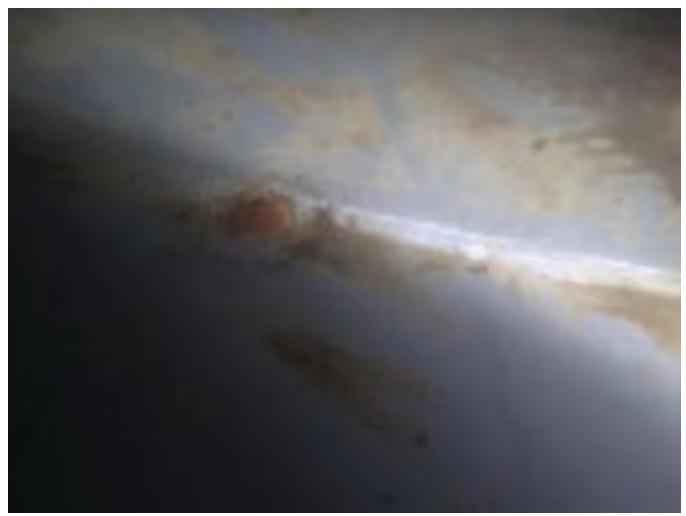
64 Floor With Coating Loss, Exposed Underlying Steel, Mild To Moderate Corrosion And Moderate To Heavy Staining

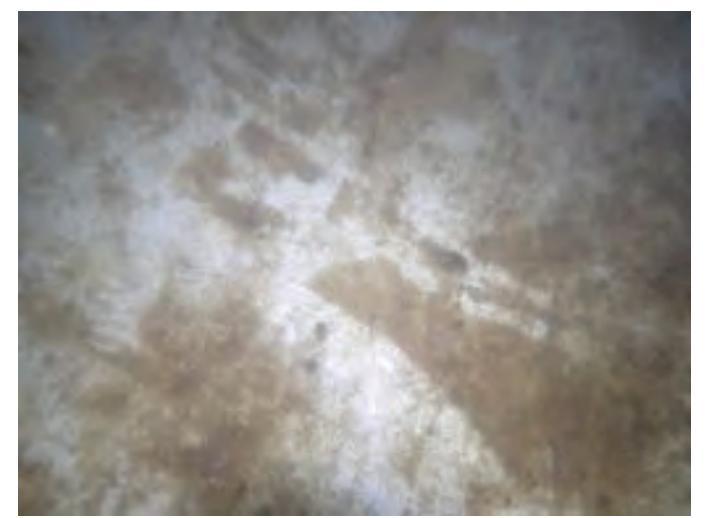
65 Floor With Coating Loss, Exposed Underlying Steel, Mild To Moderate Corrosion And Moderate To Heavy Staining

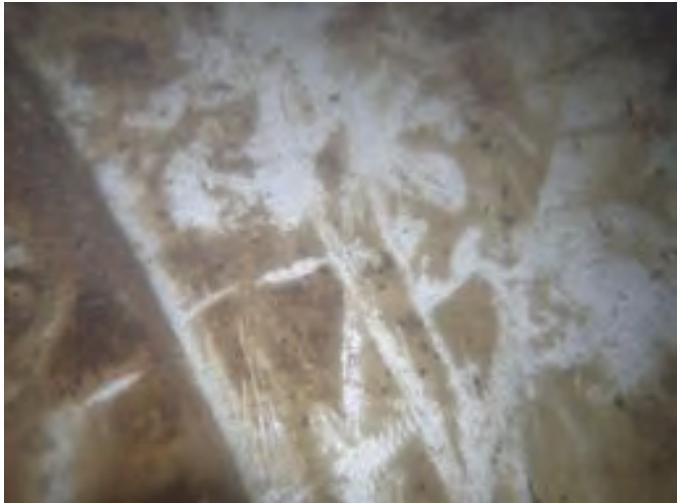
66 Floor With Moderate To Heavy Staining

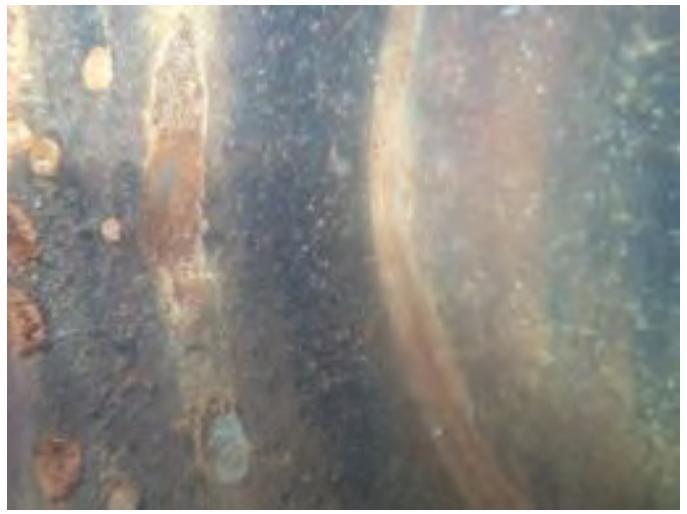
Easternmost Manway With Expired Coating, Fatigue70(Pitting), Exposed Underlying Steel And Corrosion

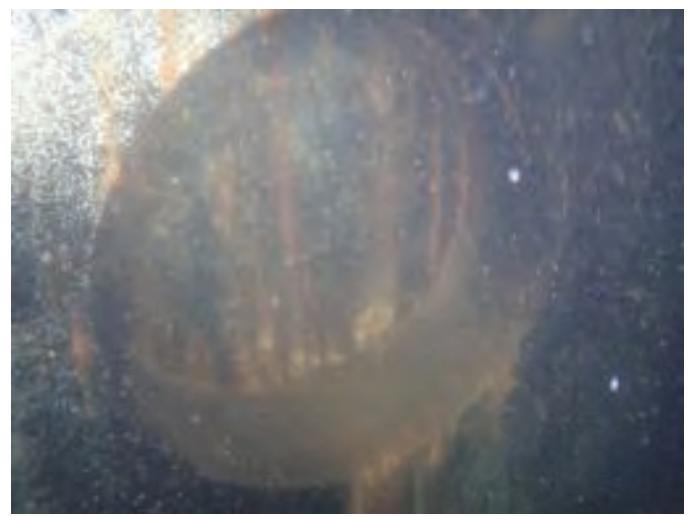
71 *Easternmost Manway With Expired Coating, Fatigue* (*Pitting*), *Exposed Underlying Steel And Corrosion*

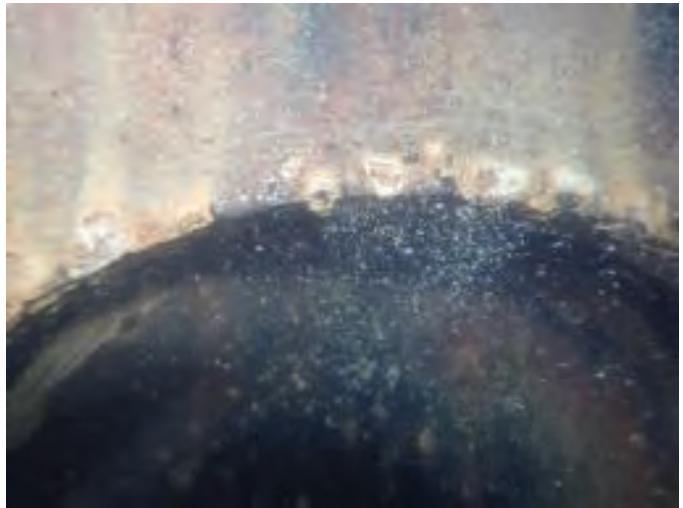
72 Westernmost Manway With Expired Coating, Fatigue (Pitting), Exposed Underlying Steel And Corrosion

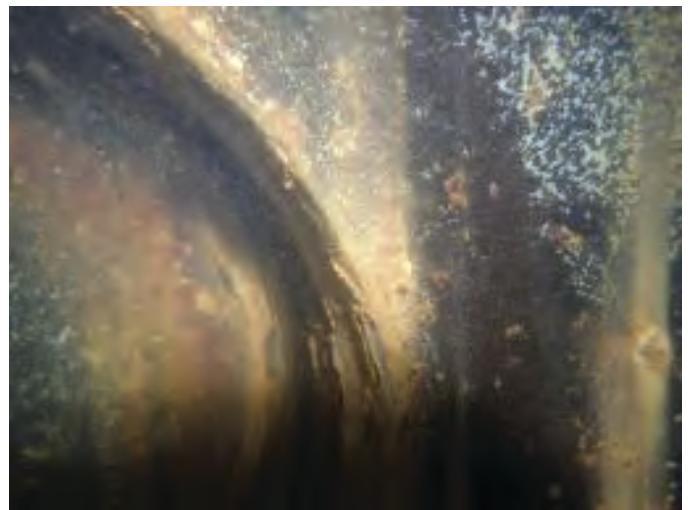
Westernmost Manway With Expired Coating, Fatigue73(Pitting), Exposed Underlying Steel And Corrosion

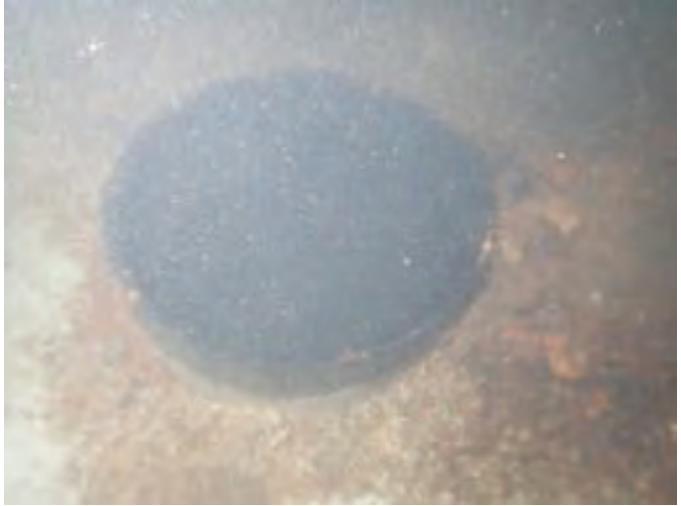
Westernmost Manway With Expired Coating, Fatigue74(Pitting), Exposed Underlying Steel And Corrosion

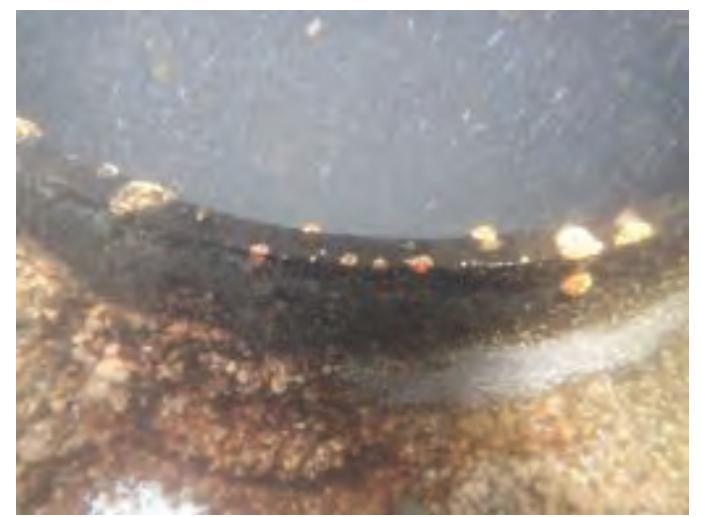
75 *12" Inside Diameter Influent/Effluent Flush Penetration*

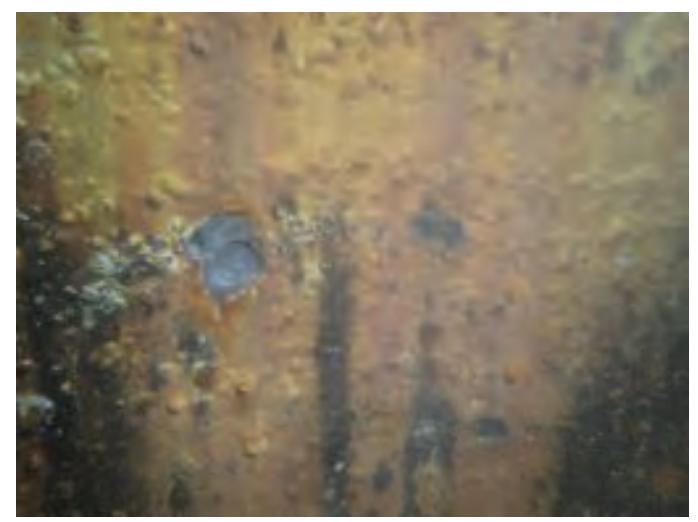
12" Inside Diameter Influent/Effluent Flush
Penetration With Coating Loss/ Ruptured Blisters, Exposed Steel And Corrosion

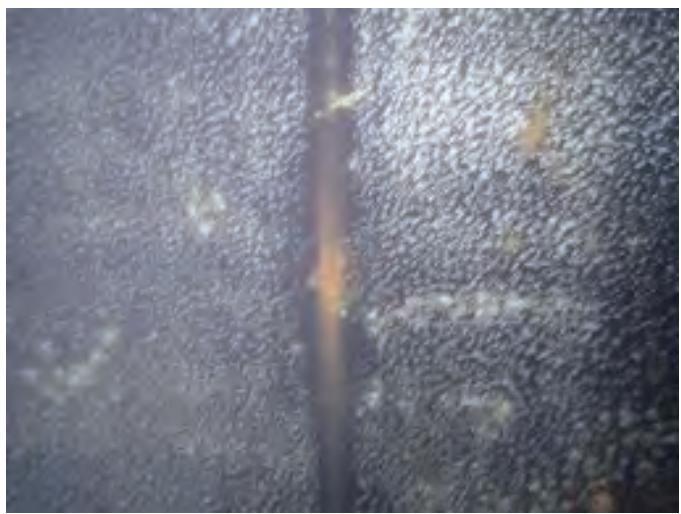
78 Interior Wall With Expired Coating, Exposed Underlying Steel, Fatigue (Pitting), Moderate Corrosion And Moderate To Heavy Staining

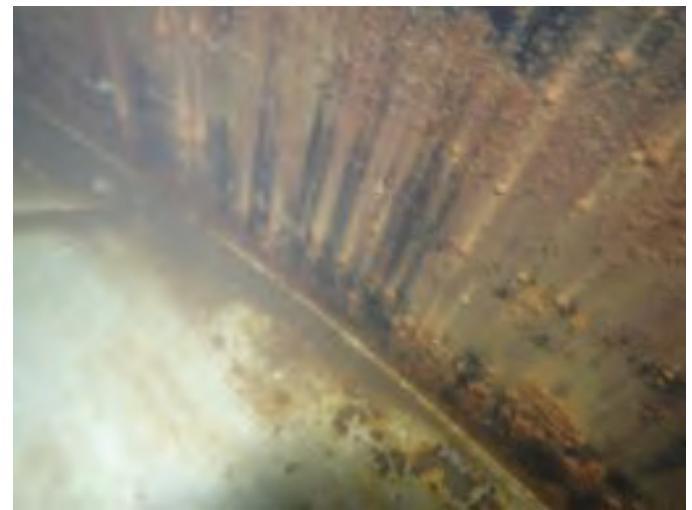
Interior Wall With Expired Coating, Exposed
Underlying Steel, Fatigue (Pitting), Moderate
Corrosion And Moderate To Heavy Staining

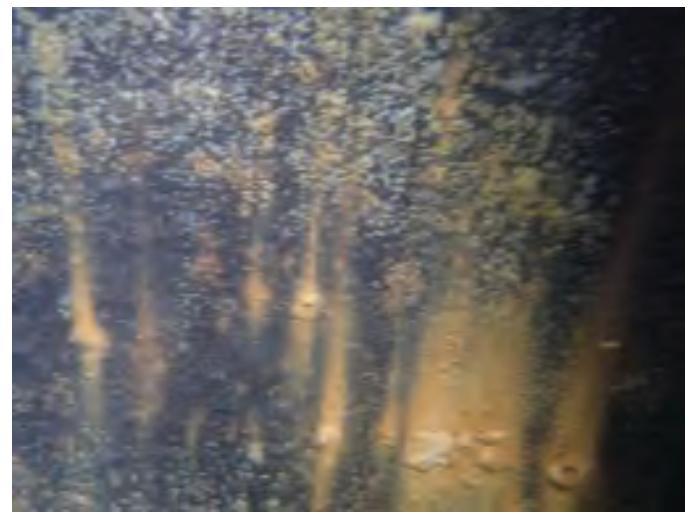
80 Interior Wall With Expired Coating, Exposed 80 Underlying Steel, Moderate Corrosion And Moderate To Heavy Staining

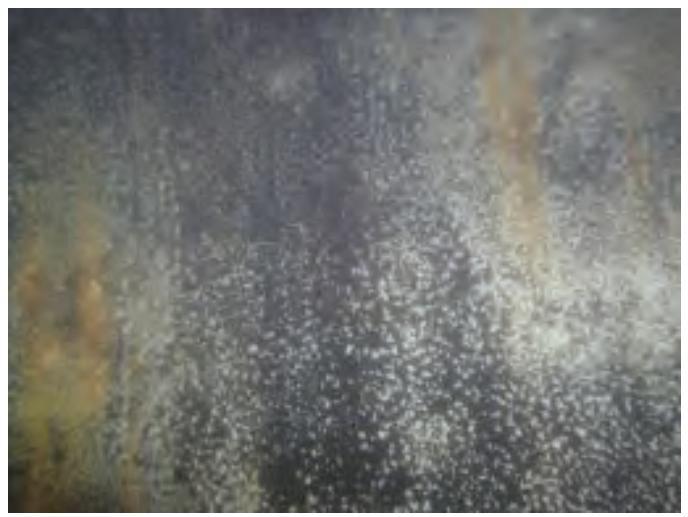
81 Interior Wall With Expired Coating, Exposed Underlying Steel, Moderate Corrosion And Moderate To Heavy Staining

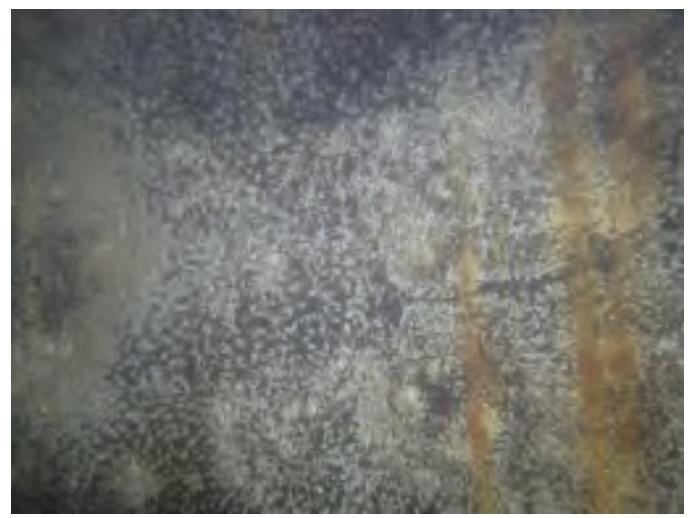
82 Interior Wall With Expired Coating, Exposed Underlying Steel, Moderate Corrosion And Moderate To Heavy Staining

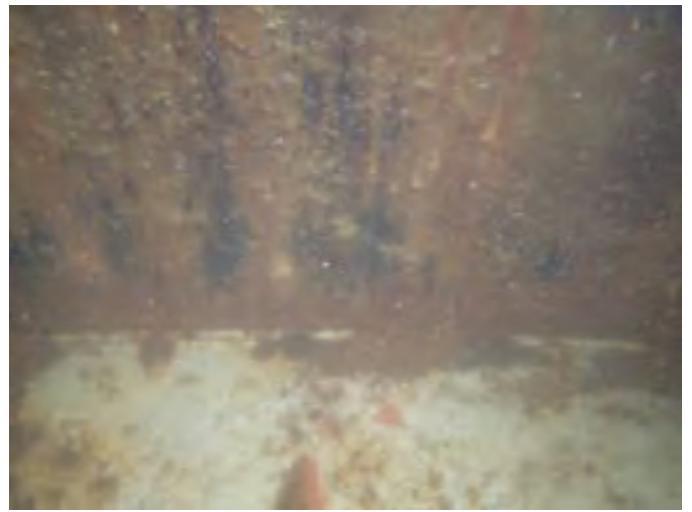
83 Interior Wall With Expired Coating, Exposed Underlying Steel, Moderate Corrosion And Moderate To Heavy Staining

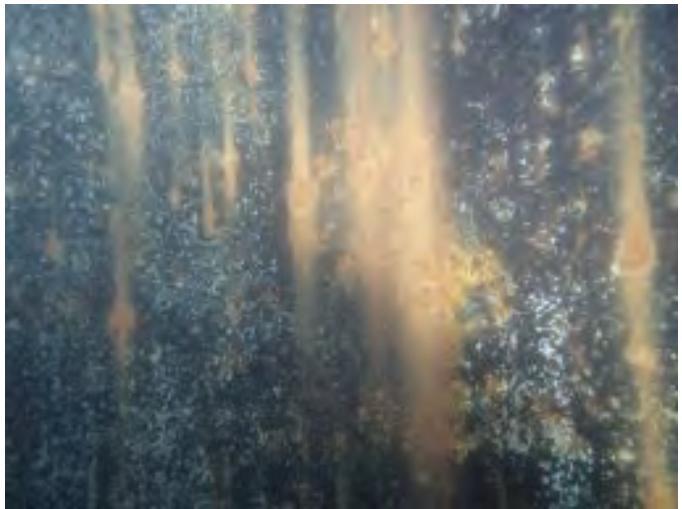
84 Interior Wall With Expired Coating, Exposed Underlying Steel, Moderate Corrosion And Moderate To Heavy Staining

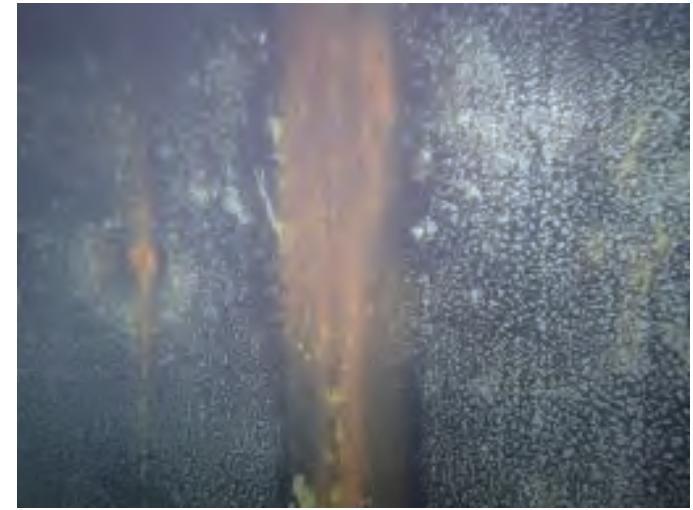
Interior Wall With Expired Coating, Exposed
Underlying Steel, Moderate Corrosion And Moderate To Heavy Staining

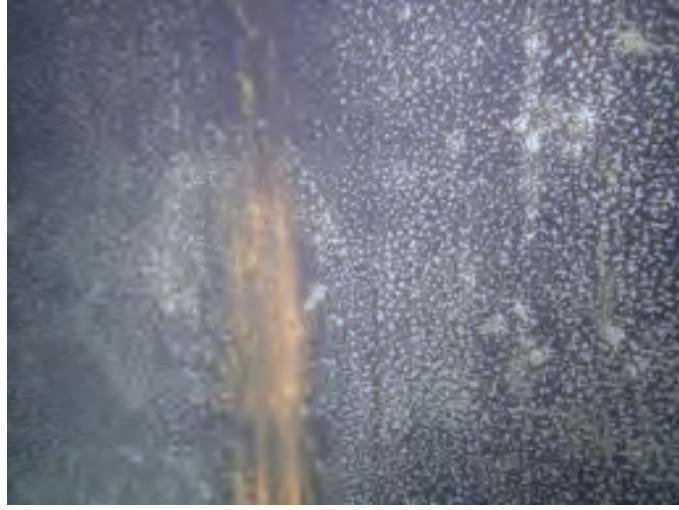
Interior Wall With Expired Coating, Exposed 86 Underlying Steel, Moderate Corrosion And Moderate To Heavy Staining

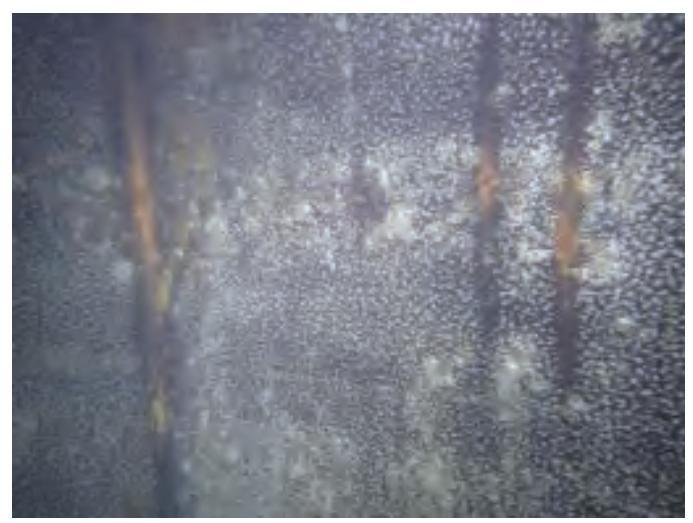
87 *Interior Wall With Expired Coating, Exposed Underlying Steel, Moderate Corrosion And Moderate To Heavy Staining*

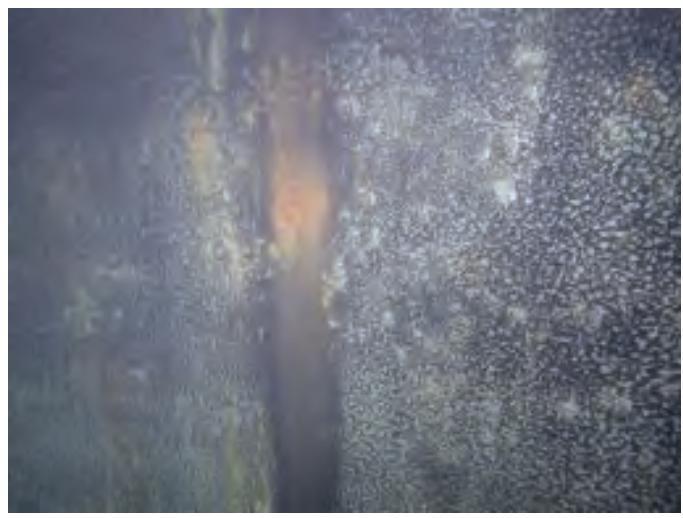
Interior Wall With Expired Coating, Exposed
Underlying Steel, Moderate Corrosion And
Moderate To Heavy Staining

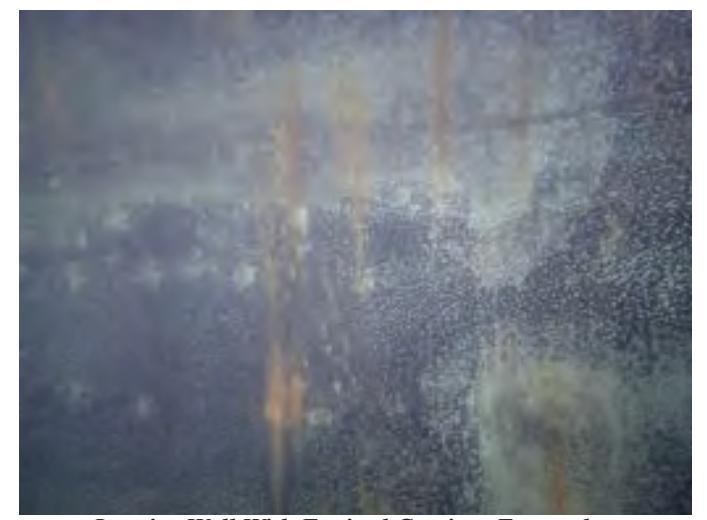
89 Interior Wall With Expired Coating, Exposed Underlying Steel, Moderate Corrosion And Moderate To Heavy Staining
