In re: City of Woonsocket Water Division - Application to Implement Multi-Year Rate Plan

Docket No. 4879

Dam Name (No):	Woonsocket Reservoir #3 Dam (068)
Location:	Smithfield/North Smithfield
Hazard Classification:	High
	-
Inspector:	David M. Matheson, P.E.
Inspection Date.	August 1, 2014

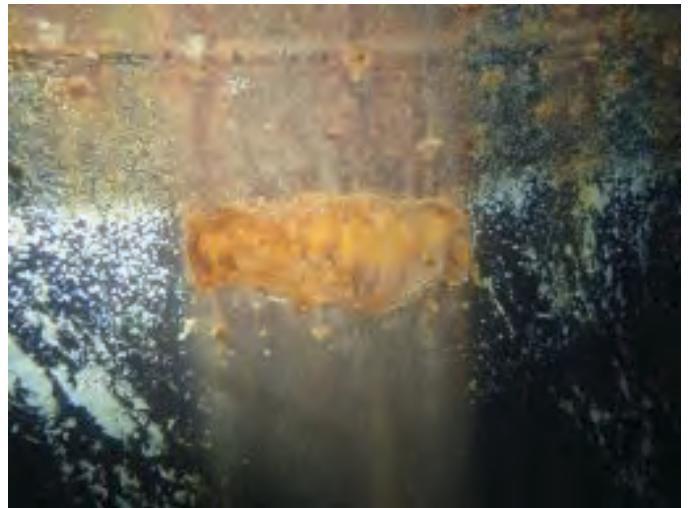
90 Interior Wall With Expired Coating, Exposed Underlying Steel, Moderate Corrosion And Moderate To Heavy Staining

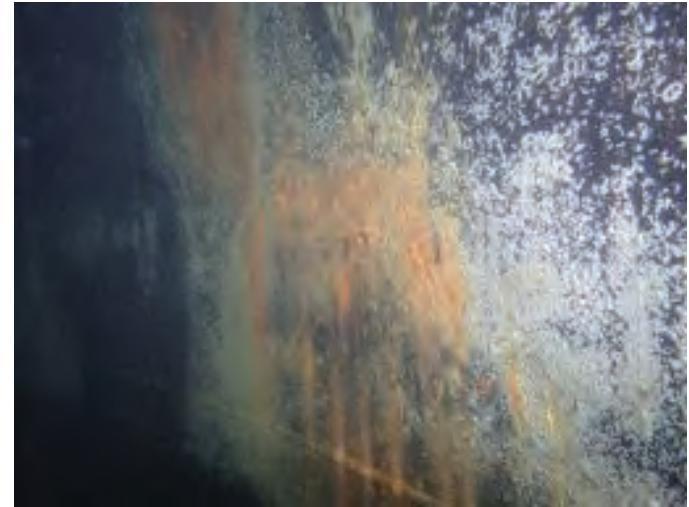
91 Interior Wall With Expired Coating, Exposed Underlying Steel, Moderate Corrosion And Moderate To Heavy Staining

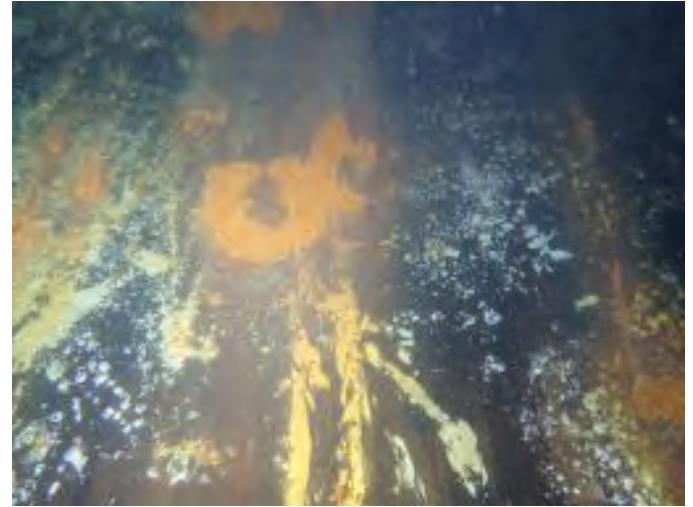
92 Interior Wall With Expired Coating, Exposed 94 Underlying Steel, Moderate Corrosion And 95 Moderate To Heavy Staining

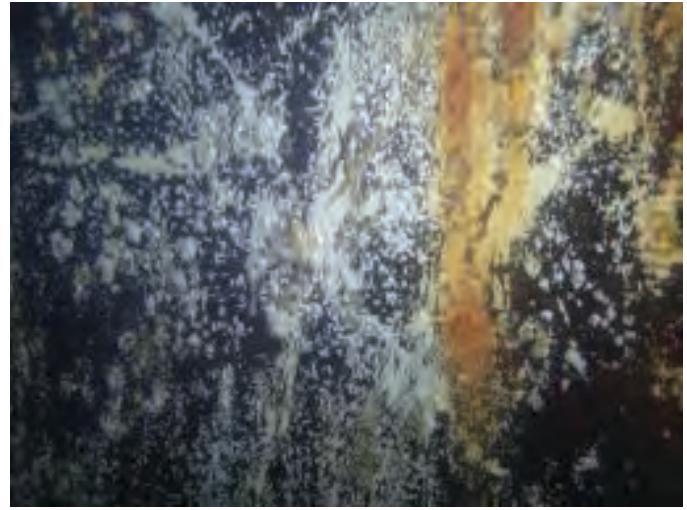
93 Interior Wall With Expired Coating, Exposed Underlying Steel, Moderate Corrosion And Moderate To Heavy Staining

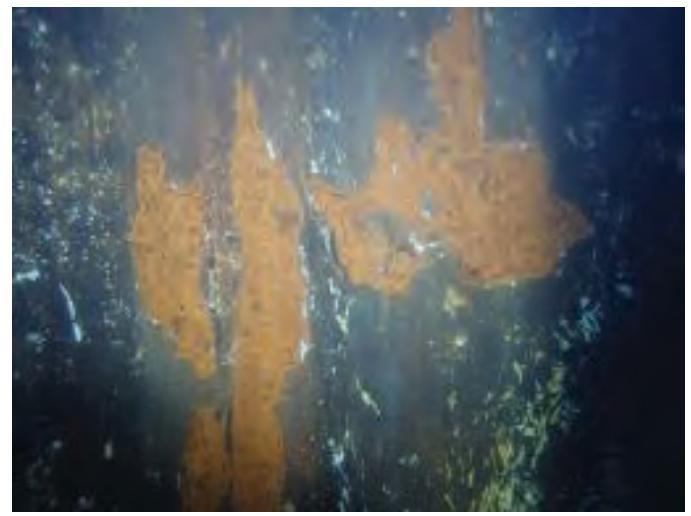
94 Interior Wall With Expired Coating, Exposed Underlying Steel, Moderate Corrosion And Moderate To Heavy Staining

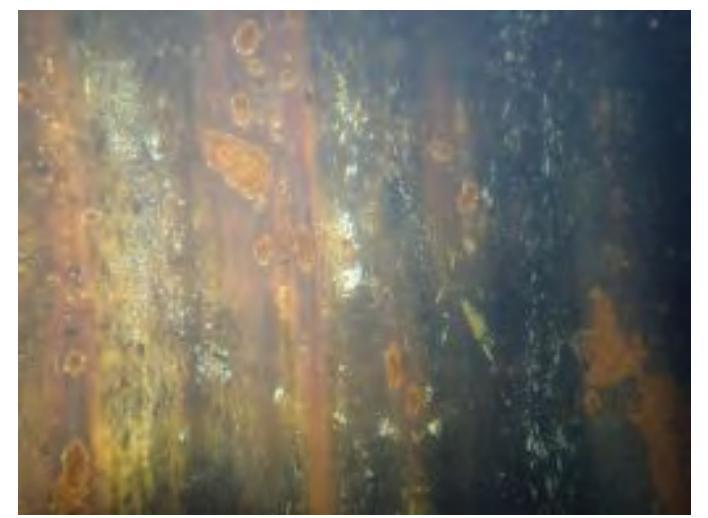
95 Interior Wall With Expired Coating, Exposed Underlying Steel, Moderate Corrosion And Moderate To Heavy Staining

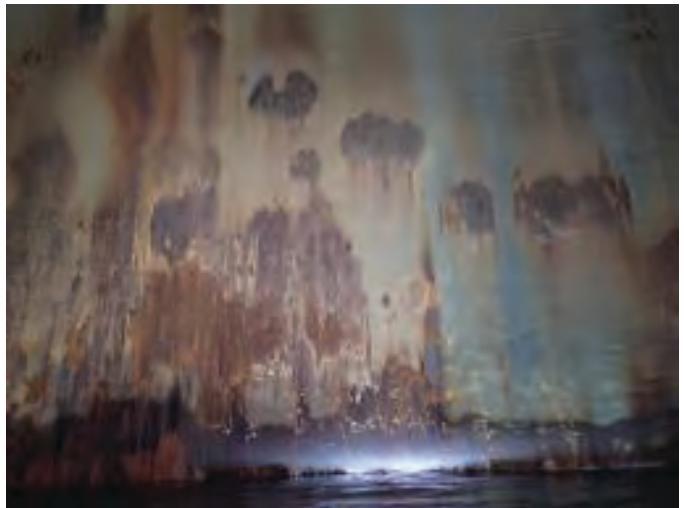
96 Interior Wall With Expired Coating, Exposed Underlying Steel, Moderate Corrosion And Moderate To Heavy Staining

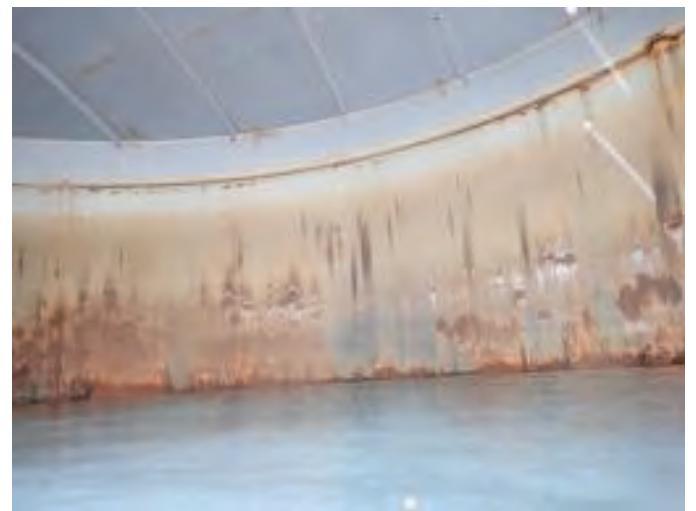
97 Interior Wall With Expired Coating, Exposed 97 Underlying Steel, Moderate Corrosion And Moderate To Heavy Staining

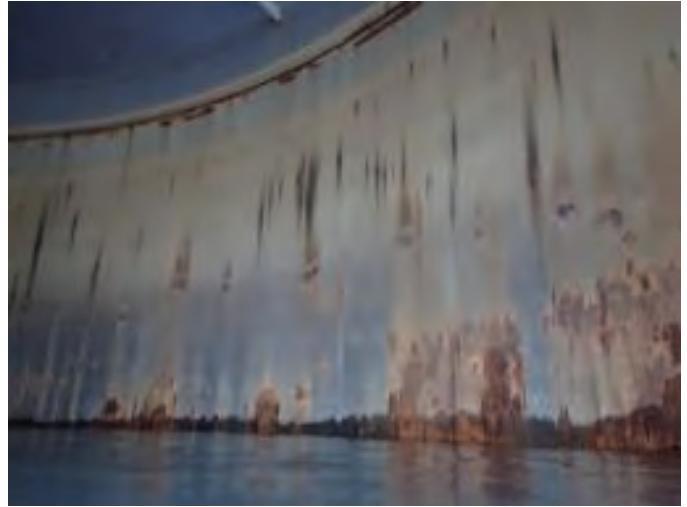
98 Interior Wall With Expired Coating, Exposed 98 Underlying Steel, Moderate Corrosion And Moderate To Heavy Staining

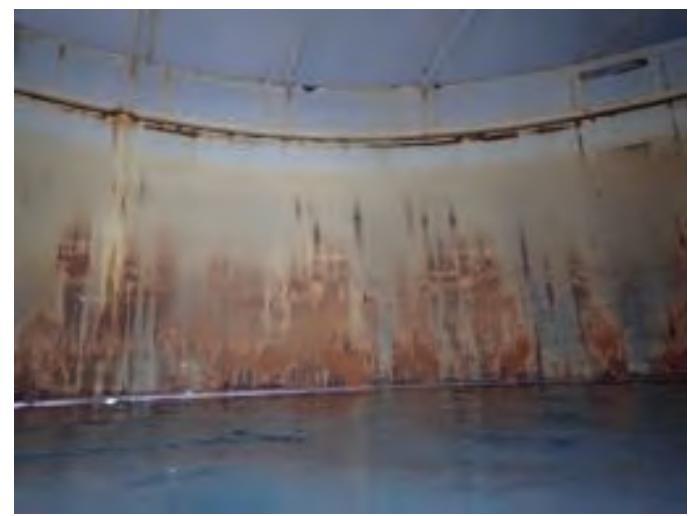
99 Interior Wall With Expired Coating, Exposed Underlying Steel, Moderate Corrosion And Moderate To Heavy Staining

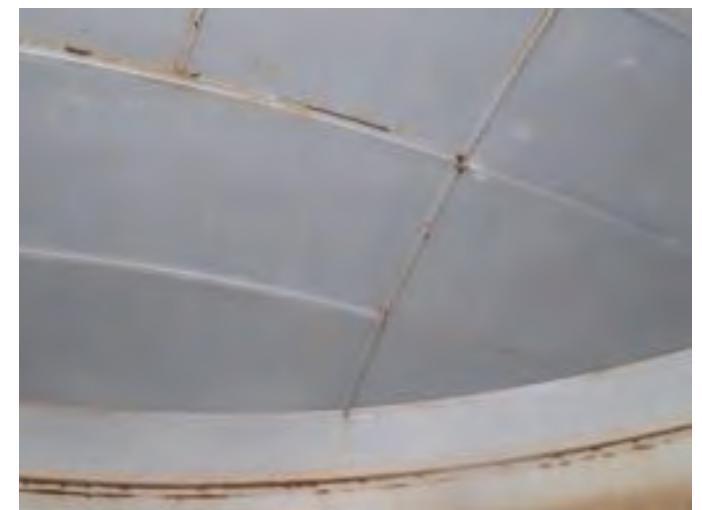
Overhead With Coating Loss (Nearing Expiration), 103 Exposed Underlying Steel And Mild Corrosion

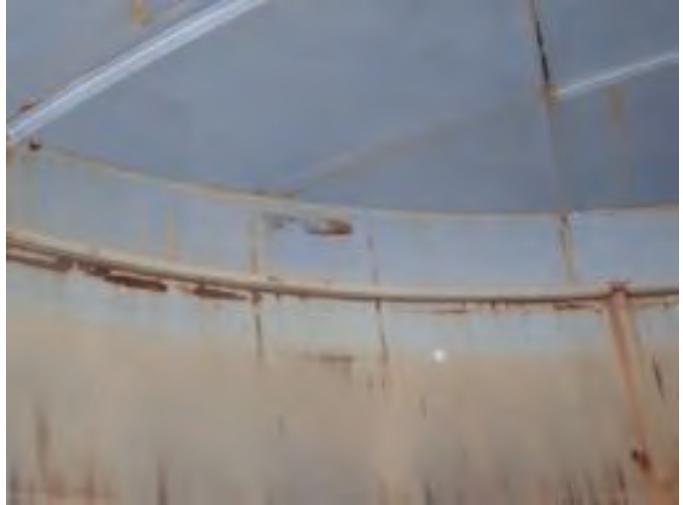
Overhead With Coating Loss (Nearing Expiration), 104 Exposed Underlying Steel And Mild Corrosion

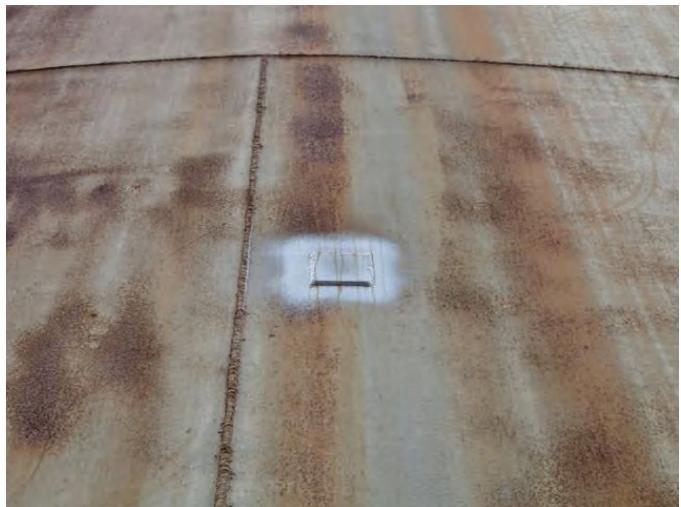
These six steel plates appeared to be securely welded in-place and no obvious leakage was evident or occurring at the location of where these six steel plates are welded to the exterior wall panels at this time.

A protective coating applied to these steel plates was found having mostly good adhesion value, however a decline in film thickness of the protective coating applied to these welded repairs causes mild surface corrosion and corrosion staining (blotch rusting). However, no obvious fatigue/deterioration of the steel plates utilized to complete these repairs or fatigue/deterioration of the wall panels at the location of these repairs was evident at the time of inspection.

1Easternmost Exterior Wall With A Steel Plate Welded1To The Second Wall Panel Above The Tank Base

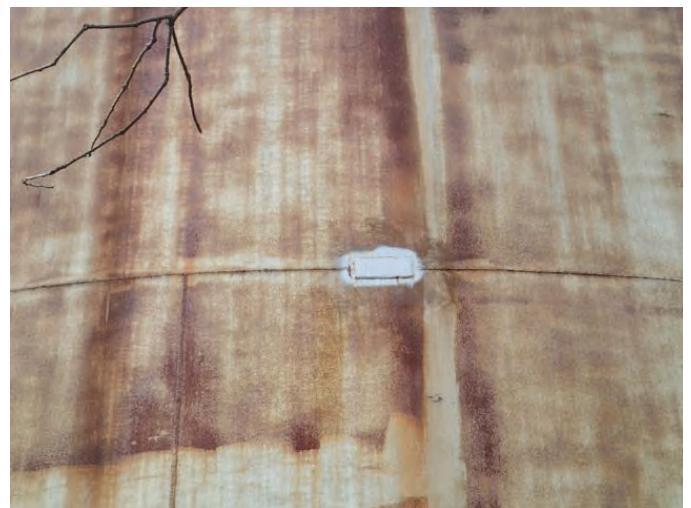
Northernmost Exterior Wall With A Steel Plate Welded To The Third And Fourth Rows Of Wall Panels Above The Tank Base

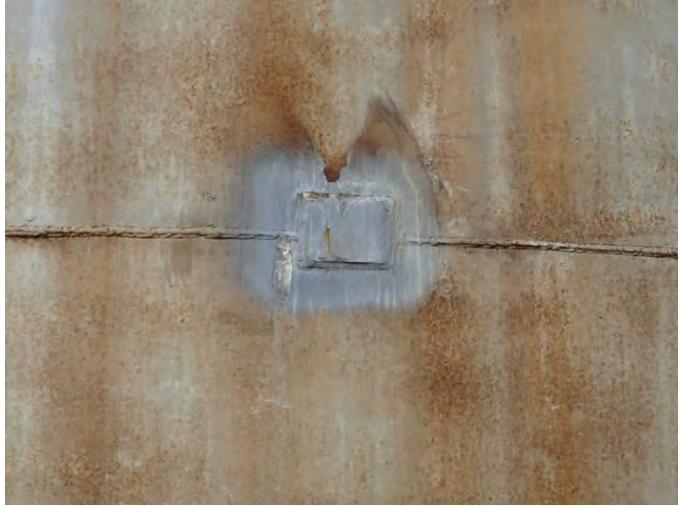
3 Westernmost Exterior Wall With A Steel Plate Welded To The Second And Third Rows Of Wall Panels Above The Tank Base

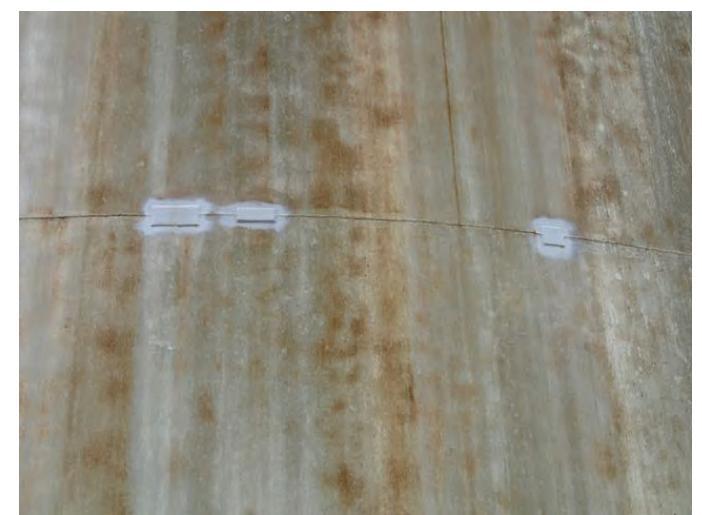
4 South-Westernmost Exterior Wall With Steel Plates 4 Welded To The Second And Third Row Of Wall Panels Above The Tank Base

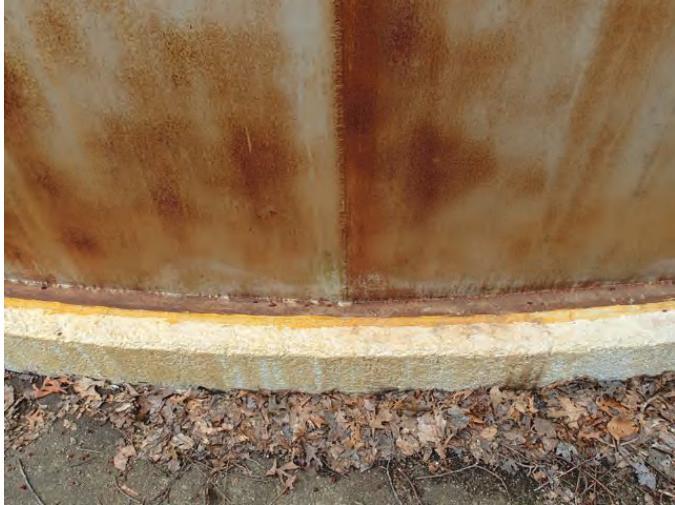
5 Exterior Wall With Expired Coating, Exposed Underlying Steel And Mild Surface Corrosion

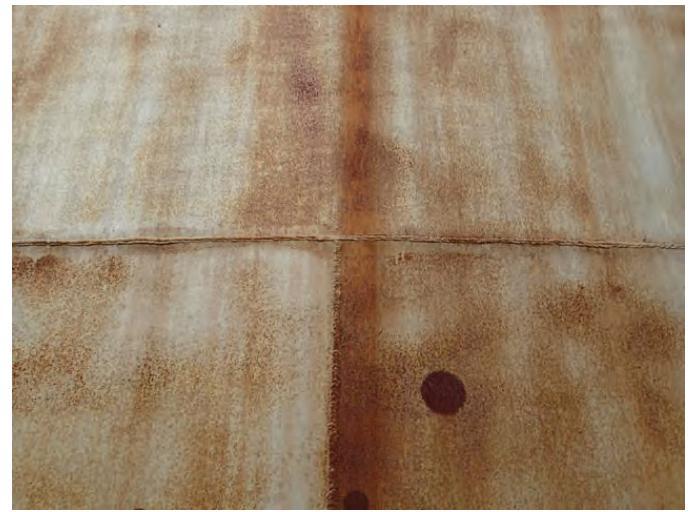
6 Exterior Wall With Expired Coating, Exposed Underlying Steel And Mild Surface Corrosion

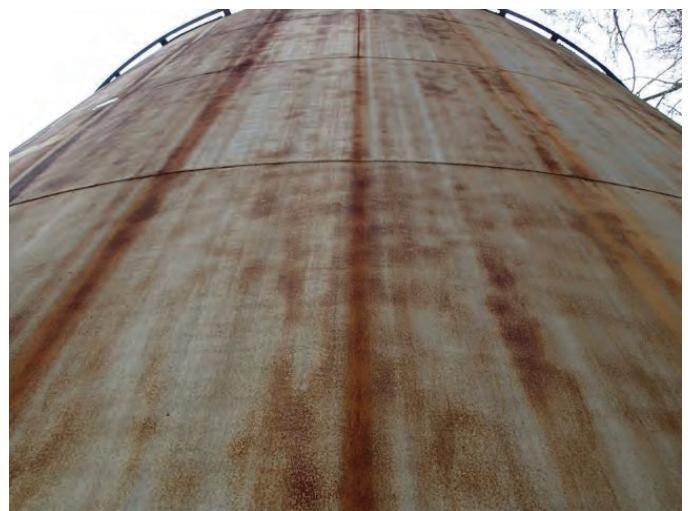
7 Exterior Wall With Expired Coating, Exposed 7 Underlying Steel And Mild Surface Corrosion

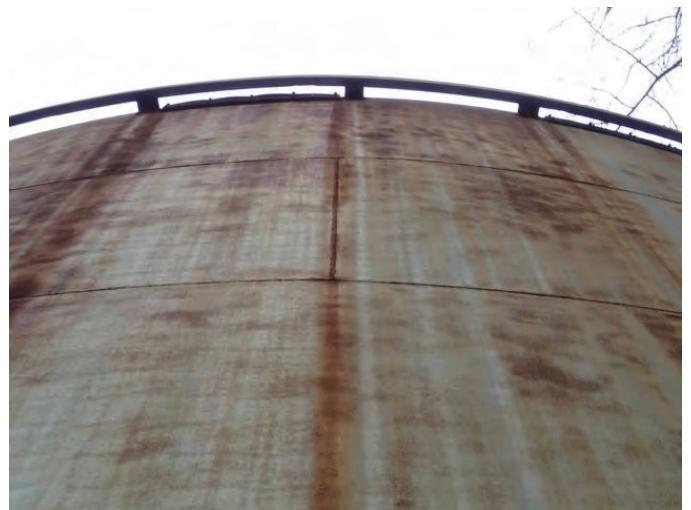
8 Exterior Wall With Expired Coating, Exposed 8 Underlying Steel And Mild Surface Corrosion

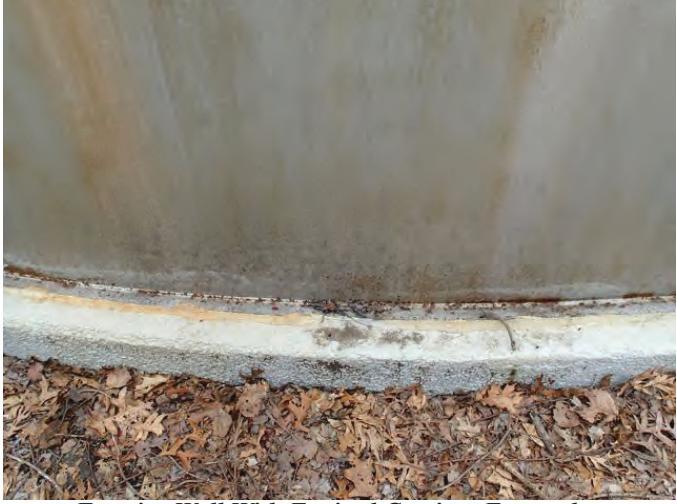
9 Exterior Wall With Expired Coating, Exposed Underlying Steel And Mild Surface Corrosion

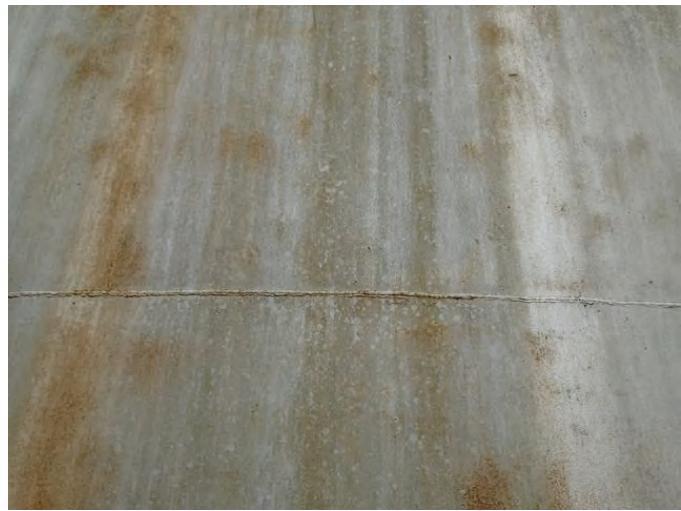
10 Exterior Wall With Expired Coating, Exposed Underlying Steel And Mild Surface Corrosion

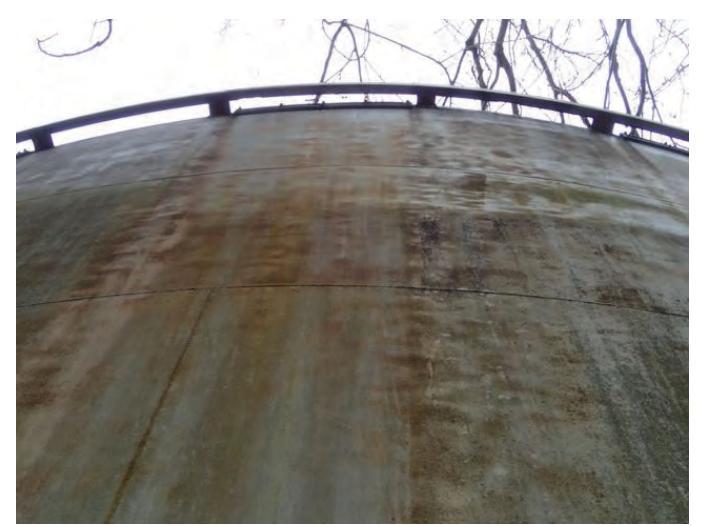
11 *Exterior Wall With Expired Coating, Exposed Underlying Steel And Mild Surface Corrosion*

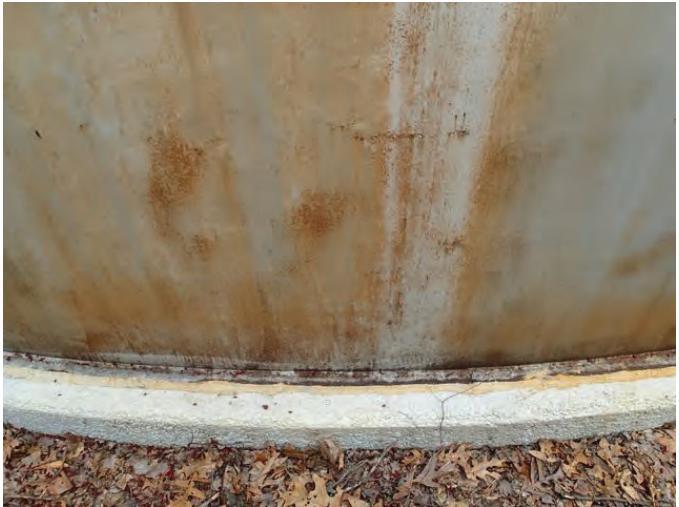
12 Exterior Wall With Expired Coating, Exposed Underlying Steel And Mild Surface Corrosion

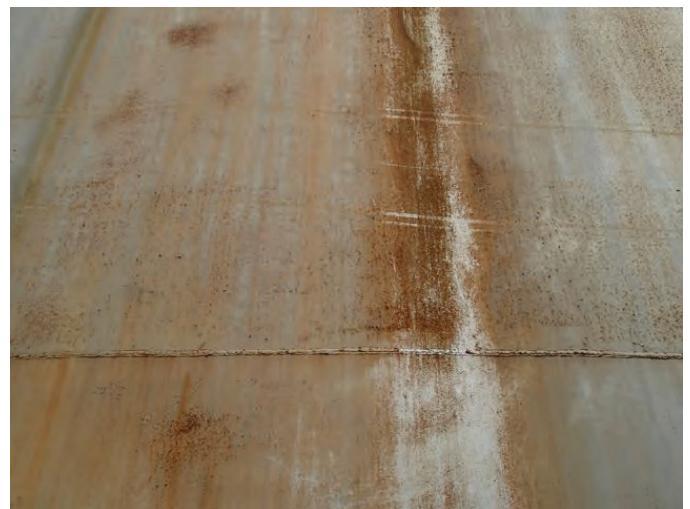
13 Exterior Wall With Expired Coating, Exposed 13 Underlying Steel And Mild Surface Corrosion

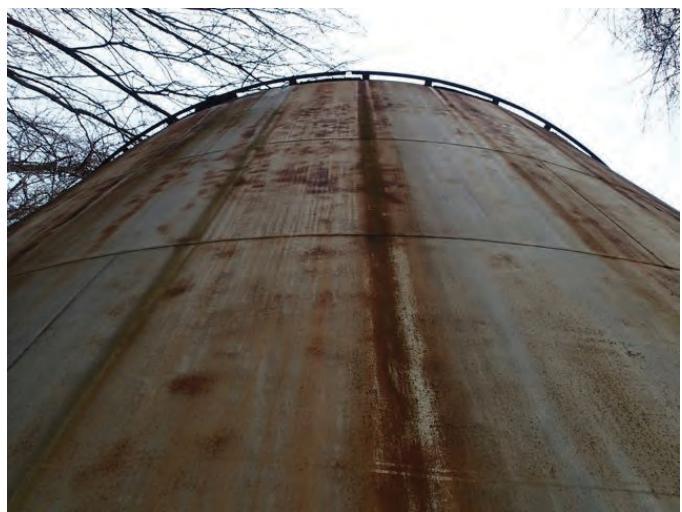
Exterior Wall With Expired Coating, Exposed 14 *Underlying Steel And Mild Surface Corrosion*

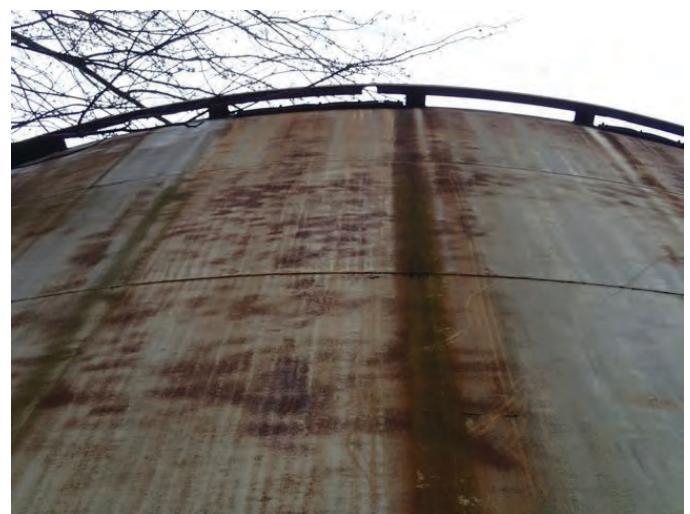
15 Exterior Wall With Expired Coating, Exposed Underlying Steel And Mild Surface Corrosion

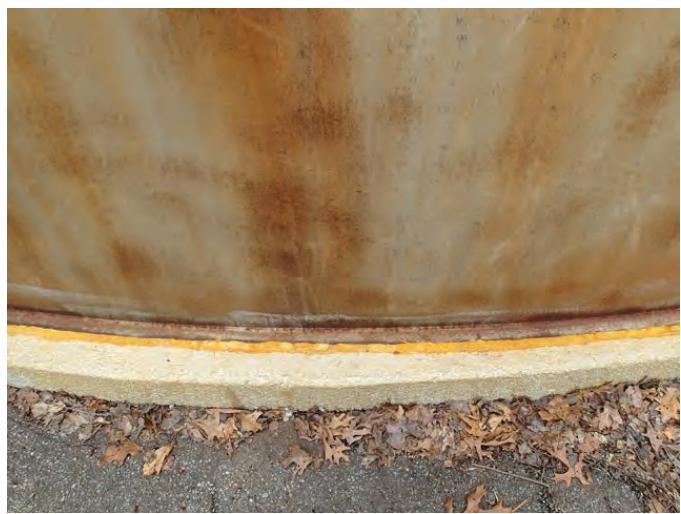
16 Exterior Wall With Expired Coating, Exposed Underlying Steel And Mild Surface Corrosion

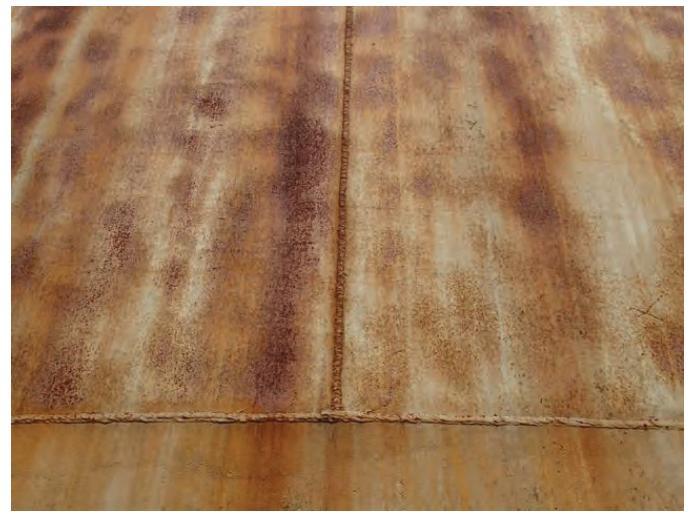
17 Exterior Wall With Expired Coating, Exposed Underlying Steel And Mild Surface Corrosion

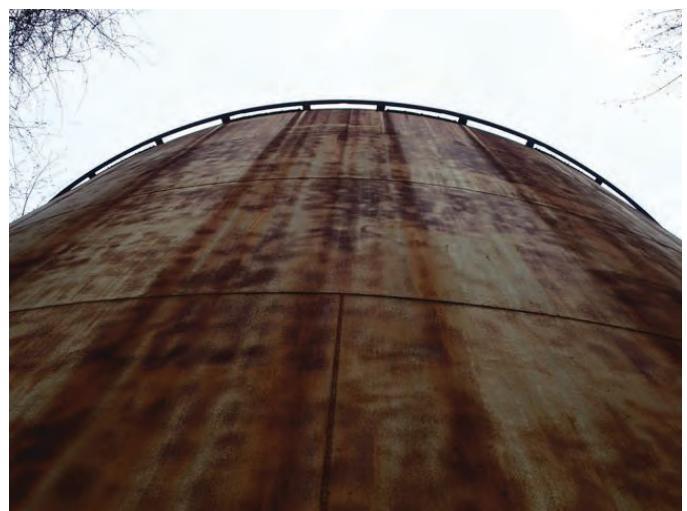
18 Exterior Wall With Expired Coating, Exposed Underlying Steel And Mild Surface Corrosion

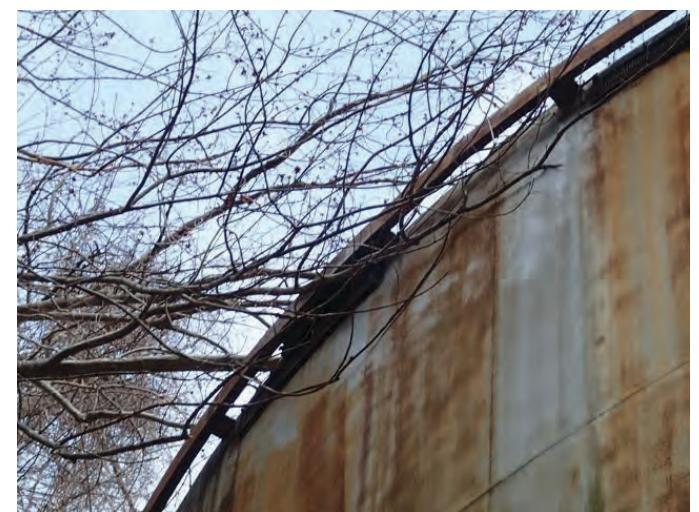
19 *Exterior Wall With Expired Coating, Exposed* Underlying Steel And Mild Surface Corrosion

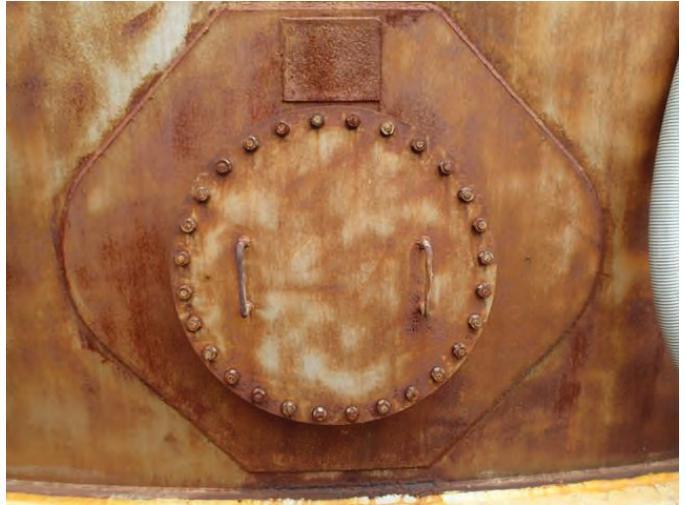
Southernmost Exterior Wall With Tree Branches 20 Found In Contact With Top Row Of Wall Panels

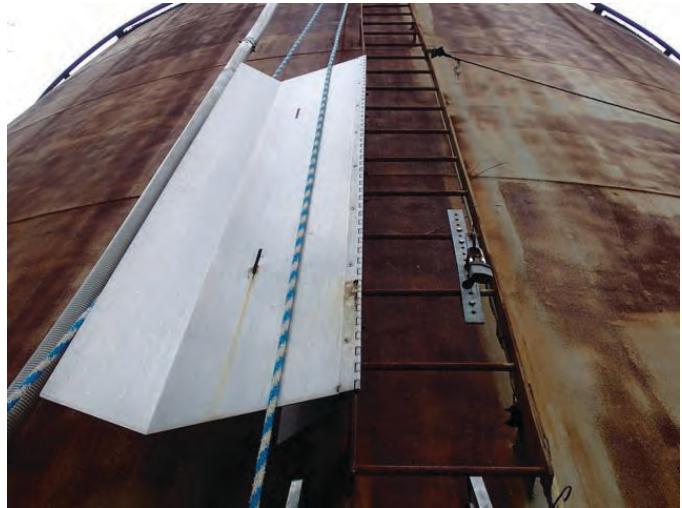
Access Ladder With Expired Coating, Exposed 22 Underlying Steel And Mild Surface Corrosion

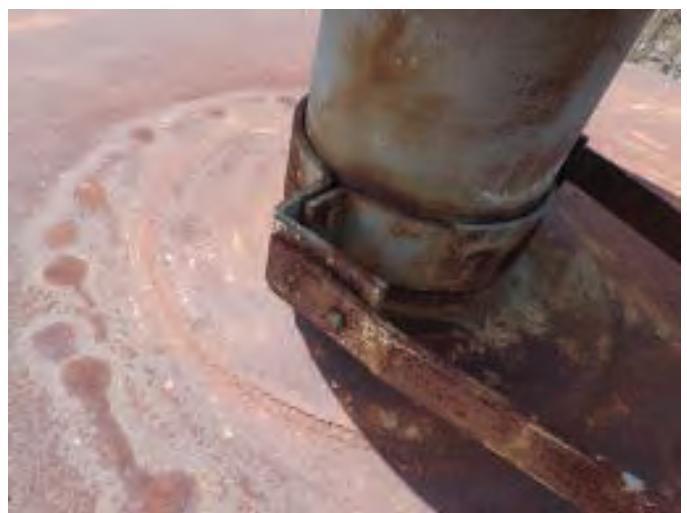
24 Vent Access Ladder With Expired Coating And Surface Corrosion

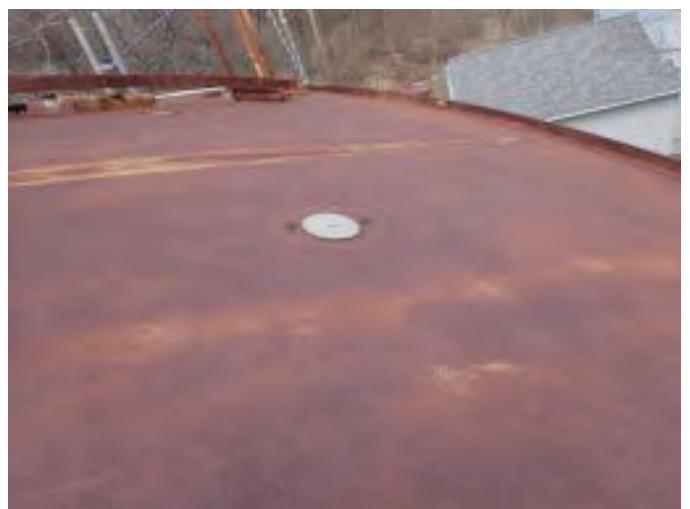
36 Roof Panels With Expired Coating, Exposed Underlying Steel And Mild Corrosion

It is our recommendation to abrasive blast all interior floor, silt stop riser, wall, manway, overhead panels and interior surfaces of the access hatch to white or near white metal.

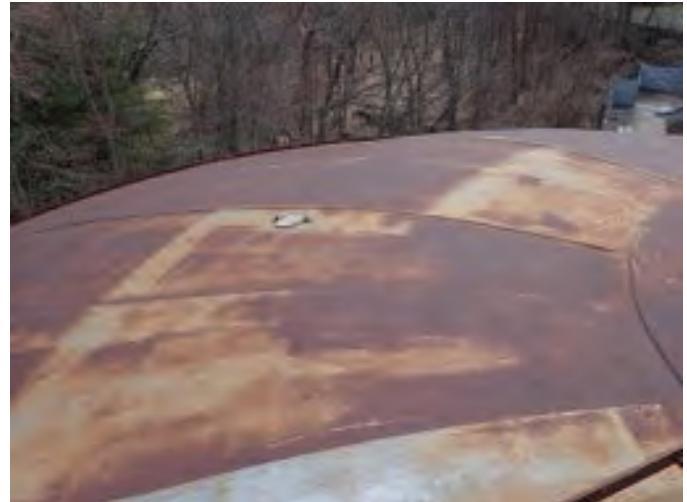
Roof Panels With Expired Coating, Exposed
 Underlying Steel And Mild Corrosion

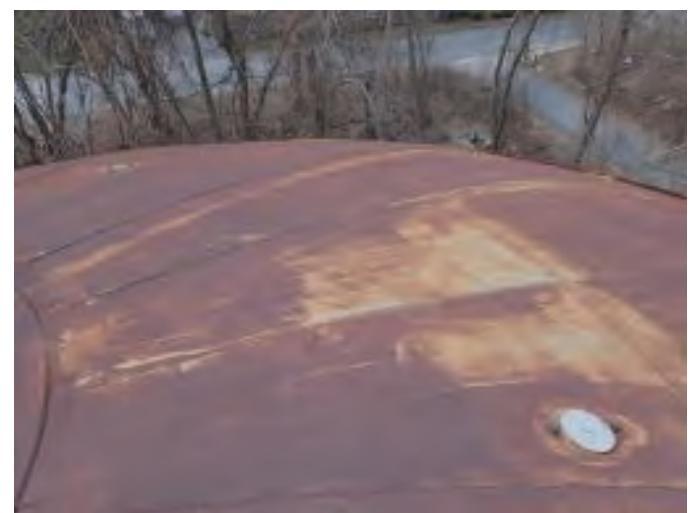
Roof Panels With Expired Coating, Exposed
 38 Underlying Steel And Mild Corrosion

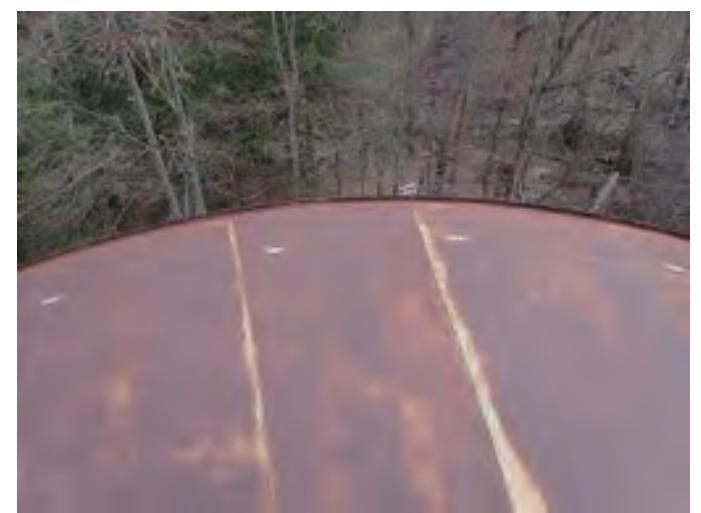
Roof Panels With Expired Coating, Exposed
 Underlying Steel And Mild Corrosion

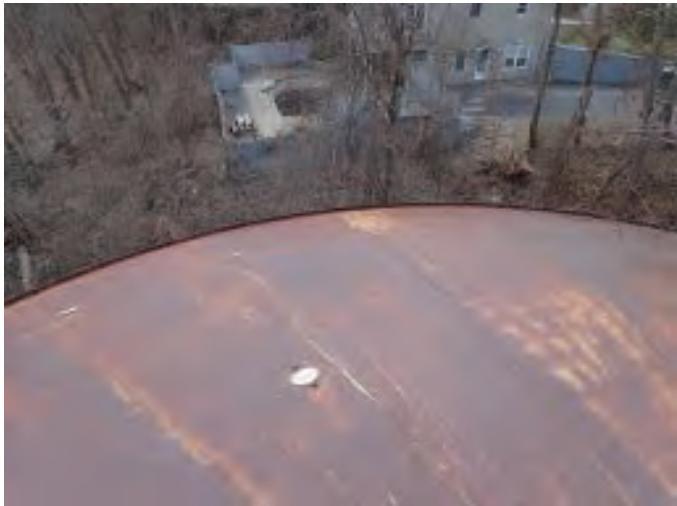
40 Roof Panels With Expired Coating, Exposed Underlying Steel And Mild Corrosion

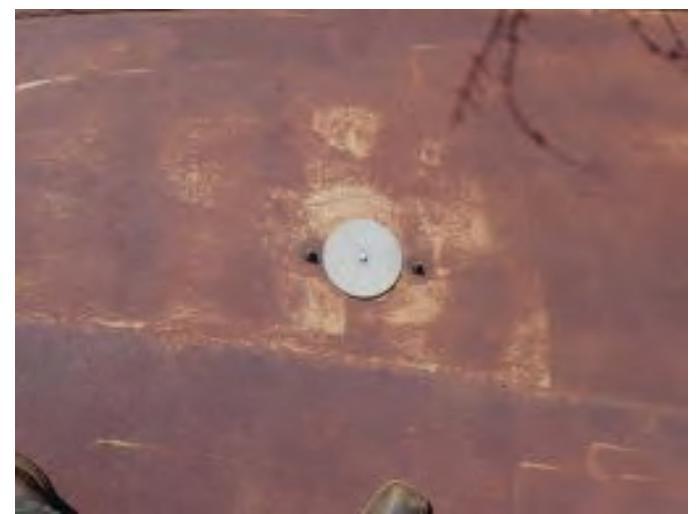
41 Roof Panels With Expired Coating, Exposed Underlying Steel And Mild Corrosion

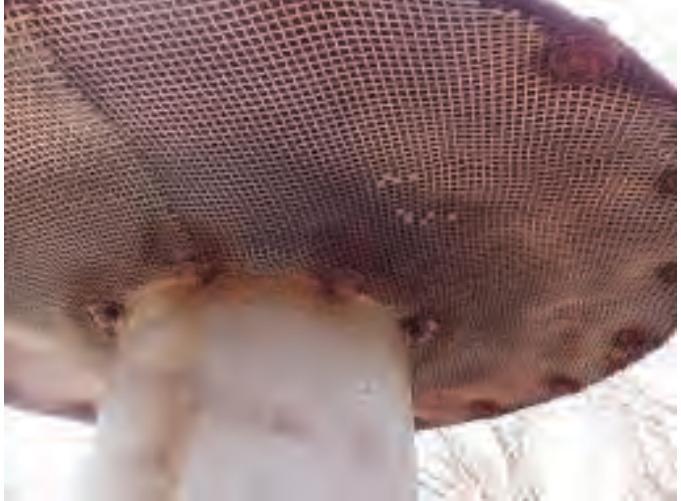
46 Secure Vent Cap With Expired Coating, Exposed Steel And Corrosion

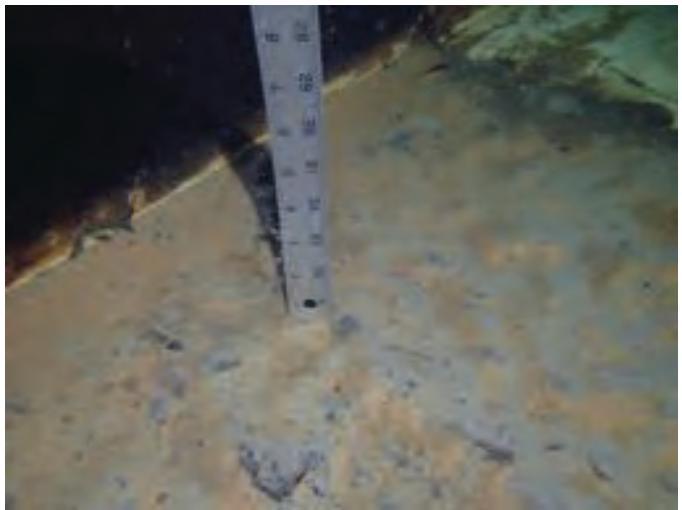
51 *Layer Of Precipitate*

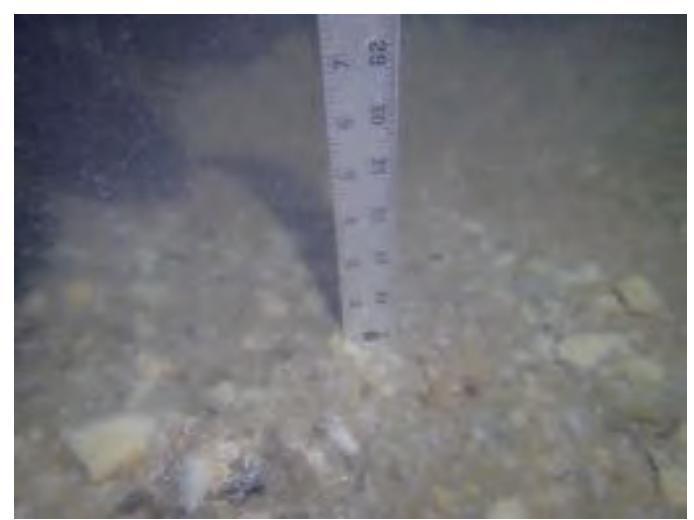
52 *Layer Of Precipitate*

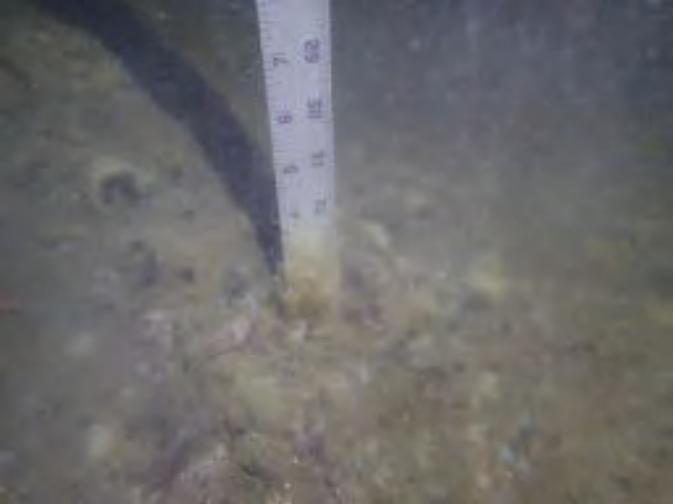
53 *Layer Of Precipitate*

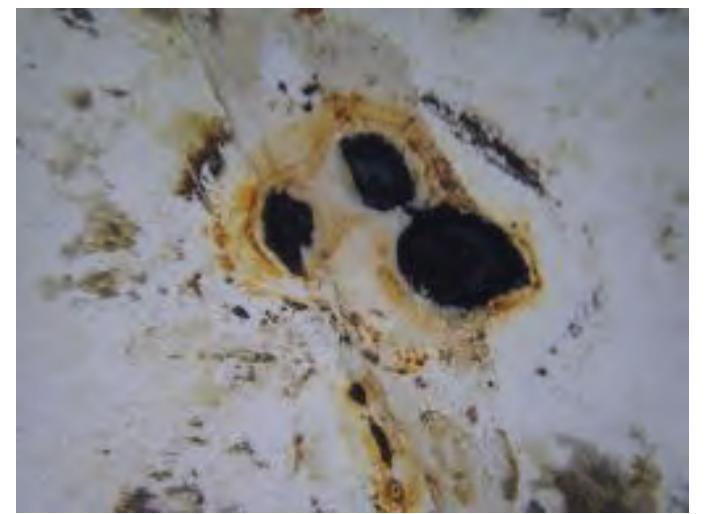
54 Floor With Coating Loss, Ruptured Coating Blisters, Exposed Underlying Steel And Mild To Moderate Staining

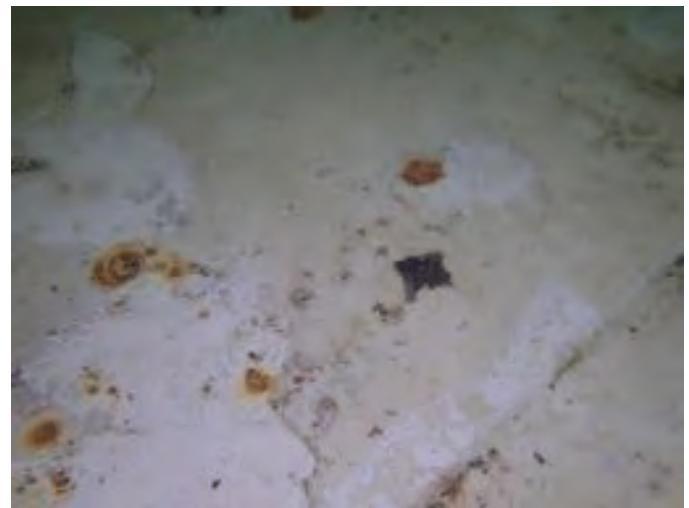
55 Floor With Coating Loss, Ruptured Coating Blisters, 55 Exposed Underlying Steel And Mild To Moderate Staining

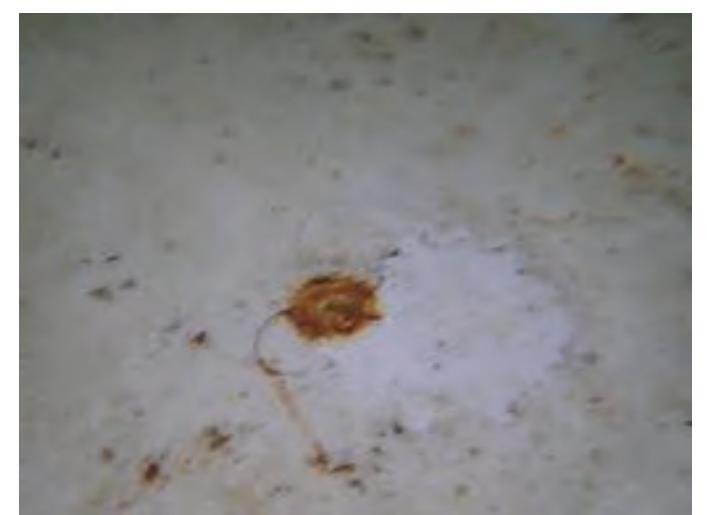
56 Floor With Coating Loss, Ruptured Coating Blisters, 57 Exposed Underlying Steel And Mild To Moderate Staining

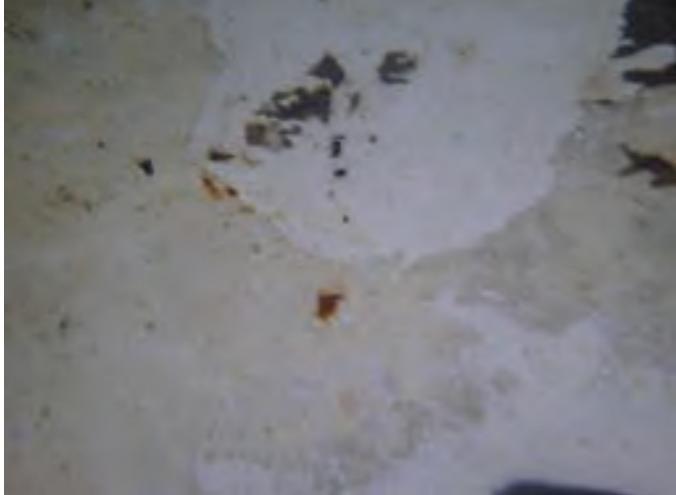
57 Floor With Coating Loss, Ruptured Coating Blisters, Exposed Underlying Steel And Mild To Moderate Staining

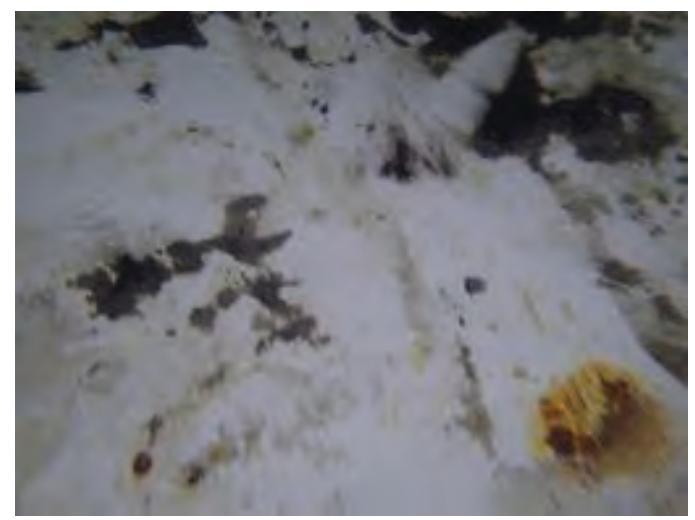
59 Floor With Coating Loss, Ruptured Coating Blisters, Exposed Underlying Steel And Mild To Moderate Staining

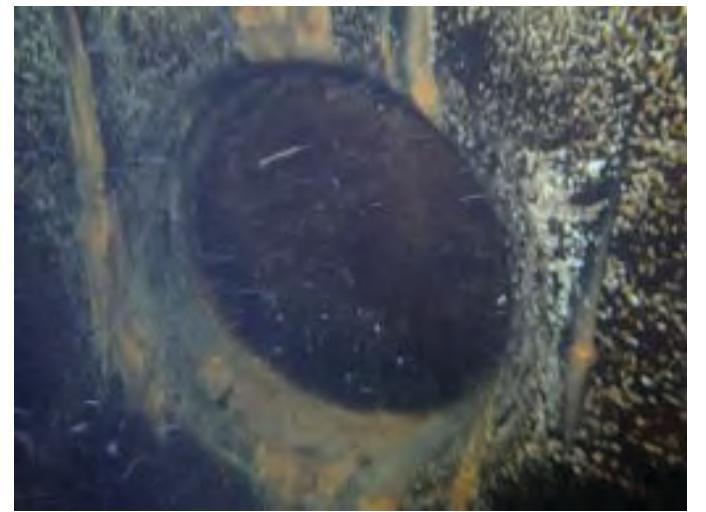
60 Manway With Coating Loss, Ruptured Coating Blisters, Exposed Underlying Steel And Corrosion

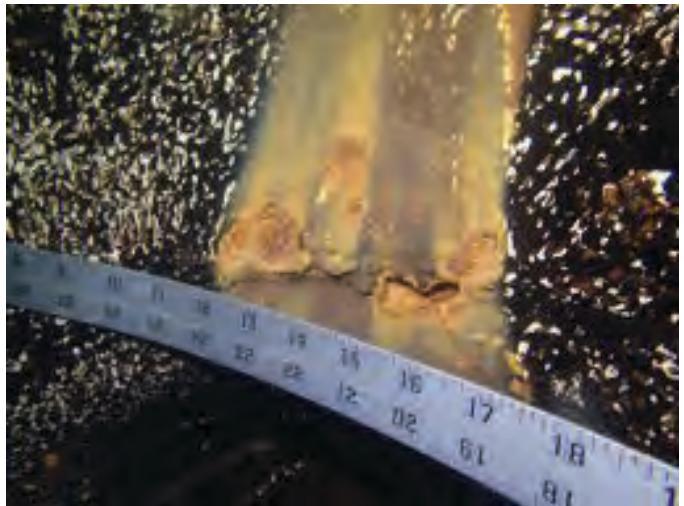
Manway/Trunk Junction With Fatigue (Pitting) Of 61 The Weld

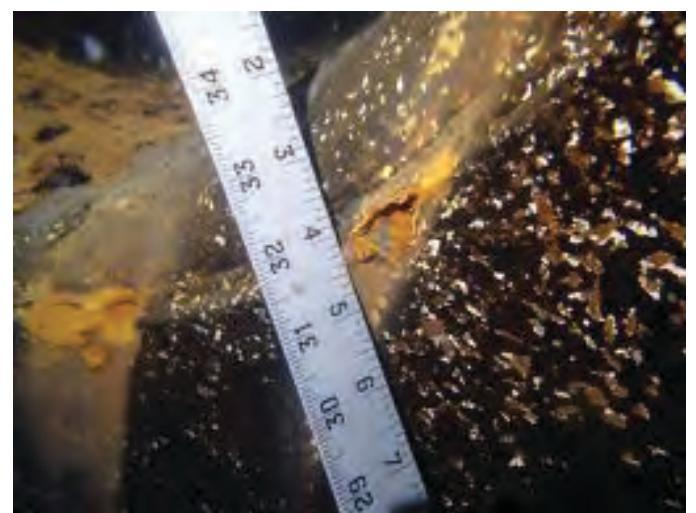
Manway/Trunk Junction With Fatigue (Pitting) Of 62 The Weld

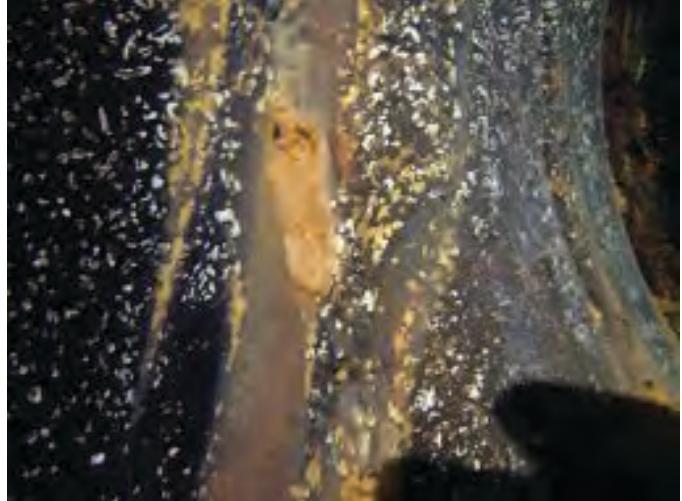
63 Manway/Trunk Junction With Fatigue (Pitting) Of The Weld

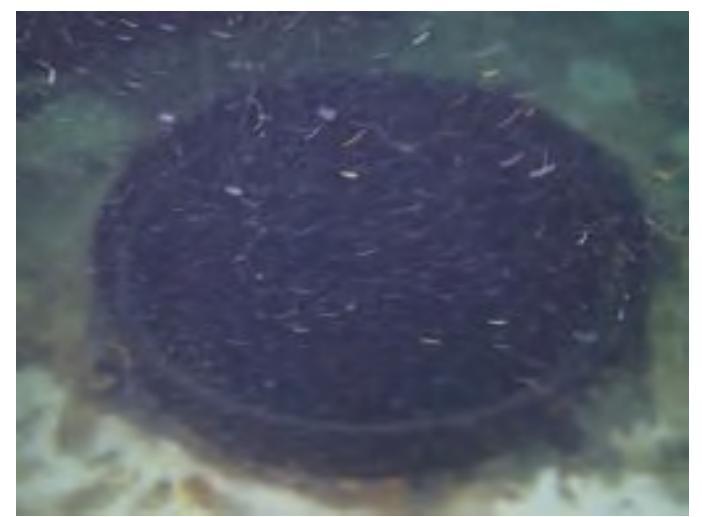
64 Influent/Effluent Pipe Flush Penetration With Coating Loss/Blistering, Exposed Underlying Steel And Mild Corrosion

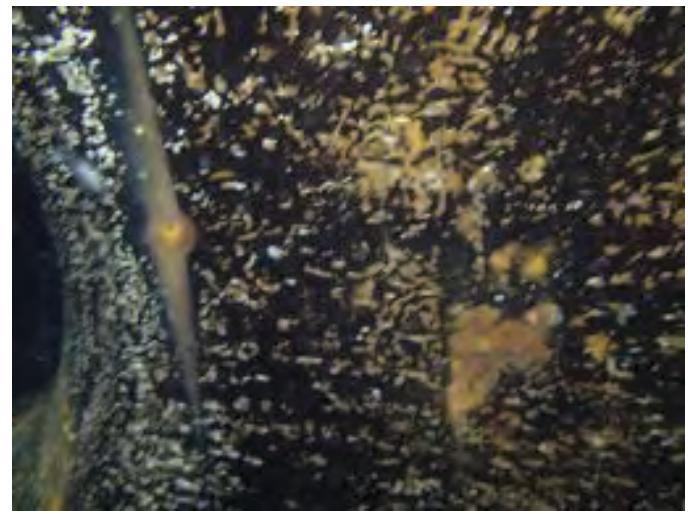
65 Interior Wall With Coating Loss, Ruptured Coating Blisters, Exposed Underlying Steel, Corrosion, Fatigue (Pitting) And Moderate To Heavy Staining

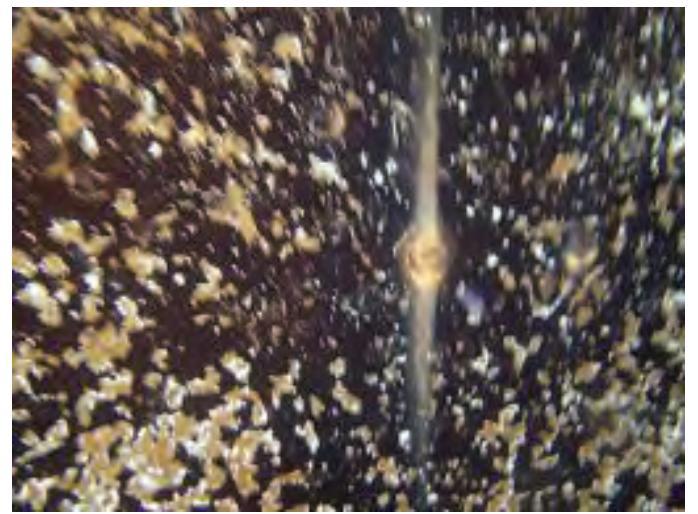
66 Interior Wall With Coating Loss, Ruptured Coating Blisters, Exposed Underlying Steel, Corrosion, Fatigue (Pitting) And Moderate To Heavy Staining

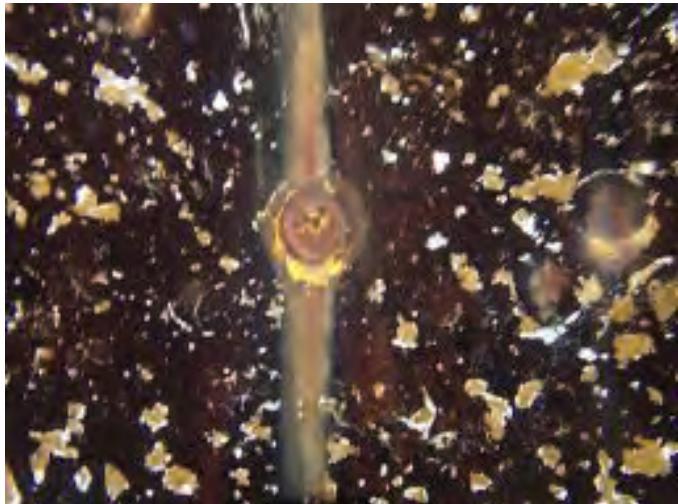
Interior Wall With Coating Loss, Ruptured Coating
 Blisters, Exposed Underlying Steel, Corrosion,
 Fatigue (Pitting) And Moderate To Heavy Staining

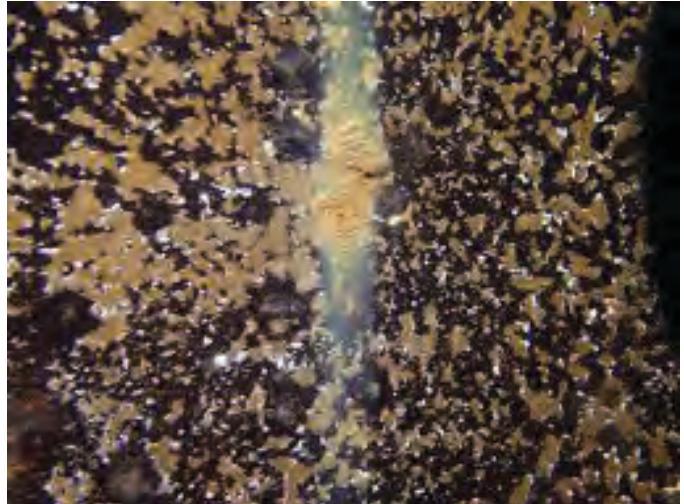
Interior Wall With Coating Loss, Ruptured Coating
Blisters, Exposed Underlying Steel, Corrosion,
Fatigue (Pitting) And Moderate To Heavy Staining

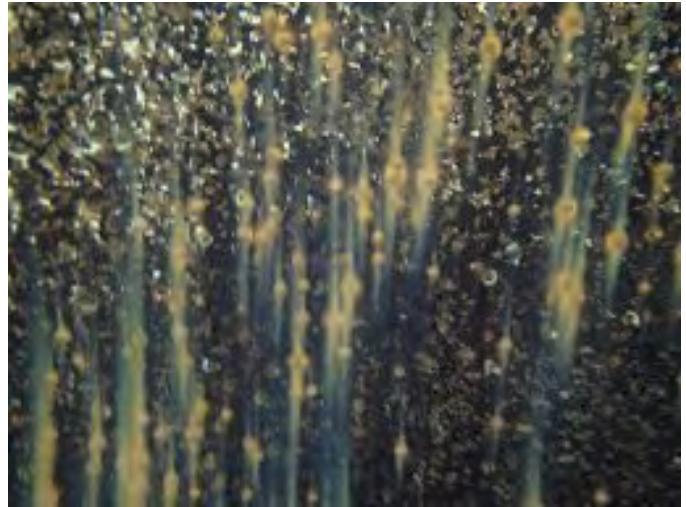
69 Interior Wall With Coating Loss, Ruptured Coating Blisters, Exposed Underlying Steel, Corrosion, Fatigue (Pitting) And Moderate To Heavy Staining

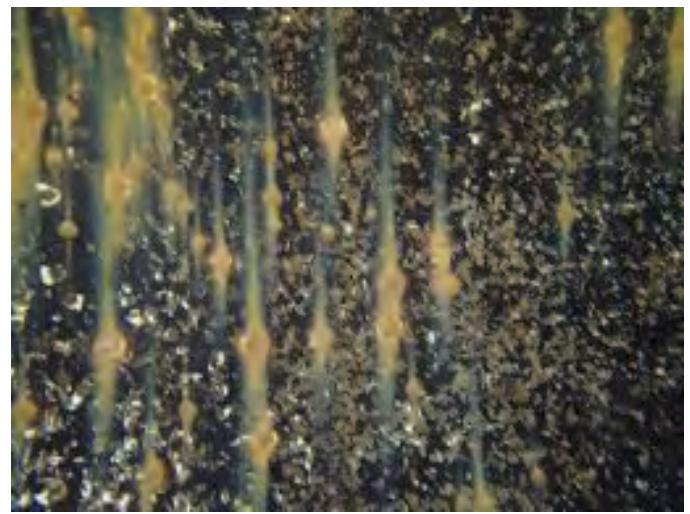
70 Interior Wall With Coating Loss, Ruptured Coating Blisters, Exposed Underlying Steel, Corrosion, Fatigue (Pitting) And Moderate To Heavy Staining
