In re: City of Woonsocket Water Division - Application to Implement Multi-Year Rate Plan

Docket No. 4879

Dam Name (No):	Woonsocket Reservoir #3 Dam (068)
Location:	Smithfield/North Smithfield
Hazard Classification:	High
	-
Inspector:	David M. Matheson, P.E.
Inspection Date.	August 1, 2014

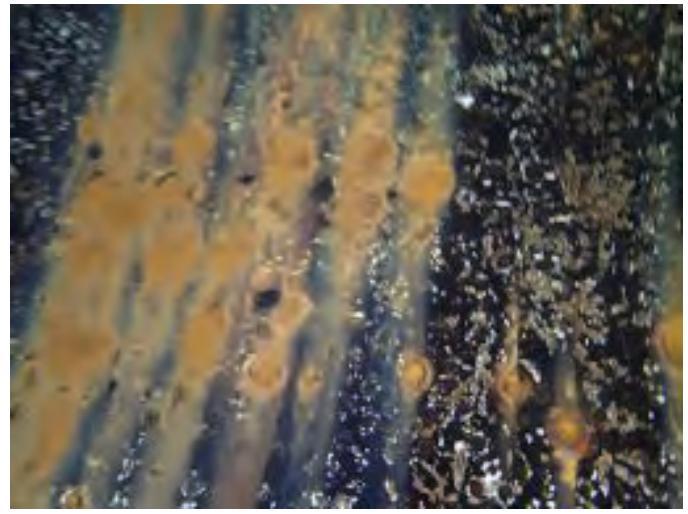
71 Interior Wall With Coating Loss, Ruptured Coating Blisters, Exposed Underlying Steel, Corrosion, Fatigue (Pitting) And Moderate To Heavy Staining

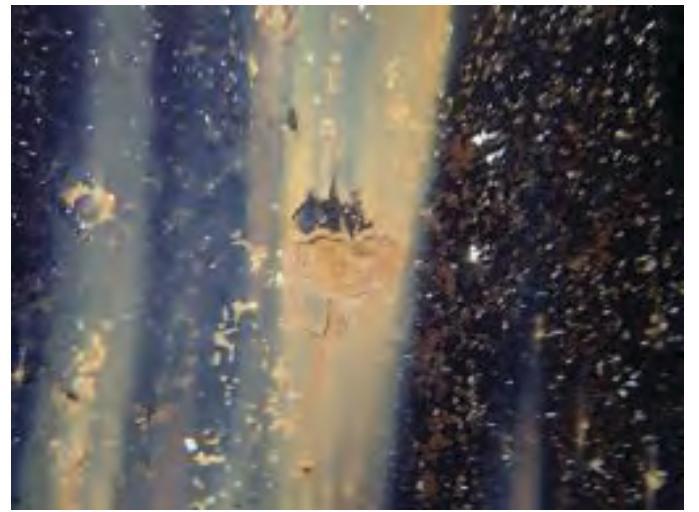
72 Interior Wall With Coating Loss, Ruptured Coating Blisters, Exposed Underlying Steel, Corrosion, Fatigue (Pitting) And Moderate To Heavy Staining

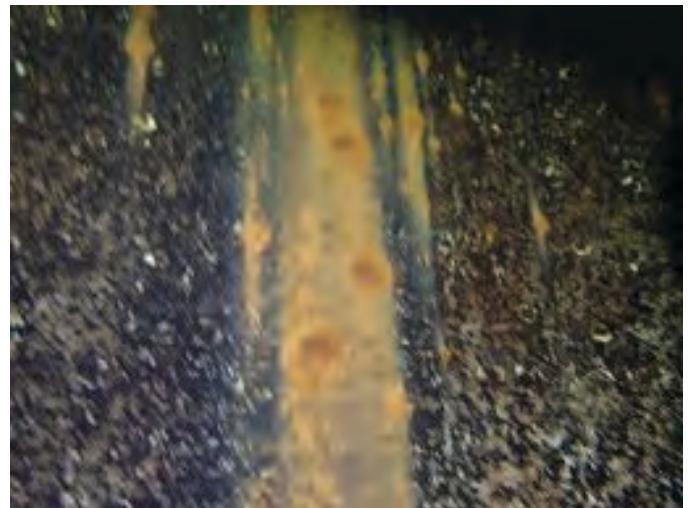
Interior Wall With Coating Loss, Ruptured Coating
 Blisters, Exposed Underlying Steel, Corrosion,
 Fatigue (Pitting) And Moderate To Heavy Staining

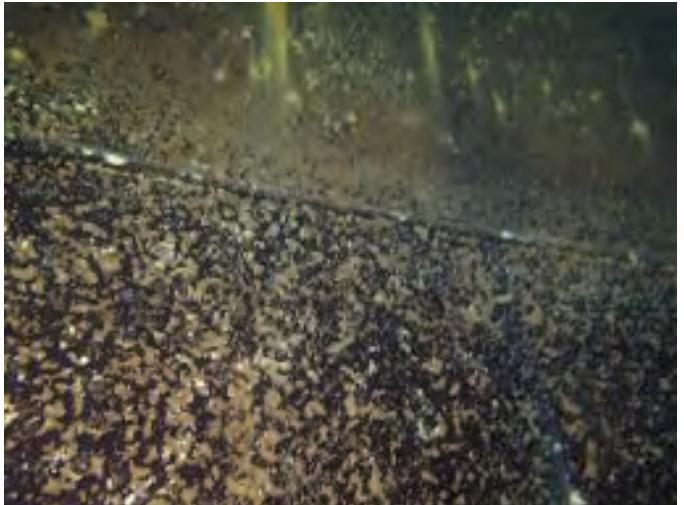
74Interior Wall With Coating Loss, Ruptured Coating74Blisters, Exposed Underlying Steel, Corrosion,
Fatigue (Pitting) And Moderate To Heavy Staining

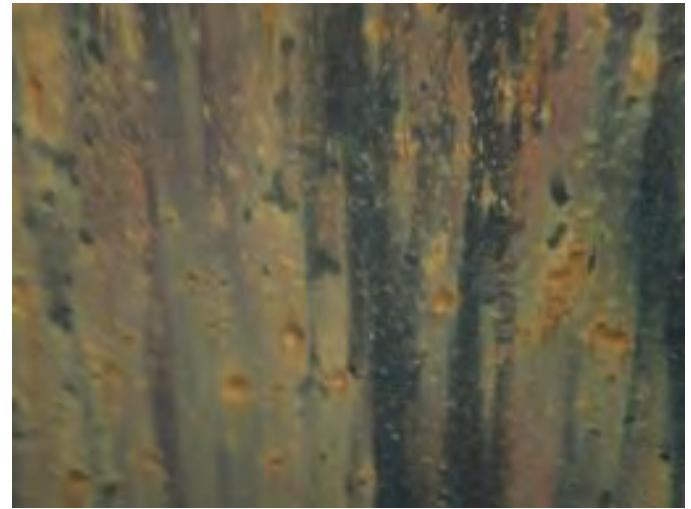
75 Interior Wall With Coating Loss, Ruptured Coating Blisters, Exposed Underlying Steel, Corrosion, Fatigue (Pitting) And Moderate To Heavy Staining

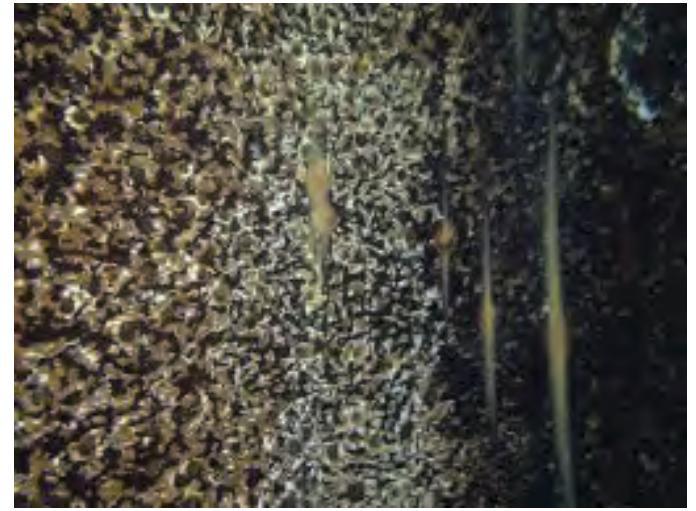
76 Interior Wall With Coating Loss, Ruptured Coating Blisters, Exposed Underlying Steel, Corrosion, Fatigue (Pitting) And Moderate To Heavy Staining

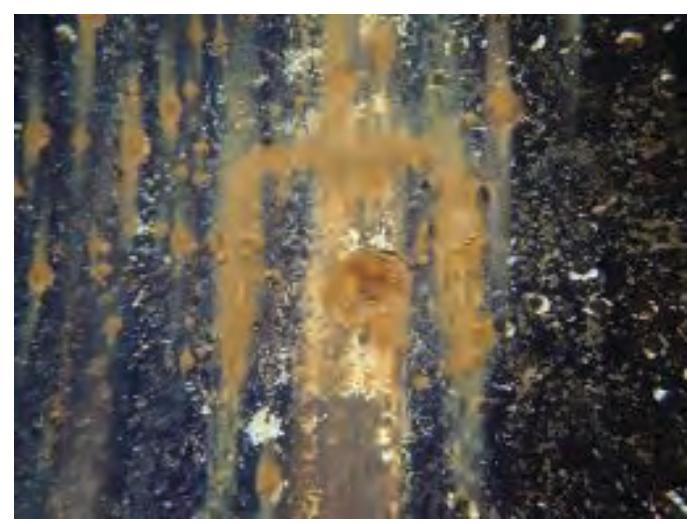
77 Interior Wall With Pitting Within The Wall Panel Where A Steel Plate Has Been Welded To The Tank Exterior

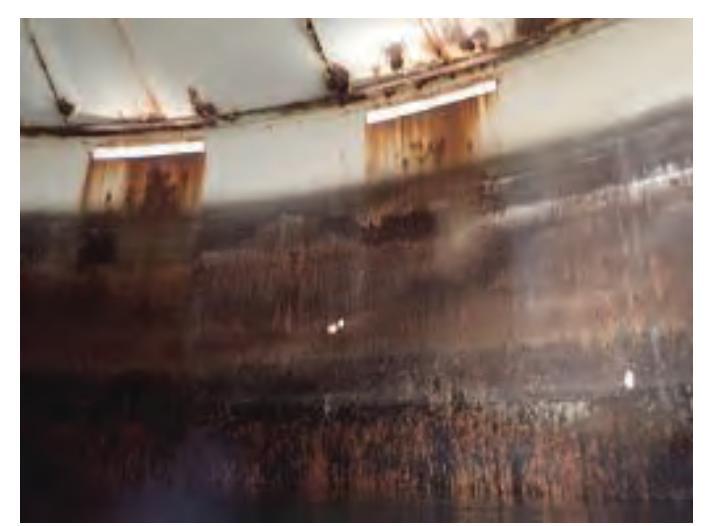
78 Interior Wall With Heavy Staining

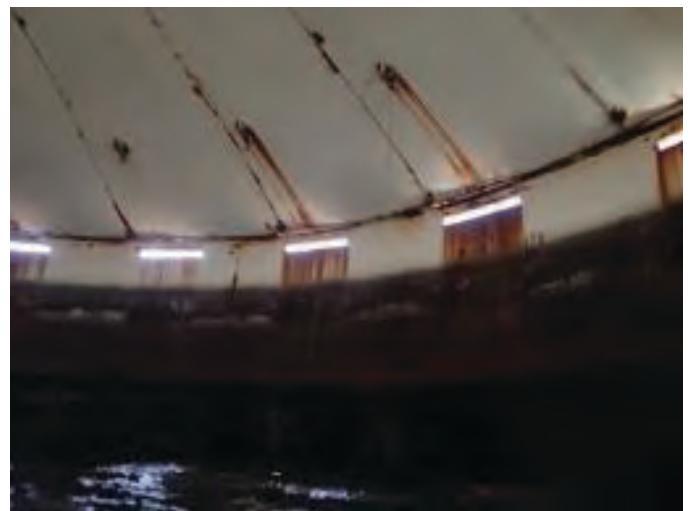
79 Interior Wall With Heavy Staining

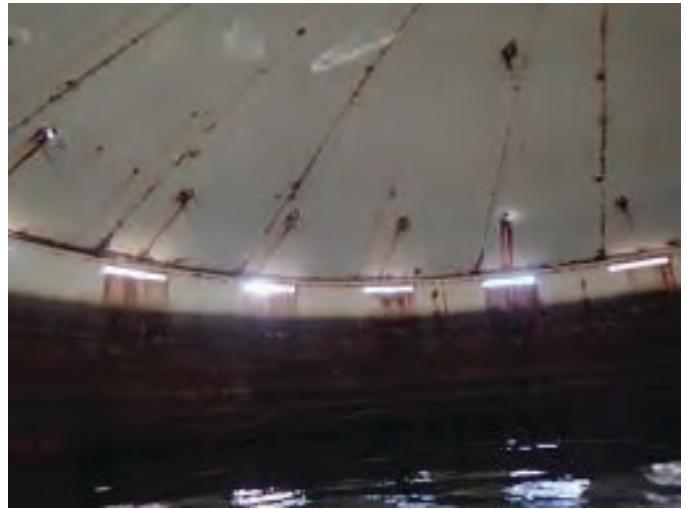
Interior Wall With Heavy Staining

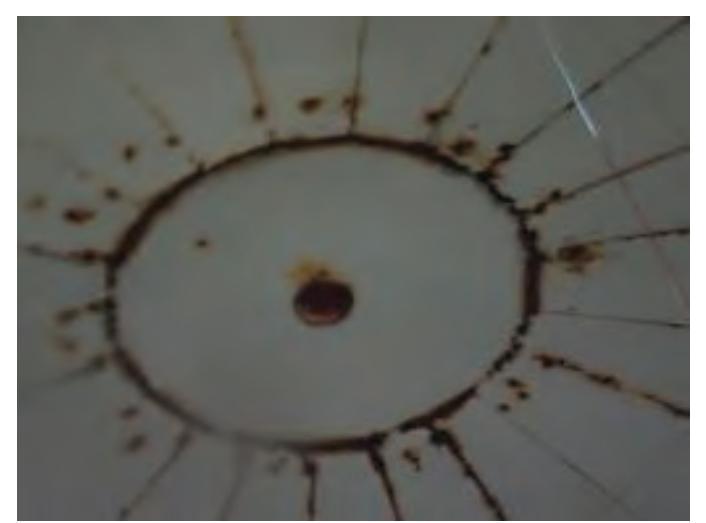
82 Overhead With Coating Loss/Peeling, Exposed Underlying Steel And Mild To Moderate Surface Corrosion

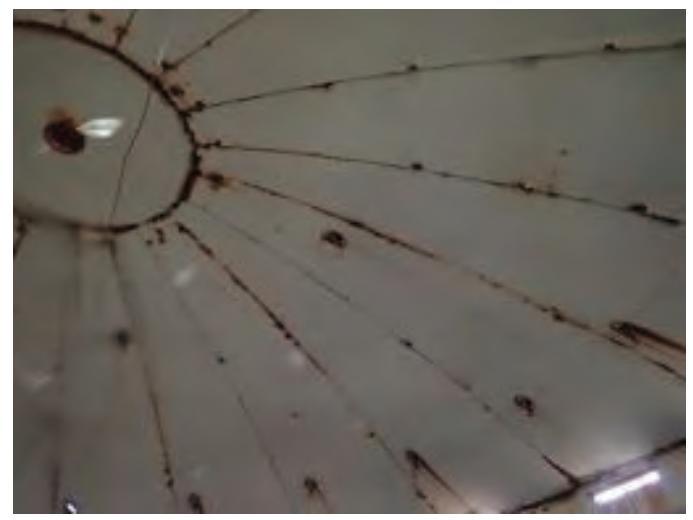
83 Overhead With Coating Loss/Peeling, Exposed Underlying Steel And Mild To Moderate Surface Corrosion

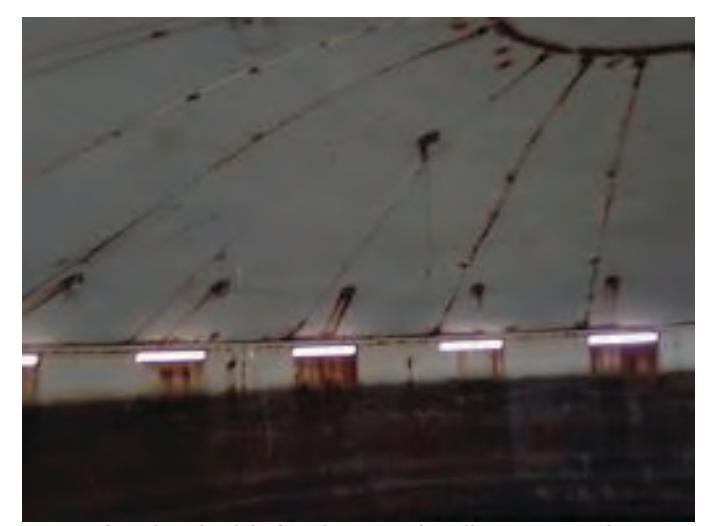
84 Overhead With Coating Loss/Peeling, Exposed Underlying Steel And Mild To Moderate Surface Corrosion

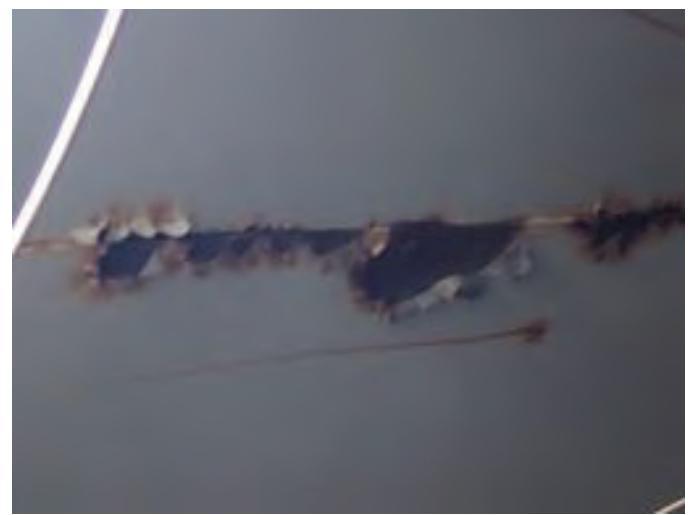
85 *Overhead With Coating Loss/Peeling, Exposed Underlying Steel And Mild To Moderate Surface Corrosion*

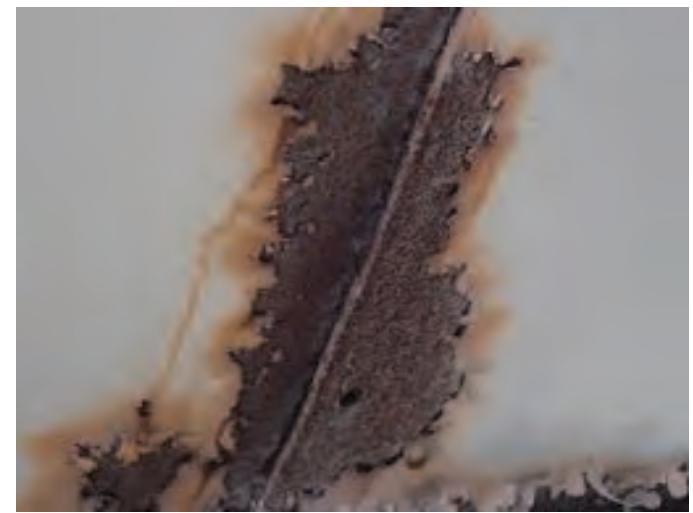
86 Overhead With Coating Loss/Peeling, Exposed Underlying Steel And Mild To Moderate Surface Corrosion

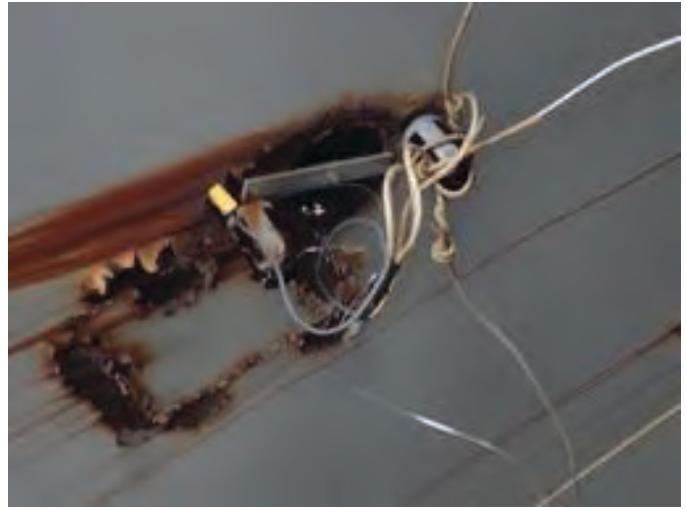
87 *Remnants Of Abandoned Cathodic Protection System Suspended From The Overhead*

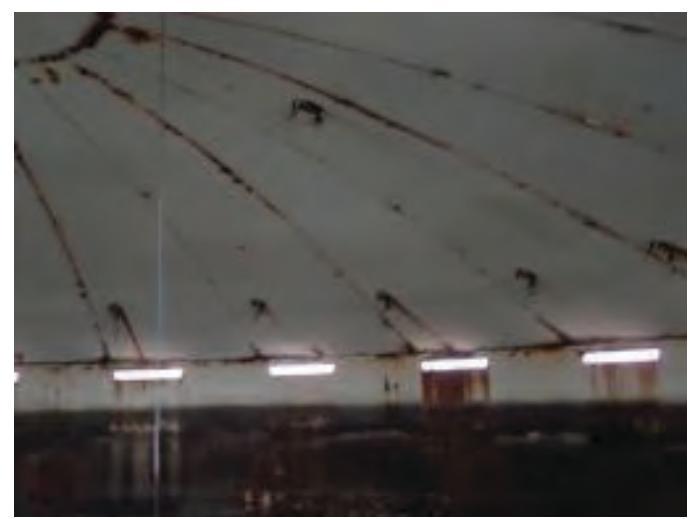
Remnants Of Abandoned Cathodic Protection System
 Suspended From The Overhead

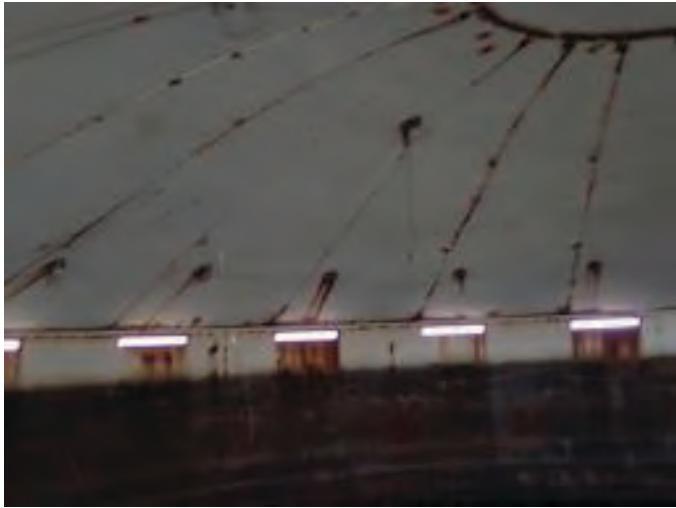
89 Overflow Cutouts

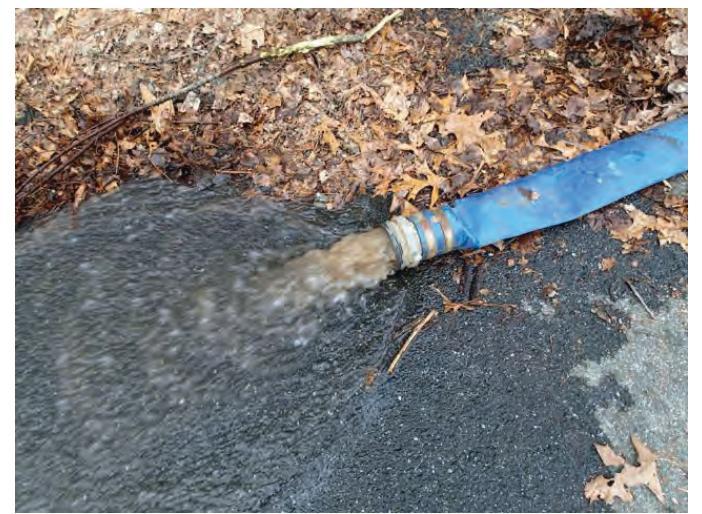
90 Discharge During Cleaning

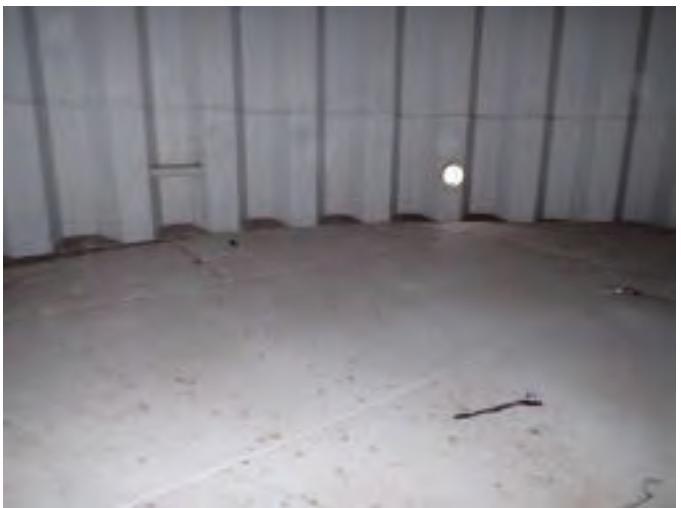
1

The protective coating applied to the interior steel surfaces of the support pedestal has an average dry film thickness of 19.1 mils and appeared to have been applied uniformly, meets the AWWA's recommendations and was found having good adhesion value, providing adequate protection for the steel.

Interior Support Pedestal

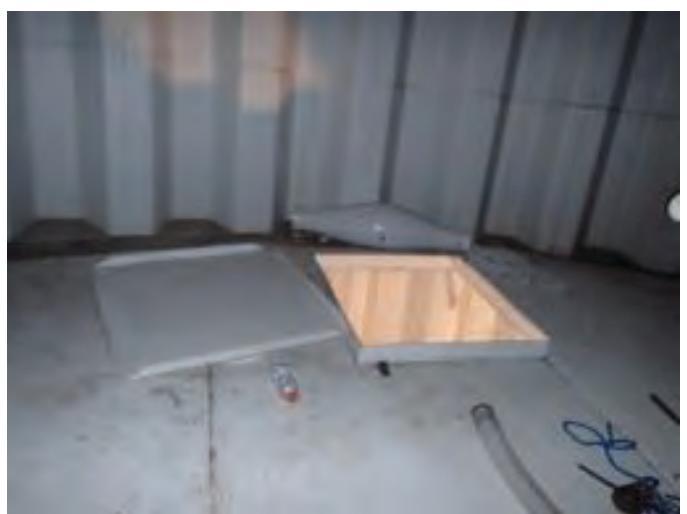
Interior Support Pedestal 2

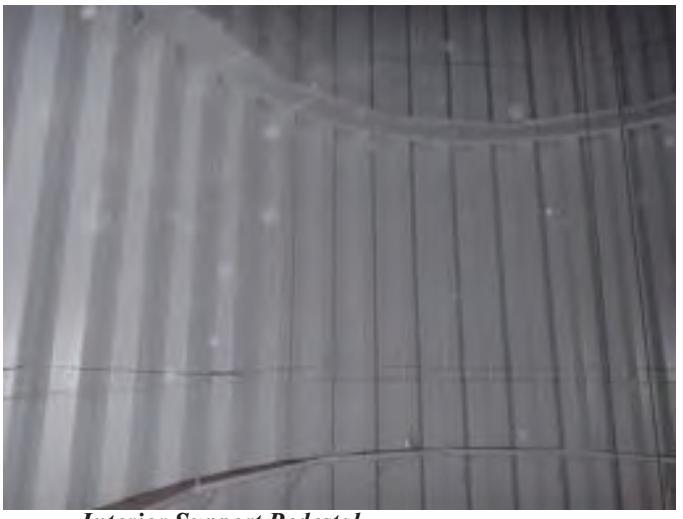
3 Interior Support Pedestal

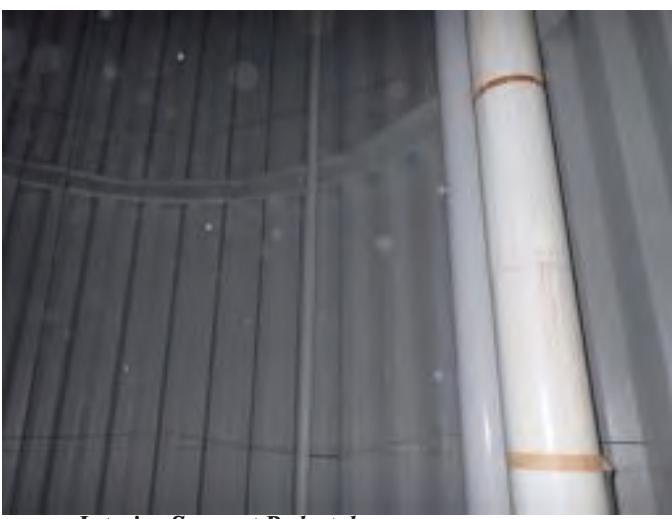
4 Interior Support Pedestal

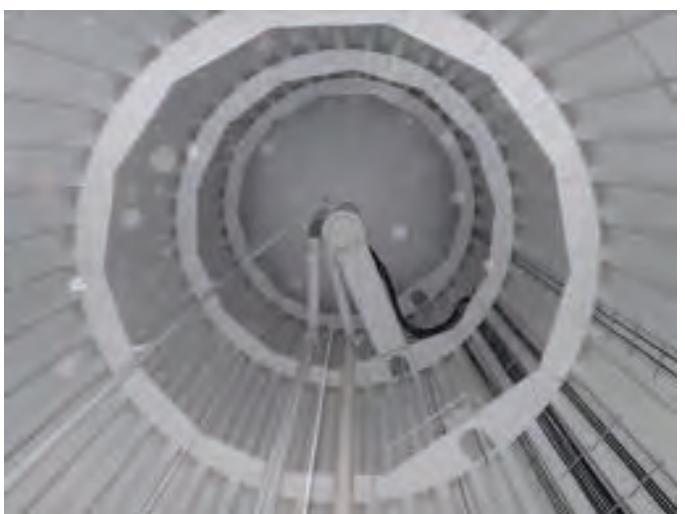
5 Interior Support Pedestal

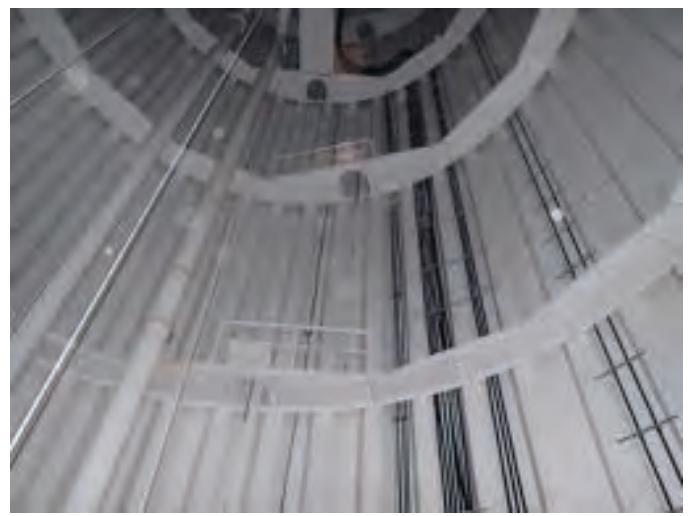
6 Interior Support Pedestal

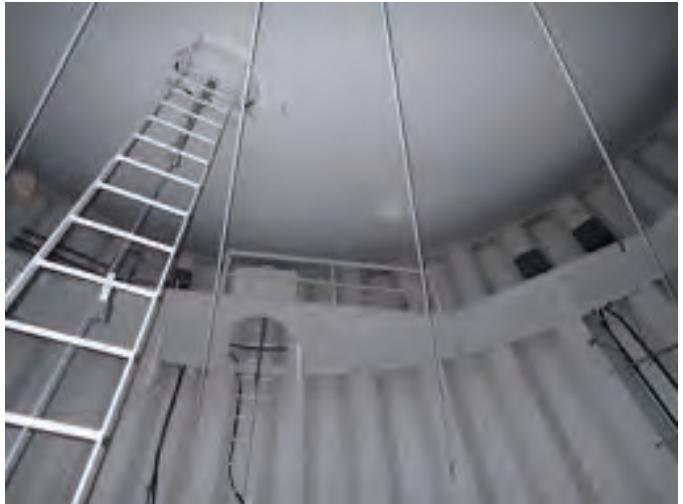
7 Interior Support Pedestal

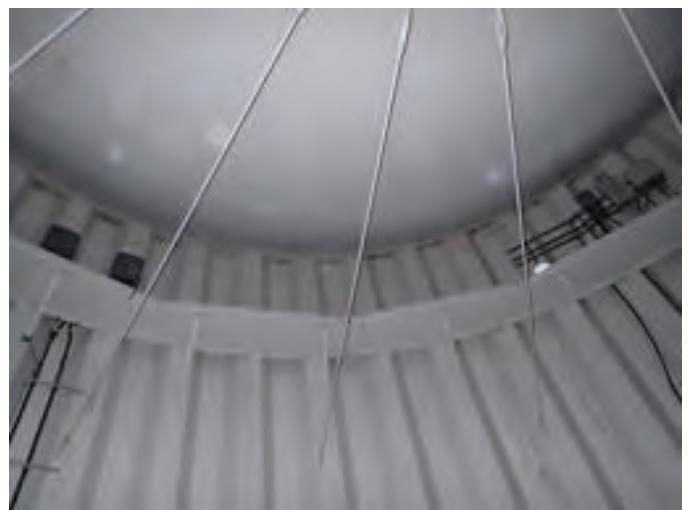
8 Interior Support Pedestal

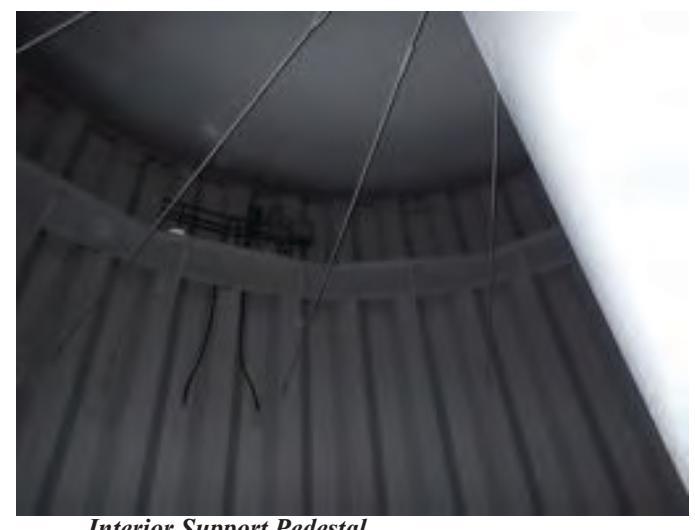
9 Interior Support Pedestal

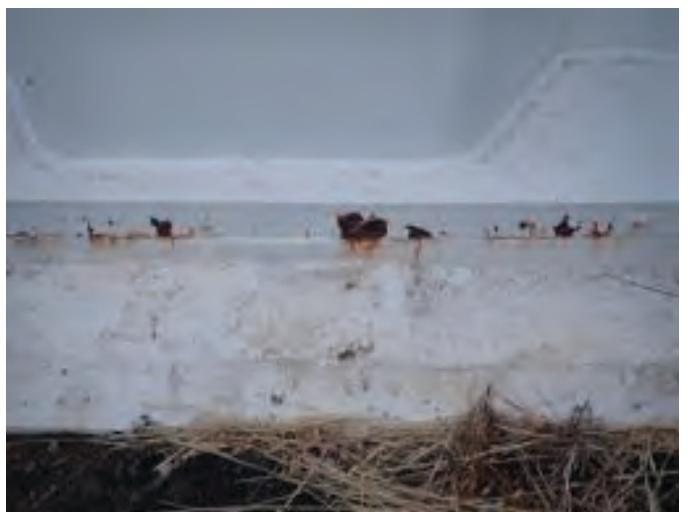
Adhesion loss of the protective coating was observed throughout approximately 10% of the steel floor extension welded to the base of the support pedestal, resulting in exposure of the underlying steel. No obvious fatigue/deterioration of the steel was evident within these areas of exposure, rather mild corrosion exists at this time.

10 Support Pedestal Floor Extension With Coating Loss, Exposed Underlying Steel, Mild Corrosion And Mild Mildew

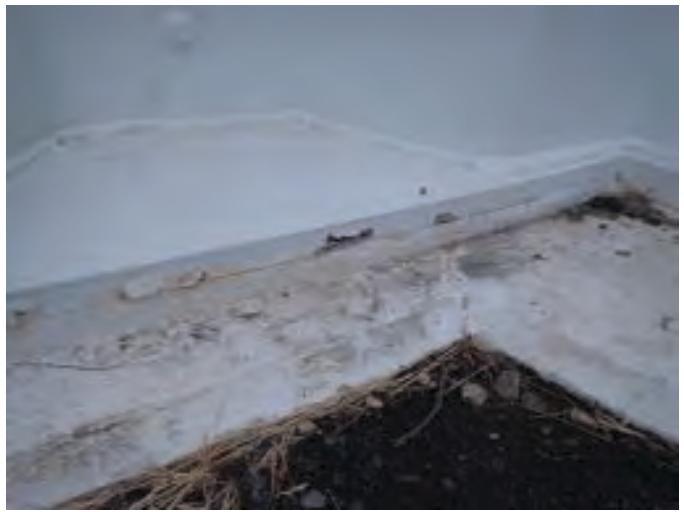
11 Support Pedestal Floor Extension With Coating Loss, Exposed Underlying Steel, Mild Corrosion And Mild Mildew

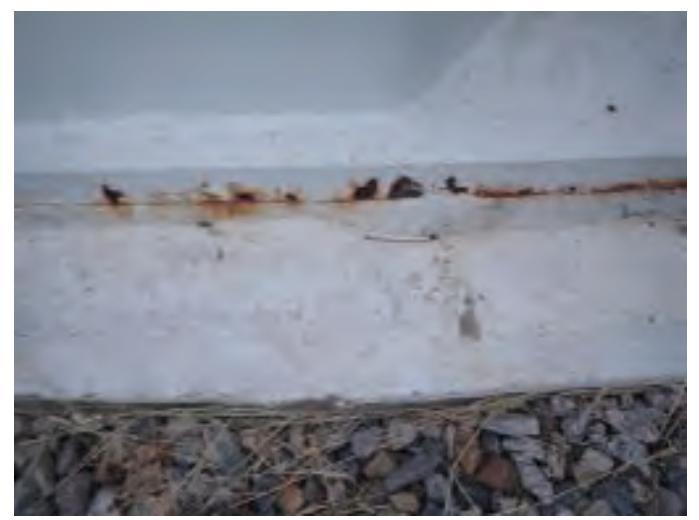
12 Support Pedestal Floor Extension With Coating Loss, Exposed Underlying Steel, Mild Corrosion And Mild Mildew

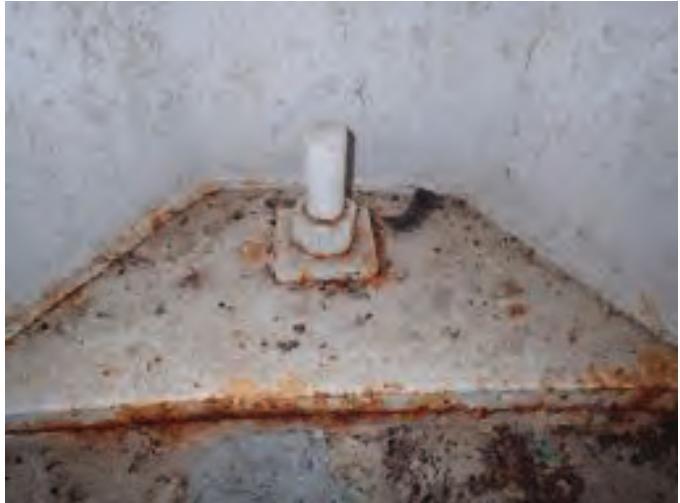
Support Pedestal Floor Extension With Coating Loss,
Exposed Underlying Steel, Mild Corrosion And Mild Mildew

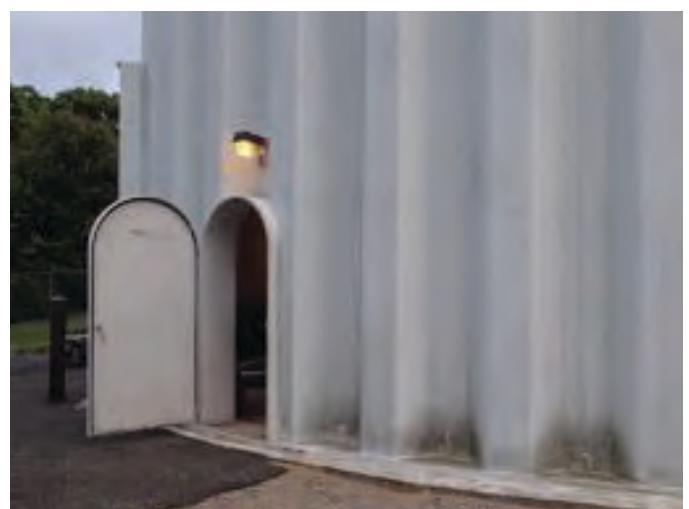
Exterior Support Pedestal With Mild Mildew 14

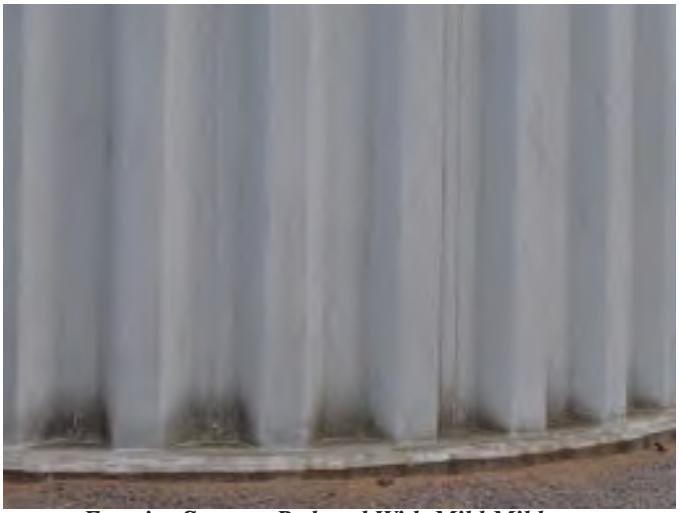
Exterior Support Pedestal With Mild Mildew

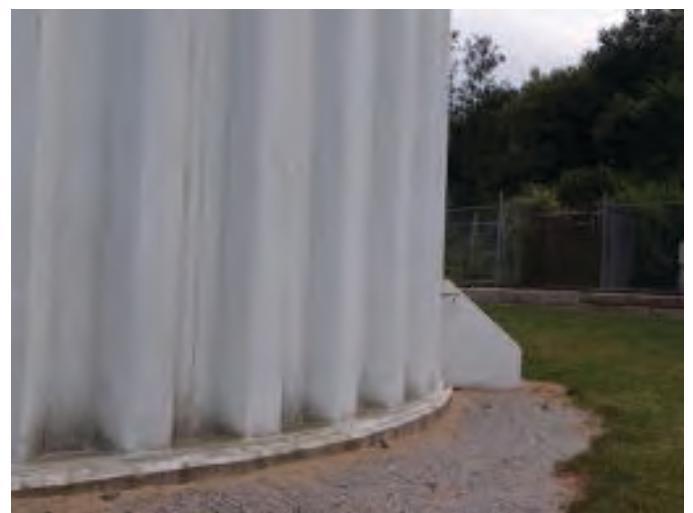
Exterior Support Pedestal With Mild Mildew 16

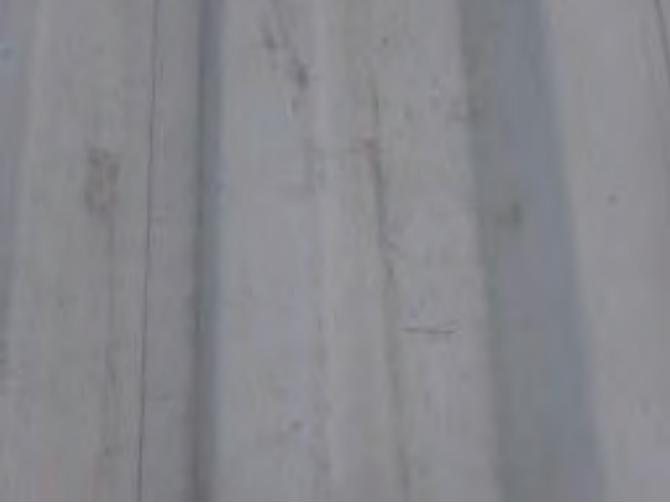
17 Exterior Support Pedestal With Mild Mildew

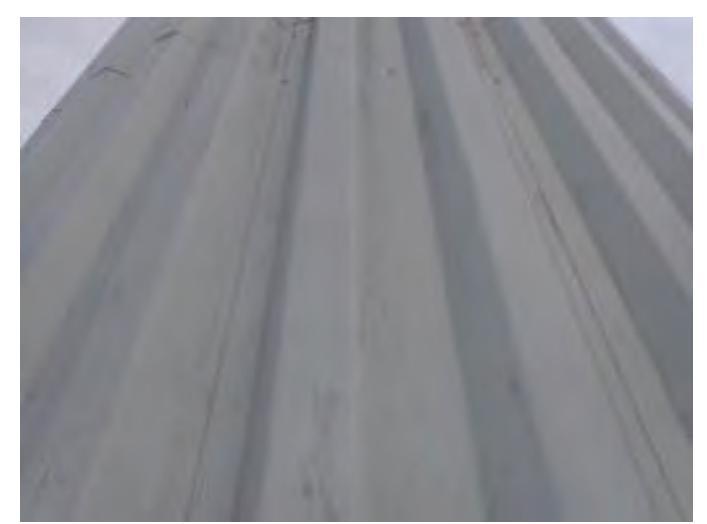
18 Exterior Support Pedestal With Mild Mildew

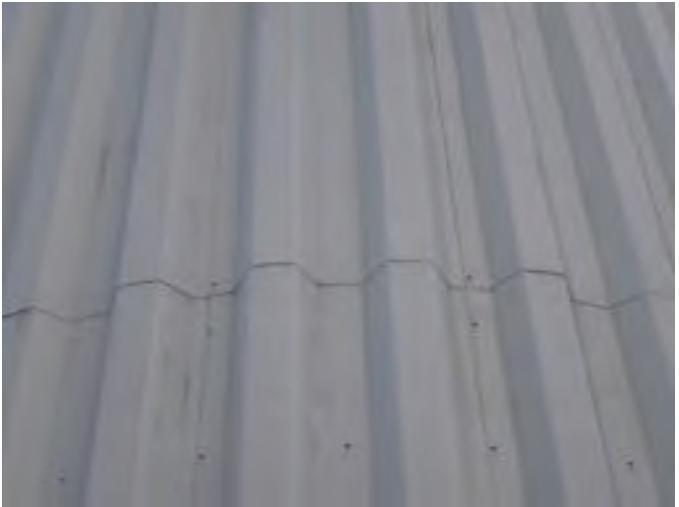
Exterior Support Pedestal With Mild Mildew 19

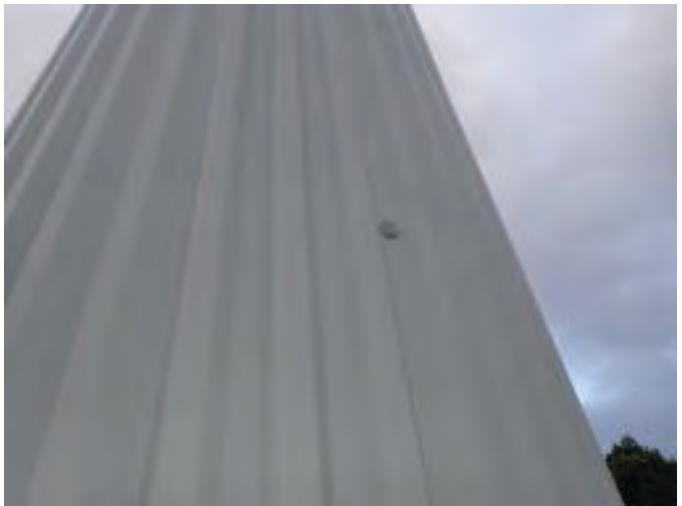
Exterior Support Pedestal With Mild Mildew 20

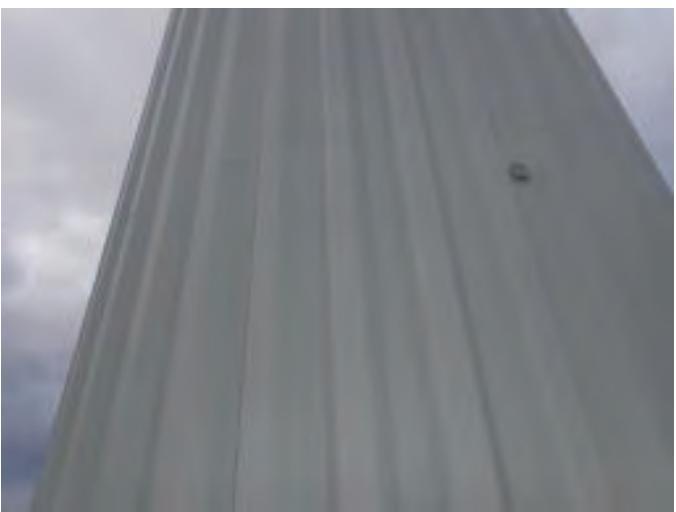
21 *Exterior Support Pedestal With Mild Mildew*

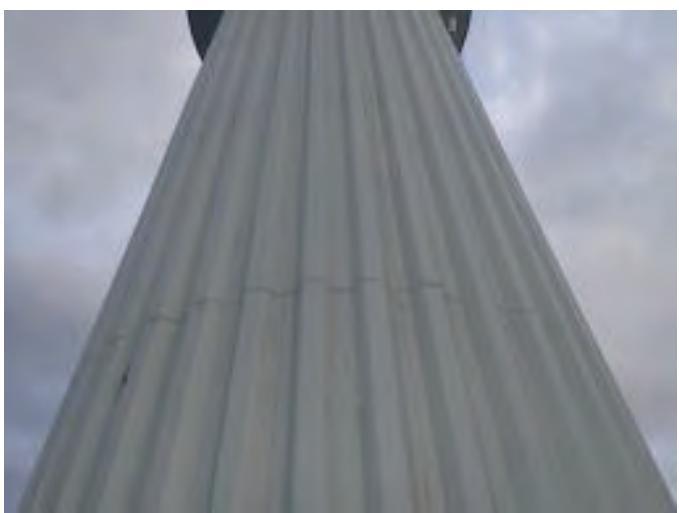
Exterior Support Pedestal With Mild Mildew

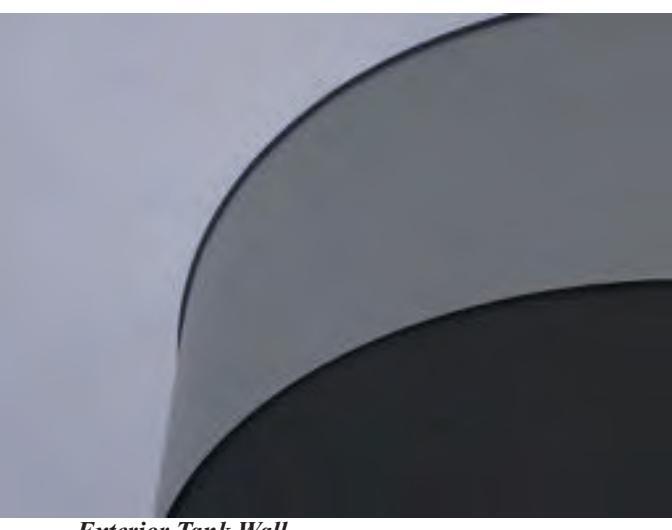
The exterior steel wall panels and associated welds of the tank were inspected and were found appearing sound and remain free of obvious fatigue or failures.

The protective coating applied to these welded steel surfaces appeared to have been applied uniformly and was found having good adhesion value, providing adequate protection for these steel panels and welds.

23 Exterior Tank Wall

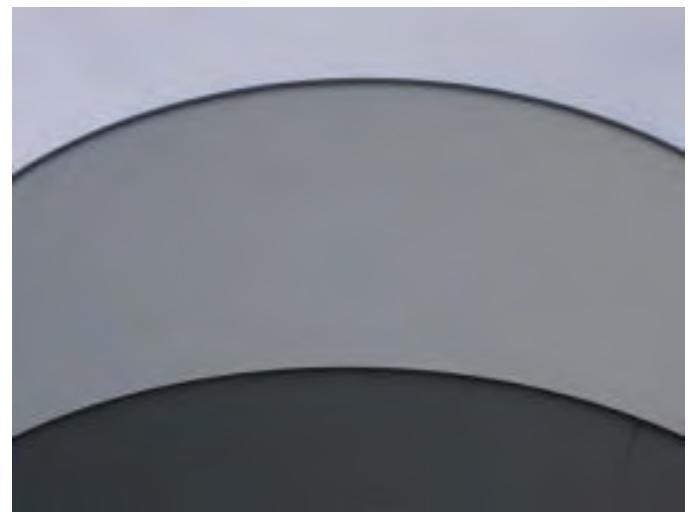
24 Exterior Tank Wall

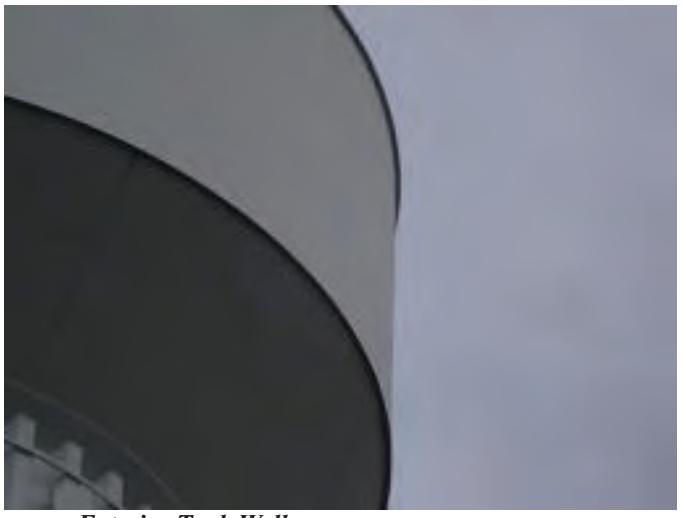
25 *Exterior Tank Wall*

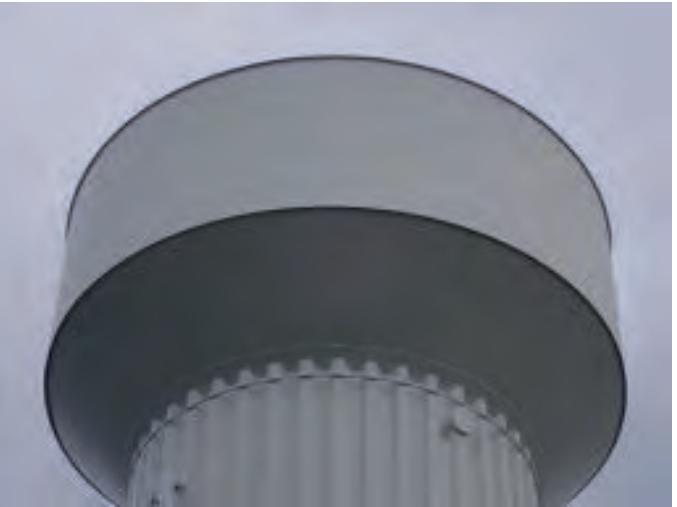
26 *Exterior Tank Wall*

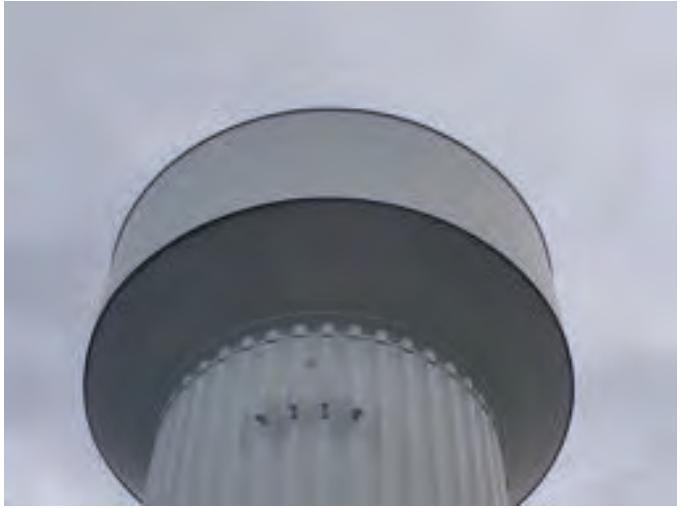
27 *Exterior Tank Wall*

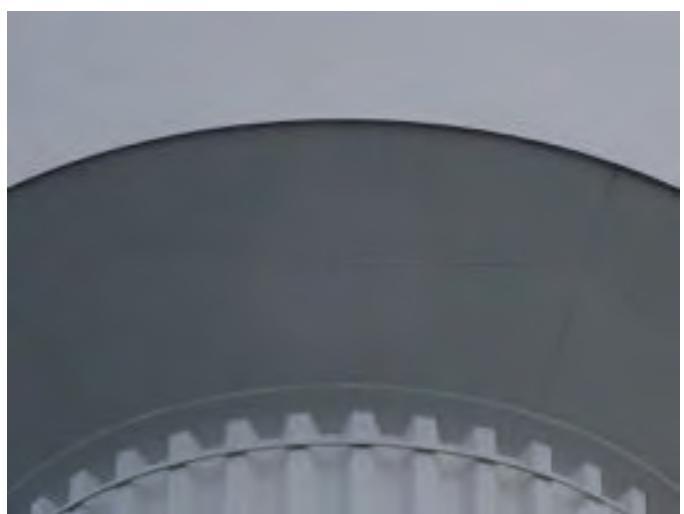
Exterior Tank Base With Mild Mildew 28

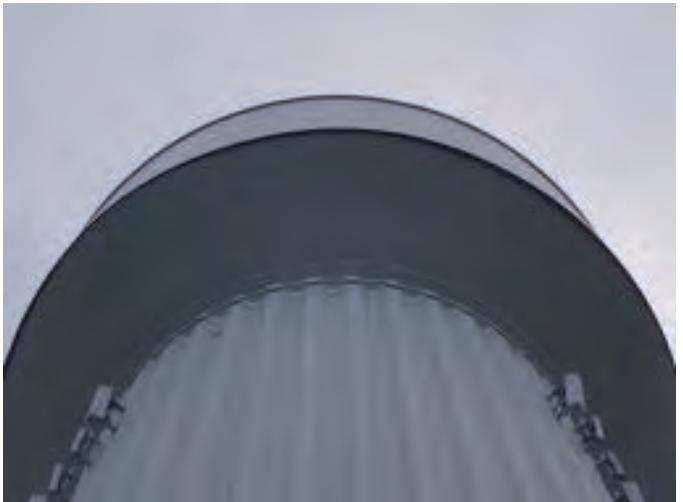
29 Exterior Tank Base With Mild Mildew

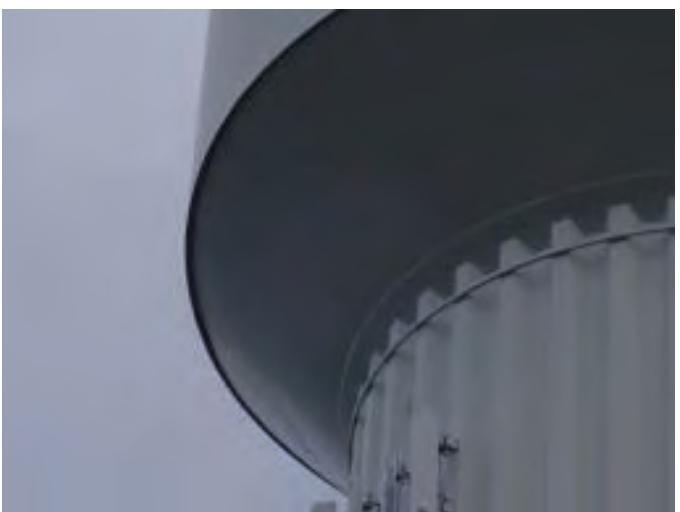
30 Exterior Tank Base With Mild Mildew

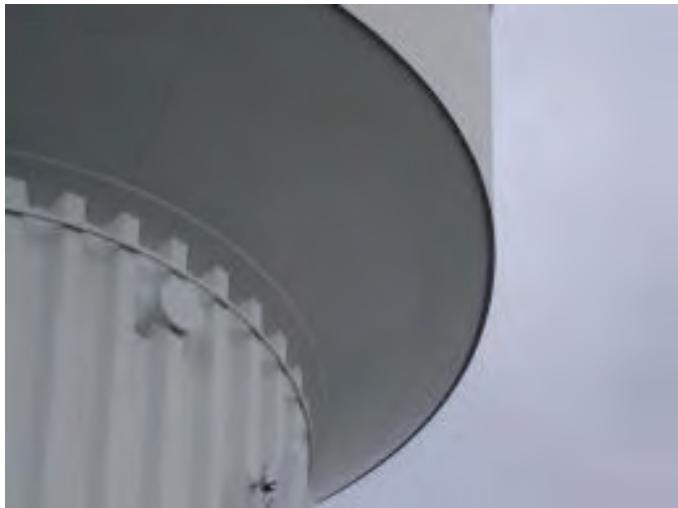
Exterior Tank Base With Mild Mildew

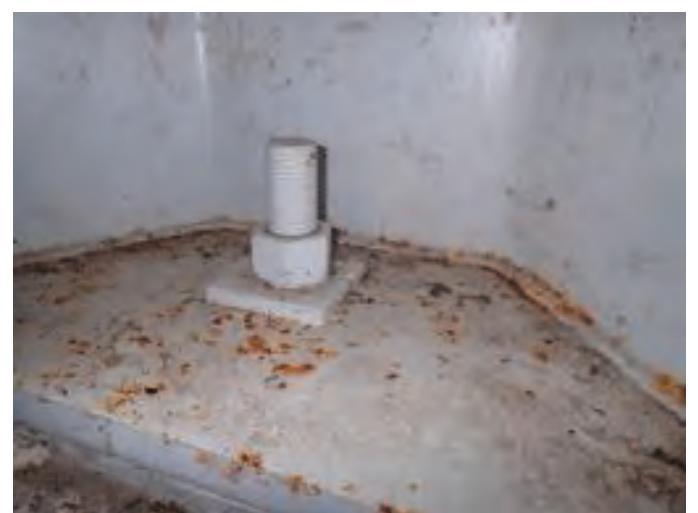
Each anchor bolt has one nut securely installed, while the protective coating applied to this support hardware appeared to have been applied uniformly and was found having good adhesion value. A mild rust stain was observed on this hardware, yet no obvious coating fatigue or steel exposure was evident at this time.

Secure Anchor Bolt With Hardware Having Mild Rust 32 Staining

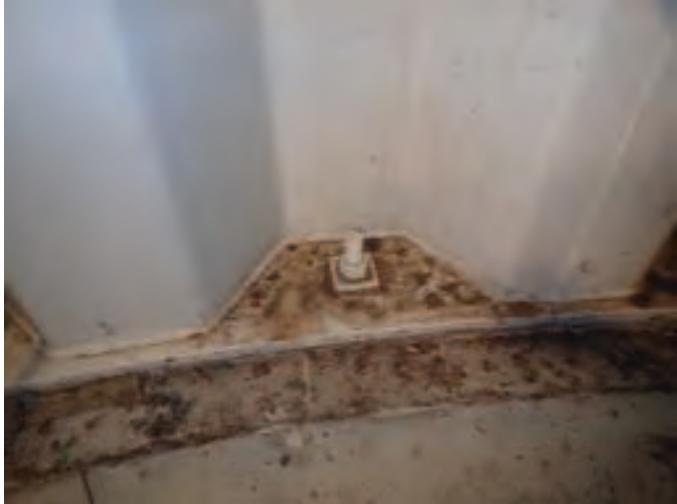
33 Secure Anchor Bolt With Hardware Having Mild Rust Staining

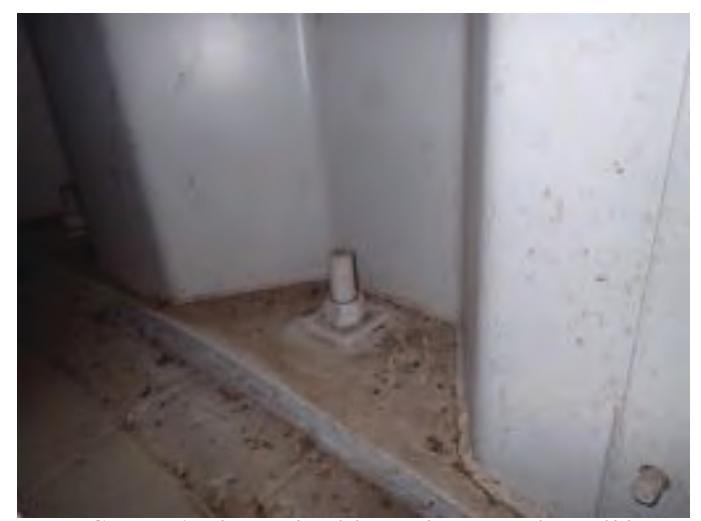
34 Secure Anchor Bolt With Hardware Having Mild Rust Staining

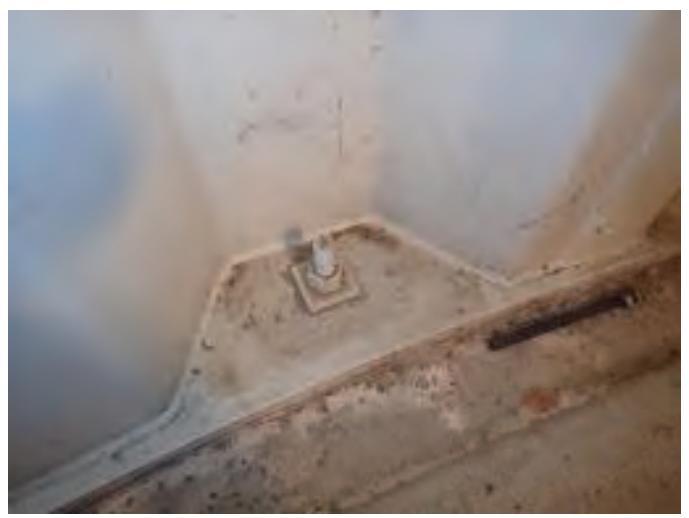
35 Secure Anchor Bolt With Hardware Having Mild Rust Staining

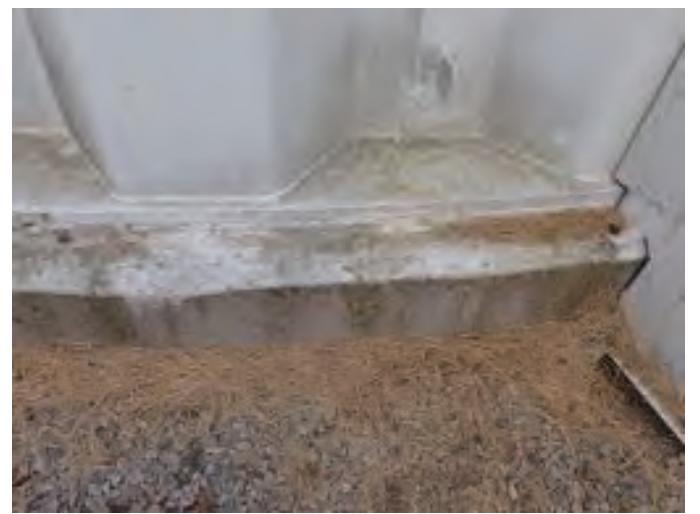
The exposed surfaces of the 24" wide by 7" tall concrete foundation appeared sound and remain free of obvious fatigue or failures. The protective coating applied to these exposed concrete surfaces was found having good adhesion value at this time.

An accumulation of mildew throughout the foundation has declined the overall aesthetics.

36 Concrete Foundation With Mildew

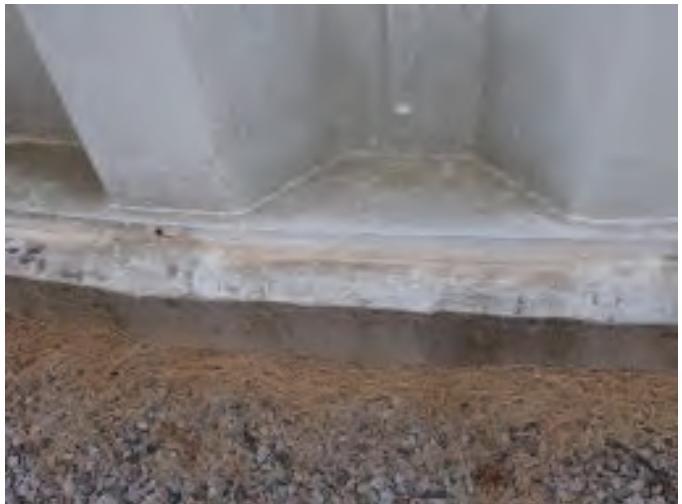
Concrete Foundation With Mildew 37

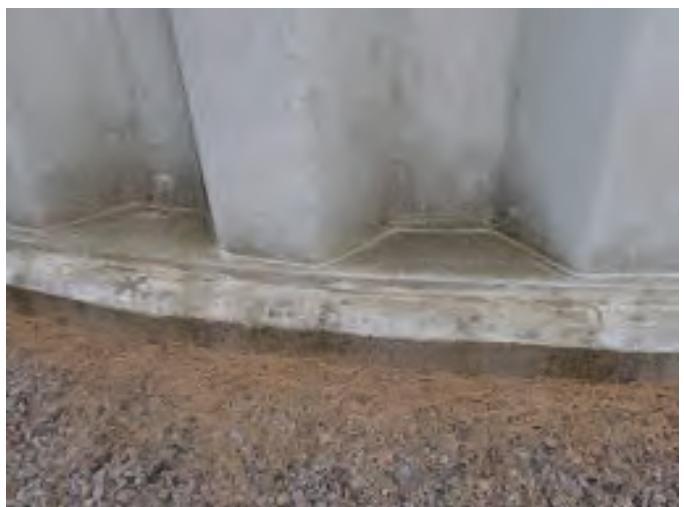
Concrete Foundation With Mildew

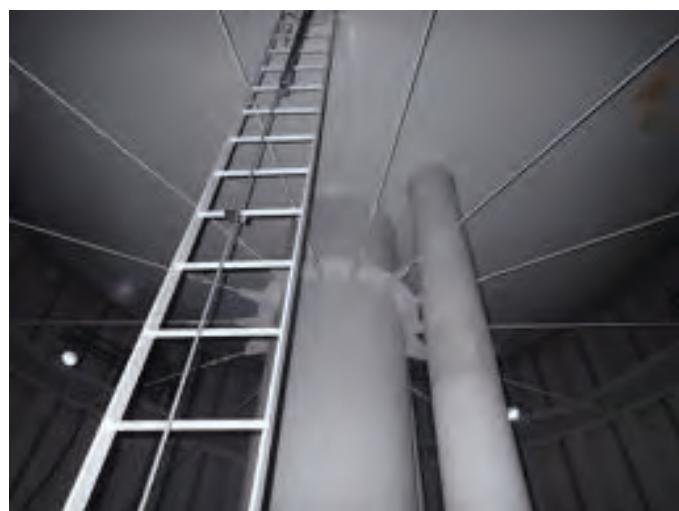
Manway Access Ladder And Fall Prevention Device 40

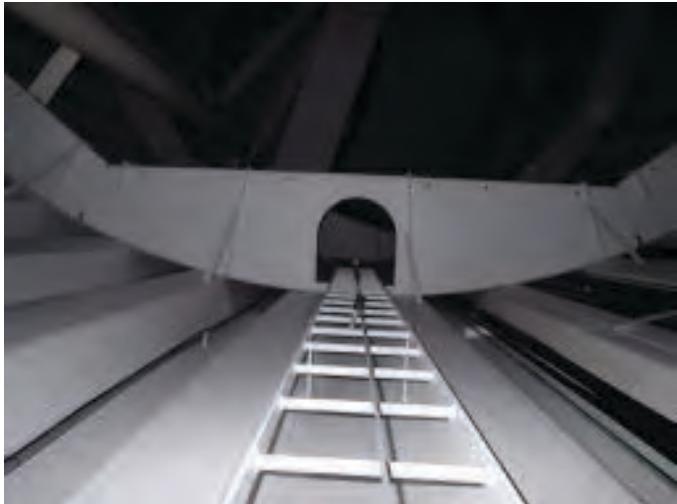
Ladder And Fall Prevention Device 41

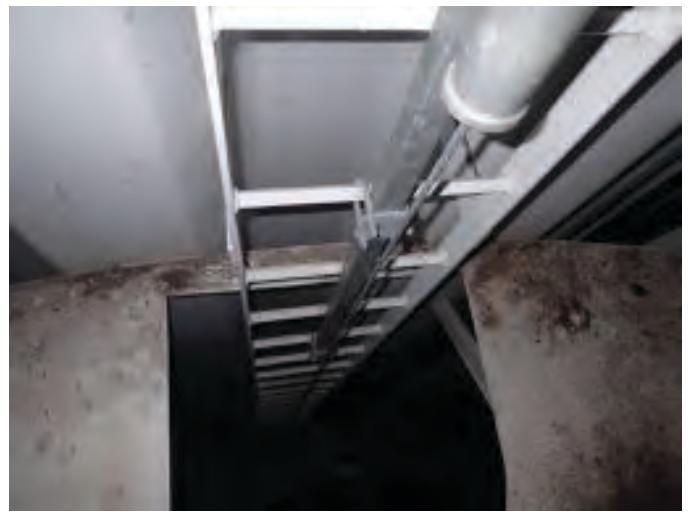
Ladder And Fall Prevention Device 42

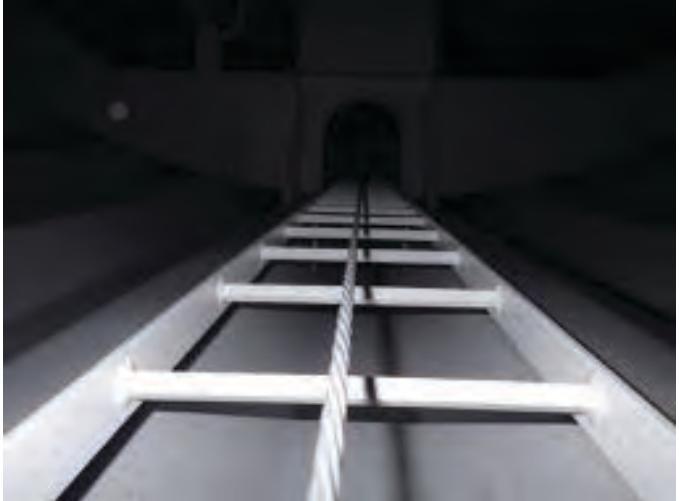
43 Ladder And Fall Prevention Device
