In re: City of Woonsocket Water Division - Application to Implement Multi-Year Rate Plan

Docket No. 4879

Dam Name (No):	Woonsocket Reservoir #3 Dam (068)
Location:	Smithfield/North Smithfield
Hazard Classification:	High
	-
Inspector:	David M. Matheson, P.E.
Inspection Date.	August 1, 2014

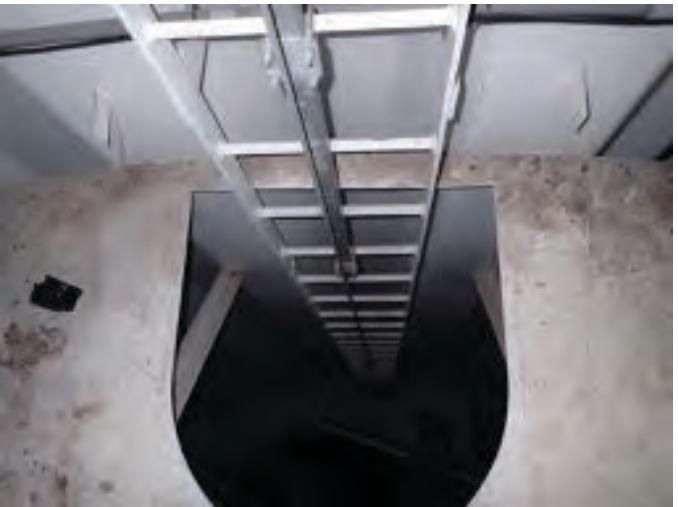
44 *Ladder And Fall Prevention Device*

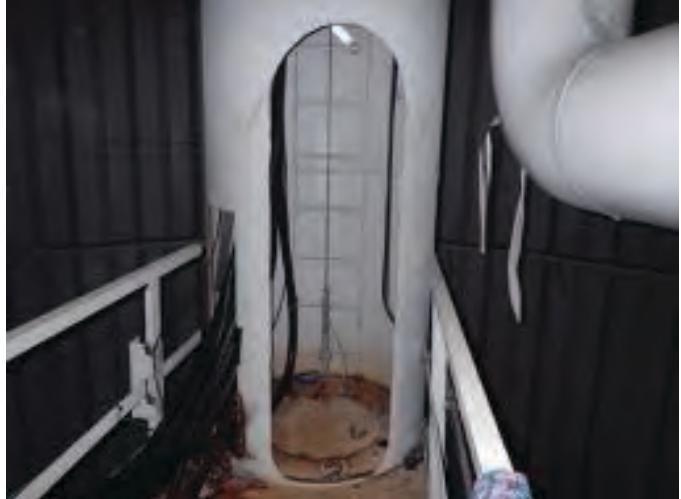
45 Center Riser Column Walkway

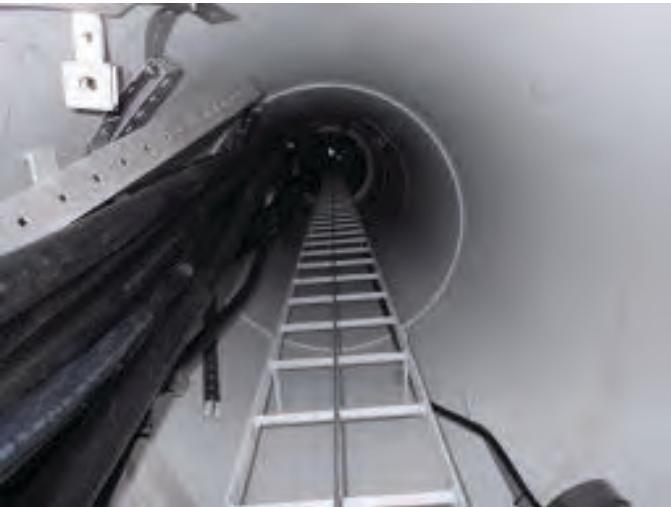
46 Center Riser Column Ladder And Fall Prevention Device

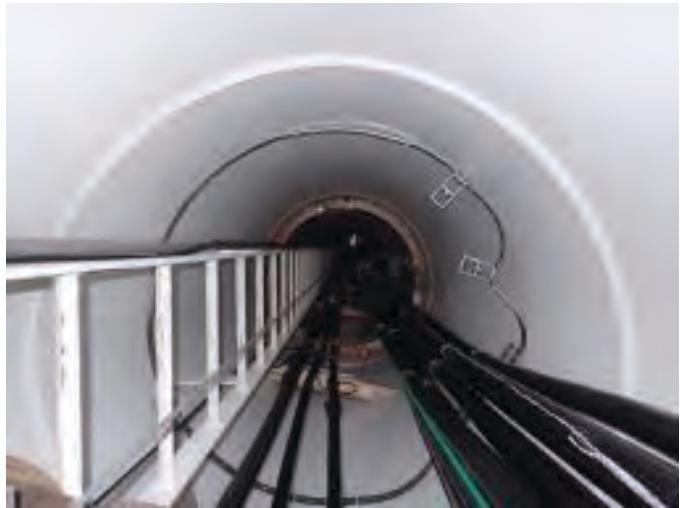
47 Center Riser Column

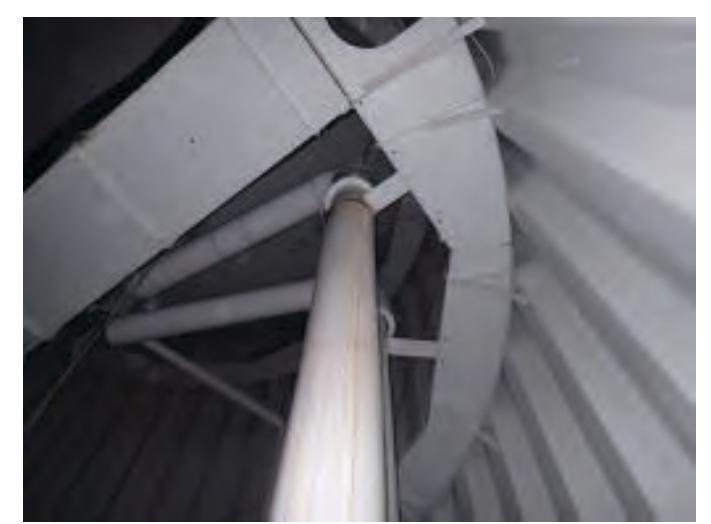
48 Overflow Pipe

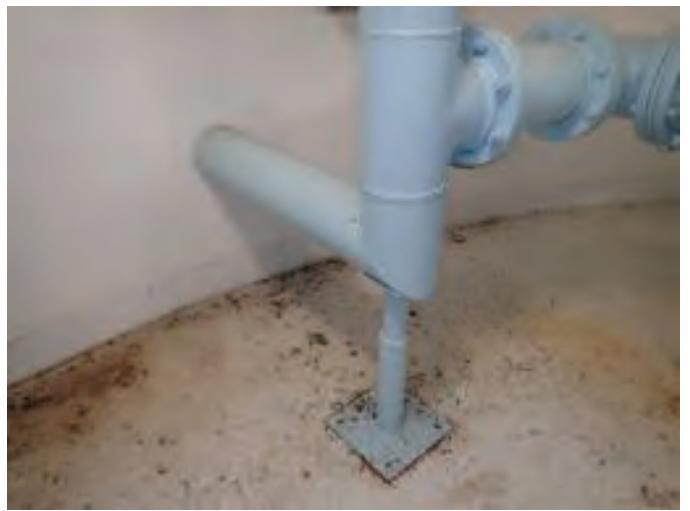
49 Overflow Pipe

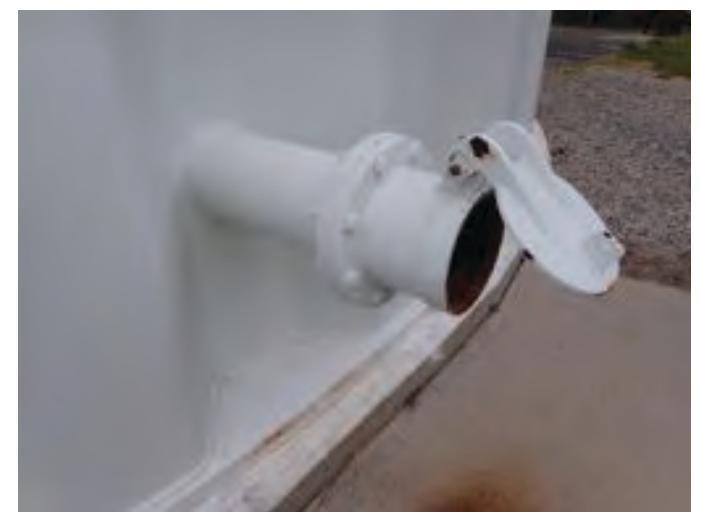
Overflow Pipe And Flap-Valve Having Coating Loss,50Exposed Steel And Corrosion

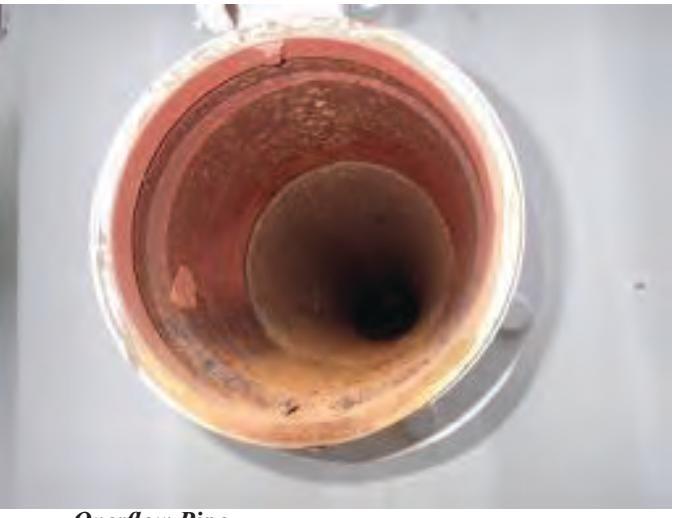
51 *Overflow Pipe*

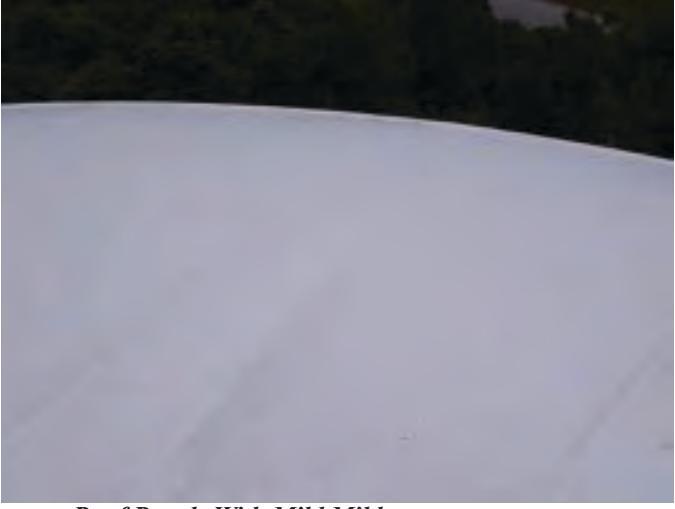
53 *Roof Panels With Mild Mildew*

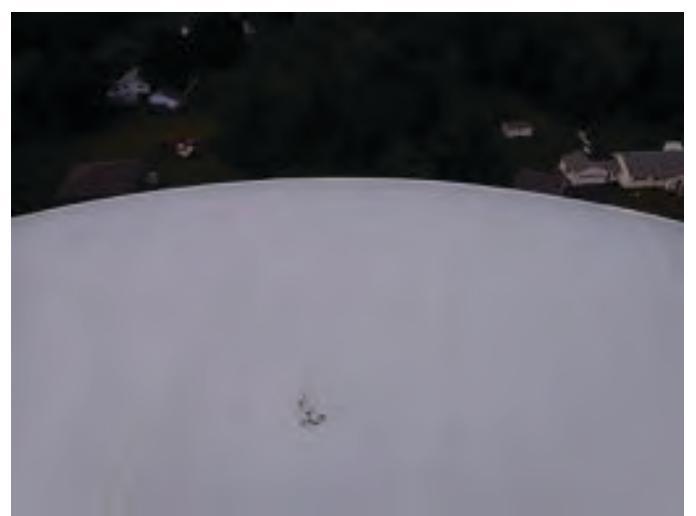
54 *Roof Panels With Mild Mildew*

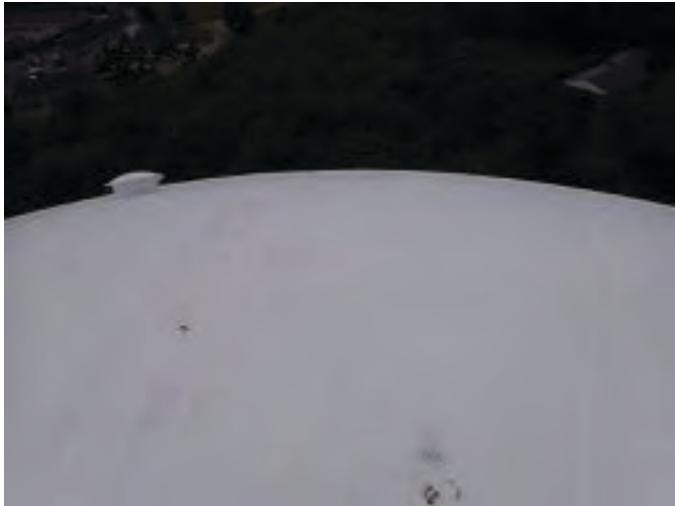
SolutionSolution55Roof Panels With Mild Mildew

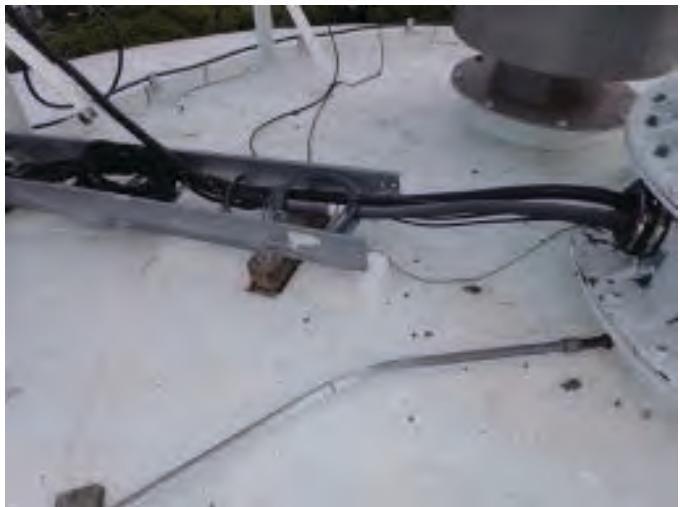
Roof Panels With Mild Mildew 56

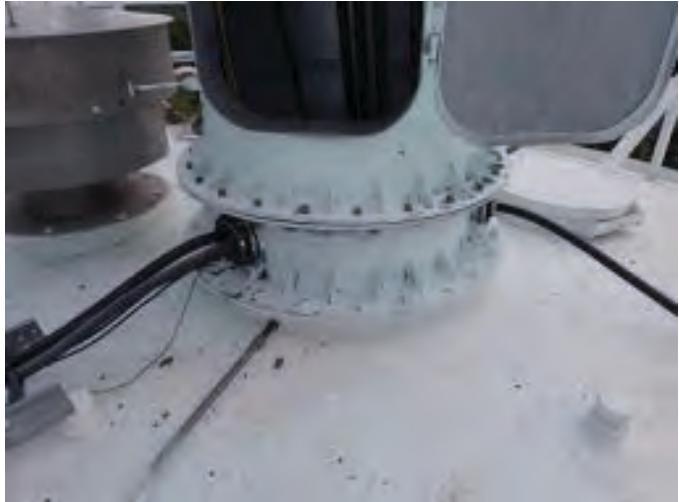
57 **Roof Panels With Mild Mildew**

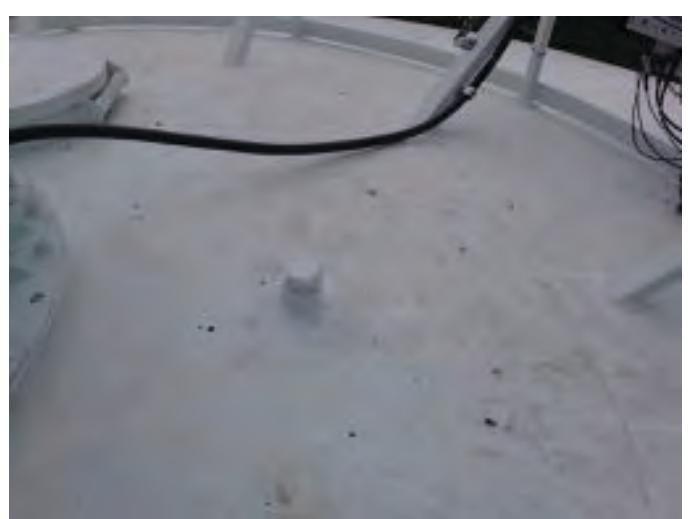
58 Secure Roof Rigging Hole Penetrations Sealed With Threaded Plug

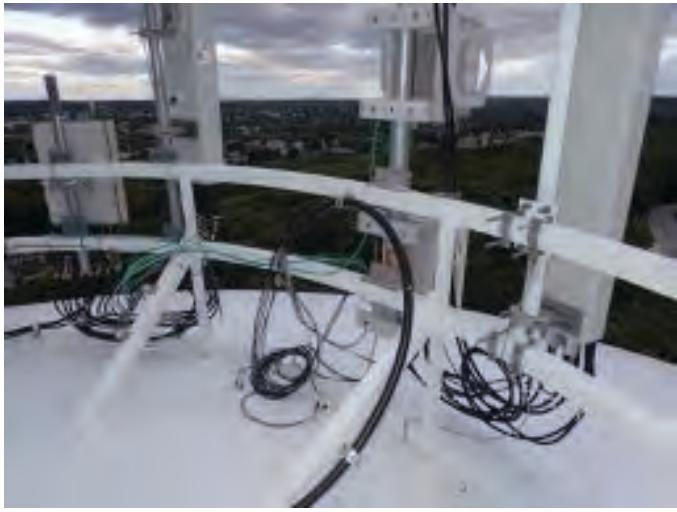
59 Secure Roof Safety Railings

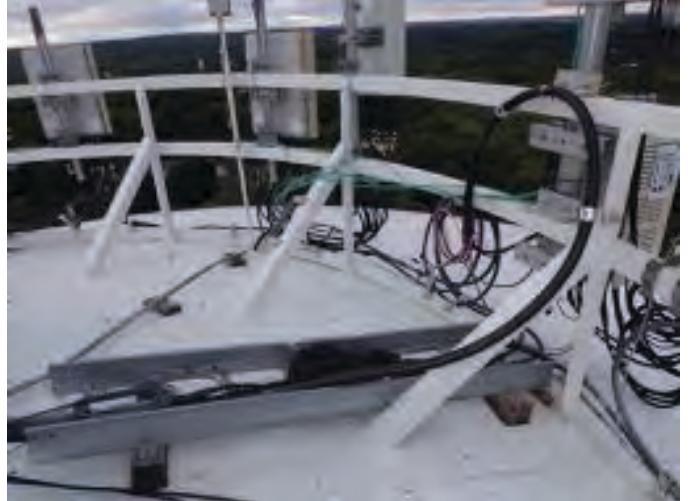
60 Secure Roof Safety Railings

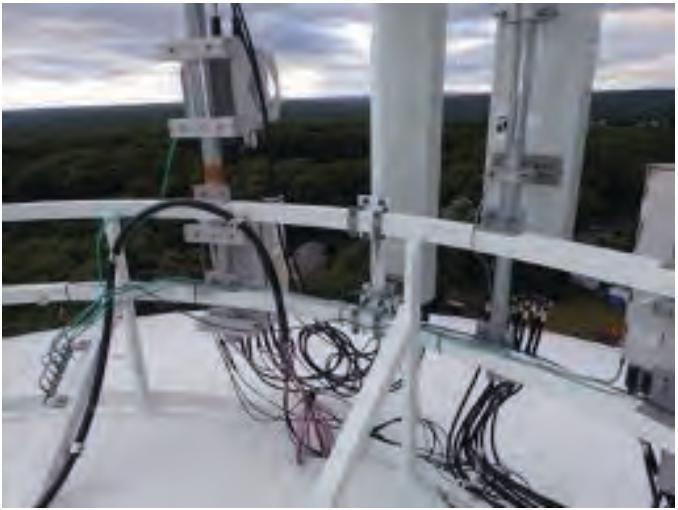
61 Secure Roof Safety Railings

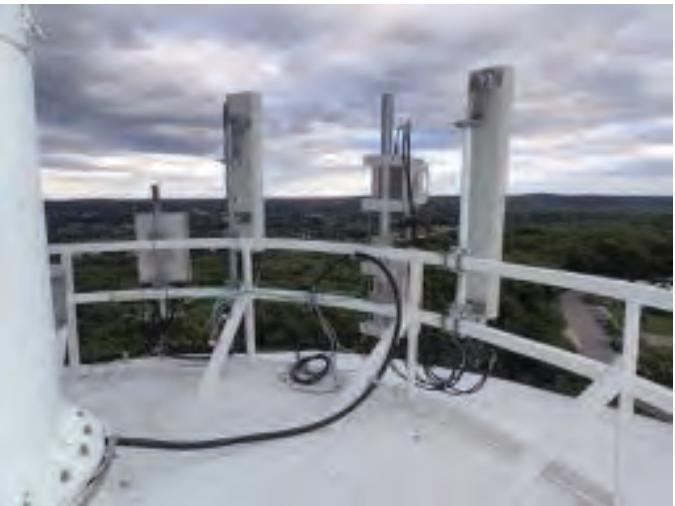
62 Secure Roof Safety Railings

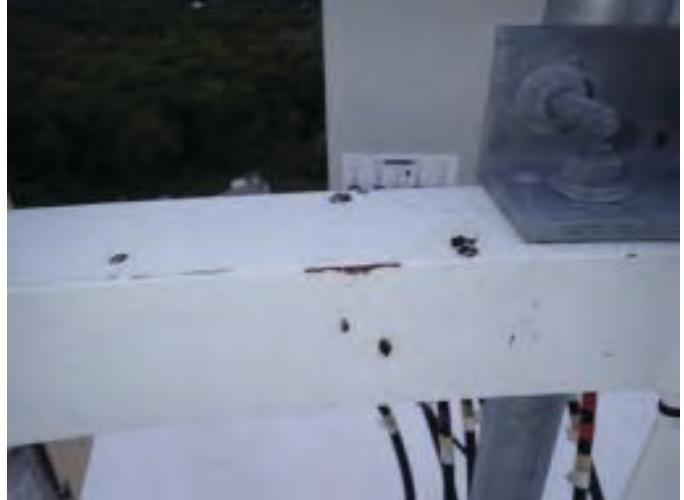
63 Secure Roof Safety Railings With Isolated Coating Loss, Exposed Underlying Steel And Mild Corrosion

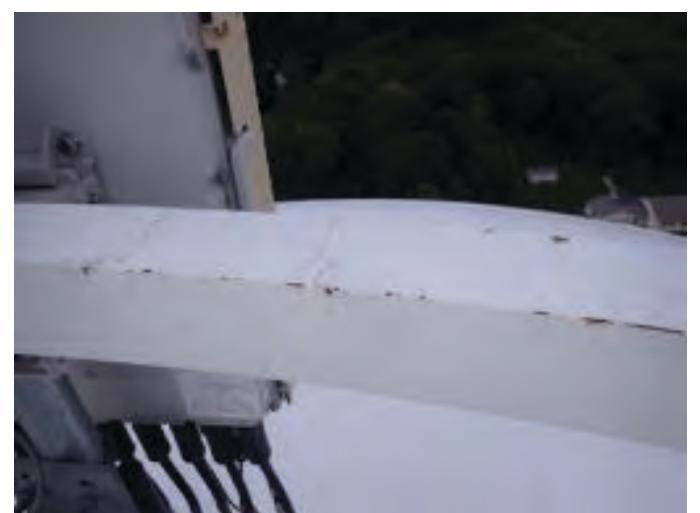
64 Secure Roof Safety Railings With Isolated Coating Loss, Exposed Underlying Steel And Mild Corrosion

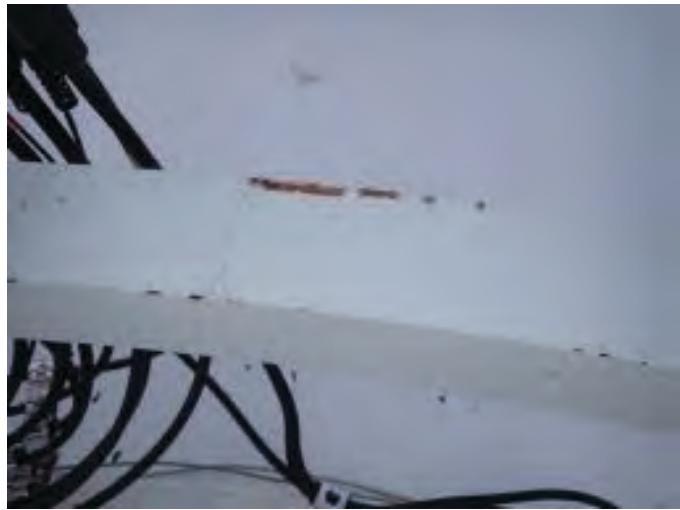
65 Secure Roof Safety Railings With Isolated Coating Loss, Exposed Underlying Steel And Mild Corrosion

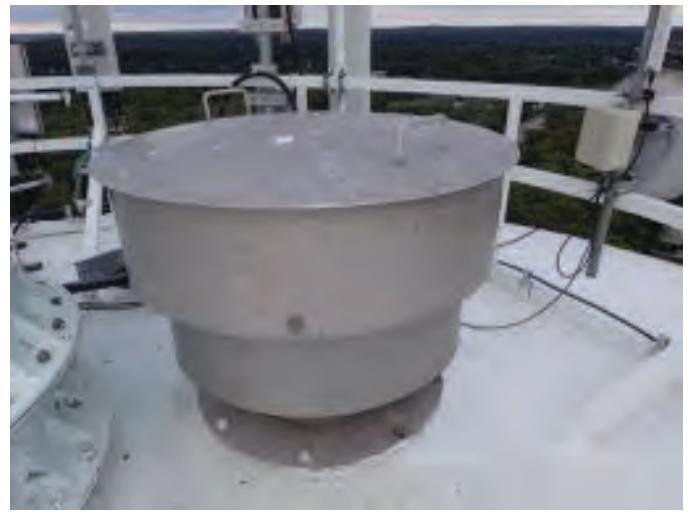
66 Secure Vent Cap

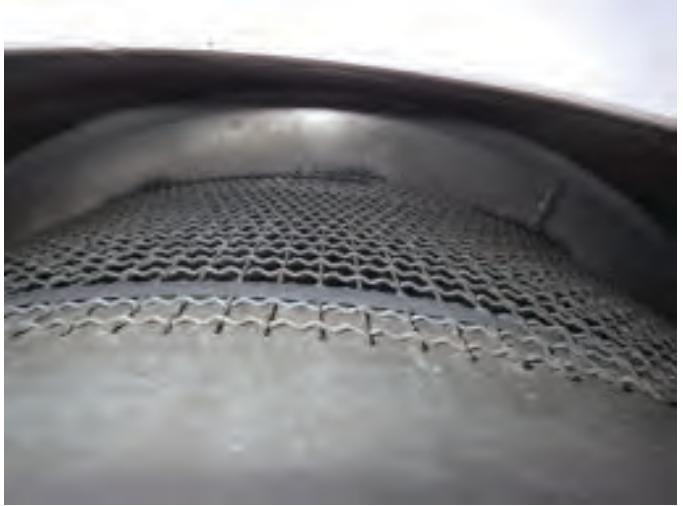
67 Secure Vent Screen

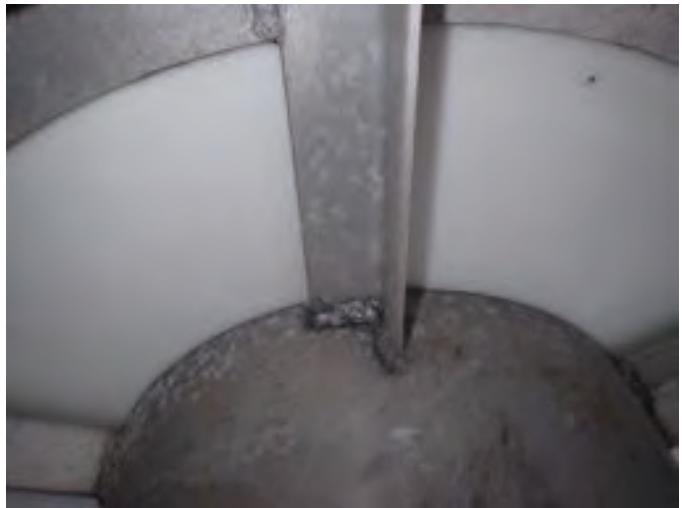
68 Secure Vacuum Release Plate

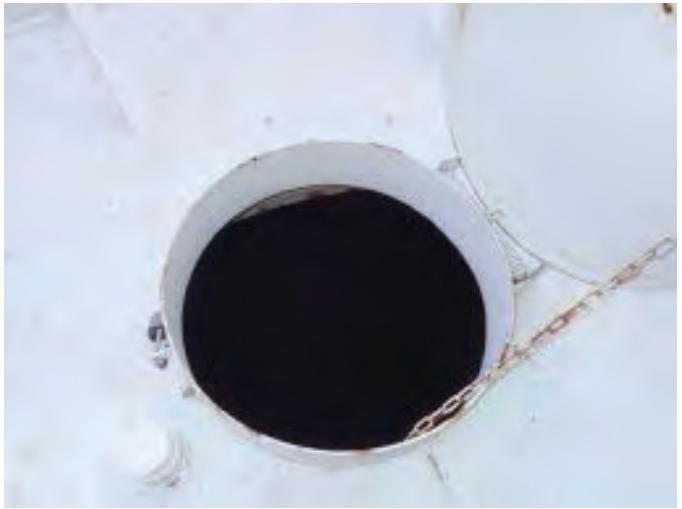
69 Open Access Hatch

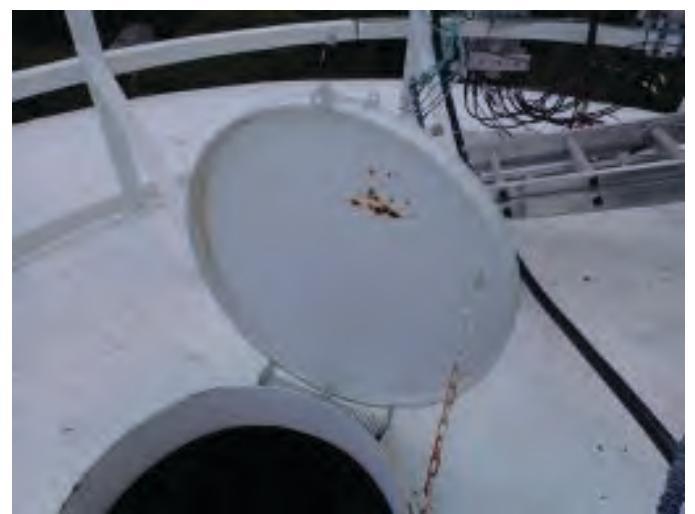
Access Hatch Lid With Isolated Coating Loss,
Exposed Underlying Steel And Mild Corrosion

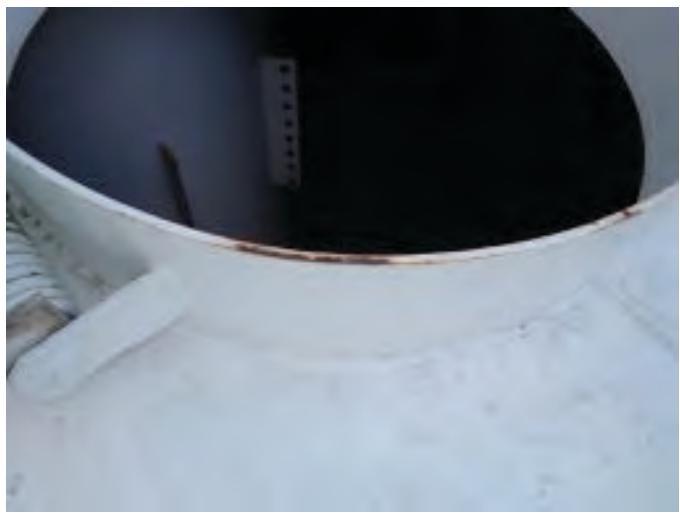
71 Access Hatch Trunk With Isolated Coating Loss, Exposed Underlying Steel And Mild Corrosion

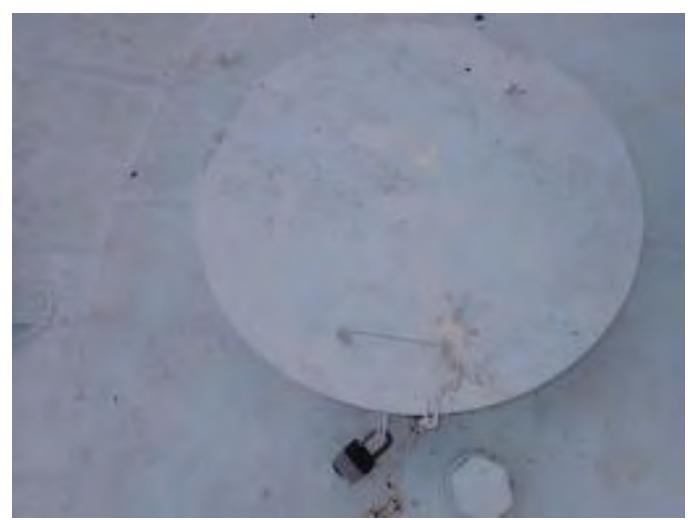
72 Closed Access Hatch

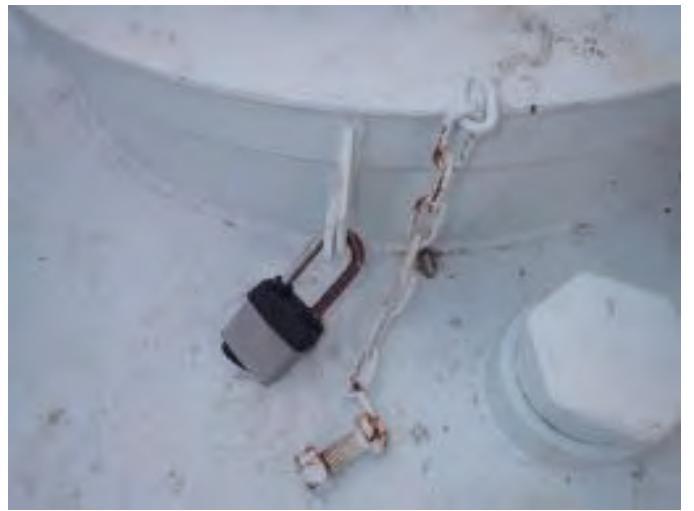
Secure Access Hatch 73

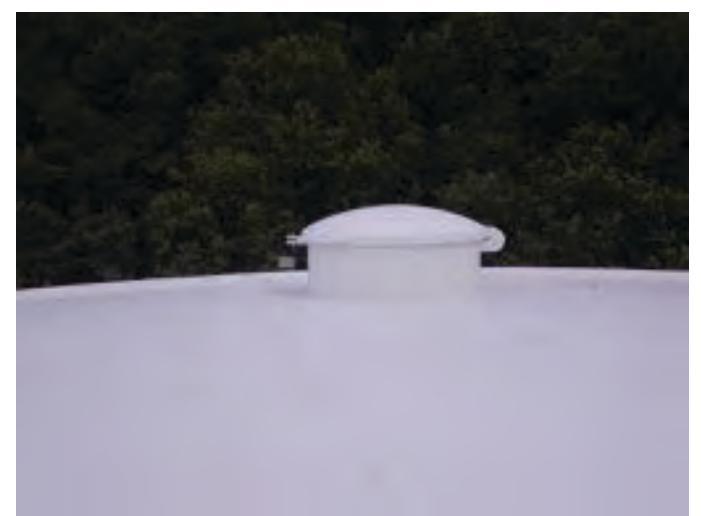
Closed Access Hatch 74

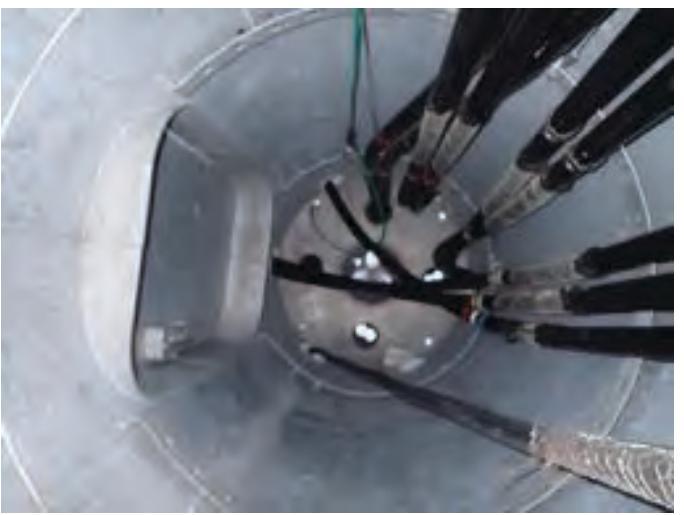
Closed Center Riser Column Access Door 76

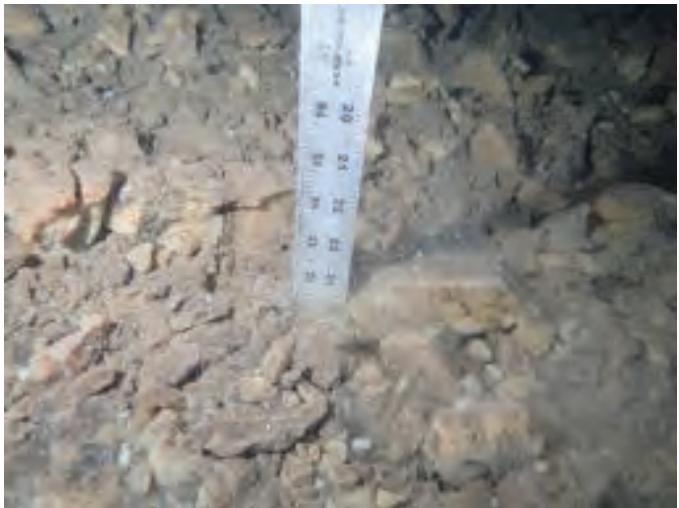
Layer Of Precipitate 77

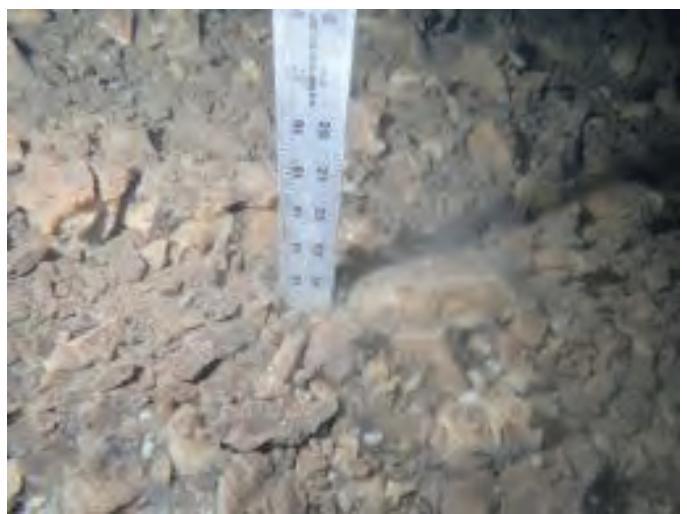
Layer Of Precipitate 78

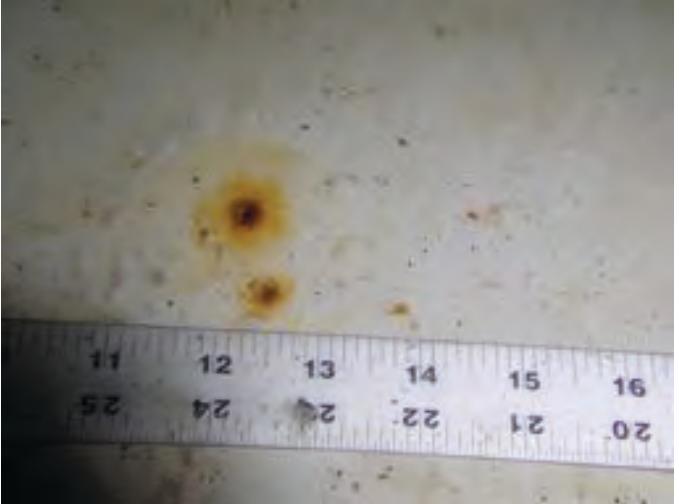
79 Floor With Coating Loss, Exposed Underlying Steel, Corrosion And Mild To Moderate Staining

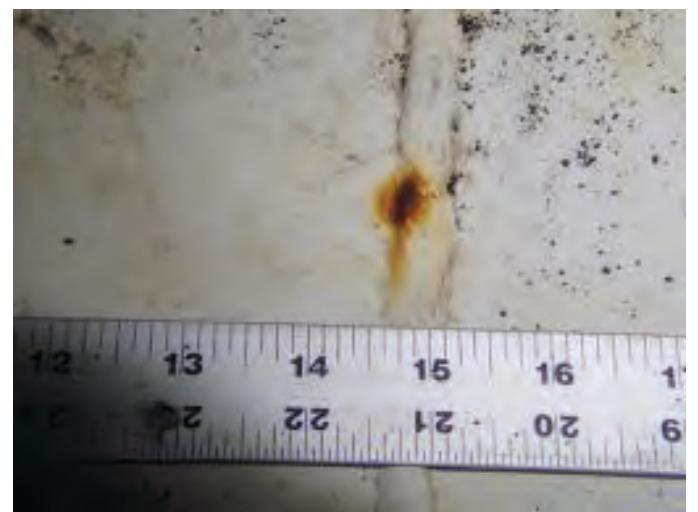
Floor With Coating Loss, Exposed Underlying Steel, 80 Corrosion And Mild To Moderate Staining

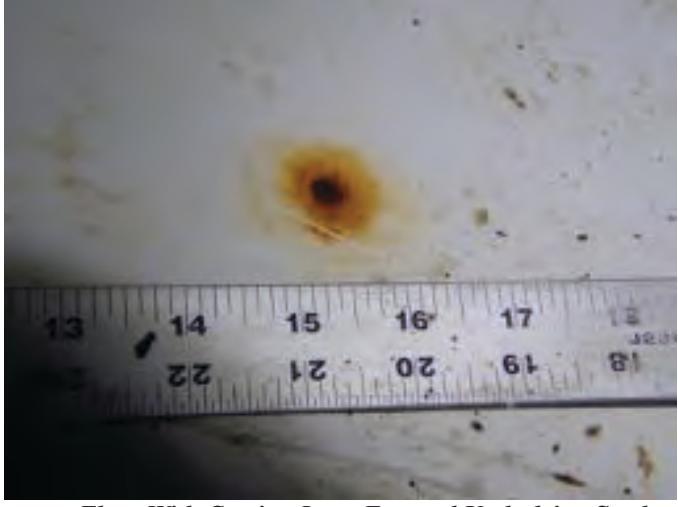
81 *Floor With Coating Loss, Exposed Underlying Steel, Corrosion And Mild To Moderate Staining*

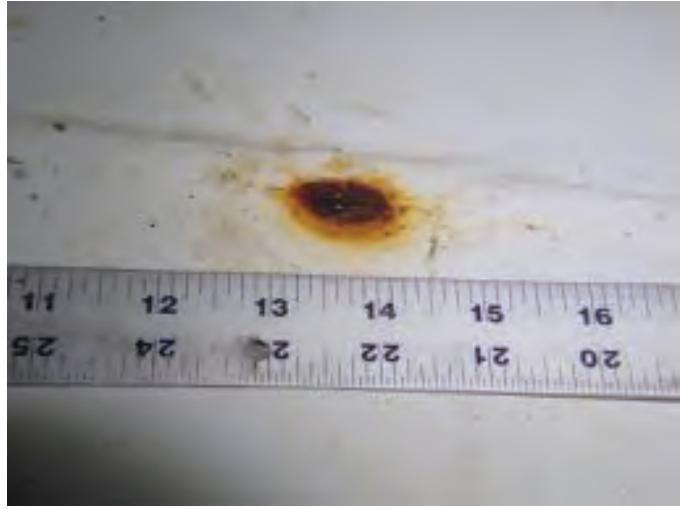
Floor With Coating Loss, Exposed Underlying Steel,
82 Corrosion And Mild To Moderate Staining

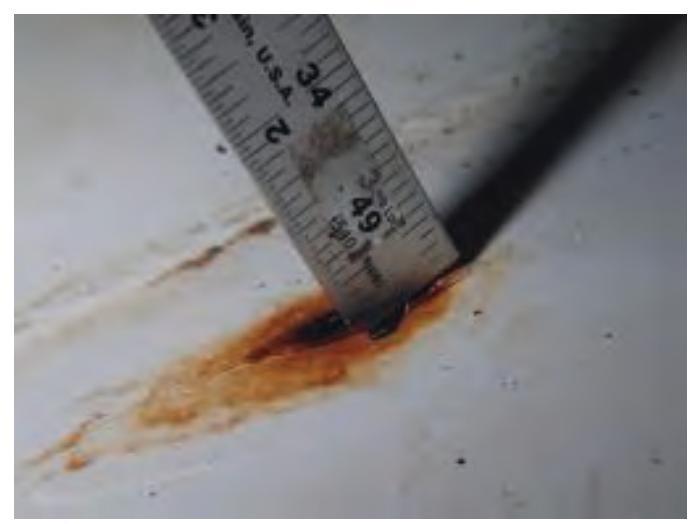
83 Floor With Coating Loss, Exposed Underlying Steel, Fatigue (Pitting), Corrosion And Mild To Moderate Staining

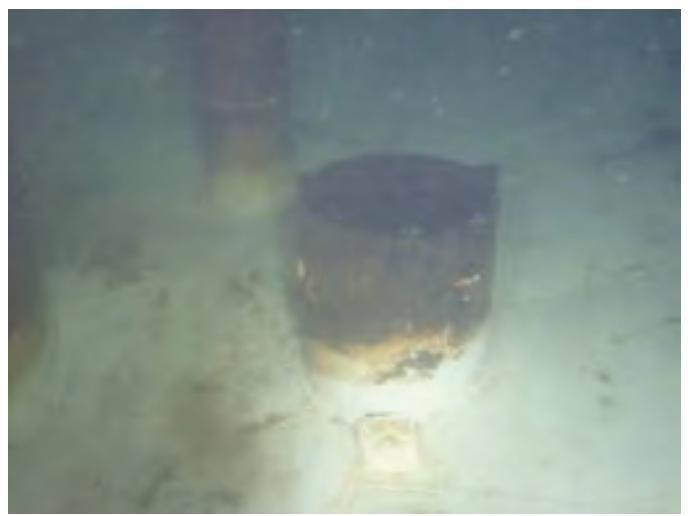
84 Floor With Mild To Moderate Staining

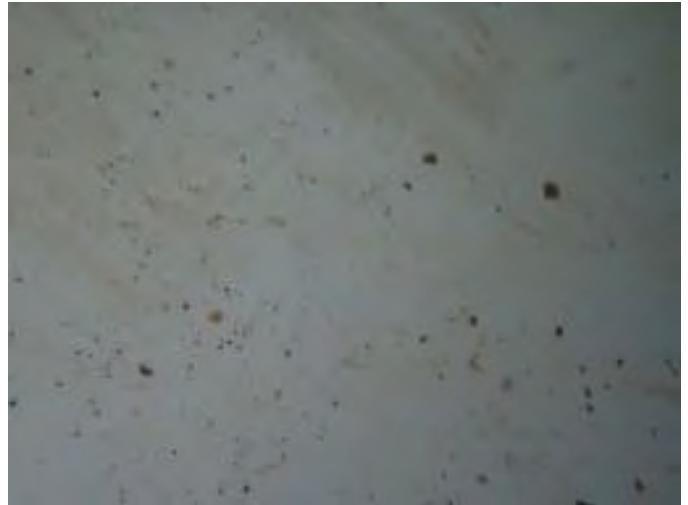
Floor With Mild To Moderate Staining

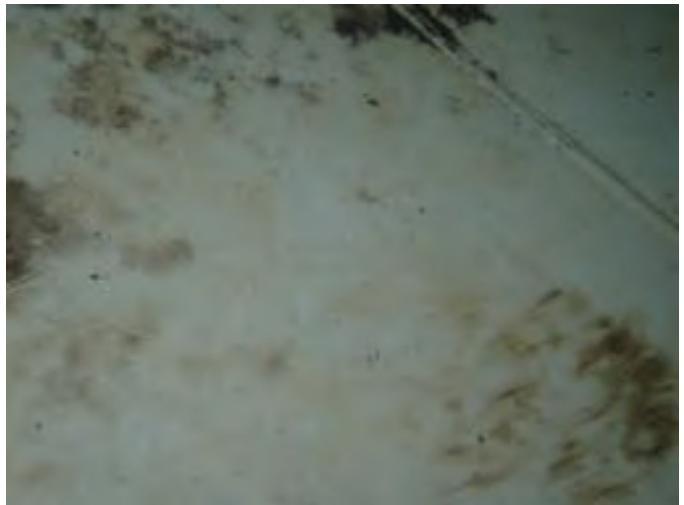
Floor With Mild To Moderate Staining 86

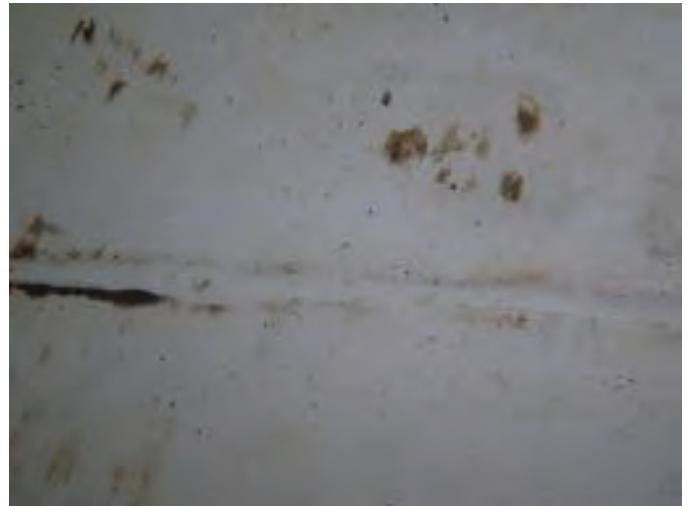
87 Floor With Mild To Moderate Staining

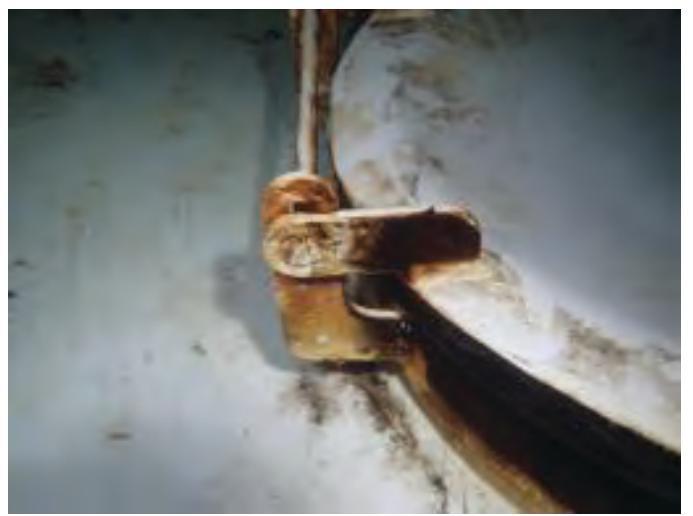
89 *Manway Hinge With Coating Loss, Exposed Steel And Corrosion*

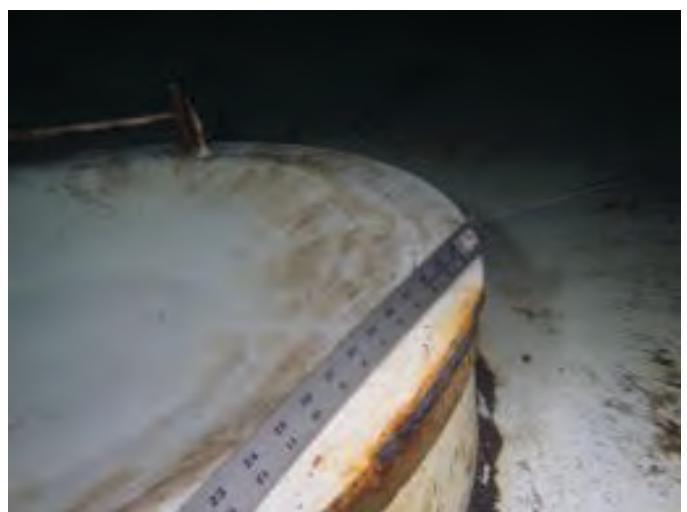
90 Manway Lid With Coating Loss, Exposed Underlying Steel And Corrosion

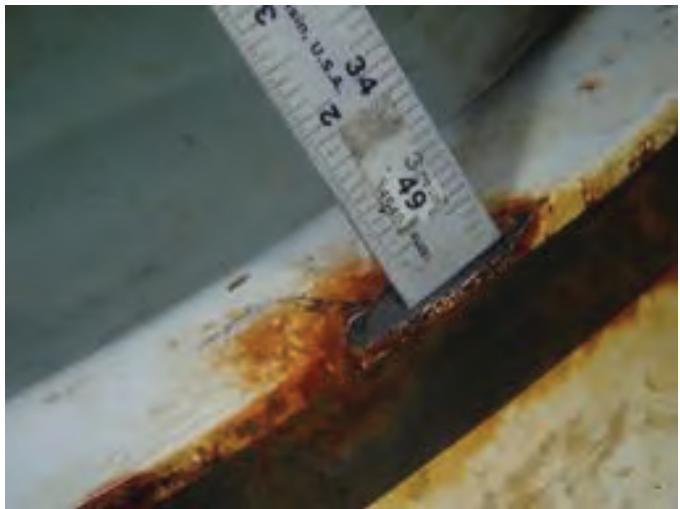
91 Manway Lid With Coating Loss, Exposed Underlying Steel, Fatigue (Pitting) And Corrosion

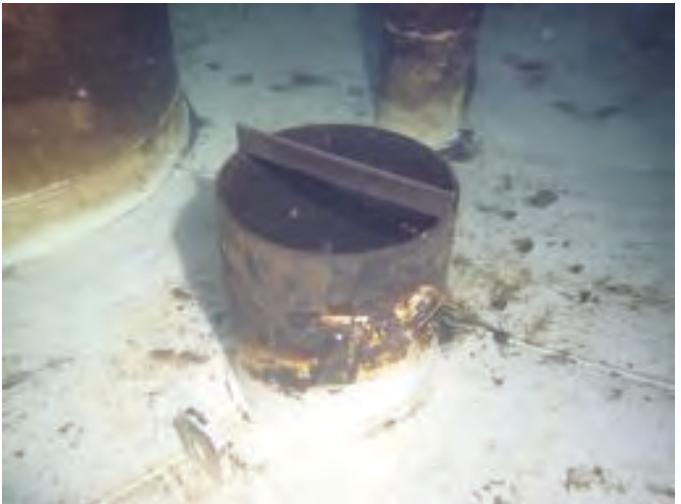
18" Inside Diameter Pipe With Heavy Staining 92

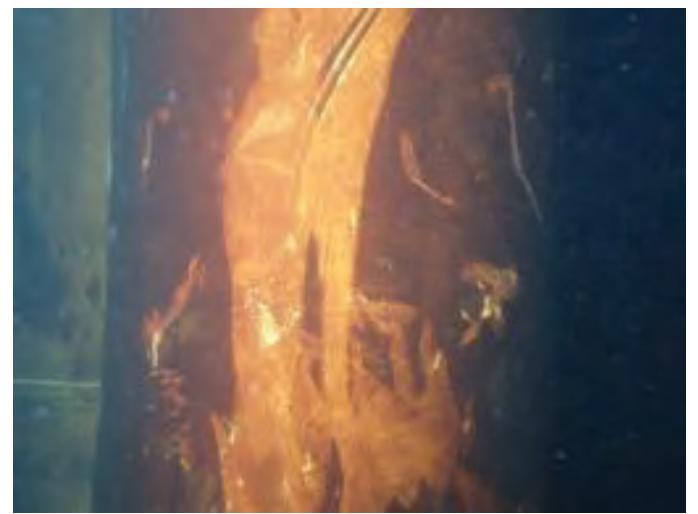
12" Inside Diameter Pipe With Heavy Staining

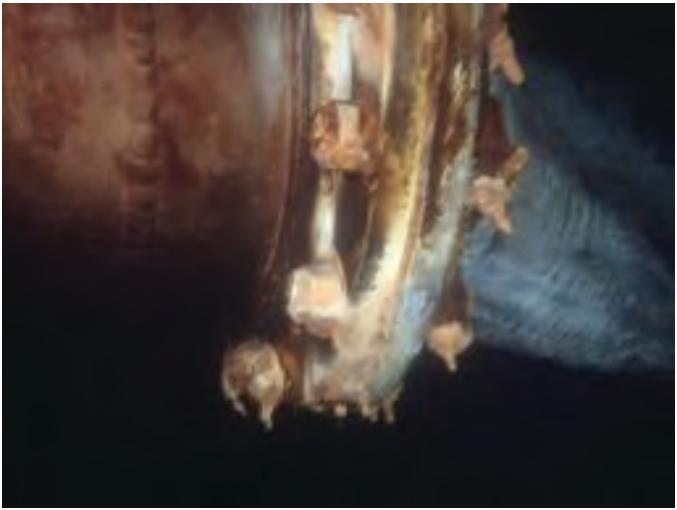
95 Flange Hardware With Coating Loss, Exposed Underlying Steel And Corrosion

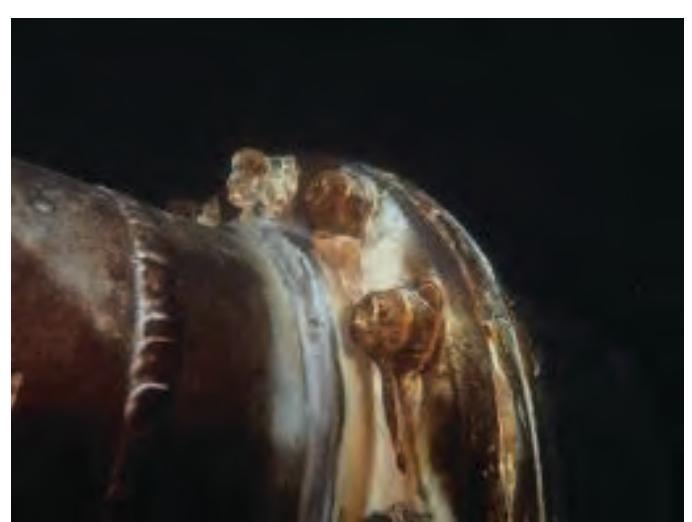
96 Flange Hardware With Coating Loss, Exposed Underlying Steel And Corrosion

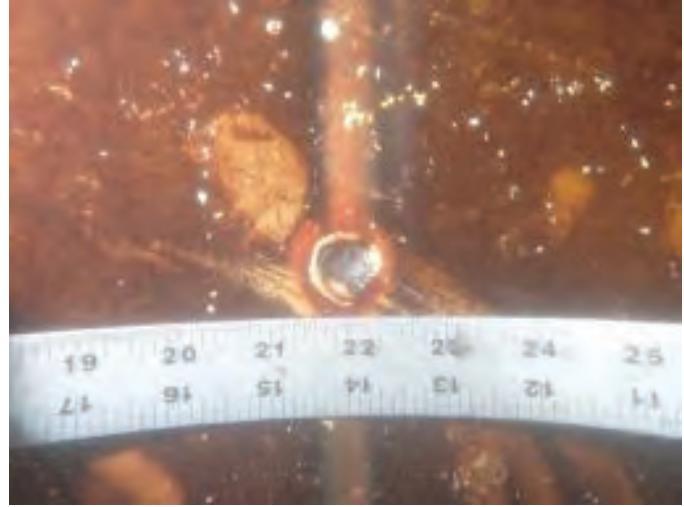
The protective coating applied to the interior welded steel wall surfaces appeared to have been applied uniformly, however was found having poor adhesion value at this time.

99 Interior Wall With Secondary Coating Loss, Exposed Primary Coating, Fatigue (Pitting), Exposed Steel, Corrosion And Heavy Staining

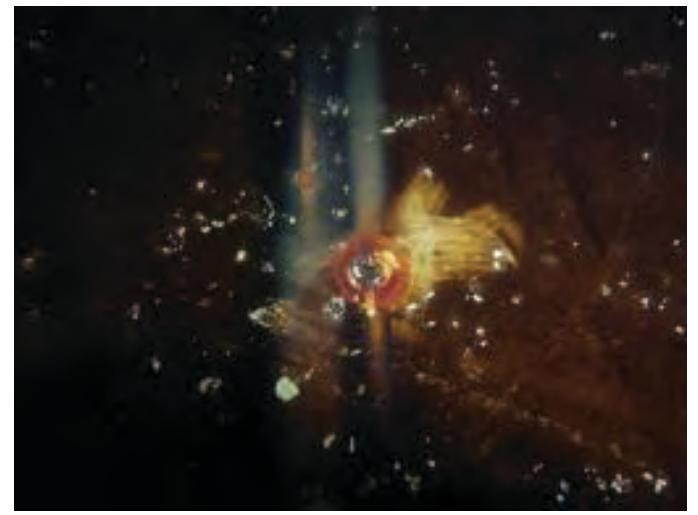
100 Interior Wall With Secondary Coating Loss, Exposed
100 Primary Coating, Fatigue (Pitting), Exposed Steel,
Corrosion And Heavy Staining

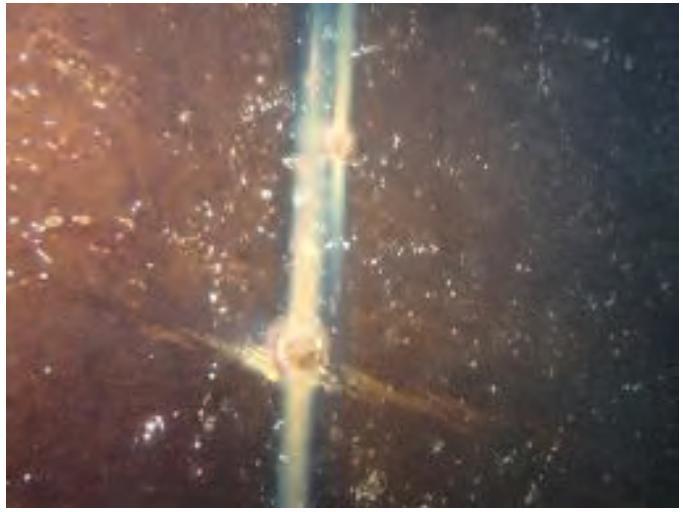
101 Interior Wall With Secondary Coating Loss, Exposed Primary Coating, Fatigue (Pitting), Exposed Steel, Corrosion And Heavy Staining

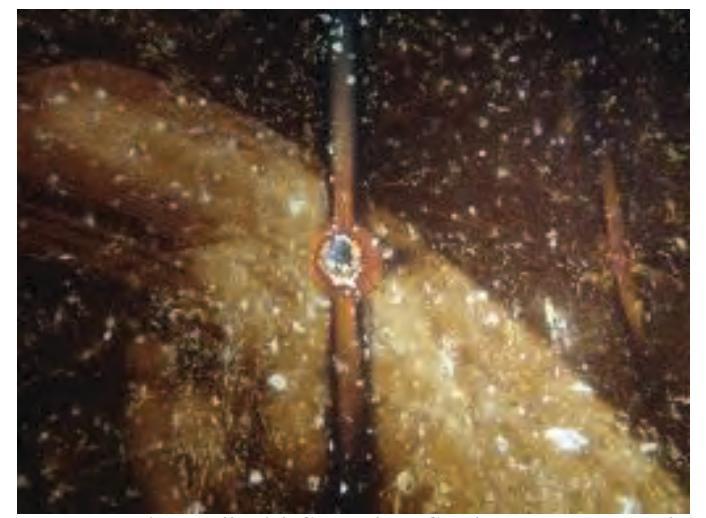
102 Interior Wall With Secondary Coating Loss, Exposed Primary Coating, Fatigue (Pitting), Exposed Steel, Corrosion And Heavy Staining

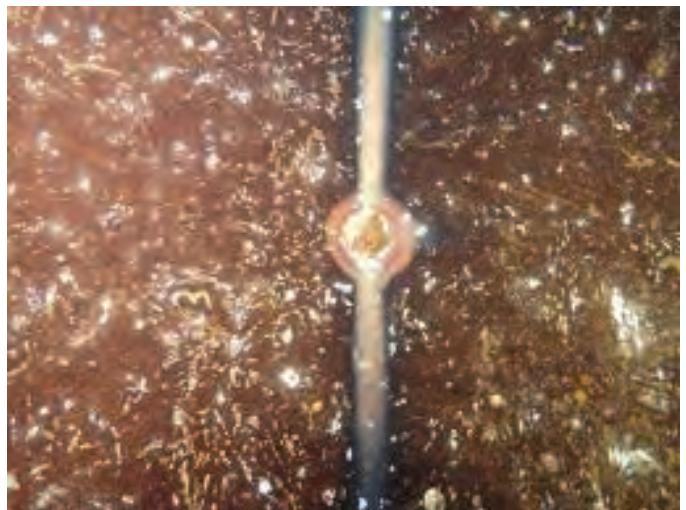
Interior Wall With Secondary Coating Loss, Exposed103Primary Coating, Fatigue (Pitting), Exposed Steel,
Corrosion And Heavy Staining

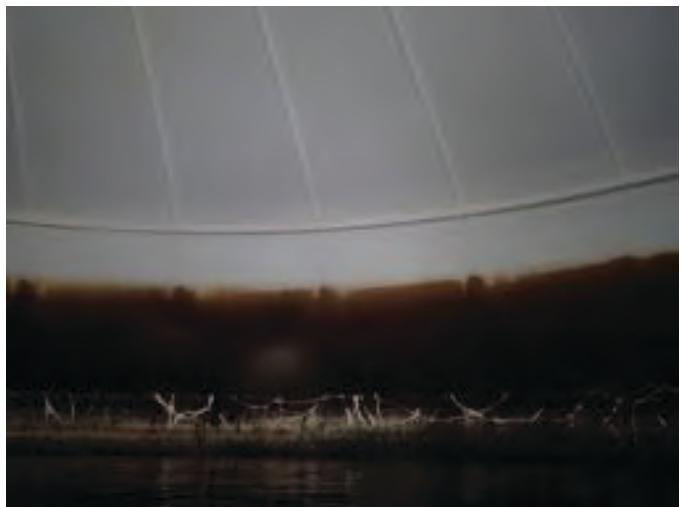
Interior Wall With Heavy Staining 104

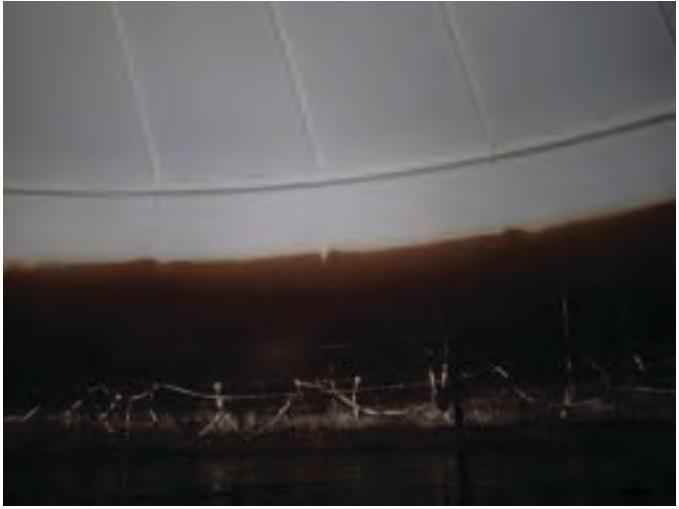
105 Interior Wall With Heavy Staining

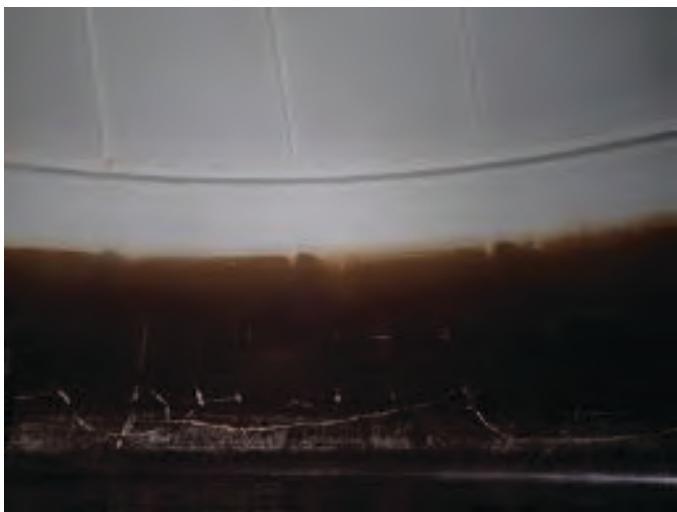
Interior Wall With Heavy Staining106

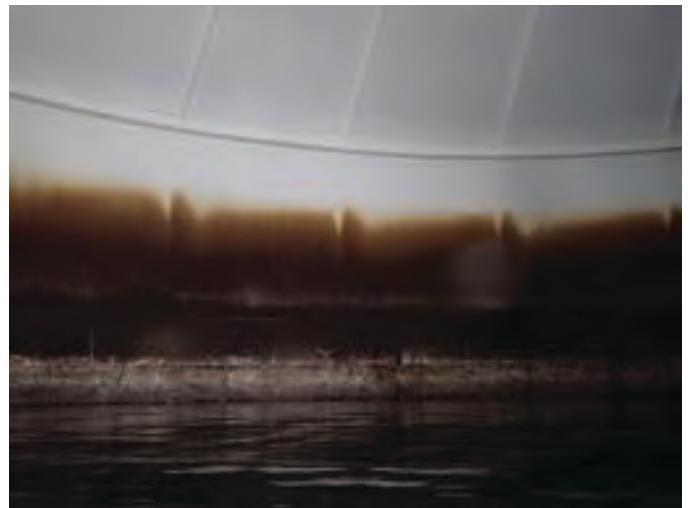
107 Interior Wall With Heavy Staining

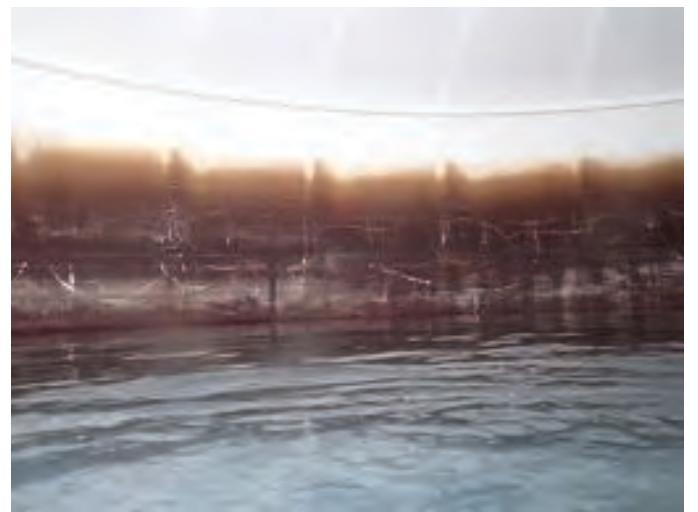
108 Interior Wall With Heavy Staining

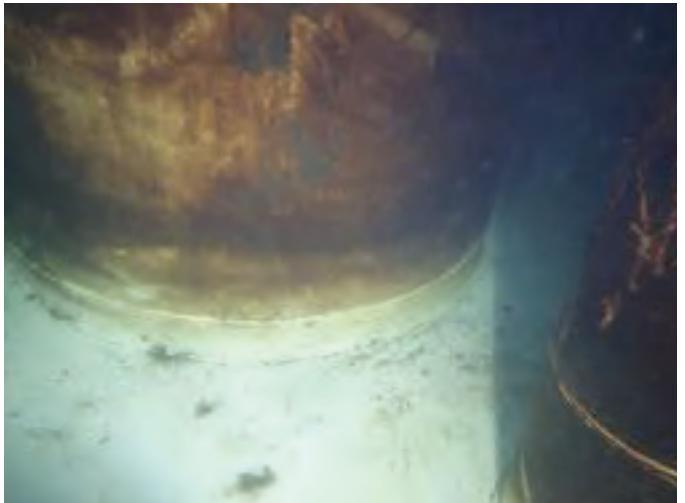
109 *Center Riser Column With Heavy Staining*

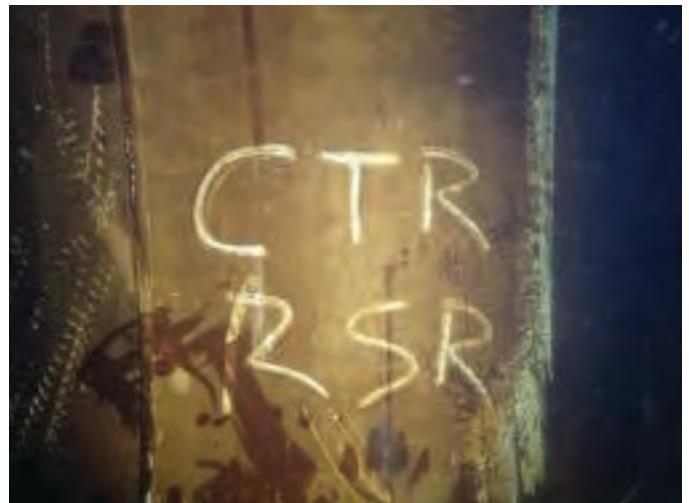
Center Riser Column With Heavy Staining

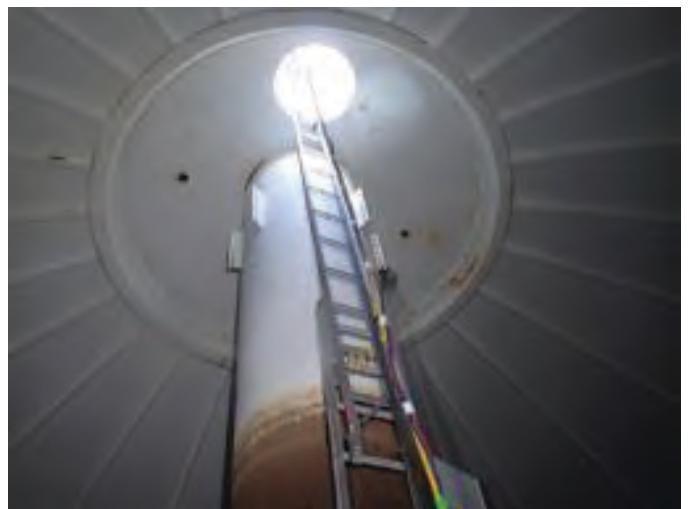
111 Center Riser Column With Heavy Staining

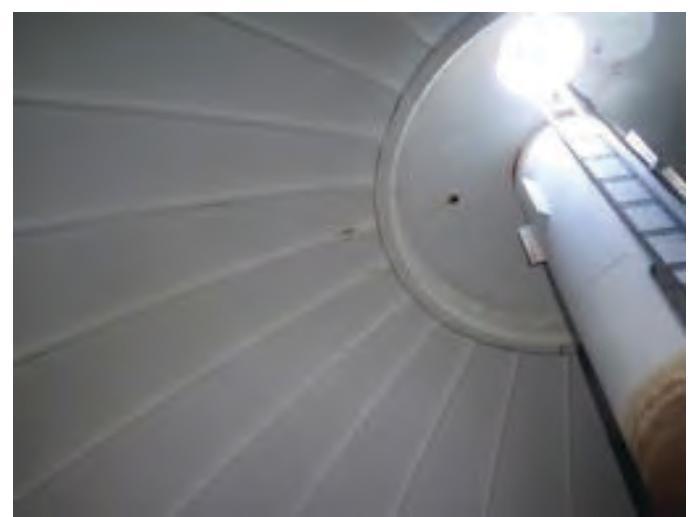
112Center Riser Column With Heavy Staining
