In re: City of Woonsocket Water Division - Application to Implement Multi-Year Rate Plan

Docket No. 4879

Dam Name (No):	Woonsocket Reservoir #3 Dam (068)
Location:	Smithfield/North Smithfield
Hazard Classification:	High
	-
Inspector:	David M. Matheson, P.E.
Inspection Date.	August 1, 2014

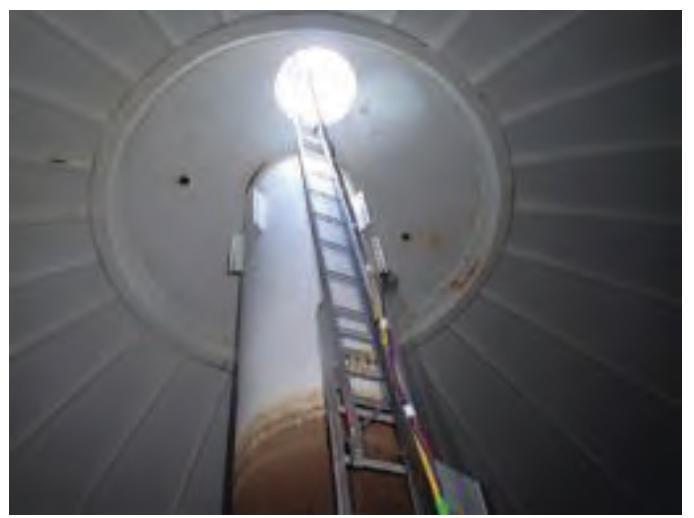
The protective coating applied to the steel supports was found having mostly good adhesion value, however declined film thickness has caused mild surface corrosion (blotch rusting) throughout approximately 5-10% of these surfaces.

113 Overhead With Coating Loss, Mild Surface Corrosion And Blotch Rusting

It is our recommendation to monitor all overhead surfaces through future scheduled inspections to ensure the coating adhesion loss does not occur and result in exposure of the underlying steel.

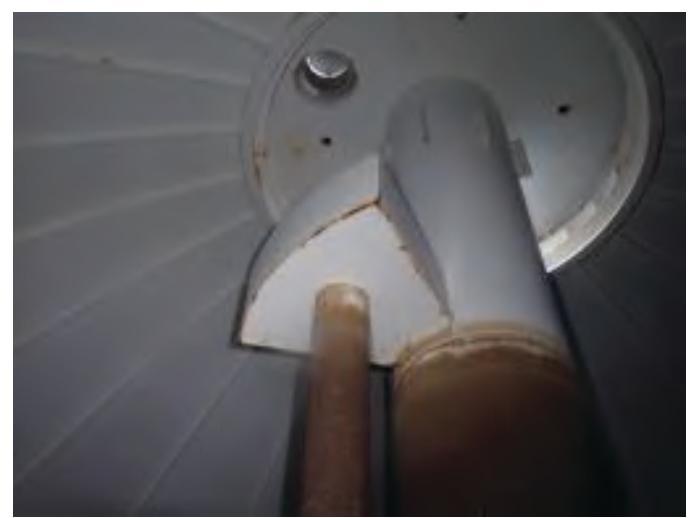
114 Overhead With Coating Loss, Mild Surface Corrosion And Blotch Rusting

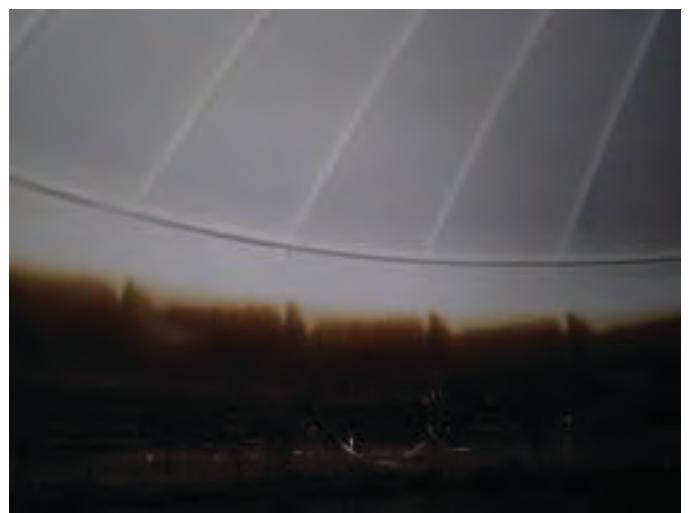
Overhead With Coating Loss, Mild Surface Corrosion 115 And Blotch Rusting

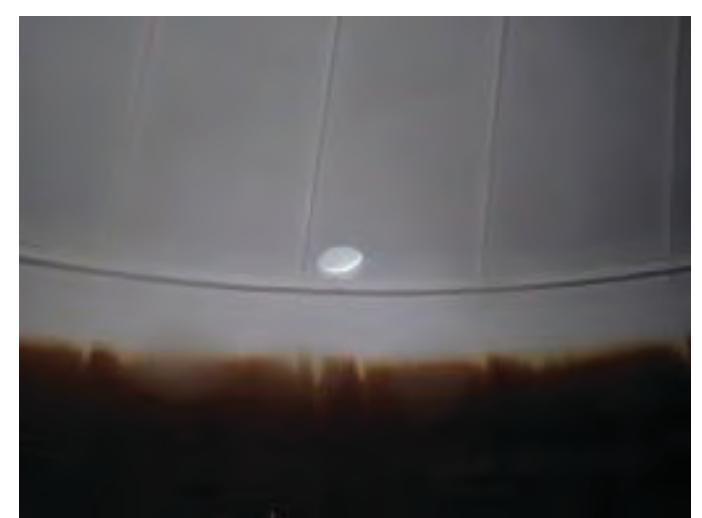
Overhead With Coating Loss, Mild Surface Corrosion 116 And Blotch Rusting

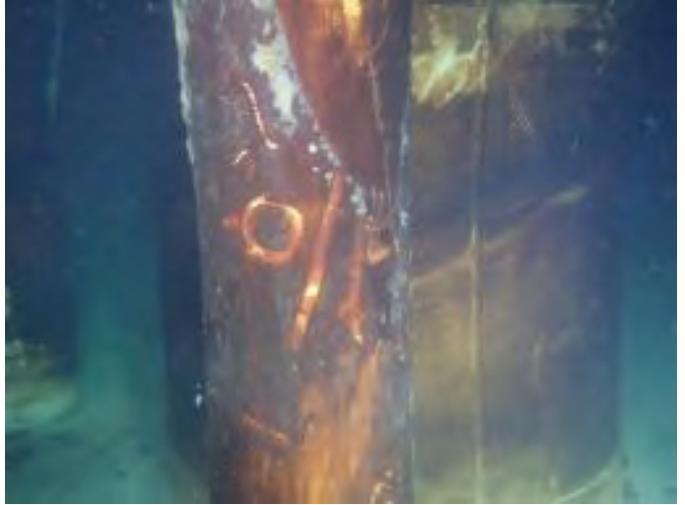
Overflow Pipe With Secondary Coating Loss And117Exposed Primary Coating

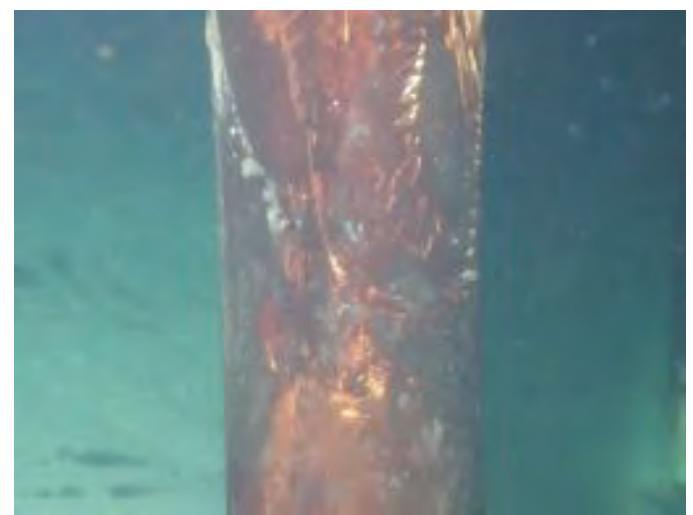
Overflow Pipe With Secondary Coating Loss And118Exposed Primary Coating
